NAMA Cycle 6

Final Report

Road Inventory and Condition Assessment of Paved Routes National Mall and Memorial Parks

Report Date: October 2019

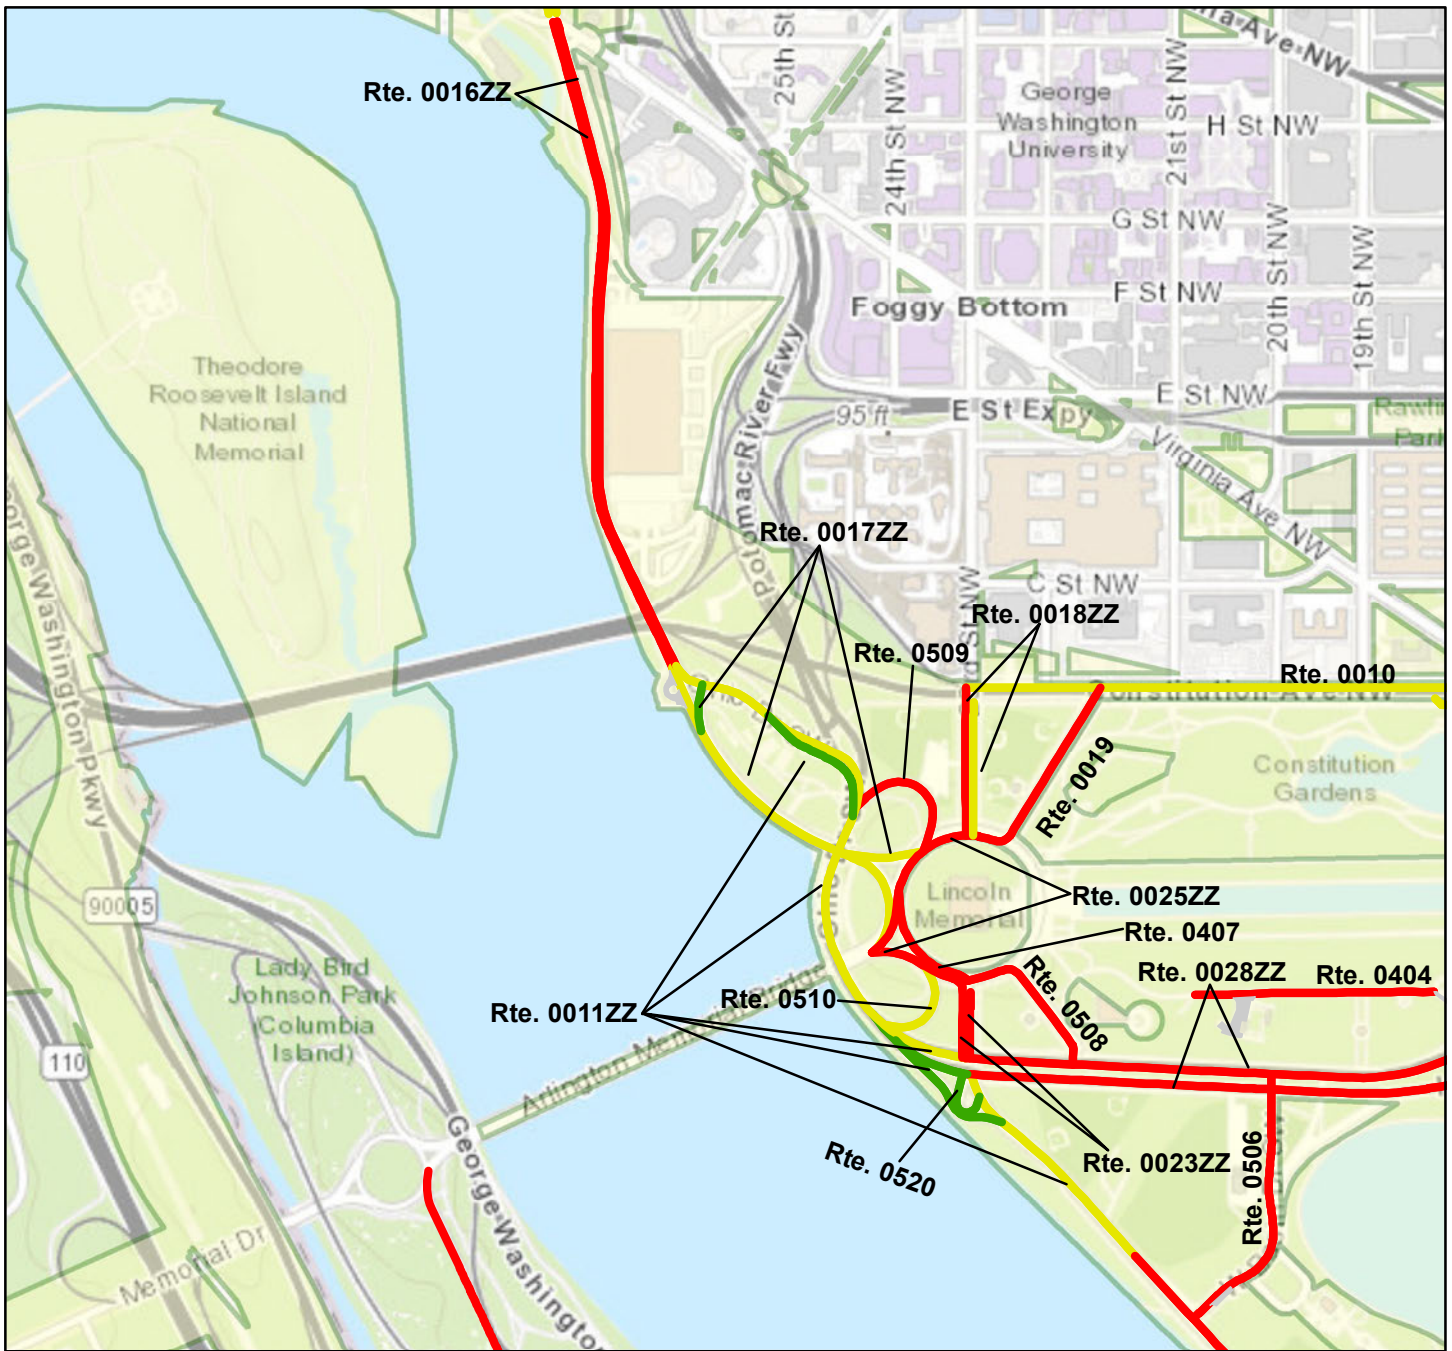
ROUTE CONDITION MAP

Colors on map represent condition scores at 1-mile intervals. See Appendix for definitions and formulas
 Only Data Collection Vehicle and Manually Rated Roads are displayed

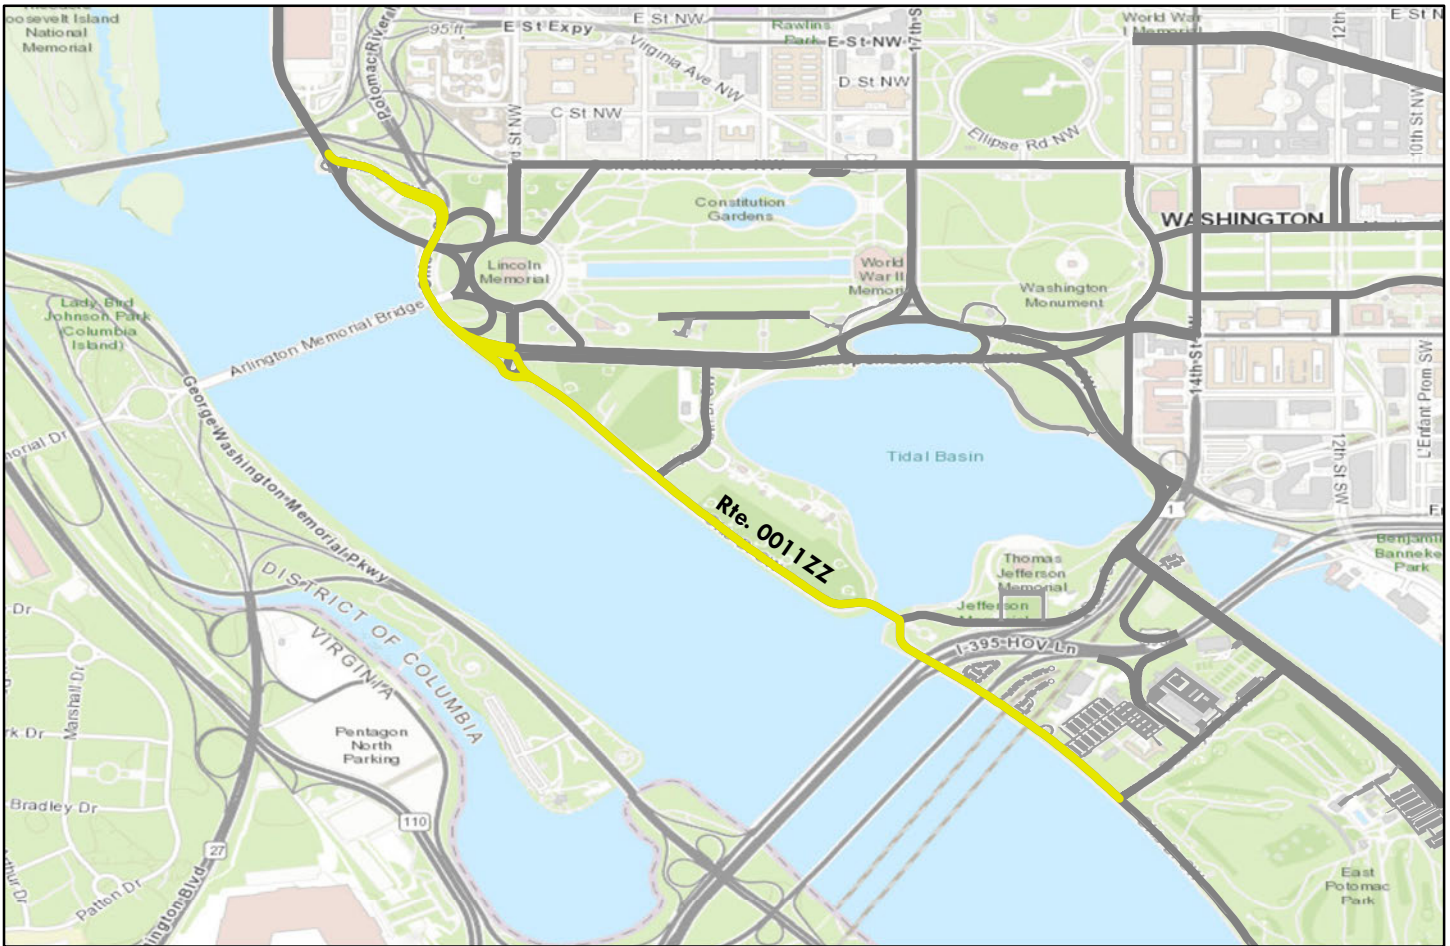
ROUTE 0011ZZ: OHIO DRIVE SW

Note: The weighted average summary PCR value is calculated from only the sections of road where the PCR was collected. The overall PCR for the summary route may not reflect individual subcomponent ratings.

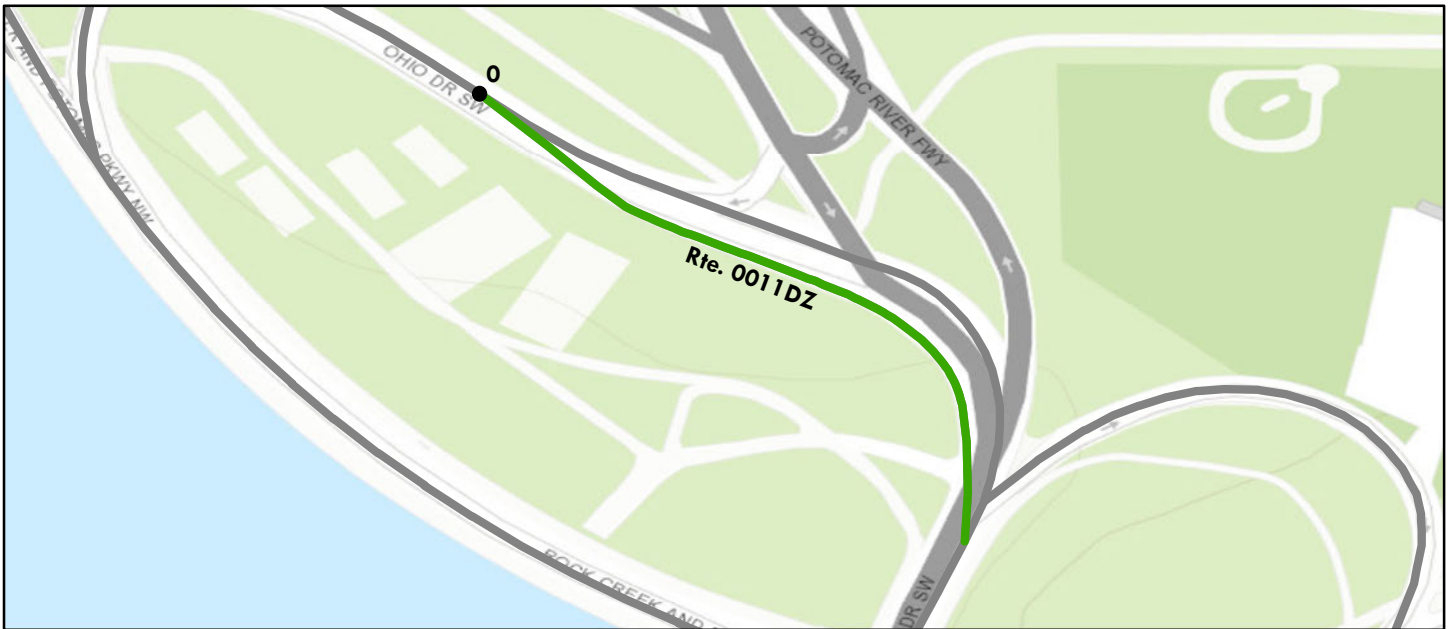
ROUTE 0011DZ: OHIO DRIVE SW (SB LANE SEPARATION AT POTOMAC RIVER FREEWAY)

Route Condition Legend – Pavement Condition Rating (PCR)						
Poor (0 - 60)	Fair (61- 84)	Good (85 - 94)	Excellent (95 - 100)	Not Rated		
Colors on map represent condition scores at 0.10-mile intervals. See Appendix for definitions and formulas.						
Inspection Date: 6/14/2018	Beginning Section MP	0				
Paved Length (Miles): 0.1	Section Length (MI)	0.1				
Surface Type: ASPHALT	Route Summary					
Roadway Condition Information						
Pavement Condition Rating (PCR)	89	89				
Surface Condition Rating (SCR)	89	89				
Roughness Condition Index (RCI)	N/A	N/A				
Distress Index Values						
Structural Crack Index	89	89				
Alligator Crack Index	100	100				
Longitudinal Crack Index	89	89				
Transverse Cracking Index	89	89				
Patching Index	99	99				
Rutting Index	98	98				
International Roughness Index (IRI)	N/A	N/A				
Lane & Width Information						
Number of Lanes	1	1				
Paved Width (ft)	13.8	13.8				
Lane Width (ft)	12.8	12.8

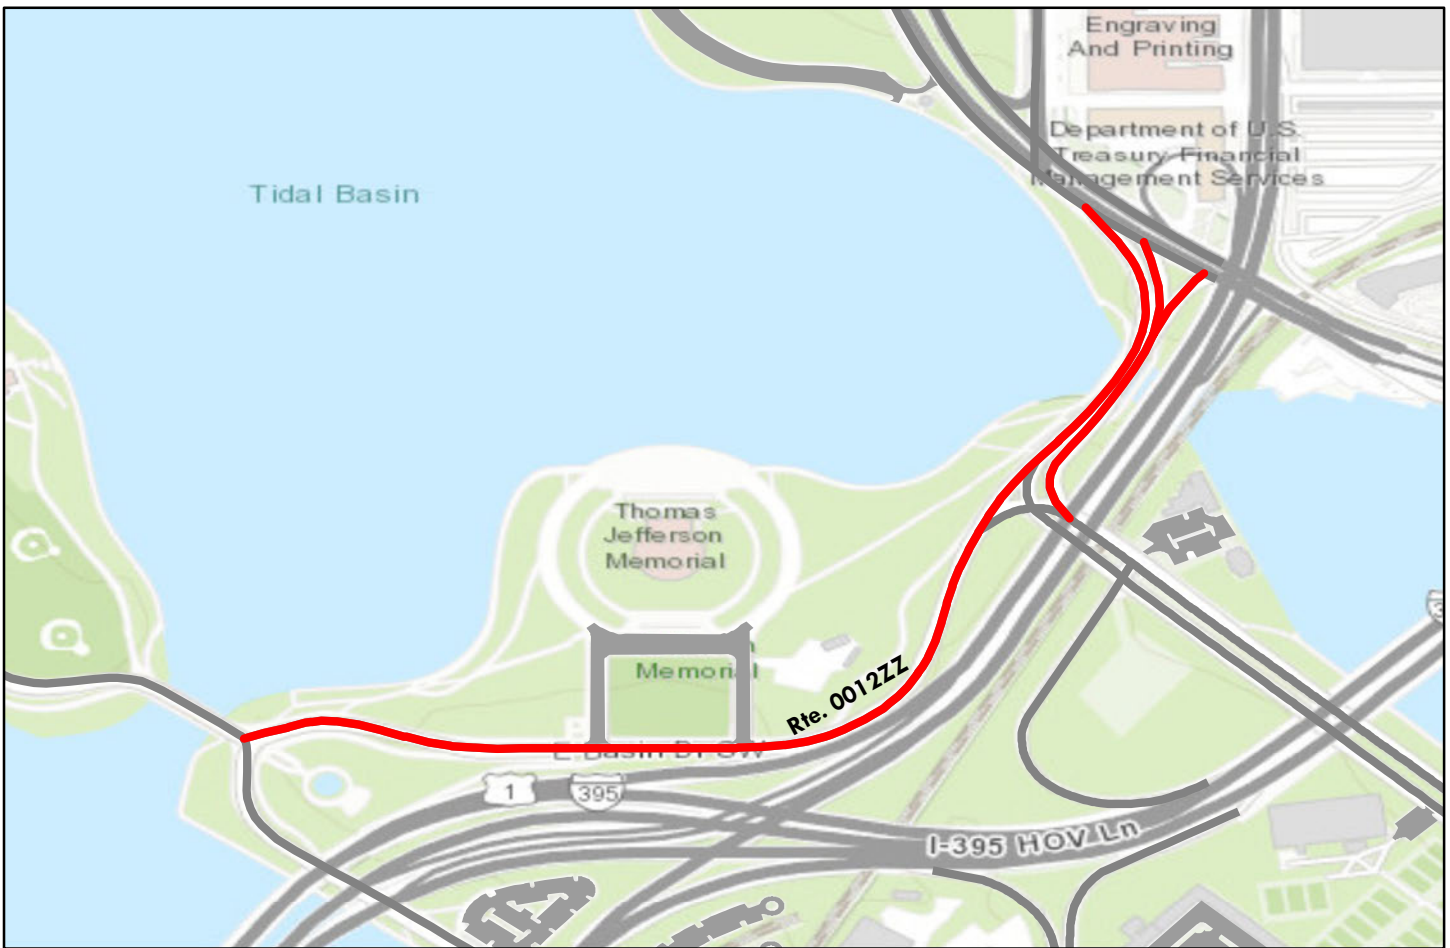
ROUTE 0012ZZ: EAST BASIN DRIVE SW

Note: The weighted average summary PCR value is calculated from only the sections of road where the PCR was collected. The overall PCR for the summary route may not reflect individual subcomponent ratings.

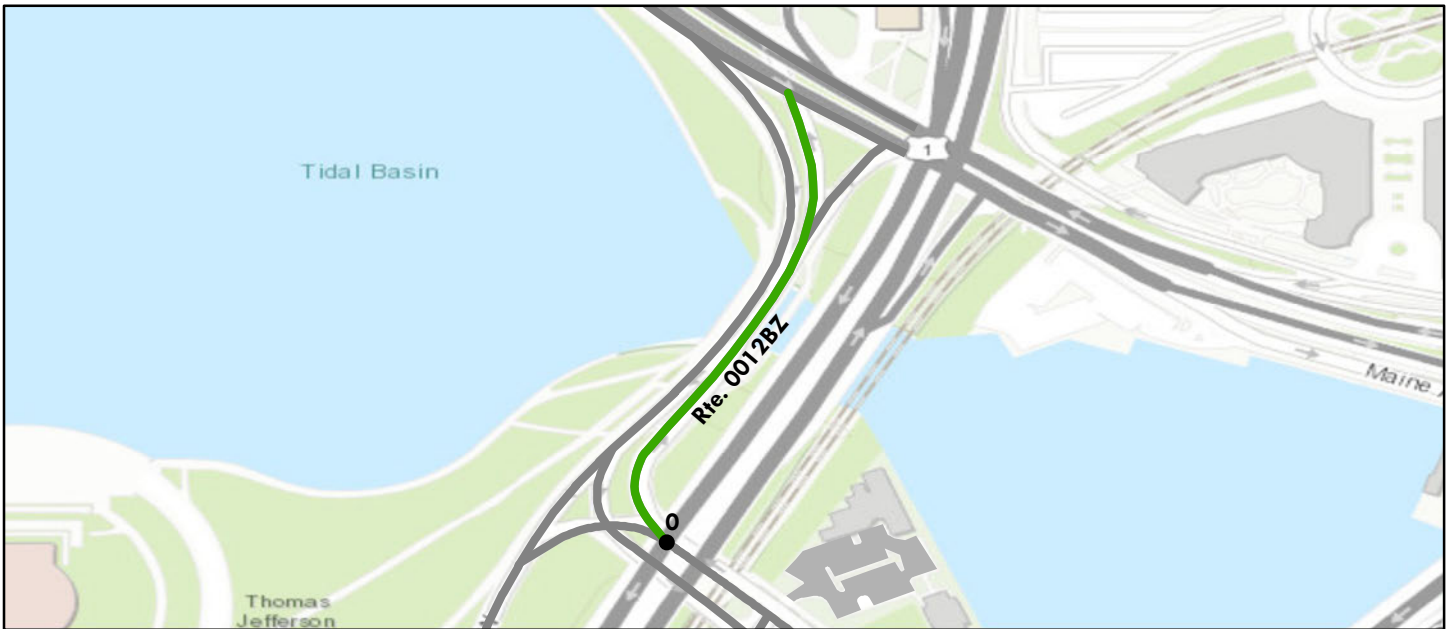
ROUTE 0012BZ: EAST BASIN DRIVE SW (EASTBOUND)

Route Condition Legend – Pavement Condition Rating (PCR)						
Poor (0 - 60)	Fair (61- 84)	Good (85 - 94)	Excellent (95 - 100)	Not Rated		
Colors on map represent condition scores at 0.10-mile intervals. See Appendix for definitions and formulas.						
Inspection Date: 6/14/2018	Beginning Section MP	0				
Paved Length (Miles): 0.16	Section Length (MI)	0.16				
Surface Type: ASPHALT	Route Summary					
Roadway Condition Information						
Pavement Condition Rating (PCR)	88	88				
Surface Condition Rating (SCR)	88	88				
Roughness Condition Index (RCI)	N/A	N/A				
Distress Index Values						
Structural Crack Index	89	89				
Alligator Crack Index	100	100				
Longitudinal Crack Index	89	89				
Transverse Cracking Index	88	88				
Patching Index	97	97				
Rutting Index	97	97				
International Roughness Index (IRI)	N/A	N/A				
Lane & Width Information						
Number of Lanes	2	2				
Paved Width (ft)	20.8	20.8				
Lane Width (ft)	10.4	10.4

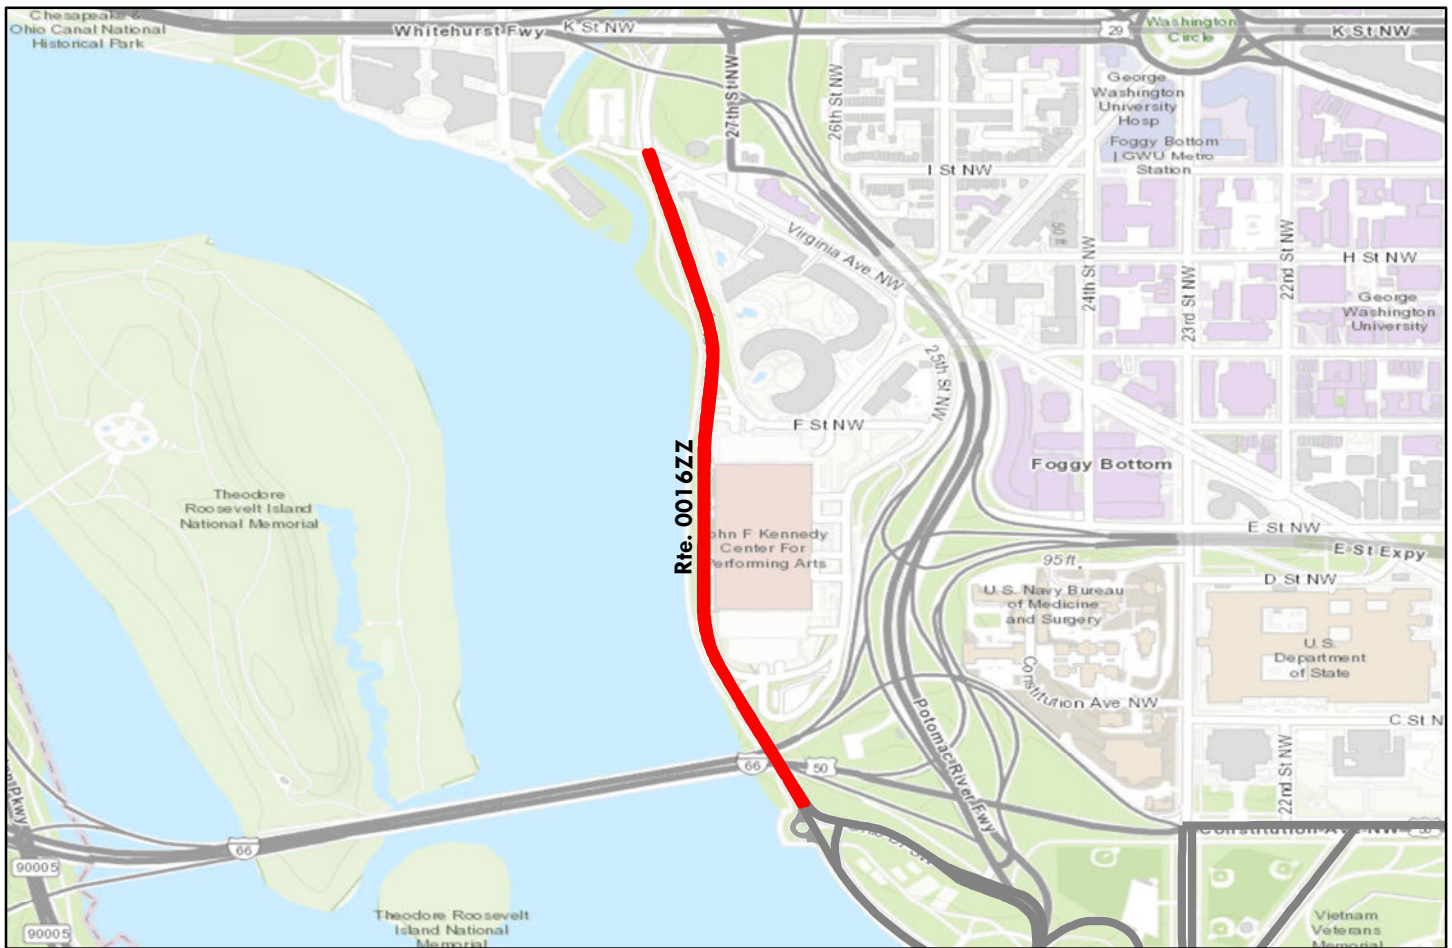
ROUTE 0016ZZ: ROCK CREEK AND POTOMAC PARKWAY

Note: The weighted average summary PCR value is calculated from only the sections of road where the PCR was collected. The overall PCR for the summary route may not reflect individual subcomponent ratings.

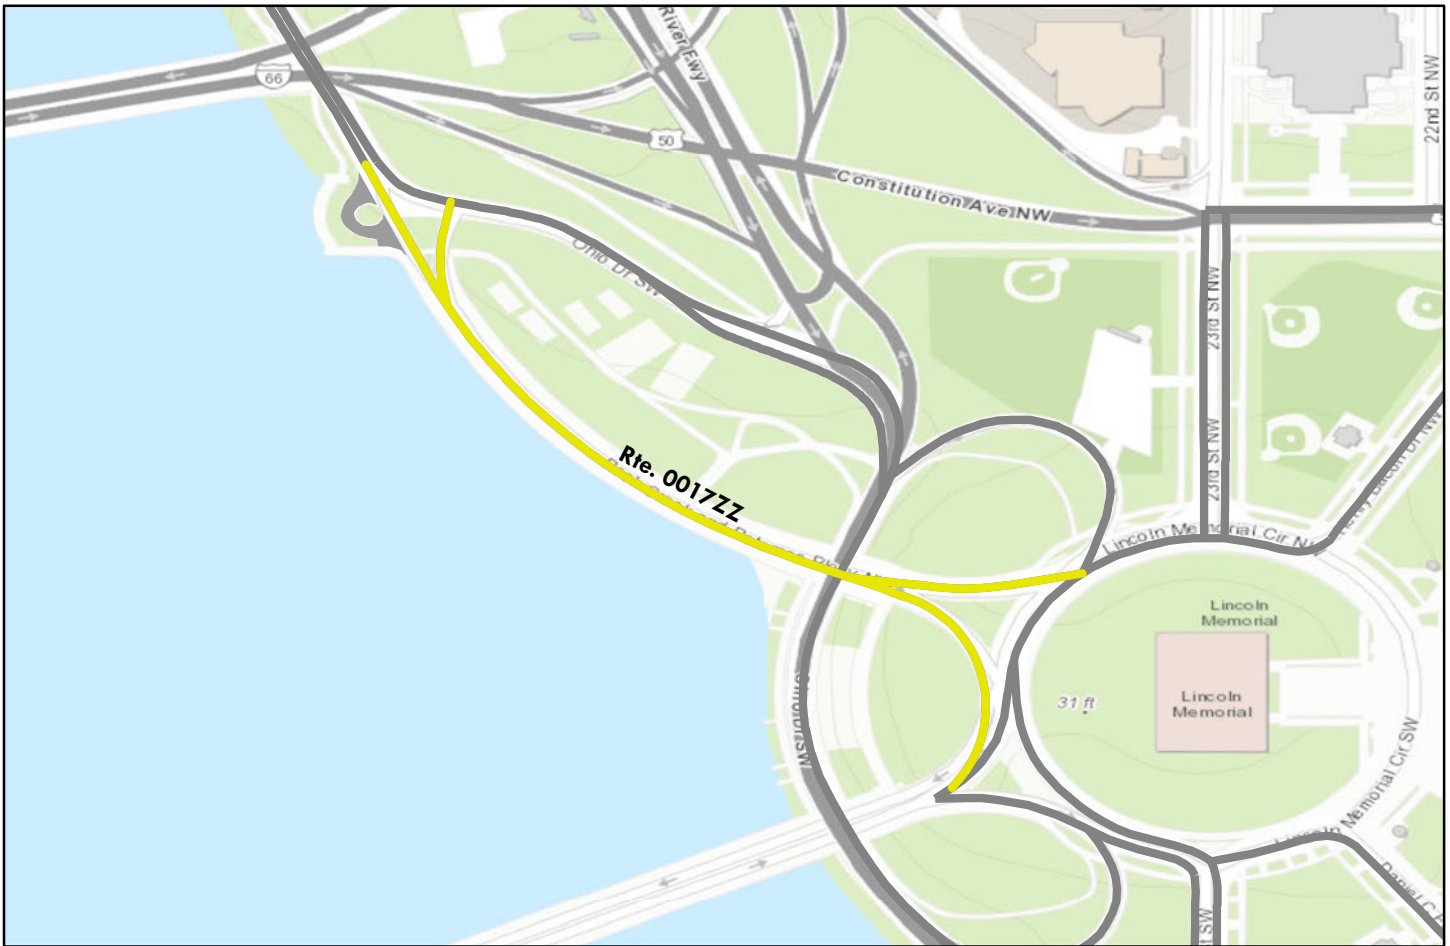
ROUTE 0017ZZ: PARKWAY DRIVE NW AND SPURS

Note: The weighted average summary PCR value is calculated from only the sections of road where the PCR was collected. The overall PCR for the summary route may not reflect individual subcomponent ratings.

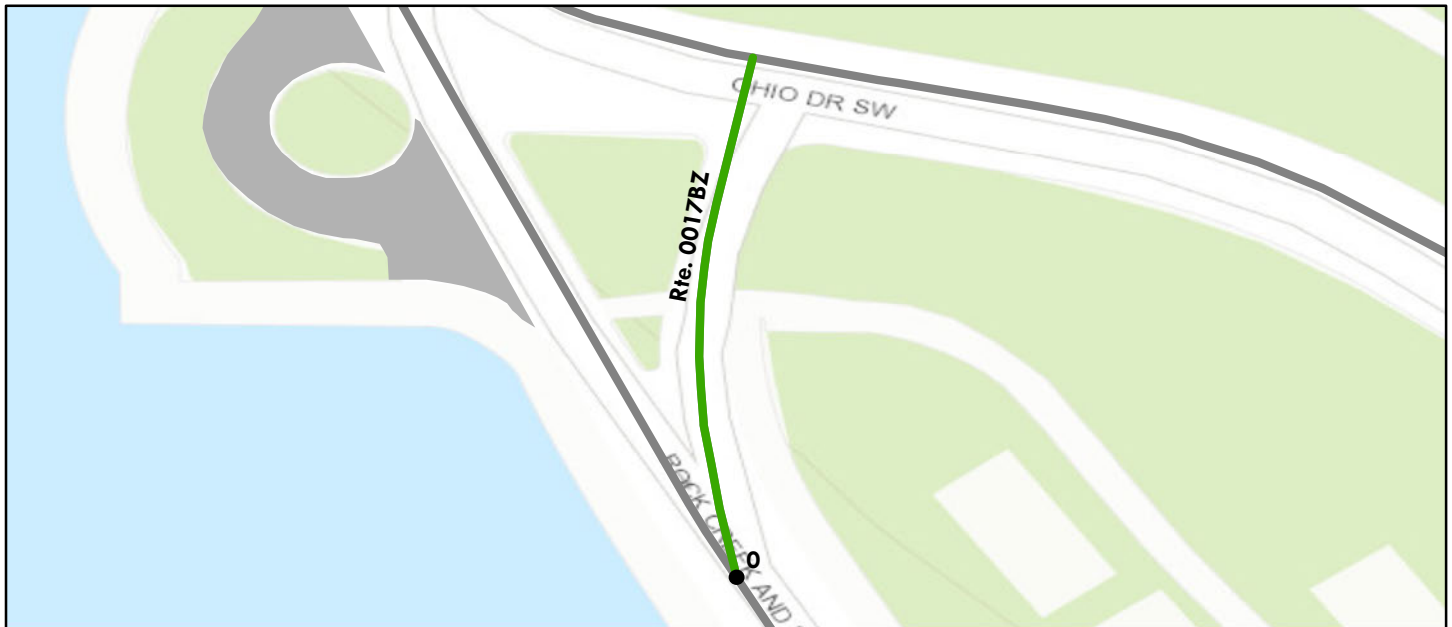
ROUTE 0017BZ: PARKWAY DRIVE RAMP TO OHIO DRIVE

Route Condition Legend – Pavement Condition Rating (PCR)						
Poor (0 - 60)	Fair (61- 84)	Good (85 - 94)	Excellent (95 - 100)	Not Rated		
Colors on map represent condition scores at 0.10-mile intervals. See Appendix for definitions and formulas.						
Inspection Date: 6/14/2018	Beginning Section MP	0				
Paved Length (Miles): 0.03	Section Length (MI)	0.03				
Surface Type: ASPHALT	Route Summary					
Roadway Condition Information						
Pavement Condition Rating (PCR)	89	89				
Surface Condition Rating (SCR)	89	89				
Roughness Condition Index (RCI)	N/A	N/A				
Distress Index Values						
Structural Crack Index	100	100				
Alligator Crack Index	100	100				
Longitudinal Crack Index	100	100				
Transverse Cracking Index	98	98				
Patching Index	100	100				
Rutting Index	89	89				
International Roughness Index (IRI)	N/A	N/A				
Lane & Width Information						
Number of Lanes	1	1				
Paved Width (ft)	16.2	16.2

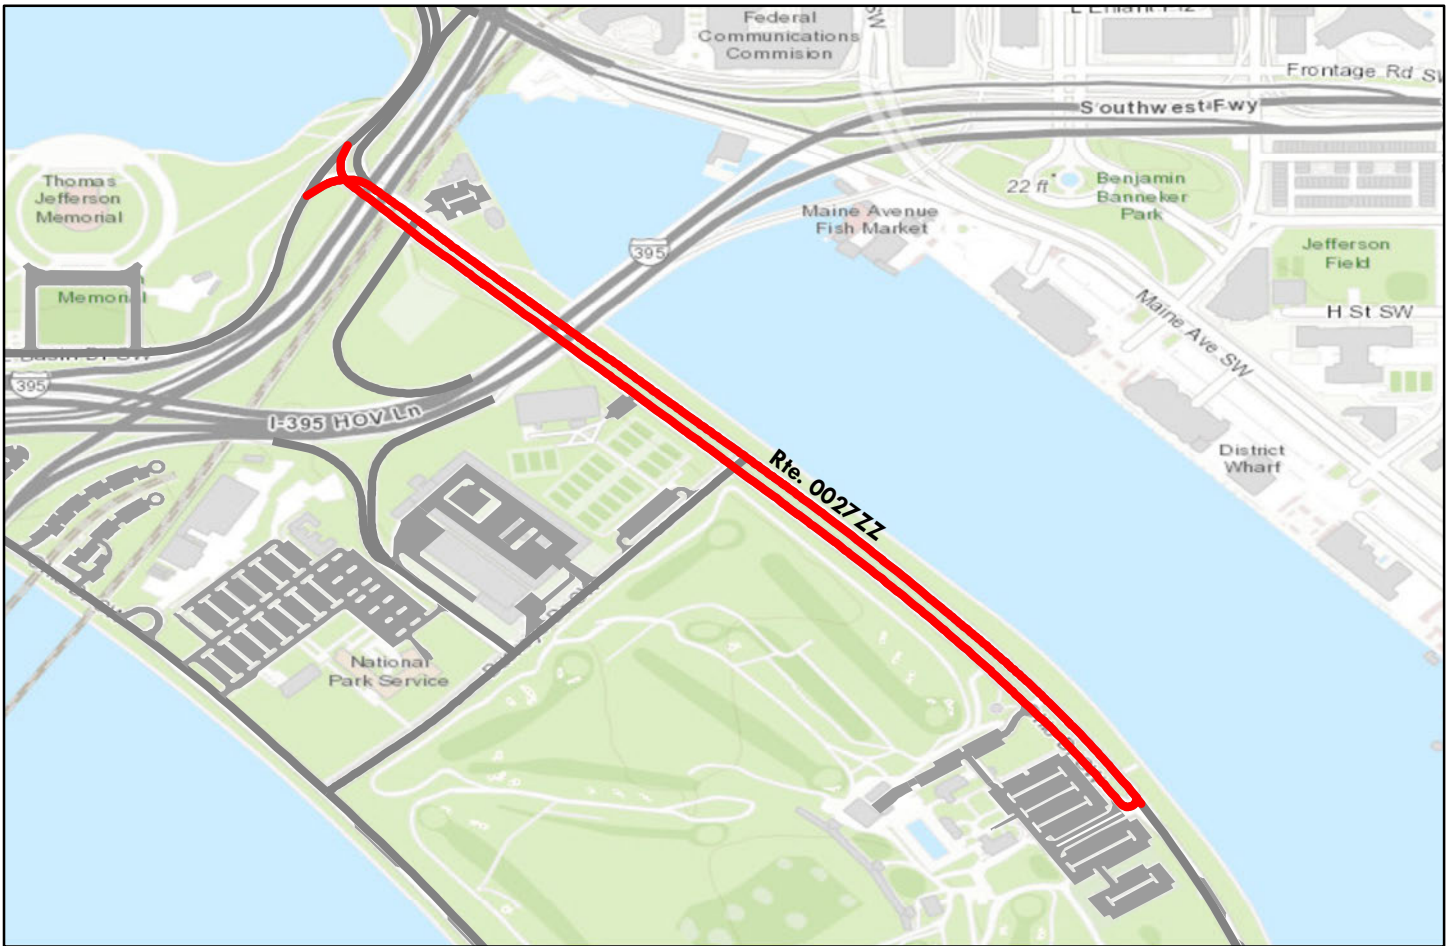
ROUTE 0027ZZ: OHIO DRIVE SW / HAINS POINT ACCESS EXIT ROAD

Note: The weighted average summary PCR value is calculated from only the sections of road where the PCR was collected. The overall PCR for the summary route may not reflect individual subcomponent ratings.

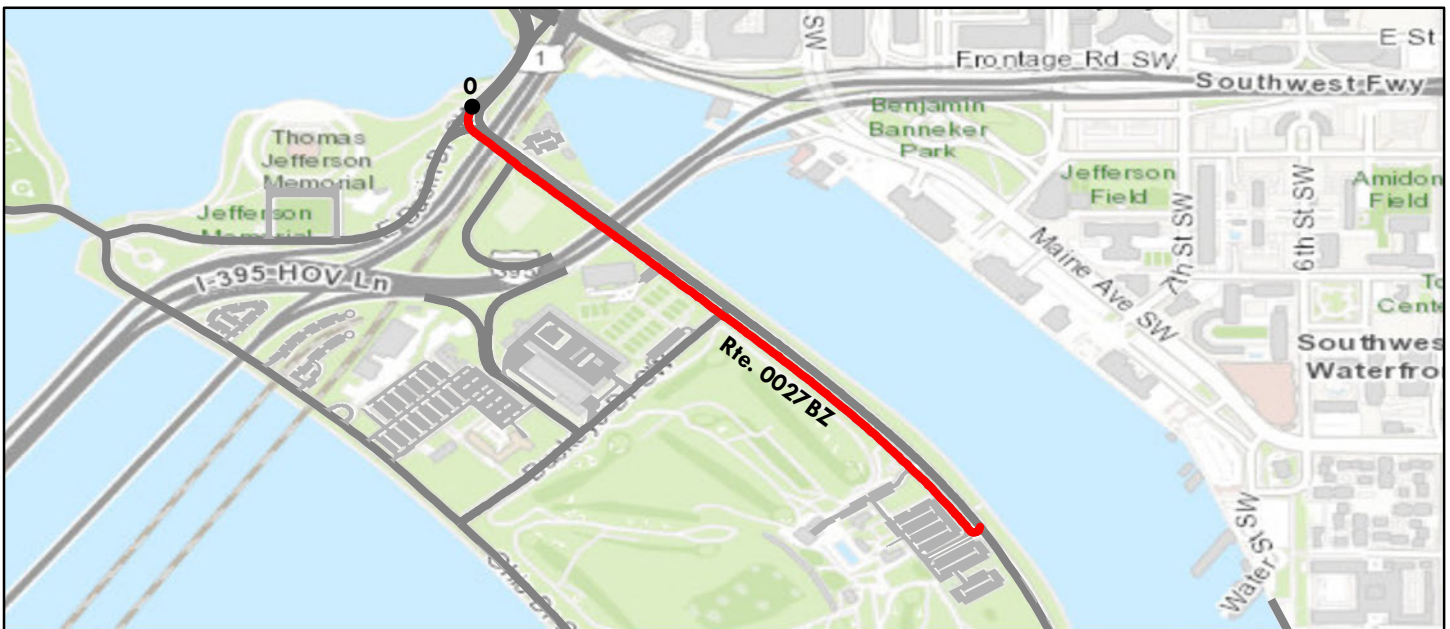
Subcomponent of Route NAMA-0027ZZ

Inspection Date:	6/14/2018	Beginning Section MP	0				
Paved Length (Miles):	0.68	Section Length (MI)	0.68				
Surface Type:	ASPHALT	Route Summary					
Roadway Condition Information							
Pavement Condition Rating (PCR)	26	26					
Surface Condition Rating (SCR)	0	0					
Roughness Condition Index (RCI)	65	65					
Distress Index Values							
Structural Crack Index	0	0					
Alligator Crack Index	97	97					
Longitudinal Crack Index	0	0					
Transverse Cracking Index	0	0					
Patching Index	99	99					
Rutting Index	99	99					
International Roughness Index (IRI)	219	219					
Lane & Width Information							
Number of Lanes	1	1					
Paved Width (ft)	20.5	20.5					
Lane Width (ft)	16.5	16.5

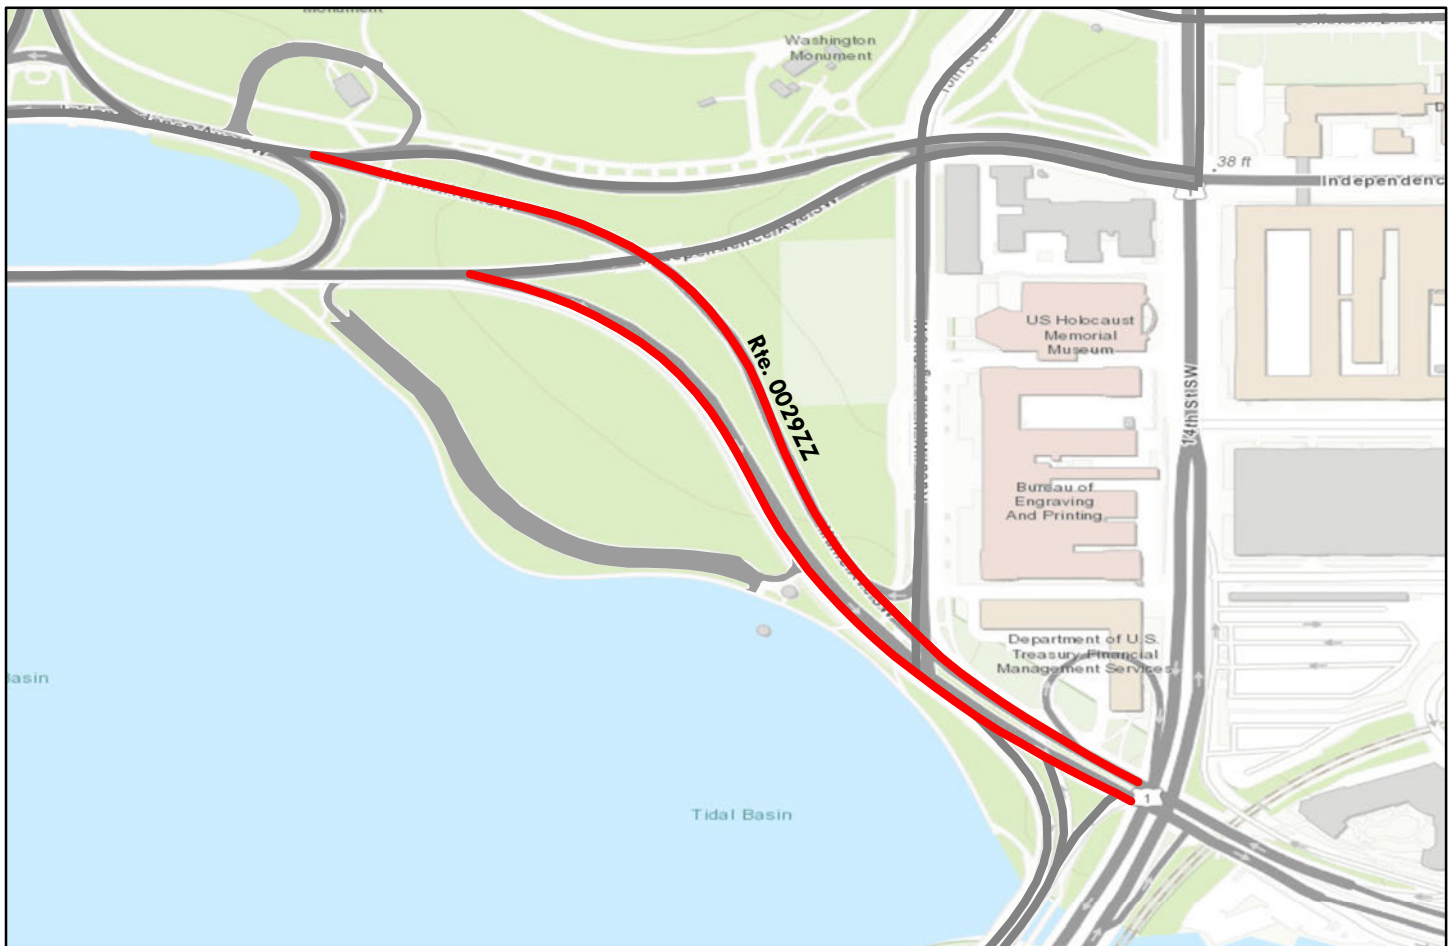
ROUTE 0029ZZ: MAINE AVENUE SW

Route Condition Legend – Pavement Condition Rating (PCR)						
Poor (0 - 60)	Fair (61- 84)	Good (85 - 94)	Excellent (95 - 100)	Not Rated		
See Appendix for definitions and formulas						
Inspection Date:	6/14/2018					
Paved Length (Miles):	0.77					
Surface Type:	ASPHALT	Route Summary				
Roadway Condition Information						
Pavement Condition Rating (PCR)	21					
Lane & Width Information						
Number of Lanes	1					
Paved Width (ft)	26.8					
Lane Width (ft)	10.6

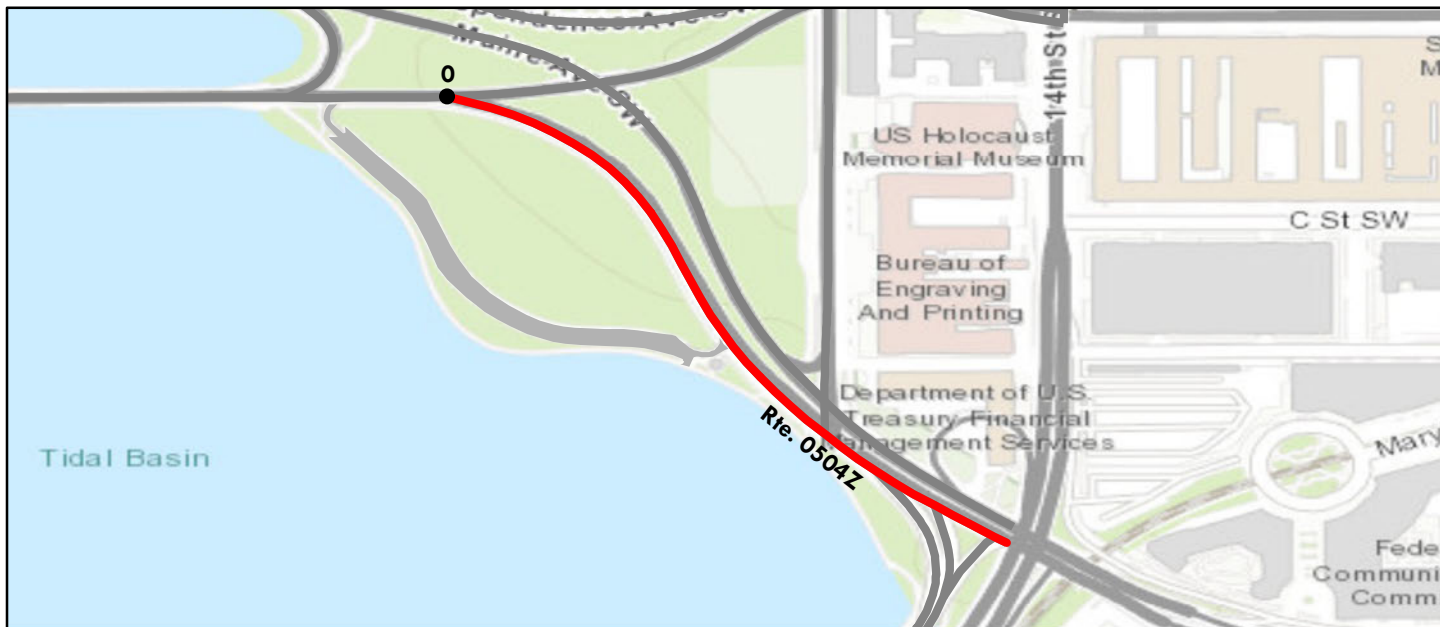
Subcomponent of Route NAMA-0029ZZ

Inspection Date: 6/14/2018	Beginning Section MP	0				
Paved Length (Miles): 0.35	Section Length (MI)	0.35				
Surface Type: ASPHALT	Route Summary					
Roadway Condition Information						
Pavement Condition Rating (PCR)	4	4				
Surface Condition Rating (SCR)	4	4				
Roughness Condition Index (RCI)	N/A	N/A				
Distress Index Values						
Structural Crack Index	4	4				
Alligator Crack Index	96	96				
Longitudinal Crack Index	8	8				
Transverse Cracking Index	23	23				
Patching Index	99	99				
Rutting Index	99	99				
International Roughness Index (IRI)	N/A	N/A				
Lane & Width Information						
Number of Lanes	3	3				
Paved Width (ft)	27.6	27.6				
Lane Width (ft)	9.9	9.9

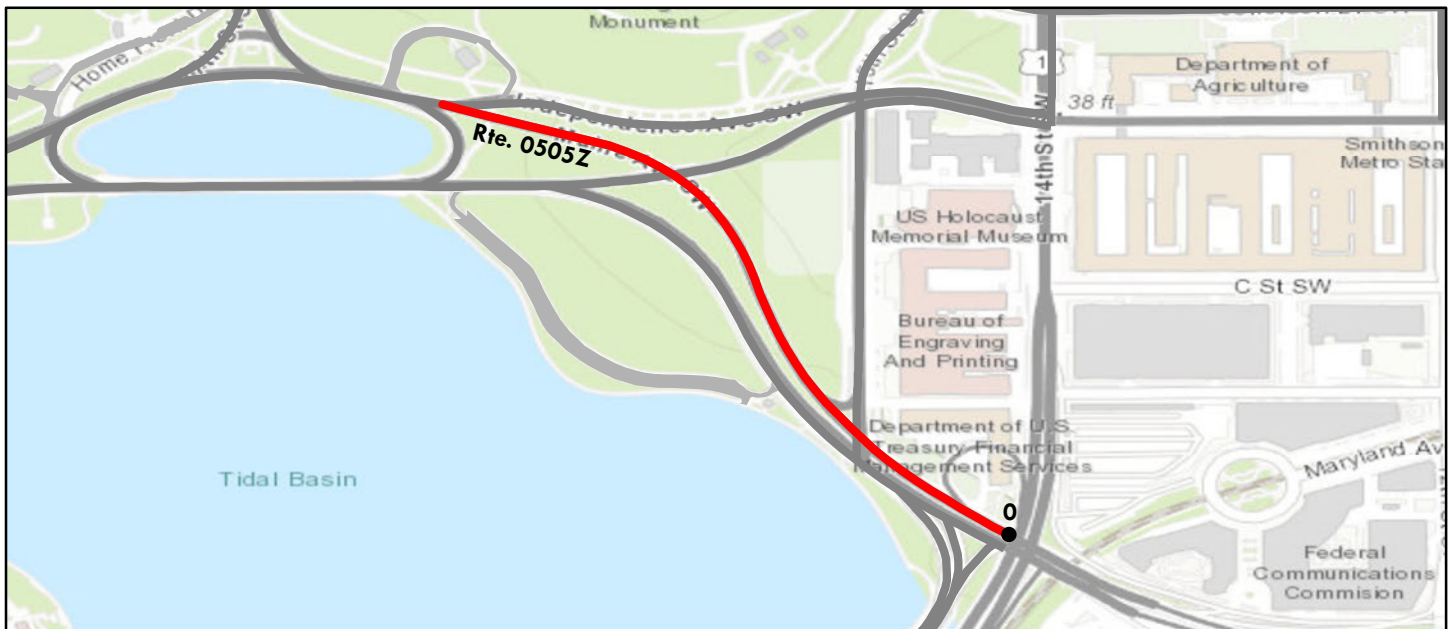
Subcomponent of Route NAMA-0029ZZ

Inspection Date:	6/14/2018	Beginning Section MP	0				
Paved Length (Miles):	0.42	Section Length (MI)	0.42				
Surface Type:	ASPHALT	Route Summary					
Roadway Condition Information							
Pavement Condition Rating (PCR)		36	36				
Surface Condition Rating (SCR)		36	36				
Roughness Condition Index (RCI)		N/A	N/A				
Distress Index Values							
Structural Crack Index		42	42				
Alligator Crack Index		100	100				
Longitudinal Crack Index		42	42				
Transverse Cracking Index		36	36				
Patching Index		99	99				
Rutting Index		96	96				
International Roughness Index (IRI)		N/A	N/A				
Lane & Width Information							
Number of Lanes		2	2				
Paved Width (ft)		26.1	26.1				
Lane Width (ft)		11.2	11.2

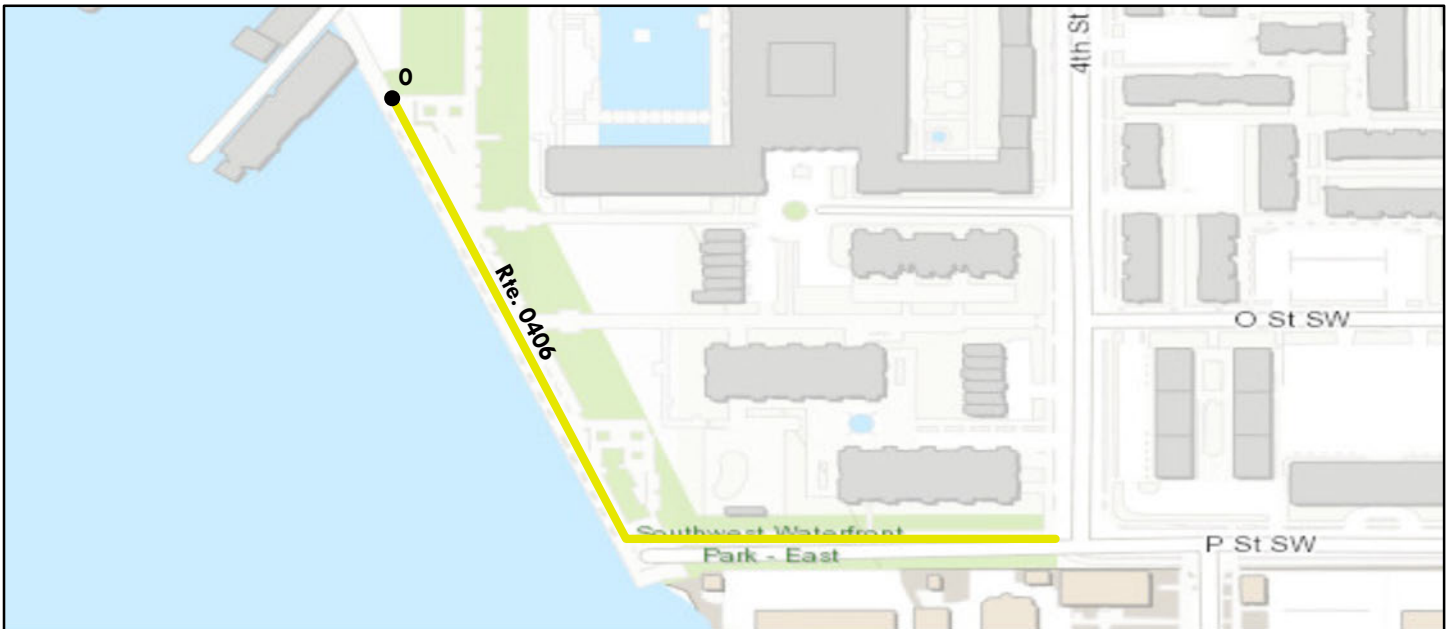
ROUTE 0406: TITANIC MEMORIAL SERVICE ROAD

Inspection Date: 2/21/2018	Beginning Section MP	0.00				
Paved Length (Miles): 0.23	Section Length (MI)	0.23				
Surface Type: CONCRETE	Route Summary					
Roadway Condition Information						
Pavement Condition Rating (PCR)	73	73				
Surface Condition Rating (SCR)	73	73				
Roughness Condition Index (RCI)	N/A	N/A				
Distress Index Values						
Structural Crack Index	N/A	N/A				
Alligator Crack Index	N/A	N/A				
Longitudinal Crack Index	N/A	N/A				
Transverse Cracking Index	N/A	N/A				
Patching Index	N/A	N/A				
Rutting Index	N/A	N/A				
International Roughness Index (IRI)	N/A	N/A				
Lane & Width Information						
Number of Lanes	1	1				
Paved Width (ft)	17.3	17.3				
Lane Width (ft)	17.3	17.3

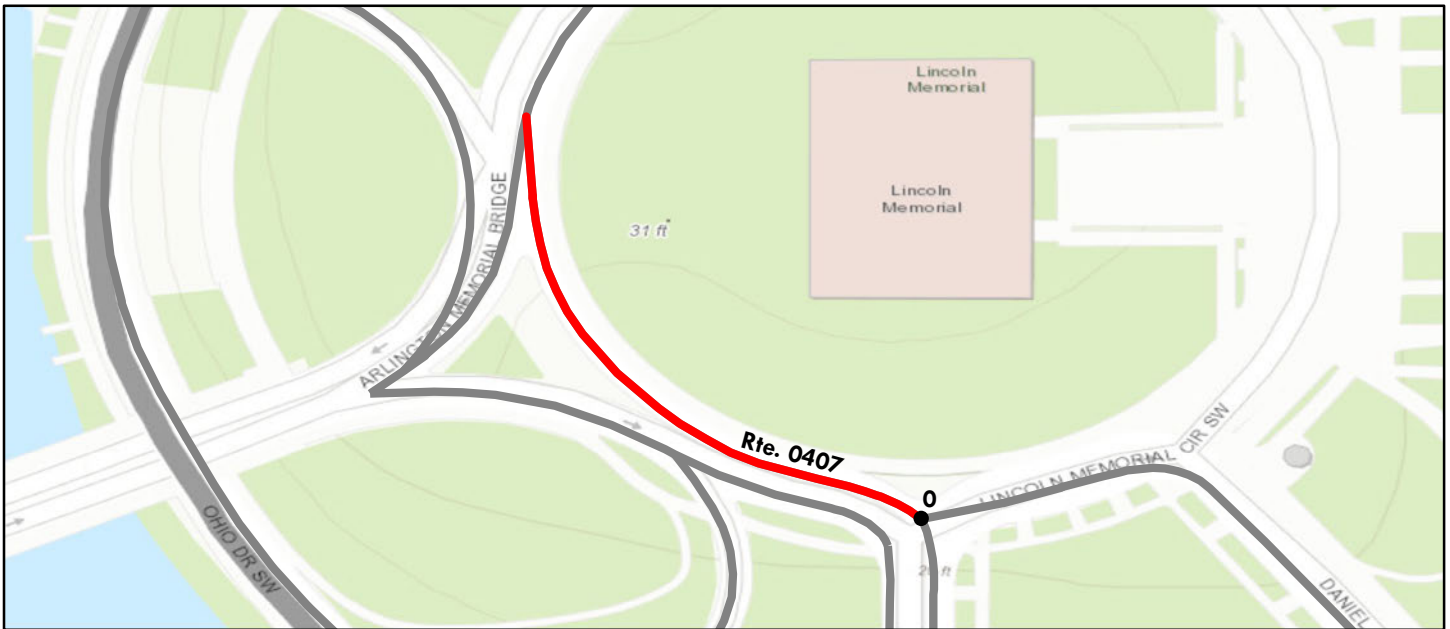
ROUTE 0407: LINCOLN MEMORIAL CIRCLE TOUR BUS ACCESS

Route Condition Legend – Pavement Condition Rating (PCR)						
Poor (0 - 60)	Fair (61- 84)	Good (85 - 94)	Excellent (95 - 100)	Not Rated		
Colors on map represent condition scores at 0.10-mile intervals. See Appendix for definitions and formulas.						
Inspection Date: 6/14/2018	Beginning Section MP	0				
Paved Length (Miles): 0.11	Section Length (MI)	0.11				
Surface Type: ASPHALT	Route Summary					
Roadway Condition Information						
Pavement Condition Rating (PCR)	55	55				
Surface Condition Rating (SCR)	55	55				
Roughness Condition Index (RCI)	N/A	N/A				
Distress Index Values						
Structural Crack Index	65	65				
Alligator Crack Index	100	100				
Longitudinal Crack Index	65	65				
Transverse Cracking Index	55	55				
Patching Index	100	100				
Rutting Index	99	99				
International Roughness Index (IRI)	N/A	N/A				
Lane & Width Information						
Number of Lanes	1	1				
Paved Width (ft)	19.9	19.9				
Lane Width (ft)	19.9	19.9

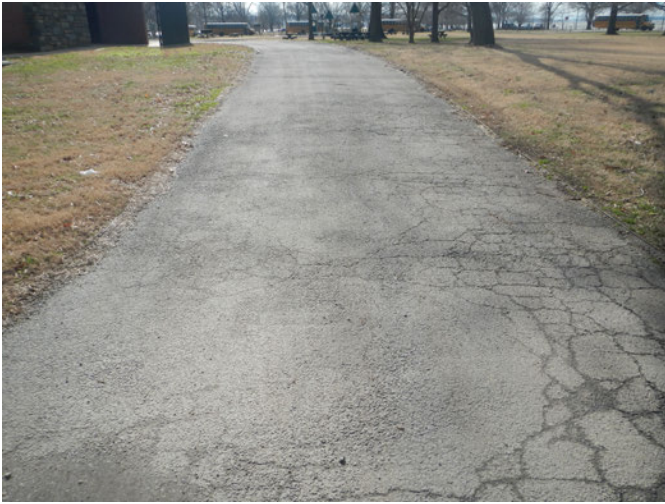
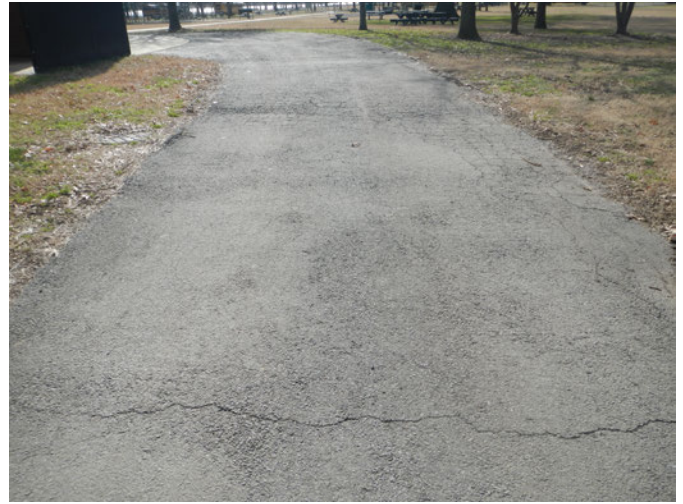
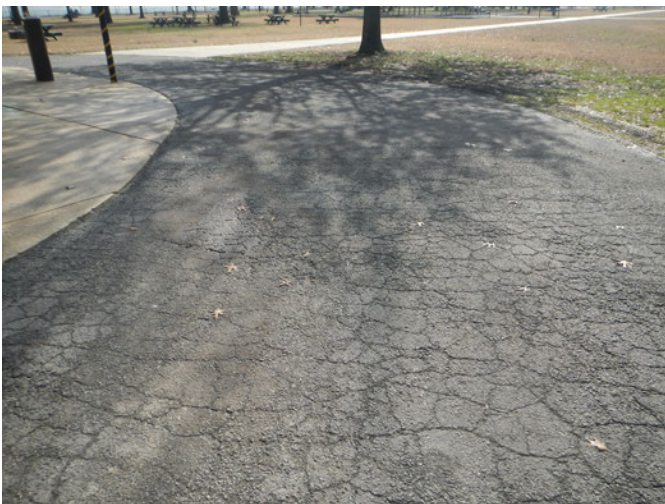
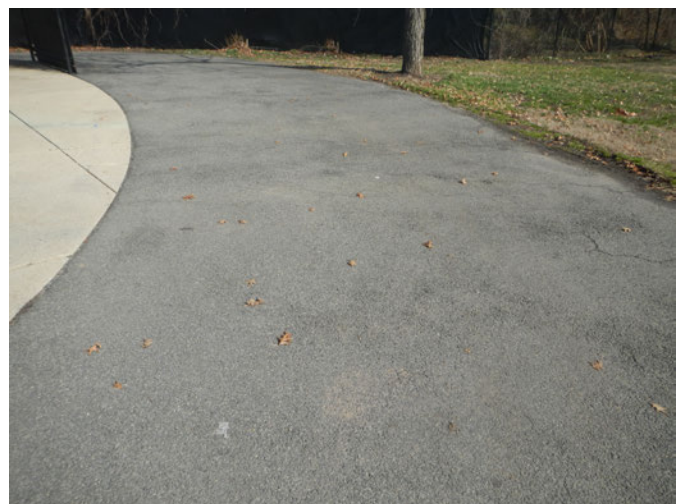
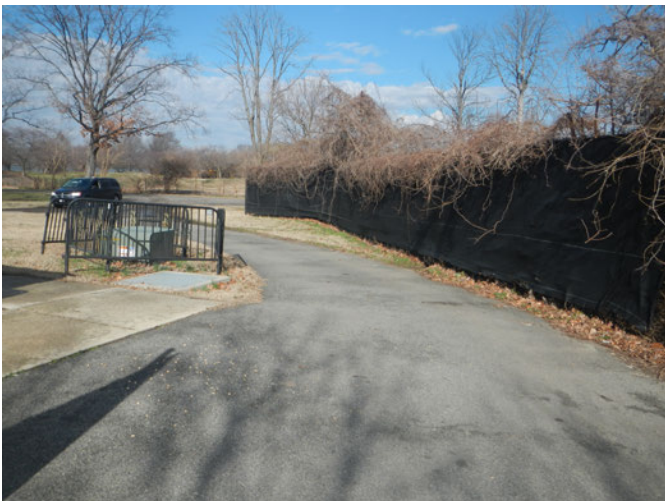
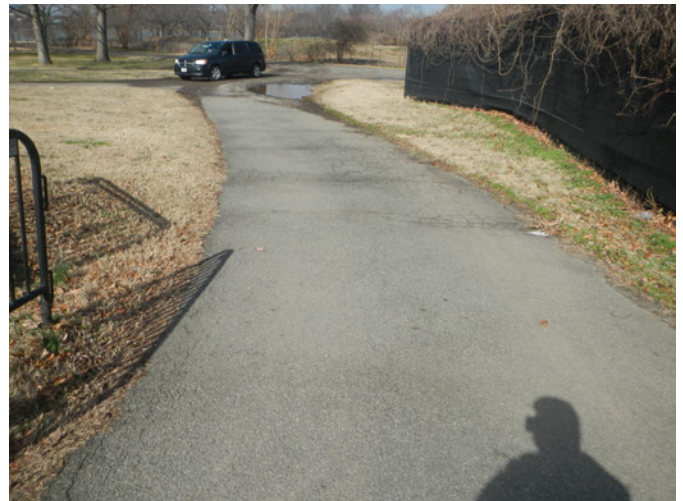
Condition Photos

Inspection Date: 2/21/2018	Beginning Section MP	0.00				
Paved Length (Miles): 0.07	Section Length (MI)	0.07				
Surface Type: ASPHALT	Route Summary					
Roadway Condition Information						
Pavement Condition Rating (PCR)	53	53				
Surface Condition Rating (SCR)	53	53				
Roughness Condition Index (RCI)	N/A	N/A				
Distress Index Values						
Structural Crack Index	N/A	N/A				
Alligator Crack Index	53	53				
Longitudinal Crack Index	90	90				
Transverse Cracking Index	73	73				
Patching Index	73	73				
Rutting Index	73	73				
International Roughness Index (IRI)	N/A	N/A				
Lane & Width Information						
Number of Lanes	1	1				
Paved Width (ft)	15	15				
Lane Width (ft)	15	15

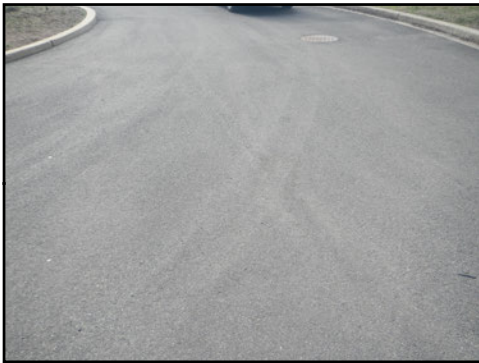
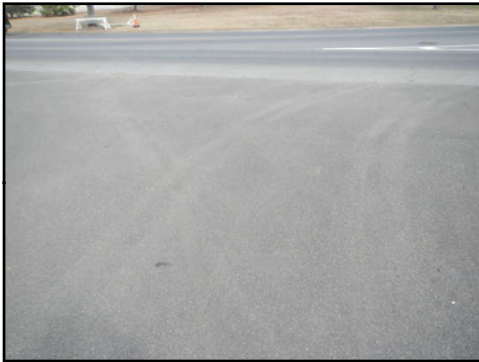
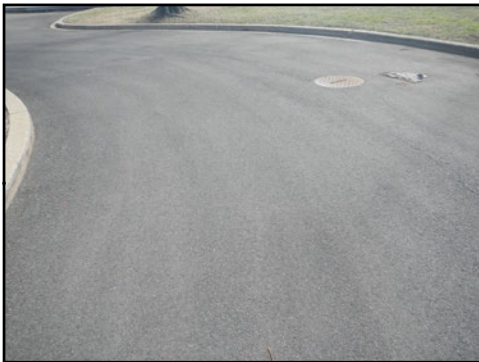
Inspection Date	FMSS Number	User Access	Surface Type
2/21/2018	104041	PUBLIC	ASPHALT
Area (Sq. Ft.)	Lane Miles (11' Widths)	Pavement Recommendation	
5,711	0.098	PREVENTIVE MAINTENANCE	
Condition Rating / PCR			
GOOD / 90			
Route Condition Legend – Pavement Condition Rating (PCR)			
Poor (0 - 60)	Fair (61- 84)	Good (85 - 94)	Excellent (95 - 100)
See Appendix for definitions and formulas
