NAMA Cycle 6

Final Report

Road Inventory and Condition Assessment of Paved Routes National Mall and Memorial Parks

Report Date: October 2019

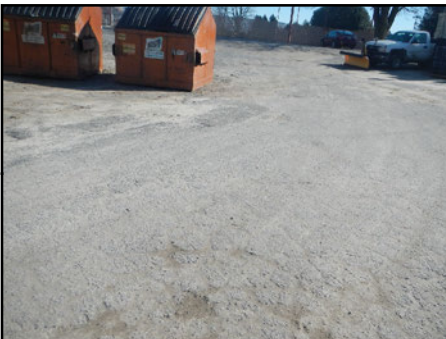
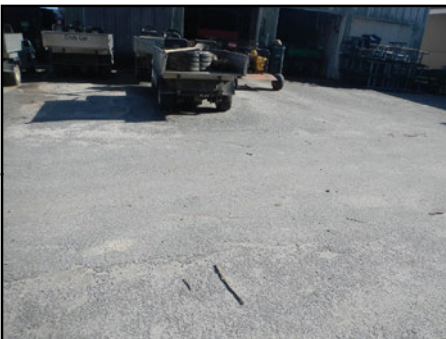
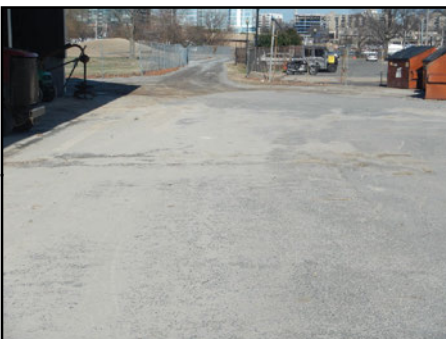
ROUTE 0910: GOLF COURSE PARKING

Inspection Date	FMSS Number	User Access	Surface Type
2/20/2018	49868	PUBLIC	ASPHALT
Area (Sq. Ft.)	Lane Miles (11' Widths)	Curb Reveal (Inches)	Curb Recommendation
136,284	2.346	6	DO NOTHING
Curb Type		Curb & Gutter Type	
CONCRETE		NO CURB AND GUTTER	
Pavement Recommendation		Condition Rating / PCR	
PREVENTIVE MAINTENANCE		GOOD / 90

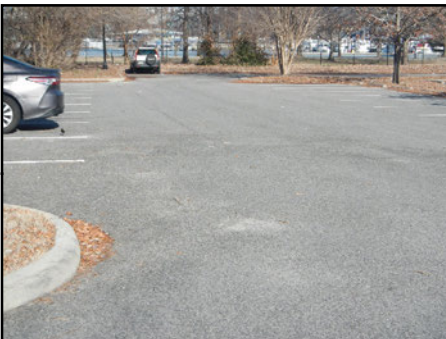
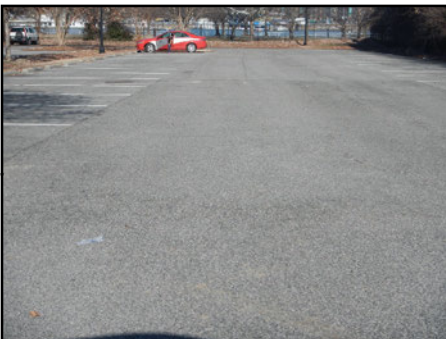
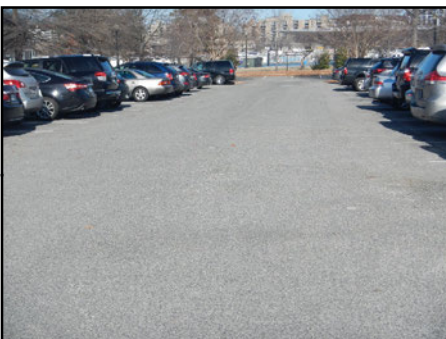
ROUTE 0939A: EAST POTOMAC PARK MAINTENANCE YARD

Inspection Date	FMSS Number	User Access	Surface Type
2/20/2018	40935	NONPUBLIC	ASPHALT
Area (Sq. Ft.)	Lane Miles (11' Widths)	Curb Reveal (Inches)	Curb Recommendation
81,138	1.397	NOT APPLICABLE	DO NOTHING
Curb Type		Curb & Gutter Type	
NO CURB		CONCRETE	
Pavement Recommendation		Condition Rating / PCR	
PREVENTIVE MAINTENANCE		GOOD / 90

Note: Parking area consists of multiple surface types: 1 part Asphalt at 77,550 square feet; 1 part Concrete at 3,588 square feet.

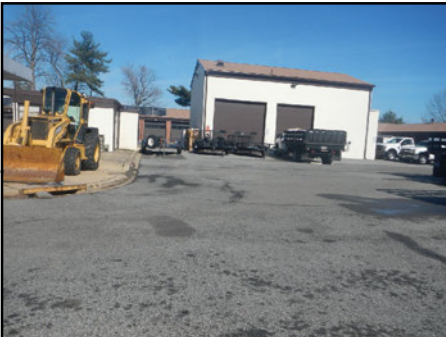
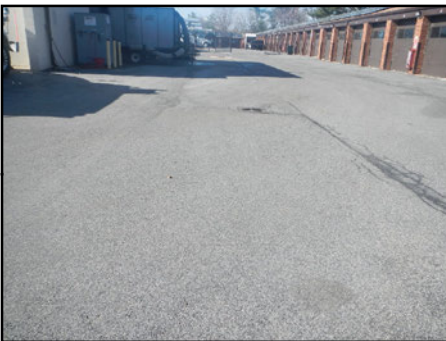
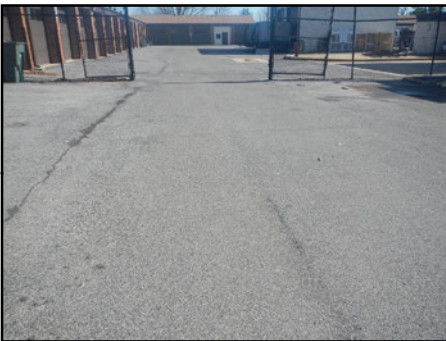
ROUTE 0939BZZ: EAST POTOMAC PARK TOURMOBILE PARKING

Inspection Date	FMSS Number	User Access	Surface Type
2/20/2018	49927	NONPUBLIC	ASPHALT
Area (Sq. Ft.)	Lane Miles (11' Widths)	Condition Rating / PCR	
37,009	0.637	SUMMARY / 67	
Route Condition Legend – Pavement Condition Rating (PCR)			
Poor (0 - 60)	Fair (61- 84)	Good (85 - 94)	Excellent (95 - 100) Not Rated
See Appendix for definitions and formulas

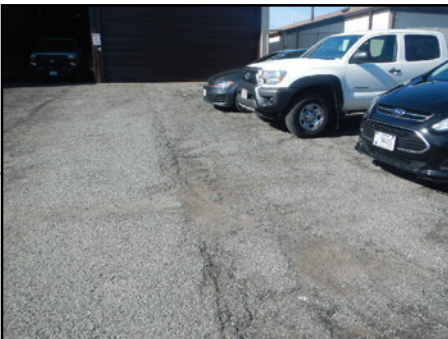
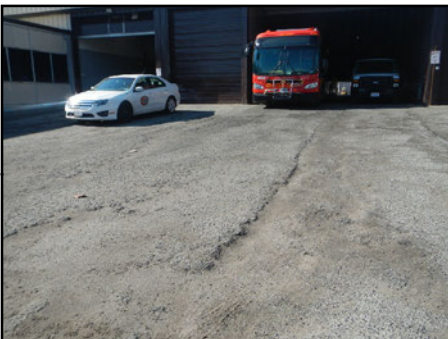
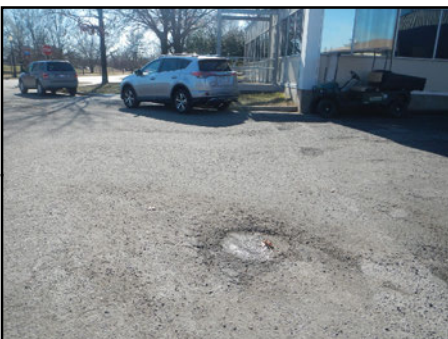
ROUTE 0939BBZ: EAST POTOMAC PARK TOURMOBILE PARKING - BACK

Inspection Date	FMSS Number	User Access	Surface Type
2/20/2018	49927	NONPUBLIC	ASPHALT
Area (Sq. Ft.)	Lane Miles (11' Widths)	Curb Reveal (Inches)	Curb Recommendation
26,127	0.45	NOT APPLICABLE	LIGHT REPAIR
Curb Type		Curb & Gutter Type	
NO CURB		CONCRETE	
Pavement Recommendation		Condition Rating / PCR	
LIGHT 3R TREATMENTS		FAIR / 73

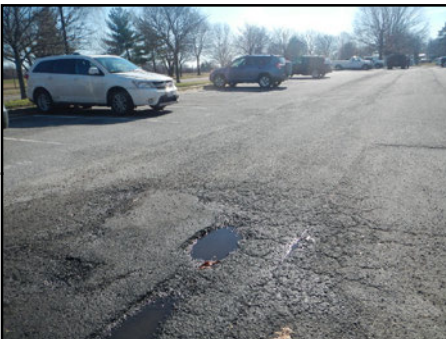
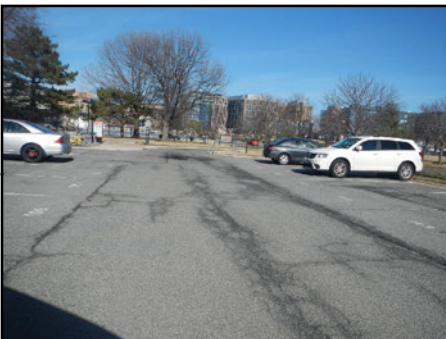
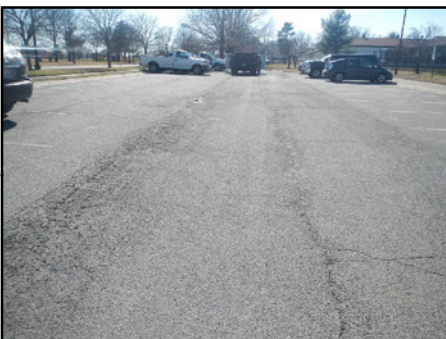
ROUTE 0941: NATIONAL CAPITOL REGION HEADQUARTERS PARKING

Inspection Date	FMSS Number	User Access	Surface Type
2/20/2018	49931	PUBLIC	ASPHALT
Area (Sq. Ft.)	Lane Miles (11' Widths)	Curb Reveal (Inches)	Curb Recommendation
181,489	3.125	NOT APPLICABLE	LIGHT REPAIR
Curb Type		Curb & Gutter Type	
NO CURB		CONCRETE	
Pavement Recommendation		Condition Rating / PCR	
LIGHT 3R TREATMENTS		FAIR / 73

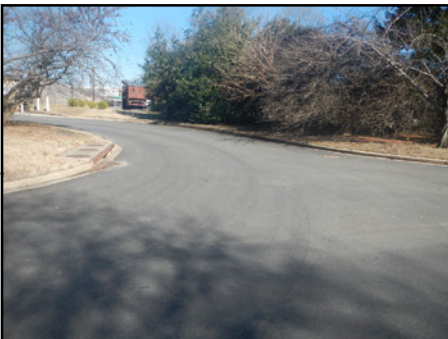
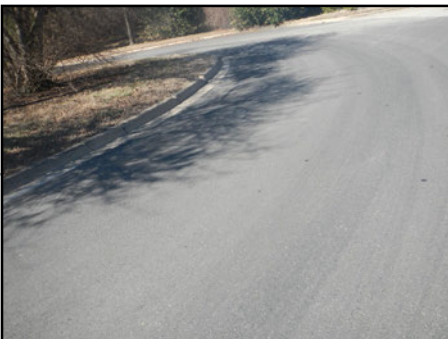
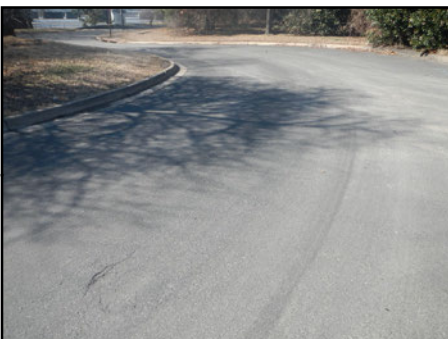
ROUTE 0943: EAST POTOMAC PARK PARKING C

Inspection Date	FMSS Number	User Access	Surface Type
2/20/2018	49934	PUBLIC	ASPHALT
Area (Sq. Ft.)	Lane Miles (11' Widths)	Curb Reveal (Inches)	Curb Recommendation
25,522	0.439	NOT APPLICABLE	DO NOTHING
Curb Type		Curb & Gutter Type	
NO CURB		CONCRETE	
Pavement Recommendation		Condition Rating / PCR	
PREVENTIVE MAINTENANCE		GOOD / 90

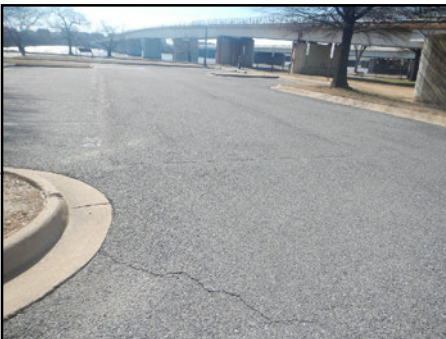
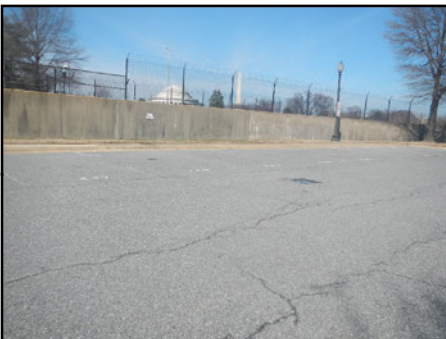
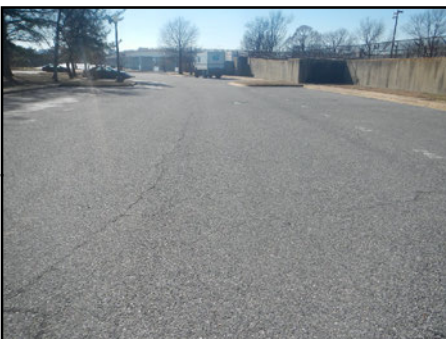
ROUTE 0944: EAST POTOMAC PARK PARKING B

Inspection Date	FMSS Number	User Access	Surface Type
2/20/2018	49935	PUBLIC	ASPHALT
Area (Sq. Ft.)	Lane Miles (11' Widths)	Curb Reveal (Inches)	Curb Recommendation
25,963	0.447	NOT APPLICABLE	DO NOTHING
Curb Type		Curb & Gutter Type	
NO CURB		CONCRETE	
Pavement Recommendation		Condition Rating / PCR	
PREVENTIVE MAINTENANCE		GOOD / 90

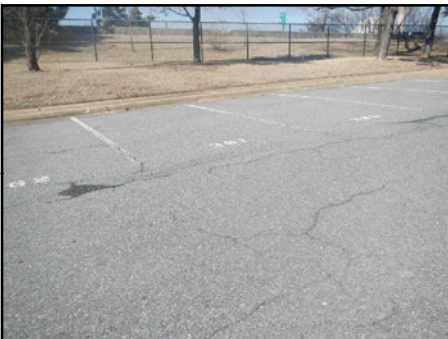
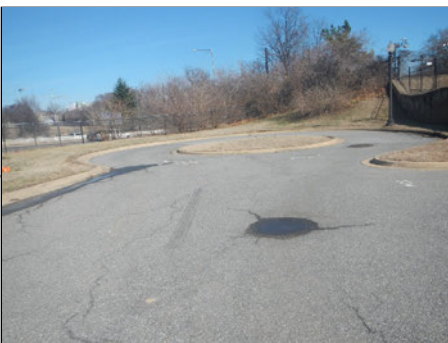
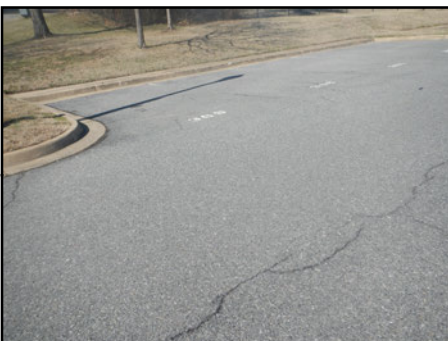
ROUTE 0945: EAST POTOMAC PARK PARKING A

Inspection Date	FMSS Number	User Access	Surface Type
2/20/2018	49937	PUBLIC	ASPHALT
Area (Sq. Ft.)	Lane Miles (11' Widths)	Curb Reveal (Inches)	Curb Recommendation
34,120	0.587	NOT APPLICABLE	LIGHT REPAIR
Curb Type		Curb & Gutter Type	
NO CURB		CONCRETE	
Pavement Recommendation		Condition Rating / PCR	
PREVENTIVE MAINTENANCE		GOOD / 90

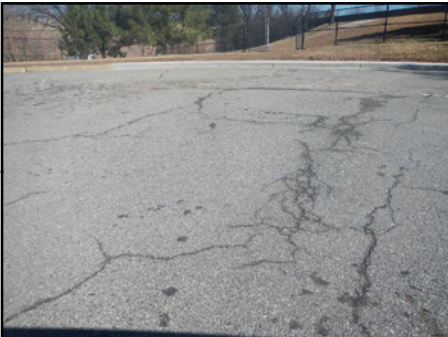
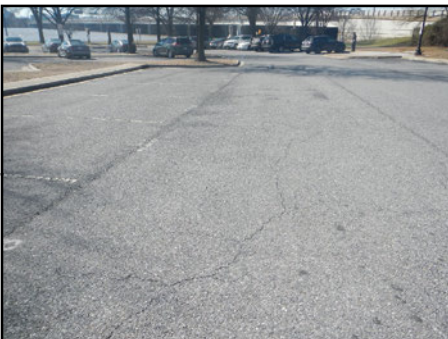
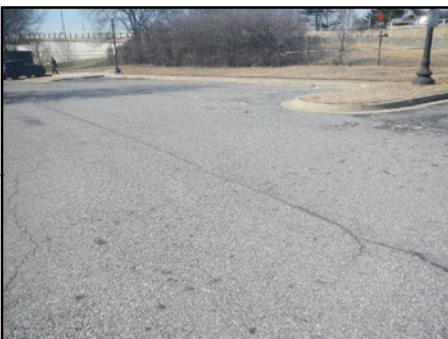
ROUTE 0946: FDR MEMORIAL HANDICAPPED PARKING

Inspection Date	FMSS Number	User Access	Surface Type
2/20/2018	N/A	PUBLIC	ASPHALT
Area (Sq. Ft.)	Lane Miles (11' Widths)	Curb Reveal (Inches)	Curb Recommendation
2,476	0.043	5	DO NOTHING
Curb Type		Curb & Gutter Type	
STONE		NO CURB AND GUTTER	
Pavement Recommendation		Condition Rating / PCR	
PREVENTIVE MAINTENANCE		GOOD / 90

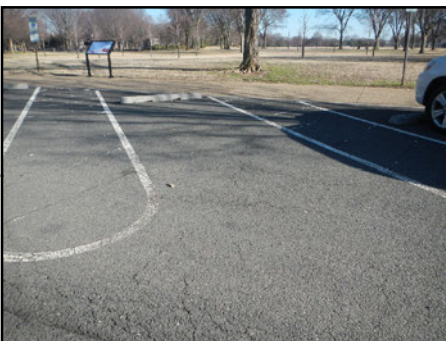
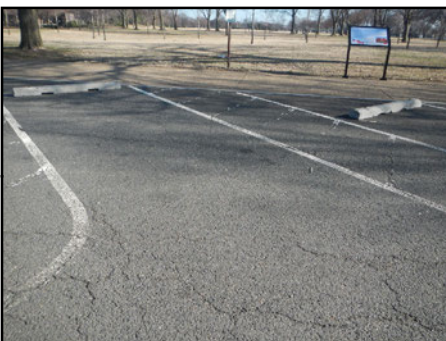
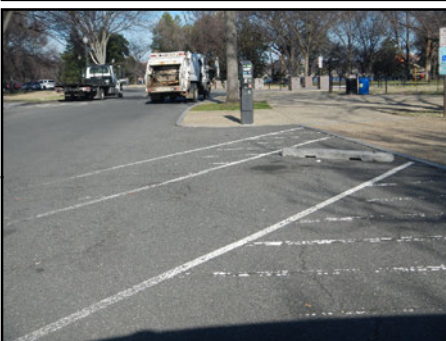
ROUTE 0957: WORLD WAR II / HOMEFRONT DRIVE HANDICAPPED PARKING

Inspection Date	FMSS Number	User Access	Surface Type
2/20/2018	89577	PUBLIC	ASPHALT
Area (Sq. Ft.)	Lane Miles (11' Widths)	Curb Reveal (Inches)	Curb Recommendation
25,963	0.447	6	DO NOTHING
Curb Type		Curb & Gutter Type	
STONE		NO CURB AND GUTTER	
Pavement Recommendation		Condition Rating / PCR	
PREVENTIVE MAINTENANCE		GOOD / 90

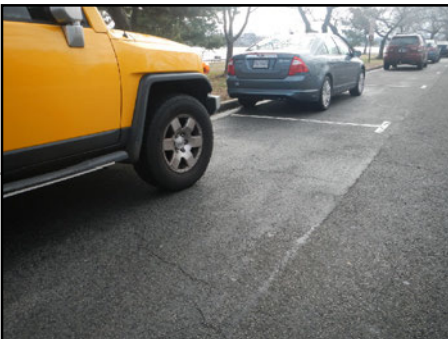
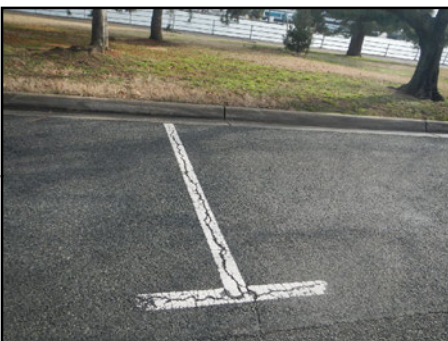
ROUTE 0912Z: HAINS POINT PARKING #2

Inspection Date	FMSS Number	User Access	Surface Type
2/21/2018	49871	PUBLIC	ASPHALT
Area (Sq. Ft.)	Lane Miles (11' Widths)	Curb Reveal (Inches)	Curb Recommendation
2,708	0.047	NOT APPLICABLE	DO NOTHING
Curb Type		Curb & Gutter Type	
NO CURB		CONCRETE	
Pavement Recommendation		Condition Rating / PCR	
PREVENTIVE MAINTENANCE		GOOD / 90

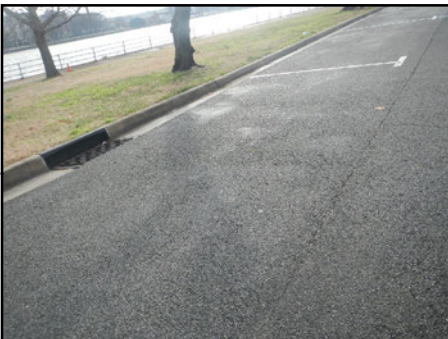
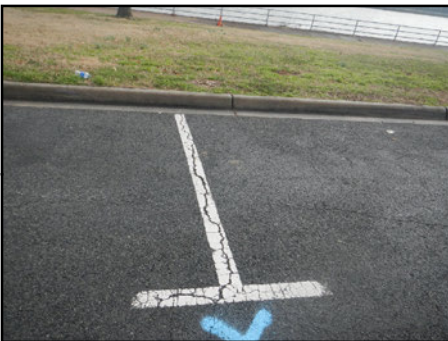
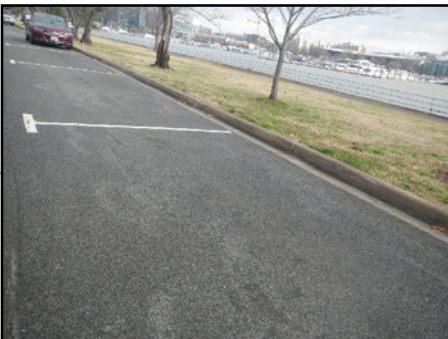
ROUTE 0913Z: HAINS POINT PARKING #3

Inspection Date	FMSS Number	User Access	Surface Type
2/21/2018	49871	PUBLIC	ASPHALT
Area (Sq. Ft.)	Lane Miles (11' Widths)	Curb Reveal (Inches)	Curb Recommendation
1,845	0.032	NOT APPLICABLE	DO NOTHING
Curb Type		Curb & Gutter Type	
NO CURB		CONCRETE	
Pavement Recommendation		Condition Rating / PCR	
PREVENTIVE MAINTENANCE		GOOD / 90

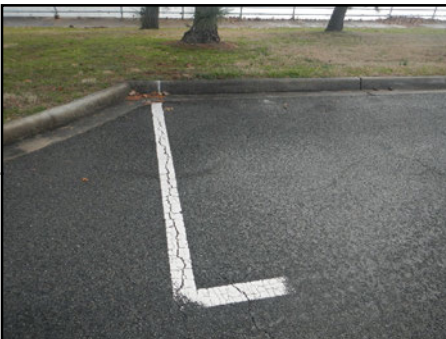
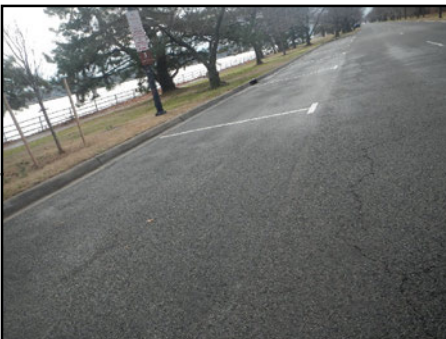
ROUTE 0914Z: HAINS POINT PARKING #4

Inspection Date	FMSS Number	User Access	Surface Type
2/21/2018	49871	PUBLIC	ASPHALT
Area (Sq. Ft.)	Lane Miles (11' Widths)	Curb Reveal (Inches)	Curb Recommendation
1,105	0.019	NOT APPLICABLE	DO NOTHING
Curb Type		Curb & Gutter Type	
NO CURB		CONCRETE	
Pavement Recommendation		Condition Rating / PCR	
PREVENTIVE MAINTENANCE		GOOD / 90

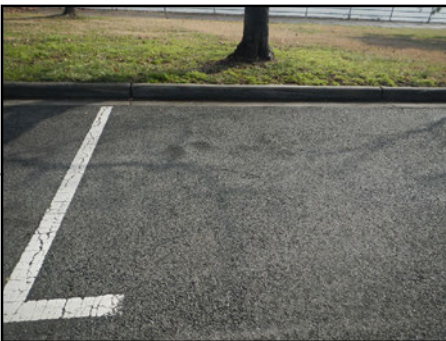
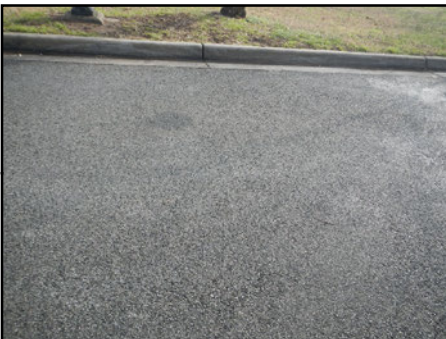
ROUTE 0915Z: HAINS POINT PARKING #5

Inspection Date	FMSS Number	User Access	Surface Type
2/21/2018	49871	PUBLIC	ASPHALT
Area (Sq. Ft.)	Lane Miles (11' Widths)	Curb Reveal (Inches)	Curb Recommendation
1,490	0.026	NOT APPLICABLE	DO NOTHING
Curb Type		Curb & Gutter Type	
NO CURB		CONCRETE	
Pavement Recommendation		Condition Rating / PCR	
PREVENTIVE MAINTENANCE		GOOD / 90

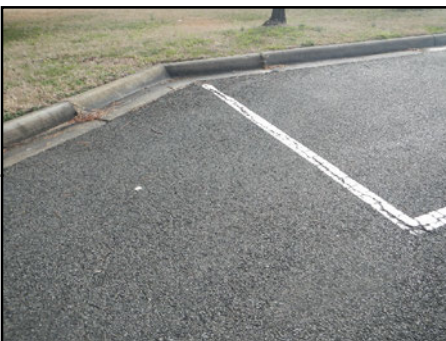
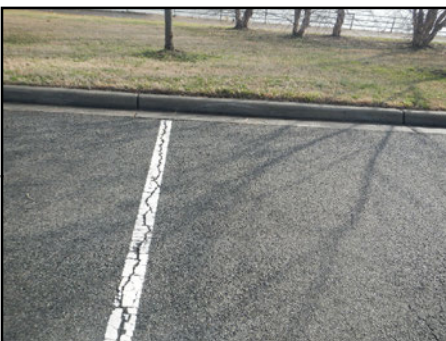
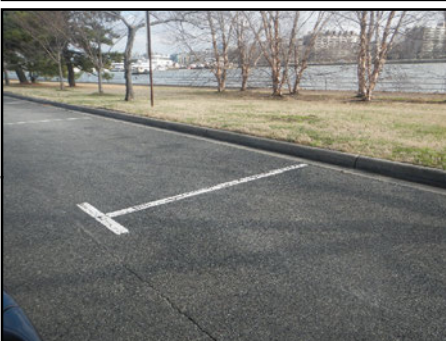
ROUTE 0916Z: HAINS POINT PARKING #6

Inspection Date	FMSS Number	User Access	Surface Type
2/21/2018	49871	PUBLIC	ASPHALT
Area (Sq. Ft.)	Lane Miles (11' Widths)	Curb Reveal (Inches)	Curb Recommendation
9,468	0.163	NOT APPLICABLE	DO NOTHING
Curb Type		Curb & Gutter Type	
NO CURB		CONCRETE	
Pavement Recommendation		Condition Rating / PCR	
PREVENTIVE MAINTENANCE		GOOD / 90

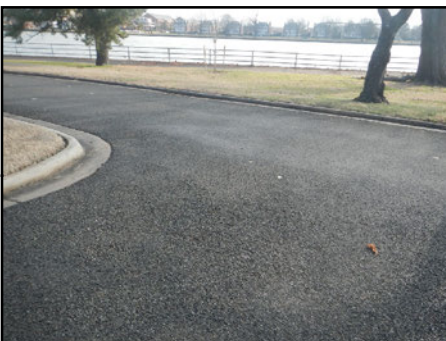
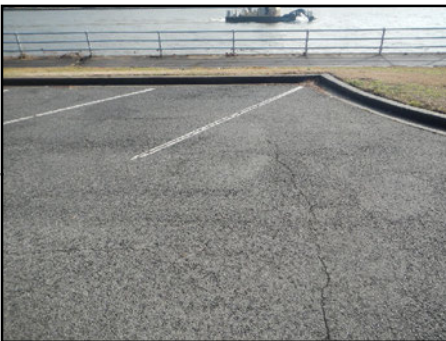
ROUTE 0917Z: HAINS POINT PARKING #7

Inspection Date	FMSS Number	User Access	Surface Type
2/21/2018	49871	PUBLIC	ASPHALT
Area (Sq. Ft.)	Lane Miles (11' Widths)	Curb Reveal (Inches)	Curb Recommendation
2,417	0.042	NOT APPLICABLE	DO NOTHING
Curb Type		Curb & Gutter Type	
NO CURB		CONCRETE	
Pavement Recommendation		Condition Rating / PCR	
PREVENTIVE MAINTENANCE		GOOD / 90

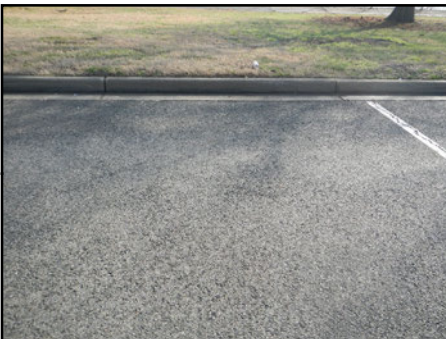
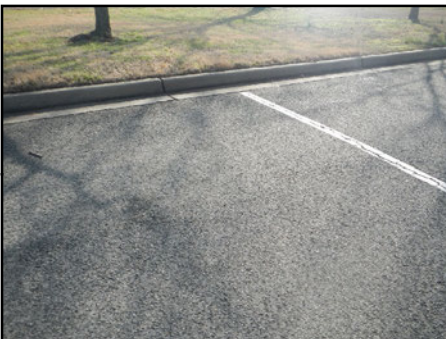
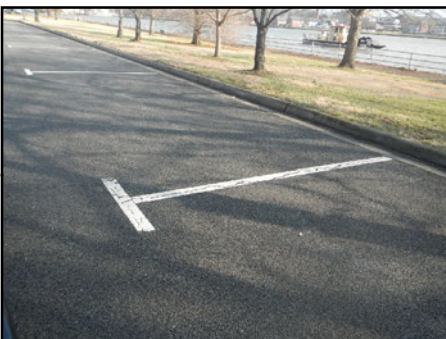
ROUTE 0918Z: HAINS POINT PARKING #8

Inspection Date	FMSS Number	User Access	Surface Type
2/21/2018	49871	PUBLIC	ASPHALT
Area (Sq. Ft.)	Lane Miles (11' Widths)	Curb Reveal (Inches)	Curb Recommendation
2,224	0.038	NOT APPLICABLE	DO NOTHING
Curb Type		Curb & Gutter Type	
NO CURB		CONCRETE	
Pavement Recommendation		Condition Rating / PCR	
PREVENTIVE MAINTENANCE		GOOD / 90

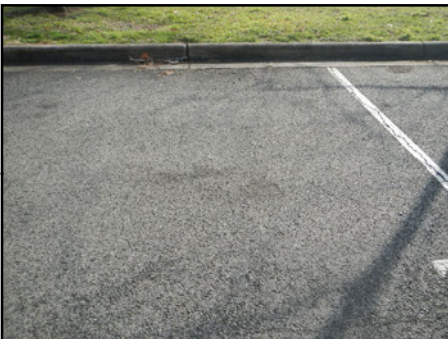
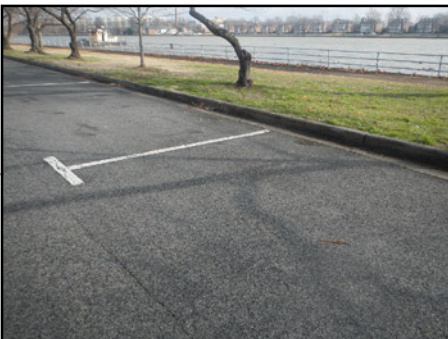
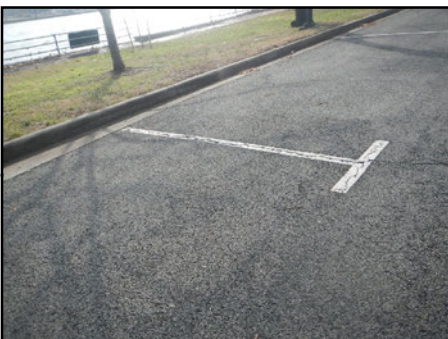
ROUTE 0919Z: HAINS POINT PARKING #9

Inspection Date	FMSS Number	User Access	Surface Type
2/21/2018	49871	PUBLIC	ASPHALT
Area (Sq. Ft.)	Lane Miles (11' Widths)	Curb Reveal (Inches)	Curb Recommendation
1,919	0.033	NOT APPLICABLE	DO NOTHING
Curb Type		Curb & Gutter Type	
NO CURB		CONCRETE	
Pavement Recommendation		Condition Rating / PCR	
PREVENTIVE MAINTENANCE		GOOD / 90

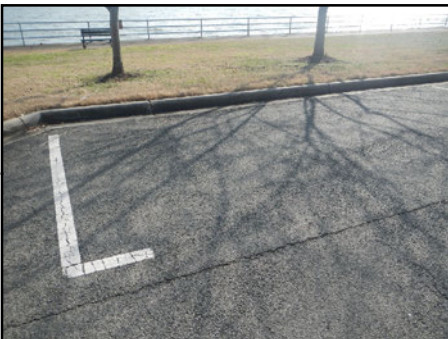
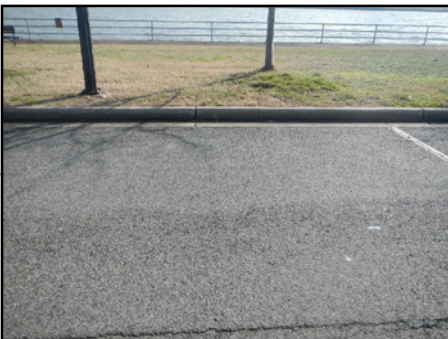
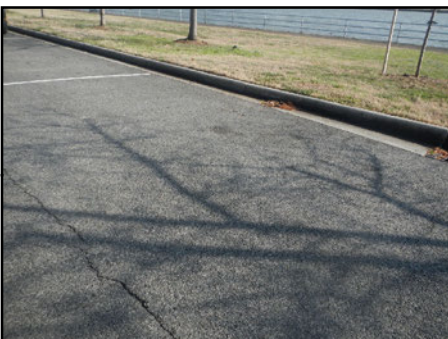
ROUTE 0920Z: HAINS POINT PARKING #10

Inspection Date	FMSS Number	User Access	Surface Type
2/21/2018	49871	PUBLIC	ASPHALT
Area (Sq. Ft.)	Lane Miles (11' Widths)	Curb Reveal (Inches)	Curb Recommendation
2,775	0.048	NOT APPLICABLE	DO NOTHING
Curb Type		Curb & Gutter Type	
NO CURB		CONCRETE	
Pavement Recommendation		Condition Rating / PCR	
PREVENTIVE MAINTENANCE		GOOD / 90

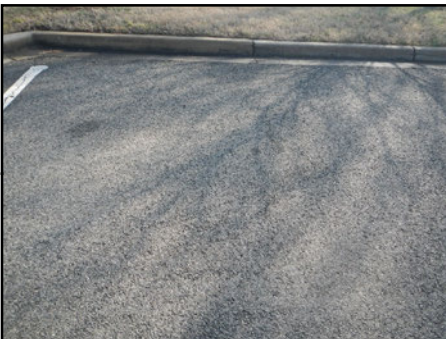
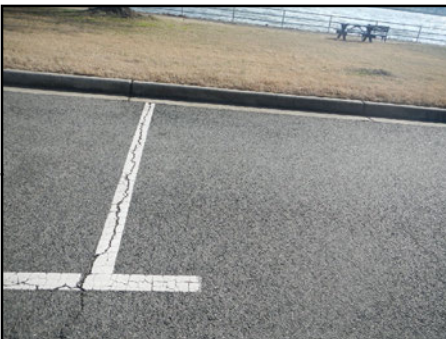
ROUTE 0921Z: HAINS POINT PARKING #11

Inspection Date	FMSS Number	User Access	Surface Type
2/21/2018	49871	PUBLIC	ASPHALT
Area (Sq. Ft.)	Lane Miles (11' Widths)	Curb Reveal (Inches)	Curb Recommendation
11,077	0.191	NOT APPLICABLE	DO NOTHING
Curb Type		Curb & Gutter Type	
NO CURB		CONCRETE	
Pavement Recommendation		Condition Rating / PCR	
PREVENTIVE MAINTENANCE		GOOD / 90

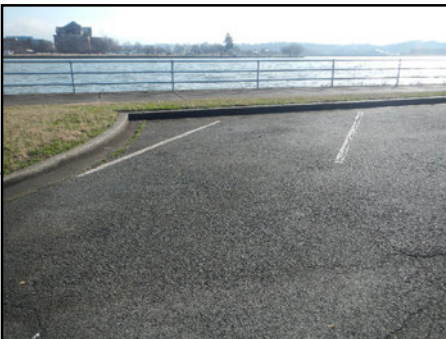
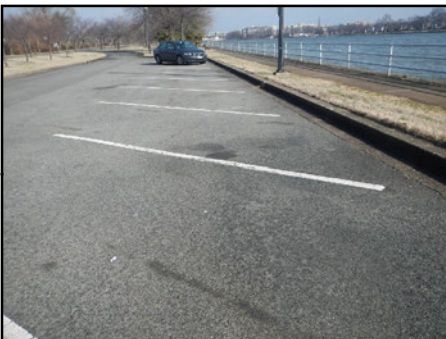
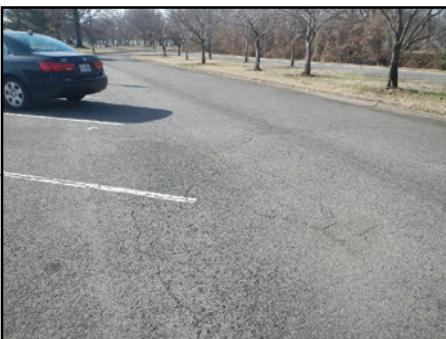
ROUTE 0922Z: HAINS POINT PARKING #12

Inspection Date	FMSS Number	User Access	Surface Type
2/21/2018	49871	PUBLIC	ASPHALT
Area (Sq. Ft.)	Lane Miles (11' Widths)	Curb Reveal (Inches)	Curb Recommendation
1,254	0.022	NOT APPLICABLE	DO NOTHING
Curb Type		Curb & Gutter Type	
NO CURB		CONCRETE	
Pavement Recommendation		Condition Rating / PCR	
PREVENTIVE MAINTENANCE		GOOD / 90

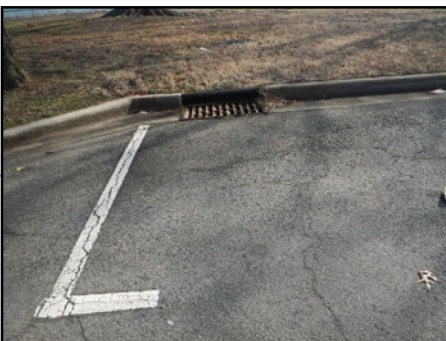
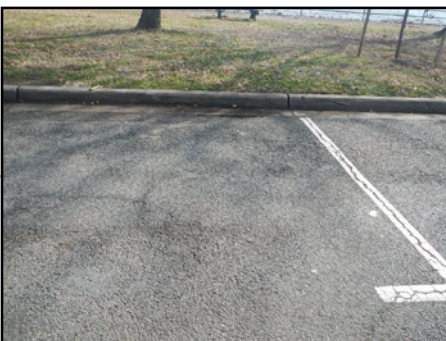
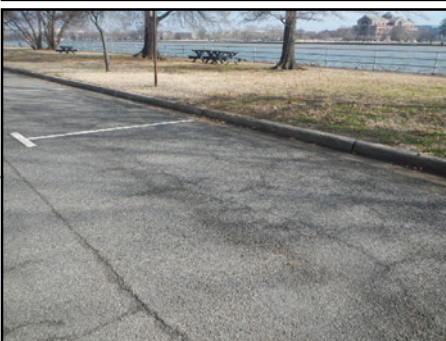
ROUTE 0923Z: HAINS POINT PLAYGROUND PARKING

Inspection Date	FMSS Number	User Access	Surface Type
2/21/2018	49871	PUBLIC	ASPHALT
Area (Sq. Ft.)	Lane Miles (11' Widths)	Curb Reveal (Inches)	Curb Recommendation
28,084	0.484	NOT APPLICABLE	DO NOTHING
Curb Type		Curb & Gutter Type	
NO CURB		CONCRETE	
Pavement Recommendation		Condition Rating / PCR	
LIGHT 3R TREATMENTS		FAIR / 73

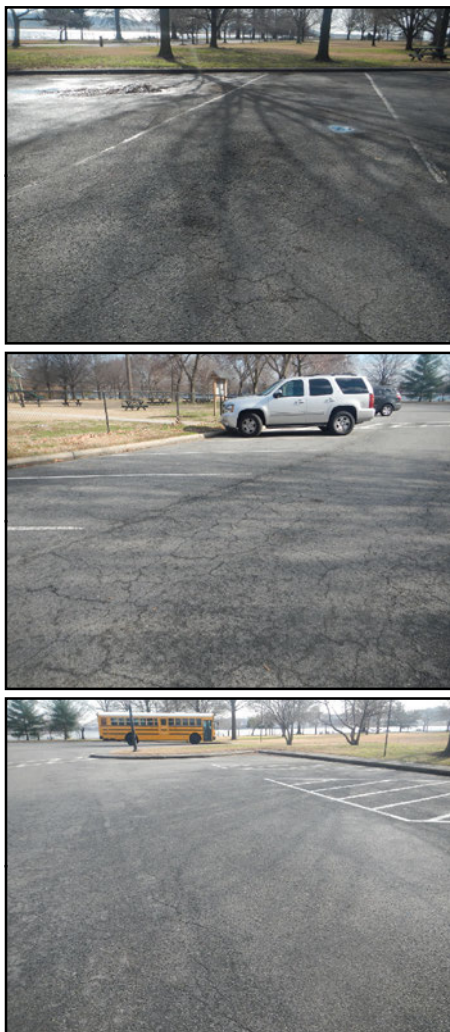
ROUTE 0924Z: HAINS POINT PARKING #13

Inspection Date	FMSS Number	User Access	Surface Type
2/21/2018	49871	PUBLIC	ASPHALT
Area (Sq. Ft.)	Lane Miles (11' Widths)	Curb Reveal (Inches)	Curb Recommendation
4,917	0.085	NOT APPLICABLE	DO NOTHING
Curb Type		Curb & Gutter Type	
NO CURB		CONCRETE	
Pavement Recommendation		Condition Rating / PCR	
PREVENTIVE MAINTENANCE		GOOD / 90

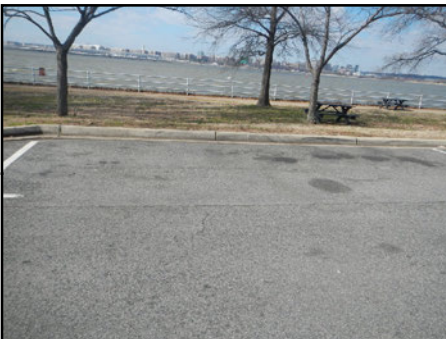
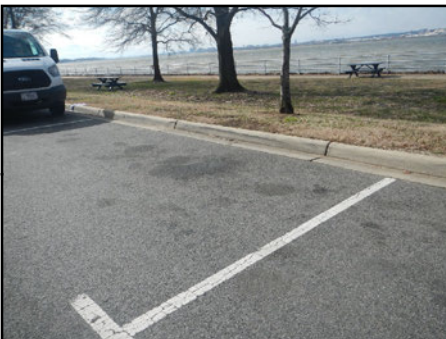
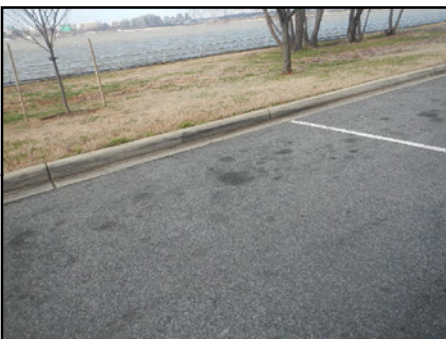
ROUTE 0928Z: HAINS POINT PARKING #17

Inspection Date	FMSS Number	User Access	Surface Type
2/21/2018	49871	PUBLIC	ASPHALT
Area (Sq. Ft.)	Lane Miles (11' Widths)	Curb Reveal (Inches)	Curb Recommendation
3,755	0.065	NOT APPLICABLE	DO NOTHING
Curb Type		Curb & Gutter Type	
NO CURB		CONCRETE	
Pavement Recommendation		Condition Rating / PCR	
PREVENTIVE MAINTENANCE		GOOD / 90

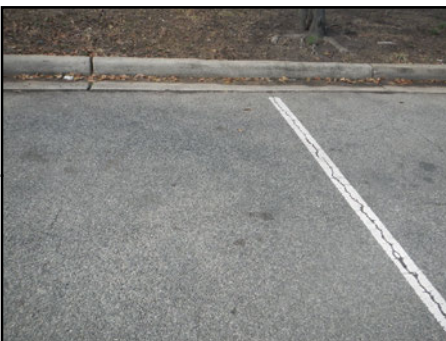
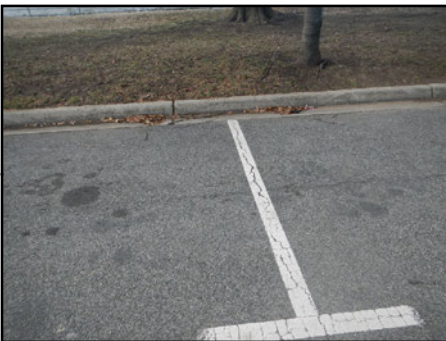
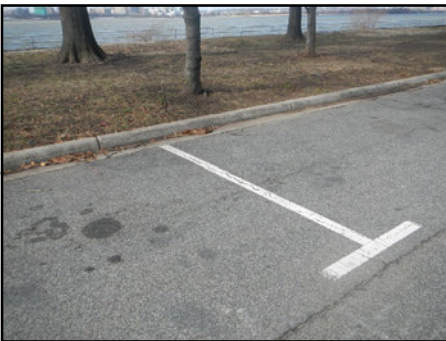
ROUTE 0929Z: HAINS POINT PARKING #18

Inspection Date	FMSS Number	User Access	Surface Type
2/21/2018	49871	PUBLIC	ASPHALT
Area (Sq. Ft.)	Lane Miles (11' Widths)	Curb Reveal (Inches)	Curb Recommendation
7,621	0.131	NOT APPLICABLE	DO NOTHING
Curb Type		Curb & Gutter Type	
NO CURB		CONCRETE	
Pavement Recommendation		Condition Rating / PCR	
PREVENTIVE MAINTENANCE		GOOD / 90

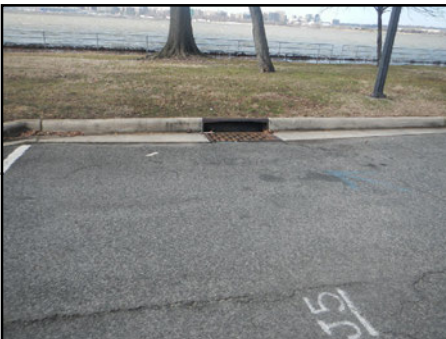
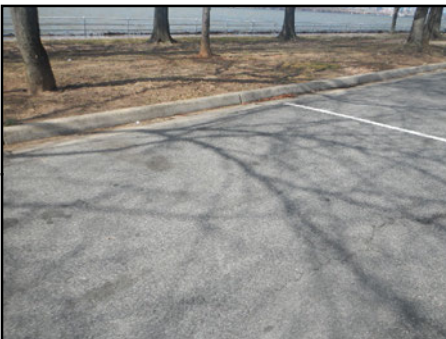
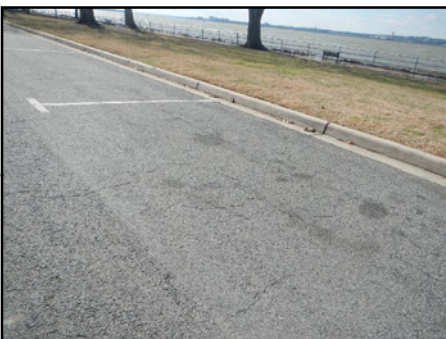
ROUTE 0930Z: HAINS POINT PARKING #18 (RESTROOM PARKING)

Inspection Date	FMSS Number	User Access	Surface Type
2/21/2018	49871	PUBLIC	ASPHALT
Area (Sq. Ft.)	Lane Miles (11' Widths)	Curb Reveal (Inches)	Curb Recommendation
812	0.014	NOT APPLICABLE	DO NOTHING
Curb Type		Curb & Gutter Type	
NO CURB		CONCRETE	
Pavement Recommendation		Condition Rating / PCR	
LIGHT 3R TREATMENTS		FAIR / 73

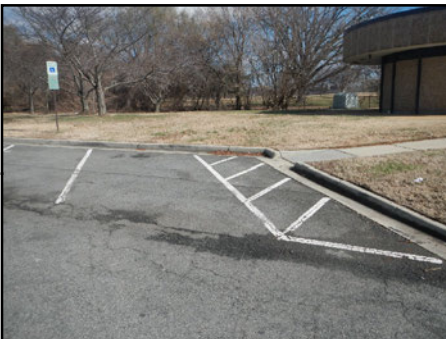
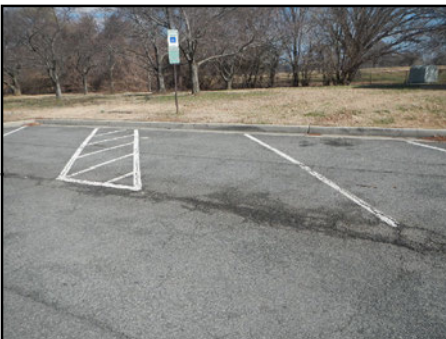
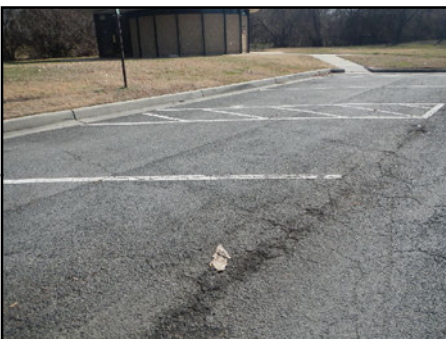
ROUTE 0931Z: HAINS POINT PARKING #19

Inspection Date	FMSS Number	User Access	Surface Type
2/21/2018	49871	PUBLIC	ASPHALT
Area (Sq. Ft.)	Lane Miles (11' Widths)	Curb Reveal (Inches)	Curb Recommendation
4,640	0.08	NOT APPLICABLE	DO NOTHING
Curb Type		Curb & Gutter Type	
NO CURB		CONCRETE	
Pavement Recommendation		Condition Rating / PCR	
PREVENTIVE MAINTENANCE		GOOD / 90

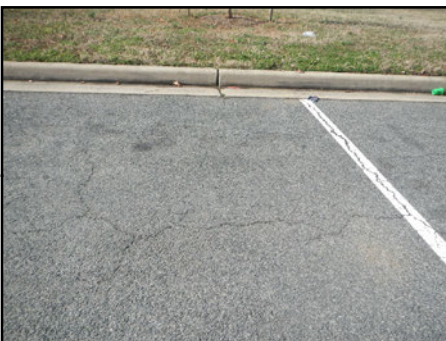
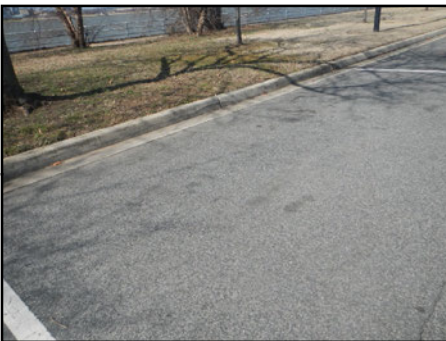
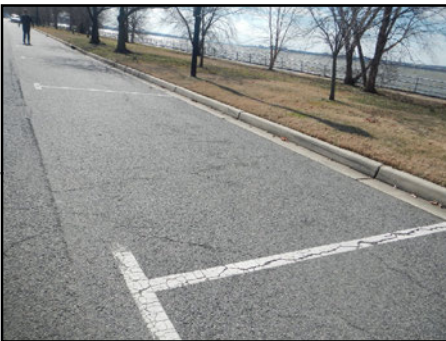
ROUTE 0932Z: HAINS POINT PARKING #20

Inspection Date	FMSS Number	User Access	Surface Type
2/21/2018	49871	PUBLIC	ASPHALT
Area (Sq. Ft.)	Lane Miles (11' Widths)	Curb Reveal (Inches)	Curb Recommendation
5,228	0.09	NOT APPLICABLE	DO NOTHING
Curb Type		Curb & Gutter Type	
NO CURB		CONCRETE	
Pavement Recommendation		Condition Rating / PCR	
PREVENTIVE MAINTENANCE		GOOD / 90

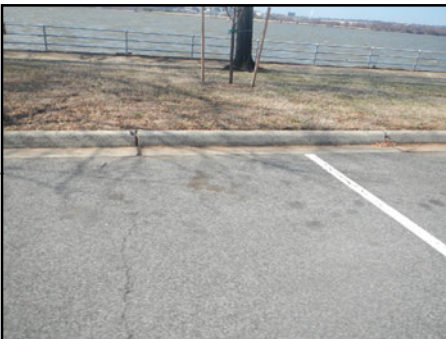
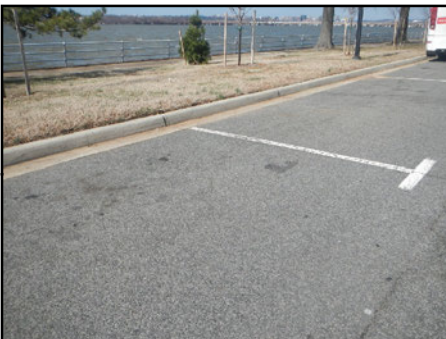
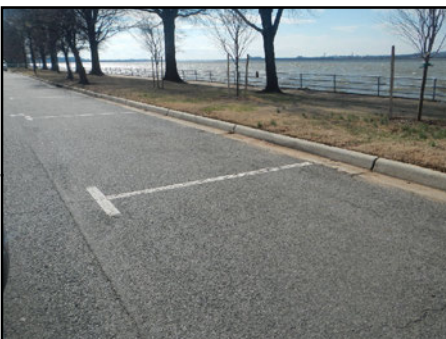
ROUTE 0933Z: HAINS POINT PARKING #21

Inspection Date	FMSS Number	User Access	Surface Type
2/21/2018	49871	PUBLIC	ASPHALT
Area (Sq. Ft.)	Lane Miles (11' Widths)	Curb Reveal (Inches)	Curb Recommendation
4,065	0.07	NOT APPLICABLE	DO NOTHING
Curb Type		Curb & Gutter Type	
NO CURB		CONCRETE	
Pavement Recommendation		Condition Rating / PCR	
PREVENTIVE MAINTENANCE		GOOD / 90

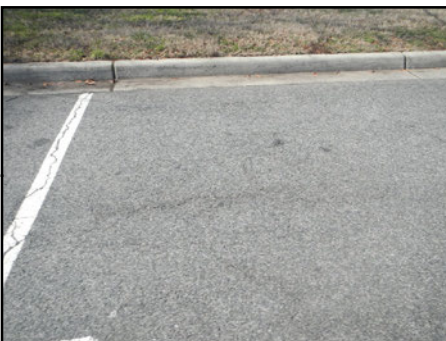
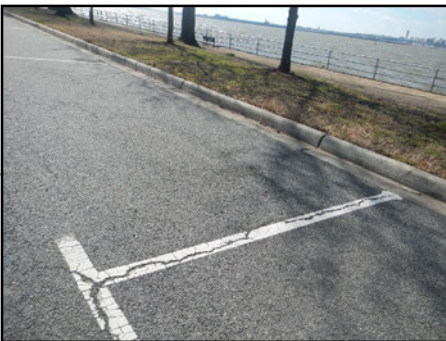
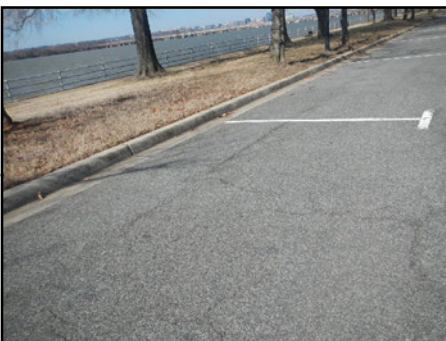
ROUTE 0934Z: HAINS POINT PARKING #22

Inspection Date	FMSS Number	User Access	Surface Type
2/21/2018	49871	PUBLIC	ASPHALT
Area (Sq. Ft.)	Lane Miles (11' Widths)	Curb Reveal (Inches)	Curb Recommendation
2,398	0.041	NOT APPLICABLE	DO NOTHING
Curb Type		Curb & Gutter Type	
NO CURB		CONCRETE	
Pavement Recommendation		Condition Rating / PCR	
PREVENTIVE MAINTENANCE		GOOD / 90

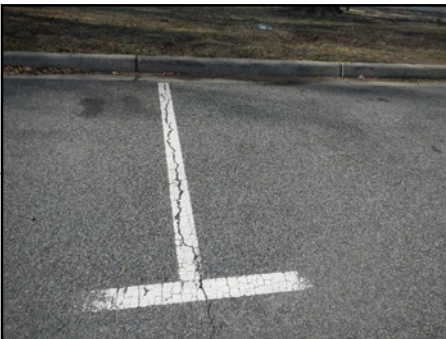
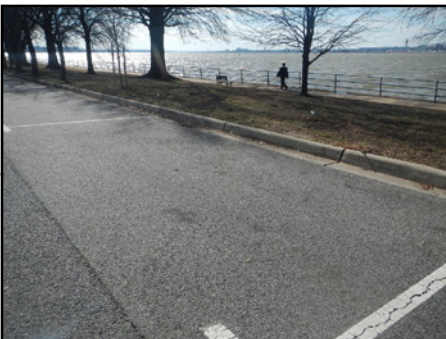
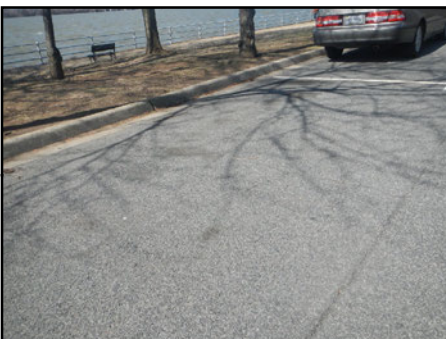
ROUTE 0935Z: HAINS POINT PARKING #23

Inspection Date	FMSS Number	User Access	Surface Type
2/21/2018	49871	PUBLIC	ASPHALT
Area (Sq. Ft.)	Lane Miles (11' Widths)	Curb Reveal (Inches)	Curb Recommendation
3,119	0.054	NOT APPLICABLE	DO NOTHING
Curb Type		Curb & Gutter Type	
NO CURB		CONCRETE	
Pavement Recommendation		Condition Rating / PCR	
PREVENTIVE MAINTENANCE		GOOD / 90

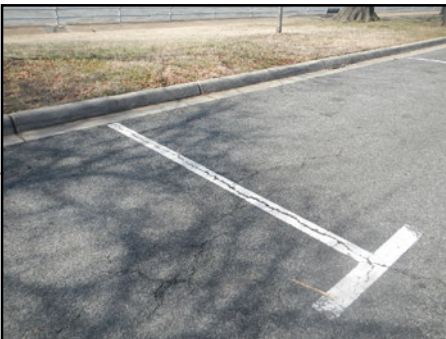
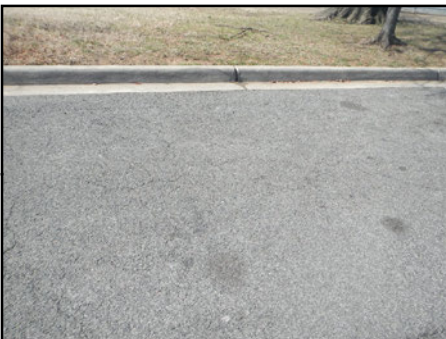
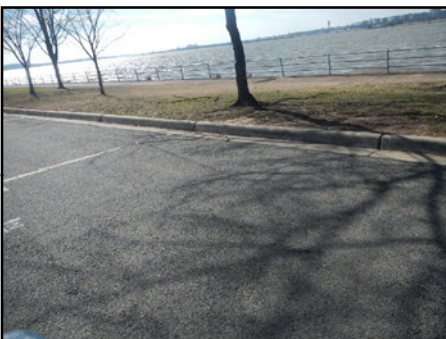
ROUTE 0936Z: HAINS POINT PARKING #24

Inspection Date	FMSS Number	User Access	Surface Type
2/21/2018	49871	PUBLIC	ASPHALT
Area (Sq. Ft.)	Lane Miles (11' Widths)	Curb Reveal (Inches)	Curb Recommendation
1,429	0.025	NOT APPLICABLE	DO NOTHING
Curb Type		Curb & Gutter Type	
NO CURB		CONCRETE	
Pavement Recommendation		Condition Rating / PCR	
PREVENTIVE MAINTENANCE		GOOD / 90

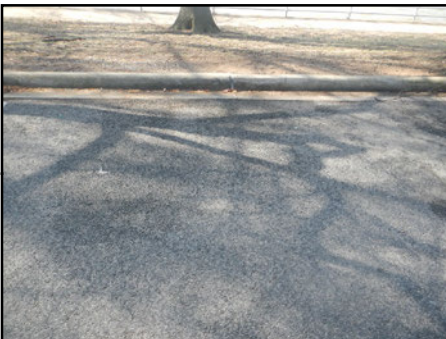
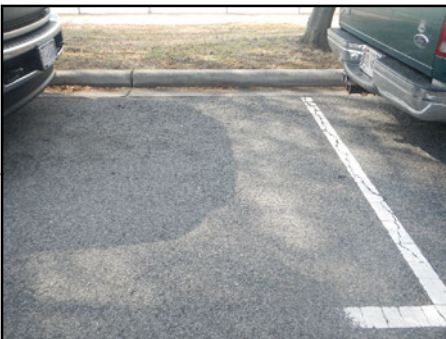
ROUTE 0937Z: HAINS POINT PARKING #25

Inspection Date	FMSS Number	User Access	Surface Type
2/21/2018	49871	PUBLIC	ASPHALT
Area (Sq. Ft.)	Lane Miles (11' Widths)	Curb Reveal (Inches)	Curb Recommendation
1,547	0.027	NOT APPLICABLE	DO NOTHING
Curb Type		Curb & Gutter Type	
NO CURB		CONCRETE	
Pavement Recommendation		Condition Rating / PCR	
PREVENTIVE MAINTENANCE		GOOD / 90

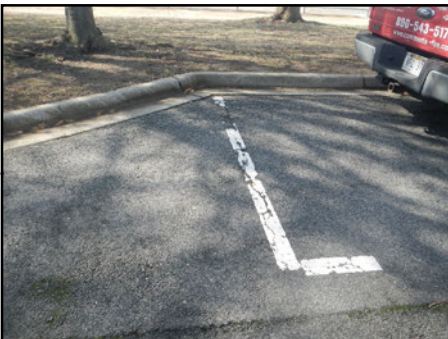
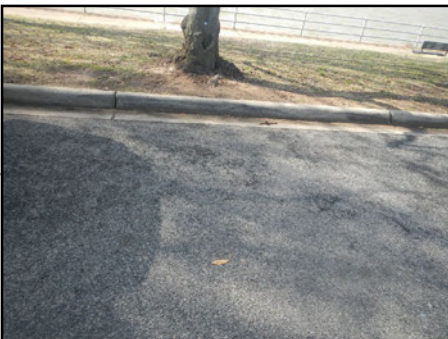
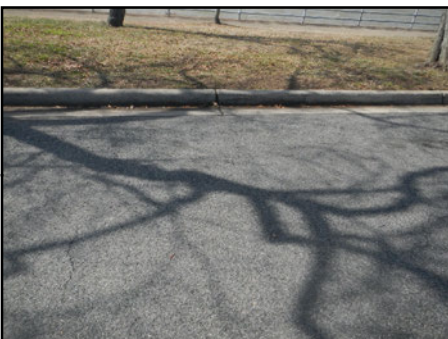
ROUTE 0947Z: HAINS POINT PARKING #15

Inspection Date	FMSS Number	User Access	Surface Type
2/20/2018	49871	PUBLIC	ASPHALT
Area (Sq. Ft.)	Lane Miles (11' Widths)	Curb Reveal (Inches)	Curb Recommendation
3,403	0.059	NOT APPLICABLE	DO NOTHING
Curb Type		Curb & Gutter Type	
NO CURB		CONCRETE	
Pavement Recommendation		Condition Rating / PCR	
PREVENTIVE MAINTENANCE		GOOD / 90
