# NAVA Cycle 6

# Road Inventory and Condition Assessment of Paved Routes Navajo National Monument

Report Date: March 2017

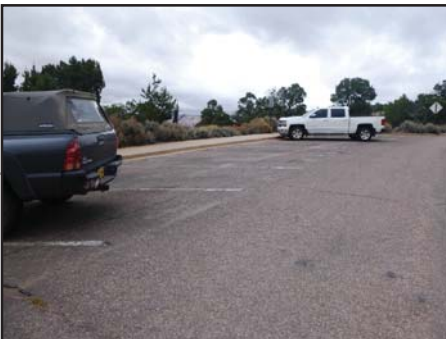
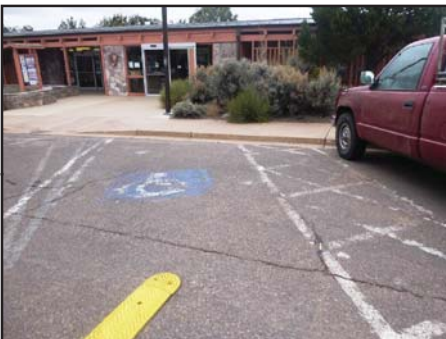
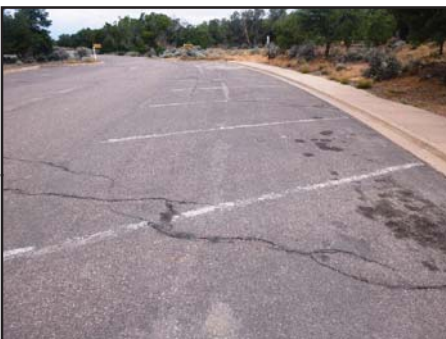
Inspection Date	FMSS Number	User Access	Surface Type
11/4/2016	59837	PUBLIC	ASPHALT
Area (Sq. Ft.)	Lane Miles (11' Widths)	Curb Reveal (Inches)	Curb Recommendation
7,428	0.128	NOT APPLICABLE	DO NOTHING
Curb Type		Curb & Gutter Type	
NO CURB		CONCRETE	
Pavement Recommendation		Condition Rating / PCR	
PREVENTIVE MAINTENANCE		GOOD / 90

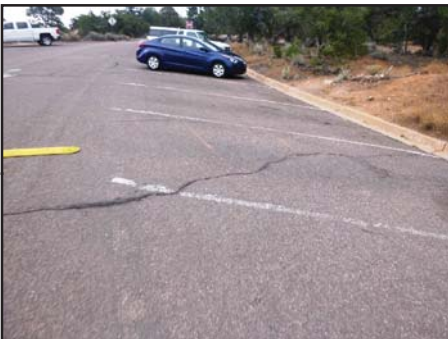
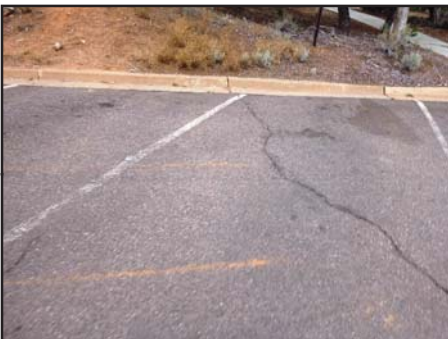
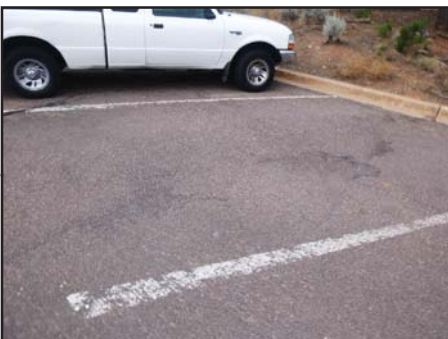
## ROUTE 0900B: VISITOR CENTER PARKING B

Inspection Date	FMSS Number	User Access	Surface Type
11/4/2016	59838	PUBLIC	ASPHALT
Area (Sq. Ft.)	Lane Miles (11' Widths)	Curb Reveal (Inches)	Curb Recommendation
6,160	0.106	NOT APPLICABLE	LIGHT REPAIR
Curb Type		Curb & Gutter Type	
NO CURB		CONCRETE	
Pavement Recommendation		Condition Rating / PCR	
PREVENTIVE MAINTENANCE		GOOD / 90

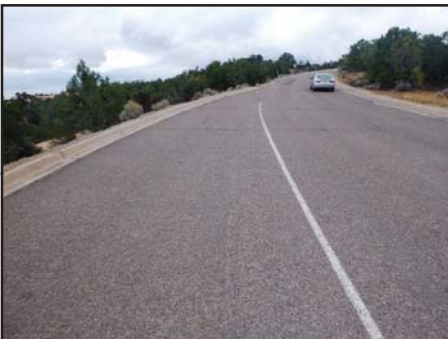
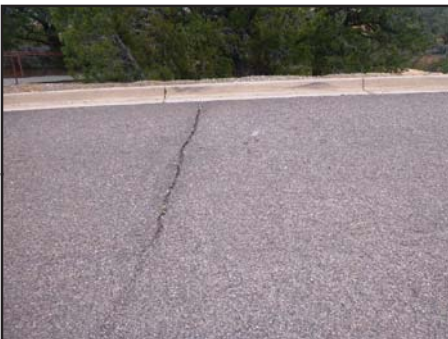
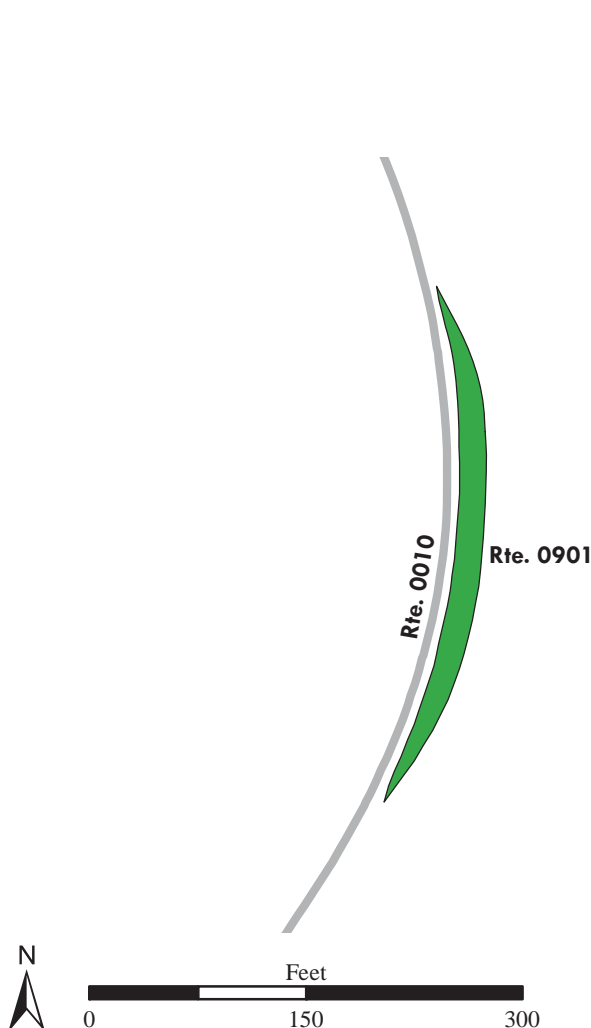
## ROUTE 0901: CANYON / TSEGI OVERLOOK PARKING

Inspection Date	FMSS Number	User Access	Surface Type
11/4/2016	59839	PUBLIC	ASPHALT
Area (Sq. Ft.)	Lane Miles (11' Widths)	Curb Reveal (Inches)	Curb Recommendation
4,363	0.075	NOT APPLICABLE	DO NOTHING
Curb Type		Curb & Gutter Type	
NO CURB		CONCRETE	
Pavement Recommendation		Condition Rating / PCR	
PREVENTIVE MAINTENANCE		GOOD / 90

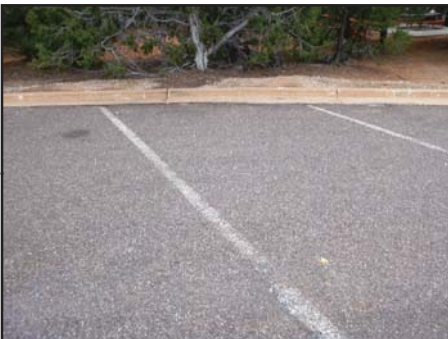
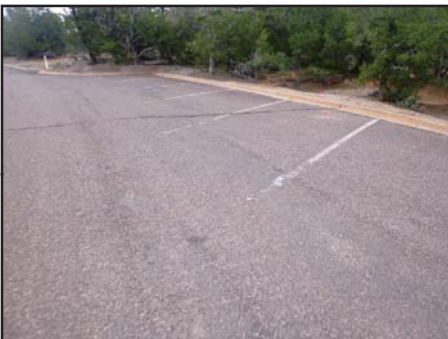
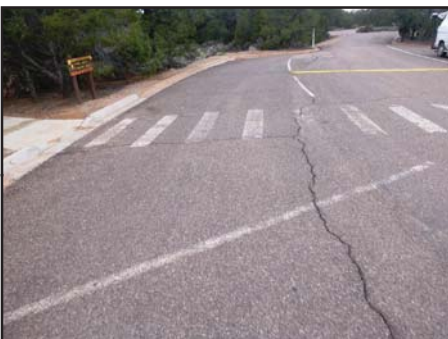
## ROUTE 0902: PICNIC AREA PARKING

Inspection Date	FMSS Number	User Access	Surface Type
11/4/2016	59840	PUBLIC	ASPHALT
Area (Sq. Ft.)	Lane Miles (11' Widths)	Curb Reveal (Inches)	Curb Recommendation
3,550	0.061	NOT APPLICABLE	LIGHT REPAIR
Curb Type		Curb & Gutter Type	
NO CURB		CONCRETE	
Pavement Recommendation		Condition Rating / PCR	
PREVENTIVE MAINTENANCE		GOOD / 90

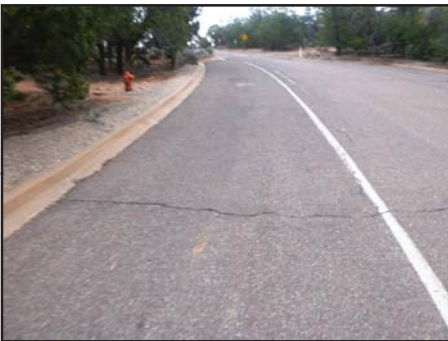
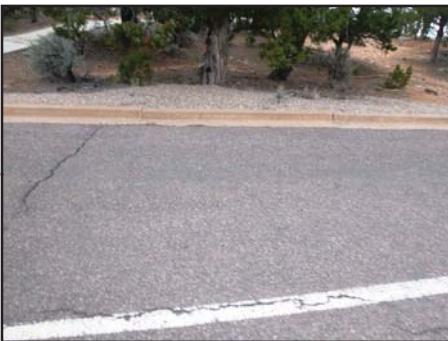
## ROUTE 0903: RV PARKING

Inspection Date	FMSS Number	User Access	Surface Type
11/4/2016	59841	PUBLIC	ASPHALT
Area (Sq. Ft.)	Lane Miles (11' Widths)	Curb Reveal (Inches)	Curb Recommendation
2,256	0.039	NOT APPLICABLE	DO NOTHING
Curb Type		Curb & Gutter Type	
NO CURB		CONCRETE	
Pavement Recommendation		Condition Rating / PCR	
PREVENTIVE MAINTENANCE		GOOD / 90

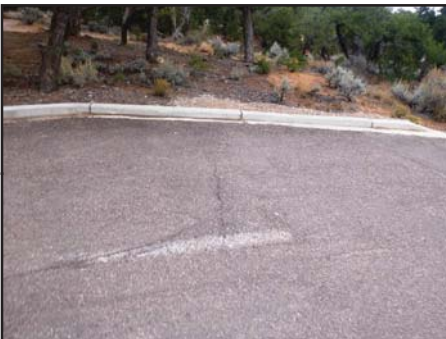
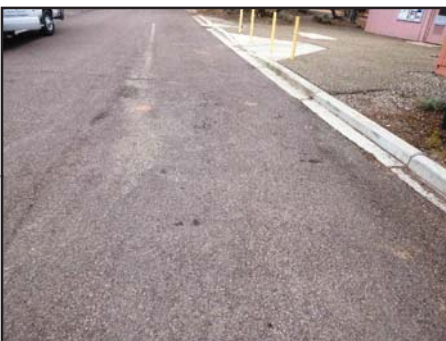
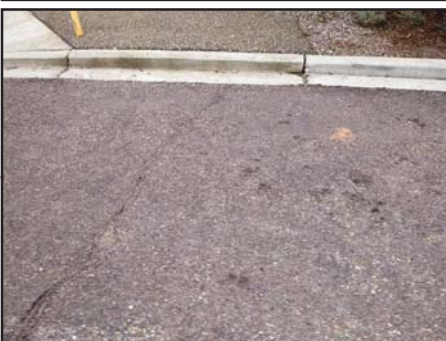
## ROUTE 0905: SUNSET VIEW CAMPGROUND PARKING

Inspection Date	FMSS Number	User Access	Surface Type
11/4/2016	59843	PUBLIC	ASPHALT
Area (Sq. Ft.)	Lane Miles (11' Widths)	Curb Reveal (Inches)	Curb Recommendation
905	0.016	NOT APPLICABLE	DO NOTHING
Curb Type		Curb & Gutter Type	
NO CURB		CONCRETE	
Pavement Recommendation		Condition Rating / PCR	
PREVENTIVE MAINTENANCE		GOOD / 90

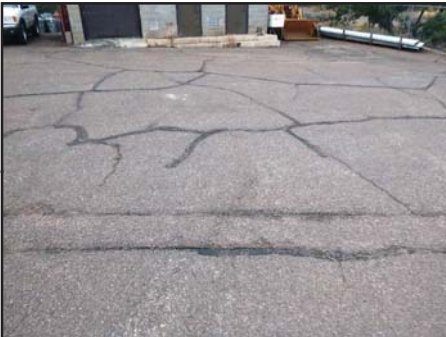
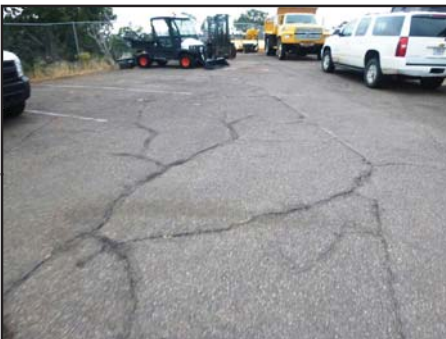
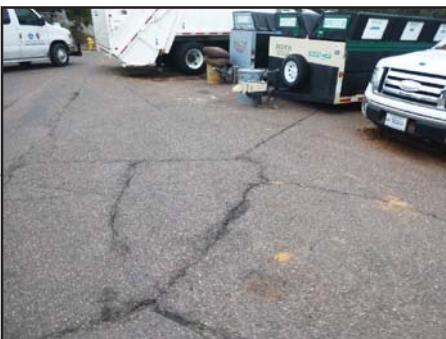
## ROUTE 0906: MAINTENANCE AREA

Inspection Date	FMSS Number	User Access	Surface Type
11/4/2016	59847	NONPUBLIC	ASPHALT
Area (Sq. Ft.)	Lane Miles (11' Widths)	Curb Reveal (Inches)	Curb Recommendation
11,812	0.203	NOT APPLICABLE	NOT APPLICABLE
Curb Type		Curb & Gutter Type	
NO CURB		NO CURB AND GUTTER	
Pavement Recommendation		Condition Rating / PCR	
LIGHT 3R TREATMENTS		FAIR / 73

Parking area consists of multiple surface types: 1 part Asphalt at 11,389 square feet; 1 part Concrete at 423 square feet.

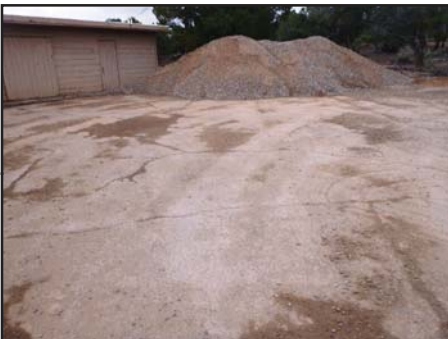
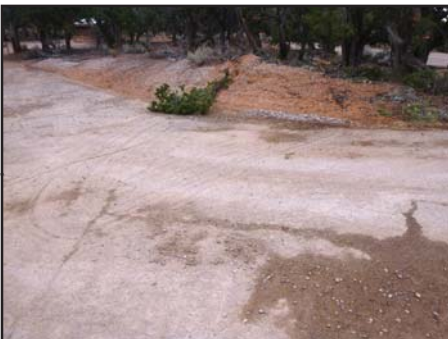
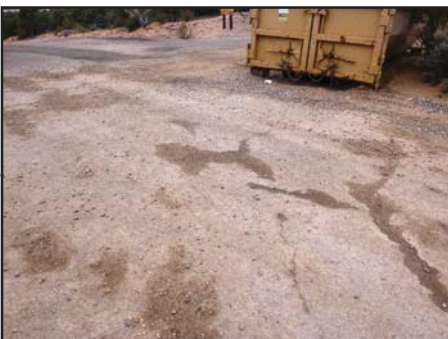
## ROUTE 0907: HORSE BARN PARKING

Inspection Date	FMSS Number	User Access	Surface Type
11/4/2016	59848	PUBLIC	ASPHALT
Area (Sq. Ft.)	Lane Miles (11' Widths)	Curb Reveal (Inches)	Curb Recommendation
3,284	0.057	NOT APPLICABLE	NOT APPLICABLE
Curb Type		Curb & Gutter Type	
NO CURB		NO CURB AND GUTTER	
Pavement Recommendation		Condition Rating / PCR	
HEAVY 3R TREATMENTS		POOR / 53

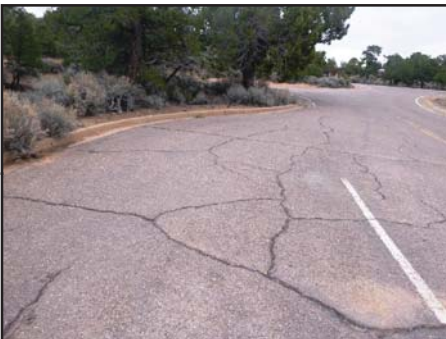
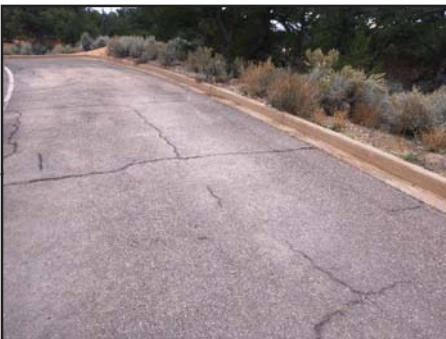
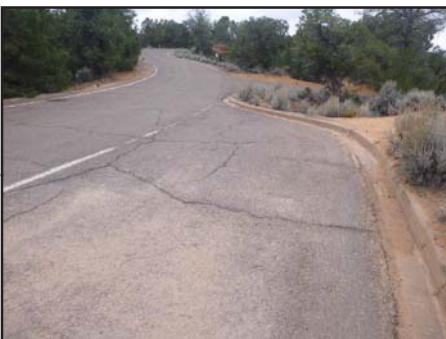
## ROUTE 0909: BUS OVERFLOW PARKING

Inspection Date	FMSS Number	User Access	Surface Type
11/4/2016	238438	PUBLIC	ASPHALT
Area (Sq. Ft.)	Lane Miles (11' Widths)	Curb Reveal (Inches)	Curb Recommendation
1,499	0.026	NOT APPLICABLE	DO NOTHING
Curb Type		Curb & Gutter Type	
NO CURB		CONCRETE	
Pavement Recommendation		Condition Rating / PCR	
LIGHT 3R TREATMENTS		FAIR / 73

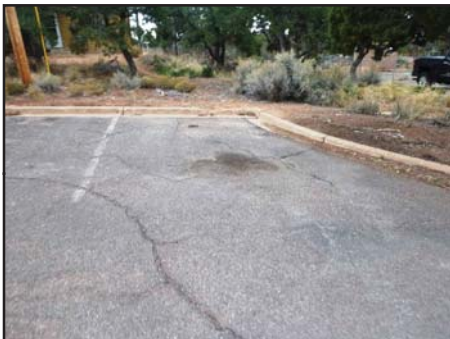
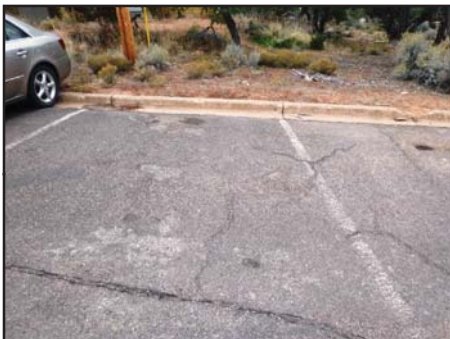
## ROUTE 0910: ARROWHEAD WAY PARKING

Inspection Date	FMSS Number	User Access	Surface Type
11/4/2016	238436	NONPUBLIC	ASPHALT
Area (Sq. Ft.)	Lane Miles (11' Widths)	Curb Reveal (Inches)	Curb Recommendation
1,563	0.027	NOT APPLICABLE	MODERATE REPAIR
Curb Type		Curb & Gutter Type	
NO CURB		CONCRETE	
Pavement Recommendation		Condition Rating / PCR	
LIGHT 3R TREATMENTS		FAIR / 73
