NEPE Cycle 6

Final Report

Road Inventory and Condition Assessment of Paved Routes Nez Perce National Historical Park

Report Date: November 2016

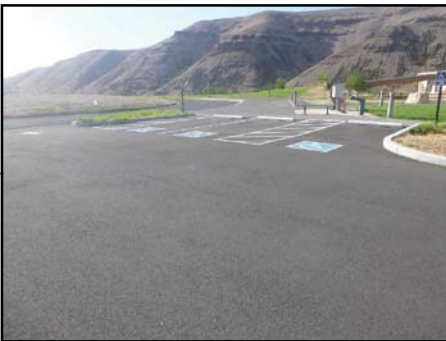
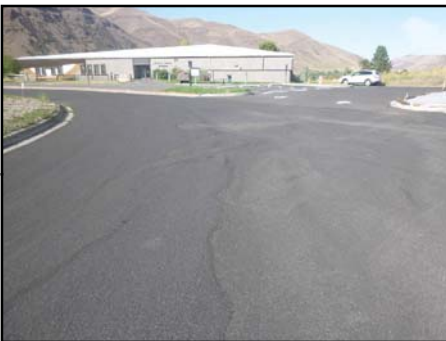
Inspection Date	FMSS Number	User Access	Surface Type
8/22/2016	104906	PUBLIC	ASPHALT
Area (Sq. Ft.)	Lane Miles (11' Widths)	Curb Reveal (Inches)	Curb Recommendation
16,064	0.277	5	DO NOTHING
Curb Type		Curb & Gutter Type	
CONCRETE		CONCRETE	
Pavement Recommendation		Condition Rating / PCR	
PREVENTIVE MAINTENANCE		GOOD / 90

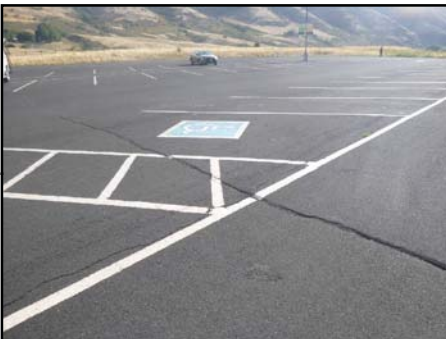
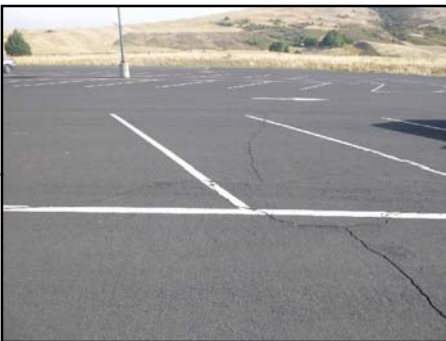
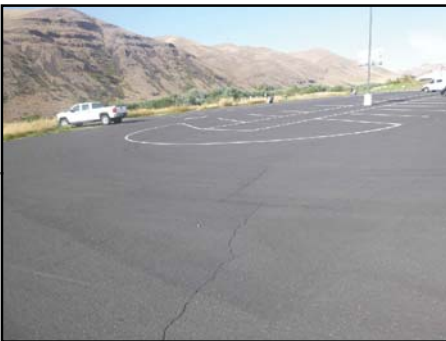
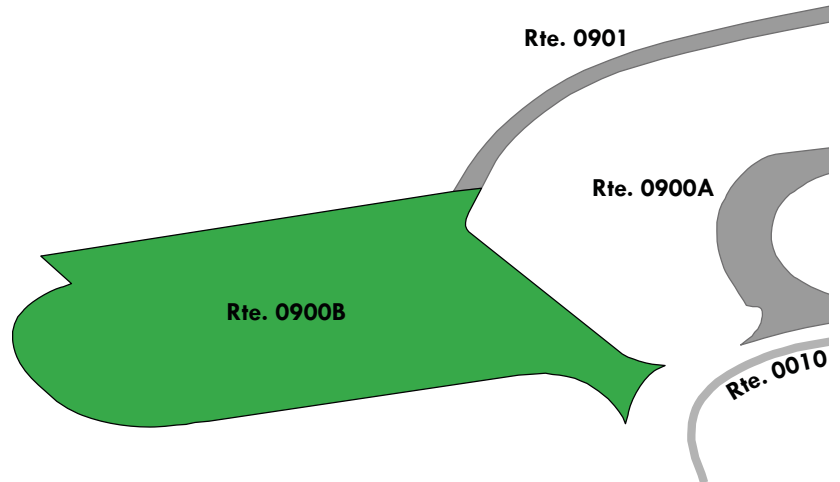
ROUTE 0900B: VISITOR CENTER PARKING B

Inspection Date	FMSS Number	User Access	Surface Type
8/22/2016	63637	PUBLIC	ASPHALT
Area (Sq. Ft.)	Lane Miles (11' Widths)	Curb Reveal (Inches)	Curb Recommendation
49,121	0.846	NOT APPLICABLE	NOT APPLICABLE
Curb Type		Curb & Gutter Type	
NOT APPLICABLE		NO CURB AND GUTTER	
Pavement Recommendation		Condition Rating / PCR	
PREVENTIVE MAINTENANCE		GOOD / 90

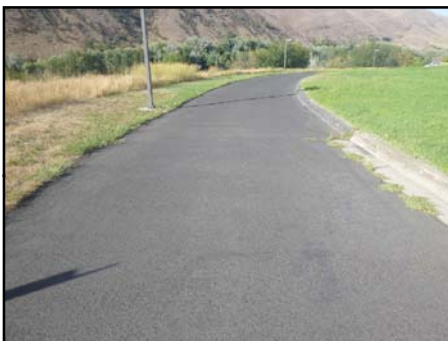
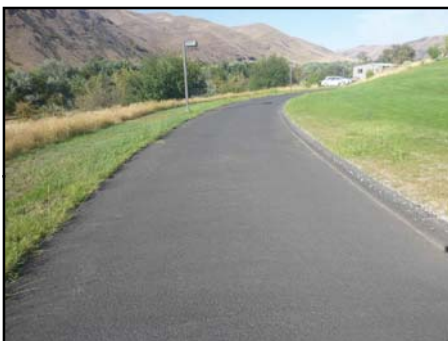
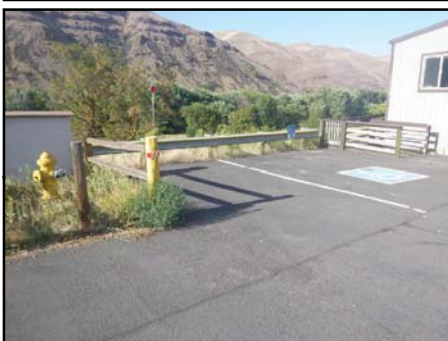
ROUTE 0901: GOVERNMENT VEHICLE PARKING

Inspection Date	FMSS Number	User Access	Surface Type
8/22/2016	102696	NONPUBLIC	ASPHALT
Area (Sq. Ft.)	Lane Miles (11' Widths)	Curb Reveal (Inches)	Curb Recommendation
7,441	0.128	5	DO NOTHING
Curb Type		Curb & Gutter Type	
ASPHALT		CONCRETE	
Pavement Recommendation		Condition Rating / PCR	
PREVENTIVE MAINTENANCE		GOOD / 90

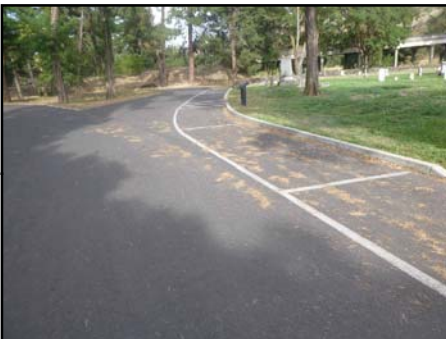
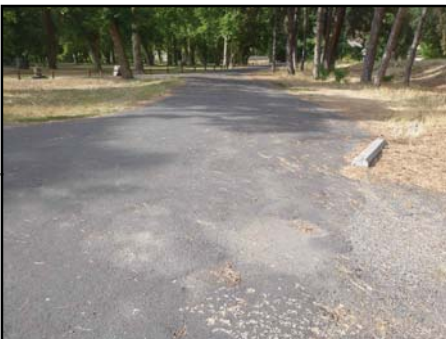
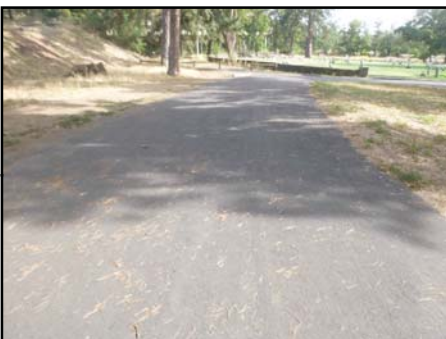
ROUTE 0902: CEMETERY PULLOUT

Inspection Date	FMSS Number	User Access	Surface Type
8/22/2016	102815	PUBLIC	ASPHALT
Area (Sq. Ft.)	Lane Miles (11' Widths)	Curb Reveal (Inches)	Curb Recommendation
3,743	0.064	5	DO NOTHING
Curb Type		Curb & Gutter Type	
CONCRETE		NO CURB AND GUTTER	
Pavement Recommendation		Condition Rating / PCR	
PREVENTIVE MAINTENANCE		GOOD / 90

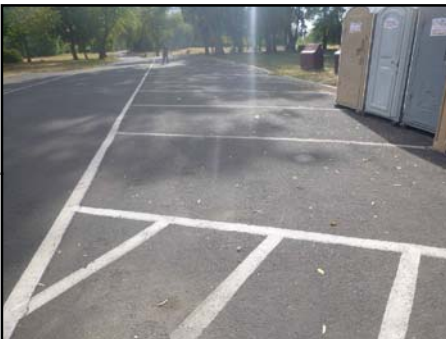
ROUTE 0904A: PICNIC PARKING A

Inspection Date	FMSS Number	User Access	Surface Type
8/22/2016	102683	PUBLIC	ASPHALT
Area (Sq. Ft.)	Lane Miles (11' Widths)	Curb Reveal (Inches)	Curb Recommendation
6,575	0.113	5	DO NOTHING
Curb Type		Curb & Gutter Type	
CONCRETE		NO CURB AND GUTTER	
Pavement Recommendation		Condition Rating / PCR	
PREVENTIVE MAINTENANCE		GOOD / 90

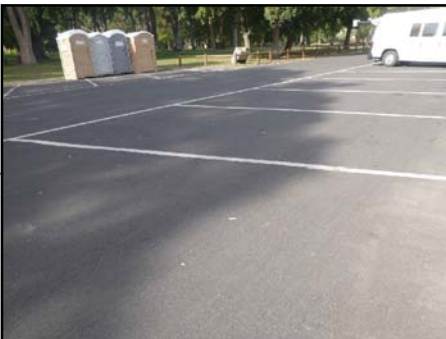
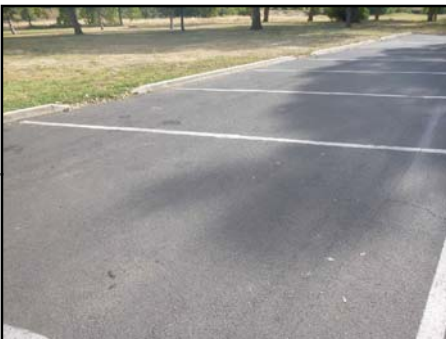
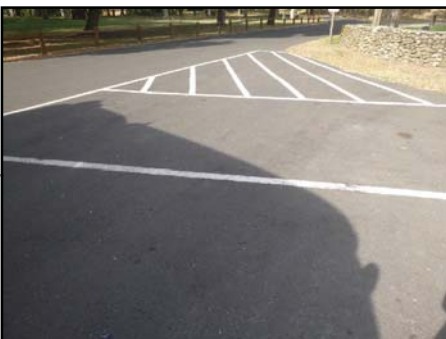
ROUTE 0904B: PICNIC PARKING B

Inspection Date	FMSS Number	User Access	Surface Type
8/22/2016	104903	PUBLIC	ASPHALT
Area (Sq. Ft.)	Lane Miles (11' Widths)	Curb Reveal (Inches)	Curb Recommendation
3,293	0.057	5	DO NOTHING
Curb Type		Curb & Gutter Type	
CONCRETE		NO CURB AND GUTTER	
Pavement Recommendation		Condition Rating / PCR	
PREVENTIVE MAINTENANCE		GOOD / 90

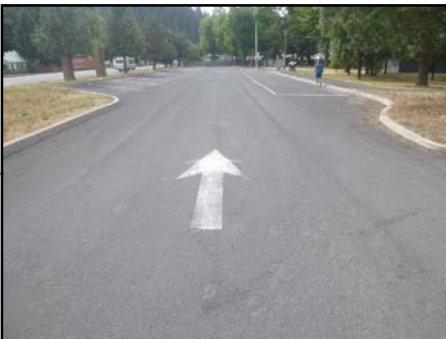
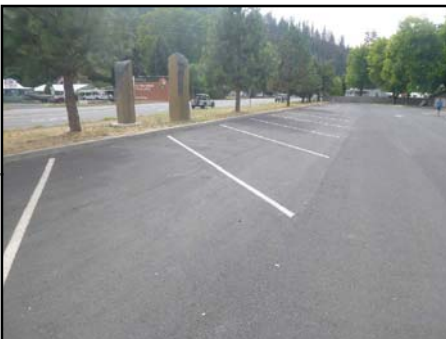
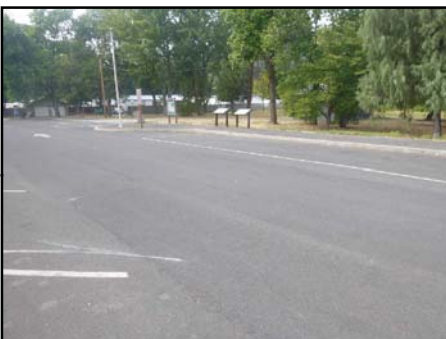
ROUTE 0905: CANOE CAMP PARKING

Inspection Date	FMSS Number	User Access	Surface Type
8/22/2016	84267	PUBLIC	ASPHALT
Area (Sq. Ft.)	Lane Miles (11' Widths)	Curb Reveal (Inches)	Curb Recommendation
18,287	0.315	5	DO NOTHING
Curb Type		Curb & Gutter Type	
CONCRETE		NO CURB AND GUTTER	
Pavement Recommendation		Condition Rating / PCR	
PREVENTIVE MAINTENANCE		GOOD / 90

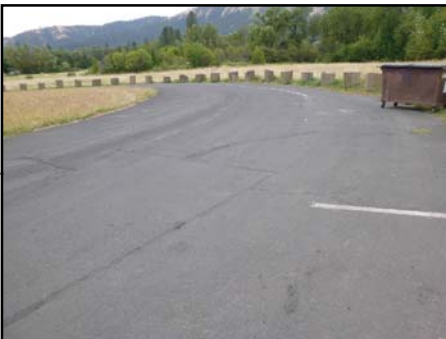
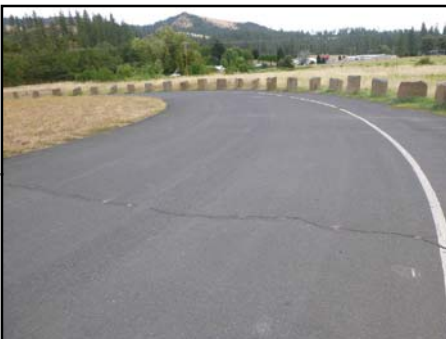
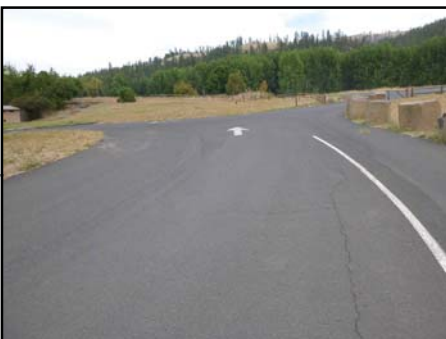
ROUTE 0906: EAST KAMIAH PARKING

Inspection Date	FMSS Number	User Access	Surface Type
8/22/2016	63934	PUBLIC	ASPHALT
Area (Sq. Ft.)	Lane Miles (11' Widths)	Curb Reveal (Inches)	Curb Recommendation
19,454	0.335	7	DO NOTHING
Curb Type		Curb & Gutter Type	
WOOD		NO CURB AND GUTTER	
Pavement Recommendation		Condition Rating / PCR	
PREVENTIVE MAINTENANCE		GOOD / 90

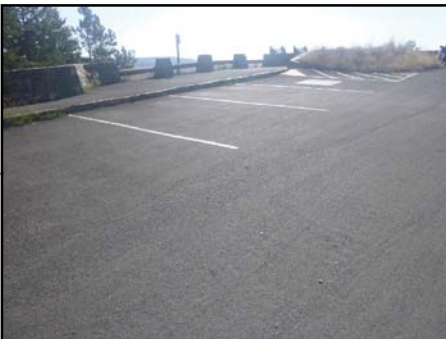
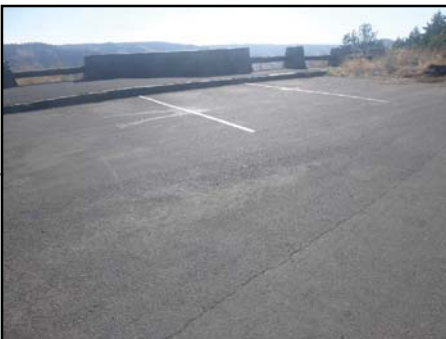
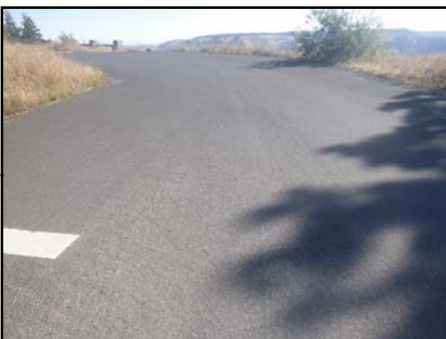
ROUTE 0907: JOSEPH CANYON VIEWPOINT PARKING

Inspection Date	FMSS Number	User Access	Surface Type
8/22/2016	108349	PUBLIC	ASPHALT
Area (Sq. Ft.)	Lane Miles (11' Widths)	Curb Reveal (Inches)	Curb Recommendation
15,626	0.269	7	DO NOTHING
Curb Type		Curb & Gutter Type	
STONE		NO CURB AND GUTTER	
Pavement Recommendation		Condition Rating / PCR	
PREVENTIVE MAINTENANCE		GOOD / 90

Parking area owned by the U.S. Forest Service.
