# NERI Cycle 6

## Final Report

### Road Inventory and Condition Assessment of Paved Routes New River Gorge National Park and Preserve

**Report Date: May 2022**

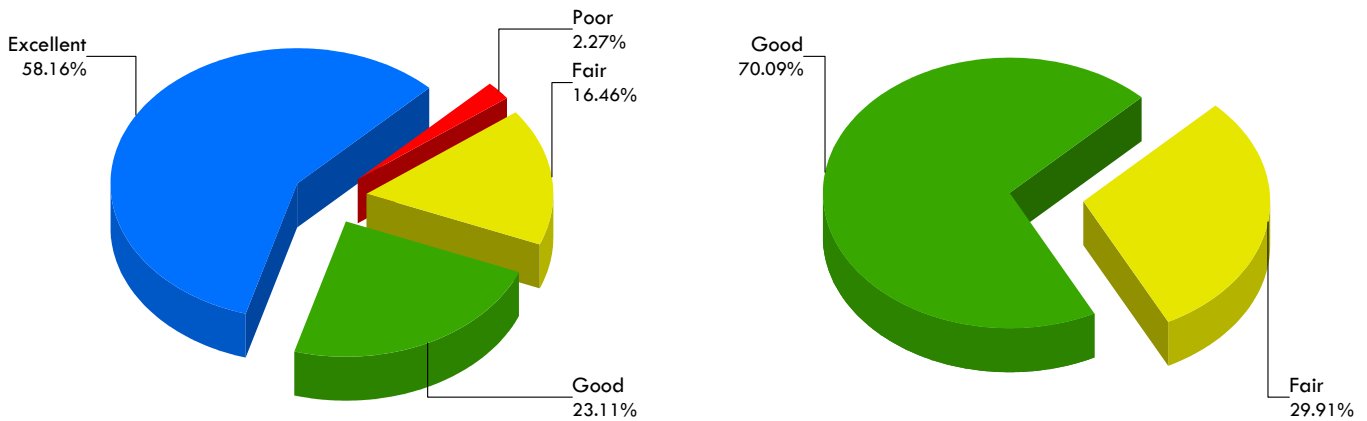
Figure 1: Pavement Condition Rating Breakdown for Paved Roads and Parking Areas

**Road Condition Percentages**

**Parking Area Condition Percentages**

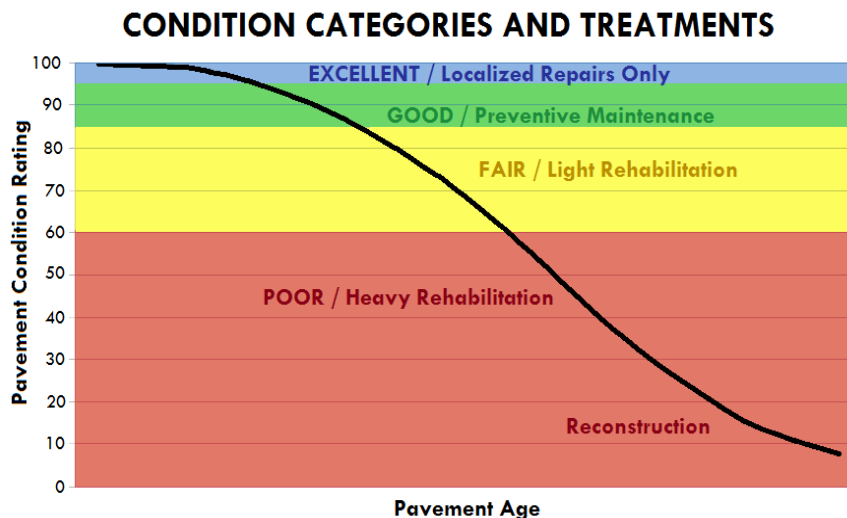
- Excellent / New: PCR of 95-100
  - Pavements in this range will require only spot repairs
- Good: PCR of 85-94
  - Pavements in this range will likely be candidates for Preventive Maintenance. Examples include Chip and Slurry Seals, Micro Surfacing and Thin Overlays.
- Fair: PCR of 61-84
  - Pavements in this range will likely be candidates of Light Rehabilitation (L3R). Examples include singlelift overlays up to 2.5 inches in total thickness, milling and overlays.
- Poor: PCR of 0-60
  - Pavements in this range will likely be candidates of Heavy Rehabilitation or Reconstruction (H3R or 4R). Examples include Pulverization, Multiple Lift Overlays, and Reconstruction.

At this time, specific Maintenance and Rehabilitation activities should be evaluated and recommended at the project level. Site-specific conditions that influence treatment type should be determined based on performing a subsurface investigation and/or pavement condition survey, and not be based solely on RIP data. Additionally, RIP produces a snapshot of conditions at the time in which the data were collected. For further information or to obtain additional Pavement Management System's data from our Highway Pavement Management Application (HPMA) please contact the Eastern Federal Lands pavement team.

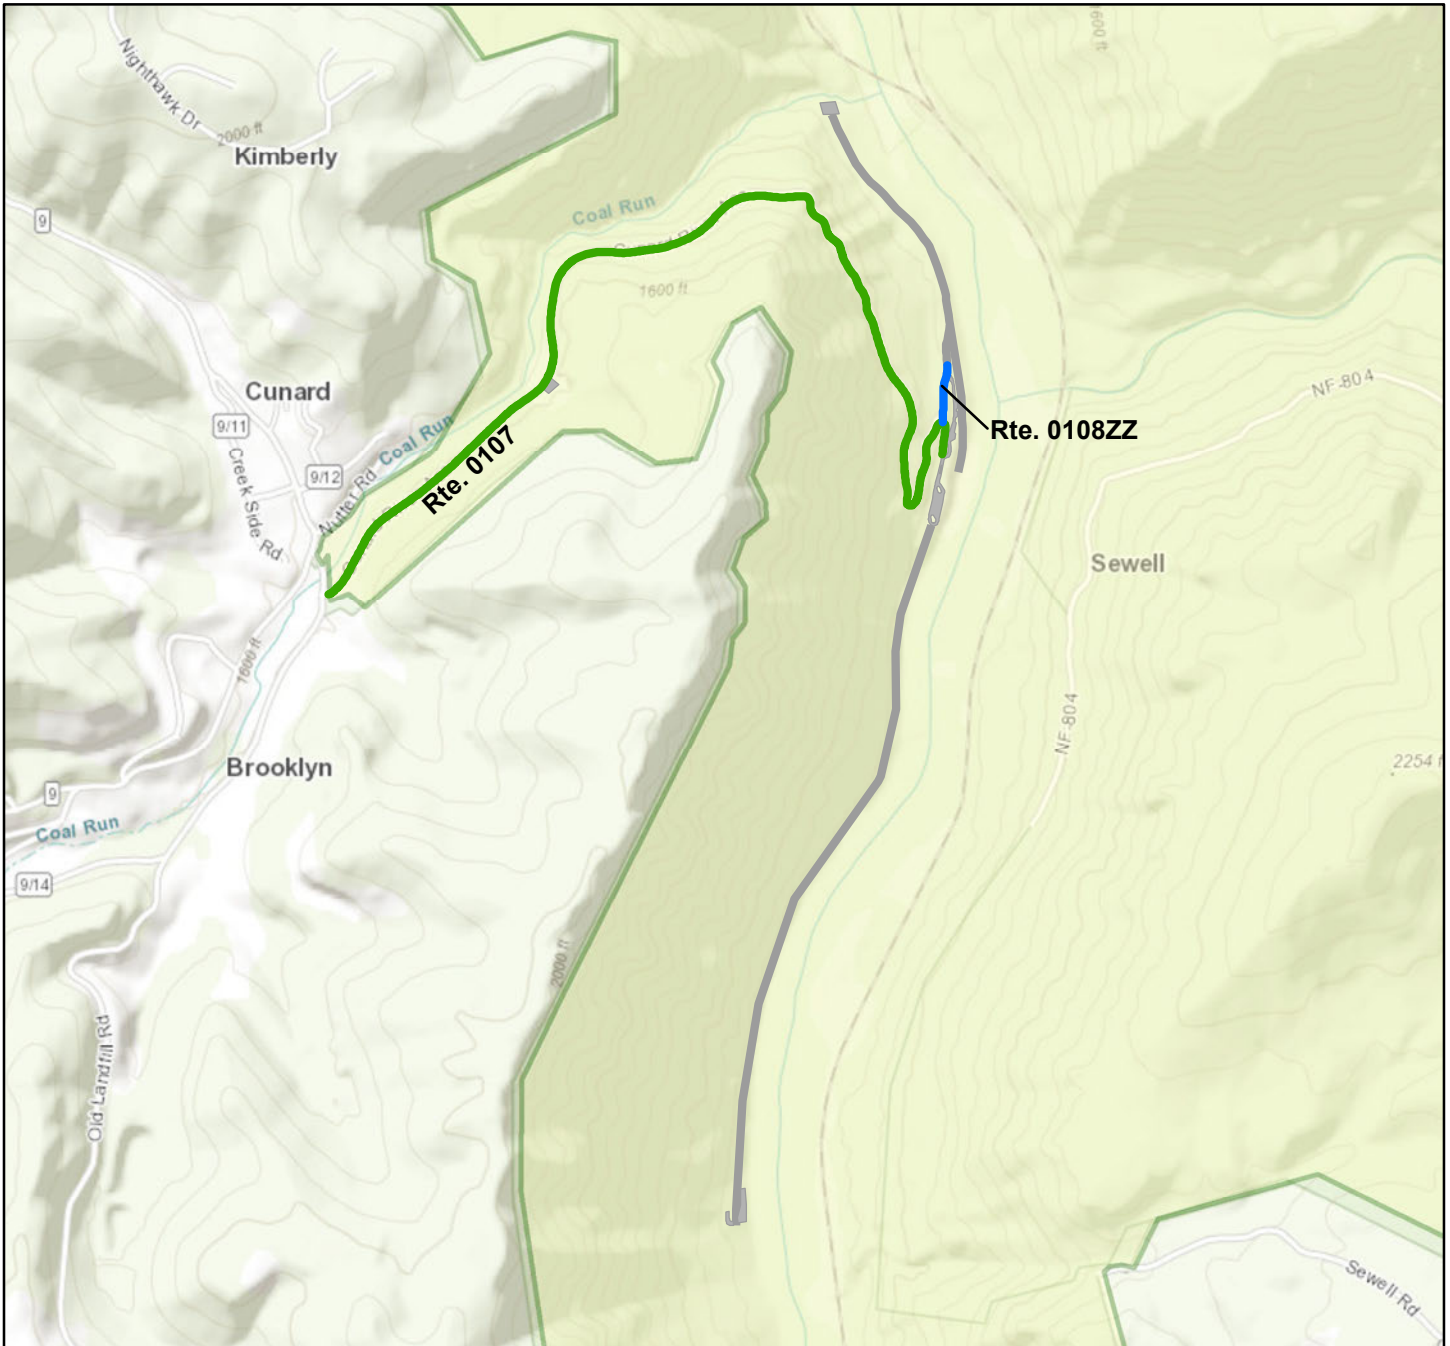
### MAP 2

Colors on map represent condition scores at 1-mile intervals. See Appendix for definitions and formulas  
Only Data Collection Vehicle and Manually Rated Roads are displayed

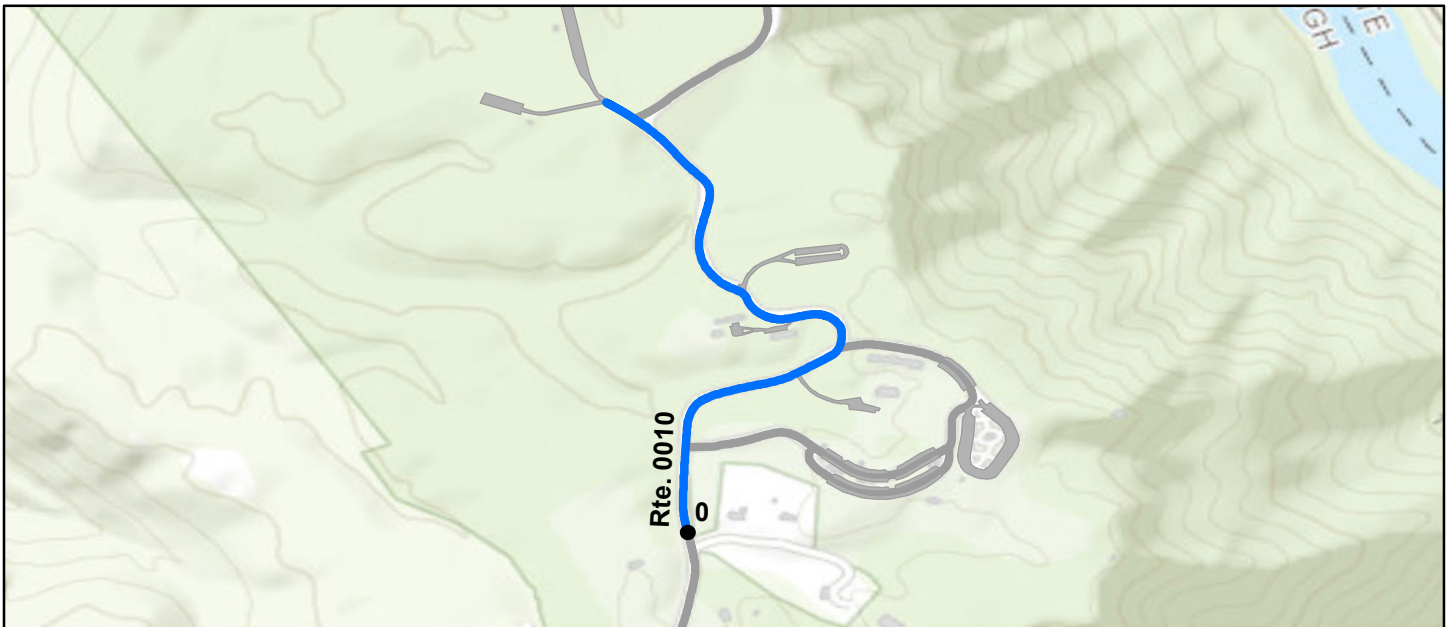
## ROUTE 0010: GRANDVIEW ROAD

Route Condition Legend – Pavement Condition Rating (PCR)						
Poor (0 - 60)	Fair (61- 84)	Good (85 - 94)	Excellent (95 - 100)	Not Rated		
Colors on map represent condition scores at 0.10-mile intervals. See Appendix for definitions and formulas.						
<b>Inspection Date:</b> 7/14/2021	<b>Beginning Section MP</b>	0				
<b>Paved Length (Miles):</b> 0.66	<b>Section Length (MI)</b>	0.66				
<b>Surface Type:</b> ASPHALT	<b>Route Summary</b>					
<b>Roadway Condition Information</b>						
Pavement Condition Rating (PCR)	99	99				
Surface Condition Rating (SCR)	99	99				
Roughness Condition Index (RCI)	N/A	N/A				
<b>Distress Index Values</b>						
Structural Crack Index	99	99				
Alligator Crack Index	100	100				
Longitudinal Crack Index	99	99				
Transverse Cracking Index	100	100				
Patching Index	100	100				
Rutting Index	100	100				
International Roughness Index (IRI)	N/A	N/A				
<b>Lane &amp; Width Information</b>

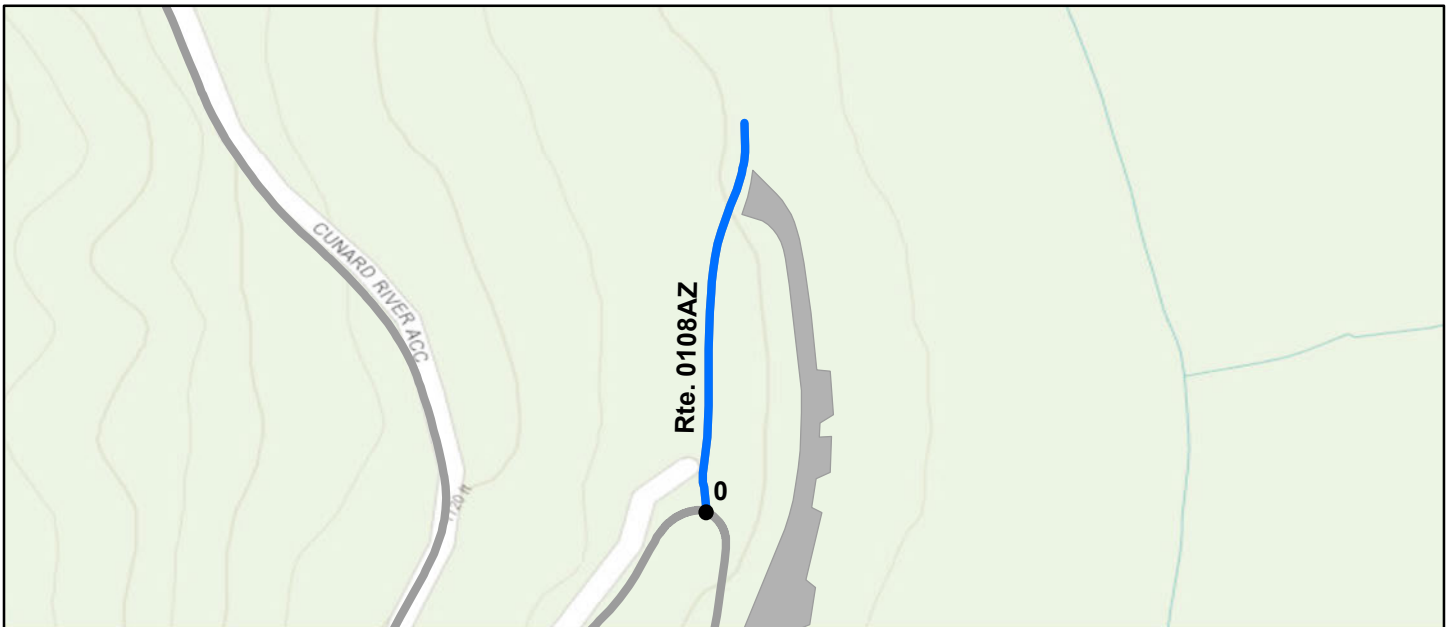
Subcomponent of Route NERI-0108ZZ

Route Condition Legend – Pavement Condition Rating (PCR)						
Poor (0 - 60)	Fair (61- 84)	Good (85 - 94)	Excellent (95 - 100)	Not Rated		
Colors on map represent condition scores at 0.10-mile intervals. See Appendix for definitions and formulas.						
<b>Inspection Date:</b> 7/14/2021	<b>Beginning Section MP</b>	0				
<b>Paved Length (Miles):</b> 0.08	<b>Section Length (MI)</b>	0.08				
<b>Surface Type:</b> ASPHALT	<b>Route Summary</b>					
<b>Roadway Condition Information</b>						
Pavement Condition Rating (PCR)	100	100				
Surface Condition Rating (SCR)	100	100				
Roughness Condition Index (RCI)	N/A	N/A				
<b>Distress Index Values</b>						
Structural Crack Index	100	100				
Alligator Crack Index	100	100				
Longitudinal Crack Index	100	100				
Transverse Cracking Index	100	100				
Patching Index	100	100				
Rutting Index	100	100				
International Roughness Index (IRI)	N/A	N/A				
<b>Lane &amp; Width Information</b>

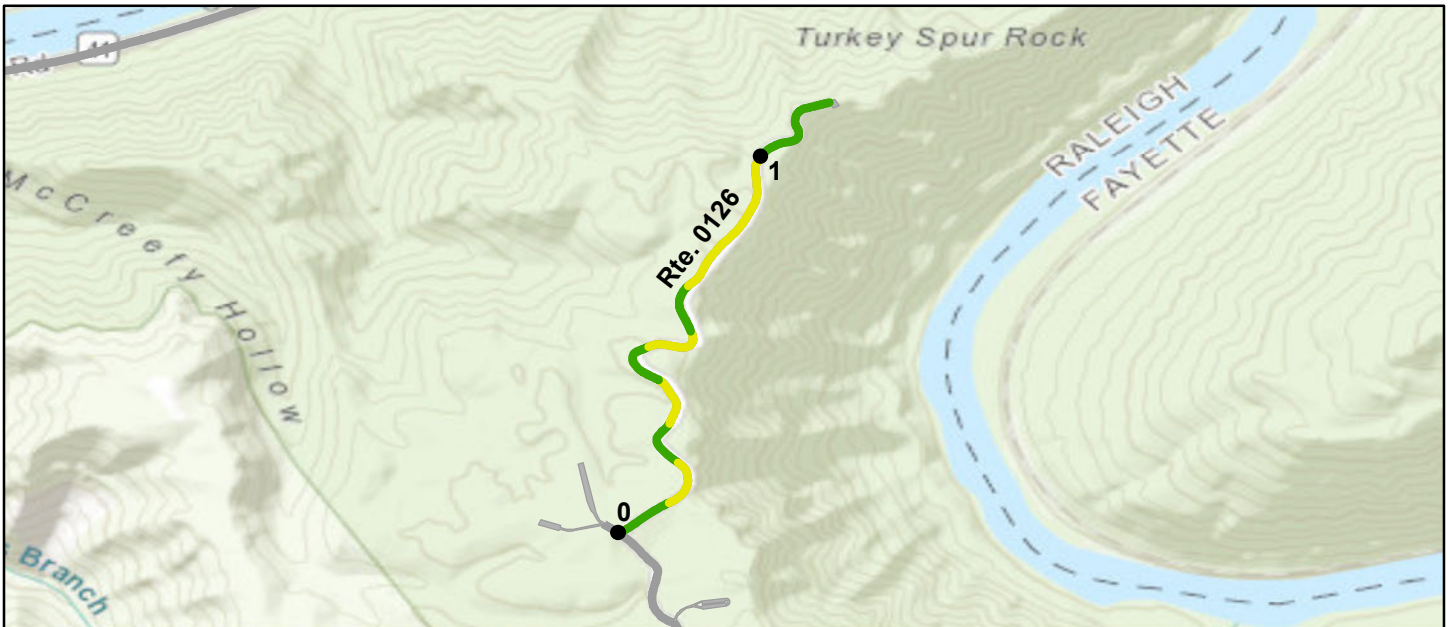
## ROUTE 0126: TURKEY SPUR ROAD

Route Condition Legend – Pavement Condition Rating (PCR)										
Poor (0 - 60)		Fair (61- 84)		Good (85 - 94)		Excellent (95 - 100)		Not Rated		
Colors on map represent condition scores at 0.10-mile intervals. See Appendix for definitions and formulas.										
<b>Inspection Date:</b>	7/14/2021	<b>Beginning Section MP</b>	0	1						
<b>Paved Length (Miles):</b>	1.18	<b>Section Length (MI)</b>	1	0.18						
<b>Surface Type:</b>	ASPHALT	<b>Route Summary</b>								
<b>Roadway Condition Information</b>										
Pavement Condition Rating (PCR)	78	79	92							
Surface Condition Rating (SCR)	93	93	92							
Roughness Condition Index (RCI)	55	58	N/A							
<b>Distress Index Values</b>										
Structural Crack Index	93	93	92							
Alligator Crack Index	98	98	100							
Longitudinal Crack Index	95	95	92							
Transverse Cracking Index	99	99	98							
Patching Index	99	99	99							
Rutting Index	97	97	95

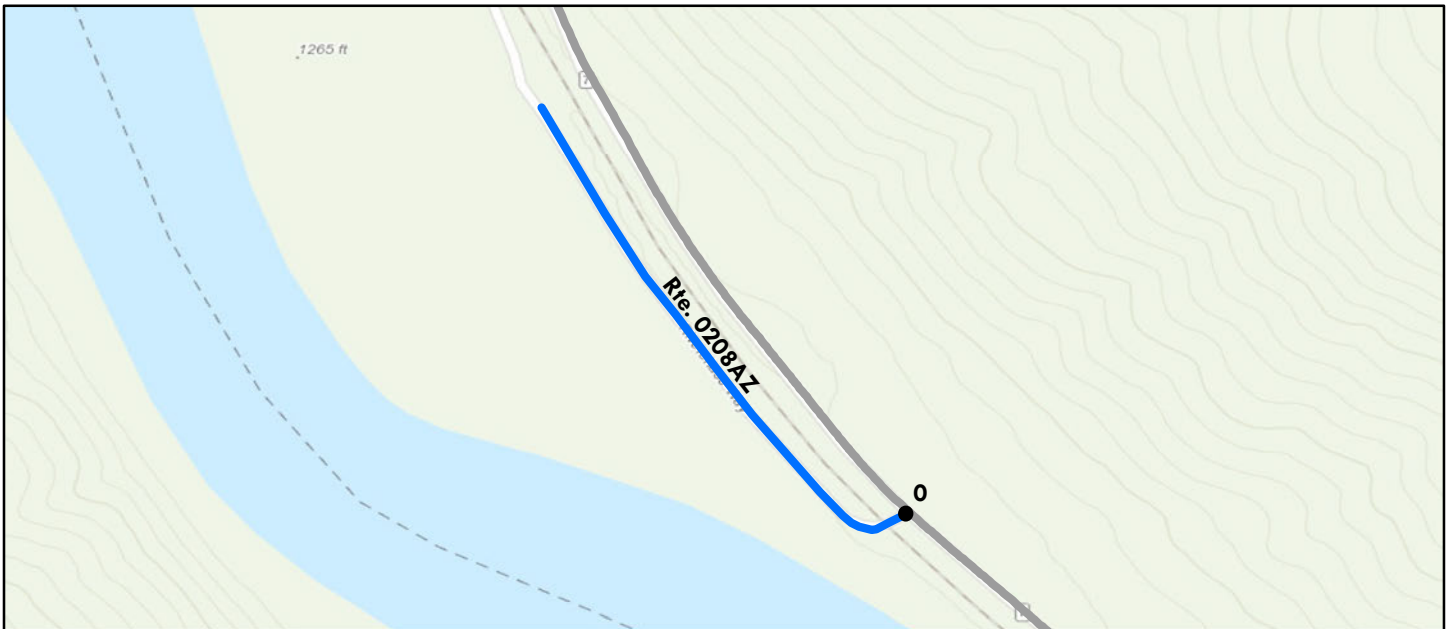
Subcomponent of Route NERI-0208ZZ

<b>Route Condition Legend – Pavement Condition Rating (PCR)</b>						
<b>Poor (0 - 60)</b>	<b>Fair (61- 84)</b>	<b>Good (85 - 94)</b>	<b>Excellent (95 - 100)</b>	<b>Not Rated</b>		
<small>See Appendix for definitions and formulas</small>						
<b>Inspection Date:</b> 10/27/2020	<b>Beginning Section MP</b>	0.00				
<b>Paved Length (Miles):</b> 0.53	<b>Section Length (MI)</b>	0.26				
<b>Surface Type:</b> ASPHALT	<b>Route Summary</b>					
<b>Roadway Condition Information</b>						
Pavement Condition Rating (PCR)	97	97				
Surface Condition Rating (SCR)	97	97				
Roughness Condition Index (RCI)	N/A	N/A				
<b>Distress Index Values</b>						
Structural Crack Index	N/A	N/A				
Alligator Crack Index	97	97				
Longitudinal Crack Index	97	97				
Transverse Cracking Index	97	97				
Patching Index	97	97				
Rutting Index	97	97				
International Roughness Index (IRI)	N/A	N/A				
<b>Lane &amp; Width Information</b>

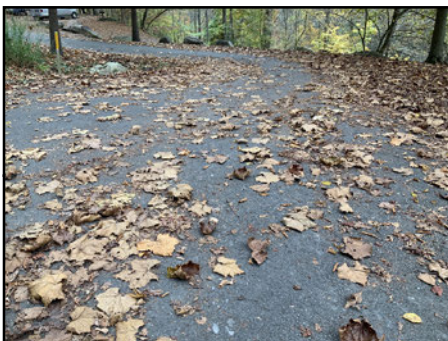
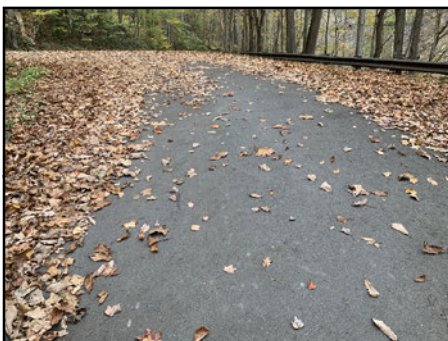
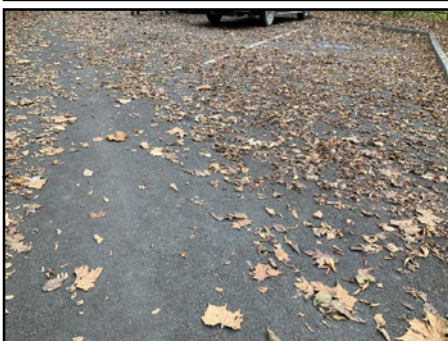
NOTE: PARKING NOT RATED - PAVEMENT COVERED BY LEAVES.

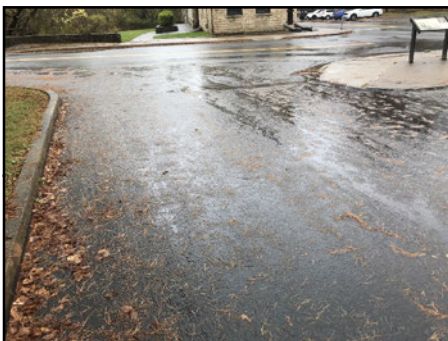
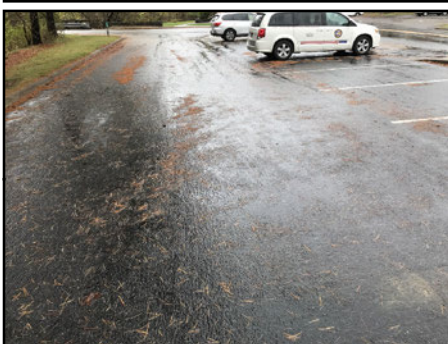
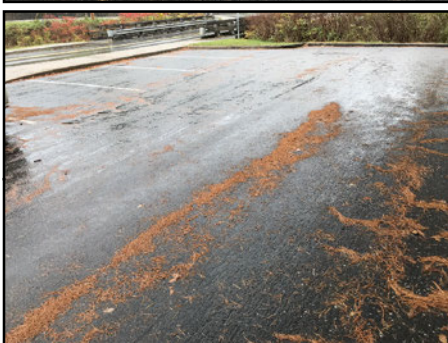
Inspection Date	FMSS Number	User Access	Surface Type
10/29/2020	13268	PUBLIC	ASPHALT
Area (Sq. Ft.)	Lane Miles (11' Widths)	Curb Reveal (Inches)	Curb Recommendation
5,168	0.089	5	DO NOTHING
Curb Type		Curb & Gutter Type	
CONCRETE		NO CURB AND GUTTER	
Pavement Recommendation		Condition Rating / PCR	
PREVENTIVE MAINTENANCE		GOOD / 90

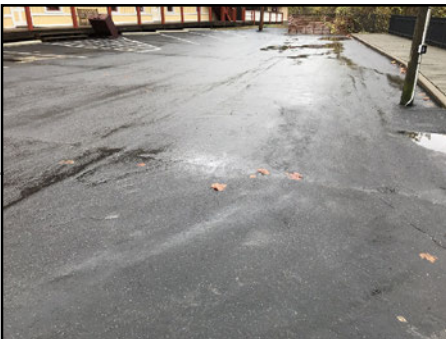
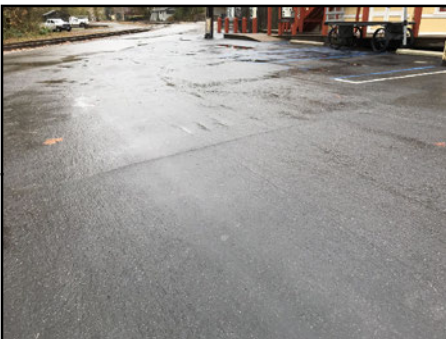
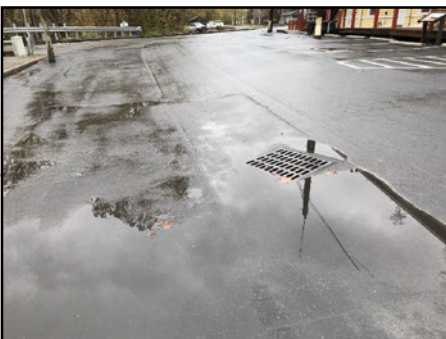
Inspection Date	FMSS Number	User Access	Surface Type
10/27/2020	53957	NONPUBLIC	ASPHALT
Area (Sq. Ft.)	Lane Miles (11' Widths)	Curb Reveal (Inches)	Curb Recommendation
14,990	0.258	NOT APPLICABLE	NOT APPLICABLE
Curb Type		Curb & Gutter Type	
NO CURB		NO CURB AND GUTTER	
Pavement Recommendation		Condition Rating / PCR	
LIGHT 3R TREATMENTS		FAIR / 73

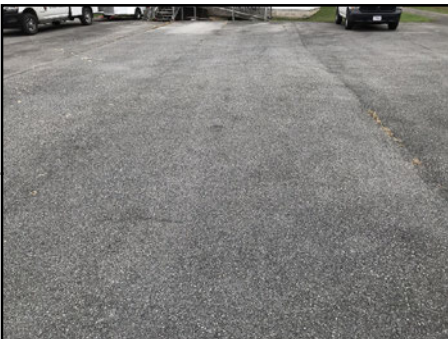
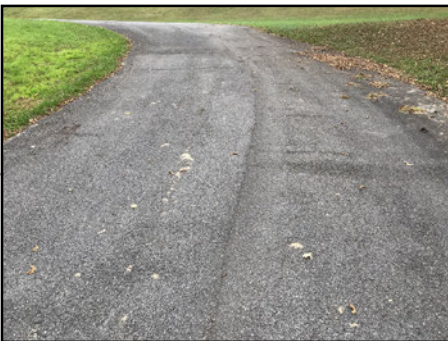
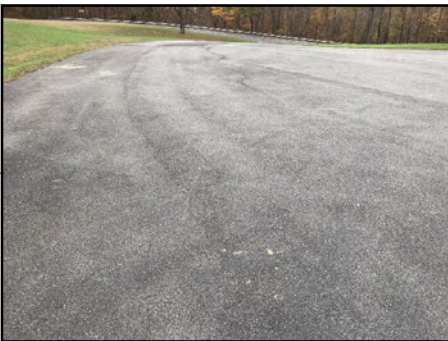
Inspection Date	FMSS Number	User Access	Surface Type
10/28/2020	53973	NONPUBLIC	ASPHALT
Area (Sq. Ft.)	Lane Miles (11' Widths)	Curb Reveal (Inches)	Curb Recommendation
11,356	0.196	3	DO NOTHING
Curb Type		Curb & Gutter Type	
ASPHALT		NO CURB AND GUTTER	
Pavement Recommendation		Condition Rating / PCR	
NOT APPLICABLE		NOT RATED

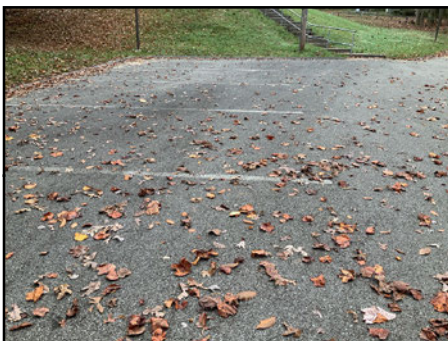
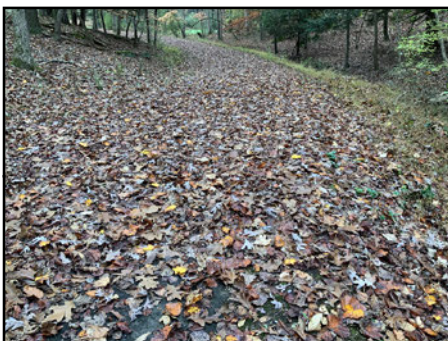
NOTE: PARKING NOT RATED - PAVEMENT COVERED BY LEAVES.

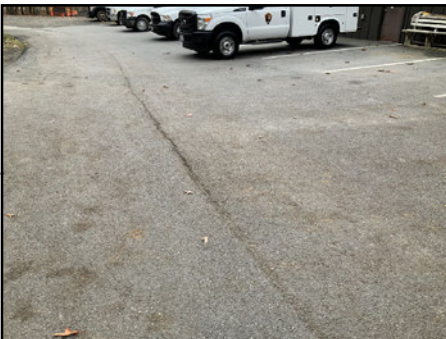
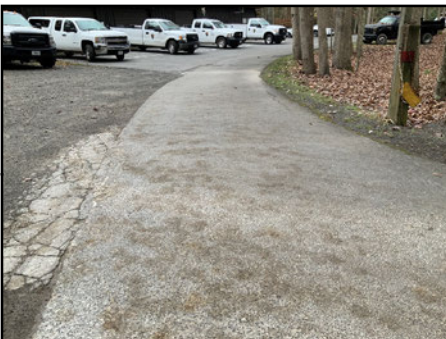
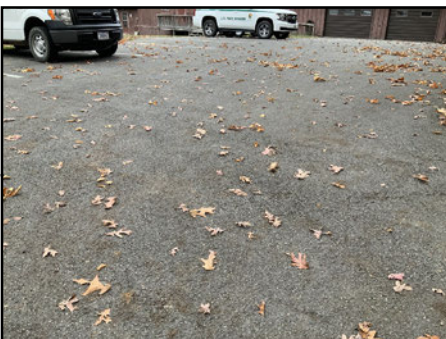
Inspection Date	FMSS Number	User Access	Surface Type
10/28/2020	53959	PUBLIC	ASPHALT
Area (Sq. Ft.)	Lane Miles (11' Widths)	Curb Reveal (Inches)	Curb Recommendation
23,713	0.408	NOT APPLICABLE	NOT APPLICABLE
Curb Type		Curb & Gutter Type	
NO CURB		NO CURB AND GUTTER	
Pavement Recommendation		Condition Rating / PCR	
PREVENTIVE MAINTENANCE		GOOD / 90

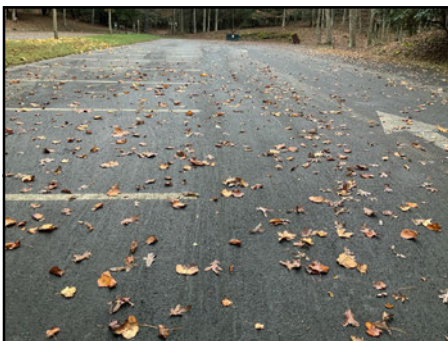
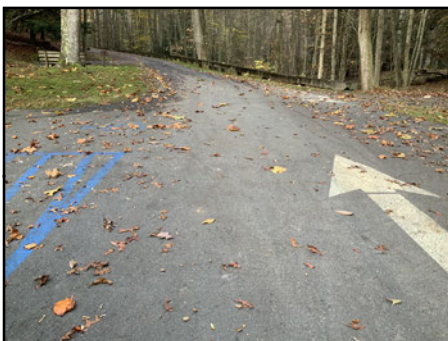
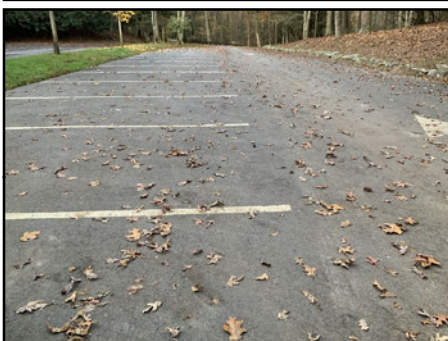
Inspection Date	FMSS Number	User Access	Surface Type
10/28/2020	53958	PUBLIC	ASPHALT
Area (Sq. Ft.)	Lane Miles (11' Widths)	Curb Reveal (Inches)	Curb Recommendation
4,631	0.08	NOT APPLICABLE	NOT APPLICABLE
Curb Type		Curb & Gutter Type	
NO CURB		NO CURB AND GUTTER	
Pavement Recommendation		Condition Rating / PCR	
LIGHT 3R TREATMENTS		FAIR / 73

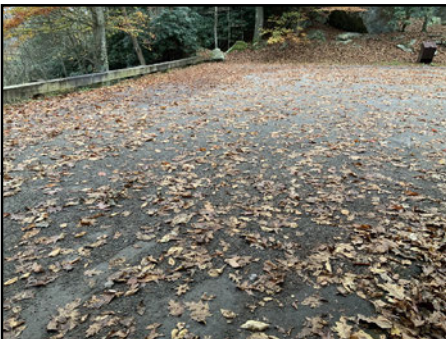
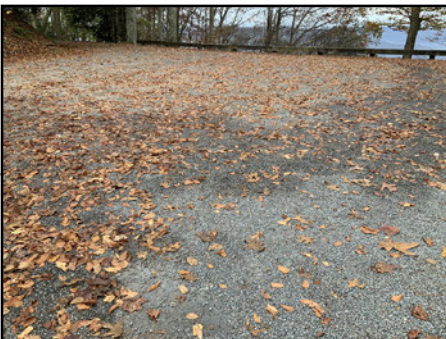
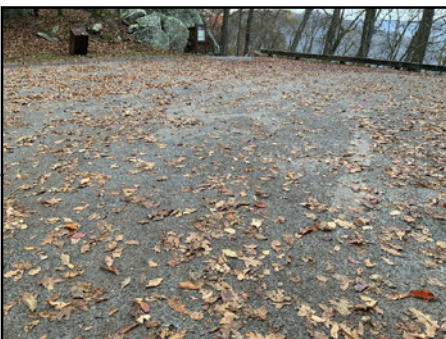
Inspection Date	FMSS Number	User Access	Surface Type
10/28/2020	53960	PUBLIC	ASPHALT
Area (Sq. Ft.)	Lane Miles (11' Widths)	Curb Reveal (Inches)	Curb Recommendation
29,688	0.511	NOT APPLICABLE	NOT APPLICABLE
Curb Type		Curb & Gutter Type	
NO CURB		NO CURB AND GUTTER	
Pavement Recommendation		Condition Rating / PCR	
PREVENTIVE MAINTENANCE		GOOD / 90

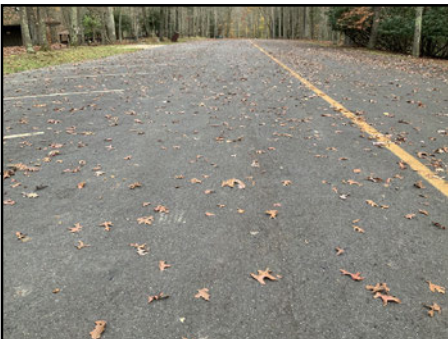
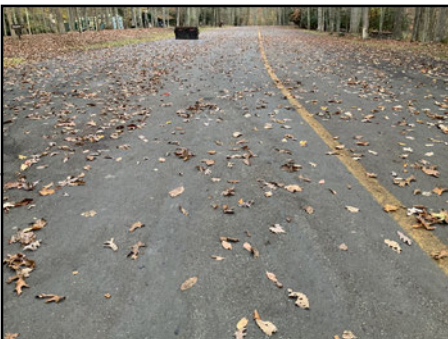
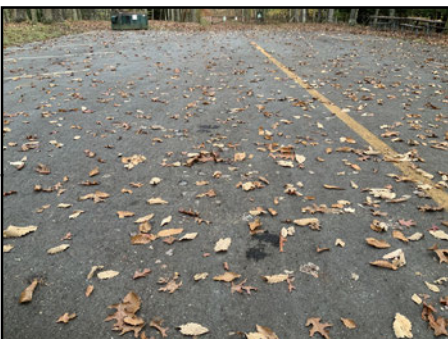
Inspection Date	FMSS Number	User Access	Surface Type
10/28/2020	53961	PUBLIC	ASPHALT
Area (Sq. Ft.)	Lane Miles (11' Widths)	Curb Reveal (Inches)	Curb Recommendation
18,191	0.313	NOT APPLICABLE	NOT APPLICABLE
Curb Type		Curb & Gutter Type	
NO CURB		NO CURB AND GUTTER	
Pavement Recommendation		Condition Rating / PCR	
NOT APPLICABLE		NOT RATED

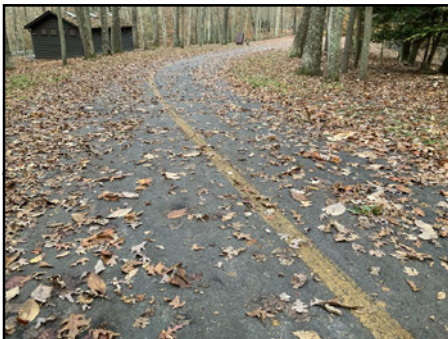
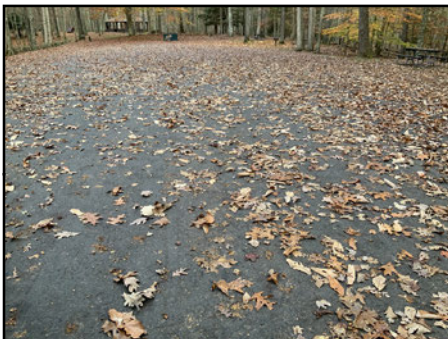
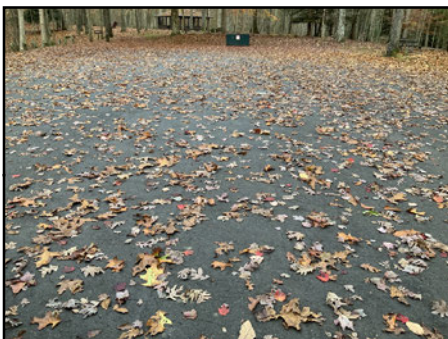
NOTE: PARKING NOT RATED - PAVEMENT COVERED BY LEAVES.

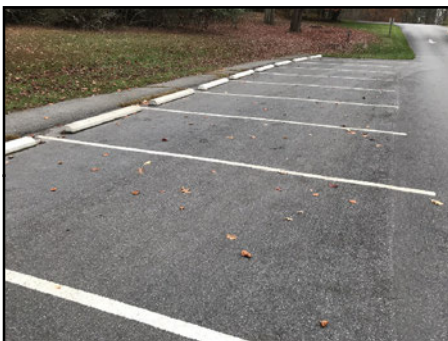
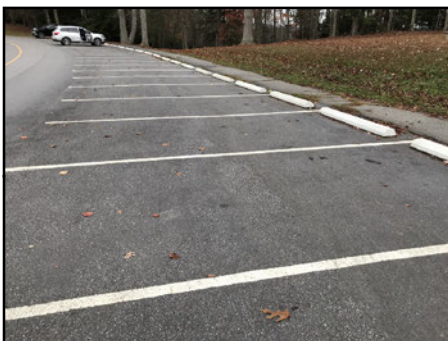
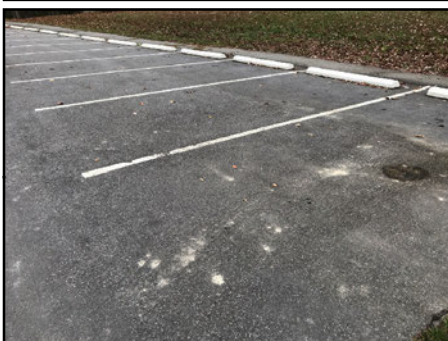
Inspection Date	FMSS Number	User Access	Surface Type
10/28/2020	53962	PUBLIC	ASPHALT
Area (Sq. Ft.)	Lane Miles (11' Widths)	Curb Reveal (Inches)	Curb Recommendation
4,847	0.083	NOT APPLICABLE	NOT APPLICABLE
Curb Type		Curb & Gutter Type	
NO CURB		NO CURB AND GUTTER	
Pavement Recommendation		Condition Rating / PCR	
PREVENTIVE MAINTENANCE		GOOD / 90

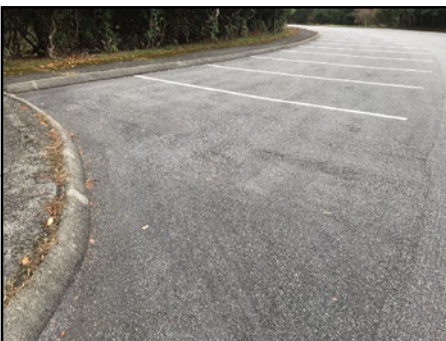
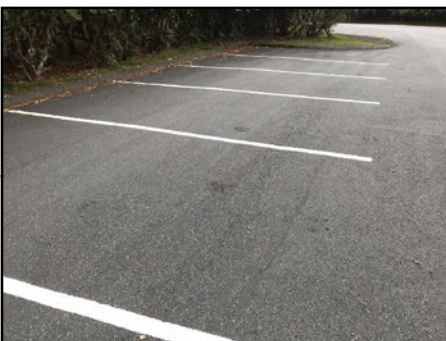
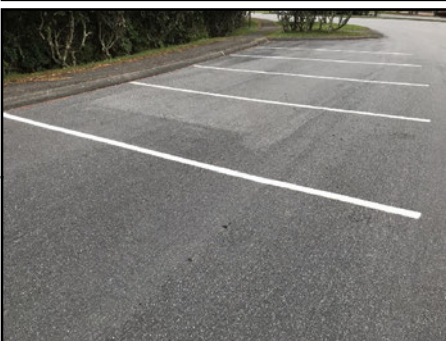
Inspection Date	FMSS Number	User Access	Surface Type
10/28/2020	53965	PUBLIC	ASPHALT
Area (Sq. Ft.)	Lane Miles (11' Widths)	Curb Reveal (Inches)	Curb Recommendation
6,961	0.12	6	LIGHT REPAIR
Curb Type		Curb & Gutter Type	
ASPHALT		NO CURB AND GUTTER	
Pavement Recommendation		Condition Rating / PCR	
LIGHT 3R TREATMENTS		FAIR / 73

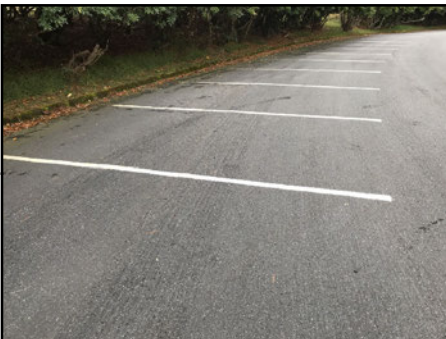
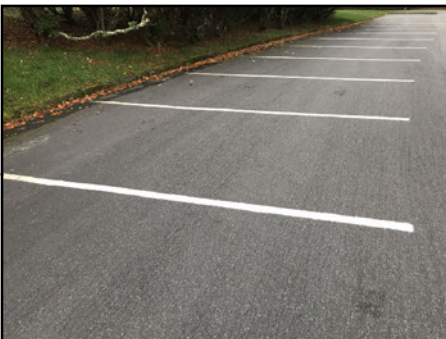
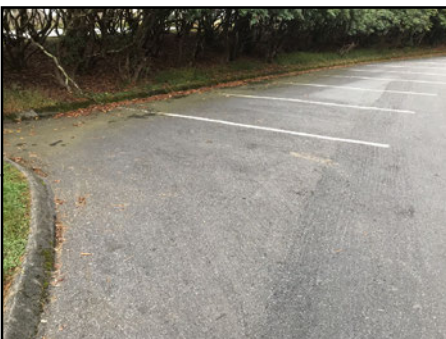
## ROUTE 0967CZ: GRANDVIEW OVERFLOW C PARKING

Inspection Date	FMSS Number	User Access	Surface Type
10/28/2020	53965	PUBLIC	ASPHALT
Area (Sq. Ft.)	Lane Miles (11' Widths)	Curb Reveal (Inches)	Curb Recommendation
6,251	0.108	6	LIGHT REPAIR
Curb Type		Curb & Gutter Type	
ASPHALT		NO CURB AND GUTTER	
Pavement Recommendation		Condition Rating / PCR	
LIGHT 3R TREATMENTS		FAIR / 73

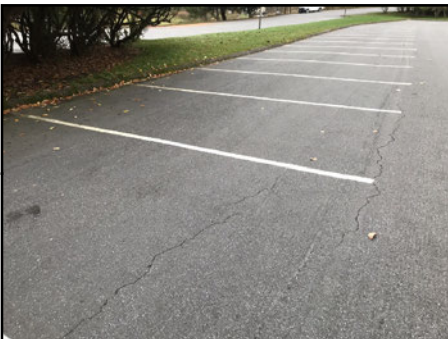
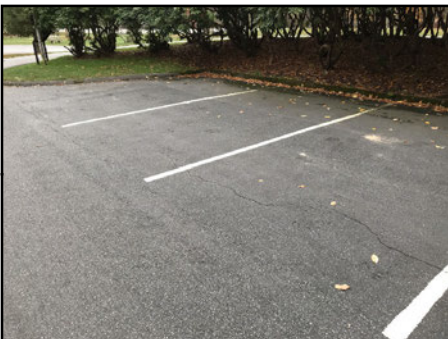
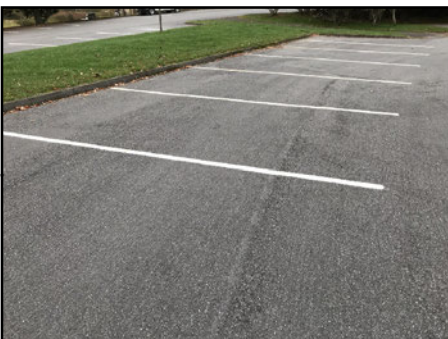
## ROUTE 0967DZ: GRANDVIEW OVERFLOW D PARKING

Inspection Date	FMSS Number	User Access	Surface Type
10/28/2020	53965	PUBLIC	ASPHALT
Area (Sq. Ft.)	Lane Miles (11' Widths)	Curb Reveal (Inches)	Curb Recommendation
4,732	0.081	6	LIGHT REPAIR
Curb Type		Curb & Gutter Type	
ASPHALT		NO CURB AND GUTTER	
Pavement Recommendation		Condition Rating / PCR	
LIGHT 3R TREATMENTS		FAIR / 73

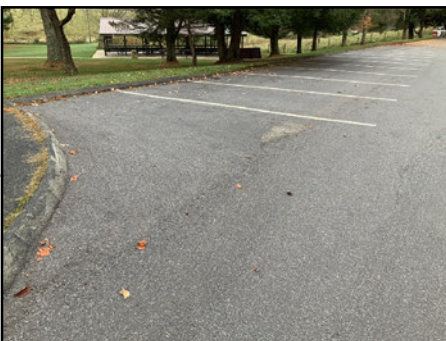
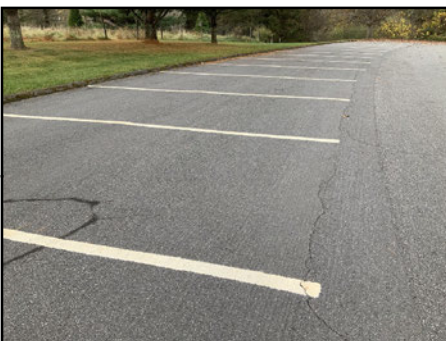
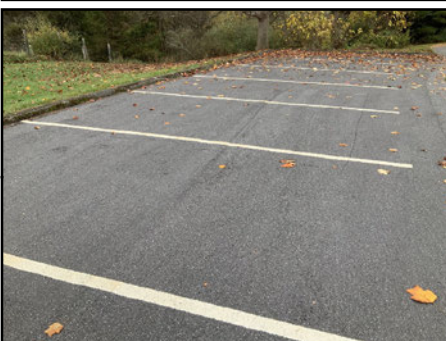
## ROUTE 0967EZ: GRANDVIEW OVERFLOW E PARKING

Inspection Date	FMSS Number	User Access	Surface Type
10/28/2020	53965	PUBLIC	ASPHALT
Area (Sq. Ft.)	Lane Miles (11' Widths)	Curb Reveal (Inches)	Curb Recommendation
12,142	0.209	4	DO NOTHING
Curb Type		Curb & Gutter Type	
ASPHALT		NO CURB AND GUTTER	
Pavement Recommendation		Condition Rating / PCR	
PREVENTIVE MAINTENANCE		GOOD / 90

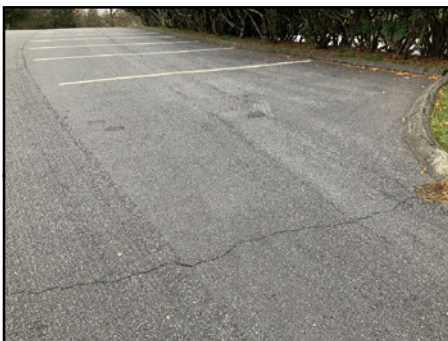
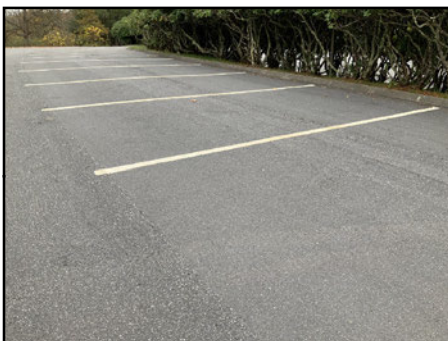
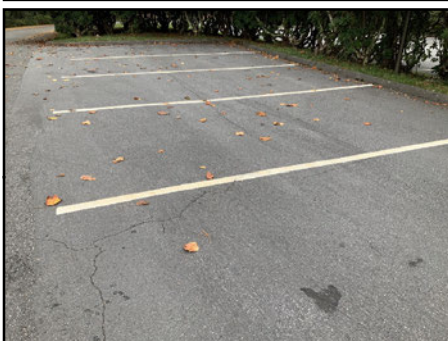
## ROUTE 0967FZ: GRANDVIEW OVERFLOW F PARKING

Inspection Date	FMSS Number	User Access	Surface Type
10/28/2020	53965	PUBLIC	ASPHALT
Area (Sq. Ft.)	Lane Miles (11' Widths)	Curb Reveal (Inches)	Curb Recommendation
6,066	0.104	3	DO NOTHING
Curb Type		Curb & Gutter Type	
ASPHALT		NO CURB AND GUTTER	
Pavement Recommendation		Condition Rating / PCR	
PREVENTIVE MAINTENANCE		GOOD / 90

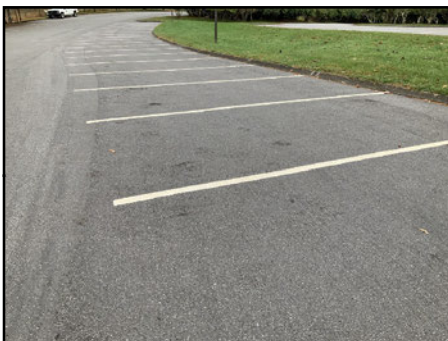
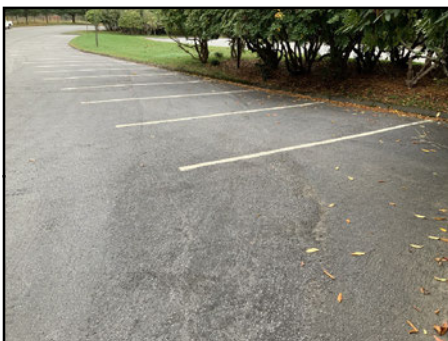
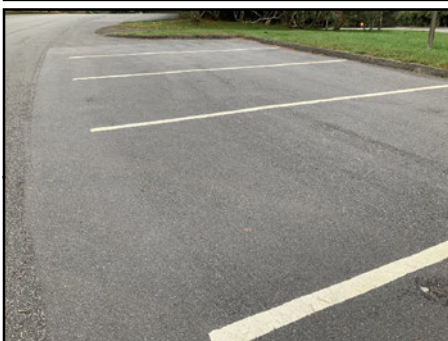
## ROUTE 0967GZ: GRANDVIEW OVERFLOW G PARKING

Inspection Date	FMSS Number	User Access	Surface Type
10/28/2020	53965	PUBLIC	ASPHALT
Area (Sq. Ft.)	Lane Miles (11' Widths)	Curb Reveal (Inches)	Curb Recommendation
4,815	0.083	3	DO NOTHING
Curb Type		Curb & Gutter Type	
ASPHALT		NO CURB AND GUTTER	
Pavement Recommendation		Condition Rating / PCR	
PREVENTIVE MAINTENANCE		GOOD / 90

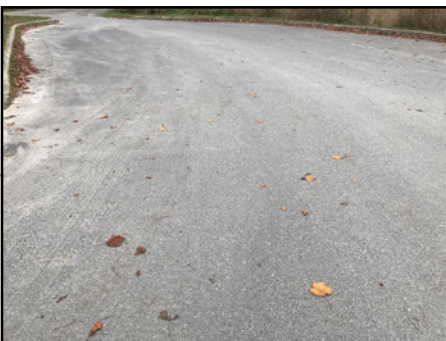
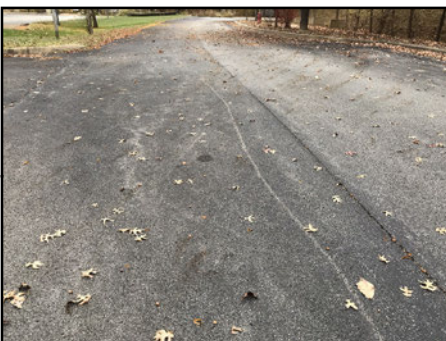
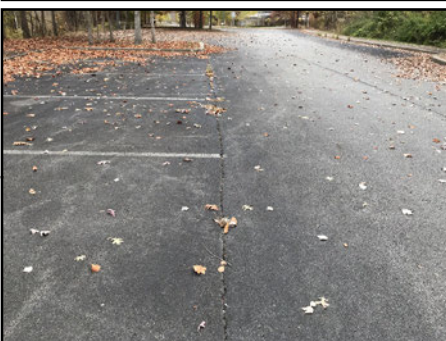
## ROUTE 0968: SANDSTONE VISITOR CENTER PARKING

Inspection Date	FMSS Number	User Access	Surface Type
10/27/2020	56828	PUBLIC	ASPHALT
Area (Sq. Ft.)	Lane Miles (11' Widths)	Curb Reveal (Inches)	Curb Recommendation
63,458	1.093	7	DO NOTHING
Curb Type		Curb & Gutter Type	
CONCRETE		NO CURB AND GUTTER	
Pavement Recommendation		Condition Rating / PCR	
LIGHT 3R TREATMENTS		FAIR / 73

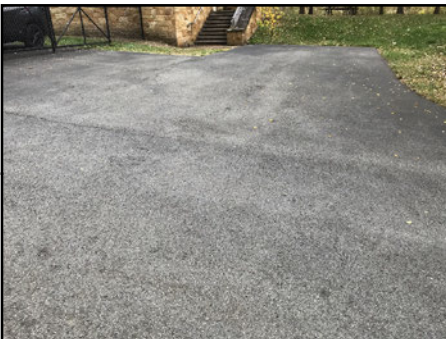
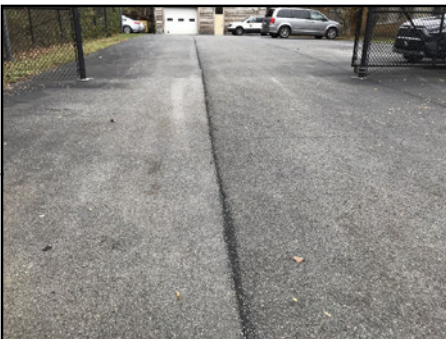
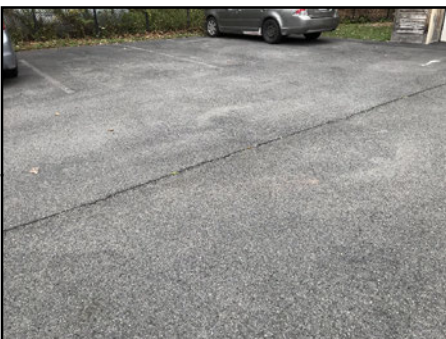
## ROUTE 0981: SANDSTONE ADMINISTRATIVE PARKING

Inspection Date	FMSS Number	User Access	Surface Type
10/27/2020	254862	NONPUBLIC	ASPHALT
Area (Sq. Ft.)	Lane Miles (11' Widths)	Curb Reveal (Inches)	Curb Recommendation
11,858	0.204	NOT APPLICABLE	NOT APPLICABLE
Curb Type		Curb & Gutter Type	
NO CURB		NO CURB AND GUTTER	
Pavement Recommendation		Condition Rating / PCR	
PREVENTIVE MAINTENANCE		GOOD / 90
