# NOCA Cycle 6

## Final Report

### Road Inventory and Condition Assessment of Paved Routes North Cascades National Park

Report Date: April 2016

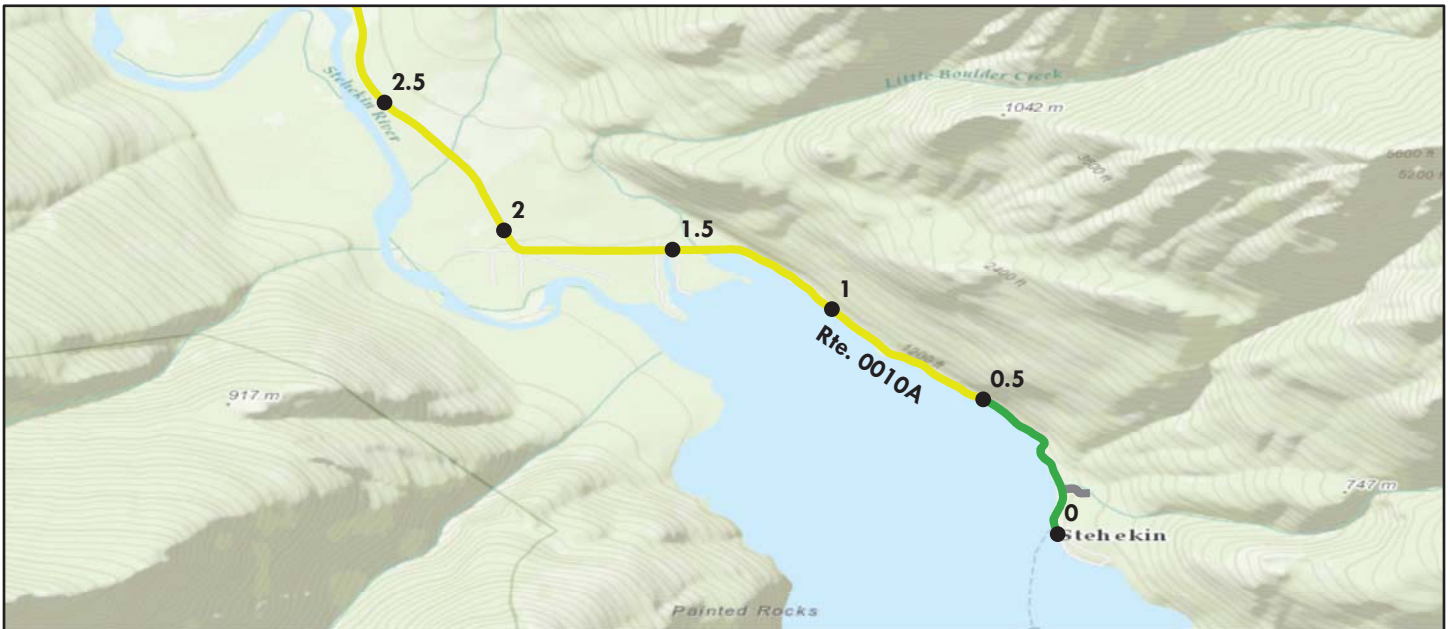
### Manual Rating

<b>Route Condition Legend – Pavement Condition Rating (PCR)</b>						
Poor (0 - 60)	Fair (61- 84)	Good (85 - 94)	Excellent (95 - 100)	Not Rated		
See Appendix for definitions and formulas						
<b>Inspection Date:</b> 6/19/2015	<b>Beginning Section MP</b>	0.00	0.50	1.00	1.50	2.00
<b>Paved Length (Miles):</b> 4.31	<b>Section Length (MI)</b>	0.50	0.50	0.50	0.50	0.50
<b>Surface Type:</b> ASPHALT	<b>Route Summary</b>					
<b>Roadway Condition Information</b>						
Pavement Condition Rating (PCR)	77	93	83	65	71	78
Surface Condition Rating (SCR)	77	93	83	65	71	78
Roughness Condition Index (RCI)	N/A	N/A	N/A	N/A	N/A	N/A
<b>Distress Index Values</b>						
Structural Crack Index	77	93	83	65	71	78
Alligator Crack Index	78	94	84	67	72	79
Longitudinal Crack Index	99	99	99	98	99	99
Transverse Cracking Index	100	100	100	100	100	100
Patching Index	94	93	98	97	95	94
Rutting Index	100	100	100	100	100	100
International Roughness Index (IRI)	N/A	N/A	N/A	N/A	N/A	N/A

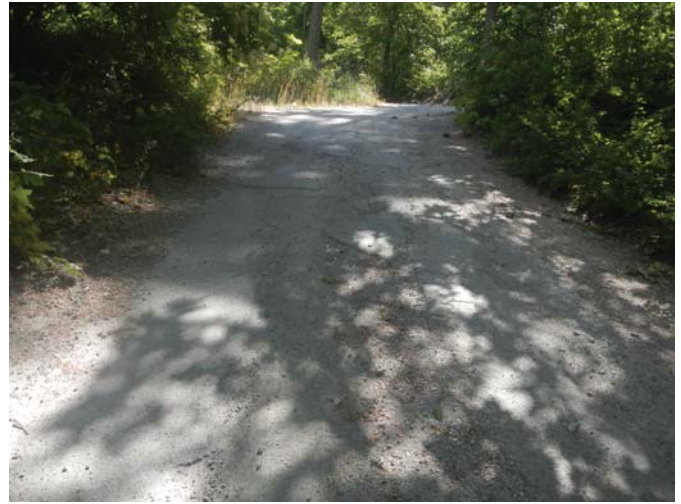
**NOCA\_0400\_0873.JPG**

Note: Individual pavement distresses could not be identified due to the route being in very poor condition and almost unpaved.

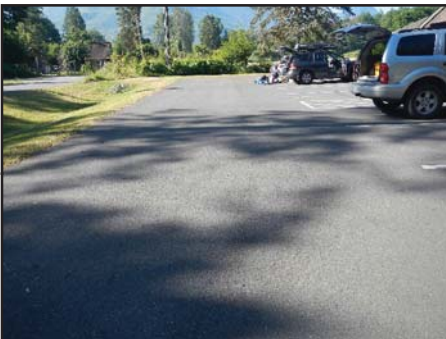
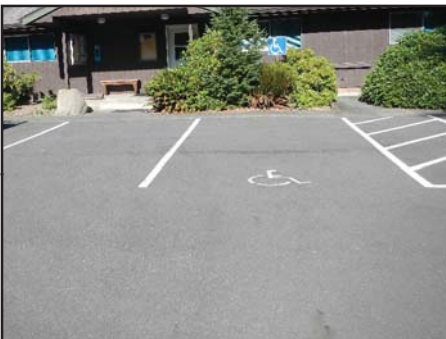
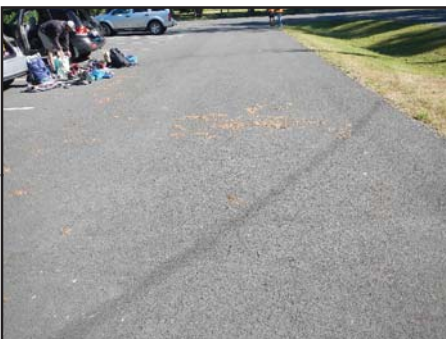
Inspection Date	FMSS Number	User Access	Surface Type
6/17/2015	16690	PUBLIC	ASPHALT
Area (Sq. Ft.)	Lane Miles (11' Widths)	Curb Reveal (Inches)	Curb Recommendation
4,490	0.077	NOT APPLICABLE	NOT APPLICABLE
Curb Type		Curb & Gutter Type	
NO CURB		NO CURB AND GUTTER	
Pavement Recommendation		Condition Rating / PCR	
DO NOTHING		EXCELLENT / 97

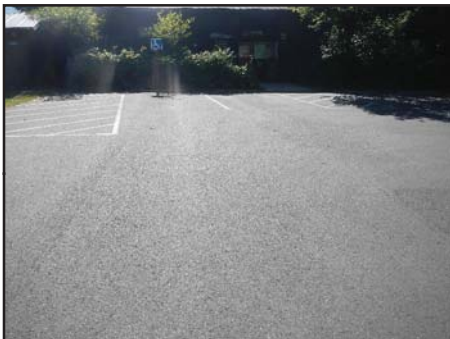
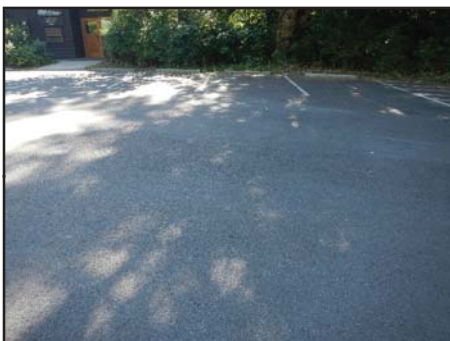
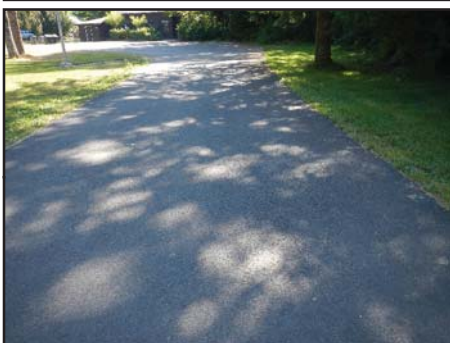
## ROUTE 0900B: MARBLEMOUNT WIC PARKING

Inspection Date	FMSS Number	User Access	Surface Type
6/17/2015	60418	PUBLIC	ASPHALT
Area (Sq. Ft.)	Lane Miles (11' Widths)	Curb Reveal (Inches)	Curb Recommendation
7,834	0.135	NOT APPLICABLE	NOT APPLICABLE
Curb Type		Curb & Gutter Type	
NO CURB		NO CURB AND GUTTER	
Pavement Recommendation		Condition Rating / PCR	
DO NOTHING		EXCELLENT / 97

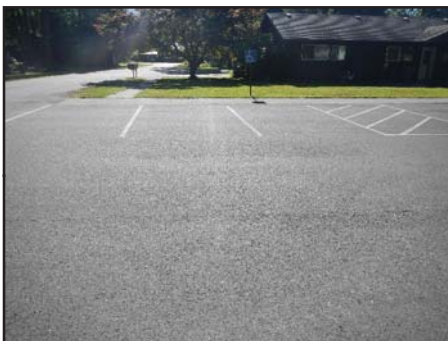
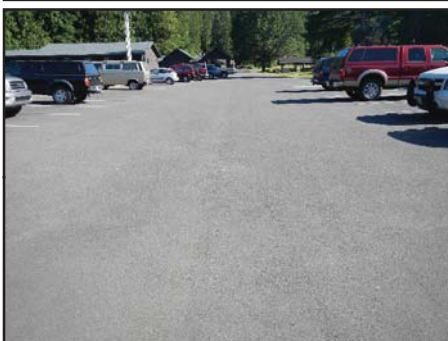
Inspection Date	FMSS Number	User Access	Surface Type
6/17/2015	108073	NONPUBLIC	ASPHALT
Area (Sq. Ft.)	Lane Miles (11' Widths)	Curb Reveal (Inches)	Curb Recommendation
11,041	0.19	NOT APPLICABLE	NOT APPLICABLE
Curb Type		Curb & Gutter Type	
NO CURB		NO CURB AND GUTTER	
Pavement Recommendation		Condition Rating / PCR	
DO NOTHING		EXCELLENT / 97

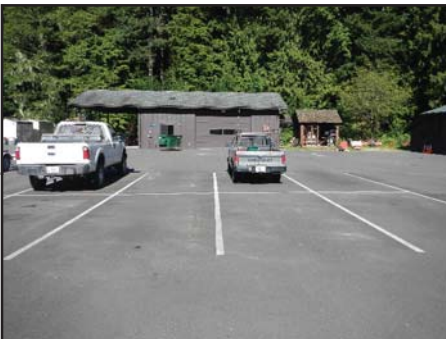
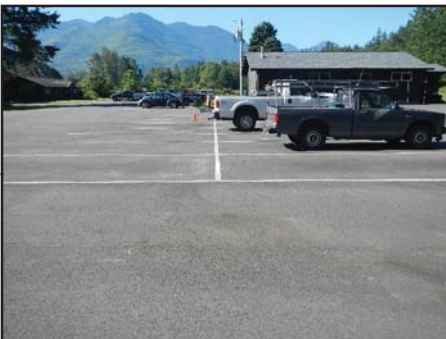
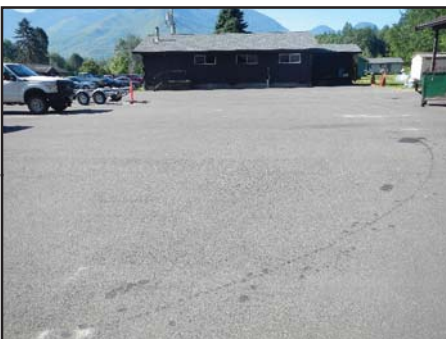
## ROUTE 0900D: MARBLEMOUNT SHOP PARKING

Inspection Date	FMSS Number	User Access	Surface Type
6/17/2015	108074	NONPUBLIC	ASPHALT
Area (Sq. Ft.)	Lane Miles (11' Widths)	Curb Reveal (Inches)	Curb Recommendation
14,666	0.253	NOT APPLICABLE	NOT APPLICABLE
Curb Type		Curb & Gutter Type	
NO CURB		NO CURB AND GUTTER	
Pavement Recommendation		Condition Rating / PCR	
DO NOTHING		EXCELLENT / 97

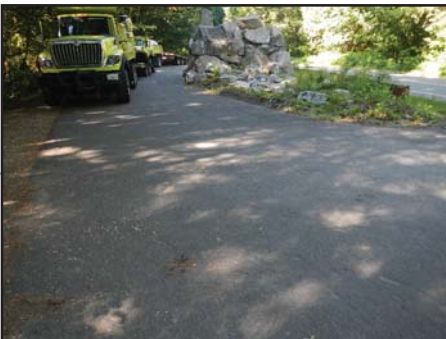
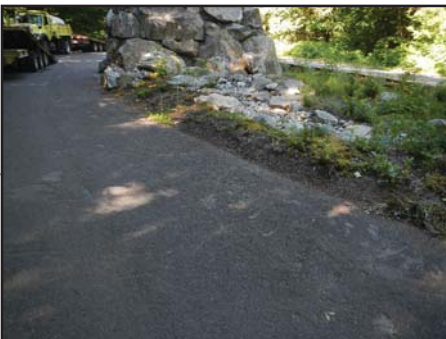
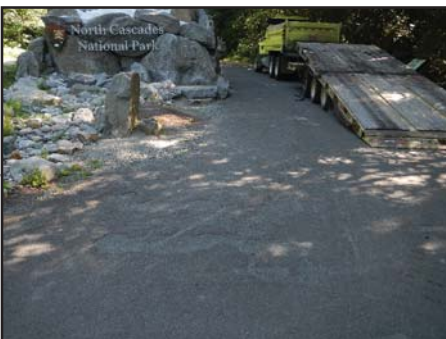
## ROUTE 0901: WEST ENTRANCE SIGN PARKING

Inspection Date	FMSS Number	User Access	Surface Type
6/17/2015	60552	PUBLIC	ASPHALT
Area (Sq. Ft.)	Lane Miles (11' Widths)	Curb Reveal (Inches)	Curb Recommendation
5,561	0.096	NOT APPLICABLE	NOT APPLICABLE
Curb Type		Curb & Gutter Type	
NO CURB		NO CURB AND GUTTER	
Pavement Recommendation		Condition Rating / PCR	
PREVENTIVE MAINTENANCE		GOOD / 90

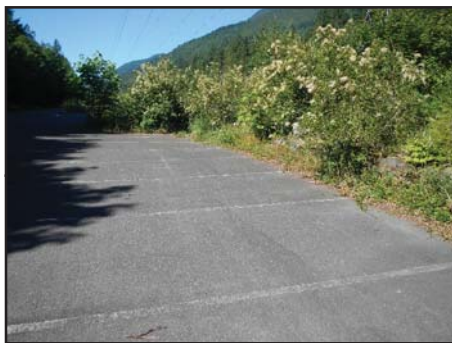
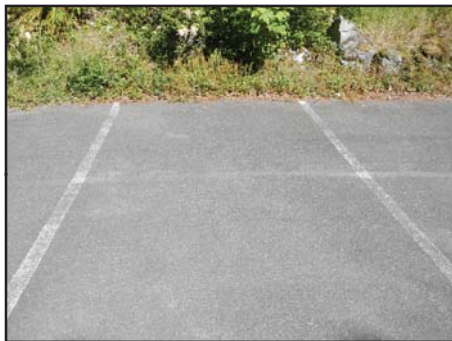
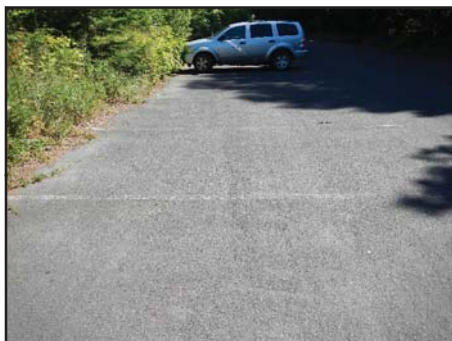
## ROUTE 0902A: GOODELL CREEK RAFT LAUNCH PARKING A

Inspection Date	FMSS Number	User Access	Surface Type
6/17/2015	114649	PUBLIC	ASPHALT
Area (Sq. Ft.)	Lane Miles (11' Widths)	Curb Reveal (Inches)	Curb Recommendation
2,557	0.044	NOT APPLICABLE	NOT APPLICABLE
Curb Type		Curb & Gutter Type	
NO CURB		NO CURB AND GUTTER	
Pavement Recommendation		Condition Rating / PCR	
PREVENTIVE MAINTENANCE		GOOD / 90

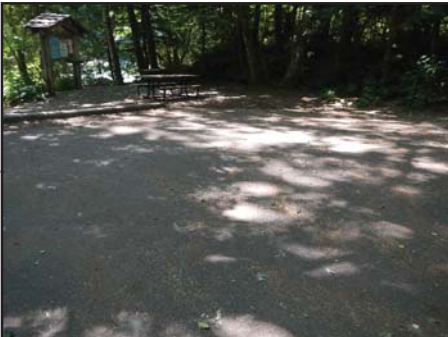
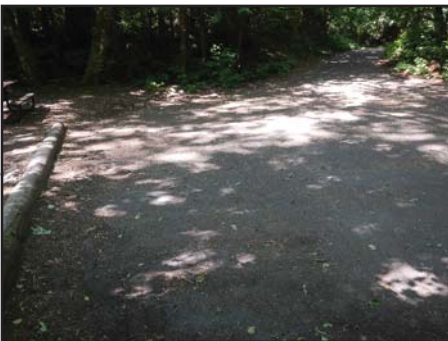
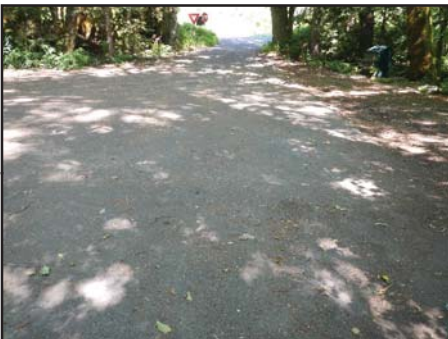
## ROUTE 0902B: GOODELL CREEK RAFT LAUNCH PARKING B

Inspection Date	FMSS Number	User Access	Surface Type
6/17/2015	108075	PUBLIC	ASPHALT
Area (Sq. Ft.)	Lane Miles (11' Widths)	Curb Reveal (Inches)	Curb Recommendation
1,946	0.034	NOT APPLICABLE	NOT APPLICABLE
Curb Type		Curb & Gutter Type	
NO CURB		NO CURB AND GUTTER	
Pavement Recommendation		Condition Rating / PCR	
PREVENTIVE MAINTENANCE		GOOD / 90

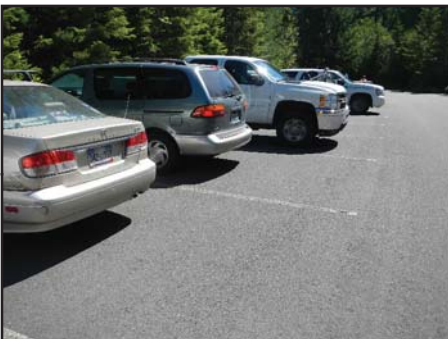
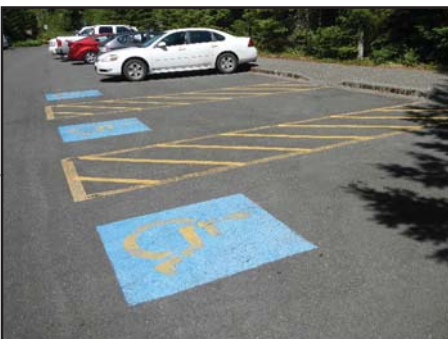
## ROUTE 0903A: NORTH CASCADES VISITOR CENTER PARKING A

Inspection Date	FMSS Number	User Access	Surface Type
6/17/2015	17427	PUBLIC	ASPHALT
Area (Sq. Ft.)	Lane Miles (11' Widths)	Curb Reveal (Inches)	Curb Recommendation
4,570	0.079	NOT APPLICABLE	LIGHT REPAIR
Curb Type		Curb & Gutter Type	
NO CURB		CONCRETE	
Pavement Recommendation		Condition Rating / PCR	
PREVENTIVE MAINTENANCE		GOOD / 90

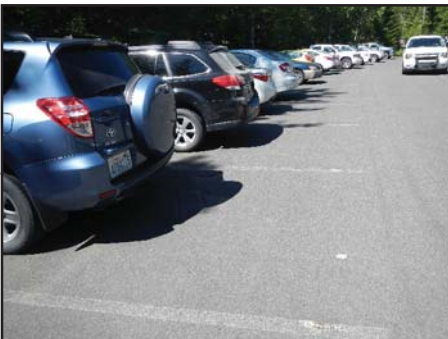
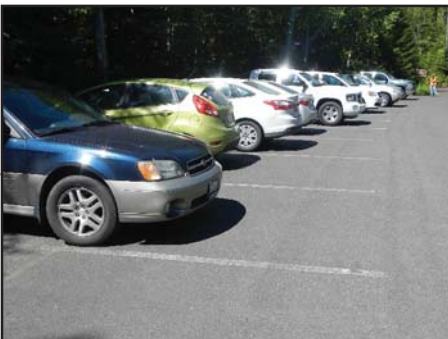
## ROUTE 0903B: NORTH CASCADES VISITOR CENTER PARKING B

Inspection Date	FMSS Number	User Access	Surface Type
6/17/2015	60510	PUBLIC	ASPHALT
Area (Sq. Ft.)	Lane Miles (11' Widths)	Curb Reveal (Inches)	Curb Recommendation
4,865	0.084	NOT APPLICABLE	DO NOTHING
Curb Type		Curb & Gutter Type	
NO CURB		CONCRETE	
Pavement Recommendation		Condition Rating / PCR	
PREVENTIVE MAINTENANCE		GOOD / 90

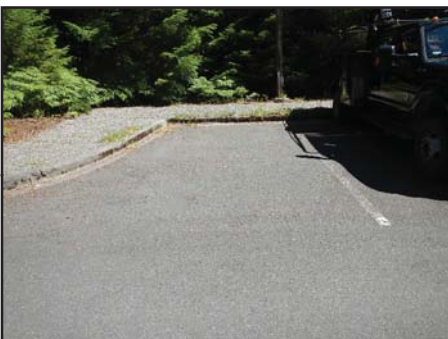
## ROUTE 0903C: NORTH CASCADES VISITOR CENTER PARKING C

Inspection Date	FMSS Number	User Access	Surface Type
6/17/2015	60512	PUBLIC	ASPHALT
Area (Sq. Ft.)	Lane Miles (11' Widths)	Curb Reveal (Inches)	Curb Recommendation
3,578	0.062	NOT APPLICABLE	DO NOTHING
Curb Type		Curb & Gutter Type	
NO CURB		CONCRETE	
Pavement Recommendation		Condition Rating / PCR	
PREVENTIVE MAINTENANCE		GOOD / 90

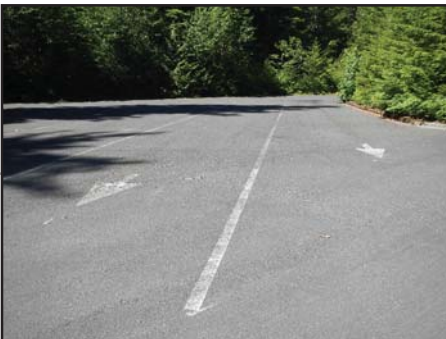
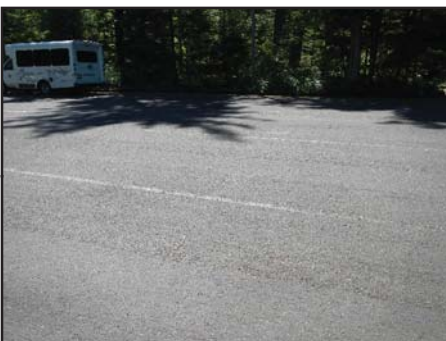
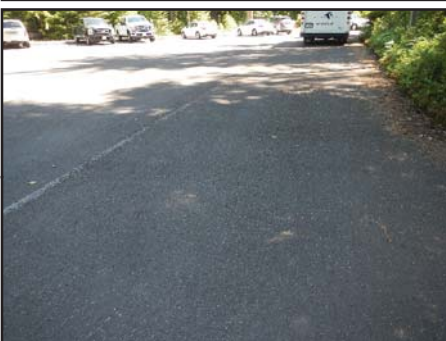
## ROUTE 0903D: NORTH CASCADES VISITOR CENTER PARKING D

Inspection Date	FMSS Number	User Access	Surface Type
6/17/2015	60514	PUBLIC	ASPHALT
Area (Sq. Ft.)	Lane Miles (11' Widths)	Curb Reveal (Inches)	Curb Recommendation
6,635	0.114	NOT APPLICABLE	DO NOTHING
Curb Type		Curb & Gutter Type	
NO CURB		CONCRETE	
Pavement Recommendation		Condition Rating / PCR	
PREVENTIVE MAINTENANCE		GOOD / 90

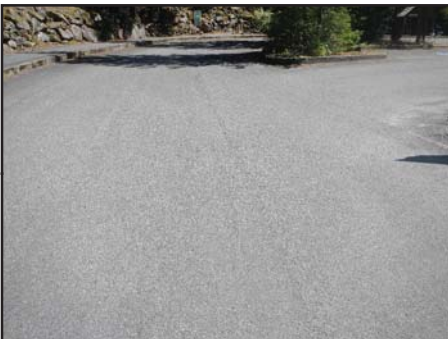
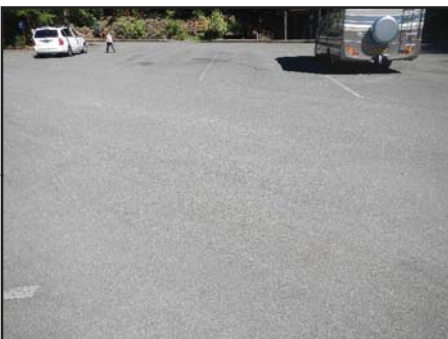
## ROUTE 0904: GORGE CREEK OVERLOOK TRAILHEAD PARKING

Inspection Date	FMSS Number	User Access	Surface Type
6/17/2015	43978	PUBLIC	ASPHALT
Area (Sq. Ft.)	Lane Miles (11' Widths)	Curb Reveal (Inches)	Curb Recommendation
27,656	0.476	6	DO NOTHING
Curb Type		Curb & Gutter Type	
CONCRETE		NO CURB AND GUTTER	
Pavement Recommendation		Condition Rating / PCR	
PREVENTIVE MAINTENANCE		GOOD / 90

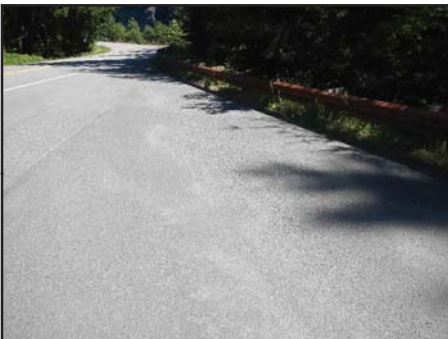
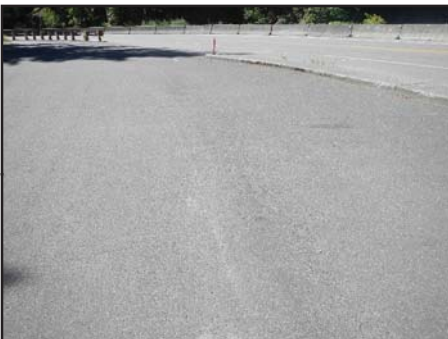
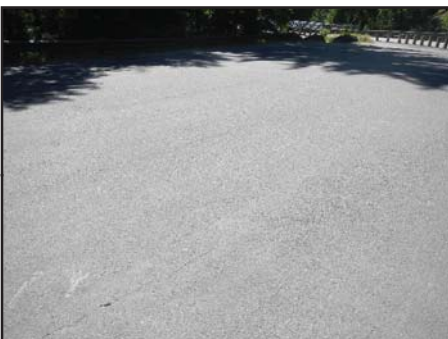
## ROUTE 0906: DIABLO LAKE OVERLOOK PARKING LOT

Inspection Date	FMSS Number	User Access	Surface Type
6/17/2015	46856	PUBLIC	ASPHALT
Area (Sq. Ft.)	Lane Miles (11' Widths)	Curb Reveal (Inches)	Curb Recommendation
56,922	0.98	1	DO NOTHING
Curb Type		Curb & Gutter Type	
CONCRETE		CONCRETE	
Pavement Recommendation		Condition Rating / PCR	
HEAVY 3R TREATMENTS		POOR / 53

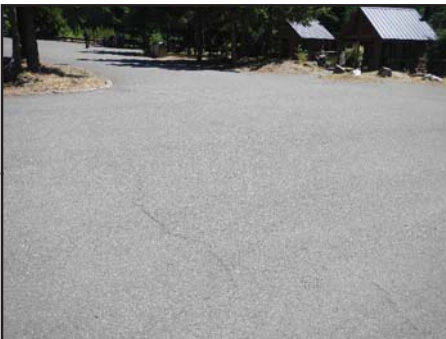
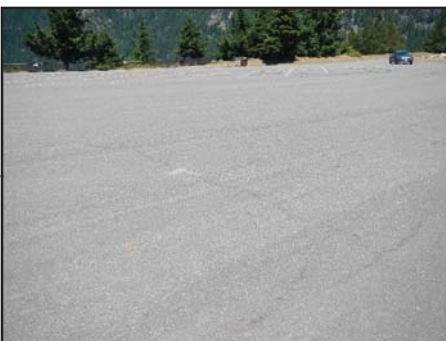
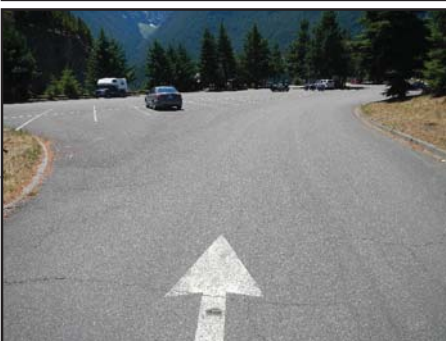
## ROUTE 0907: INTERPRETIVE PULLOUT (DIABLO LAKE)

Inspection Date	FMSS Number	User Access	Surface Type
6/17/2015	17541	PUBLIC	ASPHALT
Area (Sq. Ft.)	Lane Miles (11' Widths)	Curb Reveal (Inches)	Curb Recommendation
17,615	0.303	NOT APPLICABLE	NOT APPLICABLE
Curb Type		Curb & Gutter Type	
NO CURB		NO CURB AND GUTTER	
Pavement Recommendation		Condition Rating / PCR	
PREVENTIVE MAINTENANCE		GOOD / 90

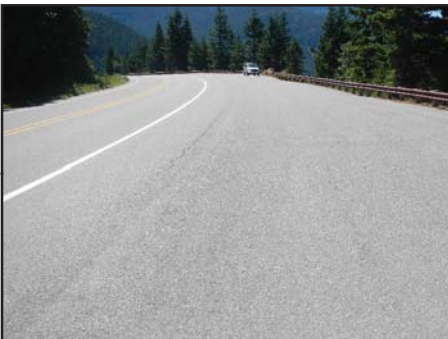
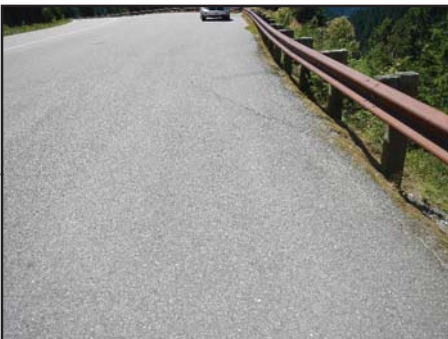
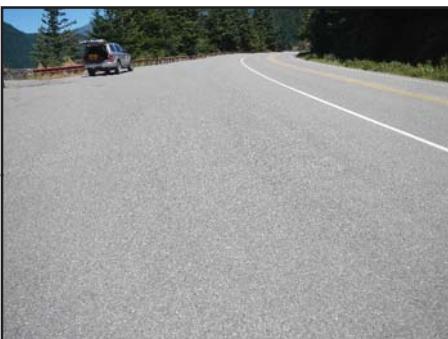
## ROUTE 0908: ROSS DAM TRAILHEAD PARKING

Inspection Date	FMSS Number	User Access	Surface Type
6/17/2015	17561	PUBLIC	ASPHALT
Area (Sq. Ft.)	Lane Miles (11' Widths)	Curb Reveal (Inches)	Curb Recommendation
11,733	0.202	NOT APPLICABLE	NOT APPLICABLE
Curb Type		Curb & Gutter Type	
NO CURB		NO CURB AND GUTTER	
Pavement Recommendation		Condition Rating / PCR	
PREVENTIVE MAINTENANCE		GOOD / 90

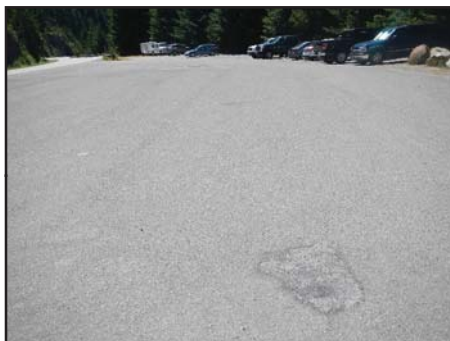
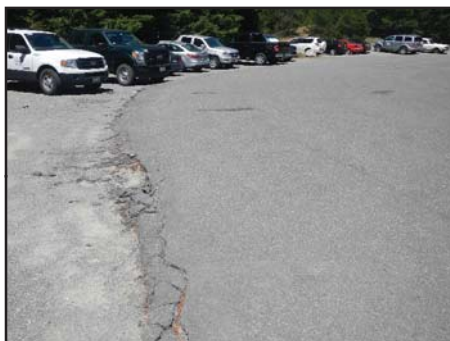
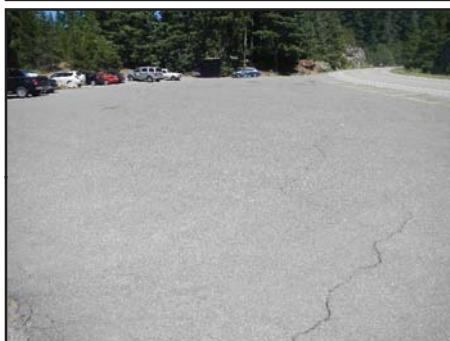
**Note: This parking lot has severe edge cracking because vehicles are parking on the unpaved perimeter around the parking lot edge.**

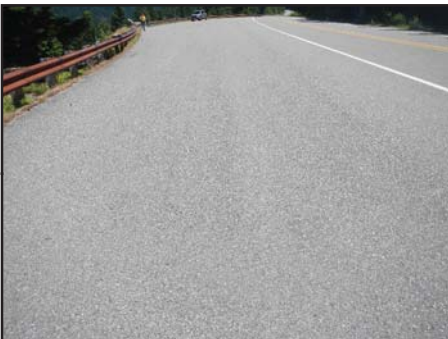
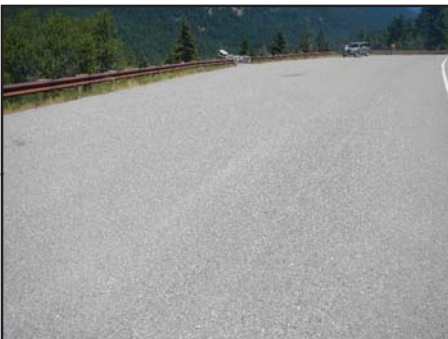
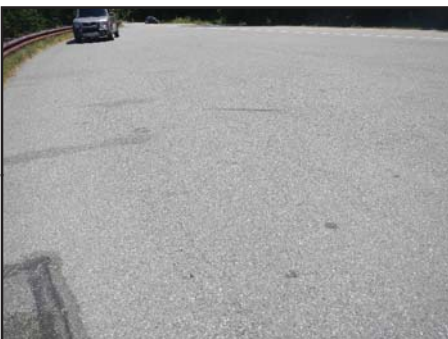
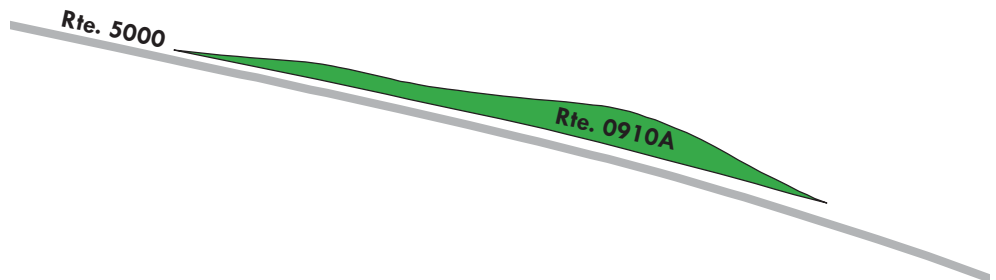
## ROUTE 0910B: ROSS LAKE OVERLOOK B

Inspection Date	FMSS Number	User Access	Surface Type
6/17/2015	60523	PUBLIC	ASPHALT
Area (Sq. Ft.)	Lane Miles (11' Widths)	Curb Reveal (Inches)	Curb Recommendation
5,141	0.089	NOT APPLICABLE	NOT APPLICABLE
Curb Type		Curb & Gutter Type	
NO CURB		NO CURB AND GUTTER	
Pavement Recommendation		Condition Rating / PCR	
PREVENTIVE MAINTENANCE		GOOD / 90

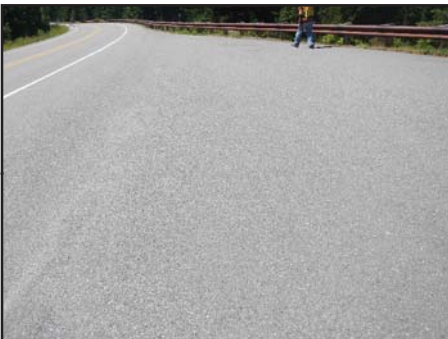
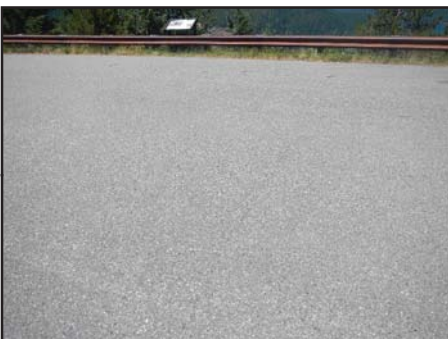
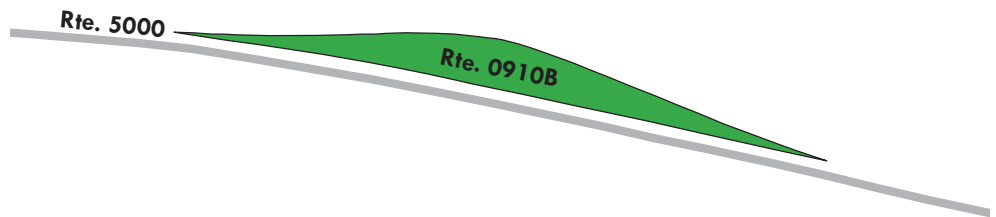
## ROUTE 0911: EAST ENTRANCE SIGN PARKING

Inspection Date	FMSS Number	User Access	Surface Type
6/18/2015	60358	PUBLIC	ASPHALT
Area (Sq. Ft.)	Lane Miles (11' Widths)	Curb Reveal (Inches)	Curb Recommendation
26,129	0.45	NOT APPLICABLE	NOT APPLICABLE
Curb Type		Curb & Gutter Type	
NO CURB		NO CURB AND GUTTER	
Pavement Recommendation		Condition Rating / PCR	
RECONSTRUCTION		POOR / 0

**Note:** This parking area is considered paved by the Park and in FBMS. The condition rating is a PCR 0 because it appears to be unpaved with only traces of deteriorating pavement remaining.

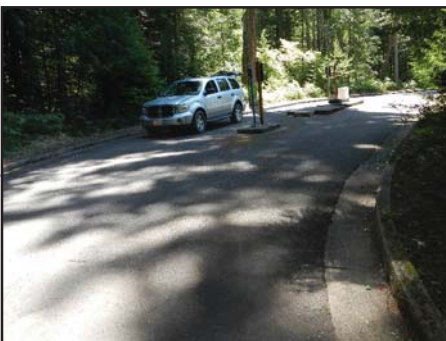
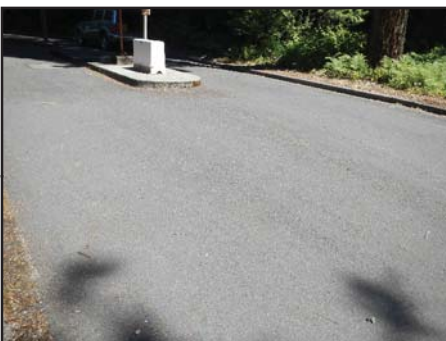
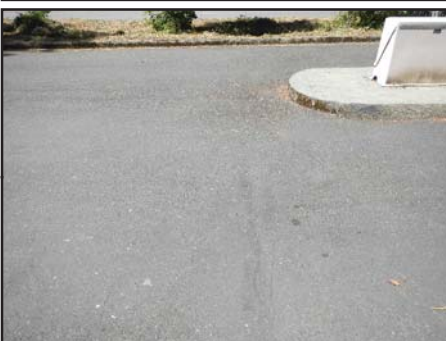
## ROUTE 0914: COLONIAL CREEK CAMPGROUND ACCESS PARKING

Inspection Date	FMSS Number	User Access	Surface Type
6/17/2015	60407	PUBLIC	ASPHALT
Area (Sq. Ft.)	Lane Miles (11' Widths)	Curb Reveal (Inches)	Curb Recommendation
65,181	1.122	NOT APPLICABLE	DO NOTHING
Curb Type		Curb & Gutter Type	
NO CURB		CONCRETE	
Pavement Recommendation		Condition Rating / PCR	
PREVENTIVE MAINTENANCE		GOOD / 90

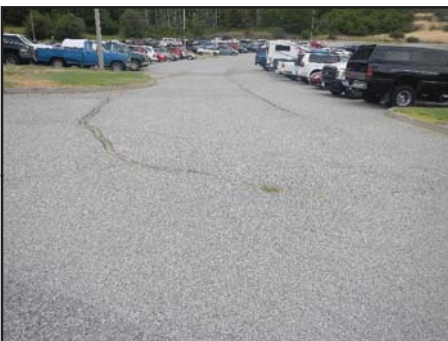
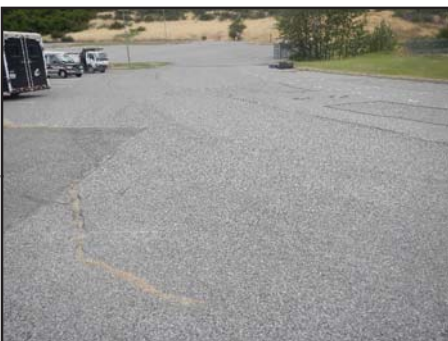
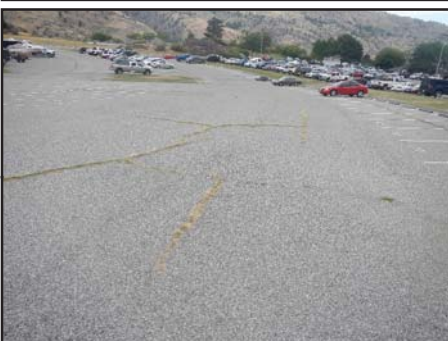
Inspection Date	FMSS Number	User Access	Surface Type
6/18/2015	81120	PUBLIC	ASPHALT
Area (Sq. Ft.)	Lane Miles (11' Widths)	Curb Reveal (Inches)	Curb Recommendation
205,342	3.536	6	LIGHT REPAIR
Curb Type		Curb & Gutter Type	
CONCRETE		NO CURB AND GUTTER	
Pavement Recommendation		Condition Rating / PCR	
PREVENTIVE MAINTENANCE		GOOD / 90

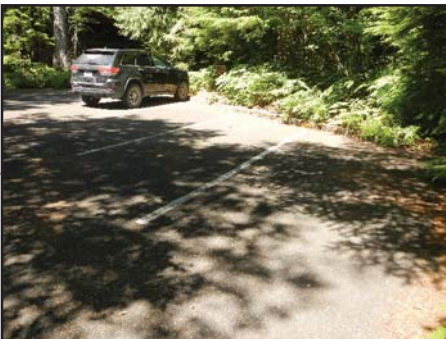
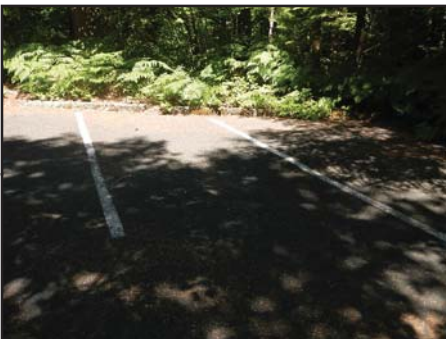
## ROUTE 0977: NEWHALEM CREEK WALK-IN SITES PARKING

Inspection Date	FMSS Number	User Access	Surface Type
6/17/2015	N/A	PUBLIC	ASPHALT
Area (Sq. Ft.)	Lane Miles (11' Widths)	Curb Reveal (Inches)	Curb Recommendation
946	0.016	NOT APPLICABLE	DO NOTHING
Curb Type		Curb & Gutter Type	
NO CURB		CONCRETE	
Pavement Recommendation		Condition Rating / PCR	
PREVENTIVE MAINTENANCE		GOOD / 90

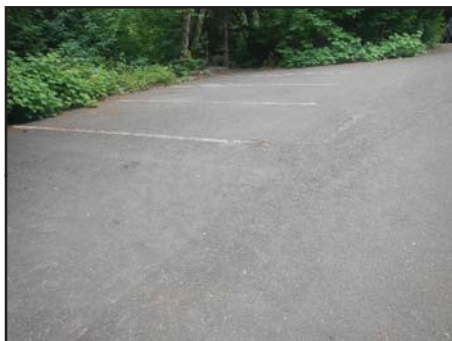
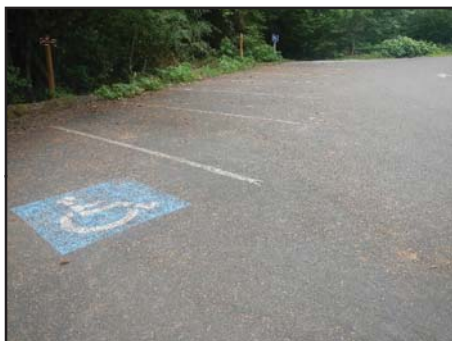
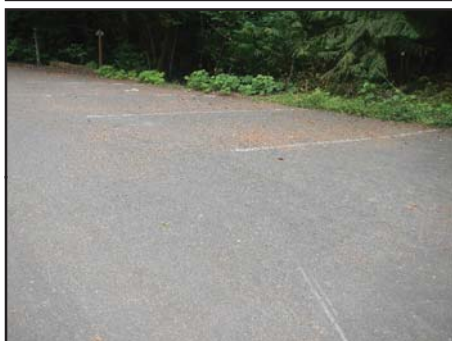
## ROUTE 0978: THUNDER CREEK TRAIL DAY USE PARKING A

Inspection Date	FMSS Number	User Access	Surface Type
6/18/2015	N/A	PUBLIC	ASPHALT
Area (Sq. Ft.)	Lane Miles (11' Widths)	Curb Reveal (Inches)	Curb Recommendation
6,732	0.116	NOT APPLICABLE	NOT APPLICABLE
Curb Type		Curb & Gutter Type	
NO CURB		NO CURB AND GUTTER	
Pavement Recommendation		Condition Rating / PCR	
PREVENTIVE MAINTENANCE		GOOD / 90

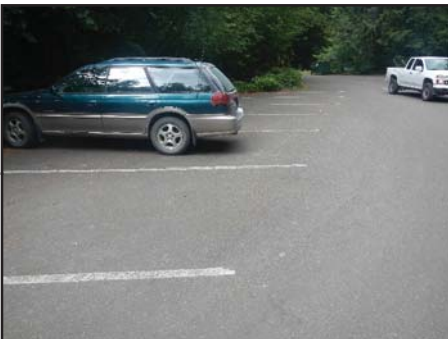
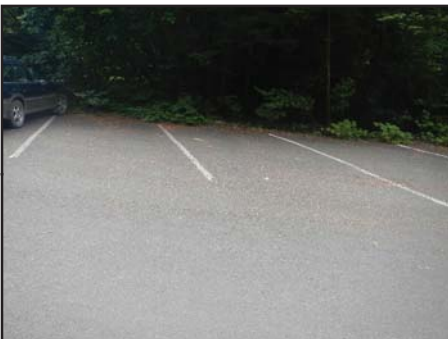
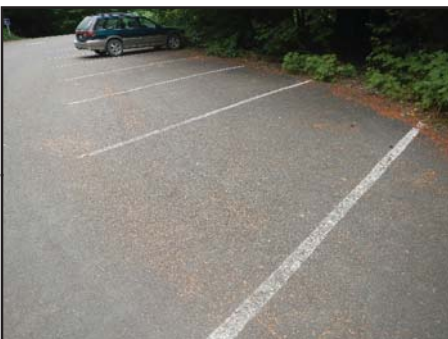
## ROUTE 0979: THUNDER CREEK TRAIL DAY USE PARKING B

Inspection Date	FMSS Number	User Access	Surface Type
6/18/2015	N/A	PUBLIC	ASPHALT
Area (Sq. Ft.)	Lane Miles (11' Widths)	Curb Reveal (Inches)	Curb Recommendation
2,912	0.05	NOT APPLICABLE	NOT APPLICABLE
Curb Type		Curb & Gutter Type	
NO CURB		NO CURB AND GUTTER	
Pavement Recommendation		Condition Rating / PCR	
PREVENTIVE MAINTENANCE		GOOD / 90
