# OLYM Cycle 6

## Final Report

# Road Inventory and Condition Assessment of Paved Routes Olympic National Park

**Federal Highway Administration  
Eastern Federal Lands Highway Division  
Road Inventory Program (RIP)**

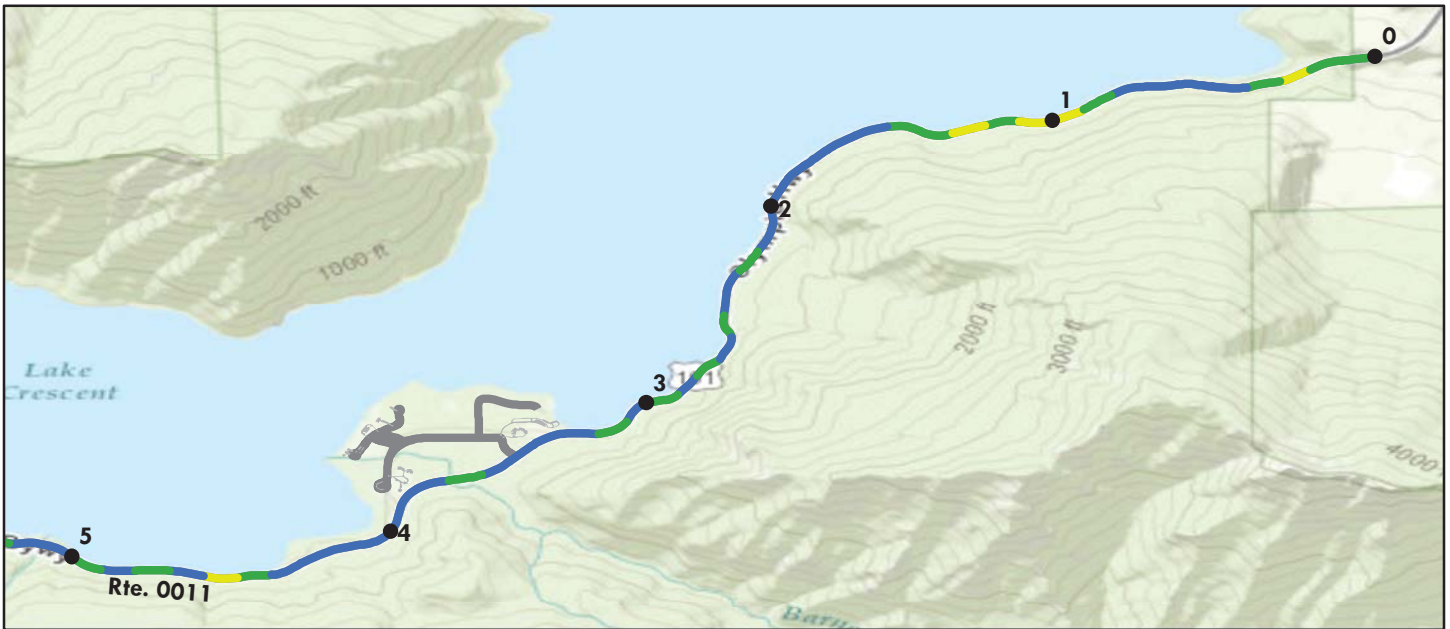
## ROUTE 0011: LAKE CRESCENT HIGHWAY (U.S. 101)

<b>Route Condition Legend – Pavement Condition Rating (PCR)</b>						
Poor (0 - 60)	Fair (61- 84)	Good (85 - 94)	Excellent (95 - 100)	Not Rated		
See Appendix for definitions and formulas						
<b>Inspection Date:</b> 9/24/2015	<b>Beginning Section MP</b>	0	1	2	3	4
<b>Paved Length (Miles):</b> 12.29	<b>Section Length (MI)</b>	1	1	1	1	1
<b>Surface Type:</b> ASPHALT	<b>Route Summary</b>					
<b>Roadway Condition Information</b>						
Pavement Condition Rating (PCR)	96	92	93	95	99	94
Surface Condition Rating (SCR)	98	98	98	99	99	98
Roughness Condition Index (RCI)	92	84	86	90	99	89
<b>Distress Index Values</b>						
Structural Crack Index	100	99	99	99	100	100
Alligator Crack Index	100	100	100	100	100	100
Longitudinal Crack Index	100	99	99	99	100	100
Transverse Cracking Index	100	100	99	100	100	100
Patching Index	99	98	99	99	100	98
Rutting Index	98	98	98	99	99	99
International Roughness Index (IRI)	134	156	151	140	118	144

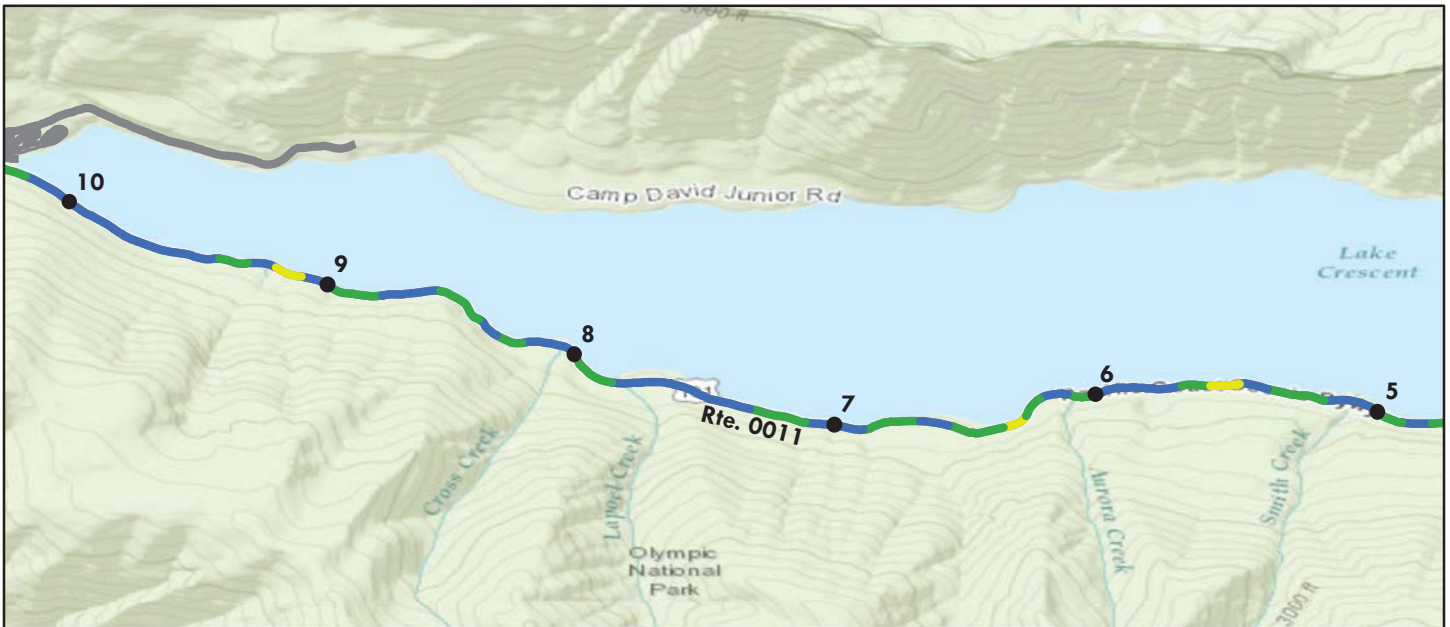
## ROUTE 0011: LAKE CRESCENT HIGHWAY (U.S. 101)

Route Condition Legend – Pavement Condition Rating (PCR)						
Poor (0 - 60)	Fair (61- 84)	Good (85 - 94)	Excellent (95 - 100)	Not Rated		
See Appendix for definitions and formulas						
<b>Inspection Date:</b> 9/24/2015	<b>Beginning Section MP</b>	5	6	7	8	9
<b>Paved Length (Miles):</b> 12.29	<b>Section Length (MI)</b>	1	1	1	1	1
<b>Surface Type:</b> ASPHALT	<b>Route Summary</b>					
<b>Roadway Condition Information</b>						
Pavement Condition Rating (PCR)	96	92	91	93	95	98
Surface Condition Rating (SCR)	98	98	98	96	97	99
Roughness Condition Index (RCI)	92	84	80	89	91	96
<b>Distress Index Values</b>						
Structural Crack Index	100	100	100	100	100	100
Alligator Crack Index	100	100	100	100	100	100
Longitudinal Crack Index	100	100	100	100	100	100
Transverse Cracking Index	100	100	100	100	100	100
Patching Index	99	100	98	99	99	99
Rutting Index	98	98	98	96	97	99
International Roughness Index (IRI)	134	157	170	143	137	124

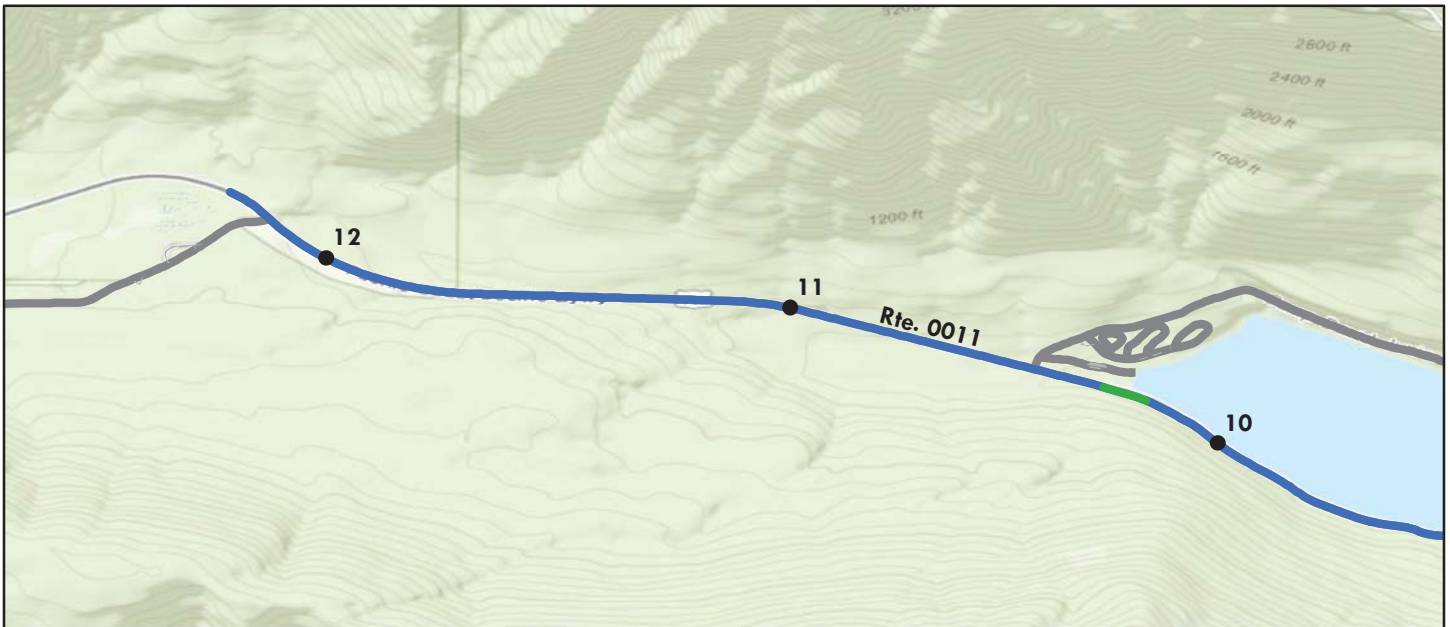
## ROUTE 0011: LAKE CRESCENT HIGHWAY (U.S. 101)

<b>Route Condition Legend – Pavement Condition Rating (PCR)</b>						
<b>Poor (0 - 60)</b>	<b>Fair (61- 84)</b>	<b>Good (85 - 94)</b>	<b>Excellent (95 - 100)</b>	<b>Not Rated</b>		
See Appendix for definitions and formulas						
<b>Inspection Date:</b> 9/24/2015	<b>Beginning Section MP</b>	10	11	12		
<b>Paved Length (Miles):</b> 12.29	<b>Section Length (MI)</b>	1	1	0.29		
<b>Surface Type:</b> ASPHALT	<b>Route Summary</b>					
<b>Roadway Condition Information</b>						
Pavement Condition Rating (PCR)	96	99	100	100		
Surface Condition Rating (SCR)	98	99	100	100		
Roughness Condition Index (RCI)	92	100	100	100		
<b>Distress Index Values</b>						
Structural Crack Index	100	100	100	100		
Alligator Crack Index	100	100	100	100		
Longitudinal Crack Index	100	100	100	100		
Transverse Cracking Index	100	100	100	100		
Patching Index	99	100	100	100		
Rutting Index	98	99	100	100		
International Roughness Index (IRI)	134	95	83	99

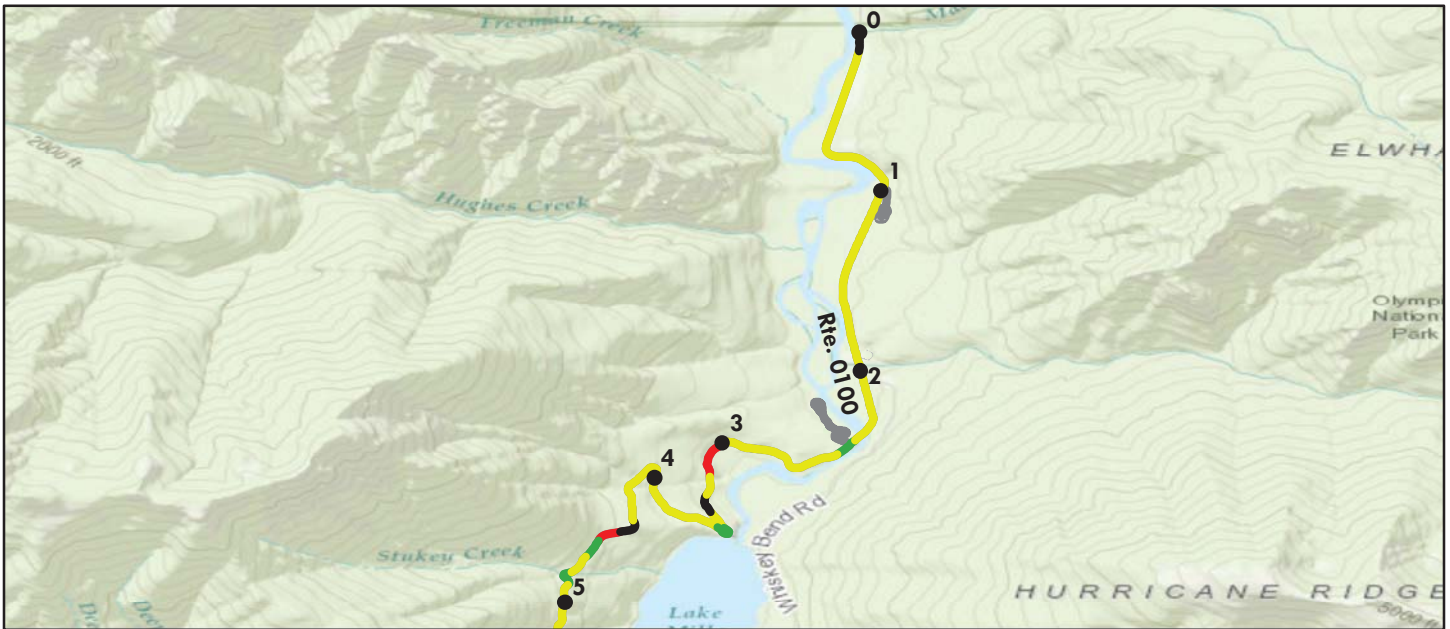
## ROUTE 0100: ELWHA VALLEY ROAD

Route Condition Legend – Pavement Condition Rating (PCR)						
Poor (0 - 60)	Fair (61- 84)	Good (85 - 94)	Excellent (95 - 100)	Not Rated		
See Appendix for definitions and formulas						
<b>Inspection Date:</b> 9/23/2015	<b>Beginning Section MP</b>	0	1	2	3	4
<b>Paved Length (Miles):</b> 8.15	<b>Section Length (MI)</b>	1	1	1	1	1
<b>Surface Type:</b> ASPHALT	<b>Route Summary</b>					
<b>Roadway Condition Information</b>						
Pavement Condition Rating (PCR)	68	74	76	71	79	75
Surface Condition Rating (SCR)	85	90	96	87	79	75
Roughness Condition Index (RCI)	43	49	45	47	N/A	N/A
<b>Distress Index Values</b>						
Structural Crack Index	85	90	96	87	79	75
Alligator Crack Index	97	99	100	95	92	88
Longitudinal Crack Index	88	91	96	92	87	87
Transverse Cracking Index	98	98	99	98	97	96
Patching Index	97	95	98	99	96	99
Rutting Index	92	97	97	95	89	89
International Roughness Index (IRI)	321	287	308	300	N/A	N/A
<b>Lane &amp; Width Information</b>

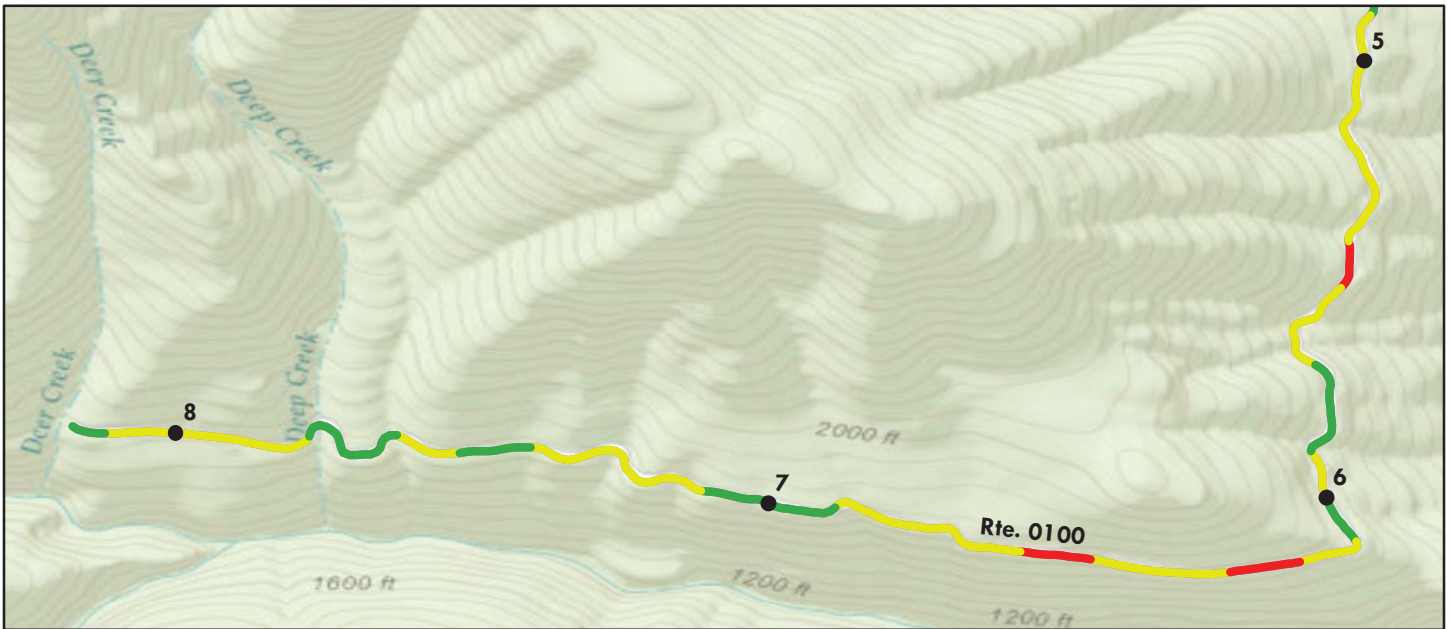
## ROUTE 0100: ELWHA VALLEY ROAD

Route Condition Legend – Pavement Condition Rating (PCR)						
Poor (0 - 60)	Fair (61- 84)	Good (85 - 94)	Excellent (95 - 100)	Not Rated		
See Appendix for definitions and formulas						
<b>Inspection Date:</b> 9/23/2015	<b>Beginning Section MP</b>	5	6	7	8	
<b>Paved Length (Miles):</b> 8.15	<b>Section Length (MI)</b>	1	1	1	0.15	
<b>Surface Type:</b> ASPHALT	<b>Route Summary</b>					
<b>Roadway Condition Information</b>						
Pavement Condition Rating (PCR)	68	61	64	89	67	
Surface Condition Rating (SCR)	85	78	81	89	84	
Roughness Condition Index (RCI)	43	35	39	N/A	42	
<b>Distress Index Values</b>						
Structural Crack Index	85	78	81	89	84	
Alligator Crack Index	97	98	100	98	100	
Longitudinal Crack Index	88	80	81	91	84	
Transverse Cracking Index	98	98	98	100	100	
Patching Index	97	98	95	97	95	
Rutting Index	92	90	90	92	91	
International Roughness Index (IRI)	321	369	345	N/A	325	
<b>Lane &amp; Width Information</b>

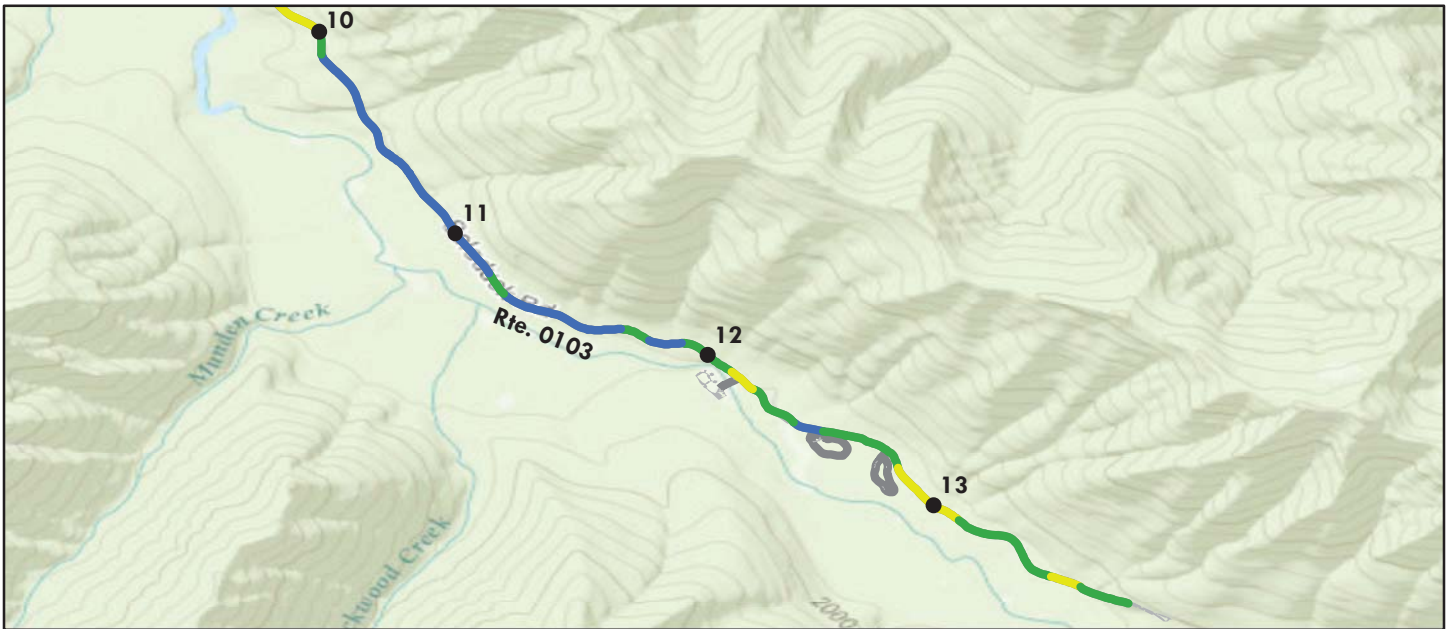
## ROUTE 0103: SOL DUC VALLEY ROAD

<b>Route Condition Legend – Pavement Condition Rating (PCR)</b>						
Poor (0 - 60)	Fair (61- 84)	Good (85 - 94)	Excellent (95 - 100)	Not Rated		
See Appendix for definitions and formulas						
<b>Inspection Date:</b> 9/24/2015	<b>Beginning Section MP</b>	10	11	12	13	
<b>Paved Length (Miles):</b> 13.76	<b>Section Length (MI)</b>	1	1	1	0.76	
<b>Surface Type:</b> ASPHALT	<b>Route Summary</b>					
<b>Roadway Condition Information</b>						
Pavement Condition Rating (PCR)	87	99	96	86	86	
Surface Condition Rating (SCR)	82	98	96	98	99	
Roughness Condition Index (RCI)	94	100	97	69	67	
<b>Distress Index Values</b>						
Structural Crack Index	82	98	96	98	99	
Alligator Crack Index	86	99	98	100	100	
Longitudinal Crack Index	96	99	98	98	99	
Transverse Cracking Index	100	100	100	99	100	
Patching Index	99	100	100	100	99	
Rutting Index	98	100	99	99	99	
International Roughness Index (IRI)	131	94	121	207	213	
<b>Lane &amp; Width Information</b>

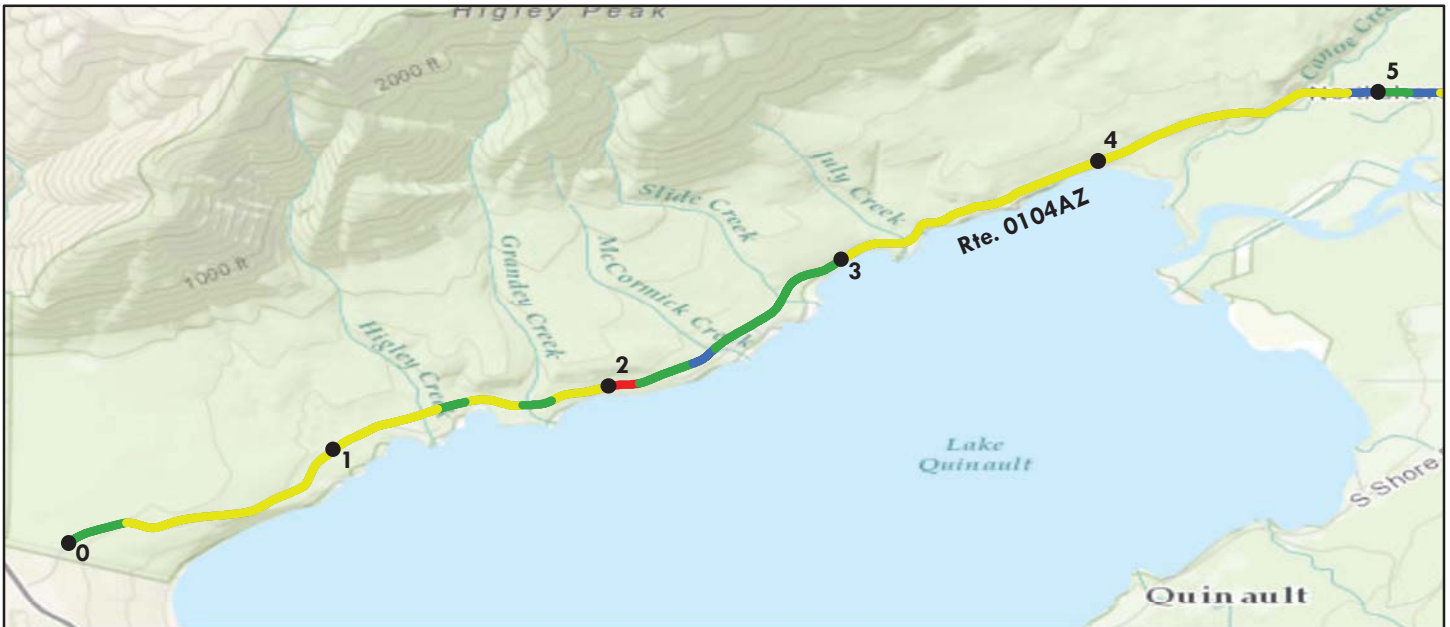
## ROUTE 0104AZ: QUINAULT NORTH SHORE ROAD A

Route Condition Legend – Pavement Condition Rating (PCR)						
Poor (0 - 60)	Fair (61- 84)	Good (85 - 94)	Excellent (95 - 100)	Not Rated		
See Appendix for definitions and formulas						
<b>Inspection Date:</b> 9/26/2015	<b>Beginning Section MP</b>	0	1	2	3	4
<b>Paved Length (Miles):</b> 7.68	<b>Section Length (MI)</b>	1	1	1	1	1
<b>Surface Type:</b> ASPHALT	<b>Route Summary</b>					
<b>Roadway Condition Information</b>						
Pavement Condition Rating (PCR)	77	77	80	86	72	77
Surface Condition Rating (SCR)	94	92	95	97	95	96
Roughness Condition Index (RCI)	52	54	57	69	37	48
<b>Distress Index Values</b>						
Structural Crack Index	94	92	95	97	95	96
Alligator Crack Index	97	96	98	98	99	99
Longitudinal Crack Index	97	96	97	99	96	97
Transverse Cracking Index	99	100	99	100	100	99
Patching Index	98	99	97	100	99	98
Rutting Index	97	95	97	99	98	97
International Roughness Index (IRI)	276	265	253	205	355	294
<b>Lane &amp; Width Information</b>

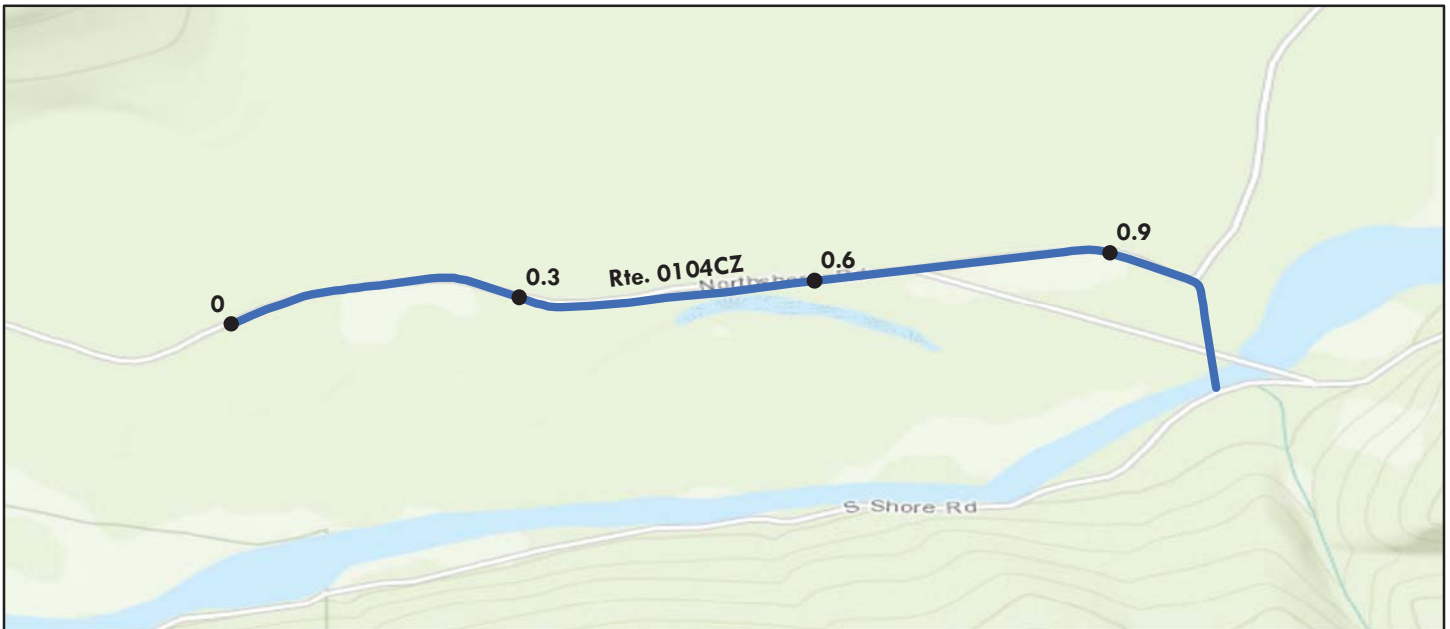
## ROUTE 0104CZ: QUINAULT NORTH SHORE ROAD C

<b>Route Condition Legend – Pavement Condition Rating (PCR)</b>						
Poor (0 - 60)	Fair (61- 84)	Good (85 - 94)	Excellent (95 - 100)	Not Rated		
See Appendix for definitions and formulas						
<b>Inspection Date:</b> 8/12/2015	<b>Beginning Section MP</b>	0.00	0.30	0.60	0.90	
<b>Paved Length (Miles):</b> 1.10	<b>Section Length (MI)</b>	0.30	0.30	0.30	0.20	
<b>Surface Type:</b> ASPHALT	<b>Route Summary</b>					
<b>Roadway Condition Information</b>						
Pavement Condition Rating (PCR)	100	100	100	100	100	
Surface Condition Rating (SCR)	100	100	100	100	100	
Roughness Condition Index (RCI)	N/A	N/A	N/A	N/A	N/A	
<b>Distress Index Values</b>						
Structural Crack Index	100	100	100	100	100	
Alligator Crack Index	100	100	100	100	100	
Longitudinal Crack Index	100	100	100	100	100	
Transverse Cracking Index	100	100	100	100	100	
Patching Index	100	100	100	100	100	
Rutting Index	100	100	100	100	100	
International Roughness Index (IRI)	N/A	N/A	N/A	N/A	N/A

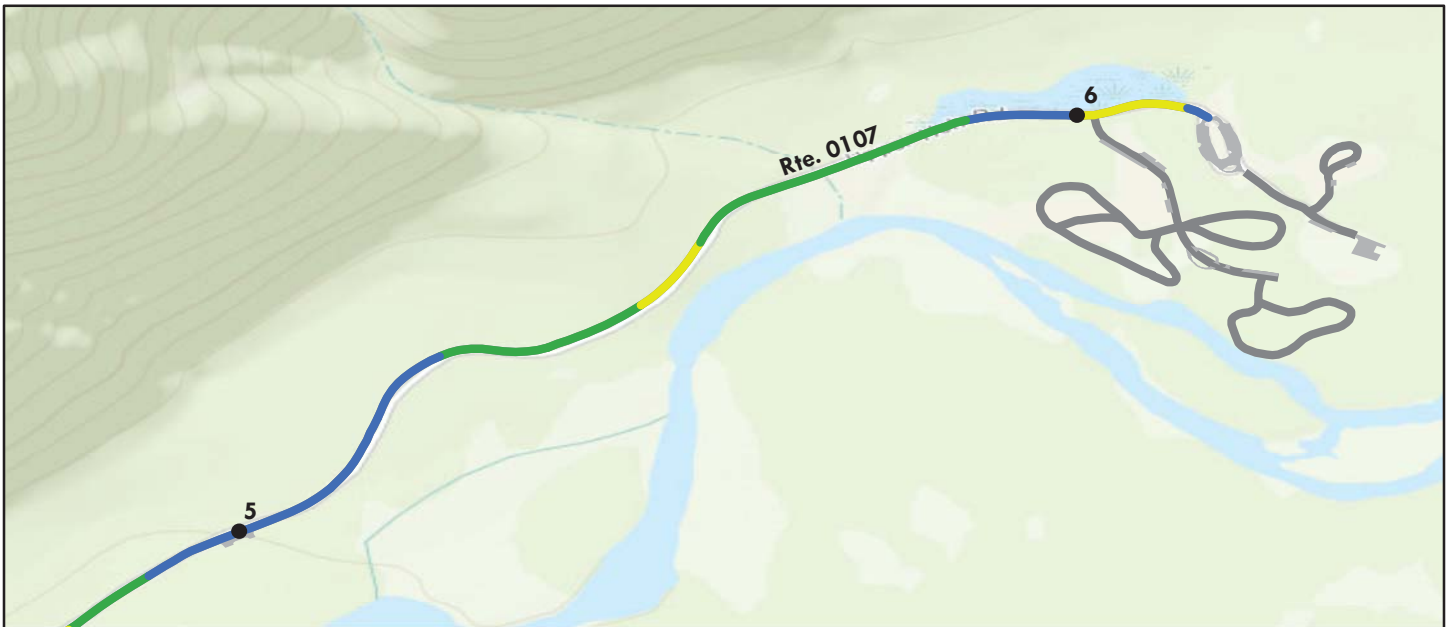
## ROUTE 0107: HOH ROAD

Route Condition Legend – Pavement Condition Rating (PCR)						
Poor (0 - 60)	Fair (61- 84)	Good (85 - 94)	Excellent (95 - 100)	Not Rated		
See Appendix for definitions and formulas						
<b>Inspection Date:</b> 9/26/2015	<b>Beginning Section MP</b>	5	6			
<b>Paved Length (Miles):</b> 6.12	<b>Section Length (MI)</b>	1	0.12			
<b>Surface Type:</b> ASPHALT	<b>Route Summary</b>					
<b>Roadway Condition Information</b>						
Pavement Condition Rating (PCR)	90	92	84			
Surface Condition Rating (SCR)	98	98	99			
Roughness Condition Index (RCI)	79	83	61			
<b>Distress Index Values</b>						
Structural Crack Index	100	100	100			
Alligator Crack Index	100	100	100			
Longitudinal Crack Index	100	100	100			
Transverse Cracking Index	100	100	100			
Patching Index	100	100	100			
Rutting Index	98	98	99			
International Roughness Index (IRI)	172	161	237			
<b>Lane &amp; Width Information</b>						
Number of Lanes	2	2	2

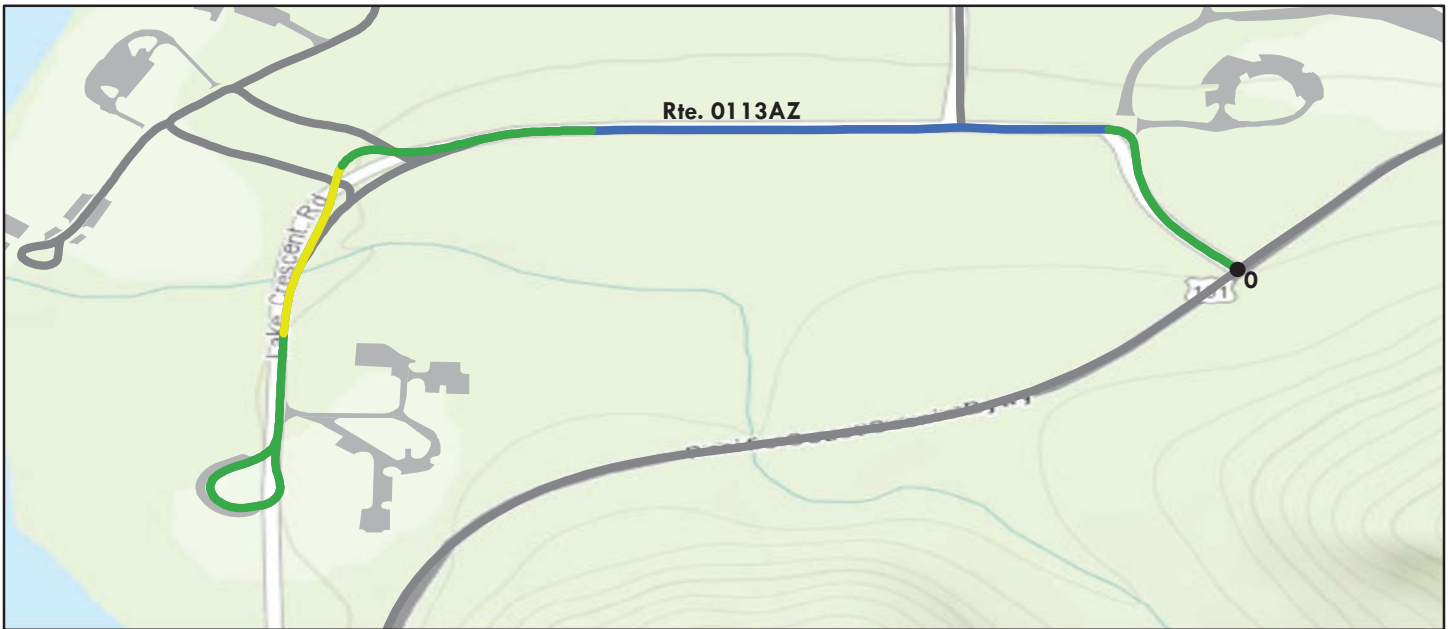
## ROUTE 0113AZ: LAKE CRESCENT ROAD A

<b>Route Condition Legend – Pavement Condition Rating (PCR)</b>						
<b>Poor (0 - 60)</b>	<b>Fair (61- 84)</b>	<b>Good (85 - 94)</b>	<b>Excellent (95 - 100)</b>	<b>Not Rated</b>		
See Appendix for definitions and formulas						
<b>Inspection Date:</b>	9/24/2015	<b>Beginning Section MP</b>	0			
<b>Paved Length (Miles):</b>	0.67	<b>Section Length (MI)</b>	0.67			
<b>Surface Type:</b>	ASPHALT	<b>Route Summary</b>				
<b>Roadway Condition Information</b>						
Pavement Condition Rating (PCR)	88	88				
Surface Condition Rating (SCR)	96	96				
Roughness Condition Index (RCI)	77	77				
<b>Distress Index Values</b>						
Structural Crack Index	100	100				
Alligator Crack Index	100	100				
Longitudinal Crack Index	100	100				
Transverse Cracking Index	100	100				
Patching Index	100	100				
Rutting Index	96	96				
International Roughness Index (IRI)	178	178				
<b>Lane &amp; Width Information</b>						
Number of Lanes	2	2

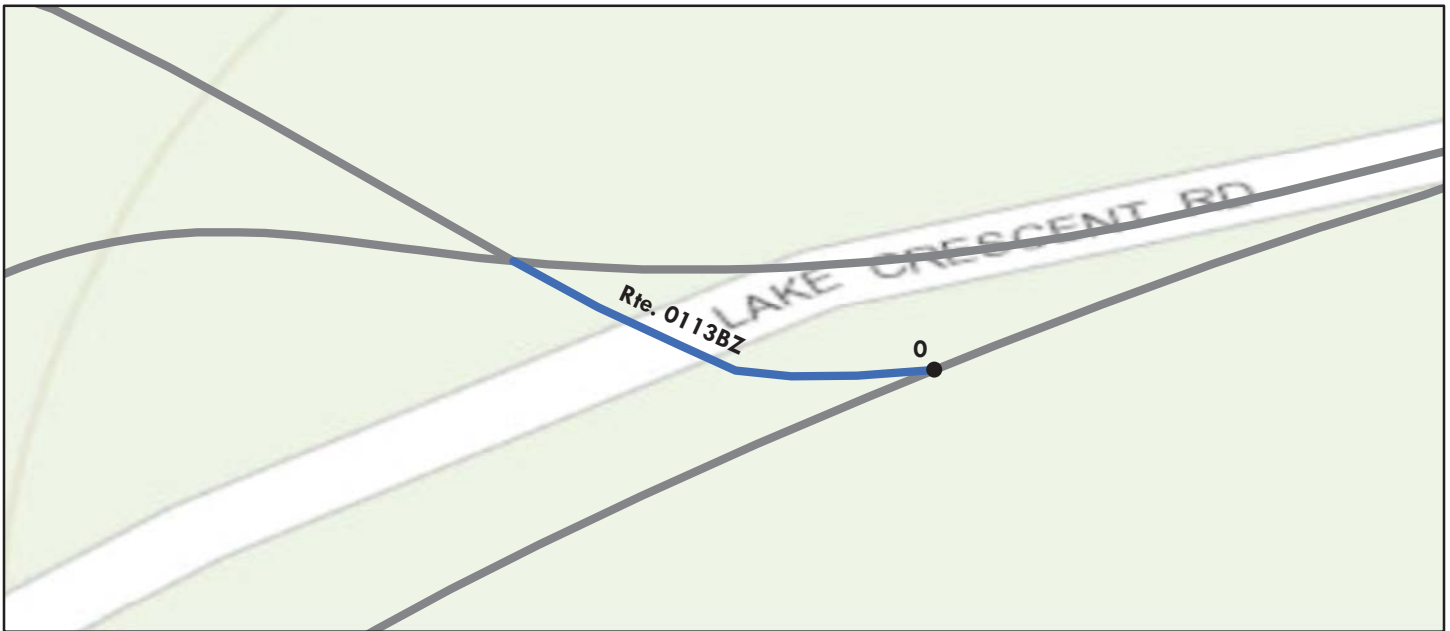
## ROUTE 0113BZ: LAKE CRESCENT SPUR B

<b>Route Condition Legend – Pavement Condition Rating (PCR)</b>						
Poor (0 - 60)	Fair (61- 84)	Good (85 - 94)	Excellent (95 - 100)	Not Rated		
See Appendix for definitions and formulas						
<b>Inspection Date:</b>	8/10/2015	<b>Beginning Section MP</b>	0.00			
<b>Paved Length (Miles):</b>	0.01	<b>Section Length (MI)</b>	0.01			
<b>Surface Type:</b>	ASPHALT	<b>Route Summary</b>				
<b>Roadway Condition Information</b>						
Pavement Condition Rating (PCR)	97	97				
Surface Condition Rating (SCR)	97	97				
Roughness Condition Index (RCI)	N/A	N/A				
<b>Distress Index Values</b>						
Structural Crack Index	N/A	N/A				
Alligator Crack Index	97	97				
Longitudinal Crack Index	97	97				
Transverse Cracking Index	97	97				
Patching Index	97	97				
Rutting Index	97	97				
International Roughness Index (IRI)	N/A	N/A				
<b>Lane &amp; Width Information</b>						
Number of Lanes	1	1				
Paved Width (ft)	12	12				
Lane Width (ft)	12	12

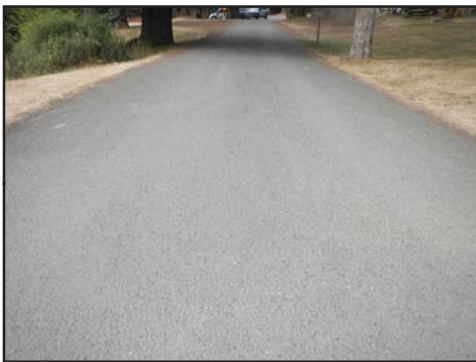
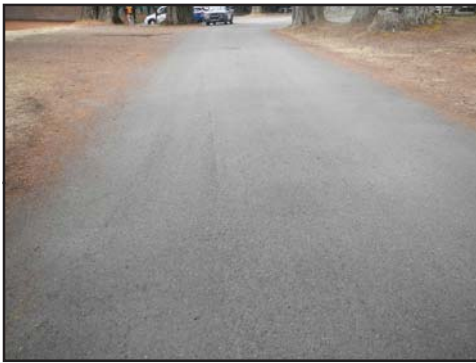
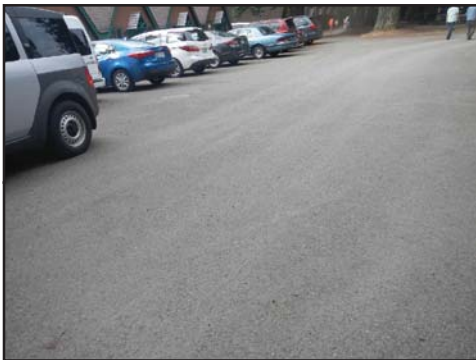
TO PARKING

Inspection Date	FMSS Number	User Access	Surface Type
8/10/2015	48599	PUBLIC	ASPHALT
Area (Sq. Ft.)	Lane Miles (11' Widths)	Pavement Recommendation	
13,397	0.231	PREVENTIVE MAINTENANCE	
Condition Rating / PCR			
GOOD / 90			
Route Condition Legend – Pavement Condition Rating (PCR)			
Poor (0 - 60)	Fair (61- 84)	Good (85 - 94)	Excellent (95 - 100)
Not Rated			
See Appendix for definitions and formulas

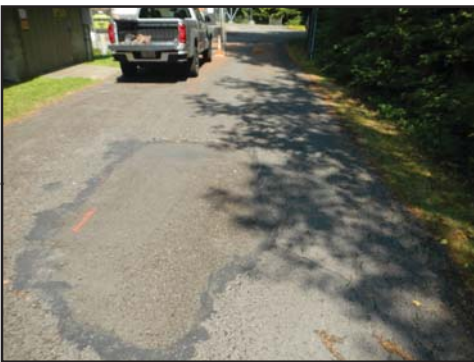
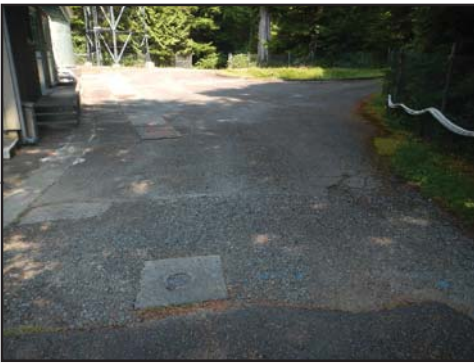
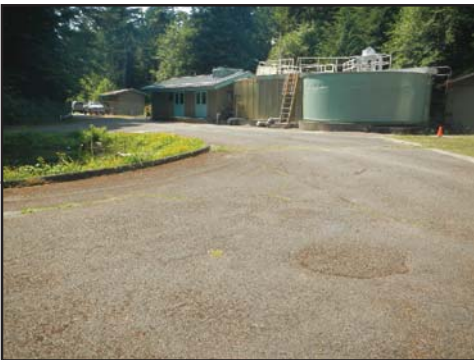
Inspection Date	FMSS Number	User Access	Surface Type
8/11/2015	48619	NONPUBLIC	ASPHALT
Area (Sq. Ft.)	Lane Miles (11' Widths)	Pavement Recommendation	
62,861	1.082	HEAVY 3R TREATMENTS	
Condition Rating / PCR			
POOR / 53			
Route Condition Legend – Pavement Condition Rating (PCR)			
Poor (0 - 60)	Fair (61- 84)	Good (85 - 94)	Excellent (95 - 100)
			Not Rated
See Appendix for definitions and formulas

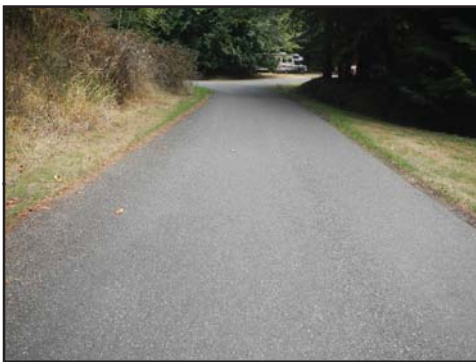
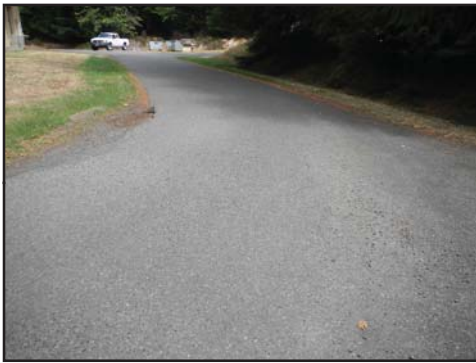
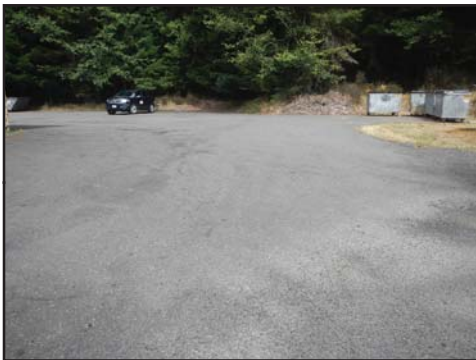
## ROUTE 0418: ALDER SITE SEWAGE ROAD

Inspection Date	FMSS Number	User Access	Surface Type
8/10/2015	48621	NONPUBLIC	ASPHALT
Area (Sq. Ft.)	Lane Miles (11' Widths)	Pavement Recommendation	
12,868	0.222	PREVENTIVE MAINTENANCE	
Condition Rating / PCR			
GOOD / 90			
Route Condition Legend – Pavement Condition Rating (PCR)			
<b>Poor (0 - 60)</b>	<b>Fair (61- 84)</b>	<b>Good (85 - 94)</b>	<b>Excellent (95 - 100)</b>
			<b>Not Rated</b>
See Appendix for definitions and formulas

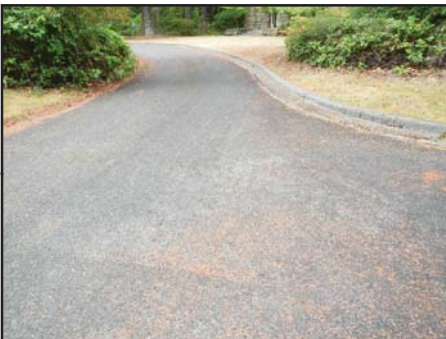
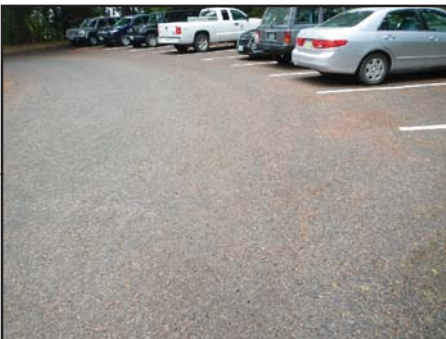
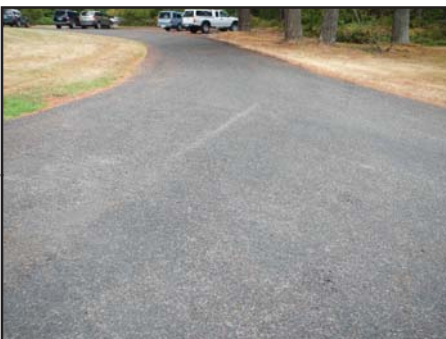
Inspection Date	FMSS Number	User Access	Surface Type
8/10/2015	48629	PUBLIC	ASPHALT
Area (Sq. Ft.)	Lane Miles (11' Widths)	Curb Reveal (Inches)	Curb Recommendation
13,108	0.226	NOT APPLICABLE	DO NOTHING
Curb Type		Curb & Gutter Type	
NO CURB		CONCRETE	
Pavement Recommendation		Condition Rating / PCR	
PREVENTIVE MAINTENANCE		GOOD / 90

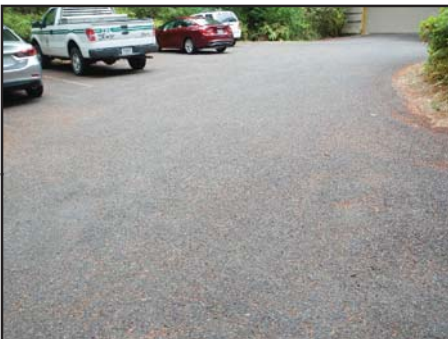
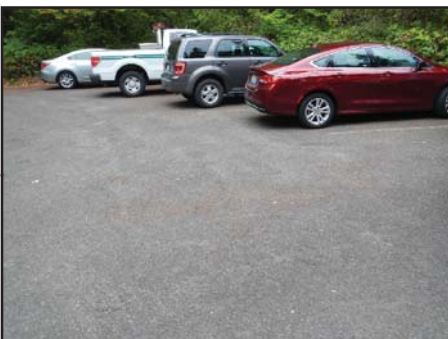
## ROUTE 0900BZ: HEADQUARTERS ADMINISTRATIVE PARKING B

Inspection Date	FMSS Number	User Access	Surface Type
8/10/2015	48629	PUBLIC	ASPHALT
Area (Sq. Ft.)	Lane Miles (11' Widths)	Curb Reveal (Inches)	Curb Recommendation
6,028	0.104	NOT APPLICABLE	NOT APPLICABLE
Curb Type		Curb & Gutter Type	
NO CURB		NO CURB AND GUTTER	
Pavement Recommendation		Condition Rating / PCR	
LIGHT 3R TREATMENTS		FAIR / 73

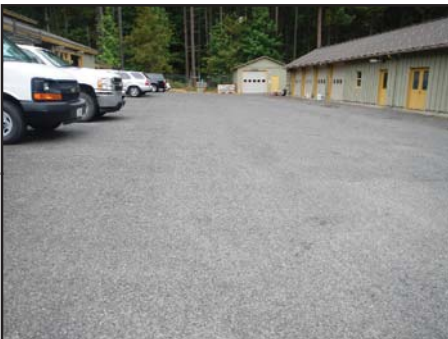
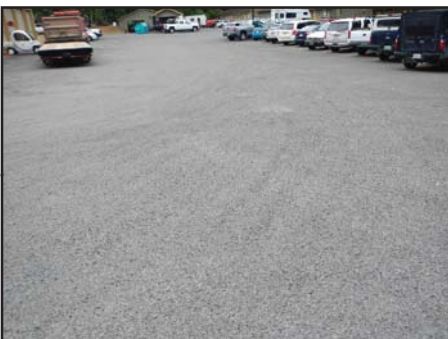
## ROUTE 0900CZ: HEADQUARTERS ADMINISTRATIVE PARKING C

Inspection Date	FMSS Number	User Access	Surface Type
8/10/2015	48629	PUBLIC	ASPHALT
Area (Sq. Ft.)	Lane Miles (11' Widths)	Curb Reveal (Inches)	Curb Recommendation
134,067	2.308	NOT APPLICABLE	NOT APPLICABLE
Curb Type		Curb & Gutter Type	
NO CURB		NO CURB AND GUTTER	
Pavement Recommendation		Condition Rating / PCR	
LIGHT 3R TREATMENTS		FAIR / 73

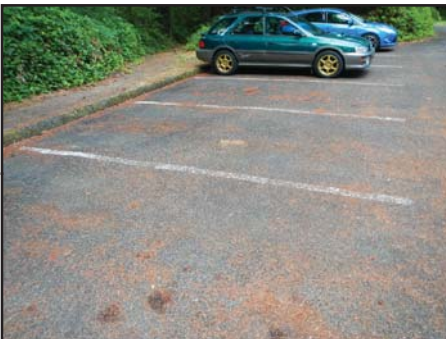
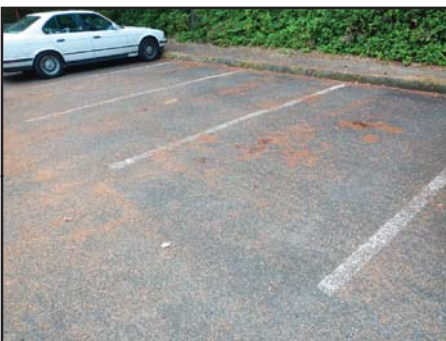
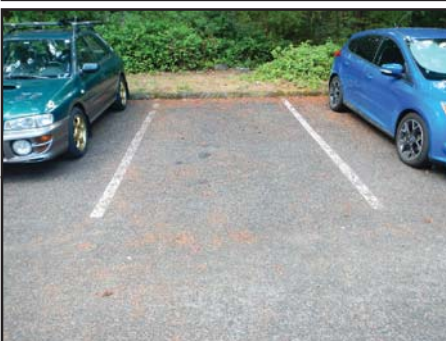
## ROUTE 0900DZ: HEADQUARTERS ADMINISTRATIVE PARKING D

Inspection Date	FMSS Number	User Access	Surface Type
8/10/2015	48629	PUBLIC	ASPHALT
Area (Sq. Ft.)	Lane Miles (11' Widths)	Curb Reveal (Inches)	Curb Recommendation
1,433	0.025	6	DO NOTHING
Curb Type		Curb & Gutter Type	
ASPHALT		NO CURB AND GUTTER	
Pavement Recommendation		Condition Rating / PCR	
PREVENTIVE MAINTENANCE		GOOD / 90

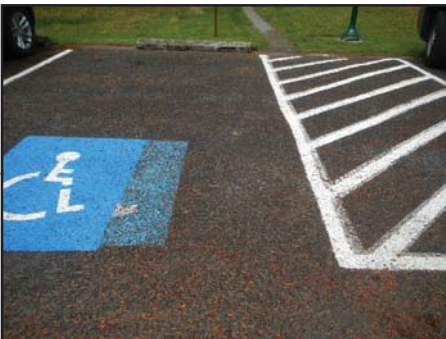
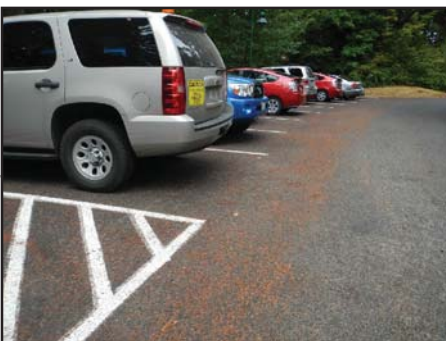
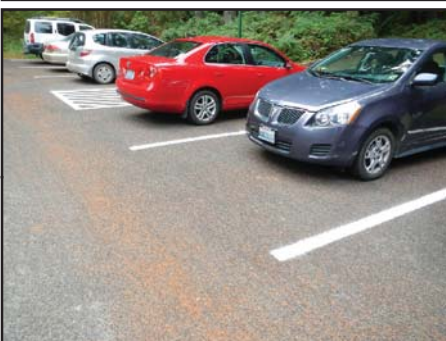
## ROUTE 0900EZ: HEADQUARTERS ADMINISTRATIVE PARKING E

Inspection Date	FMSS Number	User Access	Surface Type
8/10/2015	48629	PUBLIC	ASPHALT
Area (Sq. Ft.)	Lane Miles (11' Widths)	Curb Reveal (Inches)	Curb Recommendation
3,789	0.065	NOT APPLICABLE	NOT APPLICABLE
Curb Type		Curb & Gutter Type	
NO CURB		NO CURB AND GUTTER	
Pavement Recommendation		Condition Rating / PCR	
PREVENTIVE MAINTENANCE		GOOD / 90

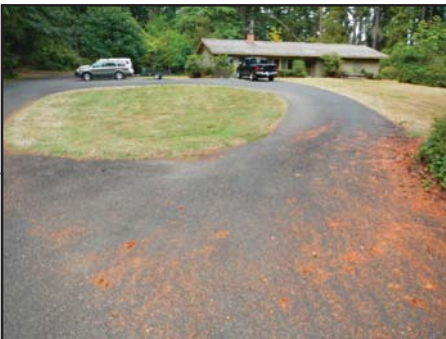
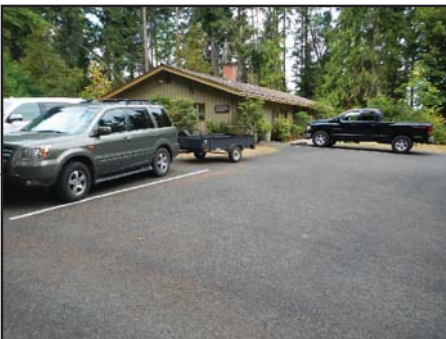
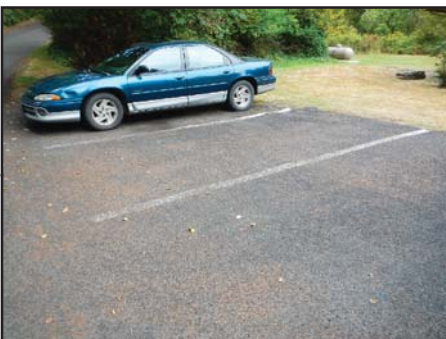
## ROUTE 0900FZ: HEADQUARTERS ADMINISTRATIVE PARKING F

Inspection Date	FMSS Number	User Access	Surface Type
8/10/2015	48629	PUBLIC	ASPHALT
Area (Sq. Ft.)	Lane Miles (11' Widths)	Curb Reveal (Inches)	Curb Recommendation
3,766	0.065	NOT APPLICABLE	NOT APPLICABLE
Curb Type		Curb & Gutter Type	
NO CURB		NO CURB AND GUTTER	
Pavement Recommendation		Condition Rating / PCR	
LIGHT 3R TREATMENTS		FAIR / 73

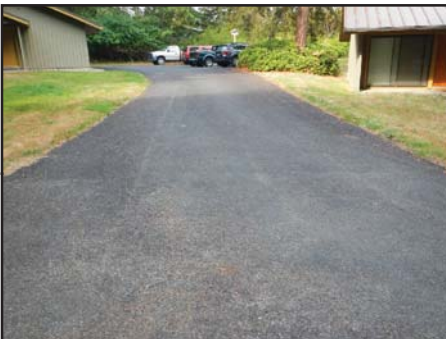
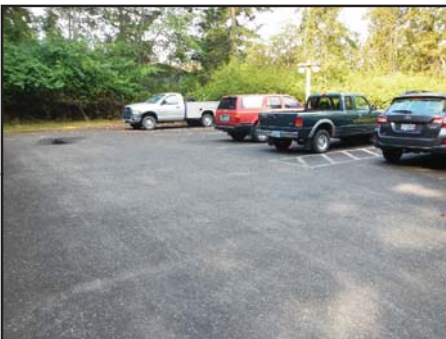
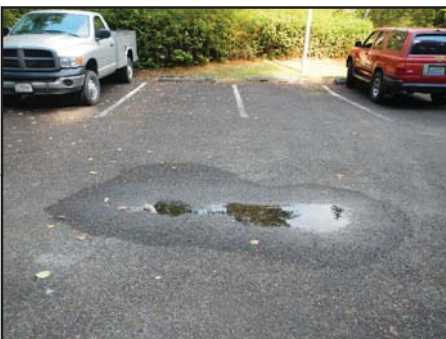
## ROUTE 0900GZ: HEADQUARTERS ADMINISTRATIVE PARKING G

Inspection Date	FMSS Number	User Access	Surface Type
8/10/2015	48629	PUBLIC	ASPHALT
Area (Sq. Ft.)	Lane Miles (11' Widths)	Curb Reveal (Inches)	Curb Recommendation
3,560	0.061	NOT APPLICABLE	NOT APPLICABLE
Curb Type		Curb & Gutter Type	
NO CURB		NO CURB AND GUTTER	
Pavement Recommendation		Condition Rating / PCR	
LIGHT 3R TREATMENTS		FAIR / 73

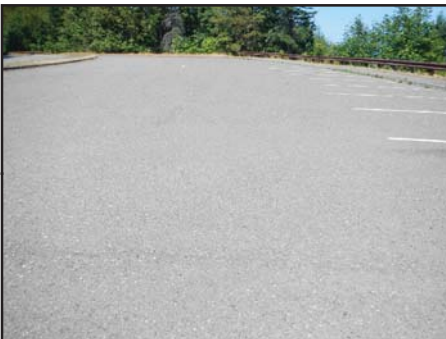
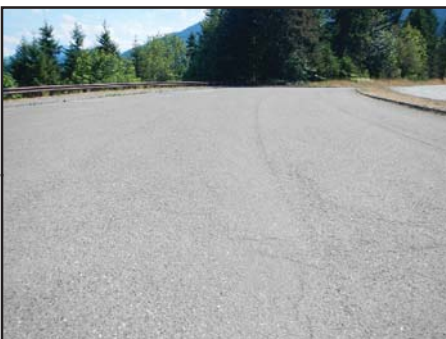
## ROUTE 0901: HEART O' THE HILLS LOOKOUT PARKING

Inspection Date	FMSS Number	User Access	Surface Type
8/10/2015	48630	PUBLIC	ASPHALT
Area (Sq. Ft.)	Lane Miles (11' Widths)	Curb Reveal (Inches)	Curb Recommendation
12,562	0.216	6	DO NOTHING
Curb Type		Curb & Gutter Type	
CONCRETE		NO CURB AND GUTTER	
Pavement Recommendation		Condition Rating / PCR	
LIGHT 3R TREATMENTS		FAIR / 73

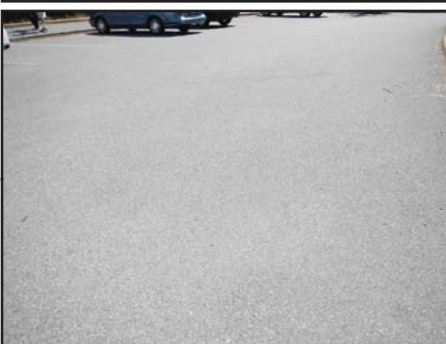
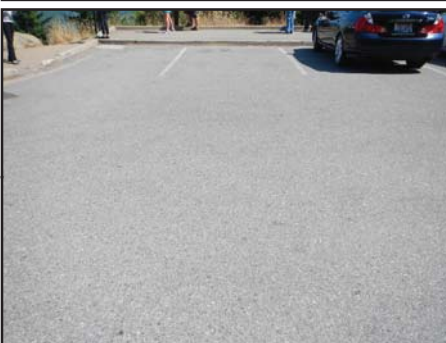
## ROUTE 0902: SIEGE OF ICE / RAINSHADOW PARKING

Inspection Date	FMSS Number	User Access	Surface Type
8/10/2015	48631	PUBLIC	ASPHALT
Area (Sq. Ft.)	Lane Miles (11' Widths)	Curb Reveal (Inches)	Curb Recommendation
6,979	0.12	6	LIGHT REPAIR
Curb Type		Curb & Gutter Type	
CONCRETE		CONCRETE	
Pavement Recommendation		Condition Rating / PCR	
DO NOTHING		EXCELLENT / 97

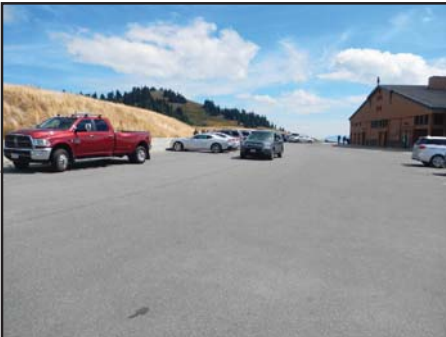
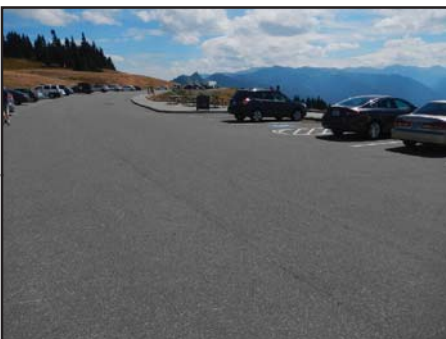
## ROUTE 0905: HURRICANE RIDGE VISITOR CENTER PARKING

Inspection Date	FMSS Number	User Access	Surface Type
8/10/2015	48634	PUBLIC	ASPHALT
Area (Sq. Ft.)	Lane Miles (11' Widths)	Curb Reveal (Inches)	Curb Recommendation
98,128	1.69	NOT APPLICABLE	DO NOTHING
Curb Type		Curb & Gutter Type	
NO CURB		CONCRETE	
Pavement Recommendation		Condition Rating / PCR	
PREVENTIVE MAINTENANCE		GOOD / 90

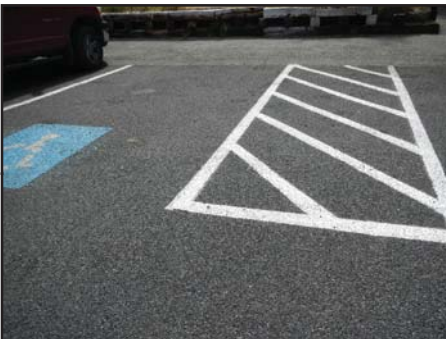
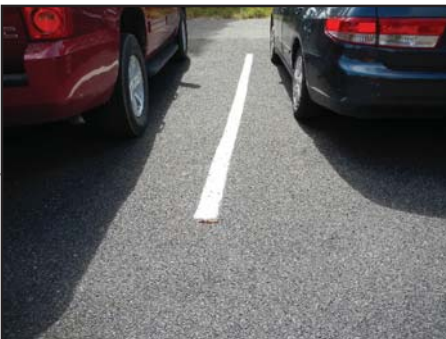
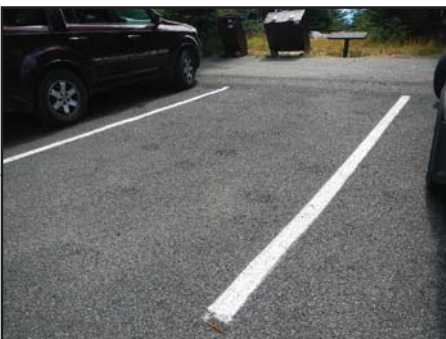
## ROUTE 0906: HURRICANE RIDGE PICNIC PARKING #1

Inspection Date	FMSS Number	User Access	Surface Type
8/10/2015	48635	PUBLIC	ASPHALT
Area (Sq. Ft.)	Lane Miles (11' Widths)	Curb Reveal (Inches)	Curb Recommendation
5,250	0.09	NOT APPLICABLE	NOT APPLICABLE
Curb Type		Curb & Gutter Type	
NO CURB		NO CURB AND GUTTER	
Pavement Recommendation		Condition Rating / PCR	
PREVENTIVE MAINTENANCE		GOOD / 90

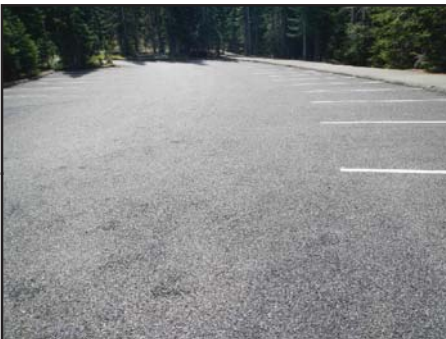
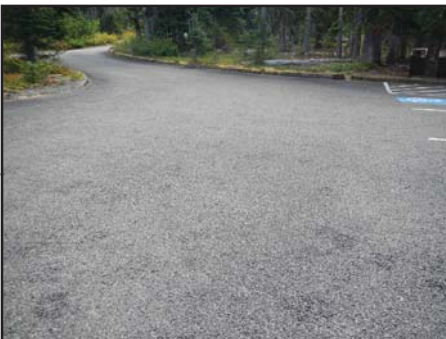
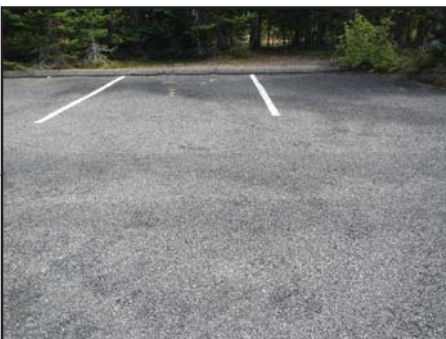
## ROUTE 0907: HURRICANE RIDGE PICNIC PARKING #2

Inspection Date	FMSS Number	User Access	Surface Type
8/10/2015	48636	PUBLIC	ASPHALT
Area (Sq. Ft.)	Lane Miles (11' Widths)	Curb Reveal (Inches)	Curb Recommendation
12,879	0.222	6	MODERATE REPAIR
Curb Type		Curb & Gutter Type	
ASPHALT		NO CURB AND GUTTER	
Pavement Recommendation		Condition Rating / PCR	
PREVENTIVE MAINTENANCE		GOOD / 90

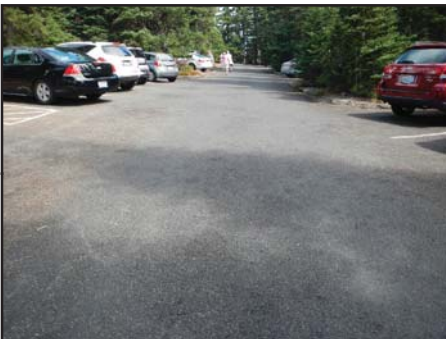
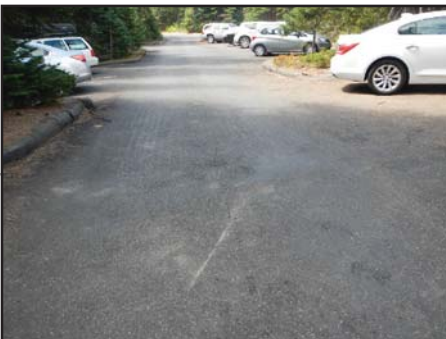
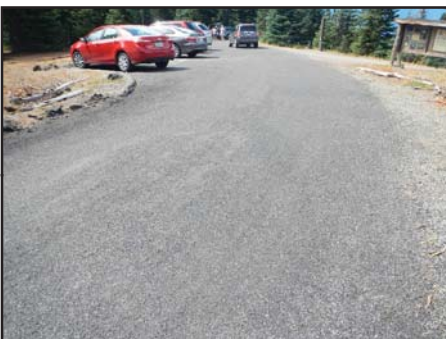
## ROUTE 0908: HURRICANE HILL TRAILHEAD PARKING

Inspection Date	FMSS Number	User Access	Surface Type
8/10/2015	48637	PUBLIC	ASPHALT
Area (Sq. Ft.)	Lane Miles (11' Widths)	Curb Reveal (Inches)	Curb Recommendation
17,026	0.293	4	REPLACE
Curb Type		Curb & Gutter Type	
ASPHALT		NO CURB AND GUTTER	
Pavement Recommendation		Condition Rating / PCR	
HEAVY 3R TREATMENTS		POOR / 53

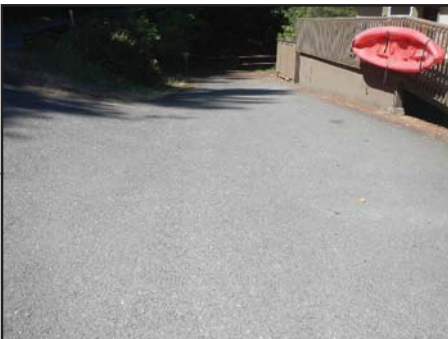
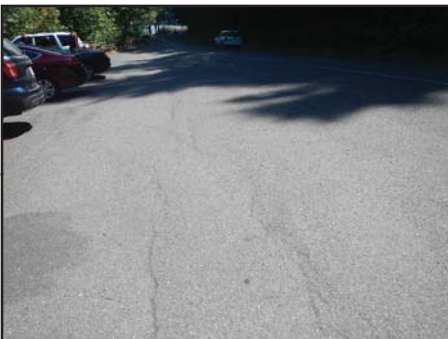
## ROUTE 0909: FAIRHOLM STORE PARKING

Inspection Date	FMSS Number	User Access	Surface Type
8/10/2015	48638	PUBLIC	ASPHALT
Area (Sq. Ft.)	Lane Miles (11' Widths)	Curb Reveal (Inches)	Curb Recommendation
5,898	0.102	NOT APPLICABLE	NOT APPLICABLE
Curb Type		Curb & Gutter Type	
NO CURB		NO CURB AND GUTTER	
Pavement Recommendation		Condition Rating / PCR	
PREVENTIVE MAINTENANCE		GOOD / 90

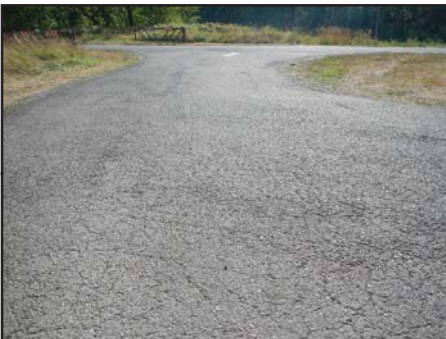
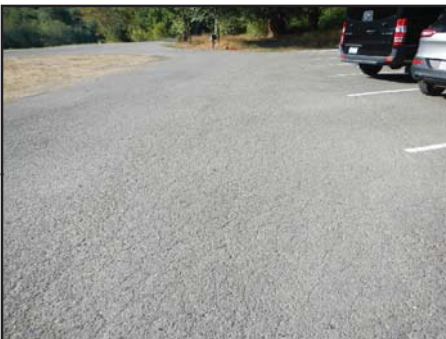
## ROUTE 0910: MADISON CREEK FALLS PARKING

Inspection Date	FMSS Number	User Access	Surface Type
8/10/2015	48639	PUBLIC	ASPHALT
Area (Sq. Ft.)	Lane Miles (11' Widths)	Curb Reveal (Inches)	Curb Recommendation
6,064	0.104	NOT APPLICABLE	NOT APPLICABLE
Curb Type		Curb & Gutter Type	
NO CURB		NO CURB AND GUTTER	
Pavement Recommendation		Condition Rating / PCR	
RECONSTRUCTION		POOR / 30
