# OLYM Cycle 6

## Final Report

# Road Inventory and Condition Assessment of Paved Routes Olympic National Park

**Federal Highway Administration  
Eastern Federal Lands Highway Division  
Road Inventory Program (RIP)**

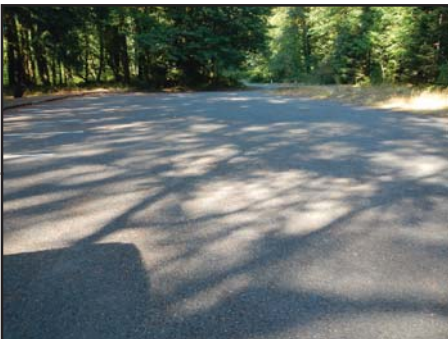
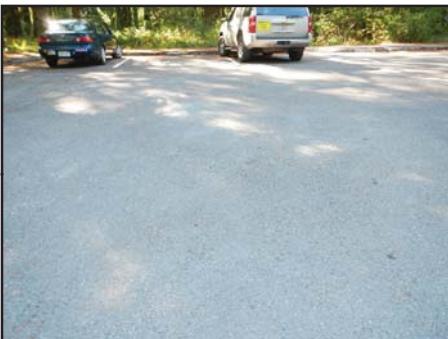
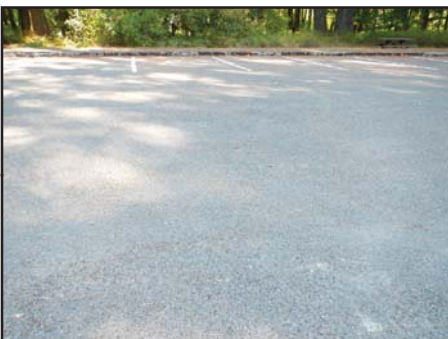
## ROUTE 0911: ELWHA AMPHITHEATER PARKING

Inspection Date	FMSS Number	User Access	Surface Type
8/10/2015	48640	PUBLIC	ASPHALT
Area (Sq. Ft.)	Lane Miles (11' Widths)	Curb Reveal (Inches)	Curb Recommendation
9,714	0.167	5	LIGHT REPAIR
Curb Type		Curb & Gutter Type	
CONCRETE		NO CURB AND GUTTER	
Pavement Recommendation		Condition Rating / PCR	
RECONSTRUCTION		POOR / 30

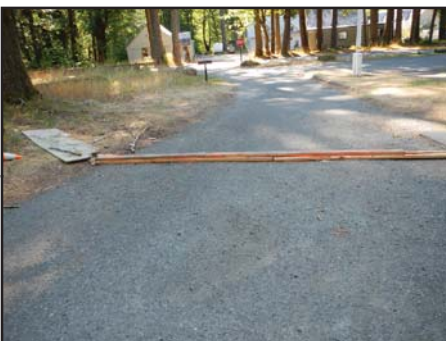
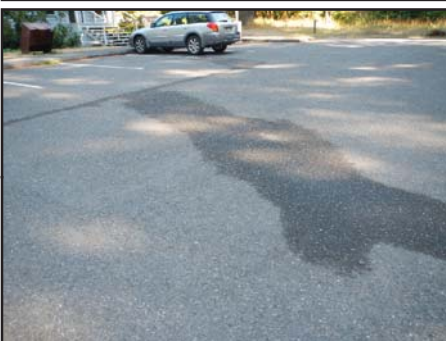
## ROUTE 0912: ELWHA RANGER STATION PARKING

Inspection Date	FMSS Number	User Access	Surface Type
8/10/2015	48641	PUBLIC	ASPHALT
Area (Sq. Ft.)	Lane Miles (11' Widths)	Curb Reveal (Inches)	Curb Recommendation
11,572	0.199	4	DO NOTHING
Curb Type		Curb & Gutter Type	
WOOD		NO CURB AND GUTTER	
Pavement Recommendation		Condition Rating / PCR	
RECONSTRUCTION		POOR / 30

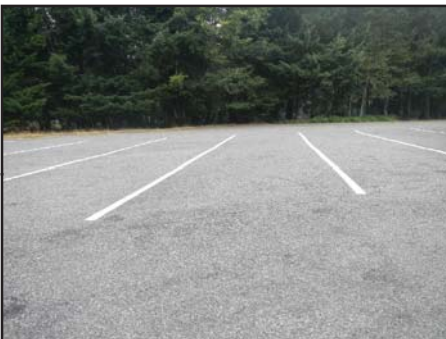
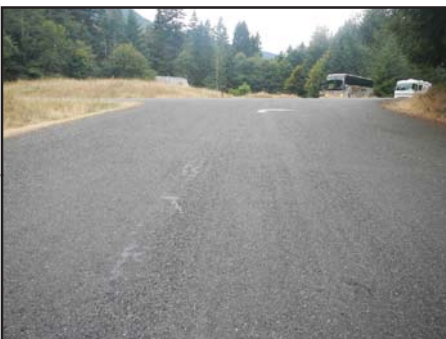
## ROUTE 0914: LAKE CRESCENT BOAT LAUNCH PARKING

Inspection Date	FMSS Number	User Access	Surface Type
8/10/2015	48643	PUBLIC	ASPHALT
Area (Sq. Ft.)	Lane Miles (11' Widths)	Curb Reveal (Inches)	Curb Recommendation
62,112	1.069	NOT APPLICABLE	NOT APPLICABLE
Curb Type		Curb & Gutter Type	
NO CURB		NO CURB AND GUTTER	
Pavement Recommendation		Condition Rating / PCR	
PREVENTIVE MAINTENANCE		GOOD / 90

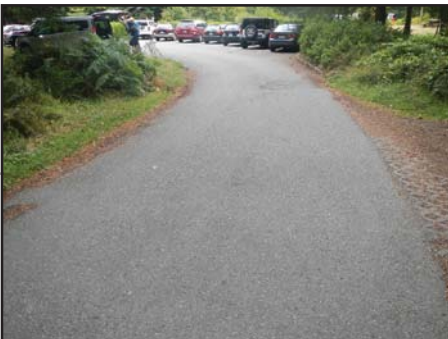
## ROUTE 0915: LAKE CRESCENT RANGER STATION PARKING

Inspection Date	FMSS Number	User Access	Surface Type
8/10/2015	48644	PUBLIC	ASPHALT
Area (Sq. Ft.)	Lane Miles (11' Widths)	Curb Reveal (Inches)	Curb Recommendation
28,909	0.498	6	DO NOTHING
Curb Type		Curb & Gutter Type	
CONCRETE		NO CURB AND GUTTER	
Pavement Recommendation		Condition Rating / PCR	
PREVENTIVE MAINTENANCE		GOOD / 90

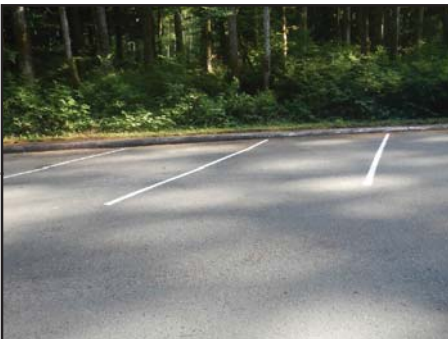
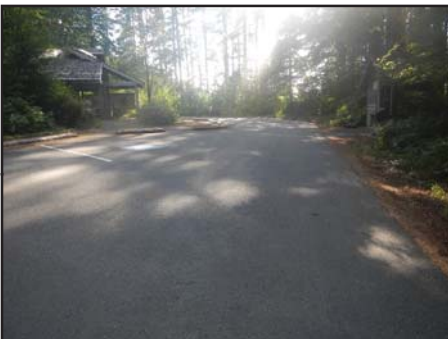
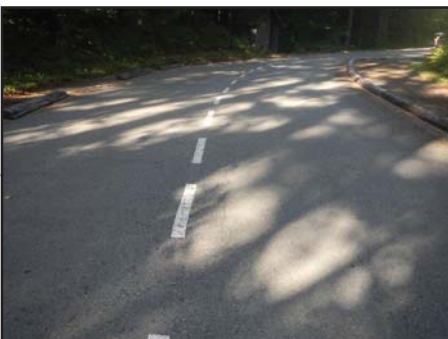
## ROUTE 0916: SOL DUC INFORMATION PARKING

Inspection Date	FMSS Number	User Access	Surface Type
8/10/2015	48645	PUBLIC	ASPHALT
Area (Sq. Ft.)	Lane Miles (11' Widths)	Curb Reveal (Inches)	Curb Recommendation
13,366	0.23	6	DO NOTHING
Curb Type		Curb & Gutter Type	
WOOD		NO CURB AND GUTTER	
Pavement Recommendation		Condition Rating / PCR	
PREVENTIVE MAINTENANCE		GOOD / 90

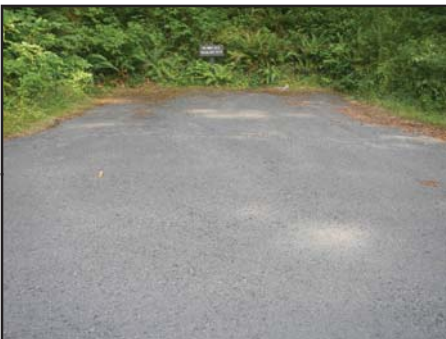
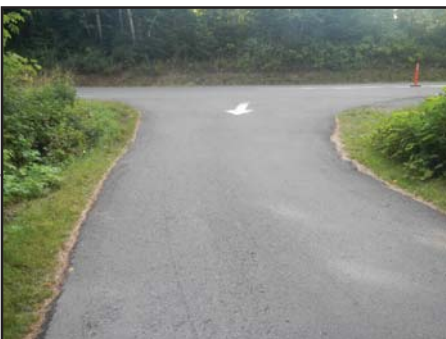
## ROUTE 0917: SOL DUC ENTRANCE STATION PARKING

Inspection Date	FMSS Number	User Access	Surface Type
8/10/2015	48646	NONPUBLIC	ASPHALT
Area (Sq. Ft.)	Lane Miles (11' Widths)	Curb Reveal (Inches)	Curb Recommendation
3,098	0.053	NOT APPLICABLE	NOT APPLICABLE
Curb Type		Curb & Gutter Type	
NO CURB		NO CURB AND GUTTER	
Pavement Recommendation		Condition Rating / PCR	
PREVENTIVE MAINTENANCE		GOOD / 90

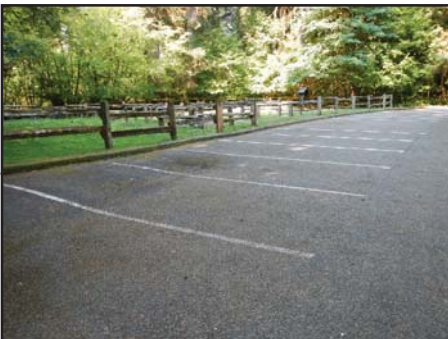
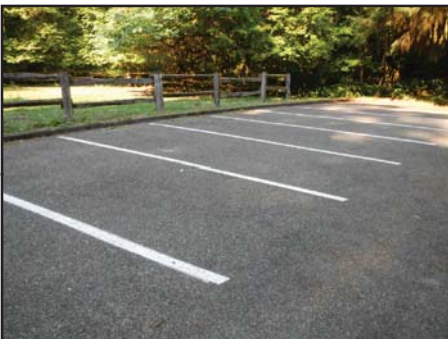
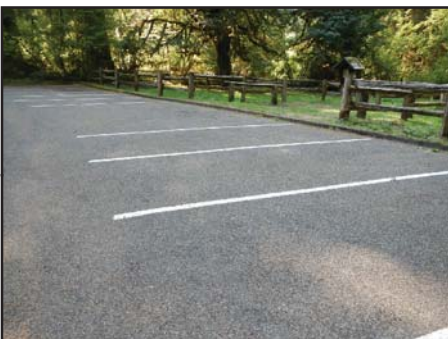
## ROUTE 0937: HOH CORRAL PARKING

Inspection Date	FMSS Number	User Access	Surface Type
8/11/2015	48666	PUBLIC	ASPHALT
Area (Sq. Ft.)	Lane Miles (11' Widths)	Curb Reveal (Inches)	Curb Recommendation
3,174	0.055	NOT APPLICABLE	DO NOTHING
Curb Type		Curb & Gutter Type	
NO CURB		CONCRETE	
Pavement Recommendation		Condition Rating / PCR	
PREVENTIVE MAINTENANCE		GOOD / 90

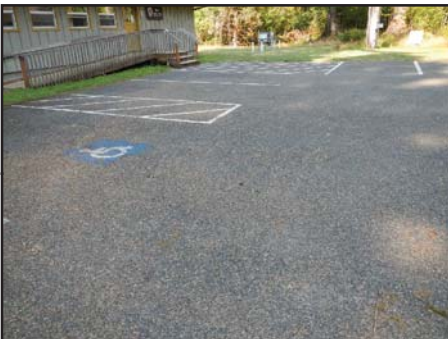
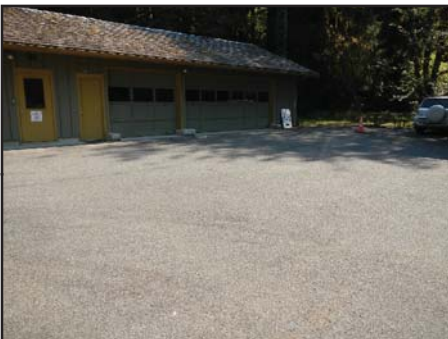
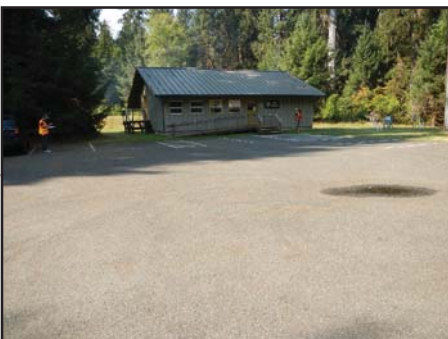
## ROUTE 0938: HOH MAINTENANCE PARKING

Inspection Date	FMSS Number	User Access	Surface Type
8/11/2015	48667	NONPUBLIC	ASPHALT
Area (Sq. Ft.)	Lane Miles (11' Widths)	Curb Reveal (Inches)	Curb Recommendation
15,329	0.264	NOT APPLICABLE	NOT APPLICABLE
Curb Type		Curb & Gutter Type	
NO CURB		NO CURB AND GUTTER	
Pavement Recommendation		Condition Rating / PCR	
PREVENTIVE MAINTENANCE		GOOD / 90

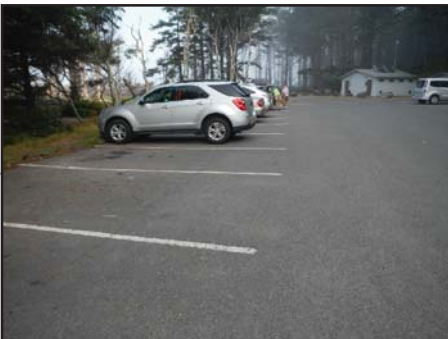
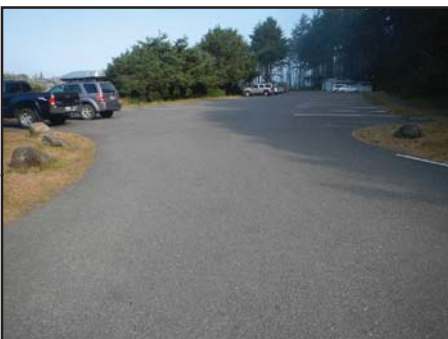
## ROUTE 0939: RIALTO BEACH PARKING

Inspection Date	FMSS Number	User Access	Surface Type
8/11/2015	48668	PUBLIC	ASPHALT
Area (Sq. Ft.)	Lane Miles (11' Widths)	Curb Reveal (Inches)	Curb Recommendation
21,298	0.367	NOT APPLICABLE	NOT APPLICABLE
Curb Type		Curb & Gutter Type	
NO CURB		NO CURB AND GUTTER	
Pavement Recommendation		Condition Rating / PCR	
PREVENTIVE MAINTENANCE		GOOD / 90

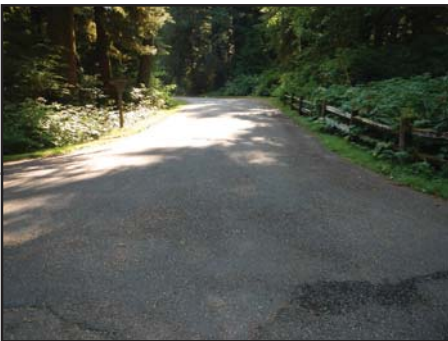
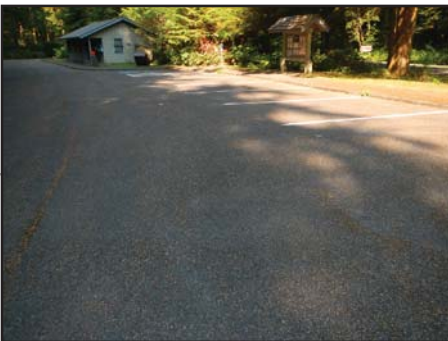
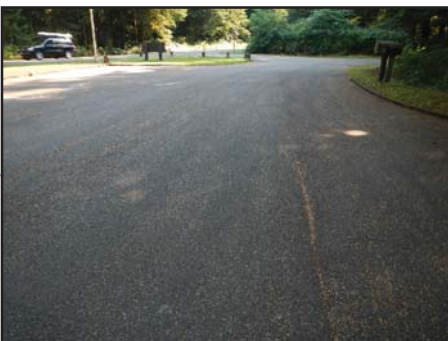
## ROUTE 0940: MORA RANGER STATION PARKING

Inspection Date	FMSS Number	User Access	Surface Type
8/11/2015	48669	PUBLIC	ASPHALT
Area (Sq. Ft.)	Lane Miles (11' Widths)	Curb Reveal (Inches)	Curb Recommendation
10,959	0.189	4	DO NOTHING
Curb Type		Curb & Gutter Type	
CONCRETE		NO CURB AND GUTTER	
Pavement Recommendation		Condition Rating / PCR	
LIGHT 3R TREATMENTS		FAIR / 73

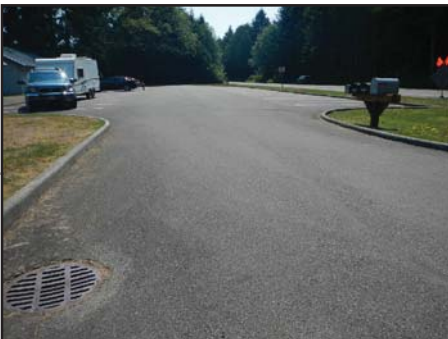
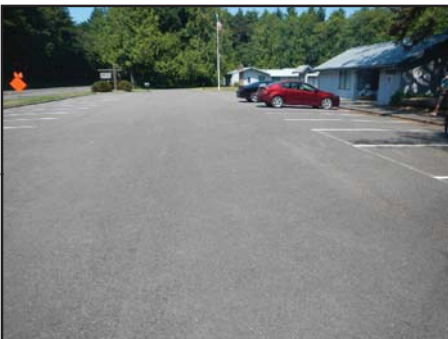
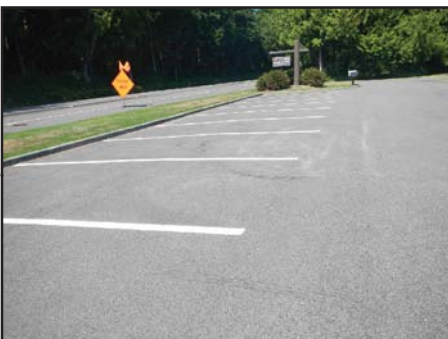
## ROUTE 0941: KALALOCH VISITOR CENTER PARKING

Inspection Date	FMSS Number	User Access	Surface Type
8/11/2015	48670	PUBLIC	ASPHALT
Area (Sq. Ft.)	Lane Miles (11' Widths)	Curb Reveal (Inches)	Curb Recommendation
16,317	0.281	4	DO NOTHING
Curb Type		Curb & Gutter Type	
CONCRETE		NO CURB AND GUTTER	
Pavement Recommendation		Condition Rating / PCR	
PREVENTIVE MAINTENANCE		GOOD / 90

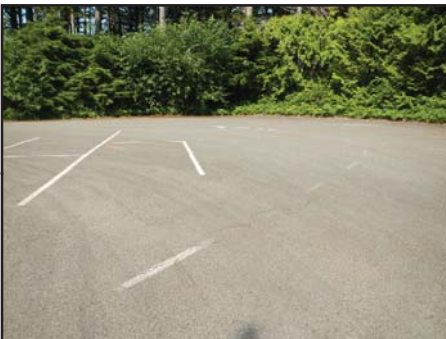
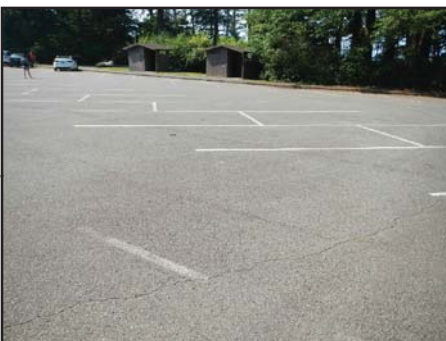
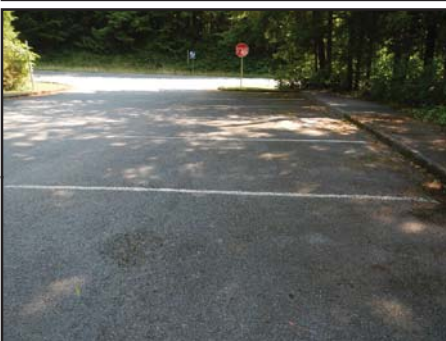
## ROUTE 0942: BEACH 4 PARKING

Inspection Date	FMSS Number	User Access	Surface Type
8/11/2015	48671	PUBLIC	ASPHALT
Area (Sq. Ft.)	Lane Miles (11' Widths)	Curb Reveal (Inches)	Curb Recommendation
33,067	0.569	NOT APPLICABLE	DO NOTHING
Curb Type		Curb & Gutter Type	
NO CURB		CONCRETE	
Pavement Recommendation		Condition Rating / PCR	
LIGHT 3R TREATMENTS		FAIR / 73

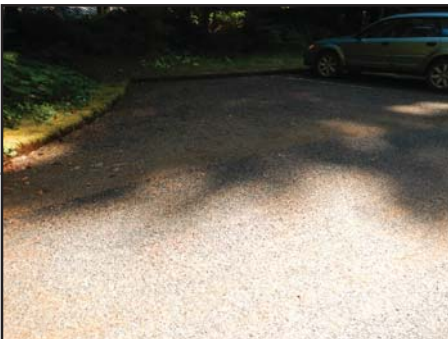
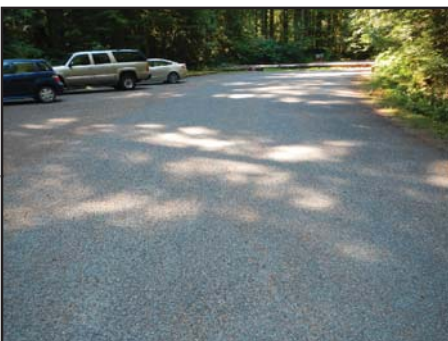
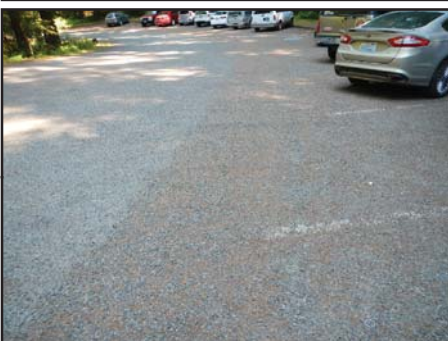
## ROUTE 0944ZZ: HEATHER PARK PARKING

Inspection Date	FMSS Number	User Access	Surface Type
8/10/2015	48673	PUBLIC	ASPHALT
Area (Sq. Ft.)	Lane Miles (11' Widths)	Curb Reveal (Inches)	Curb Recommendation
7,506	0.129	NOT APPLICABLE	DO NOTHING
Curb Type		Curb & Gutter Type	
NO CURB		CONCRETE	
Pavement Recommendation		Condition Rating / PCR	
LIGHT 3R TREATMENTS		FAIR / 73

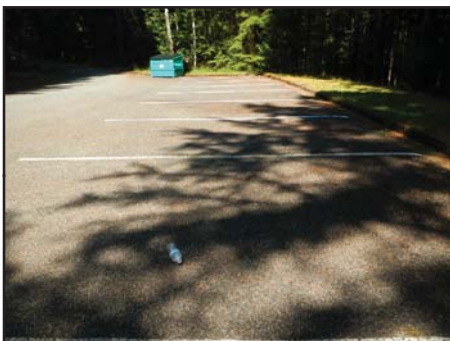
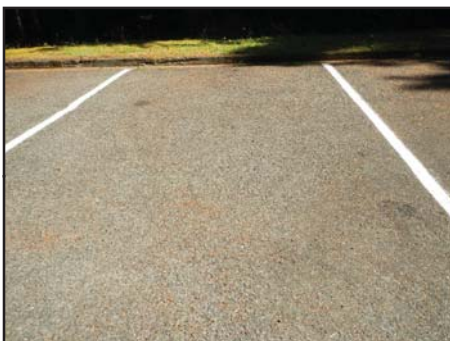
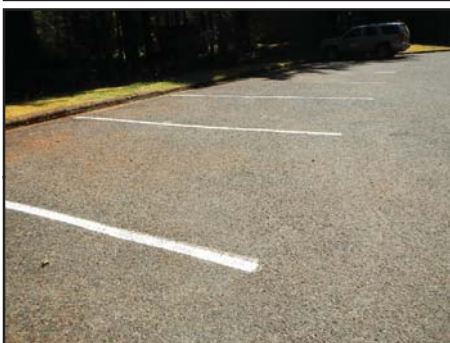
## ROUTE 0944BZ: HEATHER PARK PARKING B

Inspection Date	FMSS Number	User Access	Surface Type
8/10/2015	48673	PUBLIC	ASPHALT
Area (Sq. Ft.)	Lane Miles (11' Widths)	Curb Reveal (Inches)	Curb Recommendation
2,200	0.038	NOT APPLICABLE	DO NOTHING
Curb Type		Curb & Gutter Type	
NO CURB		CONCRETE	
Pavement Recommendation		Condition Rating / PCR	
PREVENTIVE MAINTENANCE		GOOD / 90

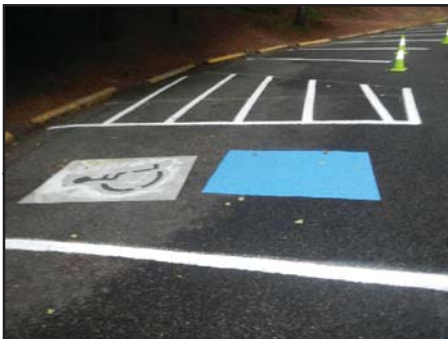
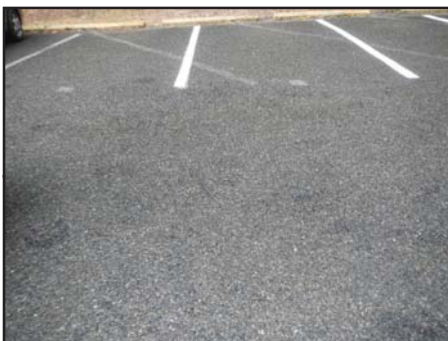
## ROUTE 0945: STAIRCASE PUBLIC PARKING

Inspection Date	FMSS Number	User Access	Surface Type
8/12/2015	48674	PUBLIC	ASPHALT
Area (Sq. Ft.)	Lane Miles (11' Widths)	Curb Reveal (Inches)	Curb Recommendation
4,033	0.069	NOT APPLICABLE	NOT APPLICABLE
Curb Type		Curb & Gutter Type	
NO CURB		NO CURB AND GUTTER	
Pavement Recommendation		Condition Rating / PCR	
DO NOTHING		EXCELLENT / 97

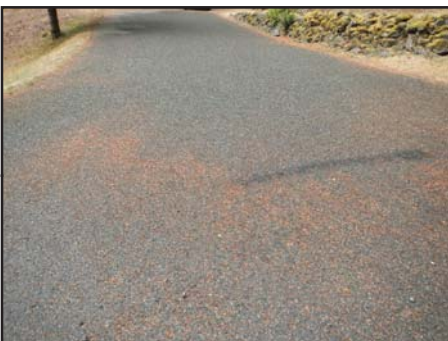
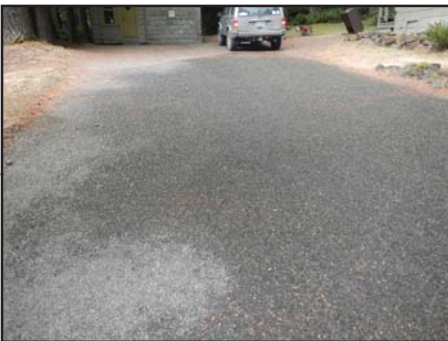
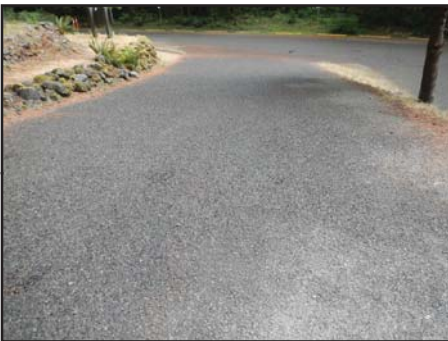
## ROUTE 0946: STAIRCASE RANGER STATION

Inspection Date	FMSS Number	User Access	Surface Type
8/12/2015	48675	NONPUBLIC	ASPHALT
Area (Sq. Ft.)	Lane Miles (11' Widths)	Curb Reveal (Inches)	Curb Recommendation
2,094	0.036	NOT APPLICABLE	NOT APPLICABLE
Curb Type		Curb & Gutter Type	
NO CURB		NO CURB AND GUTTER	
Pavement Recommendation		Condition Rating / PCR	
PREVENTIVE MAINTENANCE		GOOD / 90

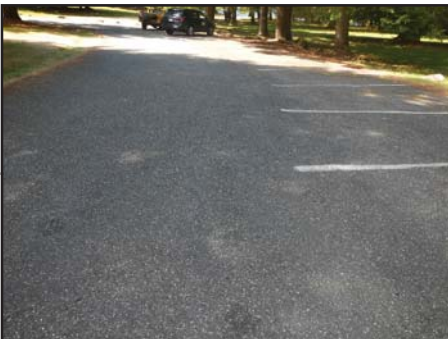
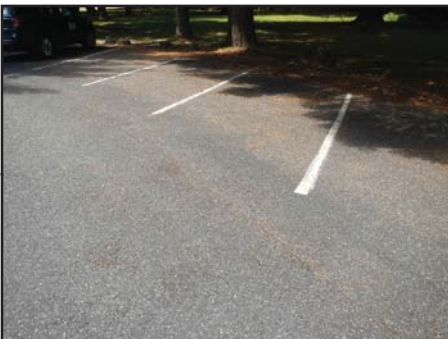
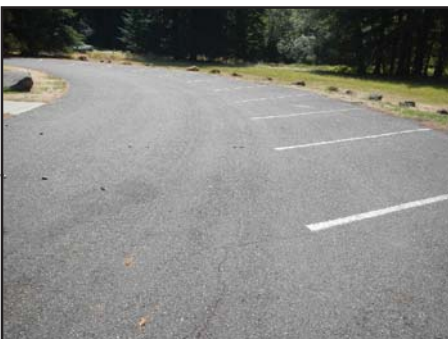
## ROUTE 0947: BOVEES MEADOW PARKING

Inspection Date	FMSS Number	User Access	Surface Type
8/10/2015	48676	PUBLIC	ASPHALT
Area (Sq. Ft.)	Lane Miles (11' Widths)	Curb Reveal (Inches)	Curb Recommendation
5,811	0.1	NOT APPLICABLE	NOT APPLICABLE
Curb Type		Curb & Gutter Type	
NO CURB		NO CURB AND GUTTER	
Pavement Recommendation		Condition Rating / PCR	
PREVENTIVE MAINTENANCE		GOOD / 90

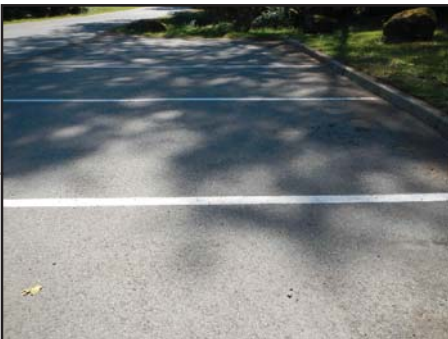
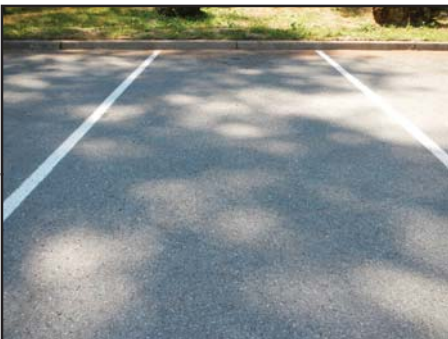
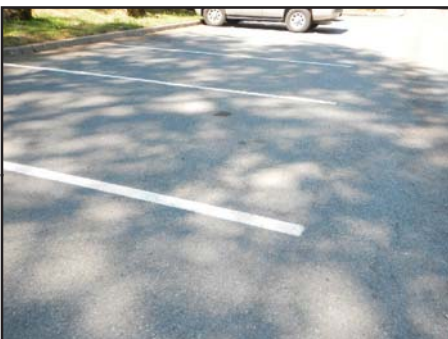
## ROUTE 0948: HEART O' THE HILLS ENTRANCE STATION PARKING

Inspection Date	FMSS Number	User Access	Surface Type
8/10/2015	48677	PUBLIC	ASPHALT
Area (Sq. Ft.)	Lane Miles (11' Widths)	Curb Reveal (Inches)	Curb Recommendation
2,509	0.043	5	DO NOTHING
Curb Type		Curb & Gutter Type	
CONCRETE		NO CURB AND GUTTER	
Pavement Recommendation		Condition Rating / PCR	
PREVENTIVE MAINTENANCE		GOOD / 90

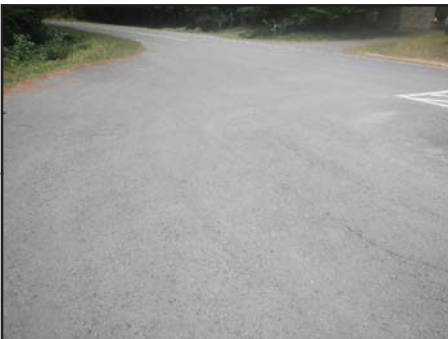
## ROUTE 0950: GEAGLE RANGER STATION PARKING

Inspection Date	FMSS Number	User Access	Surface Type
8/10/2015	48678	PUBLIC	ASPHALT
Area (Sq. Ft.)	Lane Miles (11' Widths)	Curb Reveal (Inches)	Curb Recommendation
4,749	0.082	NOT APPLICABLE	NOT APPLICABLE
Curb Type		Curb & Gutter Type	
NO CURB		NO CURB AND GUTTER	
Pavement Recommendation		Condition Rating / PCR	
PREVENTIVE MAINTENANCE		GOOD / 90

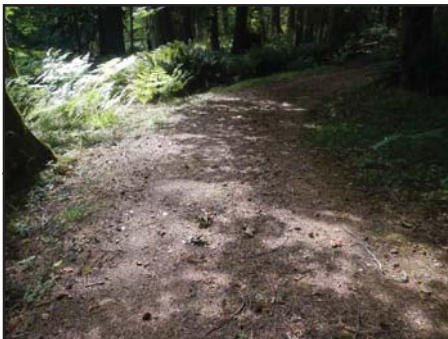
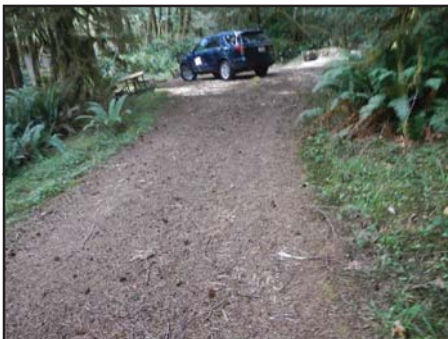
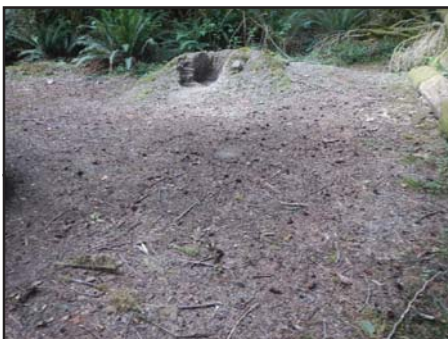
Inspection Date	FMSS Number	User Access	Surface Type
8/10/2015	114635	PUBLIC	ASPHALT
Area (Sq. Ft.)	Lane Miles (11' Widths)	Curb Reveal (Inches)	Curb Recommendation
2,531	0.044	NOT APPLICABLE	NOT APPLICABLE
Curb Type		Curb & Gutter Type	
NO CURB		NO CURB AND GUTTER	
Pavement Recommendation		Condition Rating / PCR	
NOT APPLICABLE		NOT RATED / -1

Note: Parking area could not be rated because the pavement was covered by debris.

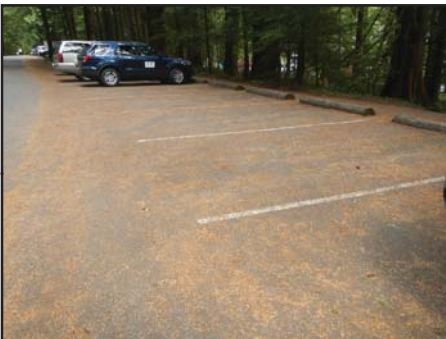
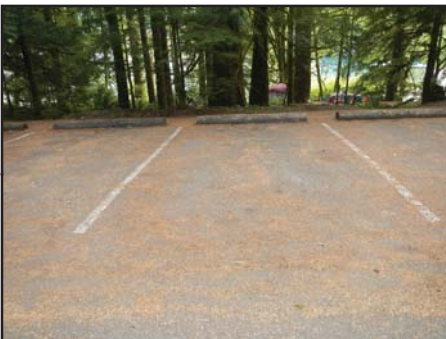
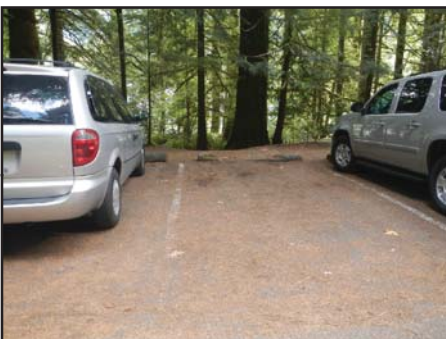
Inspection Date	FMSS Number	User Access	Surface Type
8/10/2015	114635	PUBLIC	ASPHALT
Area (Sq. Ft.)	Lane Miles (11' Widths)	Curb Reveal (Inches)	Curb Recommendation
1,576	0.027	NOT APPLICABLE	NOT APPLICABLE
Curb Type		Curb & Gutter Type	
NO CURB		NO CURB AND GUTTER	
Pavement Recommendation		Condition Rating / PCR	
PREVENTIVE MAINTENANCE		GOOD / 90

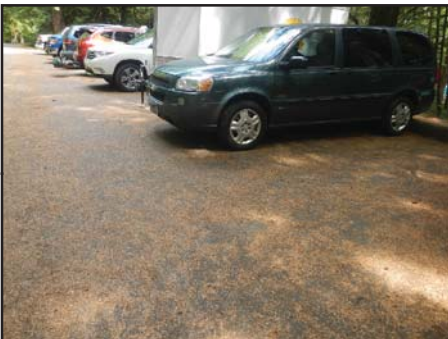
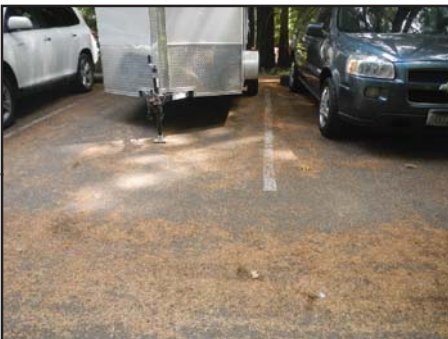
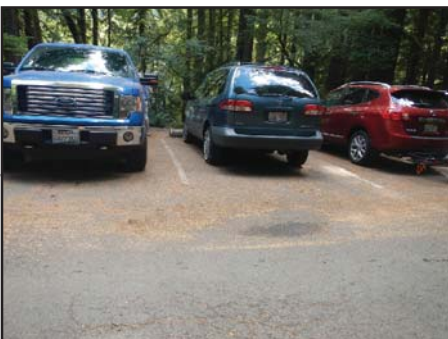
## ROUTE 0953CZ: FAIRHOLM CAMPGROUND PARKING C

Inspection Date	FMSS Number	User Access	Surface Type
8/10/2015	114635	PUBLIC	ASPHALT
Area (Sq. Ft.)	Lane Miles (11' Widths)	Curb Reveal (Inches)	Curb Recommendation
2,583	0.044	NOT APPLICABLE	NOT APPLICABLE
Curb Type		Curb & Gutter Type	
NO CURB		NO CURB AND GUTTER	
Pavement Recommendation		Condition Rating / PCR	
PREVENTIVE MAINTENANCE		GOOD / 90

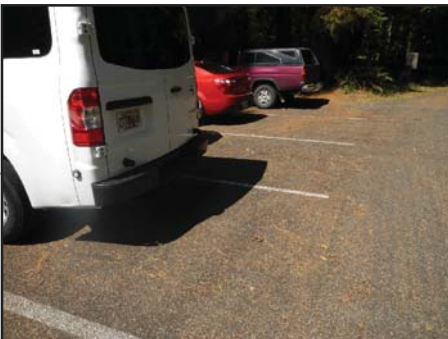
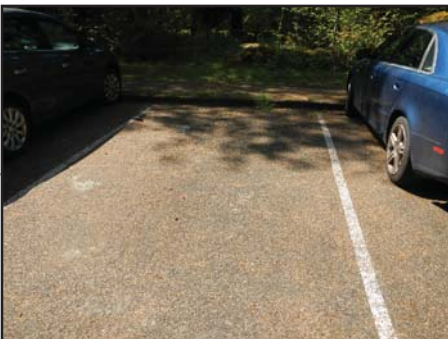
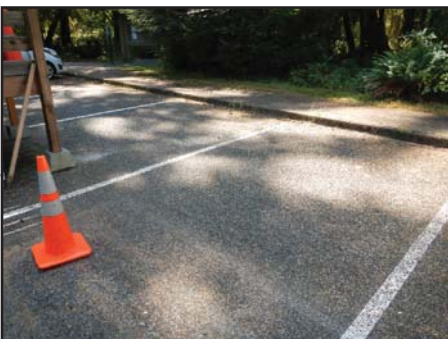
Inspection Date	FMSS Number	User Access	Surface Type
8/11/2015	114636	PUBLIC	ASPHALT
Area (Sq. Ft.)	Lane Miles (11' Widths)	Curb Reveal (Inches)	Curb Recommendation
5,975	0.103	NOT APPLICABLE	DO NOTHING
Curb Type		Curb & Gutter Type	
NO CURB		CONCRETE	
Pavement Recommendation		Condition Rating / PCR	
PREVENTIVE MAINTENANCE		GOOD / 90

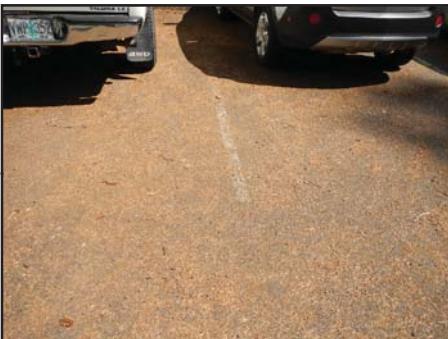
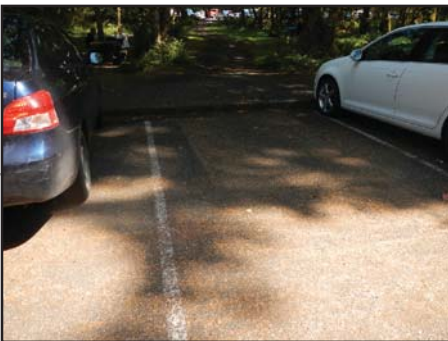
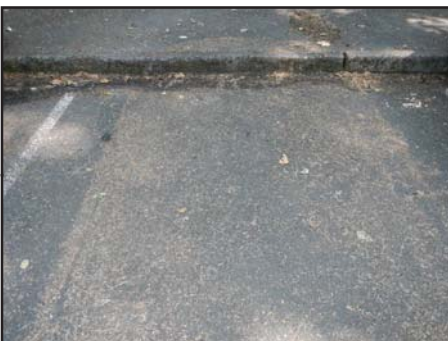
## ROUTE 0954BZ: HOH CAMPGROUND PARKING B

Inspection Date	FMSS Number	User Access	Surface Type
8/11/2015	114636	PUBLIC	ASPHALT
Area (Sq. Ft.)	Lane Miles (11' Widths)	Curb Reveal (Inches)	Curb Recommendation
4,686	0.081	NOT APPLICABLE	DO NOTHING
Curb Type		Curb & Gutter Type	
NO CURB		CONCRETE	
Pavement Recommendation		Condition Rating / PCR	
PREVENTIVE MAINTENANCE		GOOD / 90

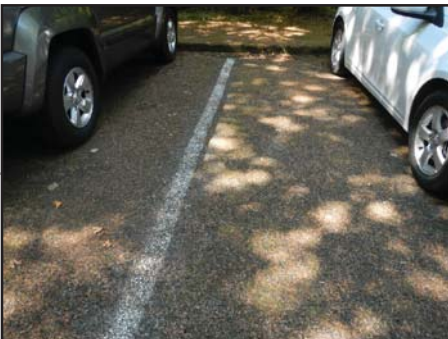
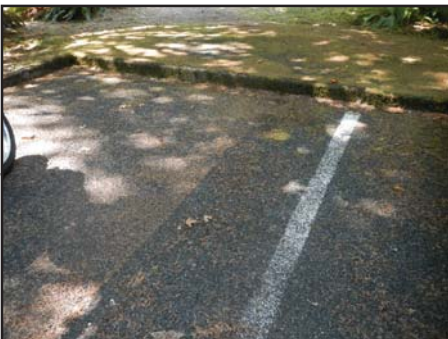
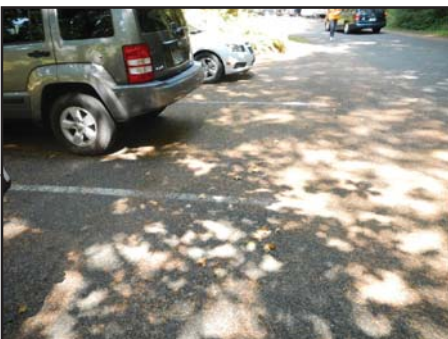
## ROUTE 0954CZ: HOH CAMPGROUND PARKING C

Inspection Date	FMSS Number	User Access	Surface Type
8/11/2015	114636	PUBLIC	ASPHALT
Area (Sq. Ft.)	Lane Miles (11' Widths)	Curb Reveal (Inches)	Curb Recommendation
920	0.016	NOT APPLICABLE	DO NOTHING
Curb Type		Curb & Gutter Type	
NO CURB		CONCRETE	
Pavement Recommendation		Condition Rating / PCR	
PREVENTIVE MAINTENANCE		GOOD / 90

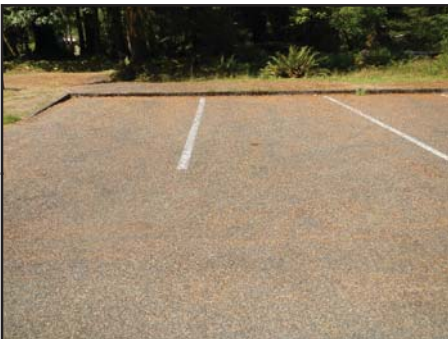
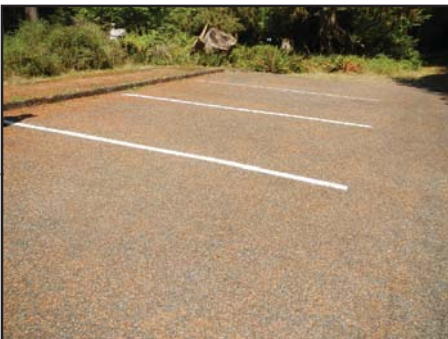
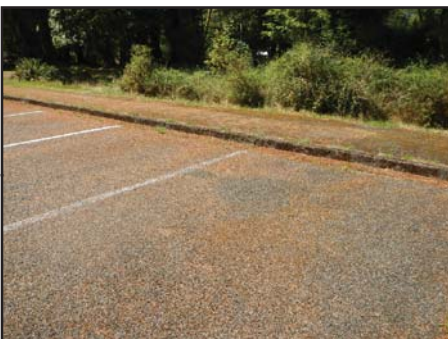
## ROUTE 0954DZ: HOH CAMPGROUND PARKING D

Inspection Date	FMSS Number	User Access	Surface Type
8/11/2015	114636	PUBLIC	ASPHALT
Area (Sq. Ft.)	Lane Miles (11' Widths)	Curb Reveal (Inches)	Curb Recommendation
2,272	0.039	NOT APPLICABLE	DO NOTHING
Curb Type		Curb & Gutter Type	
NO CURB		CONCRETE	
Pavement Recommendation		Condition Rating / PCR	
PREVENTIVE MAINTENANCE		GOOD / 90

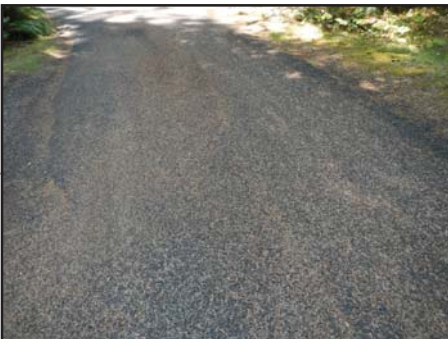
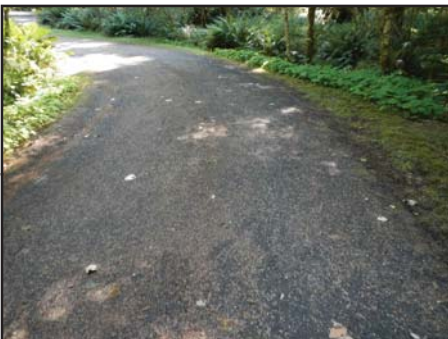
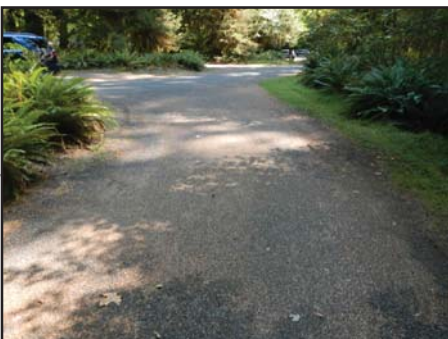
## ROUTE 0954EZ: HOH CAMPGROUND PARKING E (DUMP STATION)

Inspection Date	FMSS Number	User Access	Surface Type
8/11/2015	114636	PUBLIC	ASPHALT
Area (Sq. Ft.)	Lane Miles (11' Widths)	Curb Reveal (Inches)	Curb Recommendation
2,731	0.047	NOT APPLICABLE	NOT APPLICABLE
Curb Type		Curb & Gutter Type	
NO CURB		NO CURB AND GUTTER	
Pavement Recommendation		Condition Rating / PCR	
PREVENTIVE MAINTENANCE		GOOD / 90

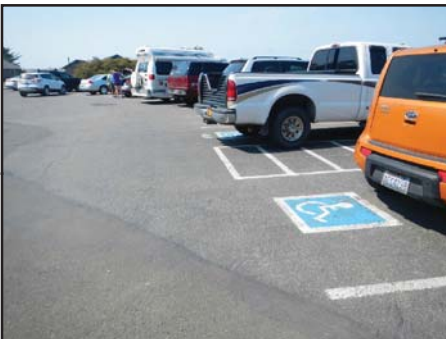
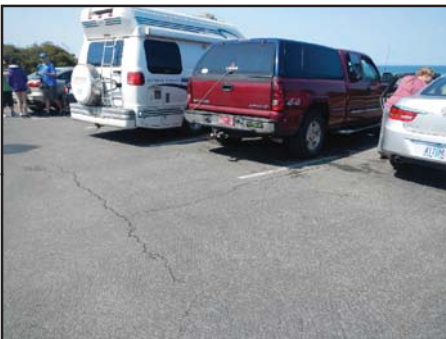
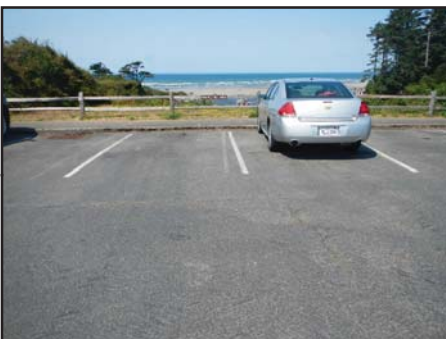
Inspection Date	FMSS Number	User Access	Surface Type
8/11/2015	N/A	PUBLIC	ASPHALT
Area (Sq. Ft.)	Lane Miles (11' Widths)	Curb Reveal (Inches)	Curb Recommendation
2,248	0.039	4	LIGHT REPAIR
Curb Type		Curb & Gutter Type	
CONCRETE		NO CURB AND GUTTER	
Pavement Recommendation		Condition Rating / PCR	
LIGHT 3R TREATMENTS		FAIR / 73

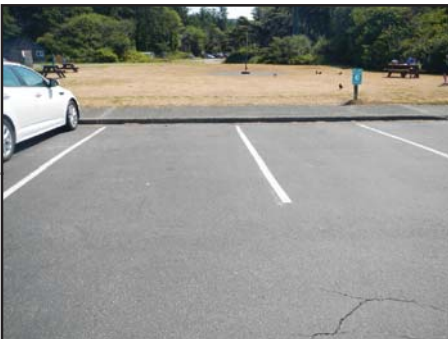
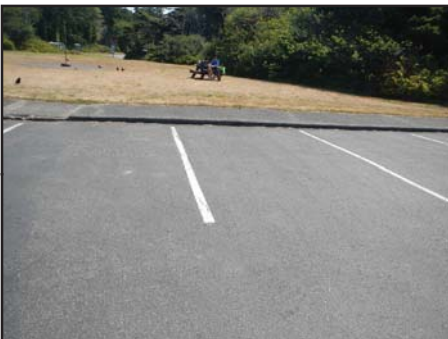
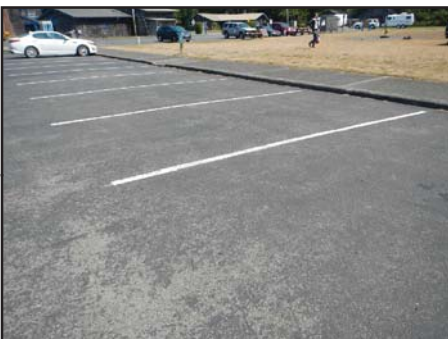
Inspection Date	FMSS Number	User Access	Surface Type
8/11/2015	N/A	PUBLIC	ASPHALT
Area (Sq. Ft.)	Lane Miles (11' Widths)	Curb Reveal (Inches)	Curb Recommendation
1,426	0.025	4	DO NOTHING
Curb Type		Curb & Gutter Type	
CONCRETE		NO CURB AND GUTTER	
Pavement Recommendation		Condition Rating / PCR	
HEAVY 3R TREATMENTS		POOR / 53

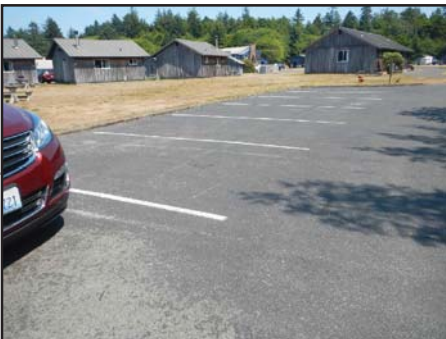
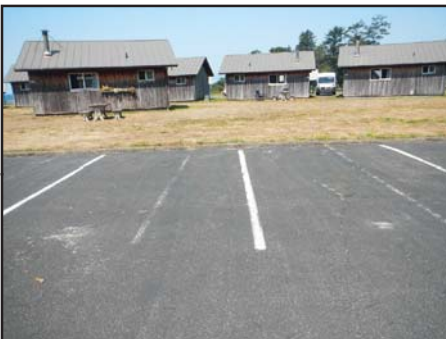
Inspection Date	FMSS Number	User Access	Surface Type
8/11/2015	N/A	PUBLIC	ASPHALT
Area (Sq. Ft.)	Lane Miles (11' Widths)	Curb Reveal (Inches)	Curb Recommendation
2,125	0.037	4	DO NOTHING
Curb Type		Curb & Gutter Type	
CONCRETE AND STONE		NO CURB AND GUTTER	
Pavement Recommendation		Condition Rating / PCR	
LIGHT 3R TREATMENTS		FAIR / 73

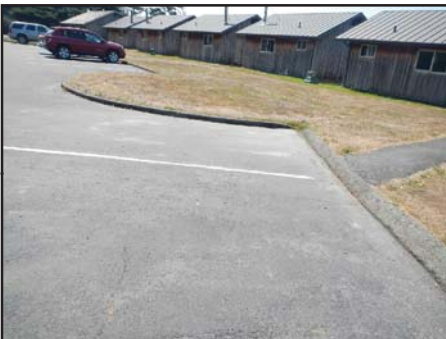
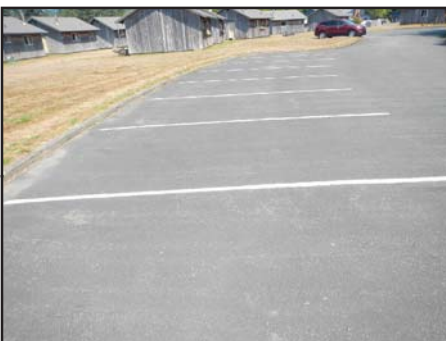
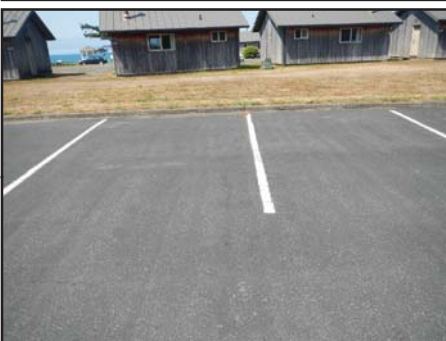
Inspection Date	FMSS Number	User Access	Surface Type
8/11/2015	N/A	PUBLIC	ASPHALT
Area (Sq. Ft.)	Lane Miles (11' Widths)	Curb Reveal (Inches)	Curb Recommendation
1,702	0.029	4	DO NOTHING
Curb Type		Curb & Gutter Type	
CONCRETE		NO CURB AND GUTTER	
Pavement Recommendation		Condition Rating / PCR	
LIGHT 3R TREATMENTS		FAIR / 73

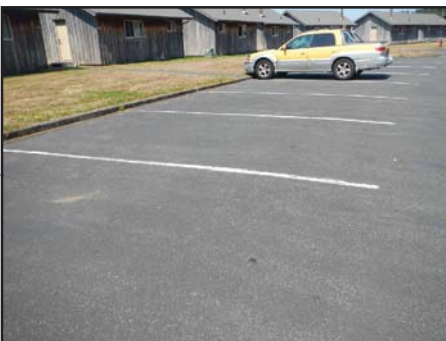
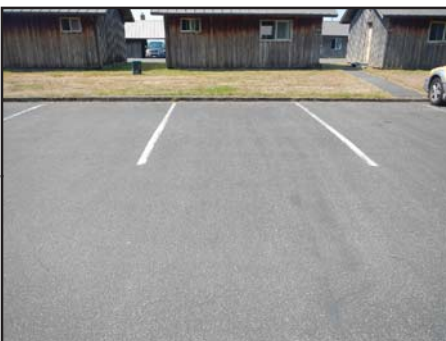
Inspection Date	FMSS Number	User Access	Surface Type
8/11/2015	N/A	PUBLIC	ASPHALT
Area (Sq. Ft.)	Lane Miles (11' Widths)	Curb Reveal (Inches)	Curb Recommendation
1,552	0.027	NOT APPLICABLE	NOT APPLICABLE
Curb Type		Curb & Gutter Type	
NO CURB		NO CURB AND GUTTER	
Pavement Recommendation		Condition Rating / PCR	
PREVENTIVE MAINTENANCE		GOOD / 90

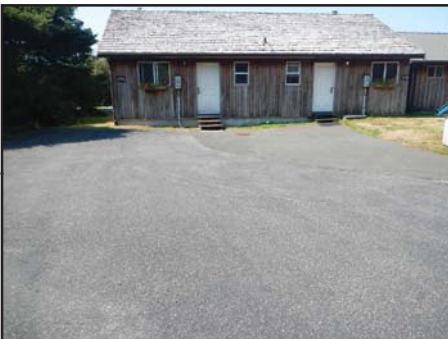
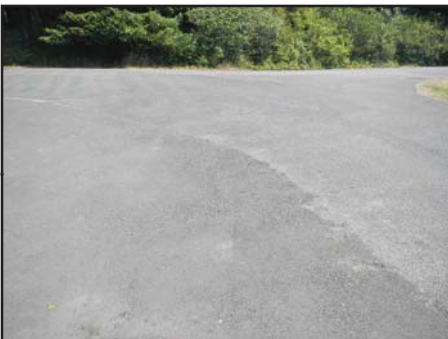
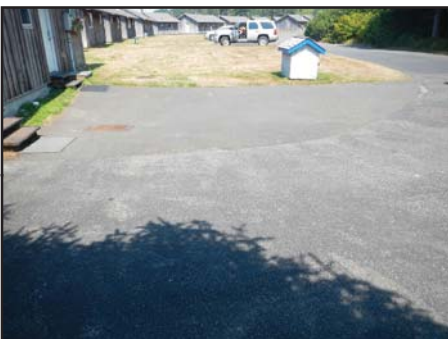
Inspection Date	FMSS Number	User Access	Surface Type
8/11/2015	N/A	PUBLIC	ASPHALT
Area (Sq. Ft.)	Lane Miles (11' Widths)	Curb Reveal (Inches)	Curb Recommendation
1,631	0.028	NOT APPLICABLE	NOT APPLICABLE
Curb Type		Curb & Gutter Type	
NO CURB		NO CURB AND GUTTER	
Pavement Recommendation		Condition Rating / PCR	
PREVENTIVE MAINTENANCE		GOOD / 90

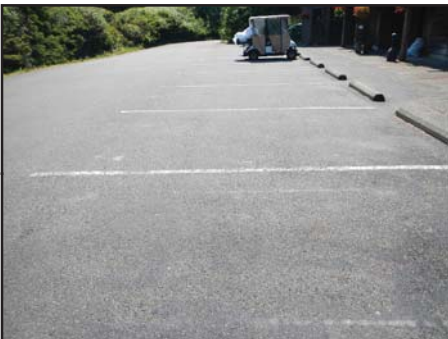
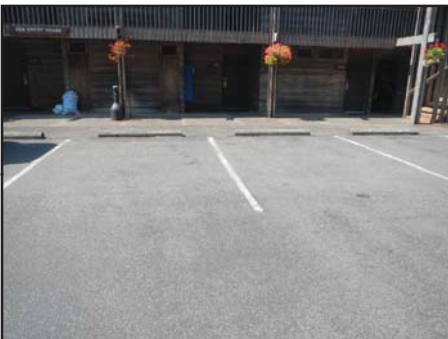
Inspection Date	FMSS Number	User Access	Surface Type
8/11/2015	N/A	PUBLIC	ASPHALT
Area (Sq. Ft.)	Lane Miles (11' Widths)	Curb Reveal (Inches)	Curb Recommendation
4,613	0.079	NOT APPLICABLE	NOT APPLICABLE
Curb Type		Curb & Gutter Type	
NO CURB		NO CURB AND GUTTER	
Pavement Recommendation		Condition Rating / PCR	
RECONSTRUCTION		POOR / 30

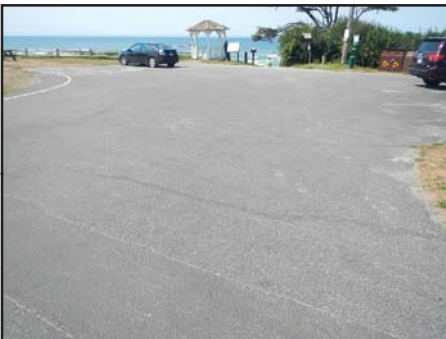
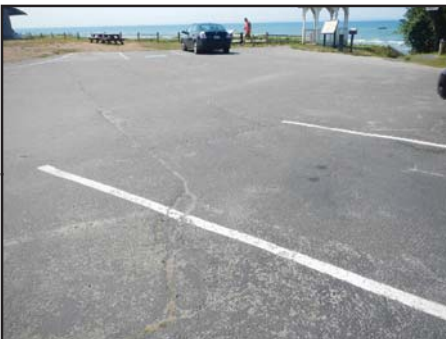
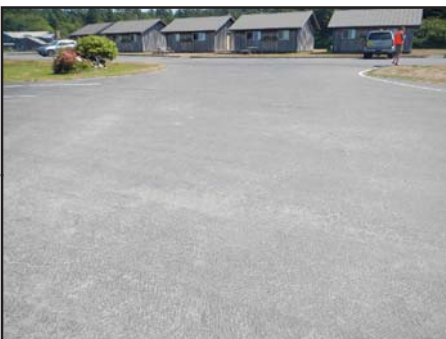
Inspection Date	FMSS Number	User Access	Surface Type
8/11/2015	N/A	PUBLIC	ASPHALT
Area (Sq. Ft.)	Lane Miles (11' Widths)	Curb Reveal (Inches)	Curb Recommendation
3,831	0.066	7	DO NOTHING
Curb Type		Curb & Gutter Type	
ASPHALT		NO CURB AND GUTTER	
Pavement Recommendation		Condition Rating / PCR	
LIGHT 3R TREATMENTS		FAIR / 73

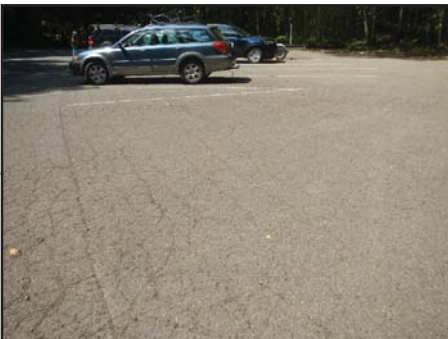
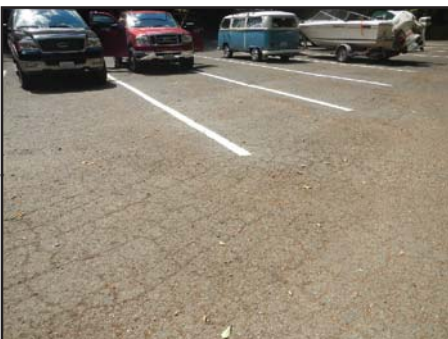
Inspection Date	FMSS Number	User Access	Surface Type
8/10/2015	N/A	PUBLIC	ASPHALT
Area (Sq. Ft.)	Lane Miles (11' Widths)	Curb Reveal (Inches)	Curb Recommendation
9,675	0.167	6	DO NOTHING
Curb Type		Curb & Gutter Type	
WOOD		NO CURB AND GUTTER	
Pavement Recommendation		Condition Rating / PCR	
RECONSTRUCTION		POOR / 30

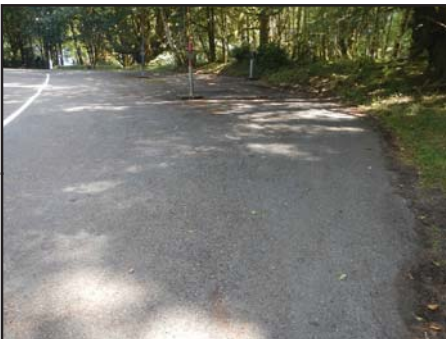
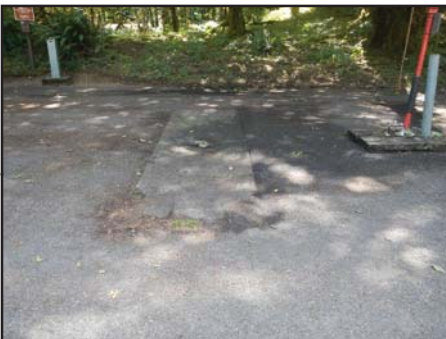
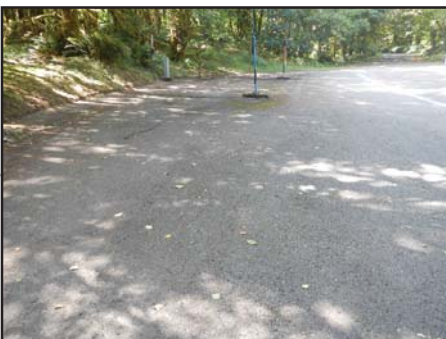
Inspection Date	FMSS Number	User Access	Surface Type
8/10/2015	N/A	PUBLIC	ASPHALT
Area (Sq. Ft.)	Lane Miles (11' Widths)	Curb Reveal (Inches)	Curb Recommendation
3,365	0.058	NOT APPLICABLE	NOT APPLICABLE
Curb Type		Curb & Gutter Type	
NO CURB		NO CURB AND GUTTER	
Pavement Recommendation		Condition Rating / PCR	
PREVENTIVE MAINTENANCE		GOOD / 90

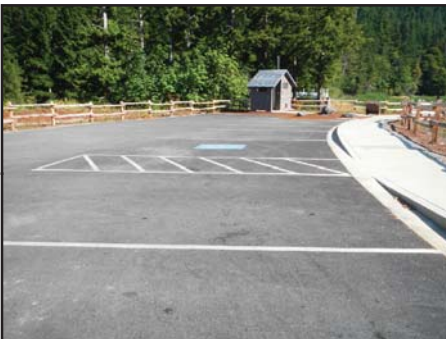
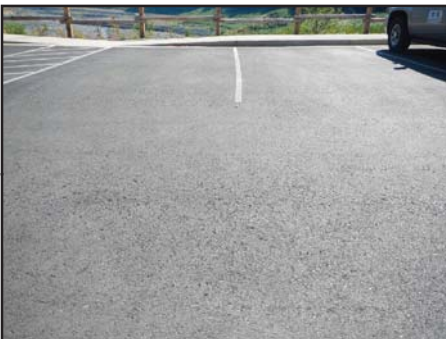
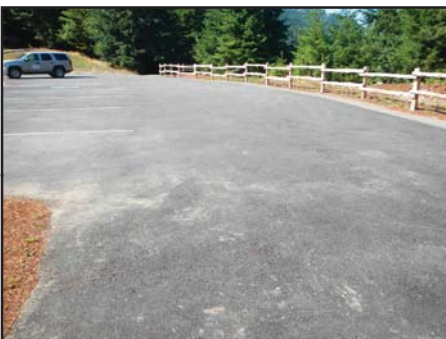
## ROUTE 0976ZZ: SOL DUC CAMPGROUND LOOP B PARKING AREAS

Inspection Date	FMSS Number	User Access	Surface Type
8/10/2015	N/A	PUBLIC	ASPHALT
Area (Sq. Ft.)	Lane Miles (11' Widths)	Condition Rating / PCR	
4,388	0.075	SUMMARY / 86

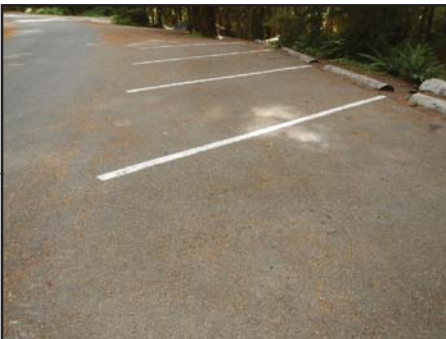
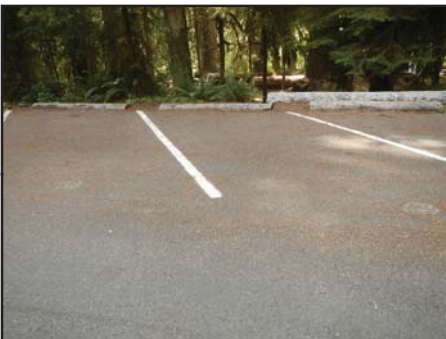
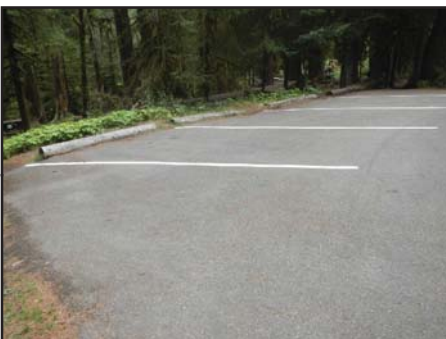
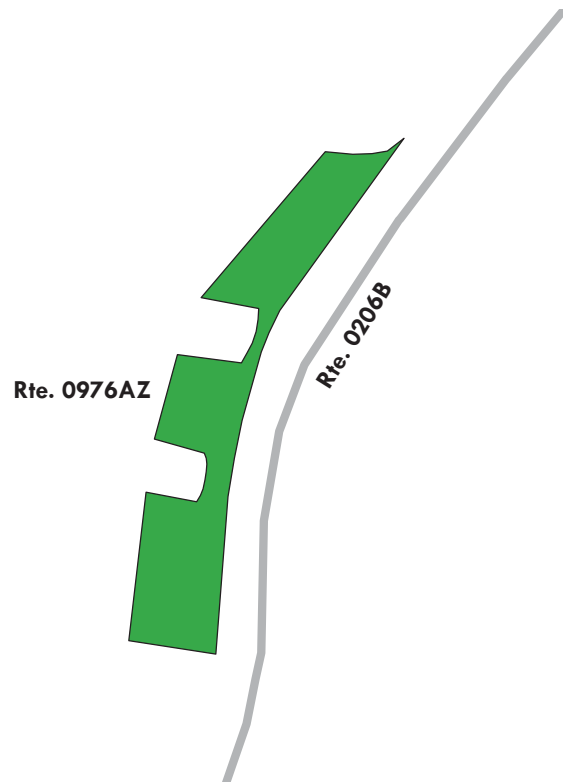
## ROUTE 0976BZ: SOL DUC CAMPGROUND LOOP B PARKING B

Inspection Date	FMSS Number	User Access	Surface Type
8/10/2015	N/A	PUBLIC	ASPHALT
Area (Sq. Ft.)	Lane Miles (11' Widths)	Curb Reveal (Inches)	Curb Recommendation
1,299	0.022	NOT APPLICABLE	NOT APPLICABLE
Curb Type		Curb & Gutter Type	
NO CURB		NO CURB AND GUTTER	
Pavement Recommendation		Condition Rating / PCR	
PREVENTIVE MAINTENANCE		GOOD / 90

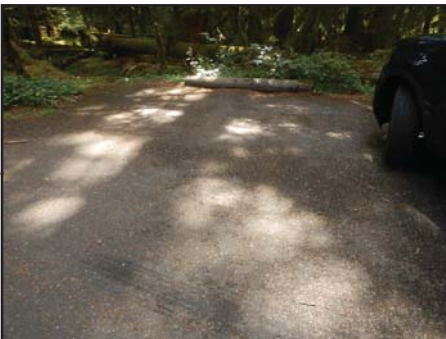
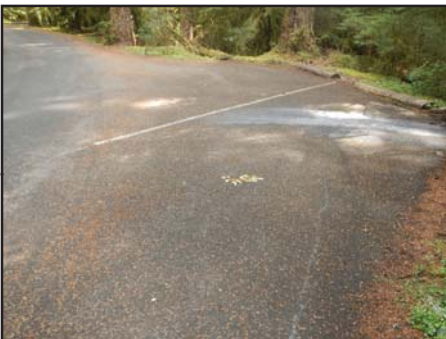
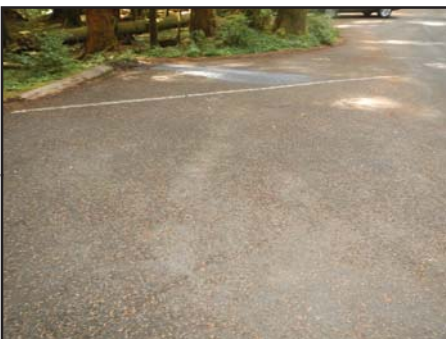
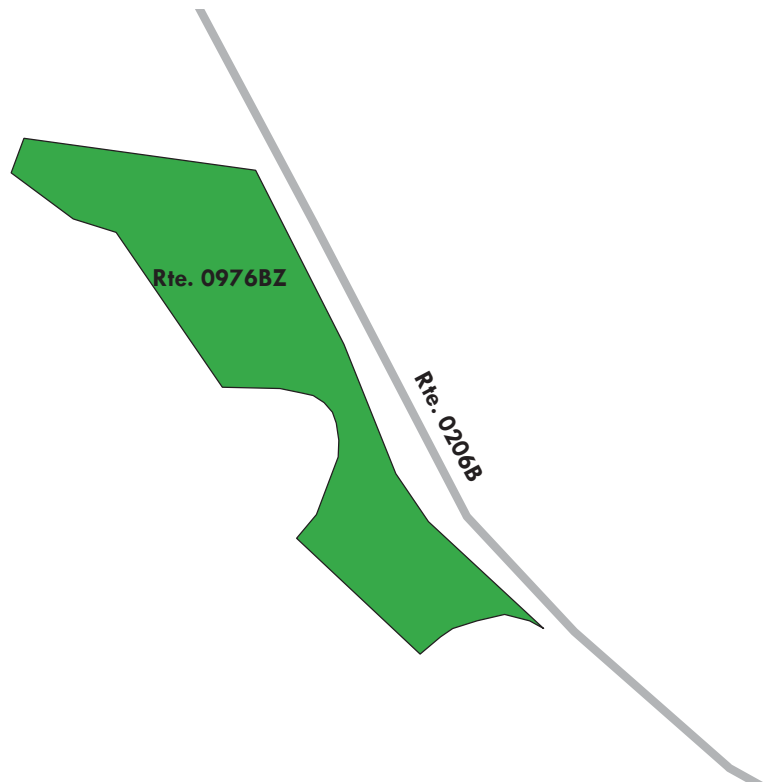
## ROUTE 0976CZ: SOL DUC CAMPGROUND LOOP B PARKING C

Inspection Date	FMSS Number	User Access	Surface Type
8/10/2015	N/A	PUBLIC	ASPHALT
Area (Sq. Ft.)	Lane Miles (11' Widths)	Curb Reveal (Inches)	Curb Recommendation
516	0.009	NOT APPLICABLE	NOT APPLICABLE
Curb Type		Curb & Gutter Type	
NO CURB		NO CURB AND GUTTER	
Pavement Recommendation		Condition Rating / PCR	
HEAVY 3R TREATMENTS		POOR / 53

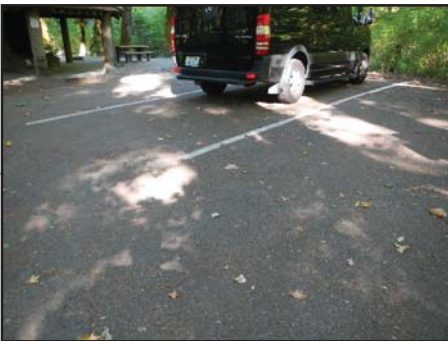
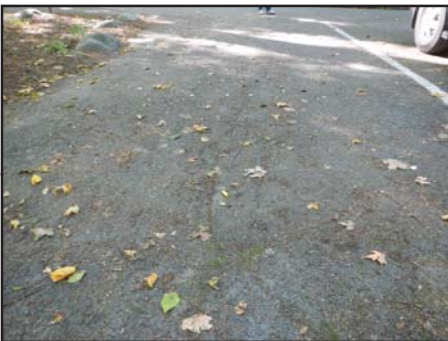
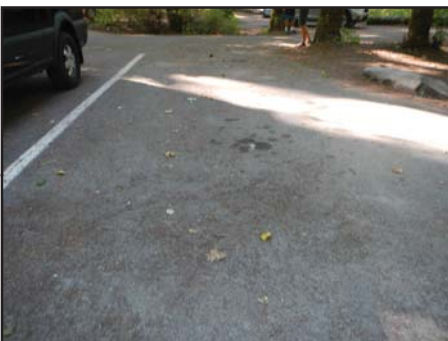
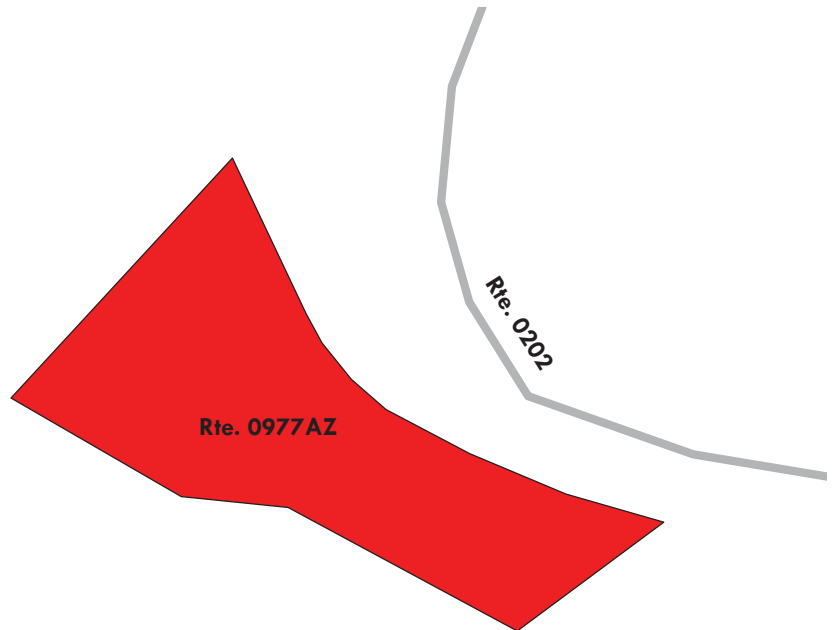
## ROUTE 0977BZ: ELWHA CAMPGROUND PARKING B

Inspection Date	FMSS Number	User Access	Surface Type
8/10/2015	N/A	PUBLIC	ASPHALT
Area (Sq. Ft.)	Lane Miles (11' Widths)	Curb Reveal (Inches)	Curb Recommendation
1,123	0.019	NOT APPLICABLE	NOT APPLICABLE
Curb Type		Curb & Gutter Type	
NO CURB		NO CURB AND GUTTER	
Pavement Recommendation		Condition Rating / PCR	
PREVENTIVE MAINTENANCE		GOOD / 90
