# OLYM Cycle 6

## Final Report

# Road Inventory and Condition Assessment of Paved Routes Olympic National Park

**Federal Highway Administration  
Eastern Federal Lands Highway Division  
Road Inventory Program (RIP)**

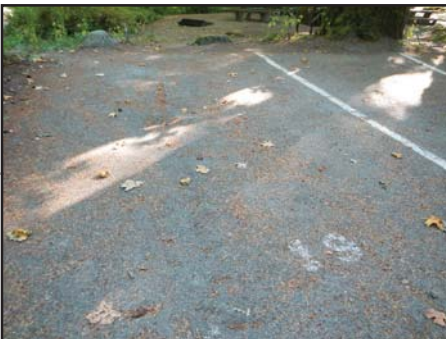
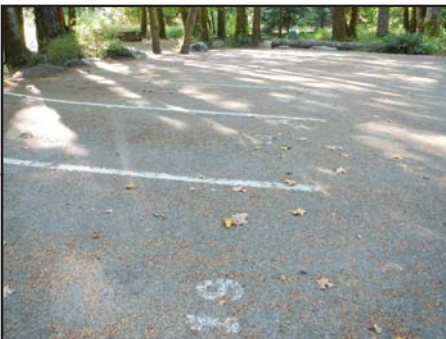
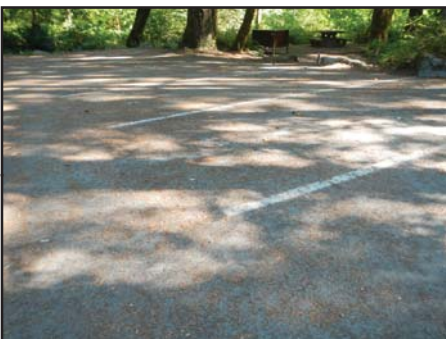
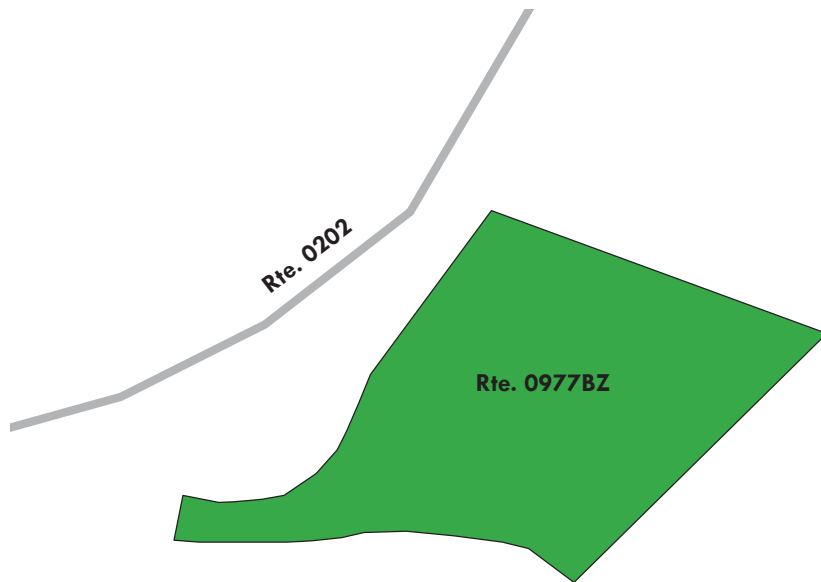
## ROUTE 0978: ELWHA RIVER VALLEY ENTRANCE BOOTH PARKING

Inspection Date	FMSS Number	User Access	Surface Type
8/10/2015	N/A	PUBLIC	ASPHALT
Area (Sq. Ft.)	Lane Miles (11' Widths)	Curb Reveal (Inches)	Curb Recommendation
5,077	0.087	NOT APPLICABLE	NOT APPLICABLE
Curb Type		Curb & Gutter Type	
NO CURB		NO CURB AND GUTTER	
Pavement Recommendation		Condition Rating / PCR	
DO NOTHING		EXCELLENT / 97

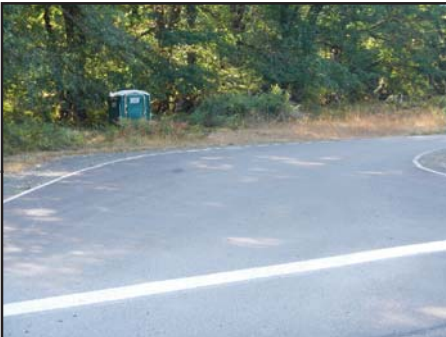
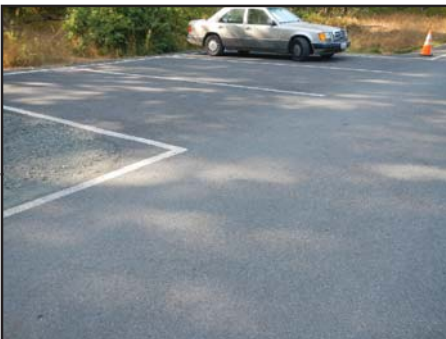
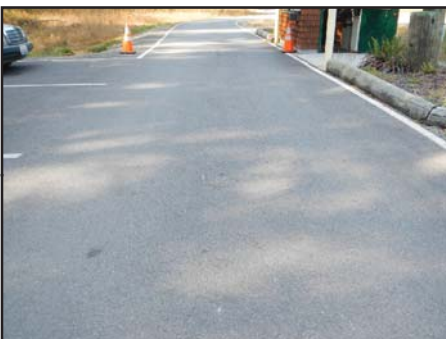
## ROUTE 0979: KALALOCK RESIDENCE PARKING

Inspection Date	FMSS Number	User Access	Surface Type
8/11/2015	N/A	NONPUBLIC	ASPHALT
Area (Sq. Ft.)	Lane Miles (11' Widths)	Curb Reveal (Inches)	Curb Recommendation
11,222	0.193	6	LIGHT REPAIR
Curb Type		Curb & Gutter Type	
CONCRETE		NO CURB AND GUTTER	
Pavement Recommendation		Condition Rating / PCR	
LIGHT 3R TREATMENTS		FAIR / 73
