ORCA Cycle 6

Final Report

Road Inventory and Condition Assessment of Paved Routes Oregon Caves National Monument and Preserve

Report Date: November 2015

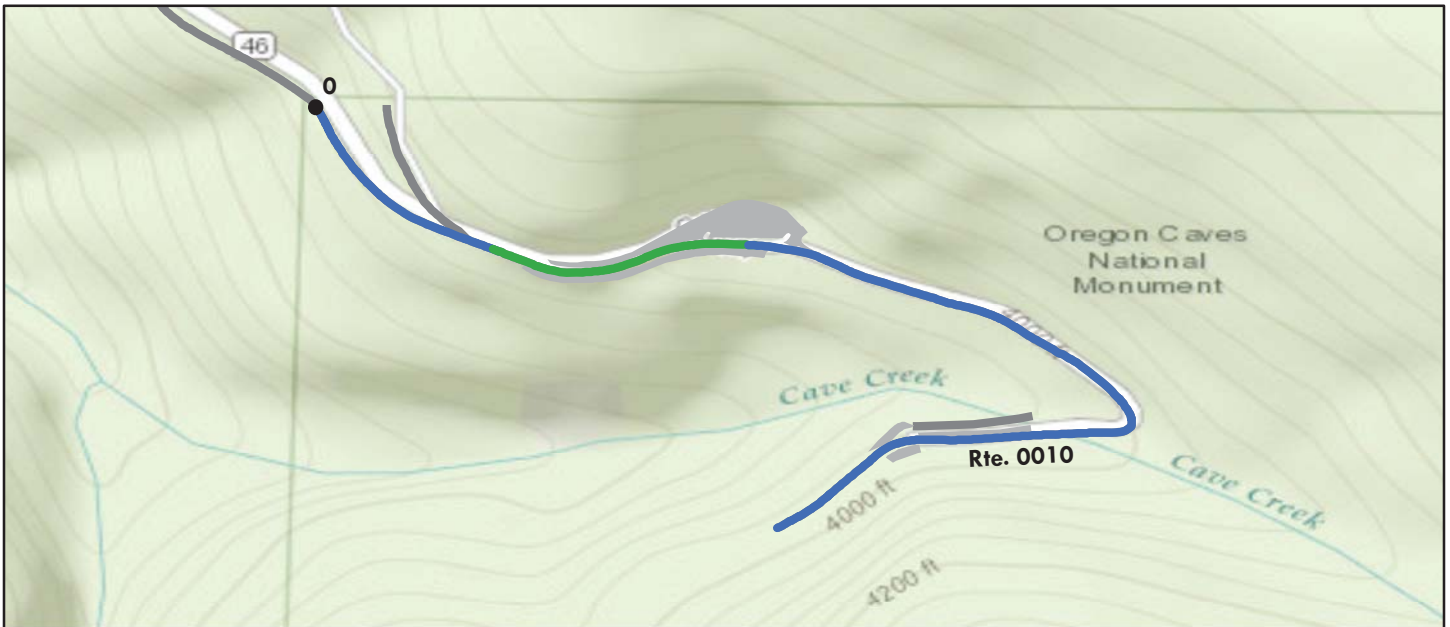
ROUTE 0010: ENTRANCE ROAD

Route Condition Legend – Pavement Condition Rating (PCR)						
Poor (0 - 60)	Fair (61- 84)	Good (85 - 94)	Excellent (95 - 100)	Not Rated		
See Appendix for definitions and formulas						
Inspection Date: 5/23/2015	Beginning Section MP	0				
Paved Length (Miles): 0.53	Section Length (MI)	0.53				
Surface Type: ASPHALT	Route Summary					
Roadway Condition Information						
Pavement Condition Rating (PCR)	96	96				
Surface Condition Rating (SCR)	96	96				
Roughness Condition Index (RCI)	N/A	N/A				
Distress Index Values						
Structural Crack Index	97	97				
Alligator Crack Index	100	100				
Longitudinal Crack Index	97	97				
Transverse Cracking Index	98	98				
Patching Index	100	100				
Rutting Index	96	96				
International Roughness Index (IRI)	N/A	N/A				
Lane & Width Information						
Number of Lanes	2	2				
Paved Width (ft)	23.9	23.9				
Lane Width (ft)	11	11

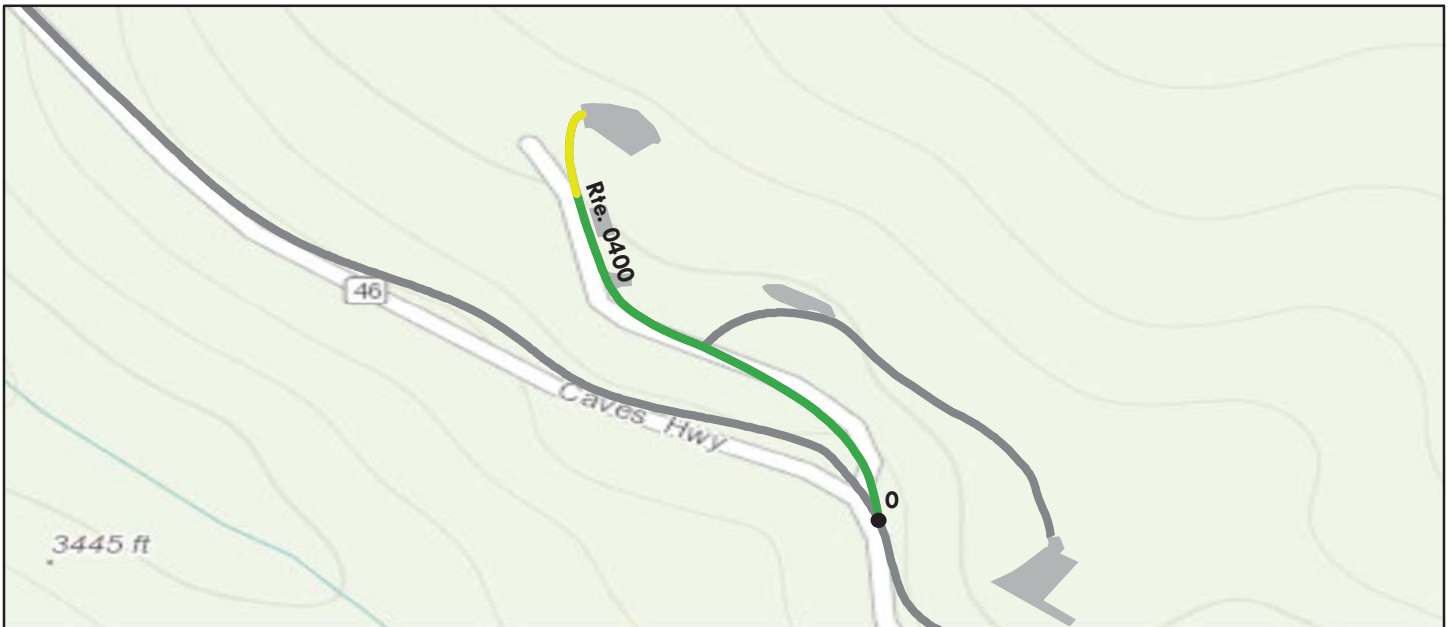
ROUTE 0400: RESIDENCE AREA ROAD

Route Condition Legend – Pavement Condition Rating (PCR)						
Poor (0 - 60)	Fair (61- 84)	Good (85 - 94)	Excellent (95 - 100)	Not Rated		
See Appendix for definitions and formulas						
Inspection Date: 5/23/2015	Beginning Section MP	0				
Paved Length (Miles): 0.12	Section Length (MI)	0.12				
Surface Type: ASPHALT	Route Summary					
Roadway Condition Information						
Pavement Condition Rating (PCR)	93	93				
Surface Condition Rating (SCR)	93	93				
Roughness Condition Index (RCI)	N/A	N/A				
Distress Index Values						
Structural Crack Index	97	97				
Alligator Crack Index	100	100				
Longitudinal Crack Index	97	97				
Transverse Cracking Index	94	94				
Patching Index	100	100				
Rutting Index	93	93				
International Roughness Index (IRI)	N/A	N/A				
Lane & Width Information						
Number of Lanes	2	2				
Paved Width (ft)	15.5	15.5				
Lane Width (ft)	7.7	7.7

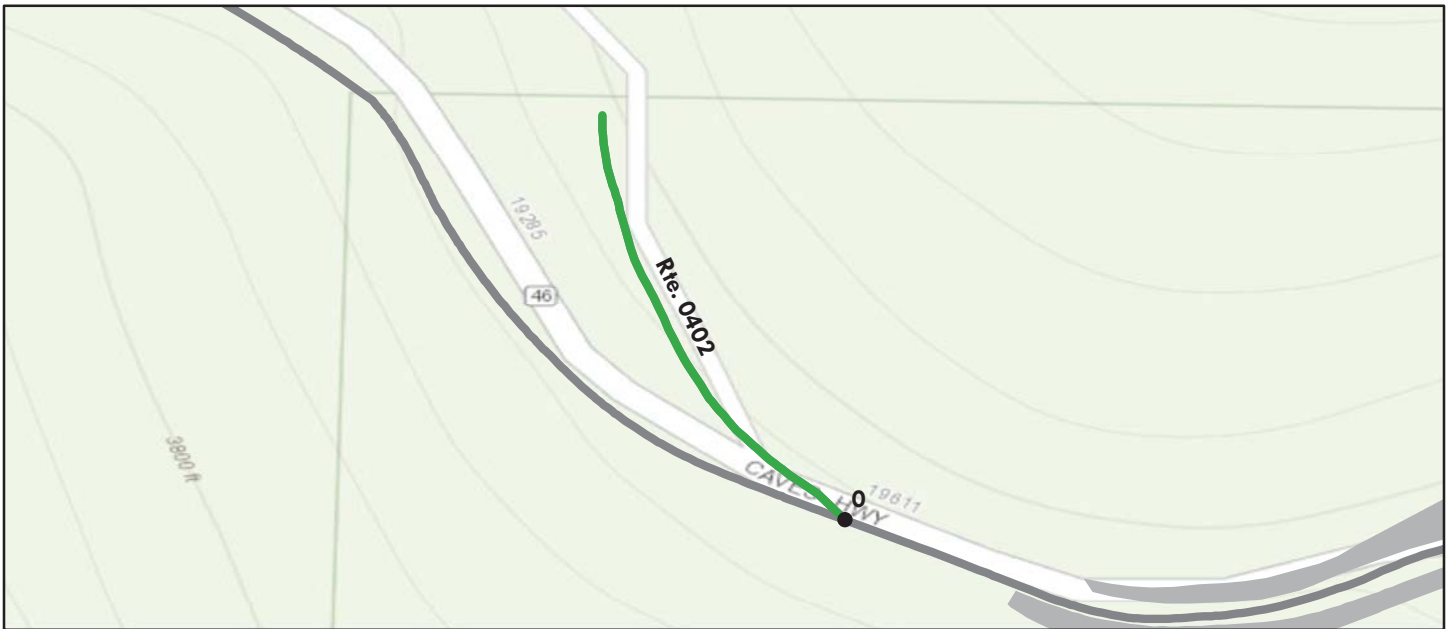
ROUTE 0402: FIRE ACCESS ROAD

Route Condition Legend – Pavement Condition Rating (PCR)						
Poor (0 - 60)	Fair (61- 84)	Good (85 - 94)	Excellent (95 - 100)	Not Rated		
See Appendix for definitions and formulas						
Inspection Date: 5/23/2015	Beginning Section MP	0				
Paved Length (Miles): 0.07	Section Length (MI)	0.07				
Surface Type: ASPHALT	Route Summary					
Roadway Condition Information						
Pavement Condition Rating (PCR)	93	93				
Surface Condition Rating (SCR)	93	93				
Roughness Condition Index (RCI)	N/A	N/A				
Distress Index Values						
Structural Crack Index	98	98				
Alligator Crack Index	100	100				
Longitudinal Crack Index	98	98				
Transverse Cracking Index	93	93				
Patching Index	100	100				
Rutting Index	94	94				
International Roughness Index (IRI)	N/A	N/A				
Lane & Width Information						
Number of Lanes	2	2				
Paved Width (ft)	17.2	17.2				
Lane Width (ft)	8.6	8.6

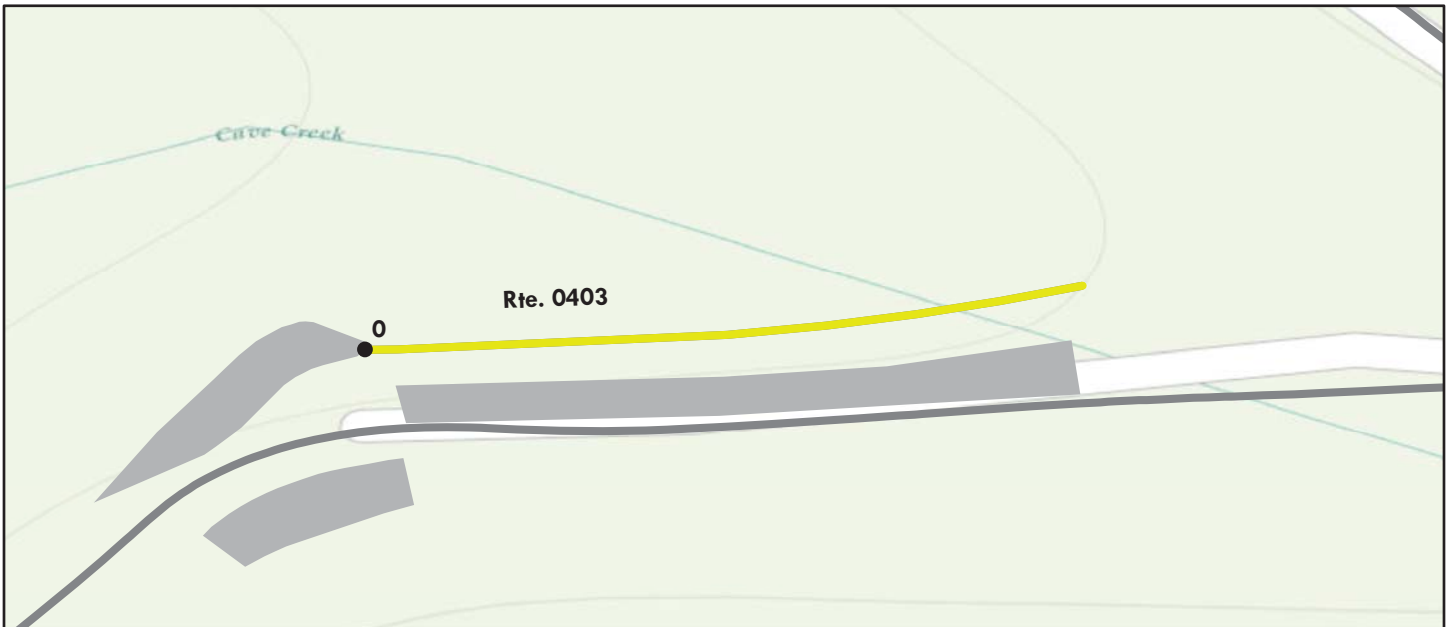
ROUTE 0403: CHATEAU SERVICE ROAD

Route Condition Legend – Pavement Condition Rating (PCR)						
Poor (0 - 60)	Fair (61- 84)	Good (85 - 94)	Excellent (95 - 100)	Not Rated		
See Appendix for definitions and formulas						
Inspection Date: 5/23/2015	Beginning Section MP	0				
Paved Length (Miles): 0.04	Section Length (MI)	0.04				
Surface Type: ASPHALT	Route Summary					
Roadway Condition Information						
Pavement Condition Rating (PCR)	79	79				
Surface Condition Rating (SCR)	79	79				
Roughness Condition Index (RCI)	N/A	N/A				
Distress Index Values						
Structural Crack Index	87	87				
Alligator Crack Index	100	100				
Longitudinal Crack Index	87	87				
Transverse Cracking Index	99	99				
Patching Index	93	93				
Rutting Index	79	79				
International Roughness Index (IRI)	N/A	N/A				
Lane & Width Information						
Number of Lanes	1	1				
Paved Width (ft)	9.6	9.6				
Lane Width (ft)	9.6	9.6

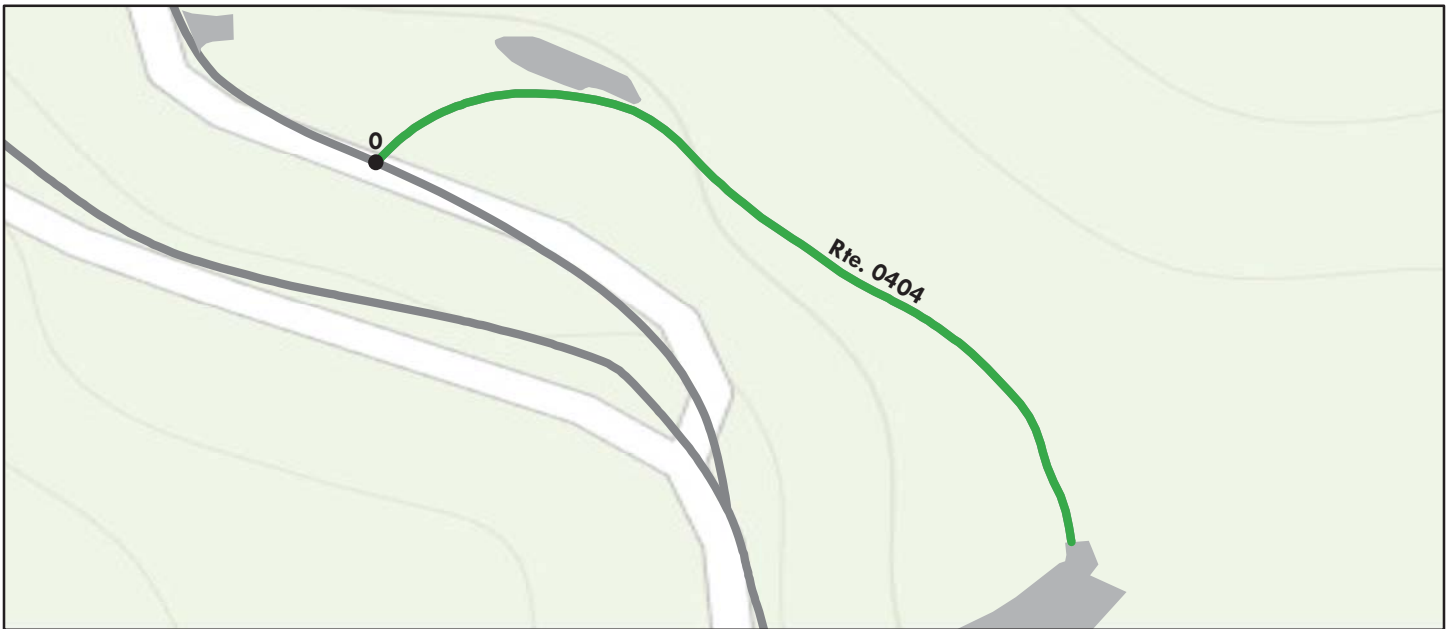
ROUTE 0404: MAINTENANCE AREA ACCESS ROAD

Route Condition Legend – Pavement Condition Rating (PCR)						
Poor (0 - 60)	Fair (61- 84)	Good (85 - 94)	Excellent (95 - 100)	Not Rated		
See Appendix for definitions and formulas						
Inspection Date: 5/23/2015	Beginning Section MP	0				
Paved Length (Miles): 0.1	Section Length (MI)	0.1				
Surface Type: ASPHALT	Route Summary					
Roadway Condition Information						
Pavement Condition Rating (PCR)	93	93				
Surface Condition Rating (SCR)	93	93				
Roughness Condition Index (RCI)	N/A	N/A				
Distress Index Values						
Structural Crack Index	96	96				
Alligator Crack Index	100	100				
Longitudinal Crack Index	96	96				
Transverse Cracking Index	99	99				
Patching Index	100	100				
Rutting Index	93	93				
International Roughness Index (IRI)	N/A	N/A				
Lane & Width Information						
Number of Lanes	2	2				
Paved Width (ft)	17.6	17.6				
Lane Width (ft)	8.8	8.8

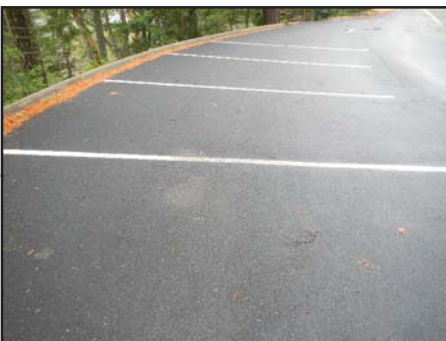
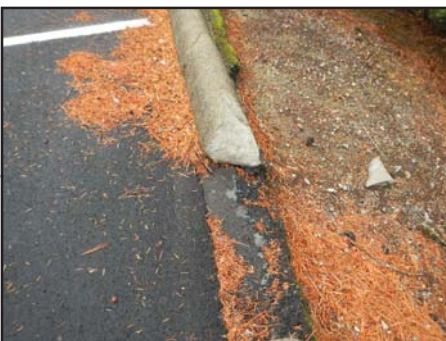
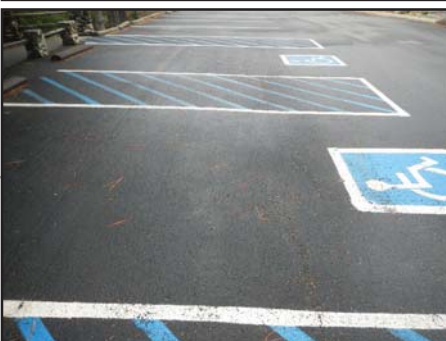
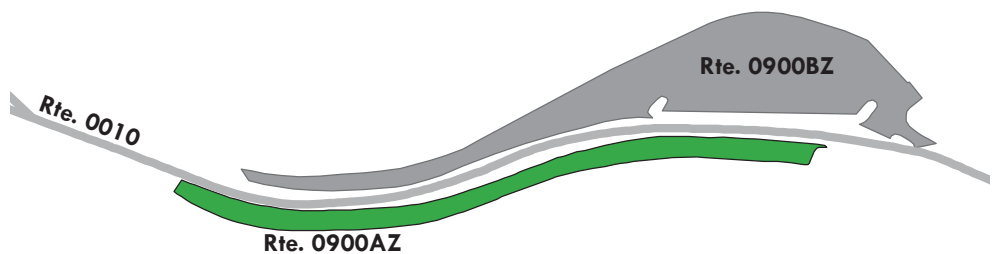
ROUTE 0900AZ: TOUR PARKING A

Inspection Date	FMSS Number	User Access	Surface Type
11/7/2014	43001	PUBLIC	ASPHALT
Area (Sq. Ft.)	Lane Miles (11' Widths)	Curb Reveal (Inches)	Curb Recommendation
9,592	0.165	6	MODERATE REPAIR
Curb Type		Curb & Gutter Type	
CONCRETE		NO CURB AND GUTTER	
Pavement Recommendation		Condition Rating / PCR	
PREVENTIVE MAINTENANCE		GOOD / 90

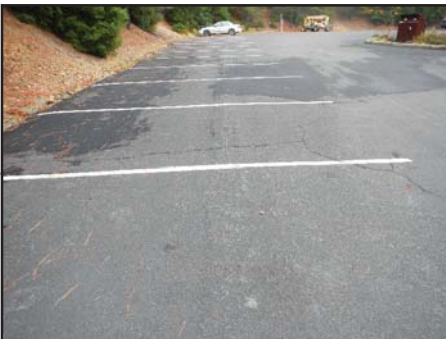
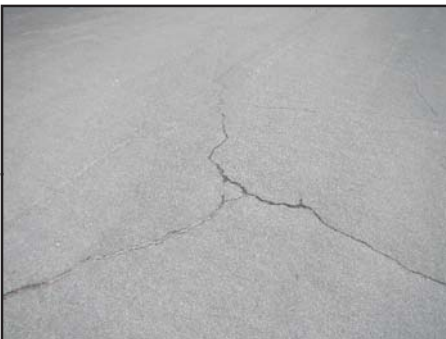
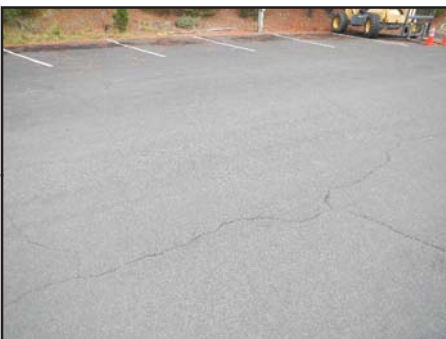
ROUTE 0900BZ: TOUR PARKING B

Inspection Date	FMSS Number	User Access	Surface Type
11/7/2014	43001	PUBLIC	ASPHALT
Area (Sq. Ft.)	Lane Miles (11' Widths)	Curb Reveal (Inches)	Curb Recommendation
23,935	0.412	6	DO NOTHING
Curb Type		Curb & Gutter Type	
CONCRETE		NO CURB AND GUTTER	
Pavement Recommendation		Condition Rating / PCR	
PREVENTIVE MAINTENANCE		GOOD / 90

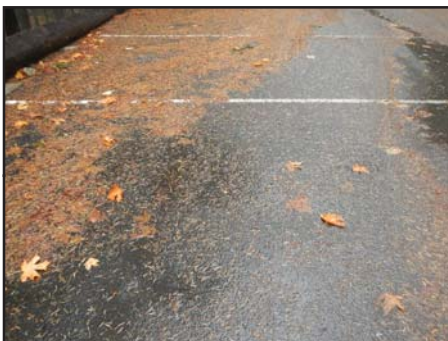
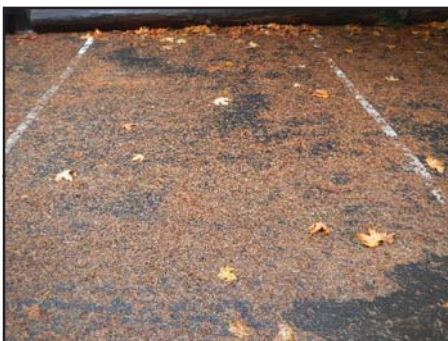
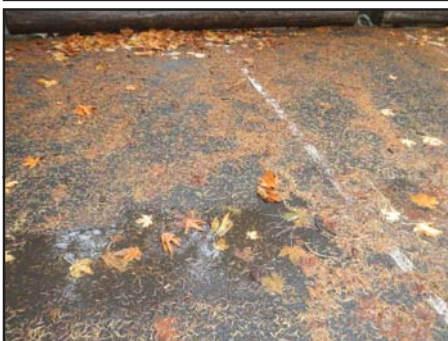
ROUTE 0901AZ: CHATEAU PARKING A

Inspection Date	FMSS Number	User Access	Surface Type
11/7/2014	105005	PUBLIC	ASPHALT
Area (Sq. Ft.)	Lane Miles (11' Widths)	Curb Reveal (Inches)	Curb Recommendation
3,899	0.067	NOT APPLICABLE	NOT APPLICABLE
Curb Type		Curb & Gutter Type	
NO CURB		NO CURB AND GUTTER	
Pavement Recommendation		Condition Rating / PCR	
PREVENTIVE MAINTENANCE		GOOD / 90

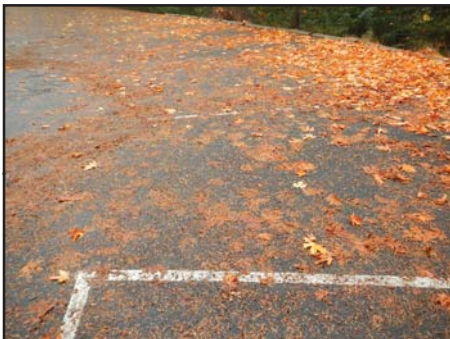
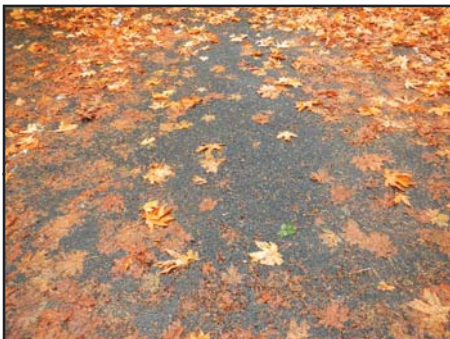
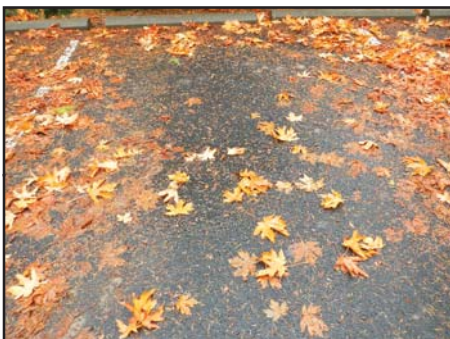
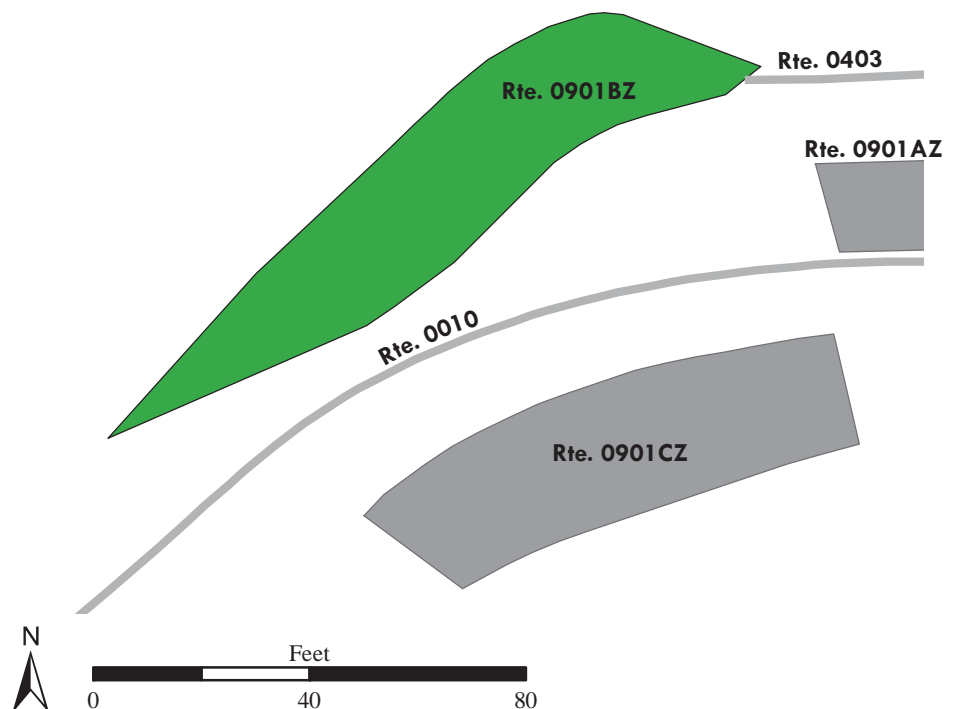
ROUTE 0901BZ: CHATEAU PARKING B

Inspection Date	FMSS Number	User Access	Surface Type
11/7/2014	105005	PUBLIC	ASPHALT
Area (Sq. Ft.)	Lane Miles (11' Widths)	Curb Reveal (Inches)	Curb Recommendation
1,767	0.03	NOT APPLICABLE	NOT APPLICABLE
Curb Type		Curb & Gutter Type	
NO CURB		NO CURB AND GUTTER	
Pavement Recommendation		Condition Rating / PCR	
PREVENTIVE MAINTENANCE		GOOD / 90

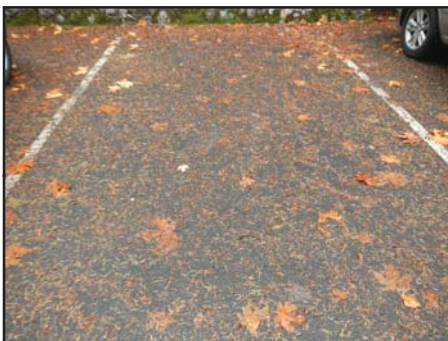
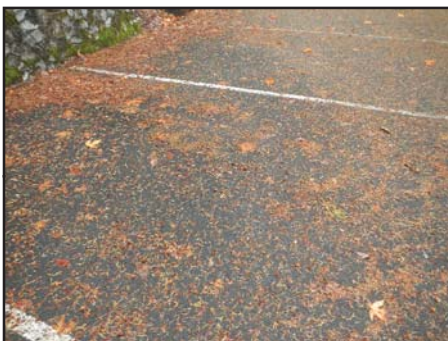
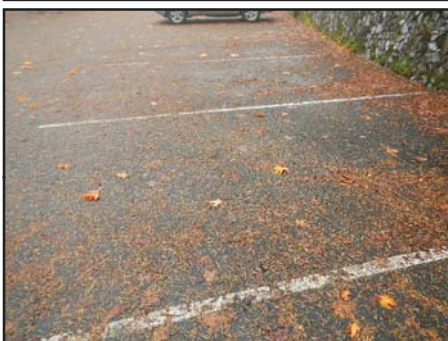
ROUTE 0901CZ: CHATEAU PARKING C

Inspection Date	FMSS Number	User Access	Surface Type
11/7/2014	105005	PUBLIC	ASPHALT
Area (Sq. Ft.)	Lane Miles (11' Widths)	Curb Reveal (Inches)	Curb Recommendation
1,547	0.027	NOT APPLICABLE	NOT APPLICABLE
Curb Type		Curb & Gutter Type	
NO CURB		NO CURB AND GUTTER	
Pavement Recommendation		Condition Rating / PCR	
PREVENTIVE MAINTENANCE		GOOD / 90

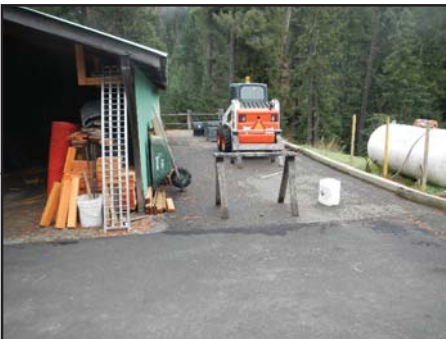
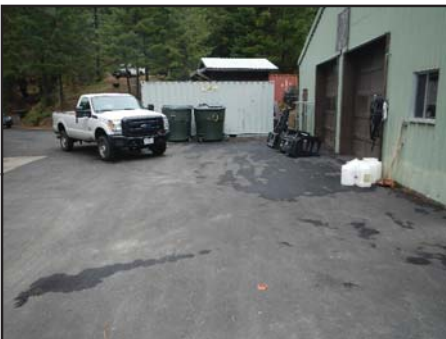
ROUTE 0903: MAINTENANCE / EMPLOYEE PARKING

Inspection Date	FMSS Number	User Access	Surface Type
11/7/2014	104764	NONPUBLIC	ASPHALT
Area (Sq. Ft.)	Lane Miles (11' Widths)	Curb Reveal (Inches)	Curb Recommendation
3,866	0.067	6	MODERATE REPAIR
Curb Type		Curb & Gutter Type	
CONCRETE		NO CURB AND GUTTER	
Pavement Recommendation		Condition Rating / PCR	
PREVENTIVE MAINTENANCE		GOOD / 90

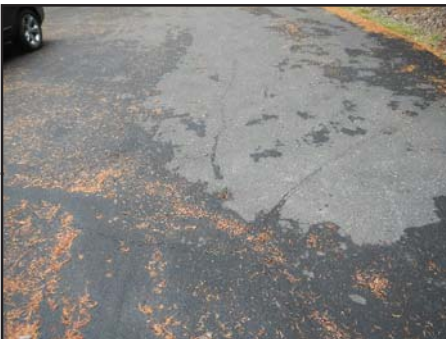
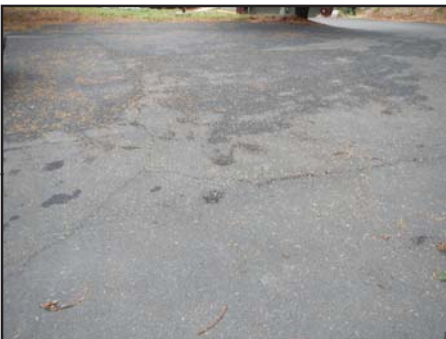
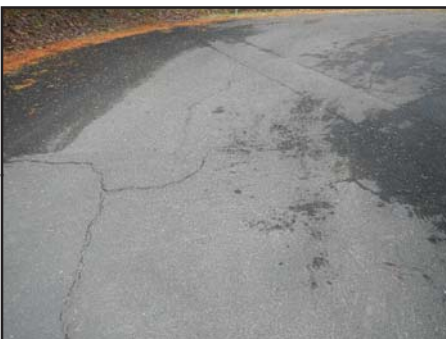
ROUTE 0904: ADMINISTRATIVE PARKING

Inspection Date	FMSS Number	User Access	Surface Type
11/7/2014	104820	NONPUBLIC	ASPHALT
Area (Sq. Ft.)	Lane Miles (11' Widths)	Curb Reveal (Inches)	Curb Recommendation
3,238	0.056	NOT APPLICABLE	NOT APPLICABLE
Curb Type		Curb & Gutter Type	
NO CURB		NO CURB AND GUTTER	
Pavement Recommendation		Condition Rating / PCR	
PREVENTIVE MAINTENANCE		GOOD / 90

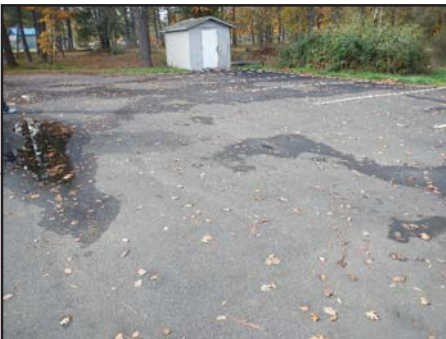
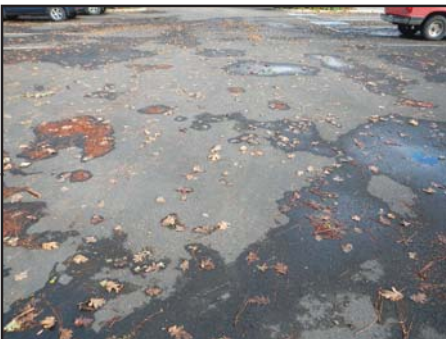
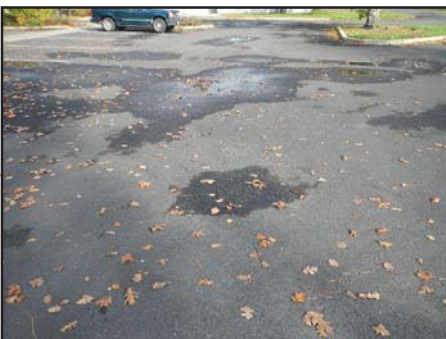
ROUTE 0905: ILLINOIS VALLEY VISITOR CENTER PARKING

Inspection Date	FMSS Number	User Access	Surface Type
11/7/2014	104823	PUBLIC	ASPHALT
Area (Sq. Ft.)	Lane Miles (11' Widths)	Curb Reveal (Inches)	Curb Recommendation
35,148	0.605	5	LIGHT REPAIR
Curb Type		Curb & Gutter Type	
CONCRETE		NO CURB AND GUTTER	
Pavement Recommendation		Condition Rating / PCR	
PREVENTIVE MAINTENANCE		GOOD / 90

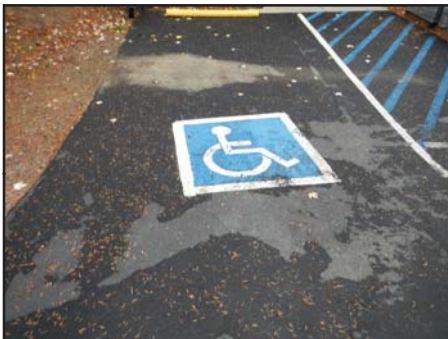
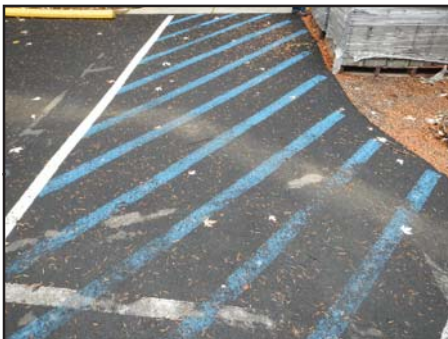
ROUTE 0906AZ: HANDICAP ADMINISTRATIVE PARKING

Inspection Date	FMSS Number	User Access	Surface Type
11/7/2014	104817	PUBLIC	ASPHALT
Area (Sq. Ft.)	Lane Miles (11' Widths)	Curb Reveal (Inches)	Curb Recommendation
398	0.007	NOT APPLICABLE	NOT APPLICABLE
Curb Type		Curb & Gutter Type	
NO CURB		NO CURB AND GUTTER	
Pavement Recommendation		Condition Rating / PCR	
DO NOTHING		EXCELLENT / 97

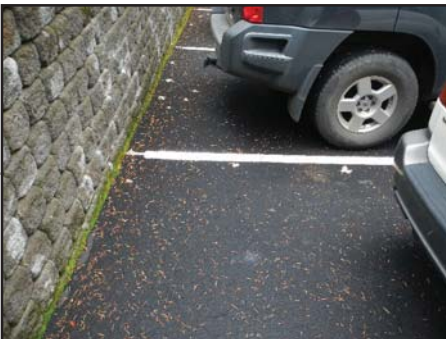
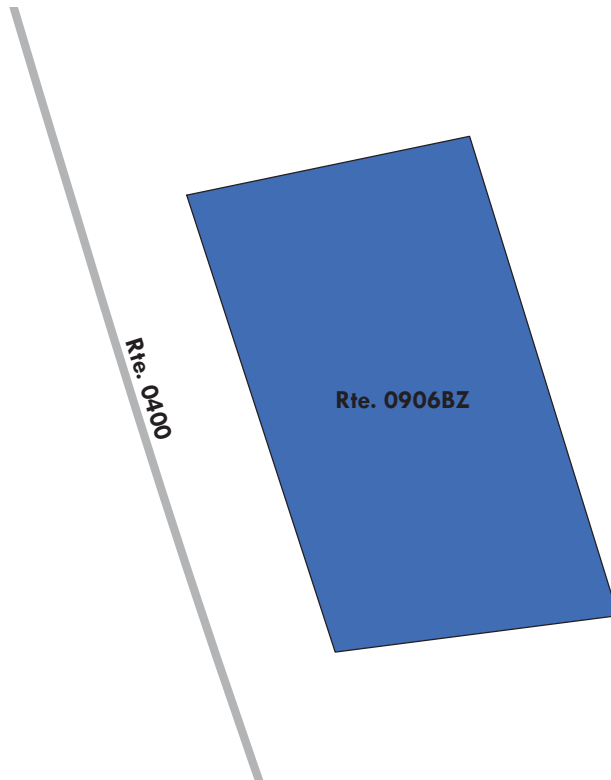
ROUTE 0906BZ: MAIN ADMINISTRATIVE PARKING

Inspection Date	FMSS Number	User Access	Surface Type
11/7/2014	104817	PUBLIC	ASPHALT
Area (Sq. Ft.)	Lane Miles (11' Widths)	Curb Reveal (Inches)	Curb Recommendation
674	0.012	NOT APPLICABLE	NOT APPLICABLE
Curb Type		Curb & Gutter Type	
NO CURB		NO CURB AND GUTTER	
Pavement Recommendation		Condition Rating / PCR	
DO NOTHING		EXCELLENT / 97

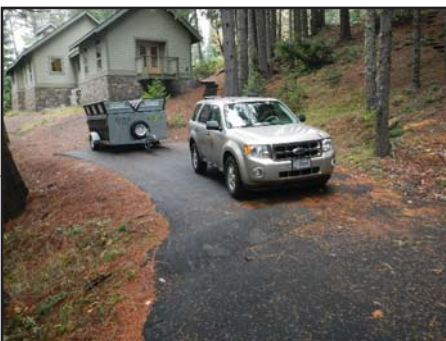
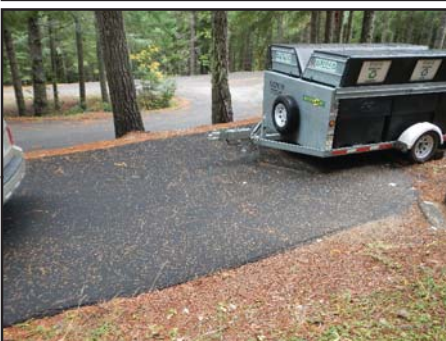
ROUTE 0906CZ: OVERFLOW ADMINISTRATIVE PARKING

Inspection Date	FMSS Number	User Access	Surface Type
11/7/2014	104817	PUBLIC	ASPHALT
Area (Sq. Ft.)	Lane Miles (11' Widths)	Curb Reveal (Inches)	Curb Recommendation
1,308	0.023	NOT APPLICABLE	NOT APPLICABLE
Curb Type		Curb & Gutter Type	
NO CURB		NO CURB AND GUTTER	
Pavement Recommendation		Condition Rating / PCR	
DO NOTHING		EXCELLENT / 97
