OZAR Cycle 6

Final Report

Road Inventory and Condition Assessment of Paved Routes Ozark National Scenic Riverways

**Federal Highway Administration
Eastern Federal Lands Highway Division
Road Inventory Program (RIP)**

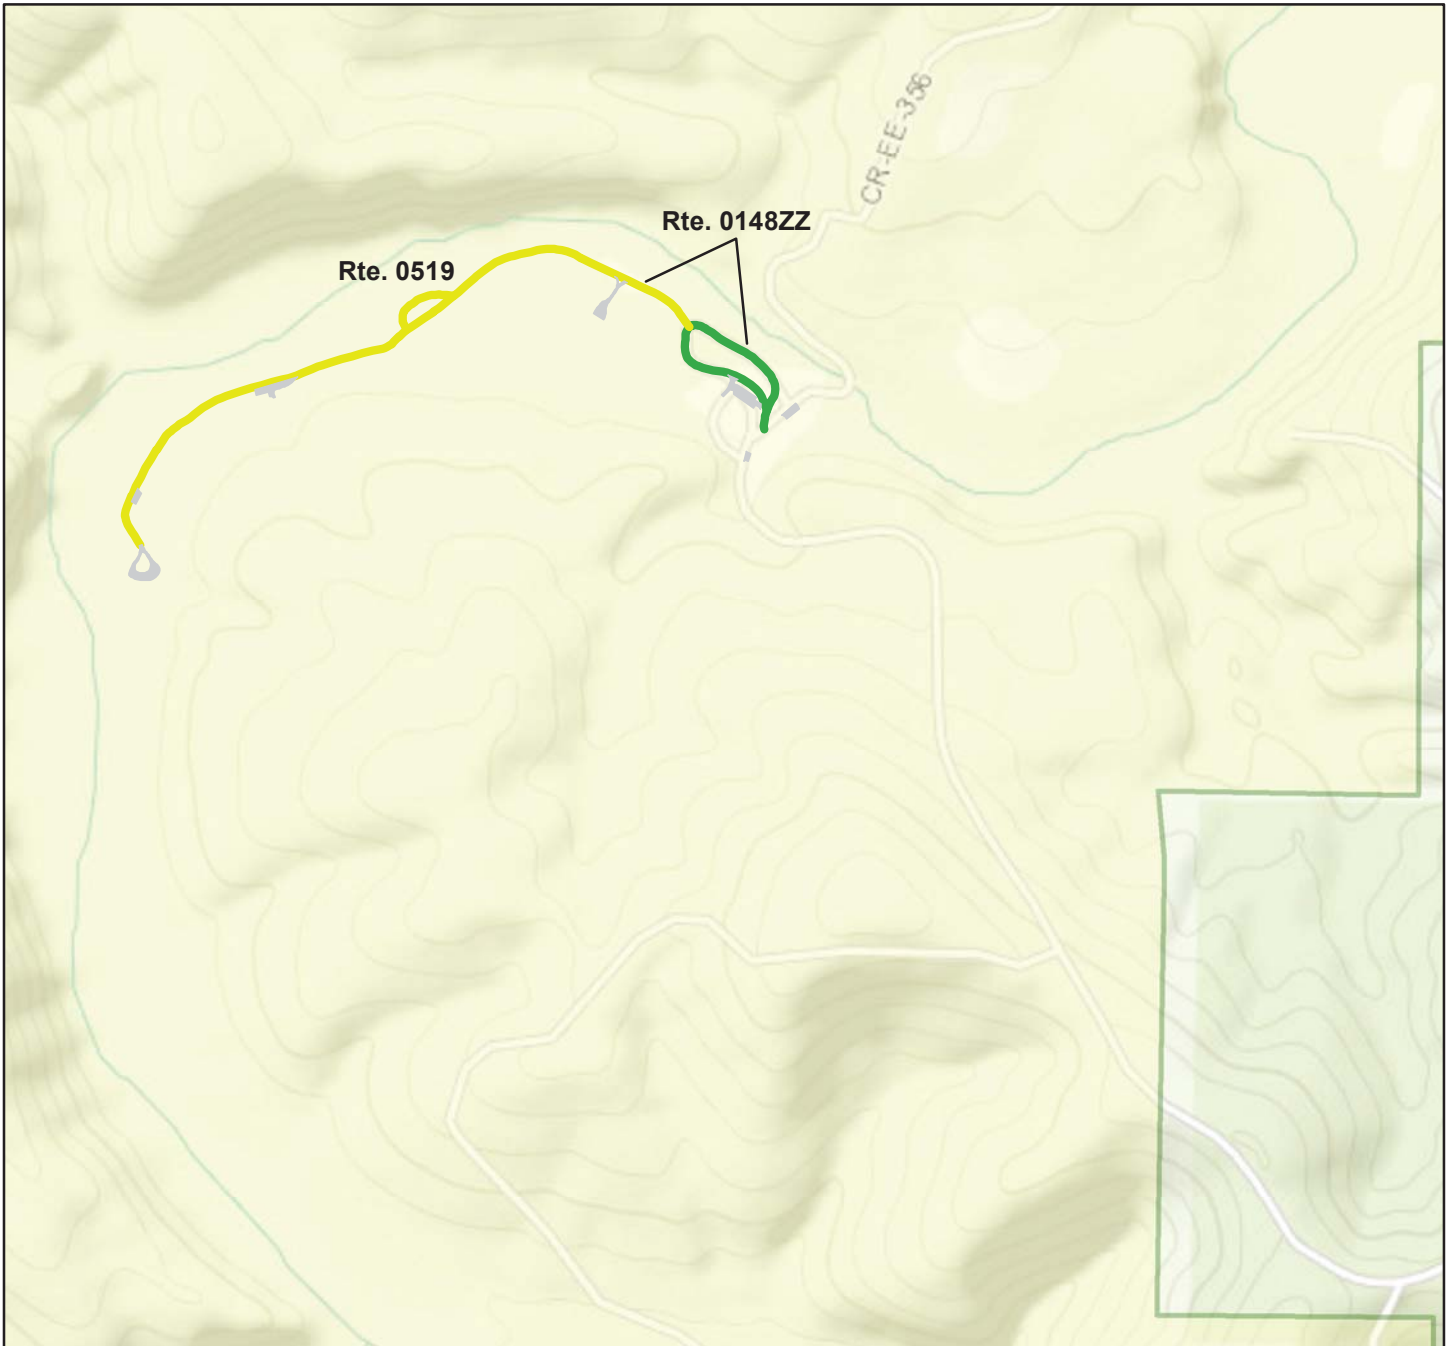
ROUTE CONDITION MAP

Colors on map represent condition scores at 1-mile intervals. See Appendix for definitions and formulas
Only Data Collection Vehicle and Manually Rated Roads are displayed

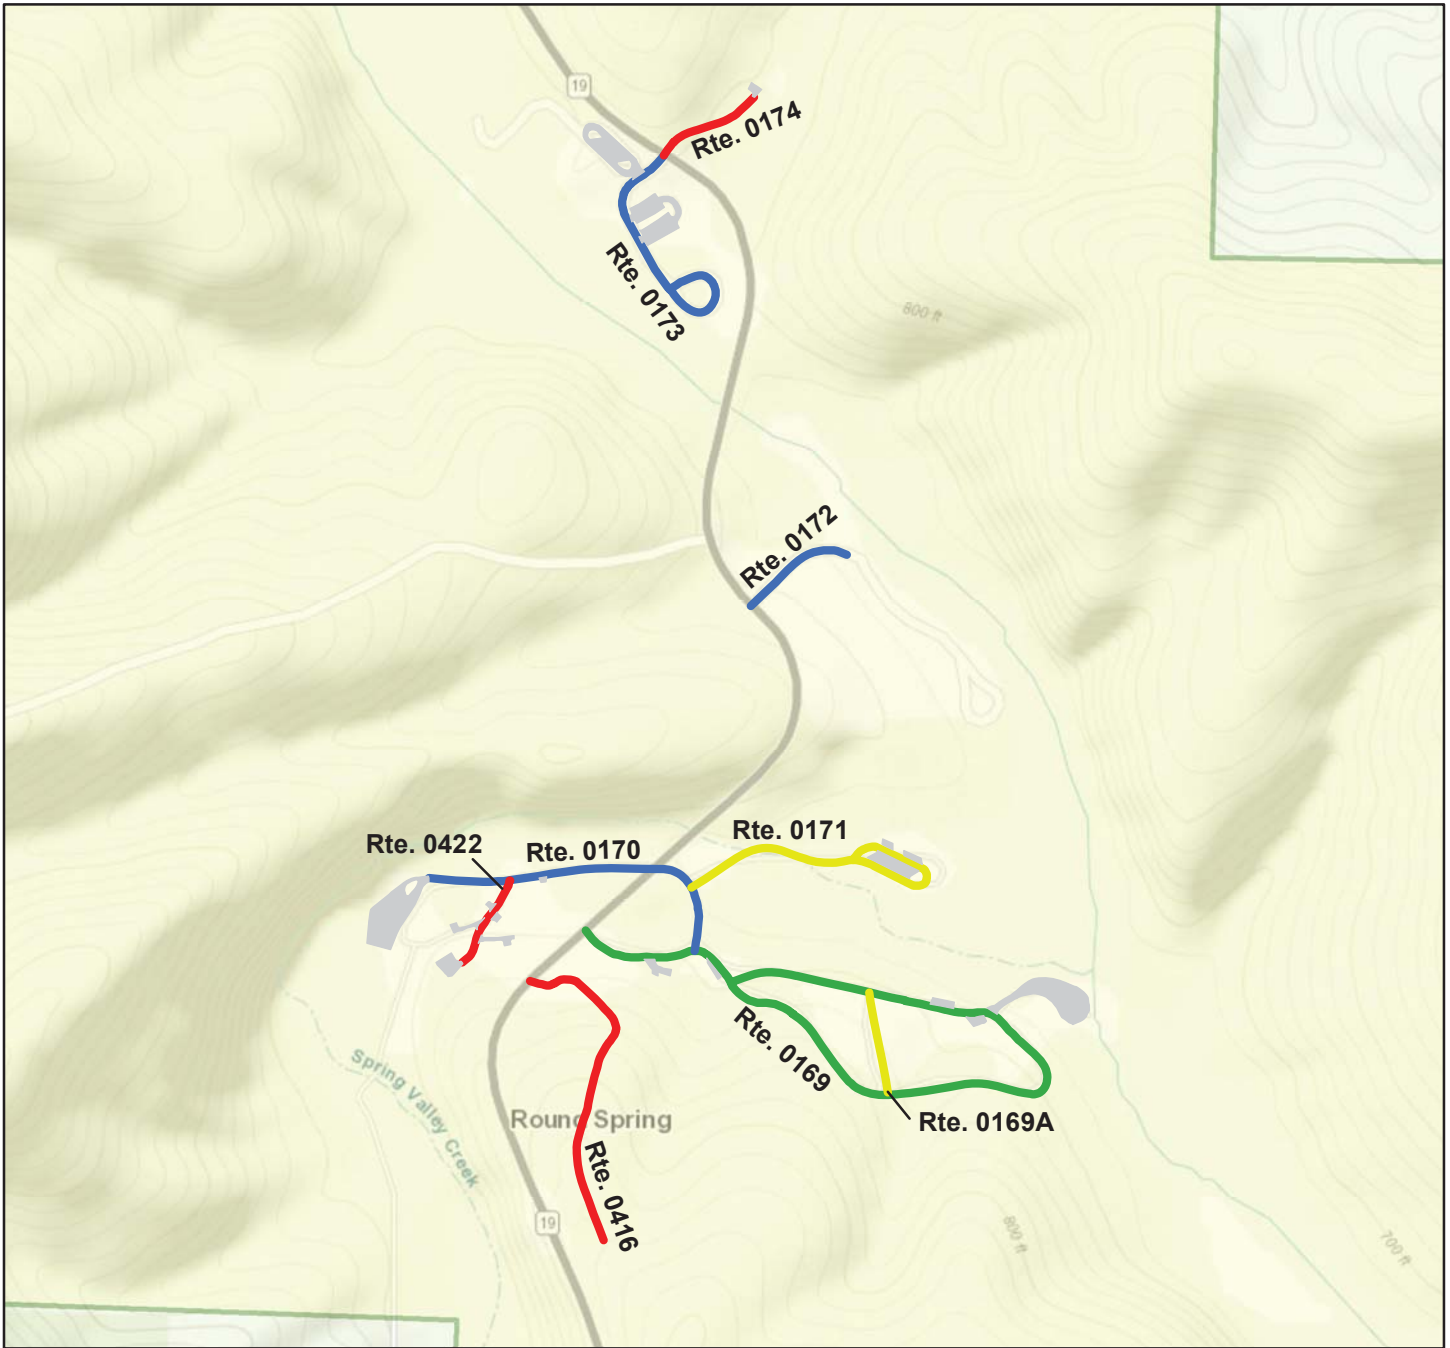
ROUTE CONDITION MAP

Colors on map represent condition scores at 1-mile intervals. See Appendix for definitions and formulas
Only Data Collection Vehicle and Manually Rated Roads are displayed

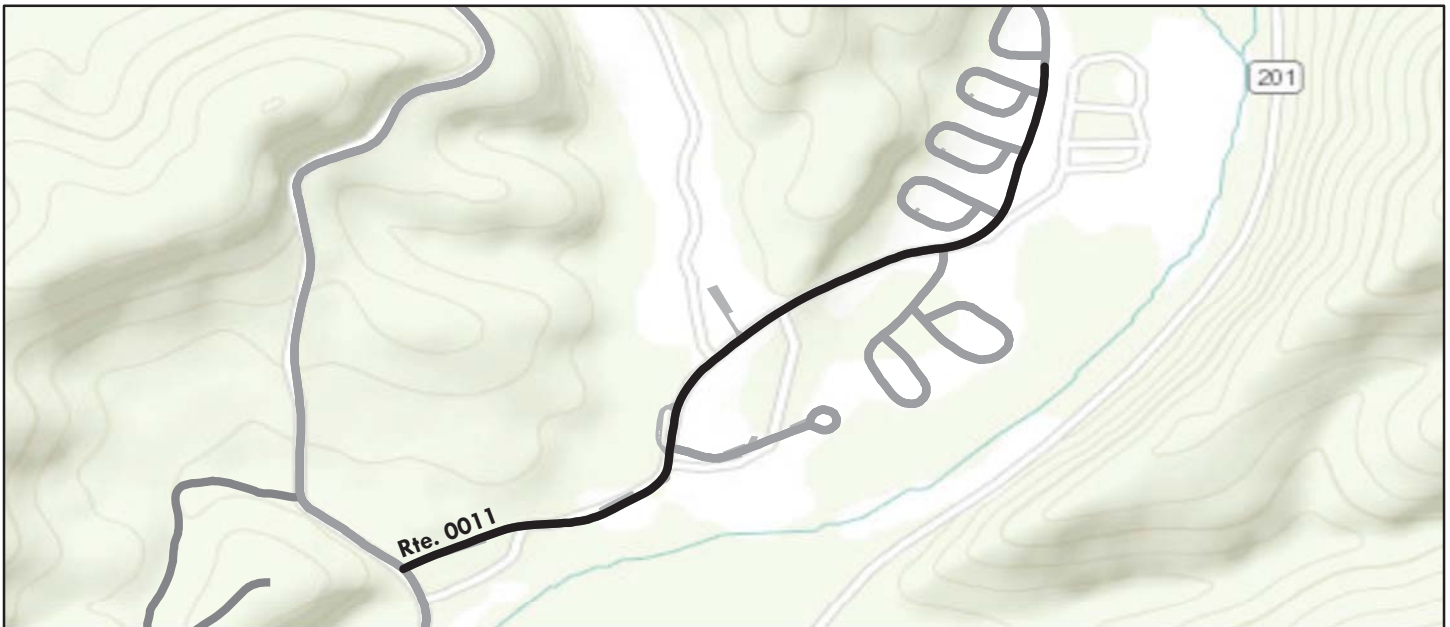
ROUTE 0011: BIG SPRING CAMPGROUND ROAD

Route Condition Legend – Pavement Condition Rating (PCR)							
Poor (0 - 60)		Fair (61- 84)		Good (85 - 94)		Excellent (95 - 100)	Not Rated
Colors on map represent condition scores at 0.10-mile intervals. See Appendix for definitions and formulas.							
Inspection Date:	NOT RATED	Beginning Section MP	0				
Paved Length (Miles):	0.83	Section Length (MI)	0.83				
Surface Type:	ASPHALT	Route Summary					
Roadway Condition Information							
Pavement Condition Rating (PCR)		N/A	N/A				
Surface Condition Rating (SCR)		N/A	N/A				
Roughness Condition Index (RCI)		N/A	N/A				
Distress Index Values							
Structural Crack Index		N/A	N/A				
Alligator Crack Index		N/A	N/A				
Longitudinal Crack Index		N/A	N/A				
Transverse Cracking Index		N/A	N/A				
Patching Index		N/A	N/A				
Rutting Index		N/A	N/A				
International Roughness Index (IRI)		N/A	N/A				
Lane & Width Information							
Number of Lanes		2	2				
Paved Width (ft)		20.6	20.6

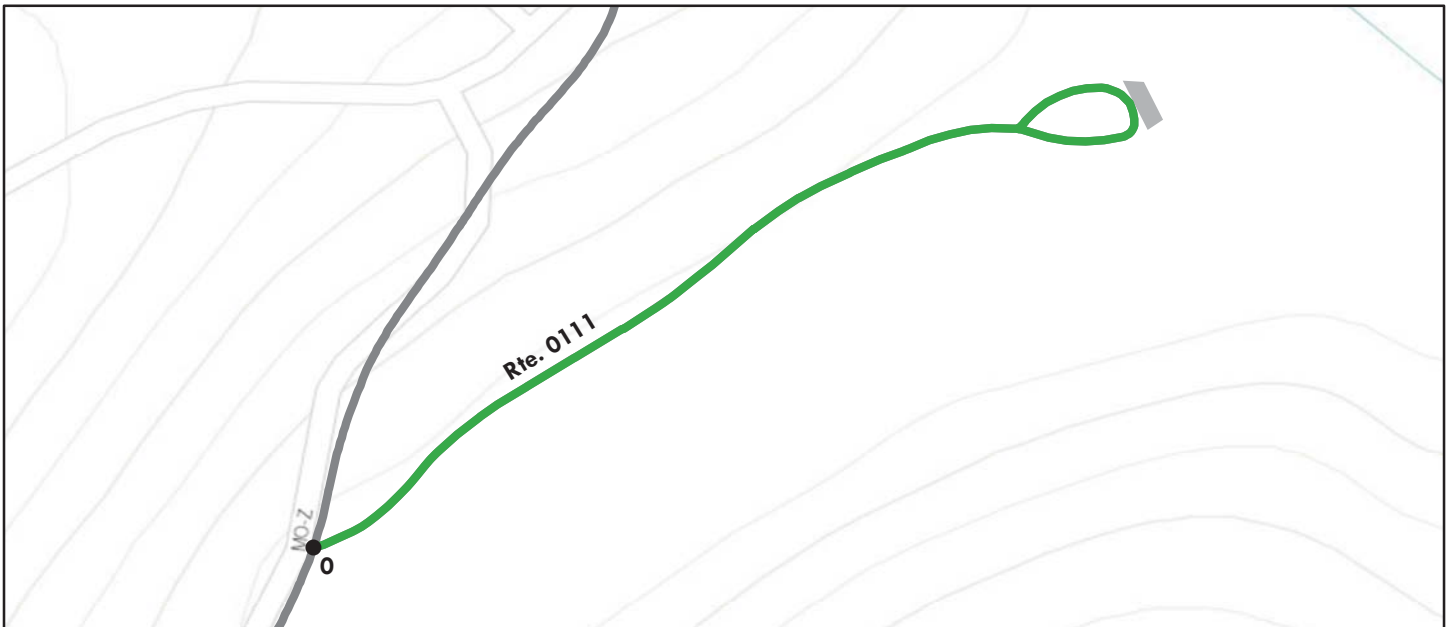
ROUTE 0111: CHUBB HOLLOW ROAD

Route Condition Legend – Pavement Condition Rating (PCR)						
Poor (0 - 60)	Fair (61- 84)	Good (85 - 94)	Excellent (95 - 100)	Not Rated		
Colors on map represent condition scores at 0.10-mile intervals. See Appendix for definitions and formulas.						
Inspection Date:	11/3/2017	Beginning Section MP	0			
Paved Length (Miles):	0.19	Section Length (MI)	0.19			
Surface Type:	ASPHALT	Route Summary				
Roadway Condition Information						
Pavement Condition Rating (PCR)	90	90				
Surface Condition Rating (SCR)	N/A	N/A				
Roughness Condition Index (RCI)	N/A	N/A				
Distress Index Values						
Structural Crack Index	N/A	N/A				
Alligator Crack Index	N/A	N/A				
Longitudinal Crack Index	N/A	N/A				
Transverse Cracking Index	N/A	N/A				
Patching Index	N/A	N/A				
Rutting Index	N/A	N/A				
International Roughness Index (IRI)	N/A	N/A				
Lane & Width Information						
Number of Lanes	2	2				
Paved Width (ft)	18.4	18.4

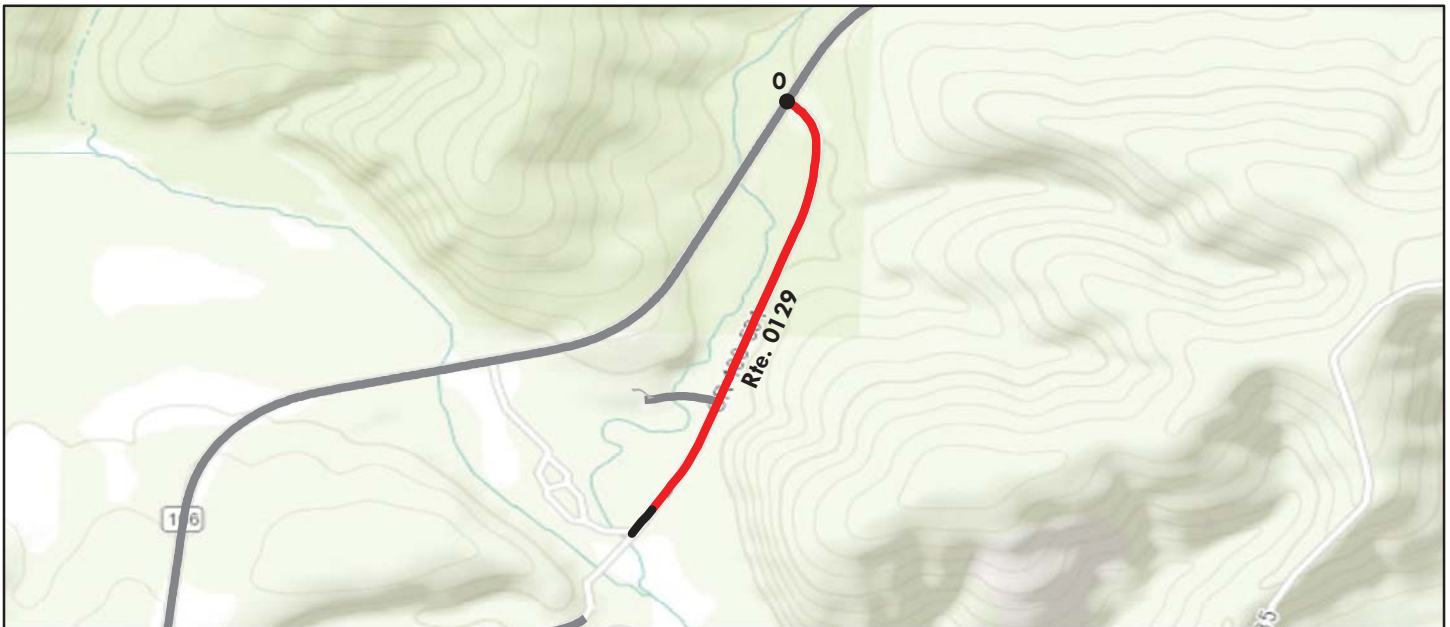
ROUTE 0129: OLD STATE HIGHWAY 106 EAST ROAD

Route Condition Legend – Pavement Condition Rating (PCR)						
Poor (0 - 60)	Fair (61- 84)	Good (85 - 94)	Excellent (95 - 100)	Not Rated		
Colors on map represent condition scores at 0.10-mile intervals. See Appendix for definitions and formulas.						
Inspection Date: 11/3/2017	Beginning Section MP	0				
Paved Length (Miles): 0.64	Section Length (MI)	0.64				
Surface Type: ASPHALT	Route Summary					
Roadway Condition Information						
Pavement Condition Rating (PCR)	22	22				
Surface Condition Rating (SCR)	0	0				
Roughness Condition Index (RCI)	56	56				
Distress Index Values						
Structural Crack Index	0	0				
Alligator Crack Index	95	95				
Longitudinal Crack Index	0	0				
Transverse Cracking Index	21	21				
Patching Index	100	100				
Rutting Index	90	90				
International Roughness Index (IRI)	256	256				
Lane & Width Information						
Number of Lanes	2	2				
Paved Width (ft)	18.7	18.7				
Lane Width (ft)	9.2	9.2

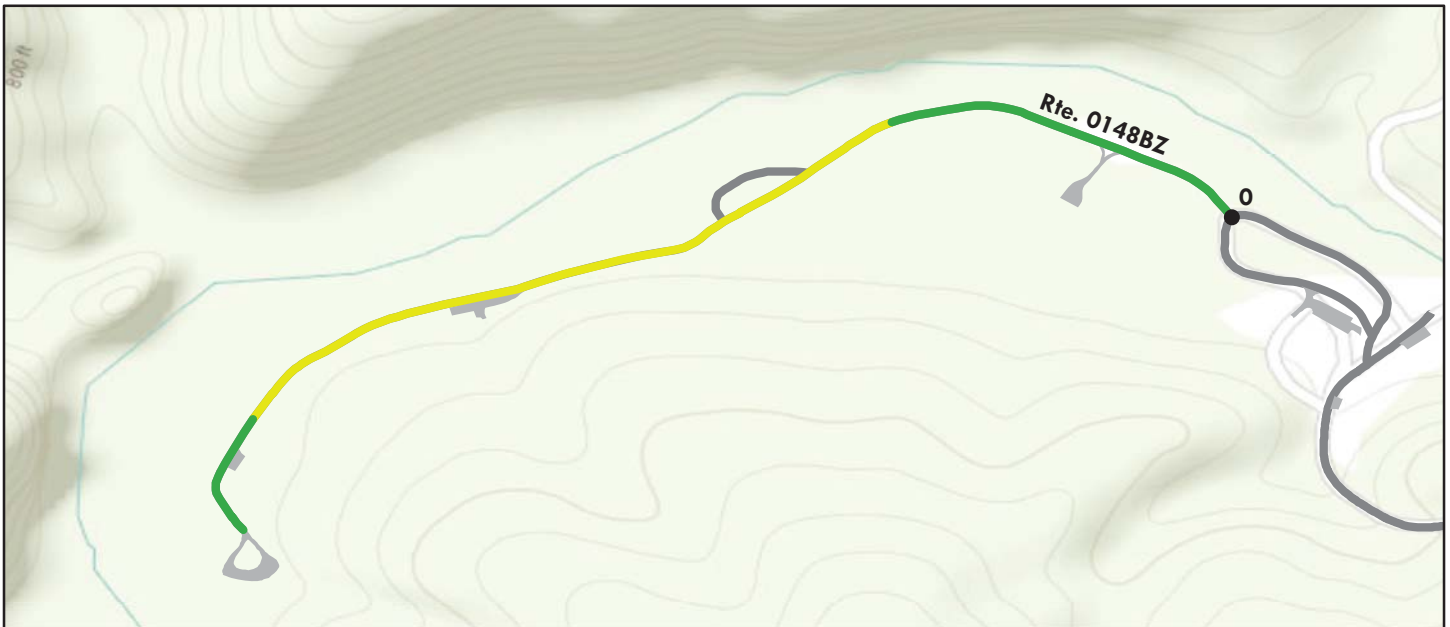
ROUTE 0148BZ: PULLTITE CAMPGROUND ROAD B

Route Condition Legend – Pavement Condition Rating (PCR)						
Poor (0 - 60)	Fair (61- 84)	Good (85 - 94)	Excellent (95 - 100)	Not Rated		
Colors on map represent condition scores at 0.10-mile intervals. See Appendix for definitions and formulas.						
Inspection Date:	11/3/2017	Beginning Section MP	0			
Paved Length (Miles):	0.68	Section Length (MI)	0.68			
Surface Type:	ASPHALT	Route Summary				
Roadway Condition Information						
Pavement Condition Rating (PCR)	81	81				
Surface Condition Rating (SCR)	81	81				
Roughness Condition Index (RCI)	N/A	N/A				
Distress Index Values						
Structural Crack Index	81	81				
Alligator Crack Index	96	96				
Longitudinal Crack Index	85	85				
Transverse Cracking Index	97	97				
Patching Index	99	99				
Rutting Index	89	89				
International Roughness Index (IRI)	N/A	N/A				
Lane & Width Information						
Number of Lanes	2	2				
Paved Width (ft)	15.8	15.8				
Lane Width (ft)	7.9	7.9

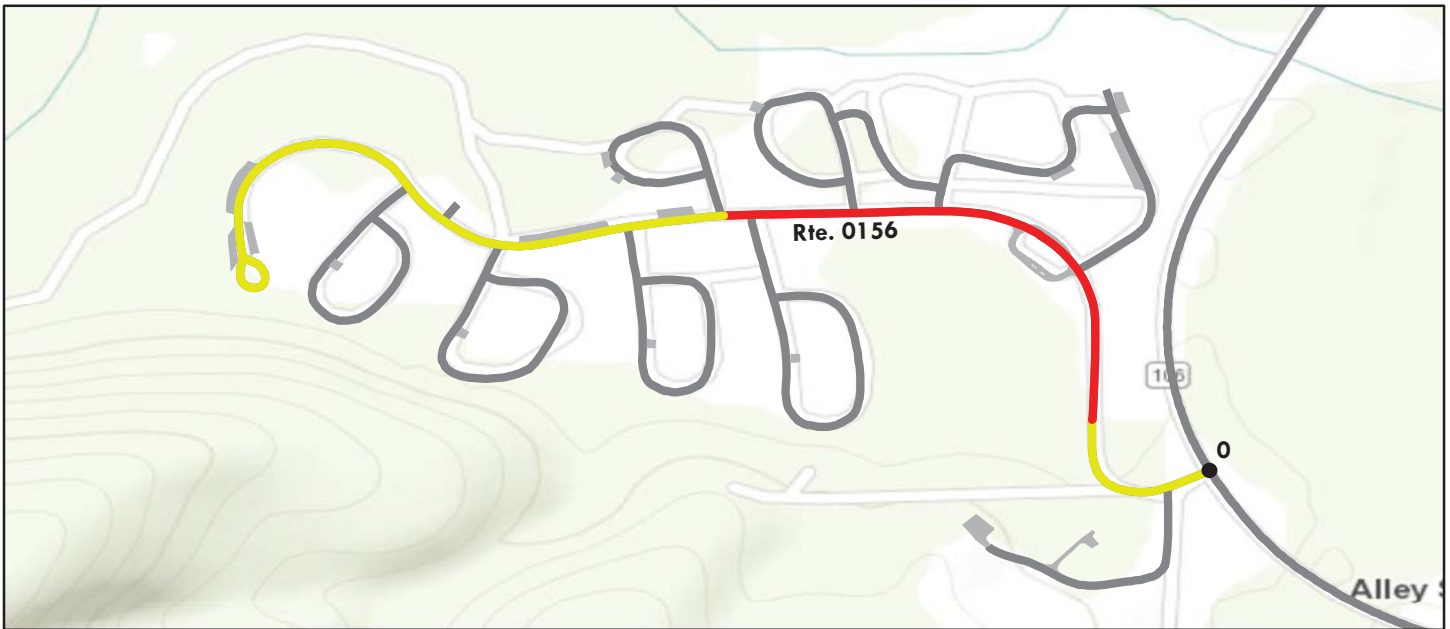
ROUTE 0156: ALLEY SPRING CAMPGROUND ROAD

Route Condition Legend – Pavement Condition Rating (PCR)						
Poor (0 - 60)	Fair (61- 84)	Good (85 - 94)	Excellent (95 - 100)	Not Rated		
Colors on map represent condition scores at 0.10-mile intervals. See Appendix for definitions and formulas.						
Inspection Date: 11/3/2017	Beginning Section MP	0				
Paved Length (Miles): 0.79	Section Length (MI)	0.79				
Surface Type: ASPHALT	Route Summary					
Roadway Condition Information						
Pavement Condition Rating (PCR)	66	66				
Surface Condition Rating (SCR)	66	66				
Roughness Condition Index (RCI)	N/A	N/A				
Distress Index Values						
Structural Crack Index	84	84				
Alligator Crack Index	100	100				
Longitudinal Crack Index	84	84				
Transverse Cracking Index	66	66				
Patching Index	100	100				
Rutting Index	98	98				
International Roughness Index (IRI)	N/A	N/A				
Lane & Width Information						
Number of Lanes	2	2				
Paved Width (ft)	20.6	20.6				
Lane Width (ft)	9.2	9.2

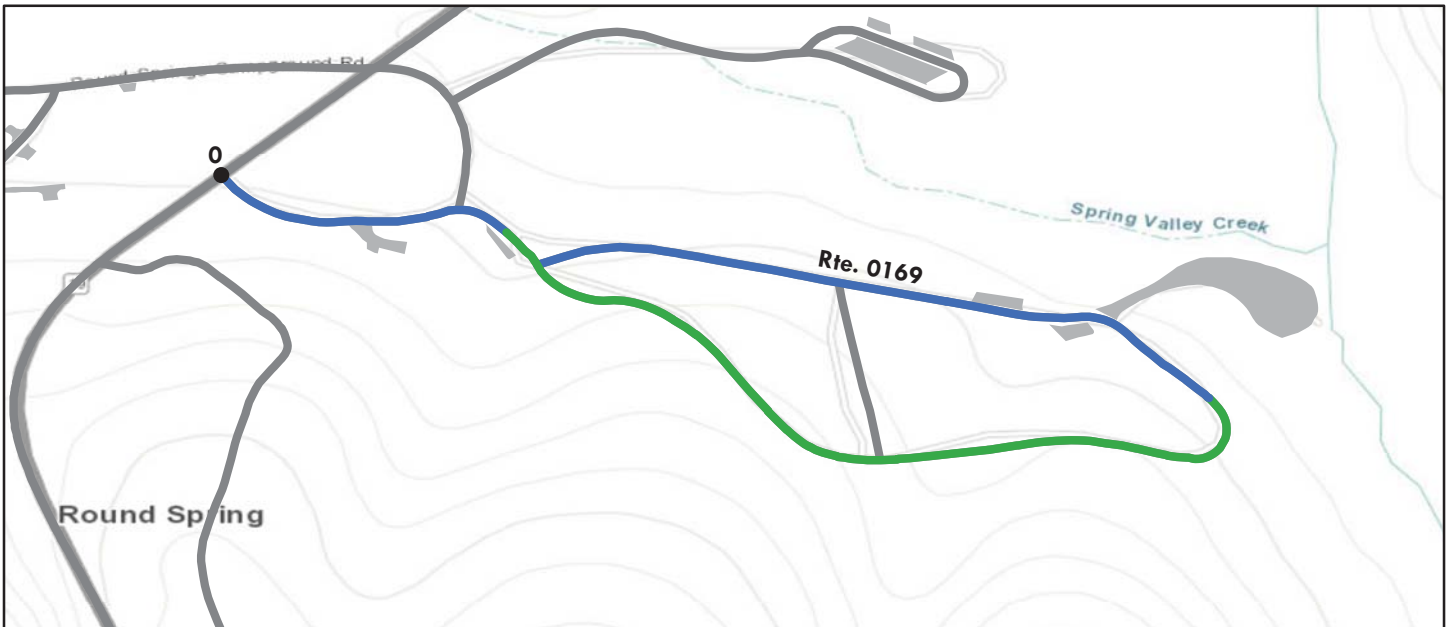
ROUTE 0169: ROUND SPRING CAMPGROUND ROAD

Route Condition Legend – Pavement Condition Rating (PCR)						
Poor (0 - 60)	Fair (61- 84)	Good (85 - 94)	Excellent (95 - 100)	Not Rated		
Colors on map represent condition scores at 0.10-mile intervals. See Appendix for definitions and formulas.						
Inspection Date:	11/3/2017	Beginning Section MP	0			
Paved Length (Miles):	0.63	Section Length (MI)	0.63			
Surface Type:	ASPHALT	Route Summary				
Roadway Condition Information						
Pavement Condition Rating (PCR)	93	93				
Surface Condition Rating (SCR)	93	93				
Roughness Condition Index (RCI)	N/A	N/A				
Distress Index Values						
Structural Crack Index	100	100				
Alligator Crack Index	100	100				
Longitudinal Crack Index	100	100				
Transverse Cracking Index	100	100				
Patching Index	100	100				
Rutting Index	93	93				
International Roughness Index (IRI)	N/A	N/A				
Lane & Width Information						
Number of Lanes	1	1				
Paved Width (ft)	17.2	17.2				
Lane Width (ft)	11.6	11.6

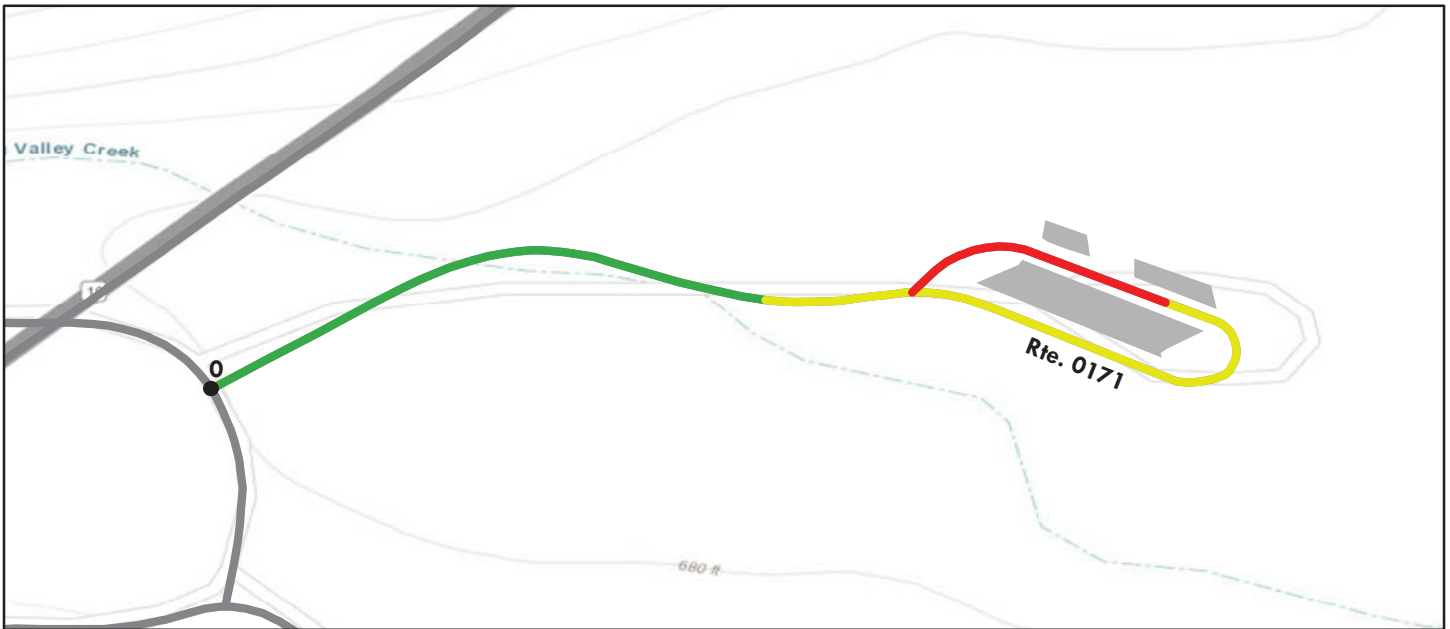
ROUTE 0171: ROUND SPRING PICNIC ACCESS ROAD

Route Condition Legend – Pavement Condition Rating (PCR)						
Poor (0 - 60)	Fair (61- 84)	Good (85 - 94)	Excellent (95 - 100)	Not Rated		
Colors on map represent condition scores at 0.10-mile intervals. See Appendix for definitions and formulas.						
Inspection Date:	11/3/2017	Beginning Section MP	0			
Paved Length (Miles):	0.24	Section Length (MI)	0.24			
Surface Type:	ASPHALT	Route Summary				
Roadway Condition Information						
Pavement Condition Rating (PCR)	78	78				
Surface Condition Rating (SCR)	78	78				
Roughness Condition Index (RCI)	N/A	N/A				
Distress Index Values						
Structural Crack Index	78	78				
Alligator Crack Index	99	99				
Longitudinal Crack Index	79	79				
Transverse Cracking Index	85	85				
Patching Index	100	100				
Rutting Index	91	91				
International Roughness Index (IRI)	N/A	N/A				
Lane & Width Information						
Number of Lanes	2	2				
Paved Width (ft)	22.4	22.4				
Lane Width (ft)	16.6	16.6

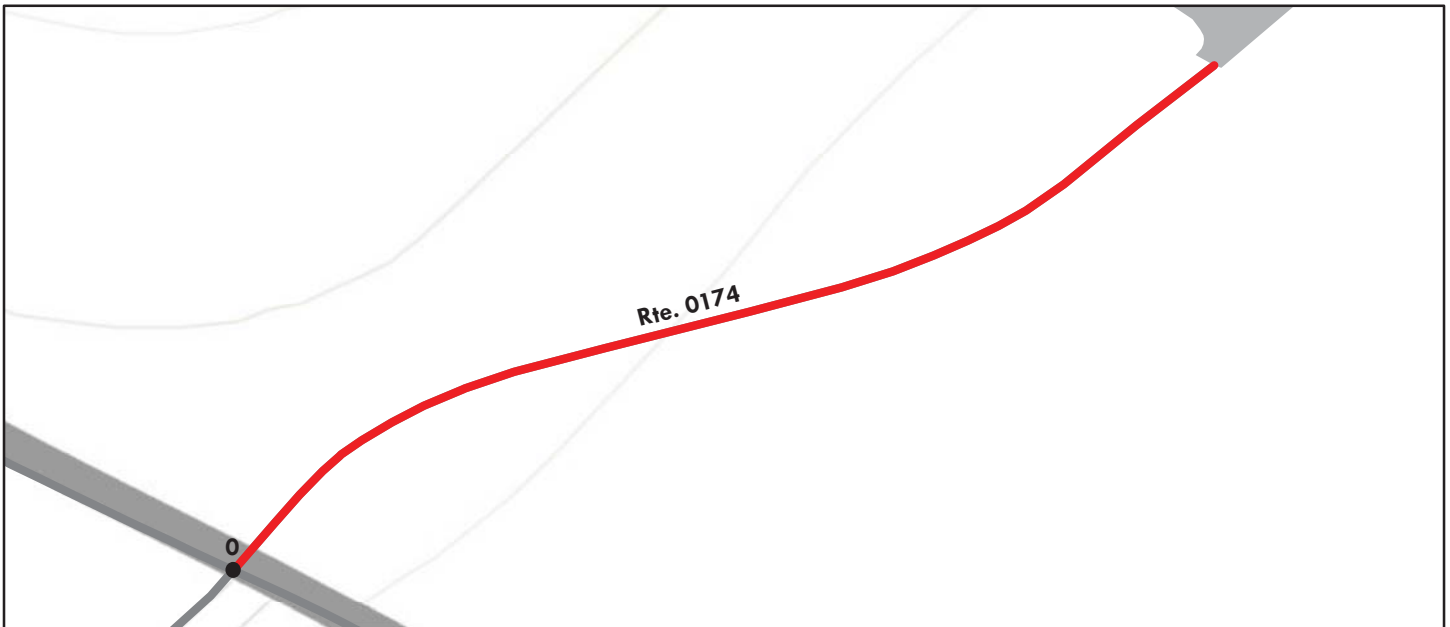
ROUTE 0174: ROUND SPRING SEWAGE TREATMENT ROAD

Route Condition Legend – Pavement Condition Rating (PCR)						
Poor (0 - 60)	Fair (61- 84)	Good (85 - 94)	Excellent (95 - 100)	Not Rated		
Colors on map represent condition scores at 0.10-mile intervals. See Appendix for definitions and formulas.						
Inspection Date: 11/3/2017	Beginning Section MP	0				
Paved Length (Miles): 0.08	Section Length (MI)	0.08				
Surface Type: ASPHALT	Route Summary					
Roadway Condition Information						
Pavement Condition Rating (PCR)	57	57				
Surface Condition Rating (SCR)	57	57				
Roughness Condition Index (RCI)	N/A	N/A				
Distress Index Values						
Structural Crack Index	57	57				
Alligator Crack Index	87	87				
Longitudinal Crack Index	70	70				
Transverse Cracking Index	65	65				
Patching Index	100	100				
Rutting Index	85	85				
International Roughness Index (IRI)	N/A	N/A				
Lane & Width Information						
Number of Lanes	1	1				
Paved Width (ft)	11.7	11.7				
Lane Width (ft)	11.7	11.7

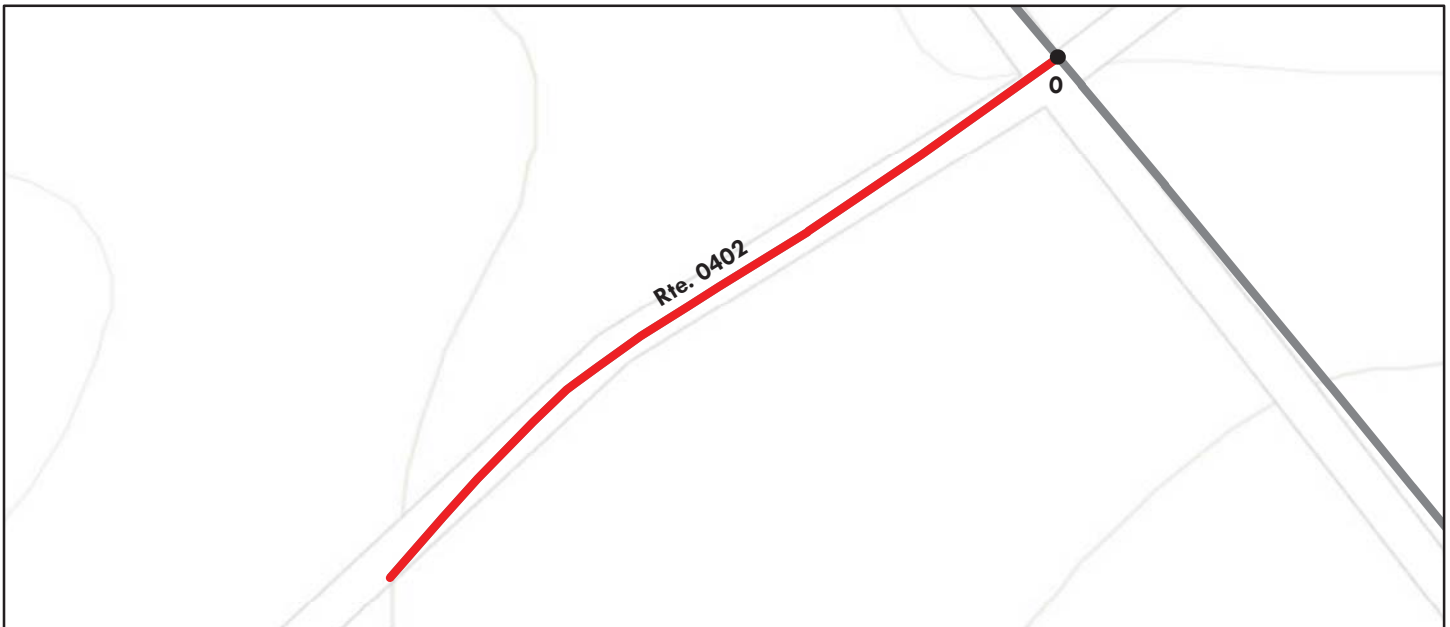
ROUTE 0402: BIG SPRING MAINTENANCE ACCESS ROAD

Route Condition Legend – Pavement Condition Rating (PCR)						
Poor (0 - 60)	Fair (61- 84)	Good (85 - 94)	Excellent (95 - 100)	Not Rated		
Colors on map represent condition scores at 0.10-mile intervals. See Appendix for definitions and formulas.						
Inspection Date: 11/3/2017	Beginning Section MP	0				
Paved Length (Miles): 0.06	Section Length (MI)	0.06				
Surface Type: ASPHALT	Route Summary					
Roadway Condition Information						
Pavement Condition Rating (PCR)	0	0				
Surface Condition Rating (SCR)	N/A	N/A				
Roughness Condition Index (RCI)	N/A	N/A				
Distress Index Values						
Structural Crack Index	N/A	N/A				
Alligator Crack Index	N/A	N/A				
Longitudinal Crack Index	N/A	N/A				
Transverse Cracking Index	N/A	N/A				
Patching Index	N/A	N/A				
Rutting Index	N/A	N/A				
International Roughness Index (IRI)	N/A	N/A				
Lane & Width Information						
Number of Lanes	1	1				
Paved Width (ft)	12.2	12.2

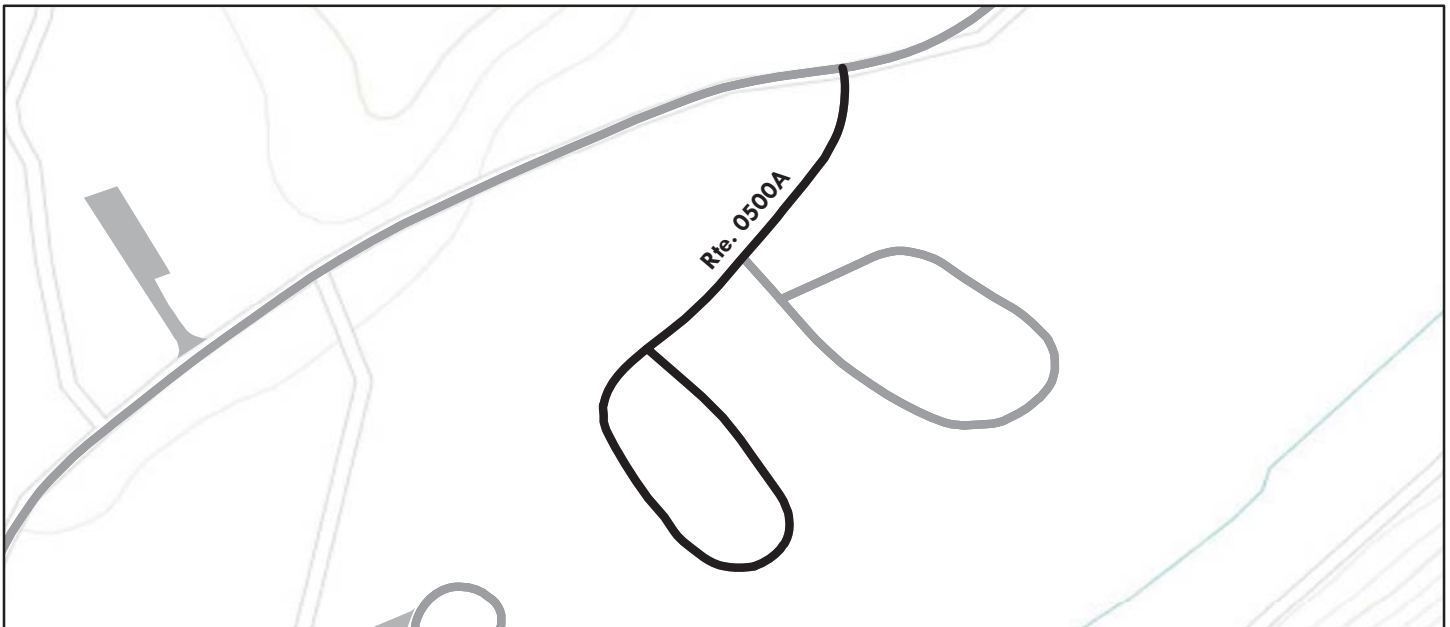
ROUTE 0500A: BIG SPRING CAMPGROUND LOOP A (SITES 101-124)

Route Condition Legend – Pavement Condition Rating (PCR)						
Poor (0 - 60)	Fair (61- 84)	Good (85 - 94)	Excellent (95 - 100)	Not Rated		
Colors on map represent condition scores at 0.10-mile intervals. See Appendix for definitions and formulas.						
Inspection Date:	NOT RATED	Beginning Section MP	0			
Paved Length (Miles):	0.28	Section Length (MI)	0.28			
Surface Type:	ASPHALT	Route Summary				
Roadway Condition Information						
Pavement Condition Rating (PCR)	N/A	N/A				
Surface Condition Rating (SCR)	N/A	N/A				
Roughness Condition Index (RCI)	N/A	N/A				
Distress Index Values						
Structural Crack Index	N/A	N/A				
Alligator Crack Index	N/A	N/A				
Longitudinal Crack Index	N/A	N/A				
Transverse Cracking Index	N/A	N/A				
Patching Index	N/A	N/A				
Rutting Index	N/A	N/A				
International Roughness Index (IRI)	N/A	N/A				
Lane & Width Information						
Number of Lanes	1	1				
Paved Width (ft)	15.5	15.5

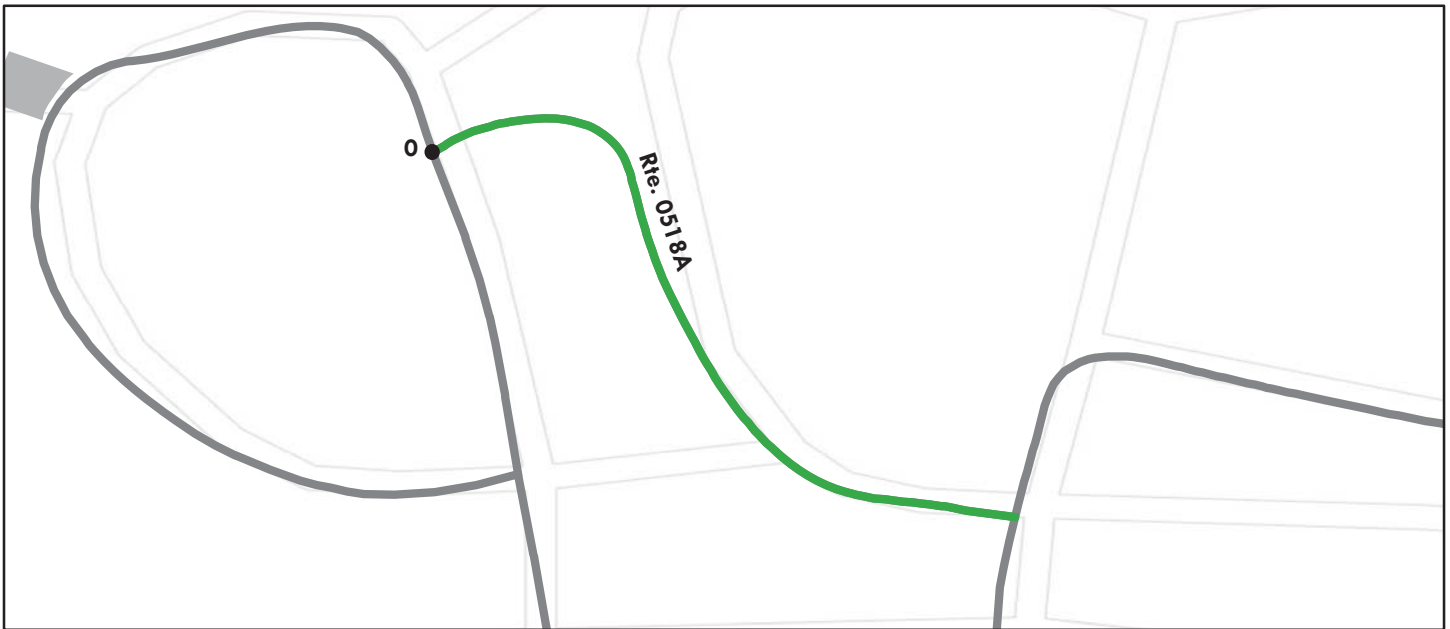
ROUTE 0518A: ALLEY SPRING CAMPGROUND LOOP A

Route Condition Legend – Pavement Condition Rating (PCR)						
Poor (0 - 60)	Fair (61- 84)	Good (85 - 94)	Excellent (95 - 100)	Not Rated		
Colors on map represent condition scores at 0.10-mile intervals. See Appendix for definitions and formulas.						
Inspection Date:	11/3/2017	Beginning Section MP	0			
Paved Length (Miles):	0.08	Section Length (MI)	0.08			
Surface Type:	ASPHALT	Route Summary				
Roadway Condition Information						
Pavement Condition Rating (PCR)	90	90				
Surface Condition Rating (SCR)	90	90				
Roughness Condition Index (RCI)	N/A	N/A				
Distress Index Values						
Structural Crack Index	97	97				
Alligator Crack Index	100	100				
Longitudinal Crack Index	97	97				
Transverse Cracking Index	90	90				
Patching Index	100	100				
Rutting Index	92	92				
International Roughness Index (IRI)	N/A	N/A				
Lane & Width Information						
Number of Lanes	1	1				
Paved Width (ft)	12.1	12.1				
Lane Width (ft)	12.1	12.1

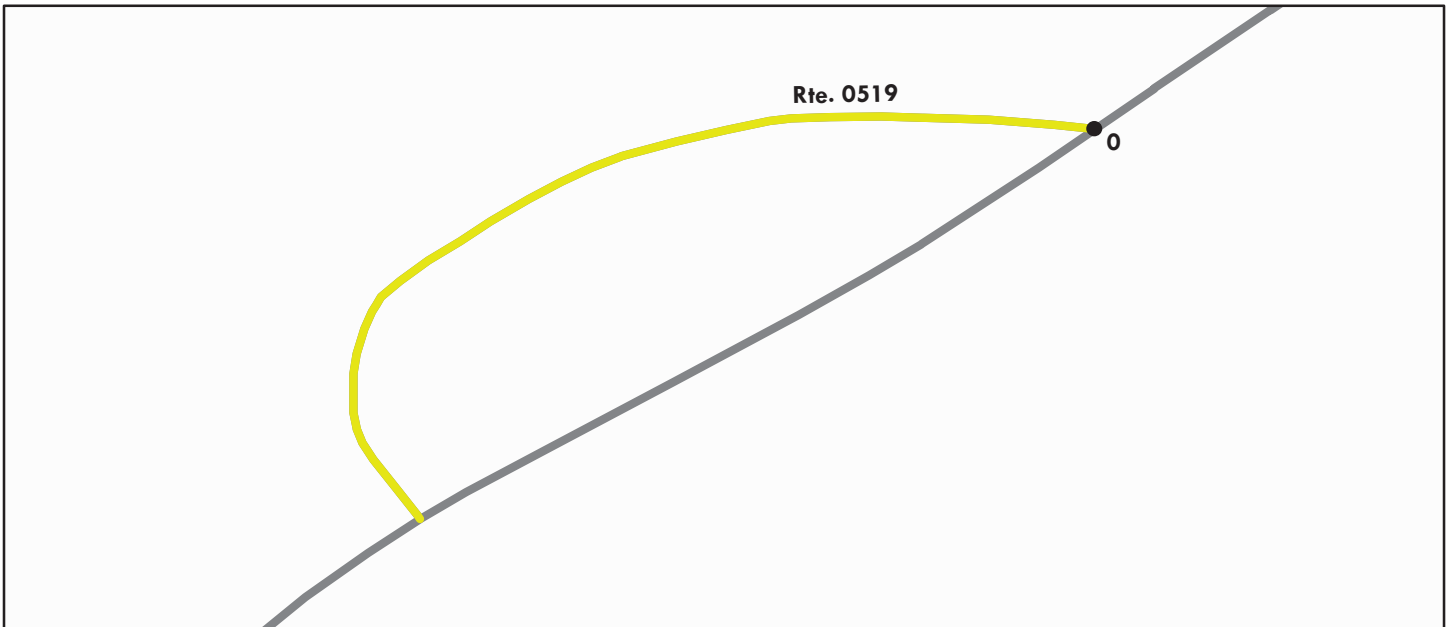
ROUTE 0519: PULLTITE FLOATER CAMP ROAD

Inspection Date: 11/3/2017	Beginning Section MP	0				
Paved Length (Miles): 0.07	Section Length (MI)	0.07				
Surface Type: ASPHALT	Route Summary					
Roadway Condition Information						
Pavement Condition Rating (PCR)	84	84				
Surface Condition Rating (SCR)	84	84				
Roughness Condition Index (RCI)	N/A	N/A				
Distress Index Values						
Structural Crack Index	100	100				
Alligator Crack Index	100	100				
Longitudinal Crack Index	100	100				
Transverse Cracking Index	100	100				
Patching Index	100	100				
Rutting Index	84	84				
International Roughness Index (IRI)	N/A	N/A				
Lane & Width Information						
Number of Lanes	1	1				
Paved Width (ft)	10.2	10.2				
Lane Width (ft)	10.2	10.2

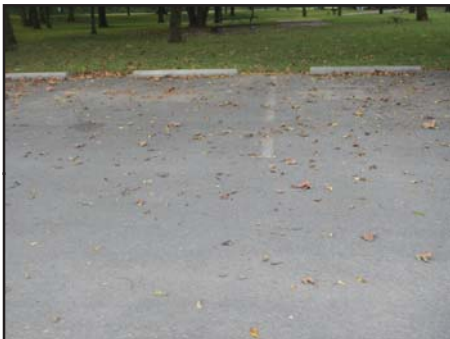
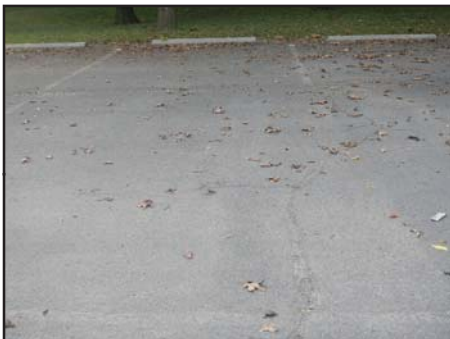
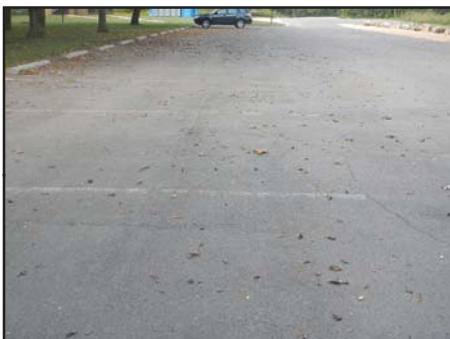
Inspection Date	FMSS Number	User Access	Surface Type
9/20/2017	78739	PUBLIC	ASPHALT
Area (Sq. Ft.)	Lane Miles (11' Widths)	Curb Reveal (Inches)	Curb Recommendation
5,589	0.096	NOT APPLICABLE	NOT APPLICABLE
Curb Type		Curb & Gutter Type	
NO CURB		NO CURB AND GUTTER	
Pavement Recommendation		Condition Rating / PCR	
PREVENTIVE MAINTENANCE		GOOD / 90

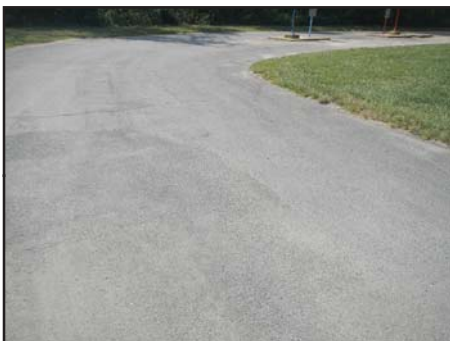
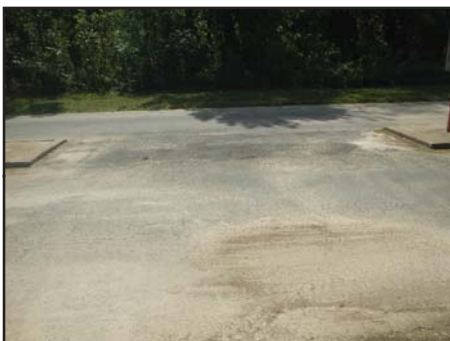
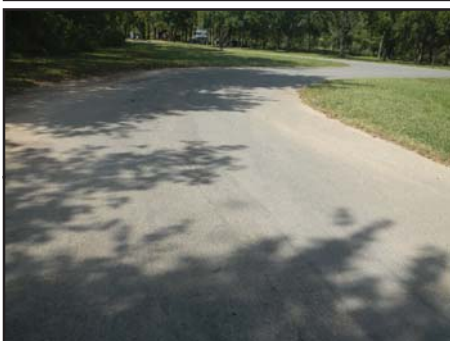
ROUTE 0902: ALLEY SPRING DUMP STATION PARKING

Inspection Date	FMSS Number	User Access	Surface Type
9/20/2017	78740	PUBLIC	ASPHALT
Area (Sq. Ft.)	Lane Miles (11' Widths)	Curb Reveal (Inches)	Curb Recommendation
7,007	0.121	3	DO NOTHING
Curb Type		Curb & Gutter Type	
CONCRETE		NO CURB AND GUTTER	
Pavement Recommendation		Condition Rating / PCR	
PREVENTIVE MAINTENANCE		GOOD / 90

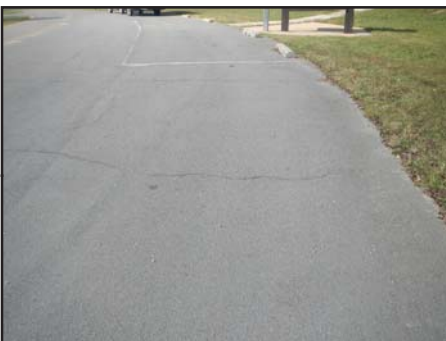
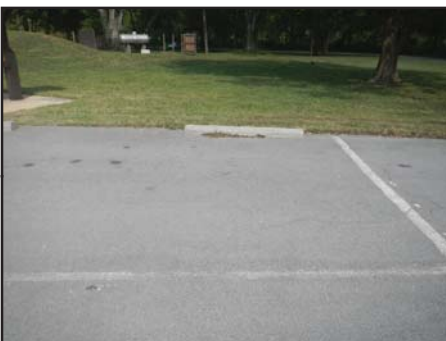
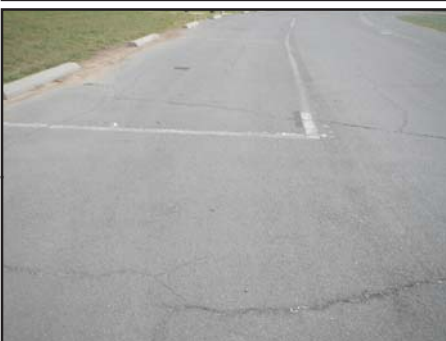
ROUTE 0903: ALLEY SPRING RANGER STATION PARKING

Inspection Date	FMSS Number	User Access	Surface Type
9/20/2017	78741	PUBLIC	ASPHALT
Area (Sq. Ft.)	Lane Miles (11' Widths)	Curb Reveal (Inches)	Curb Recommendation
2,366	0.041	NOT APPLICABLE	NOT APPLICABLE
Curb Type		Curb & Gutter Type	
NO CURB		NO CURB AND GUTTER	
Pavement Recommendation		Condition Rating / PCR	
PREVENTIVE MAINTENANCE		GOOD / 90

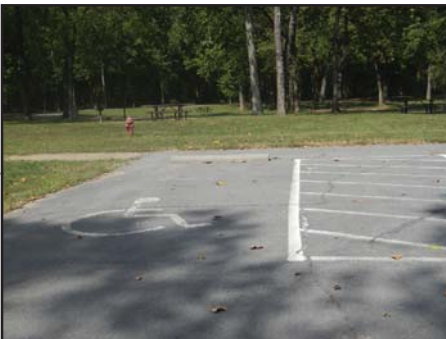
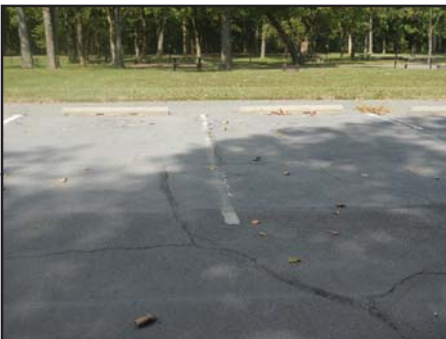
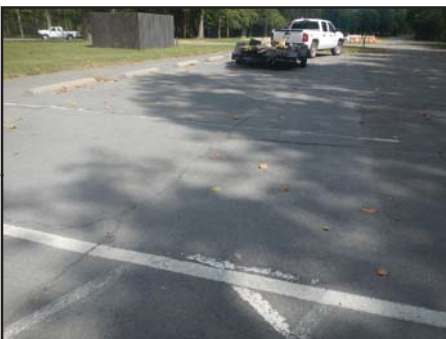
ROUTE 0904A: ALLEY SPRING CAMPGROUND ROAD PARKING A

Inspection Date	FMSS Number	User Access	Surface Type
9/20/2017	78742	PUBLIC	ASPHALT
Area (Sq. Ft.)	Lane Miles (11' Widths)	Curb Reveal (Inches)	Curb Recommendation
3,620	0.062	NOT APPLICABLE	NOT APPLICABLE
Curb Type		Curb & Gutter Type	
NO CURB		NO CURB AND GUTTER	
Pavement Recommendation		Condition Rating / PCR	
LIGHT 3R TREATMENTS		FAIR / 73

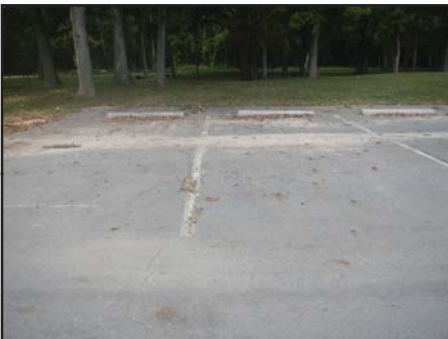
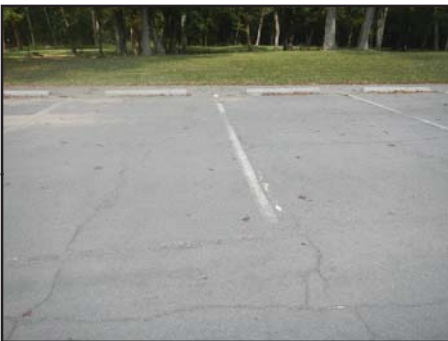
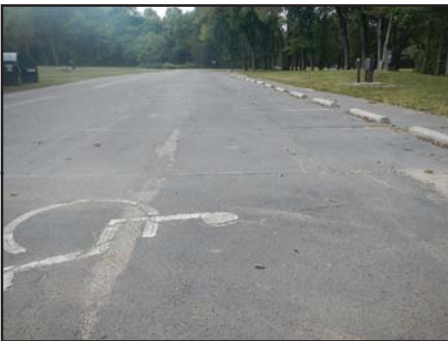
ROUTE 0904B: ALLEY SPRING CAMPGROUND ROAD PARKING B "WALK-IN CAMPGROUND"

Inspection Date	FMSS Number	User Access	Surface Type
9/20/2017	102100	PUBLIC	ASPHALT
Area (Sq. Ft.)	Lane Miles (11' Widths)	Curb Reveal (Inches)	Curb Recommendation
6,661	0.115	NOT APPLICABLE	NOT APPLICABLE
Curb Type		Curb & Gutter Type	
NO CURB		NO CURB AND GUTTER	
Pavement Recommendation		Condition Rating / PCR	
LIGHT 3R TREATMENTS		FAIR / 73

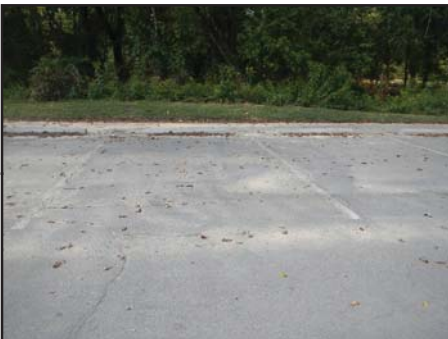
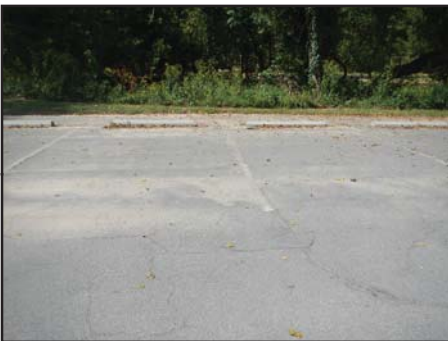
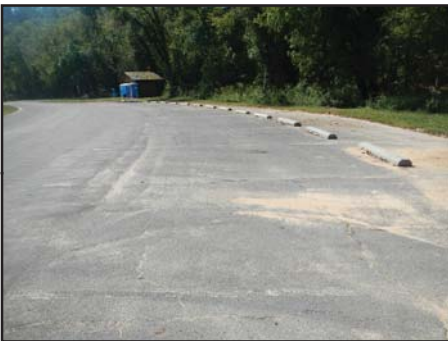
ROUTE 0904C: ALLEY SPRING CAMPGROUND ROAD PARKING C "GROUP CAMPSITES"

Inspection Date	FMSS Number	User Access	Surface Type
9/20/2017	102101	PUBLIC	ASPHALT
Area (Sq. Ft.)	Lane Miles (11' Widths)	Curb Reveal (Inches)	Curb Recommendation
5,364	0.092	NOT APPLICABLE	NOT APPLICABLE
Curb Type		Curb & Gutter Type	
NO CURB		NO CURB AND GUTTER	
Pavement Recommendation		Condition Rating / PCR	
PREVENTIVE MAINTENANCE		GOOD / 90

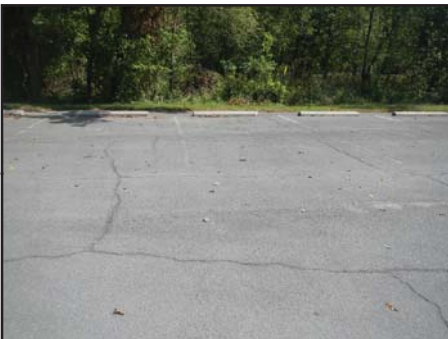
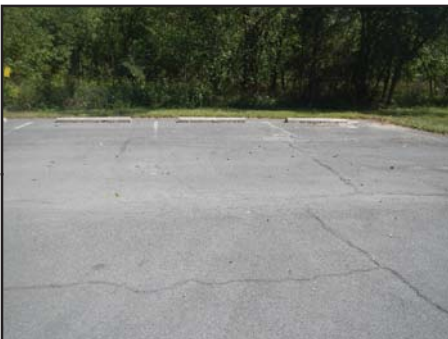
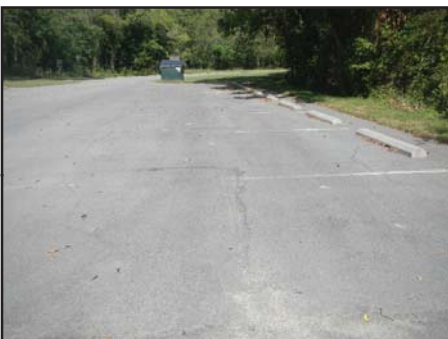
ROUTE 0904D: ALLEY SPRING CAMPGROUND ROAD PARKING D

Inspection Date	FMSS Number	User Access	Surface Type
9/20/2017	102103	PUBLIC	ASPHALT
Area (Sq. Ft.)	Lane Miles (11' Widths)	Curb Reveal (Inches)	Curb Recommendation
2,664	0.046	NOT APPLICABLE	NOT APPLICABLE
Curb Type		Curb & Gutter Type	
NO CURB		NO CURB AND GUTTER	
Pavement Recommendation		Condition Rating / PCR	
PREVENTIVE MAINTENANCE		GOOD / 90

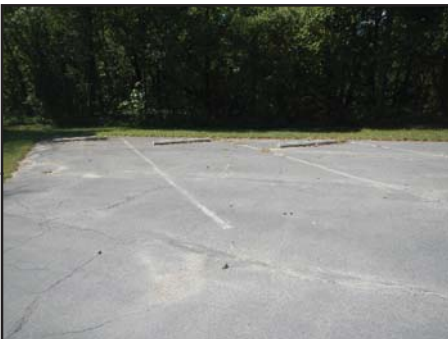
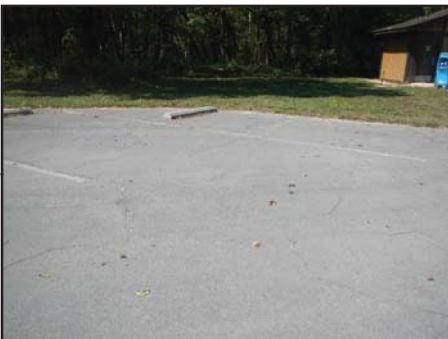
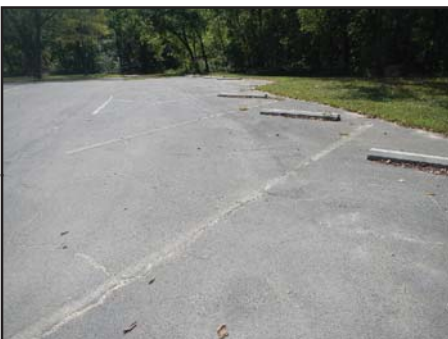
ROUTE 0904E: ALLEY SPRING CAMPGROUND ROAD PARKING E

Inspection Date	FMSS Number	User Access	Surface Type
9/20/2017	102104	PUBLIC	ASPHALT
Area (Sq. Ft.)	Lane Miles (11' Widths)	Curb Reveal (Inches)	Curb Recommendation
2,781	0.048	NOT APPLICABLE	NOT APPLICABLE
Curb Type		Curb & Gutter Type	
NO CURB		NO CURB AND GUTTER	
Pavement Recommendation		Condition Rating / PCR	
PREVENTIVE MAINTENANCE		GOOD / 90
