OZAR Cycle 6

Final Report

Road Inventory and Condition Assessment of Paved Routes Ozark National Scenic Riverways

**Federal Highway Administration
Eastern Federal Lands Highway Division
Road Inventory Program (RIP)**

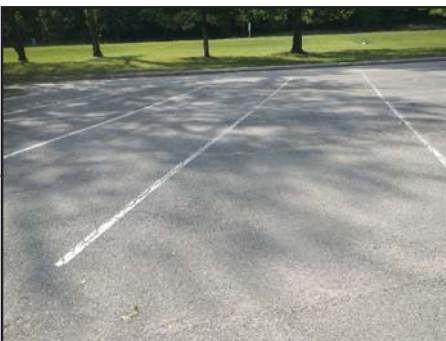
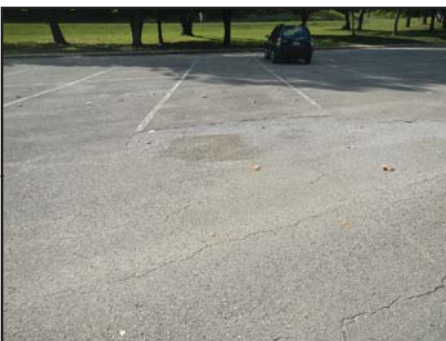
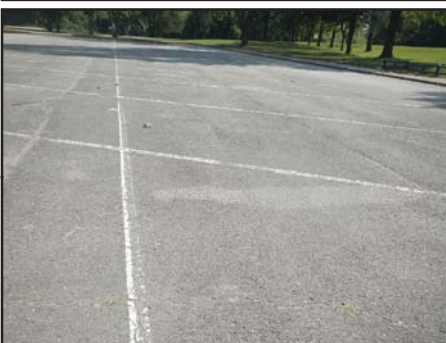
ROUTE 0905: ALLEY SPRING PICNIC AREA ROAD PARKING

Inspection Date	FMSS Number	User Access	Surface Type
9/20/2017	78743	PUBLIC	ASPHALT
Area (Sq. Ft.)	Lane Miles (11' Widths)	Curb Reveal (Inches)	Curb Recommendation
34,389	0.592	3	DO NOTHING
Curb Type		Curb & Gutter Type	
ASPHALT		NO CURB AND GUTTER	
Pavement Recommendation		Condition Rating / PCR	
LIGHT 3R TREATMENTS		FAIR / 73

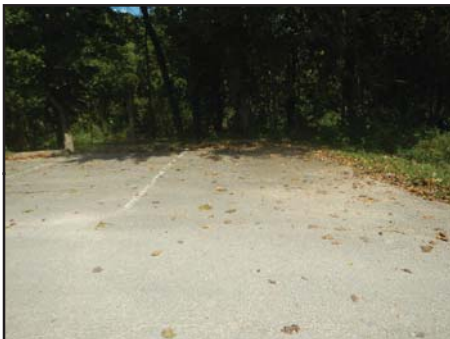
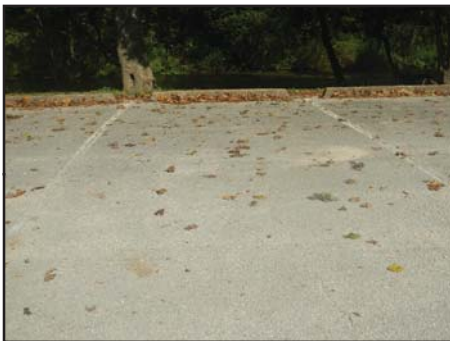
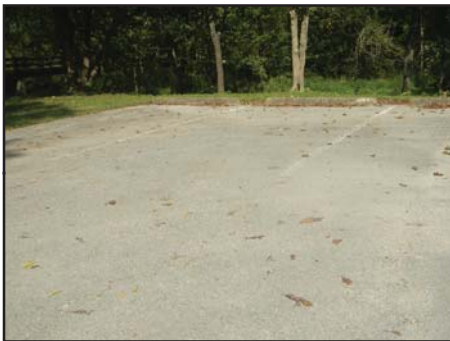
ROUTE 0906: ALLEY SPRING PICNIC AREA RIVER PARKING

Inspection Date	FMSS Number	User Access	Surface Type
9/20/2017	78744	PUBLIC	ASPHALT
Area (Sq. Ft.)	Lane Miles (11' Widths)	Curb Reveal (Inches)	Curb Recommendation
4,282	0.074	NOT APPLICABLE	NOT APPLICABLE
Curb Type		Curb & Gutter Type	
NO CURB		NO CURB AND GUTTER	
Pavement Recommendation		Condition Rating / PCR	
PREVENTIVE MAINTENANCE		GOOD / 90

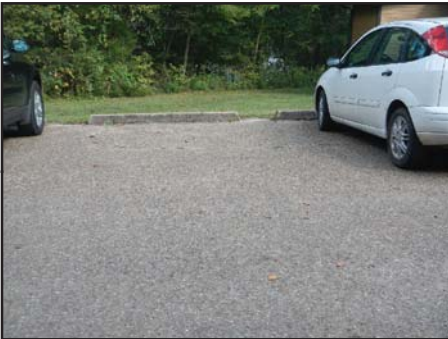
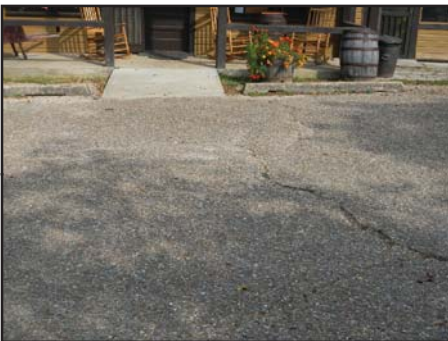
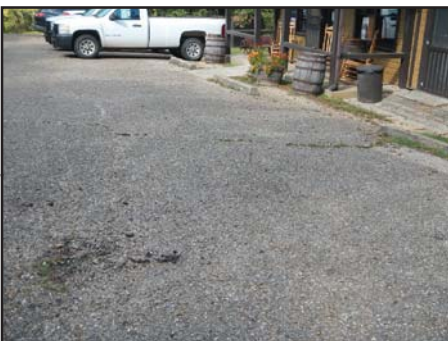
ROUTE 0907: ALLEY SPRING HOLLOW PARKING

Inspection Date	FMSS Number	User Access	Surface Type
9/20/2017	78745	PUBLIC	ASPHALT
Area (Sq. Ft.)	Lane Miles (11' Widths)	Curb Reveal (Inches)	Curb Recommendation
3,010	0.052	NOT APPLICABLE	NOT APPLICABLE
Curb Type		Curb & Gutter Type	
NO CURB		NO CURB AND GUTTER	
Pavement Recommendation		Condition Rating / PCR	
LIGHT 3R TREATMENTS		FAIR / 73

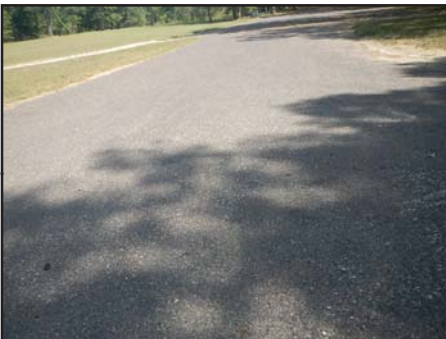
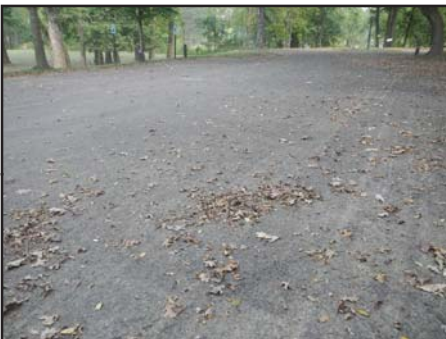
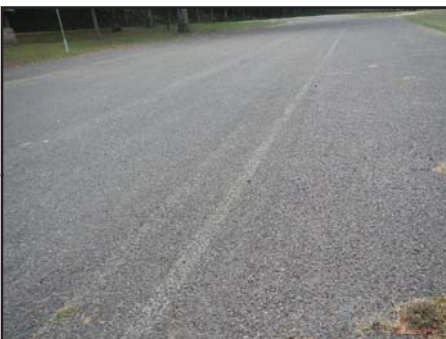
ROUTE 0910: BIG SPRING LODGE ROAD PARKING

Inspection Date	FMSS Number	User Access	Surface Type
9/21/2017	78746	PUBLIC	ASPHALT
Area (Sq. Ft.)	Lane Miles (11' Widths)	Curb Reveal (Inches)	Curb Recommendation
31,502	0.542	2	DO NOTHING
Curb Type		Curb & Gutter Type	
STONE		NO CURB AND GUTTER	
Pavement Recommendation		Condition Rating / PCR	
LIGHT 3R TREATMENTS		FAIR / 73

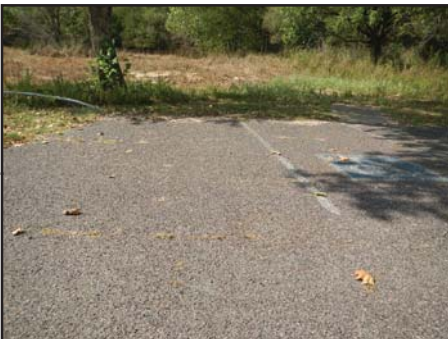
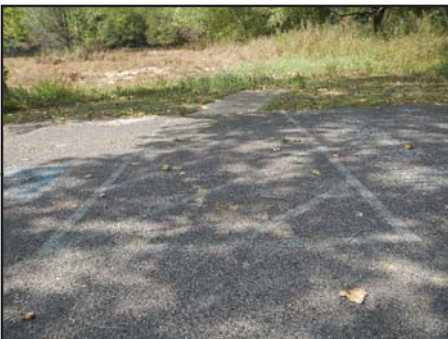
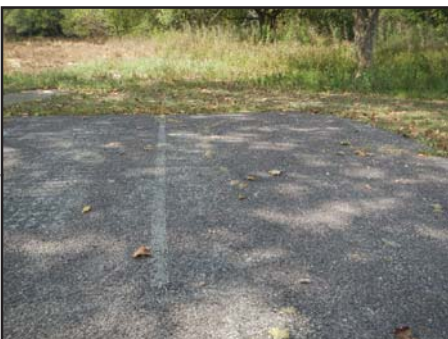
ROUTE 0911A: PEA VINE ROAD PARKING A

Inspection Date	FMSS Number	User Access	Surface Type
9/21/2017	78747	PUBLIC	ASPHALT
Area (Sq. Ft.)	Lane Miles (11' Widths)	Curb Reveal (Inches)	Curb Recommendation
1,270	0.022	NOT APPLICABLE	NOT APPLICABLE
Curb Type		Curb & Gutter Type	
NO CURB		NO CURB AND GUTTER	
Pavement Recommendation		Condition Rating / PCR	
PREVENTIVE MAINTENANCE		GOOD / 90

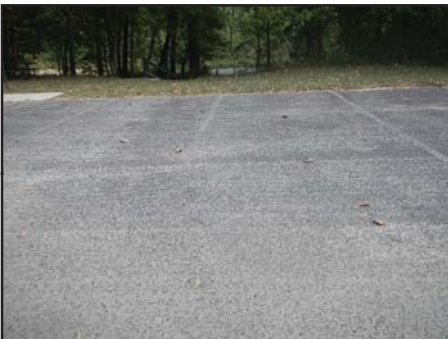
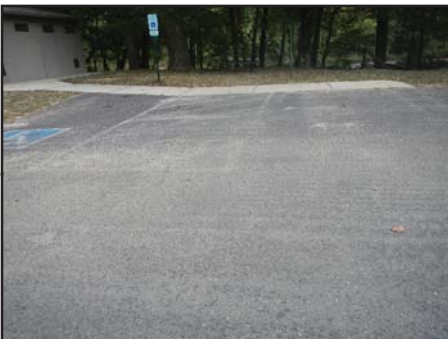
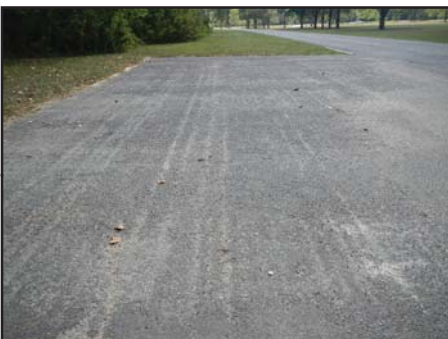
Inspection Date	FMSS Number	User Access	Surface Type
9/21/2017	102105	PUBLIC	ASPHALT
Area (Sq. Ft.)	Lane Miles (11' Widths)	Curb Reveal (Inches)	Curb Recommendation
2,259	0.039	NOT APPLICABLE	NOT APPLICABLE
Curb Type		Curb & Gutter Type	
NO CURB		NO CURB AND GUTTER	
Pavement Recommendation		Condition Rating / PCR	
PREVENTIVE MAINTENANCE		GOOD / 90

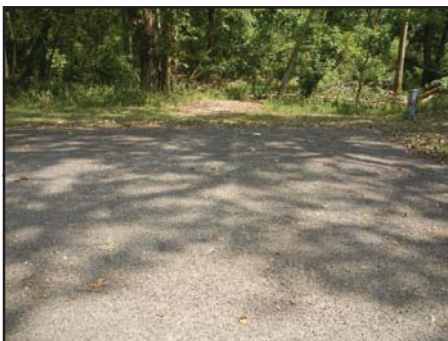
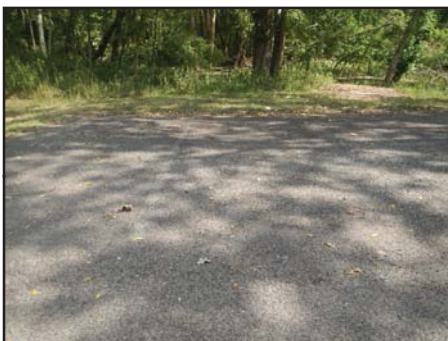
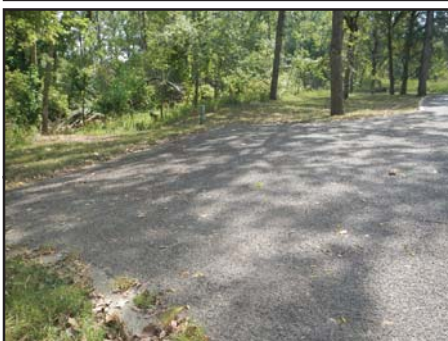
Inspection Date	FMSS Number	User Access	Surface Type
9/21/2017	102106	PUBLIC	ASPHALT
Area (Sq. Ft.)	Lane Miles (11' Widths)	Curb Reveal (Inches)	Curb Recommendation
968	0.017	NOT APPLICABLE	NOT APPLICABLE
Curb Type		Curb & Gutter Type	
NO CURB		NO CURB AND GUTTER	
Pavement Recommendation		Condition Rating / PCR	
LIGHT 3R TREATMENTS		FAIR / 73

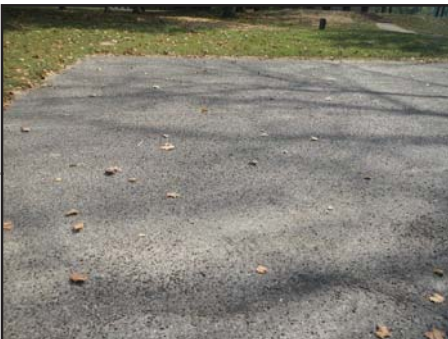
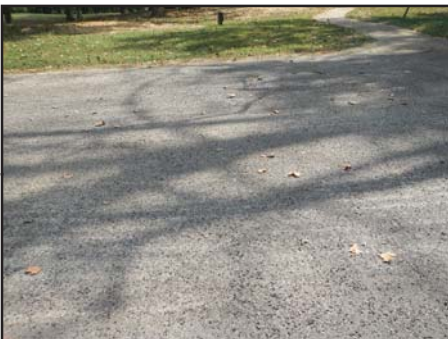
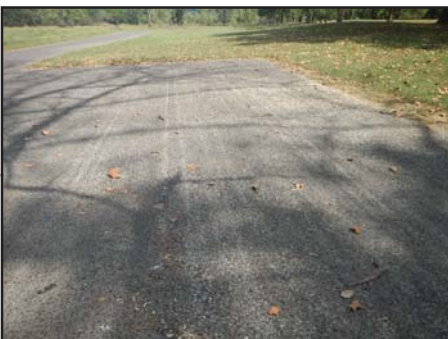
Inspection Date	FMSS Number	User Access	Surface Type
9/21/2017	78748	PUBLIC	ASPHALT
Area (Sq. Ft.)	Lane Miles (11' Widths)	Curb Reveal (Inches)	Curb Recommendation
1,337	0.023	NOT APPLICABLE	NOT APPLICABLE
Curb Type		Curb & Gutter Type	
NO CURB		NO CURB AND GUTTER	
Pavement Recommendation		Condition Rating / PCR	
LIGHT 3R TREATMENTS		FAIR / 73

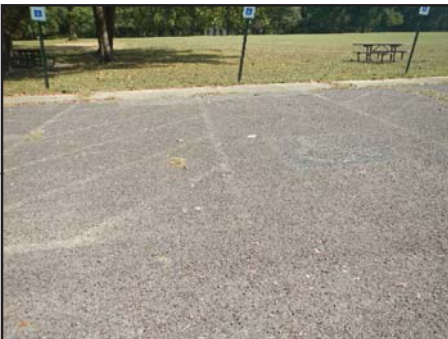
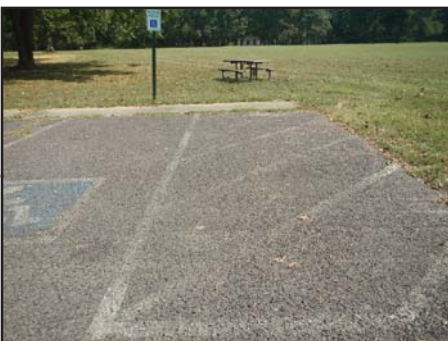
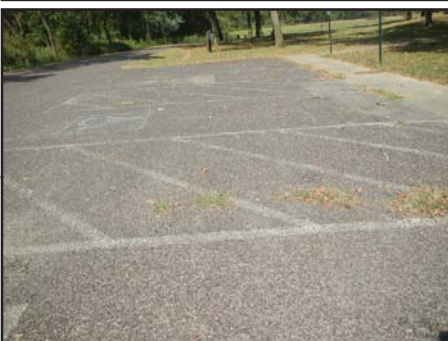
Inspection Date	FMSS Number	User Access	Surface Type
9/21/2017	102107	PUBLIC	ASPHALT
Area (Sq. Ft.)	Lane Miles (11' Widths)	Curb Reveal (Inches)	Curb Recommendation
1,486	0.026	NOT APPLICABLE	NOT APPLICABLE
Curb Type		Curb & Gutter Type	
NO CURB		NO CURB AND GUTTER	
Pavement Recommendation		Condition Rating / PCR	
LIGHT 3R TREATMENTS		FAIR / 73

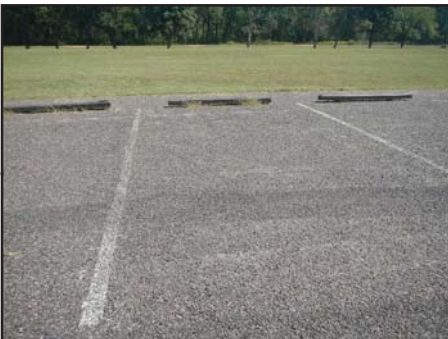
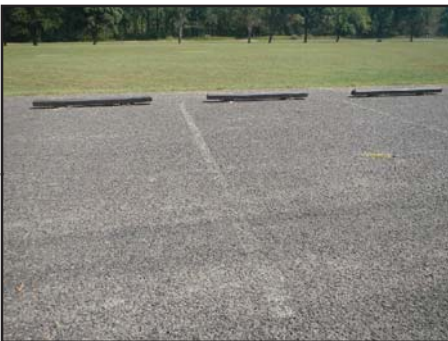
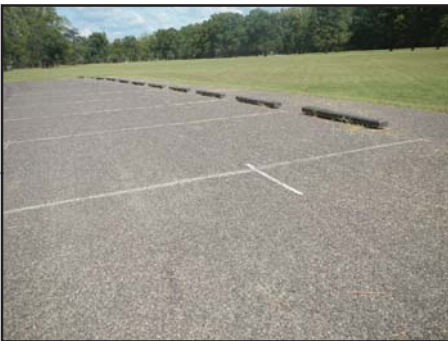
Inspection Date	FMSS Number	User Access	Surface Type
9/21/2017	102108	PUBLIC	ASPHALT
Area (Sq. Ft.)	Lane Miles (11' Widths)	Curb Reveal (Inches)	Curb Recommendation
3,618	0.062	NOT APPLICABLE	NOT APPLICABLE
Curb Type		Curb & Gutter Type	
NO CURB		NO CURB AND GUTTER	
Pavement Recommendation		Condition Rating / PCR	
PREVENTIVE MAINTENANCE		GOOD / 90

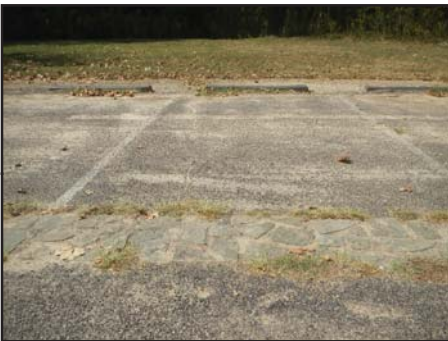
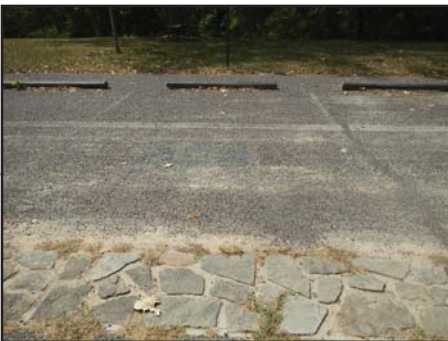
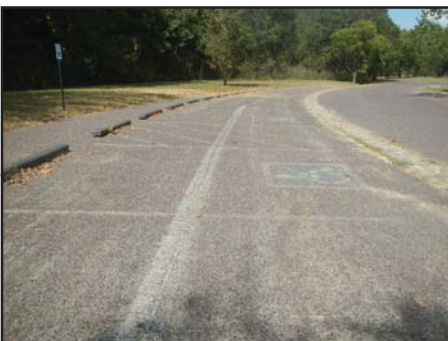
Inspection Date	FMSS Number	User Access	Surface Type
9/21/2017	102109	PUBLIC	ASPHALT
Area (Sq. Ft.)	Lane Miles (11' Widths)	Curb Reveal (Inches)	Curb Recommendation
4,575	0.079	NOT APPLICABLE	NOT APPLICABLE
Curb Type		Curb & Gutter Type	
NO CURB		NO CURB AND GUTTER	
Pavement Recommendation		Condition Rating / PCR	
LIGHT 3R TREATMENTS		FAIR / 73

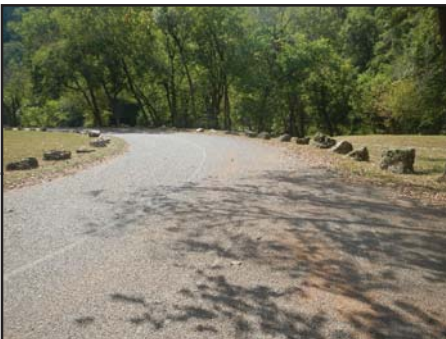
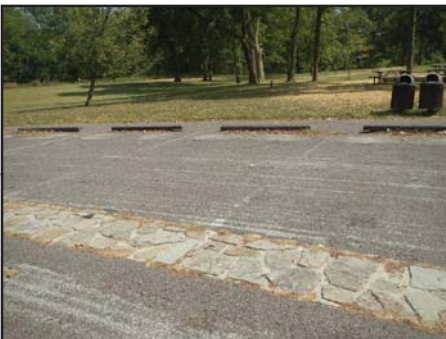
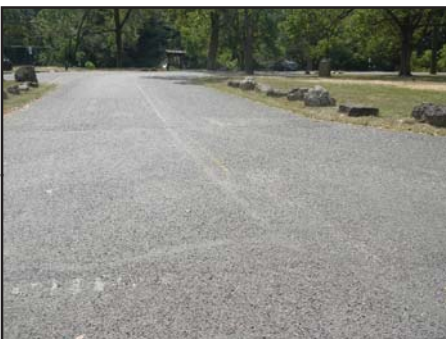
Inspection Date	FMSS Number	User Access	Surface Type
9/21/2017	102110	PUBLIC	ASPHALT
Area (Sq. Ft.)	Lane Miles (11' Widths)	Curb Reveal (Inches)	Curb Recommendation
21,086	0.363	NOT APPLICABLE	NOT APPLICABLE
Curb Type		Curb & Gutter Type	
NO CURB		NO CURB AND GUTTER	
Pavement Recommendation		Condition Rating / PCR	
PREVENTIVE MAINTENANCE		GOOD / 90

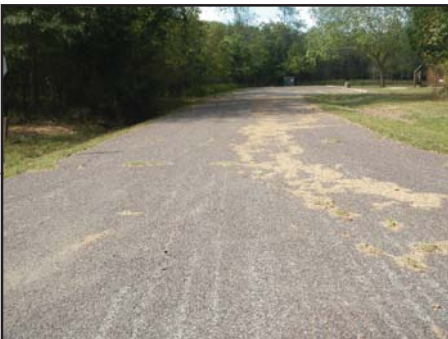
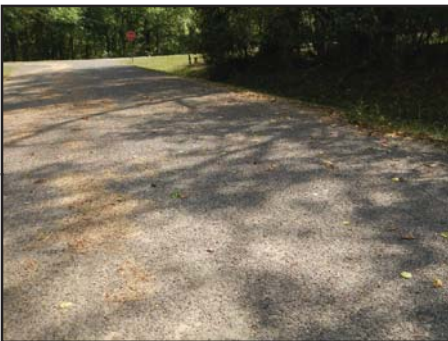
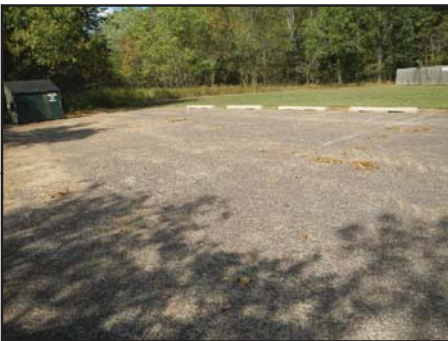
Inspection Date	FMSS Number	User Access	Surface Type
9/21/2017	78750	PUBLIC	ASPHALT
Area (Sq. Ft.)	Lane Miles (11' Widths)	Curb Reveal (Inches)	Curb Recommendation
10,944	0.188	NOT APPLICABLE	NOT APPLICABLE
Curb Type		Curb & Gutter Type	
NO CURB		NO CURB AND GUTTER	
Pavement Recommendation		Condition Rating / PCR	
LIGHT 3R TREATMENTS		FAIR / 73

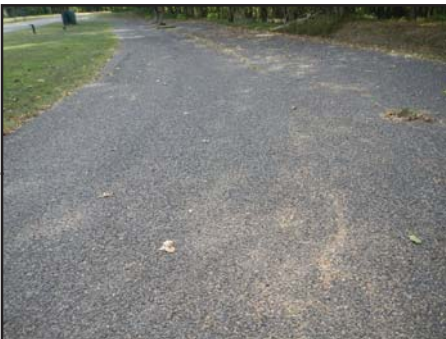
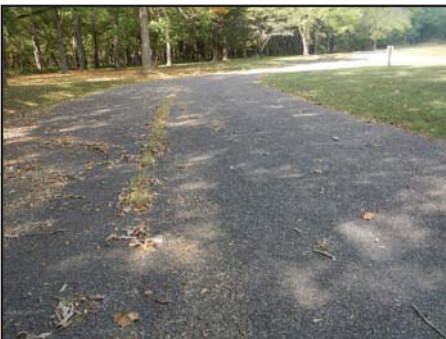
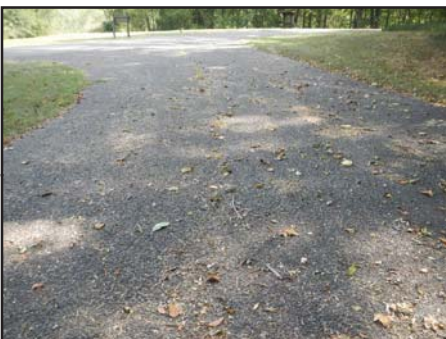
Inspection Date	FMSS Number	User Access	Surface Type
9/21/2017	78751	PUBLIC	ASPHALT
Area (Sq. Ft.)	Lane Miles (11' Widths)	Curb Reveal (Inches)	Curb Recommendation
8,020	0.138	NOT APPLICABLE	NOT APPLICABLE
Curb Type		Curb & Gutter Type	
NO CURB		NO CURB AND GUTTER	
Pavement Recommendation		Condition Rating / PCR	
PREVENTIVE MAINTENANCE		GOOD / 90

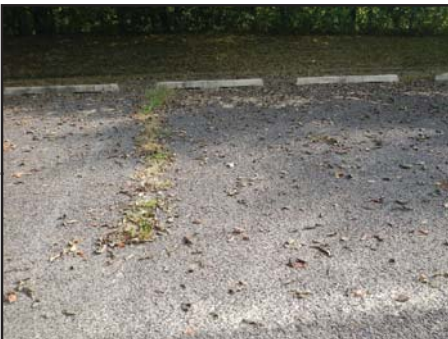
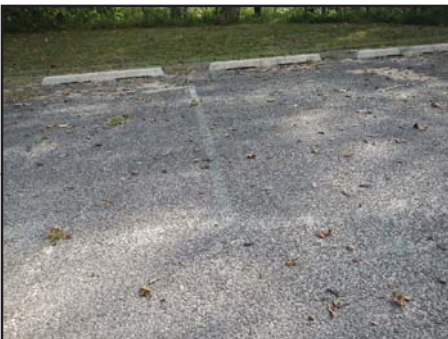
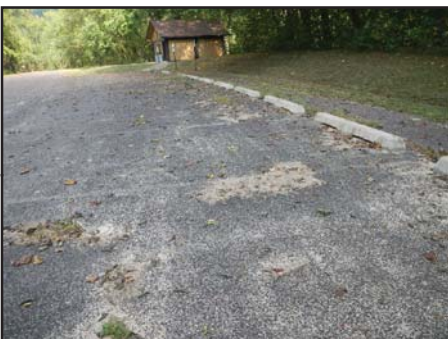
Inspection Date	FMSS Number	User Access	Surface Type
9/21/2017	78752	PUBLIC	ASPHALT
Area (Sq. Ft.)	Lane Miles (11' Widths)	Curb Reveal (Inches)	Curb Recommendation
2,118	0.036	NOT APPLICABLE	NOT APPLICABLE
Curb Type		Curb & Gutter Type	
NO CURB		NO CURB AND GUTTER	
Pavement Recommendation		Condition Rating / PCR	
PREVENTIVE MAINTENANCE		GOOD / 90

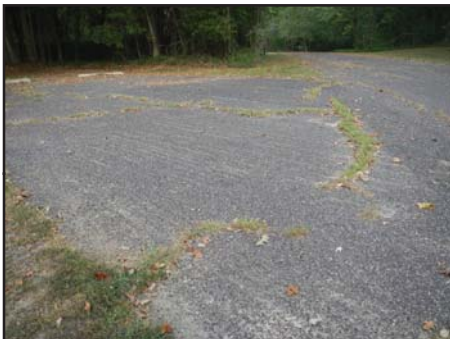
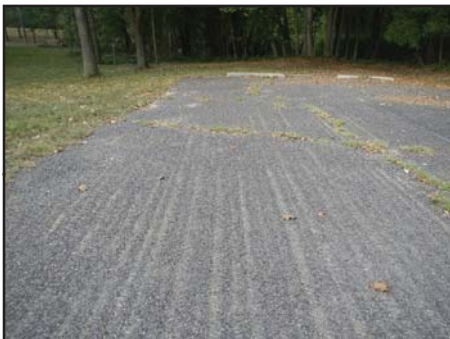
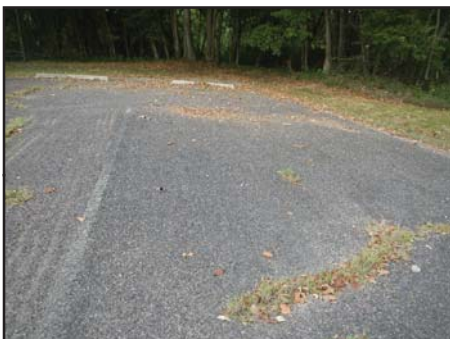
Inspection Date	FMSS Number	User Access	Surface Type
9/21/2017	102121	PUBLIC	ASPHALT
Area (Sq. Ft.)	Lane Miles (11' Widths)	Curb Reveal (Inches)	Curb Recommendation
1,378	0.024	NOT APPLICABLE	NOT APPLICABLE
Curb Type		Curb & Gutter Type	
NO CURB		NO CURB AND GUTTER	
Pavement Recommendation		Condition Rating / PCR	
LIGHT 3R TREATMENTS		FAIR / 73

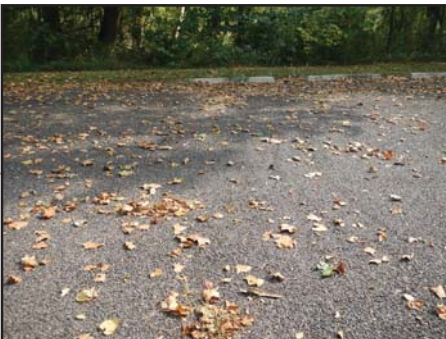
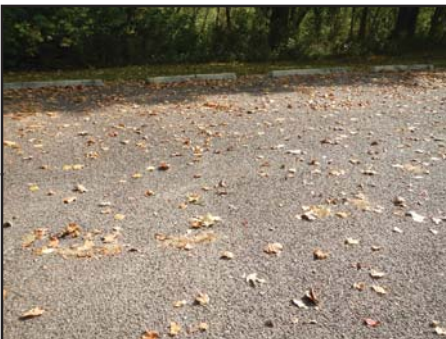
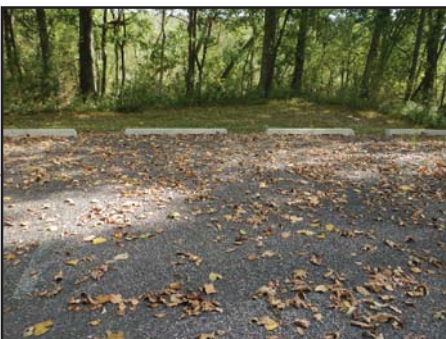
Inspection Date	FMSS Number	User Access	Surface Type
9/21/2017	102122	PUBLIC	ASPHALT
Area (Sq. Ft.)	Lane Miles (11' Widths)	Curb Reveal (Inches)	Curb Recommendation
1,464	0.025	NOT APPLICABLE	NOT APPLICABLE
Curb Type		Curb & Gutter Type	
NO CURB		NO CURB AND GUTTER	
Pavement Recommendation		Condition Rating / PCR	
PREVENTIVE MAINTENANCE		GOOD / 90

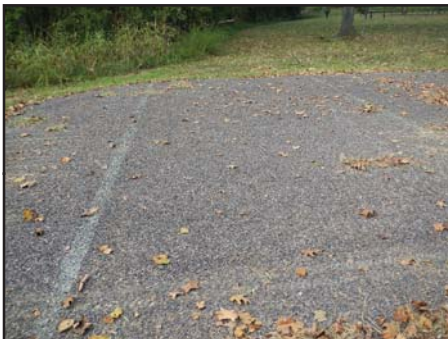
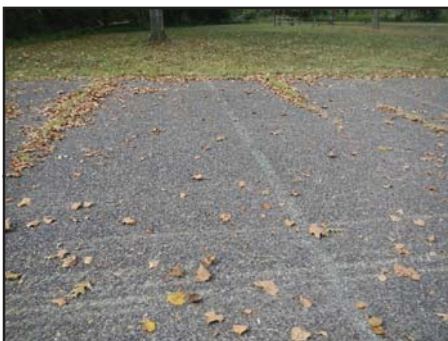
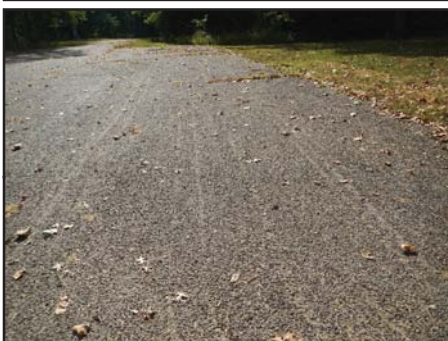
ROUTE 0917A: BIG SPRING CAMP LOOPS ROAD PARKING A

Inspection Date	FMSS Number	User Access	Surface Type
9/21/2017	78753	PUBLIC	ASPHALT
Area (Sq. Ft.)	Lane Miles (11' Widths)	Curb Reveal (Inches)	Curb Recommendation
4,448	0.077	NOT APPLICABLE	NOT APPLICABLE
Curb Type		Curb & Gutter Type	
NO CURB		NO CURB AND GUTTER	
Pavement Recommendation		Condition Rating / PCR	
PREVENTIVE MAINTENANCE		GOOD / 90

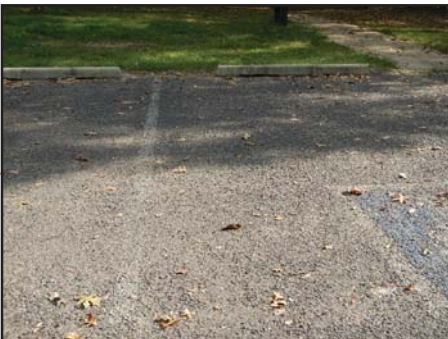
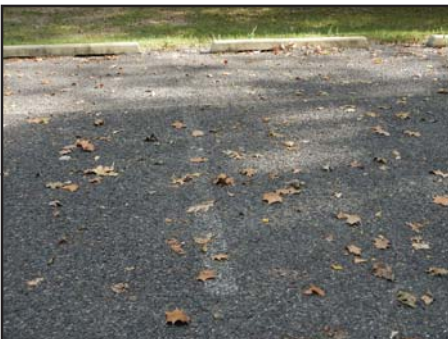
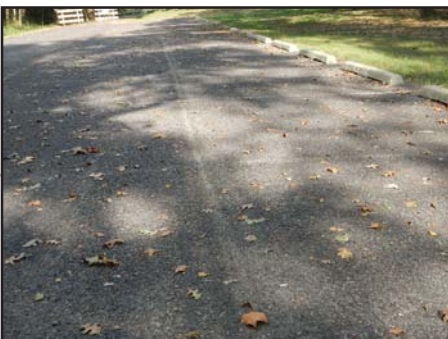
ROUTE 0917B: BIG SPRING CAMP LOOPS ROAD PARKING B

Inspection Date	FMSS Number	User Access	Surface Type
9/21/2017	102125	PUBLIC	ASPHALT
Area (Sq. Ft.)	Lane Miles (11' Widths)	Curb Reveal (Inches)	Curb Recommendation
4,239	0.073	NOT APPLICABLE	NOT APPLICABLE
Curb Type		Curb & Gutter Type	
NO CURB		NO CURB AND GUTTER	
Pavement Recommendation		Condition Rating / PCR	
PREVENTIVE MAINTENANCE		GOOD / 90

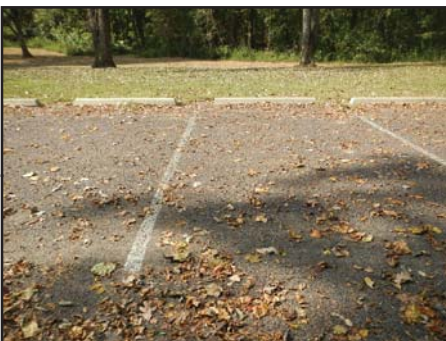
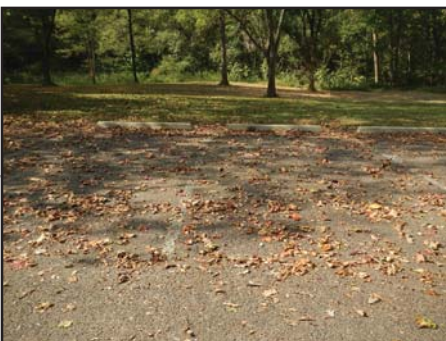
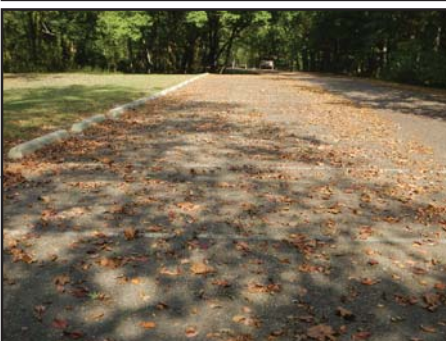
ROUTE 0917C: BIG SPRING CAMP LOOPS ROAD PARKING C

Inspection Date	FMSS Number	User Access	Surface Type
9/21/2017	102126	PUBLIC	ASPHALT
Area (Sq. Ft.)	Lane Miles (11' Widths)	Curb Reveal (Inches)	Curb Recommendation
1,815	0.031	NOT APPLICABLE	NOT APPLICABLE
Curb Type		Curb & Gutter Type	
NO CURB		NO CURB AND GUTTER	
Pavement Recommendation		Condition Rating / PCR	
PREVENTIVE MAINTENANCE		GOOD / 90

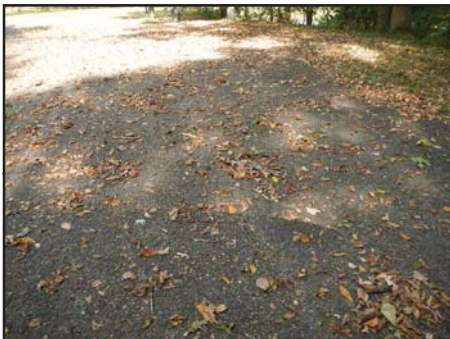
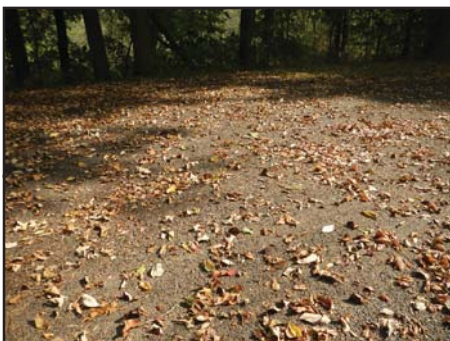
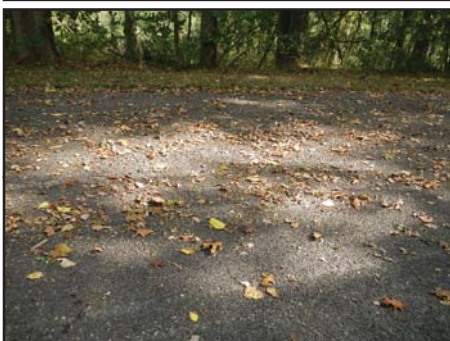
ROUTE 0918: BIG SPRING SEWAGE LAGOON PARKING

Inspection Date	FMSS Number	User Access	Surface Type
9/21/2017	78754	NONPUBLIC	ASPHALT
Area (Sq. Ft.)	Lane Miles (11' Widths)	Curb Reveal (Inches)	Curb Recommendation
3,302	0.057	NOT APPLICABLE	NOT APPLICABLE
Curb Type		Curb & Gutter Type	
NO CURB		NO CURB AND GUTTER	
Pavement Recommendation		Condition Rating / PCR	
PREVENTIVE MAINTENANCE		GOOD / 90

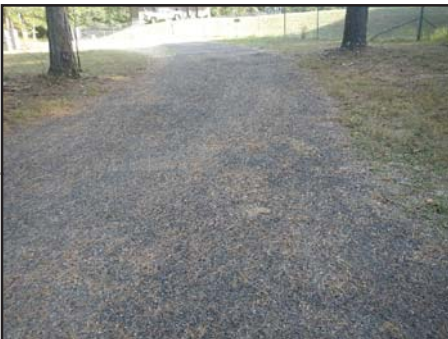
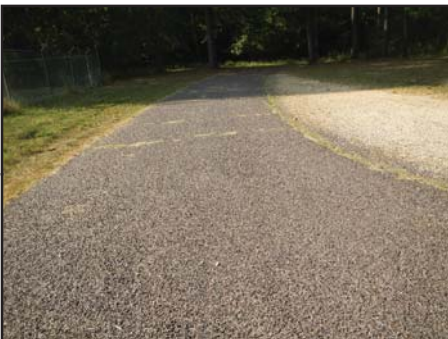
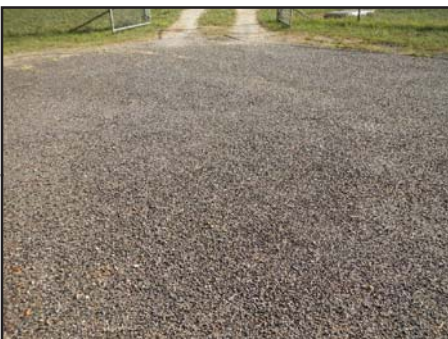
ROUTE 0930: ROUND SPRING CAVE PARKING

Inspection Date	FMSS Number	User Access	Surface Type
9/20/2017	78755	PUBLIC	ASPHALT
Area (Sq. Ft.)	Lane Miles (11' Widths)	Curb Reveal (Inches)	Curb Recommendation
28,991	0.499	2	DO NOTHING
Curb Type		Curb & Gutter Type	
CONCRETE		CONCRETE	
Pavement Recommendation		Condition Rating / PCR	
DO NOTHING		EXCELLENT / 97

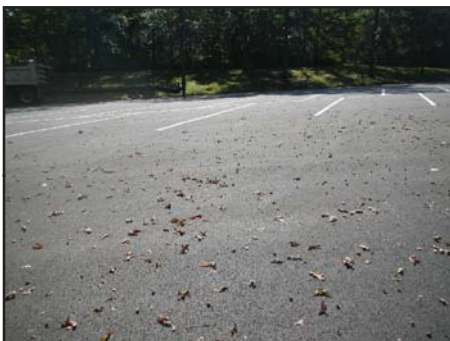
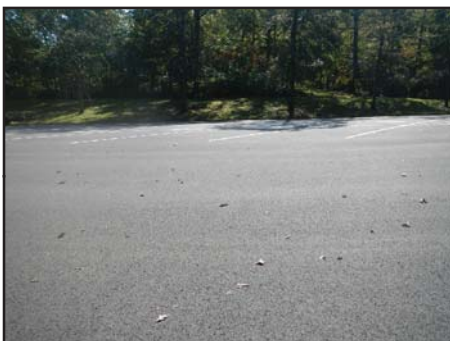
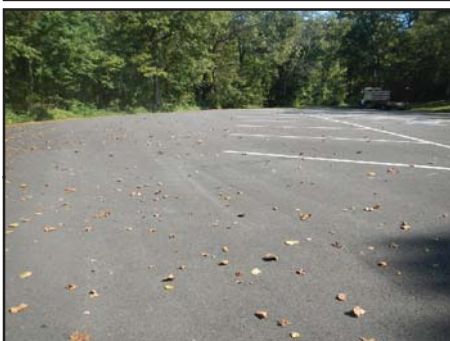
ROUTE 0931A: ROUND SPRING PICNIC PARKING A

Inspection Date	FMSS Number	User Access	Surface Type
9/20/2017	78756	PUBLIC	ASPHALT
Area (Sq. Ft.)	Lane Miles (11' Widths)	Curb Reveal (Inches)	Curb Recommendation
7,116	0.123	4	DO NOTHING
Curb Type		Curb & Gutter Type	
ASPHALT		NO CURB AND GUTTER	
Pavement Recommendation		Condition Rating / PCR	
PREVENTIVE MAINTENANCE		GOOD / 90

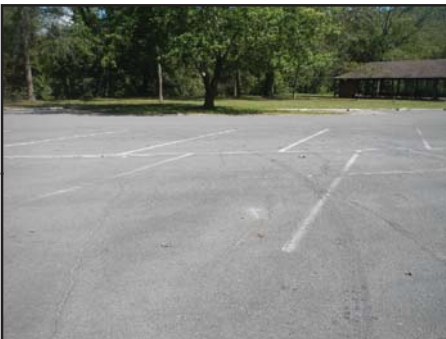
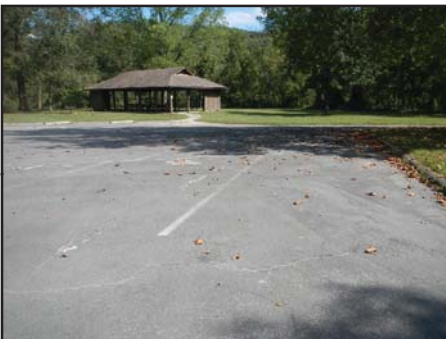
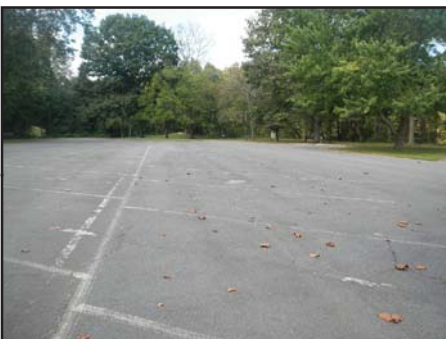
ROUTE 0931B: ROUND SPRING PICNIC PARKING B

Inspection Date	FMSS Number	User Access	Surface Type
9/20/2017	102132	PUBLIC	ASPHALT
Area (Sq. Ft.)	Lane Miles (11' Widths)	Curb Reveal (Inches)	Curb Recommendation
1,466	0.025	NOT APPLICABLE	NOT APPLICABLE
Curb Type		Curb & Gutter Type	
NO CURB		NO CURB AND GUTTER	
Pavement Recommendation		Condition Rating / PCR	
PREVENTIVE MAINTENANCE		GOOD / 90

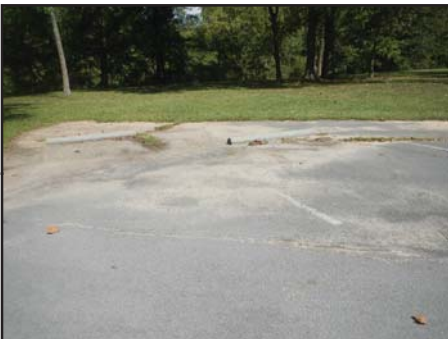
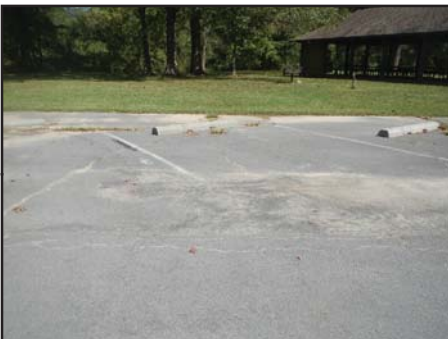
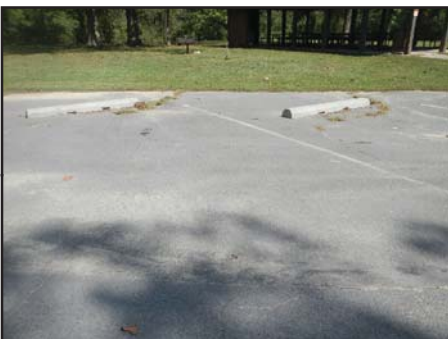
ROUTE 0931C: ROUND SPRING PICNIC PARKING C

Inspection Date	FMSS Number	User Access	Surface Type
9/20/2017	102133	PUBLIC	ASPHALT
Area (Sq. Ft.)	Lane Miles (11' Widths)	Curb Reveal (Inches)	Curb Recommendation
888	0.015	NOT APPLICABLE	NOT APPLICABLE
Curb Type		Curb & Gutter Type	
NO CURB		NO CURB AND GUTTER	
Pavement Recommendation		Condition Rating / PCR	
PREVENTIVE MAINTENANCE		GOOD / 90

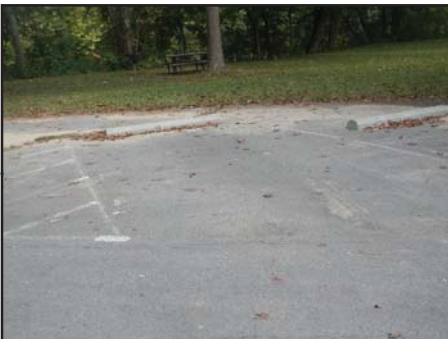
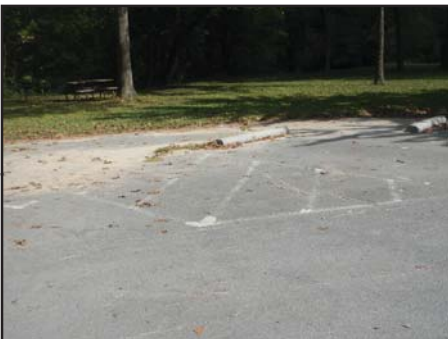
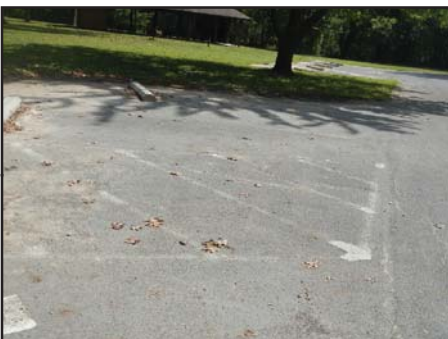
ROUTE 0932A: ROUND SPRING CAMPGROUND WALK-IN CAMPSITE PARKING

Inspection Date	FMSS Number	User Access	Surface Type
9/20/2017	78757	PUBLIC	ASPHALT
Area (Sq. Ft.)	Lane Miles (11' Widths)	Curb Reveal (Inches)	Curb Recommendation
2,085	0.036	NOT APPLICABLE	NOT APPLICABLE
Curb Type		Curb & Gutter Type	
NO CURB		NO CURB AND GUTTER	
Pavement Recommendation		Condition Rating / PCR	
DO NOTHING		EXCELLENT / 97

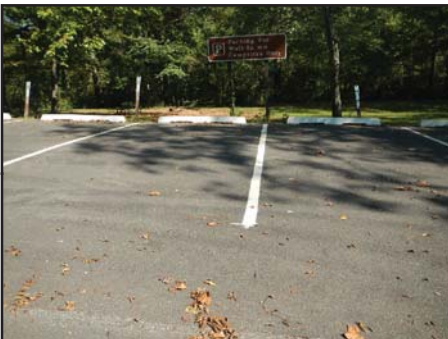
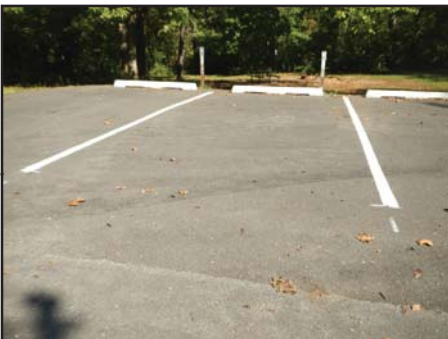
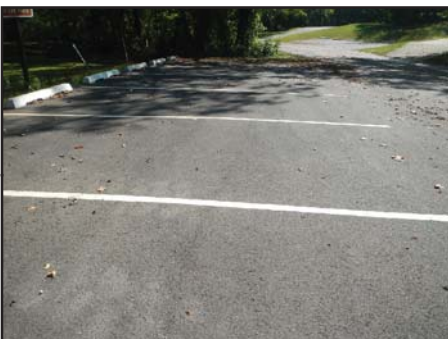
ROUTE 0932B: ROUND SPRING CAMPGROUND RESTROOM PARKING

Inspection Date	FMSS Number	User Access	Surface Type
9/20/2017	102134	PUBLIC	ASPHALT
Area (Sq. Ft.)	Lane Miles (11' Widths)	Curb Reveal (Inches)	Curb Recommendation
1,759	0.03	NOT APPLICABLE	NOT APPLICABLE
Curb Type		Curb & Gutter Type	
NO CURB		NO CURB AND GUTTER	
Pavement Recommendation		Condition Rating / PCR	
DO NOTHING		EXCELLENT / 97

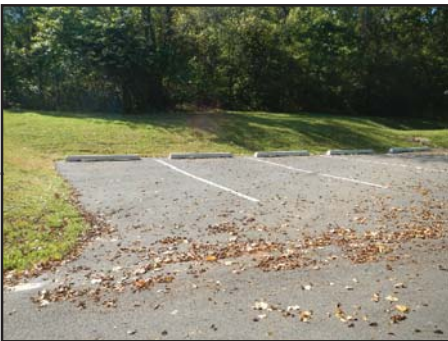
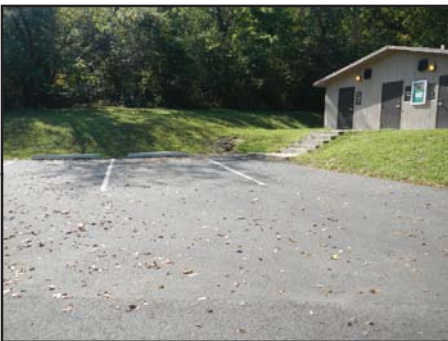
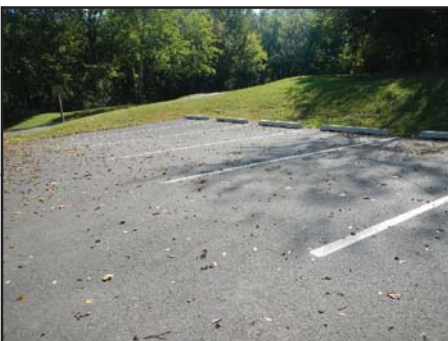
ROUTE 0933: ROUND SPRING UPPER RIVER ACCESS PARKING

Inspection Date	FMSS Number	User Access	Surface Type
9/20/2017	78758	PUBLIC	ASPHALT
Area (Sq. Ft.)	Lane Miles (11' Widths)	Curb Reveal (Inches)	Curb Recommendation
19,043	0.328	NOT APPLICABLE	NOT APPLICABLE
Curb Type		Curb & Gutter Type	
NO CURB		NO CURB AND GUTTER	
Pavement Recommendation		Condition Rating / PCR	
DO NOTHING		EXCELLENT / 97

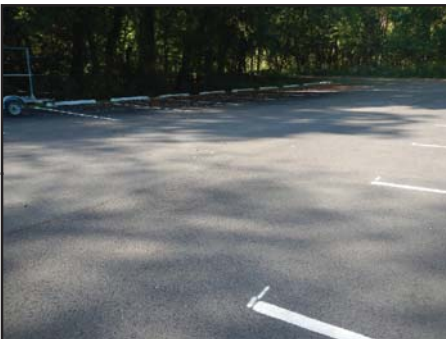
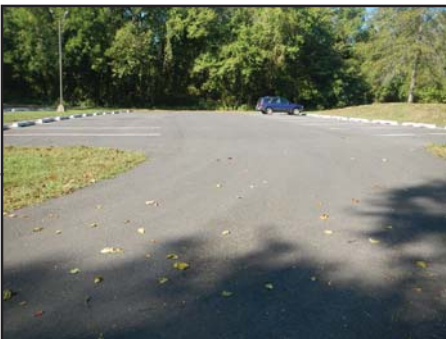
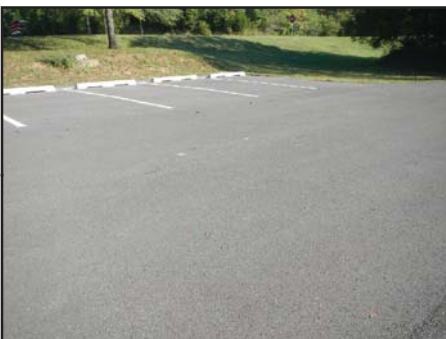
ROUTE 0934: ROUND SPRING GROUP CAMPSITE PARKING

Inspection Date	FMSS Number	User Access	Surface Type
9/20/2017	78760	PUBLIC	ASPHALT
Area (Sq. Ft.)	Lane Miles (11' Widths)	Curb Reveal (Inches)	Curb Recommendation
17,252	0.297	2	LIGHT REPAIR
Curb Type		Curb & Gutter Type	
ASPHALT		NO CURB AND GUTTER	
Pavement Recommendation		Condition Rating / PCR	
DO NOTHING		EXCELLENT / 97

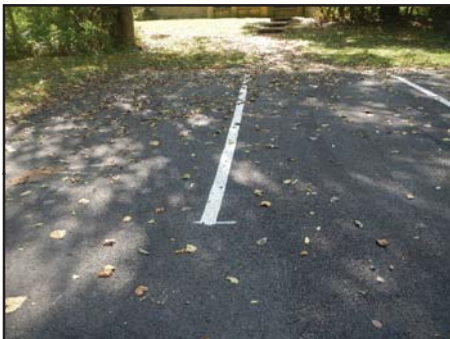
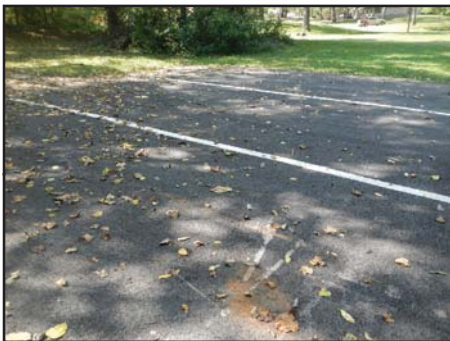
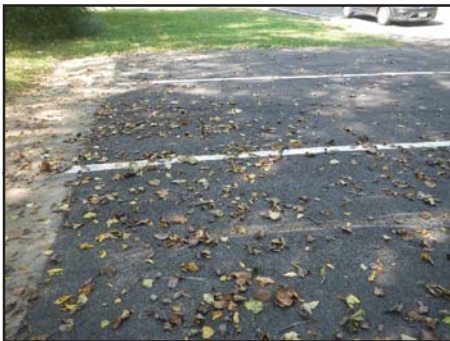
ROUTE 0935B: ROUND SPRING RESIDENCE PARKING B

Inspection Date	FMSS Number	User Access	Surface Type
9/20/2017	102135	NONPUBLIC	ASPHALT
Area (Sq. Ft.)	Lane Miles (11' Widths)	Curb Reveal (Inches)	Curb Recommendation
583	0.01	NOT APPLICABLE	NOT APPLICABLE
Curb Type		Curb & Gutter Type	
NO CURB		NO CURB AND GUTTER	
Pavement Recommendation		Condition Rating / PCR	
LIGHT 3R TREATMENTS		FAIR / 73

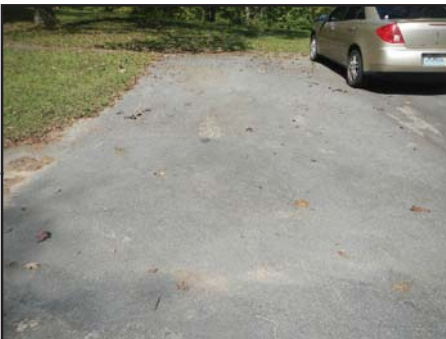
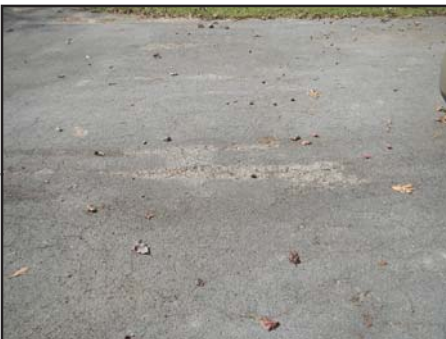
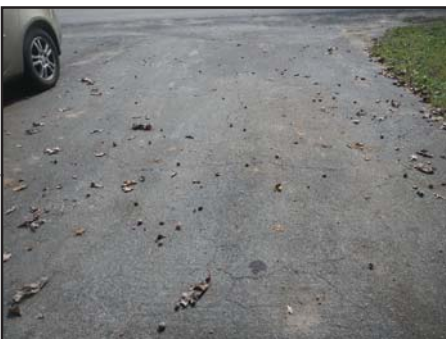
ROUTE 0935C: ROUND SPRING RESIDENCE PARKING C

Inspection Date	FMSS Number	User Access	Surface Type
9/20/2017	102137	NONPUBLIC	ASPHALT
Area (Sq. Ft.)	Lane Miles (11' Widths)	Curb Reveal (Inches)	Curb Recommendation
654	0.011	NOT APPLICABLE	NOT APPLICABLE
Curb Type		Curb & Gutter Type	
NO CURB		NO CURB AND GUTTER	
Pavement Recommendation		Condition Rating / PCR	
LIGHT 3R TREATMENTS		FAIR / 73

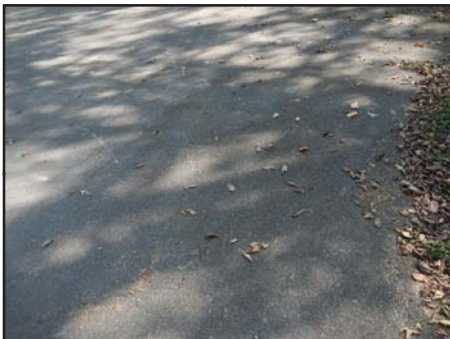
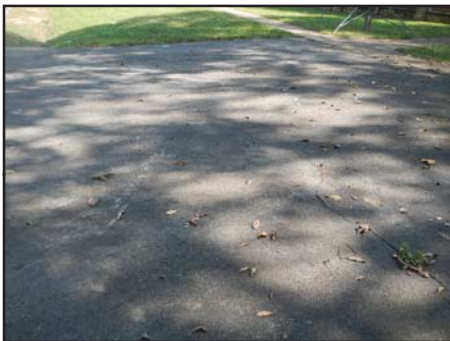
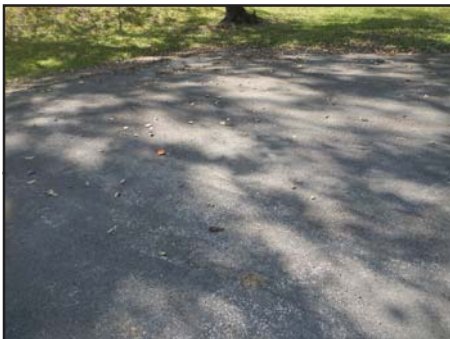
ROUTE 0935D: ROUND SPRING RESIDENCE PARKING D

Inspection Date	FMSS Number	User Access	Surface Type
9/20/2017	102185	NONPUBLIC	ASPHALT
Area (Sq. Ft.)	Lane Miles (11' Widths)	Curb Reveal (Inches)	Curb Recommendation
1,800	0.031	NOT APPLICABLE	NOT APPLICABLE
Curb Type		Curb & Gutter Type	
NO CURB		NO CURB AND GUTTER	
Pavement Recommendation		Condition Rating / PCR	
HEAVY 3R TREATMENTS		POOR / 53

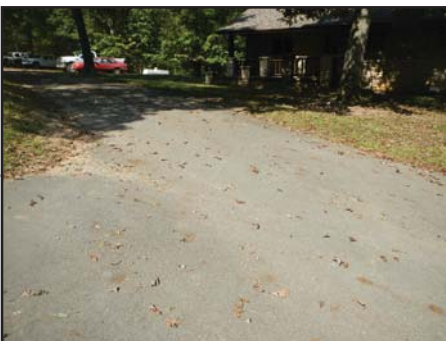
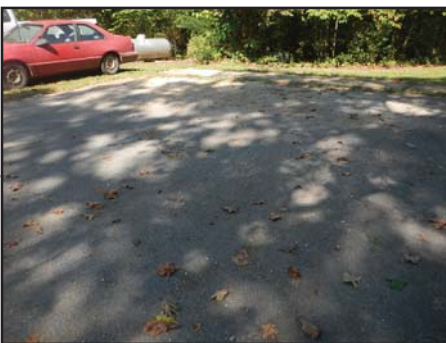
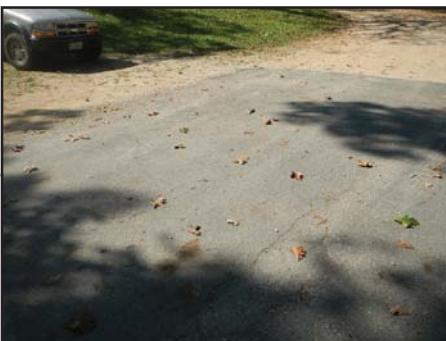
ROUTE 0935E: ROUND SPRING RESIDENCE PARKING E

Inspection Date	FMSS Number	User Access	Surface Type
9/20/2017	102187	NONPUBLIC	ASPHALT
Area (Sq. Ft.)	Lane Miles (11' Widths)	Curb Reveal (Inches)	Curb Recommendation
2,260	0.039	NOT APPLICABLE	NOT APPLICABLE
Curb Type		Curb & Gutter Type	
NO CURB		NO CURB AND GUTTER	
Pavement Recommendation		Condition Rating / PCR	
LIGHT 3R TREATMENTS		FAIR / 73

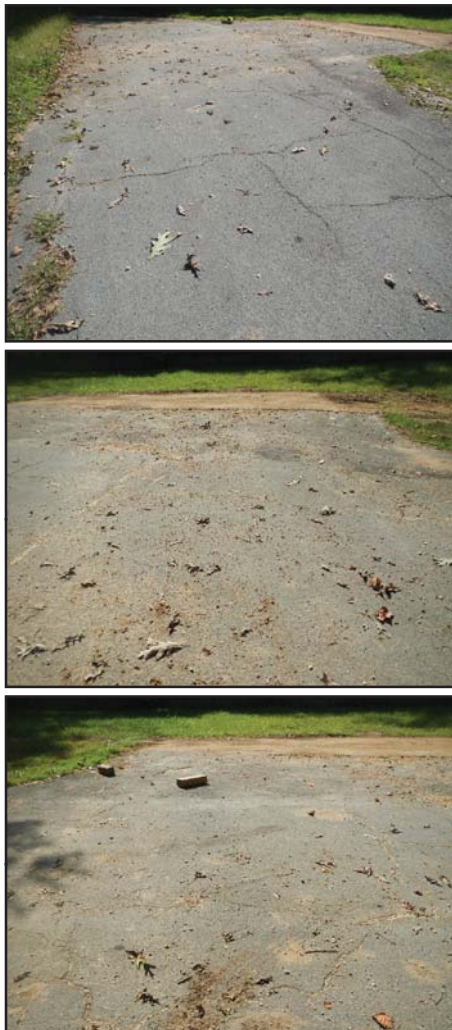
ROUTE 0935F: ROUND SPRING MAINTENANCE PARKING

Inspection Date	FMSS Number	User Access	Surface Type
9/20/2017	102188	NONPUBLIC	ASPHALT
Area (Sq. Ft.)	Lane Miles (11' Widths)	Curb Reveal (Inches)	Curb Recommendation
4,694	0.081	NOT APPLICABLE	NOT APPLICABLE
Curb Type		Curb & Gutter Type	
NO CURB		NO CURB AND GUTTER	
Pavement Recommendation		Condition Rating / PCR	
LIGHT 3R TREATMENTS		FAIR / 73

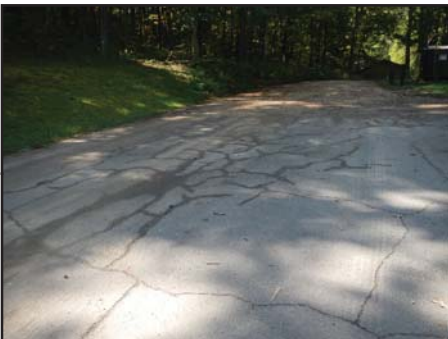
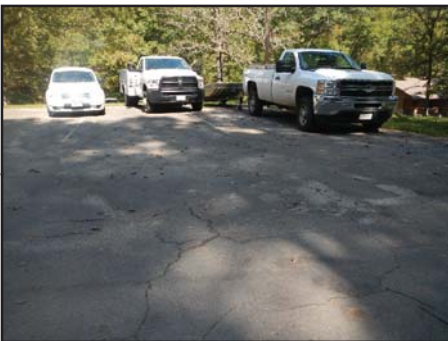
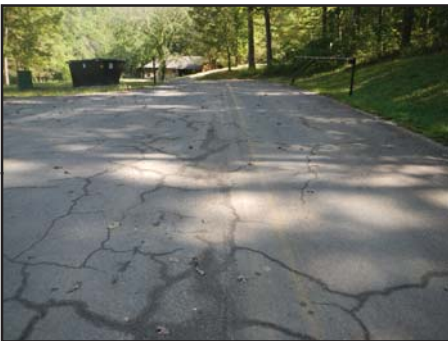
ROUTE 0936: ROUND SPRING SEWAGE LAGOON PARKING

Inspection Date	FMSS Number	User Access	Surface Type
9/20/2017	78762	NONPUBLIC	ASPHALT
Area (Sq. Ft.)	Lane Miles (11' Widths)	Curb Reveal (Inches)	Curb Recommendation
1,333	0.023	NOT APPLICABLE	NOT APPLICABLE
Curb Type		Curb & Gutter Type	
NO CURB		NO CURB AND GUTTER	
Pavement Recommendation		Condition Rating / PCR	
LIGHT 3R TREATMENTS		FAIR / 73

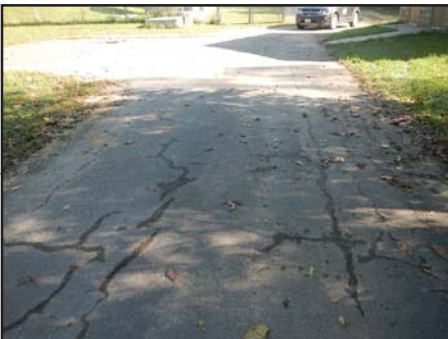
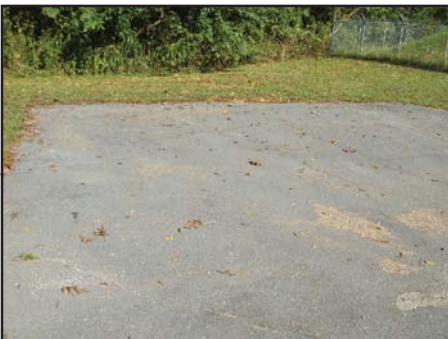
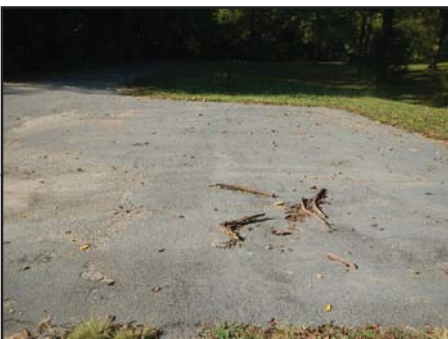
ROUTE 0937: ROUND SPRING RANGER STATION PARKING

Inspection Date	FMSS Number	User Access	Surface Type
9/20/2017	78763	PUBLIC	ASPHALT
Area (Sq. Ft.)	Lane Miles (11' Widths)	Curb Reveal (Inches)	Curb Recommendation
981	0.017	NOT APPLICABLE	NOT APPLICABLE
Curb Type		Curb & Gutter Type	
NO CURB		NO CURB AND GUTTER	
Pavement Recommendation		Condition Rating / PCR	
DO NOTHING		EXCELLENT / 97

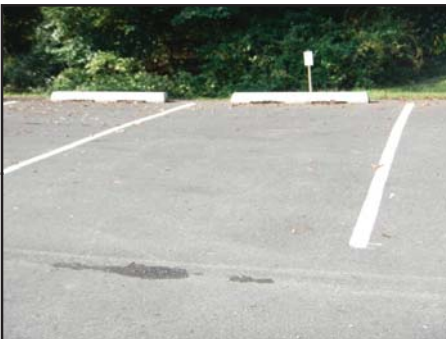
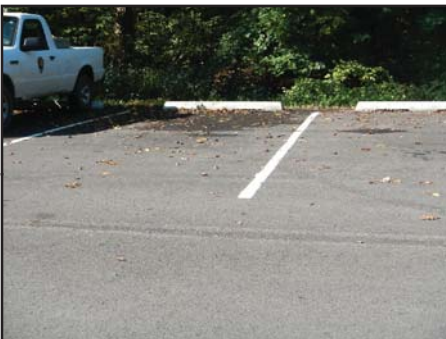
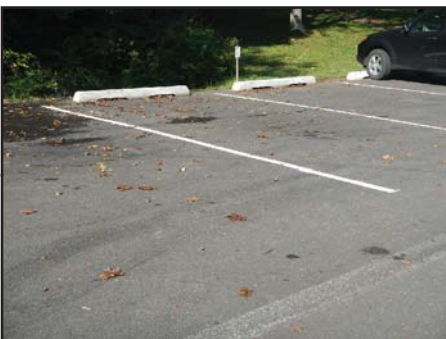
ROUTE 0938: ROUND SPRING RANGER STATION UPPER PARKING

Inspection Date	FMSS Number	User Access	Surface Type
9/20/2017	78764	PUBLIC	ASPHALT
Area (Sq. Ft.)	Lane Miles (11' Widths)	Curb Reveal (Inches)	Curb Recommendation
2,773	0.048	NOT APPLICABLE	NOT APPLICABLE
Curb Type		Curb & Gutter Type	
NO CURB		NO CURB AND GUTTER	
Pavement Recommendation		Condition Rating / PCR	
LIGHT 3R TREATMENTS		FAIR / 73

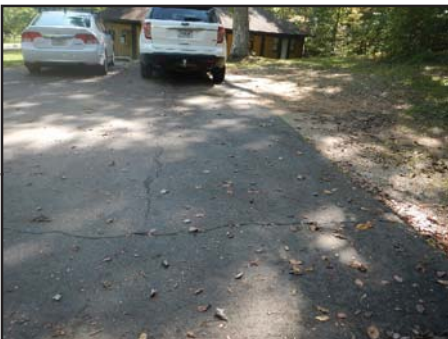
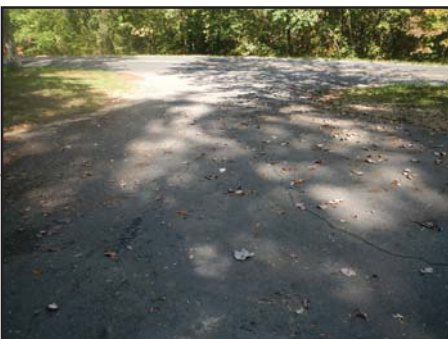
ROUTE 0940: BAPTIST ACCESS PARKING

Inspection Date	FMSS Number	User Access	Surface Type
9/19/2017	78765	PUBLIC	ASPHALT
Area (Sq. Ft.)	Lane Miles (11' Widths)	Curb Reveal (Inches)	Curb Recommendation
36,795	0.634	NOT APPLICABLE	NOT APPLICABLE
Curb Type		Curb & Gutter Type	
NO CURB		NO CURB AND GUTTER	
Pavement Recommendation		Condition Rating / PCR	
LIGHT 3R TREATMENTS		FAIR / 73

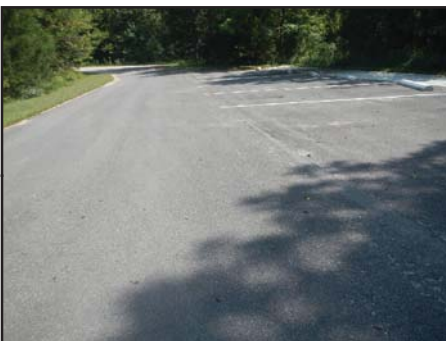
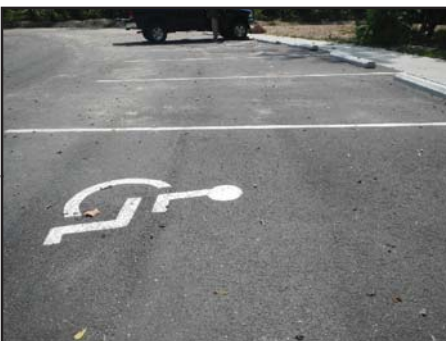
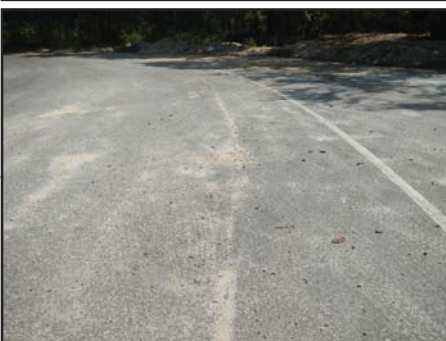
ROUTE 0941A: PULLTITE PARKING A

Inspection Date	FMSS Number	User Access	Surface Type
9/19/2017	78766	PUBLIC	ASPHALT
Area (Sq. Ft.)	Lane Miles (11' Widths)	Curb Reveal (Inches)	Curb Recommendation
988	0.017	NOT APPLICABLE	NOT APPLICABLE
Curb Type		Curb & Gutter Type	
NO CURB		NO CURB AND GUTTER	
Pavement Recommendation		Condition Rating / PCR	
LIGHT 3R TREATMENTS		FAIR / 73

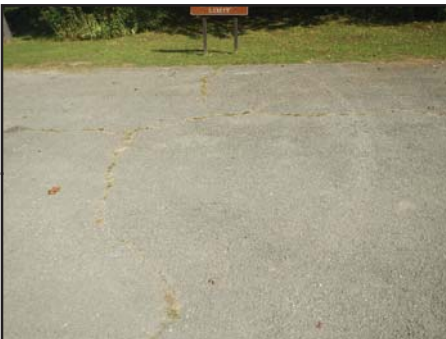
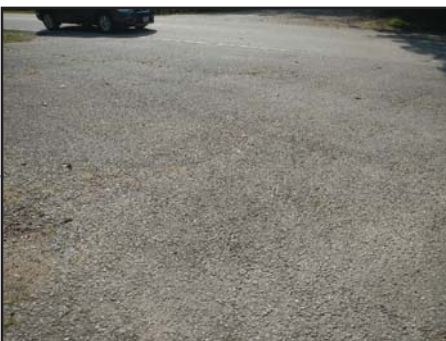
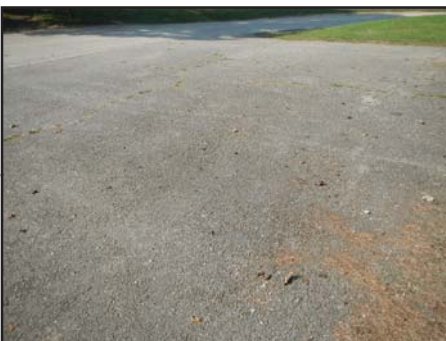
ROUTE 0941B: PULLTITE PARKING B

Inspection Date	FMSS Number	User Access	Surface Type
9/19/2017	102191	PUBLIC	ASPHALT
Area (Sq. Ft.)	Lane Miles (11' Widths)	Curb Reveal (Inches)	Curb Recommendation
2,657	0.046	NOT APPLICABLE	NOT APPLICABLE
Curb Type		Curb & Gutter Type	
NO CURB		NO CURB AND GUTTER	
Pavement Recommendation		Condition Rating / PCR	
PREVENTIVE MAINTENANCE		GOOD / 90
