OZAR Cycle 6

Final Report

Road Inventory and Condition Assessment of Paved Routes Ozark National Scenic Riverways

**Federal Highway Administration
Eastern Federal Lands Highway Division
Road Inventory Program (RIP)**

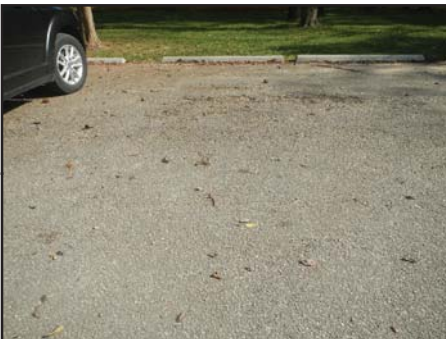
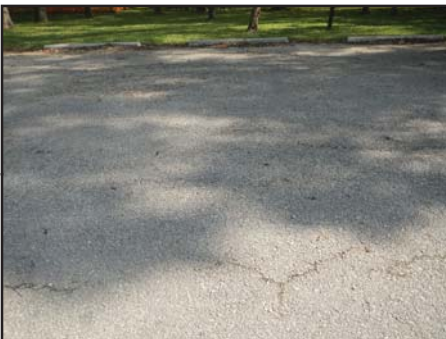
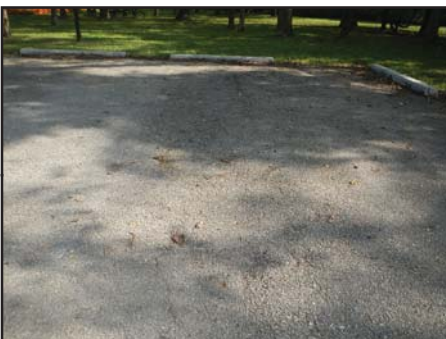
ROUTE 0942A: POWDER MILL VISITOR CENTER PARKING A

Inspection Date	FMSS Number	User Access	Surface Type
9/20/2017	78767	PUBLIC	ASPHALT
Area (Sq. Ft.)	Lane Miles (11' Widths)	Curb Reveal (Inches)	Curb Recommendation
2,306	0.04	NOT APPLICABLE	NOT APPLICABLE
Curb Type		Curb & Gutter Type	
NO CURB		NO CURB AND GUTTER	
Pavement Recommendation		Condition Rating / PCR	
RECONSTRUCTION		POOR / 0

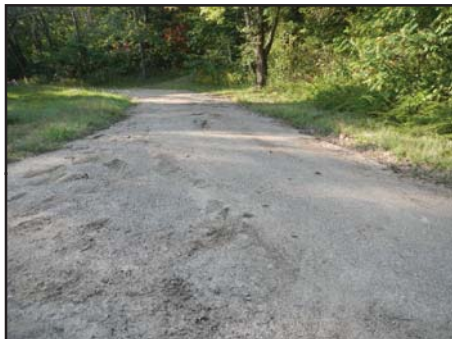
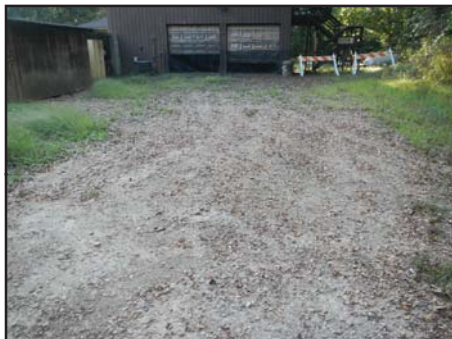
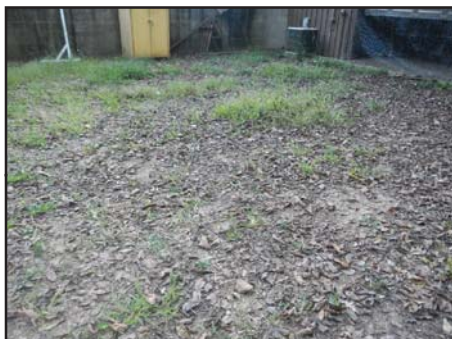
Note: Area was flooded and pavement is gone.

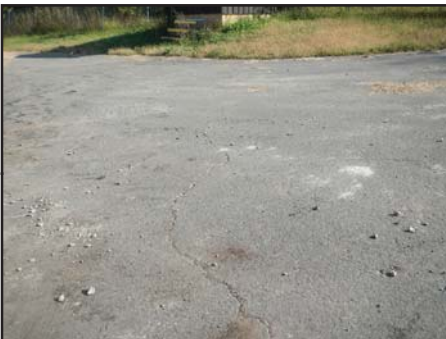
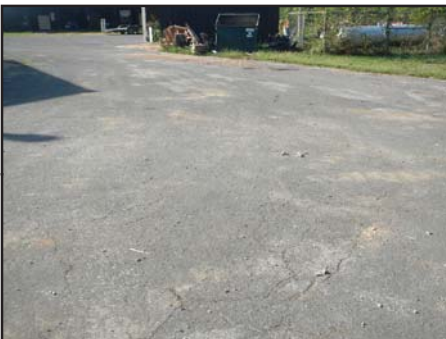
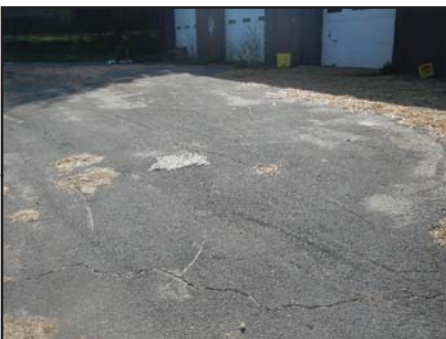
ROUTE 0943A: SHAWNEE SHOP PARKING A

Inspection Date	FMSS Number	User Access	Surface Type
9/21/2017	78768	NONPUBLIC	ASPHALT
Area (Sq. Ft.)	Lane Miles (11' Widths)	Curb Reveal (Inches)	Curb Recommendation
27,282	0.47	NOT APPLICABLE	NOT APPLICABLE
Curb Type		Curb & Gutter Type	
NO CURB		NO CURB AND GUTTER	
Pavement Recommendation		Condition Rating / PCR	
HEAVY 3R TREATMENTS		POOR / 53

Note: Parking area consists of multiple surface types: 1 part Asphalt at 25,593 square feet; 1 part Concrete at 1,689 square feet.

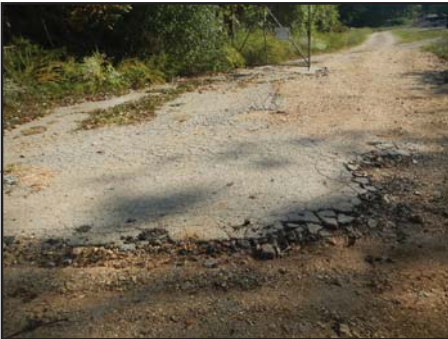
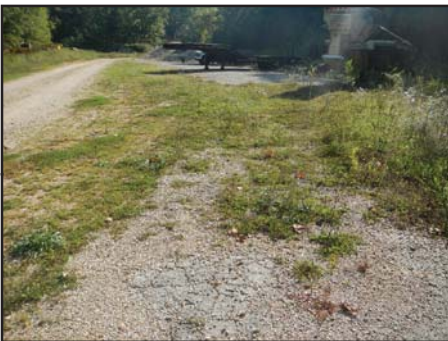
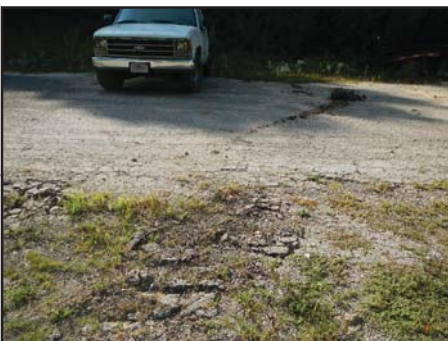
Inspection Date	FMSS Number	User Access	Surface Type
9/21/2017	102195	NONPUBLIC	ASPHALT
Area (Sq. Ft.)	Lane Miles (11' Widths)	Curb Reveal (Inches)	Curb Recommendation
13,982	0.241	NOT APPLICABLE	NOT APPLICABLE
Curb Type		Curb & Gutter Type	
NO CURB		NO CURB AND GUTTER	
Pavement Recommendation		Condition Rating / PCR	
RECONSTRUCTION		POOR / 0

Note: Area was flooded, almost no pavement available to rate.

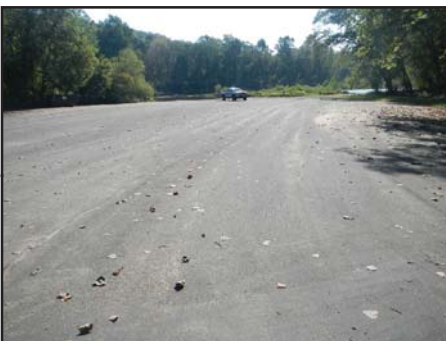
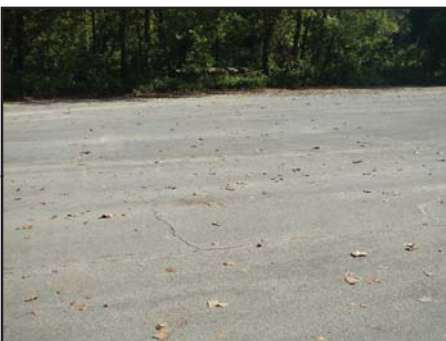
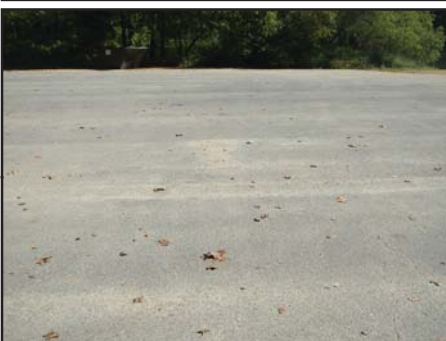
ROUTE 0944: ROUND SPRING LOWER RIVER ACCESS PARKING

Inspection Date	FMSS Number	User Access	Surface Type
9/20/2017	102196	PUBLIC	ASPHALT
Area (Sq. Ft.)	Lane Miles (11' Widths)	Curb Reveal (Inches)	Curb Recommendation
26,973	0.464	NOT APPLICABLE	NOT APPLICABLE
Curb Type		Curb & Gutter Type	
NO CURB		NO CURB AND GUTTER	
Pavement Recommendation		Condition Rating / PCR	
LIGHT 3R TREATMENTS		FAIR / 73

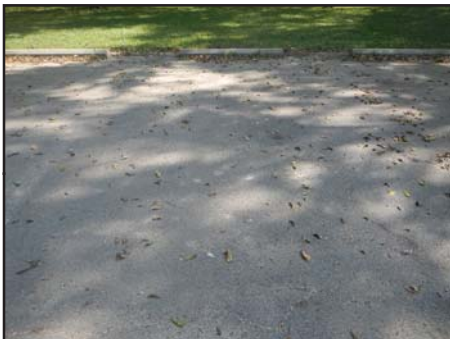
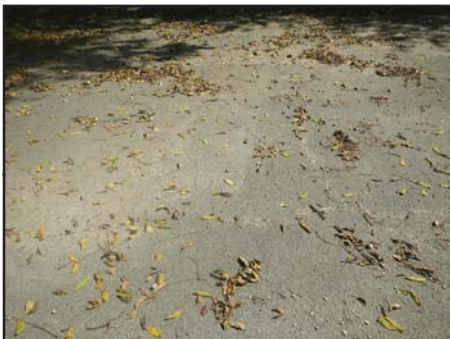
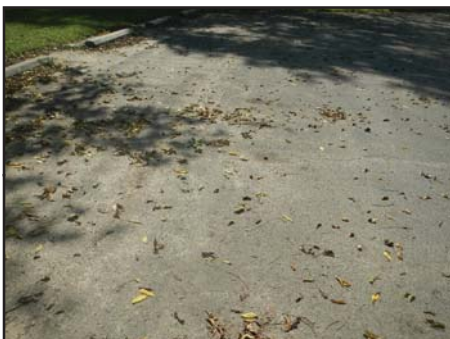
ROUTE 0945A: ALLEY SPRINGS CAMPGROUND PARKING A

Inspection Date	FMSS Number	User Access	Surface Type
9/20/2017	102197	PUBLIC	ASPHALT
Area (Sq. Ft.)	Lane Miles (11' Widths)	Curb Reveal (Inches)	Curb Recommendation
1,459	0.025	NOT APPLICABLE	NOT APPLICABLE
Curb Type		Curb & Gutter Type	
NO CURB		NO CURB AND GUTTER	
Pavement Recommendation		Condition Rating / PCR	
PREVENTIVE MAINTENANCE		GOOD / 90

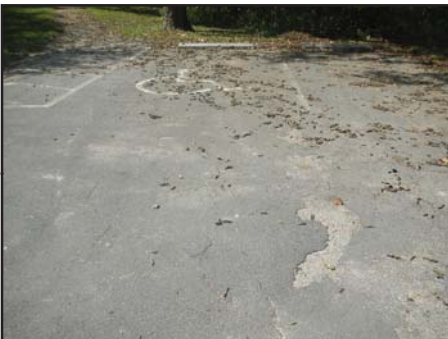
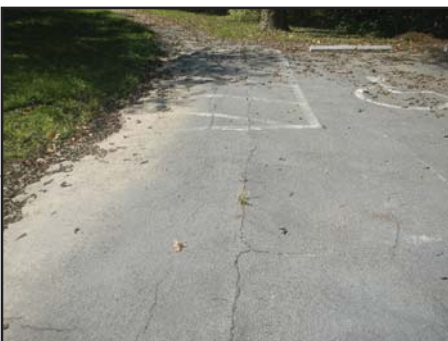
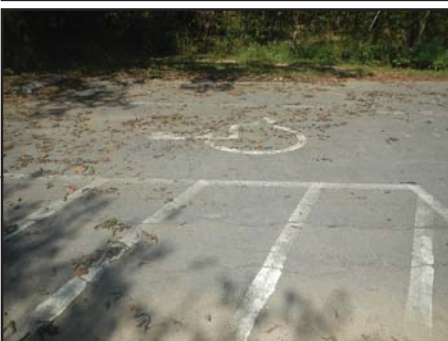
ROUTE 0945B: ALLEY SPRINGS CAMPGROUND HANDICAPPED PARKING B

Inspection Date	FMSS Number	User Access	Surface Type
9/20/2017	102198	PUBLIC	ASPHALT
Area (Sq. Ft.)	Lane Miles (11' Widths)	Curb Reveal (Inches)	Curb Recommendation
1,109	0.019	NOT APPLICABLE	NOT APPLICABLE
Curb Type		Curb & Gutter Type	
NO CURB		NO CURB AND GUTTER	
Pavement Recommendation		Condition Rating / PCR	
LIGHT 3R TREATMENTS		FAIR / 73

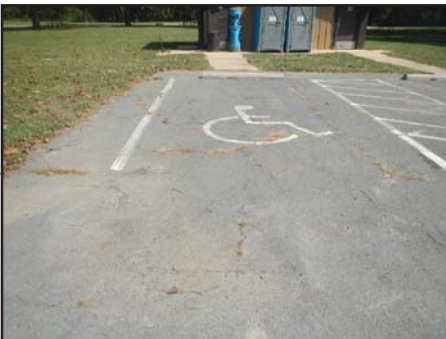
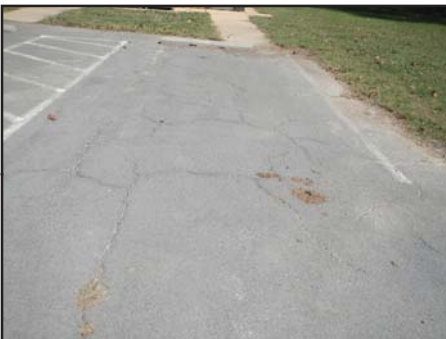
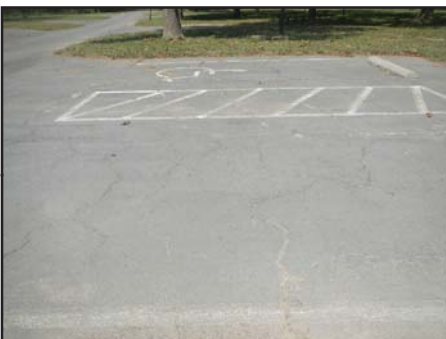
ROUTE 0945C: ALLEY SPRINGS CAMPGROUND PARKING C

Inspection Date	FMSS Number	User Access	Surface Type
9/20/2017	102199	PUBLIC	ASPHALT
Area (Sq. Ft.)	Lane Miles (11' Widths)	Curb Reveal (Inches)	Curb Recommendation
801	0.014	NOT APPLICABLE	NOT APPLICABLE
Curb Type		Curb & Gutter Type	
NO CURB		NO CURB AND GUTTER	
Pavement Recommendation		Condition Rating / PCR	
LIGHT 3R TREATMENTS		FAIR / 73

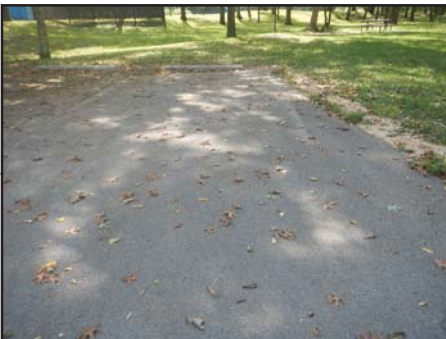
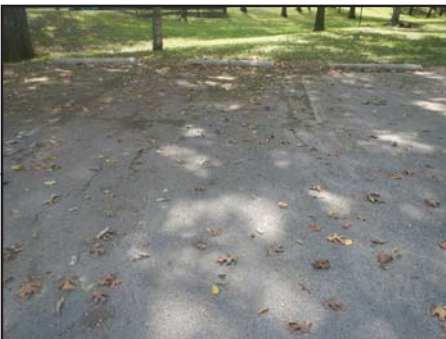
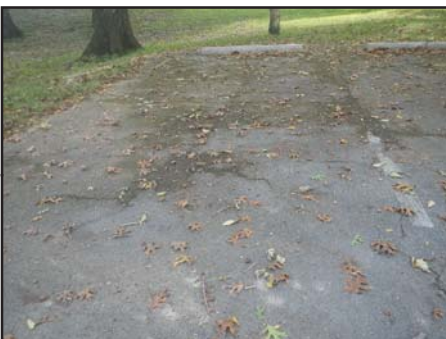
Inspection Date	FMSS Number	User Access	Surface Type
9/20/2017	102200	PUBLIC	ASPHALT
Area (Sq. Ft.)	Lane Miles (11' Widths)	Curb Reveal (Inches)	Curb Recommendation
984	0.017	NOT APPLICABLE	NOT APPLICABLE
Curb Type		Curb & Gutter Type	
NO CURB		NO CURB AND GUTTER	
Pavement Recommendation		Condition Rating / PCR	
PREVENTIVE MAINTENANCE		GOOD / 90

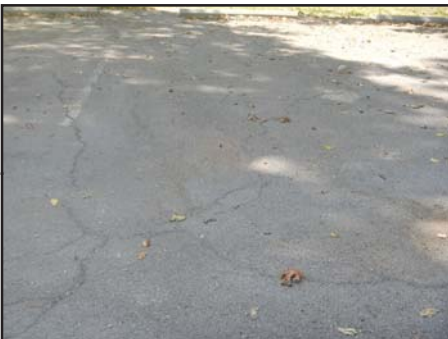
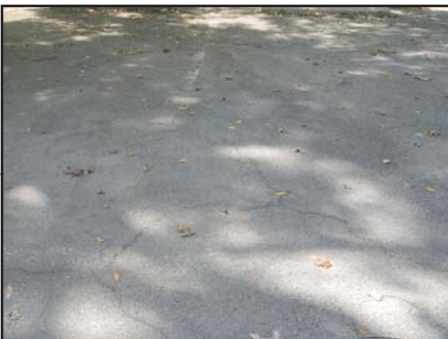
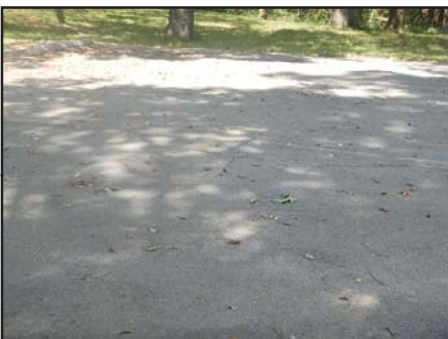
ROUTE 0945E: ALLEY SPRINGS CAMPGROUND PARKING E

Inspection Date	FMSS Number	User Access	Surface Type
9/20/2017	102201	PUBLIC	ASPHALT
Area (Sq. Ft.)	Lane Miles (11' Widths)	Curb Reveal (Inches)	Curb Recommendation
1,243	0.021	NOT APPLICABLE	NOT APPLICABLE
Curb Type		Curb & Gutter Type	
NO CURB		NO CURB AND GUTTER	
Pavement Recommendation		Condition Rating / PCR	
PREVENTIVE MAINTENANCE		GOOD / 90

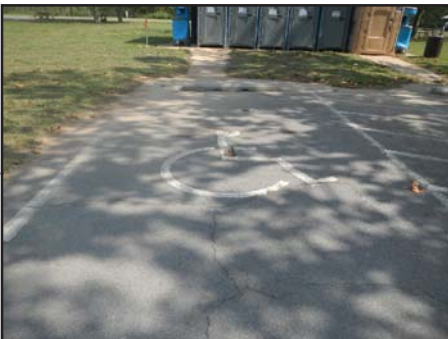
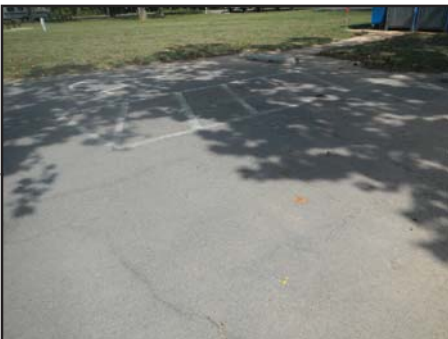
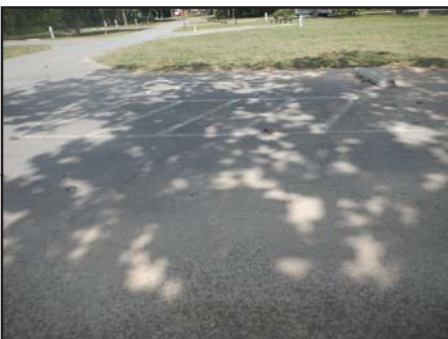
ROUTE 0945F: ALLEY SPRINGS CAMPGROUND BATHROOM PARKING F

Inspection Date	FMSS Number	User Access	Surface Type
9/20/2017	102202	PUBLIC	ASPHALT
Area (Sq. Ft.)	Lane Miles (11' Widths)	Curb Reveal (Inches)	Curb Recommendation
762	0.013	NOT APPLICABLE	NOT APPLICABLE
Curb Type		Curb & Gutter Type	
NO CURB		NO CURB AND GUTTER	
Pavement Recommendation		Condition Rating / PCR	
PREVENTIVE MAINTENANCE		GOOD / 90

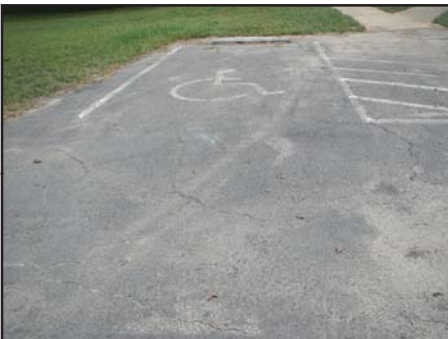
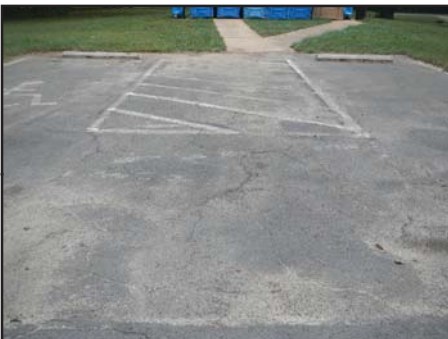
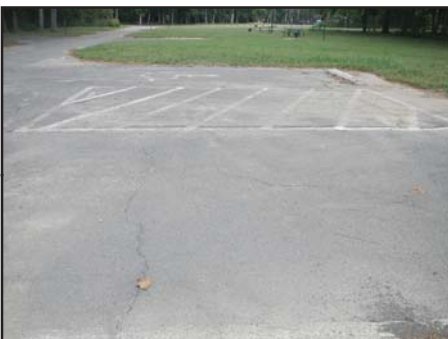
ROUTE 0945G: ALLEY SPRINGS CAMPGROUND BATHROOM PARKING G

Inspection Date	FMSS Number	User Access	Surface Type
9/20/2017	102203	PUBLIC	ASPHALT
Area (Sq. Ft.)	Lane Miles (11' Widths)	Curb Reveal (Inches)	Curb Recommendation
839	0.014	NOT APPLICABLE	NOT APPLICABLE
Curb Type		Curb & Gutter Type	
NO CURB		NO CURB AND GUTTER	
Pavement Recommendation		Condition Rating / PCR	
LIGHT 3R TREATMENTS		FAIR / 73

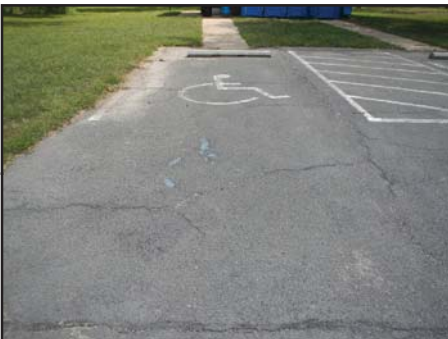
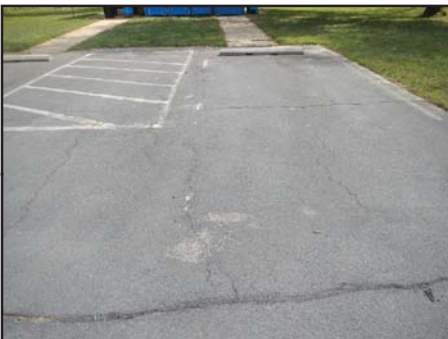
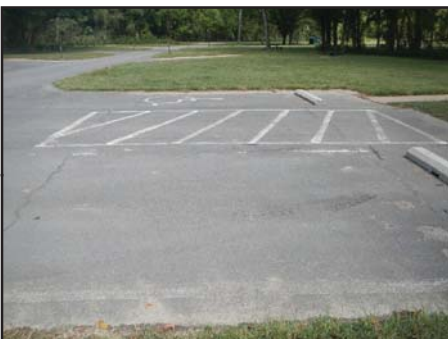
ROUTE 0945H: ALLEY SPRINGS CAMPGROUND PARKING H

Inspection Date	FMSS Number	User Access	Surface Type
9/20/2017	102204	PUBLIC	ASPHALT
Area (Sq. Ft.)	Lane Miles (11' Widths)	Curb Reveal (Inches)	Curb Recommendation
896	0.015	NOT APPLICABLE	NOT APPLICABLE
Curb Type		Curb & Gutter Type	
NO CURB		NO CURB AND GUTTER	
Pavement Recommendation		Condition Rating / PCR	
LIGHT 3R TREATMENTS		FAIR / 73

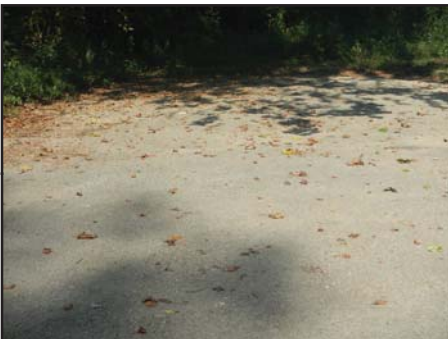
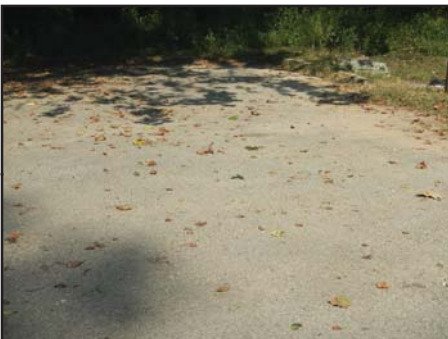
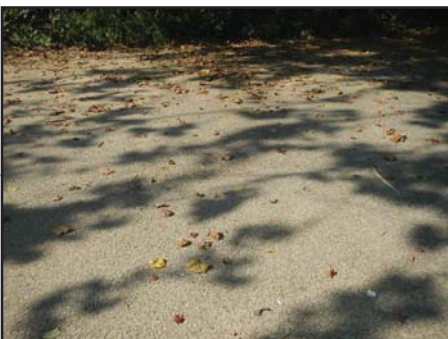
ROUTE 0946: TWO RIVERS BOAT LAUNCH PARKING

Inspection Date	FMSS Number	User Access	Surface Type
9/21/2017	102205	PUBLIC	ASPHALT
Area (Sq. Ft.)	Lane Miles (11' Widths)	Curb Reveal (Inches)	Curb Recommendation
1,359	0.023	NOT APPLICABLE	NOT APPLICABLE
Curb Type		Curb & Gutter Type	
NO CURB		NO CURB AND GUTTER	
Pavement Recommendation		Condition Rating / PCR	
PREVENTIVE MAINTENANCE		GOOD / 90

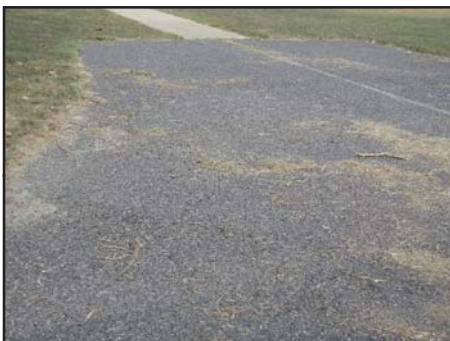
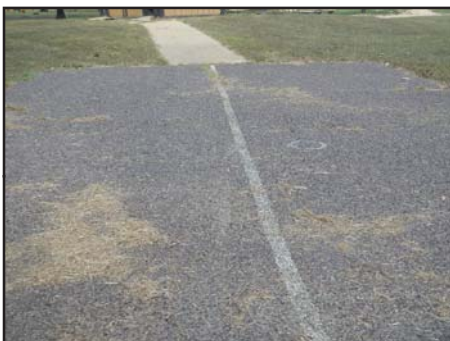
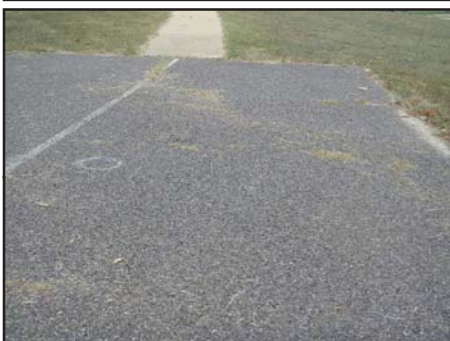
ROUTE 0947A: BIG SPRINGS CAMPGROUND BATHROOM PARKING A

Inspection Date	FMSS Number	User Access	Surface Type
9/21/2017	102254	PUBLIC	ASPHALT
Area (Sq. Ft.)	Lane Miles (11' Widths)	Curb Reveal (Inches)	Curb Recommendation
595	0.01	NOT APPLICABLE	NOT APPLICABLE
Curb Type		Curb & Gutter Type	
NO CURB		NO CURB AND GUTTER	
Pavement Recommendation		Condition Rating / PCR	
PREVENTIVE MAINTENANCE		GOOD / 90

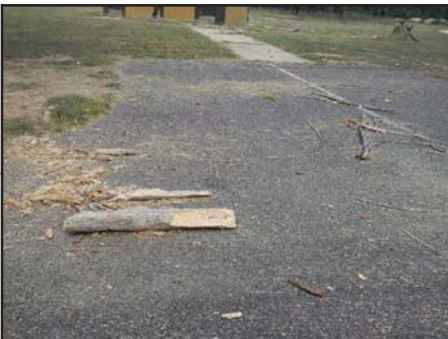
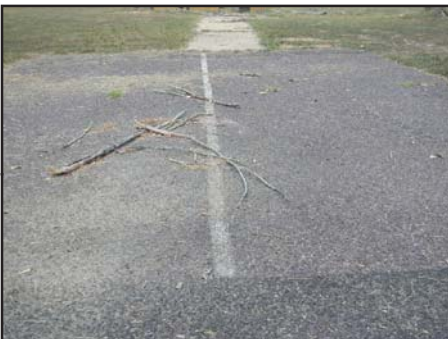
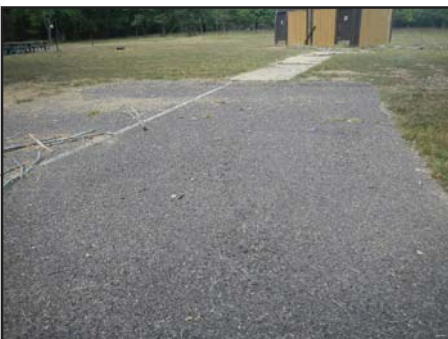
Inspection Date	FMSS Number	User Access	Surface Type
9/21/2017	102256	PUBLIC	ASPHALT
Area (Sq. Ft.)	Lane Miles (11' Widths)	Curb Reveal (Inches)	Curb Recommendation
612	0.011	NOT APPLICABLE	NOT APPLICABLE
Curb Type		Curb & Gutter Type	
NO CURB		NO CURB AND GUTTER	
Pavement Recommendation		Condition Rating / PCR	
PREVENTIVE MAINTENANCE		GOOD / 90

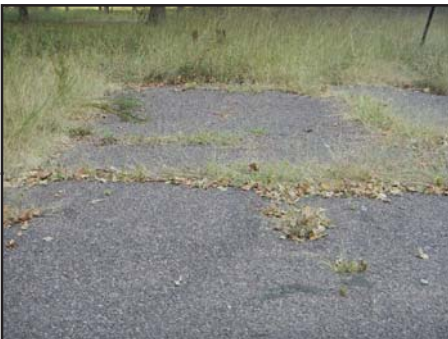
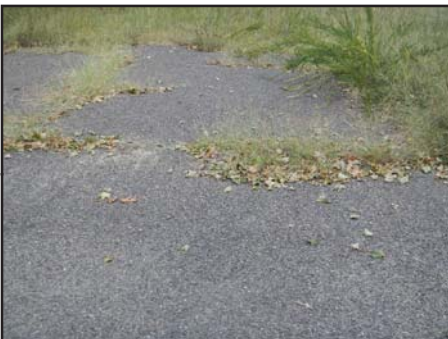
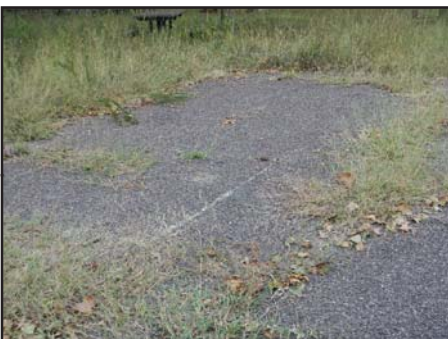
ROUTE 0947C: BIG SPRINGS BATHROOM CAMPGROUND PARKING C

Inspection Date	FMSS Number	User Access	Surface Type
9/21/2017	102257	PUBLIC	ASPHALT
Area (Sq. Ft.)	Lane Miles (11' Widths)	Curb Reveal (Inches)	Curb Recommendation
536	0.009	NOT APPLICABLE	NOT APPLICABLE
Curb Type		Curb & Gutter Type	
NO CURB		NO CURB AND GUTTER	
Pavement Recommendation		Condition Rating / PCR	
HEAVY 3R TREATMENTS		POOR / 53

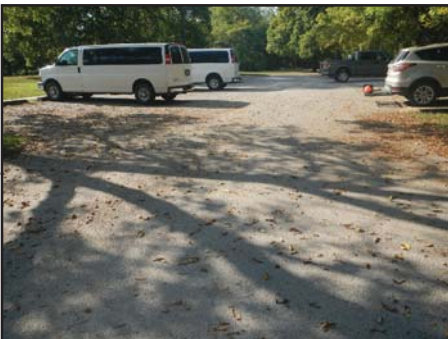
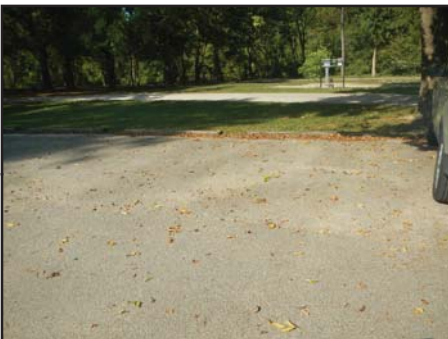
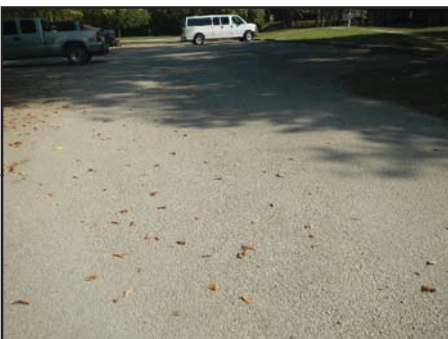
ROUTE 0952: PULLTITE CAMPGROUND ROAD PARKING

Inspection Date	FMSS Number	User Access	Surface Type
9/19/2017	78774	PUBLIC	ASPHALT
Area (Sq. Ft.)	Lane Miles (11' Widths)	Curb Reveal (Inches)	Curb Recommendation
9,656	0.166	NOT APPLICABLE	NOT APPLICABLE
Curb Type		Curb & Gutter Type	
NO CURB		NO CURB AND GUTTER	
Pavement Recommendation		Condition Rating / PCR	
PREVENTIVE MAINTENANCE		GOOD / 90

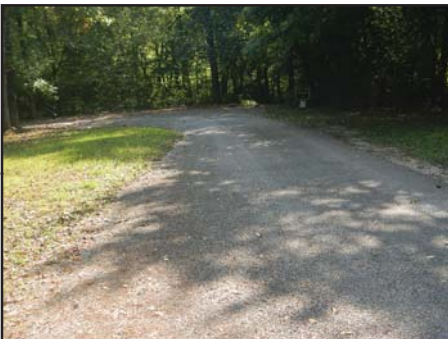
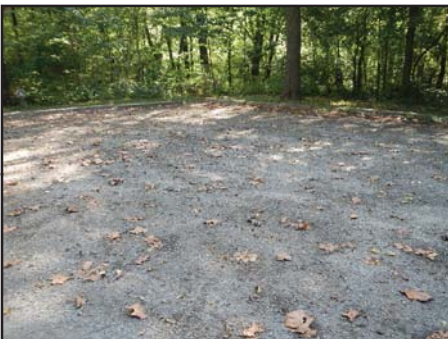
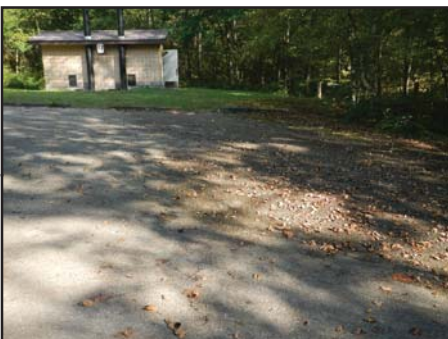
ROUTE 0955: PULLTITE ROAD PARKING

Inspection Date	FMSS Number	User Access	Surface Type
9/19/2017	78779	PUBLIC	ASPHALT
Area (Sq. Ft.)	Lane Miles (11' Widths)	Curb Reveal (Inches)	Curb Recommendation
10,758	0.185	NOT APPLICABLE	NOT APPLICABLE
Curb Type		Curb & Gutter Type	
NO CURB		NO CURB AND GUTTER	
Pavement Recommendation		Condition Rating / PCR	
LIGHT 3R TREATMENTS		FAIR / 73

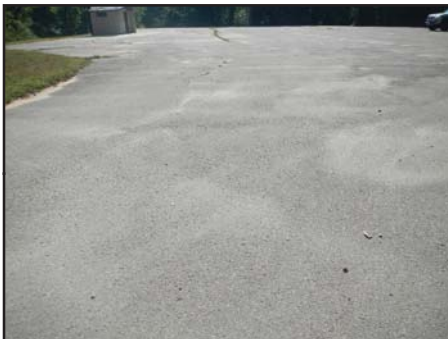
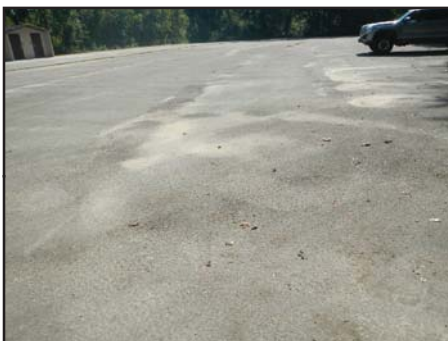
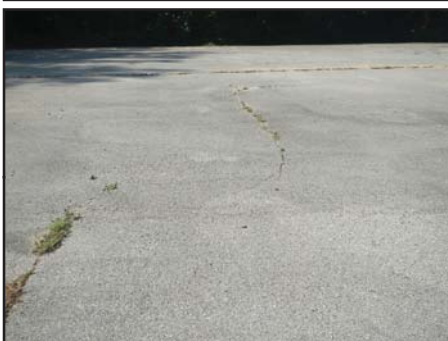
ROUTE 0956: TWO RIVERS PARKING

Inspection Date	FMSS Number	User Access	Surface Type
9/21/2017	78780	PUBLIC	ASPHALT
Area (Sq. Ft.)	Lane Miles (11' Widths)	Curb Reveal (Inches)	Curb Recommendation
44,794	0.771	NOT APPLICABLE	NOT APPLICABLE
Curb Type		Curb & Gutter Type	
NO CURB		NO CURB AND GUTTER	
Pavement Recommendation		Condition Rating / PCR	
LIGHT 3R TREATMENTS		FAIR / 73

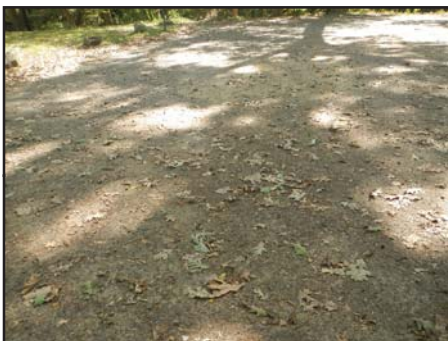
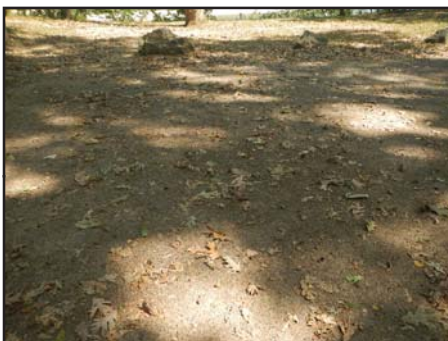
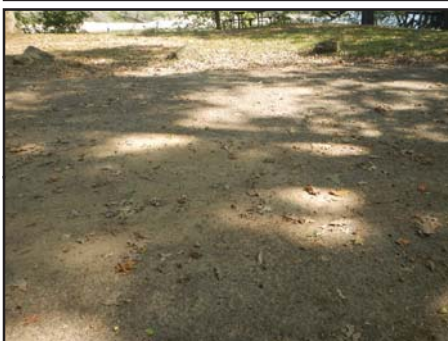
ROUTE 0959: CHUBB HOLLOW ROAD PARKING

Inspection Date	FMSS Number	User Access	Surface Type
9/21/2017	80583	PUBLIC	ASPHALT
Area (Sq. Ft.)	Lane Miles (11' Widths)	Curb Reveal (Inches)	Curb Recommendation
846	0.015	NOT APPLICABLE	NOT APPLICABLE
Curb Type		Curb & Gutter Type	
NO CURB		NO CURB AND GUTTER	
Pavement Recommendation		Condition Rating / PCR	
LIGHT 3R TREATMENTS		FAIR / 73

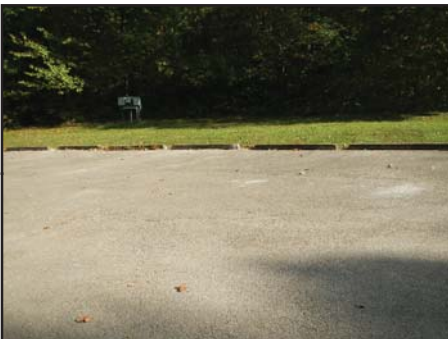
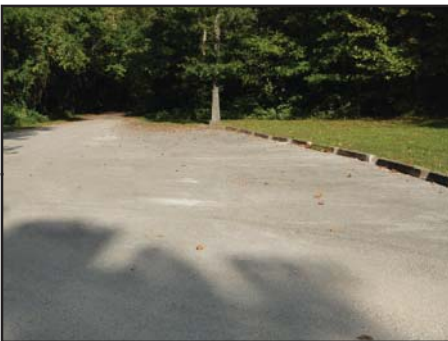
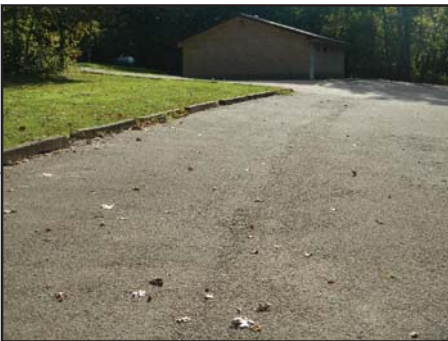
ROUTE 0971: PULLTITE LOWER SHOWER HOUSE PARKING

Inspection Date	FMSS Number	User Access	Surface Type
9/19/2017	78800	PUBLIC	ASPHALT
Area (Sq. Ft.)	Lane Miles (11' Widths)	Curb Reveal (Inches)	Curb Recommendation
6,395	0.11	NOT APPLICABLE	NOT APPLICABLE
Curb Type		Curb & Gutter Type	
NO CURB		NO CURB AND GUTTER	
Pavement Recommendation		Condition Rating / PCR	
LIGHT 3R TREATMENTS		FAIR / 73

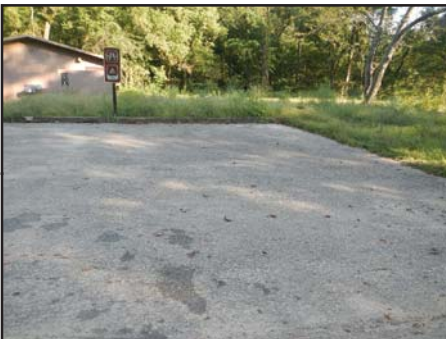
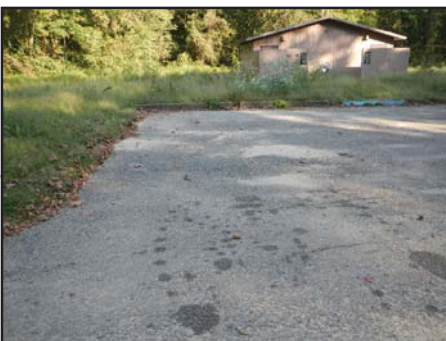
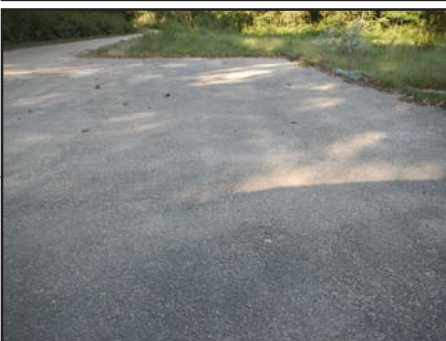
ROUTE 0988: POWDER MILL BOAT LANDING RESTROOM PARKING

Inspection Date	FMSS Number	User Access	Surface Type
9/20/2017	239972	PUBLIC	ASPHALT
Area (Sq. Ft.)	Lane Miles (11' Widths)	Curb Reveal (Inches)	Curb Recommendation
1,779	0.031	NOT APPLICABLE	NOT APPLICABLE
Curb Type		Curb & Gutter Type	
NO CURB		NO CURB AND GUTTER	
Pavement Recommendation		Condition Rating / PCR	
LIGHT 3R TREATMENTS		FAIR / 73

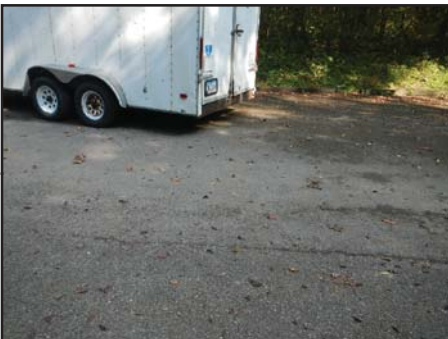
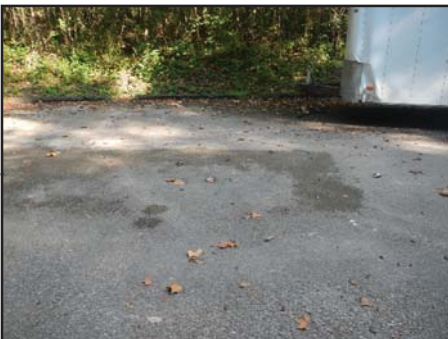
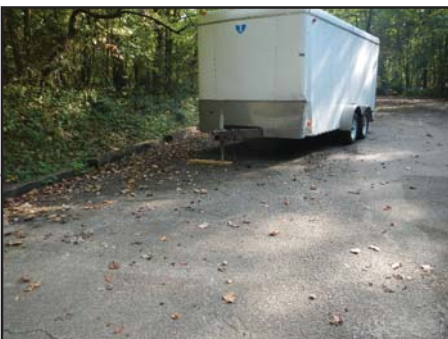
ROUTE 0989: PULLTITE CAMPGROUND ROAD PARKING B

Inspection Date	FMSS Number	User Access	Surface Type
9/19/2017	239973	PUBLIC	ASPHALT
Area (Sq. Ft.)	Lane Miles (11' Widths)	Curb Reveal (Inches)	Curb Recommendation
1,698	0.029	NOT APPLICABLE	NOT APPLICABLE
Curb Type		Curb & Gutter Type	
NO CURB		NO CURB AND GUTTER	
Pavement Recommendation		Condition Rating / PCR	
PREVENTIVE MAINTENANCE		GOOD / 90

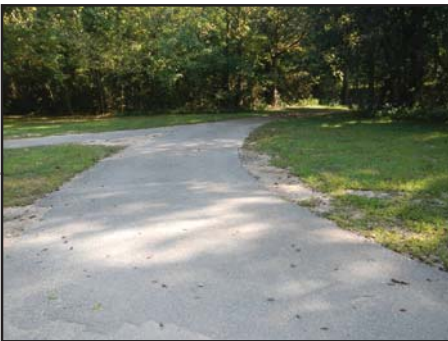
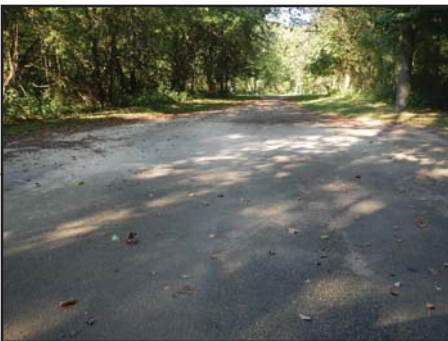
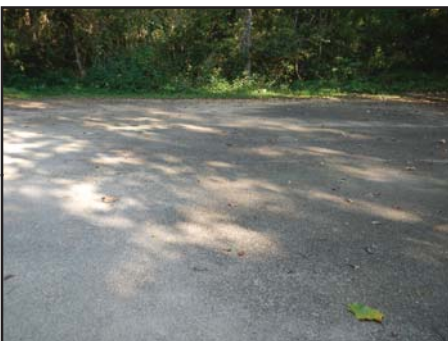
ROUTE 0990: PULLTITE CAMPGROUND AMPHITHEATER PARKING

Inspection Date	FMSS Number	User Access	Surface Type
9/19/2017	239974	PUBLIC	ASPHALT
Area (Sq. Ft.)	Lane Miles (11' Widths)	Curb Reveal (Inches)	Curb Recommendation
5,886	0.101	NOT APPLICABLE	NOT APPLICABLE
Curb Type		Curb & Gutter Type	
NO CURB		NO CURB AND GUTTER	
Pavement Recommendation		Condition Rating / PCR	
LIGHT 3R TREATMENTS		FAIR / 73

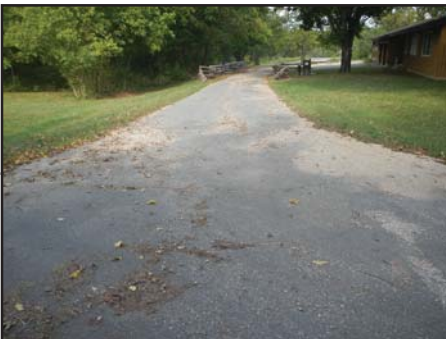
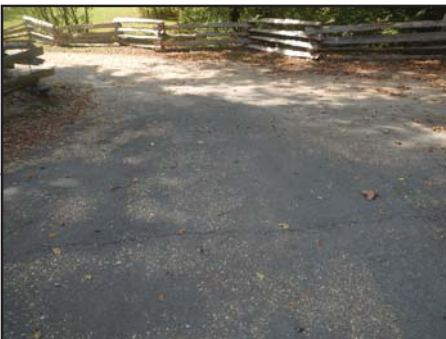
ROUTE 0991: ALLEY SPRING RESIDENCE PARKING

Inspection Date	FMSS Number	User Access	Surface Type
9/20/2017	239969	NONPUBLIC	ASPHALT
Area (Sq. Ft.)	Lane Miles (11' Widths)	Curb Reveal (Inches)	Curb Recommendation
3,495	0.06	NOT APPLICABLE	NOT APPLICABLE
Curb Type		Curb & Gutter Type	
NO CURB		NO CURB AND GUTTER	
Pavement Recommendation		Condition Rating / PCR	
LIGHT 3R TREATMENTS		FAIR / 73

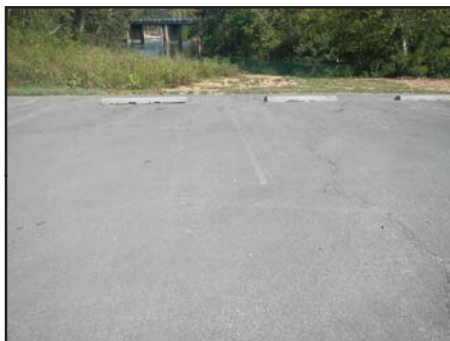
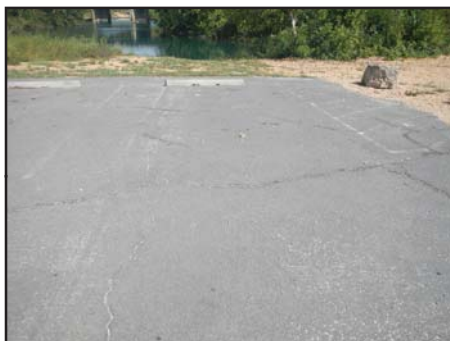
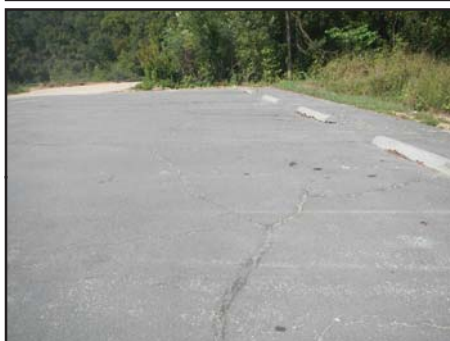
ROUTE 0992: ALLEY SPRING BOAT LAUNCH PARKING B

Inspection Date	FMSS Number	User Access	Surface Type
9/20/2017	239970	PUBLIC	ASPHALT
Area (Sq. Ft.)	Lane Miles (11' Widths)	Curb Reveal (Inches)	Curb Recommendation
2,380	0.041	NOT APPLICABLE	NOT APPLICABLE
Curb Type		Curb & Gutter Type	
NO CURB		NO CURB AND GUTTER	
Pavement Recommendation		Condition Rating / PCR	
PREVENTIVE MAINTENANCE		GOOD / 90
