Road Inventory and Condition Assessment of Paved Routes Palo Alto Battlefield National Historical Park

Federal Highway Administration
Eastern Federal Lands Highway Division
Road Inventory Program (RIP)

Report Date: July 2017

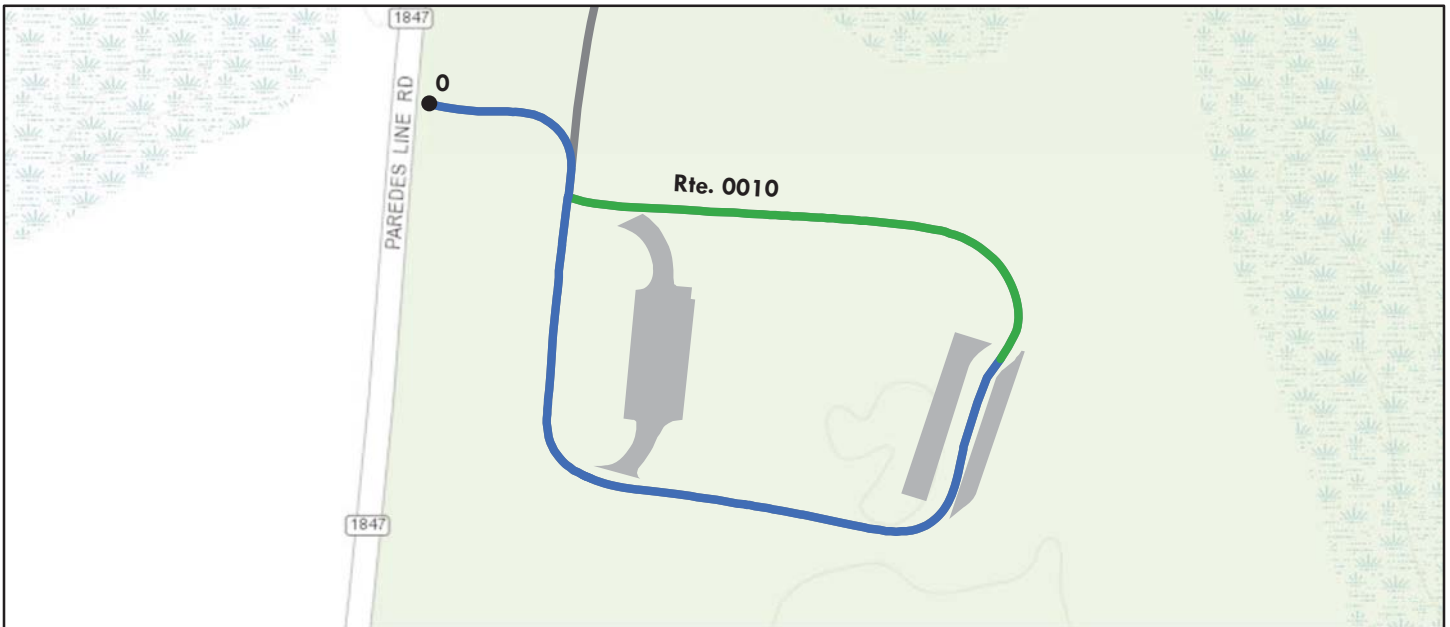
ROUTE 0010: VISITOR CENTER ENTRANCE ROAD

Route Condition Legend – Pavement Condition Rating (PCR)						
Poor (0 - 60)	Fair (61- 84)	Good (85 - 94)	Excellent (95 - 100)	Not Rated		
See Appendix for definitions and formulas						
Inspection Date: 3/17/2017	Beginning Section MP	0				
Paved Length (Miles): 0.3	Section Length (MI)	0.3				
Surface Type: ASPHALT	Route Summary					
Roadway Condition Information						
Pavement Condition Rating (PCR)	95	95				
Surface Condition Rating (SCR)	95	95				
Roughness Condition Index (RCI)	N/A	N/A				
Distress Index Values						
Structural Crack Index	96	96				
Alligator Crack Index	100	100				
Longitudinal Crack Index	96	96				
Transverse Cracking Index	100	100				
Patching Index	100	100				
Rutting Index	95	95				
International Roughness Index (IRI)	N/A	N/A				
Lane & Width Information						
Number of Lanes	2	2				
Paved Width (ft)	20.9	20.9				
Lane Width (ft)	10.5	10.5

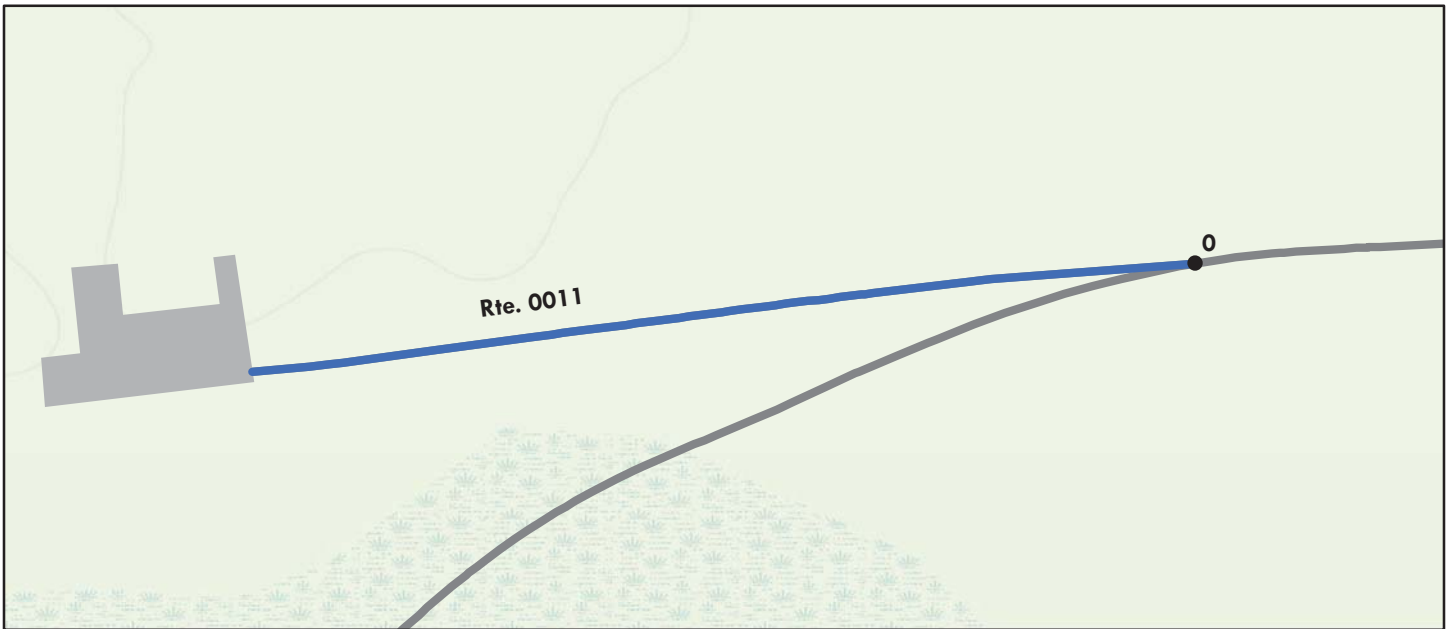
ROUTE 0011: MAINTENANCE AREA ROAD

Route Condition Legend – Pavement Condition Rating (PCR)						
Poor (0 - 60)	Fair (61- 84)	Good (85 - 94)	Excellent (95 - 100)	Not Rated		
See Appendix for definitions and formulas						
Inspection Date: 3/17/2017	Beginning Section MP	0				
Paved Length (Miles): 0.1	Section Length (MI)	0.1				
Surface Type: ASPHALT	Route Summary					
Roadway Condition Information						
Pavement Condition Rating (PCR)	95	95				
Surface Condition Rating (SCR)	95	95				
Roughness Condition Index (RCI)	N/A	N/A				
Distress Index Values						
Structural Crack Index	100	100				
Alligator Crack Index	100	100				
Longitudinal Crack Index	100	100				
Transverse Cracking Index	100	100				
Patching Index	100	100				
Rutting Index	95	95				
International Roughness Index (IRI)	N/A	N/A				
Lane & Width Information						
Number of Lanes	1	1				
Paved Width (ft)	14.2	14.2				
Lane Width (ft)	12.2	12.2

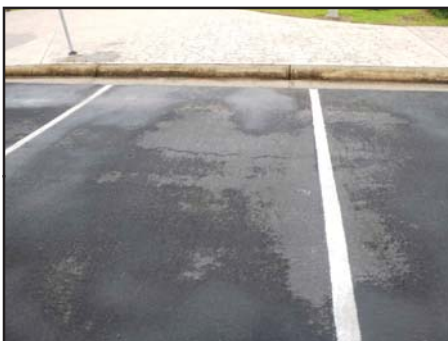
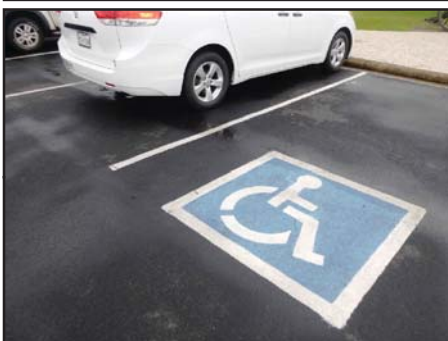
ROUTE 0900AZ: MAIN PARKING AREA A

Inspection Date	FMSS Number	User Access	Surface Type
2/20/2017	74887	PUBLIC	ASPHALT
Area (Sq. Ft.)	Lane Miles (11' Widths)	Curb Reveal (Inches)	Curb Recommendation
2,943	0.051	NOT APPLICABLE	DO NOTHING
Curb Type		Curb & Gutter Type	
NO CURB		CONCRETE	
Pavement Recommendation		Condition Rating / PCR	
PREVENTIVE MAINTENANCE		GOOD / 90

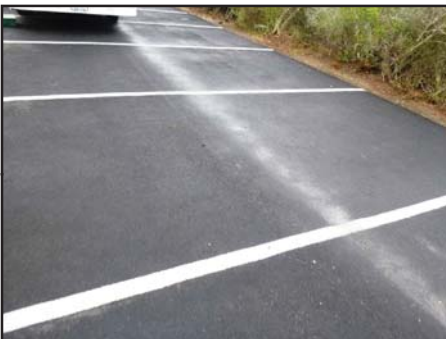
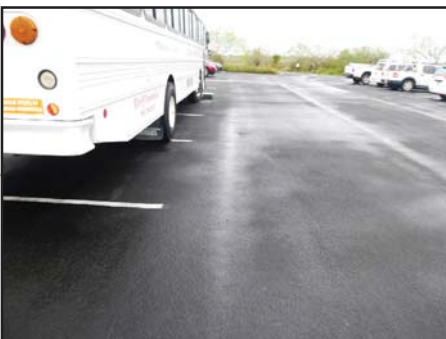
ROUTE 0900BZ: MAIN PARKING AREA B

Inspection Date	FMSS Number	User Access	Surface Type
2/20/2017	74887	PUBLIC	ASPHALT
Area (Sq. Ft.)	Lane Miles (11' Widths)	Curb Reveal (Inches)	Curb Recommendation
4,633	0.08	NOT APPLICABLE	NOT APPLICABLE
Curb Type		Curb & Gutter Type	
NO CURB		NO CURB AND GUTTER	
Pavement Recommendation		Condition Rating / PCR	
PREVENTIVE MAINTENANCE		GOOD / 90

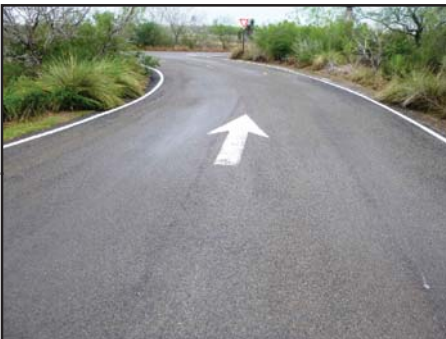
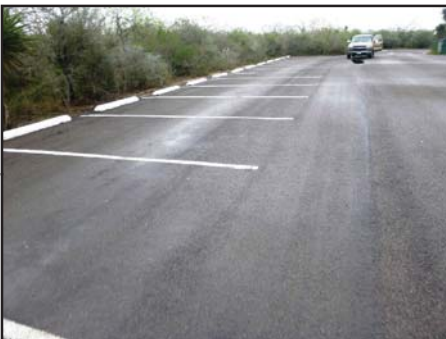
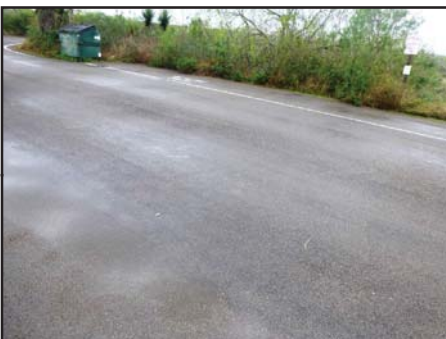
ROUTE 0901: OVERFLOW PARKING AREA

Inspection Date	FMSS Number	User Access	Surface Type
2/20/2017	74889	PUBLIC	ASPHALT
Area (Sq. Ft.)	Lane Miles (11' Widths)	Curb Reveal (Inches)	Curb Recommendation
11,652	0.201	NOT APPLICABLE	NOT APPLICABLE
Curb Type		Curb & Gutter Type	
NO CURB		NO CURB AND GUTTER	
Pavement Recommendation		Condition Rating / PCR	
PREVENTIVE MAINTENANCE		GOOD / 90

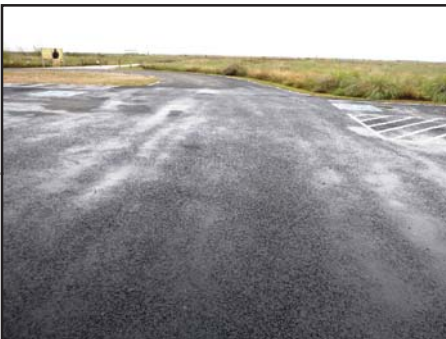
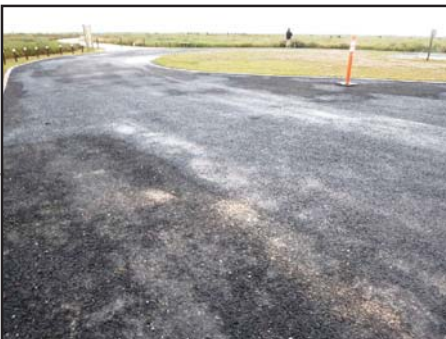
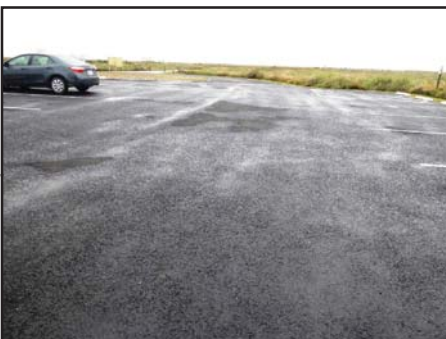
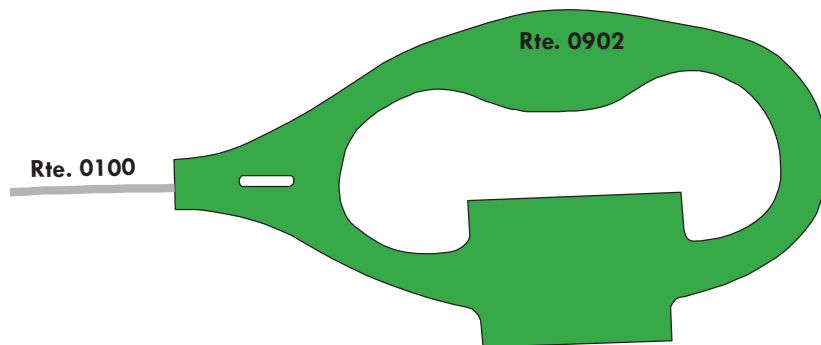
ROUTE 0902: OVERLOOK PARKING AREA

Inspection Date	FMSS Number	User Access	Surface Type
2/20/2017	92208	PUBLIC	ASPHALT
Area (Sq. Ft.)	Lane Miles (11' Widths)	Curb Reveal (Inches)	Curb Recommendation
13,114	0.226	NOT APPLICABLE	NOT APPLICABLE
Curb Type		Curb & Gutter Type	
NO CURB		NO CURB AND GUTTER	
Pavement Recommendation		Condition Rating / PCR	
PREVENTIVE MAINTENANCE		GOOD / 90

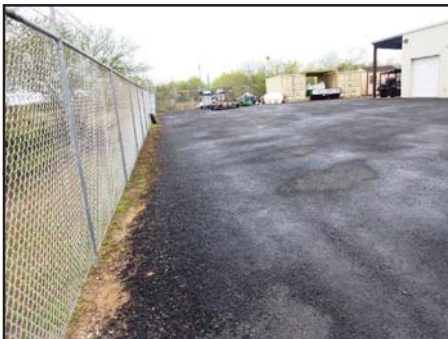
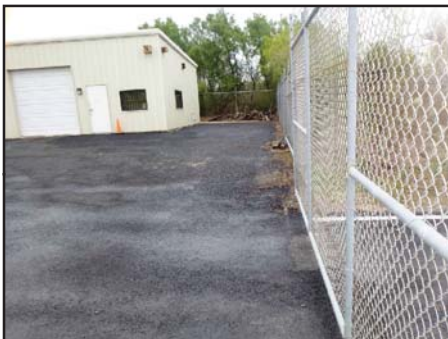
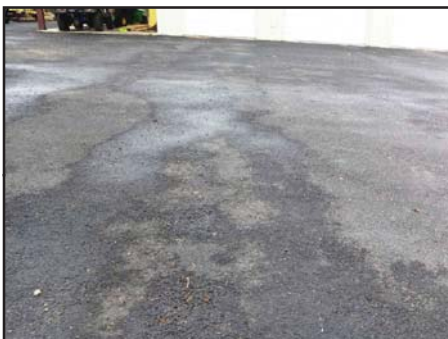
ROUTE 0903: MAINTENANCE AREA PARKING

Inspection Date	FMSS Number	User Access	Surface Type
2/20/2017	113684	NONPUBLIC	ASPHALT
Area (Sq. Ft.)	Lane Miles (11' Widths)	Curb Reveal (Inches)	Curb Recommendation
7,301	0.126	NOT APPLICABLE	NOT APPLICABLE
Curb Type		Curb & Gutter Type	
NO CURB		NO CURB AND GUTTER	
Pavement Recommendation		Condition Rating / PCR	
LIGHT 3R TREATMENTS		FAIR / 73

Note: Parking area consists of multiple surface types: 1 part Asphalt at 6,985 square feet; 1 part Concrete at 316 square feet.

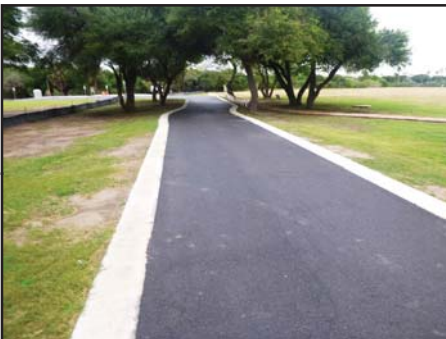
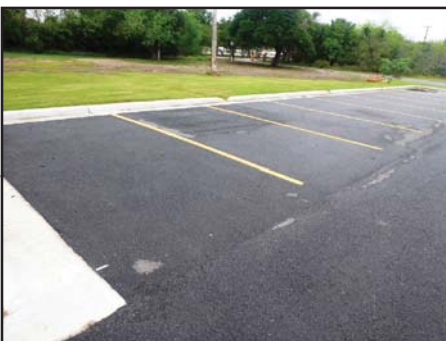
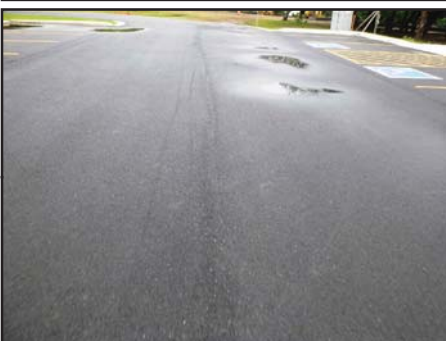
ROUTE 0904: RESACA DE LA PALMA PARKING

Inspection Date	FMSS Number	User Access	Surface Type
2/20/2017	235932	PUBLIC	ASPHALT
Area (Sq. Ft.)	Lane Miles (11' Widths)	Curb Reveal (Inches)	Curb Recommendation
14,290	0.246	0	DO NOTHING
Curb Type		Curb & Gutter Type	
CONCRETE		CONCRETE	
Pavement Recommendation		Condition Rating / PCR	
DO NOTHING		EXCELLENT / 97
