PERI Cycle 6

Final Report

Road Inventory and Condition Assessment of Paved Routes Pea Ridge National Military Park

Report Date: August 2018

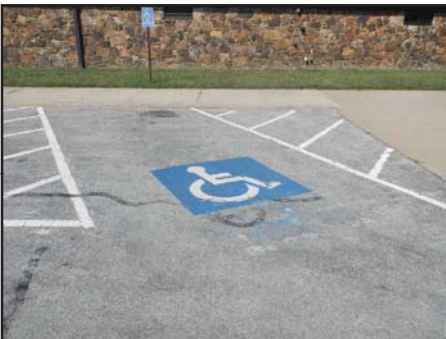
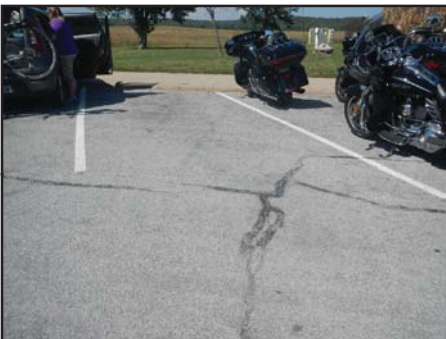
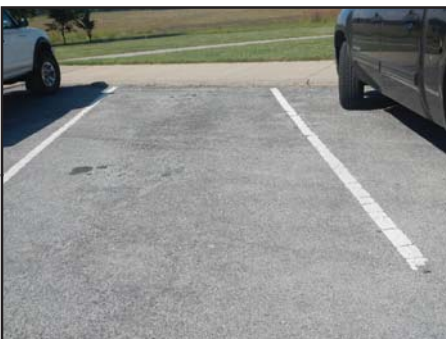
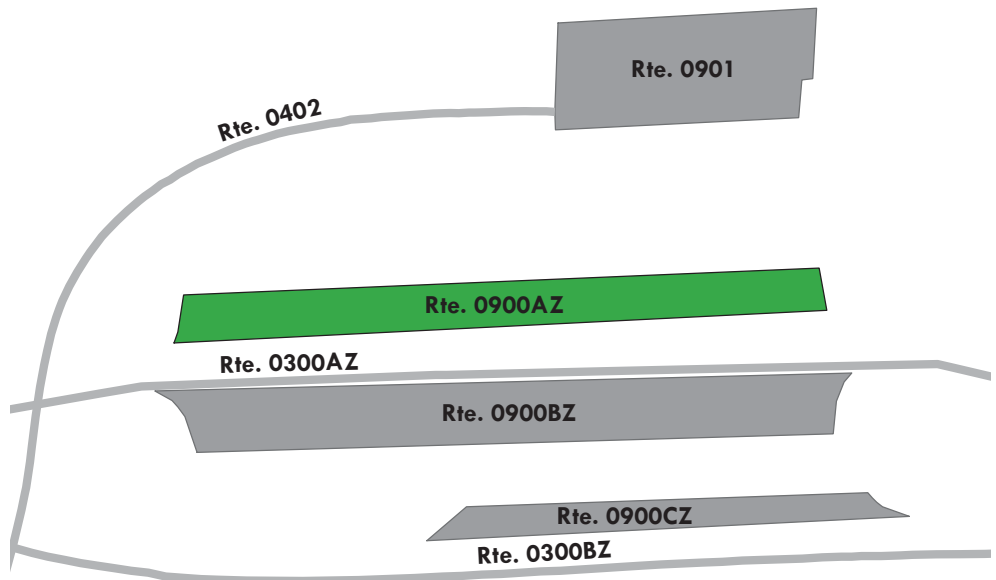
ROUTE 0900AZ: VISITOR CENTER PARKING A

Inspection Date	FMSS Number	User Access	Surface Type
9/23/2017	78006	PUBLIC	ASPHALT
Area (Sq. Ft.)	Lane Miles (11' Widths)	Curb Reveal (Inches)	Curb Recommendation
3,461	0.06	3	DO NOTHING
Curb Type		Curb & Gutter Type	
CONCRETE		NO CURB AND GUTTER	
Pavement Recommendation		Condition Rating / PCR	
PREVENTIVE MAINTENANCE		GOOD / 90

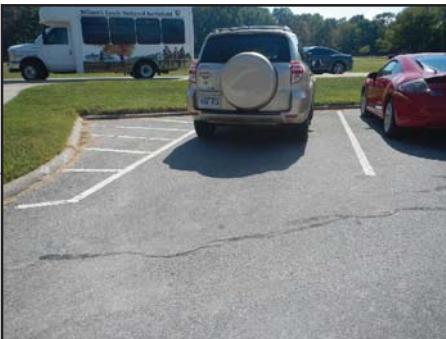
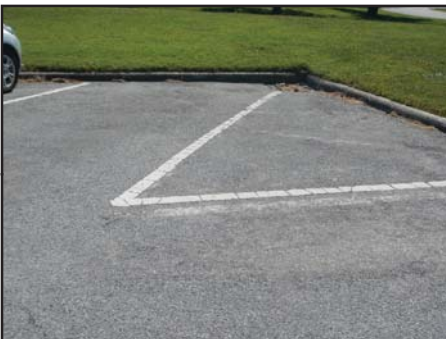
ROUTE 0900BZ: VISITOR CENTER PARKING B

Inspection Date	FMSS Number	User Access	Surface Type
9/23/2017	78006	PUBLIC	ASPHALT
Area (Sq. Ft.)	Lane Miles (11' Widths)	Curb Reveal (Inches)	Curb Recommendation
4,817	0.083	3	DO NOTHING
Curb Type		Curb & Gutter Type	
CONCRETE		NO CURB AND GUTTER	
Pavement Recommendation		Condition Rating / PCR	
PREVENTIVE MAINTENANCE		GOOD / 90

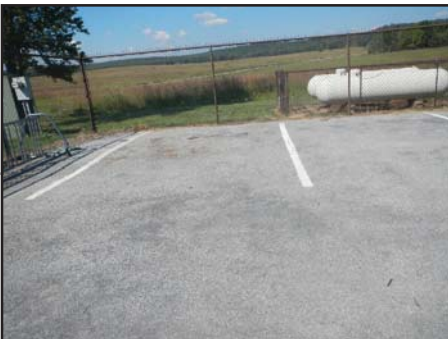
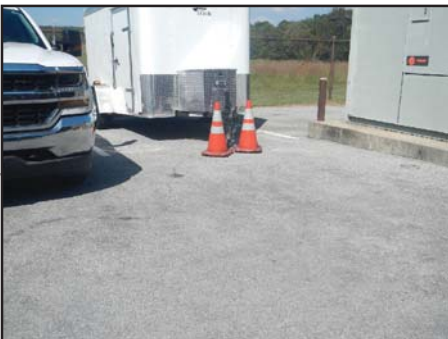
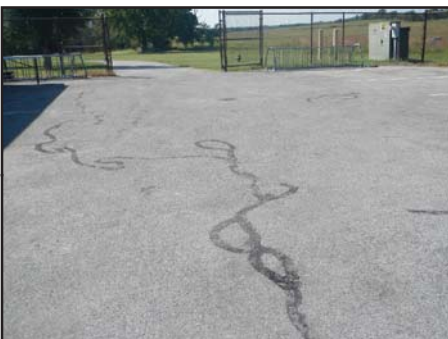
ROUTE 0901: MAINTENANCE COMPLEX PARKING

Inspection Date	FMSS Number	User Access	Surface Type
9/23/2017	78014	NONPUBLIC	ASPHALT
Area (Sq. Ft.)	Lane Miles (11' Widths)	Curb Reveal (Inches)	Curb Recommendation
3,258	0.056	NOT APPLICABLE	NOT APPLICABLE
Curb Type		Curb & Gutter Type	
NO CURB		NO CURB AND GUTTER	
Pavement Recommendation		Condition Rating / PCR	
PREVENTIVE MAINTENANCE		GOOD / 90

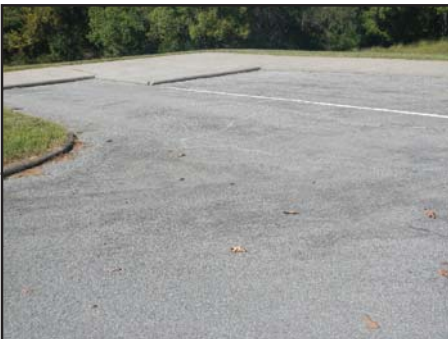
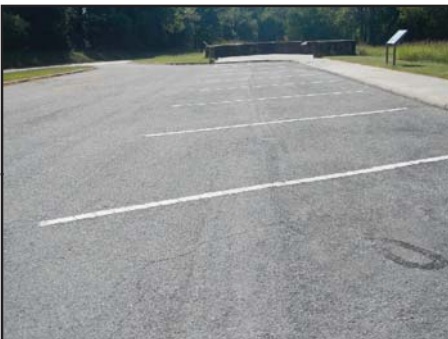
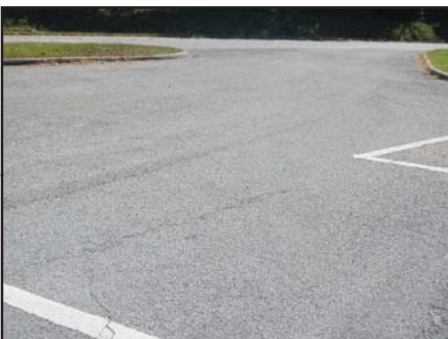
ROUTE 0905: GENERAL CURTIS' HEADQUARTERS PARKING / STOP 2

Inspection Date	FMSS Number	User Access	Surface Type
9/23/2017	77897	PUBLIC	ASPHALT
Area (Sq. Ft.)	Lane Miles (11' Widths)	Curb Reveal (Inches)	Curb Recommendation
7,521	0.129	3	DO NOTHING
Curb Type		Curb & Gutter Type	
CONCRETE		NO CURB AND GUTTER	
Pavement Recommendation		Condition Rating / PCR	
PREVENTIVE MAINTENANCE		GOOD / 90

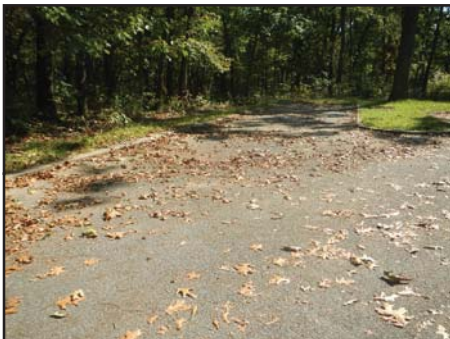
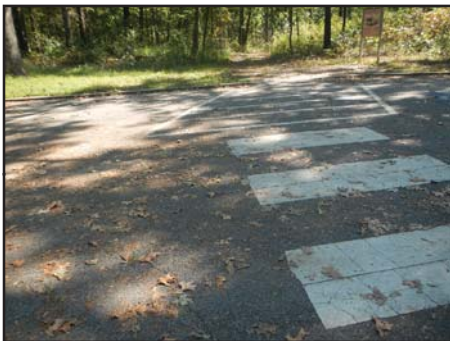
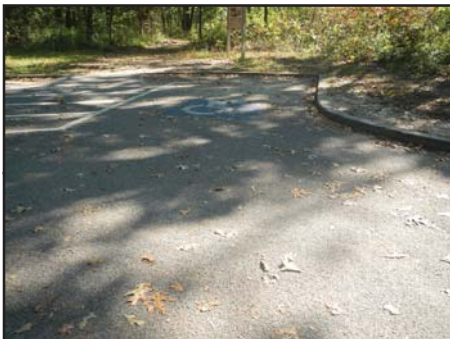
ROUTE 0906: LEETOWN HAMLET PARKING / STOP 3

Inspection Date	FMSS Number	User Access	Surface Type
9/23/2017	78058	PUBLIC	ASPHALT
Area (Sq. Ft.)	Lane Miles (11' Widths)	Curb Reveal (Inches)	Curb Recommendation
2,569	0.044	3	DO NOTHING
Curb Type		Curb & Gutter Type	
CONCRETE		NO CURB AND GUTTER	
Pavement Recommendation		Condition Rating / PCR	
PREVENTIVE MAINTENANCE		GOOD / 90
