PINN Cycle 6

Final Report

Road Inventory and Condition Assessment of Paved Routes Pinnacles National Park

Report Date: October 2015

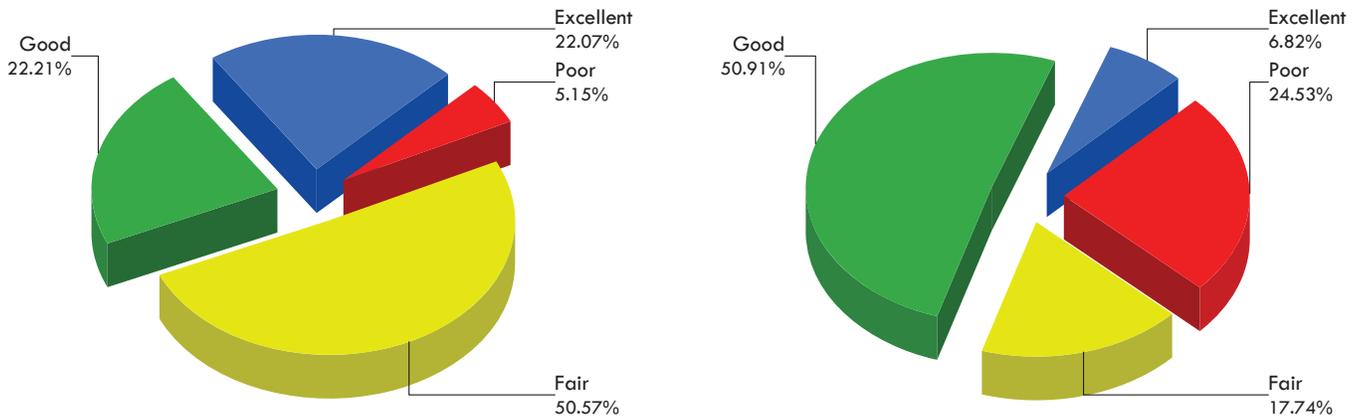
Figure 1: Pavement Condition Rating Breakdown for Paved Roads and Parking Areas

Road Condition Percentages

Parking Area Condition Percentages

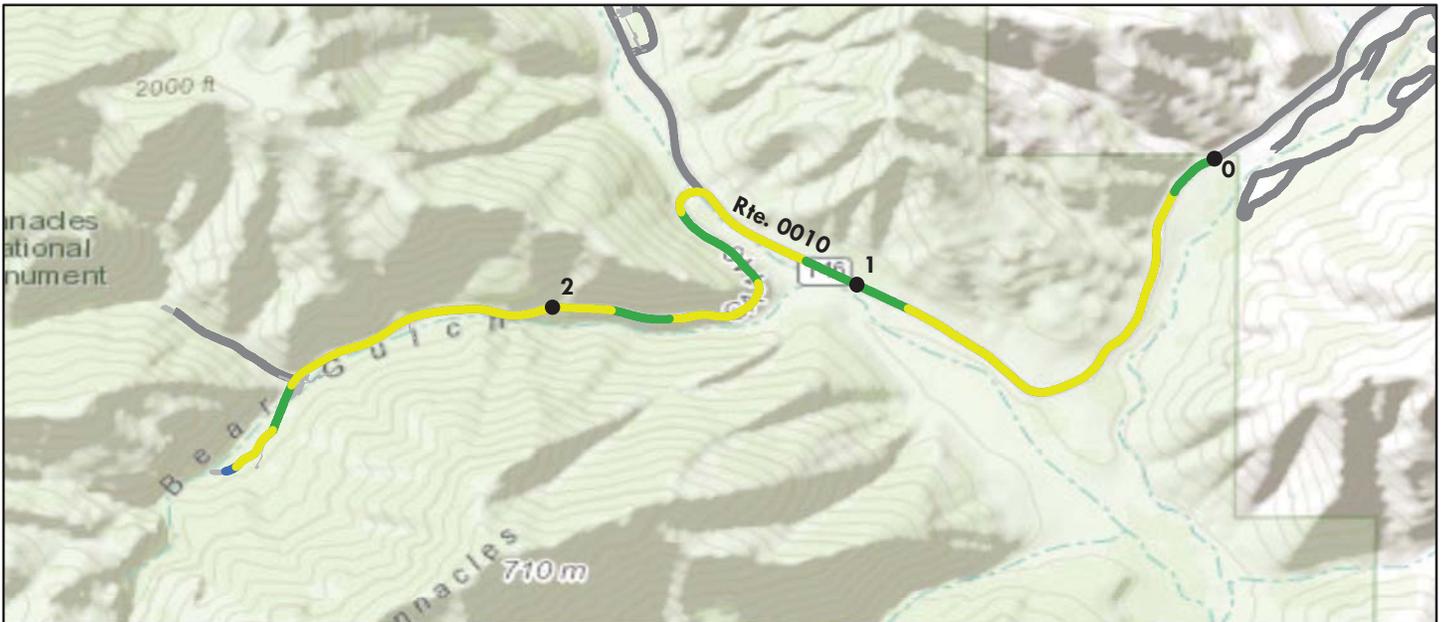
Data Collection Vehicle (DCV) Rating

Route Condition Legend – Pavement Condition Rating (PCR)									
Poor (0 - 60)		Fair (61- 84)		Good (85 - 94)		Excellent (95 - 100)		Not Rated	
See Appendix for definitions and formulas									
Inspection Date:	3/4/2015	Beginning Section MP	0	1	2				
Paved Length (Miles):	2.72	Section Length (MI)	1	1	0.72				
Surface Type:	ASPHALT	Route Summary							
Roadway Condition Information									
Pavement Condition Rating (PCR)	78	73	83	78					
Surface Condition Rating (SCR)	94	90	96	96					
Roughness Condition Index (RCI)	54	48	63	52					
Distress Index Values									
Structural Crack Index	98	96	98	99					
Alligator Crack Index	100	99	100	100					
Longitudinal Crack Index	98	97	98	99					
Transverse Cracking Index	94	90	96	96					
Patching Index	100	100	100	100					
Rutting Index	96	92	97	98					
International Roughness Index (IRI)	264	292	229	276					
Lane & Width Information									
Number of Lanes	2	2	2	2

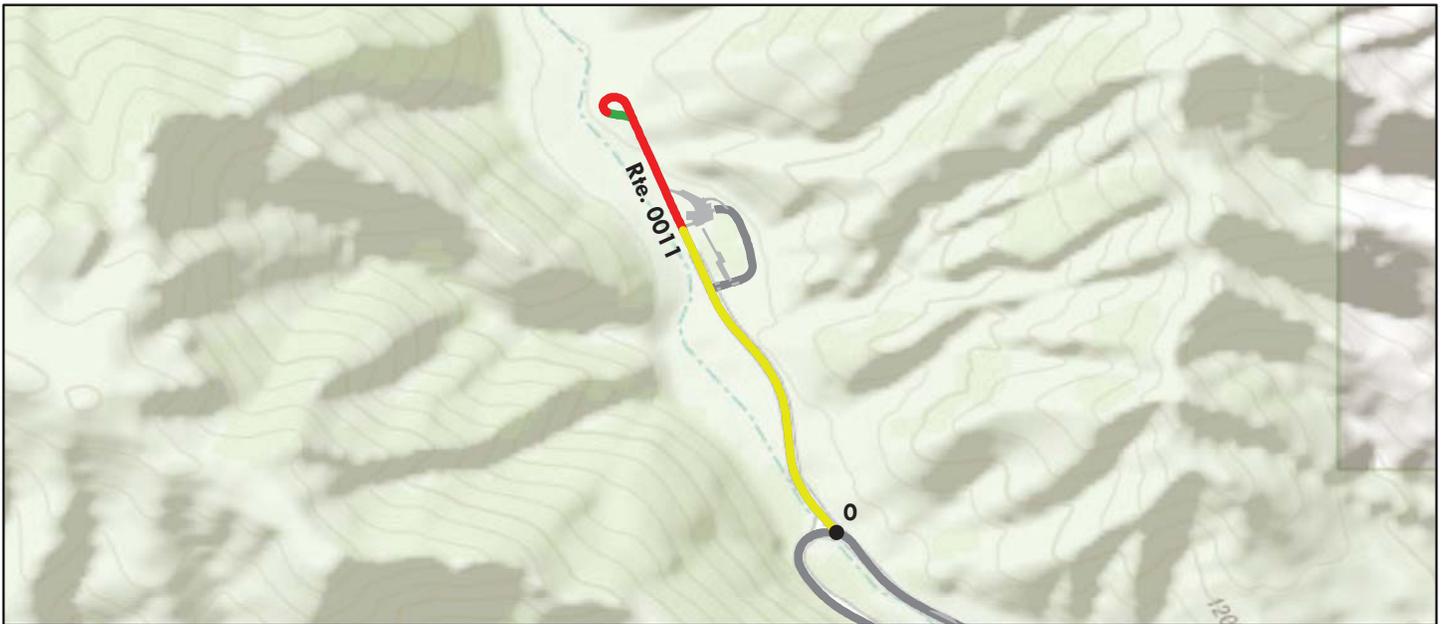
Data Collection Vehicle (DCV) Rating

Route Condition Legend – Pavement Condition Rating (PCR)						
Poor (0 - 60)	Fair (61- 84)	Good (85 - 94)	Excellent (95 - 100)	Not Rated		
See Appendix for definitions and formulas						
Inspection Date: 3/4/2015	Beginning Section MP	0				
Paved Length (Miles): 0.63	Section Length (MI)	0.63				
Surface Type: ASPHALT	Route Summary					
Roadway Condition Information						
Pavement Condition Rating (PCR)	63	63				
Surface Condition Rating (SCR)	72	72				
Roughness Condition Index (RCI)	50	50				
Distress Index Values						
Structural Crack Index	94	94				
Alligator Crack Index	100	100				
Longitudinal Crack Index	94	94				
Transverse Cracking Index	72	72				
Patching Index	100	100				
Rutting Index	98	98				
International Roughness Index (IRI)	285	285				
Lane & Width Information						
Number of Lanes	2	2				
Paved Width (ft)	17.4	17.4				
Lane Width (ft)	8.2	8.2

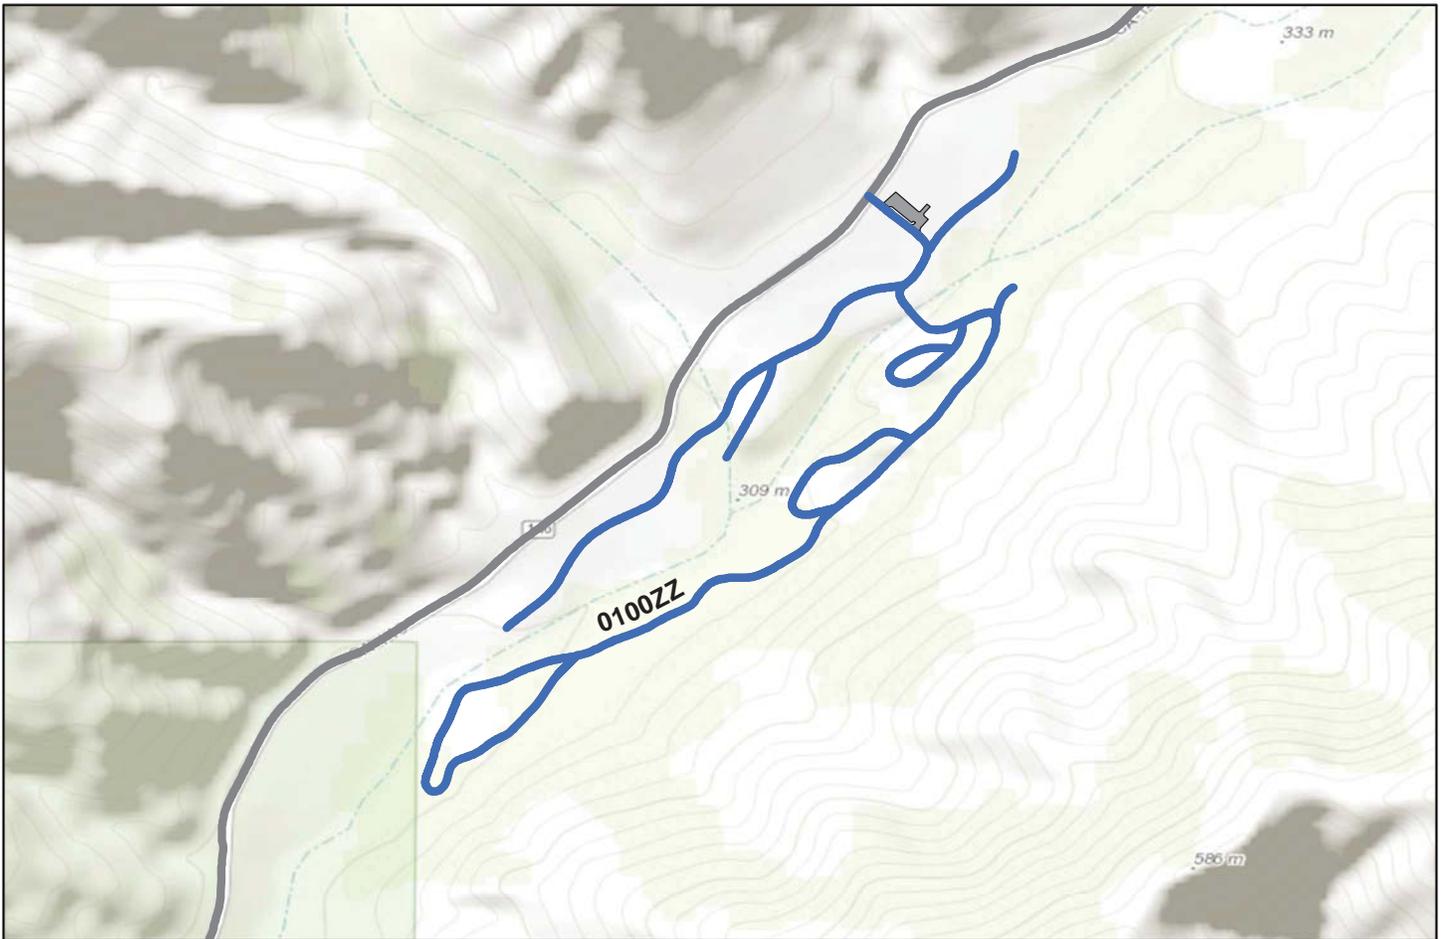
Summary Route

The condition shown on this page reflects the overall route condition; it might not reflect individual subcomponent ratings.

Route Condition Legend – Pavement Condition Rating (PCR)						
Poor (0 - 60)	Fair (61- 84)	Good (85 - 94)	Excellent (95 - 100)	Not Rated		
See Appendix for definitions and formulas						
Inspection Date:	3/4/2015					
Paved Length (Miles):	1.9					
Surface Type:	ASPHALT	Route Summary				
Roadway Condition Information						
Pavement Condition Rating (PCR)	97					
Lane & Width Information						
Number of Lanes	1					
Paved Width (ft)	13.7					
Lane Width (ft)	11.1

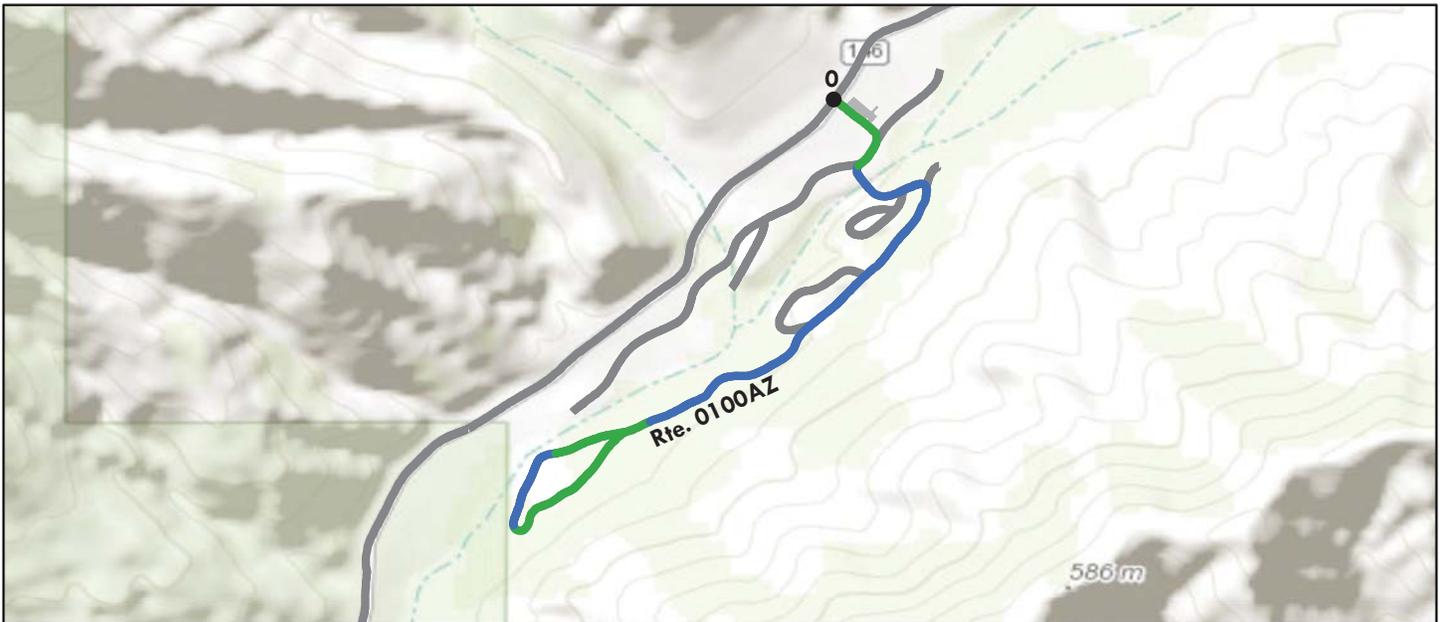
Subcomponent of Route PINN-0100ZZ
Data Collection Vehicle (DCV) Rating

Route Condition Legend – Pavement Condition Rating (PCR)						
Poor (0 - 60)	Fair (61- 84)	Good (85 - 94)	Excellent (95 - 100)	Not Rated		
See Appendix for definitions and formulas						
Inspection Date: 3/4/2015	Beginning Section MP	0				
Paved Length (Miles): 0.96	Section Length (MI)	0.96				
Surface Type: ASPHALT	Route Summary					
Roadway Condition Information						
Pavement Condition Rating (PCR)	96	96				
Surface Condition Rating (SCR)	96	96				
Roughness Condition Index (RCI)	N/A	N/A				
Distress Index Values						
Structural Crack Index	96	96				
Alligator Crack Index	100	100				
Longitudinal Crack Index	96	96				
Transverse Cracking Index	99	99				
Patching Index	100	100				
Rutting Index	97	97				
International Roughness Index (IRI)	N/A	N/A				
Lane & Width Information						
Number of Lanes	1	1				
Paved Width (ft)	14.2	14.2				
Lane Width (ft)	12.2	12.2

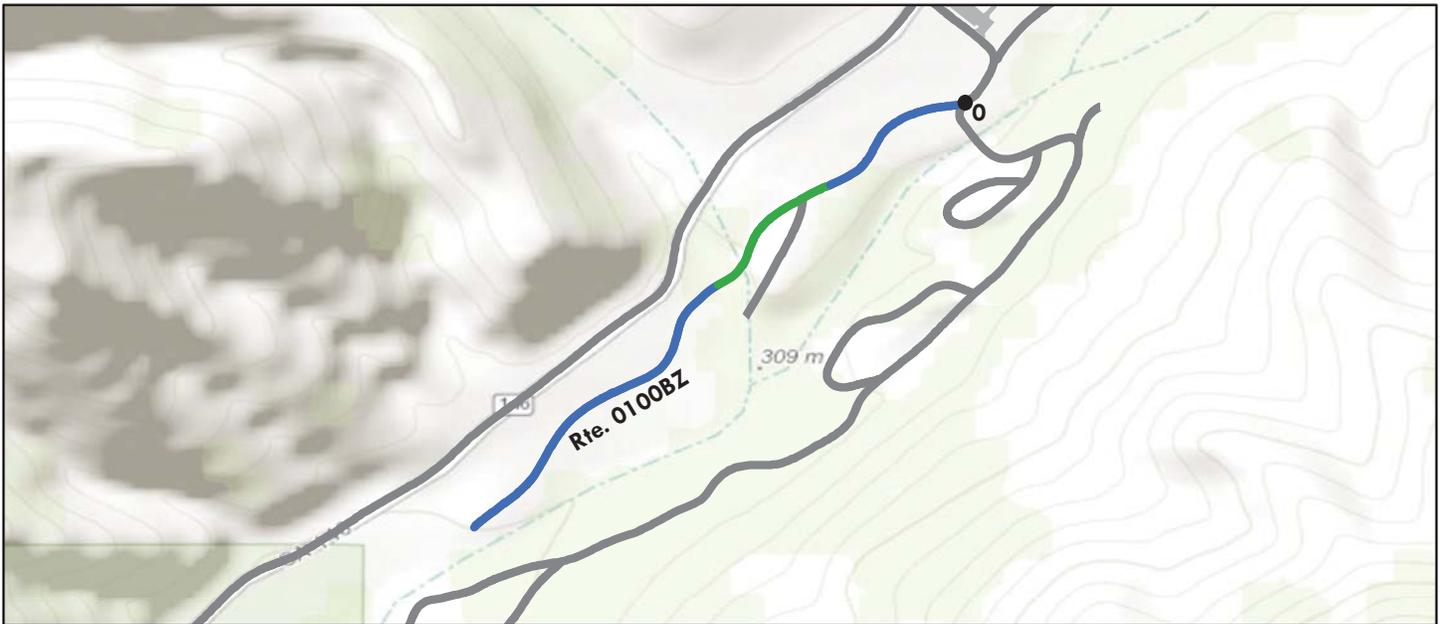
Subcomponent of Route PINN-0100ZZ
 Data Collection Vehicle (DCV) Rating

Route Condition Legend – Pavement Condition Rating (PCR)						
Poor (0 - 60)	Fair (61- 84)	Good (85 - 94)	Excellent (95 - 100)	Not Rated		
See Appendix for definitions and formulas						
Inspection Date: 3/4/2015	Beginning Section MP	0				
Paved Length (Miles): 0.42	Section Length (MI)	0.42				
Surface Type: ASPHALT	Route Summary					
Roadway Condition Information						
Pavement Condition Rating (PCR)	97	97				
Surface Condition Rating (SCR)	97	97				
Roughness Condition Index (RCI)	N/A	N/A				
Distress Index Values						
Structural Crack Index	99	99				
Alligator Crack Index	100	100				
Longitudinal Crack Index	99	99				
Transverse Cracking Index	100	100				
Patching Index	100	100				
Rutting Index	97	97				
International Roughness Index (IRI)	N/A	N/A				
Lane & Width Information						
Number of Lanes	2	2				
Paved Width (ft)	14.7	14.7				
Lane Width (ft)	7.3	7.3

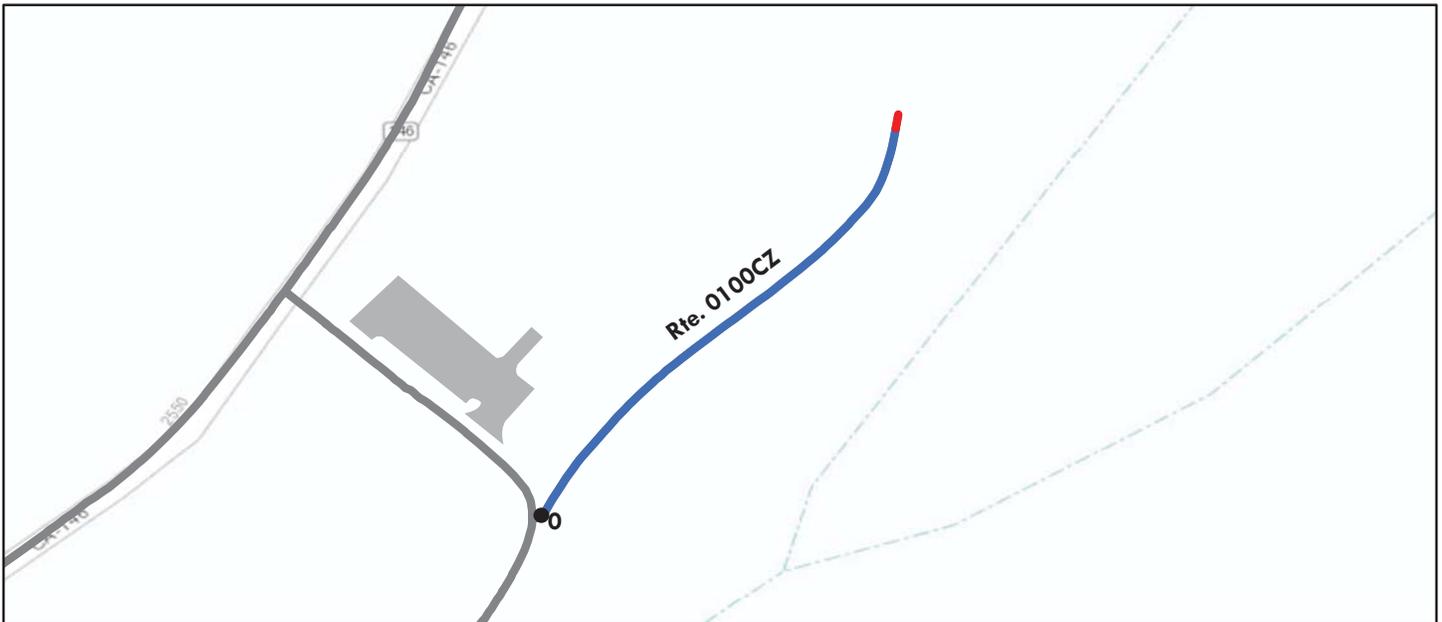
Subcomponent of Route PINN-0100ZZ
Data Collection Vehicle (DCV) Rating

Route Condition Legend – Pavement Condition Rating (PCR)						
Poor (0 - 60)	Fair (61- 84)	Good (85 - 94)	Excellent (95 - 100)	Not Rated		
See Appendix for definitions and formulas						
Inspection Date: 3/4/2015	Beginning Section MP	0				
Paved Length (Miles): 0.1	Section Length (MI)	0.1				
Surface Type: ASPHALT	Route Summary					
Roadway Condition Information						
Pavement Condition Rating (PCR)	93	93				
Surface Condition Rating (SCR)	93	93				
Roughness Condition Index (RCI)	N/A	N/A				
Distress Index Values						
Structural Crack Index	100	100				
Alligator Crack Index	100	100				
Longitudinal Crack Index	100	100				
Transverse Cracking Index	100	100				
Patching Index	100	100				
Rutting Index	93	93				
International Roughness Index (IRI)	N/A	N/A				
Lane & Width Information						
Number of Lanes	1	1				
Paved Width (ft)	12.2	12.2				
Lane Width (ft)	12.2	12.2

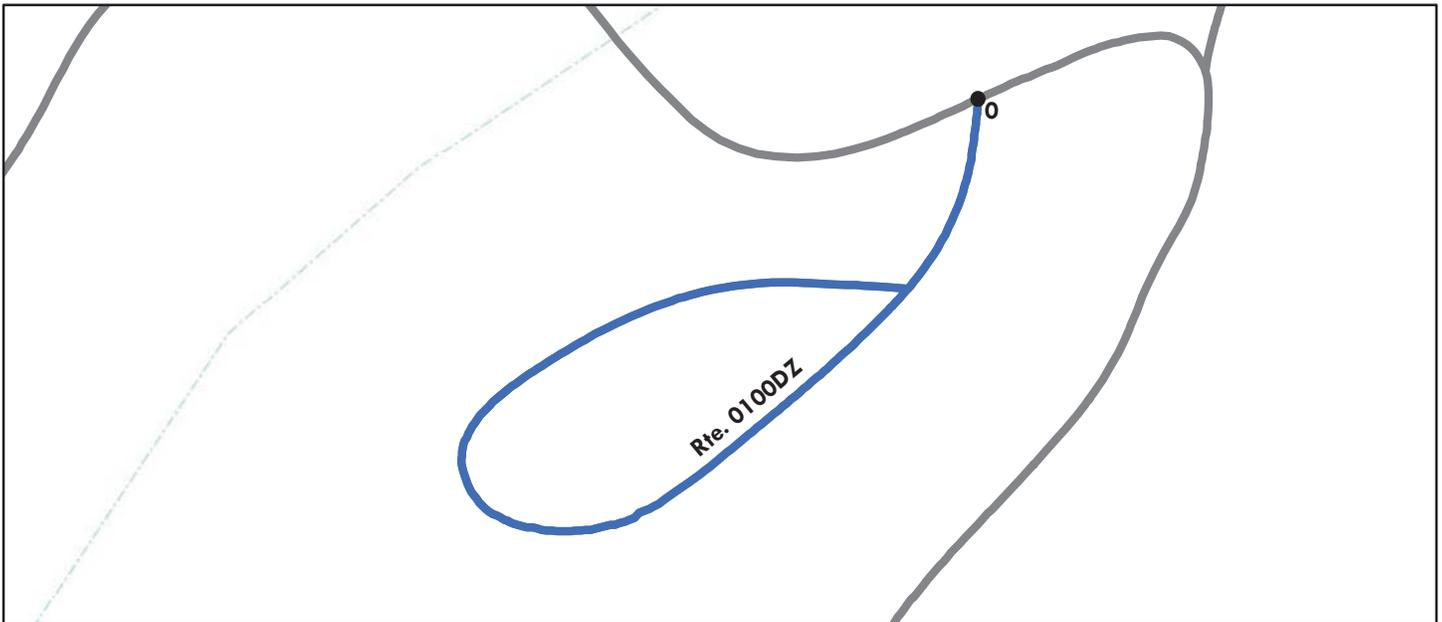
Subcomponent of Route PINN-0100ZZ
Data Collection Vehicle (DCV) Rating

Route Condition Legend – Pavement Condition Rating (PCR)						
Poor (0 - 60)	Fair (61- 84)	Good (85 - 94)	Excellent (95 - 100)	Not Rated		
See Appendix for definitions and formulas						
Inspection Date: 3/4/2015	Beginning Section MP	0				
Paved Length (Miles): 0.14	Section Length (MI)	0.14				
Surface Type: ASPHALT	Route Summary					
Roadway Condition Information						
Pavement Condition Rating (PCR)	99	99				
Surface Condition Rating (SCR)	99	99				
Roughness Condition Index (RCI)	N/A	N/A				
Distress Index Values						
Structural Crack Index	99	99				
Alligator Crack Index	100	100				
Longitudinal Crack Index	99	99				
Transverse Cracking Index	100	100				
Patching Index	100	100				
Rutting Index	99	99				
International Roughness Index (IRI)	N/A	N/A				
Lane & Width Information						
Number of Lanes	1	1				
Paved Width (ft)	12.2	12.2				
Lane Width (ft)	12.2	12.2

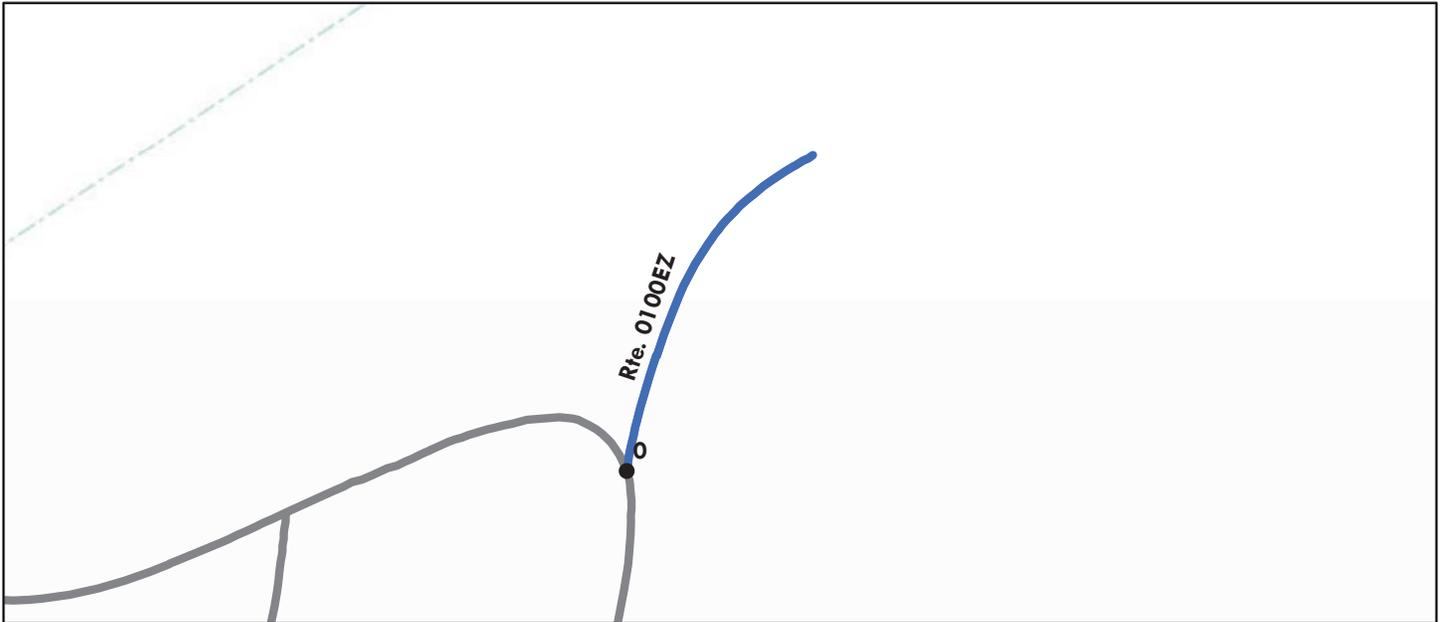
Subcomponent of Route PINN-0100ZZ
Data Collection Vehicle (DCV) Rating

Inspection Date: 3/4/2015	Beginning Section MP	0				
Paved Length (Miles): 0.03	Section Length (MI)	0.03				
Surface Type: ASPHALT	Route Summary					
Roadway Condition Information						
Pavement Condition Rating (PCR)	97	97				
Surface Condition Rating (SCR)	97	97				
Roughness Condition Index (RCI)	N/A	N/A				
Distress Index Values						
Structural Crack Index	98	98				
Alligator Crack Index	100	100				
Longitudinal Crack Index	98	98				
Transverse Cracking Index	100	100				
Patching Index	100	100				
Rutting Index	97	97				
International Roughness Index (IRI)	N/A	N/A				
Lane & Width Information						
Number of Lanes	1	1				
Paved Width (ft)	11.3	11.3				
Lane Width (ft)	11.3	11.3

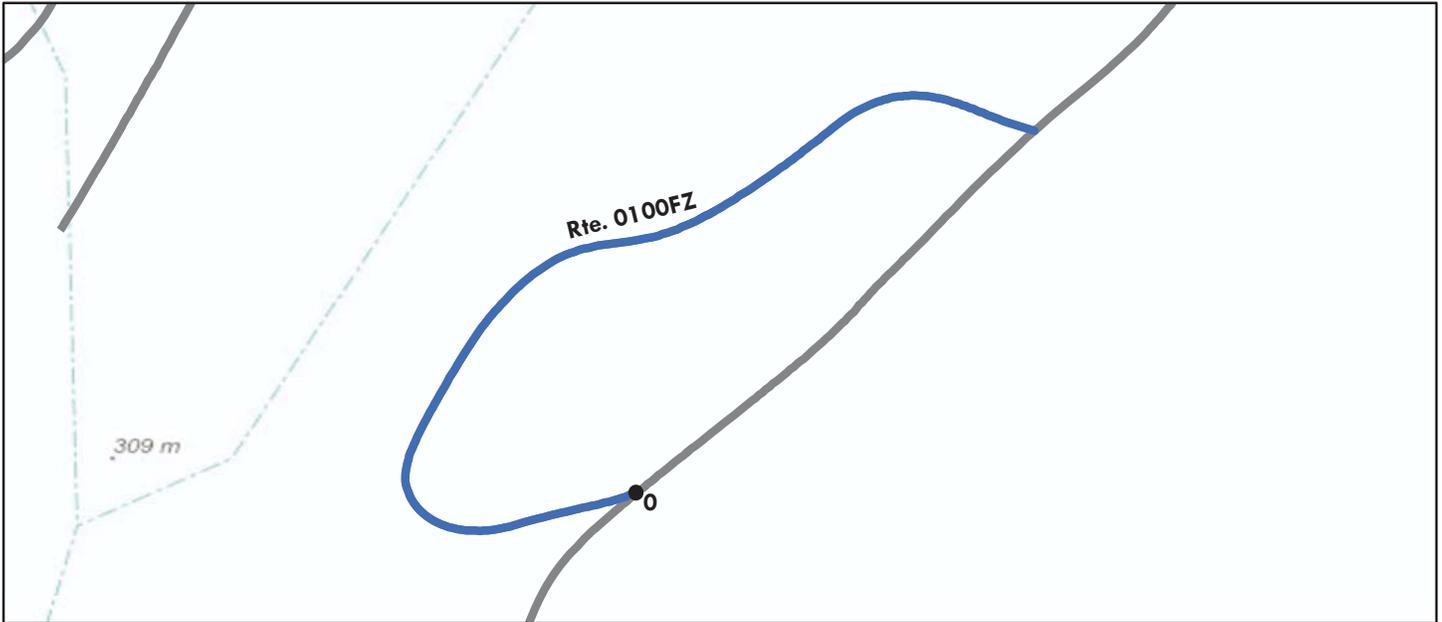
Subcomponent of Route PINN-0100ZZ
Data Collection Vehicle (DCV) Rating

Route Condition Legend – Pavement Condition Rating (PCR)						
Poor (0 - 60)	Fair (61- 84)	Good (85 - 94)	Excellent (95 - 100)	Not Rated		
See Appendix for definitions and formulas						
Inspection Date: 3/4/2015	Beginning Section MP	0				
Paved Length (Miles): 0.15	Section Length (MI)	0.15				
Surface Type: ASPHALT	Route Summary					
Roadway Condition Information						
Pavement Condition Rating (PCR)	99	99				
Surface Condition Rating (SCR)	99	99				
Roughness Condition Index (RCI)	N/A	N/A				
Distress Index Values						
Structural Crack Index	99	99				
Alligator Crack Index	100	100				
Longitudinal Crack Index	99	99				
Transverse Cracking Index	100	100				
Patching Index	100	100				
Rutting Index	99	99				
International Roughness Index (IRI)	N/A	N/A				
Lane & Width Information						
Number of Lanes	1	1				
Paved Width (ft)	11.1	11.1				
Lane Width (ft)	11.1	11.1

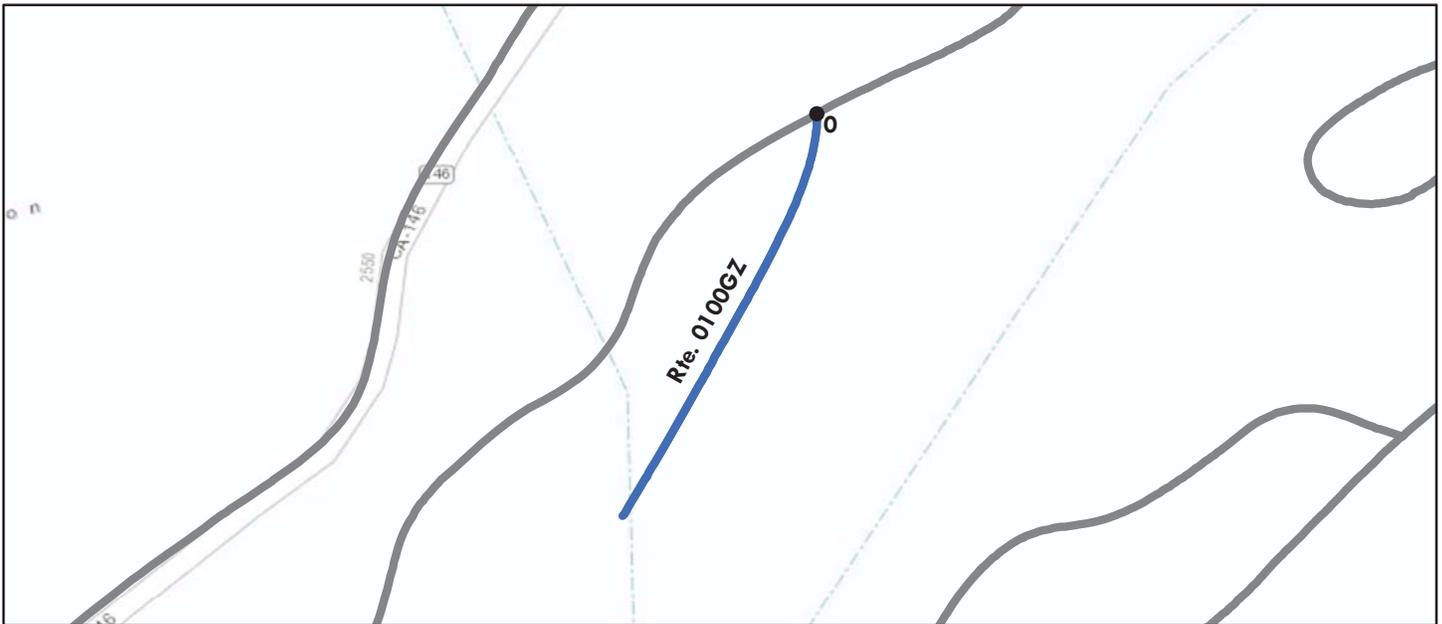
Subcomponent of Route PINN-0100ZZ
 Data Collection Vehicle (DCV) Rating

Route Condition Legend – Pavement Condition Rating (PCR)						
Poor (0 - 60)	Fair (61- 84)	Good (85 - 94)	Excellent (95 - 100)	Not Rated		
See Appendix for definitions and formulas						
Inspection Date: 3/4/2015	Beginning Section MP	0				
Paved Length (Miles): 0.09	Section Length (MI)	0.09				
Surface Type: ASPHALT	Route Summary					
Roadway Condition Information						
Pavement Condition Rating (PCR)	98	98				
Surface Condition Rating (SCR)	98	98				
Roughness Condition Index (RCI)	N/A	N/A				
Distress Index Values						
Structural Crack Index	100	100				
Alligator Crack Index	100	100				
Longitudinal Crack Index	100	100				
Transverse Cracking Index	100	100				
Patching Index	100	100				
Rutting Index	98	98				
International Roughness Index (IRI)	N/A	N/A				
Lane & Width Information						
Number of Lanes	1	1				
Paved Width (ft)	13.3	13.3				
Lane Width (ft)	13.3	13.3

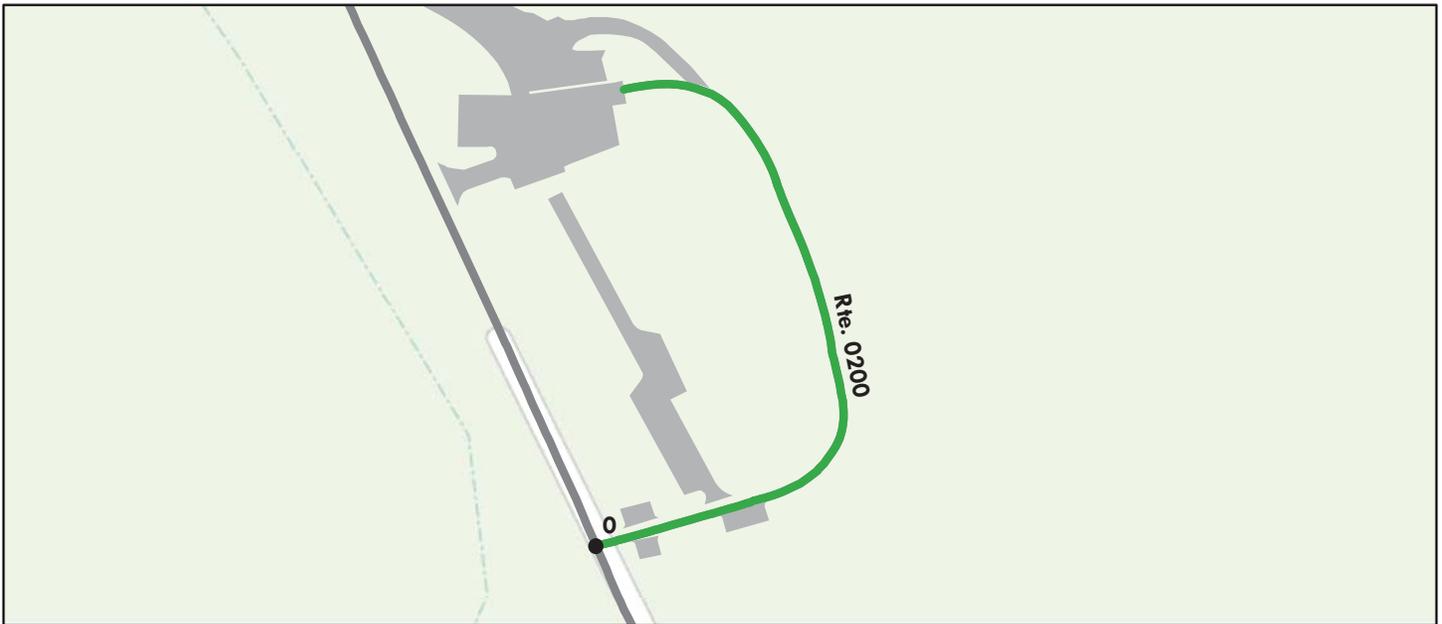
Data Collection Vehicle (DCV) Rating

Route Condition Legend – Pavement Condition Rating (PCR)						
Poor (0 - 60)	Fair (61- 84)	Good (85 - 94)	Excellent (95 - 100)	Not Rated		
See Appendix for definitions and formulas						
Inspection Date: 3/4/2015	Beginning Section MP	0				
Paved Length (Miles): 0.14	Section Length (MI)	0.14				
Surface Type: ASPHALT	Route Summary					
Roadway Condition Information						
Pavement Condition Rating (PCR)	92	92				
Surface Condition Rating (SCR)	92	92				
Roughness Condition Index (RCI)	N/A	N/A				
Distress Index Values						
Structural Crack Index	98	98				
Alligator Crack Index	100	100				
Longitudinal Crack Index	98	98				
Transverse Cracking Index	92	92				
Patching Index	100	100				
Rutting Index	94	94				
International Roughness Index (IRI)	N/A	N/A				
Lane & Width Information						
Number of Lanes	2	2				
Paved Width (ft)	20.3	20.3				
Lane Width (ft)	10.9	10.9

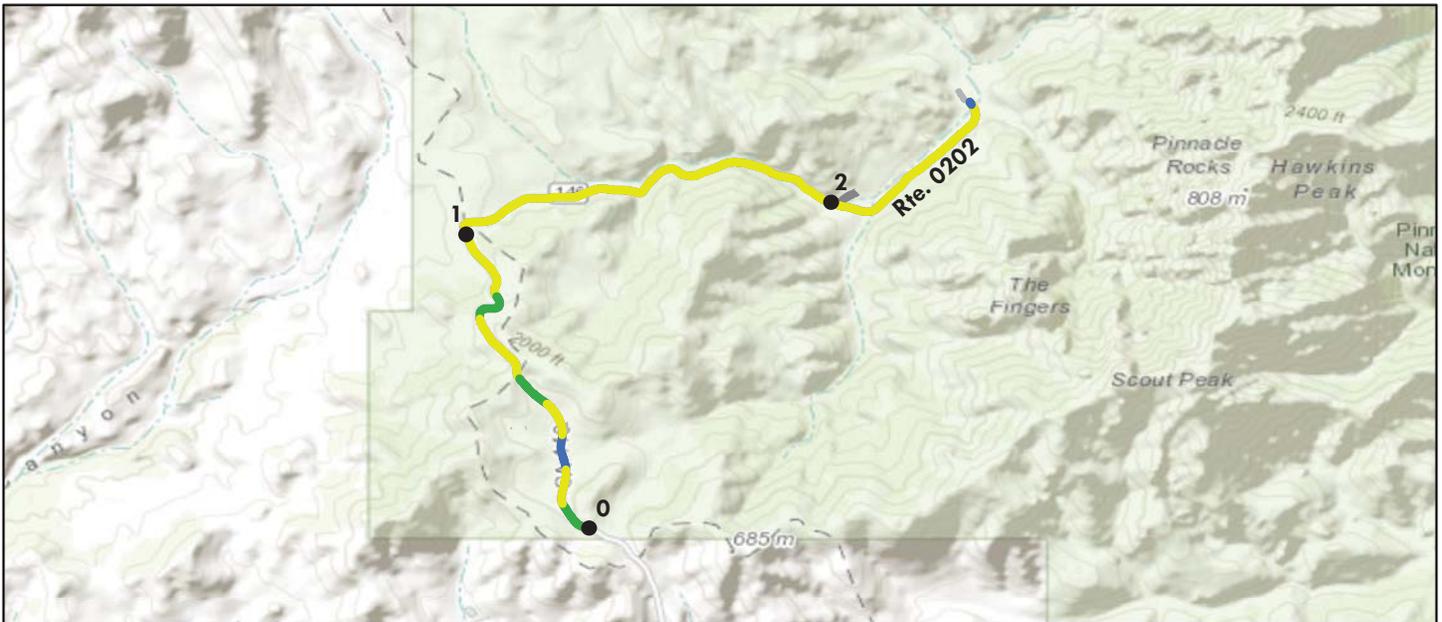
Data Collection Vehicle (DCV) Rating

Route Condition Legend – Pavement Condition Rating (PCR)						
Poor (0 - 60)	Fair (61- 84)	Good (85 - 94)	Excellent (95 - 100)	Not Rated		
See Appendix for definitions and formulas						
Inspection Date: 3/4/2015	Beginning Section MP	0	1	2		
Paved Length (Miles): 2.51	Section Length (MI)	1	1	0.51		
Surface Type: ASPHALT	Route Summary					
Roadway Condition Information						
Pavement Condition Rating (PCR)	76	80	71	77		
Surface Condition Rating (SCR)	93	94	90	93		
Roughness Condition Index (RCI)	50	58	43	52		
Distress Index Values						
Structural Crack Index	98	98	98	99		
Alligator Crack Index	100	100	100	100		
Longitudinal Crack Index	98	98	98	99		
Transverse Cracking Index	93	94	90	97		
Patching Index	100	100	100	99		
Rutting Index	93	94	93	93		
International Roughness Index (IRI)	282	249	319	273		
Lane & Width Information						
Number of Lanes	2	2	2	2		
Paved Width (ft)	16.5	16.8	16	16.9		
Lane Width (ft)	8.2	8.4	8.1	8.5

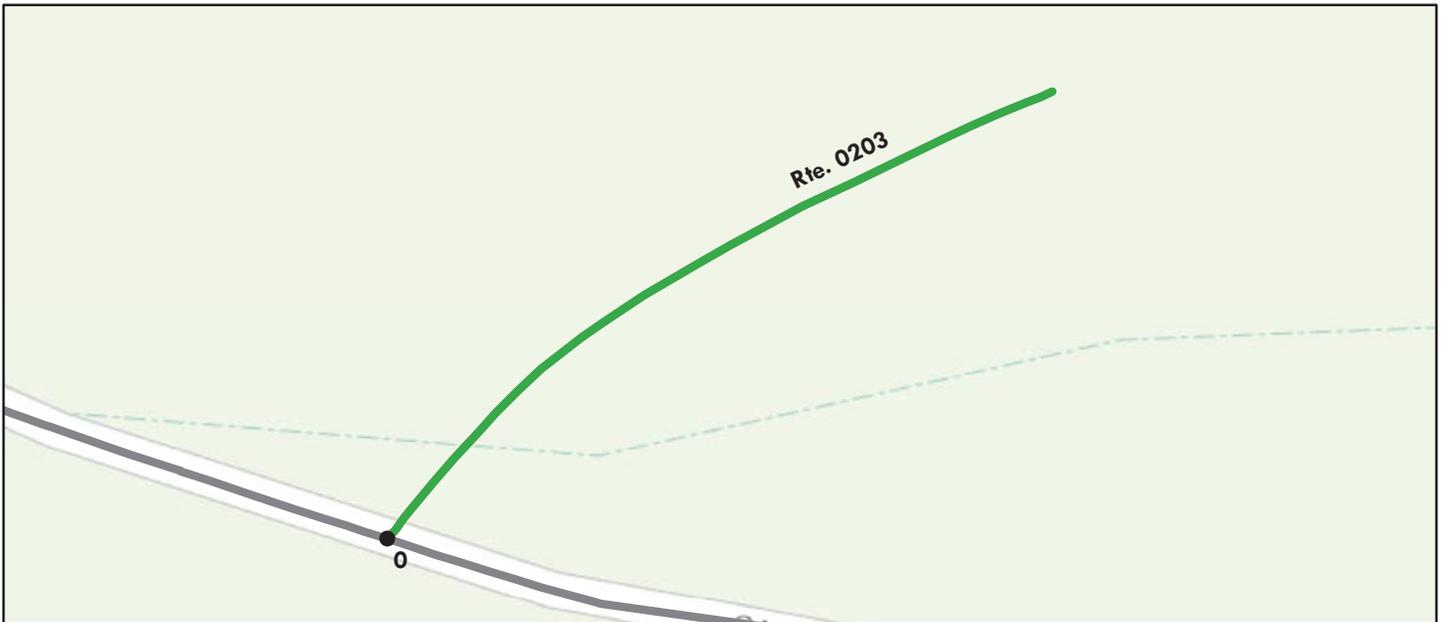
Data Collection Vehicle (DCV) Rating

Route Condition Legend – Pavement Condition Rating (PCR)						
Poor (0 - 60)	Fair (61- 84)	Good (85 - 94)	Excellent (95 - 100)	Not Rated		
See Appendix for definitions and formulas						
Inspection Date: 3/4/2015	Beginning Section MP	0				
Paved Length (Miles): 0.06	Section Length (MI)	0.06				
Surface Type: ASPHALT	Route Summary					
Roadway Condition Information						
Pavement Condition Rating (PCR)	91	91				
Surface Condition Rating (SCR)	91	91				
Roughness Condition Index (RCI)	N/A	N/A				
Distress Index Values						
Structural Crack Index	91	91				
Alligator Crack Index	100	100				
Longitudinal Crack Index	91	91				
Transverse Cracking Index	99	99				
Patching Index	100	100				
Rutting Index	99	99				
International Roughness Index (IRI)	N/A	N/A				
Lane & Width Information						
Number of Lanes	1	1				
Paved Width (ft)	11.1	11.1				
Lane Width (ft)	11.1	11.1

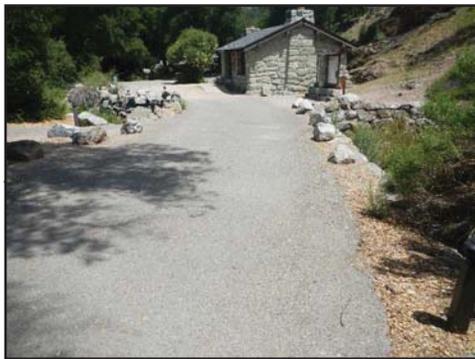
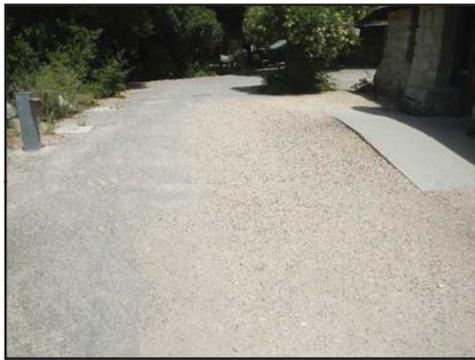
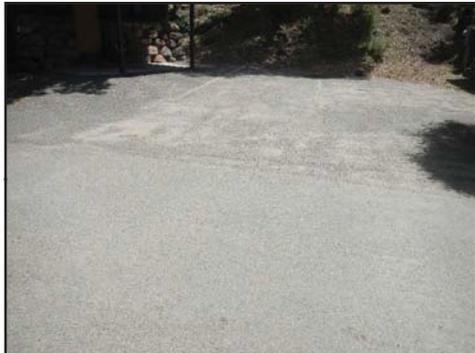
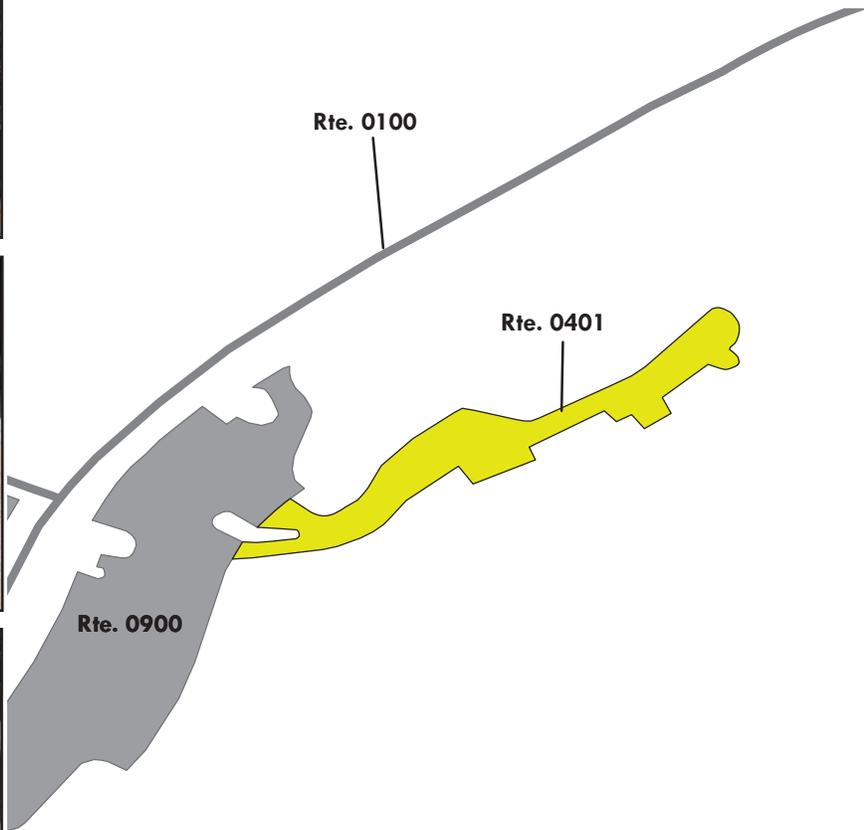
Inspection Date	FMSS Number	User Access	Surface Type
5/5/2014	89622	NONPUBLIC	ASPHALT
Area (Sq. Ft.)	Lane Miles (11' Widths)	Pavement Recommendation	
6,237	0.107	LIGHT 3R TREATMENTS	
Condition Rating / PCR			
FAIR / 73			
Route Condition Legend – Pavement Condition Rating (PCR)			
Poor (0 - 60)	Fair (61- 84)	Good (85 - 94)	Excellent (95 - 100)
See Appendix for definitions and formulas

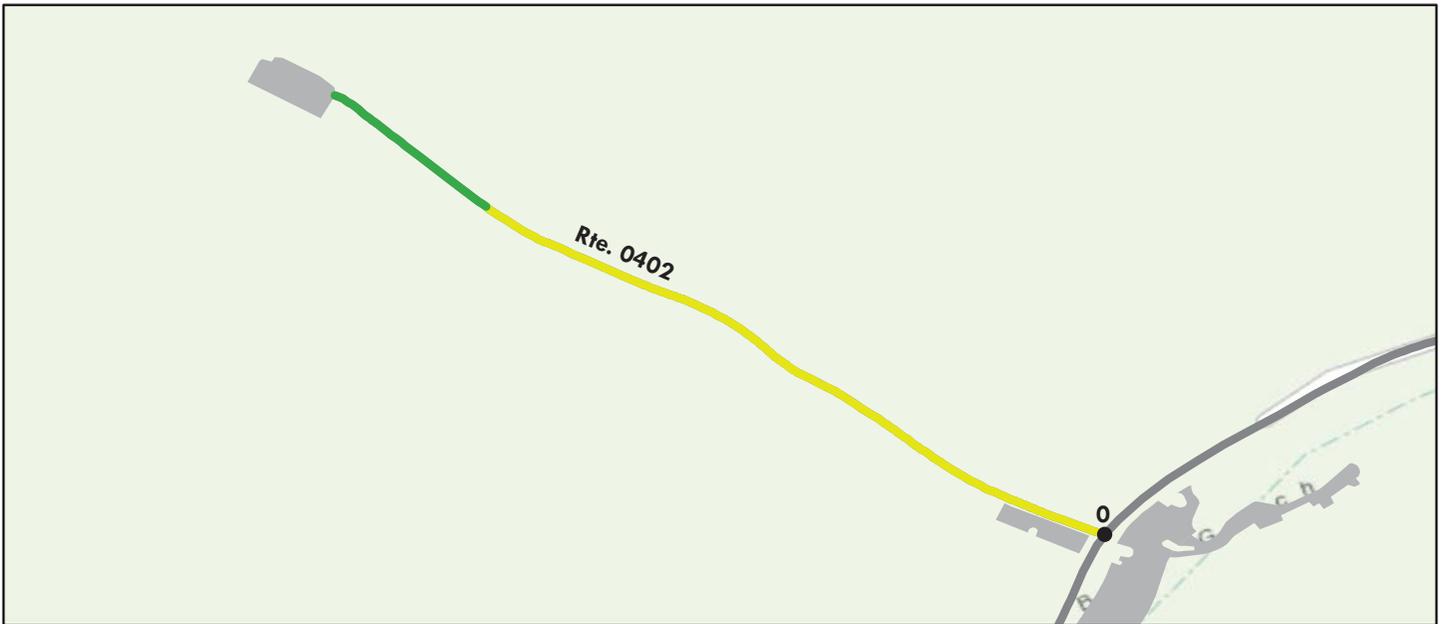
Data Collection Vehicle (DCV) Rating

Route Condition Legend – Pavement Condition Rating (PCR)						
Poor (0 - 60)	Fair (61- 84)	Good (85 - 94)	Excellent (95 - 100)	Not Rated		
See Appendix for definitions and formulas						
Inspection Date: 3/4/2015	Beginning Section MP	0				
Paved Length (Miles): 0.25	Section Length (MI)	0.25				
Surface Type: ASPHALT	Route Summary					
Roadway Condition Information						
Pavement Condition Rating (PCR)	83	83				
Surface Condition Rating (SCR)	83	83				
Roughness Condition Index (RCI)	N/A	N/A				
Distress Index Values						
Structural Crack Index	83	83				
Alligator Crack Index	100	100				
Longitudinal Crack Index	83	83				
Transverse Cracking Index	89	89				
Patching Index	100	100				
Rutting Index	96	96				
International Roughness Index (IRI)	N/A	N/A				
Lane & Width Information						
Number of Lanes	1	1				
Paved Width (ft)	12.6	12.6				
Lane Width (ft)	12.6	12.6

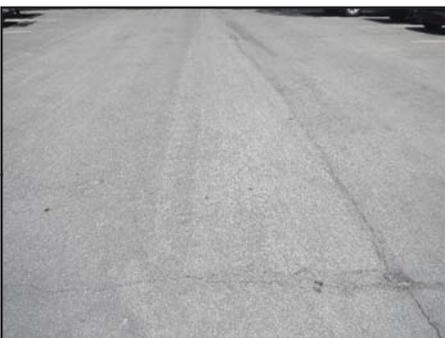
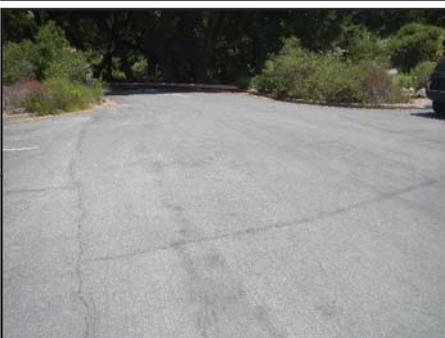
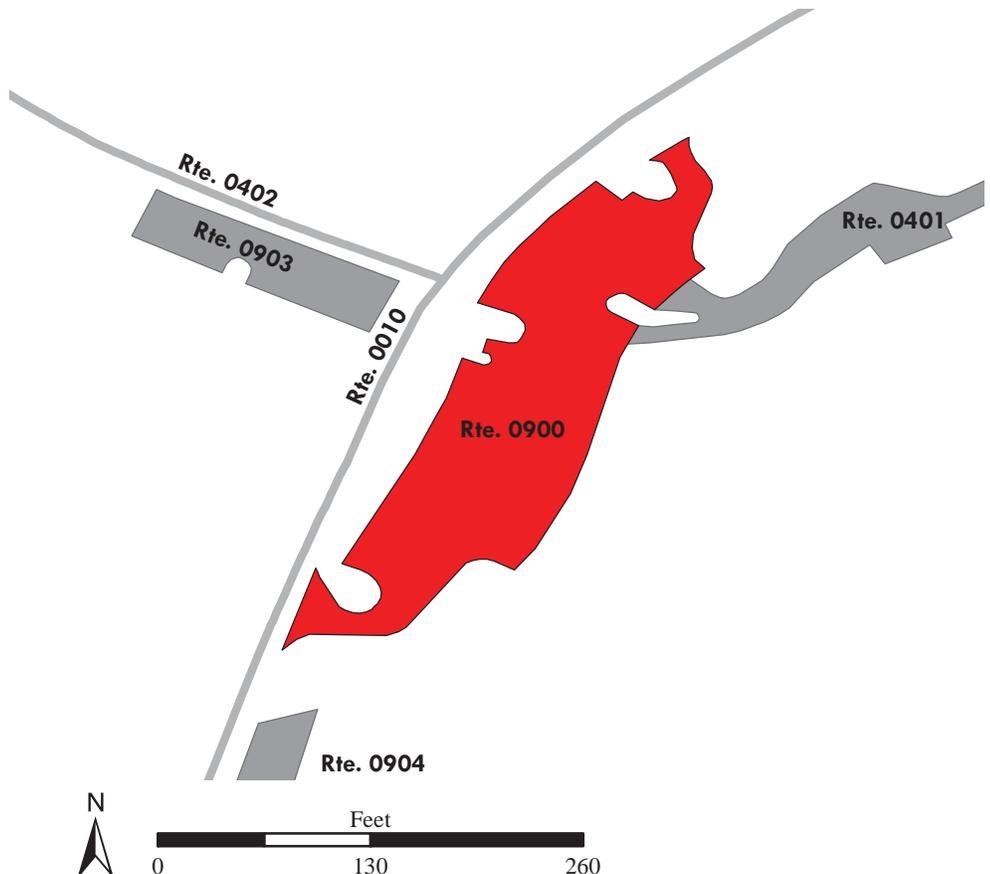
Inspection Date	FMSS Number	User Access	Surface Type
5/5/2014	59596	PUBLIC	ASPHALT
Area (Sq. Ft.)	Lane Miles (11' Widths)	Curb Reveal (Inches)	Curb Recommendation
20,825	0.359	NOT APPLICABLE	DO NOTHING
Curb Type		Curb & Gutter Type	
NO CURB		CONCRETE	
Pavement Recommendation		Condition Rating / PCR	
HEAVY 3R TREATMENTS		POOR / 53
