PIPE Cycle 6

Final Report

Road Inventory and Condition Assessment of Paved Routes Pipestone National Monument

Report Date: August 2019

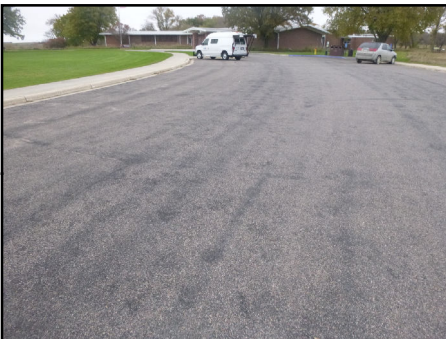
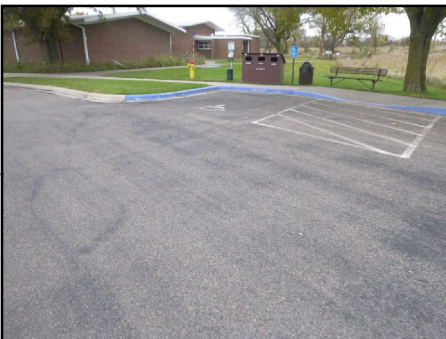
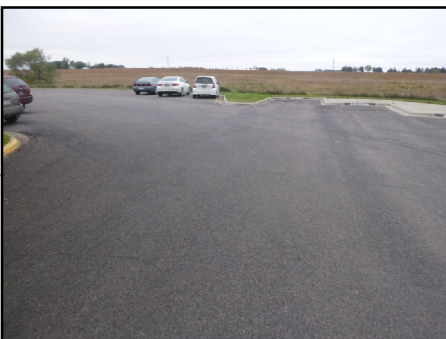
Inspection Date	FMSS Number	User Access	Surface Type
10/11/2018	62916	PUBLIC	ASPHALT
Area (Sq. Ft.)	Lane Miles (11' Widths)	Curb Reveal (Inches)	Curb Recommendation
39,013	0.672	NOT APPLICABLE	LIGHT REPAIR
Curb Type		Curb & Gutter Type	
NO CURB		CONCRETE	
Pavement Recommendation		Condition Rating / PCR	
PREVENTIVE MAINTENANCE		GOOD / 90

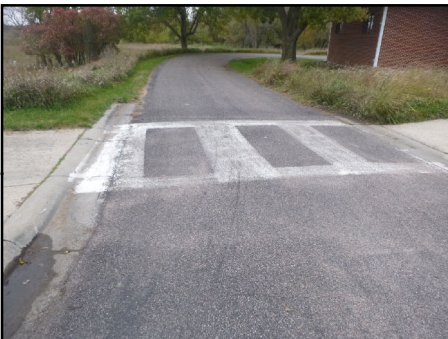
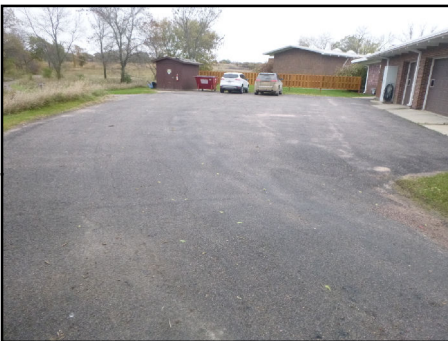
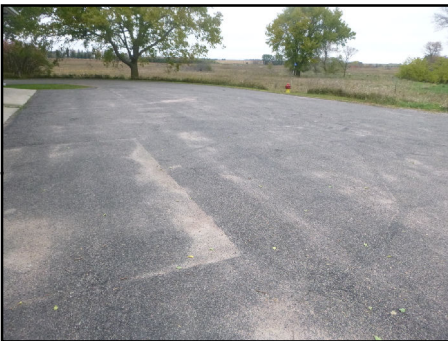
ROUTE 0901: MAINTENANCE AREA PARKING

Inspection Date	FMSS Number	User Access	Surface Type
10/11/2018	62919	NONPUBLIC	ASPHALT
Area (Sq. Ft.)	Lane Miles (11' Widths)	Curb Reveal (Inches)	Curb Recommendation
5,399	0.093	NOT APPLICABLE	DO NOTHING
Curb Type		Curb & Gutter Type	
NO CURB		CONCRETE	
Pavement Recommendation		Condition Rating / PCR	
LIGHT 3R TREATMENTS		FAIR / 73

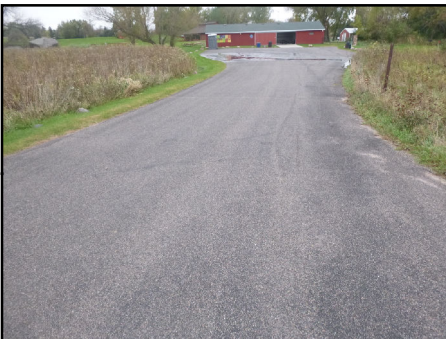
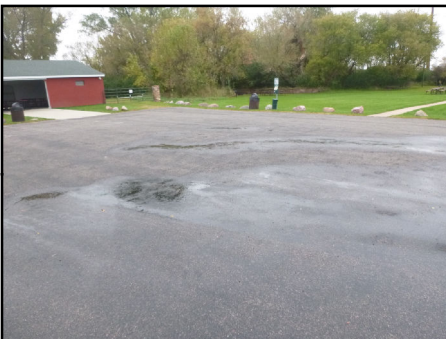
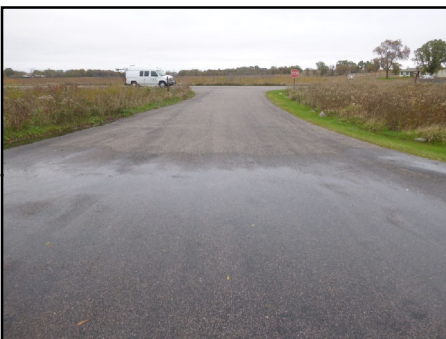
ROUTE 0902: PICNIC AREA PARKING

Inspection Date	FMSS Number	User Access	Surface Type
10/11/2018	62943	PUBLIC	ASPHALT
Area (Sq. Ft.)	Lane Miles (11' Widths)	Curb Reveal (Inches)	Curb Recommendation
8,004	0.138	NOT APPLICABLE	NOT APPLICABLE
Curb Type		Curb & Gutter Type	
NO CURB		NO CURB AND GUTTER	
Pavement Recommendation		Condition Rating / PCR	
LIGHT 3R TREATMENTS		FAIR / 73

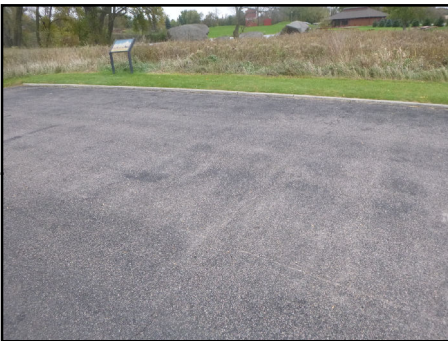
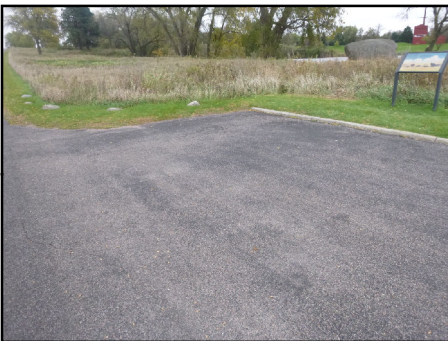
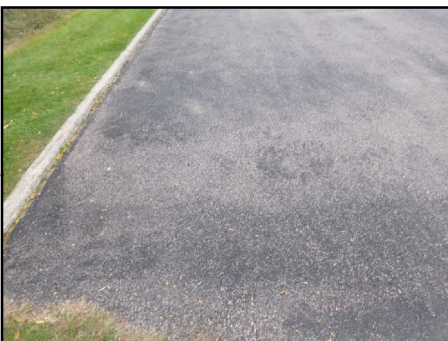
ROUTE 0903: THREE MAIDENS PARKING

Inspection Date	FMSS Number	User Access	Surface Type
10/11/2018	63198	PUBLIC	ASPHALT
Area (Sq. Ft.)	Lane Miles (11' Widths)	Curb Reveal (Inches)	Curb Recommendation
1,326	0.023	2	LIGHT REPAIR
Curb Type		Curb & Gutter Type	
CONCRETE		NO CURB AND GUTTER	
Pavement Recommendation		Condition Rating / PCR	
LIGHT 3R TREATMENTS		FAIR / 73
