PISP Cycle 6

Final Report

Road Inventory and Condition Assessment of Paved Routes Pipe Spring National Monument

Report Date: November 2016

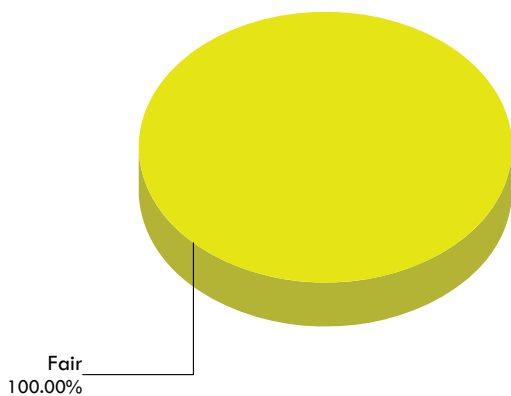
Figure 1: Pavement Condition Rating Breakdown for Paved Roads and Parking Areas

Parkwide Condition Percentages

Road Condition Percentages

Parking Area Condition Percentages

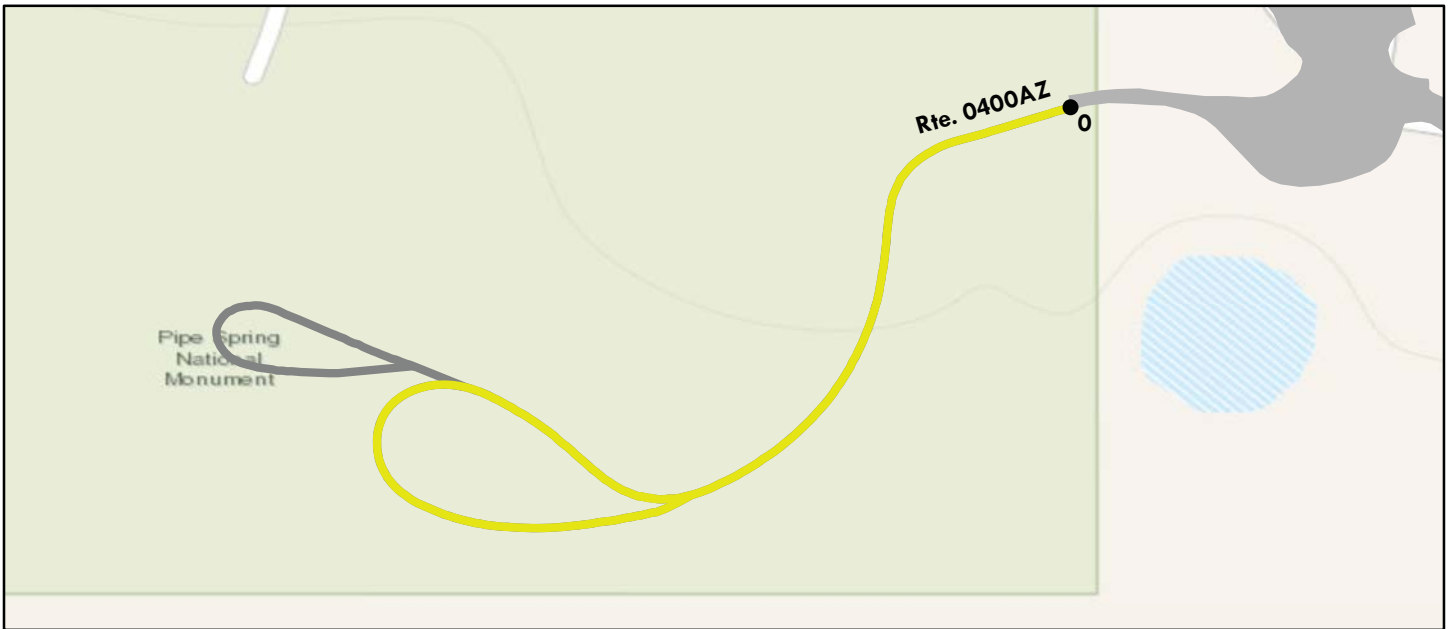
ROUTE 0400AZ: HOUSING AND MAINTENANCE ACCESS ROAD

Subcomponent of Route PISP-0400ZZ
Data Collection Vehicle (DCV) Rating

Route Condition Legend – Pavement Condition Rating (PCR)						
Poor (0 - 60)	Fair (61- 84)	Good (85 - 94)	Excellent (95 - 100)	Not Rated		
See Appendix for definitions and formulas						
Inspection Date: 7/6/2016	Beginning Section MP	0				
Paved Length (Miles): 0.19	Section Length (MI)	0.19				
Surface Type: ASPHALT	Route Summary					
Roadway Condition Information						
Pavement Condition Rating (PCR)	76	76				
Surface Condition Rating (SCR)	76	76				
Roughness Condition Index (RCI)	N/A	N/A				
Distress Index Values						
Structural Crack Index	76	76				
Alligator Crack Index	100	100				
Longitudinal Crack Index	76	76				
Transverse Cracking Index	78	78				
Patching Index	100	100				
Rutting Index	92	92				
International Roughness Index (IRI)	N/A	N/A				
Lane & Width Information						
Number of Lanes	2	2				
Paved Width (ft)	15.3	15.3				
Lane Width (ft)	7.6	7.6

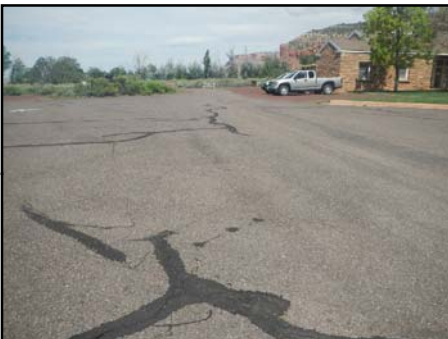
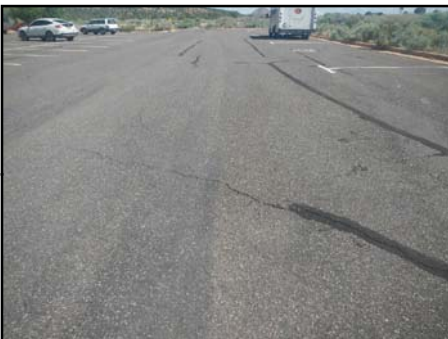
Inspection Date	FMSS Number	User Access	Surface Type
5/20/2016	75913	PUBLIC	ASPHALT
Area (Sq. Ft.)	Lane Miles (11' Widths)	Curb Reveal (Inches)	Curb Recommendation
38,472	0.662	NOT APPLICABLE	DO NOTHING
Curb Type		Curb & Gutter Type	
NO CURB		CONCRETE	
Pavement Recommendation		Condition Rating / PCR	
PREVENTIVE MAINTENANCE		GOOD / 90
