PUHE Cycle 6

Final Report

Road Inventory and Condition Assessment of Paved Routes Pu'ukohola Heiau National Historic Site

**Federal Highway Administration
Eastern Federal Lands Highway Division
Road Inventory Program (RIP)**

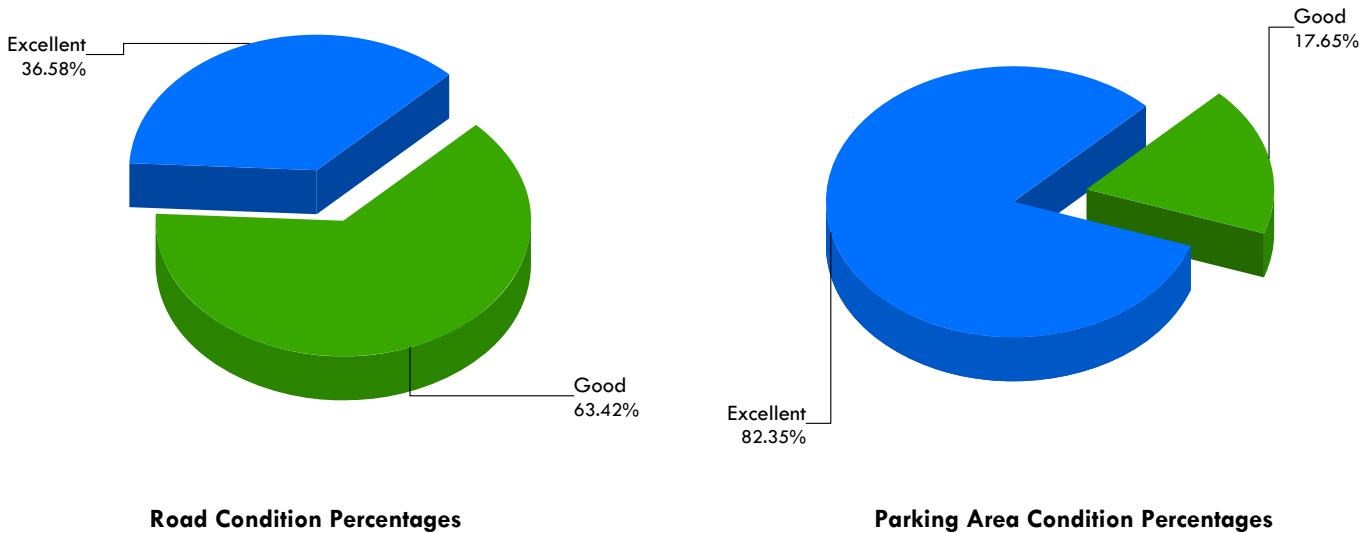
Figure 1: Pavement Condition Rating Breakdown for Paved Roads and Parking Areas

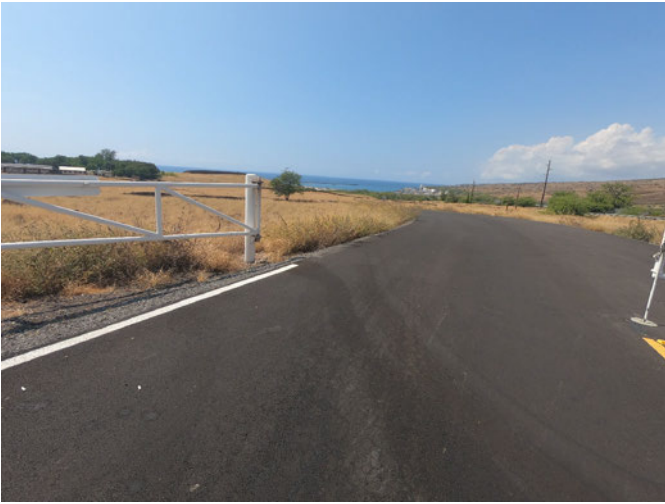
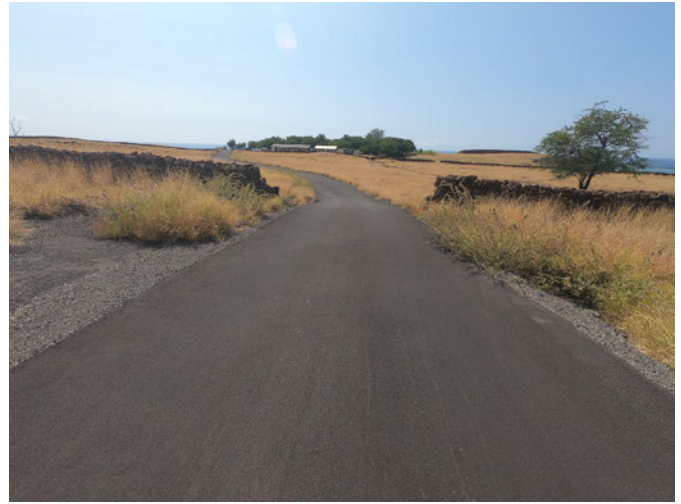
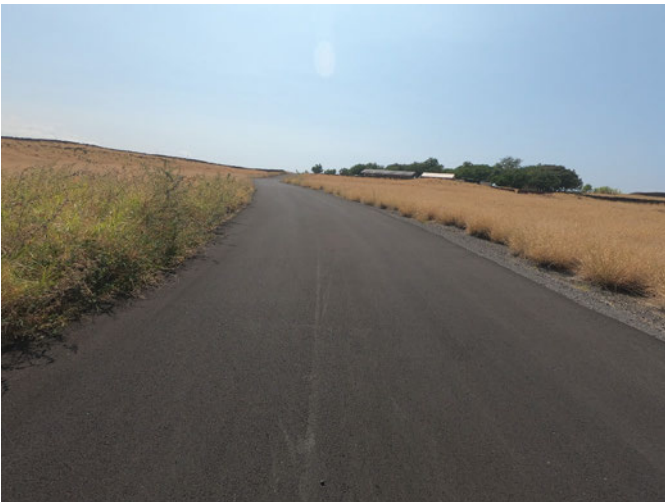
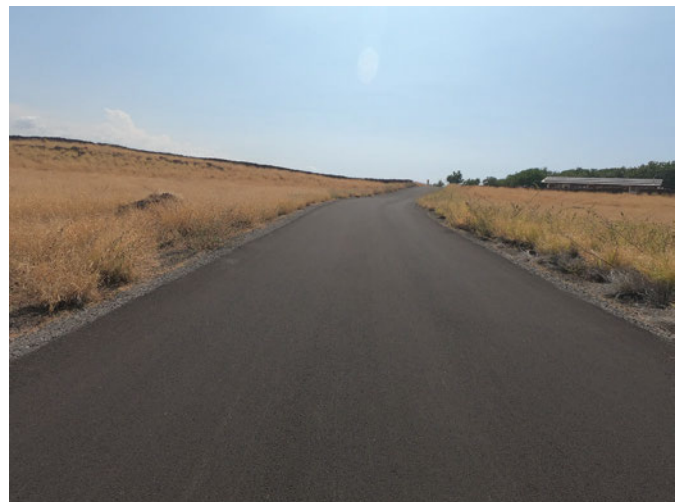
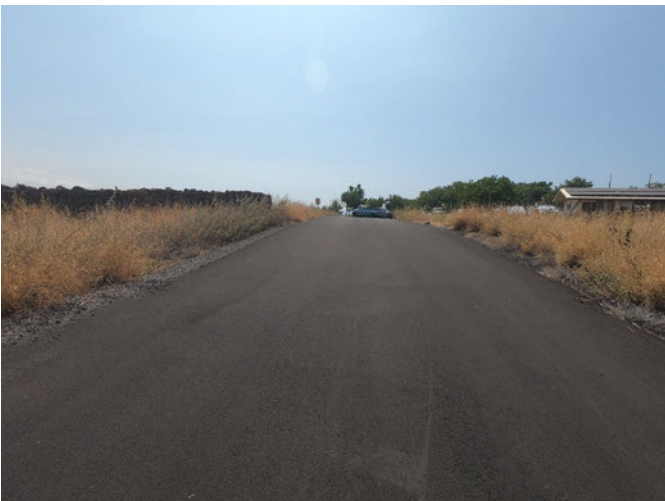
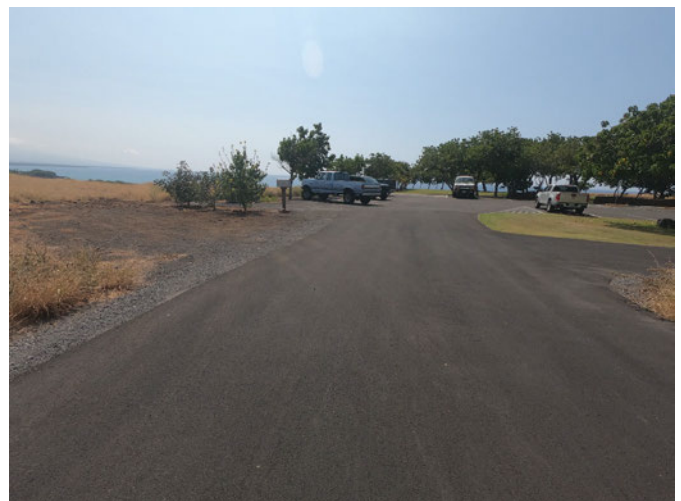
ROUTE 0010: PARK HEADQUARTERS ENTRANCE ROAD

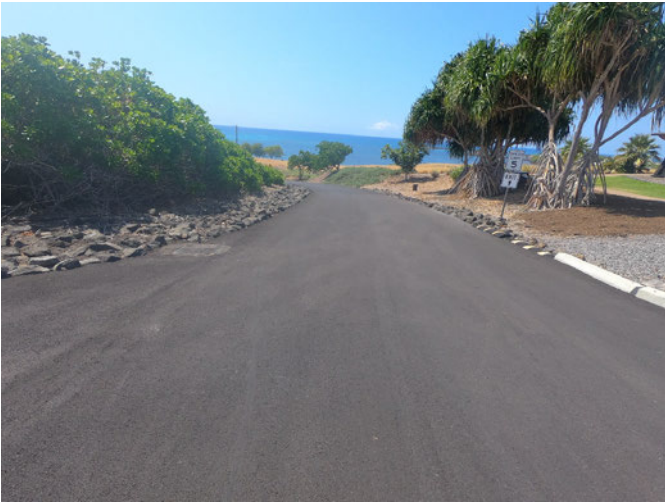
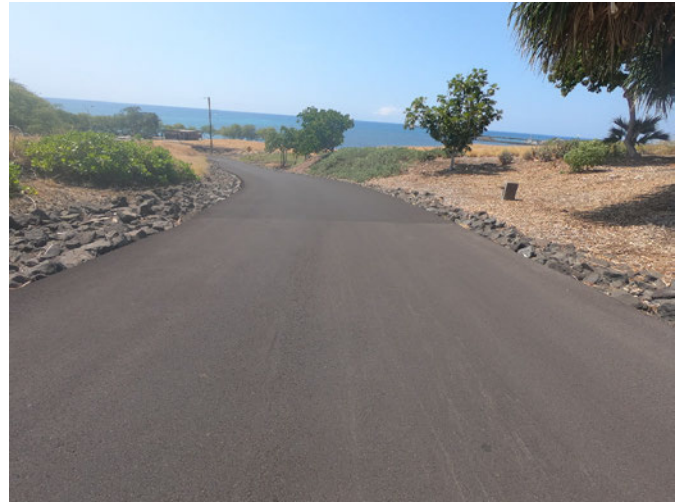
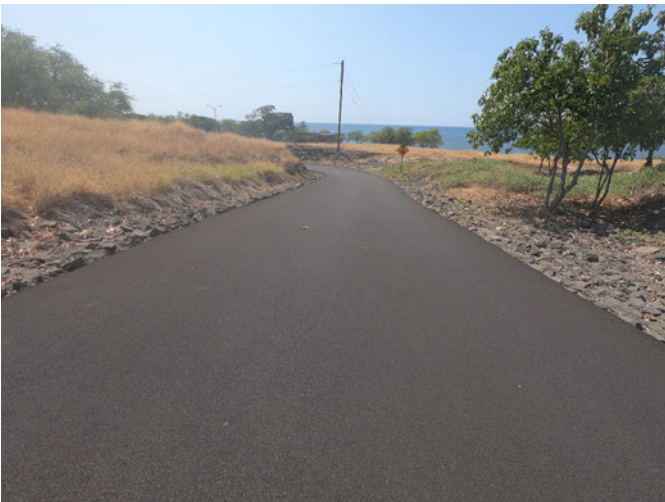
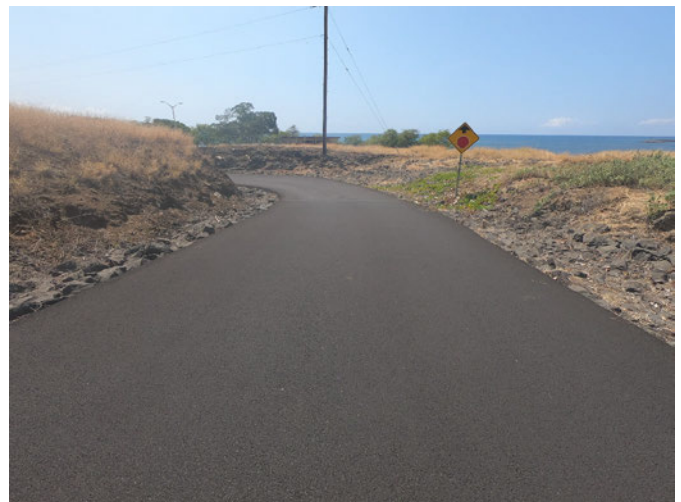
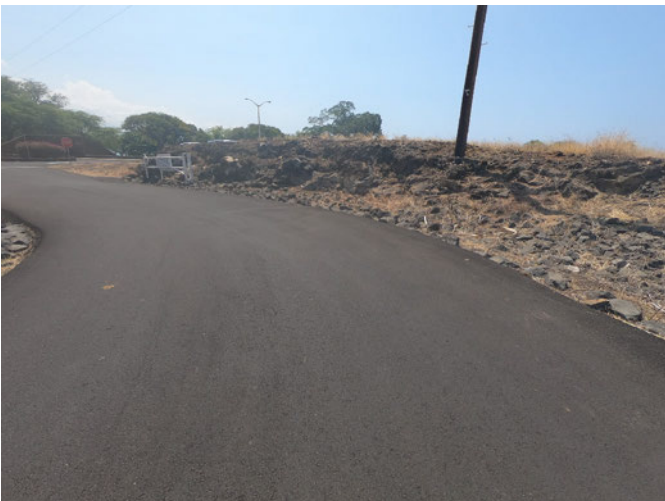
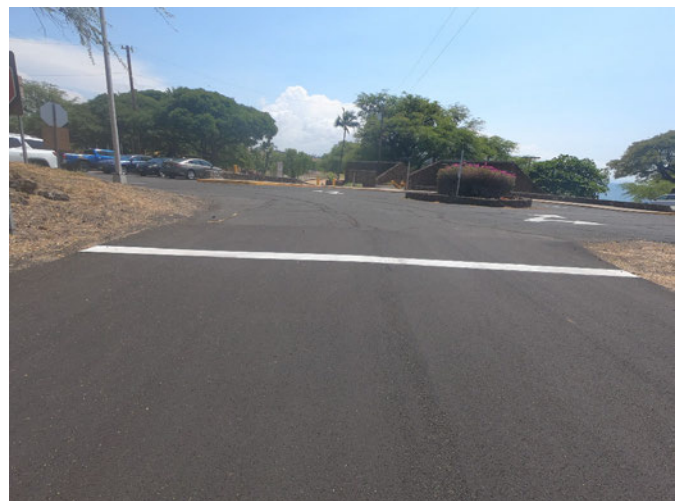
ROUTE 0011: VISITOR CENTER EXIT ROAD

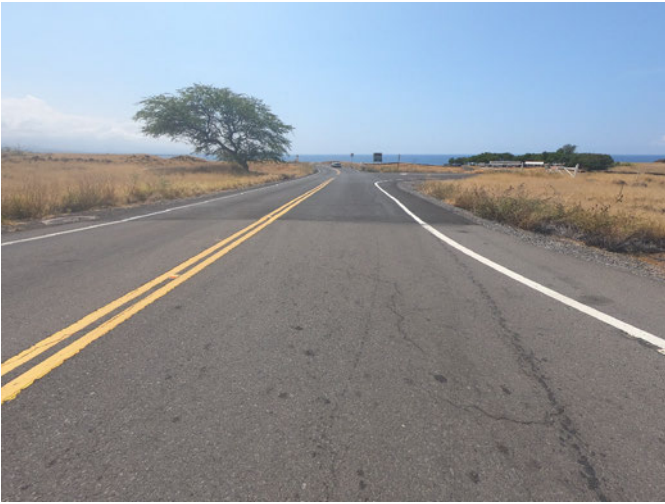
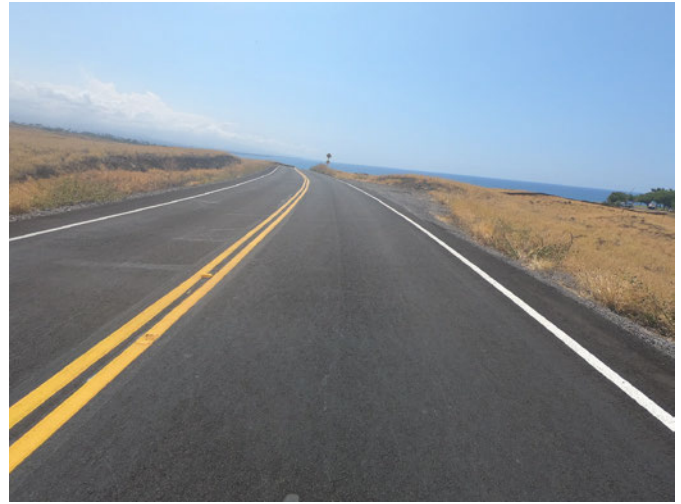
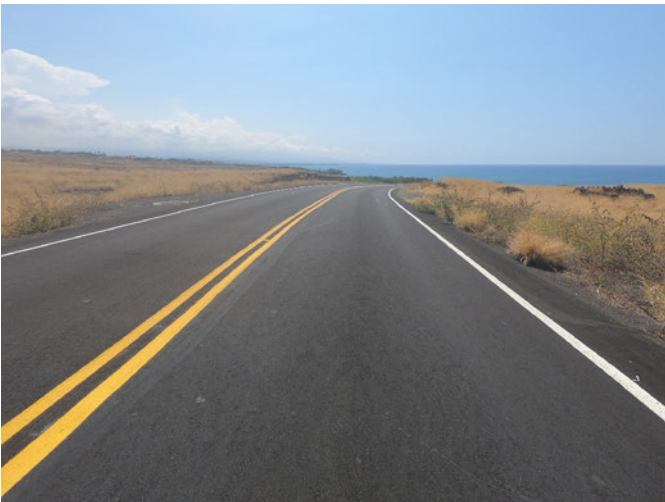
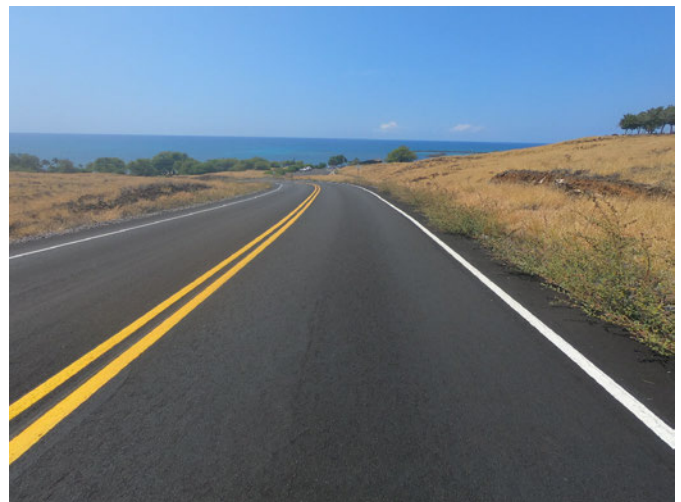
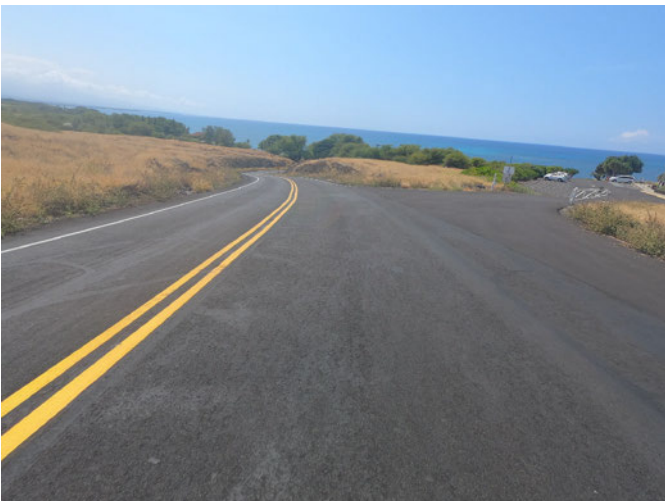
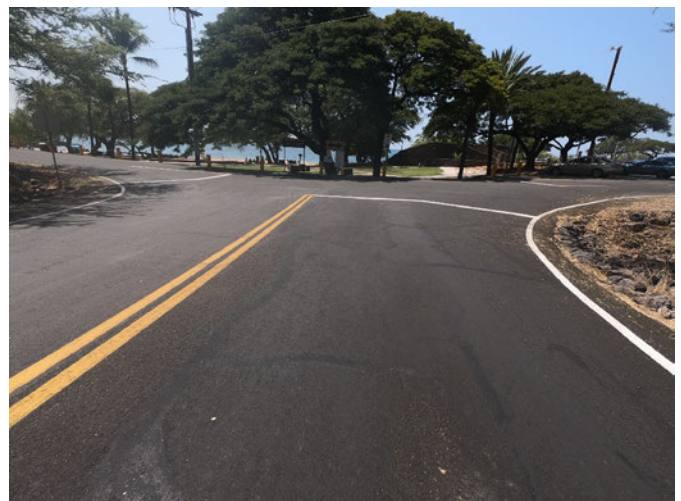
Inspection Date: 3/9/2022	Beginning Section MP	0.00				
Paved Length (Miles): 0.36	Section Length (MI)	0.36				
Surface Type: ASPHALT	Route Summary					
Roadway Condition Information						
Pavement Condition Rating (PCR)	90	90				
Surface Condition Rating (SCR)	90	90				
Roughness Condition Index (RCI)	N/A	N/A				
Distress Index Values						
Structural Crack Index	N/A	N/A				
Alligator Crack Index	97	97				
Longitudinal Crack Index	97	97				
Transverse Cracking Index	90	90				
Patching Index	97	97				
Rutting Index	97	97				
International Roughness Index (IRI)	N/A	N/A				
Lane & Width Information						
Number of Lanes	2	2				
Paved Width (ft)	28.6	28.6				
Lane Width (ft)	12	12

ROUTE 0100: SPENCER BEACH PARK ROAD

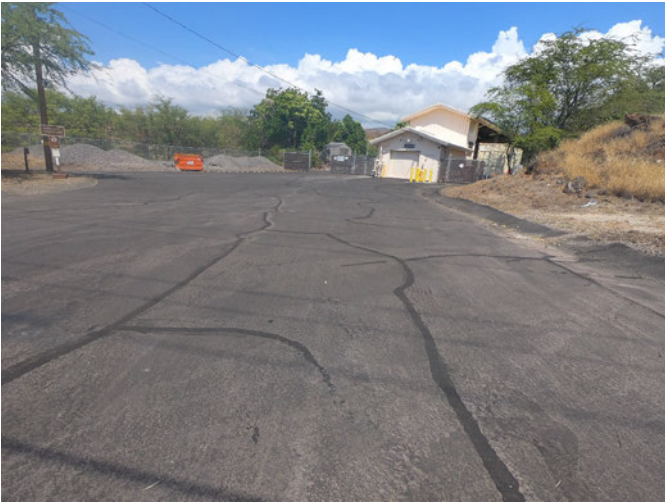
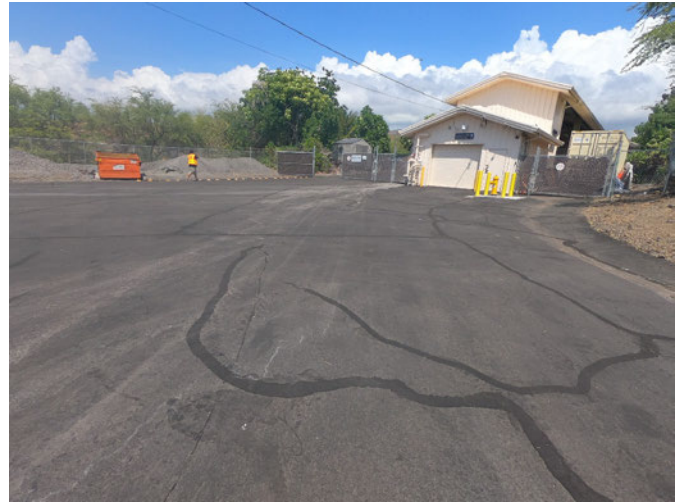
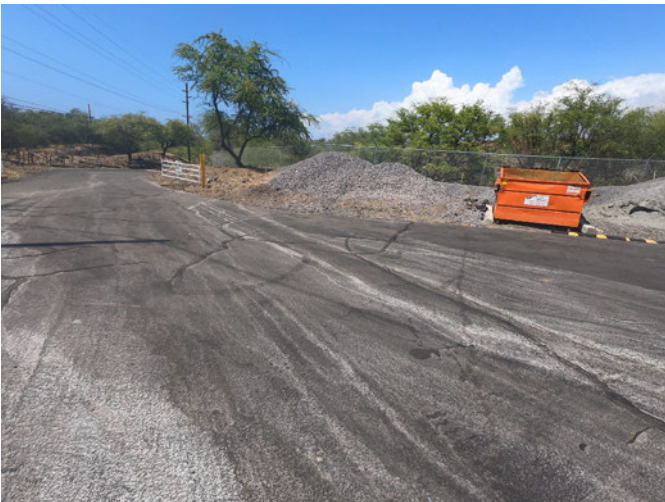
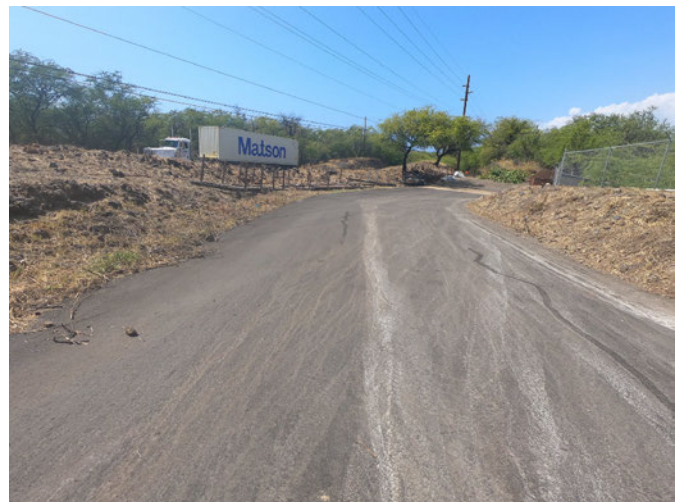
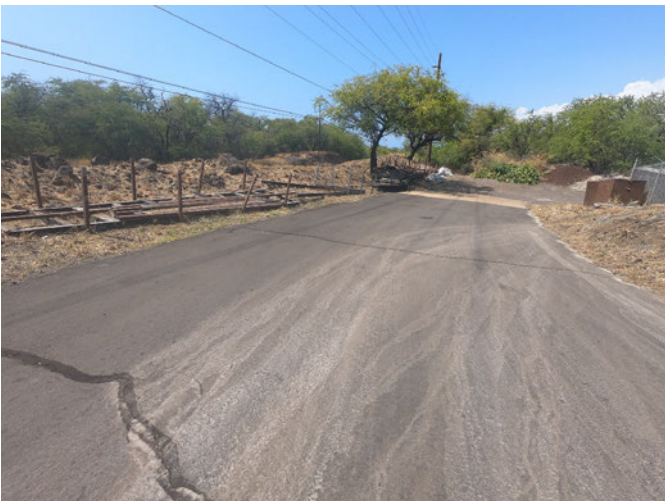
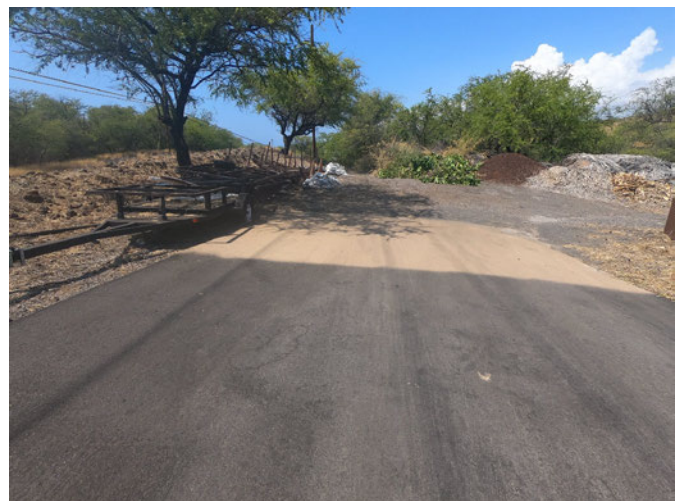
Inspection Date: 3/9/2022	Beginning Section MP	0.00				
Paved Length (Miles): 0.05	Section Length (MI)	0.05				
Surface Type: ASPHALT	Route Summary					
Roadway Condition Information						
Pavement Condition Rating (PCR)	90	90				
Surface Condition Rating (SCR)	90	90				
Roughness Condition Index (RCI)	N/A	N/A				
Distress Index Values						
Structural Crack Index	N/A	N/A				
Alligator Crack Index	97	97				
Longitudinal Crack Index	90	90				
Transverse Cracking Index	90	90				
Patching Index	97	97				
Rutting Index	97	97				
International Roughness Index (IRI)	N/A	N/A				
Lane & Width Information						
Number of Lanes	2	2				
Paved Width (ft)	30	30				
Lane Width (ft)	11	11

ROUTE 0400: MAINTENANCE FACILITY ACCESS ROAD

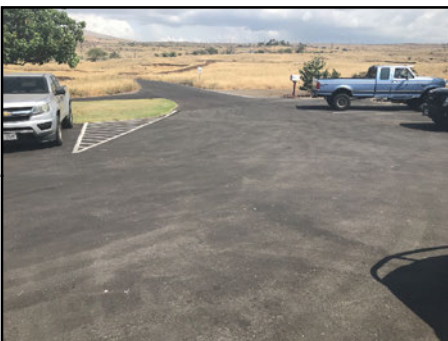
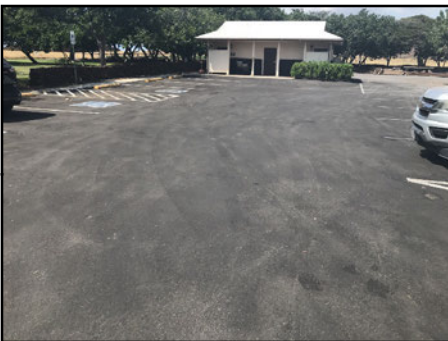
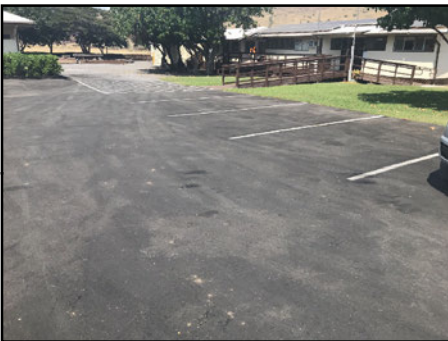
Inspection Date	FMSS Number	User Access	Surface Type
3/9/2022	104734	PUBLIC	ASPHALT
Area (Sq. Ft.)	Lane Miles (11' Widths)	Curb Reveal (Inches)	Curb Recommendation
8,248	0.142	5	DO NOTHING
Curb Type		Curb & Gutter Type	
STONE		NO CURB AND GUTTER	
Pavement Recommendation		Condition Rating / PCR	
DO NOTHING		EXCELLENT / 97

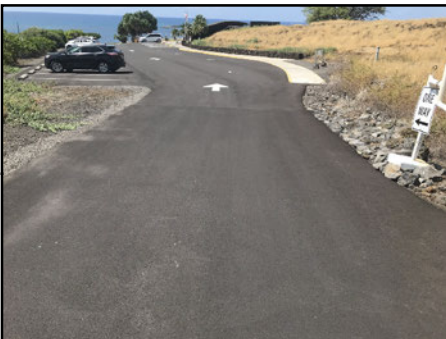
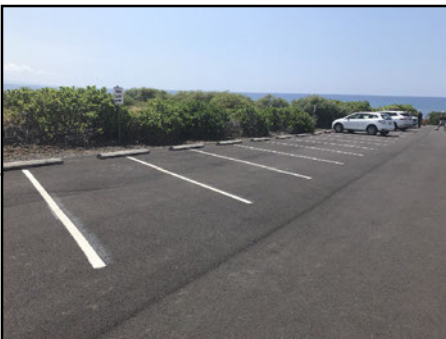
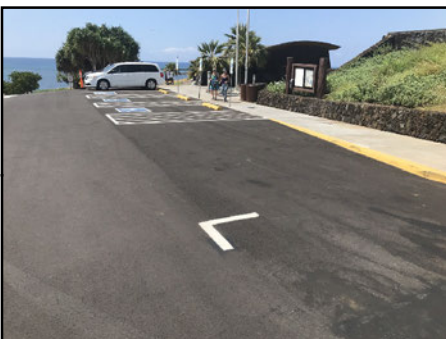
ROUTE 0901: VISITOR CENTER PARKING

Inspection Date	FMSS Number	User Access	Surface Type
3/9/2022	108664	PUBLIC	ASPHALT
Area (Sq. Ft.)	Lane Miles (11' Widths)	Curb Reveal (Inches)	Curb Recommendation
18,806	0.324	5	DO NOTHING
Curb Type		Curb & Gutter Type	
CONCRETE		NO CURB AND GUTTER	
Pavement Recommendation		Condition Rating / PCR	
DO NOTHING		EXCELLENT / 97

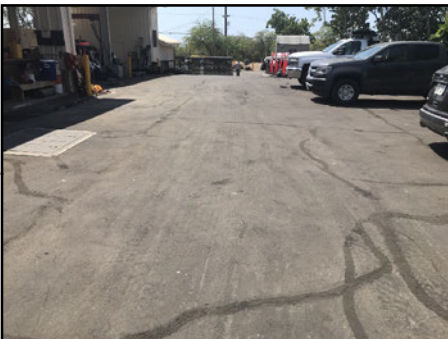
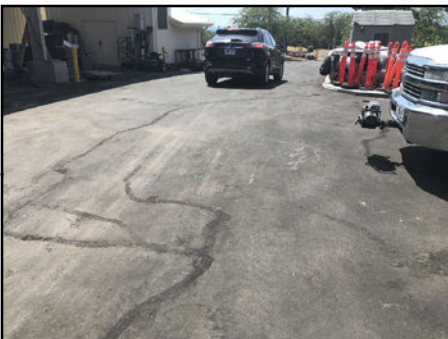
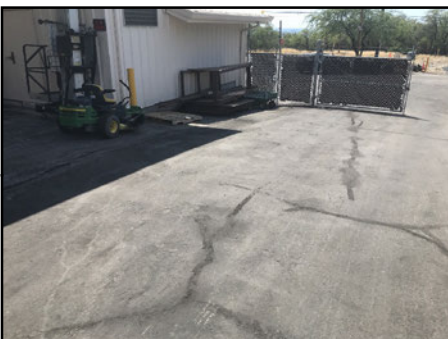
ROUTE 0902: MAINTENANCE FACILITY PARKING AREA

Inspection Date	FMSS Number	User Access	Surface Type
3/9/2022	108667	NONPUBLIC	ASPHALT
Area (Sq. Ft.)	Lane Miles (11' Widths)	Curb Reveal (Inches)	Curb Recommendation
5,798	0.1	4	LIGHT REPAIR
Curb Type		Curb & Gutter Type	
CONCRETE		NO CURB AND GUTTER	
Pavement Recommendation		Condition Rating / PCR	
PREVENTIVE MAINTENANCE		GOOD / 90
