REDW Cycle 6

Final Report

Road Inventory and Condition Assessment of Paved Routes Redwood National Park

Report Date: September 2015

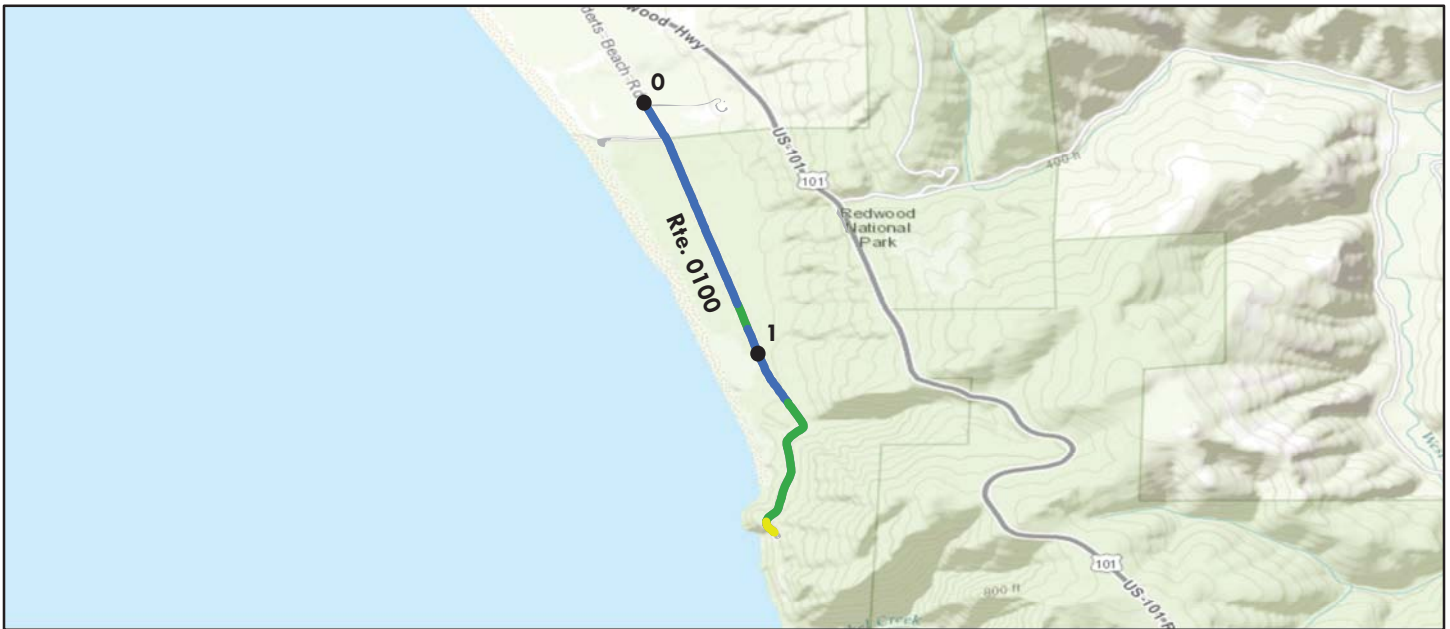
ROUTE 0100: ENDERTS BEACH ROAD

Route Condition Legend – Pavement Condition Rating (PCR)						
Poor (0 - 60)	Fair (61- 84)	Good (85 - 94)	Excellent (95 - 100)	Not Rated		
See Appendix for definitions and formulas						
Inspection Date: 1/15/2015	Beginning Section MP	0	1			
Paved Length (Miles): 1.74	Section Length (MI)	1	0.74			
Surface Type: ASPHALT	Route Summary					
Roadway Condition Information						
Pavement Condition Rating (PCR)	95	97	92			
Surface Condition Rating (SCR)	97	98	96			
Roughness Condition Index (RCI)	92	96	86			
Distress Index Values						
Structural Crack Index	99	99	99			
Alligator Crack Index	100	100	100			
Longitudinal Crack Index	99	99	99			
Transverse Cracking Index	100	100	100			
Patching Index	100	100	100			
Rutting Index	97	98	96			
International Roughness Index (IRI)	136	124	152			
Lane & Width Information						
Number of Lanes	2	2	2			
Paved Width (ft)	21.2	21.6	20.7			
Lane Width (ft)	10.7	11.1	10.2

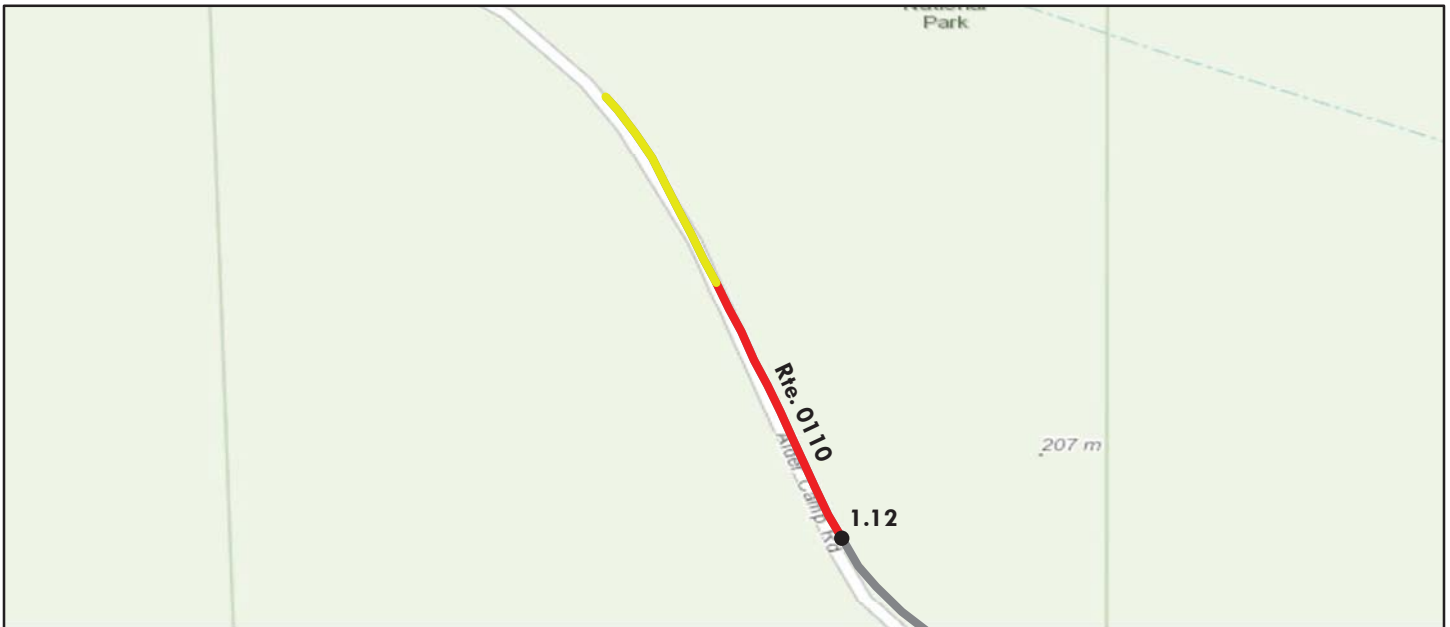
ROUTE 0110: RED ALDER ROAD

Route Condition Legend – Pavement Condition Rating (PCR)						
Poor (0 - 60)	Fair (61- 84)	Good (85 - 94)	Excellent (95 - 100)	Not Rated		
See Appendix for definitions and formulas						
Inspection Date: 1/15/2015	Beginning Section MP	1.12				
Paved Length (Miles): 0.18	Section Length (MI)	0.18				
Surface Type: ASPHALT	Route Summary					
Roadway Condition Information						
Pavement Condition Rating (PCR)	64	64				
Surface Condition Rating (SCR)	64	64				
Roughness Condition Index (RCI)	N/A	N/A				
Distress Index Values						
Structural Crack Index	64	64				
Alligator Crack Index	100	100				
Longitudinal Crack Index	64	64				
Transverse Cracking Index	75	75				
Patching Index	100	100				
Rutting Index	100	100				
International Roughness Index (IRI)	N/A	N/A				
Lane & Width Information						
Number of Lanes	2	2				
Paved Width (ft)	22.1	22.2				
Lane Width (ft)	11.6	11.6

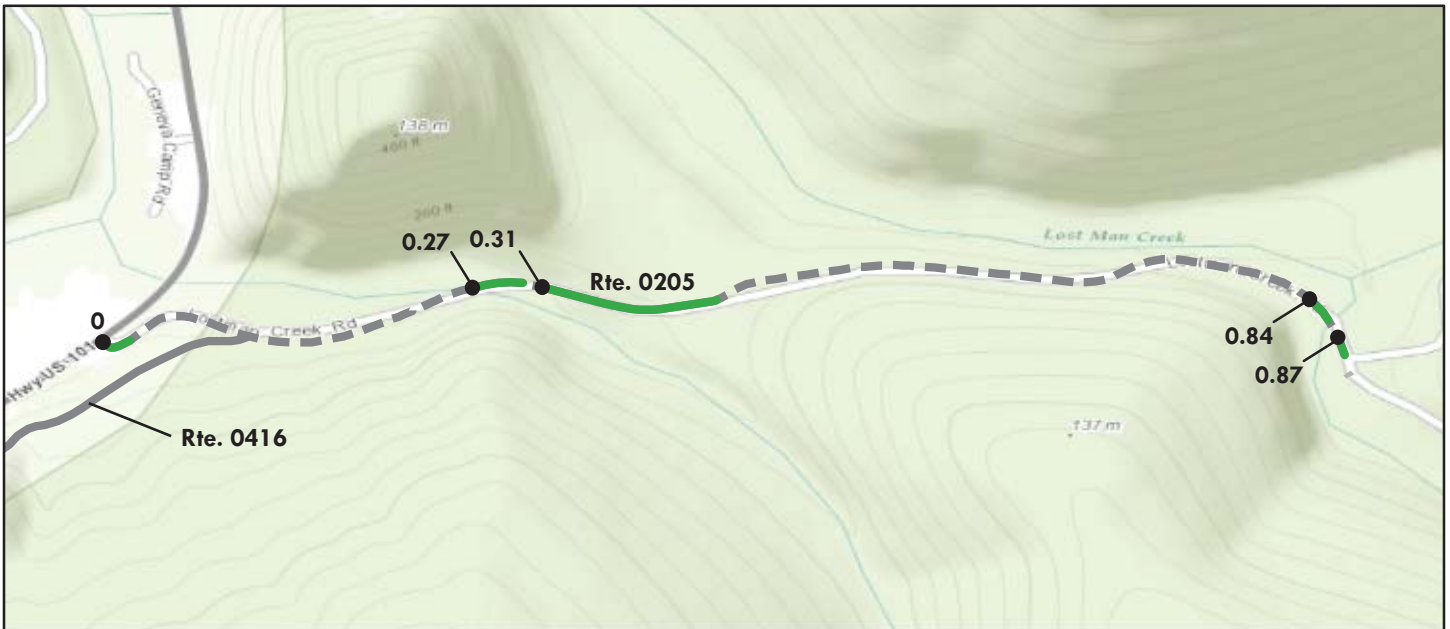
Manual Rating

Route Condition Legend – Pavement Condition Rating (PCR)							
Poor (0 - 60)	Fair (61- 84)	Good (85 - 94)	Excellent (95 - 100)	Not Rated			
See Appendix for definitions and formulas							
Inspection Date:	11/10/2014	Beginning Section MP	0.00	0.27	0.31	0.84	0.87
Paved Length (Miles):	0.21	Section Length (MI)	0.02	0.03	0.12	0.02	0.02
Surface Type:	ASPHALT	Route Summary					
Roadway Condition Information							
Pavement Condition Rating (PCR)	90	90	90	90	90	90	90
Surface Condition Rating (SCR)	90	90	90	90	90	90	90
Roughness Condition Index (RCI)	N/A	N/A	N/A	N/A	N/A	N/A	N/A
Distress Index Values							
Structural Crack Index	N/A	N/A	N/A	N/A	N/A	N/A	N/A
Alligator Crack Index	96	90	97	97	97	97	97
Longitudinal Crack Index	96	90	97	97	97	97	97
Transverse Cracking Index	90	90	90	90	90	90	90
Patching Index	97	97	97	97	97	97	97
Rutting Index	96	90	97	97	97	97	97
International Roughness Index (IRI)	N/A	N/A	N/A	N/A	N/A	N/A	N/A

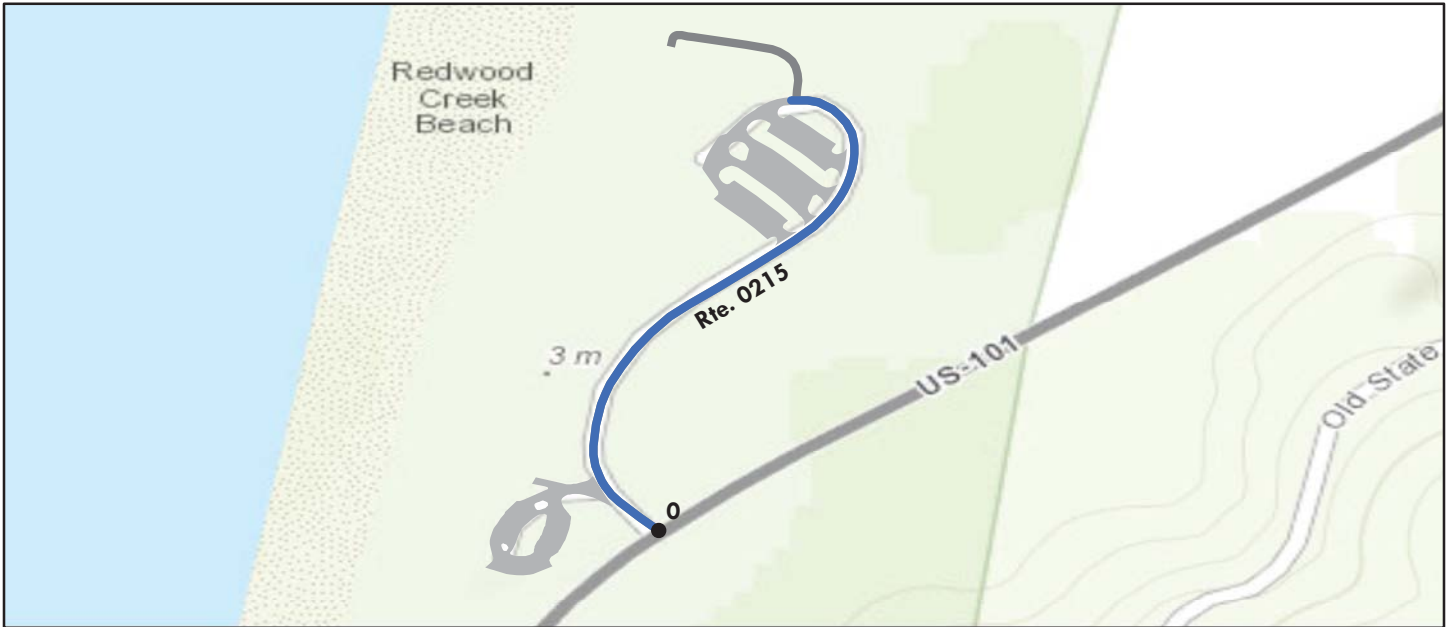
ROUTE 0215: THOMAS KUCHEL VISITOR CENTER ACCESS ROAD

Route Condition Legend – Pavement Condition Rating (PCR)						
Poor (0 - 60)	Fair (61- 84)	Good (85 - 94)	Excellent (95 - 100)	Not Rated		
See Appendix for definitions and formulas						
Inspection Date: 1/15/2015	Beginning Section MP	0				
Paved Length (Miles): 0.26	Section Length (MI)	0.26				
Surface Type: ASPHALT	Route Summary					
Roadway Condition Information						
Pavement Condition Rating (PCR)	97	97				
Surface Condition Rating (SCR)	97	97				
Roughness Condition Index (RCI)	N/A	N/A				
Distress Index Values						
Structural Crack Index	100	100				
Alligator Crack Index	100	100				
Longitudinal Crack Index	100	100				
Transverse Cracking Index	100	100				
Patching Index	100	100				
Rutting Index	97	97				
International Roughness Index (IRI)	N/A	N/A				
Lane & Width Information						
Number of Lanes	2	2				
Paved Width (ft)	22.1	22.1				
Lane Width (ft)	10.1	10.1

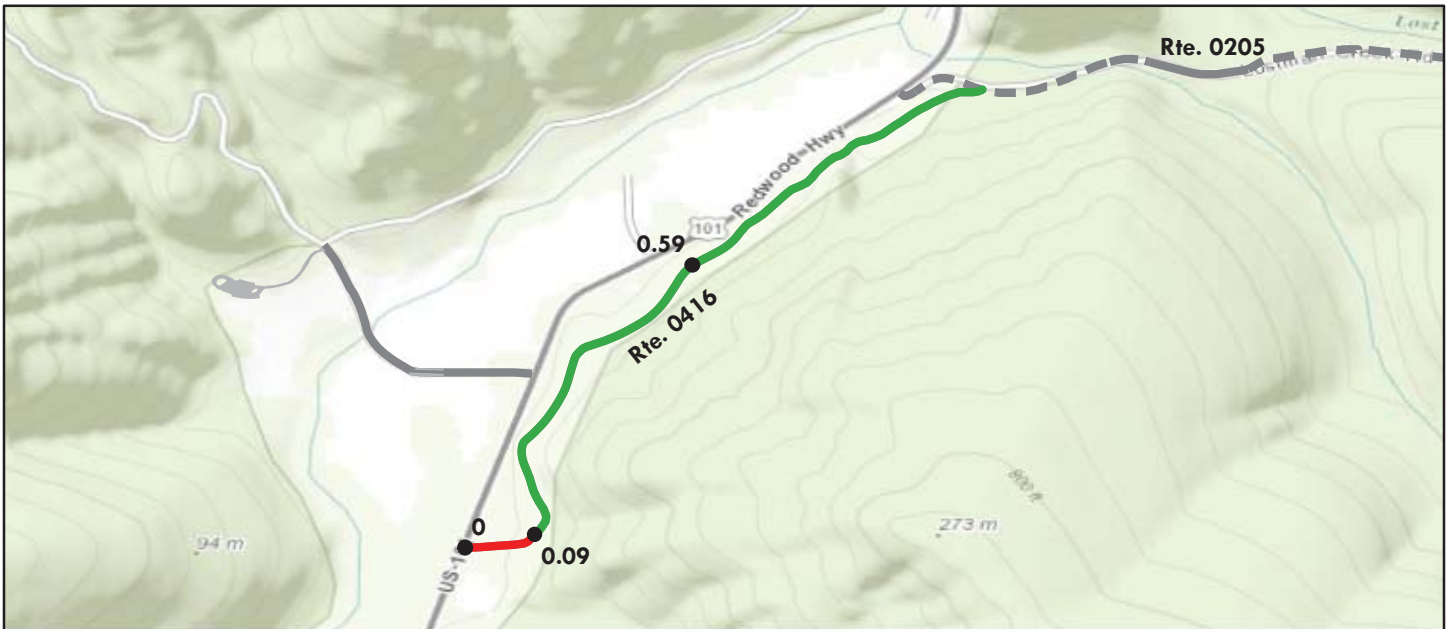
Manual Rating

Route Condition Legend – Pavement Condition Rating (PCR)						
Poor (0 - 60)	Fair (61- 84)	Good (85 - 94)	Excellent (95 - 100)	Not Rated		
See Appendix for definitions and formulas						
Inspection Date: 1/15/2015	Beginning Section MP	0.00	0.09	0.59		
Paved Length (Miles): 1.03	Section Length (MI)	0.09	0.50	0.44		
Surface Type: ASPHALT	Route Summary					
Roadway Condition Information						
Pavement Condition Rating (PCR)	85	30	90	90		
Surface Condition Rating (SCR)	85	30	90	90		
Roughness Condition Index (RCI)	N/A	N/A	N/A	N/A		
Distress Index Values						
Structural Crack Index	N/A	N/A	N/A	N/A		
Alligator Crack Index	87	30	97	97		
Longitudinal Crack Index	85	53	90	90		
Transverse Cracking Index	85	53	90	97		
Patching Index	97	97	97	97		
Rutting Index	97	97	97	97		
International Roughness Index (IRI)	N/A	N/A	N/A	N/A		
Lane & Width Information						
Number of Lanes	1	1	1	1		
Paved Width (ft)	9.5	15	9	9		
Lane Width (ft)	9.5	15	9	9

Route was manually rated because there were low hanging branches that could damage the Data Collection Vehicle. Roughness data was not collected because this route is a low speed road.

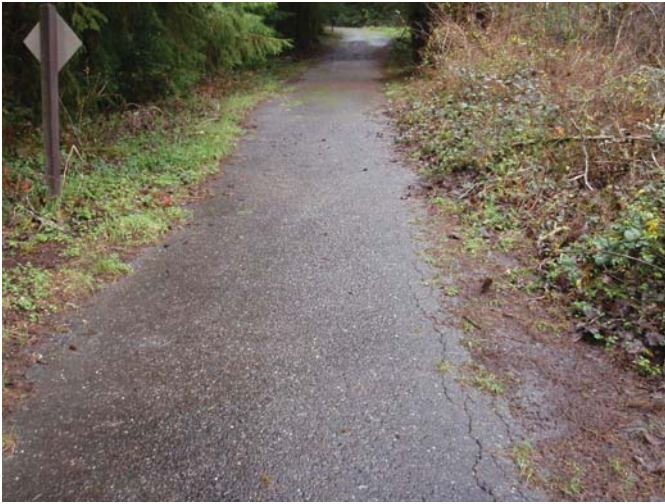
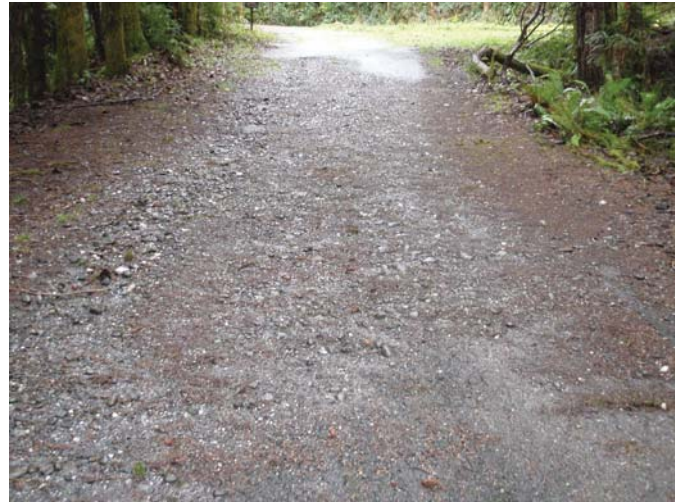
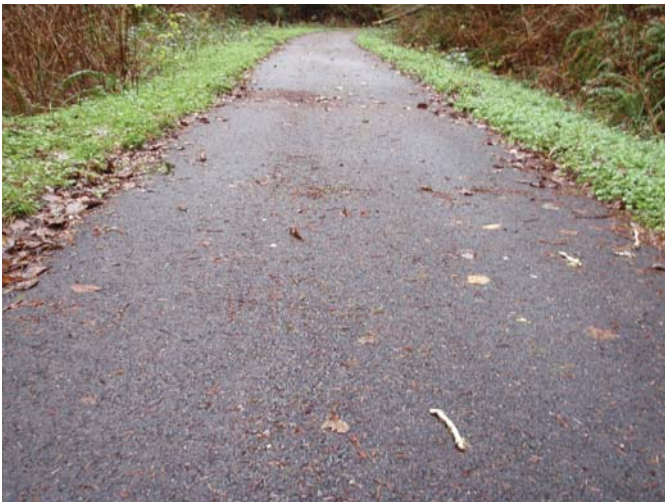
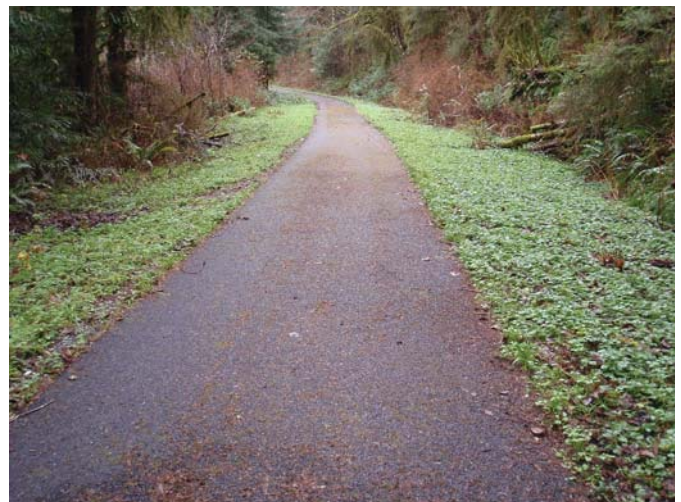
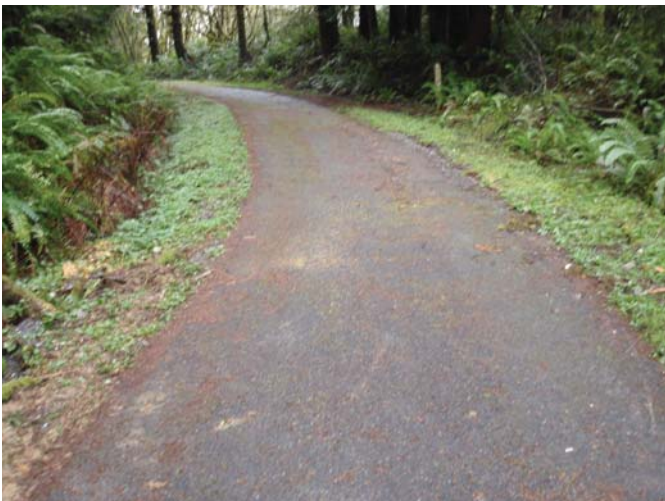
Condition Photos

Route No.	FMSS No.	Route Name	Functional Class	Surf. Type	Paved Length (Miles)	Pavement Condition Rating (PCR)	Roughness Condition Index (RCI)	Surface Condition Rating (SCR)	Structural Crack Index	Alligator Crack Index	Longitudinal Cracking Index	Transverse Cracking Index	Patch / Pothole Index	Rutting Index
REDW-0205	15653	LOST MAN CREEK ROAD	3	AS	0.21	90	NR	90	NR	96	96	90	97	96
REDW-0416	3445	OFF HIGHWAY ROAD	6	AS	1.03	87	NR	87	NR	91	87	90	97	97

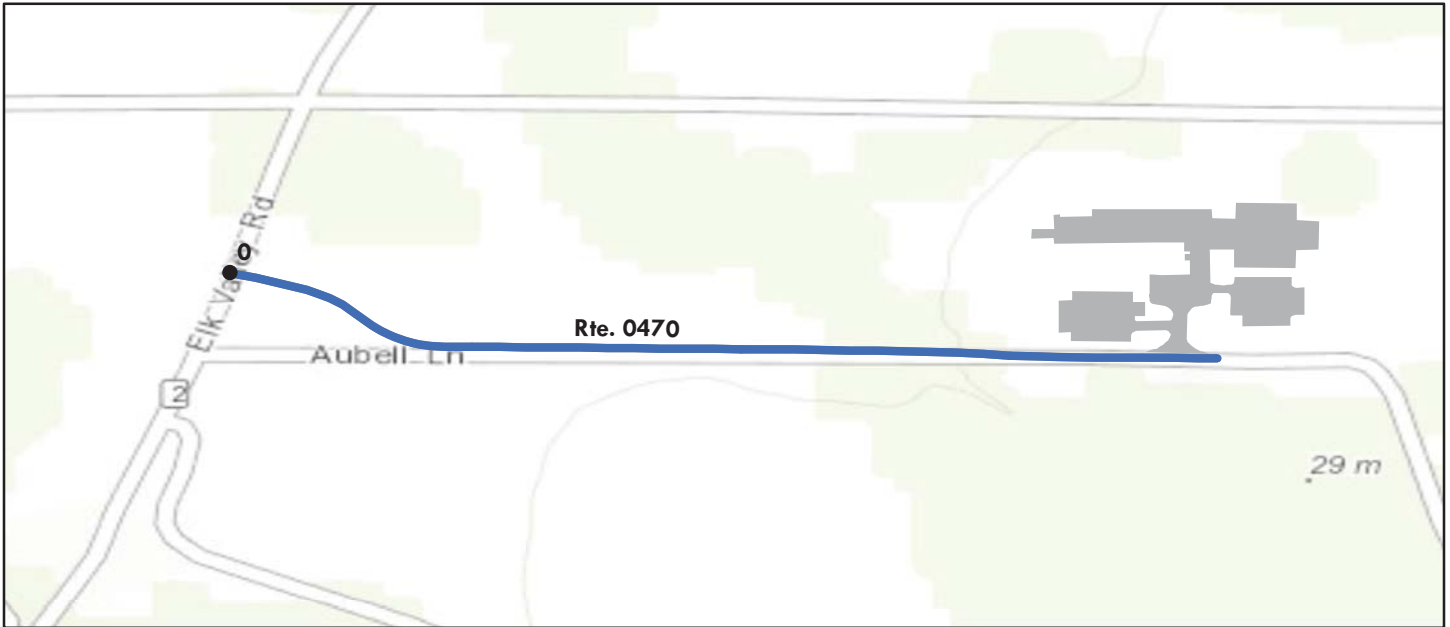
ROUTE 0470: AUBELL LANE/ NOC MAINTENANCE ROAD

Route Condition Legend – Pavement Condition Rating (PCR)						
Poor (0 - 60)	Fair (61- 84)	Good (85 - 94)	Excellent (95 - 100)	Not Rated		
See Appendix for definitions and formulas						
Inspection Date: 1/15/2015	Beginning Section MP	0				
Paved Length (Miles): 0.38	Section Length (MI)	0.38				
Surface Type: ASPHALT	Route Summary					
Roadway Condition Information						
Pavement Condition Rating (PCR)	100	100				
Surface Condition Rating (SCR)	100	100				
Roughness Condition Index (RCI)	N/A	N/A				
Distress Index Values						
Structural Crack Index	100	100				
Alligator Crack Index	100	100				
Longitudinal Crack Index	100	100				
Transverse Cracking Index	100	100				
Patching Index	100	100				
Rutting Index	100	100				
International Roughness Index (IRI)	N/A	N/A				
Lane & Width Information						
Number of Lanes	2	2				
Paved Width (ft)	25	25				
Lane Width (ft)	12.5	12.5

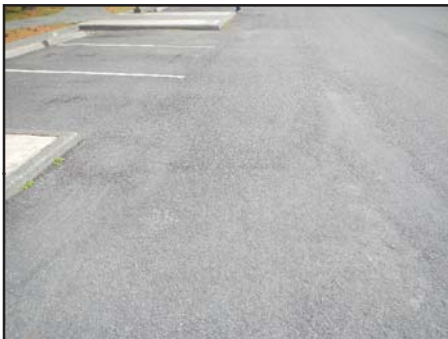
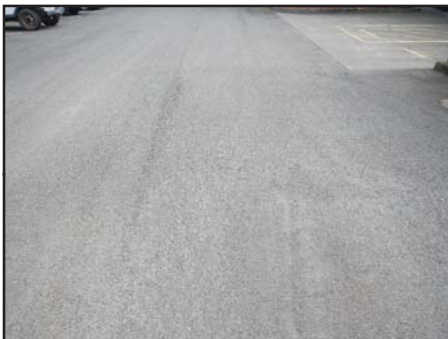
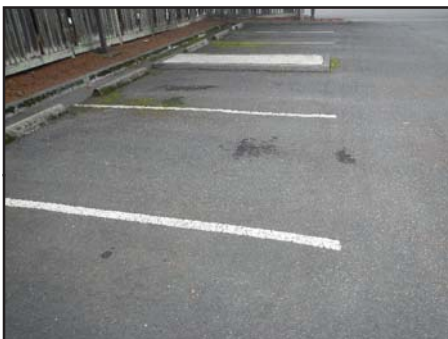
Parking area consists of multiple surface types: 1 part Asphalt at 10,463 square feet; 1 part Concrete at 492 square feet.

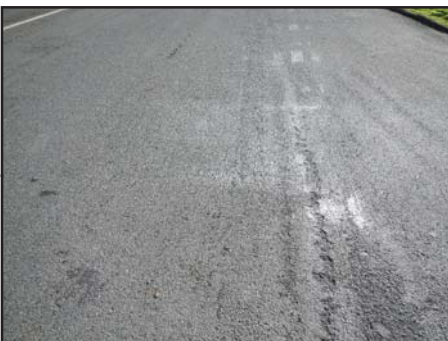
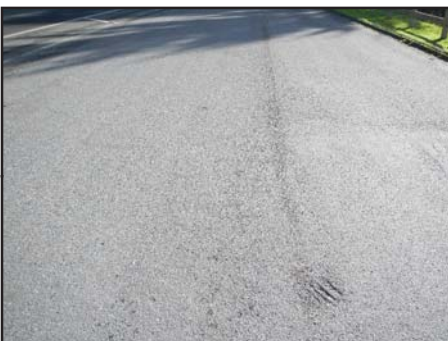
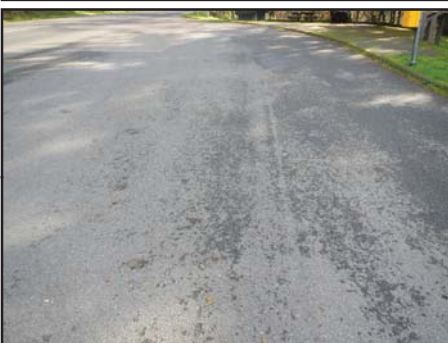
ROUTE 0905: CRESCENT BEACH PICNIC AREA PARKING

Inspection Date	FMSS Number	User Access	Surface Type
11/8/2014	13408	PUBLIC	ASPHALT
Area (Sq. Ft.)	Lane Miles (11' Widths)	Curb Reveal (Inches)	Curb Recommendation
38,068	0.655	NOT APPLICABLE	NOT APPLICABLE
Curb Type		Curb & Gutter Type	
NO CURB		NO CURB AND GUTTER	
Pavement Recommendation		Condition Rating / PCR	
PREVENTIVE MAINTENANCE		GOOD / 90

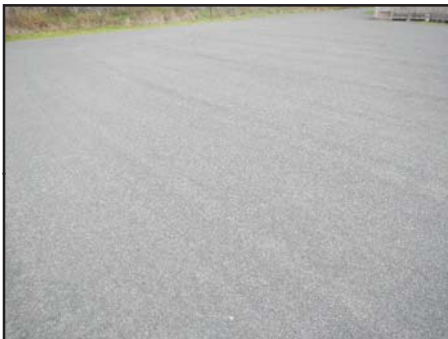
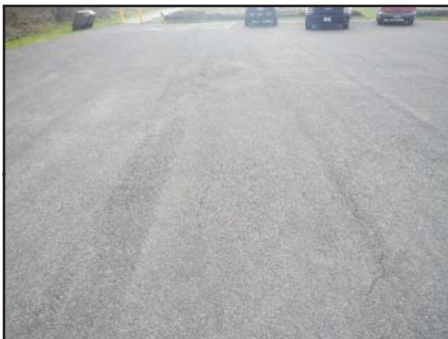
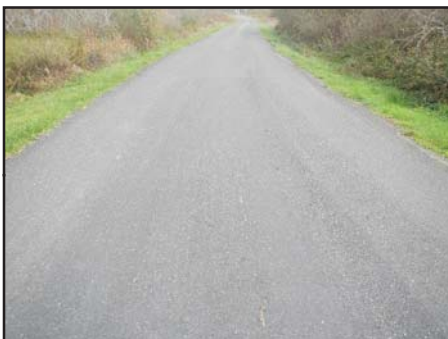
ROUTE 0906: CRESCENT BEACH OVERLOOK PARKING

Inspection Date	FMSS Number	User Access	Surface Type
11/8/2014	15614	PUBLIC	ASPHALT
Area (Sq. Ft.)	Lane Miles (11' Widths)	Curb Reveal (Inches)	Curb Recommendation
2,798	0.048	NOT APPLICABLE	NOT APPLICABLE
Curb Type		Curb & Gutter Type	
NO CURB		NO CURB AND GUTTER	
Pavement Recommendation		Condition Rating / PCR	
PREVENTIVE MAINTENANCE		GOOD / 90

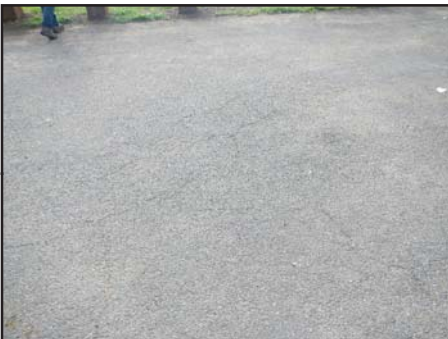
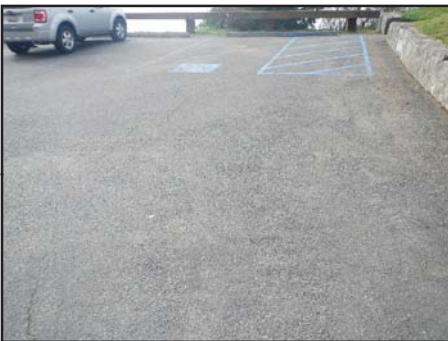
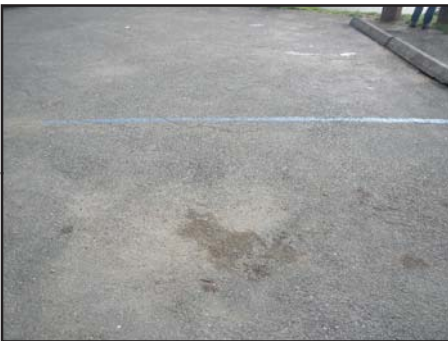
ROUTE 0907: LAGOON CREEK DAY USE/ PICNIC PARKING

Inspection Date	FMSS Number	User Access	Surface Type
11/9/2014	11037	PUBLIC	ASPHALT
Area (Sq. Ft.)	Lane Miles (11' Widths)	Curb Reveal (Inches)	Curb Recommendation
38,817	0.668	4	LIGHT REPAIR
Curb Type		Curb & Gutter Type	
ASPHALT		NO CURB AND GUTTER	
Pavement Recommendation		Condition Rating / PCR	
PREVENTIVE MAINTENANCE		GOOD / 90

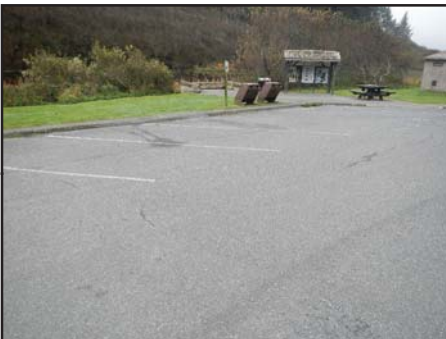
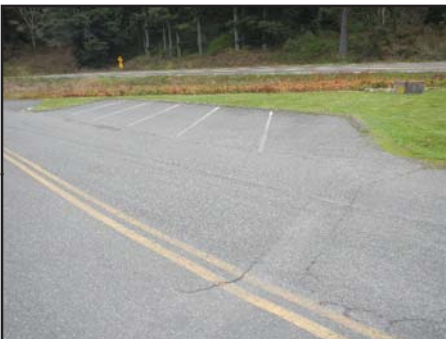
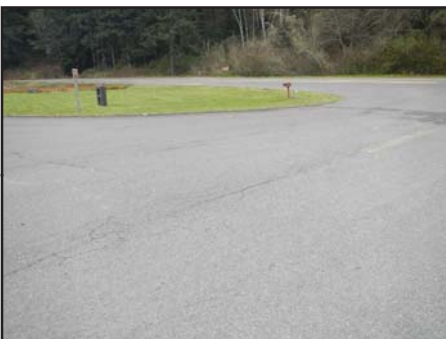
ROUTE 0910: KLAMATH OVERLOOK PARKING

Inspection Date	FMSS Number	User Access	Surface Type
11/9/2014	11018	PUBLIC	ASPHALT
Area (Sq. Ft.)	Lane Miles (11' Widths)	Curb Reveal (Inches)	Curb Recommendation
10,908	0.188	NOT APPLICABLE	DO NOTHING
Curb Type		Curb & Gutter Type	
NO CURB		CONCRETE	
Pavement Recommendation		Condition Rating / PCR	
LIGHT 3R TREATMENTS		FAIR / 73

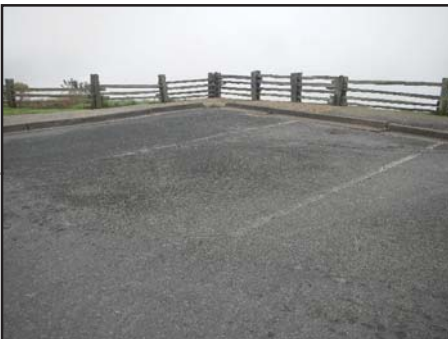
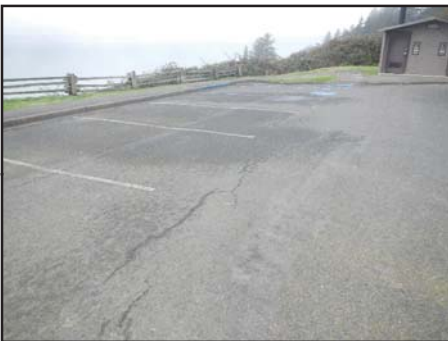
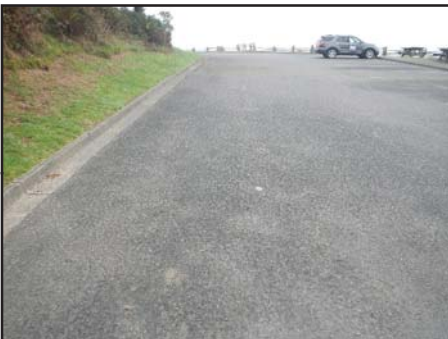
ROUTE 0911: CRESCENT BEACH ENVIRONMENTAL EDUCATION CENTER PARKING

Inspection Date	FMSS Number	User Access	Surface Type
11/8/2014	15613	PUBLIC	ASPHALT
Area (Sq. Ft.)	Lane Miles (11' Widths)	Curb Reveal (Inches)	Curb Recommendation
29,070	0.501	6	LIGHT REPAIR
Curb Type		Curb & Gutter Type	
CONCRETE		NO CURB AND GUTTER	
Pavement Recommendation		Condition Rating / PCR	
PREVENTIVE MAINTENANCE		GOOD / 90

Parking area consists of multiple surface types: 1 part Asphalt at 18,240 square feet; 2 parts Concrete at 10,830 square feet. Concrete surface is in POOR condition.

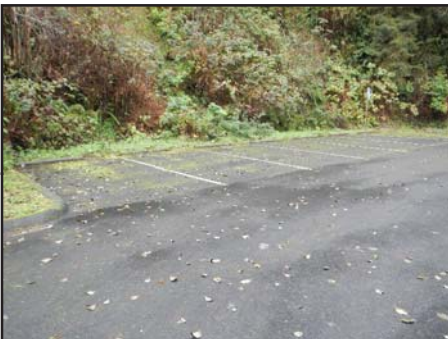
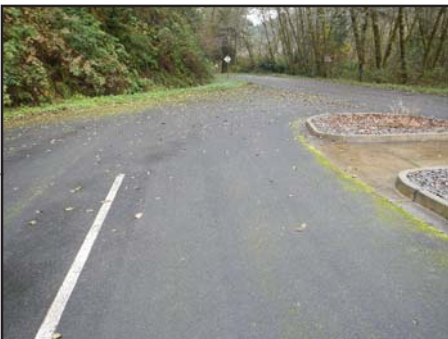
ROUTE 0913: ELK MEADOW DAY USE AREA PARKING

Inspection Date	FMSS Number	User Access	Surface Type
11/9/2014	15658	PUBLIC	ASPHALT
Area (Sq. Ft.)	Lane Miles (11' Widths)	Curb Reveal (Inches)	Curb Recommendation
45,452	0.783	6	DO NOTHING
Curb Type		Curb & Gutter Type	
CONCRETE		NO CURB AND GUTTER	
Pavement Recommendation		Condition Rating / PCR	
PREVENTIVE MAINTENANCE		GOOD / 90

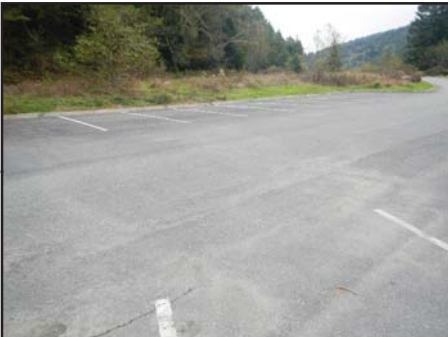
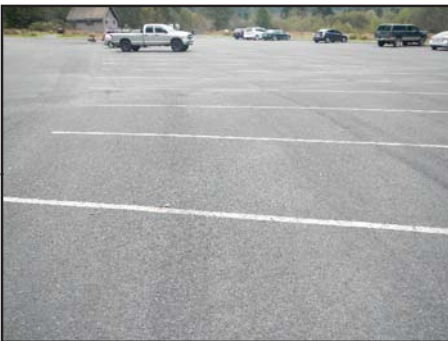
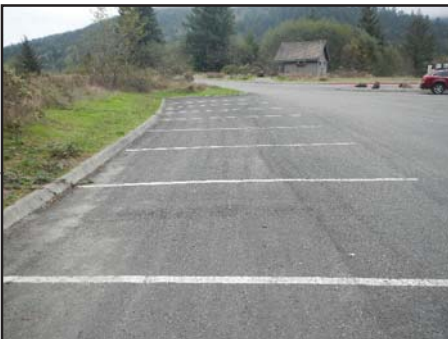
ROUTE 0914: LADY BIRD JOHNSON GROVE PARKING

Inspection Date	FMSS Number	User Access	Surface Type
11/9/2014	11036	PUBLIC	ASPHALT
Area (Sq. Ft.)	Lane Miles (11' Widths)	Curb Reveal (Inches)	Curb Recommendation
10,754	0.185	2	DO NOTHING
Curb Type		Curb & Gutter Type	
ASPHALT		NO CURB AND GUTTER	
Pavement Recommendation		Condition Rating / PCR	
DO NOTHING		EXCELLENT / 97

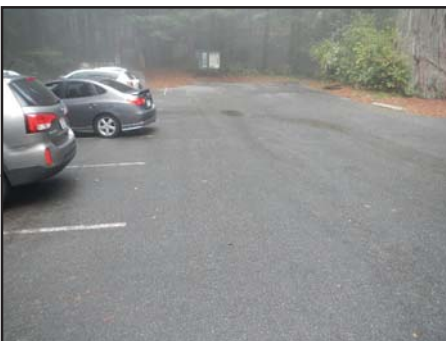
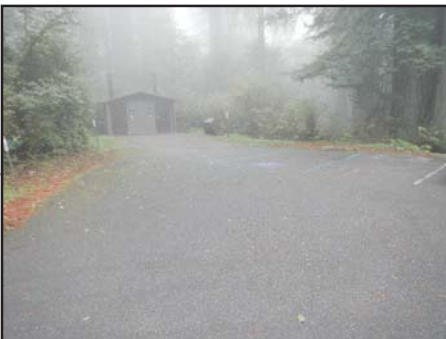
ROUTE 0915: REDWOOD CREEK TRAILHEAD PARKING

Inspection Date	FMSS Number	User Access	Surface Type
11/9/2014	13407	PUBLIC	ASPHALT
Area (Sq. Ft.)	Lane Miles (11' Widths)	Curb Reveal (Inches)	Curb Recommendation
24,190	0.416	4	DO NOTHING
Curb Type		Curb & Gutter Type	
CONCRETE		NO CURB AND GUTTER	
Pavement Recommendation		Condition Rating / PCR	
PREVENTIVE MAINTENANCE		GOOD / 90

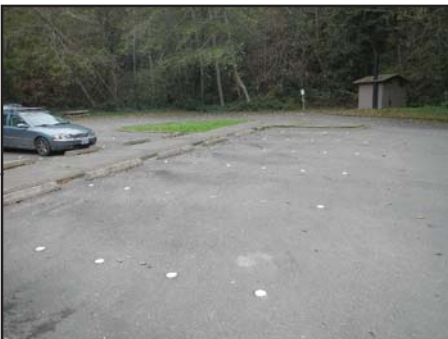
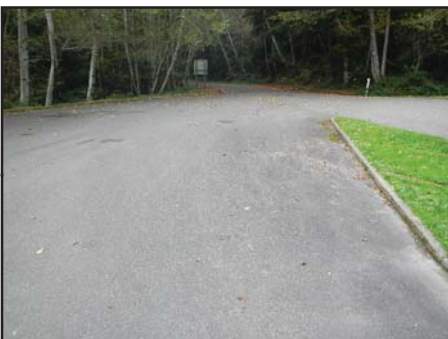
ROUTE 0916: REDWOOD CREEK OVERLOOK PARKING

Inspection Date	FMSS Number	User Access	Surface Type
11/9/2014	11045	PUBLIC	ASPHALT
Area (Sq. Ft.)	Lane Miles (11' Widths)	Curb Reveal (Inches)	Curb Recommendation
4,075	0.07	NOT APPLICABLE	NOT APPLICABLE
Curb Type		Curb & Gutter Type	
NO CURB		NO CURB AND GUTTER	
Pavement Recommendation		Condition Rating / PCR	
PREVENTIVE MAINTENANCE		GOOD / 90

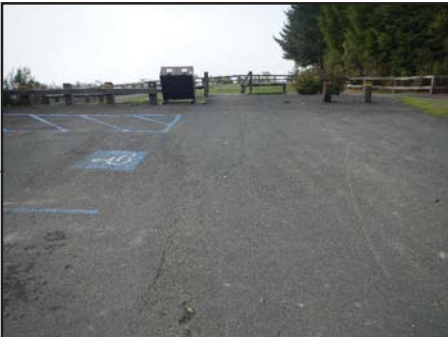
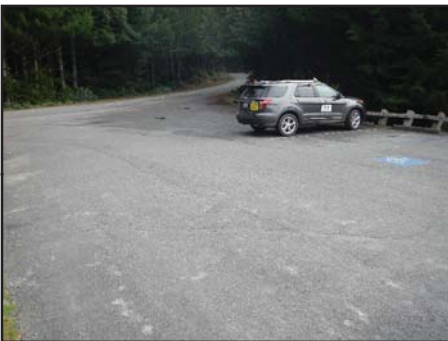
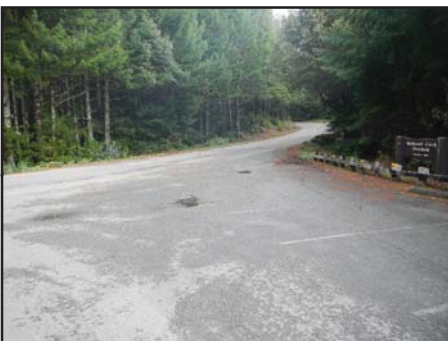
ROUTE 0918: HIOUCHI TRAILER PARKING

Inspection Date	FMSS Number	User Access	Surface Type
11/8/2014	11023	NONPUBLIC	ASPHALT
Area (Sq. Ft.)	Lane Miles (11' Widths)	Curb Reveal (Inches)	Curb Recommendation
9,552	0.164	NOT APPLICABLE	NOT APPLICABLE
Curb Type		Curb & Gutter Type	
NO CURB		NO CURB AND GUTTER	
Pavement Recommendation		Condition Rating / PCR	
LIGHT 3R TREATMENTS		FAIR / 73

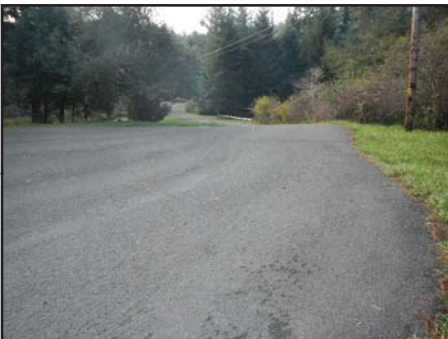
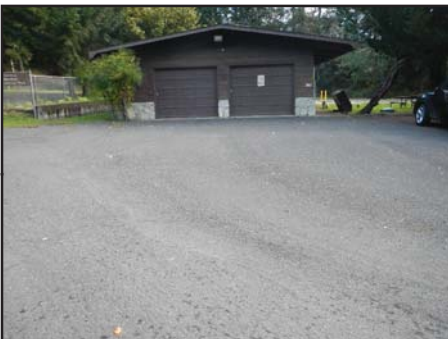
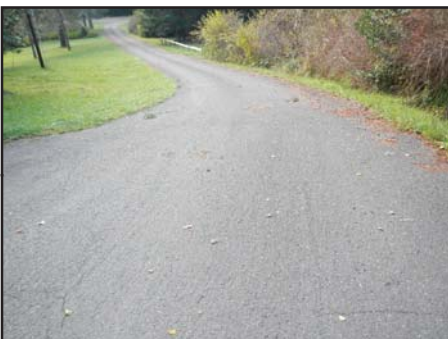
ROUTE 0919: NICKEL CREEK CAMPGROUND ACCESS PARKING

Inspection Date	FMSS Number	User Access	Surface Type
11/8/2014	15615	PUBLIC	ASPHALT
Area (Sq. Ft.)	Lane Miles (11' Widths)	Curb Reveal (Inches)	Curb Recommendation
8,651	0.149	5	LIGHT REPAIR
Curb Type		Curb & Gutter Type	
STONE		NO CURB AND GUTTER	
Pavement Recommendation		Condition Rating / PCR	
PREVENTIVE MAINTENANCE		GOOD / 90

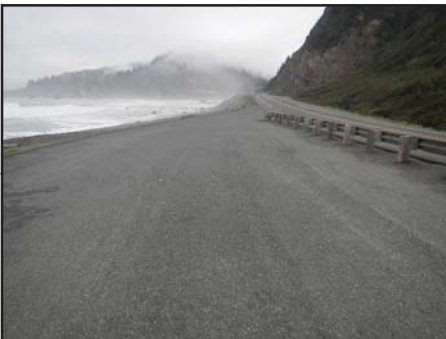
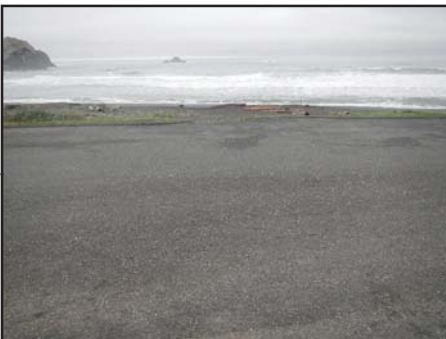
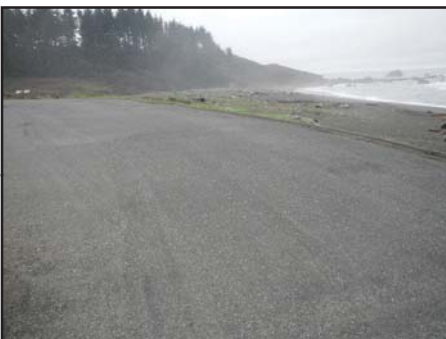
ROUTE 0921ZZ: DAVISON ROAD ELK VIEWING PARKING AREAS

Inspection Date	FMSS Number	User Access	Surface Type
11/9/2014	15659	PUBLIC	ASPHALT
Area (Sq. Ft.)	Lane Miles (11' Widths)	Condition Rating / PCR	
7,361	0.127	SUMMARY / 90

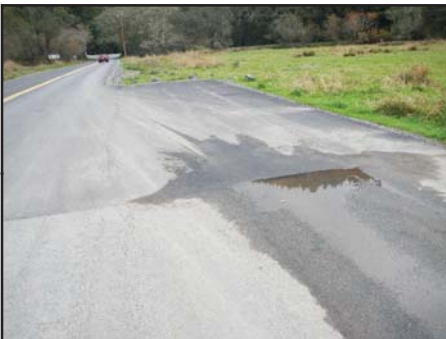
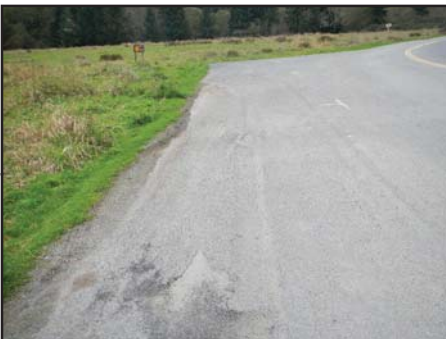
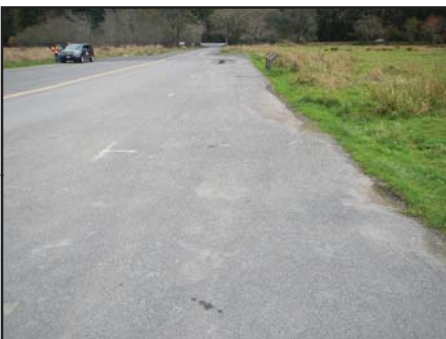
Inspection Date	FMSS Number	User Access	Surface Type
11/9/2014	15659	PUBLIC	ASPHALT
Area (Sq. Ft.)	Lane Miles (11' Widths)	Curb Reveal (Inches)	Curb Recommendation
4,531	0.078	NOT APPLICABLE	NOT APPLICABLE
Curb Type		Curb & Gutter Type	
NO CURB		NO CURB AND GUTTER	
Pavement Recommendation		Condition Rating / PCR	
PREVENTIVE MAINTENANCE		GOOD / 90

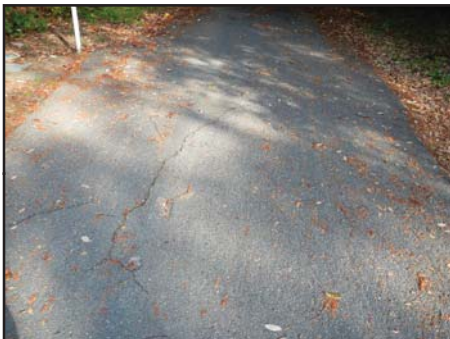
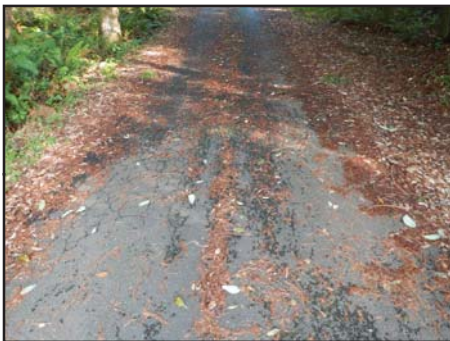
ROUTE 0922: HIOUCHI DORM PARKING

Inspection Date	FMSS Number	User Access	Surface Type
11/8/2014	15645	NONPUBLIC	ASPHALT
Area (Sq. Ft.)	Lane Miles (11' Widths)	Curb Reveal (Inches)	Curb Recommendation
3,544	0.061	NOT APPLICABLE	NOT APPLICABLE
Curb Type		Curb & Gutter Type	
NO CURB		NO CURB AND GUTTER	
Pavement Recommendation		Condition Rating / PCR	
PREVENTIVE MAINTENANCE		GOOD / 90

Parking area consists of multiple surface types: 1 part Asphalt at 2,967 square feet; 1 part Concrete at 577 square feet.

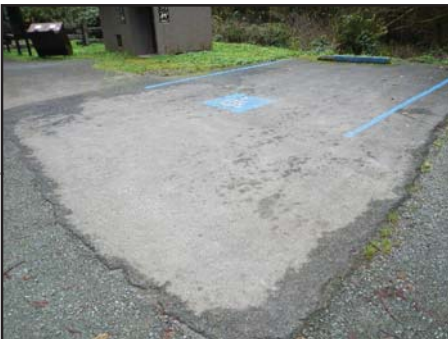
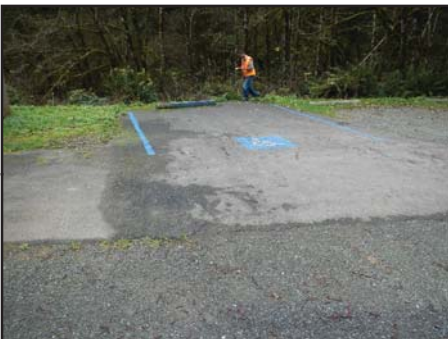
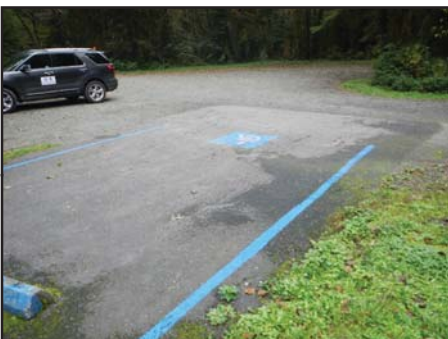
Inspection Date	FMSS Number	User Access	Surface Type
11/9/2014	N/A	PUBLIC	ASPHALT
Area (Sq. Ft.)	Lane Miles (11' Widths)	Curb Reveal (Inches)	Curb Recommendation
619	0.011	NOT APPLICABLE	NOT APPLICABLE
Curb Type		Curb & Gutter Type	
NO CURB		NO CURB AND GUTTER	
Pavement Recommendation		Condition Rating / PCR	
PREVENTIVE MAINTENANCE		GOOD / 90

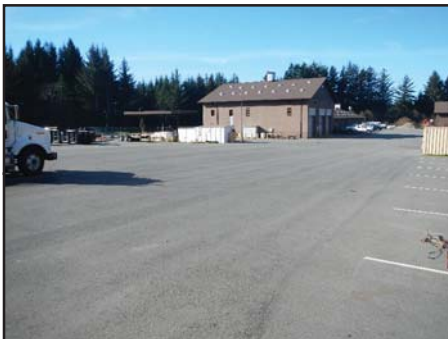
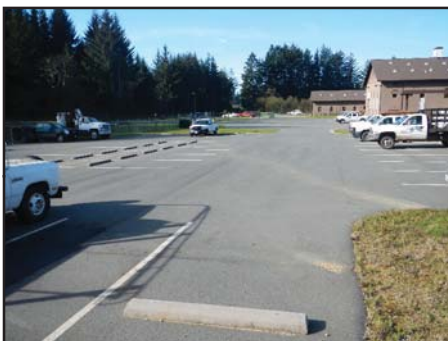
ROUTE 0938: NOC PARKING

Inspection Date	FMSS Number	User Access	Surface Type
11/8/2014	15118	NONPUBLIC	ASPHALT
Area (Sq. Ft.)	Lane Miles (11' Widths)	Curb Reveal (Inches)	Curb Recommendation
109,733	1.889	NOT APPLICABLE	NOT APPLICABLE
Curb Type		Curb & Gutter Type	
NO CURB		NO CURB AND GUTTER	
Pavement Recommendation		Condition Rating / PCR	
DO NOTHING		EXCELLENT / 97

Parking area consists of multiple surface types: 1 part Asphalt at 107,995 square feet; 3 parts Concrete at 1,738 square feet.

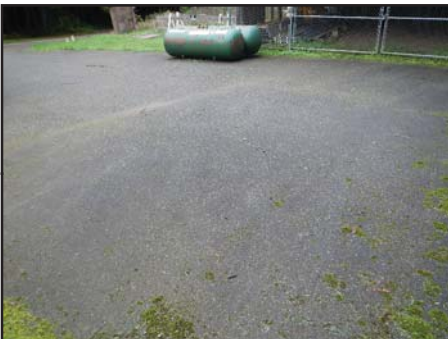
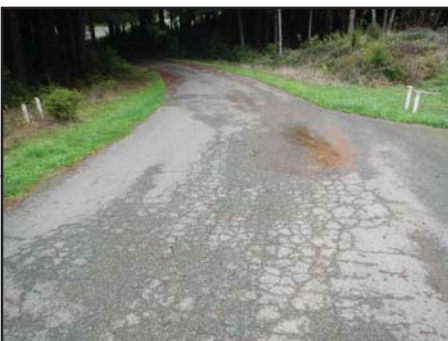
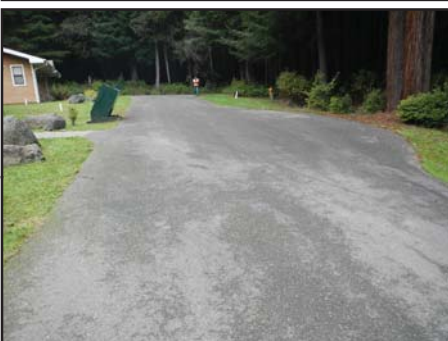
ROUTE 0939: WOLF CREEK HOUSING COMPLEX

Inspection Date	FMSS Number	User Access	Surface Type
11/9/2014	16030	NONPUBLIC	ASPHALT
Area (Sq. Ft.)	Lane Miles (11' Widths)	Curb Reveal (Inches)	Curb Recommendation
8,586	0.148	NOT APPLICABLE	NOT APPLICABLE
Curb Type		Curb & Gutter Type	
NO CURB		NO CURB AND GUTTER	
Pavement Recommendation		Condition Rating / PCR	
PREVENTIVE MAINTENANCE		GOOD / 90
