# ROCR Cycle 6

## Final Report

### Road Inventory and Condition Assessment of Paved Routes Rock Creek Park

**Report Date: November 2019**

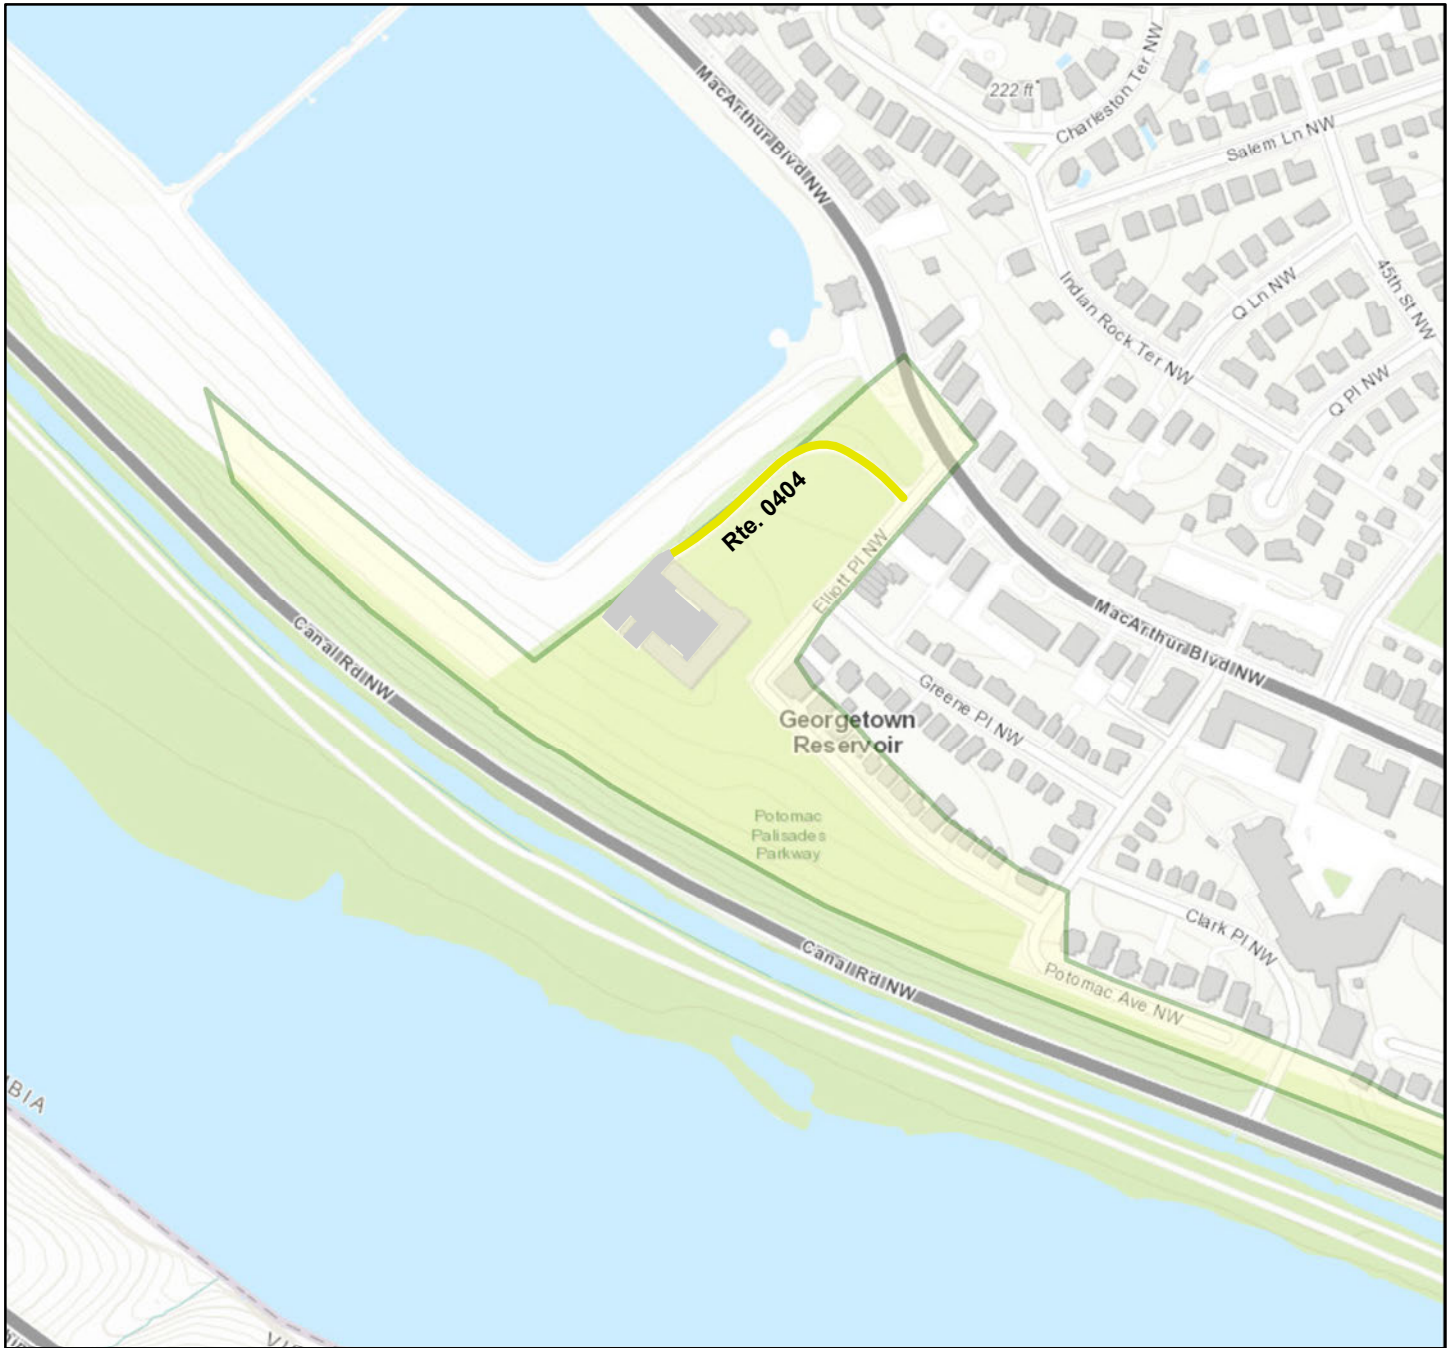
#### Area Map 4

Colors on map represent condition scores at 1-mile intervals. See Appendix for definitions and formulas  
 Only Data Collection Vehicle and Manually Rated Roads are displayed

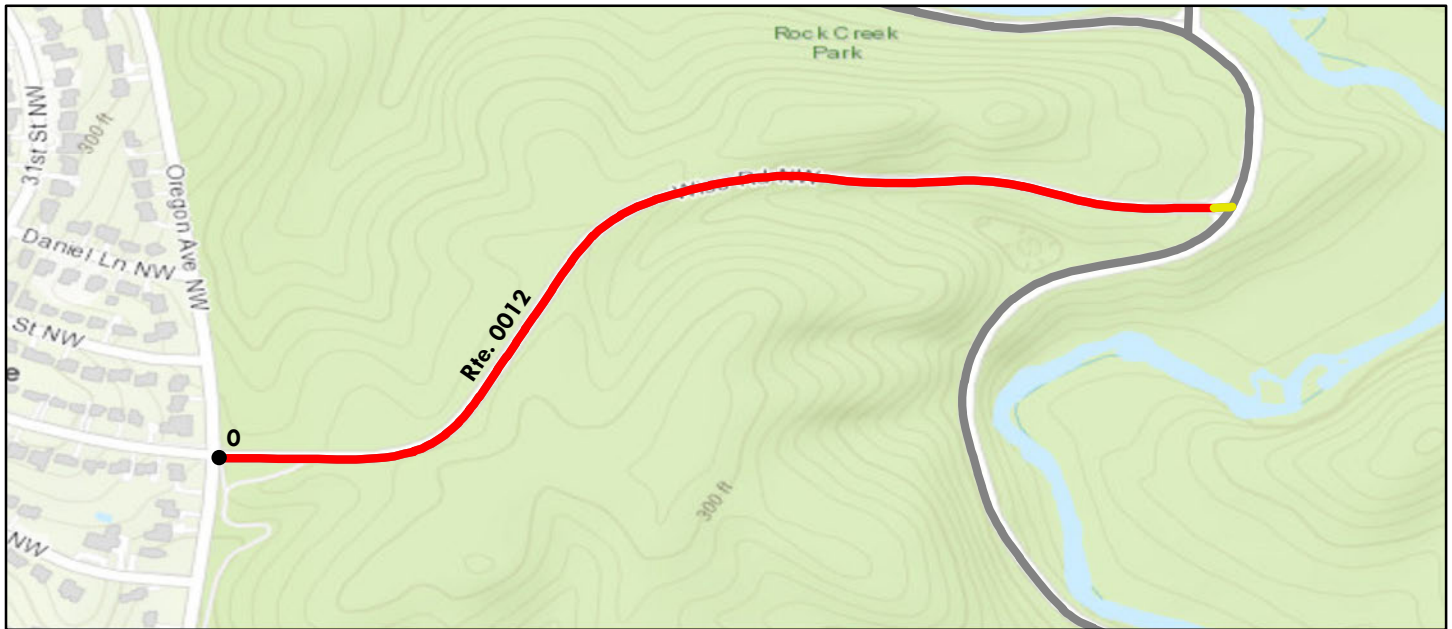
## ROUTE 0012: WISE ROAD NORTHWEST

<b>Route Condition Legend – Pavement Condition Rating (PCR)</b>						
<b>Poor (0 - 60)</b>	<b>Fair (61- 84)</b>	<b>Good (85 - 94)</b>	<b>Excellent (95 - 100)</b>	<b>Not Rated</b>		
Colors on map represent condition scores at 0.10-mile intervals. See Appendix for definitions and formulas.						
<b>Inspection Date:</b>	3/23/2018	<b>Beginning Section MP</b>	0			
<b>Paved Length (Miles):</b>	0.61	<b>Section Length (MI)</b>	0.61			
<b>Surface Type:</b>	ASPHALT	<b>Route Summary</b>				
<b>Roadway Condition Information</b>						
Pavement Condition Rating (PCR)	27	27				
Surface Condition Rating (SCR)	0	0				
Roughness Condition Index (RCI)	67	67				
<b>Distress Index Values</b>						
Structural Crack Index	0	0				
Alligator Crack Index	69	69				
Longitudinal Crack Index	1	1				
Transverse Cracking Index	77	77				
Patching Index	93	93				
Rutting Index	92	92				
International Roughness Index (IRI)	212	212				
<b>Lane &amp; Width Information</b>

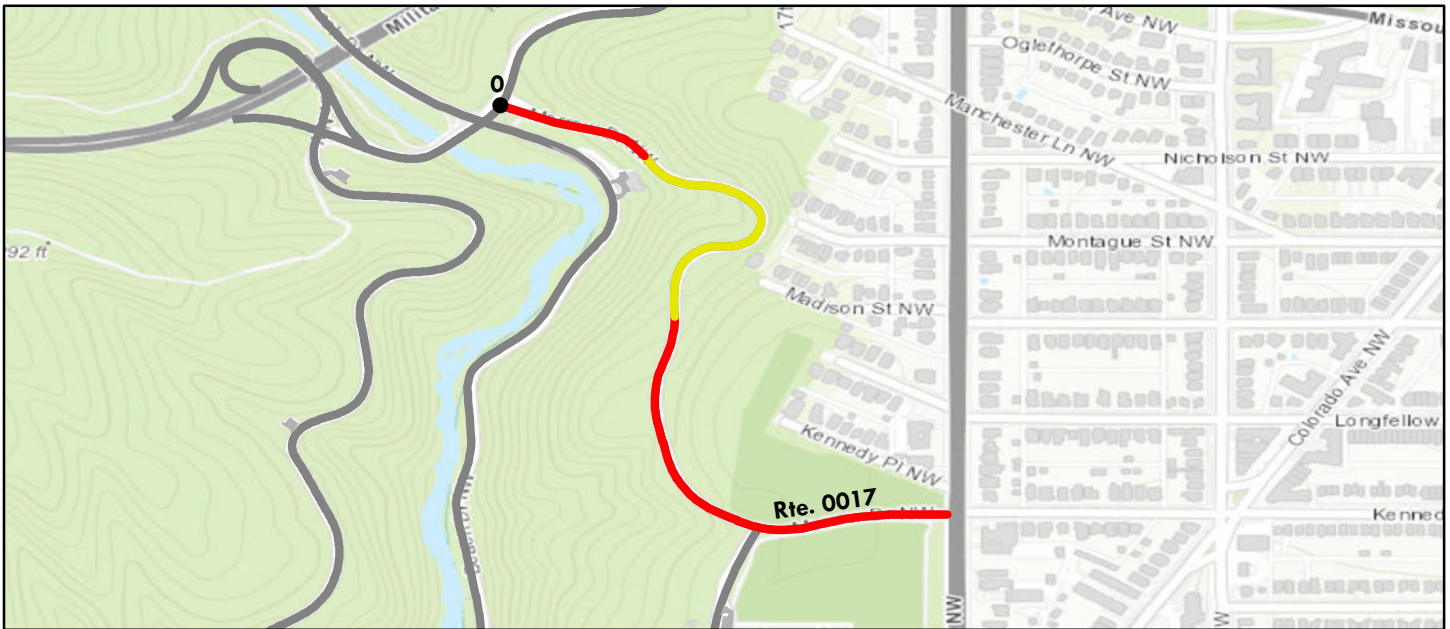
## ROUTE 0017: MORROW DRIVE NORTHWEST

<b>Route Condition Legend – Pavement Condition Rating (PCR)</b>						
<b>Poor (0 - 60)</b>	<b>Fair (61- 84)</b>	<b>Good (85 - 94)</b>	<b>Excellent (95 - 100)</b>	<b>Not Rated</b>		
Colors on map represent condition scores at 0.10-mile intervals. See Appendix for definitions and formulas.						
<b>Inspection Date:</b>	3/23/2018	<b>Beginning Section MP</b>	0			
<b>Paved Length (Miles):</b>	0.61	<b>Section Length (MI)</b>	0.61			
<b>Surface Type:</b>	ASPHALT	<b>Route Summary</b>				
<b>Roadway Condition Information</b>						
Pavement Condition Rating (PCR)	46	46				
Surface Condition Rating (SCR)	30	30				
Roughness Condition Index (RCI)	69	69				
<b>Distress Index Values</b>						
Structural Crack Index	47	47				
Alligator Crack Index	100	100				
Longitudinal Crack Index	47	47				
Transverse Cracking Index	30	30				
Patching Index	98	98				
Rutting Index	97	97				
International Roughness Index (IRI)	204	204

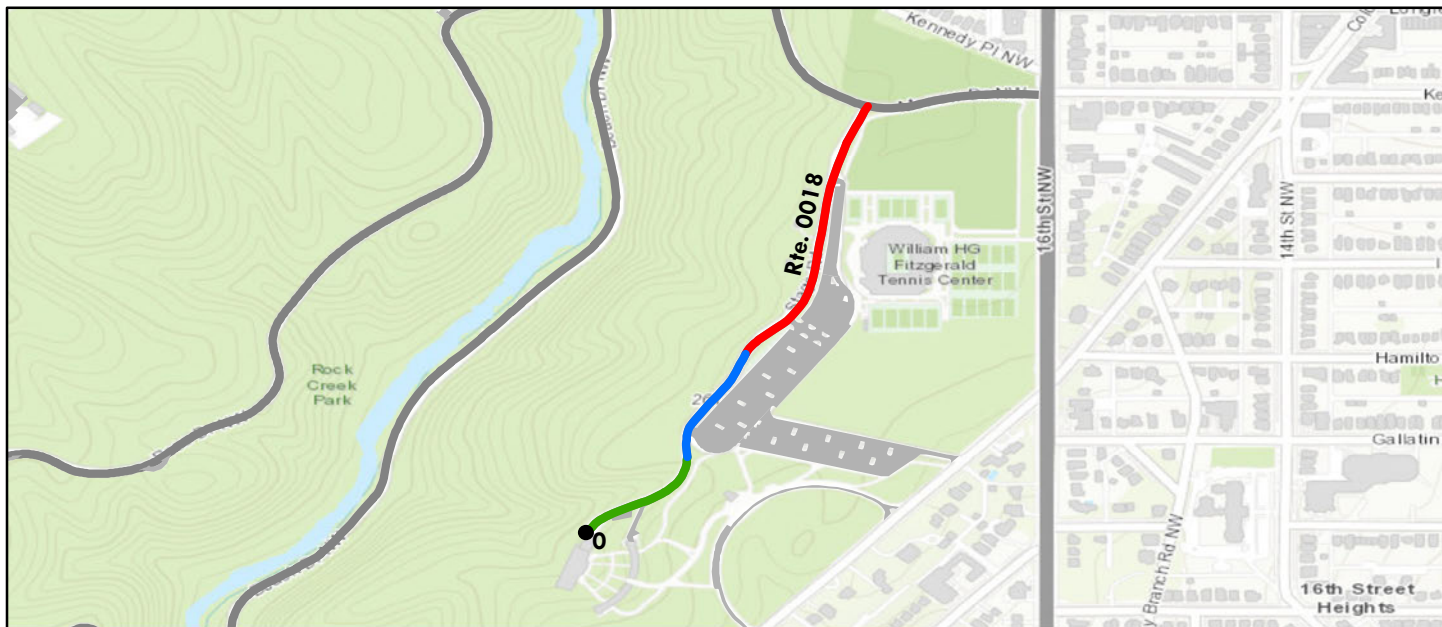
## ROUTE 0018: STAGE ROAD

<b>Route Condition Legend – Pavement Condition Rating (PCR)</b>						
<b>Poor (0 - 60)</b>	<b>Fair (61- 84)</b>	<b>Good (85 - 94)</b>	<b>Excellent (95 - 100)</b>	<b>Not Rated</b>		
Colors on map represent condition scores at 0.10-mile intervals. See Appendix for definitions and formulas.						
<b>Inspection Date:</b>	3/23/2018	<b>Beginning Section MP</b>	0			
<b>Paved Length (Miles):</b>	0.43	<b>Section Length (MI)</b>	0.43			
<b>Surface Type:</b>	ASPHALT	<b>Route Summary</b>				
<b>Roadway Condition Information</b>						
Pavement Condition Rating (PCR)	58	58				
Surface Condition Rating (SCR)	58	58				
Roughness Condition Index (RCI)	N/A	N/A				
<b>Distress Index Values</b>						
Structural Crack Index	58	58				
Alligator Crack Index	91	91				
Longitudinal Crack Index	67	67				
Transverse Cracking Index	61	61				
Patching Index	100	100				
Rutting Index	97	97				
International Roughness Index (IRI)	N/A	N/A

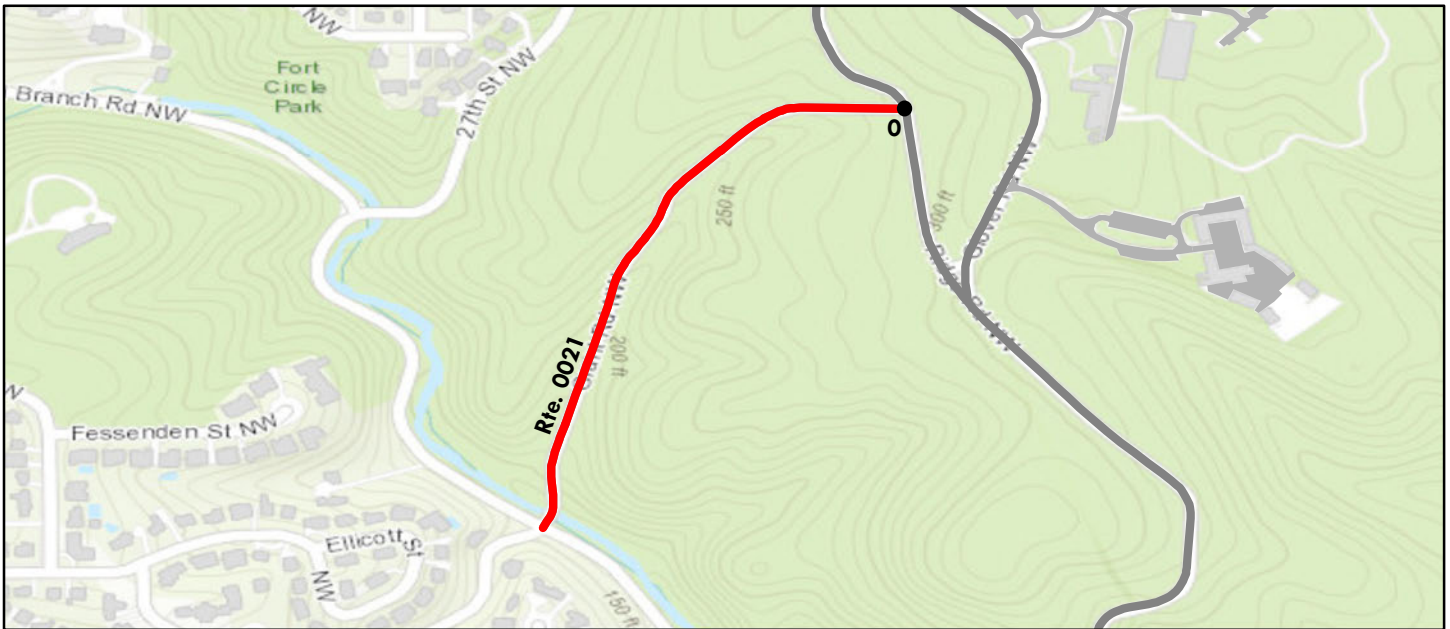
## ROUTE 0021: GRANT ROAD NORTHWEST

<b>Route Condition Legend – Pavement Condition Rating (PCR)</b>						
<b>Poor (0 - 60)</b>	<b>Fair (61- 84)</b>	<b>Good (85 - 94)</b>	<b>Excellent (95 - 100)</b>	<b>Not Rated</b>		
Colors on map represent condition scores at 0.10-mile intervals. See Appendix for definitions and formulas.						
<b>Inspection Date:</b> 3/23/2018	<b>Beginning Section MP</b>	0				
<b>Paved Length (Miles):</b> 0.37	<b>Section Length (MI)</b>	0.37				
<b>Surface Type:</b> ASPHALT	<b>Route Summary</b>					
<b>Roadway Condition Information</b>						
Pavement Condition Rating (PCR)	12	12				
Surface Condition Rating (SCR)	12	12				
Roughness Condition Index (RCI)	N/A	N/A				
<b>Distress Index Values</b>						
Structural Crack Index	12	12				
Alligator Crack Index	92	92				
Longitudinal Crack Index	20	20				
Transverse Cracking Index	87	87				
Patching Index	99	99				
Rutting Index	93	93				
International Roughness Index (IRI)	N/A	N/A

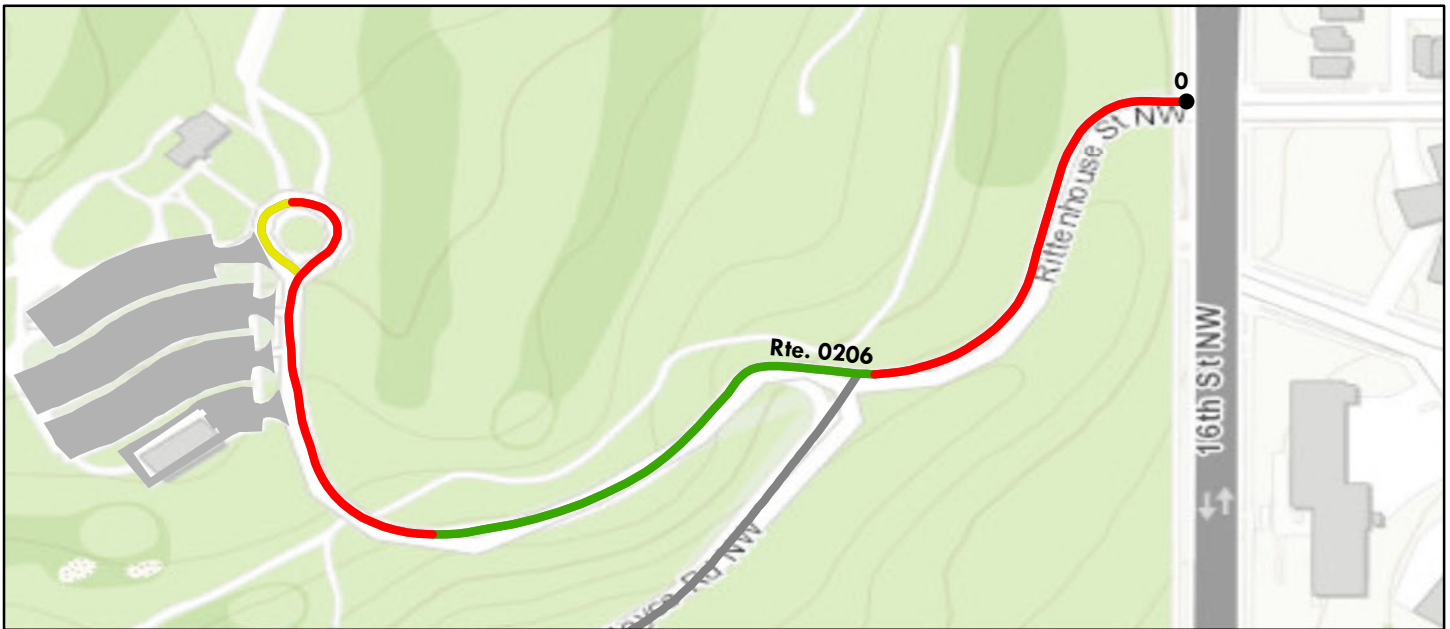
## ROUTE 0206: ROCK CREEK PARK GOLF COURSE ACCESS ROAD

Route Condition Legend – Pavement Condition Rating (PCR)										
Poor (0 - 60)		Fair (61- 84)		Good (85 - 94)		Excellent (95 - 100)		Not Rated		
Colors on map represent condition scores at 0.10-mile intervals. See Appendix for definitions and formulas.										
<b>Inspection Date:</b>	3/23/2018	<b>Beginning Section MP</b>	0							
<b>Paved Length (Miles):</b>	0.32	<b>Section Length (MI)</b>	0.32							
<b>Surface Type:</b>	ASPHALT	<b>Route Summary</b>								
<b>Roadway Condition Information</b>										
Pavement Condition Rating (PCR)		59	59							
Surface Condition Rating (SCR)		59	59							
Roughness Condition Index (RCI)		N/A	N/A							
<b>Distress Index Values</b>										
Structural Crack Index		59	59							
Alligator Crack Index		84	84							
Longitudinal Crack Index		75	75							
Transverse Cracking Index		61	61							
Patching Index		100	100							
Rutting Index		96	96							
International Roughness Index (IRI)		N/A	N/A

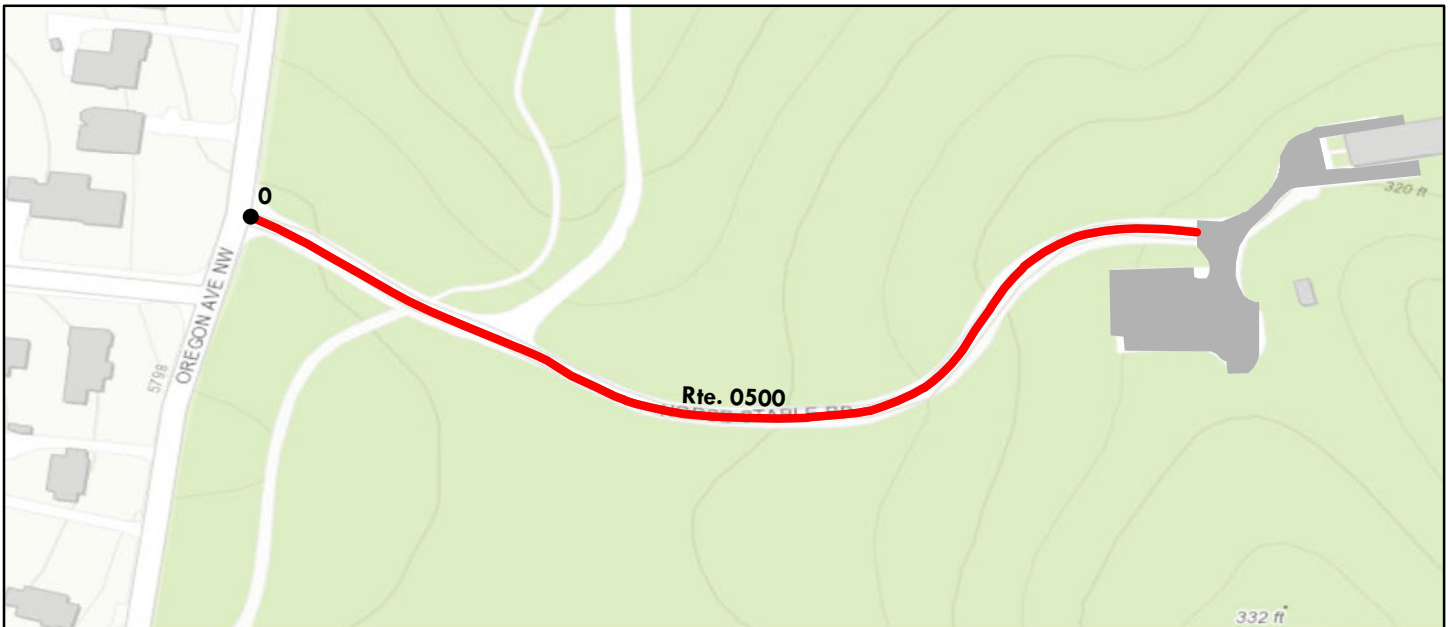
## ROUTE 0500: HORSE STABLE ROAD

<b>Route Condition Legend – Pavement Condition Rating (PCR)</b>						
<b>Poor (0 - 60)</b>	<b>Fair (61- 84)</b>	<b>Good (85 - 94)</b>	<b>Excellent (95 - 100)</b>	<b>Not Rated</b>		
Colors on map represent condition scores at 0.10-mile intervals. See Appendix for definitions and formulas.						
<b>Inspection Date:</b> 6/7/2018	<b>Beginning Section MP</b>	0				
<b>Paved Length (Miles):</b> 0.18	<b>Section Length (MI)</b>	0.18				
<b>Surface Type:</b> ASPHALT	<b>Route Summary</b>					
<b>Roadway Condition Information</b>						
Pavement Condition Rating (PCR)	0	0				
Surface Condition Rating (SCR)	0	0				
Roughness Condition Index (RCI)	N/A	N/A				
<b>Distress Index Values</b>						
Structural Crack Index	0	0				
Alligator Crack Index	98	98				
Longitudinal Crack Index	0	0				
Transverse Cracking Index	46	46				
Patching Index	93	93				
Rutting Index	83	83				
International Roughness Index (IRI)	N/A	N/A				
<b>Lane &amp; Width Information</b>

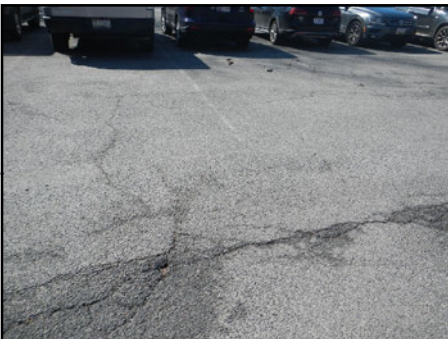
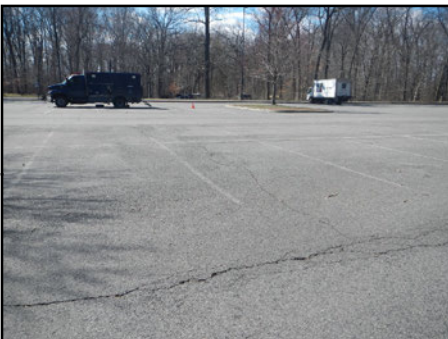
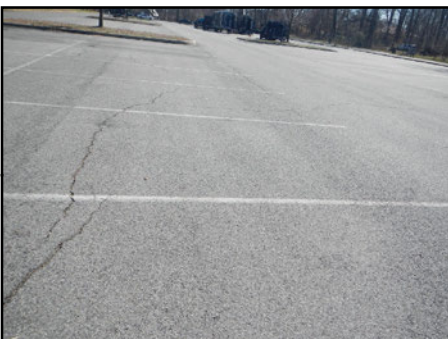
Inspection Date	FMSS Number	User Access	Surface Type
3/8/2018	51730	PUBLIC	ASPHALT
Area (Sq. Ft.)	Lane Miles (11' Widths)	Curb Reveal (Inches)	Curb Recommendation
88,271	1.52	7	DO NOTHING
Curb Type		Curb & Gutter Type	
CONCRETE		NO CURB AND GUTTER	
Pavement Recommendation		Condition Rating / PCR	
LIGHT 3R TREATMENTS		FAIR / 73

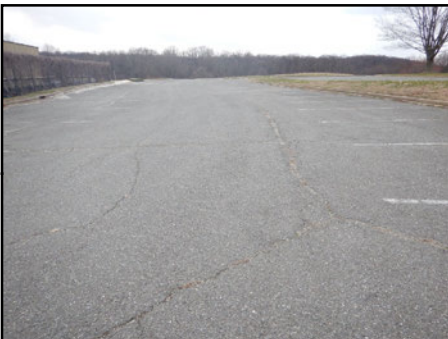
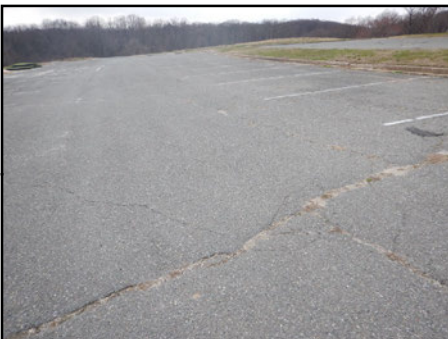
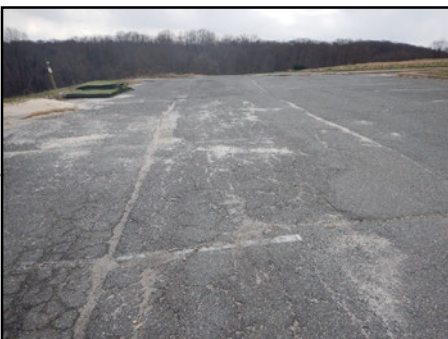
Inspection Date	FMSS Number	User Access	Surface Type
3/8/2018	51731	PUBLIC	ASPHALT
Area (Sq. Ft.)	Lane Miles (11' Widths)	Curb Reveal (Inches)	Curb Recommendation
13,698	0.236	NOT APPLICABLE	MODERATE REPAIR
Curb Type		Curb & Gutter Type	
NO CURB		CONCRETE	
Pavement Recommendation		Condition Rating / PCR	
HEAVY 3R TREATMENTS		POOR / 53

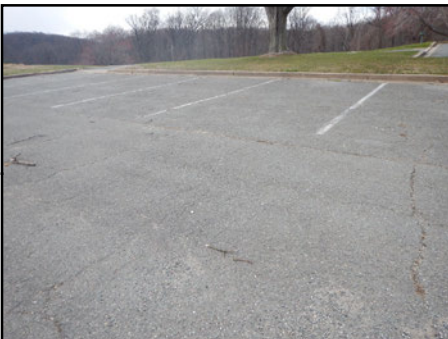
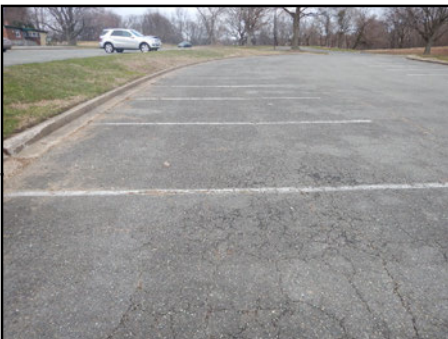
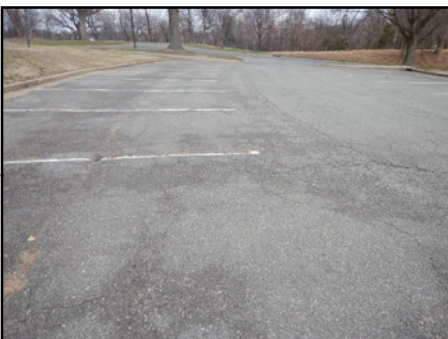
Inspection Date	FMSS Number	User Access	Surface Type
3/8/2018	51731	PUBLIC	ASPHALT
Area (Sq. Ft.)	Lane Miles (11' Widths)	Curb Reveal (Inches)	Curb Recommendation
15,865	0.273	NOT APPLICABLE	MODERATE REPAIR
Curb Type		Curb & Gutter Type	
NO CURB		CONCRETE	
Pavement Recommendation		Condition Rating / PCR	
RECONSTRUCTION		POOR / 30

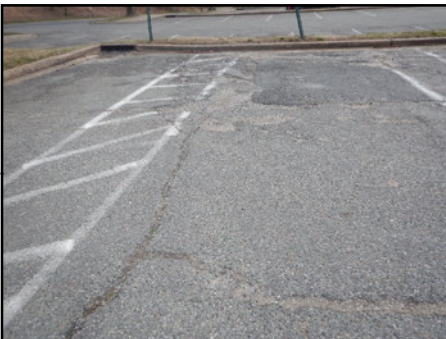
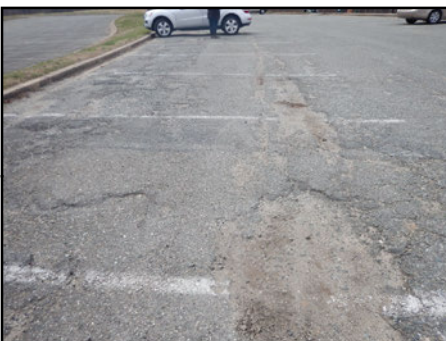
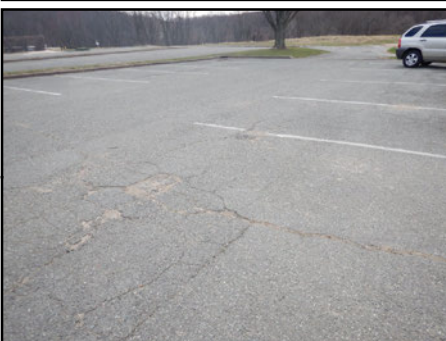
Inspection Date	FMSS Number	User Access	Surface Type
3/8/2018	51731	PUBLIC	ASPHALT
Area (Sq. Ft.)	Lane Miles (11' Widths)	Curb Reveal (Inches)	Curb Recommendation
13,288	0.229	NOT APPLICABLE	LIGHT REPAIR
Curb Type		Curb & Gutter Type	
NO CURB		CONCRETE	
Pavement Recommendation		Condition Rating / PCR	
RECONSTRUCTION		POOR / 30

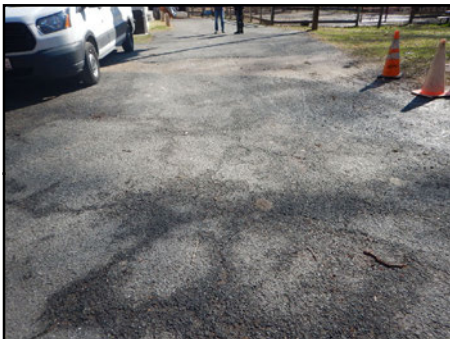
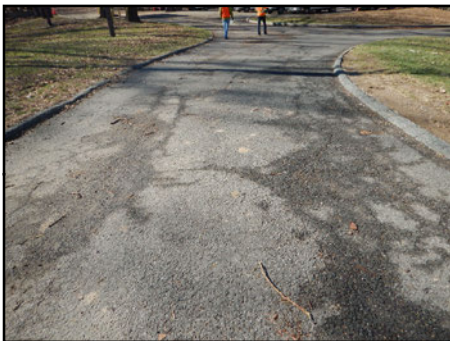
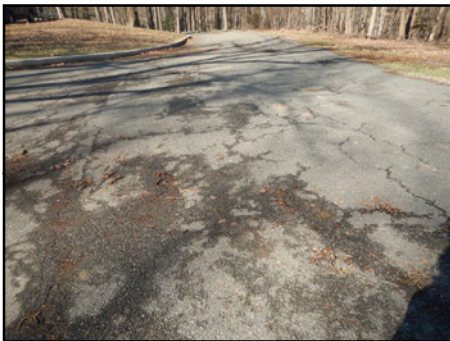
Inspection Date	FMSS Number	User Access	Surface Type
3/8/2018	51732	NONPUBLIC	ASPHALT
Area (Sq. Ft.)	Lane Miles (11' Widths)	Curb Reveal (Inches)	Curb Recommendation
17,798	0.306	3	MODERATE REPAIR
Curb Type		Curb & Gutter Type	
ASPHALT AND CONCRETE		NO CURB AND GUTTER	
Pavement Recommendation		Condition Rating / PCR	
HEAVY 3R TREATMENTS		POOR / 53

Note: Parking area consists of multiple surface types: 1 part Asphalt at 16,912 square feet; 1 part Concrete 886 square feet.

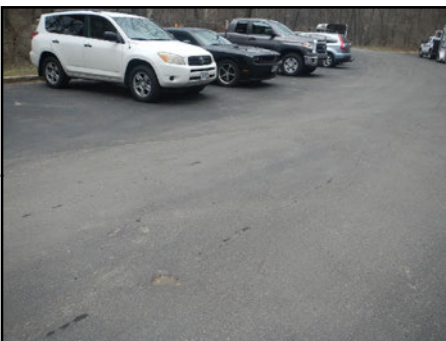
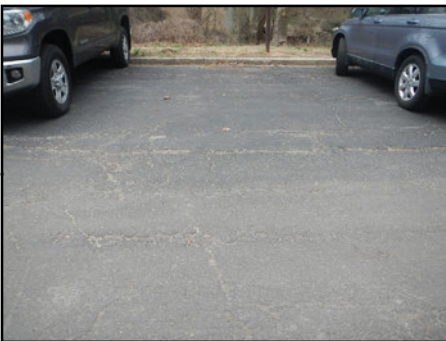
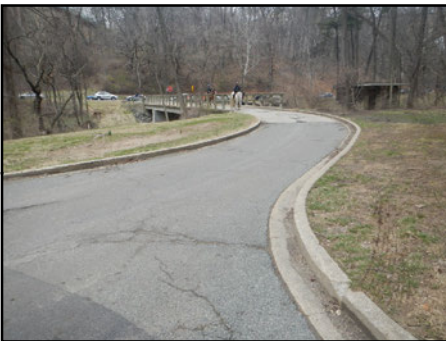
Inspection Date	FMSS Number	User Access	Surface Type
3/8/2018	51734	NONPUBLIC	ASPHALT
Area (Sq. Ft.)	Lane Miles (11' Widths)	Curb Reveal (Inches)	Curb Recommendation
26,672	0.459	6	LIGHT REPAIR
Curb Type		Curb & Gutter Type	
CONCRETE		CONCRETE	
Pavement Recommendation		Condition Rating / PCR	
HEAVY 3R TREATMENTS		POOR / 53

Note: Parking area consists of multiple surface types: 2 parts Asphalt at 16,220 square feet; 2 part Concrete 10,452 square feet.

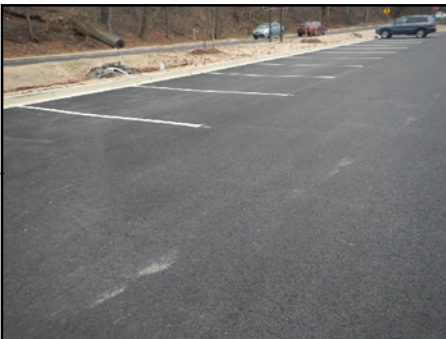
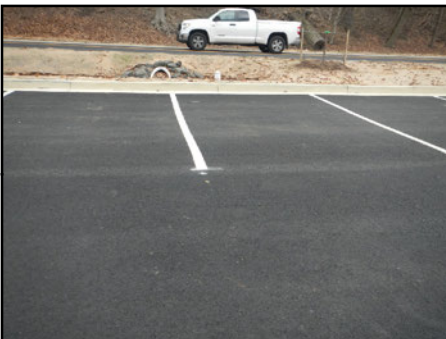
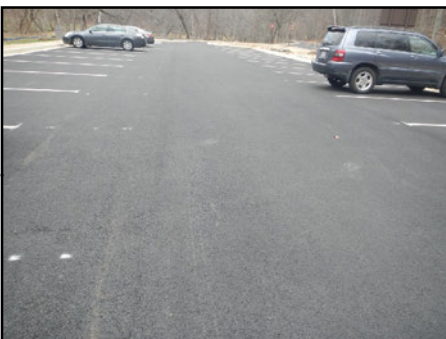
Inspection Date	FMSS Number	User Access	Surface Type
3/8/2018	51735	PUBLIC	ASPHALT
Area (Sq. Ft.)	Lane Miles (11' Widths)	Curb Reveal (Inches)	Curb Recommendation
10,987	0.189	NOT APPLICABLE	DO NOTHING
Curb Type		Curb & Gutter Type	
NO CURB		CONCRETE	
Pavement Recommendation		Condition Rating / PCR	
DO NOTHING		EXCELLENT / 97

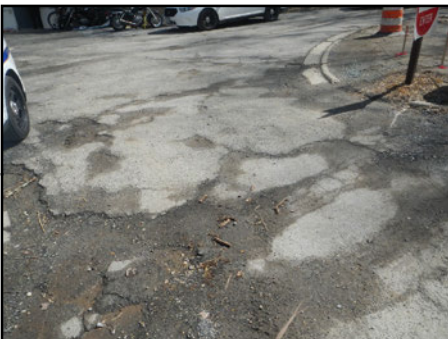
Inspection Date	FMSS Number	User Access	Surface Type
3/8/2018	51736	NONPUBLIC	ASPHALT
Area (Sq. Ft.)	Lane Miles (11' Widths)	Curb Reveal (Inches)	Curb Recommendation
3,318	0.057	NOT APPLICABLE	MODERATE REPAIR
Curb Type		Curb & Gutter Type	
NO CURB		CONCRETE	
Pavement Recommendation		Condition Rating / PCR	
RECONSTRUCTION		POOR / 0

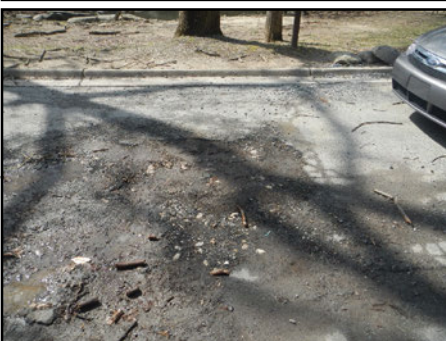
Inspection Date	FMSS Number	User Access	Surface Type
3/8/2018	51736	NONPUBLIC	ASPHALT
Area (Sq. Ft.)	Lane Miles (11' Widths)	Curb Reveal (Inches)	Curb Recommendation
1,766	0.03	NOT APPLICABLE	MODERATE REPAIR
Curb Type		Curb & Gutter Type	
NO CURB		CONCRETE	
Pavement Recommendation		Condition Rating / PCR	
RECONSTRUCTION		POOR / 30

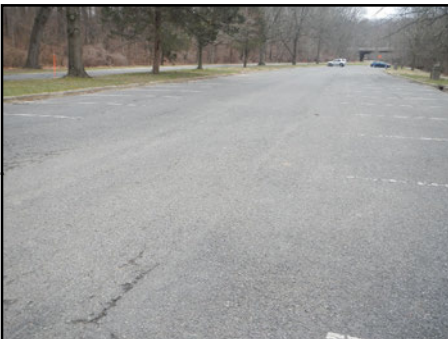
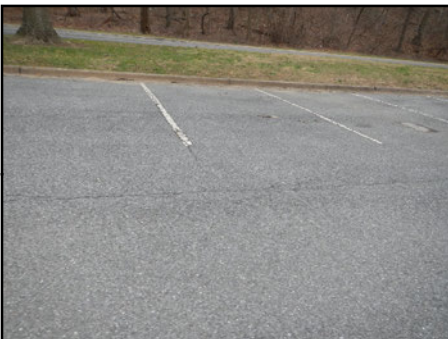
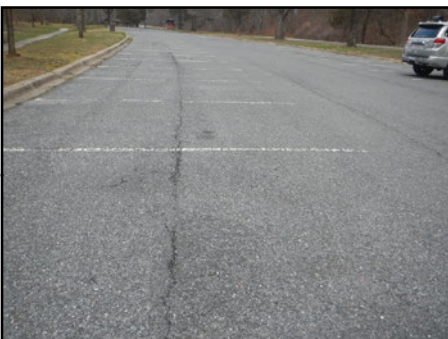
Inspection Date	FMSS Number	User Access	Surface Type
3/8/2018	51738	PUBLIC	ASPHALT
Area (Sq. Ft.)	Lane Miles (11' Widths)	Curb Reveal (Inches)	Curb Recommendation
23,743	0.409	NOT APPLICABLE	LIGHT REPAIR
Curb Type		Curb & Gutter Type	
NO CURB		CONCRETE	
Pavement Recommendation		Condition Rating / PCR	
LIGHT 3R TREATMENTS		FAIR / 73

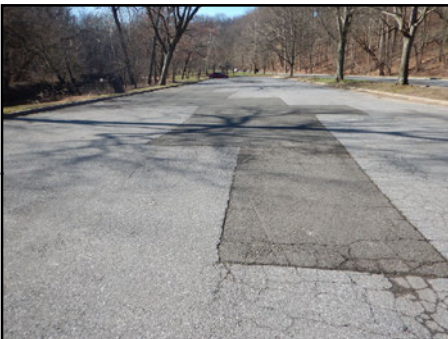
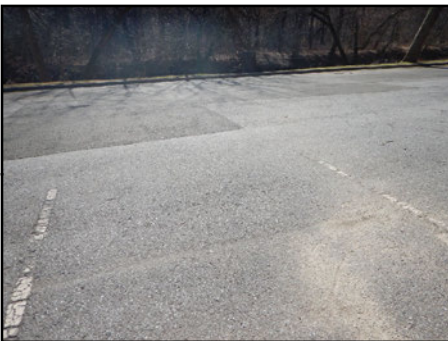
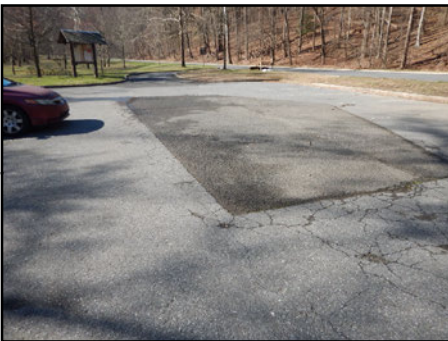
Inspection Date	FMSS Number	User Access	Surface Type
3/8/2018	51739	PUBLIC	ASPHALT
Area (Sq. Ft.)	Lane Miles (11' Widths)	Curb Reveal (Inches)	Curb Recommendation
18,249	0.314	NOT APPLICABLE	LIGHT REPAIR
Curb Type		Curb & Gutter Type	
NO CURB		CONCRETE	
Pavement Recommendation		Condition Rating / PCR	
RECONSTRUCTION		POOR / 30

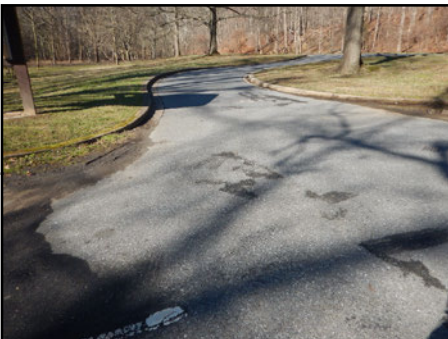
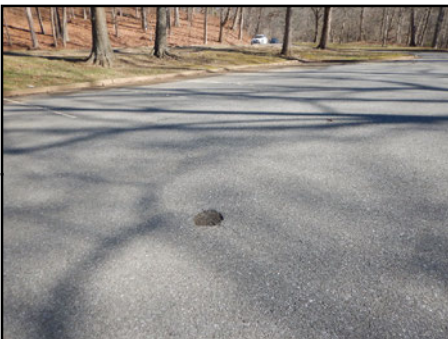
Inspection Date	FMSS Number	User Access	Surface Type
3/8/2018	51740	PUBLIC	ASPHALT
Area (Sq. Ft.)	Lane Miles (11' Widths)	Curb Reveal (Inches)	Curb Recommendation
11,773	0.203	NOT APPLICABLE	LIGHT REPAIR
Curb Type		Curb & Gutter Type	
NO CURB		CONCRETE	
Pavement Recommendation		Condition Rating / PCR	
PREVENTIVE MAINTENANCE		GOOD / 90

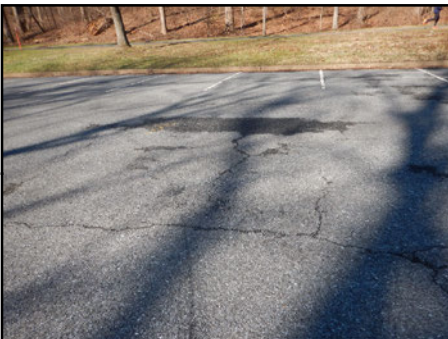
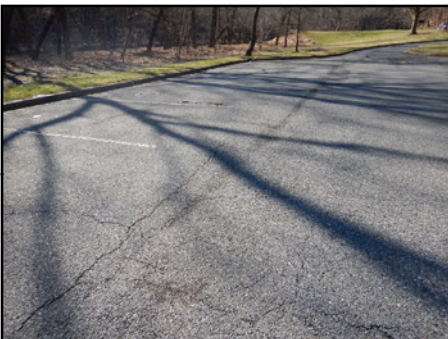
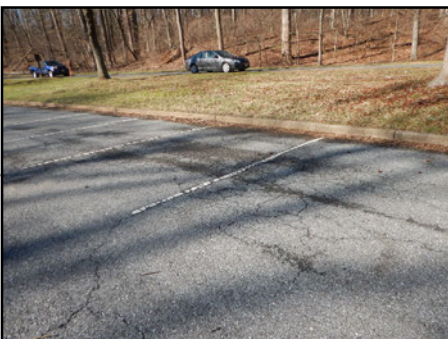
Inspection Date	FMSS Number	User Access	Surface Type
3/8/2018	51780	PUBLIC	ASPHALT
Area (Sq. Ft.)	Lane Miles (11' Widths)	Curb Reveal (Inches)	Curb Recommendation
10,631	0.183	NOT APPLICABLE	LIGHT REPAIR
Curb Type		Curb & Gutter Type	
NO CURB		CONCRETE	
Pavement Recommendation		Condition Rating / PCR	
HEAVY 3R TREATMENTS		POOR / 53

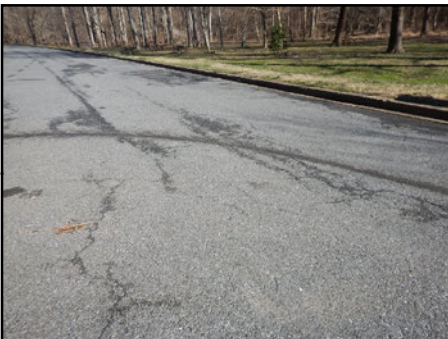
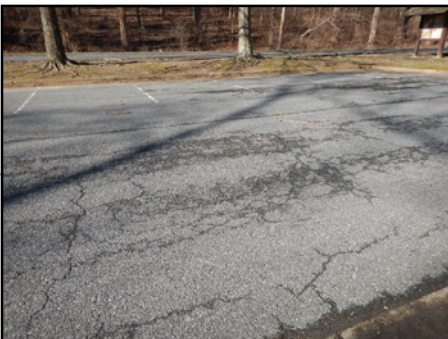
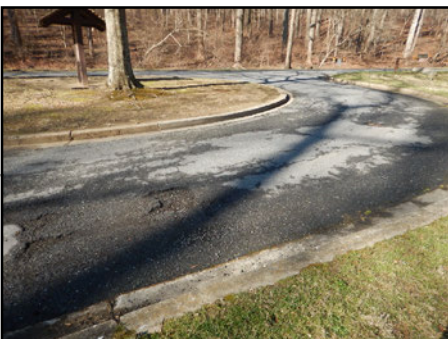
Inspection Date	FMSS Number	User Access	Surface Type
3/8/2018	51783	PUBLIC	ASPHALT
Area (Sq. Ft.)	Lane Miles (11' Widths)	Curb Reveal (Inches)	Curb Recommendation
14,492	0.25	NOT APPLICABLE	LIGHT REPAIR
Curb Type		Curb & Gutter Type	
NO CURB		CONCRETE	
Pavement Recommendation		Condition Rating / PCR	
HEAVY 3R TREATMENTS		POOR / 53	
Route Condition Legend – Pavement Condition Rating (PCR)			
<b>Poor (0 - 60)</b>	<b>Fair (61- 84)</b>	<b>Good (85 - 94)</b>	<b>Excellent (95 - 100)</b>
			<b>Not Rated</b>
See Appendix for definitions and formulas

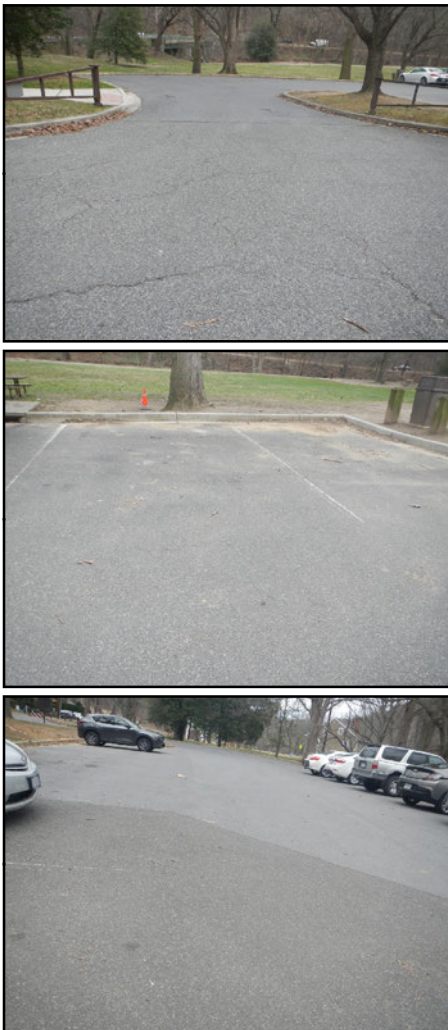
Inspection Date	FMSS Number	User Access	Surface Type
3/8/2018	51784	PUBLIC	ASPHALT
Area (Sq. Ft.)	Lane Miles (11' Widths)	Curb Reveal (Inches)	Curb Recommendation
10,233	0.176	NOT APPLICABLE	DO NOTHING
Curb Type		Curb & Gutter Type	
NO CURB		CONCRETE	
Pavement Recommendation		Condition Rating / PCR	
PREVENTIVE MAINTENANCE		GOOD / 90

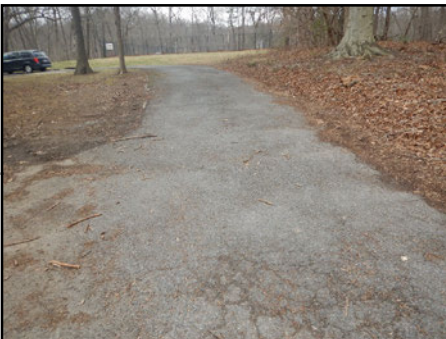
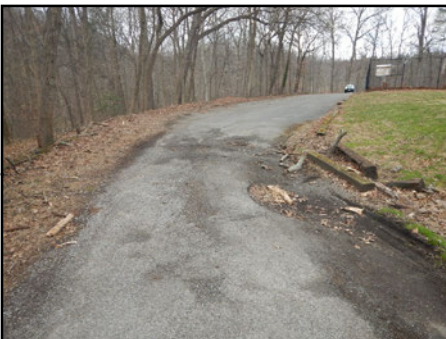
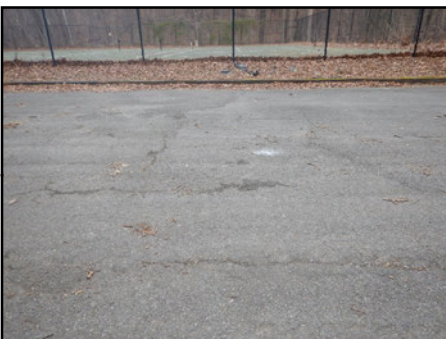
Inspection Date	FMSS Number	User Access	Surface Type
3/8/2018	51787	PUBLIC	ASPHALT
Area (Sq. Ft.)	Lane Miles (11' Widths)	Curb Reveal (Inches)	Curb Recommendation
15,518	0.267	6	REPLACE
Curb Type		Curb & Gutter Type	
STONE AND WOOD		NO CURB AND GUTTER	
Pavement Recommendation		Condition Rating / PCR	
RECONSTRUCTION		POOR / 30

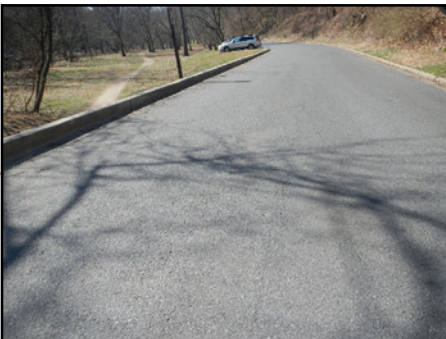
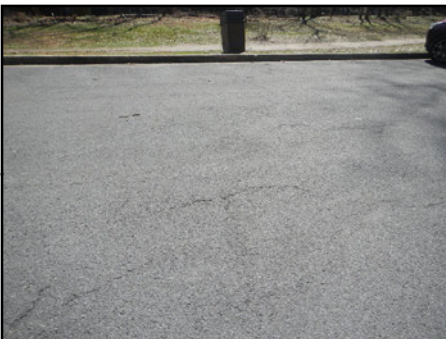
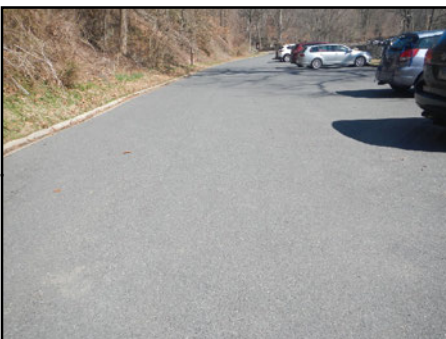
## ROUTE 0921: PICNIC AREA #2 NORTH / BROAD BRANCH PARKING

Inspection Date	FMSS Number	User Access	Surface Type
3/8/2018	51788	PUBLIC	ASPHALT
Area (Sq. Ft.)	Lane Miles (11' Widths)	Curb Reveal (Inches)	Curb Recommendation
11,400	0.196	NOT APPLICABLE	DO NOTHING
Curb Type		Curb & Gutter Type	
NO CURB		CONCRETE	
Pavement Recommendation		Condition Rating / PCR	
PREVENTIVE MAINTENANCE		GOOD / 90

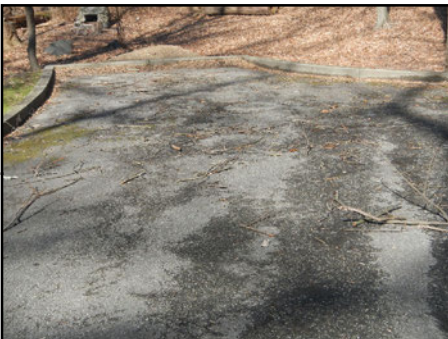
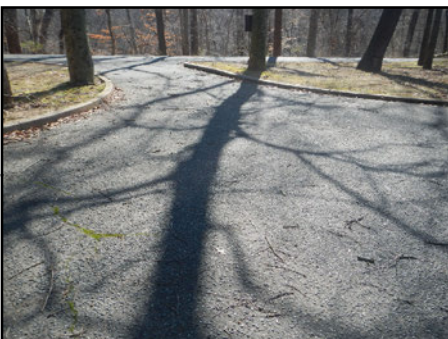
## ROUTE 0922: PICNIC GROVE #27 PARKING

Inspection Date	FMSS Number	User Access	Surface Type
3/8/2018	51790	PUBLIC	ASPHALT
Area (Sq. Ft.)	Lane Miles (11' Widths)	Curb Reveal (Inches)	Curb Recommendation
1,980	0.034	5	DO NOTHING
Curb Type		Curb & Gutter Type	
CONCRETE		NO CURB AND GUTTER	
Pavement Recommendation		Condition Rating / PCR	
PREVENTIVE MAINTENANCE		GOOD / 90

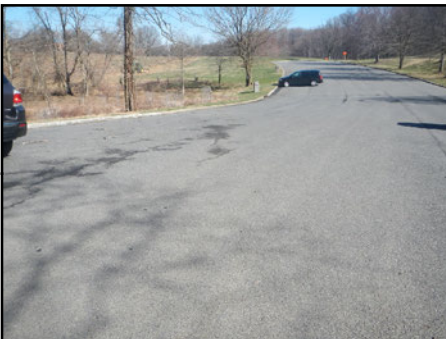
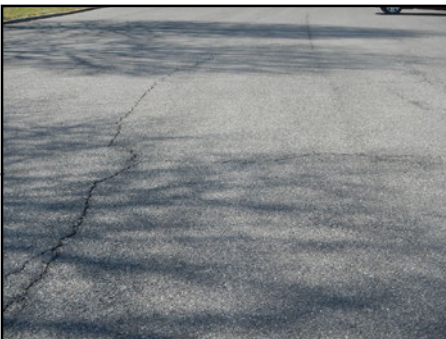
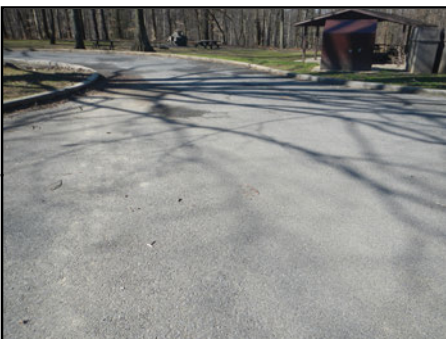
## ROUTE 0923: PICNIC GROVE #13 PARKING

Inspection Date	FMSS Number	User Access	Surface Type
3/8/2018	51792	PUBLIC	ASPHALT
Area (Sq. Ft.)	Lane Miles (11' Widths)	Curb Reveal (Inches)	Curb Recommendation
23,127	0.398	4	DO NOTHING
Curb Type		Curb & Gutter Type	
CONCRETE		NO CURB AND GUTTER	
Pavement Recommendation		Condition Rating / PCR	
PREVENTIVE MAINTENANCE		GOOD / 90

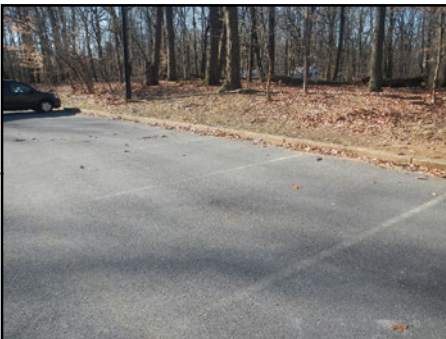
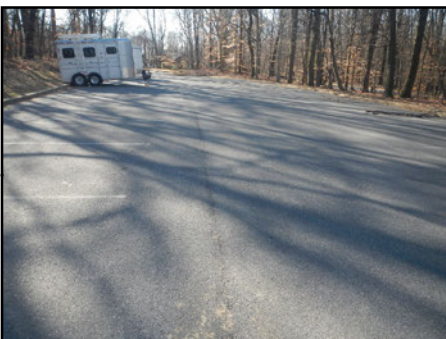
## ROUTE 0924: NATURE CENTER ACCESS PARKING

Inspection Date	FMSS Number	User Access	Surface Type
3/8/2018	51794	PUBLIC	ASPHALT
Area (Sq. Ft.)	Lane Miles (11' Widths)	Curb Reveal (Inches)	Curb Recommendation
49,861	0.858	NOT APPLICABLE	LIGHT REPAIR
Curb Type		Curb & Gutter Type	
NO CURB		CONCRETE	
Pavement Recommendation		Condition Rating / PCR	
PREVENTIVE MAINTENANCE		GOOD / 90

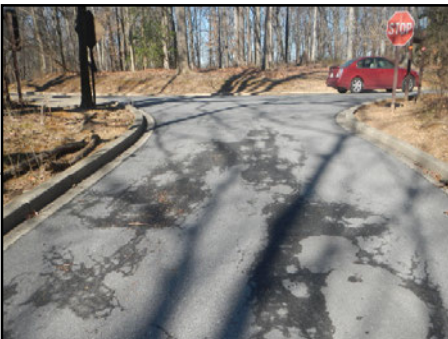
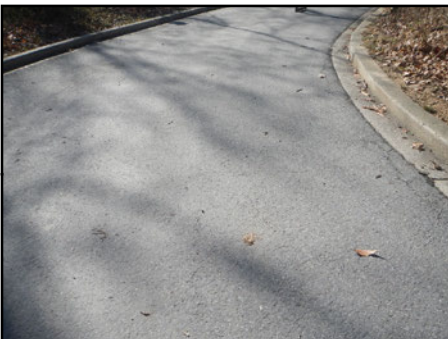
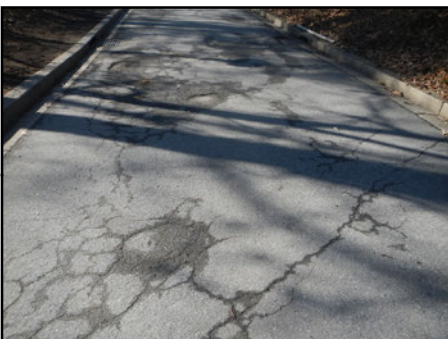
## ROUTE 0925A: BOARDING STABLE ACCESS ROAD PARKING A

Inspection Date	FMSS Number	User Access	Surface Type
3/8/2018	51797	NONPUBLIC	ASPHALT
Area (Sq. Ft.)	Lane Miles (11' Widths)	Curb Reveal (Inches)	Curb Recommendation
8,720	0.15	NOT APPLICABLE	DO NOTHING
Curb Type		Curb & Gutter Type	
NO CURB		CONCRETE	
Pavement Recommendation		Condition Rating / PCR	
PREVENTIVE MAINTENANCE		GOOD / 90

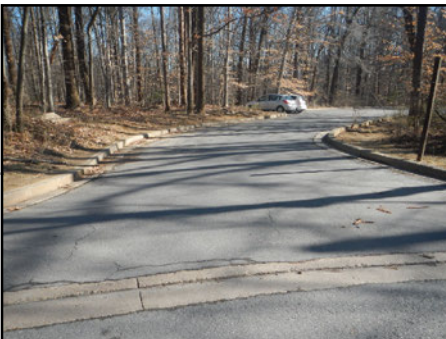
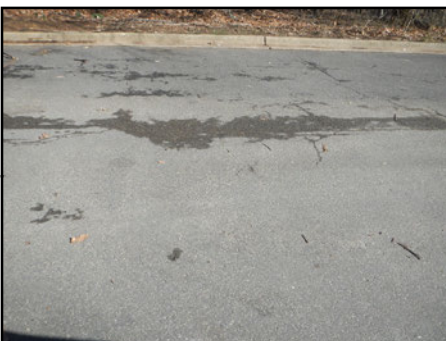
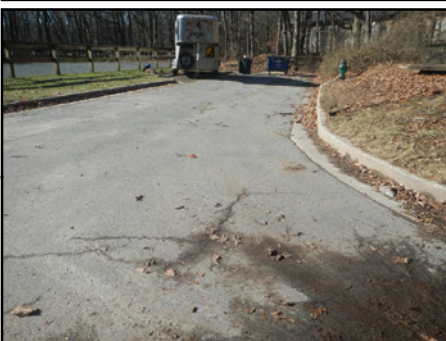
## ROUTE 0925B: BOARDING STABLE ACCESS ROAD PARKING B

Inspection Date	FMSS Number	User Access	Surface Type
3/8/2018	N/A	PUBLIC	ASPHALT
Area (Sq. Ft.)	Lane Miles (11' Widths)	Curb Reveal (Inches)	Curb Recommendation
16,800	0.289	NOT APPLICABLE	DO NOTHING
Curb Type		Curb & Gutter Type	
NO CURB		CONCRETE	
Pavement Recommendation		Condition Rating / PCR	
PREVENTIVE MAINTENANCE		GOOD / 90

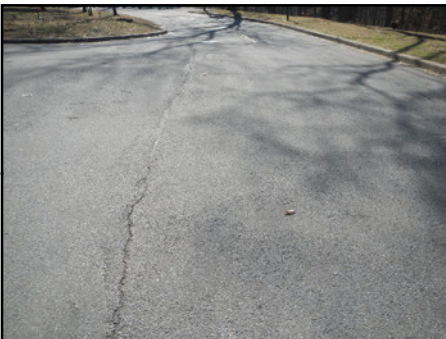
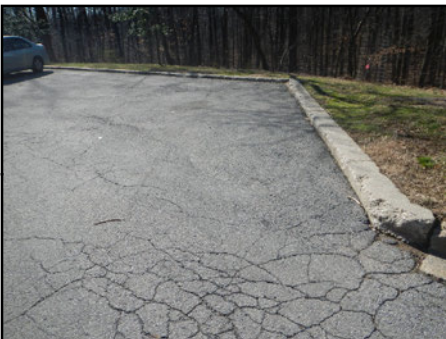
## ROUTE 0926: ROCR MAINTENANCE PARKING WEST

Inspection Date	FMSS Number	User Access	Surface Type
3/8/2018	51798	PUBLIC	ASPHALT
Area (Sq. Ft.)	Lane Miles (11' Widths)	Curb Reveal (Inches)	Curb Recommendation
34,354	0.591	4	LIGHT REPAIR
Curb Type		Curb & Gutter Type	
CONCRETE		CONCRETE	
Pavement Recommendation		Condition Rating / PCR	
LIGHT 3R TREATMENTS		FAIR / 73

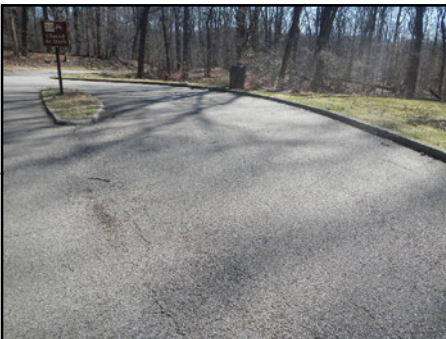
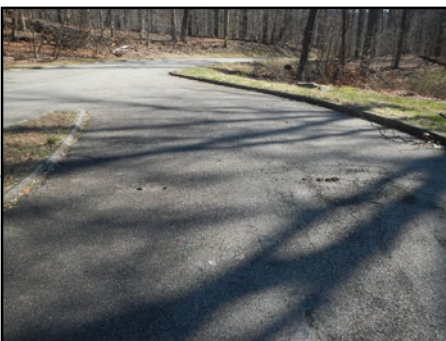
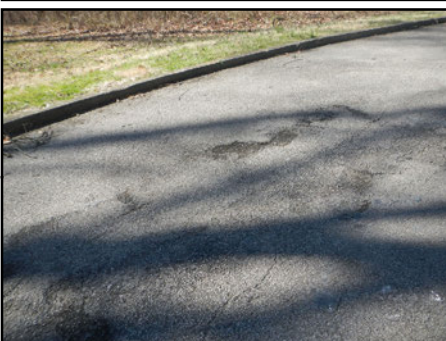
## ROUTE 0927: PICNIC GROVE #20 PARKING

Inspection Date	FMSS Number	User Access	Surface Type
3/8/2018	51800	PUBLIC	ASPHALT
Area (Sq. Ft.)	Lane Miles (11' Widths)	Curb Reveal (Inches)	Curb Recommendation
1,254	0.022	5	DO NOTHING
Curb Type		Curb & Gutter Type	
CONCRETE		NO CURB AND GUTTER	
Pavement Recommendation		Condition Rating / PCR	
PREVENTIVE MAINTENANCE		GOOD / 90

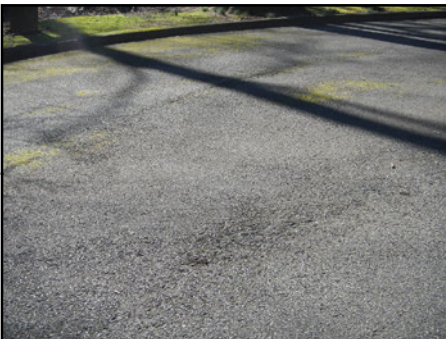
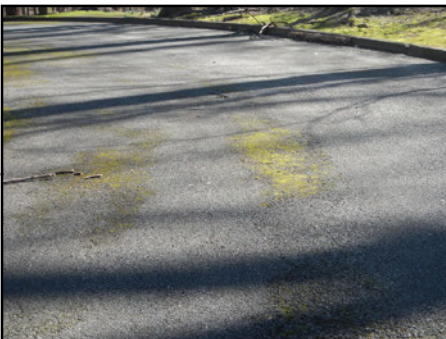
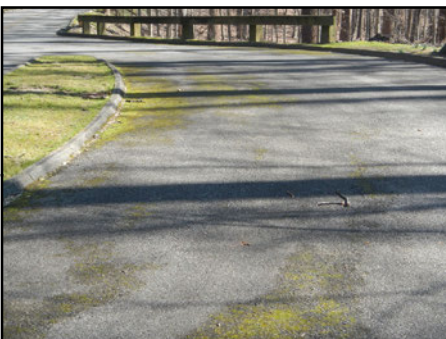
## ROUTE 0928: PICNIC GROVE #20A PARKING

Inspection Date	FMSS Number	User Access	Surface Type
3/8/2018	51801	PUBLIC	ASPHALT
Area (Sq. Ft.)	Lane Miles (11' Widths)	Curb Reveal (Inches)	Curb Recommendation
2,403	0.041	5	DO NOTHING
Curb Type		Curb & Gutter Type	
CONCRETE		NO CURB AND GUTTER	
Pavement Recommendation		Condition Rating / PCR	
PREVENTIVE MAINTENANCE		GOOD / 90

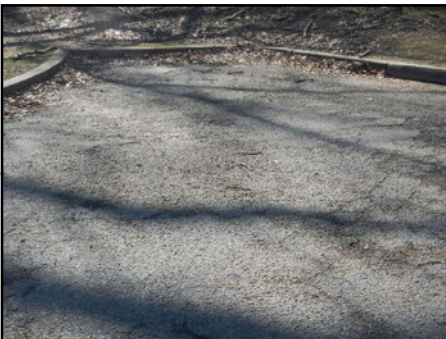
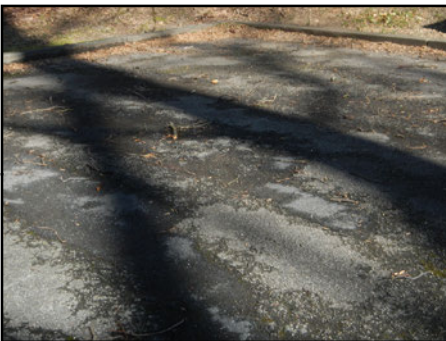
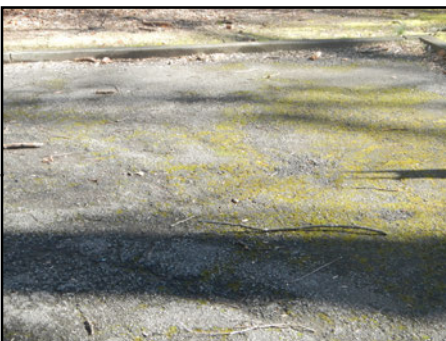
## ROUTE 0929: PICNIC GROVE #21 PARKING

Inspection Date	FMSS Number	User Access	Surface Type
3/8/2018	51802	PUBLIC	ASPHALT
Area (Sq. Ft.)	Lane Miles (11' Widths)	Curb Reveal (Inches)	Curb Recommendation
1,661	0.029	7	DO NOTHING
Curb Type		Curb & Gutter Type	
CONCRETE		NO CURB AND GUTTER	
Pavement Recommendation		Condition Rating / PCR	
PREVENTIVE MAINTENANCE		GOOD / 90

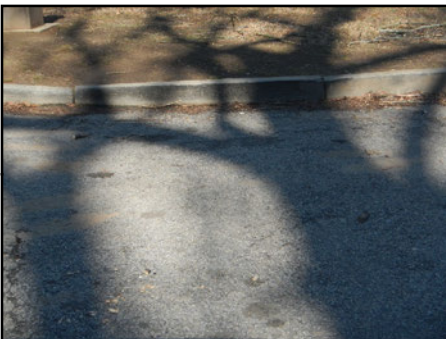
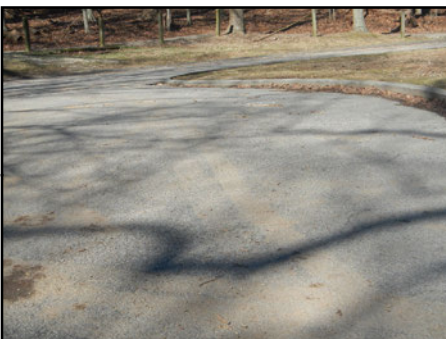
## ROUTE 0930: PICNIC GROVE #22 PARKING

Inspection Date	FMSS Number	User Access	Surface Type
3/8/2018	51804	PUBLIC	ASPHALT
Area (Sq. Ft.)	Lane Miles (11' Widths)	Curb Reveal (Inches)	Curb Recommendation
2,611	0.045	5	DO NOTHING
Curb Type		Curb & Gutter Type	
CONCRETE		NO CURB AND GUTTER	
Pavement Recommendation		Condition Rating / PCR	
LIGHT 3R TREATMENTS		FAIR / 73
