# ROCR Cycle 6

## Final Report

### Road Inventory and Condition Assessment of Paved Routes Rock Creek Park

**Report Date: November 2019**

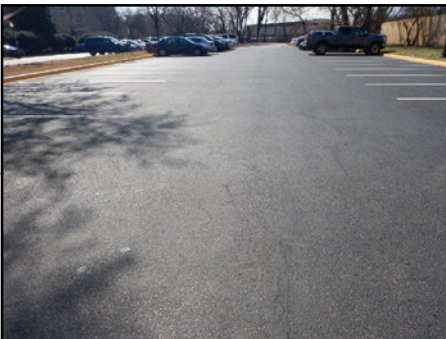
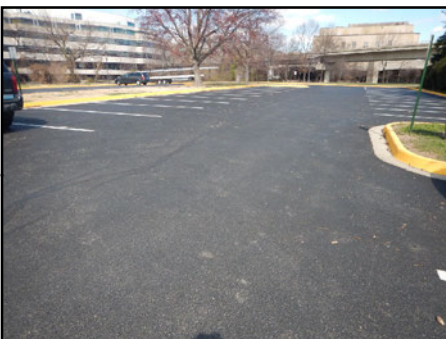
## ROUTE 0932: THOMPSON'S BOAT CENTER PARKING

Inspection Date	FMSS Number	User Access	Surface Type
3/8/2018	51807	PUBLIC	ASPHALT
Area (Sq. Ft.)	Lane Miles (11' Widths)	Curb Reveal (Inches)	Curb Recommendation
34,949	0.602	NOT APPLICABLE	DO NOTHING
Curb Type		Curb & Gutter Type	
NO CURB		CONCRETE	
Pavement Recommendation		Condition Rating / PCR	
PREVENTIVE MAINTENANCE		GOOD / 90

Note: Parking area consists of multiple surface types: 2 parts Asphalt at 33,735 square feet; 1 part Concrete 1,214 square feet.

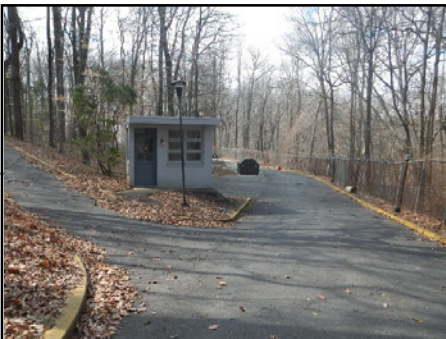
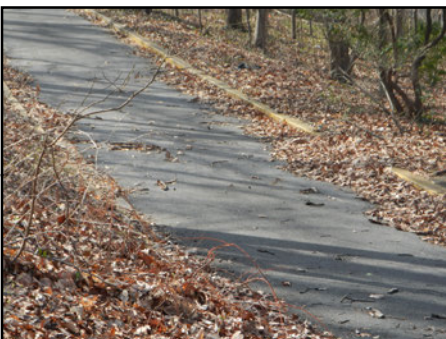
Inspection Date	FMSS Number	User Access	Surface Type
3/8/2018	51809	NONPUBLIC	ASPHALT
Area (Sq. Ft.)	Lane Miles (11' Widths)	Curb Reveal (Inches)	Curb Recommendation
3,370	0.058	NOT APPLICABLE	DO NOTHING
Curb Type		Curb & Gutter Type	
NO CURB		CONCRETE	
Pavement Recommendation		Condition Rating / PCR	
PREVENTIVE MAINTENANCE		GOOD / 90

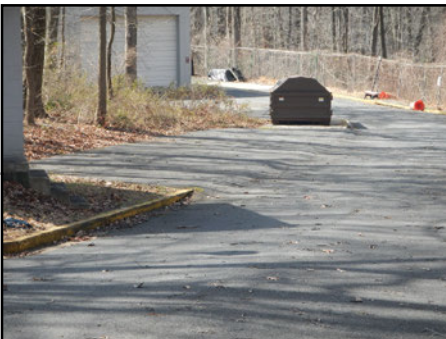
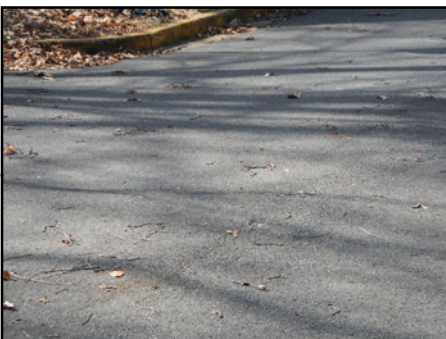
## ROUTE 0934: CARTER BARRON STAGE OVERFLOW PARKING

Inspection Date	FMSS Number	User Access	Surface Type
3/8/2018	51810	NONPUBLIC	ASPHALT
Area (Sq. Ft.)	Lane Miles (11' Widths)	Curb Reveal (Inches)	Curb Recommendation
2,487	0.043	7	DO NOTHING
Curb Type		Curb & Gutter Type	
NO CURB		CONCRETE	
Pavement Recommendation		Condition Rating / PCR	
PREVENTIVE MAINTENANCE		GOOD / 90

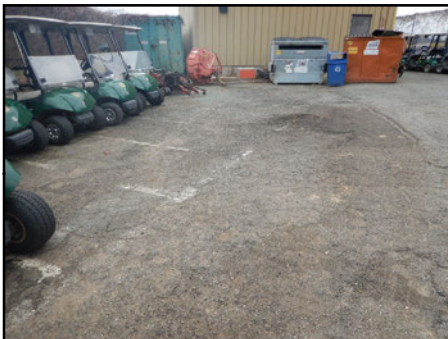
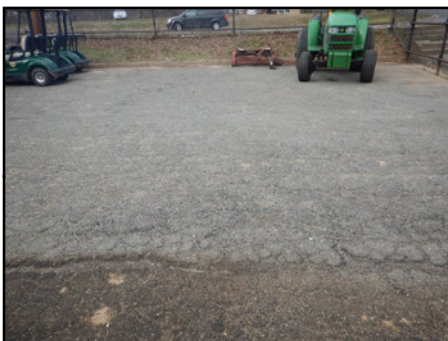
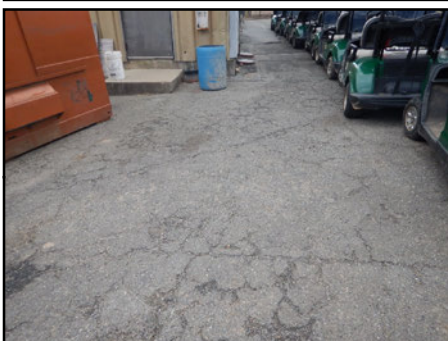
Inspection Date	FMSS Number	User Access	Surface Type
3/8/2018	51811	NONPUBLIC	ASPHALT
Area (Sq. Ft.)	Lane Miles (11' Widths)	Curb Reveal (Inches)	Curb Recommendation
6,095	0.105	NOT APPLICABLE	LIGHT REPAIR
Curb Type		Curb & Gutter Type	
NO CURB		CONCRETE	
Pavement Recommendation		Condition Rating / PCR	
RECONSTRUCTION		POOR / 30

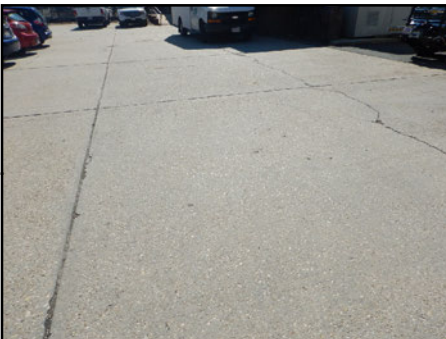
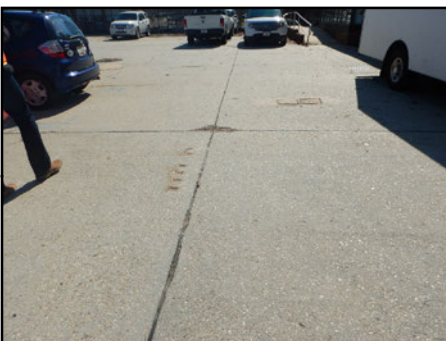
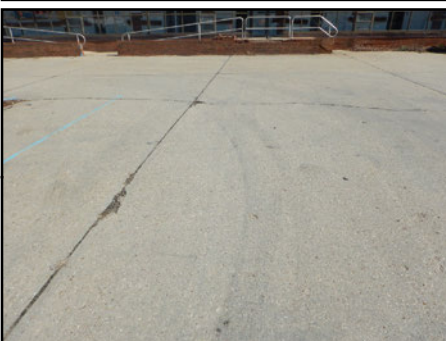
Inspection Date	FMSS Number	User Access	Surface Type
3/8/2018	51815	NONPUBLIC	CONCRETE
Area (Sq. Ft.)	Lane Miles (11' Widths)	Curb Reveal (Inches)	Curb Recommendation
19,188	0.33	NOT APPLICABLE	NOT APPLICABLE
Curb Type		Curb & Gutter Type	
NO CURB		NO CURB AND GUTTER	
Pavement Recommendation		Condition Rating / PCR	
LIGHT 3R TREATMENTS		FAIR / 73

Note: Parking area consists of multiple surface types: 2 parts Asphalt at 6,630 square feet; 1 part Concrete 12,558 square feet.

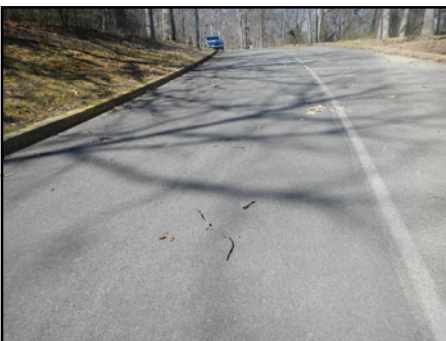
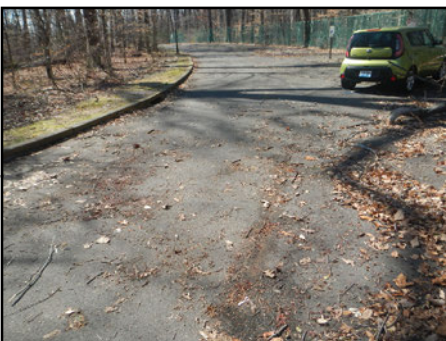
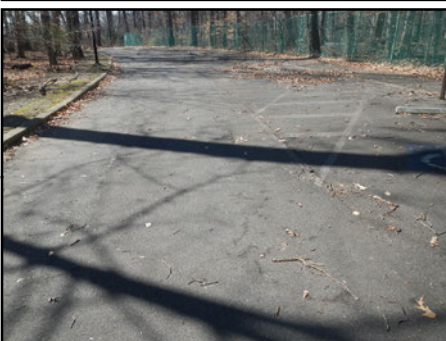
Inspection Date	FMSS Number	User Access	Surface Type
3/8/2018	51641	PUBLIC	ASPHALT
Area (Sq. Ft.)	Lane Miles (11' Widths)	Curb Reveal (Inches)	Curb Recommendation
18,791	0.324	7	DO NOTHING
Curb Type		Curb & Gutter Type	
CONCRETE		NO CURB AND GUTTER	
Pavement Recommendation		Condition Rating / PCR	
PREVENTIVE MAINTENANCE		GOOD / 90

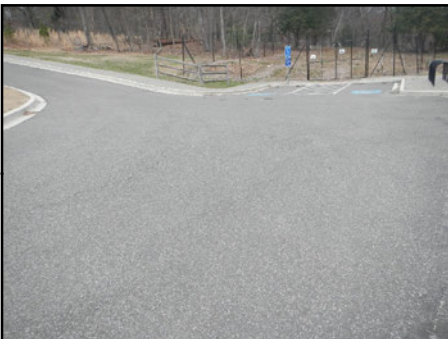
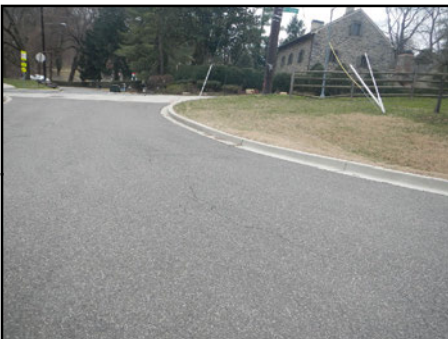
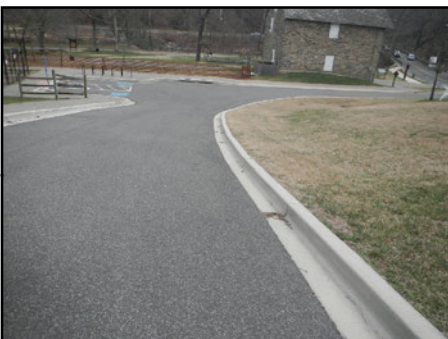
## ROUTE 0940: PIERCE MILL BUS LOOP

Inspection Date	FMSS Number	User Access	Surface Type
3/8/2018	51875	PUBLIC	ASPHALT
Area (Sq. Ft.)	Lane Miles (11' Widths)	Curb Reveal (Inches)	Curb Recommendation
4,809	0.083	NOT APPLICABLE	DO NOTHING
Curb Type		Curb & Gutter Type	
NO CURB		CONCRETE	
Pavement Recommendation		Condition Rating / PCR	
PREVENTIVE MAINTENANCE		GOOD / 90

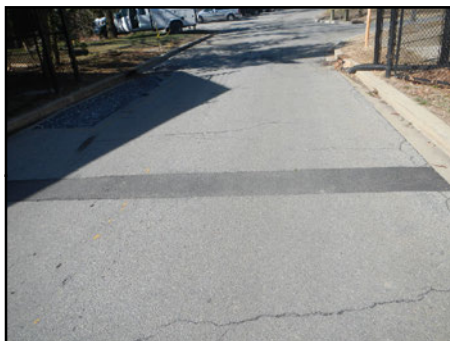
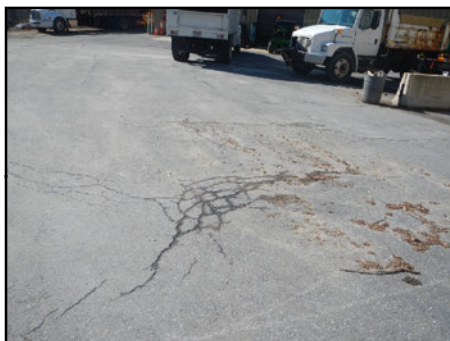
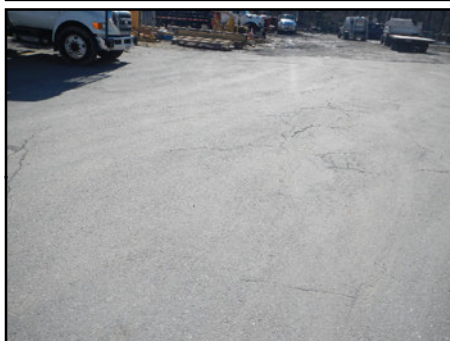
## ROUTE 0941: ROCR MAINTENANCE STAFF EAST PARKING

Inspection Date	FMSS Number	User Access	Surface Type
3/8/2018	N/A	NONPUBLIC	ASPHALT
Area (Sq. Ft.)	Lane Miles (11' Widths)	Curb Reveal (Inches)	Curb Recommendation
32,436	0.558	NOT APPLICABLE	LIGHT REPAIR
Curb Type		Curb & Gutter Type	
NO CURB		CONCRETE	
Pavement Recommendation		Condition Rating / PCR	
LIGHT 3R TREATMENTS		FAIR / 73

Note: Parking area consists of multiple surface types: 1 part Asphalt at 30,998 square feet; 1 part Concrete 1,438 square feet.
