SAFR Cycle 6

Final Report

Road Inventory and Condition Assessment of Paved Routes San Francisco Maritime National Historical Park

Report Date: August 2015

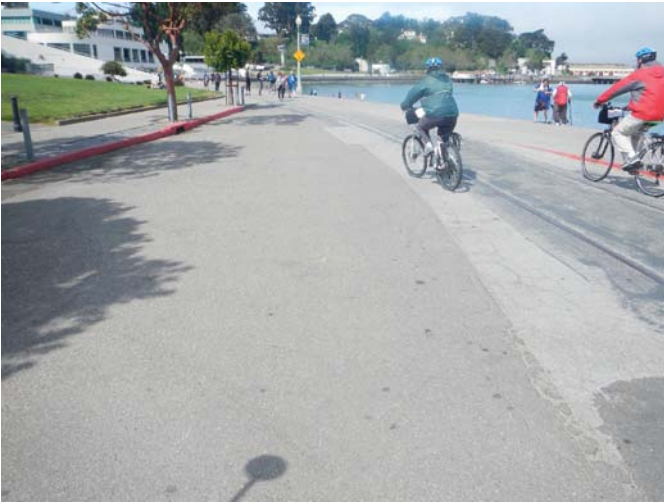
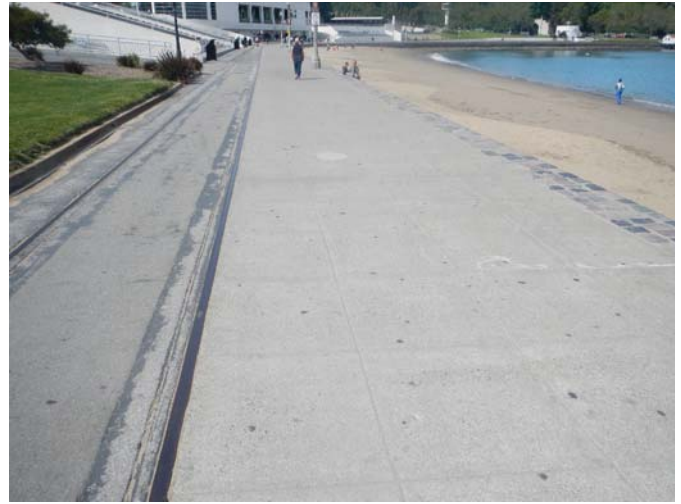
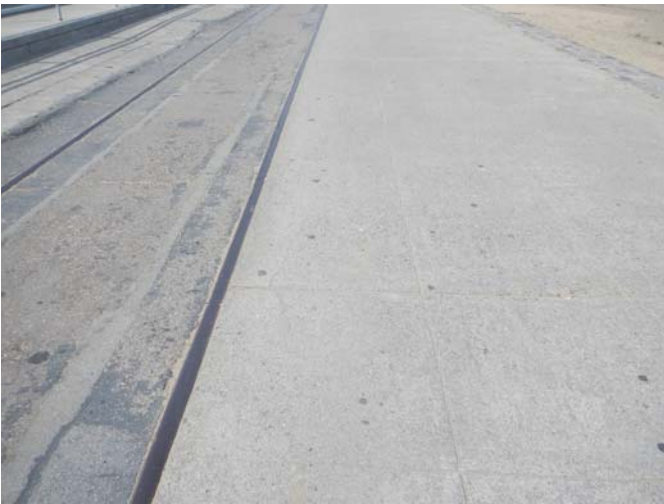
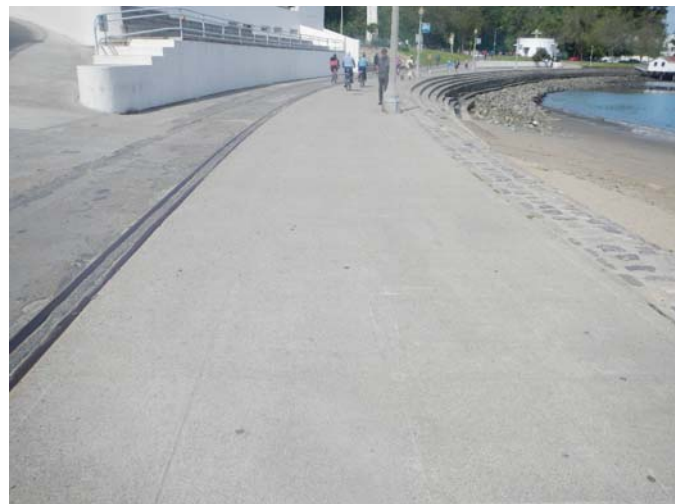
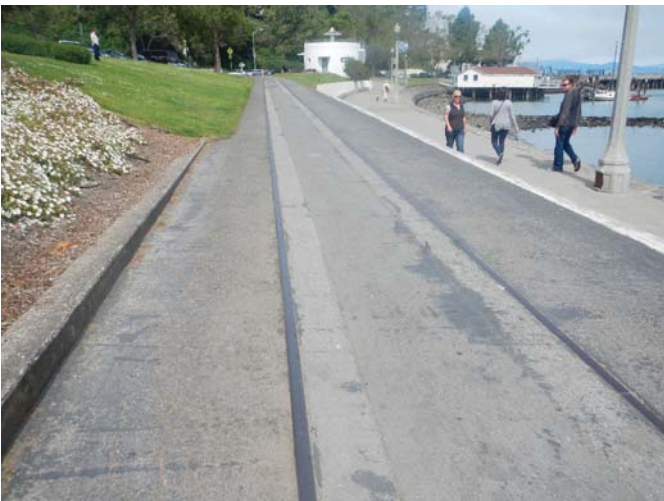
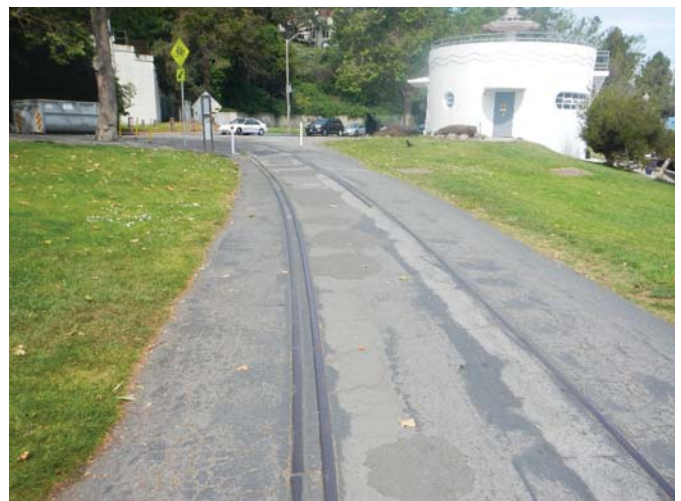
ROUTE 0400: AQUATIC PARK SERVICE ROAD / PROMENADE

Inspection Date: 5/2/2014	Beginning Section MP	0.00				
Paved Length (Miles): 0.24	Section Length (MI)	0.24				
Surface Type: CONCRETE	Route Summary					
Roadway Condition Information						
Pavement Condition Rating (PCR)	90	90				
Lane & Width Information						
Number of Lanes	1	1				
Paved Width (ft)	12.7	12.7				
Lane Width (ft)	12.7	12.7

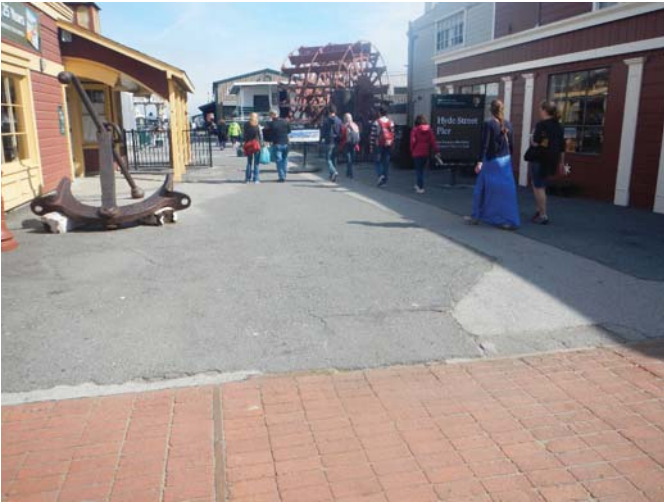
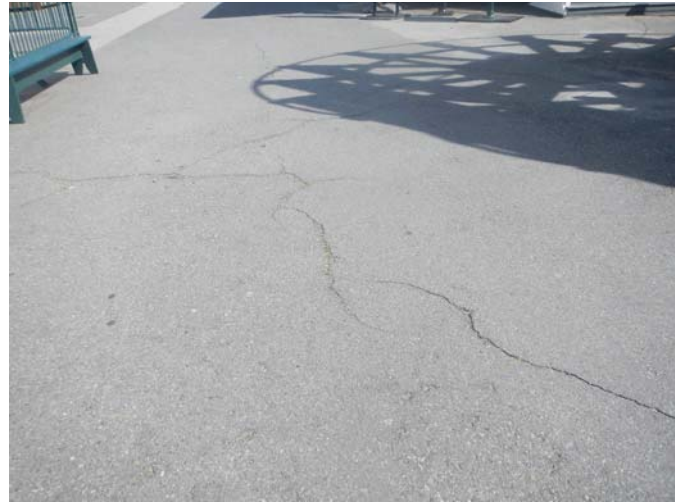
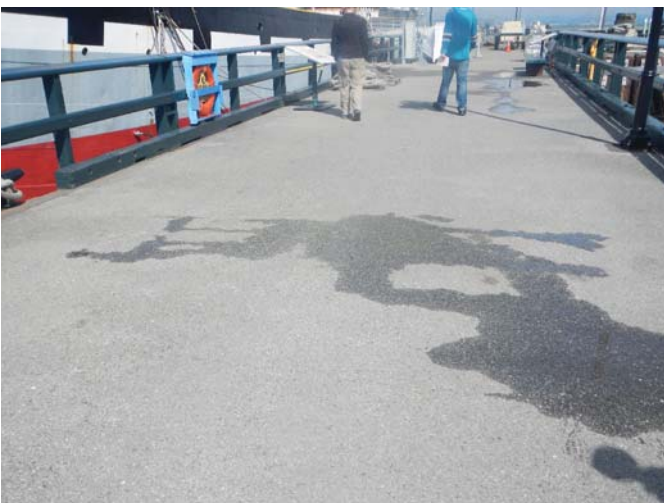
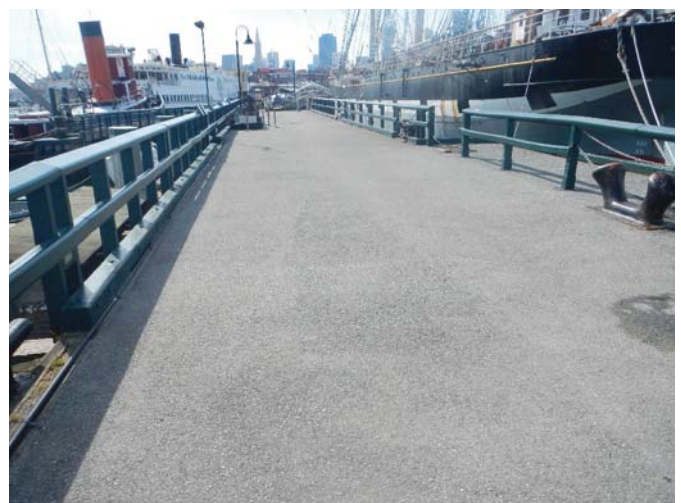
ROUTE 0602: HYDE STREET HISTORIC ROAD / PIER

Inspection Date: 5/2/2014	Beginning Section MP	0.00				
Paved Length (Miles): 0.22	Section Length (MI)	0.22				
Surface Type: ASPHALT	Route Summary					
Roadway Condition Information						
Pavement Condition Rating (PCR)	90	90				
Lane & Width Information						
Number of Lanes	2	2				
Paved Width (ft)	32	32				
Lane Width (ft)	16	16

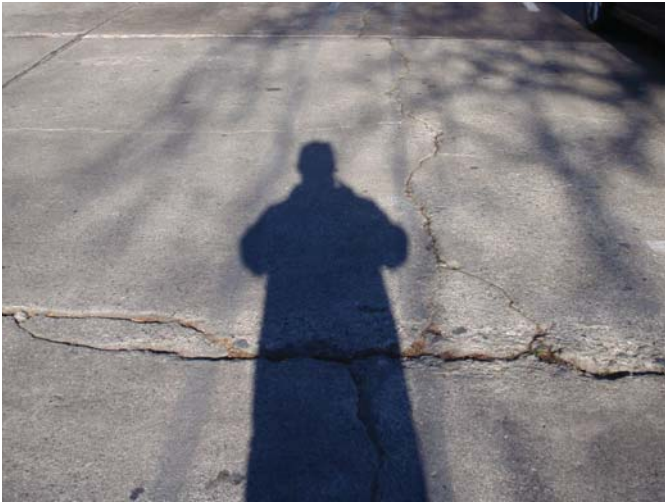
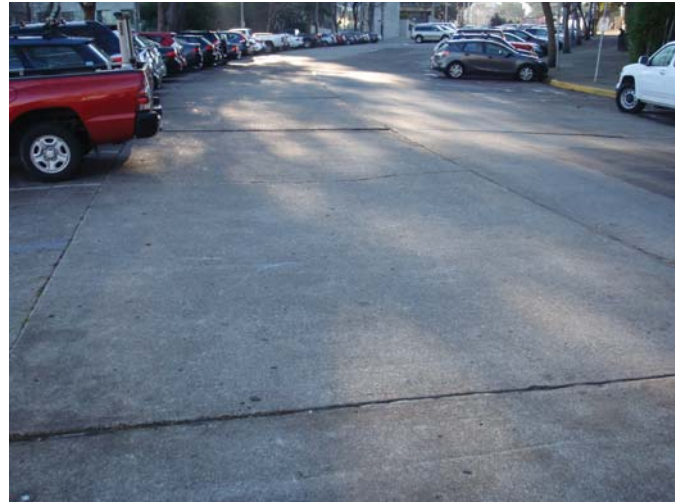
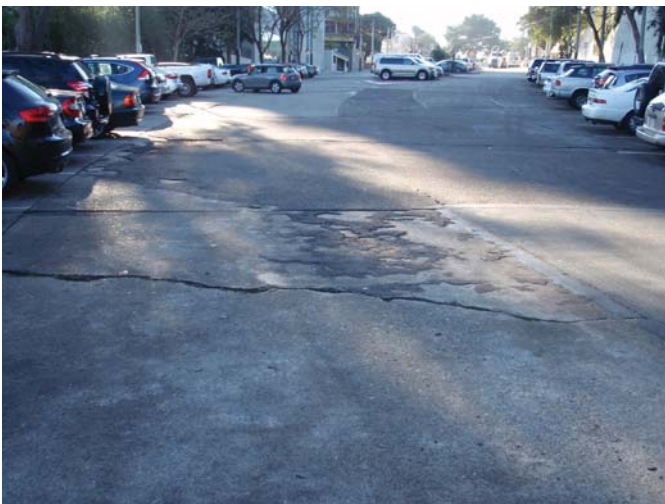
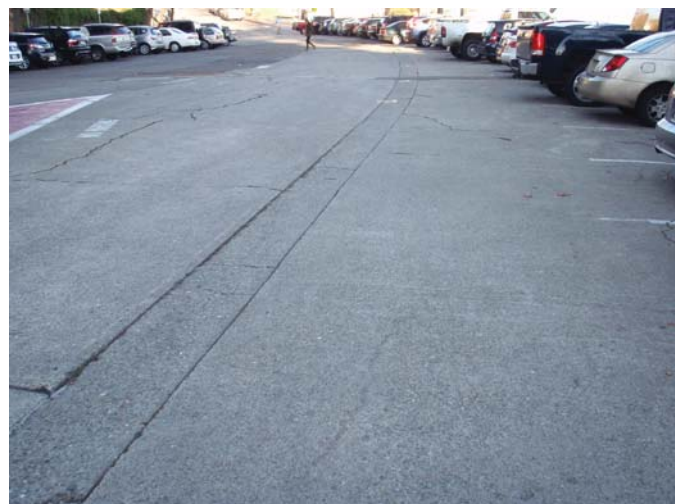
ROUTE 0603: LOWER VAN NESS ROAD

Inspection Date:	1/21/2015	Beginning Section MP	0.00				
Paved Length (Miles):	0.16	Section Length (MI)	0.16				
Surface Type:	CONCRETE	Route Summary					
Roadway Condition Information							
Pavement Condition Rating (PCR)	53	53					
Lane & Width Information							
Number of Lanes	2	2					
Paved Width (ft)	21	21					
Lane Width (ft)	10.5	10.5

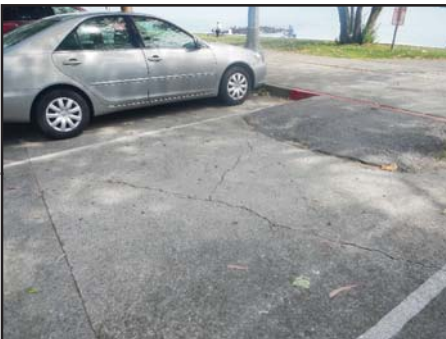
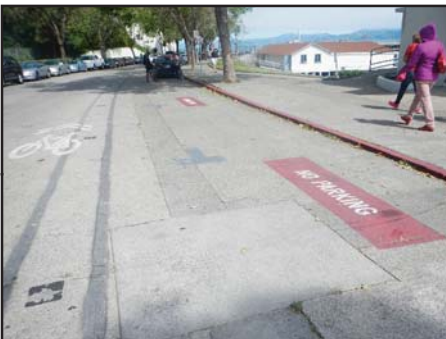
ROUTE 0900AZ: LOWER VAN NESS PARKING EAST

Inspection Date	FMSS Number	User Access	Surface Type
5/2/2014	229837	PUBLIC	CONCRETE
Area (Sq. Ft.)	Lane Miles (11' Widths)	Curb Reveal (Inches)	Curb Recommendation
11,257	0.194	6	LIGHT REPAIR
Curb Type		Curb & Gutter Type	
CONCRETE		NO CURB AND GUTTER	
Pavement Recommendation		Condition Rating / PCR	
RECONSTRUCTION		POOR / 30

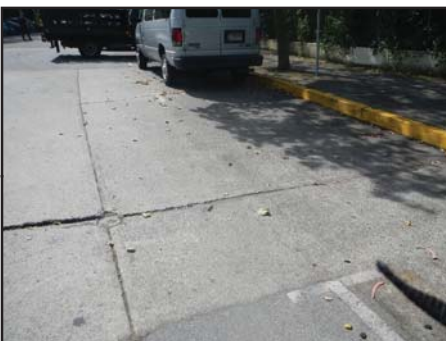
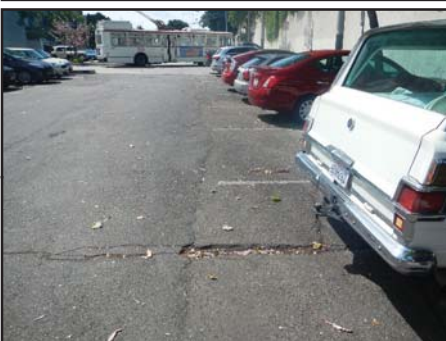
ROUTE 0900BZ: LOWER VAN NESS PARKING WEST

Inspection Date	FMSS Number	User Access	Surface Type
5/2/2014	229837	PUBLIC	CONCRETE
Area (Sq. Ft.)	Lane Miles (11' Widths)	Curb Reveal (Inches)	Curb Recommendation
10,115	0.174	6	MODERATE REPAIR
Curb Type		Curb & Gutter Type	
CONCRETE		NO CURB AND GUTTER	
Pavement Recommendation		Condition Rating / PCR	
RECONSTRUCTION		POOR / 30

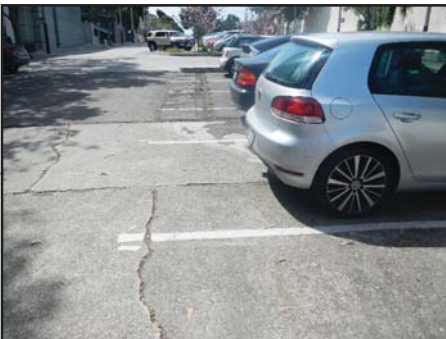
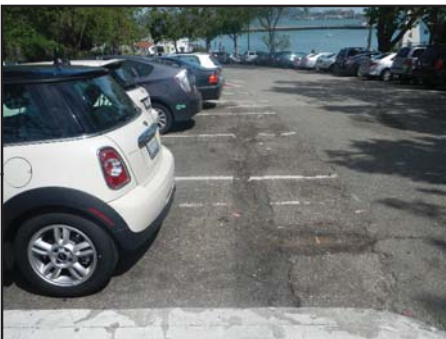
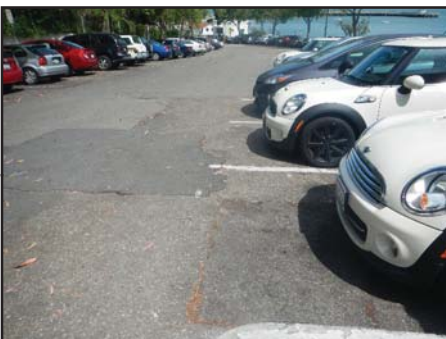
ROUTE 0900CZ: LOWER VAN NESS PARKING CENTER

Inspection Date	FMSS Number	User Access	Surface Type
5/2/2014	229837	PUBLIC	CONCRETE
Area (Sq. Ft.)	Lane Miles (11' Widths)	Curb Reveal (Inches)	Curb Recommendation
1,040	0.018	NOT APPLICABLE	NOT APPLICABLE
Curb Type		Curb & Gutter Type	
NO CURB		NO CURB AND GUTTER	
Pavement Recommendation		Condition Rating / PCR	
RECONSTRUCTION		POOR / 30

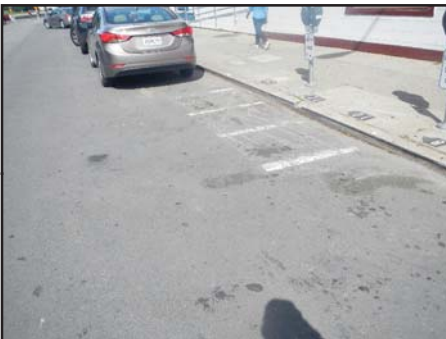
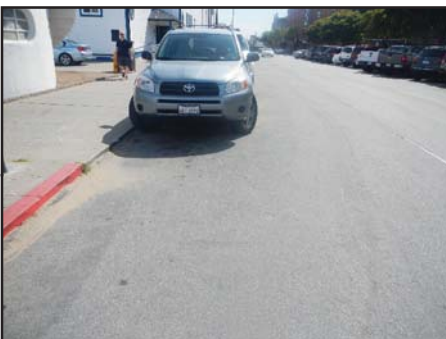
ROUTE 0901A: JEFFERSON STREET PARKING A

Inspection Date	FMSS Number	User Access	Surface Type
5/2/2014	102650	PUBLIC	ASPHALT
Area (Sq. Ft.)	Lane Miles (11' Widths)	Curb Reveal (Inches)	Curb Recommendation
1,930	0.033	4	MODERATE REPAIR
Curb Type		Curb & Gutter Type	
CONCRETE		NO CURB AND GUTTER	
Pavement Recommendation		Condition Rating / PCR	
PREVENTIVE MAINTENANCE		GOOD / 90

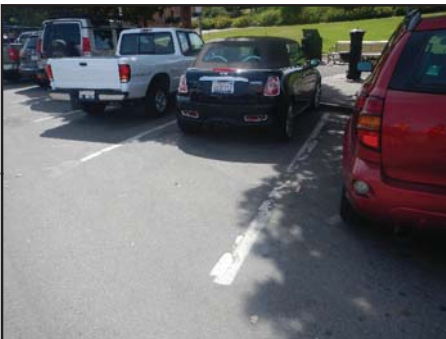
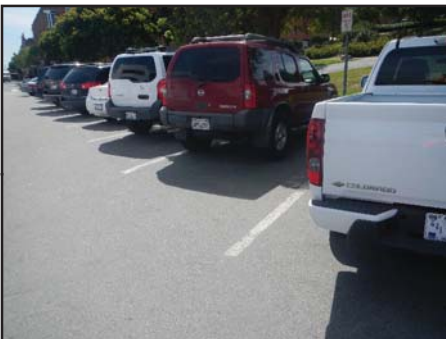
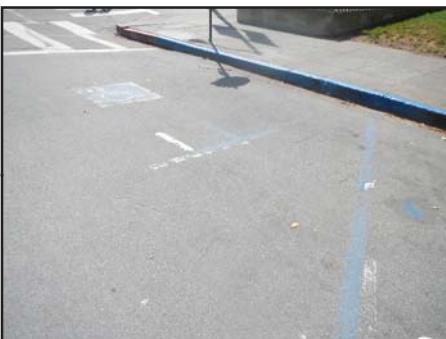
ROUTE 0901B: JEFFERSON STREET PARKING B

Inspection Date	FMSS Number	User Access	Surface Type
5/2/2014	102652	PUBLIC	ASPHALT
Area (Sq. Ft.)	Lane Miles (11' Widths)	Curb Reveal (Inches)	Curb Recommendation
4,545	0.078	4	LIGHT REPAIR
Curb Type		Curb & Gutter Type	
CONCRETE		NO CURB AND GUTTER	
Pavement Recommendation		Condition Rating / PCR	
LIGHT 3R TREATMENTS		FAIR / 73
