# SAJH Cycle 6

## Final Report

### Road Inventory and Condition Assessment of Paved Routes San Juan Island National Historical Park

Report Date: February 2016

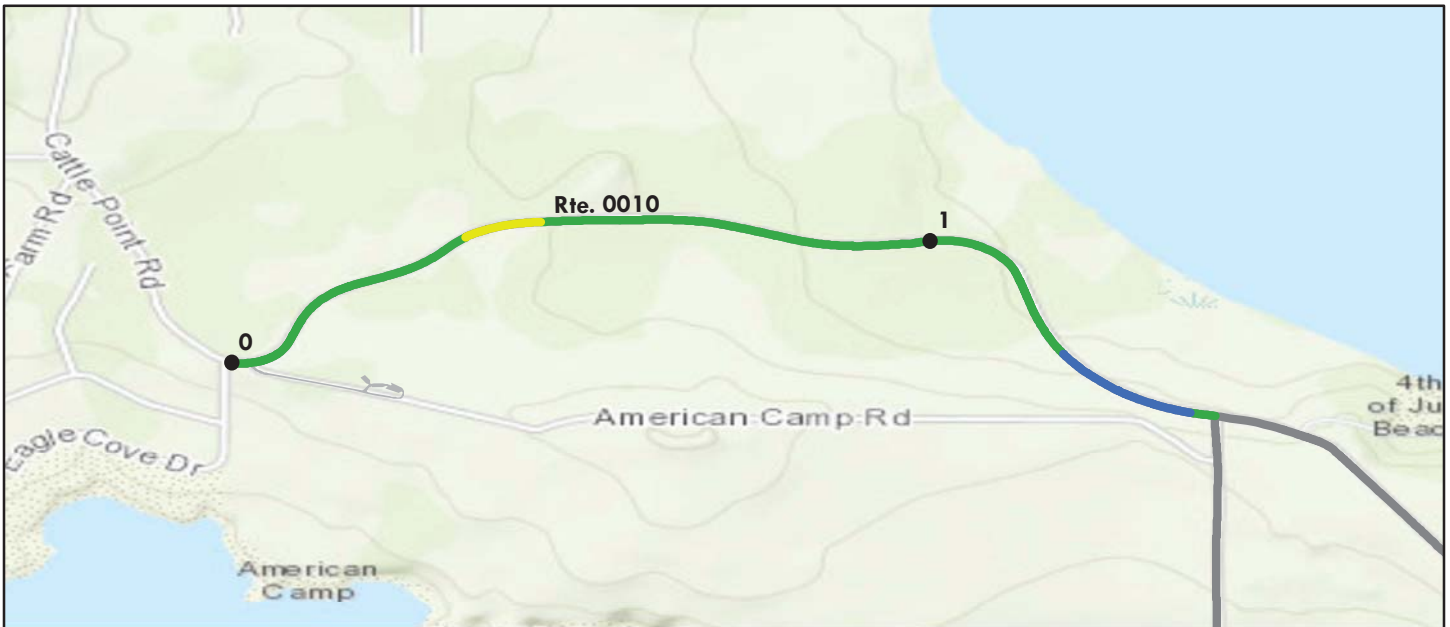
## ROUTE 0010: CATTLE POINT ROAD (WEST)

Route Condition Legend – Pavement Condition Rating (PCR)						
Poor (0 - 60)	Fair (61- 84)	Good (85 - 94)	Excellent (95 - 100)	Not Rated		
See Appendix for definitions and formulas						
<b>Inspection Date:</b> 9/28/2015	<b>Beginning Section MP</b>	0	1			
<b>Paved Length (Miles):</b> 1.53	<b>Section Length (MI)</b>	1	0.53			
<b>Surface Type:</b> ASPHALT	<b>Route Summary</b>					
<b>Roadway Condition Information</b>						
Pavement Condition Rating (PCR)	90	88	94			
Surface Condition Rating (SCR)	90	89	91			
Roughness Condition Index (RCI)	90	86	98			
<b>Distress Index Values</b>						
Structural Crack Index	100	100	100			
Alligator Crack Index	100	100	100			
Longitudinal Crack Index	100	100	100			
Transverse Cracking Index	100	100	100			
Patching Index	100	100	100			
Rutting Index	90	89	91			
International Roughness Index (IRI)	141	152	121			
<b>Lane &amp; Width Information</b>						
Number of Lanes	2	2	2

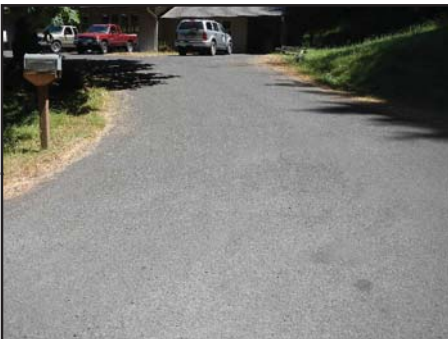
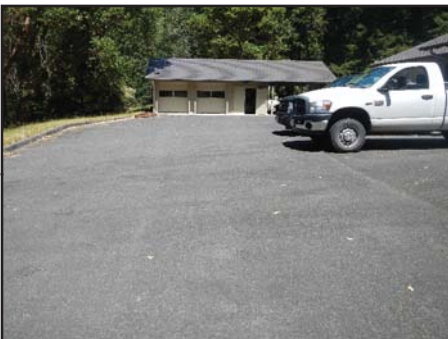
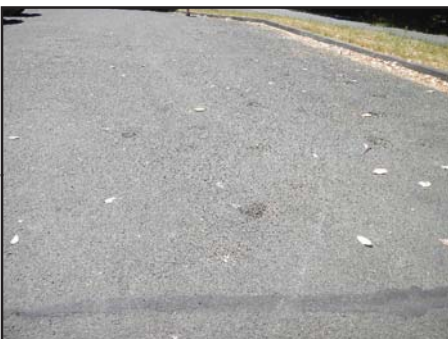
Inspection Date	FMSS Number	User Access	Surface Type
6/16/2015	105182	PUBLIC	ASPHALT
Area (Sq. Ft.)	Lane Miles (11' Widths)	Curb Reveal (Inches)	Curb Recommendation
7,805	0.134	NOT APPLICABLE	DO NOTHING
Curb Type		Curb & Gutter Type	
NO CURB		CONCRETE	
Pavement Recommendation		Condition Rating / PCR	
LIGHT 3R TREATMENTS		FAIR / 73

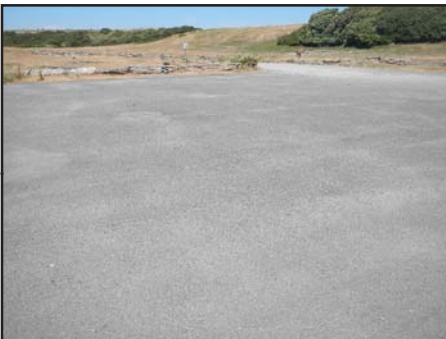
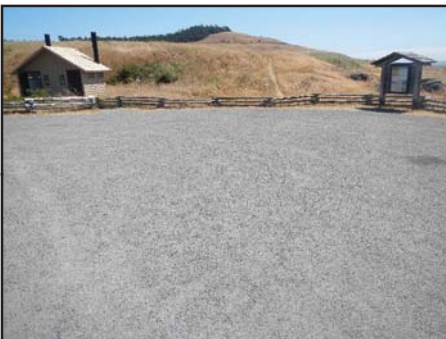
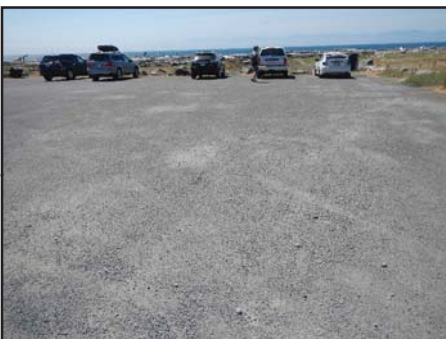
## ROUTE 0901: SOUTH BEACH PARKING

Inspection Date	FMSS Number	User Access	Surface Type
6/16/2015	105189	PUBLIC	ASPHALT
Area (Sq. Ft.)	Lane Miles (11' Widths)	Curb Reveal (Inches)	Curb Recommendation
18,878	0.325	NOT APPLICABLE	NOT APPLICABLE
Curb Type		Curb & Gutter Type	
NO CURB		NO CURB AND GUTTER	
Pavement Recommendation		Condition Rating / PCR	
LIGHT 3R TREATMENTS		FAIR / 73

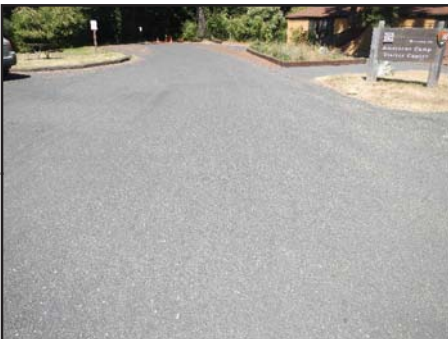
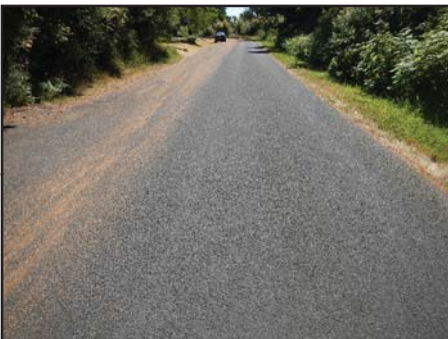
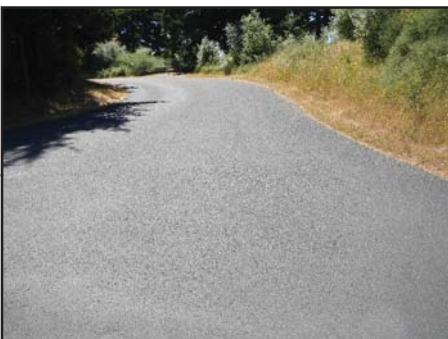
## ROUTE 0905: VISITOR CENTER PARKING

Inspection Date	FMSS Number	User Access	Surface Type
6/16/2015	105195	PUBLIC	ASPHALT
Area (Sq. Ft.)	Lane Miles (11' Widths)	Curb Reveal (Inches)	Curb Recommendation
37,094	0.639	5	DO NOTHING
Curb Type		Curb & Gutter Type	
WOOD		NO CURB AND GUTTER	
Pavement Recommendation		Condition Rating / PCR	
PREVENTIVE MAINTENANCE		GOOD / 90

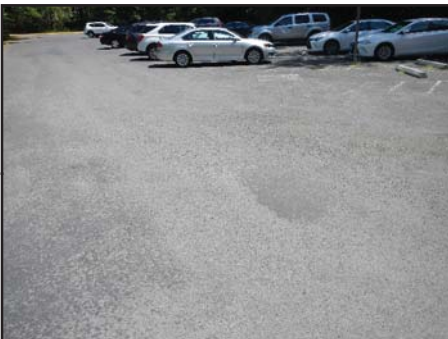
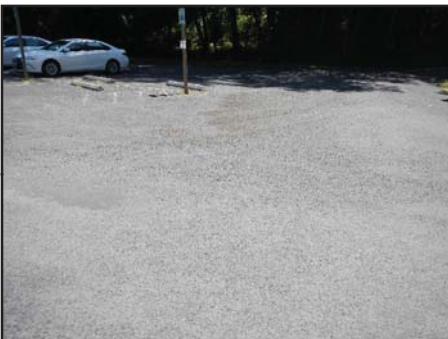
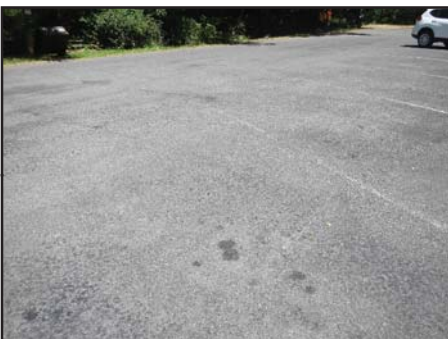
## ROUTE 0906: ENGLISH CAMP PARKING AREA

Inspection Date	FMSS Number	User Access	Surface Type
6/16/2015	116515	PUBLIC	ASPHALT
Area (Sq. Ft.)	Lane Miles (11' Widths)	Curb Reveal (Inches)	Curb Recommendation
27,227	0.469	NOT APPLICABLE	NOT APPLICABLE
Curb Type		Curb & Gutter Type	
NO CURB		NO CURB AND GUTTER	
Pavement Recommendation		Condition Rating / PCR	
LIGHT 3R TREATMENTS		FAIR / 73
