SAPU Cycle 6

Final Report

Road Inventory and Condition Assessment of Paved Routes Salinas Pueblo Missions National Monument

Federal Highway Administration
Eastern Federal Lands Highway Division
Road Inventory Program (RIP)

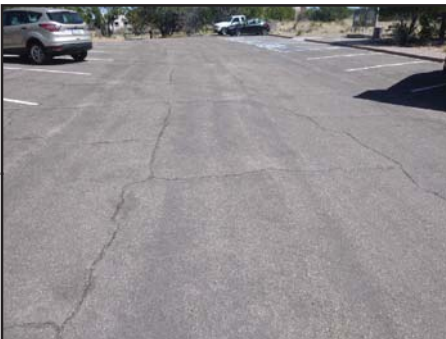
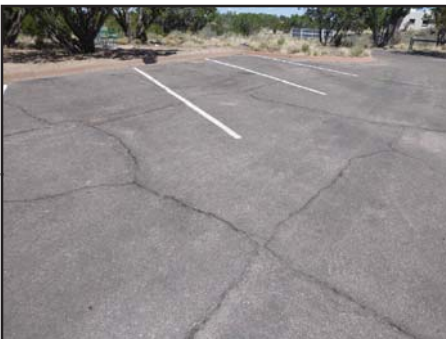
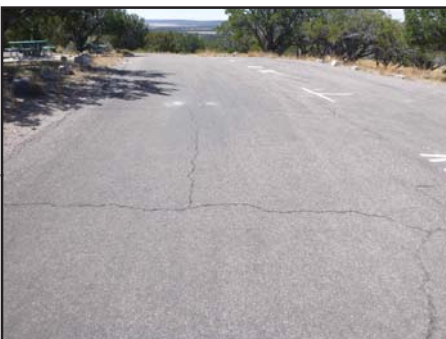
Inspection Date	FMSS Number	User Access	Surface Type
3/23/2017	72030	PUBLIC	ASPHALT
Area (Sq. Ft.)	Lane Miles (11' Widths)	Curb Reveal (Inches)	Curb Recommendation
22,986	0.396	NOT APPLICABLE	LIGHT REPAIR
Curb Type		Curb & Gutter Type	
NO CURB		CONCRETE	
Pavement Recommendation		Condition Rating / PCR	
HEAVY 3R TREATMENTS		POOR / 53

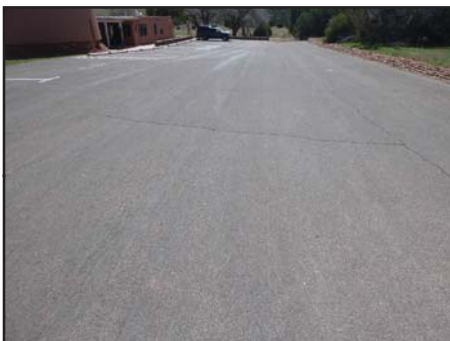
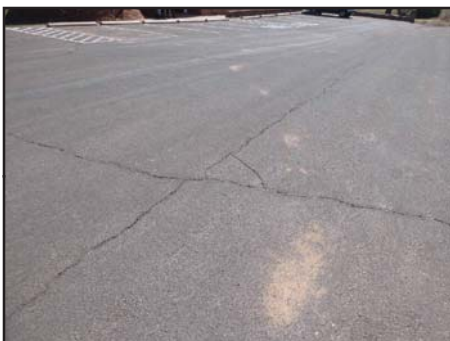
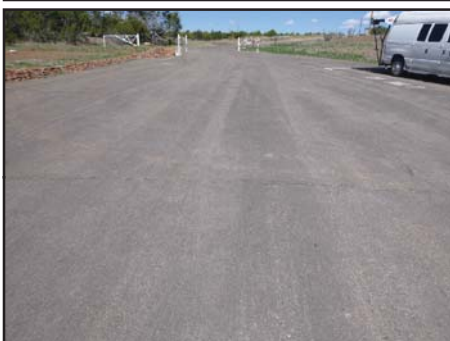
ROUTE 0901: QUARAI VISITOR CENTER PARKING

Inspection Date	FMSS Number	User Access	Surface Type
3/23/2017	72230	PUBLIC	ASPHALT
Area (Sq. Ft.)	Lane Miles (11' Widths)	Curb Reveal (Inches)	Curb Recommendation
12,013	0.207	1	MODERATE REPAIR
Curb Type		Curb & Gutter Type	
WOOD		NO CURB AND GUTTER	
Pavement Recommendation		Condition Rating / PCR	
HEAVY 3R TREATMENTS		POOR / 53
