SARA Cycle 6

Final Report

Road Inventory and Condition Assessment for Saratoga National Historical Park

Report Date: October 2021

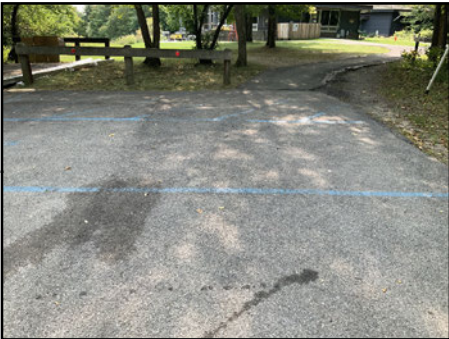
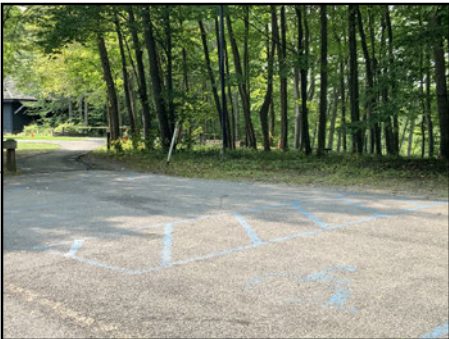
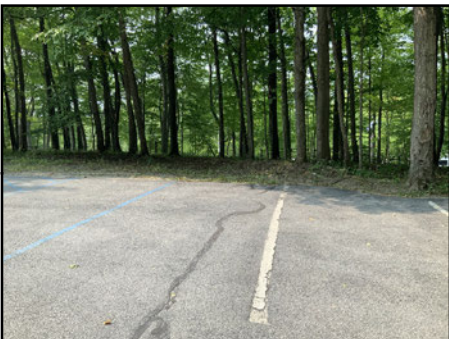
ROUTE 0901: ROOSEVELT ROAD PARKING

Inspection Date	FMSS Number	User Access	Surface Type
9/15/2020	102948	PUBLIC	ASPHALT
Area (Sq. Ft.)	Lane Miles (11' Widths)	Curb Reveal (Inches)	Curb Recommendation
1,816	0.031	NOT APPLICABLE	NOT APPLICABLE
Curb Type		Curb & Gutter Type	
NO CURB		NO CURB AND GUTTER	
Pavement Recommendation		Condition Rating / PCR	
PREVENTIVE MAINTENANCE		GOOD / 90

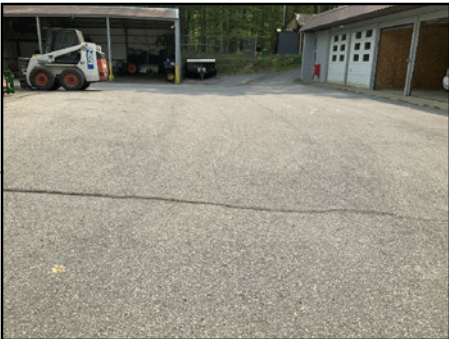
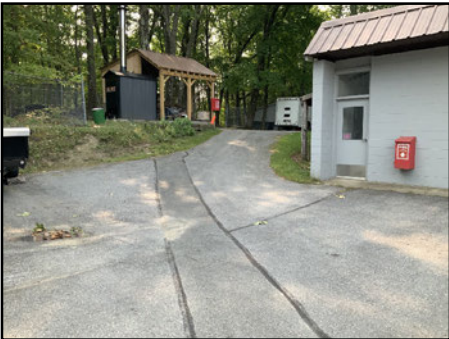
ROUTE 0902: MAINTENANCE AREA

Inspection Date	FMSS Number	User Access	Surface Type
9/15/2020	57919	NONPUBLIC	ASPHALT
Area (Sq. Ft.)	Lane Miles (11' Widths)	Curb Reveal (Inches)	Curb Recommendation
21,278	0.366	6	LIGHT REPAIR
Curb Type		Curb & Gutter Type	
CONCRETE		NO CURB AND GUTTER	
Pavement Recommendation		Condition Rating / PCR	
PREVENTIVE MAINTENANCE		GOOD / 90

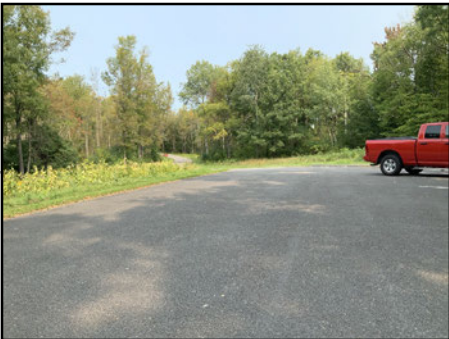
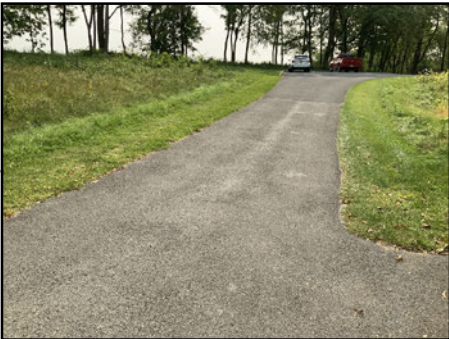
ROUTE 0904: STOP 1 PARKING

Inspection Date	FMSS Number	User Access	Surface Type
9/15/2020	80453	PUBLIC	ASPHALT
Area (Sq. Ft.)	Lane Miles (11' Widths)	Curb Reveal (Inches)	Curb Recommendation
11,463	0.197	6	LIGHT REPAIR
Curb Type		Curb & Gutter Type	
CONCRETE		NO CURB AND GUTTER	
Pavement Recommendation		Condition Rating / PCR	
PREVENTIVE MAINTENANCE		GOOD / 90

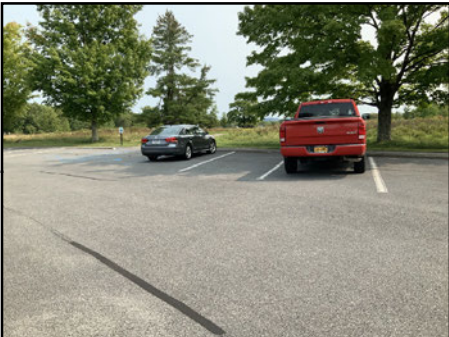
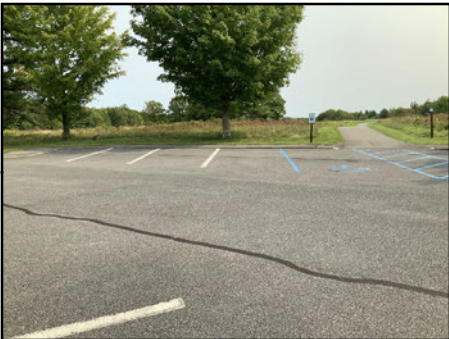
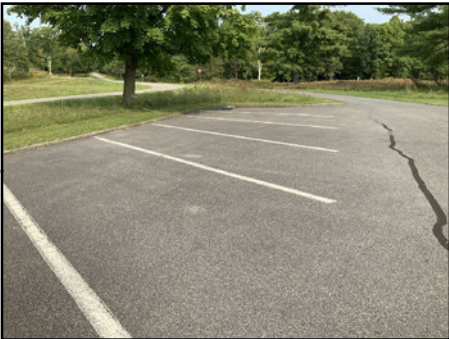
Inspection Date	FMSS Number	User Access	Surface Type
9/15/2020	80467	PUBLIC	ASPHALT
Area (Sq. Ft.)	Lane Miles (11' Widths)	Curb Reveal (Inches)	Curb Recommendation
10,641	0.183	5	LIGHT REPAIR
Curb Type		Curb & Gutter Type	
CONCRETE		NO CURB AND GUTTER	
Pavement Recommendation		Condition Rating / PCR	
PREVENTIVE MAINTENANCE		GOOD / 90

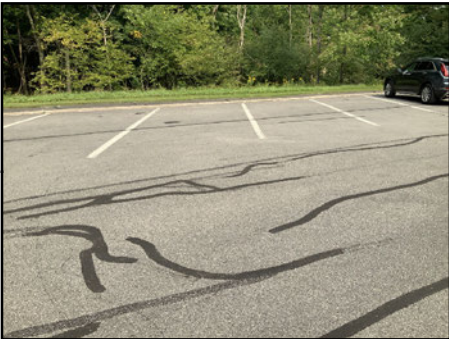
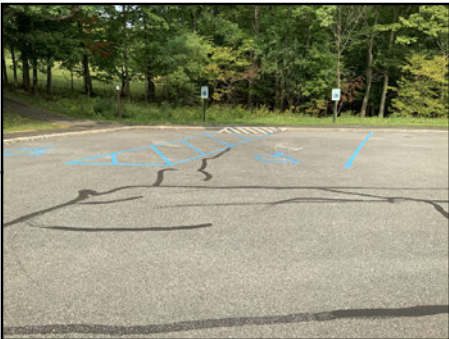
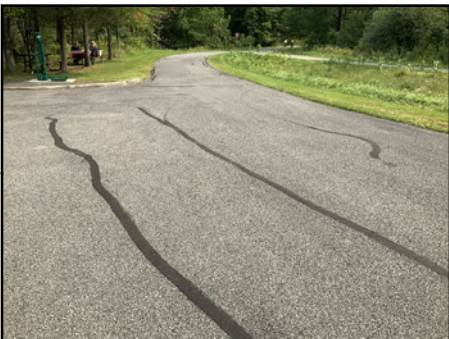
ROUTE 0912: STOP 8 PARKING

Inspection Date	FMSS Number	User Access	Surface Type
9/15/2020	80468	PUBLIC	ASPHALT
Area (Sq. Ft.)	Lane Miles (11' Widths)	Curb Reveal (Inches)	Curb Recommendation
9,290	0.16	5	DO NOTHING
Curb Type		Curb & Gutter Type	
CONCRETE		NO CURB AND GUTTER	
Pavement Recommendation		Condition Rating / PCR	
PREVENTIVE MAINTENANCE		GOOD / 90

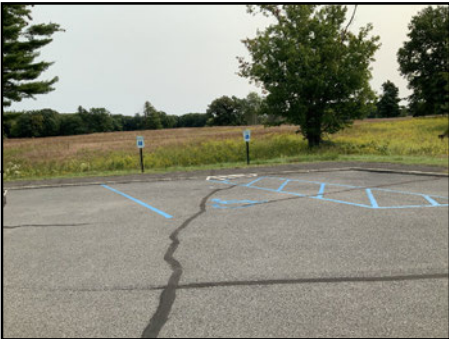
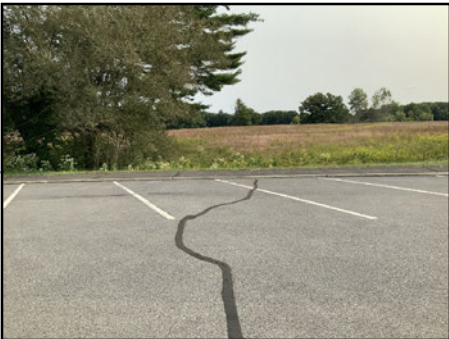
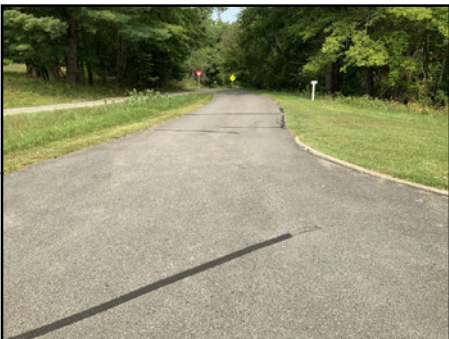
ROUTE 0913: STOP 9 PARKING

Inspection Date	FMSS Number	User Access	Surface Type
9/15/2020	80469	PUBLIC	ASPHALT
Area (Sq. Ft.)	Lane Miles (11' Widths)	Curb Reveal (Inches)	Curb Recommendation
24,980	0.43	5	DO NOTHING
Curb Type		Curb & Gutter Type	
CONCRETE		NO CURB AND GUTTER	
Pavement Recommendation		Condition Rating / PCR	
PREVENTIVE MAINTENANCE		GOOD / 90

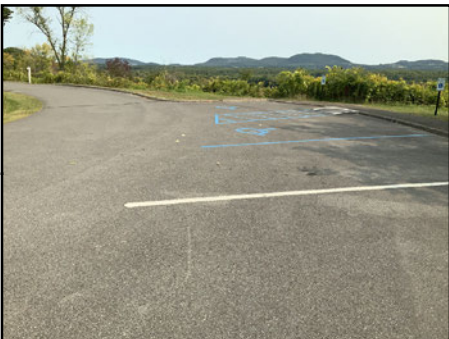
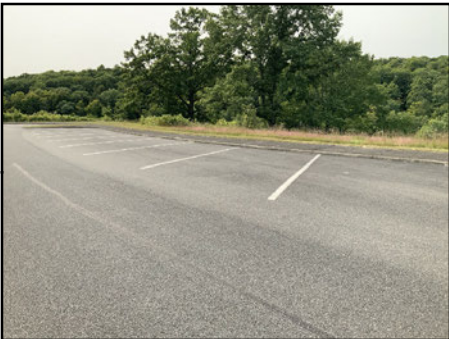
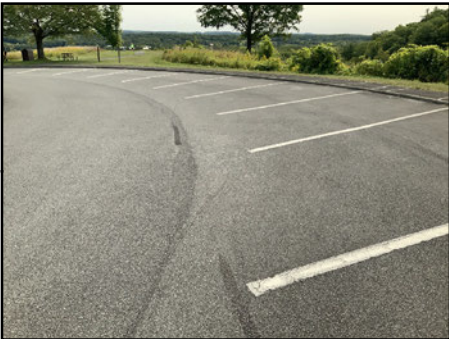
ROUTE 0914: STOP 10 PARKING

Inspection Date	FMSS Number	User Access	Surface Type
9/15/2020	80471	PUBLIC	ASPHALT
Area (Sq. Ft.)	Lane Miles (11' Widths)	Curb Reveal (Inches)	Curb Recommendation
7,843	0.135	5	MODERATE REPAIR
Curb Type		Curb & Gutter Type	
CONCRETE		NO CURB AND GUTTER	
Pavement Recommendation		Condition Rating / PCR	
PREVENTIVE MAINTENANCE		GOOD / 90

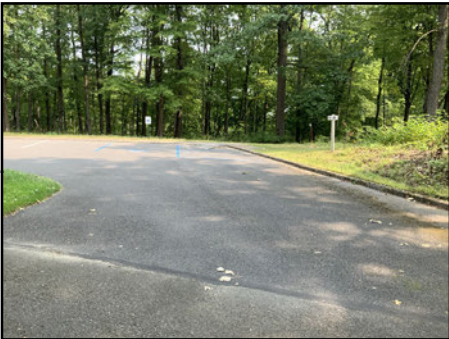
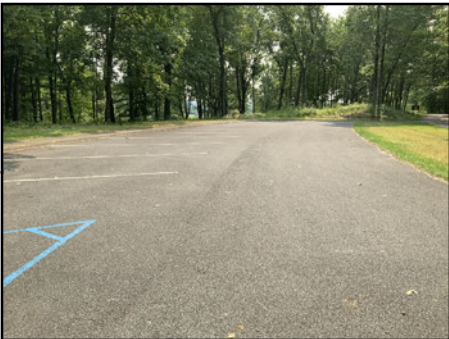
ROUTE 0915: SCHUYLER ESTATE PARKING

Inspection Date	FMSS Number	User Access	Surface Type
9/15/2020	102930	PUBLIC	ASPHALT
Area (Sq. Ft.)	Lane Miles (11' Widths)	Curb Reveal (Inches)	Curb Recommendation
16,613	0.286	3	LIGHT REPAIR
Curb Type		Curb & Gutter Type	
CONCRETE		NO CURB AND GUTTER	
Pavement Recommendation		Condition Rating / PCR	
PREVENTIVE MAINTENANCE		GOOD / 90

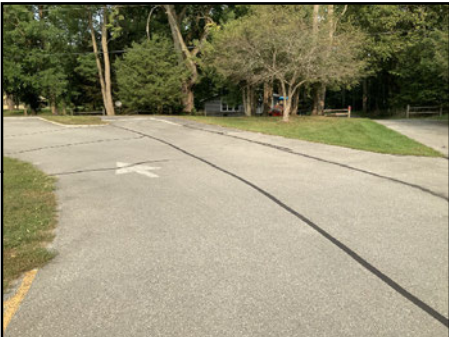
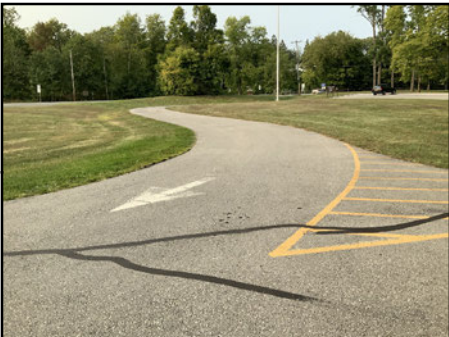
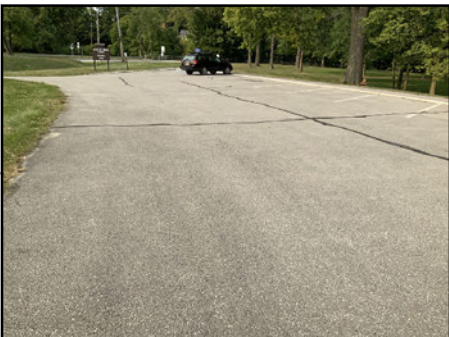
ROUTE 0916: MONUMENT PARKING

Inspection Date	FMSS Number	User Access	Surface Type
9/15/2020	58084	PUBLIC	ASPHALT
Area (Sq. Ft.)	Lane Miles (11' Widths)	Curb Reveal (Inches)	Curb Recommendation
13,259	0.228	5	LIGHT REPAIR
Curb Type		Curb & Gutter Type	
CONCRETE		NO CURB AND GUTTER	
Pavement Recommendation		Condition Rating / PCR	
PREVENTIVE MAINTENANCE		GOOD / 90

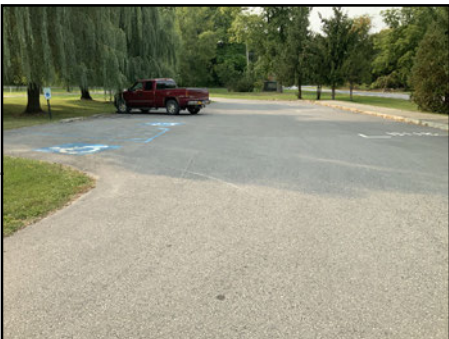
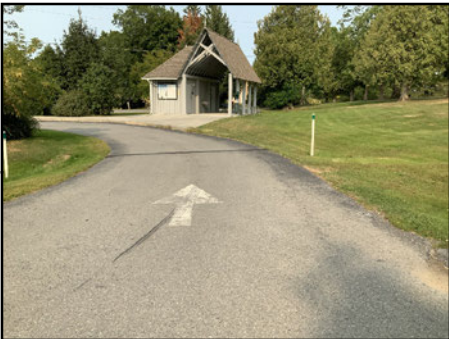
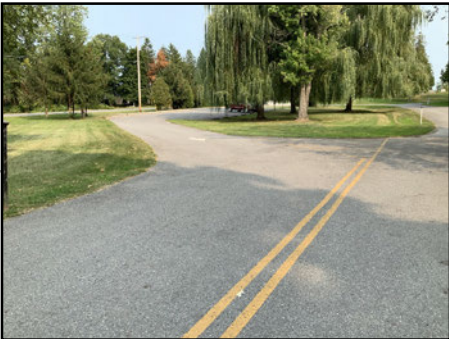
ROUTE 0919: SCHUYLER ESTATE RESIDENCE PARKING

Inspection Date	FMSS Number	User Access	Surface Type
9/15/2020	226767	NONPUBLIC	ASPHALT
Area (Sq. Ft.)	Lane Miles (11' Widths)	Curb Reveal (Inches)	Curb Recommendation
2,560	0.044	NOT APPLICABLE	NOT APPLICABLE
Curb Type		Curb & Gutter Type	
NO CURB		NO CURB AND GUTTER	
Pavement Recommendation		Condition Rating / PCR	
PREVENTIVE MAINTENANCE		GOOD / 90

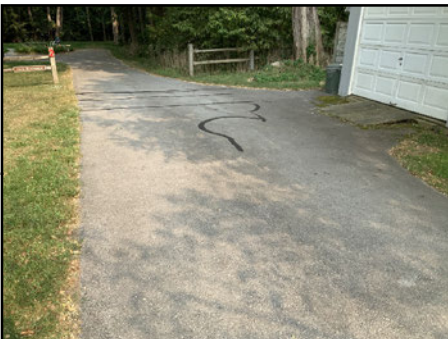
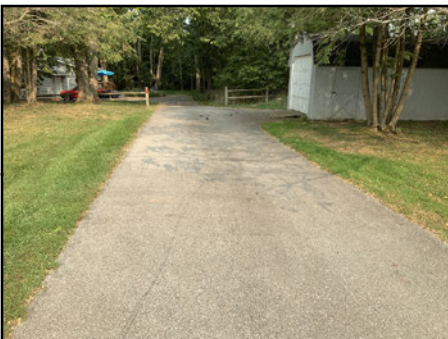
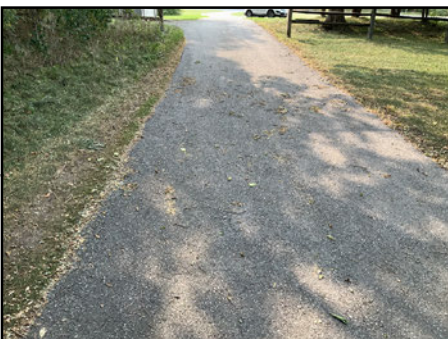
ROUTE 0920: VICTORY WOODS PARKING

Inspection Date	FMSS Number	User Access	Surface Type
9/15/2020	247625	PUBLIC	ASPHALT
Area (Sq. Ft.)	Lane Miles (11' Widths)	Curb Reveal (Inches)	Curb Recommendation
3,091	0.053	NOT APPLICABLE	NOT APPLICABLE
Curb Type		Curb & Gutter Type	
NO CURB		NO CURB AND GUTTER	
Pavement Recommendation		Condition Rating / PCR	
HEAVY 3R TREATMENTS		POOR / 53

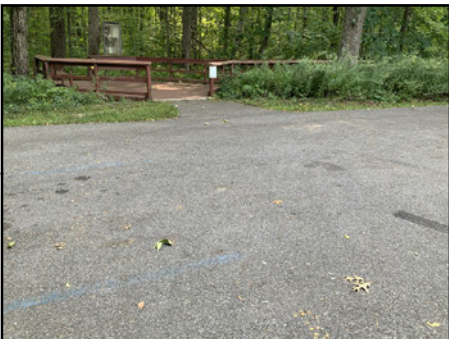
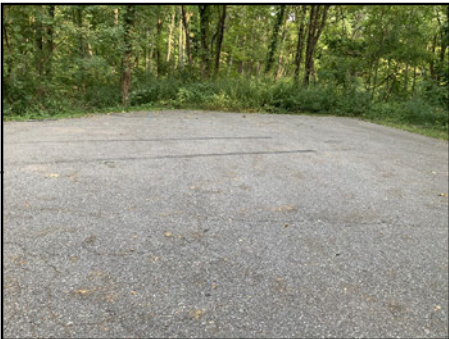
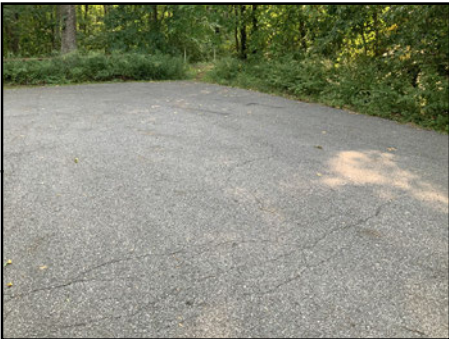
ROUTE 0921: STOP 2 SOUTHGATE ENTRANCE PARKING

Inspection Date	FMSS Number	User Access	Surface Type
9/15/2020	226777	PUBLIC	GRAVEL
Area (Sq. Ft.)	Lane Miles (11' Widths)	Curb Reveal (Inches)	Curb Recommendation
33,026	0.569		NOT APPLICABLE
Curb Type		Curb & Gutter Type	
NO CURB		NO CURB AND GUTTER	
Treatment Recommendation		Condition Rating	
Routine Maintenance		4
