Road Inventory and Condition Assessment of Paved Routes Selma to Montgomery National Historic Trail

**Federal Lands Highway
Road Inventory Program**

**Federal Highway Administration
Eastern Federal Lands Highway Division
Road Inventory Program (RIP)**

Report Date: May 2019

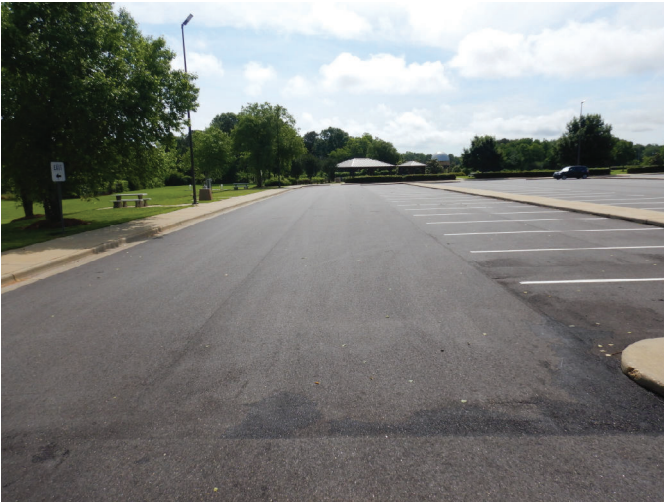
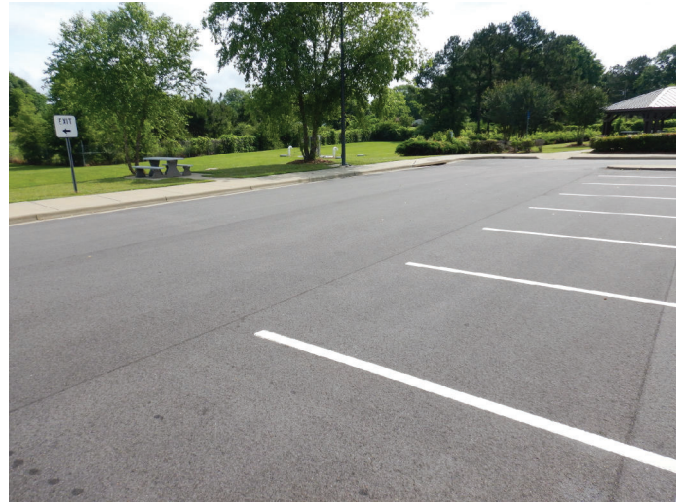
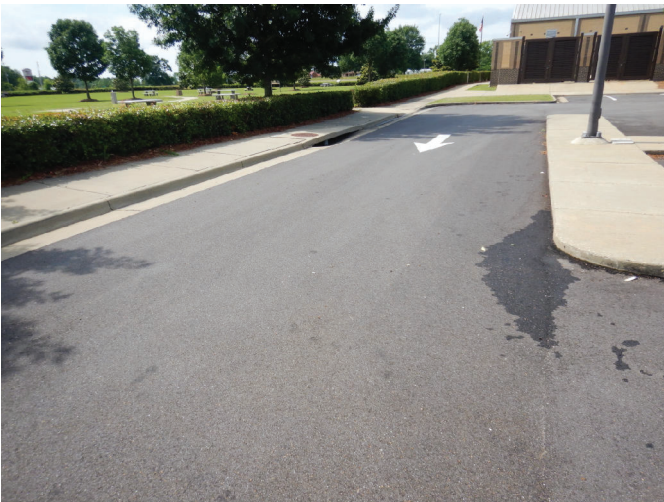
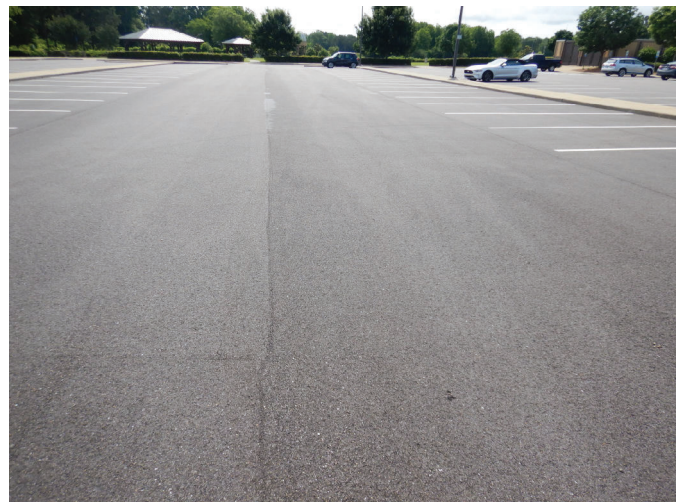
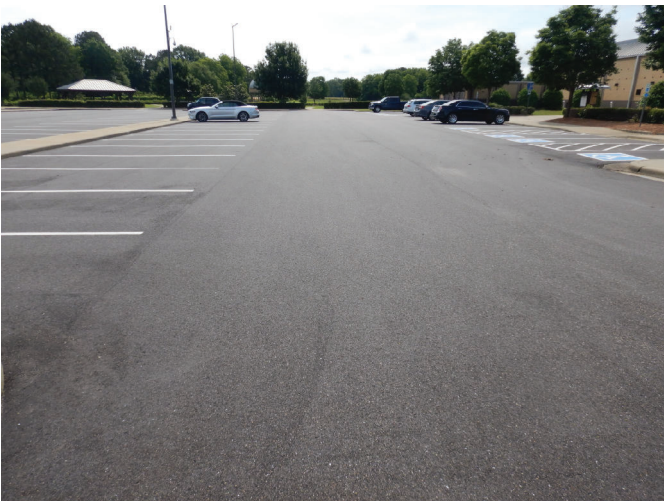
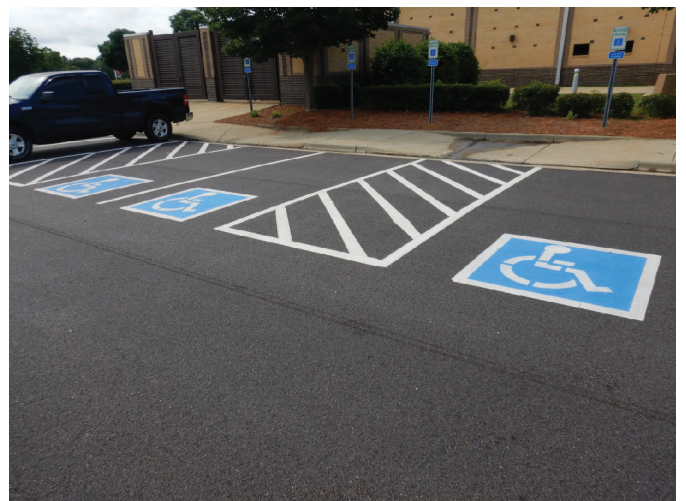
ROUTE 0900: LOWNDES VISITOR CENTER PARKING

Inspection Date	FMSS Number	User Access	Surface Type
5/10/2019	108329	PUBLIC	ASPHALT
Area (Sq. Ft.)	Lane Miles (11' Widths)	Curb Reveal (Inches)	Curb Recommendation
41,496	0.714	4	DO NOTHING
Curb Type		Curb & Gutter Type	
CONCRETE		CONCRETE	
Pavement Recommendation		Condition Rating / PCR	
PREVENTIVE MAINTENANCE		GOOD / 90

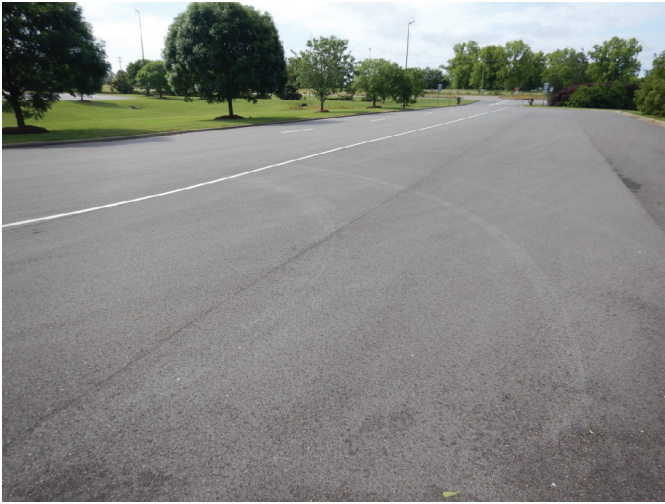
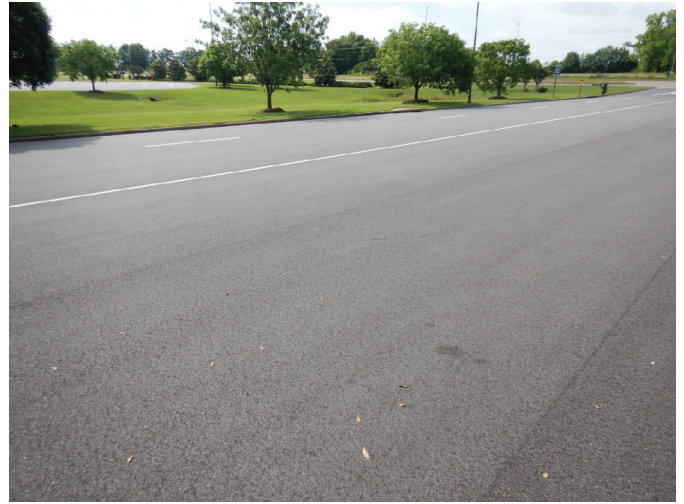
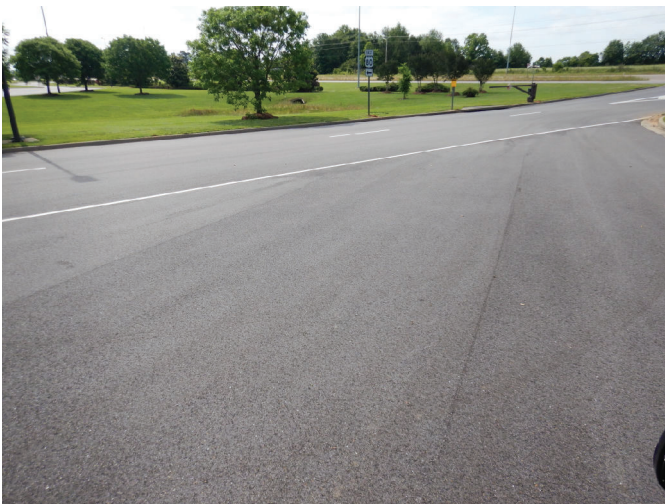
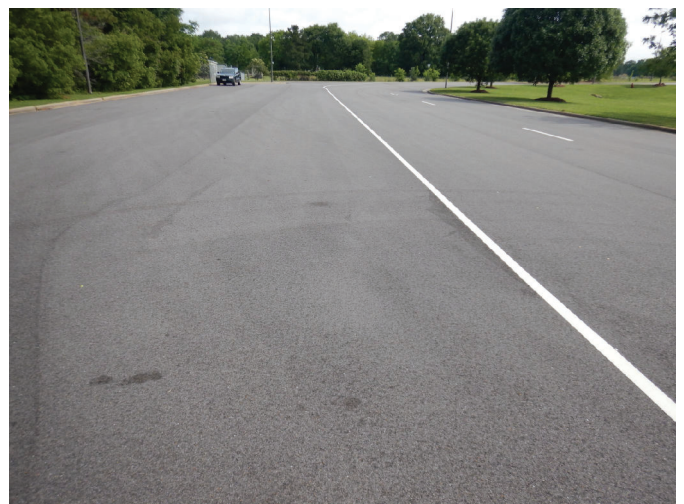
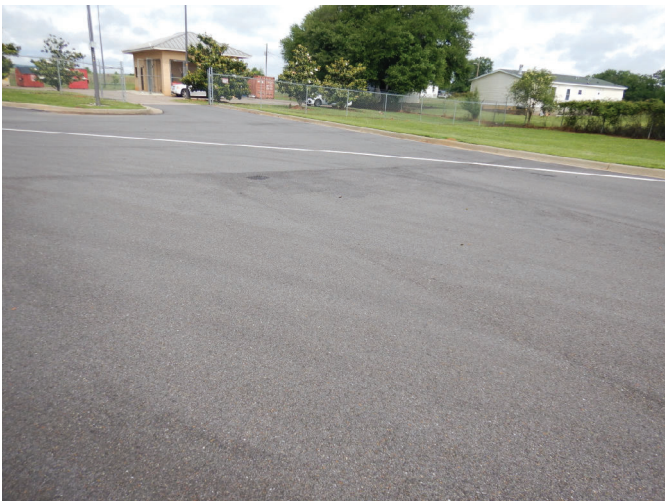
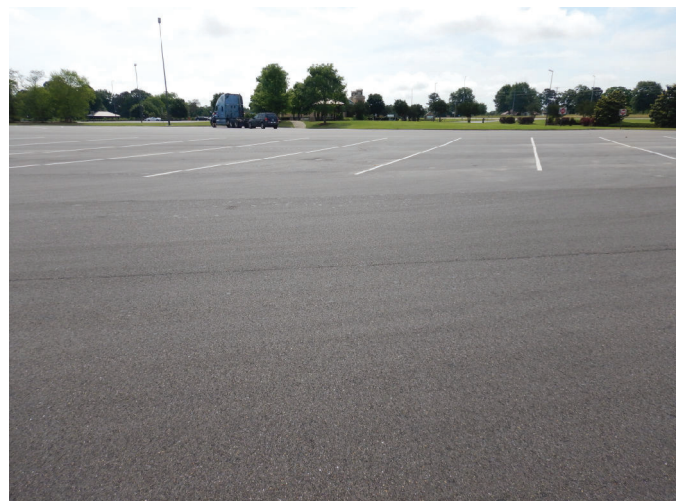
ROUTE 0901: LOWNDES VISITOR CENTER BUS PARKING

Inspection Date	FMSS Number	User Access	Surface Type
5/10/2019	111217	PUBLIC	ASPHALT
Area (Sq. Ft.)	Lane Miles (11' Widths)	Curb Reveal (Inches)	Curb Recommendation
185,429	3.193	NOT APPLICABLE	DO NOTHING
Curb Type		Curb & Gutter Type	
NO CURB		CONCRETE	
Pavement Recommendation		Condition Rating / PCR	
PREVENTIVE MAINTENANCE		GOOD / 90

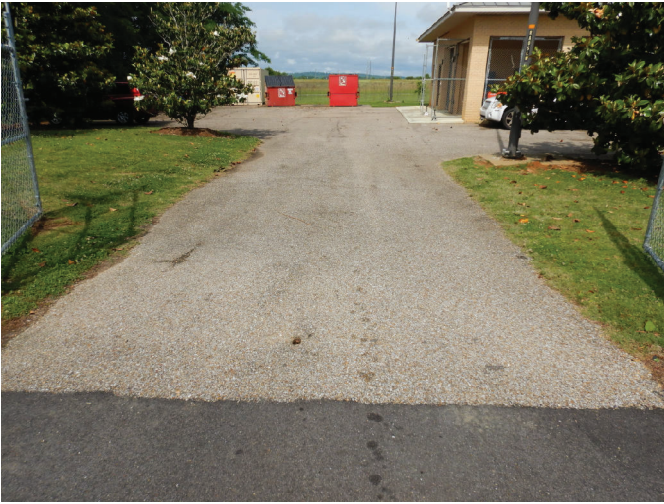
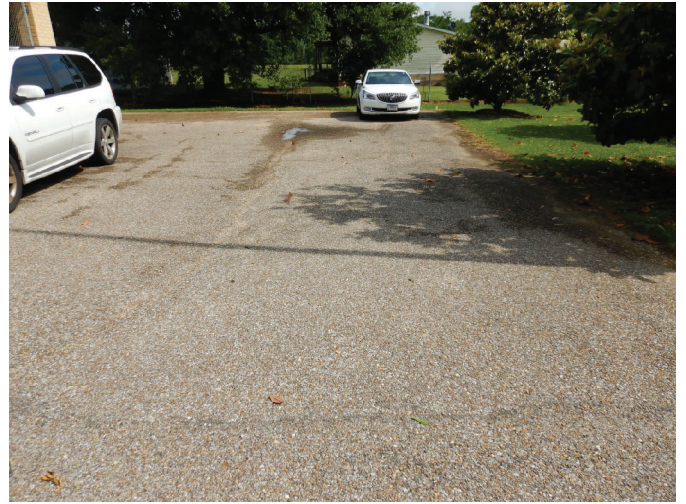
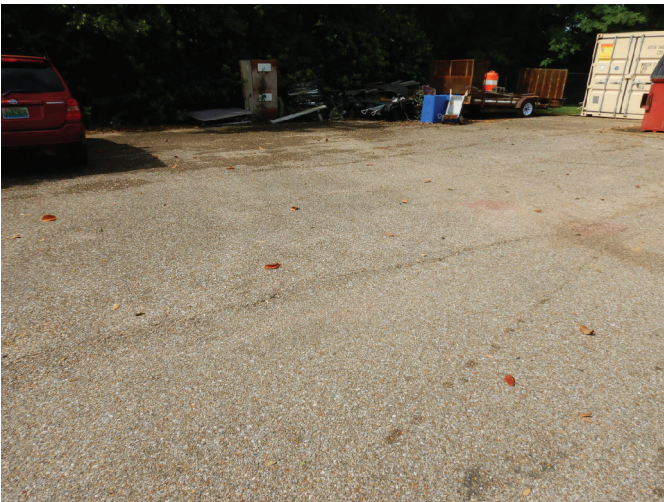
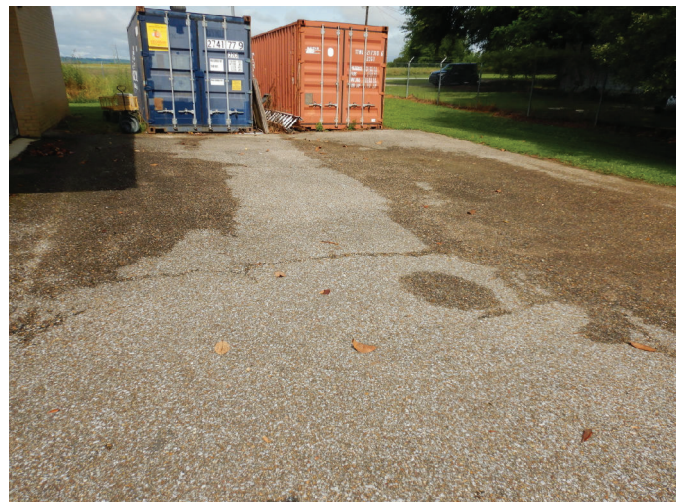
ROUTE 0902: MAINTENANCE PARKING

Inspection Date	FMSS Number	User Access	Surface Type
5/10/2019	111227	NONPUBLIC	ASPHALT
Area (Sq. Ft.)	Lane Miles (11' Widths)	Curb Reveal (Inches)	Curb Recommendation
6,064	0.104	NOT APPLICABLE	NOT APPLICABLE
Curb Type		Curb & Gutter Type	
NO CURB		NO CURB AND GUTTER	
Pavement Recommendation		Condition Rating / PCR	
HEAVY 3R TREATMENTS		POOR / 53

Note: Parking area consists of multiple surface types: 1 part Asphalt at 5,679 square feet; 1 part Concrete at 385 square feet.

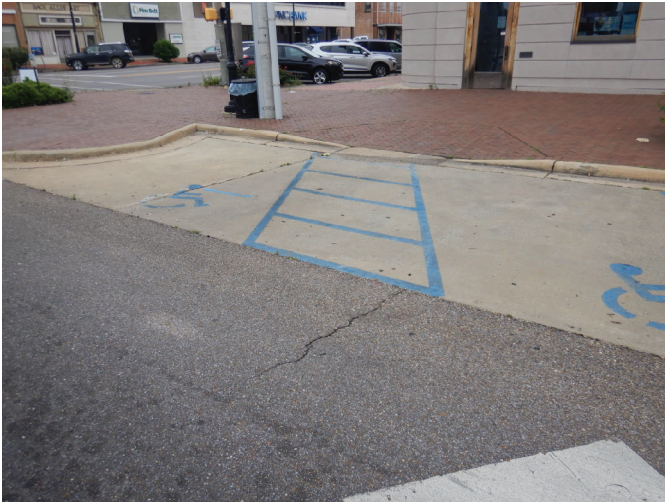
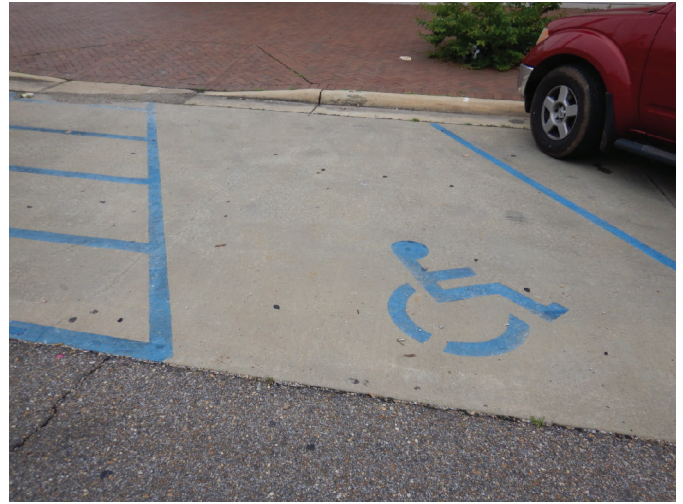
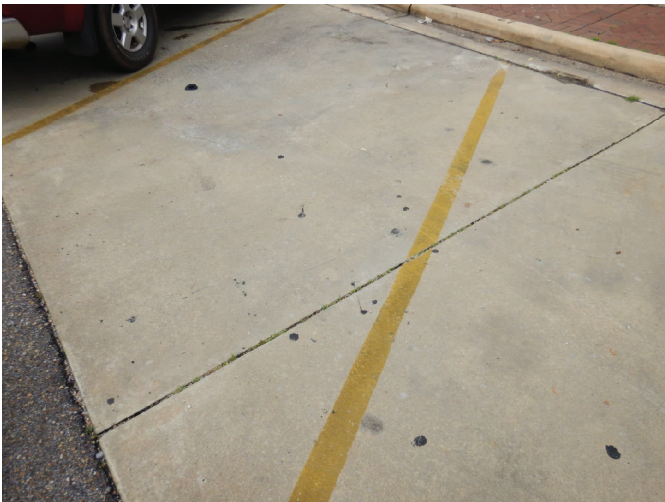
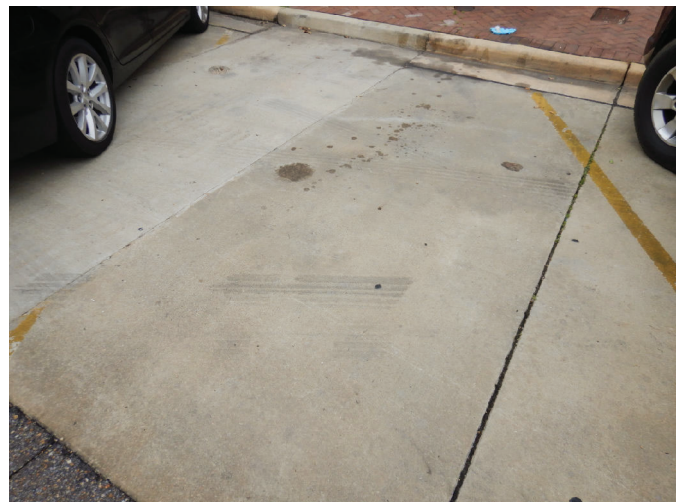
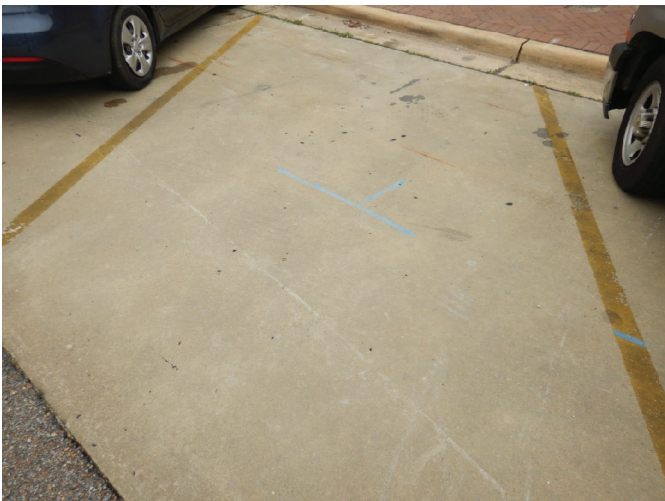
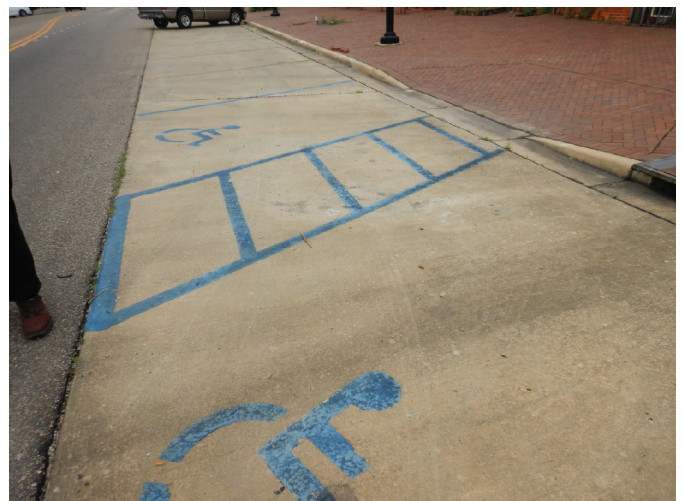
ROUTE 0903: SELMA VISITOR CENTER CAR PARKING

Inspection Date	FMSS Number	User Access	Surface Type
5/10/2019	111385	PUBLIC	CONCRETE
Area (Sq. Ft.)	Lane Miles (11' Widths)	Curb Reveal (Inches)	Curb Recommendation
3,141	0.054	NOT APPLICABLE	DO NOTHING
Curb Type		Curb & Gutter Type	
NO CURB		CONCRETE	
Pavement Recommendation		Condition Rating / PCR	
PREVENTIVE MAINTENANCE		GOOD / 90

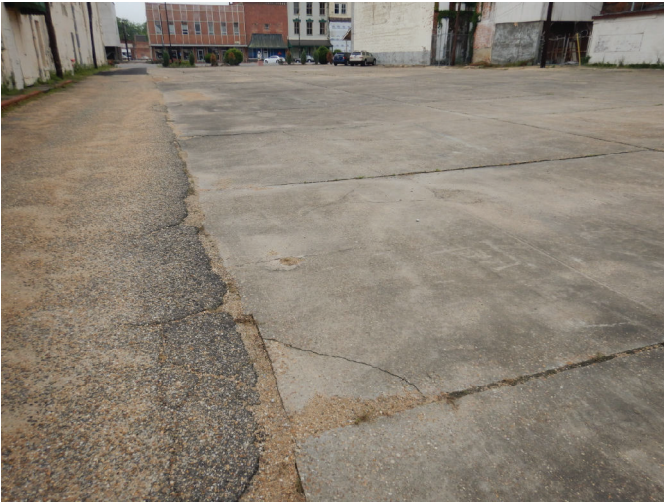
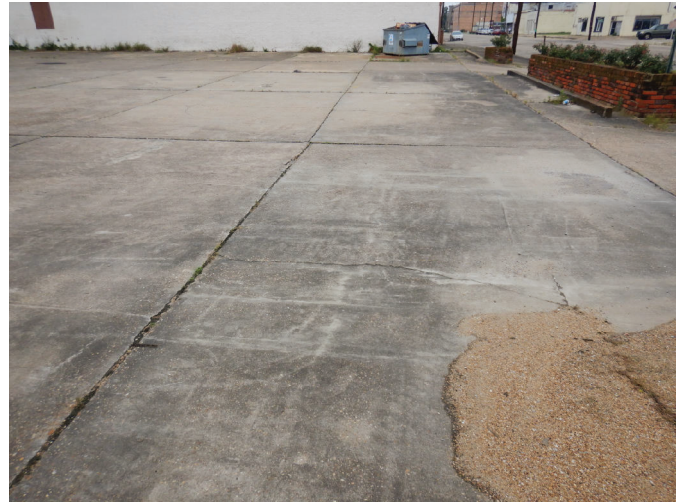
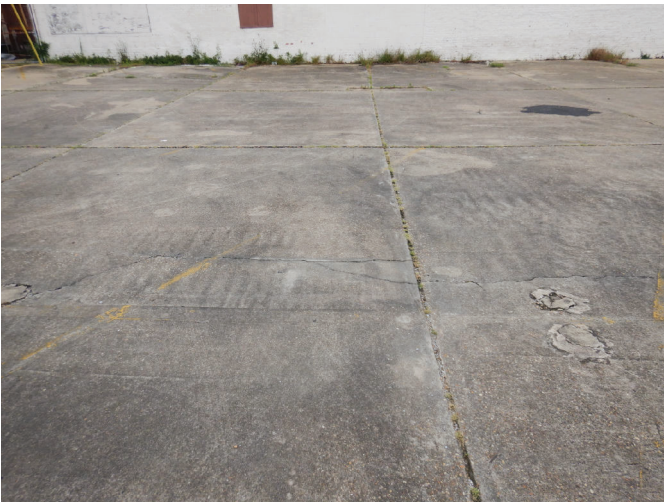
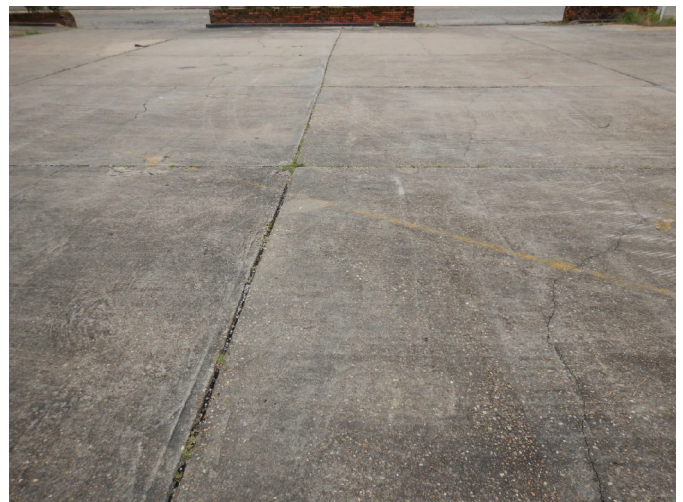
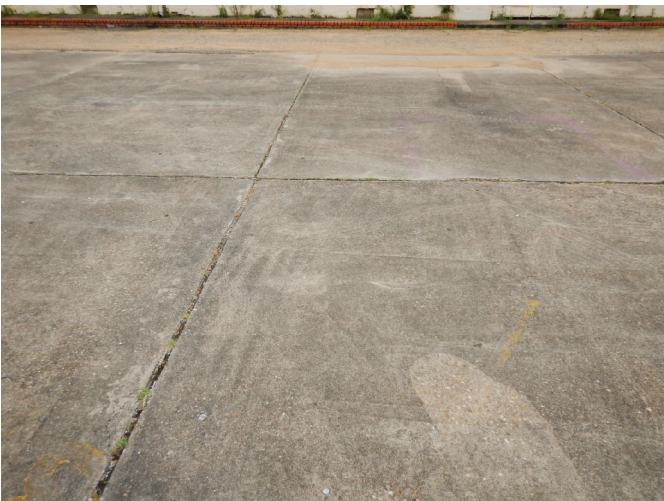
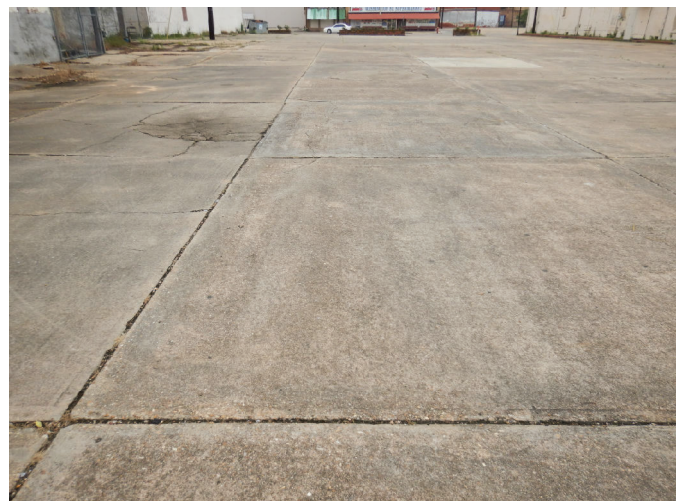
ROUTE 0904: SELMA VISITOR CENTER BUS PARKING

Inspection Date	FMSS Number	User Access	Surface Type
5/10/2019	111386	PUBLIC	CONCRETE
Area (Sq. Ft.)	Lane Miles (11' Widths)	Curb Reveal (Inches)	Curb Recommendation
24,971	0.43	NOT APPLICABLE	NOT APPLICABLE
Curb Type		Curb & Gutter Type	
NO CURB		NO CURB AND GUTTER	
Pavement Recommendation		Condition Rating / PCR	
RECONSTRUCTION		POOR / 30
