SHIL Cycle 6

Final Report

Road Inventory and Condition Assessment of Paved Routes Shiloh National Military Park

Report Date: May 2021

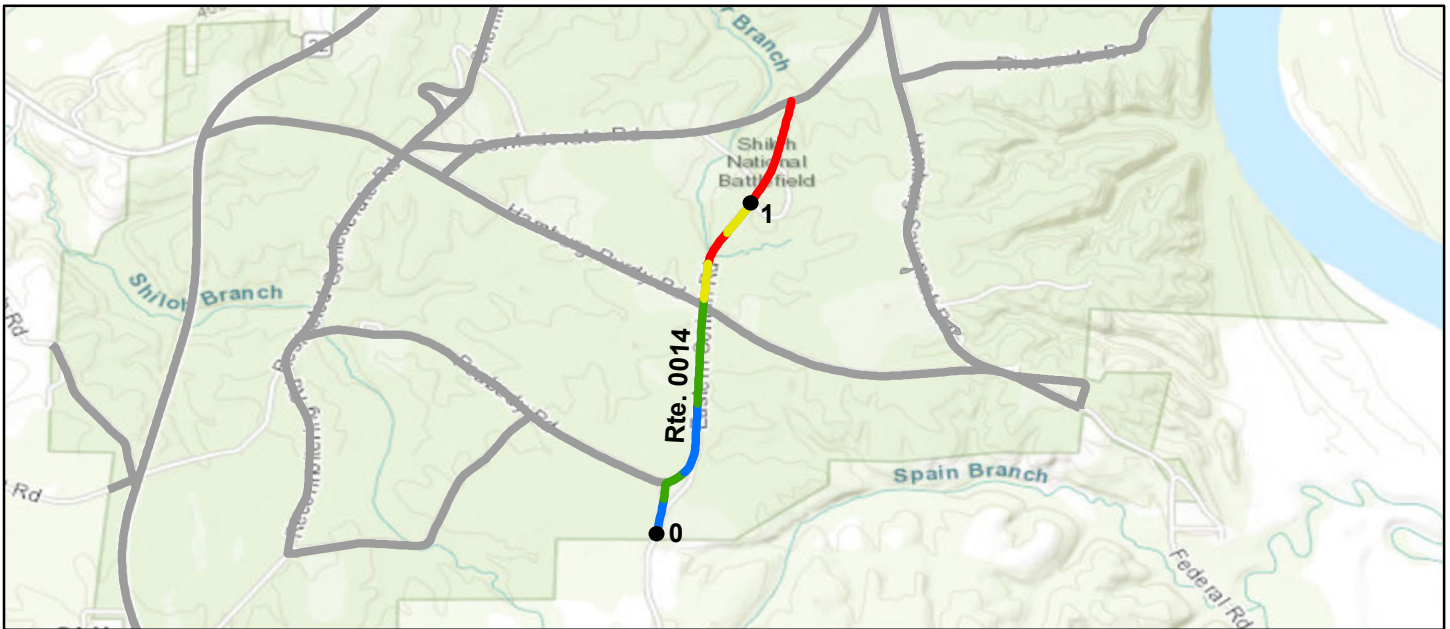
Inspection Date:	10/1/2020	Beginning Section MP	0	1			
Paved Length (Miles):	1.3	Section Length (MI)	1	0.3			
Surface Type:	ASPHALT	Route Summary					
Roadway Condition Information							
Pavement Condition Rating (PCR)	75	87	37				
Surface Condition Rating (SCR)	61	79	3				
Roughness Condition Index (RCI)	97	99	88				
Distress Index Values							
Structural Crack Index	76	84	48				
Alligator Crack Index	100	100	100				
Longitudinal Crack Index	76	84	48				
Transverse Cracking Index	61	79	3				
Patching Index	100	100	100				
Rutting Index	99	99	97				
International Roughness Index (IRI)	123	116	146				
Lane & Width Information							
Number of Lanes	2	2	2				
Paved Width (ft)	17.1	17.4	16.2				
Lane Width (ft)	8.5	8.7	8.1

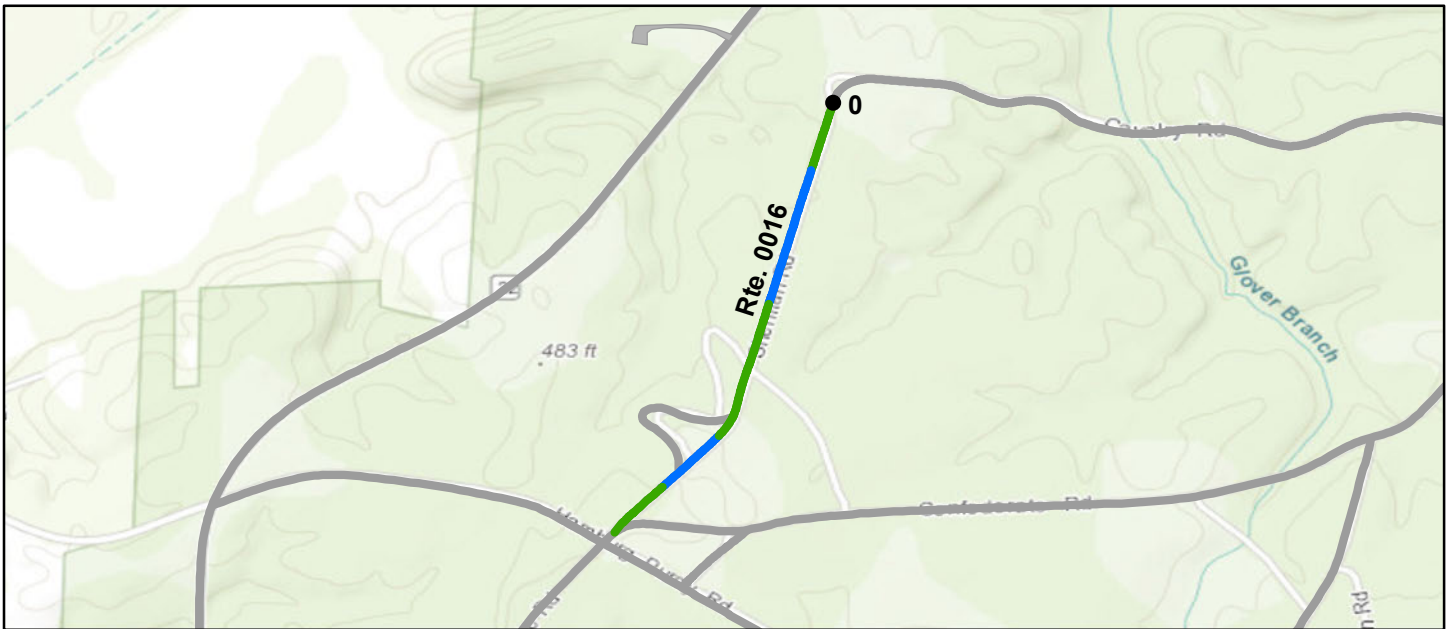
Inspection Date:	10/1/2020	Beginning Section MP	0				
Paved Length (Miles):	0.67	Section Length (MI)	0.67				
Surface Type:	ASPHALT	Route Summary					
Roadway Condition Information							
Pavement Condition Rating (PCR)	95	95					
Surface Condition Rating (SCR)	94	94					
Roughness Condition Index (RCI)	97	97					
Distress Index Values							
Structural Crack Index	99	99					
Alligator Crack Index	100	100					
Longitudinal Crack Index	99	99					
Transverse Cracking Index	94	94					
Patching Index	100	100					
Rutting Index	100	100					
International Roughness Index (IRI)	122	122					
Lane & Width Information							
Number of Lanes	1	1					
Paved Width (ft)	13.2	13.2					
Lane Width (ft)	13.2	13.2

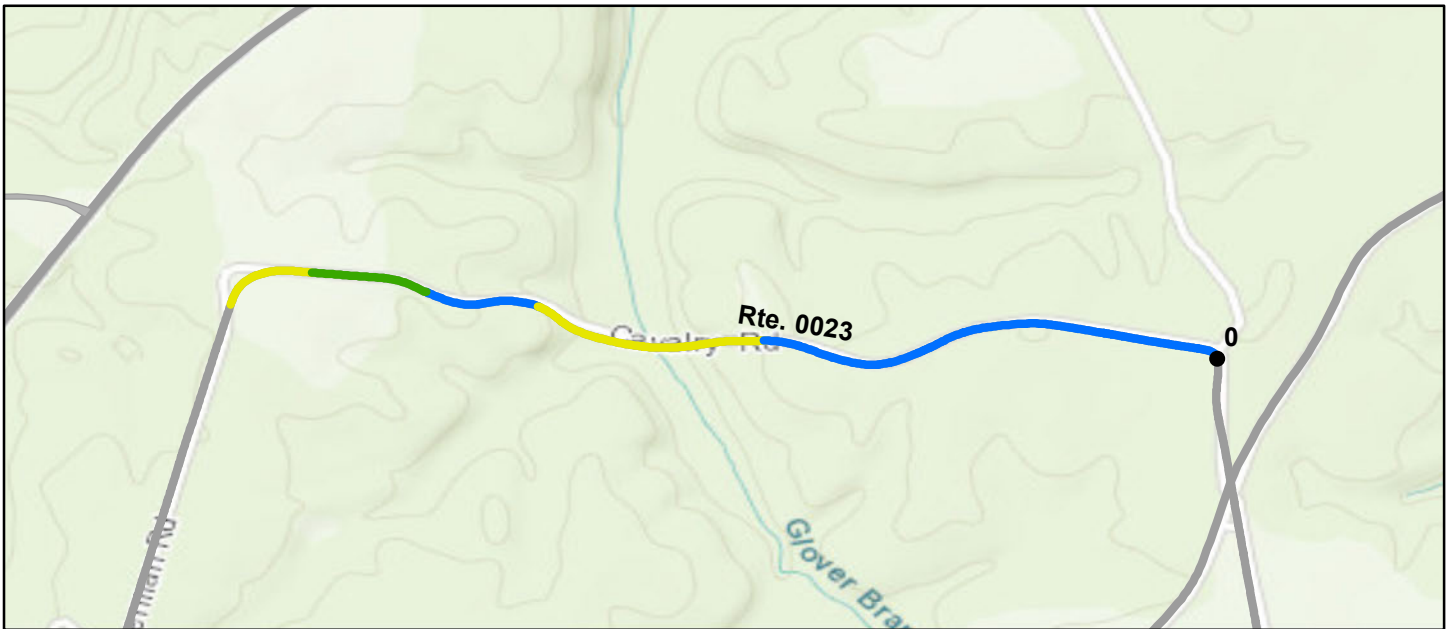
Inspection Date:	10/1/2020	Beginning Section MP	0				
Paved Length (Miles):	0.89	Section Length (MI)	0.89				
Surface Type:	ASPHALT	Route Summary					
Roadway Condition Information							
Pavement Condition Rating (PCR)		91	91				
Surface Condition Rating (SCR)		92	92				
Roughness Condition Index (RCI)		89	89				
Distress Index Values							
Structural Crack Index		98	98				
Alligator Crack Index		100	100				
Longitudinal Crack Index		98	98				
Transverse Cracking Index		92	92				
Patching Index		100	100				
Rutting Index		100	100				
International Roughness Index (IRI)		143	143				
Lane & Width Information							
Number of Lanes		1	1				
Paved Width (ft)		13	13				
Lane Width (ft)		13	13
