SPAR Cycle 6

Road Inventory and Condition Assessment of Paved Routes Springfield Armory National Historic Site

**Federal Highway Administration
Eastern Federal Lands Highway Division
Road Inventory Program (RIP)**

Report Date: September 2021

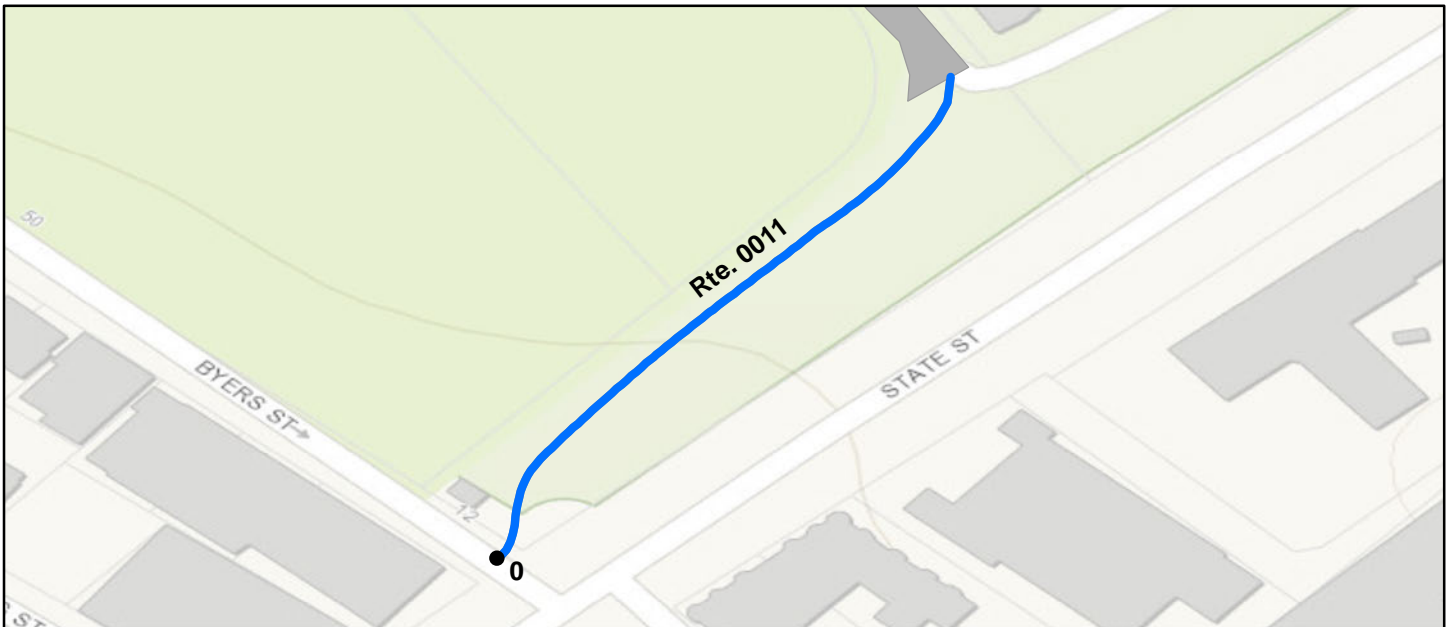
ROUTE 0011: ENTRANCE ROAD (CEREMONIAL)

Route Condition Legend – Pavement Condition Rating (PCR)						
Poor (0 - 60)	Fair (61- 84)	Good (85 - 94)	Excellent (95 - 100)	Not Rated		
Colors on map represent condition scores at 0.10-mile intervals. See Appendix for definitions and formulas.						
Inspection Date:	10/21/2020	Beginning Section MP	0			
Paved Length (Miles):	0.1	Section Length (MI)	0.1			
Surface Type:	CONCRETE	Route Summary				
Roadway Condition Information						
Pavement Condition Rating (PCR)	97	97				
Surface Condition Rating (SCR)	N/A	N/A				
Roughness Condition Index (RCI)	N/A	N/A				
Distress Index Values						
Structural Crack Index	N/A	N/A				
Alligator Crack Index	N/A	N/A				
Longitudinal Crack Index	N/A	N/A				
Transverse Cracking Index	N/A	N/A				
Patching Index	N/A	N/A				
Rutting Index	N/A	N/A				
International Roughness Index (IRI)	N/A	N/A				
Lane & Width Information						
Number of Lanes	2	2				
Paved Width (ft)	20.7	20.7

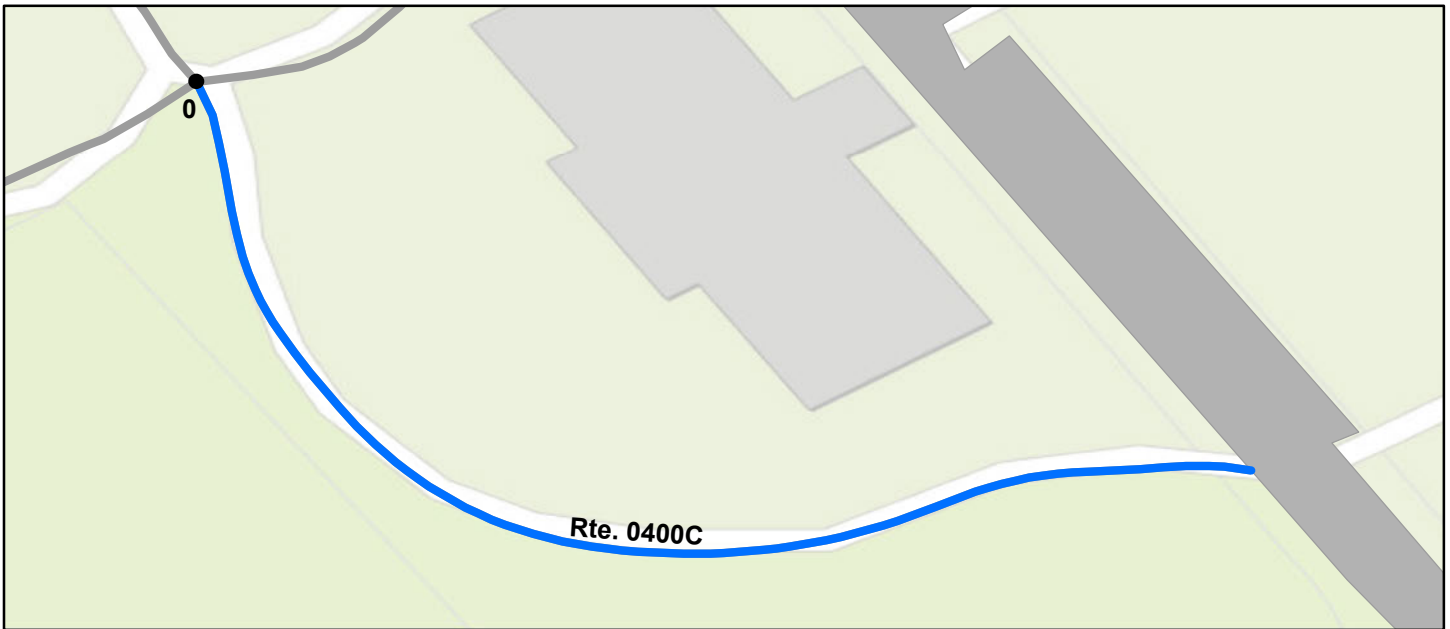
ROUTE 0400C: BUILDING 13 CIRCULAR ROAD

Route Condition Legend – Pavement Condition Rating (PCR)						
Poor (0 - 60)		Fair (61- 84)		Good (85 - 94)		Excellent (95 - 100)
						Not Rated
Colors on map represent condition scores at 0.10-mile intervals. See Appendix for definitions and formulas.						
Inspection Date:	10/21/2020	Beginning Section MP	0			
Paved Length (Miles):	0.09	Section Length (MI)	0.09			
Surface Type:	ASPHALT	Route Summary				
Roadway Condition Information						
Pavement Condition Rating (PCR)	96	96				
Surface Condition Rating (SCR)	96	96				
Roughness Condition Index (RCI)	N/A	N/A				
Distress Index Values						
Structural Crack Index	100	100				
Alligator Crack Index	100	100				
Longitudinal Crack Index	100	100				
Transverse Cracking Index	100	100				
Patching Index	100	100				
Rutting Index	96	96				
International Roughness Index (IRI)	N/A	N/A				
Lane & Width Information						
Number of Lanes	1	1				
Paved Width (ft)	13.2	13.2

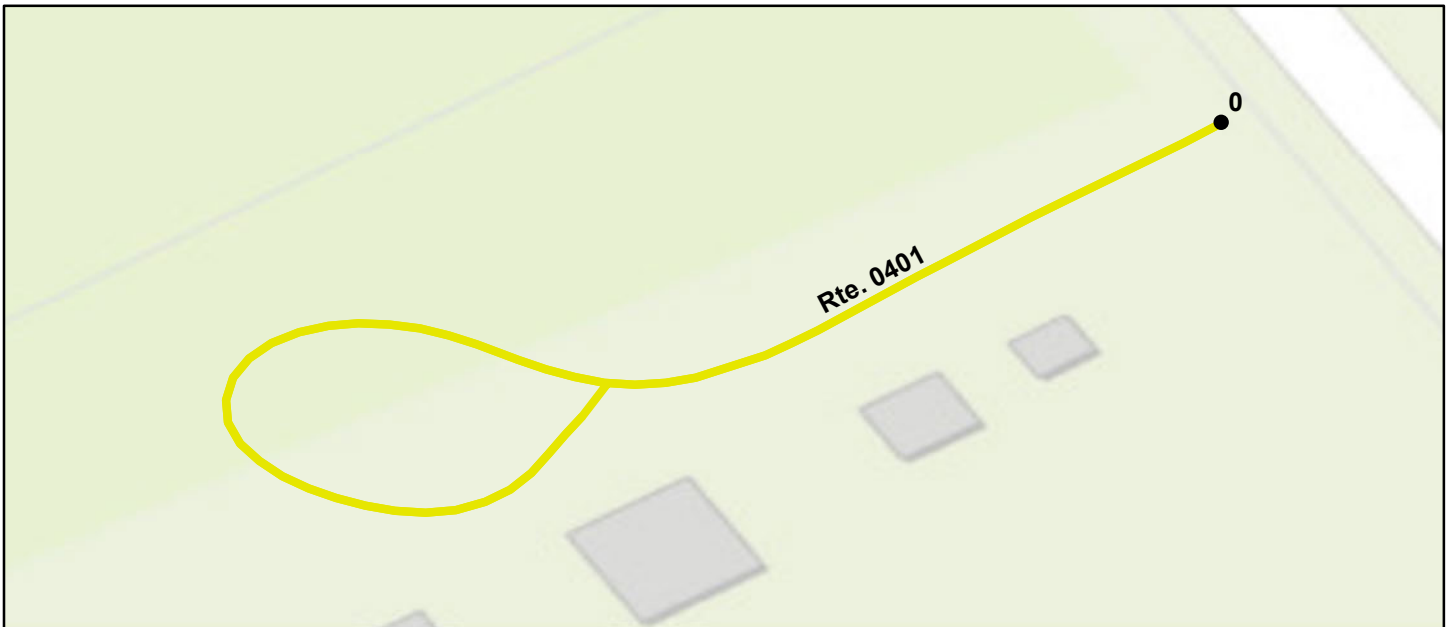
ROUTE 0401: GARAGE DRIVEWAY

Route Condition Legend – Pavement Condition Rating (PCR)						
Poor (0 - 60)	Fair (61- 84)	Good (85 - 94)	Excellent (95 - 100)	Not Rated		
Colors on map represent condition scores at 0.10-mile intervals. See Appendix for definitions and formulas.						
Inspection Date: 10/21/2020	Beginning Section MP	0				
Paved Length (Miles): 0.05	Section Length (MI)	0.05				
Surface Type: ASPHALT	Route Summary					
Roadway Condition Information						
Pavement Condition Rating (PCR)	71	71				
Surface Condition Rating (SCR)	71	71				
Roughness Condition Index (RCI)	N/A	N/A				
Distress Index Values						
Structural Crack Index	79	79				
Alligator Crack Index	100	100				
Longitudinal Crack Index	79	79				
Transverse Cracking Index	71	71				
Patching Index	100	100				
Rutting Index	96	96				
International Roughness Index (IRI)	N/A	N/A				
Lane & Width Information						
Number of Lanes	1	1				
Paved Width (ft)	10.7	10.7				
Lane Width (ft)	10.7	10.7

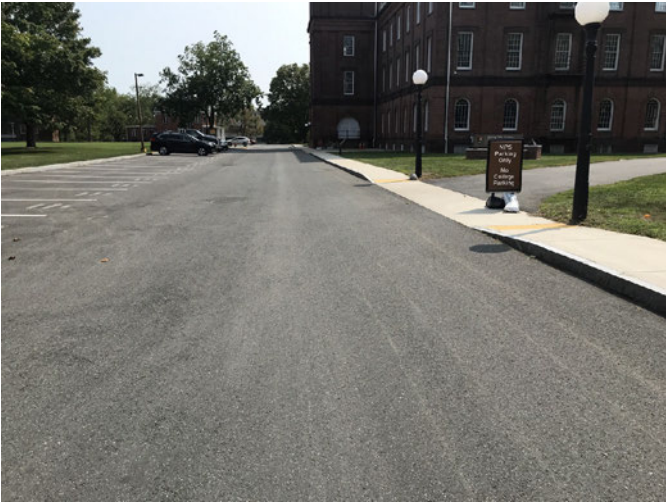
SPAR_0900_1.jpg

ROUTE 0900: MAIN PARKING AREA (MUSEUM)

Condition Photos

Inspection Date	FMSS Number	User Access	Surface Type
9/16/2020	58564	PUBLIC	ASPHALT
Area (Sq. Ft.)	Lane Miles (11' Widths)	Curb Reveal (Inches)	Curb Recommendation
21,503	0.37	6	DO NOTHING
Curb Type		Curb & Gutter Type	
STONE		NO CURB AND GUTTER	
Pavement Recommendation		Condition Rating / PCR	
PREVENTIVE MAINTENANCE		GOOD / 90
