# STRI Cycle 6

## Final Report

### Road Inventory and Condition Assessment of Paved Routes Stones River National Battlefield

Federal Highway Administration  
Eastern Federal Lands Highway Division  
Road Inventory Program (RIP)

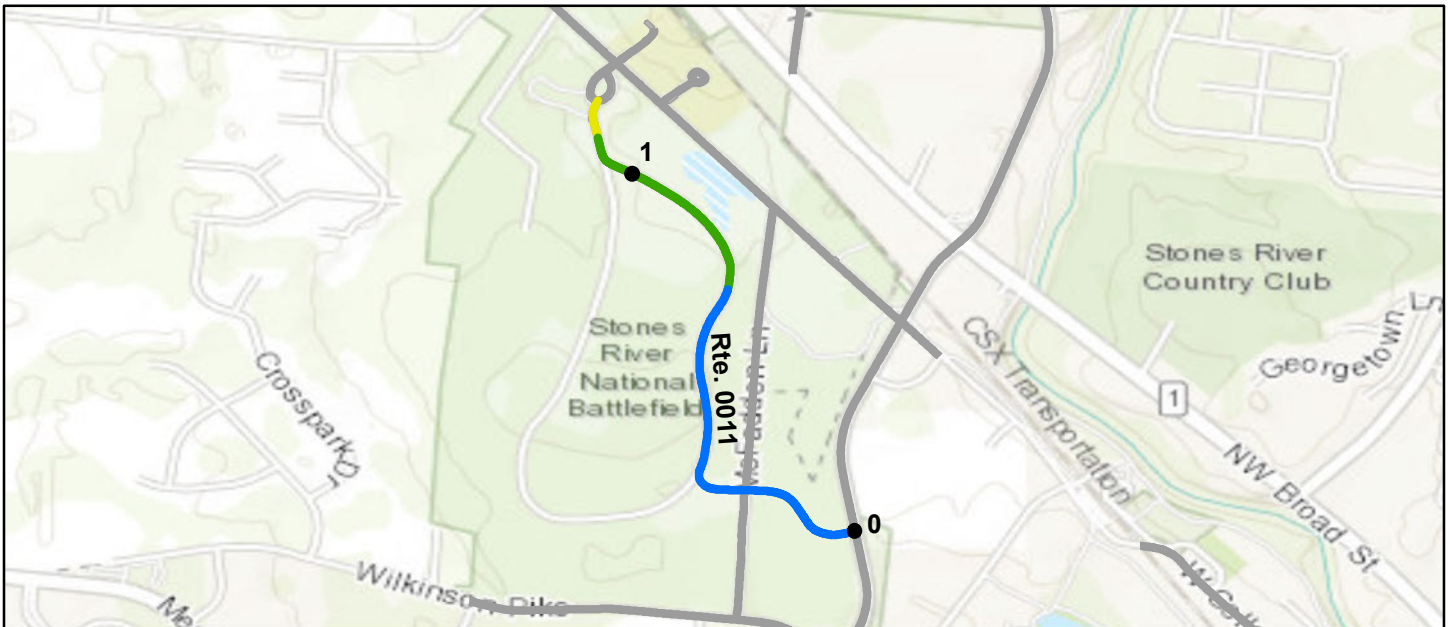
## ROUTE 0011: PARK ROAD

<b>Inspection Date:</b>	10/2/2020	<b>Beginning Section MP</b>	0	1			
<b>Paved Length (Miles):</b>	1.17	<b>Section Length (MI)</b>	1	0.17			
<b>Surface Type:</b>	ASPHALT	<b>Route Summary</b>					
<b>Roadway Condition Information</b>							
Pavement Condition Rating (PCR)	95	97	84				
Surface Condition Rating (SCR)	95	97	84				
Roughness Condition Index (RCI)	N/A	N/A	N/A				
<b>Distress Index Values</b>							
Structural Crack Index	99	100	96				
Alligator Crack Index	100	100	100				
Longitudinal Crack Index	99	100	96				
Transverse Cracking Index	95	97	84				
Patching Index	100	100	100				
Rutting Index	100	100	99				
International Roughness Index (IRI)	N/A	N/A	N/A				
<b>Lane &amp; Width Information</b>							
Number of Lanes	1	1	1				
Paved Width (ft)	14.6	14.7	14.1				
Lane Width (ft)	12.3	11.9	14.1

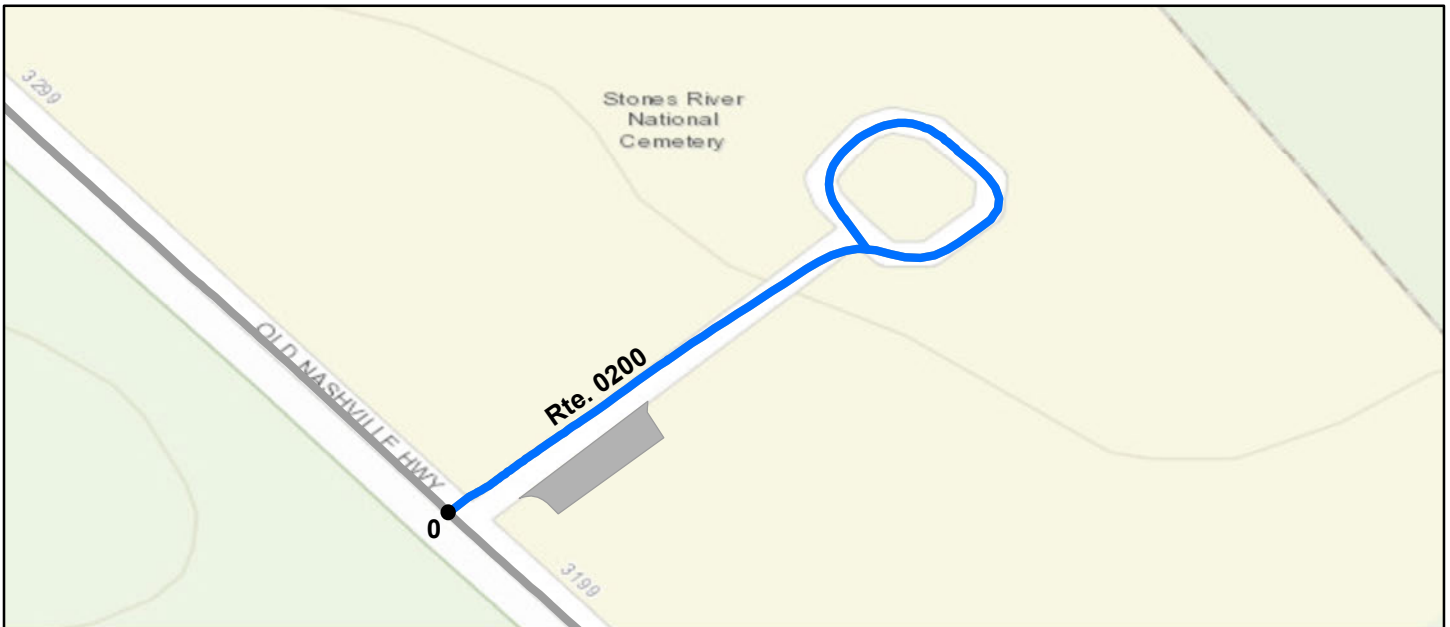
## ROUTE 0200: CEMETERY ROAD

Route Condition Legend – Pavement Condition Rating (PCR)						
Poor (0 - 60)	Fair (61- 84)	Good (85 - 94)	Excellent (95 - 100)	Not Rated		
Colors on map represent condition scores at 0.10-mile intervals. See Appendix for definitions and formulas.						
<b>Inspection Date:</b> 10/2/2020	<b>Beginning Section MP</b>	0				
<b>Paved Length (Miles):</b> 0.13	<b>Section Length (MI)</b>	0.13				
<b>Surface Type:</b> ASPHALT	<b>Route Summary</b>					
<b>Roadway Condition Information</b>						
Pavement Condition Rating (PCR)	97	97				
Surface Condition Rating (SCR)	97	97				
Roughness Condition Index (RCI)	N/A	N/A				
<b>Distress Index Values</b>						
Structural Crack Index	99	99				
Alligator Crack Index	100	100				
Longitudinal Crack Index	99	99				
Transverse Cracking Index	100	100				
Patching Index	100	100				
Rutting Index	97	97				
International Roughness Index (IRI)	N/A	N/A				
<b>Lane &amp; Width Information</b>

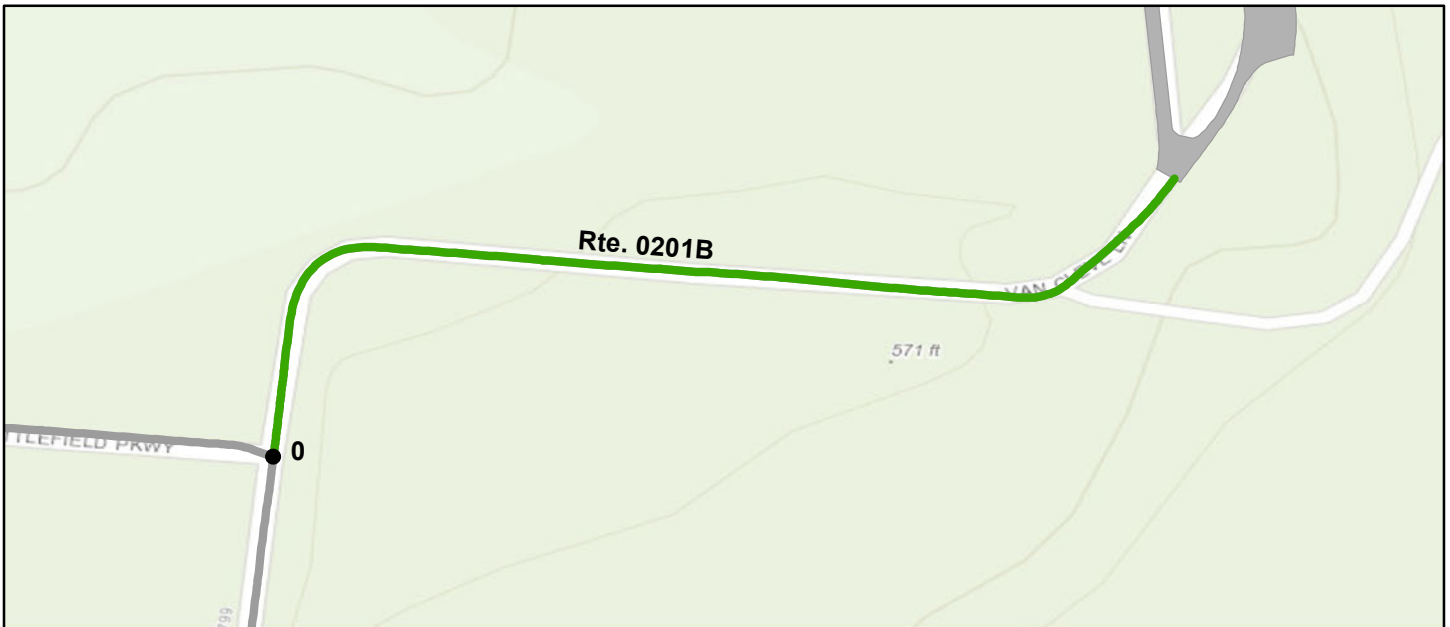
## ROUTE 0201B: MCFADDEN FARM/ VAN CLEVE LANE

<b>Route Condition Legend – Pavement Condition Rating (PCR)</b>						
<b>Poor (0 - 60)</b>	<b>Fair (61- 84)</b>	<b>Good (85 - 94)</b>	<b>Excellent (95 - 100)</b>	<b>Not Rated</b>		
Colors on map represent condition scores at 0.10-mile intervals. See Appendix for definitions and formulas.						
<b>Inspection Date:</b>	10/2/2020	<b>Beginning Section MP</b>	0			
<b>Paved Length (Miles):</b>	0.2	<b>Section Length (MI)</b>	0.2			
<b>Surface Type:</b>	ASPHALT	<b>Route Summary</b>				
<b>Roadway Condition Information</b>						
Pavement Condition Rating (PCR)	91	91				
Surface Condition Rating (SCR)	91	91				
Roughness Condition Index (RCI)	N/A	N/A				
<b>Distress Index Values</b>						
Structural Crack Index	99	99				
Alligator Crack Index	100	100				
Longitudinal Crack Index	99	99				
Transverse Cracking Index	91	91				
Patching Index	100	100				
Rutting Index	100	100				
International Roughness Index (IRI)	N/A	N/A

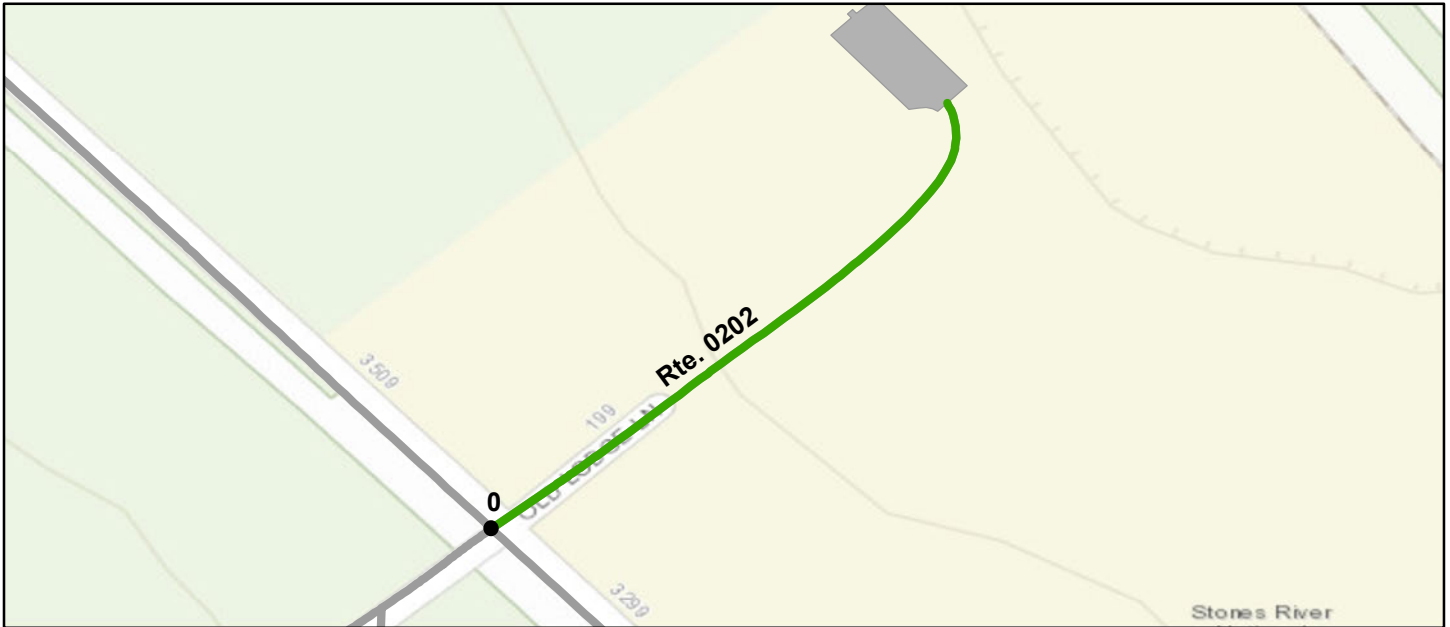
## ROUTE 0202: OLD LODGE LANE

<b>Route Condition Legend – Pavement Condition Rating (PCR)</b>						
<b>Poor (0 - 60)</b>	<b>Fair (61- 84)</b>	<b>Good (85 - 94)</b>	<b>Excellent (95 - 100)</b>	<b>Not Rated</b>		
Colors on map represent condition scores at 0.10-mile intervals. See Appendix for definitions and formulas.						
<b>Inspection Date:</b> 10/2/2020	<b>Beginning Section MP</b>	0				
<b>Paved Length (Miles):</b> 0.1	<b>Section Length (MI)</b>	0.1				
<b>Surface Type:</b> ASPHALT	<b>Route Summary</b>					
<b>Roadway Condition Information</b>						
Pavement Condition Rating (PCR)	88	88				
Surface Condition Rating (SCR)	88	88				
Roughness Condition Index (RCI)	N/A	N/A				
<b>Distress Index Values</b>						
Structural Crack Index	88	88				
Alligator Crack Index	98	98				
Longitudinal Crack Index	90	90				
Transverse Cracking Index	98	98				
Patching Index	100	100				
Rutting Index	94	94				
International Roughness Index (IRI)	N/A	N/A

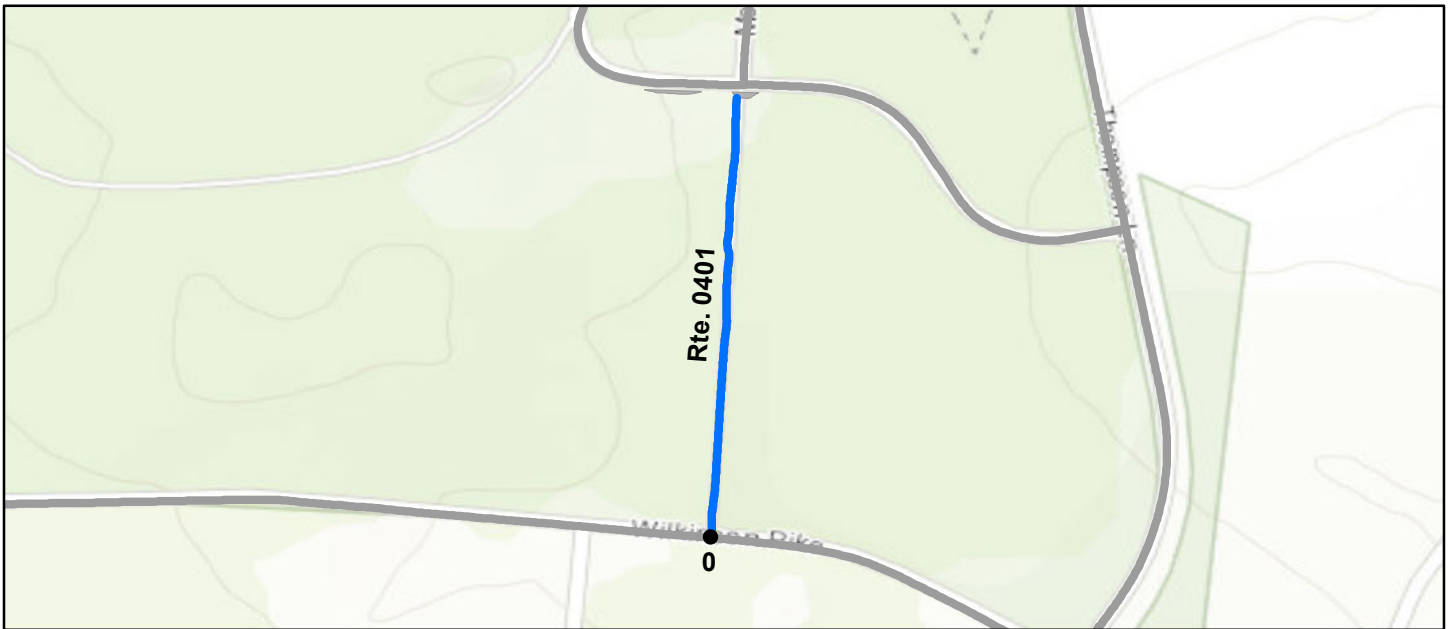
## ROUTE 0401: VAN CLEVE LANE SOUTH (TS 2 TO WILKINSON PIKE)

<b>Route Condition Legend – Pavement Condition Rating (PCR)</b>						
<b>Poor (0 - 60)</b>	<b>Fair (61- 84)</b>	<b>Good (85 - 94)</b>	<b>Excellent (95 - 100)</b>	<b>Not Rated</b>		
Colors on map represent condition scores at 0.10-mile intervals. See Appendix for definitions and formulas.						
<b>Inspection Date:</b>	10/2/2020	<b>Beginning Section MP</b>	0			
<b>Paved Length (Miles):</b>	0.25	<b>Section Length (MI)</b>	0.25			
<b>Surface Type:</b>	ASPHALT	<b>Route Summary</b>				
<b>Roadway Condition Information</b>						
Pavement Condition Rating (PCR)	97	97				
Surface Condition Rating (SCR)	97	97				
Roughness Condition Index (RCI)	N/A	N/A				
<b>Distress Index Values</b>						
Structural Crack Index	97	97				
Alligator Crack Index	100	100				
Longitudinal Crack Index	97	97				
Transverse Cracking Index	99	99				
Patching Index	100	100				
Rutting Index	100	100				
International Roughness Index (IRI)	N/A	N/A

<b>Lane &amp; Width Information</b>						
Number of Lanes	2	2				
Paved Width (ft)	17.6	17.6				
Lane Width (ft)	8.8	8.8

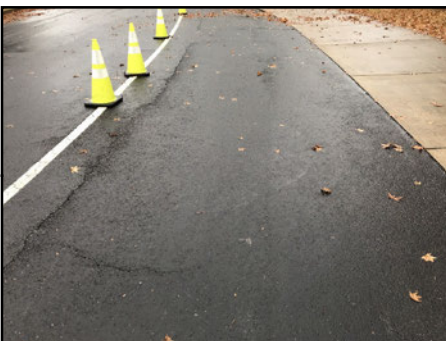
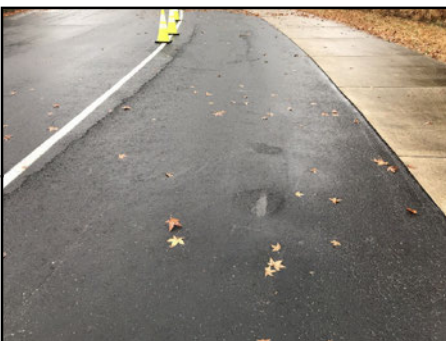
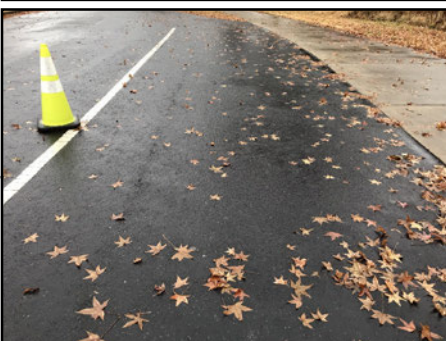
## ROUTE 0900B: VISITOR CENTER PARKING B BUS & RV

Inspection Date	FMSS Number	User Access	Surface Type
11/23/2019	78837	PUBLIC	ASPHALT
Area (Sq. Ft.)	Lane Miles (11' Widths)	Curb Reveal (Inches)	Curb Recommendation
1,499	0.026	NOT APPLICABLE	NOT APPLICABLE
Curb Type		Curb & Gutter Type	
NO CURB		NO CURB AND GUTTER	
Pavement Recommendation		Condition Rating / PCR	
PREVENTIVE MAINTENANCE		GOOD / 90

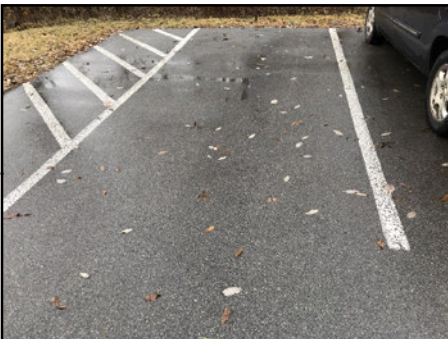
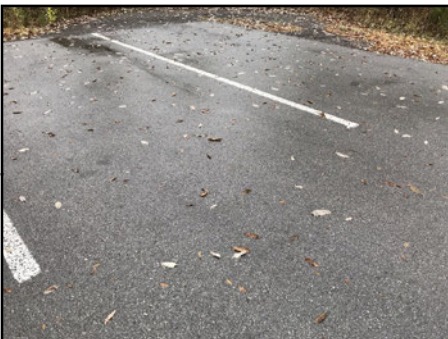
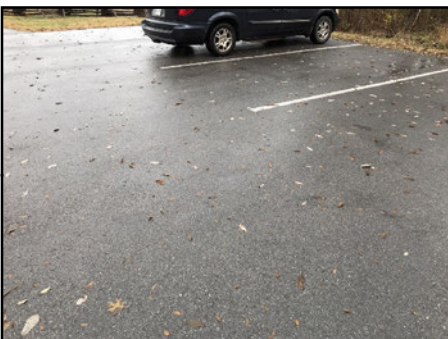
## ROUTE 0901: TOUR STOP 3 PARKING COTTON FIELD

Inspection Date	FMSS Number	User Access	Surface Type
11/23/2019	78838	PUBLIC	ASPHALT
Area (Sq. Ft.)	Lane Miles (11' Widths)	Curb Reveal (Inches)	Curb Recommendation
1,457	0.025	NOT APPLICABLE	NOT APPLICABLE
Curb Type		Curb & Gutter Type	
NO CURB		NO CURB AND GUTTER	
Pavement Recommendation		Condition Rating / PCR	
PREVENTIVE MAINTENANCE		GOOD / 90

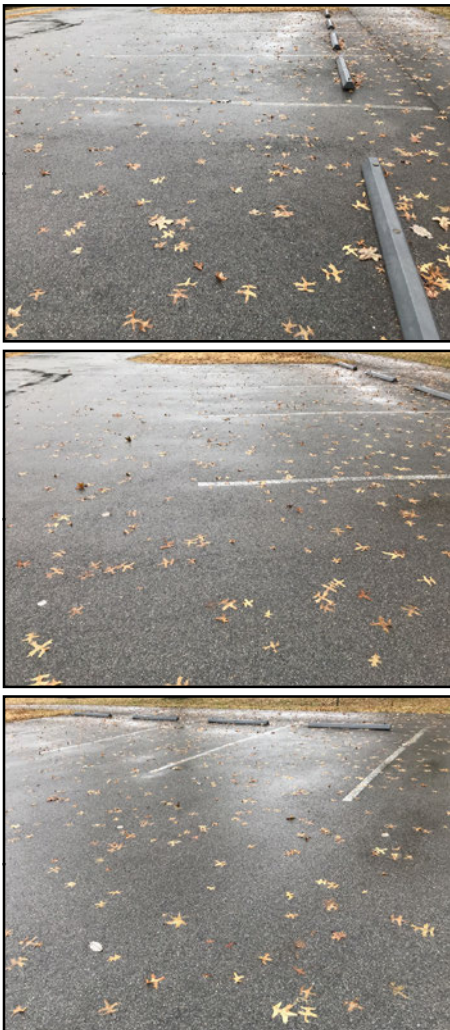
## ROUTE 0904AZ: TOUR STOP 4 CHICAGO BOARD OF TRADE

Inspection Date	FMSS Number	User Access	Surface Type
11/23/2019	78841	PUBLIC	ASPHALT
Area (Sq. Ft.)	Lane Miles (11' Widths)	Curb Reveal (Inches)	Curb Recommendation
1,698	0.029	NOT APPLICABLE	NOT APPLICABLE
Curb Type		Curb & Gutter Type	
NO CURB		NO CURB AND GUTTER	
Pavement Recommendation		Condition Rating / PCR	
PREVENTIVE MAINTENANCE		GOOD / 90

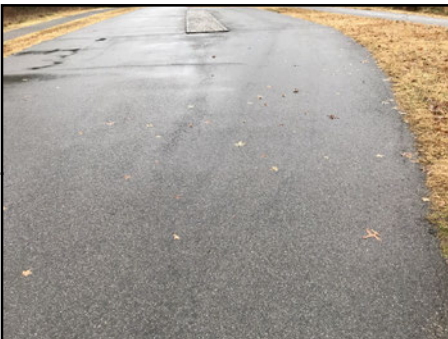
## ROUTE 0904BZ: TOUR STOP 4 BUS AND RV PARKING

Inspection Date	FMSS Number	User Access	Surface Type
11/23/2019	78841	PUBLIC	ASPHALT
Area (Sq. Ft.)	Lane Miles (11' Widths)	Curb Reveal (Inches)	Curb Recommendation
1,653	0.028	NOT APPLICABLE	NOT APPLICABLE
Curb Type		Curb & Gutter Type	
NO CURB		NO CURB AND GUTTER	
Pavement Recommendation		Condition Rating / PCR	
PREVENTIVE MAINTENANCE		GOOD / 90

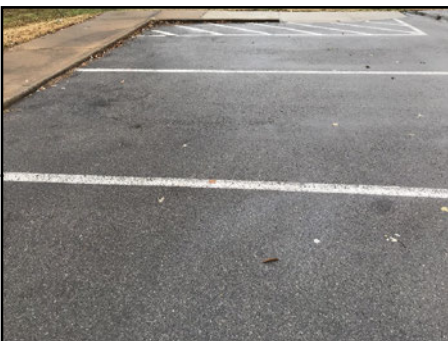
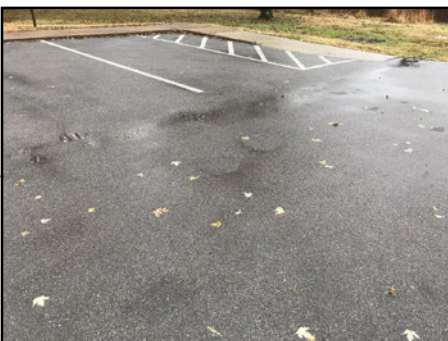
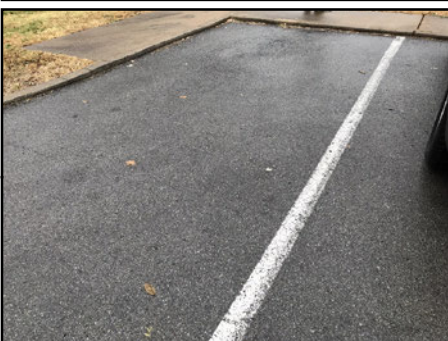
## ROUTE 0905: TOUR STOP 5 PARKING HAZEN MONUMENT

Inspection Date	FMSS Number	User Access	Surface Type
11/23/2019	69957	PUBLIC	ASPHALT
Area (Sq. Ft.)	Lane Miles (11' Widths)	Curb Reveal (Inches)	Curb Recommendation
1,555	0.027	4	LIGHT REPAIR
Curb Type		Curb & Gutter Type	
CONCRETE		NO CURB AND GUTTER	
Pavement Recommendation		Condition Rating / PCR	
PREVENTIVE MAINTENANCE		GOOD / 90

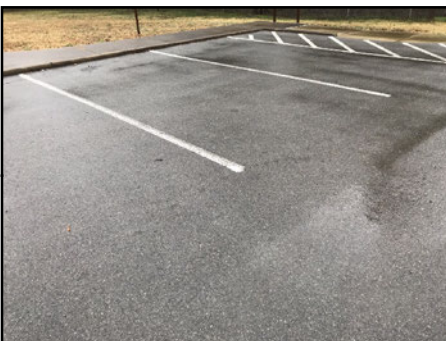
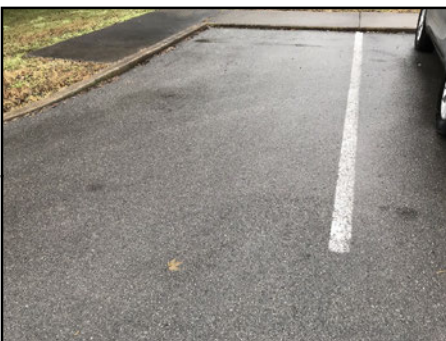
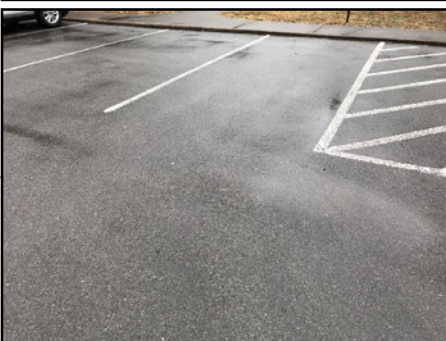
## ROUTE 0907: GENERAL ROSECRANS HEADQUARTERS PARKING

Inspection Date	FMSS Number	User Access	Surface Type
11/23/2019	78842	PUBLIC	ASPHALT
Area (Sq. Ft.)	Lane Miles (11' Widths)	Curb Reveal (Inches)	Curb Recommendation
1,888	0.033	4	LIGHT REPAIR
Curb Type		Curb & Gutter Type	
CONCRETE		NO CURB AND GUTTER	
Pavement Recommendation		Condition Rating / PCR	
PREVENTIVE MAINTENANCE		GOOD / 90

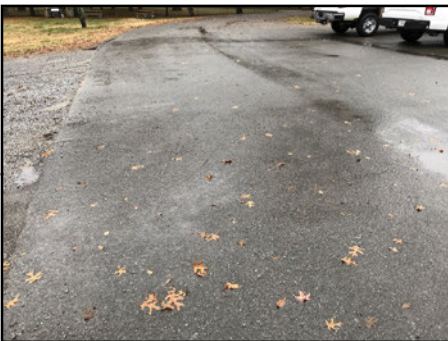
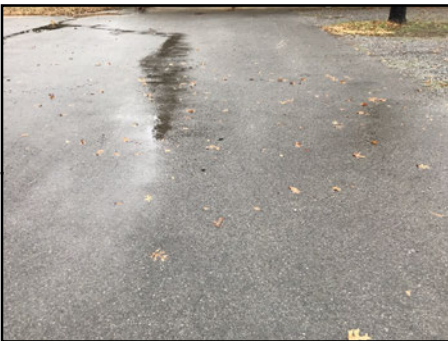
## ROUTE 0908A: MAINTENANCE PARKING AREA A

Inspection Date	FMSS Number	User Access	Surface Type
11/23/2019	98087	NONPUBLIC	ASPHALT
Area (Sq. Ft.)	Lane Miles (11' Widths)	Curb Reveal (Inches)	Curb Recommendation
4,362	0.075	NOT APPLICABLE	NOT APPLICABLE
Curb Type		Curb & Gutter Type	
NO CURB		NO CURB AND GUTTER	
Pavement Recommendation		Condition Rating / PCR	
PREVENTIVE MAINTENANCE		GOOD / 90

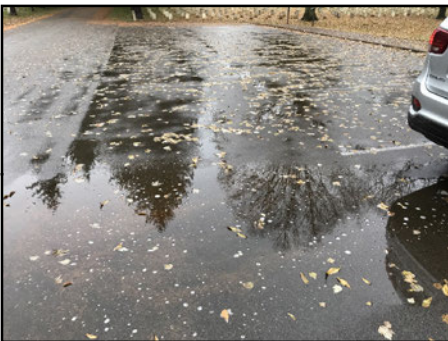
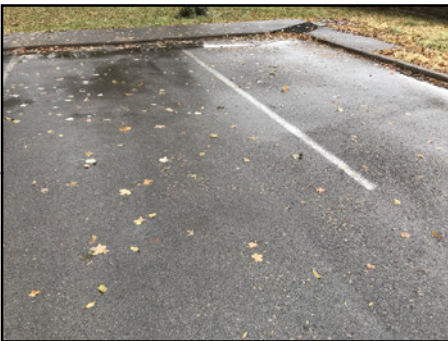
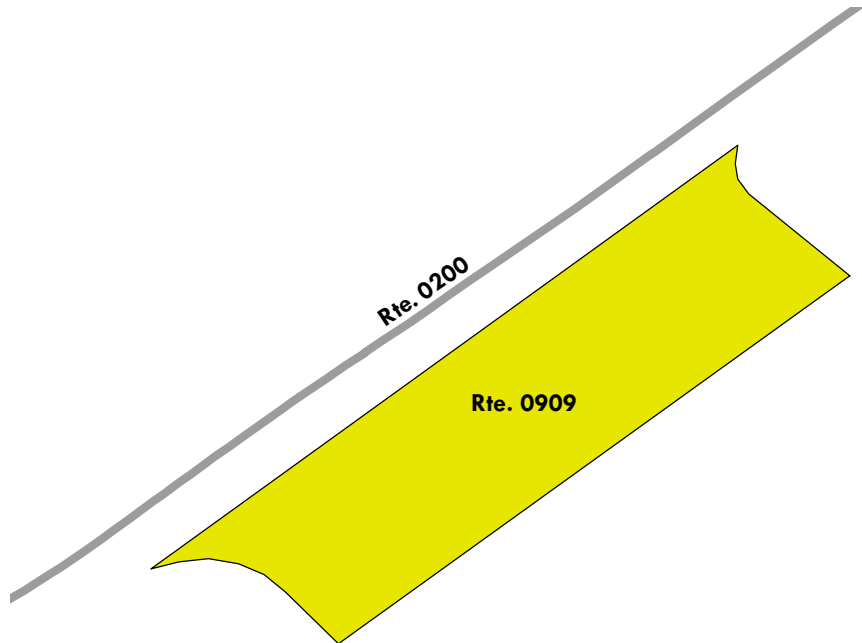
## ROUTE 0909: CEMETERY PARKING

Inspection Date	FMSS Number	User Access	Surface Type
11/23/2019	78843	PUBLIC	ASPHALT
Area (Sq. Ft.)	Lane Miles (11' Widths)	Curb Reveal (Inches)	Curb Recommendation
2,844	0.049	4	LIGHT REPAIR
Curb Type		Curb & Gutter Type	
CONCRETE		NO CURB AND GUTTER	
Pavement Recommendation		Condition Rating / PCR	
LIGHT 3R TREATMENTS		FAIR / 73

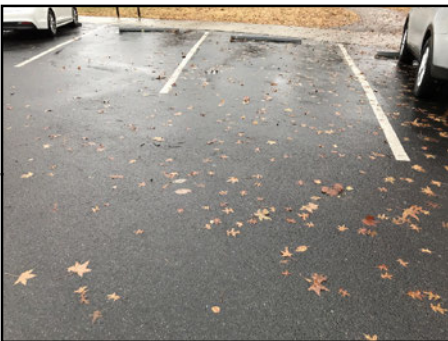
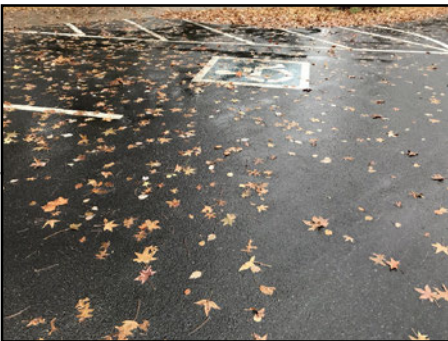
## ROUTE 0910: VISITOR CENTER PARKING C PICNIC AREA

Inspection Date	FMSS Number	User Access	Surface Type
11/23/2019	95887	PUBLIC	ASPHALT
Area (Sq. Ft.)	Lane Miles (11' Widths)	Curb Reveal (Inches)	Curb Recommendation
2,615	0.045	NOT APPLICABLE	NOT APPLICABLE
Curb Type		Curb & Gutter Type	
NO CURB		NO CURB AND GUTTER	
Pavement Recommendation		Condition Rating / PCR	
PREVENTIVE MAINTENANCE		GOOD / 90
