Final Report

Road Inventory and Condition Assessment of Paved Routes Sunset Crater Volcano National Monument

Federal Highway Administration
Eastern Federal Lands Highway Division
Road Inventory Program (RIP)

Report Date: December 2016

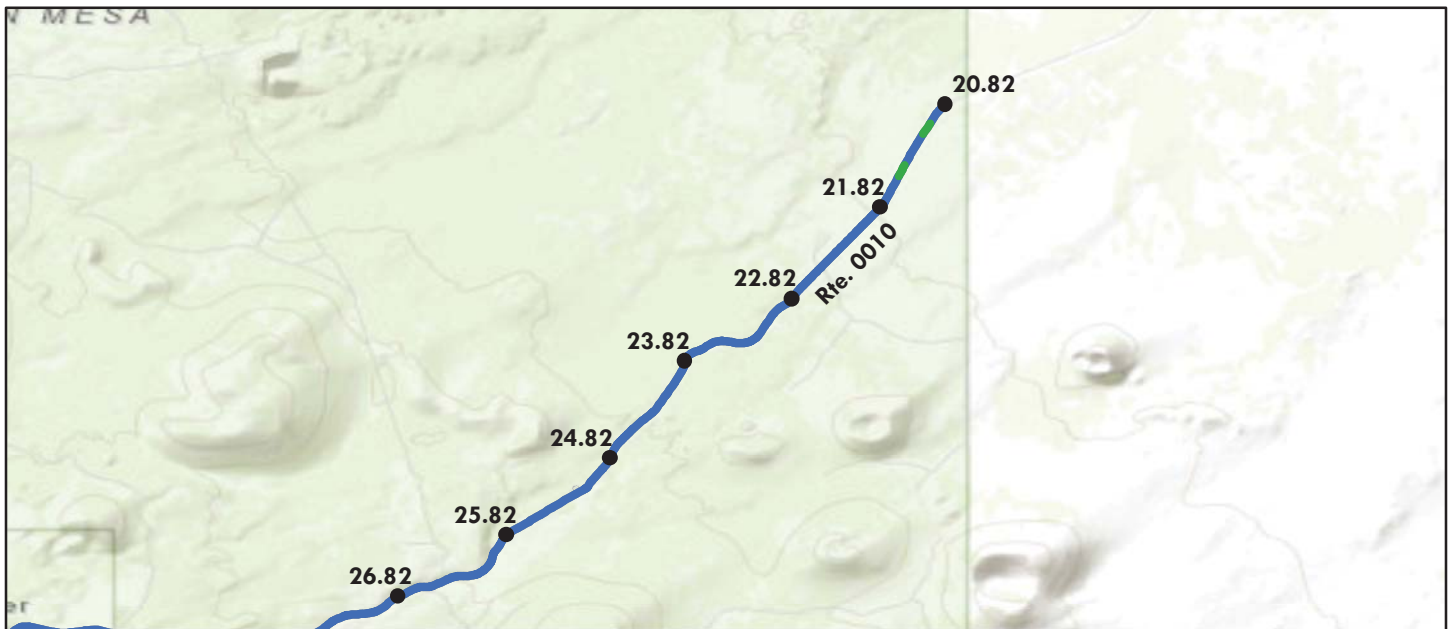
ROUTE 0010: WUPATKI-SUNSET CRATER SCENIC LOOP ROAD

Route Condition Legend – Pavement Condition Rating (PCR)						
Poor (0 - 60)	Fair (61- 84)	Good (85 - 94)	Excellent (95 - 100)	Not Rated		
See Appendix for definitions and formulas						
Inspection Date: 7/12/2016	Beginning Section MP	20.82	21.82	22.82	23.82	24.82
Paved Length (Miles): 13.78	Section Length (MI)	1	1	1	1	1
Surface Type: ASPHALT	Route Summary					
Roadway Condition Information						
Pavement Condition Rating (PCR)	99	97	99	99	99	99
Surface Condition Rating (SCR)	99	95	99	99	99	99
Roughness Condition Index (RCI)	100	100	100	100	100	100
Distress Index Values						
Structural Crack Index	99	95	99	99	99	100
Alligator Crack Index	100	100	100	100	100	100
Longitudinal Crack Index	99	95	99	99	99	100
Transverse Cracking Index	99	100	100	100	100	100
Patching Index	100	100	100	100	100	100
Rutting Index	99	100	100	100	100	99
International Roughness Index (IRI)	65	62	59	72	58	60
Lane & Width Information

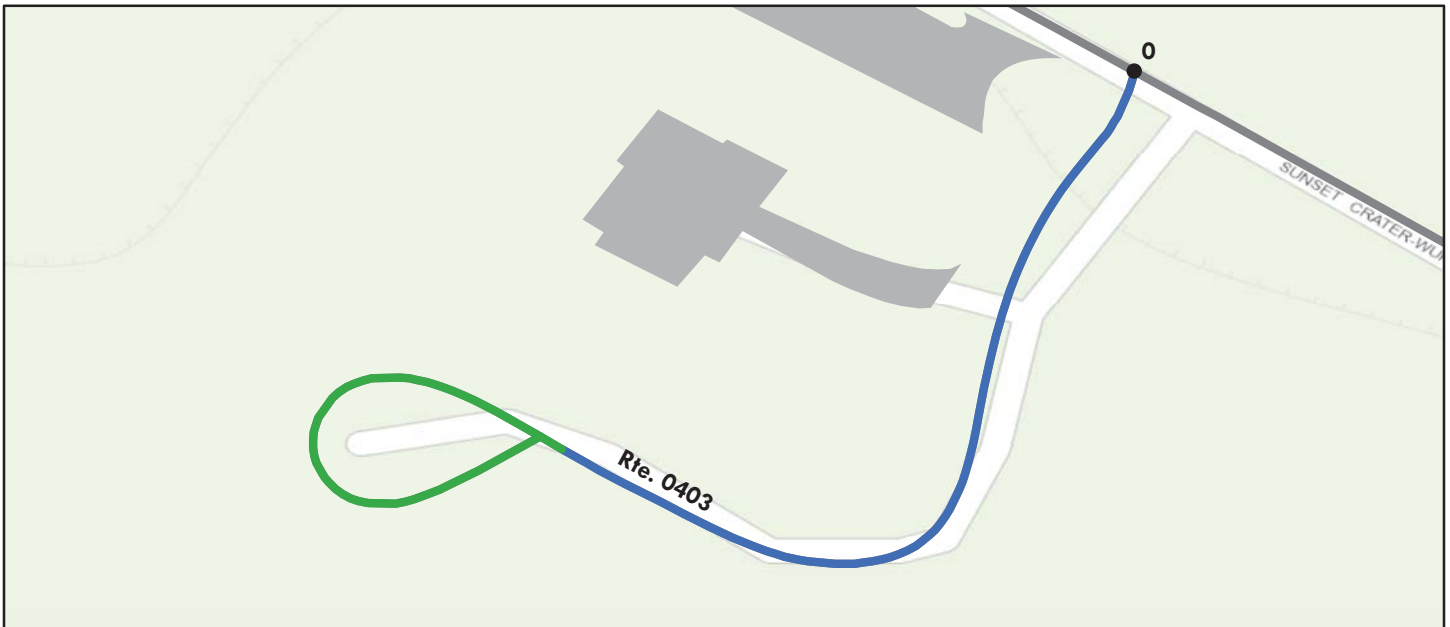
ROUTE 0403: SUNSET CRATER RESIDENCE ROAD

Route Condition Legend – Pavement Condition Rating (PCR)						
Poor (0 - 60)	Fair (61- 84)	Good (85 - 94)	Excellent (95 - 100)	Not Rated		
See Appendix for definitions and formulas						
Inspection Date: 7/12/2016	Beginning Section MP	0				
Paved Length (Miles): 0.16	Section Length (MI)	0.16				
Surface Type: ASPHALT	Route Summary					
Roadway Condition Information						
Pavement Condition Rating (PCR)	96	96				
Surface Condition Rating (SCR)	96	96				
Roughness Condition Index (RCI)	N/A	N/A				
Distress Index Values						
Structural Crack Index	100	100				
Alligator Crack Index	100	100				
Longitudinal Crack Index	100	100				
Transverse Cracking Index	97	97				
Patching Index	98	98				
Rutting Index	96	96				
International Roughness Index (IRI)	N/A	N/A				
Lane & Width Information						
Number of Lanes	2	2				
Paved Width (ft)	18.3	18.3				
Lane Width (ft)	9.1	9.1

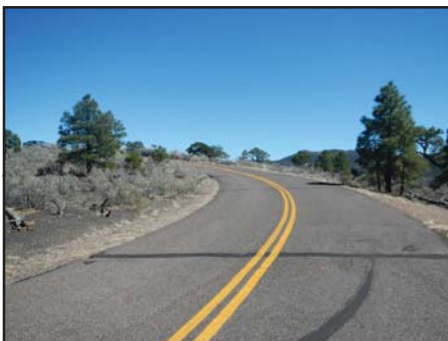
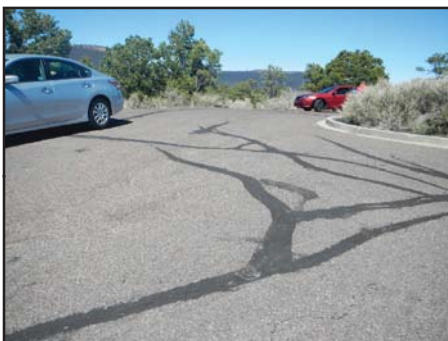
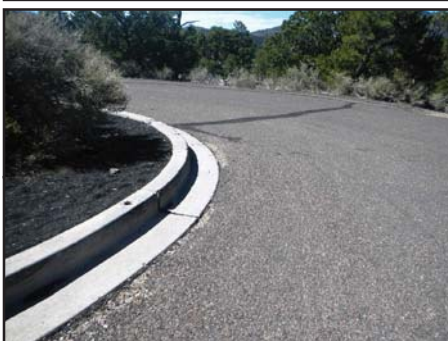
ROUTE 0910: CINDER HILLS OVERLOOK PARKING

Inspection Date	FMSS Number	User Access	Surface Type
3/24/2016	47318	PUBLIC	ASPHALT
Area (Sq. Ft.)	Lane Miles (11' Widths)	Curb Reveal (Inches)	Curb Recommendation
23,091	0.398	NOT APPLICABLE	DO NOTHING
Curb Type		Curb & Gutter Type	
NO CURB		CONCRETE	
Pavement Recommendation		Condition Rating / PCR	
PREVENTIVE MAINTENANCE		GOOD / 90

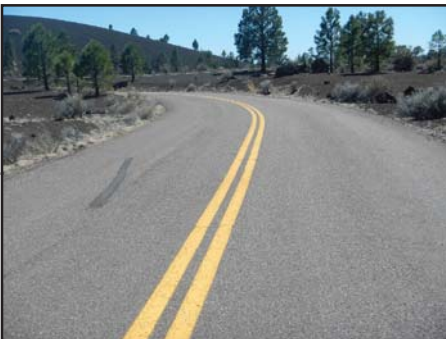
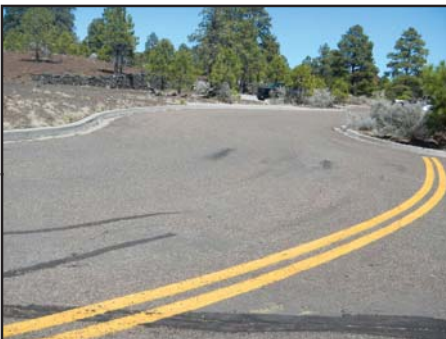
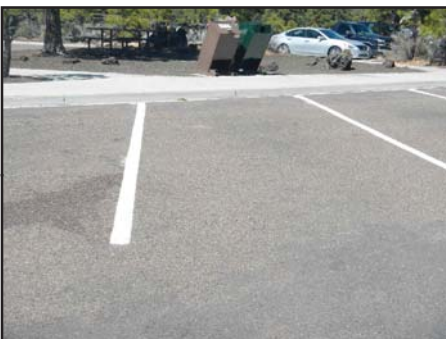
ROUTE 0911: LAVA FLOW TRAIL PARKING

Inspection Date	FMSS Number	User Access	Surface Type
3/24/2016	47328	PUBLIC	ASPHALT
Area (Sq. Ft.)	Lane Miles (11' Widths)	Curb Reveal (Inches)	Curb Recommendation
39,705	0.684	NOT APPLICABLE	DO NOTHING
Curb Type		Curb & Gutter Type	
NO CURB		CONCRETE	
Pavement Recommendation		Condition Rating / PCR	
PREVENTIVE MAINTENANCE		GOOD / 90

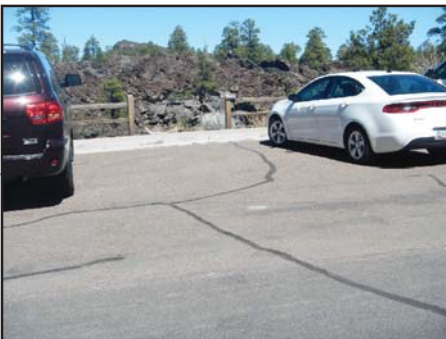
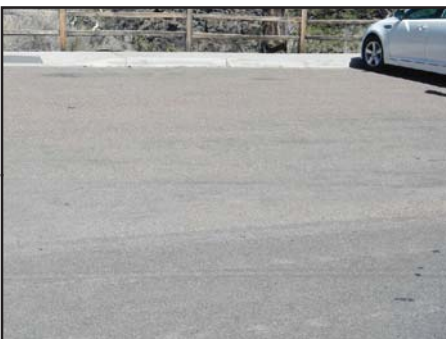
ROUTE 0912: LENOX CRATER PULLOUT PARKING

Inspection Date	FMSS Number	User Access	Surface Type
3/24/2016	47333	PUBLIC	ASPHALT
Area (Sq. Ft.)	Lane Miles (11' Widths)	Curb Reveal (Inches)	Curb Recommendation
4,771	0.082	NOT APPLICABLE	DO NOTHING
Curb Type		Curb & Gutter Type	
NO CURB		CONCRETE	
Pavement Recommendation		Condition Rating / PCR	
PREVENTIVE MAINTENANCE		GOOD / 90

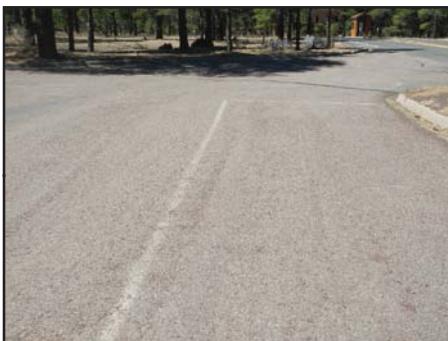
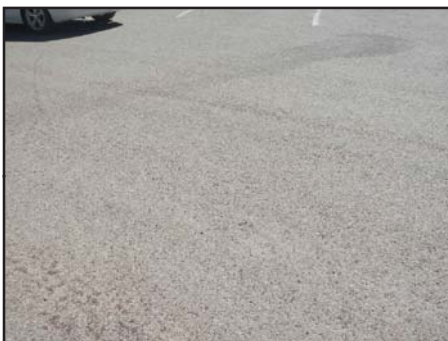
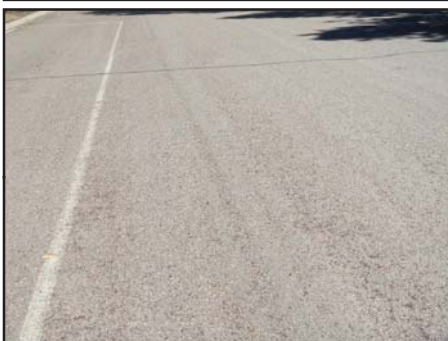
ROUTE 0914: SUNSET CRATER VISITOR CENTER PARKING

Inspection Date	FMSS Number	User Access	Surface Type
3/24/2016	47336	PUBLIC	ASPHALT
Area (Sq. Ft.)	Lane Miles (11' Widths)	Curb Reveal (Inches)	Curb Recommendation
13,206	0.227	NOT APPLICABLE	LIGHT REPAIR
Curb Type		Curb & Gutter Type	
NO CURB		CONCRETE	
Pavement Recommendation		Condition Rating / PCR	
PREVENTIVE MAINTENANCE		GOOD / 90

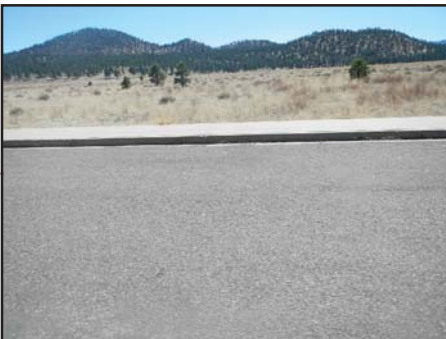
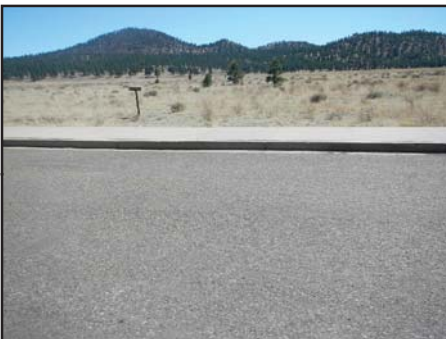
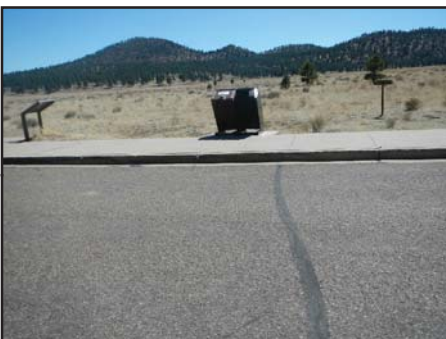
ROUTE 0915: BONITO PARK PULLOUT PARKING

Inspection Date	FMSS Number	User Access	Surface Type
3/24/2016	47337	PUBLIC	ASPHALT
Area (Sq. Ft.)	Lane Miles (11' Widths)	Curb Reveal (Inches)	Curb Recommendation
4,801	0.083	NOT APPLICABLE	MODERATE REPAIR
Curb Type		Curb & Gutter Type	
NO CURB		CONCRETE	
Pavement Recommendation		Condition Rating / PCR	
PREVENTIVE MAINTENANCE		GOOD / 90

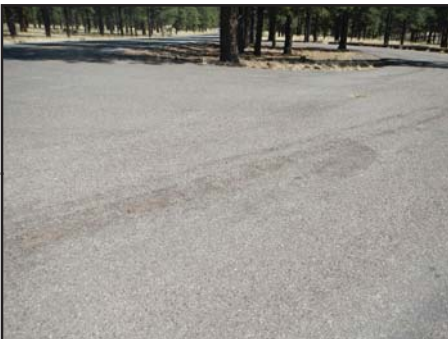
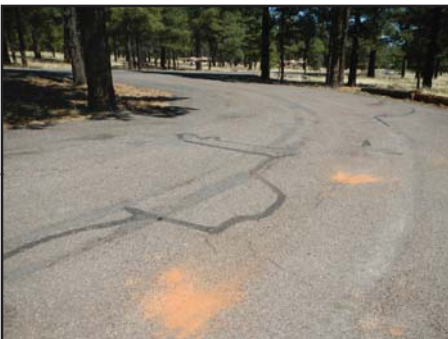
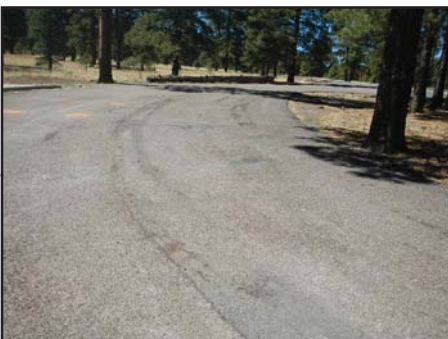
ROUTE 0916: SUNSET CRATER ORIENTATION PARKING

Inspection Date	FMSS Number	User Access	Surface Type
3/24/2016	47338	PUBLIC	ASPHALT
Area (Sq. Ft.)	Lane Miles (11' Widths)	Curb Reveal (Inches)	Curb Recommendation
8,242	0.142	NOT APPLICABLE	NOT APPLICABLE
Curb Type		Curb & Gutter Type	
NO CURB		NO CURB AND GUTTER	
Pavement Recommendation		Condition Rating / PCR	
LIGHT 3R TREATMENTS		FAIR / 73

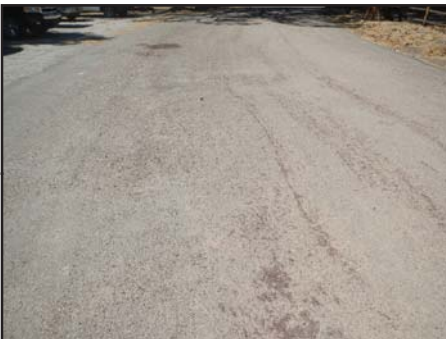
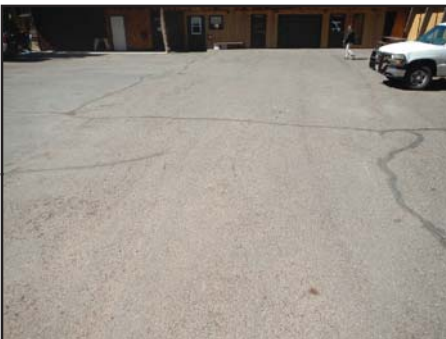
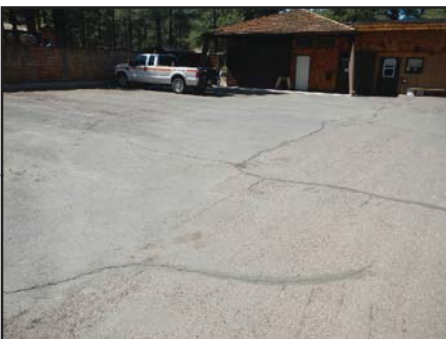
ROUTE 0919: SUNSET CRATER MAINTENANCE AREA PARKING

Inspection Date	FMSS Number	User Access	Surface Type
3/24/2016	114670	NONPUBLIC	ASPHALT
Area (Sq. Ft.)	Lane Miles (11' Widths)	Curb Reveal (Inches)	Curb Recommendation
9,528	0.164	NOT APPLICABLE	NOT APPLICABLE
Curb Type		Curb & Gutter Type	
NO CURB		NO CURB AND GUTTER	
Pavement Recommendation		Condition Rating / PCR	
LIGHT 3R TREATMENTS		FAIR / 73

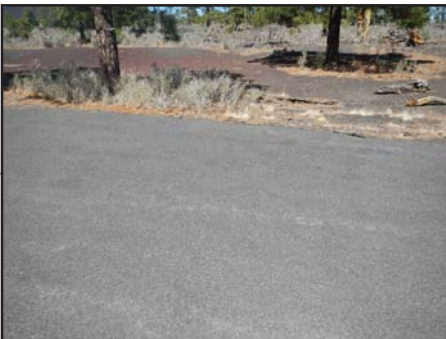
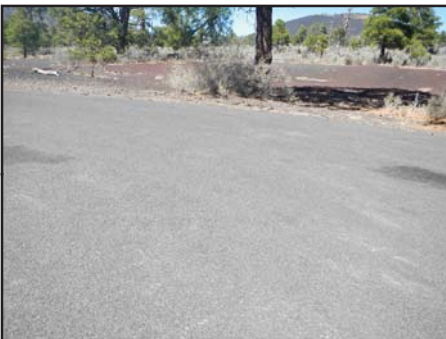
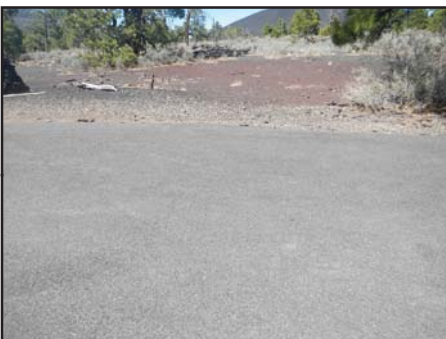
ROUTE 0920: SUNSET CRATER EAST ENTRANCE PULLOUT PARKING

Inspection Date	FMSS Number	User Access	Surface Type
3/24/2016	228022	PUBLIC	ASPHALT
Area (Sq. Ft.)	Lane Miles (11' Widths)	Curb Reveal (Inches)	Curb Recommendation
2,127	0.037	NOT APPLICABLE	NOT APPLICABLE
Curb Type		Curb & Gutter Type	
NO CURB		NO CURB AND GUTTER	
Pavement Recommendation		Condition Rating / PCR	
PREVENTIVE MAINTENANCE		GOOD / 90

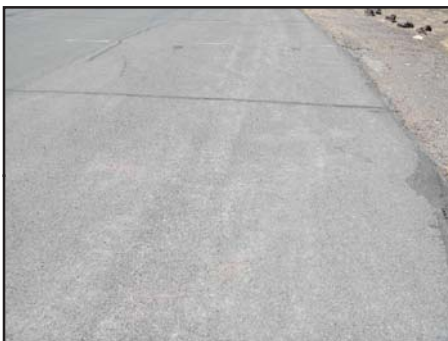
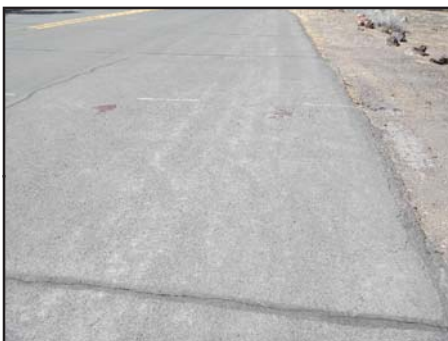
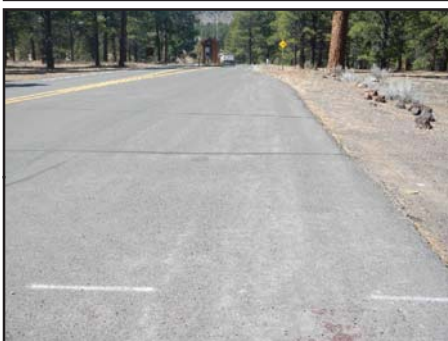
ROUTE 0921: PEAKS VIEW PULLOUT PARKING

Inspection Date	FMSS Number	User Access	Surface Type
3/24/2016	228021	PUBLIC	ASPHALT
Area (Sq. Ft.)	Lane Miles (11' Widths)	Curb Reveal (Inches)	Curb Recommendation
1,609	0.028	NOT APPLICABLE	NOT APPLICABLE
Curb Type		Curb & Gutter Type	
NO CURB		NO CURB AND GUTTER	
Pavement Recommendation		Condition Rating / PCR	
PREVENTIVE MAINTENANCE		GOOD / 90
