THRO Cycle 6

Final Report

Road Inventory and Condition Assessment of Paved Routes Theodore Roosevelt National Park

Federal Highway Administration
Eastern Federal Lands Highway Division
Road Inventory Program (RIP)

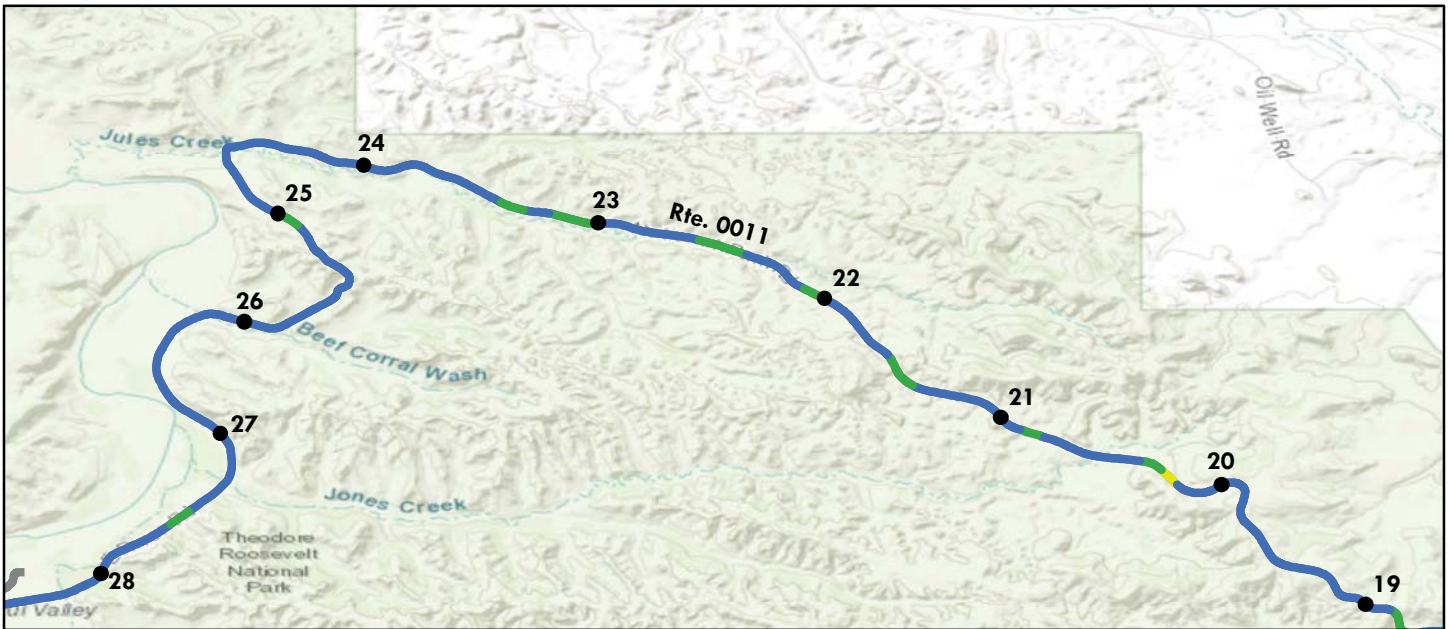
Route Condition Legend – Pavement Condition Rating (PCR)						
Poor (0 - 60)	Fair (61- 84)	Good (85 - 94)	Excellent (95 - 100)	Not Rated		
See Appendix for definitions and formulas						
Inspection Date: 7/25/2017	Beginning Section MP	20	21	22	23	24
Paved Length (Miles): 28.75	Section Length (MI)	1	1	1	1	1
Surface Type: ASPHALT	Route Summary					
Roadway Condition Information						
Pavement Condition Rating (PCR)	89	97	98	96	96	99
Surface Condition Rating (SCR)	93	95	97	94	94	99
Roughness Condition Index (RCI)	83	100	100	100	100	100
Distress Index Values						
Structural Crack Index	93	95	97	94	94	99
Alligator Crack Index	100	100	100	100	100	100
Longitudinal Crack Index	93	95	97	94	94	99
Transverse Cracking Index	96	97	97	98	100	100
Patching Index	99	100	99	100	100	99
Rutting Index	95	100	99	99	98	99
International Roughness Index (IRI)	159	110	105	82	77	84
Lane & Width Information						
Number of Lanes	2	2	2	2	2	2

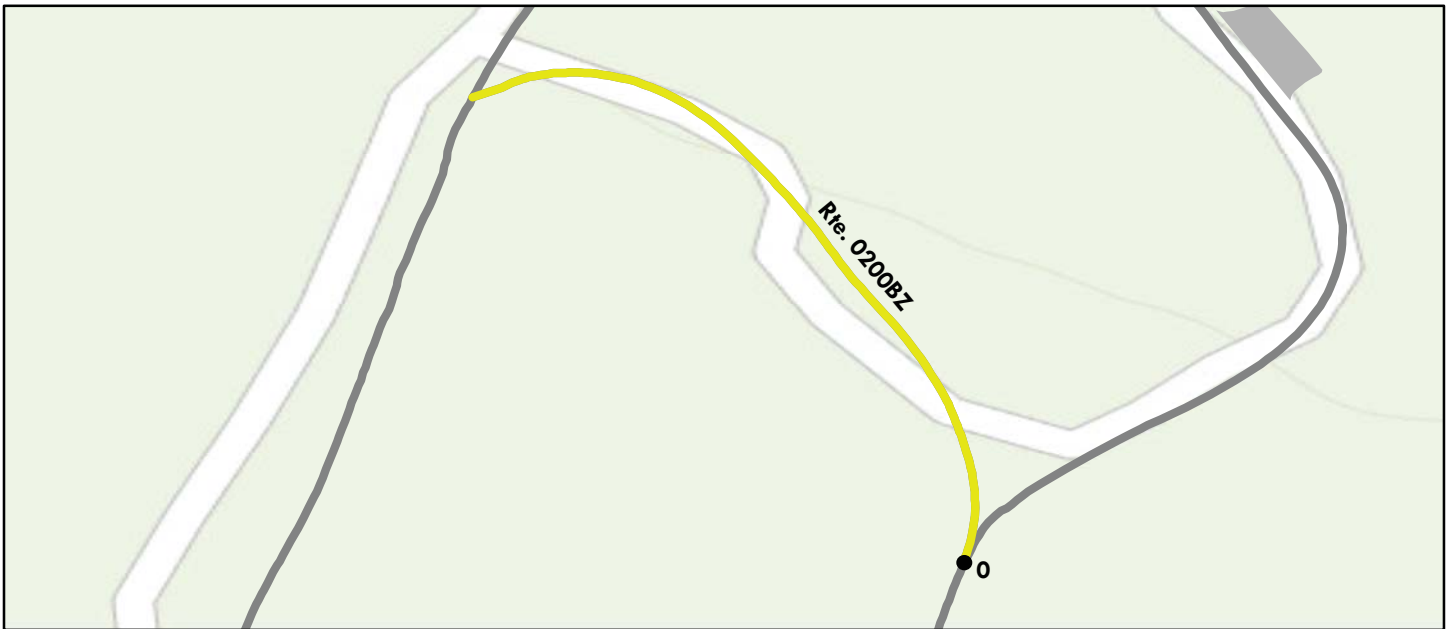
Route Condition Legend – Pavement Condition Rating (PCR)						
Poor (0 - 60)	Fair (61- 84)	Good (85 - 94)	Excellent (95 - 100)	Not Rated		
See Appendix for definitions and formulas						
Inspection Date: 7/24/2017	Beginning Section MP	0				
Paved Length (Miles): 0.08	Section Length (MI)	0.08				
Surface Type: ASPHALT	Route Summary					
Roadway Condition Information						
Pavement Condition Rating (PCR)	84	84				
Surface Condition Rating (SCR)	84	84				
Roughness Condition Index (RCI)	N/A	N/A				
Distress Index Values						
Structural Crack Index	93	93				
Alligator Crack Index	100	100				
Longitudinal Crack Index	93	93				
Transverse Cracking Index	87	87				
Patching Index	100	100				
Rutting Index	84	84				
International Roughness Index (IRI)	N/A	N/A				
Lane & Width Information						
Number of Lanes	1	1				
Paved Width (ft)	12.8	12.8				
Lane Width (ft)	12.8	12.8

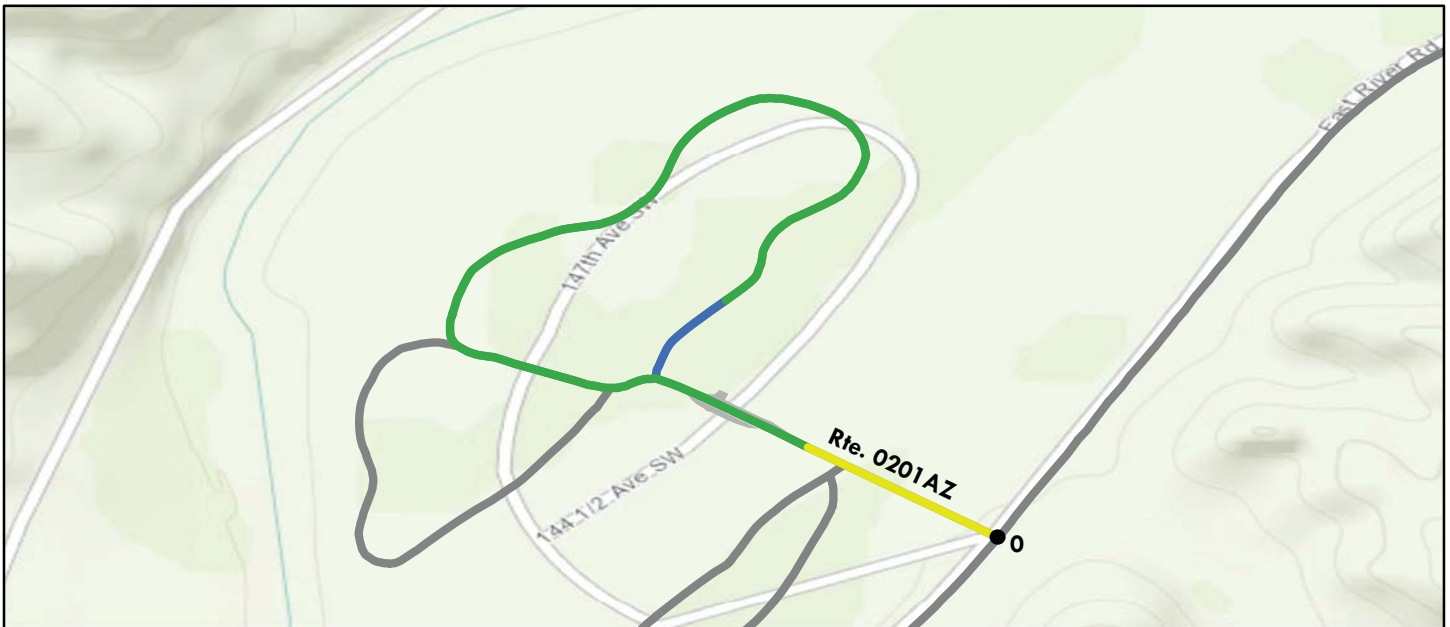
ROUTE 0201AZ: COTTONWOOD CAMPGROUND LOOP A

Route Condition Legend – Pavement Condition Rating (PCR)						
Poor (0 - 60)	Fair (61- 84)	Good (85 - 94)	Excellent (95 - 100)	Not Rated		
See Appendix for definitions and formulas						
Inspection Date: 7/25/2017	Beginning Section MP	0				
Paved Length (Miles): 0.76	Section Length (MI)	0.76				
Surface Type: ASPHALT	Route Summary					
Roadway Condition Information						
Pavement Condition Rating (PCR)	91	91				
Surface Condition Rating (SCR)	91	91				
Roughness Condition Index (RCI)	N/A	N/A				
Distress Index Values						
Structural Crack Index	95	95				
Alligator Crack Index	100	100				
Longitudinal Crack Index	95	95				
Transverse Cracking Index	91	91				
Patching Index	100	100				
Rutting Index	93	93				
International Roughness Index (IRI)	N/A	N/A				
Lane & Width Information						
Number of Lanes	1	1				
Paved Width (ft)	14.8	14.8				
Lane Width (ft)	11.1	11.1

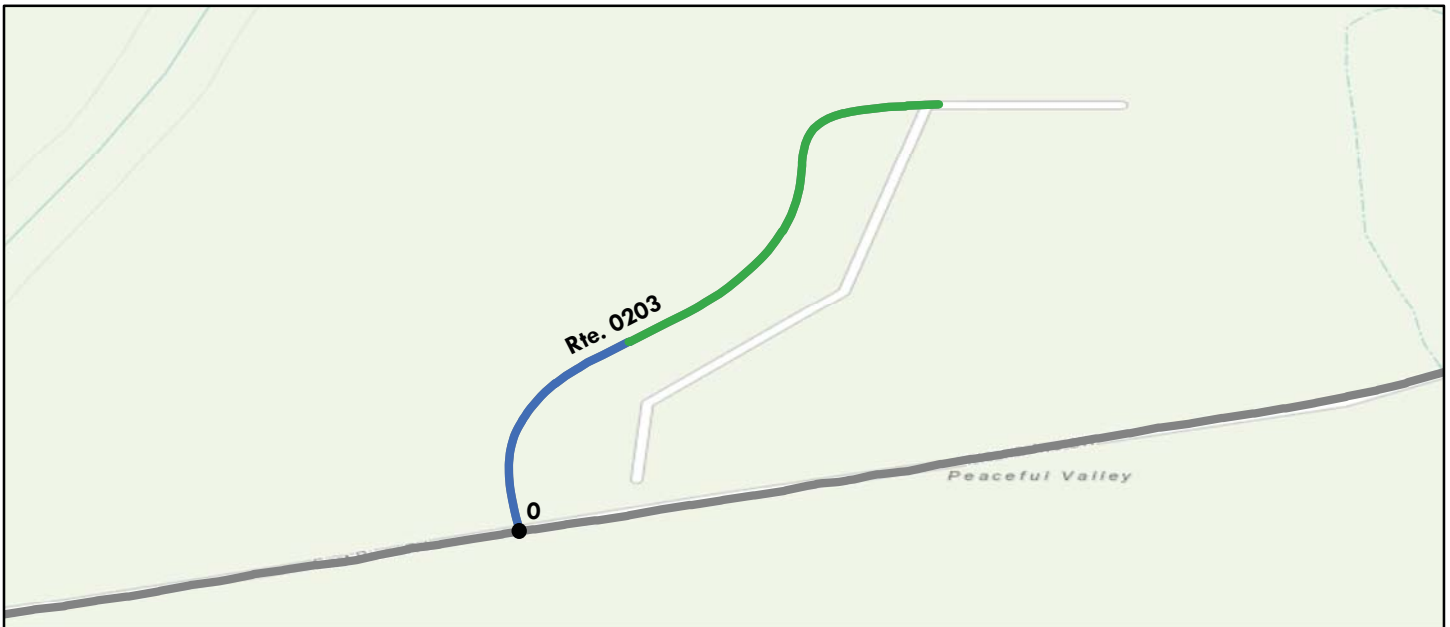
ROUTE 0203: PEACEFUL VALLEY ROAD - STABLE ACCESS

Route Condition Legend – Pavement Condition Rating (PCR)						
Poor (0 - 60)	Fair (61- 84)	Good (85 - 94)	Excellent (95 - 100)	Not Rated		
See Appendix for definitions and formulas						
Inspection Date: 7/25/2017	Beginning Section MP	0				
Paved Length (Miles): 0.26	Section Length (MI)	0.26				
Surface Type: ASPHALT	Route Summary					
Roadway Condition Information						
Pavement Condition Rating (PCR)	94	94				
Surface Condition Rating (SCR)	94	94				
Roughness Condition Index (RCI)	N/A	N/A				
Distress Index Values						
Structural Crack Index	97	97				
Alligator Crack Index	100	100				
Longitudinal Crack Index	97	97				
Transverse Cracking Index	94	94				
Patching Index	100	100				
Rutting Index	97	97				
International Roughness Index (IRI)	N/A	N/A				
Lane & Width Information						
Number of Lanes	2	2				
Paved Width (ft)	16.2	16.2				
Lane Width (ft)	8.1	8.1

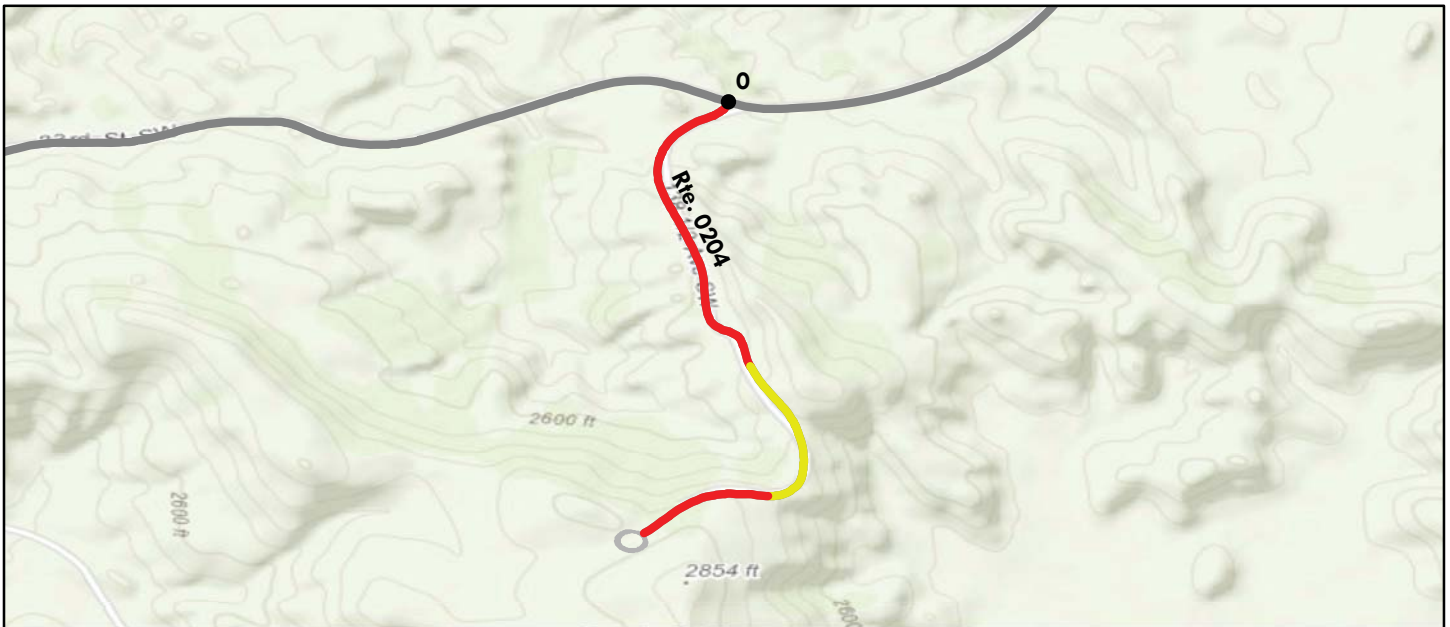
Badly degraded Asphalt in some sections (could be unpaved).

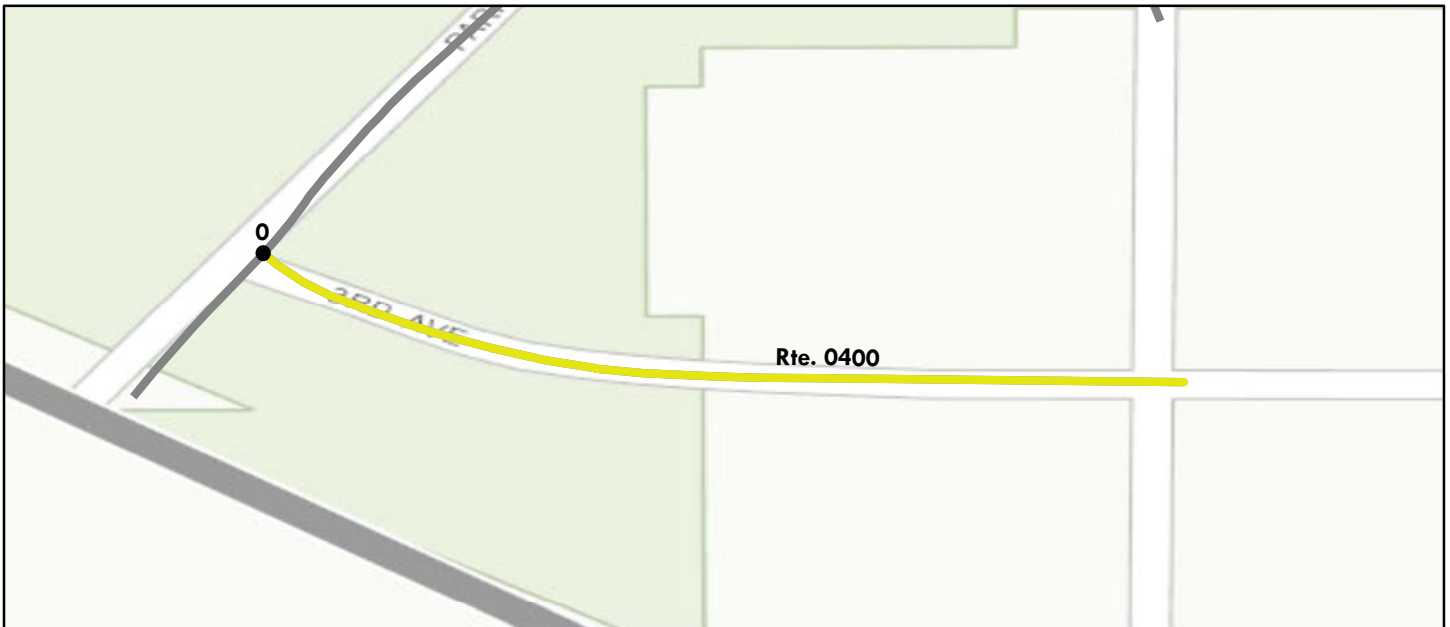
ROUTE 0400: HEADQUARTERS AREA - THIRD AVENUE

Route Condition Legend – Pavement Condition Rating (PCR)						
Poor (0 - 60)	Fair (61- 84)	Good (85 - 94)	Excellent (95 - 100)	Not Rated		
See Appendix for definitions and formulas						
Inspection Date: 7/25/2017	Beginning Section MP	0				
Paved Length (Miles): 0.08	Section Length (MI)	0.08				
Surface Type: ASPHALT	Route Summary					
Roadway Condition Information						
Pavement Condition Rating (PCR)	78	78				
Surface Condition Rating (SCR)	78	78				
Roughness Condition Index (RCI)	N/A	N/A				
Distress Index Values						
Structural Crack Index	91	91				
Alligator Crack Index	100	100				
Longitudinal Crack Index	91	91				
Transverse Cracking Index	78	78				
Patching Index	100	100				
Rutting Index	94	94				
International Roughness Index (IRI)	N/A	N/A				
Lane & Width Information						
Number of Lanes	2	2				
Paved Width (ft)	33.1	33.1				
Lane Width (ft)	17.1	17.1

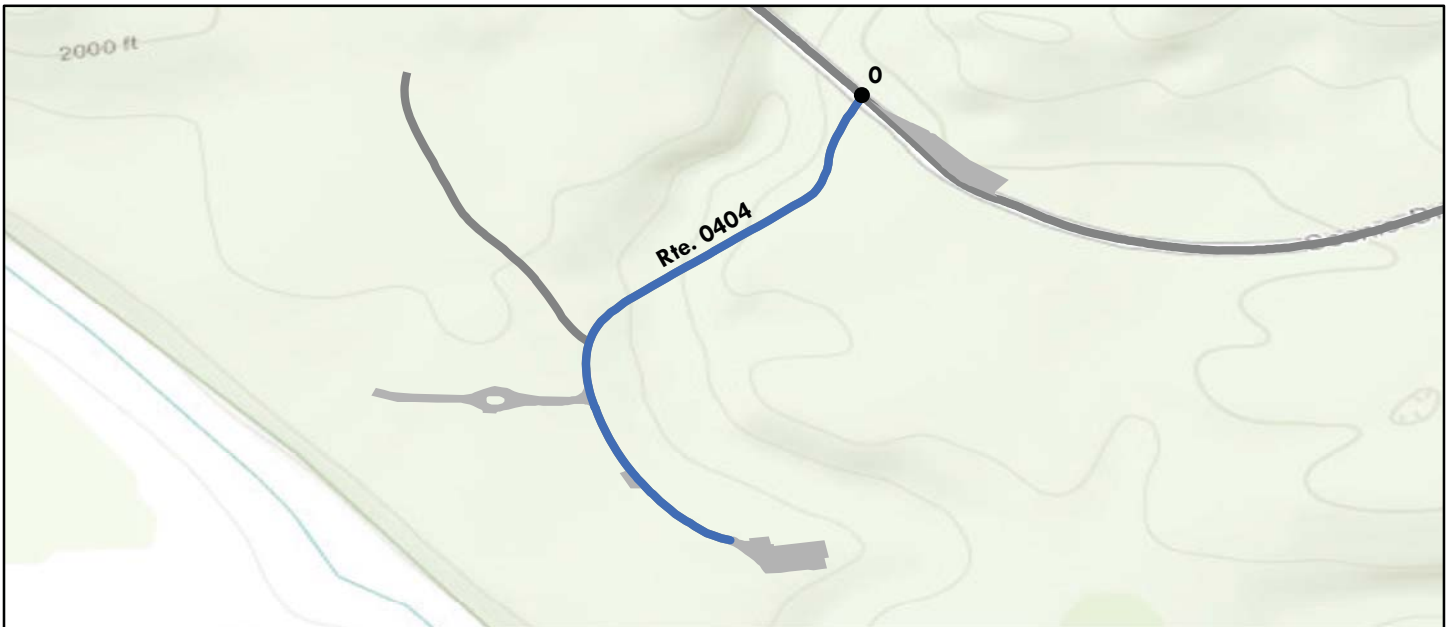
ROUTE 0404: NORTH UNIT MAINTENANCE AREA ACCESS ROAD

Route Condition Legend – Pavement Condition Rating (PCR)						
Poor (0 - 60)	Fair (61- 84)	Good (85 - 94)	Excellent (95 - 100)	Not Rated		
See Appendix for definitions and formulas						
Inspection Date: 7/24/2017	Beginning Section MP	0				
Paved Length (Miles): 0.3	Section Length (MI)	0.3				
Surface Type: ASPHALT	Route Summary					
Roadway Condition Information						
Pavement Condition Rating (PCR)	96	96				
Surface Condition Rating (SCR)	96	96				
Roughness Condition Index (RCI)	N/A	N/A				
Distress Index Values						
Structural Crack Index	96	96				
Alligator Crack Index	100	100				
Longitudinal Crack Index	96	96				
Transverse Cracking Index	98	98				
Patching Index	100	100				
Rutting Index	96	96				
International Roughness Index (IRI)	N/A	N/A				
Lane & Width Information						
Number of Lanes	2	2				
Paved Width (ft)	19.8	19.8				
Lane Width (ft)	10.1	10.1

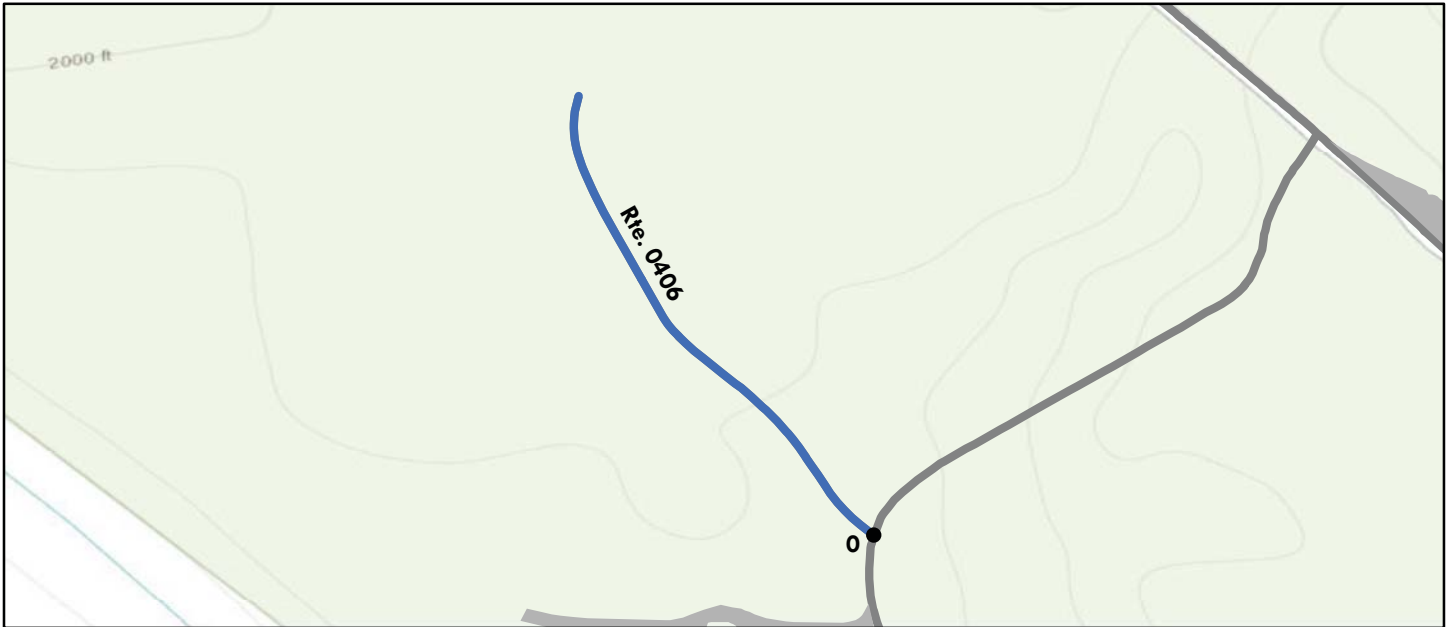
ROUTE 0406: GRAY HOUSE ACCESS ROAD

Route Condition Legend – Pavement Condition Rating (PCR)						
Poor (0 - 60)	Fair (61- 84)	Good (85 - 94)	Excellent (95 - 100)	Not Rated		
See Appendix for definitions and formulas						
Inspection Date: 7/24/2017	Beginning Section MP	0				
Paved Length (Miles): 0.16	Section Length (MI)	0.16				
Surface Type: ASPHALT	Route Summary					
Roadway Condition Information						
Pavement Condition Rating (PCR)	97	97				
Surface Condition Rating (SCR)	97	97				
Roughness Condition Index (RCI)	N/A	N/A				
Distress Index Values						
Structural Crack Index	99	99				
Alligator Crack Index	100	100				
Longitudinal Crack Index	99	99				
Transverse Cracking Index	98	98				
Patching Index	100	100				
Rutting Index	97	97				
International Roughness Index (IRI)	N/A	N/A				
Lane & Width Information						
Number of Lanes	2	2				
Paved Width (ft)	19.8	19.8				
Lane Width (ft)	9.9	9.9

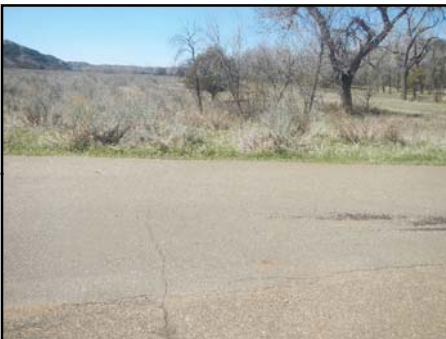
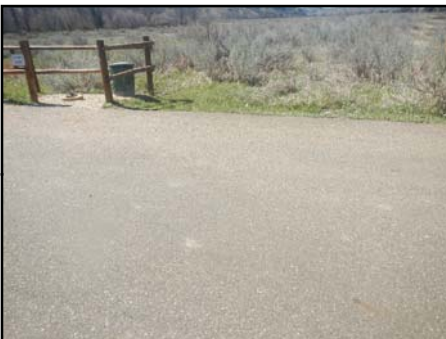
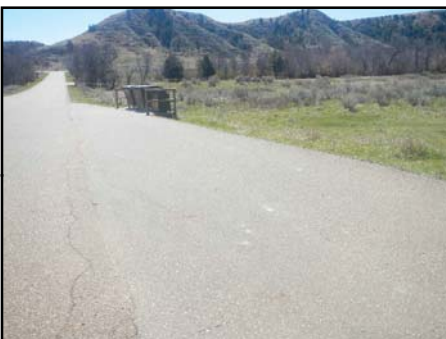
ROUTE 0908: COTTONWOOD CAMPGROUND SOUTH PARKING

Inspection Date	FMSS Number	User Access	Surface Type
4/30/2017	56796	PUBLIC	ASPHALT
Area (Sq. Ft.)	Lane Miles (11' Widths)	Curb Reveal (Inches)	Curb Recommendation
2,737	0.047	NOT APPLICABLE	NOT APPLICABLE
Curb Type		Curb & Gutter Type	
NO CURB		NO CURB AND GUTTER	
Pavement Recommendation		Condition Rating / PCR	
PREVENTIVE MAINTENANCE		GOOD / 90

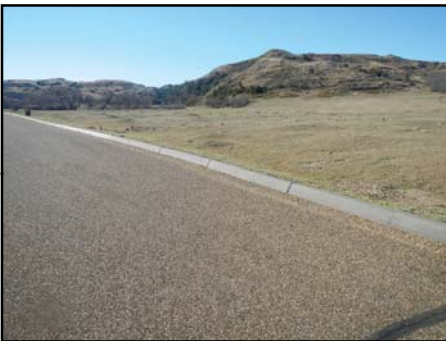
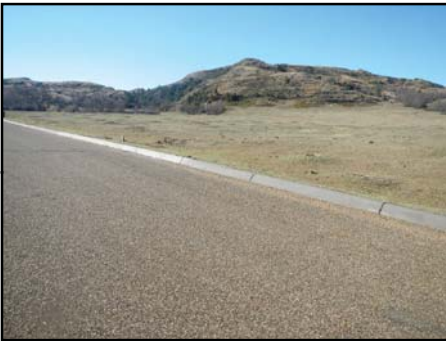
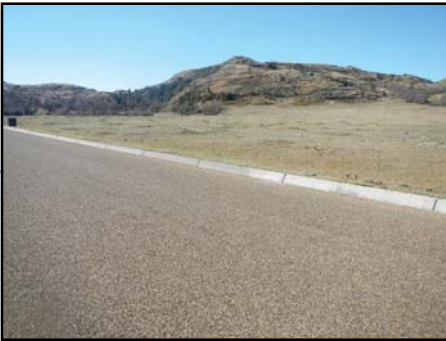
ROUTE 0909: PRAIRIE DOG TOWN PARKING AREA

Inspection Date	FMSS Number	User Access	Surface Type
4/30/2017	56797	PUBLIC	ASPHALT
Area (Sq. Ft.)	Lane Miles (11' Widths)	Curb Reveal (Inches)	Curb Recommendation
5,283	0.091	7	DO NOTHING
Curb Type		Curb & Gutter Type	
CONCRETE		NO CURB AND GUTTER	
Pavement Recommendation		Condition Rating / PCR	
PREVENTIVE MAINTENANCE		GOOD / 90

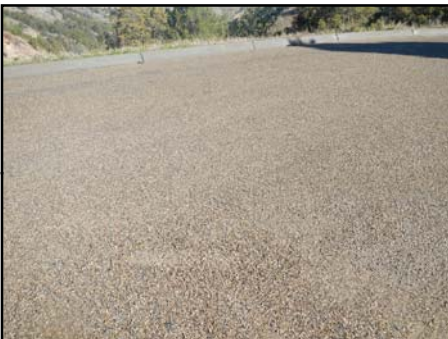
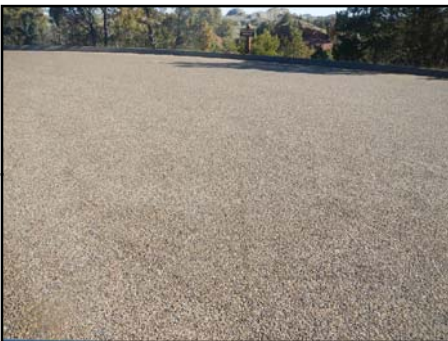
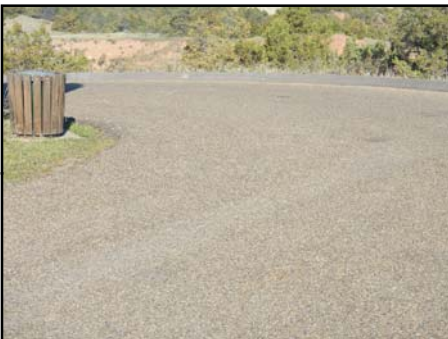
ROUTE 0910: SCORIA POINT OVERLOOK

Inspection Date	FMSS Number	User Access	Surface Type
4/30/2017	56798	PUBLIC	ASPHALT
Area (Sq. Ft.)	Lane Miles (11' Widths)	Curb Reveal (Inches)	Curb Recommendation
6,110	0.105	8	DO NOTHING
Curb Type		Curb & Gutter Type	
CONCRETE		NO CURB AND GUTTER	
Pavement Recommendation		Condition Rating / PCR	
PREVENTIVE MAINTENANCE		GOOD / 90

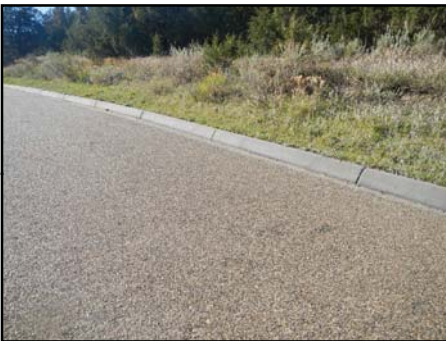
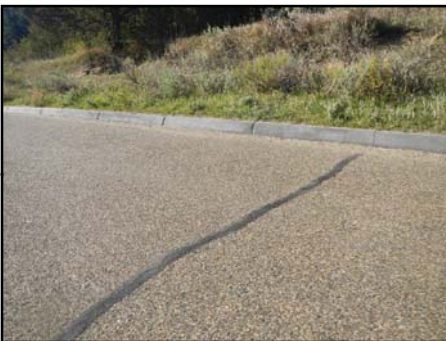
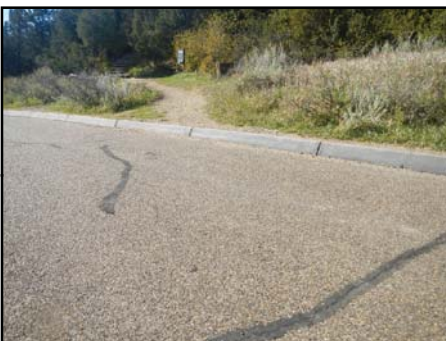
ROUTE 0911: RIDGELINE TRAILHEAD

Inspection Date	FMSS Number	User Access	Surface Type
4/30/2017	56799	PUBLIC	ASPHALT
Area (Sq. Ft.)	Lane Miles (11' Widths)	Curb Reveal (Inches)	Curb Recommendation
2,468	0.042	8	DO NOTHING
Curb Type		Curb & Gutter Type	
CONCRETE		NO CURB AND GUTTER	
Pavement Recommendation		Condition Rating / PCR	
PREVENTIVE MAINTENANCE		GOOD / 90

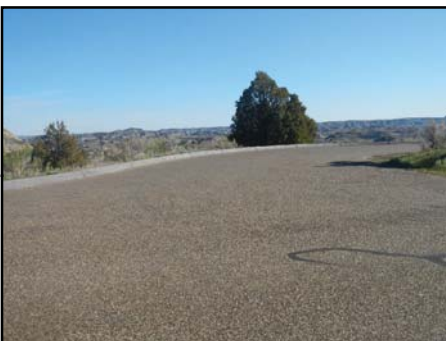
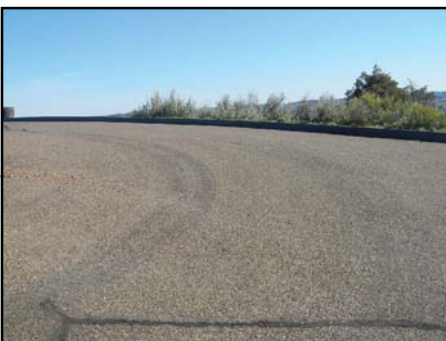
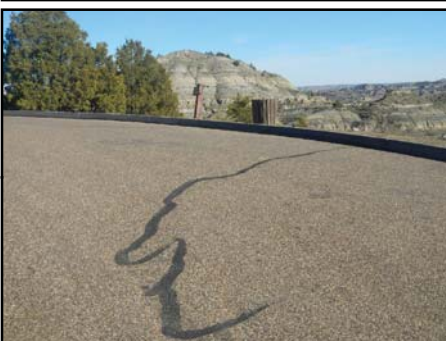
ROUTE 0912: NORTH DAKOTA BADLANDS OVERLOOK

Inspection Date	FMSS Number	User Access	Surface Type
4/30/2017	56800	PUBLIC	ASPHALT
Area (Sq. Ft.)	Lane Miles (11' Widths)	Curb Reveal (Inches)	Curb Recommendation
6,569	0.113	9	DO NOTHING
Curb Type		Curb & Gutter Type	
CONCRETE		NO CURB AND GUTTER	
Pavement Recommendation		Condition Rating / PCR	
PREVENTIVE MAINTENANCE		GOOD / 90

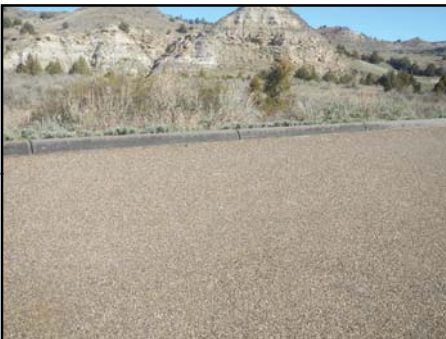
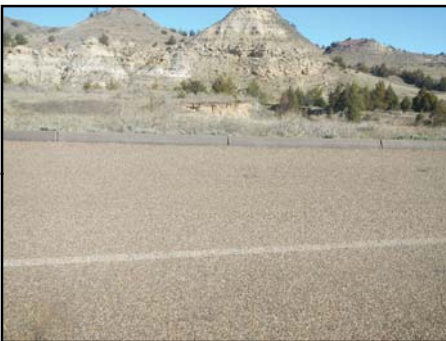
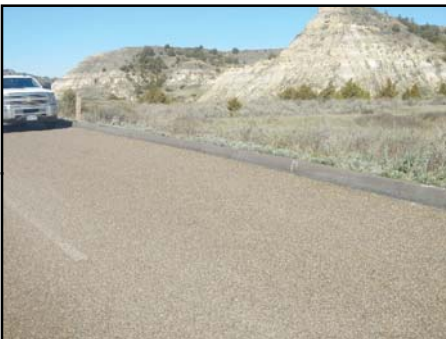
ROUTE 0913: PADDOCK CREEK TURNOUT

Inspection Date	FMSS Number	User Access	Surface Type
4/30/2017	56801	PUBLIC	ASPHALT
Area (Sq. Ft.)	Lane Miles (11' Widths)	Curb Reveal (Inches)	Curb Recommendation
3,168	0.055	7	DO NOTHING
Curb Type		Curb & Gutter Type	
CONCRETE		NO CURB AND GUTTER	
Pavement Recommendation		Condition Rating / PCR	
PREVENTIVE MAINTENANCE		GOOD / 90

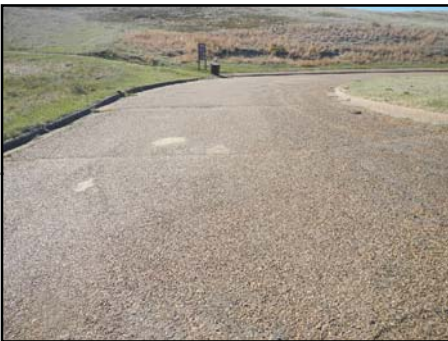
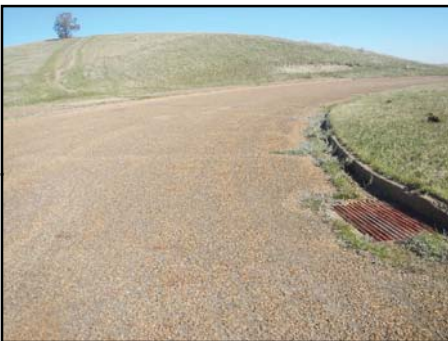
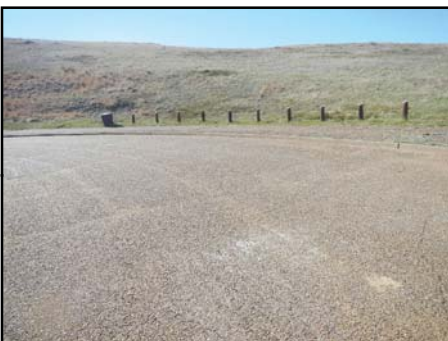
ROUTE 0915: BUCK HILL OVERLOOK

Inspection Date	FMSS Number	User Access	Surface Type
4/30/2017	56802	PUBLIC	ASPHALT
Area (Sq. Ft.)	Lane Miles (11' Widths)	Curb Reveal (Inches)	Curb Recommendation
12,757	0.22	5	LIGHT REPAIR
Curb Type		Curb & Gutter Type	
CONCRETE		CONCRETE	
Pavement Recommendation		Condition Rating / PCR	
LIGHT 3R TREATMENTS		FAIR / 73

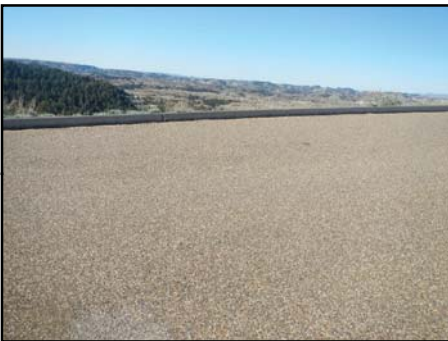
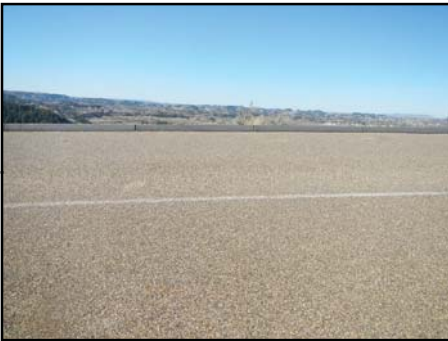
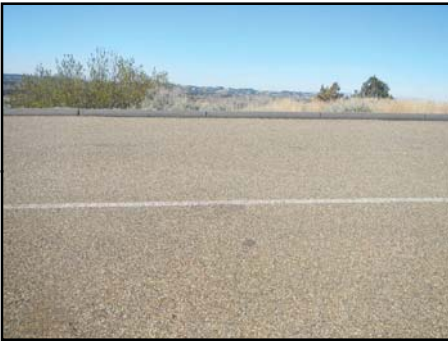
ROUTE 0916A: BOICOURT OVERLOOK PARKING A

Inspection Date	FMSS Number	User Access	Surface Type
4/30/2017	56803	PUBLIC	ASPHALT
Area (Sq. Ft.)	Lane Miles (11' Widths)	Curb Reveal (Inches)	Curb Recommendation
4,998	0.086	7	DO NOTHING
Curb Type		Curb & Gutter Type	
CONCRETE		NO CURB AND GUTTER	
Pavement Recommendation		Condition Rating / PCR	
PREVENTIVE MAINTENANCE		GOOD / 90

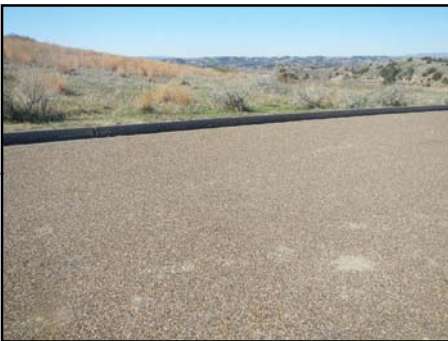
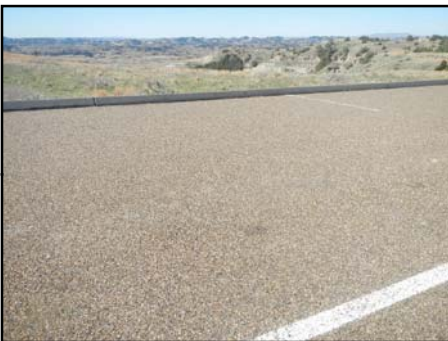
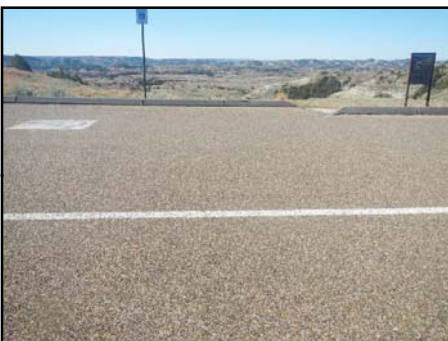
ROUTE 0916B: BOICOURT OVERLOOK PARKING B

Inspection Date	FMSS Number	User Access	Surface Type
4/30/2017	56806	PUBLIC	ASPHALT
Area (Sq. Ft.)	Lane Miles (11' Widths)	Curb Reveal (Inches)	Curb Recommendation
6,597	0.114	6	DO NOTHING
Curb Type		Curb & Gutter Type	
CONCRETE		NO CURB AND GUTTER	
Pavement Recommendation		Condition Rating / PCR	
PREVENTIVE MAINTENANCE		GOOD / 90

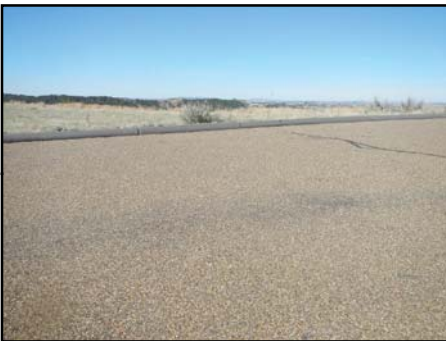
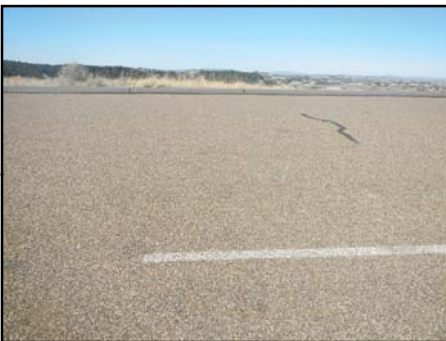
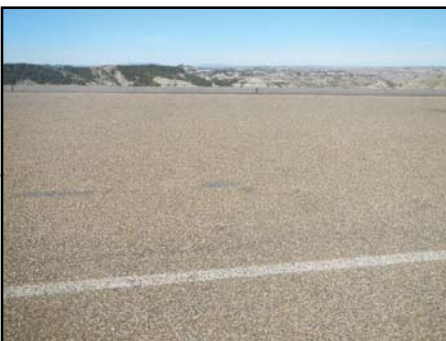
ROUTE 0916C: BOICOURT OVERLOOK PARKING C

Inspection Date	FMSS Number	User Access	Surface Type
4/30/2017	56807	PUBLIC	ASPHALT
Area (Sq. Ft.)	Lane Miles (11' Widths)	Curb Reveal (Inches)	Curb Recommendation
6,630	0.114	7	DO NOTHING
Curb Type		Curb & Gutter Type	
CONCRETE		NO CURB AND GUTTER	
Pavement Recommendation		Condition Rating / PCR	
PREVENTIVE MAINTENANCE		GOOD / 90

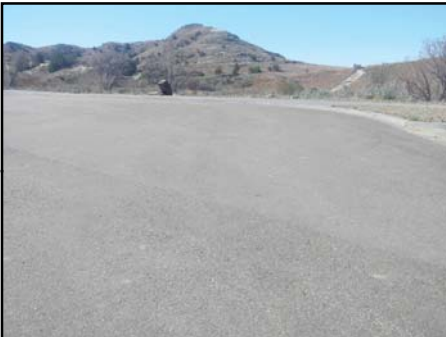
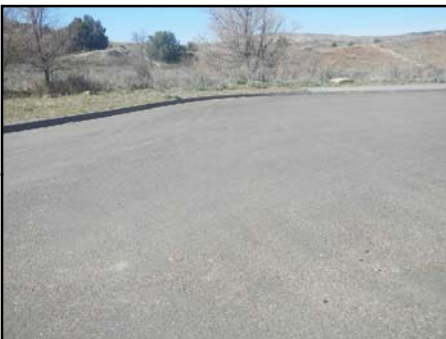
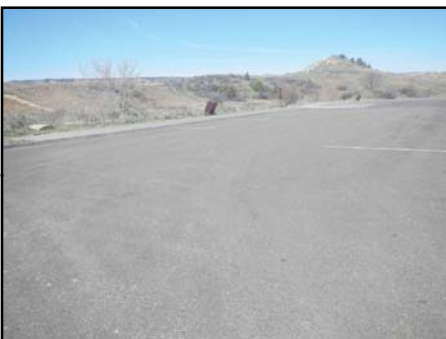
ROUTE 0918: WIND CANYON PARKING

Inspection Date	FMSS Number	User Access	Surface Type
4/30/2017	56808	PUBLIC	ASPHALT
Area (Sq. Ft.)	Lane Miles (11' Widths)	Curb Reveal (Inches)	Curb Recommendation
13,309	0.229	NOT APPLICABLE	DO NOTHING
Curb Type		Curb & Gutter Type	
NO CURB		CONCRETE	
Pavement Recommendation		Condition Rating / PCR	
PREVENTIVE MAINTENANCE		GOOD / 90

Note: Parking area consists of multiple surface types: 1 part Asphalt at 12,941 square feet; 1 part Concrete at 368 square feet.

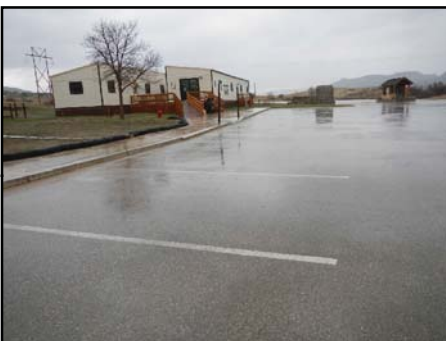
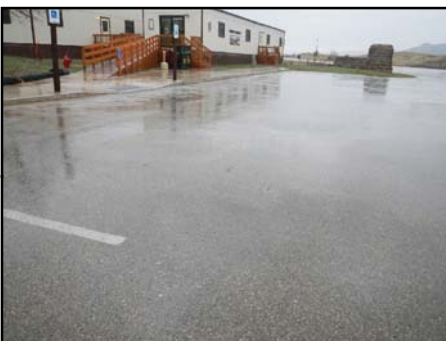
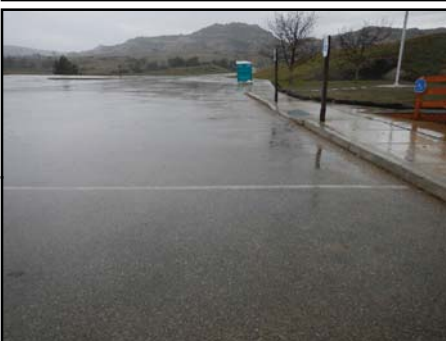
ROUTE 0924: NORTH UNIT VISITOR'S CENTER PARKING

Inspection Date	FMSS Number	User Access	Surface Type
5/1/2017	56970	PUBLIC	ASPHALT
Area (Sq. Ft.)	Lane Miles (11' Widths)	Curb Reveal (Inches)	Curb Recommendation
13,338	0.23	5	DO NOTHING
Curb Type		Curb & Gutter Type	
CONCRETE		NO CURB AND GUTTER	
Pavement Recommendation		Condition Rating / PCR	
PREVENTIVE MAINTENANCE		GOOD / 90

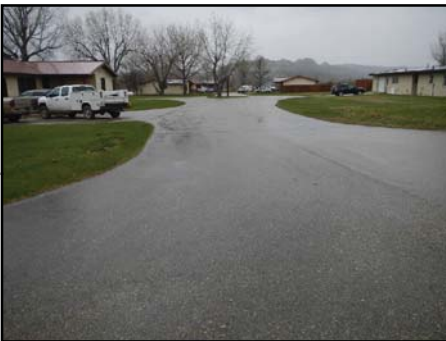
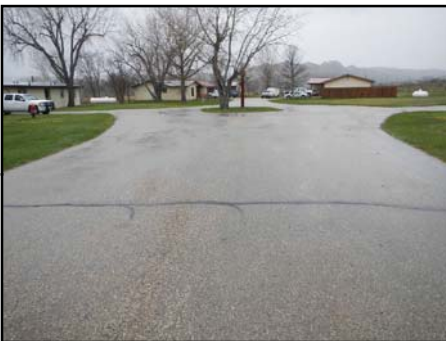
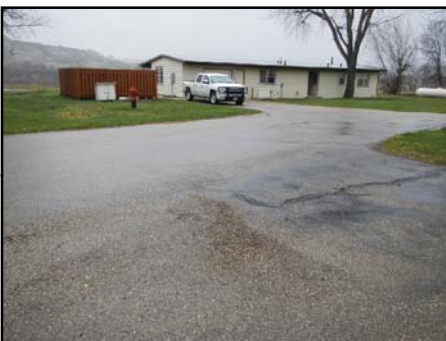
ROUTE 0925: RESIDENCE SPUR AND PARKING

Inspection Date	FMSS Number	User Access	Surface Type
5/1/2017	56868	NONPUBLIC	ASPHALT
Area (Sq. Ft.)	Lane Miles (11' Widths)	Curb Reveal (Inches)	Curb Recommendation
13,053	0.225	NOT APPLICABLE	NOT APPLICABLE
Curb Type		Curb & Gutter Type	
NO CURB		NO CURB AND GUTTER	
Pavement Recommendation		Condition Rating / PCR	
PREVENTIVE MAINTENANCE		GOOD / 90

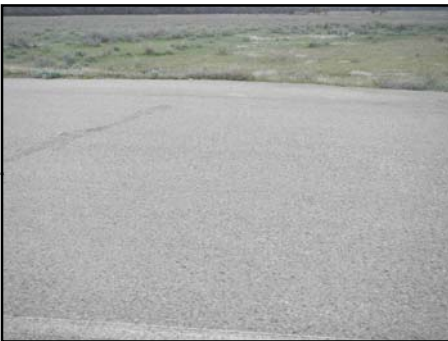
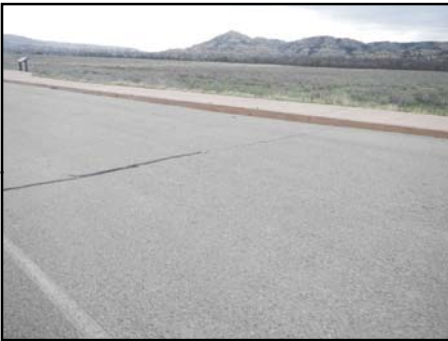
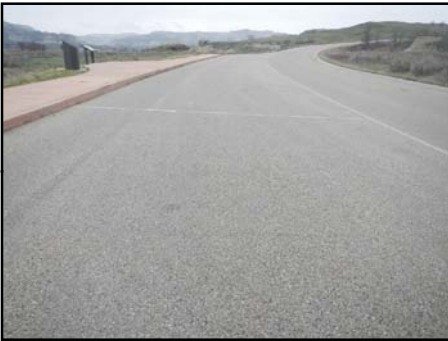
ROUTE 0926: LONGHORN PARKING

Inspection Date	FMSS Number	User Access	Surface Type
5/1/2017	56876	PUBLIC	ASPHALT
Area (Sq. Ft.)	Lane Miles (11' Widths)	Curb Reveal (Inches)	Curb Recommendation
6,123	0.105	7	DO NOTHING
Curb Type		Curb & Gutter Type	
CONCRETE		NO CURB AND GUTTER	
Pavement Recommendation		Condition Rating / PCR	
PREVENTIVE MAINTENANCE		GOOD / 90

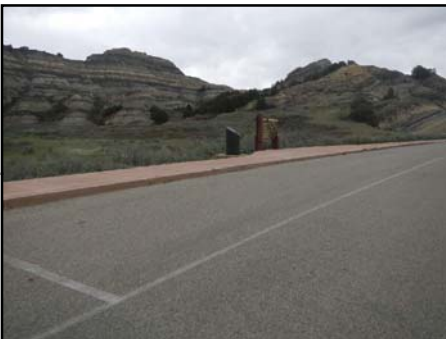
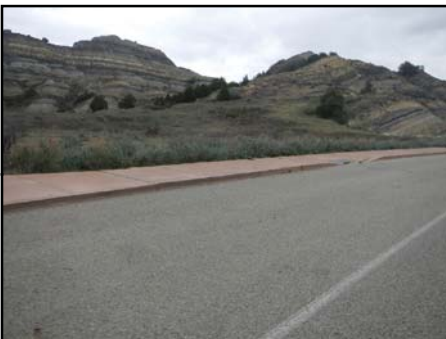
ROUTE 0927: SLUMP BLOCK PARKING

Inspection Date	FMSS Number	User Access	Surface Type
5/1/2017	56877	PUBLIC	ASPHALT
Area (Sq. Ft.)	Lane Miles (11' Widths)	Curb Reveal (Inches)	Curb Recommendation
3,307	0.057	5	DO NOTHING
Curb Type		Curb & Gutter Type	
CONCRETE		NO CURB AND GUTTER	
Pavement Recommendation		Condition Rating / PCR	
PREVENTIVE MAINTENANCE		GOOD / 90

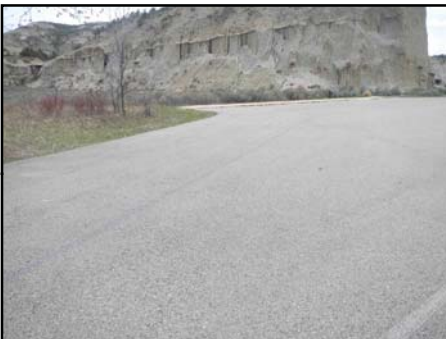
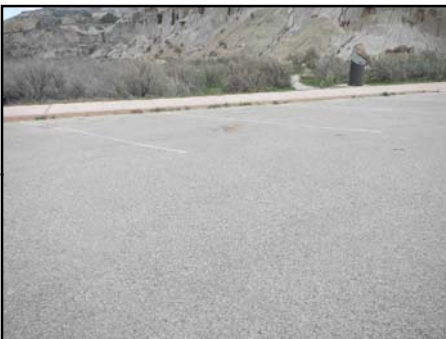
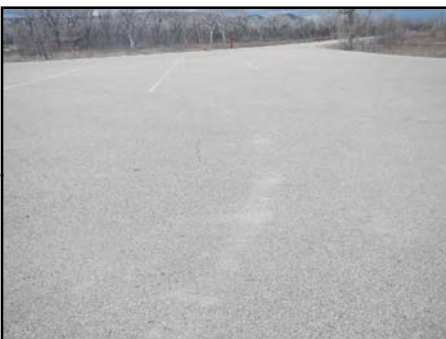
ROUTE 0928: CANNONBALL CONCRETIONS PARKING

Inspection Date	FMSS Number	User Access	Surface Type
5/1/2017	56878	PUBLIC	ASPHALT
Area (Sq. Ft.)	Lane Miles (11' Widths)	Curb Reveal (Inches)	Curb Recommendation
13,649	0.235	4	DO NOTHING
Curb Type		Curb & Gutter Type	
CONCRETE		NO CURB AND GUTTER	
Pavement Recommendation		Condition Rating / PCR	
PREVENTIVE MAINTENANCE		GOOD / 90

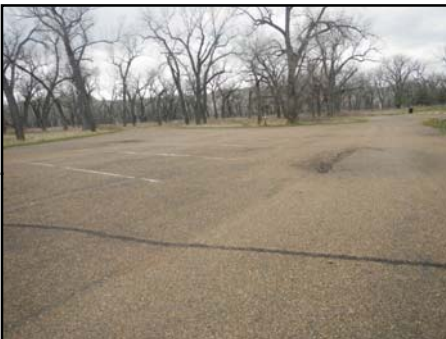
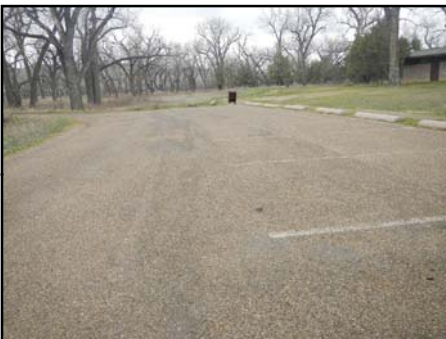
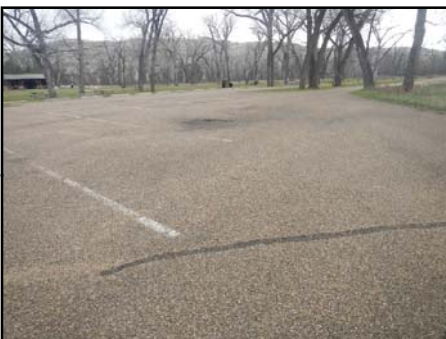
ROUTE 0930ZZ: JUNIPER CAMPGROUND PARKING AREAS

Inspection Date	FMSS Number	User Access	Surface Type
5/1/2017	56889	PUBLIC	ASPHALT
Area (Sq. Ft.)	Lane Miles (11' Widths)	Curb Reveal (Inches)	Curb Recommendation
33,457	0.576	NOT APPLICABLE	NOT APPLICABLE
Curb Type		Curb & Gutter Type	
NO CURB		NO CURB AND GUTTER	
Pavement Recommendation		Condition Rating / PCR	
LIGHT 3R TREATMENTS		FAIR / 73

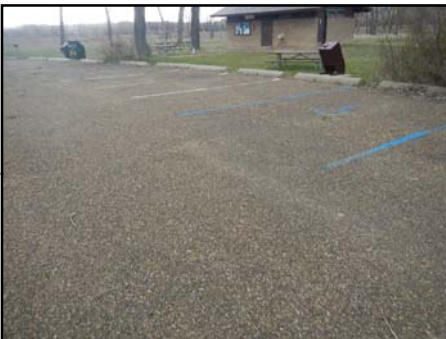
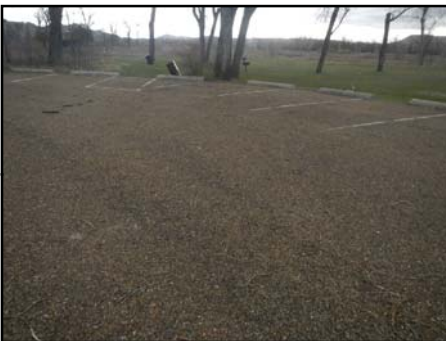
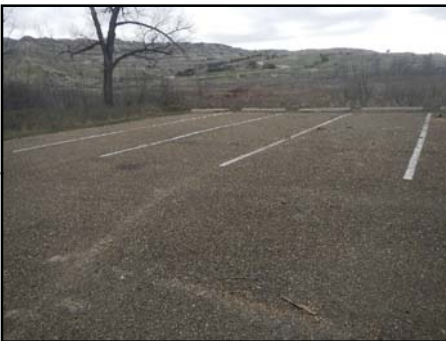
ROUTE 0931Z: JUNIPER GROUP SITE PARKING

Inspection Date	FMSS Number	User Access	Surface Type
5/1/2017	56889	PUBLIC	ASPHALT
Area (Sq. Ft.)	Lane Miles (11' Widths)	Curb Reveal (Inches)	Curb Recommendation
19,533	0.336	NOT APPLICABLE	NOT APPLICABLE
Curb Type		Curb & Gutter Type	
NO CURB		NO CURB AND GUTTER	
Pavement Recommendation		Condition Rating / PCR	
PREVENTIVE MAINTENANCE		GOOD / 90

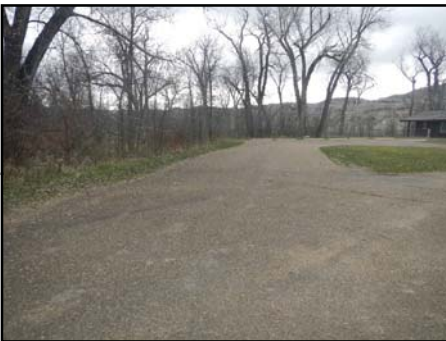
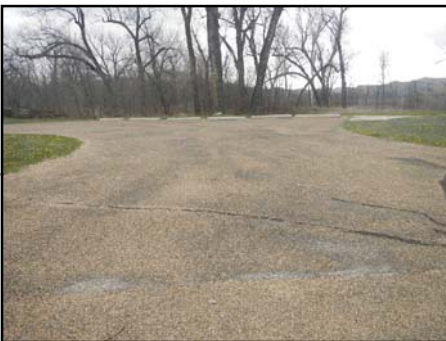
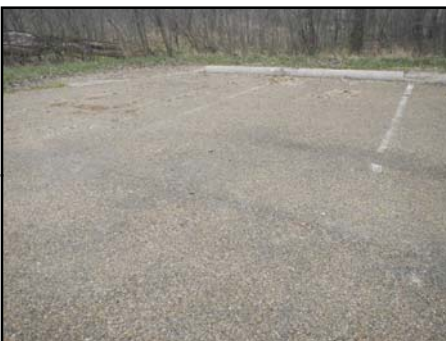
ROUTE 0946Z: JUNIPER CAMPGROUND REGISTRATION PARKING

Inspection Date	FMSS Number	User Access	Surface Type
5/1/2017	56889	PUBLIC	ASPHALT
Area (Sq. Ft.)	Lane Miles (11' Widths)	Curb Reveal (Inches)	Curb Recommendation
7,285	0.125	NOT APPLICABLE	NOT APPLICABLE
Curb Type		Curb & Gutter Type	
NO CURB		NO CURB AND GUTTER	
Pavement Recommendation		Condition Rating / PCR	
LIGHT 3R TREATMENTS		FAIR / 73

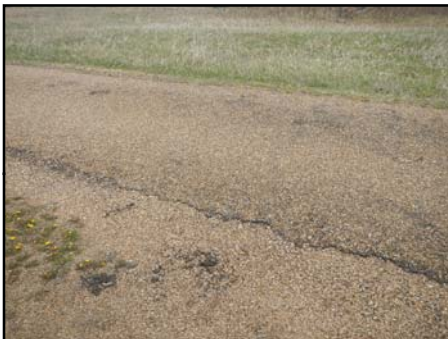
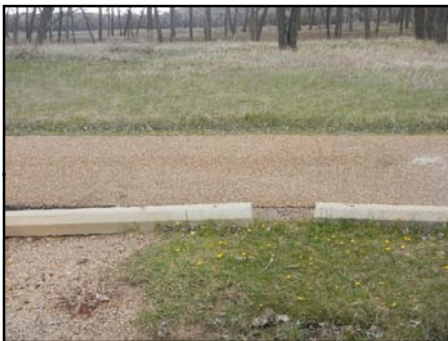
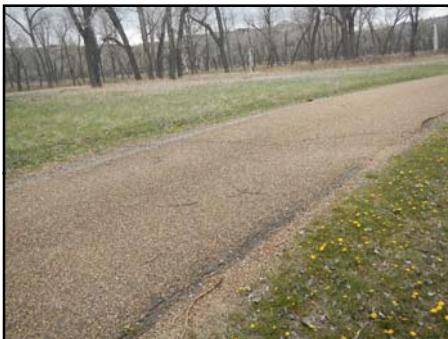
ROUTE 0947Z: JUNIPER CAMPGROUND DUMPSTATION

Inspection Date	FMSS Number	User Access	Surface Type
5/1/2017	56889	PUBLIC	ASPHALT
Area (Sq. Ft.)	Lane Miles (11' Widths)	Curb Reveal (Inches)	Curb Recommendation
3,085	0.053	NOT APPLICABLE	NOT APPLICABLE
Curb Type		Curb & Gutter Type	
NO CURB		NO CURB AND GUTTER	
Pavement Recommendation		Condition Rating / PCR	
LIGHT 3R TREATMENTS		FAIR / 73

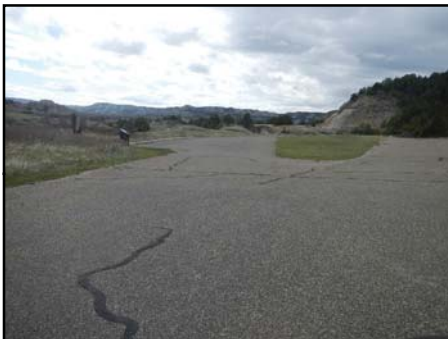
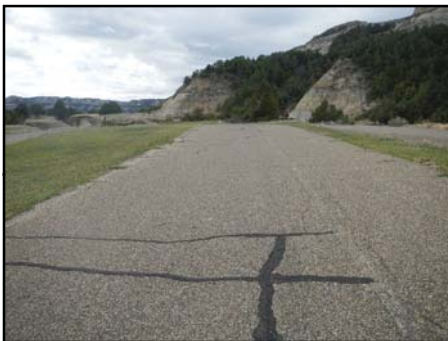
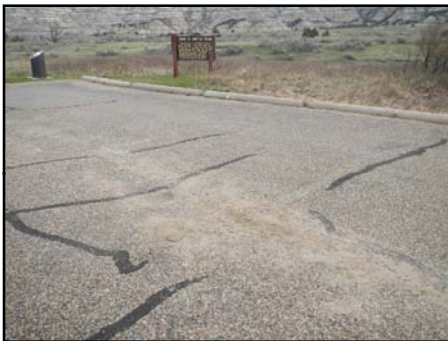
ROUTE 0932: LONG X TRAIL PARKING

Inspection Date	FMSS Number	User Access	Surface Type
5/1/2017	56897	PUBLIC	ASPHALT
Area (Sq. Ft.)	Lane Miles (11' Widths)	Curb Reveal (Inches)	Curb Recommendation
13,005	0.224	NOT APPLICABLE	NOT APPLICABLE
Curb Type		Curb & Gutter Type	
NO CURB		NO CURB AND GUTTER	
Pavement Recommendation		Condition Rating / PCR	
PREVENTIVE MAINTENANCE		GOOD / 90

Note: Parking has wheelstops, not curbing.

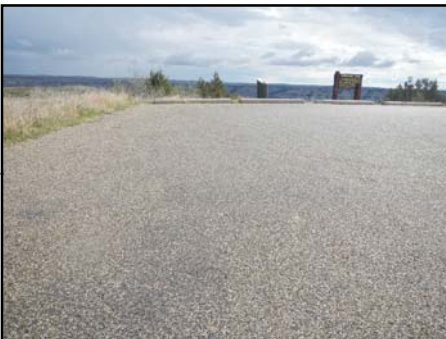
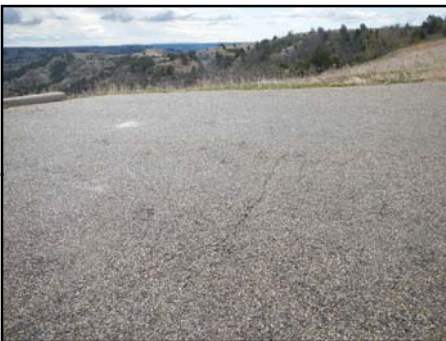
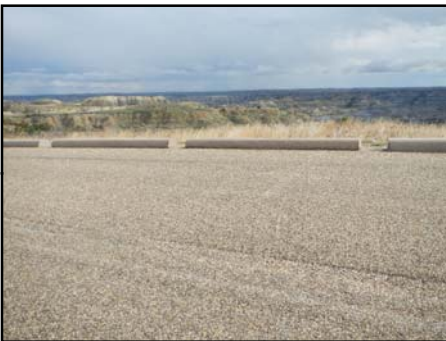
ROUTE 0936: MAN AND GRASS PARKING

Inspection Date	FMSS Number	User Access	Surface Type
5/1/2017	56909	PUBLIC	ASPHALT
Area (Sq. Ft.)	Lane Miles (11' Widths)	Curb Reveal (Inches)	Curb Recommendation
8,695	0.15	NOT APPLICABLE	NOT APPLICABLE
Curb Type		Curb & Gutter Type	
NO CURB		NO CURB AND GUTTER	
Pavement Recommendation		Condition Rating / PCR	
PREVENTIVE MAINTENANCE		GOOD / 90

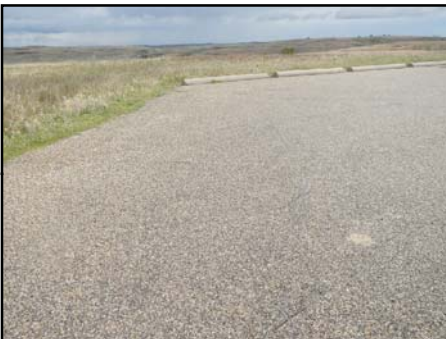
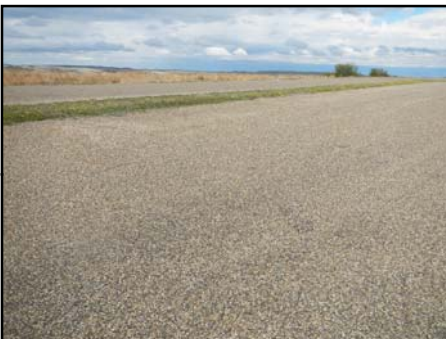
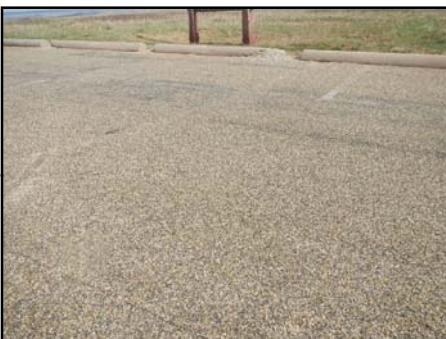
ROUTE 0937: EDGE OF GLACIER PARKING

Inspection Date	FMSS Number	User Access	Surface Type
5/1/2017	56923	PUBLIC	ASPHALT
Area (Sq. Ft.)	Lane Miles (11' Widths)	Curb Reveal (Inches)	Curb Recommendation
7,475	0.129	NOT APPLICABLE	NOT APPLICABLE
Curb Type		Curb & Gutter Type	
NO CURB		NO CURB AND GUTTER	
Pavement Recommendation		Condition Rating / PCR	
PREVENTIVE MAINTENANCE		GOOD / 90

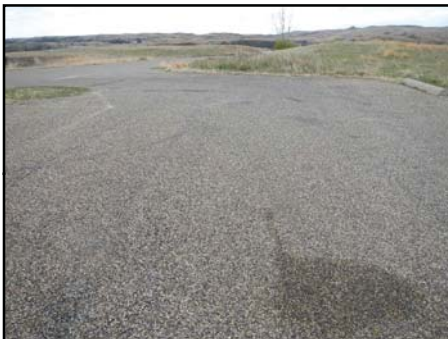
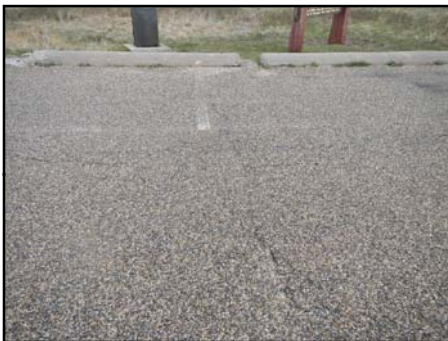
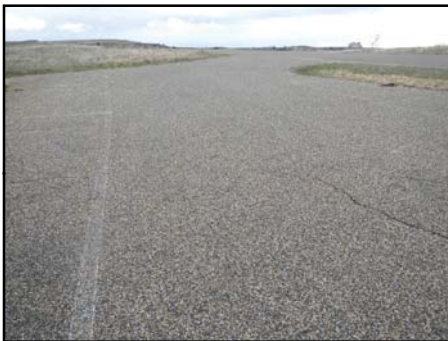
ROUTE 0938: OXBOW OVERLOOK PARKING

Inspection Date	FMSS Number	User Access	Surface Type
5/1/2017	56930	PUBLIC	ASPHALT
Area (Sq. Ft.)	Lane Miles (11' Widths)	Curb Reveal (Inches)	Curb Recommendation
29,352	0.505	NOT APPLICABLE	NOT APPLICABLE
Curb Type		Curb & Gutter Type	
NO CURB		NO CURB AND GUTTER	
Pavement Recommendation		Condition Rating / PCR	
HEAVY 3R TREATMENTS		POOR / 53
