THRO Cycle 6

Final Report

Road Inventory and Condition Assessment of Paved Routes Theodore Roosevelt National Park

Federal Highway Administration
Eastern Federal Lands Highway Division
Road Inventory Program (RIP)

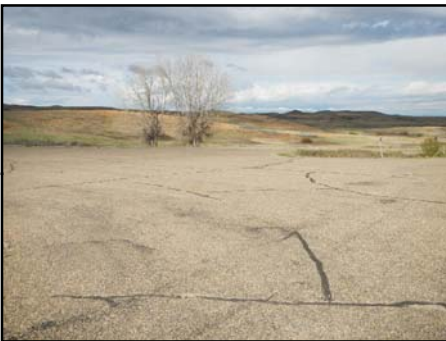
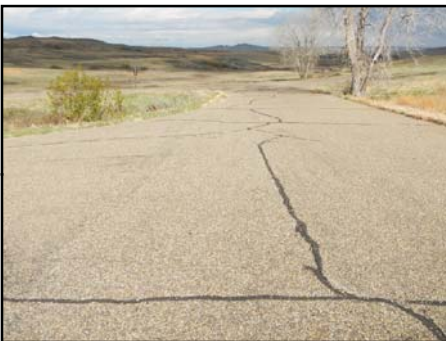
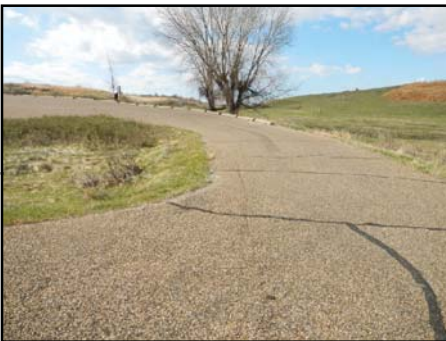
ROUTE 0940: NORTH UNIT MAINTENANCE YARD

Inspection Date	FMSS Number	User Access	Surface Type
5/1/2017	56941	NONPUBLIC	ASPHALT
Area (Sq. Ft.)	Lane Miles (11' Widths)	Curb Reveal (Inches)	Curb Recommendation
12,880	0.222	NOT APPLICABLE	NOT APPLICABLE
Curb Type		Curb & Gutter Type	
NO CURB		NO CURB AND GUTTER	
Pavement Recommendation		Condition Rating / PCR	
PREVENTIVE MAINTENANCE		GOOD / 90

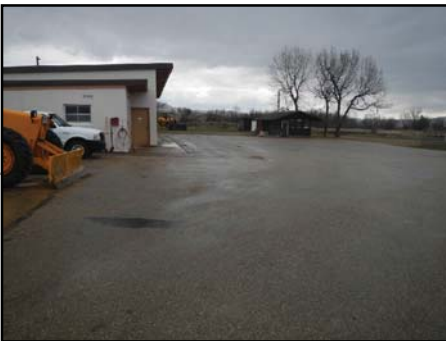
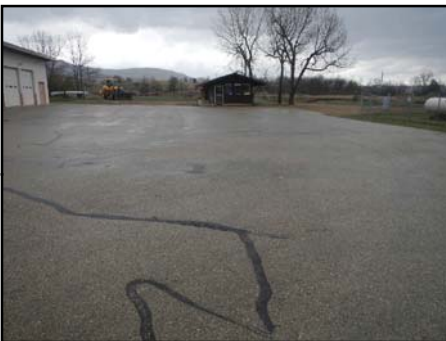
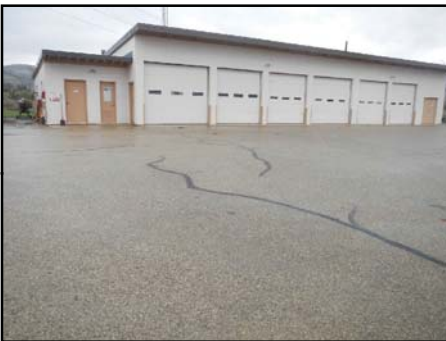
ROUTE 0941: OLD EAST ENTRANCE TRAILHEAD PARKING

Note: Parking area consists of multiple surface types: 1 part Asphalt at 12,210 square feet; 1 part Concrete at 670 square feet.

Inspection Date	FMSS Number	User Access	Surface Type
4/30/2017	104633	PUBLIC	ASPHALT
Area (Sq. Ft.)	Lane Miles (11' Widths)	Curb Reveal (Inches)	Curb Recommendation
8,202	0.141	NOT APPLICABLE	NOT APPLICABLE
Curb Type		Curb & Gutter Type	
NO CURB		NO CURB AND GUTTER	
Pavement Recommendation		Condition Rating / PCR	
PREVENTIVE MAINTENANCE		GOOD / 90

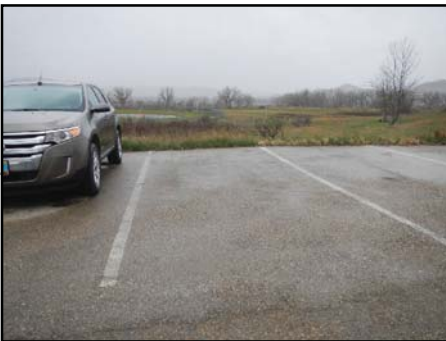
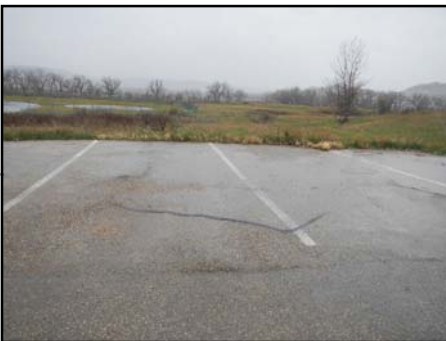
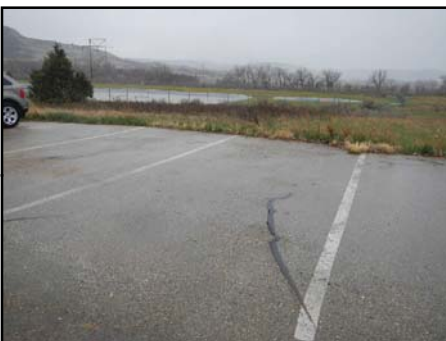
ROUTE 0944: HEADQUARTERS PARKING

Inspection Date	FMSS Number	User Access	Surface Type
4/30/2017	N/A	PUBLIC	CONCRETE
Area (Sq. Ft.)	Lane Miles (11' Widths)	Curb Reveal (Inches)	Curb Recommendation
1,423	0.025	5	DO NOTHING
Curb Type		Curb & Gutter Type	
CONCRETE		NO CURB AND GUTTER	
Pavement Recommendation		Condition Rating / PCR	
LIGHT 3R TREATMENTS		FAIR / 73

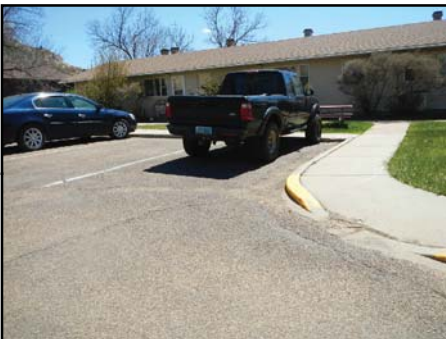
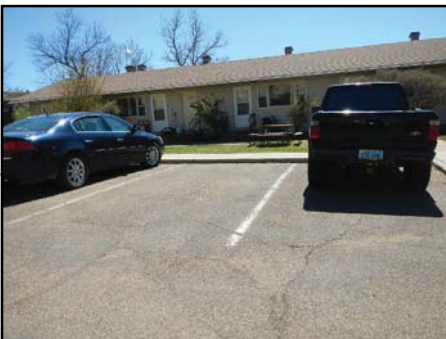
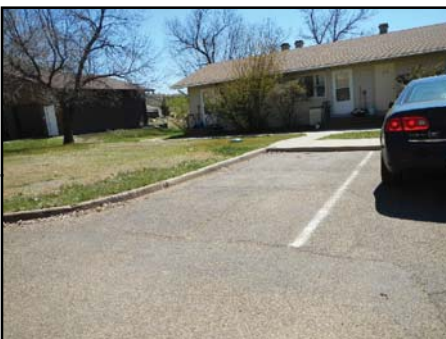
ROUTE 0945BZ: RESIDENCE PARKING B

Inspection Date	FMSS Number	User Access	Surface Type
4/30/2017	238775	NONPUBLIC	ASPHALT
Area (Sq. Ft.)	Lane Miles (11' Widths)	Curb Reveal (Inches)	Curb Recommendation
858	0.015	NOT APPLICABLE	DO NOTHING
Curb Type		Curb & Gutter Type	
NO CURB		CONCRETE	
Pavement Recommendation		Condition Rating / PCR	
PREVENTIVE MAINTENANCE		GOOD / 90

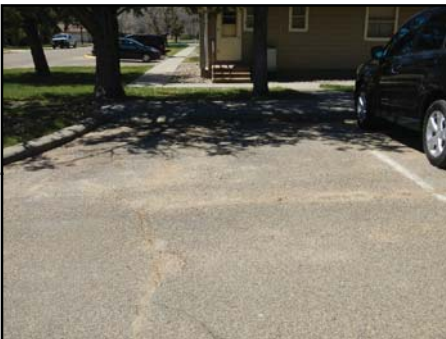
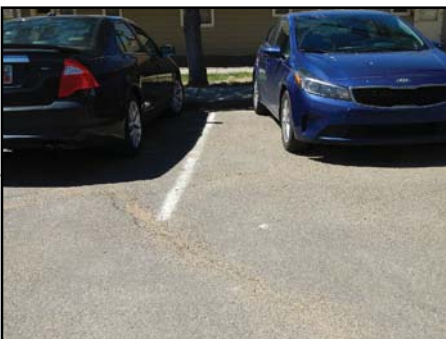
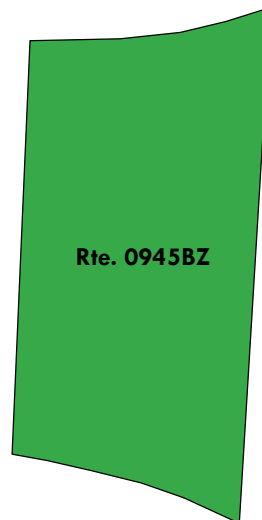
ROUTE 0945CZ: RESIDENCE PARKING C

Inspection Date	FMSS Number	User Access	Surface Type
4/30/2017	238775	NONPUBLIC	ASPHALT
Area (Sq. Ft.)	Lane Miles (11' Widths)	Curb Reveal (Inches)	Curb Recommendation
1,192	0.021	NOT APPLICABLE	DO NOTHING
Curb Type		Curb & Gutter Type	
NO CURB		CONCRETE	
Pavement Recommendation		Condition Rating / PCR	
PREVENTIVE MAINTENANCE		GOOD / 90
