TONT Cycle 6

Final Report

Road Inventory and Condition Assessment of Paved Routes Tonto National Monument

Tonto National Monument in Arizona

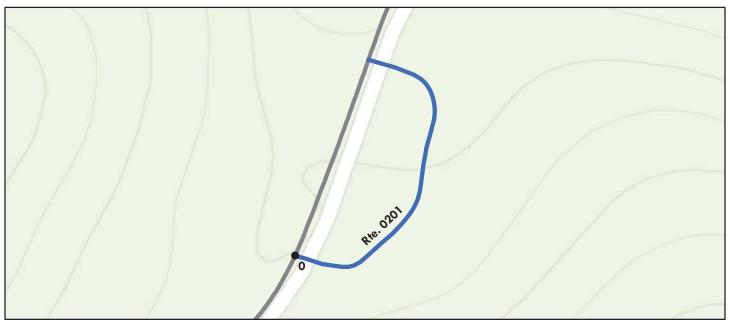
ROUTE 0201: PICNIC AREA ROAD

| Ro | oute Condition Legend – Pav | vement Cond | lition Rating (PCR) | |
|---|---|---|---|---|
| Pavement Condition Rating (PCR) | 95 | 95 | | |
| Surface Condition Rating (SCR) | 95 | 95 | | |
