Final Report

Road Inventory and Condition Assessment of Paved Routes Tuskegee Institute National Historic Site

**Federal Highway Administration
Eastern Federal Lands Highway Division
Road Inventory Program (RIP)**

Report Date: May 2019

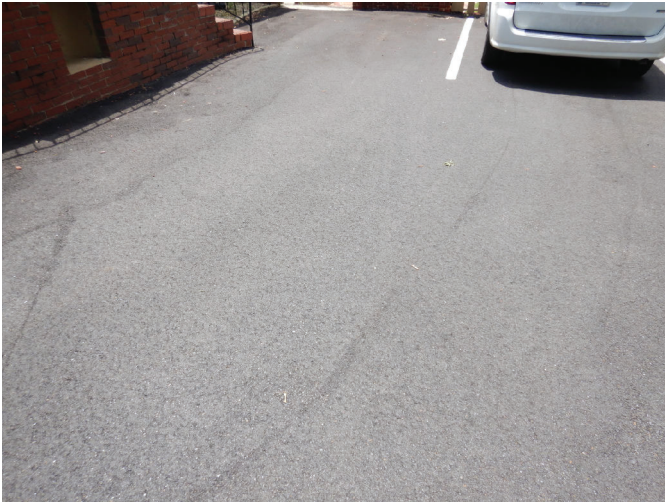
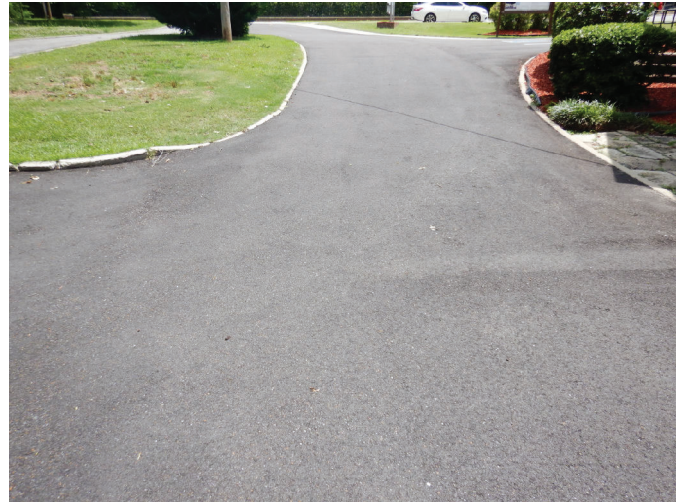
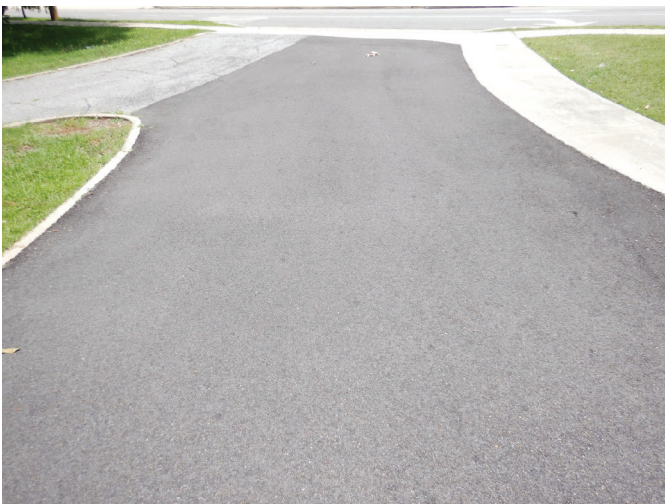
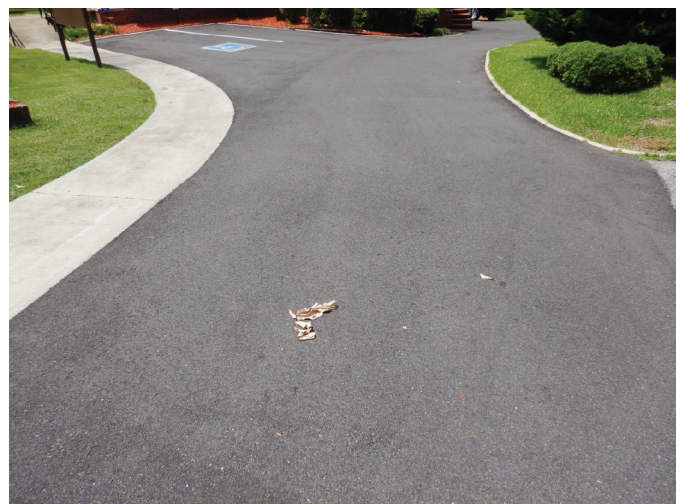
Inspection Date	FMSS Number	User Access	Surface Type
5/10/2019	57147	PUBLIC	ASPHALT
Area (Sq. Ft.)	Lane Miles (11' Widths)	Curb Reveal (Inches)	Curb Recommendation
3,484	0.06	1	DO NOTHING
Curb Type		Curb & Gutter Type	
CONCRETE		NO CURB AND GUTTER	
Pavement Recommendation		Condition Rating / PCR	
PREVENTIVE MAINTENANCE		GOOD / 90

ROUTE 0900AZ: TUIN HEADQUARTERS PARKING A

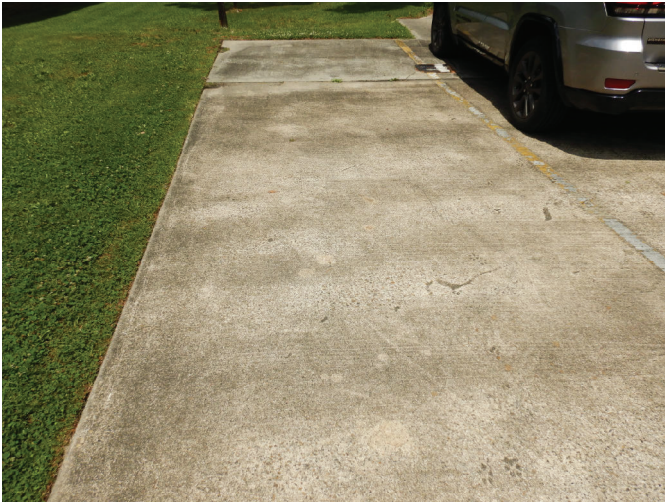
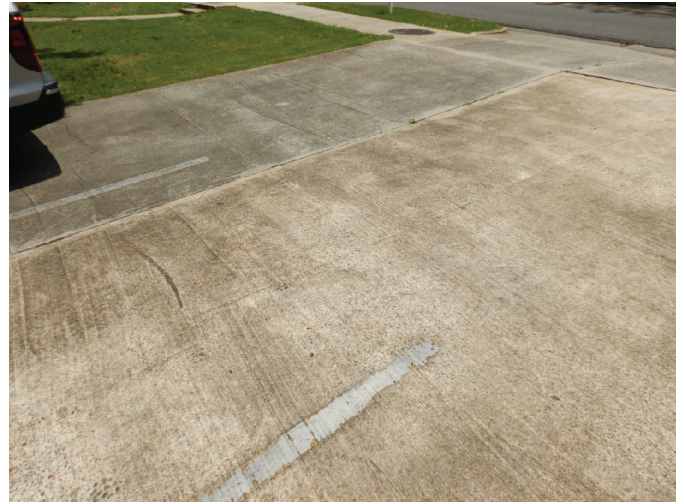
Inspection Date	FMSS Number	User Access	Surface Type
5/10/2019	57147	PUBLIC	CONCRETE
Area (Sq. Ft.)	Lane Miles (11' Widths)	Curb Reveal (Inches)	Curb Recommendation
1,348	0.023	NOT APPLICABLE	NOT APPLICABLE
Curb Type		Curb & Gutter Type	
NO CURB		NO CURB AND GUTTER	
Pavement Recommendation		Condition Rating / PCR	
PREVENTIVE MAINTENANCE		GOOD / 90

Tuskegee Institute National Historic Site
ROUTE 0900BZ: TUIN HEADQUARTERS PARKING B

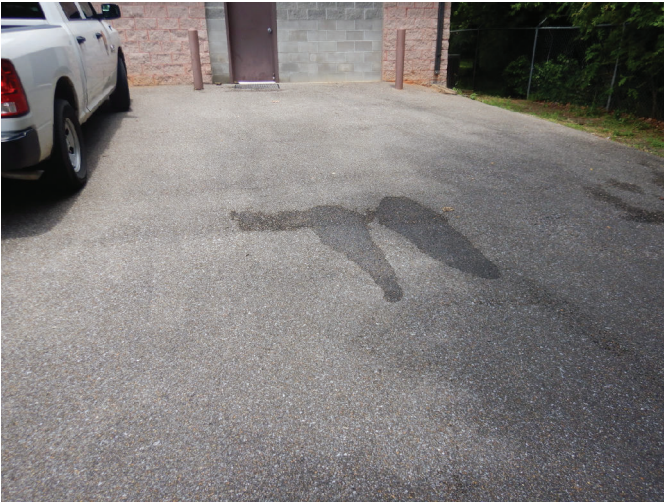
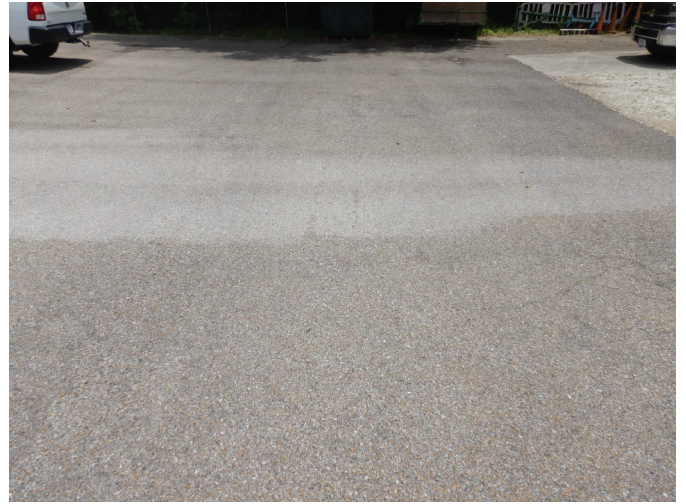
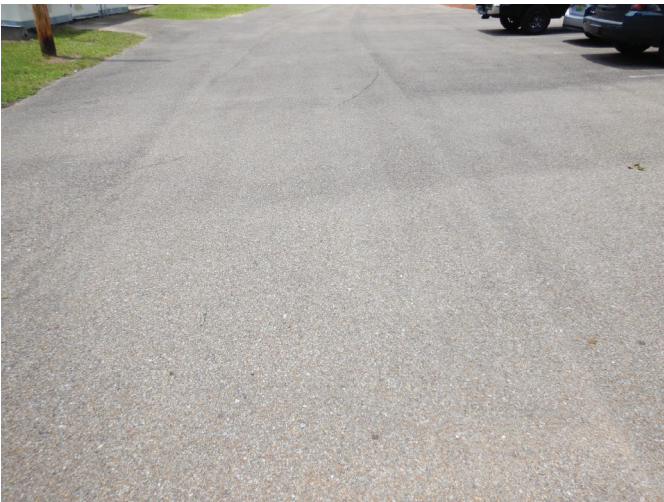
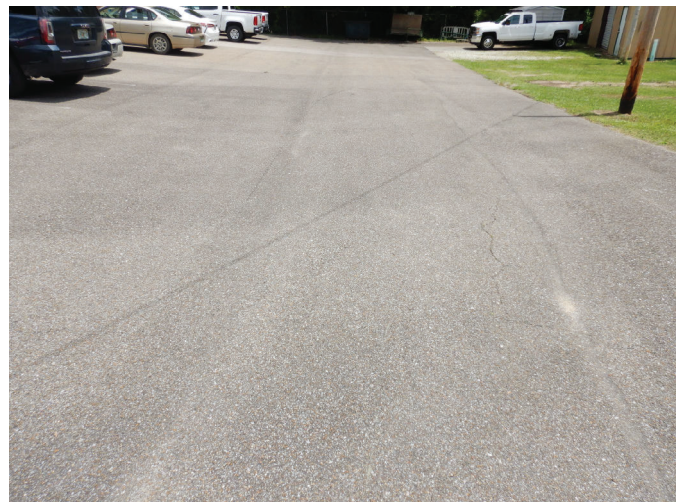
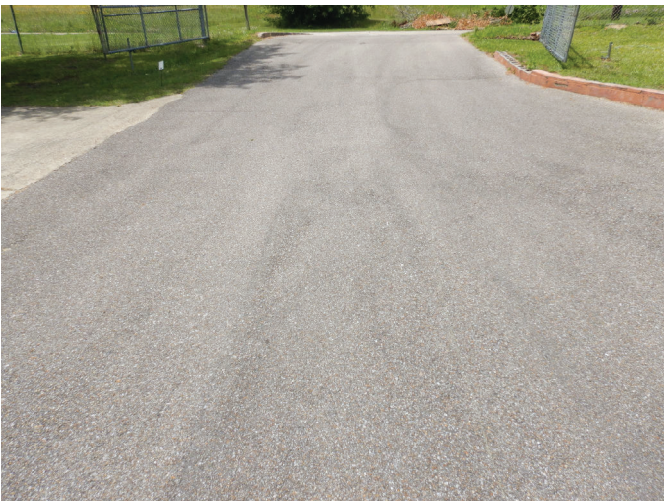
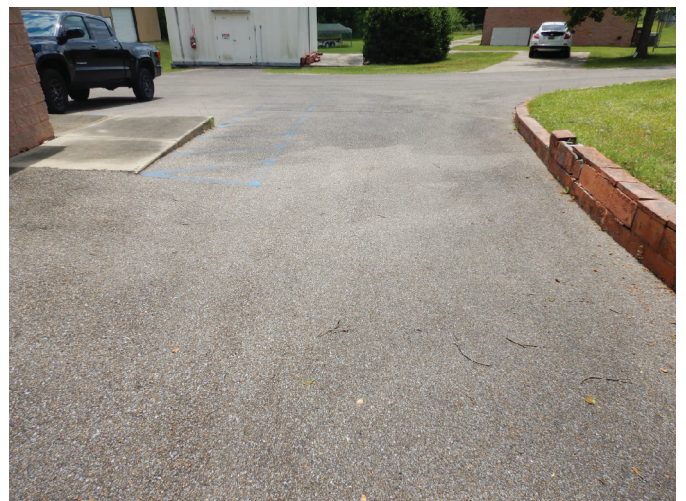
Inspection Date	FMSS Number	User Access	Surface Type
5/10/2019	57148	NONPUBLIC	ASPHALT
Area (Sq. Ft.)	Lane Miles (11' Widths)	Curb Reveal (Inches)	Curb Recommendation
10,161	0.175	NOT APPLICABLE	NOT APPLICABLE
Curb Type		Curb & Gutter Type	
NO CURB		NO CURB AND GUTTER	
Pavement Recommendation		Condition Rating / PCR	
PREVENTIVE MAINTENANCE		GOOD / 90

Note: Parking area consists of multiple surface types: 1 part Asphalt at 8,686 square feet; 2 parts Concrete at 1,475 square feet.

ROUTE 0901: MAINTENANCE PARKING

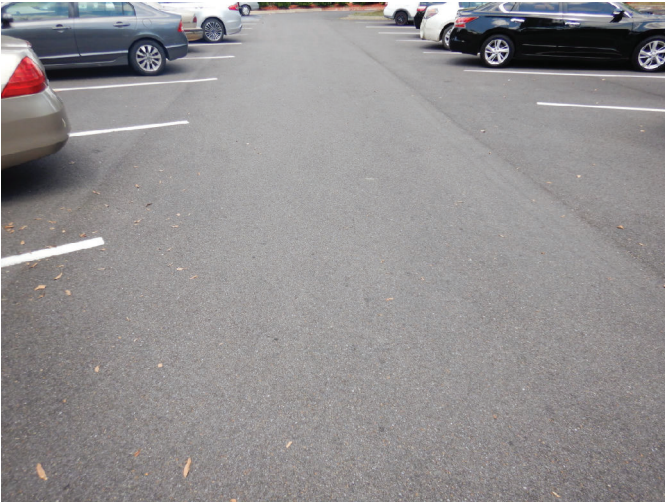
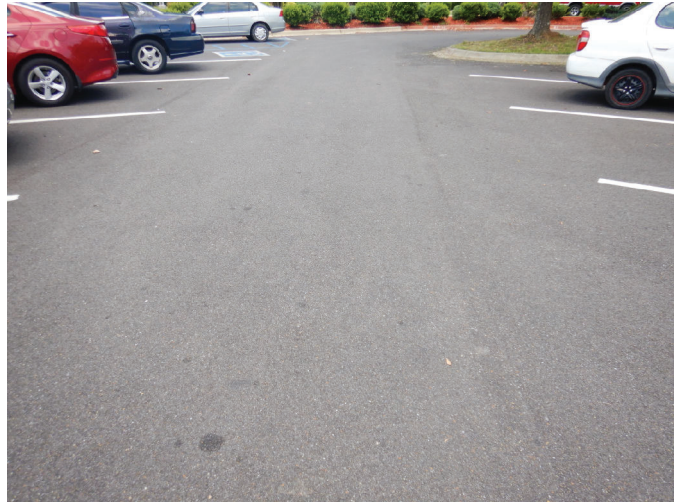
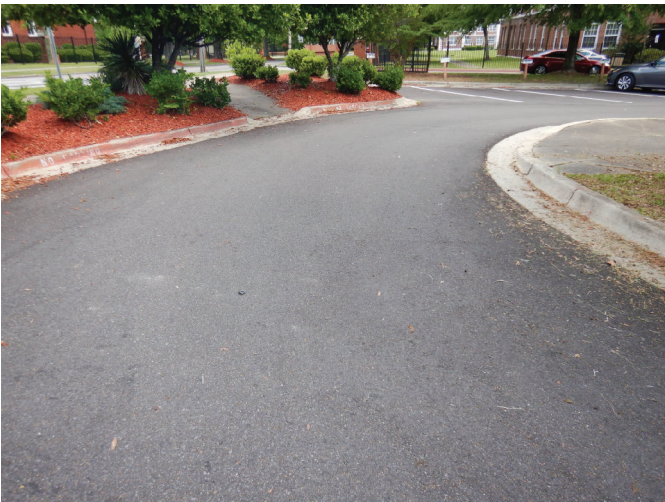
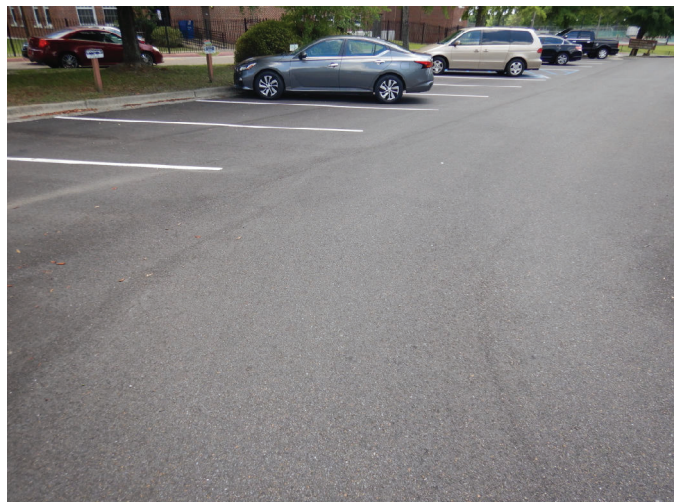
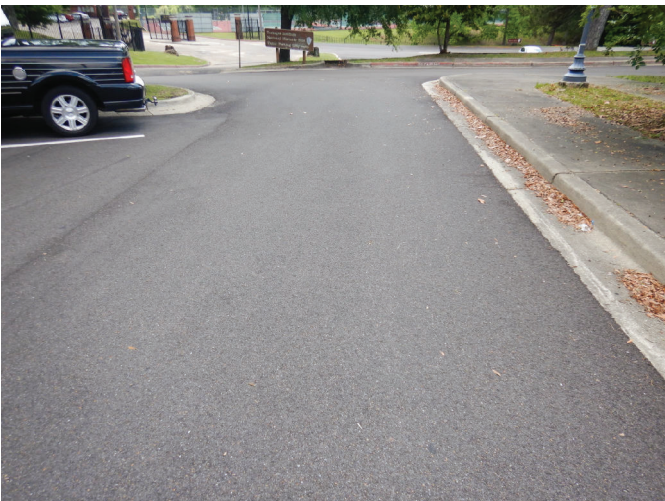
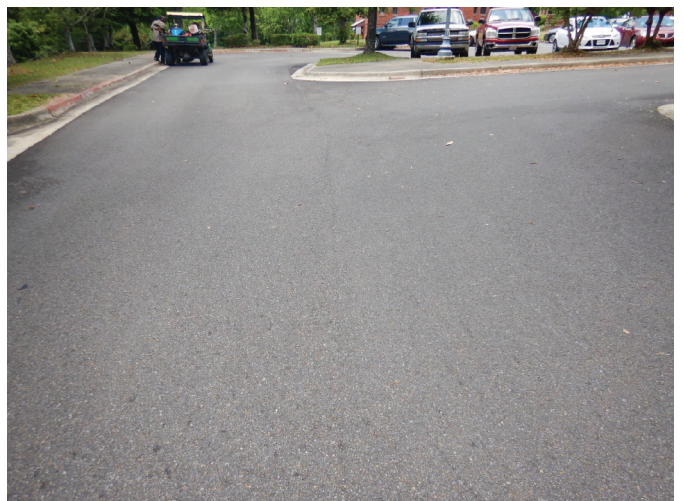
Inspection Date	FMSS Number	User Access	Surface Type
5/10/2019	57149	PUBLIC	ASPHALT
Area (Sq. Ft.)	Lane Miles (11' Widths)	Curb Reveal (Inches)	Curb Recommendation
14,494	0.25	4	DO NOTHING
Curb Type		Curb & Gutter Type	
CONCRETE		CONCRETE	
Pavement Recommendation		Condition Rating / PCR	
PREVENTIVE MAINTENANCE		GOOD / 90

ROUTE 0902: THE OAKS UPPER LEVEL PARKING AREA

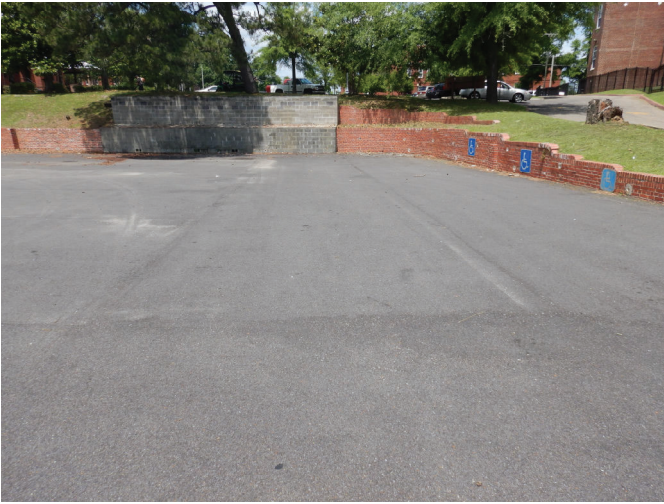
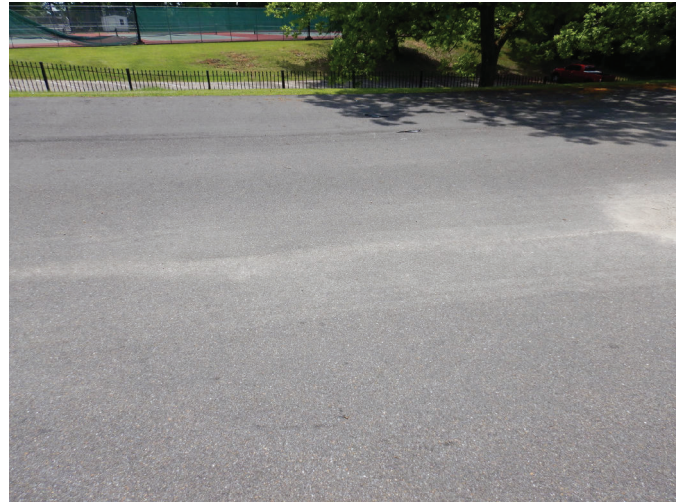
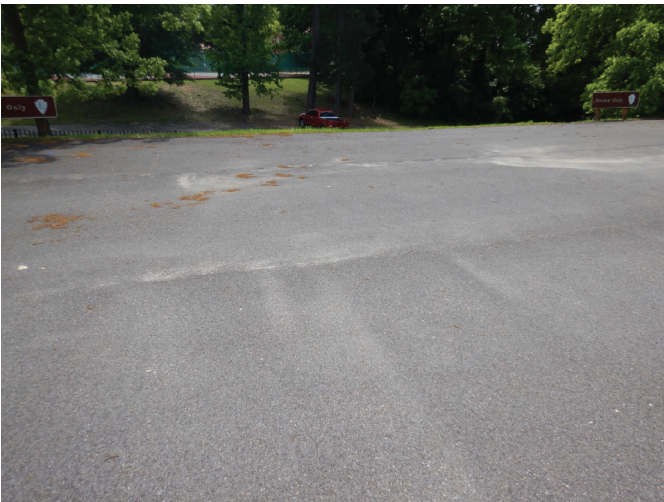
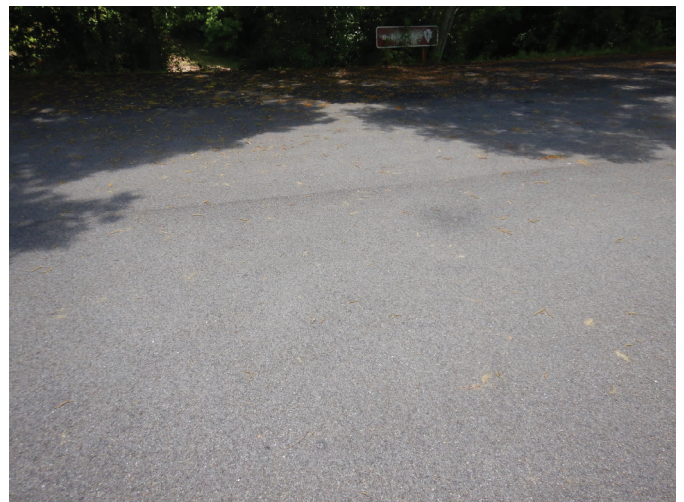
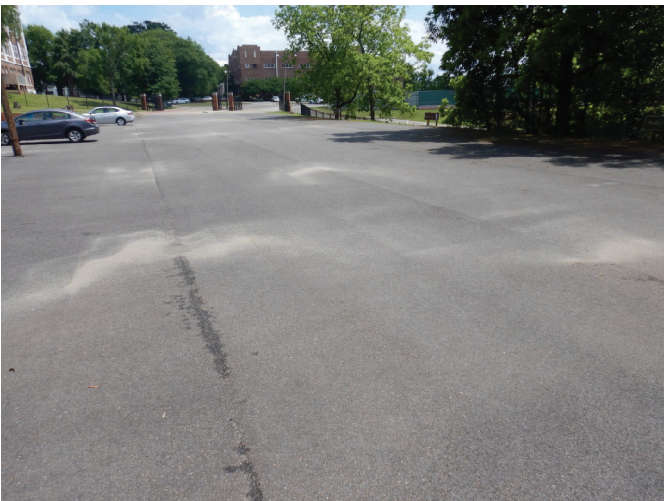
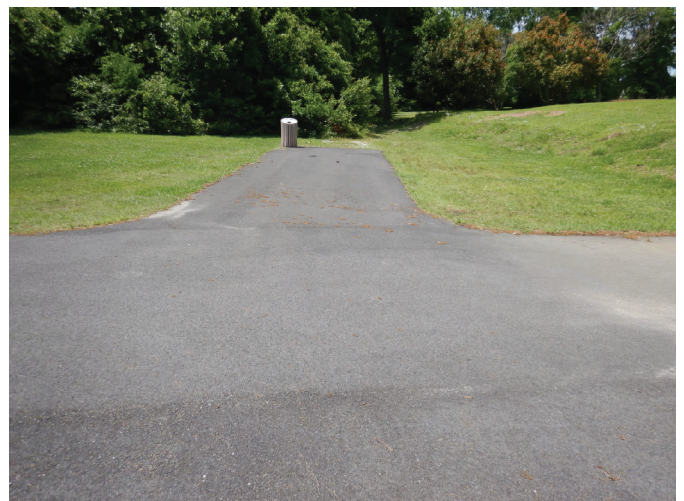
Inspection Date	FMSS Number	User Access	Surface Type
5/10/2019	57152	PUBLIC	ASPHALT
Area (Sq. Ft.)	Lane Miles (11' Widths)	Curb Reveal (Inches)	Curb Recommendation
28,096	0.484	NOT APPLICABLE	NOT APPLICABLE
Curb Type		Curb & Gutter Type	
NO CURB		NO CURB AND GUTTER	
Pavement Recommendation		Condition Rating / PCR	
PREVENTIVE MAINTENANCE		GOOD / 90

ROUTE 0903: THE OAKS LOWER LEVEL PARKING AREA

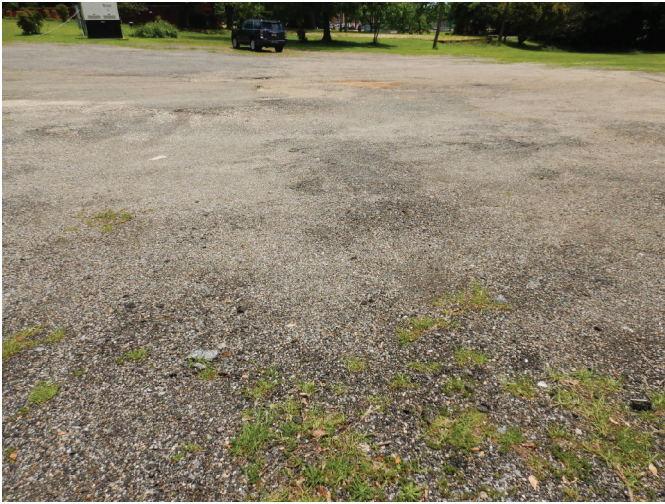
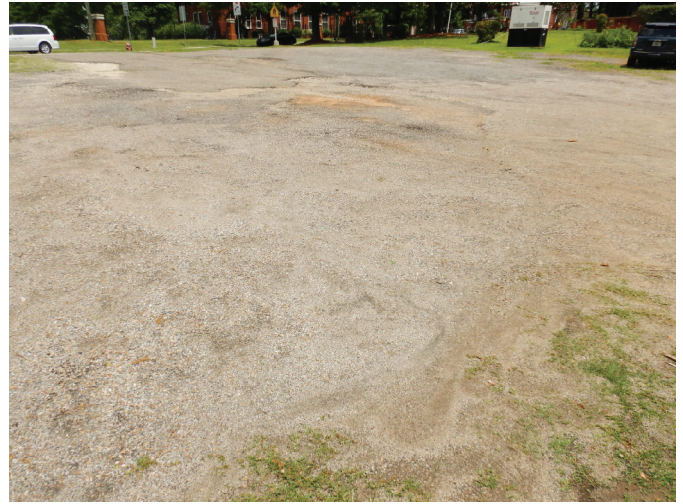
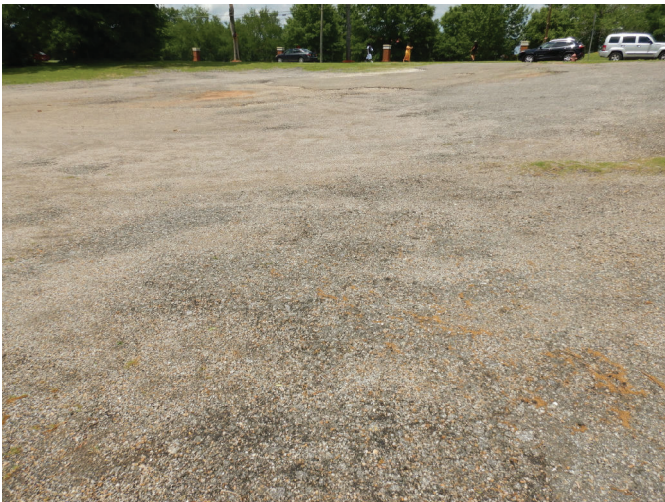
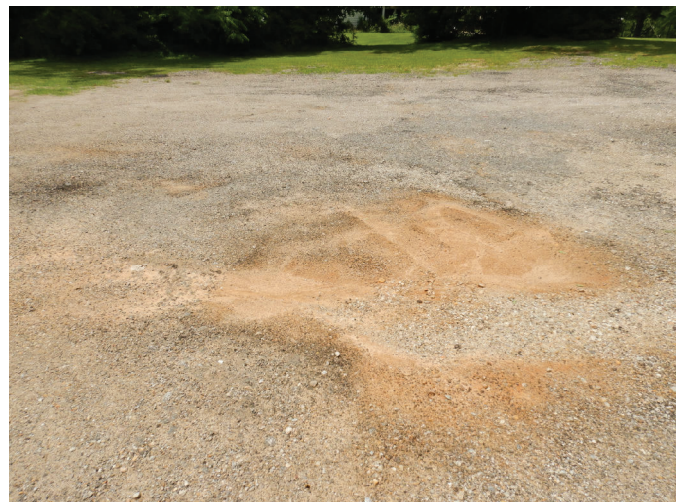
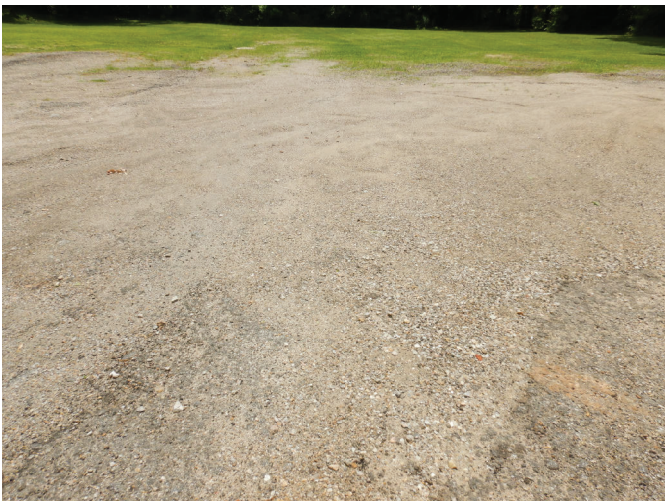
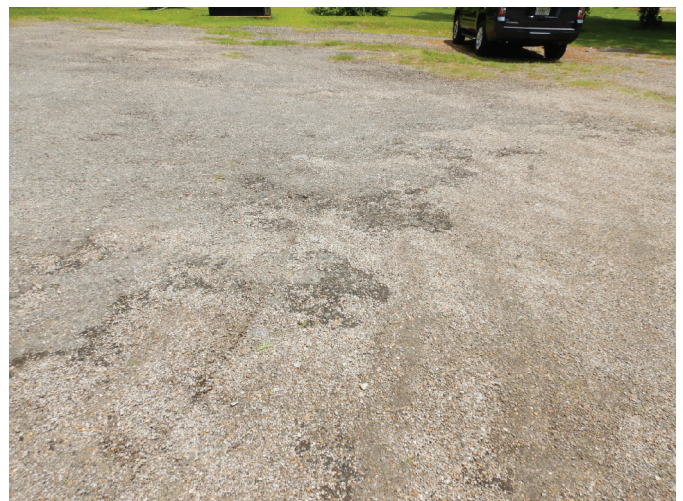
Inspection Date	FMSS Number	User Access	Surface Type
5/10/2019	104832	PUBLIC	ASPHALT
Area (Sq. Ft.)	Lane Miles (11' Widths)	Curb Reveal (Inches)	Curb Recommendation
14,298	0.246	NOT APPLICABLE	NOT APPLICABLE
Curb Type		Curb & Gutter Type	
NO CURB		NO CURB AND GUTTER	
Pavement Recommendation		Condition Rating / PCR	
RECONSTRUCTION		POOR / 0

ROUTE 0905A: ALUMNI HOUSE AND BELTON HOUSE PARKING A
