Road Inventory and Condition Assessment of Paved Routes Tumacácori National Historical Park

**Federal Lands Highway
Road Inventory Program**

Federal Highway Administration
Eastern Federal Lands Highway Division
Road Inventory Program (RIP)

Report Date: May 2017

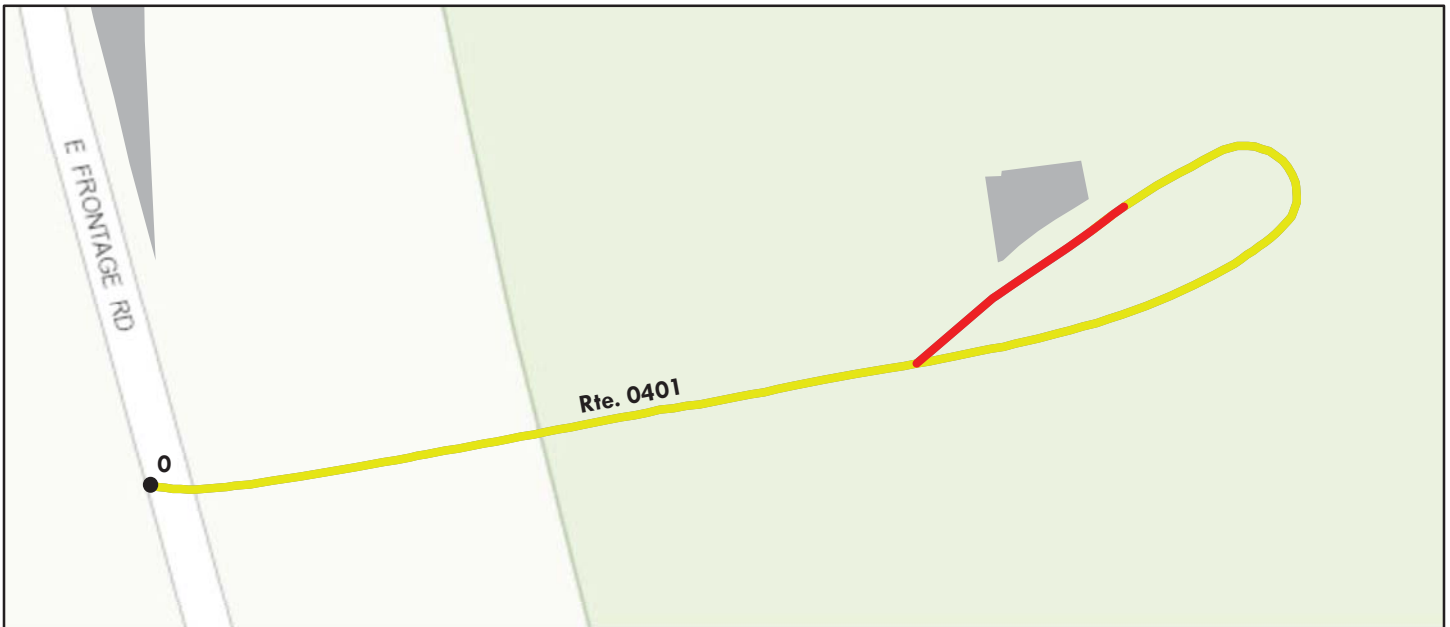
ROUTE 0401: RANCH ENTRANCE ROAD

Route Condition Legend – Pavement Condition Rating (PCR)						
Poor (0 - 60)	Fair (61- 84)	Good (85 - 94)	Excellent (95 - 100)	Not Rated		
See Appendix for definitions and formulas						
Inspection Date: 1/7/2017	Beginning Section MP	0				
Paved Length (Miles): 0.11	Section Length (MI)	0.11				
Surface Type: ASPHALT	Route Summary					
Roadway Condition Information						
Pavement Condition Rating (PCR)	60	60				
Surface Condition Rating (SCR)	60	60				
Roughness Condition Index (RCI)	N/A	N/A				
Distress Index Values						
Structural Crack Index	60	60				
Alligator Crack Index	100	100				
Longitudinal Crack Index	60	60				
Transverse Cracking Index	82	82				
Patching Index	100	100				
Rutting Index	94	94				
International Roughness Index (IRI)	N/A	N/A				
Lane & Width Information						
Number of Lanes	1	1				
Paved Width (ft)	15.6	15.6				
Lane Width (ft)	15.6	15.6

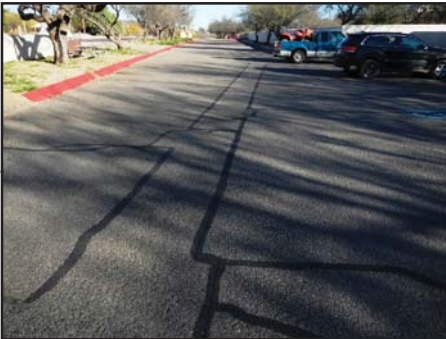
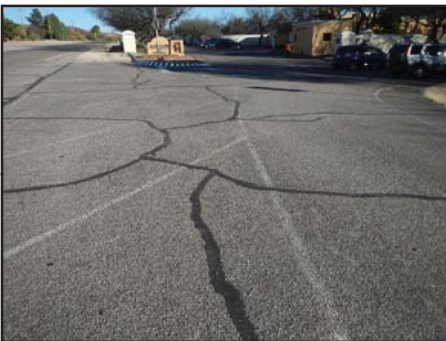
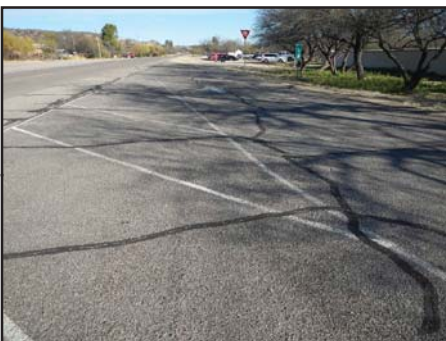
Inspection Date	FMSS Number	User Access	Surface Type
1/24/2016	53892	PUBLIC	ASPHALT
Area (Sq. Ft.)	Lane Miles (11' Widths)	Curb Reveal (Inches)	Curb Recommendation
34,035	0.586	4	DO NOTHING
Curb Type		Curb & Gutter Type	
CONCRETE AND STONE		NO CURB AND GUTTER	
Pavement Recommendation		Condition Rating / PCR	
PREVENTIVE MAINTENANCE		GOOD / 90

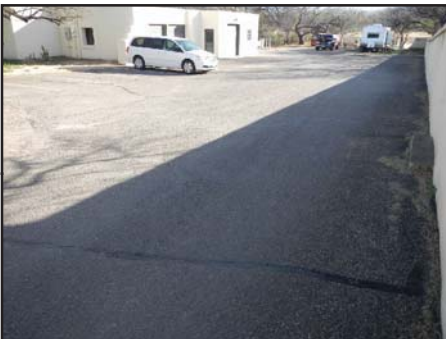
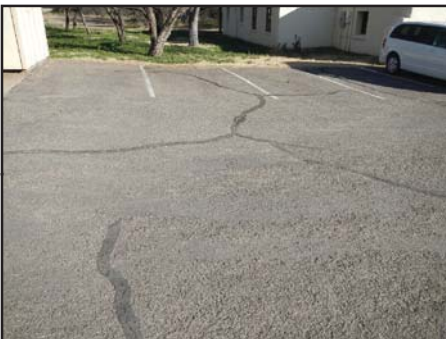
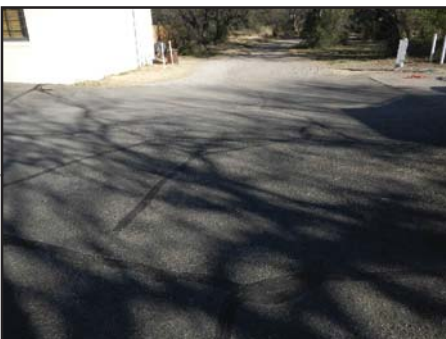
ROUTE 0901: RESOURCE PARKING

Inspection Date	FMSS Number	User Access	Surface Type
1/24/2016	105033	NONPUBLIC	ASPHALT
Area (Sq. Ft.)	Lane Miles (11' Widths)	Curb Reveal (Inches)	Curb Recommendation
5,816	0.1	NOT APPLICABLE	NOT APPLICABLE
Curb Type		Curb & Gutter Type	
NO CURB		NO CURB AND GUTTER	
Pavement Recommendation		Condition Rating / PCR	
LIGHT 3R TREATMENTS		FAIR / 73

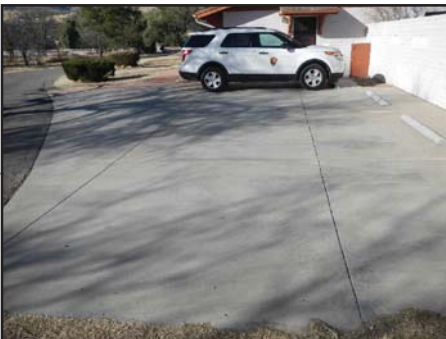
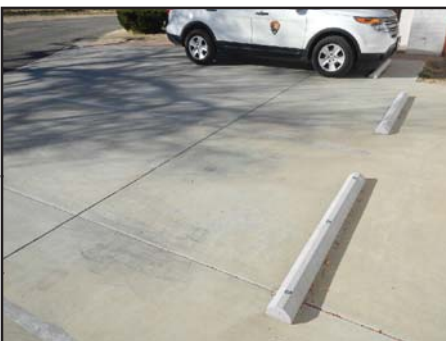
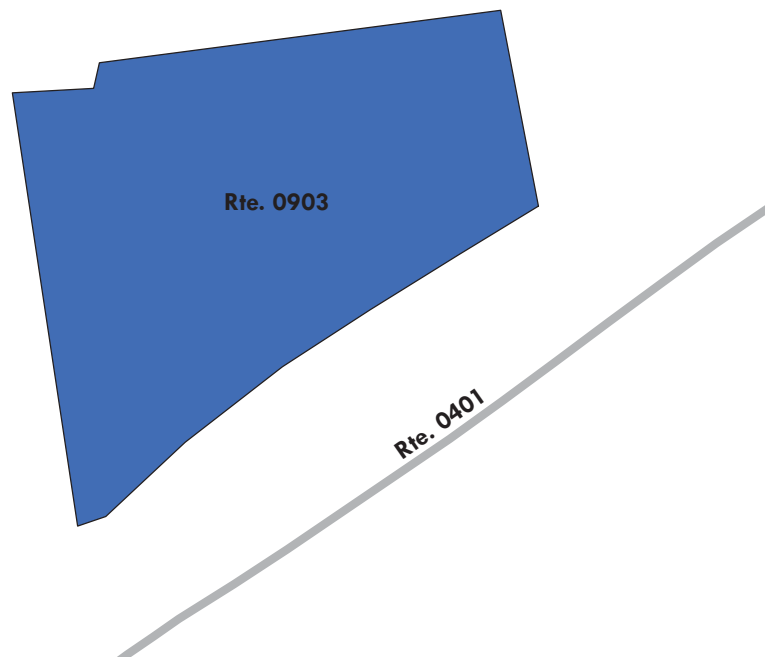
ROUTE 0903: ADMINISTRATIVE COMPOUND PARKING

Inspection Date	FMSS Number	User Access	Surface Type
1/24/2016	247131	NONPUBLIC	CONCRETE
Area (Sq. Ft.)	Lane Miles (11' Widths)	Curb Reveal (Inches)	Curb Recommendation
994	0.017	NOT APPLICABLE	NOT APPLICABLE
Curb Type		Curb & Gutter Type	
NO CURB		NO CURB AND GUTTER	
Pavement Recommendation		Condition Rating / PCR	
DO NOTHING		EXCELLENT / 97
