TUZI Cycle 6

Road Inventory and Condition Assessment of Paved Routes Tuzigoot National Monument

**Federal Lands Highway
Road Inventory Program**

Report Date: November 2016

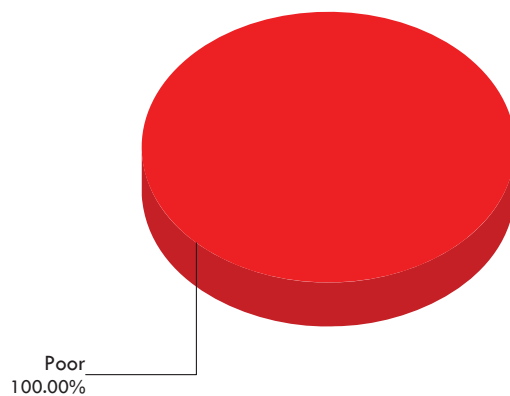
Figure 1: Pavement Condition Rating Breakdown for Paved Roads and Parking Areas

Parkwide Condition Percentages

Road Condition Percentages

Parking Area Condition Percentages

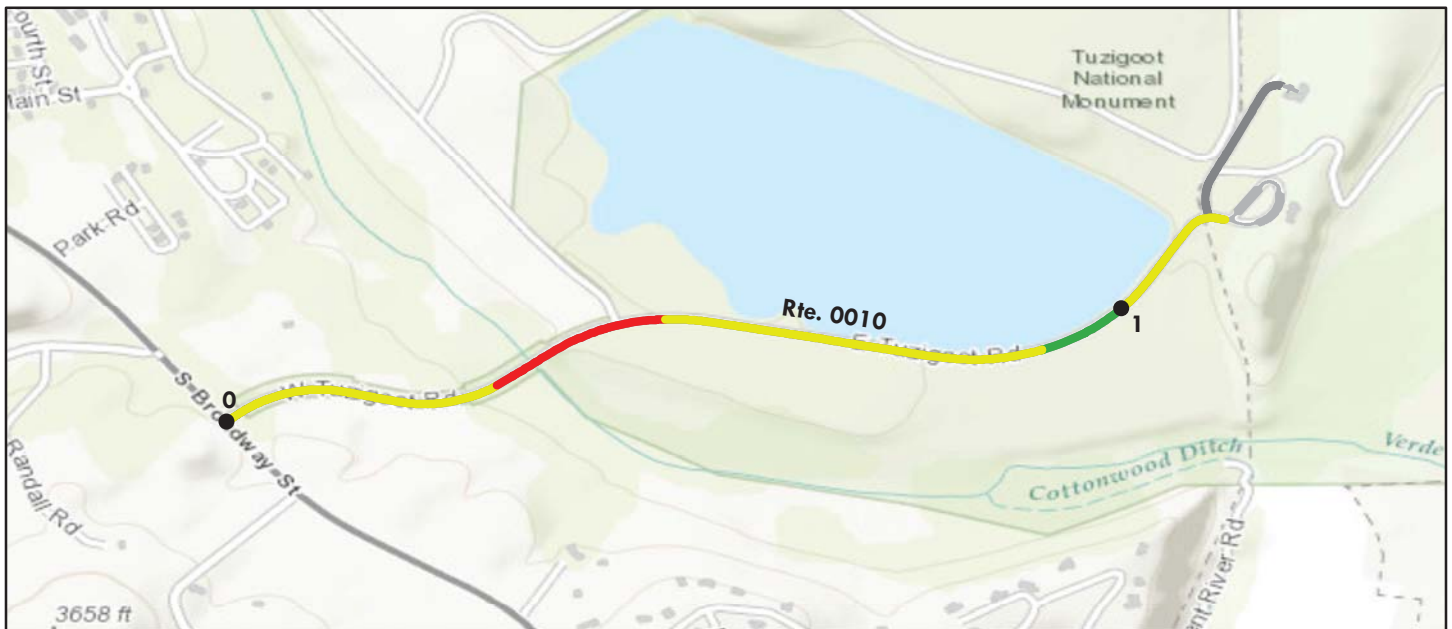
ROUTE 0010: TUZI ENTRANCE ROAD

Data Collection Vehicle (DCV) Rating

Route Condition Legend – Pavement Condition Rating (PCR)						
Poor (0 - 60)	Fair (61- 84)	Good (85 - 94)	Excellent (95 - 100)	Not Rated		
See Appendix for definitions and formulas						
Inspection Date: 7/11/2016	Beginning Section MP	0	1			
Paved Length (Miles): 1.17	Section Length (MI)	1	0.17			
Surface Type: ASPHALT	Route Summary					
Roadway Condition Information						
Pavement Condition Rating (PCR)	70	69	77			
Surface Condition Rating (SCR)	64	61	77			
Roughness Condition Index (RCI)	80	81	77			
Distress Index Values						
Structural Crack Index	74	73	82			
Alligator Crack Index	100	100	100			
Longitudinal Crack Index	74	73	82			
Transverse Cracking Index	64	61	77			
Patching Index	100	100	100			
Rutting Index	95	94	96			
International Roughness Index (IRI)	169	168	178			
Lane & Width Information						
Number of Lanes	2	2	2			
Paved Width (ft)	26.7	26.3	28.9			
Lane Width (ft)	11.2	11.1	11.6

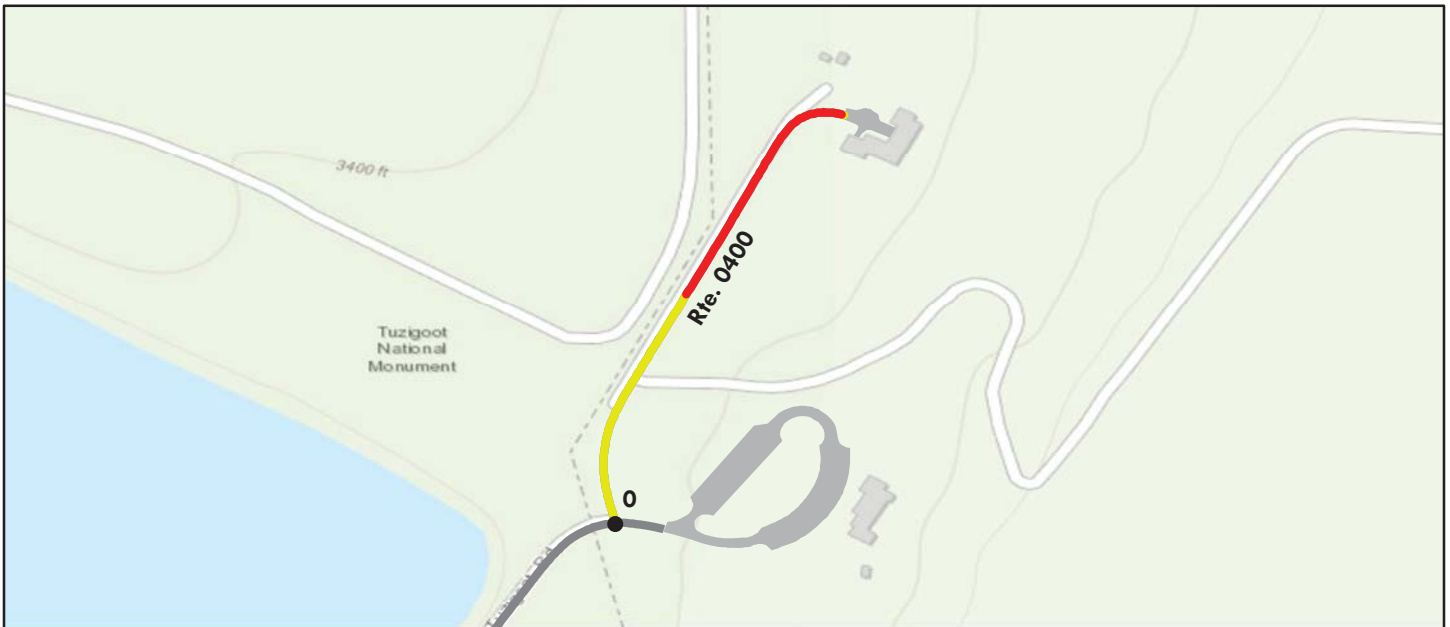
ROUTE 0400: TUZI RESIDENCE AREA ROAD

Data Collection Vehicle (DCV) Rating

Route Condition Legend – Pavement Condition Rating (PCR)						
Poor (0 - 60)	Fair (61- 84)	Good (85 - 94)	Excellent (95 - 100)	Not Rated		
See Appendix for definitions and formulas						
Inspection Date: 7/11/2016	Beginning Section MP	0				
Paved Length (Miles): 0.2	Section Length (MI)	0.2				
Surface Type: ASPHALT	Route Summary					
Roadway Condition Information						
Pavement Condition Rating (PCR)	61	61				
Surface Condition Rating (SCR)	61	61				
Roughness Condition Index (RCI)	N/A	N/A				
Distress Index Values						
Structural Crack Index	79	79				
Alligator Crack Index	100	100				
Longitudinal Crack Index	79	79				
Transverse Cracking Index	61	61				
Patching Index	100	100				
Rutting Index	95	95				
International Roughness Index (IRI)	N/A	N/A				
Lane & Width Information						
Number of Lanes	2	2				
Paved Width (ft)	22.7	22.7				
Lane Width (ft)	11.3	11.3

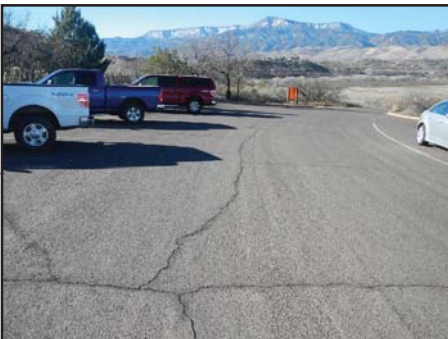
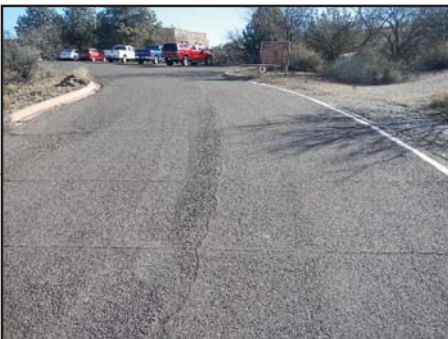
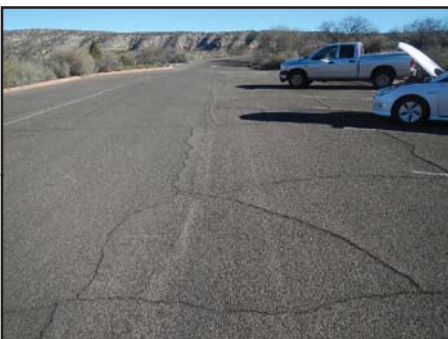
Inspection Date	FMSS Number	User Access	Surface Type
1/27/2016	58049	PUBLIC	ASPHALT
Area (Sq. Ft.)	Lane Miles (11' Widths)	Curb Reveal (Inches)	Curb Recommendation
35,442	0.61	NOT APPLICABLE	DO NOTHING
Curb Type		Curb & Gutter Type	
NO CURB		CONCRETE	
Pavement Recommendation		Condition Rating / PCR	
HEAVY 3R TREATMENTS		POOR / 53

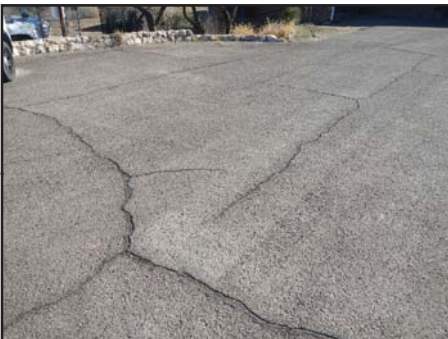
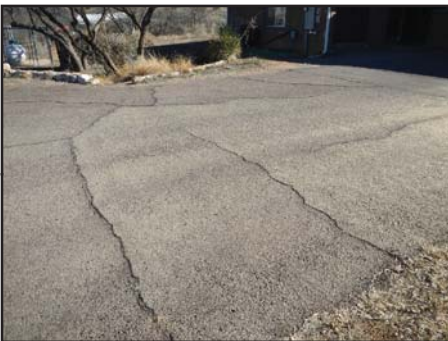
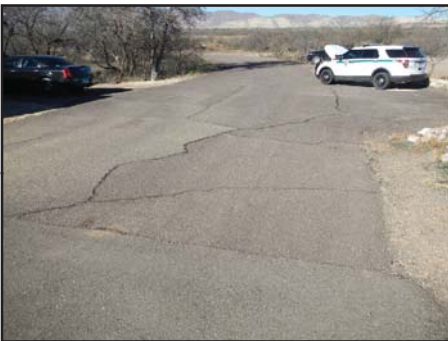
ROUTE 0901: TUZI RESIDENCE AREA PARKING

Inspection Date	FMSS Number	User Access	Surface Type
1/27/2016	230218	PUBLIC	ASPHALT
Area (Sq. Ft.)	Lane Miles (11' Widths)	Curb Reveal (Inches)	Curb Recommendation
3,210	0.055	NOT APPLICABLE	NOT APPLICABLE
Curb Type		Curb & Gutter Type	
NO CURB		NO CURB AND GUTTER	
Pavement Recommendation		Condition Rating / PCR	
HEAVY 3R TREATMENTS		POOR / 53
