# **Final Report**

# Road Inventory and Condition Assessment of Paved Routes Pearl Harbor National Memorial

Prepared By: Federal Highway Administration Eastern Federal Lands Highway Division Road Inventory Program (RIP)

**Report Date: June 2022**

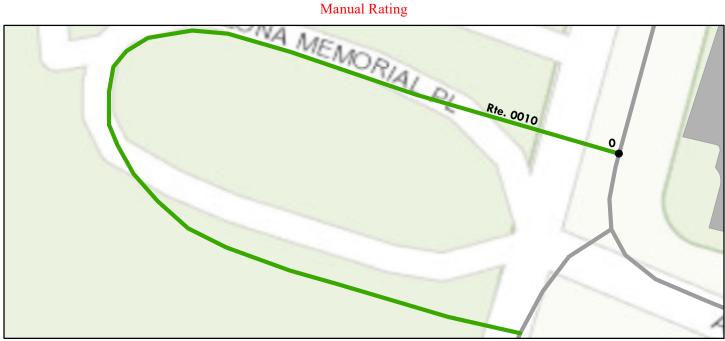
ROUTE 0010: USS ARIZONA MEMORIAL "U" ROAD

<b>Route Condition Legend – Pavement Condition Rating (PCR)</b>									
<b>Poor (0 - 60) Fa</b>	ir (61- 84) Good	(85 - 94)	Excellent (95 - 100)	Not Rated					
	See Appendix for def	initions and i	formulas						
Inspection Date: 3/16/2022	Beginning Section MP	0.00							
Paved Length (Miles): 0.08	Section Length (MI)	0.08							
Surface Type: CONCRETE	Route Summary								
Roadway Condition Information									
Pavement Condition Rating (PCR)	90	90							
Surface Condition Rating (SCR)	90	90							
Roughness Condition Index (RCI)	N/A	N/A							
Distress Index Values									
Structural Crack Index	N/A	N/A							
Alligator Crack Index	N/A	N/A							
Longitudinal Crack Index	N/A	N/A							
Transverse Cracking Index	N/A	N/A							
Patching Index	N/A	N/A							
Rutting Index	N/A	N/A							
International Roughness Index (IRI)	N/A	N/A							
Lane & Width Information									
Number of Lanes	2	2							
Paved Width (ft)	28	28

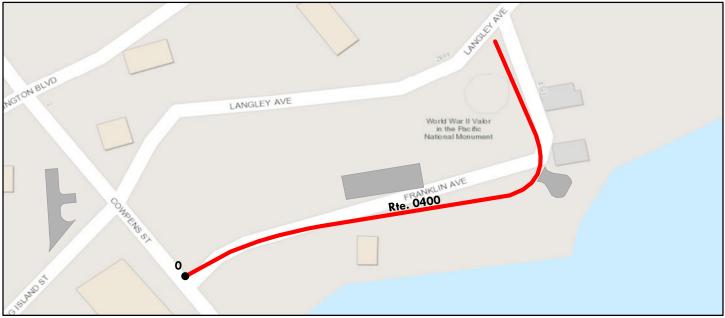
ROUTE 0400: BELLEAU WOOD ROAD

<b>Route Condition Legend – Pavement Condition Rating (PCR)</b>									
Poor (0 - 60) Fair	(61- 84) Good	(85 - 94)	Excellent (95 - 100)	Not Rated					
See Appendix for definitions and formulas									
Inspection Date: 3/16/2022	Beginning Section MP	0.00							
Paved Length (Miles): 0.12	Section Length (MI)	0.12							
Surface Type: ASPHALT	Route Summary								
Roadway Condition Information									
Pavement Condition Rating (PCR)	30	30							
Surface Condition Rating (SCR)	30	30							
Roughness Condition Index (RCI)	N/A	N/A							
Distress Index Values									
Structural Crack Index	N/A	N/A							
Alligator Crack Index	30	30							
Longitudinal Crack Index	53	53							
Transverse Cracking Index	53	53							
Patching Index	73	73							
Rutting Index	90	90							
International Roughness Index (IRI)	N/A	N/A							
Lane & Width Information									
Number of Lanes	2	2							
Paved Width (ft)	16	16							
Lane Width (ft)	8	8

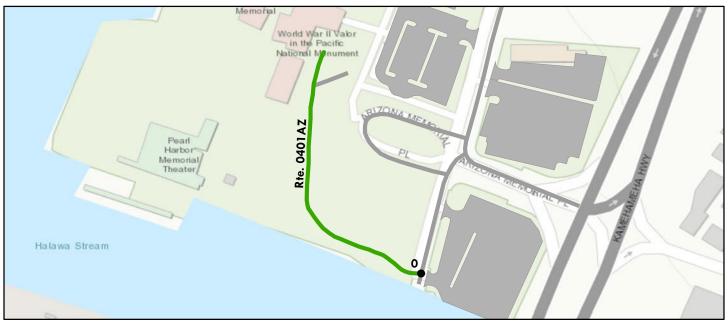
## **Pearl Harbor National Memorial** ROUTE 0401AZ: EMERGENCY/MAINTENANCE VEHICLE ACCESS ROAD A

<b>Route Condition Legend – Pavement Condition Rating (PCR)</b>									
<b>Poor (0 - 60)</b> Fair (	61- 84) Good (	(85 - 94)	Excellent (95 - 100)	Not Rated					
	See Appendix for def	finitions and f	formulas						
Inspection Date: 3/16/2022	Beginning Section MP	0.00							
Paved Length (Miles): 0.12	Section Length (MI)	0.12							
Surface Type: ASPHALT	Route Summary		•						
Roadway Condition Information									
Pavement Condition Rating (PCR)	90	90							
Surface Condition Rating (SCR)	90	90							
Roughness Condition Index (RCI)	N/A	N/A							
Distress Index Values									
Structural Crack Index	N/A	N/A							
Alligator Crack Index	97	97							
Longitudinal Crack Index	97	97							
Transverse Cracking Index	97	97							
Patching Index	90	90							
Rutting Index	97	97							
International Roughness Index (IRI)	N/A	N/A							
Lane & Width Information									
Number of Lanes	2	2							
Paved Width (ft)	20	20

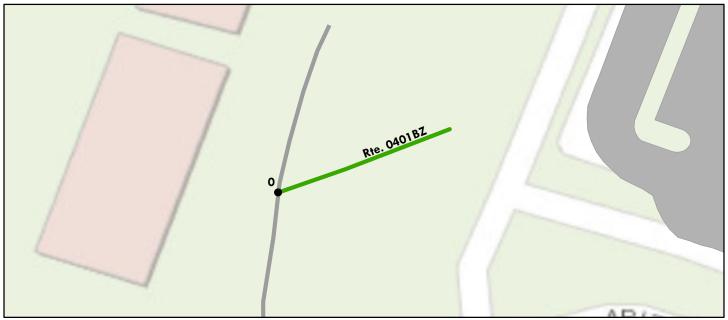
## **Pearl Harbor National Memorial** ROUTE 0401BZ: EMERGENCY/MAINTENANCE VEHICLE ACCESS ROAD B

<b>Route Condition Legend – Pavement Condition Rating (PCR)</b>									
<b>Poor (0 - 60)</b> Fair (6	1- 84) Good (	(85 - 94)	Excellent (95 - 100)	Not Rated					
	See Appendix for definitions and formulas								
Inspection Date: 3/16/2022	<b>Beginning Section MP</b>	0.00							
Paved Length (Miles): 0.01	Section Length (MI)	0.01							
Surface Type: ASPHALT	Route Summary		• • •						
Roadway Condition Information									
Pavement Condition Rating (PCR)	90	90							
Surface Condition Rating (SCR)	90	90							
Roughness Condition Index (RCI)	N/A	N/A							
Distress Index Values									
Structural Crack Index	N/A	N/A							
Alligator Crack Index	97	97							
Longitudinal Crack Index	97	97							
Transverse Cracking Index	97	97							
Patching Index	90	90							
Rutting Index	97	97							
International Roughness Index (IRI)	N/A	N/A							
Lane & Width Information									
Number of Lanes	2	2							
Paved Width (ft)	20	20
