# Final Report

# Road Inventory and Condition Assessment of Paved Routes War in the Pacific National Historical Park

**Report Date: August 2022**

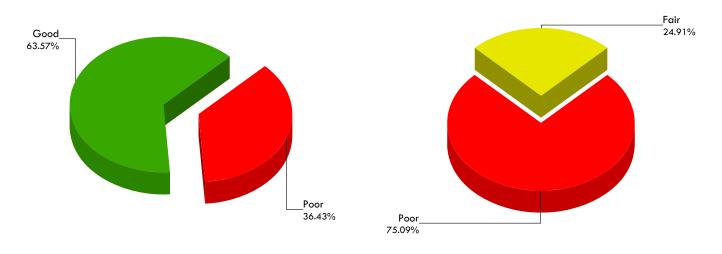
Figure 1: Pavement Condition Rating Breakdown for Paved Roads and Parking Areas

#### **Road Condition Percentages**

**Parking Area Condition Percentages**

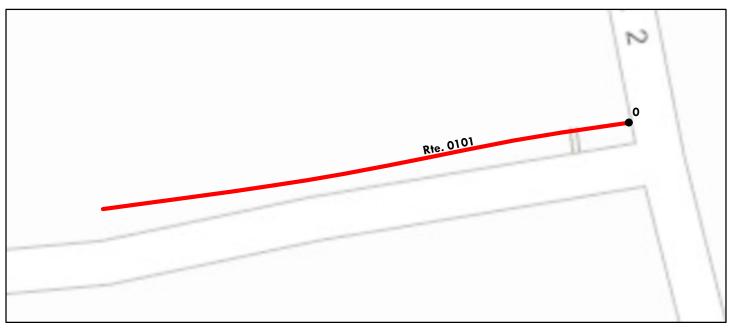
ROUTE 0101: RIZAL POINT ROAD (CLOSED TO PUBLIC)

Pouto (	Condition Legend – Pav	omant Candi	tion Dating (	DCD)		
Poor (0 - 60)			(85 - 94)	Excellent (		Not Ra	ted
		See Appendix for def					
Inspection Date:	3/20/2022	Beginning Section MP					
Paved Length (Miles	s): 0.04	Section Length (MI)	0.04				
Surface Type:	ASPHALT	Route Summary				ļ	
Roadway Condition	Information						
Pavement Condition	Rating (PCR)	30	30				
Surface Condition Ra	ating (SCR)	30	30				
Roughness Condition	Index (RCI)	N/A	N/A				
Distress Index Value	s						
Structural Crack Ind	lex	N/A	N/A				
Alligator Crack Inde	ex	30	30				
Longitudinal Crack	Index	30	30				
Transverse Cracking	g Index	53	53				
Patching Index		90	90				
Rutting Index		73	73				
International Roughness Index (IRI)		N/A	N/A				
Lane & Width Infor	mation						
Number of Lanes		2	2				
Paved Width (ft)		20	20				
Lane Width (ft)		10	10

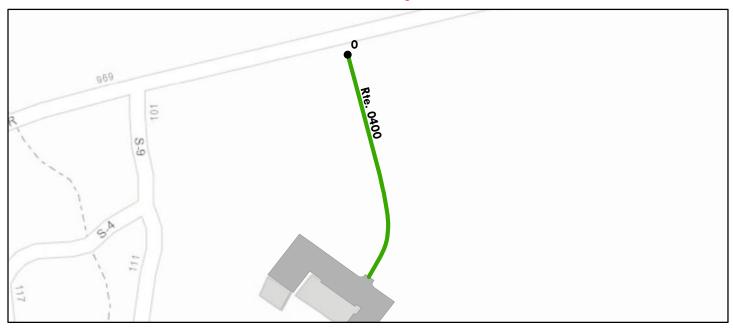
# ROUTE 0400: RONALD D. WILSON LANE MAINTENANCE ACCESS

Route (	Condition Legend – Pav	ement Condi	ition Rating (	PCR)		
Poor (0 - 60)	_		(85 - 94)	Excellent (9		Not Ra	ted
	11 (1	See Appendix for def		×			
Inspection Date:	3/20/2022	Beginning Section MP					
Paved Length (Miles	): 0.08	Section Length (MI)	0.08				
Surface Type:	ASPHALT	Route Summary					
Roadway Condition	Information						
Pavement Condition	Rating (PCR)	90	90				
Surface Condition Ra	ting (SCR)	90	90				
Roughness Condition	Index (RCI)	N/A	N/A				
Distress Index Values	s						
Structural Crack Ind	ex	N/A	N/A				
Alligator Crack Inde	ex	90	90				
Longitudinal Crack	Index	97	97				
Transverse Cracking	Index	90	90				
Patching Index		90	90				
Rutting Index		97	97				
International Roughi	ness Index (IRI)	N/A	N/A				
Lane & Width Inform	mation						
Number of Lanes		1	1				
Paved Width (ft)		12	12				
Lane Width (ft)		12	12

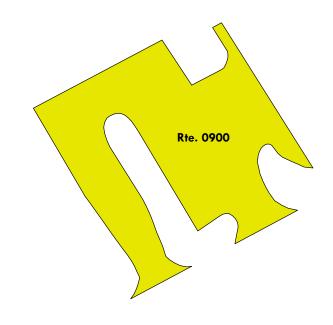
**ROUTE 0900: HALODA PARKING**

Inspection Date	FMSS Number	User Access	Surface Type			
3/20/2022	104854	PUBLIC	ASPHALT			
Area (Sq. Ft.)	Lane Miles (11' Widths)	Curb Reveal (Inches)	Curb Recommendation			
10,037	0.173	NOT APPLICABLE	NOT APPLICABLE			
Curb	Туре	Curb & Gutter Type				
NO C	CURB	NO CURB AND GUTTER				
Pavement Rec	commendation	Condition Rating / PCR				
LIGHT 3R T	REATMENTS	FAIR / 73

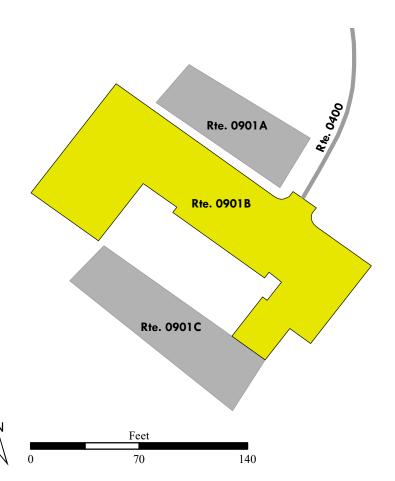
ROUTE 0901B: MAINTENANCE SHOP PAVED PARKING

Inspecti	on Date	FMSS Number	User Access	Surface Type			
3/20/	2022	104847	NONPUBLIC	ASPHALT			
Area (S	Sq. Ft.)	Lane Miles (11' Widths)	Curb Reveal (Inches)	Curb Recommendation			
12,7	728	0.219	NOT APPLICABLE	NOT APPLICABLE			
	Curb	Туре	Curb & Gutter Type				
	NO (	CURB	NO CURB AND GUTTER				
	Pavement Re	commendation	Condition Rating / PCR				
	LIGHT 3R T	REATMENTS	FAIR / 73

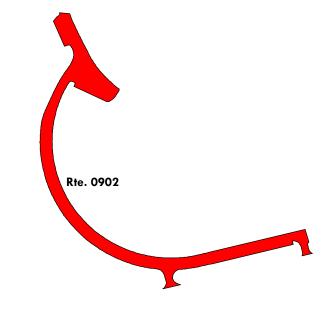
**ROUTE 0902: ASAN BEACH PARKING**

Inspection Date	FMSS Number	User Access	Surface Type	
3/20/2022	71219	PUBLIC	ASPHALT	
Area (Sq. Ft.)	Lane Miles (11' Widths)	Curb Reveal (Inches)	Curb Recommendation	
166,643	2.869	5	MODERATE REPAIR	
Curb Type		Curb & Gutter Type		
CONCRETE		CONCRETE		
Pavement Recommendation		Condition Rating / PCR		
HEAVY 3R TREATMENTS		POOR / 53		
Pouts Condition Legend Present Condition Poting (PCP)
