WHIS Cycle 6

Final Report

Road Inventory and Condition Assessment of Paved Routes Whiskeytown National Recreation Area

Report Date: November 2015

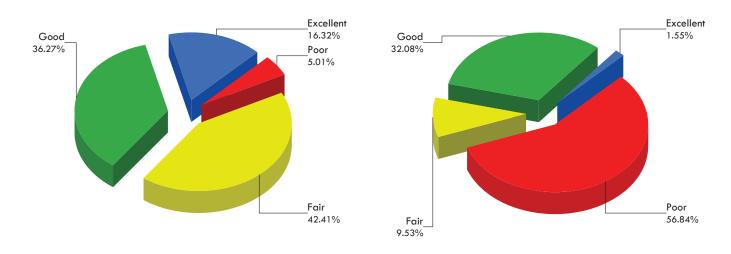
Figure 1: Pavement Condition Rating Breakdown for Paved Roads and Parking Areas

Road Condition Percentages

Parking Area Condition Percentages

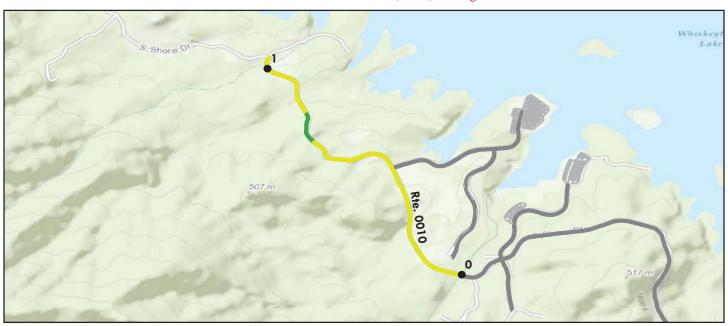
Data Collection Vehicle (DCV) Rating

Poute (Condition Legend – Pav	romant Candi	tion Poting (PCP)		
Poor (0 - 60)	Fair (6		(85 - 94)	Excellent (Not Rat	ed
	17 (1	See Appendix for det	· ·				
Inspection Date:	5/22/2015	Beginning Section MP	0	1			
Paved Length (Miles):	1.04	Section Length (MI)	1	0.04			
Surface Type:	ASPHALT	Route Summary					
Roadway Condition In	formation						
Pavement Condition R	ating (PCR)	77	77	72			
Surface Condition Ratin	ig (SCR)	85	85	89			
Roughness Condition In	dex (RCI)	64	65	46			
Distress Index Values							
Structural Crack Index		92	92	99			
Alligator Crack Index		100	100	100			
Longitudinal Crack Inc	dex	92	92	99			
Transverse Cracking Ir	ndex	85	85	91			
Patching Index		100	100	100			
Rutting Index		94	94	89			
International Roughness Index (IRI)		222	220	302			
Lane & Width Informa	ation						
Number of Lanes		2	2	2			
Paved Width (ft)		25.2	25.4	20			
Lane Width (ft)		11.6	11.7	9.1

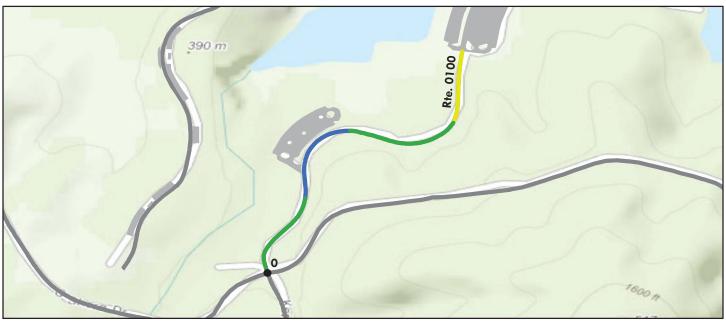
Data Collection Vehicle (DCV) Rating

Route Cond	lition Legend – Pa	vement Condi	tion Rating (PCR)		
Poor (0 - 60)	Fair (61- 84		(85 - 94)	Excellent (-	Not Rat	ted
	S	See Appendix for de	efinitions and f	ormulas			
Inspection Date: 5/22/2	015 Beg	ginning Section MI	P 0				
Paved Length (Miles): 0.38	Sec	tion Length (MI)	0.38				
Surface Type: ASPH	ALT Ro	ıte Summary					
Roadway Condition Informa	tion						
Pavement Condition Rating (PCR)	90	90				
Surface Condition Rating (SCI	(3)	90	90				
Roughness Condition Index (R	CI)	N/A	N/A				
Distress Index Values							
Structural Crack Index		96	96				
Alligator Crack Index		100	100				
Longitudinal Crack Index		96	96				
Transverse Cracking Index		90	90				
Patching Index		99	99				
Rutting Index		97	97				
International Roughness Index (IRI)		N/A	N/A				
Lane & Width Information							
Number of Lanes		2	2				
Paved Width (ft)		22.8	22.8				
Lane Width (ft)		10.8	10.8

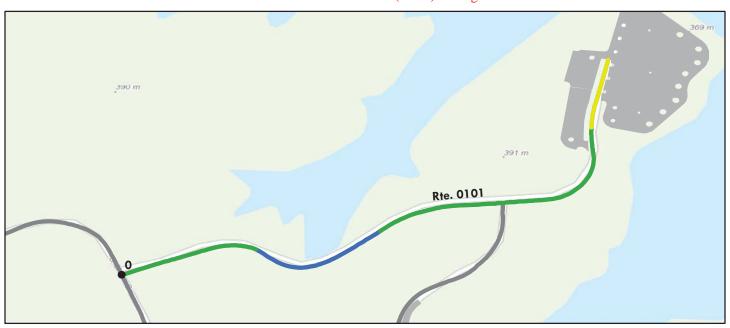
Data Collection Vehicle (DCV) Rating

Route Condition	Legend – Pav	ement Condi	tion Rating (PCR)		
Poor (0 - 60)	Fair (61- 84)		(85 - 94)	Excellent (-	Not Rat	ted
	See Ap	pendix for det	finitions and f	ormulas			
Inspection Date: 5/22/201	5 Beginnin	g Section MP	0				
Paved Length (Miles): 0.46	Section I	ength (MI)	0.46				
Surface Type: ASPHAI	T Route Su	mmary					
Roadway Condition Information	on						
Pavement Condition Rating (PC	CR)	89	89				
Surface Condition Rating (SCR)		89	89				
Roughness Condition Index (RCI)	N/A	N/A				
Distress Index Values							
Structural Crack Index		97	97				
Alligator Crack Index		100	100				
Longitudinal Crack Index		97	97				
Transverse Cracking Index		89	89				
Patching Index		100	100				
Rutting Index		98	98				
International Roughness Index	(IRI)	N/A	N/A				
Lane & Width Information							
Number of Lanes		2	2				
Paved Width (ft)		30.8	30.8				
Lane Width (ft)		12.3	12.3

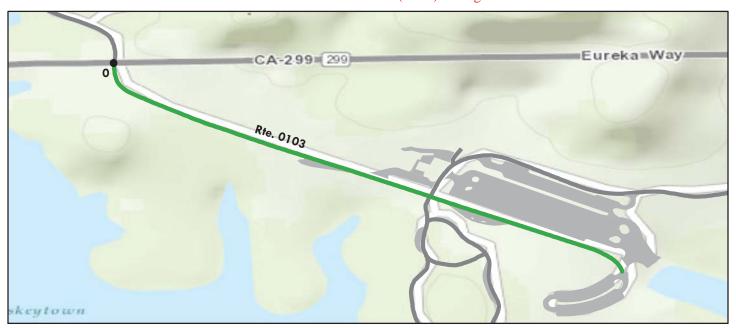
ROUTE 0103: OAK BOTTOM BEACH ROAD

Pout	e Condition Legend – Pav	oment Cond	ition Dating (DCD)	
		(85 - 94)	Excellent (95 - 100)	Not Rated
1 001 (0 00)	See Appendix for def	1		1100 214004
T D 5/22/2015			T I	
Inspection Date: 5/22/2015	Beginning Section MP	0		
Paved Length (Miles): 0.44	Section Length (MI)	0.44		
Surface Type: ASPHALT	Route Summary		•	•
Roadway Condition Information				
Pavement Condition Rating (PCR)	90	90		
Surface Condition Rating (SCR)	90	90		
Roughness Condition Index (RCI)	N/A	N/A		
Distress Index Values				
Structural Crack Index	97	97		
Alligator Crack Index	100	100		
Longitudinal Crack Index	97	97		
Transverse Cracking Index	93	93		
Patching Index	100	100		
Rutting Index	90	90		
International Roughness Index (IRI)	N/A	N/A		
Lane & Width Information				
Number of Lanes	2	2		
Paved Width (ft)	25.8	25.8		
Lane Width (ft)	10.8	10.8

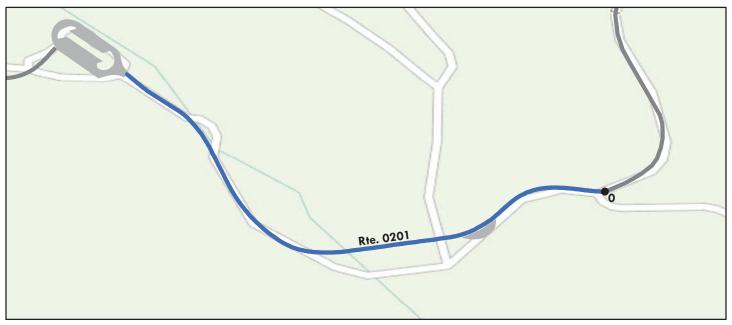
ROUTE 0201: N.E.E.D. CAMP ROAD

Route (Condition Leg	end – Pave	ment Condi	tion Rating (PCR)		
Poor (0 - 60)	Fair (6			85 - 94)	Excellent (-	Not Rat	ted
		See Appen	dix for defi	nitions and f	ormulas			
Inspection Date: 5/22	/2015	Beginning Se	ection MP	0				
Paved Length (Miles): 0.27		Section Leng	gth (MI)	0.27				
Surface Type: ASF	HALT	Route Summ	nary		•			
Roadway Condition Inforn	nation							
Pavement Condition Rating	g (PCR)	97		97				
Surface Condition Rating (S	CR)	97		97				
Roughness Condition Index	(RCI)	N/A	1	N/A				
Distress Index Values								
Structural Crack Index		100)	100				
Alligator Crack Index		100)	100				
Longitudinal Crack Index		100)	100				
Transverse Cracking Index		97		97				
Patching Index		100)	100				
Rutting Index		97		97				
International Roughness Index (IRI)		N/A	Λ	N/A				
Lane & Width Information	ı							
Number of Lanes		2		2				
Paved Width (ft)		20.1	1	20.1				
Lane Width (ft)		10.9)	10.9

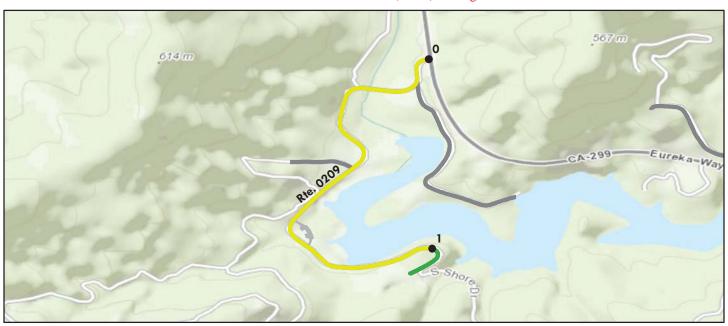
ROUTE 0209: CARR POWERHOUSE ROAD

Poute (Condition Legend – Pav	ement Condi	tion Poting (PCP)		
Poor (0 - 60)	Fair (6		(85 - 94)	Excellent (Not Rated	
1 301 (0 30)	1 442 (0	See Appendix for det			200)	1,0021	
Inspection Date:	5/22/2015	Beginning Section MP		1			
Paved Length (Miles):	1.1	Section Length (MI)	1	0.1			
	ASPHALT	Route Summary					
Roadway Condition In	formation						
Pavement Condition R	ating (PCR)	73	73	91			
Surface Condition Ratin	ng (SCR)	94	94	91			
Roughness Condition In	ndex (RCI)	42	42	N/A			
Distress Index Values							
Structural Crack Index		99	99	100			
Alligator Crack Index		100	100	100			
Longitudinal Crack Inc	dex	99	99	100			
Transverse Cracking Ir	ndex	97	96	100			
Patching Index		100	100	100			
Rutting Index		93	94	91			
International Roughnes	International Roughness Index (IRI)		328	N/A			
Lane & Width Informa	ation						
Number of Lanes		2	2	1			
Paved Width (ft)		20.9	21.8	13.8			
Lane Width (ft)		10.8	10.5	13.8

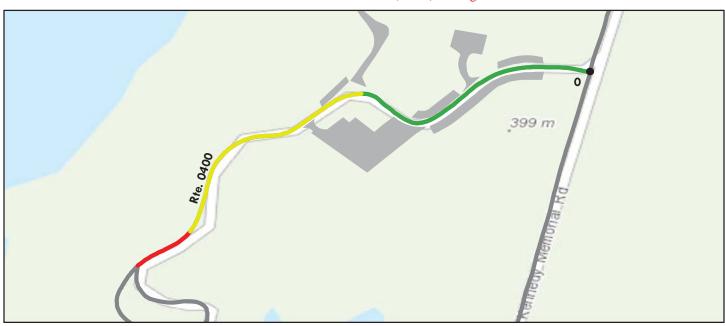
ROUTE 0400: HEADQUARTERS ROAD

Route	Condition Legend – Pav	ement Condi	ition Rating (PCR)	
		(85 - 94)	Excellent (95 - 100)	Not Rated
	See Appendix for def			
Inspection Date: 5/22/2015	Beginning Section MP	0		
Paved Length (Miles): 0.23	Section Length (MI)	0.23		
Surface Type: ASPHALT	Route Summary		'	'
Roadway Condition Information				
Pavement Condition Rating (PCR)	77	77		
Surface Condition Rating (SCR)	77	77		
Roughness Condition Index (RCI)	N/A	N/A		
Distress Index Values				
Structural Crack Index	77	77		
Alligator Crack Index	98	98		
Longitudinal Crack Index	79	79		
Transverse Cracking Index	89	89		
Patching Index	98	98		
Rutting Index	89	89		
International Roughness Index (IRI)	N/A	N/A		
Lane & Width Information				
Number of Lanes	2	2		
Paved Width (ft)	25.8	25.8		
Lane Width (ft)	11	11

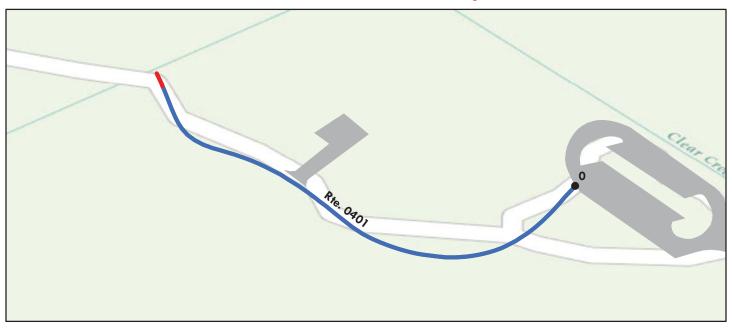
ROUTE 0401: N.E.E.D. CAMP RESIDENCE ROAD

Route (Condition Legend – Pay	zement Condi	tion Rating (PCR)			
Poor (0 - 60)	Fair (6		(85 - 94)	Excellent (9		Not Rated		
		See Appendix for de						
Inspection Date:	5/22/2015	Beginning Section MP	0					
Paved Length (Miles):	0.1	Section Length (MI)	0.1					
Surface Type:	ASPHALT	Route Summary						
Roadway Condition Ir	nformation							
Pavement Condition F	Rating (PCR)	96	96					
Surface Condition Ration	ng (SCR)	96	96					
Roughness Condition In	ndex (RCI)	N/A	N/A					
Distress Index Values								
Structural Crack Index	ζ	100	100					
Alligator Crack Index		100	100					
Longitudinal Crack In	dex	100	100					
Transverse Cracking I	ndex	97	97					
Patching Index		100	100					
Rutting Index		96	96					
International Roughne	ess Index (IRI)	N/A	N/A					
Lane & Width Inform	ation							
Number of Lanes		1	1					
Paved Width (ft)		12	12					
Lane Width (ft)		12	12

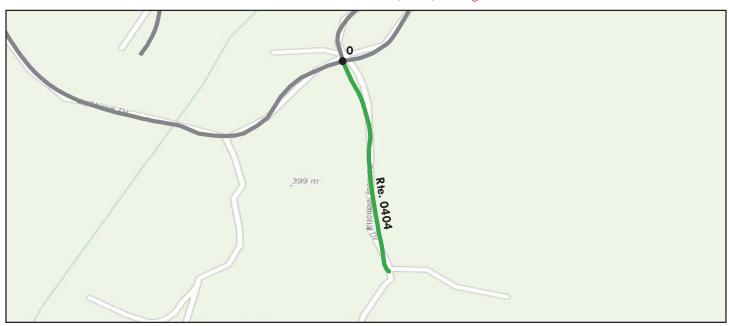
ROUTE 0404: BRANDY CREEK SERVICE ROAD SOUTH

D	C 1'4' I 1 . D		'A' D -A' (DCD)	
	Condition Legend – Pav			
Poor (0 - 60) Fair	61- 84) Good	(85 - 94)	Excellent (95 - 100)	Not Rated
	See Appendix for def	initions and f	Formulas	
Inspection Date: 5/22/2015	Beginning Section MP	0		
Paved Length (Miles): 0.17	Section Length (MI)	0.17		
Surface Type: ASPHALT	Route Summary			
Roadway Condition Information				
Pavement Condition Rating (PCR)	92	92		
Surface Condition Rating (SCR)	92	92		
Roughness Condition Index (RCI)	N/A	N/A		
Distress Index Values				
Structural Crack Index	92	92		
Alligator Crack Index	100	100		
Longitudinal Crack Index	92	92		
Transverse Cracking Index	96	96		
Patching Index	100	100		
Rutting Index	94	94		
International Roughness Index (IRI)	N/A	N/A		
Lane & Width Information				
Number of Lanes	1	1		
Paved Width (ft)	10.1	10.1		
Lane Width (ft)	10.1	10.1

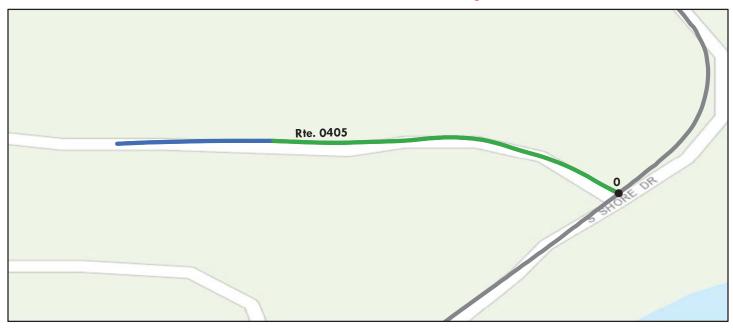
ROUTE 0405: CARR POWERHOUSE SERVICE ROAD

Route (Condition Legend – Pay	ement Condi	ition Rating ()	PCR)		
Poor (0 - 60)	Fair (6						
		See Appendix for de					
Inspection Date:	5/22/2015	Beginning Section MP	0				
Paved Length (Miles):	0.14	Section Length (MI)	0.14				
Surface Type:	ASPHALT	Route Summary					
Roadway Condition In	formation						
Pavement Condition R	ating (PCR)	89	89				
Surface Condition Ratin	ng (SCR)	89	89				
Roughness Condition In	ndex (RCI)	N/A	N/A				
Distress Index Values							
Structural Crack Index		99	99				
Alligator Crack Index		100	100				
Longitudinal Crack Inc	dex	99	99				
Transverse Cracking In	ndex	98	98				
Patching Index		100	100				
Rutting Index		89	89				
International Roughne	ss Index (IRI)	N/A	N/A				
Lane & Width Informa	ation						
Number of Lanes		1	1				
Paved Width (ft)		11.2	11.2				
Lane Width (ft)		11.2	11.2

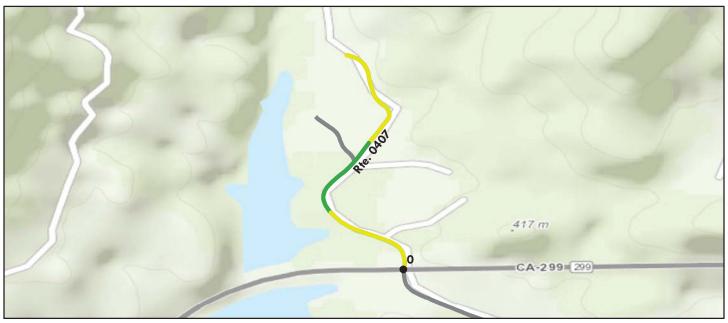
ROUTE 0407: GRIZZLY GULCH ROAD

Route Condition	Legend – Pav	ement Condi	tion Rating (PCR)			
Poor (0 - 60)	Fair (61- 84)		(85 - 94)	Excellent (Not Rated		
	See Ap	pendix for def	finitions and f	ormulas				
Inspection Date: 5/22/201	5 Beginnin	g Section MP	0					
Paved Length (Miles): 0.33	Section L	ength (MI)	0.33					
Surface Type: ASPHA	Route Su	mmary			•			
Roadway Condition Information	on							
Pavement Condition Rating (PC	CR)	80	80					
Surface Condition Rating (SCR)		80	80					
Roughness Condition Index (RCI		N/A	N/A					
Distress Index Values								
Structural Crack Index		82	82					
Alligator Crack Index		99	99					
Longitudinal Crack Index		83	83					
Transverse Cracking Index		80	80					
Patching Index		96	96					
Rutting Index		87	87					
International Roughness Index	(IRI)	N/A	N/A					
Lane & Width Information								
Number of Lanes		1	1					
Paved Width (ft)		12.6	12.6					
Lane Width (ft)		12.6	12.6

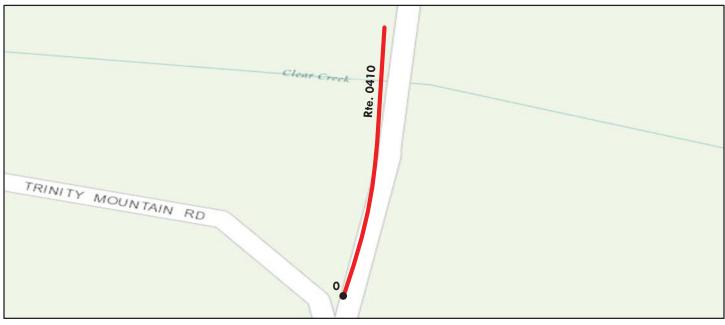
Manual Rating

Route (Condition Legend – Pav	ement Condi	tion Rating (PCR)	
Poor (0 - 60) Fair (6	1- 84) Good ((85 - 94)	Excellent (95 - 100)	Not Rated
	See Appendix for def	initions and f	ormulas	
Inspection Date: 11/3/2014	Beginning Section MP	0.00		
Paved Length (Miles): 0.05	Section Length (MI)	0.05		
Surface Type: ASPHALT	Route Summary			
Roadway Condition Information				
Pavement Condition Rating (PCR)	53	53		
Surface Condition Rating (SCR)	53	53		
Roughness Condition Index (RCI)	N/A	N/A		
Distress Index Values				
Structural Crack Index	N/A	N/A		
Alligator Crack Index	90	90		
Longitudinal Crack Index	53	53		
Transverse Cracking Index	53	53		
Patching Index	97	97		
Rutting Index	97	97		
International Roughness Index (IRI)	N/A	N/A		
Lane & Width Information				
Number of Lanes	1	1		
Paved Width (ft)	12	12		
Lane Width (ft)	12	12

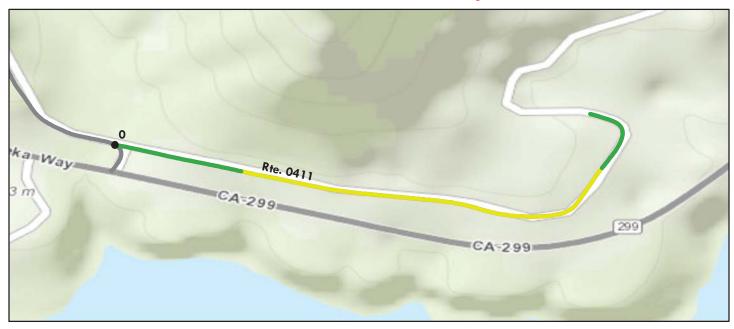
ROUTE 0411: BULL GULCH SERVICE ROAD

Route (Condition Legend – Pav	ement Condi	tion Rating (PCR)		
Poor (0 - 60			(85 - 94)	Excellent (95 - 100)		Not Rated	
		See Appendix for def	finitions and f	ormulas			
Inspection Date:	5/22/2015	Beginning Section MP	0				
Paved Length (Mile	es): 0.47	Section Length (MI)	0.47				
Surface Type:	ASPHALT	Route Summary					
Roadway Condition	n Information						
Pavement Condition	on Rating (PCR)	82	82				
Surface Condition Rating (SCR)		82	82				
Roughness Condition	on Index (RCI)	N/A	N/A				
Distress Index Valu	es						
Structural Crack In	dex	93	93				
Alligator Crack Inc	lex	100	100				
Longitudinal Crack	Index	93	93				
Transverse Crackin	ng Index	82	82				
Patching Index		100	100				
Rutting Index		93	93				
International Roug	hness Index (IRI)	N/A	N/A				
Lane & Width Info	rmation						
Number of Lanes		2	2				
Paved Width (ft)		17.2	17.2				
Lane Width (ft)		8.6	8.6

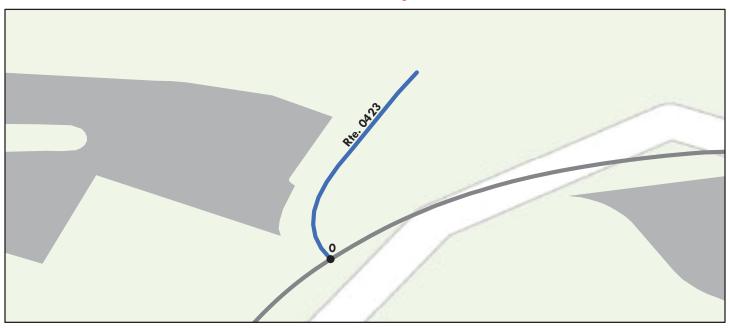
Manual Rating

Route Condition Legend – Pavement Condition Rating (PCR)								
Poor (0 - 60) Fair (6	Good (85 - 94)		Excellent (95 - 100)	Not Rated				
See Appendix for definitions and formulas								
Inspection Date: 11/4/2014	Beginning Section MP	0.00						
Paved Length (Miles): 0.02	Section Length (MI)	0.02						
Surface Type: ASPHALT	Route Summary							
Roadway Condition Information								
Pavement Condition Rating (PCR)	97	97						
Surface Condition Rating (SCR)	97	97						
Roughness Condition Index (RCI)	N/A	N/A						
Distress Index Values								
Structural Crack Index	N/A	N/A						
Alligator Crack Index	97	97						
Longitudinal Crack Index	97	97						
Transverse Cracking Index	97	97						
Patching Index	97	97						
Rutting Index	97	97						
International Roughness Index (IRI)	N/A	N/A						
Lane & Width Information								
Number of Lanes	1	1						
Paved Width (ft)	19	19						
Lane Width (ft)	19	19

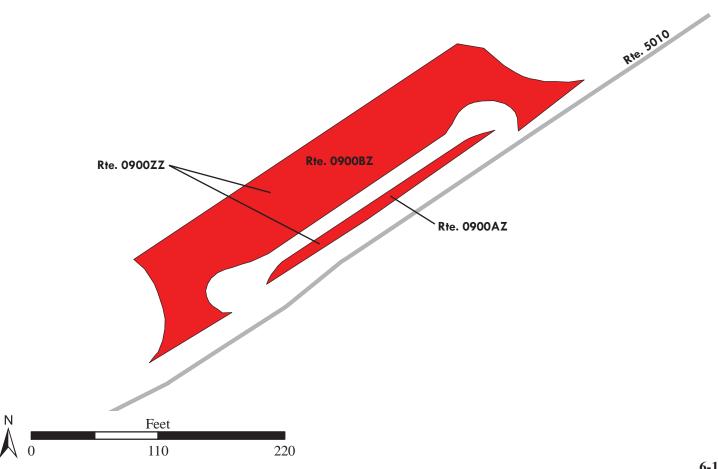
ROUTE 0900AZ: VISITOR CENTER PARKING A

Inspection Date	FMSS Number	User Access	Surface Type	
11/5/2014	23363	PUBLIC	ASPHALT	
Area (Sq. Ft.)	Lane Miles (11' Widths)	Curb Reveal (Inches)	Curb Recommendation	
1,523	0.026	NOT APPLICABLE	DO NOTHING	
Curb	Curb Type Curb & Gutter Type		utter Type	
NO C	NO CURB CONCRETE		CRETE	
Pavement Rec	Pavement Recommendation		Rating / PCR	
HEAVY 3R TREATMENTS		POOR / 53		
Route Condition Legend – Pavement Condition Rating (PCR)				
Poor (0 - 60)				
See Appendix for definitions and formulas
