Final Report

Road Inventory and Condition Assessment of Paved Routes White Sands National Monument

**Federal Lands Highway
Road Inventory Program**

Report Date: July 2017

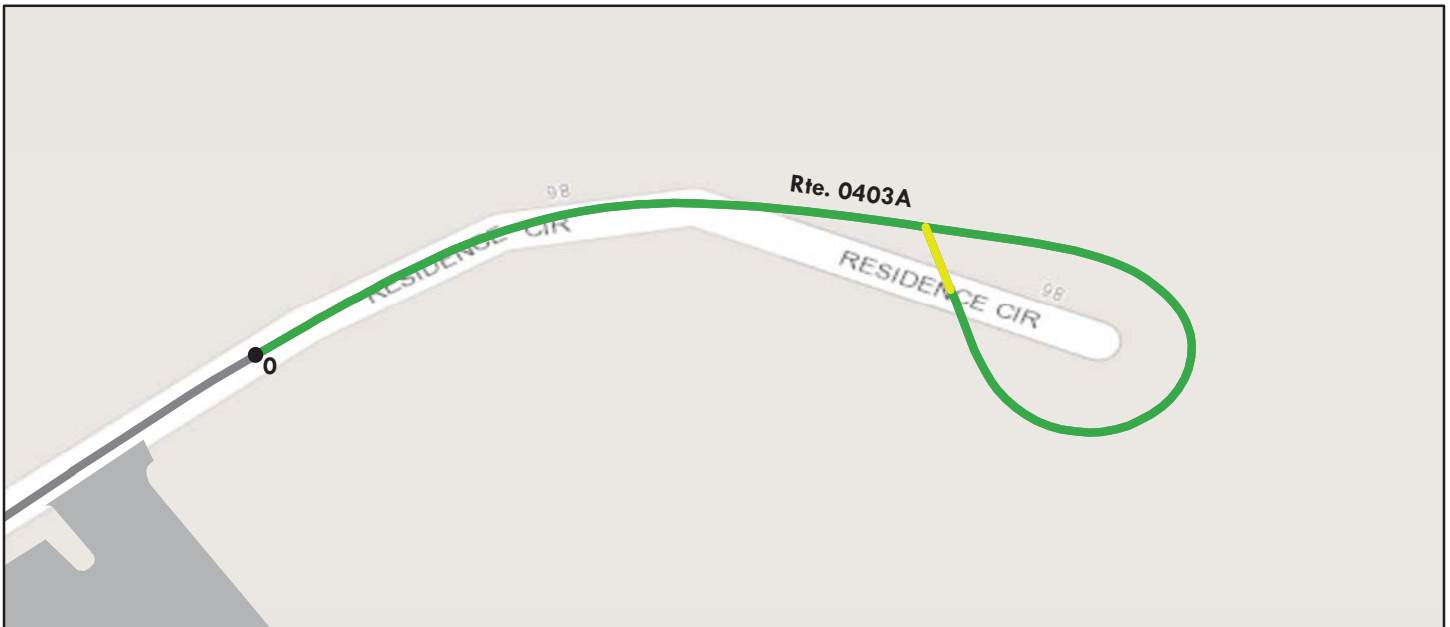
ROUTE 0403A: RESIDENCE AREA ROAD LOOP

Route Condition Legend – Pavement Condition Rating (PCR)						
Poor (0 - 60)	Fair (61- 84)	Good (85 - 94)	Excellent (95 - 100)	Not Rated		
See Appendix for definitions and formulas						
Inspection Date: 3/22/2017	Beginning Section MP	0				
Paved Length (Miles): 0.1	Section Length (MI)	0.1				
Surface Type: ASPHALT	Route Summary					
Roadway Condition Information						
Pavement Condition Rating (PCR)	88	88				
Surface Condition Rating (SCR)	88	88				
Roughness Condition Index (RCI)	N/A	N/A				
Distress Index Values						
Structural Crack Index	99	99				
Alligator Crack Index	100	100				
Longitudinal Crack Index	99	99				
Transverse Cracking Index	88	88				
Patching Index	100	100				
Rutting Index	97	97				
International Roughness Index (IRI)	N/A	N/A				
Lane & Width Information						
Number of Lanes	2	2				
Paved Width (ft)	11.5	11.5				
Lane Width (ft)	5.8	5.8

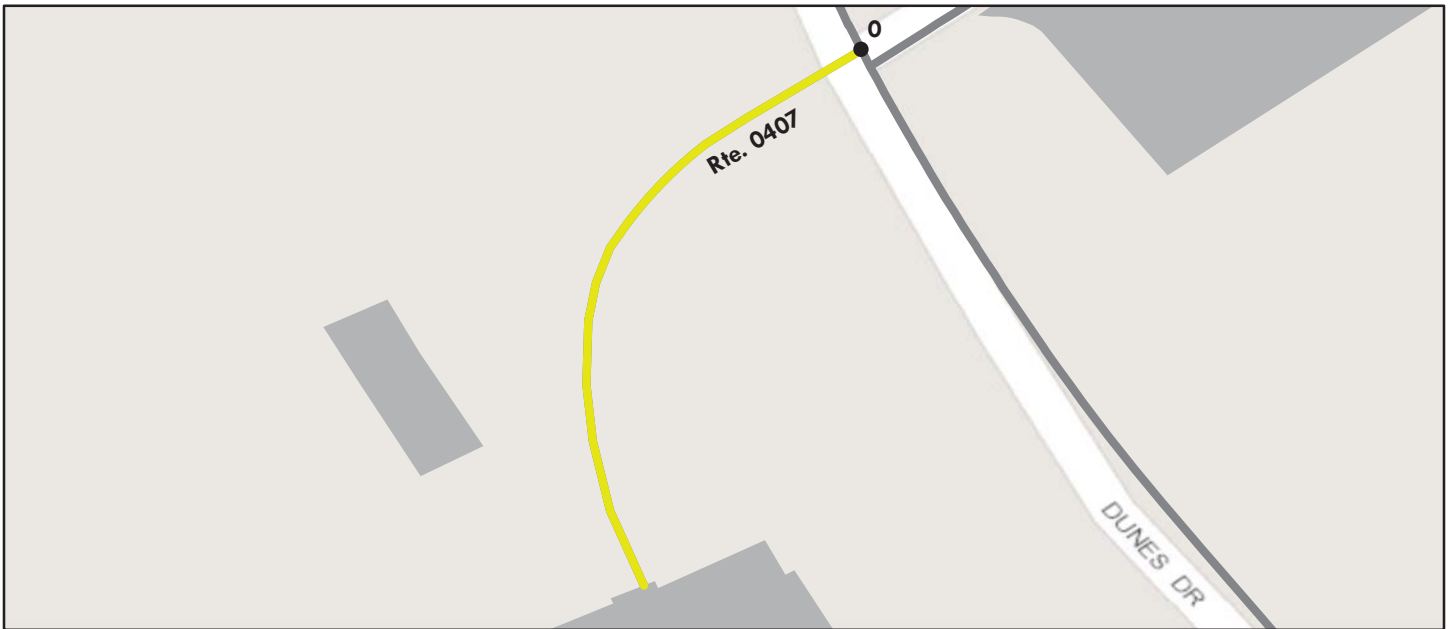
ROUTE 0407: UTILITY AREA ROAD

Route Condition Legend – Pavement Condition Rating (PCR)						
Poor (0 - 60)	Fair (61- 84)	Good (85 - 94)	Excellent (95 - 100)	Not Rated		
See Appendix for definitions and formulas						
Inspection Date: 3/22/2017	Beginning Section MP	0				
Paved Length (Miles): 0.05	Section Length (MI)	0.05				
Surface Type: ASPHALT	Route Summary					
Roadway Condition Information						
Pavement Condition Rating (PCR)	84	84				
Surface Condition Rating (SCR)	84	84				
Roughness Condition Index (RCI)	N/A	N/A				
Distress Index Values						
Structural Crack Index	84	84				
Alligator Crack Index	100	100				
Longitudinal Crack Index	84	84				
Transverse Cracking Index	89	89				
Patching Index	100	100				
Rutting Index	94	94				
International Roughness Index (IRI)	N/A	N/A				
Lane & Width Information						
Number of Lanes	2	2				
Paved Width (ft)	18.1	18.1				
Lane Width (ft)	11	11

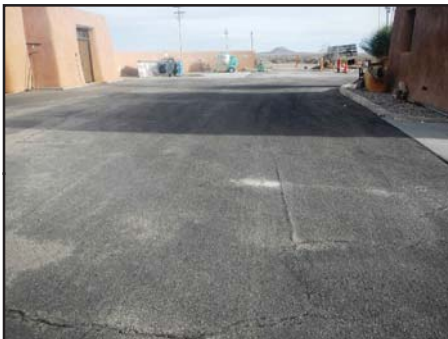
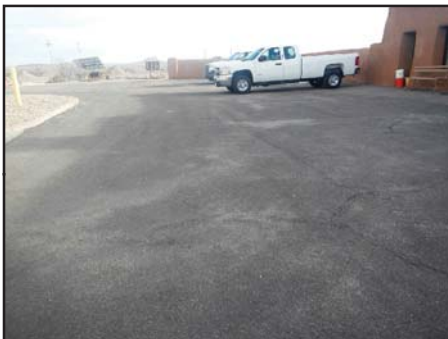
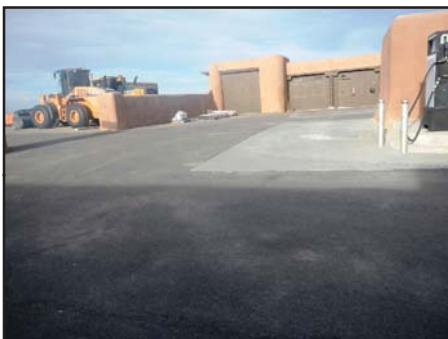
ROUTE 0901: UTILITY AREA PARKING

Inspection Date	FMSS Number	User Access	Surface Type
2/27/2017	N/A	NONPUBLIC	ASPHALT
Area (Sq. Ft.)	Lane Miles (11' Widths)	Curb Reveal (Inches)	Curb Recommendation
11,252	0.194	4	DO NOTHING
Curb Type		Curb & Gutter Type	
CONCRETE		NO CURB AND GUTTER	
Pavement Recommendation		Condition Rating / PCR	
PREVENTIVE MAINTENANCE		GOOD / 90

Note: Parking area consists of multiple surface types: 1 part Asphalt at 10,783 square feet; 1 part Concrete at 469 square feet.

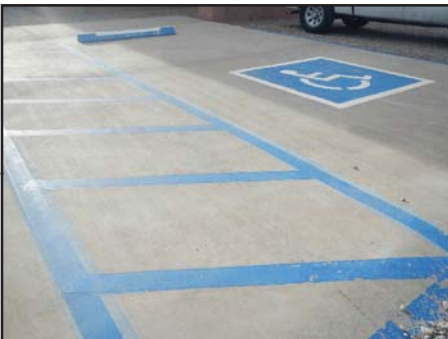
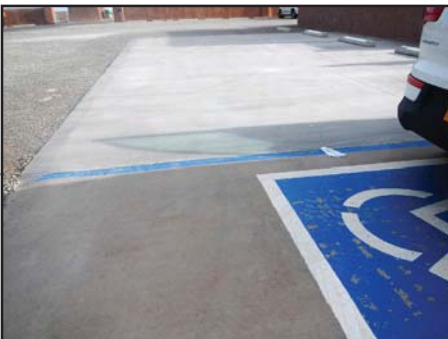
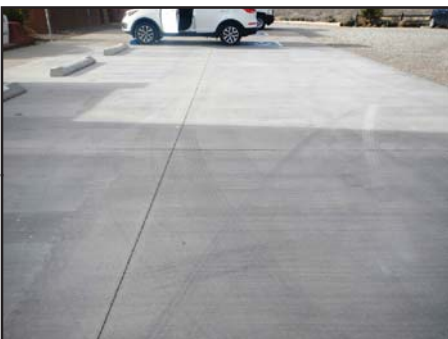
ROUTE 0903: ADMINISTRATIVE HANDICAP PARKING

Inspection Date	FMSS Number	User Access	Surface Type
2/27/2017	60212	PUBLIC	CONCRETE
Area (Sq. Ft.)	Lane Miles (11' Widths)	Curb Reveal (Inches)	Curb Recommendation
1,902	0.033	NOT APPLICABLE	NOT APPLICABLE
Curb Type		Curb & Gutter Type	
NO CURB		NO CURB AND GUTTER	
Pavement Recommendation		Condition Rating / PCR	
PREVENTIVE MAINTENANCE		GOOD / 90

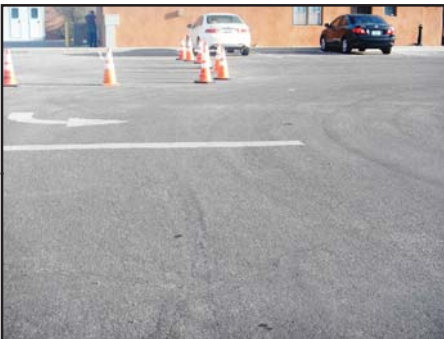
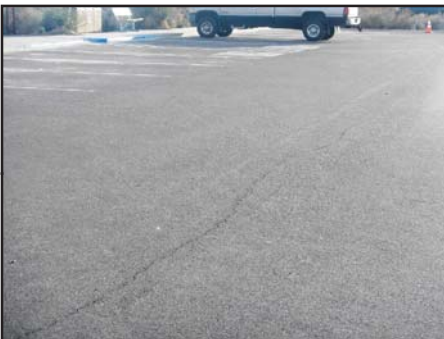
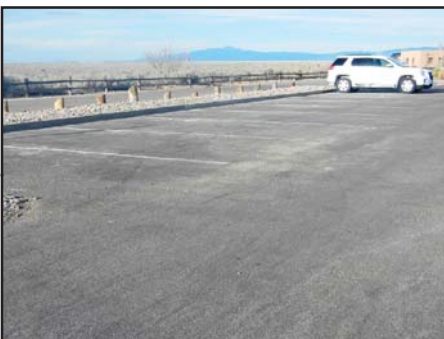
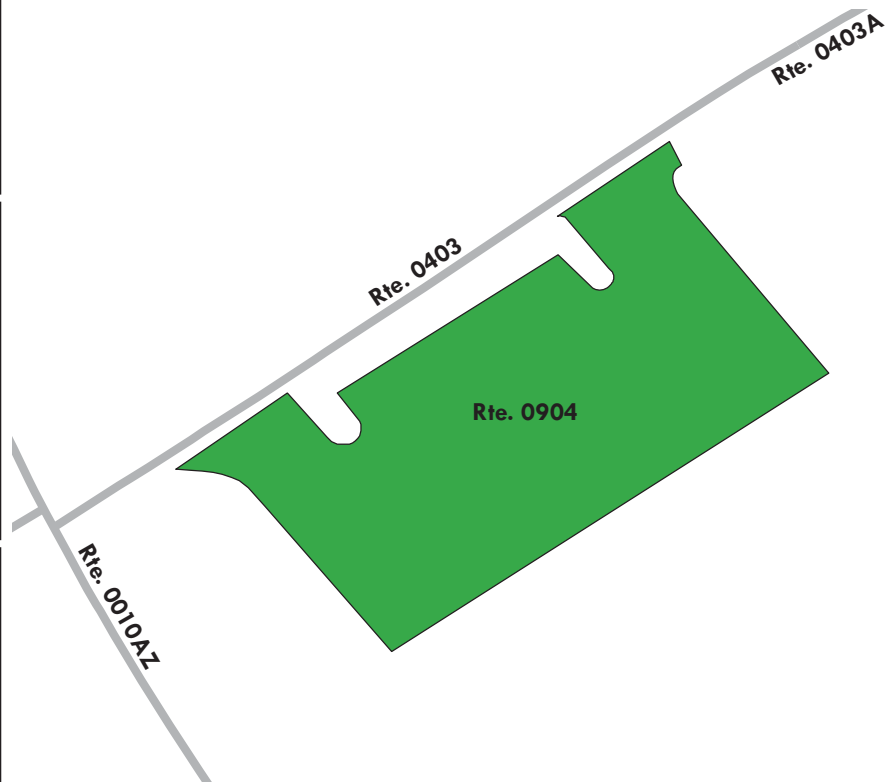
ROUTE 0904: VISITOR CENTER NORTH PARKING

Inspection Date	FMSS Number	User Access	Surface Type
2/27/2017	56210	PUBLIC	ASPHALT
Area (Sq. Ft.)	Lane Miles (11' Widths)	Curb Reveal (Inches)	Curb Recommendation
16,220	0.279	4	DO NOTHING
Curb Type		Curb & Gutter Type	
CONCRETE		CONCRETE	
Pavement Recommendation		Condition Rating / PCR	
PREVENTIVE MAINTENANCE		GOOD / 90

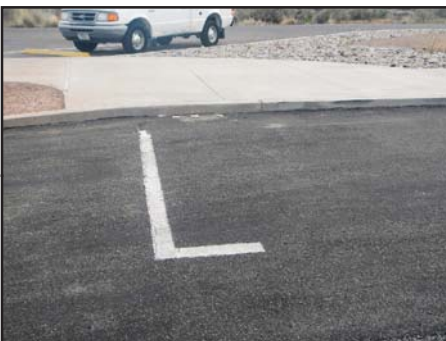
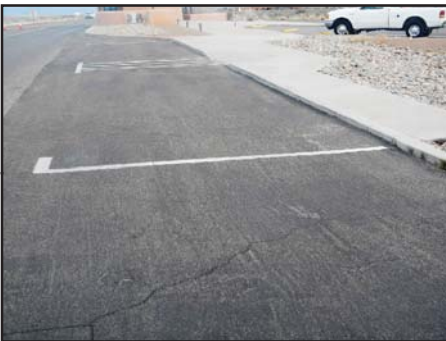
ROUTE 0907AZ: ENTRANCE STATION PARKING AREA A

Inspection Date	FMSS Number	User Access	Surface Type
2/27/2017	240229	PUBLIC	ASPHALT
Area (Sq. Ft.)	Lane Miles (11' Widths)	Curb Reveal (Inches)	Curb Recommendation
752	0.013	3	DO NOTHING
Curb Type		Curb & Gutter Type	
CONCRETE		NO CURB AND GUTTER	
Pavement Recommendation		Condition Rating / PCR	
PREVENTIVE MAINTENANCE		GOOD / 90

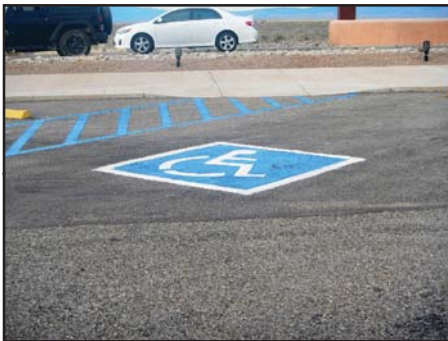
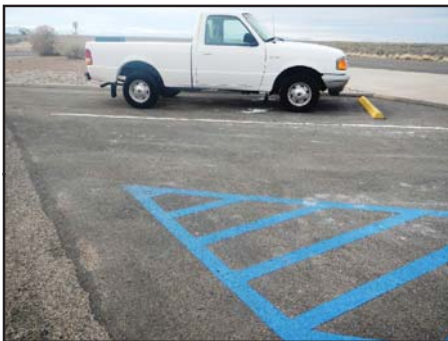
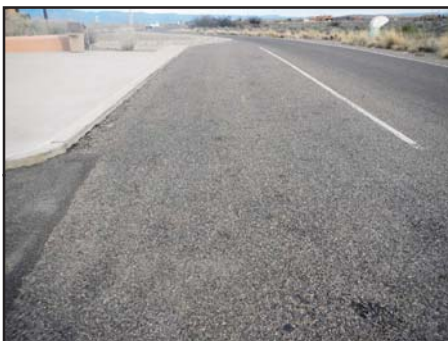
ROUTE 0907BZ: ENTRANCE STATION PARKING AREA B

Inspection Date	FMSS Number	User Access	Surface Type
2/27/2017	240229	PUBLIC	ASPHALT
Area (Sq. Ft.)	Lane Miles (11' Widths)	Curb Reveal (Inches)	Curb Recommendation
2,400	0.041	3	DO NOTHING
Curb Type		Curb & Gutter Type	
CONCRETE		NO CURB AND GUTTER	
Pavement Recommendation		Condition Rating / PCR	
PREVENTIVE MAINTENANCE		GOOD / 90
