# WICR Cycle 6

## Final Report

### Road Inventory and Condition Assessment of Paved Routes Wilson's Creek National Battlefield

**Report Date: May 2018**

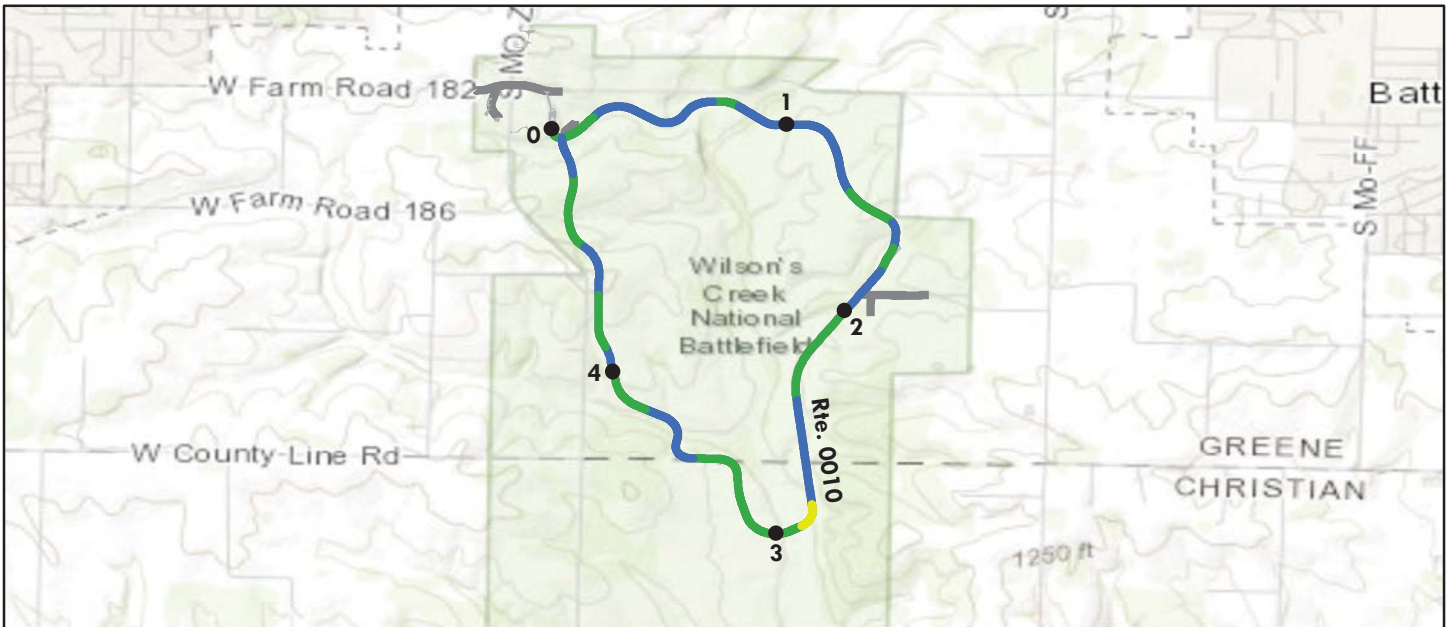
## ROUTE 0010: TOUR ROAD

Colors on map represent condition scores at 0.10-mile intervals. See Appendix for definitions and formulas.

Inspection Date:	Beginning Section MP					
	0	1	2	3	4	
Paved Length (Miles): 4.95	Section Length (MI)					
Surface Type: ASPHALT	Route Summary					
<b>Roadway Condition Information</b>						
Pavement Condition Rating (PCR)	94	95	96	92	93	95
Surface Condition Rating (SCR)	96	97	96	95	95	96
Roughness Condition Index (RCI)	92	91	96	88	90	93
<b>Distress Index Values</b>						
Structural Crack Index	99	100	99	99	98	98
Alligator Crack Index	100	100	100	100	100	100
Longitudinal Crack Index	99	100	99	99	98	98
Transverse Cracking Index	96	97	96	95	95	97
Patching Index	100	99	100	100	100	100
Rutting Index	96	99	96	96	96	96
International Roughness Index (IRI)	136	138	125	146	140	133
<b>Lane &amp; Width Information</b>						
Number of Lanes	1	1	1	1	1	1
Paved Width (ft)	19.4	19.6	18.8	18.8	19.8	20
Lane Width (ft)	12.4	12.7	12.2	12.1	12.5	12.4

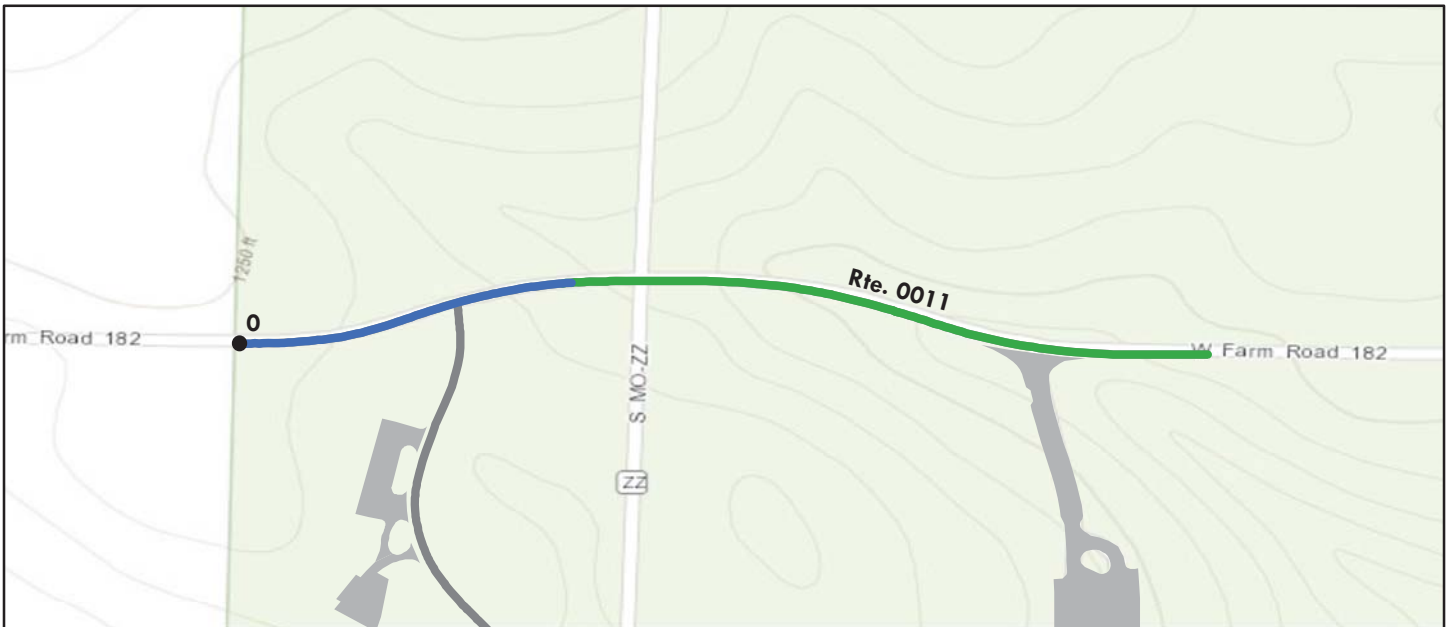
## ROUTE 0011: HIGHWAY 182 / ELM STREET

Colors on map represent condition scores at 0.10-mile intervals. See Appendix for definitions and formulas.

<b>Inspection Date:</b>	11/5/2017	<b>Beginning Section MP</b>	0				
<b>Paved Length (Miles):</b>	0.3	<b>Section Length (MI)</b>	0.29				
<b>Surface Type:</b>	ASPHALT	<b>Route Summary</b>					
<b>Roadway Condition Information</b>							
Pavement Condition Rating (PCR)	91	91					
Surface Condition Rating (SCR)	91	91					
Roughness Condition Index (RCI)	N/A	N/A					
<b>Distress Index Values</b>							
Structural Crack Index	96	96					
Alligator Crack Index	100	100					
Longitudinal Crack Index	96	96					
Transverse Cracking Index	91	91					
Patching Index	100	100					
Rutting Index	96	96					
International Roughness Index (IRI)	N/A	N/A					
<b>Lane &amp; Width Information</b>							
Number of Lanes	2	2					
Paved Width (ft)	34.6	34.6					
Lane Width (ft)	12.5	12.5

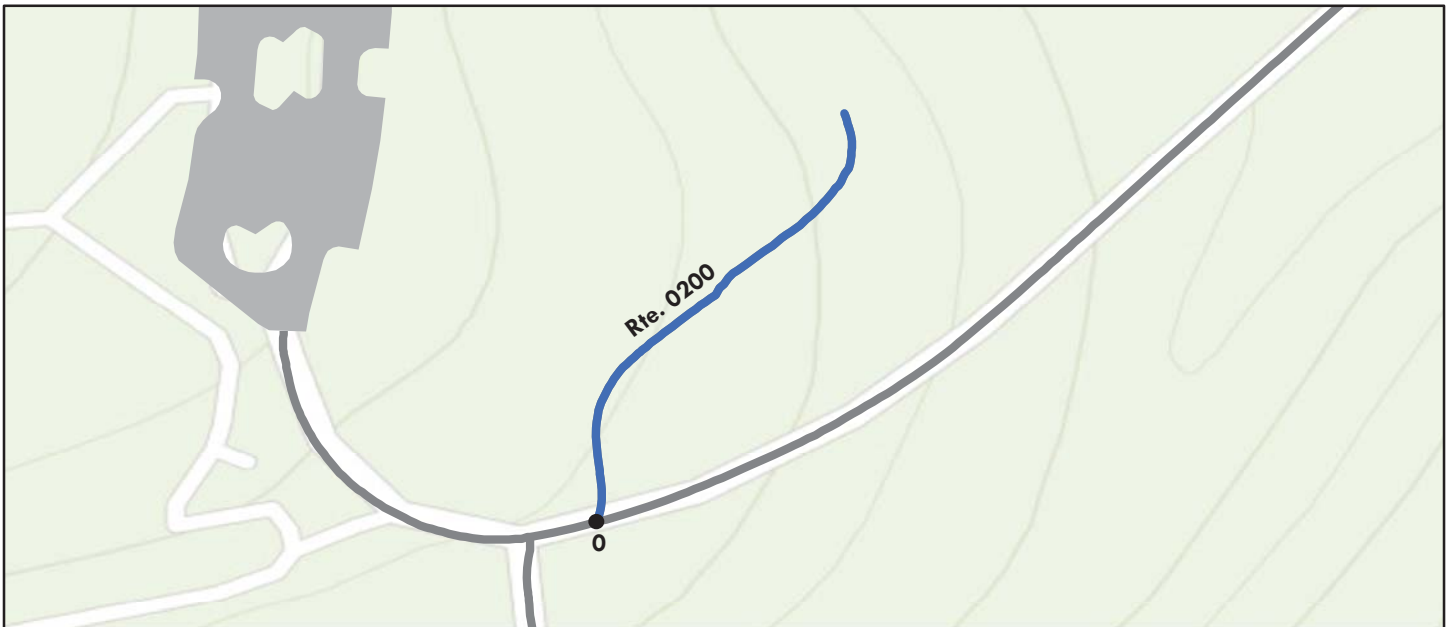
## ROUTE 0200: WASTEWATER PLANT ROAD

Colors on map represent condition scores at 0.10-mile intervals. See Appendix for definitions and formulas.

<b>Inspection Date:</b>	11/5/2017	<b>Beginning Section MP</b>	0				
<b>Paved Length (Miles):</b>	0.08	<b>Section Length (MI)</b>	0.08				
<b>Surface Type:</b>	ASPHALT	<b>Route Summary</b>					
<b>Roadway Condition Information</b>							
Pavement Condition Rating (PCR)	96	96					
Surface Condition Rating (SCR)	96	96					
Roughness Condition Index (RCI)	N/A	N/A					
<b>Distress Index Values</b>							
Structural Crack Index	99	99					
Alligator Crack Index	100	100					
Longitudinal Crack Index	99	99					
Transverse Cracking Index	97	97					
Patching Index	99	99					
Rutting Index	96	96					
International Roughness Index (IRI)	N/A	N/A					
<b>Lane &amp; Width Information</b>							
Number of Lanes	2	2					
Paved Width (ft)	22.6	22.6					
Lane Width (ft)	11.3	11.3

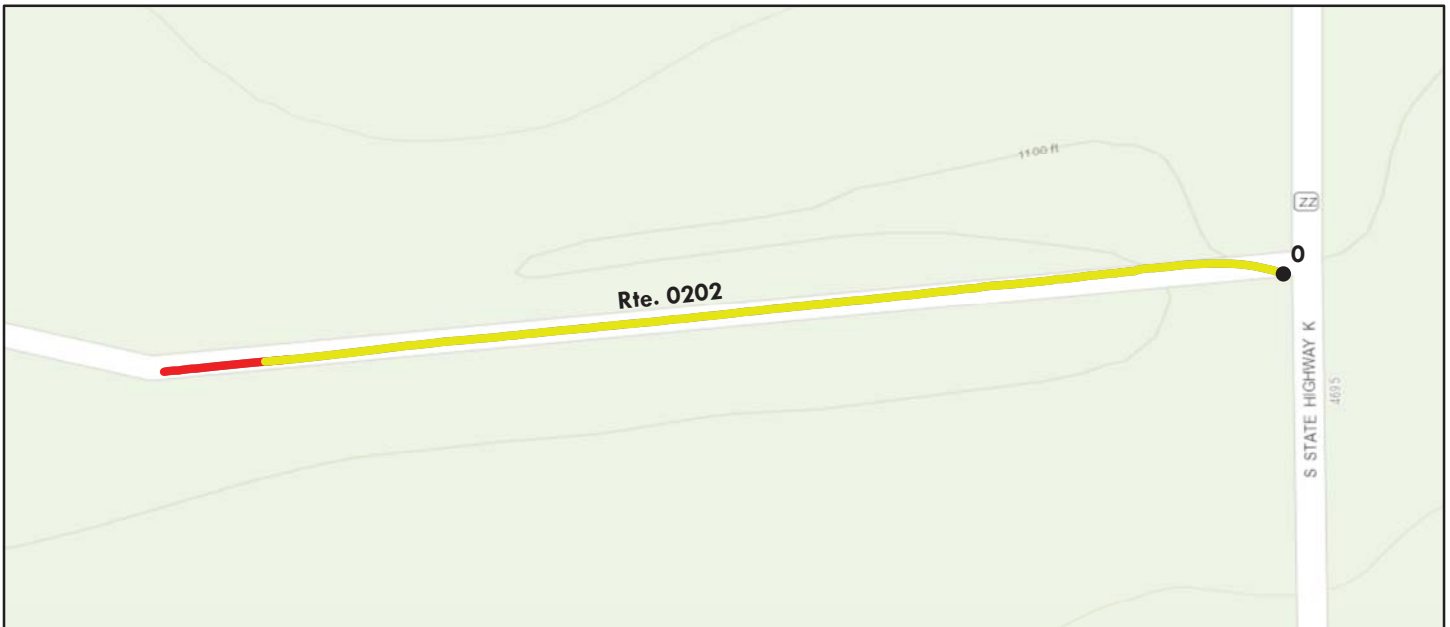
## ROUTE 0202: DOUBLE SPRINGS ROAD

Colors on map represent condition scores at 0.10-mile intervals. See Appendix for definitions and formulas.

<b>Inspection Date:</b>	11/5/2017	<b>Beginning Section MP</b>	0				
<b>Paved Length (Miles):</b>	0.11	<b>Section Length (MI)</b>	0.11				
<b>Surface Type:</b>	ASPHALT	<b>Route Summary</b>					
<b>Roadway Condition Information</b>							
Pavement Condition Rating (PCR)	71	71					
Surface Condition Rating (SCR)	71	71					
Roughness Condition Index (RCI)	N/A	N/A					
<b>Distress Index Values</b>							
Structural Crack Index	85	85					
Alligator Crack Index	100	100					
Longitudinal Crack Index	85	85					
Transverse Cracking Index	71	71					
Patching Index	100	100					
Rutting Index	92	92					
International Roughness Index (IRI)	N/A	N/A					
<b>Lane &amp; Width Information</b>							
Number of Lanes	2	2					
Paved Width (ft)	15.6	15.6					
Lane Width (ft)	7.8	7.8

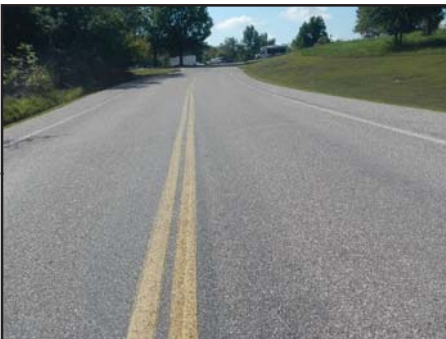
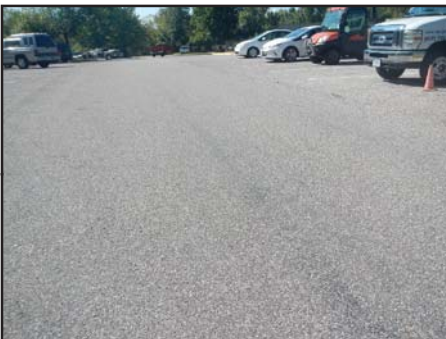
Inspection Date	FMSS Number	User Access	Surface Type
9/22/2017	65300	PUBLIC	ASPHALT
Area (Sq. Ft.)	Lane Miles (11' Widths)	Curb Reveal (Inches)	Curb Recommendation
60,203	1.037	NOT APPLICABLE	DO NOTHING
Curb Type		Curb & Gutter Type	
NO CURB		CONCRETE	
Pavement Recommendation		Condition Rating / PCR	
PREVENTIVE MAINTENANCE		GOOD / 90

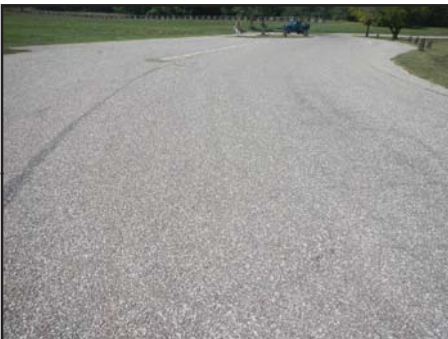
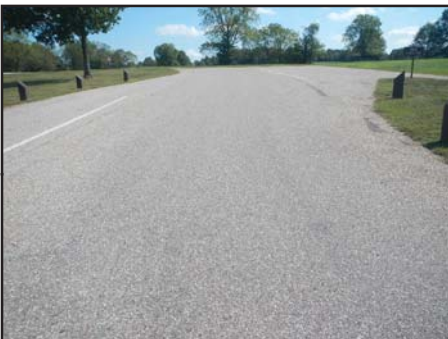
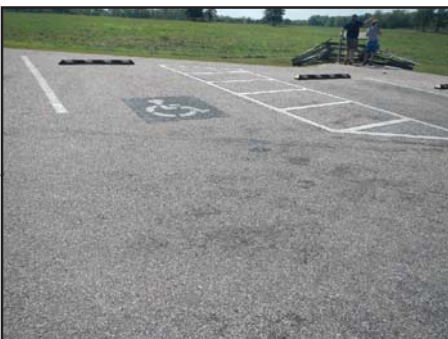
## ROUTE 0901: GIBSON MILL PARKING (TOUR STOP 1)

Inspection Date	FMSS Number	User Access	Surface Type
9/22/2017	65301	PUBLIC	ASPHALT
Area (Sq. Ft.)	Lane Miles (11' Widths)	Curb Reveal (Inches)	Curb Recommendation
15,209	0.262	NOT APPLICABLE	NOT APPLICABLE
Curb Type		Curb & Gutter Type	
NO CURB		NO CURB AND GUTTER	
Pavement Recommendation		Condition Rating / PCR	
PREVENTIVE MAINTENANCE		GOOD / 90

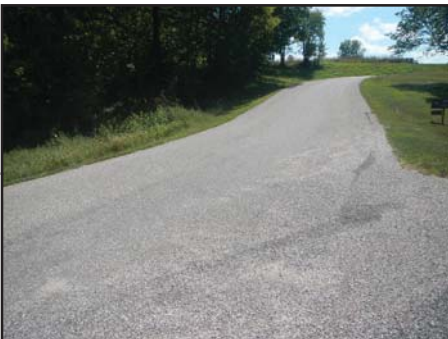
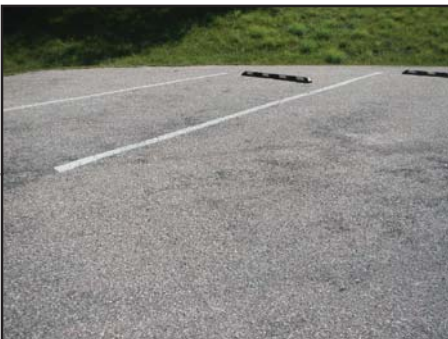
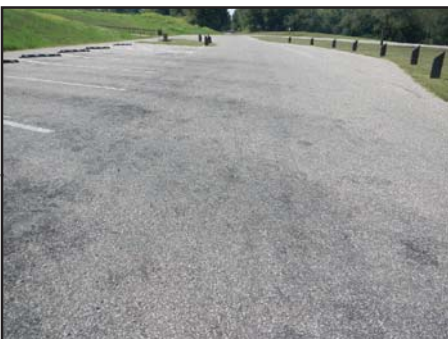
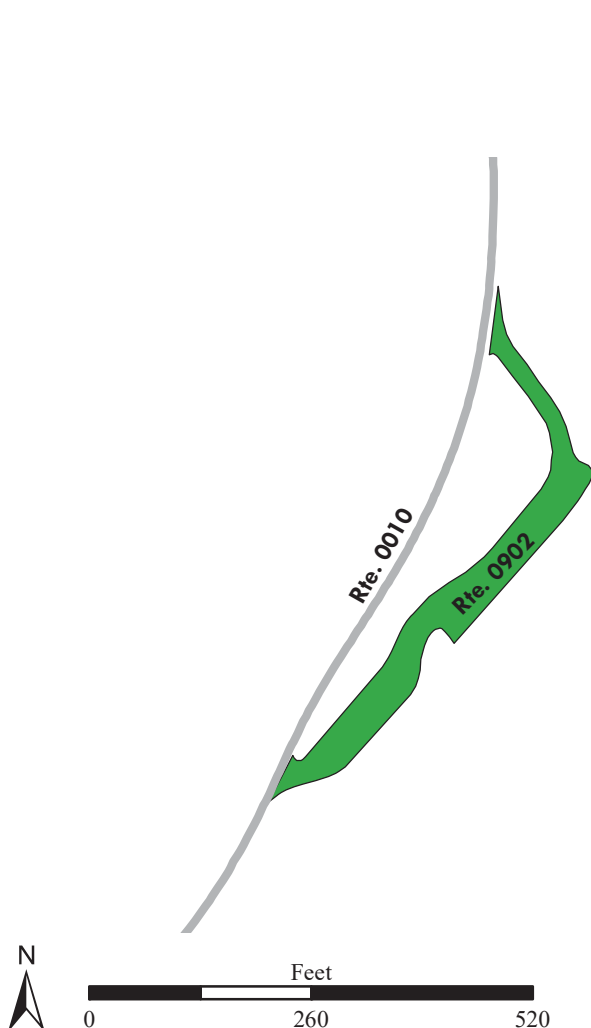
## ROUTE 0902: RAY HOUSE PARKING (TOUR STOP 2)

Inspection Date	FMSS Number	User Access	Surface Type
9/22/2017	65302	PUBLIC	ASPHALT
Area (Sq. Ft.)	Lane Miles (11' Widths)	Curb Reveal (Inches)	Curb Recommendation
20,898	0.36	NOT APPLICABLE	NOT APPLICABLE
Curb Type		Curb & Gutter Type	
NO CURB		NO CURB AND GUTTER	
Pavement Recommendation		Condition Rating / PCR	
PREVENTIVE MAINTENANCE		GOOD / 90

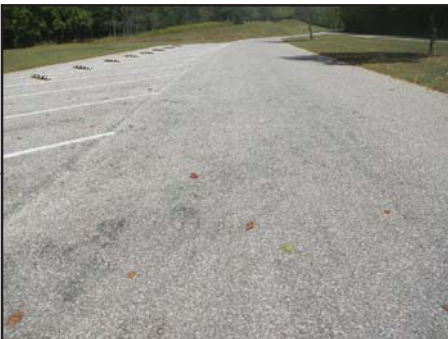
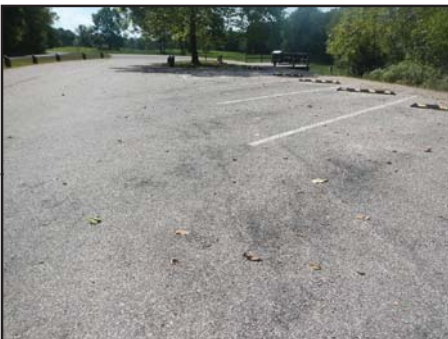
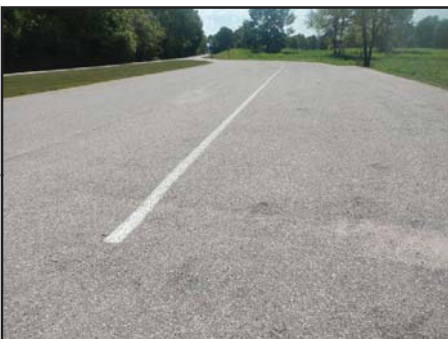
## ROUTE 0903: PRICE PULASKI PARKING (TOUR STOP 3)

Inspection Date	FMSS Number	User Access	Surface Type
9/22/2017	65303	PUBLIC	ASPHALT
Area (Sq. Ft.)	Lane Miles (11' Widths)	Curb Reveal (Inches)	Curb Recommendation
23,114	0.398	NOT APPLICABLE	NOT APPLICABLE
Curb Type		Curb & Gutter Type	
NO CURB		NO CURB AND GUTTER	
Pavement Recommendation		Condition Rating / PCR	
PREVENTIVE MAINTENANCE		GOOD / 90

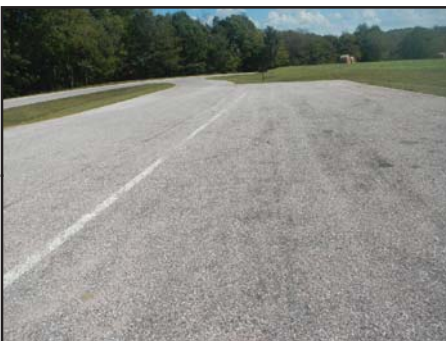
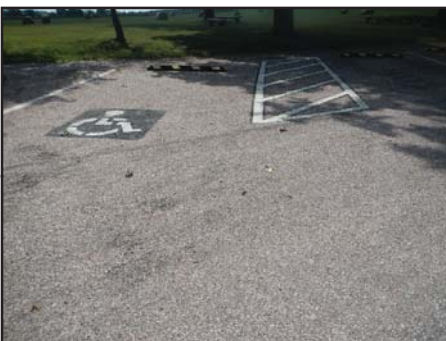
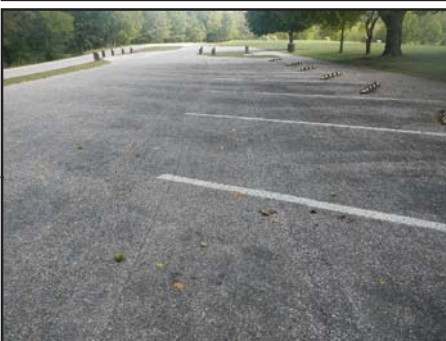
## ROUTE 0904: SIGEL'S FINAL PARKING (TOUR STOP 5)

Inspection Date	FMSS Number	User Access	Surface Type
9/22/2017	65308	PUBLIC	ASPHALT
Area (Sq. Ft.)	Lane Miles (11' Widths)	Curb Reveal (Inches)	Curb Recommendation
16,565	0.285	NOT APPLICABLE	NOT APPLICABLE
Curb Type		Curb & Gutter Type	
NO CURB		NO CURB AND GUTTER	
Pavement Recommendation		Condition Rating / PCR	
PREVENTIVE MAINTENANCE		GOOD / 90

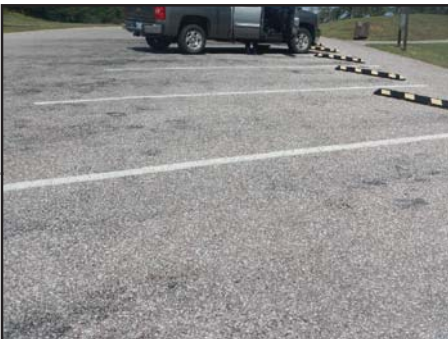
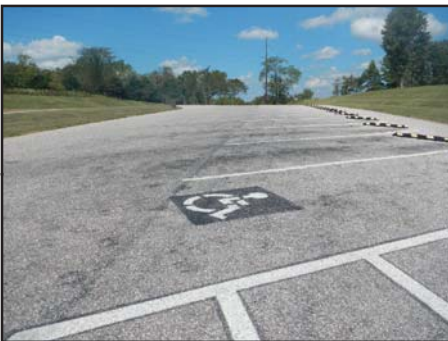
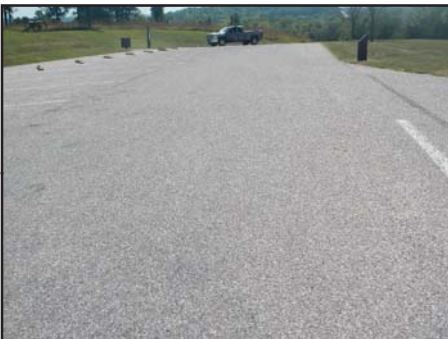
## ROUTE 0905: BLOODY HILL PARKING (TOUR STOP 7)

Inspection Date	FMSS Number	User Access	Surface Type
9/22/2017	65310	PUBLIC	ASPHALT
Area (Sq. Ft.)	Lane Miles (11' Widths)	Curb Reveal (Inches)	Curb Recommendation
21,241	0.366	NOT APPLICABLE	NOT APPLICABLE
Curb Type		Curb & Gutter Type	
NO CURB		NO CURB AND GUTTER	
Pavement Recommendation		Condition Rating / PCR	
PREVENTIVE MAINTENANCE		GOOD / 90

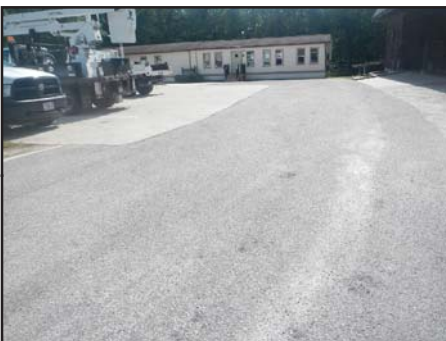
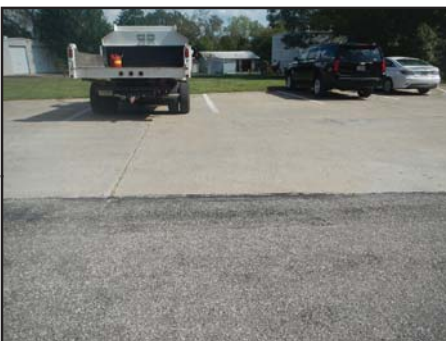
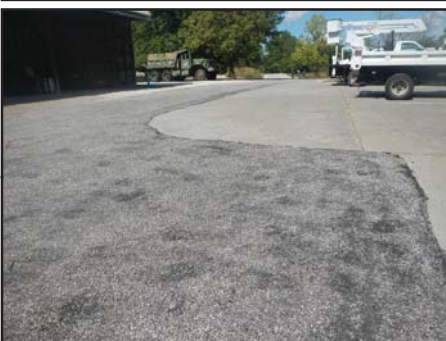
## ROUTE 0907: MAINTENANCE OFFICE PARKING

Inspection Date	FMSS Number	User Access	Surface Type
9/22/2017	103182	NONPUBLIC	CONCRETE
Area (Sq. Ft.)	Lane Miles (11' Widths)	Curb Reveal (Inches)	Curb Recommendation
7,470	0.129	NOT APPLICABLE	NOT APPLICABLE
Curb Type		Curb & Gutter Type	
NO CURB		NO CURB AND GUTTER	
Pavement Recommendation		Condition Rating / PCR	
PREVENTIVE MAINTENANCE		GOOD / 90

Note: Parking area consists of multiple surface types: 1 part Asphalt at 3,205 square feet; 2 parts Concrete at 4,265 square feet.
