# WOTR Cycle 6

## Final Report

### Road Inventory and Condition Assessment of Paved Routes Wolf Trap National Park for the Performing Arts

Report Date: October 2018

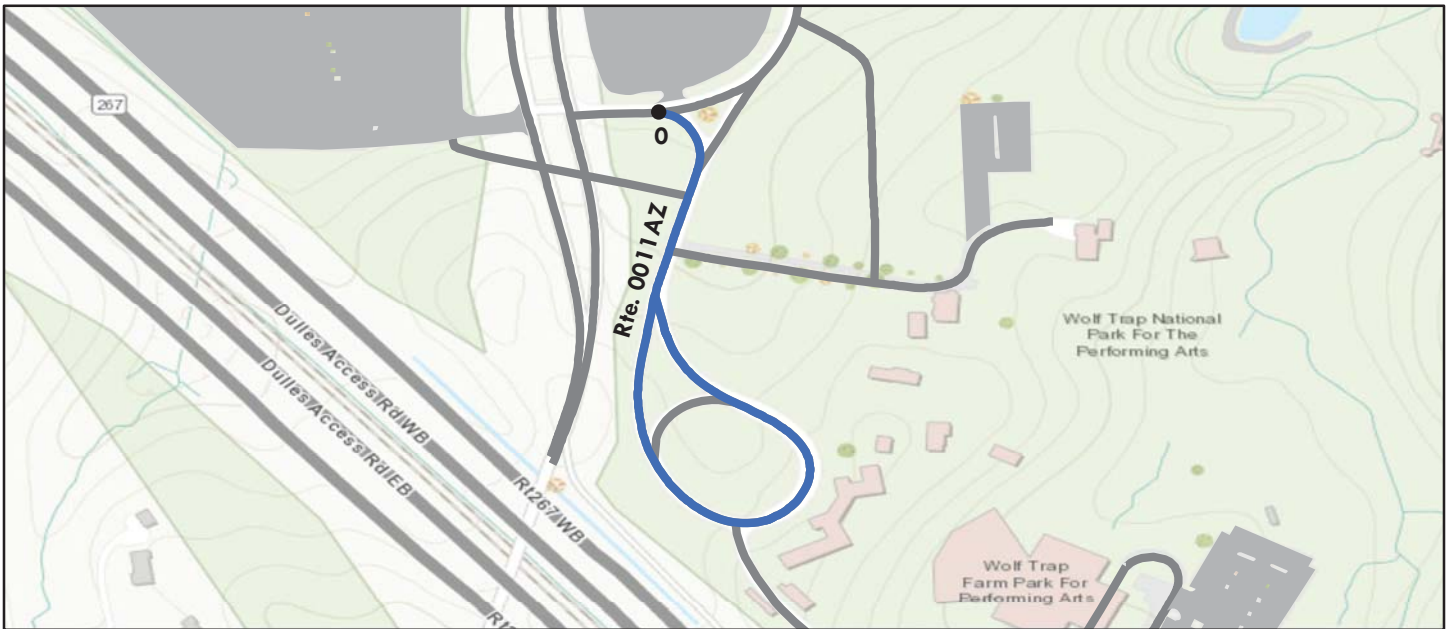
## ROUTE 0011AZ: MAIN CIRCLE ROAD

<b>Inspection Date:</b> 3/26/2018	<b>Beginning Section MP</b>	0				
<b>Paved Length (Miles):</b> 0.31	<b>Section Length (MI)</b>	0.31				
<b>Surface Type:</b> ASPHALT	<b>Route Summary</b>					
<b>Roadway Condition Information</b>						
Pavement Condition Rating (PCR)	99	99				
Surface Condition Rating (SCR)	99	99				
Roughness Condition Index (RCI)	N/A	N/A				
<b>Distress Index Values</b>						
Structural Crack Index	100	100				
Alligator Crack Index	100	100				
Longitudinal Crack Index	100	100				
Transverse Cracking Index	99	99				
Patching Index	100	100				
Rutting Index	99	99				
International Roughness Index (IRI)	N/A	N/A				
<b>Lane &amp; Width Information</b>						
Number of Lanes	1	1				
Paved Width (ft)	18.3	18.3				
Lane Width (ft)	14.6	14.6

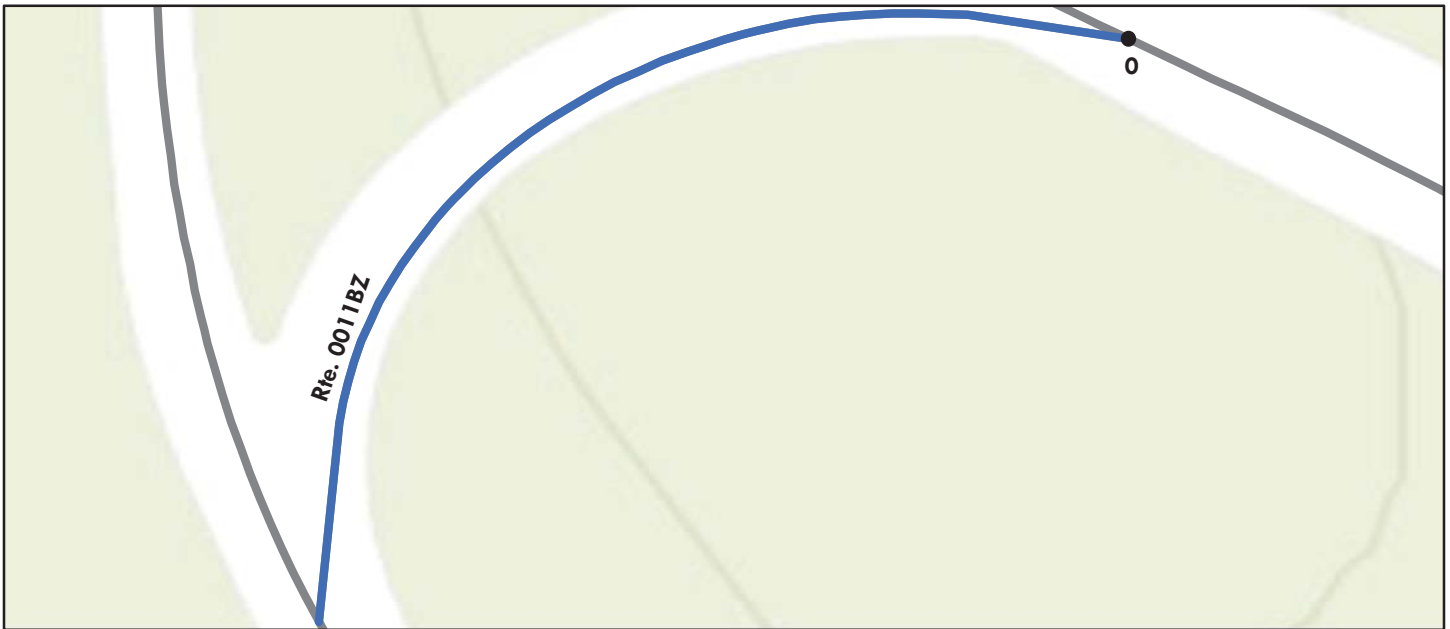
Subcomponent of Route WOTR-0011ZZ

<b>Inspection Date:</b>	3/26/2018	<b>Beginning Section MP</b>	0				
<b>Paved Length (Miles):</b>	0.03	<b>Section Length (MI)</b>	0.03				
<b>Surface Type:</b>	ASPHALT	<b>Route Summary</b>					
<b>Roadway Condition Information</b>							
Pavement Condition Rating (PCR)	97	97					
Surface Condition Rating (SCR)	97	97					
Roughness Condition Index (RCI)	N/A	N/A					
<b>Distress Index Values</b>							
Structural Crack Index	100	100					
Alligator Crack Index	100	100					
Longitudinal Crack Index	100	100					
Transverse Cracking Index	100	100					
Patching Index	100	100					
Rutting Index	97	97					
International Roughness Index (IRI)	N/A	N/A					
<b>Lane &amp; Width Information</b>							
Number of Lanes	1	1					
Paved Width (ft)	25.2	25.2					
Lane Width (ft)	25.2	25.2

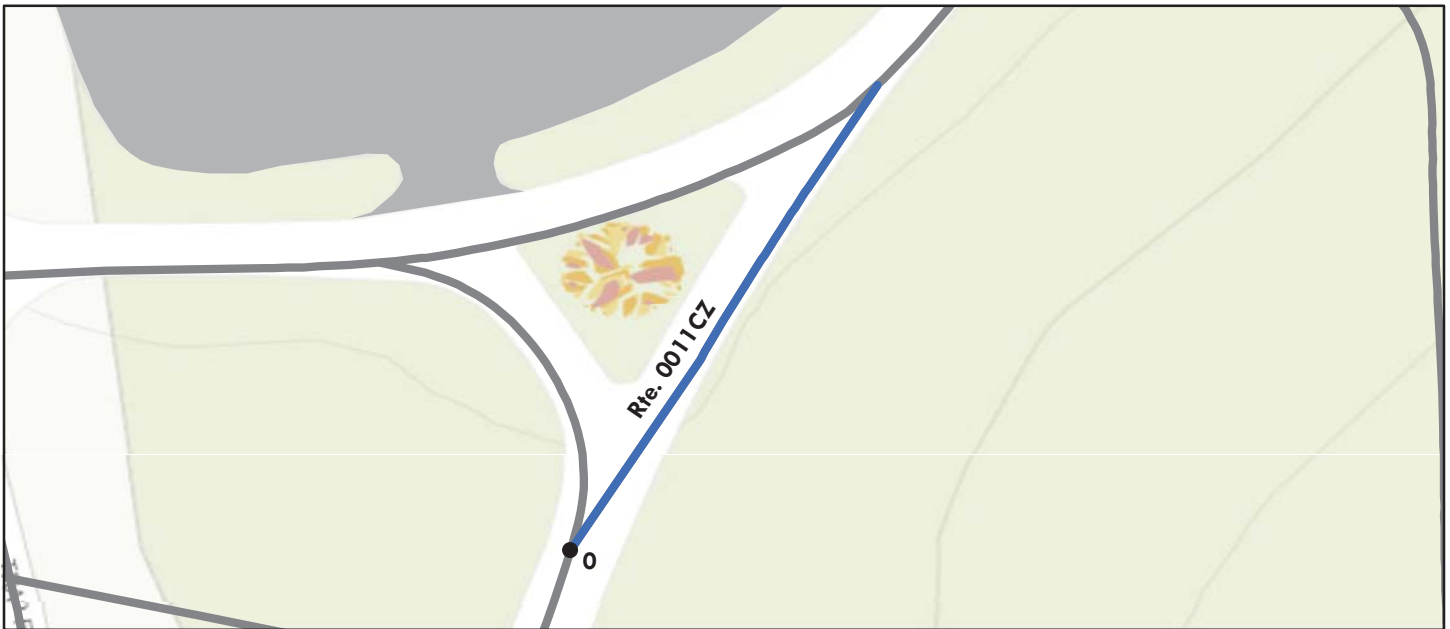
Subcomponent of Route WOTR-0011ZZ

<b>Inspection Date:</b> 3/26/2018	<b>Beginning Section MP</b>	0				
<b>Paved Length (Miles):</b> 0.03	<b>Section Length (MI)</b>	0.03				
<b>Surface Type:</b> ASPHALT	<b>Route Summary</b>					
<b>Roadway Condition Information</b>						
Pavement Condition Rating (PCR)	100	100				
Surface Condition Rating (SCR)	100	100				
Roughness Condition Index (RCI)	N/A	N/A				
<b>Distress Index Values</b>						
Structural Crack Index	100	100				
Alligator Crack Index	100	100				
Longitudinal Crack Index	100	100				
Transverse Cracking Index	100	100				
Patching Index	100	100				
Rutting Index	100	100				
International Roughness Index (IRI)	N/A	N/A				
<b>Lane &amp; Width Information</b>						
Number of Lanes	2	2				
Paved Width (ft)	21.6	21.6				
Lane Width (ft)	10.8	10.8

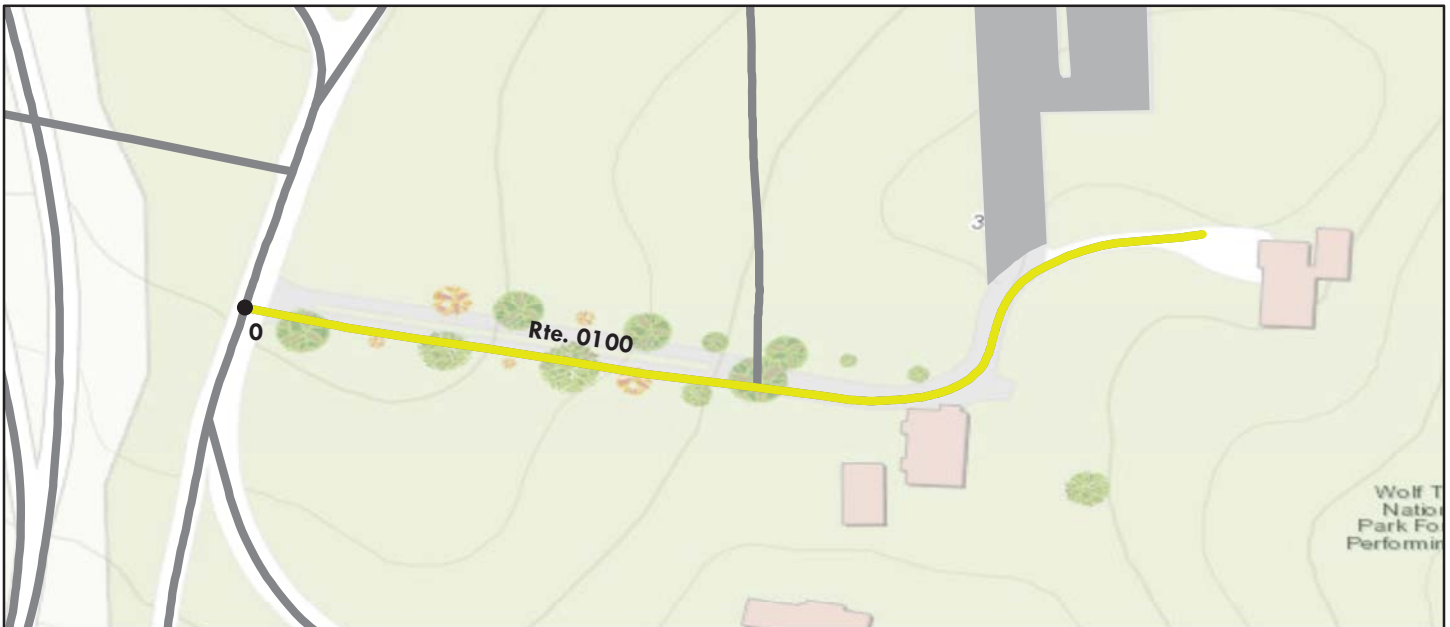
## ROUTE 0100: BARN ROAD

<b>Inspection Date:</b> 3/26/2018	<b>Beginning Section MP</b>	0				
<b>Paved Length (Miles):</b> 0.14	<b>Section Length (MI)</b>	0.14				
<b>Surface Type:</b> ASPHALT	<b>Route Summary</b>					
<b>Roadway Condition Information</b>						
Pavement Condition Rating (PCR)	67	67				
Surface Condition Rating (SCR)	67	67				
Roughness Condition Index (RCI)	N/A	N/A				
<b>Distress Index Values</b>						
Structural Crack Index	79	79				
Alligator Crack Index	100	100				
Longitudinal Crack Index	79	79				
Transverse Cracking Index	67	67				
Patching Index	100	100				
Rutting Index	95	95				
International Roughness Index (IRI)	N/A	N/A				
<b>Lane &amp; Width Information</b>						
Number of Lanes	1	1				
Paved Width (ft)	15.9	15.9				
Lane Width (ft)	11.6	11.6

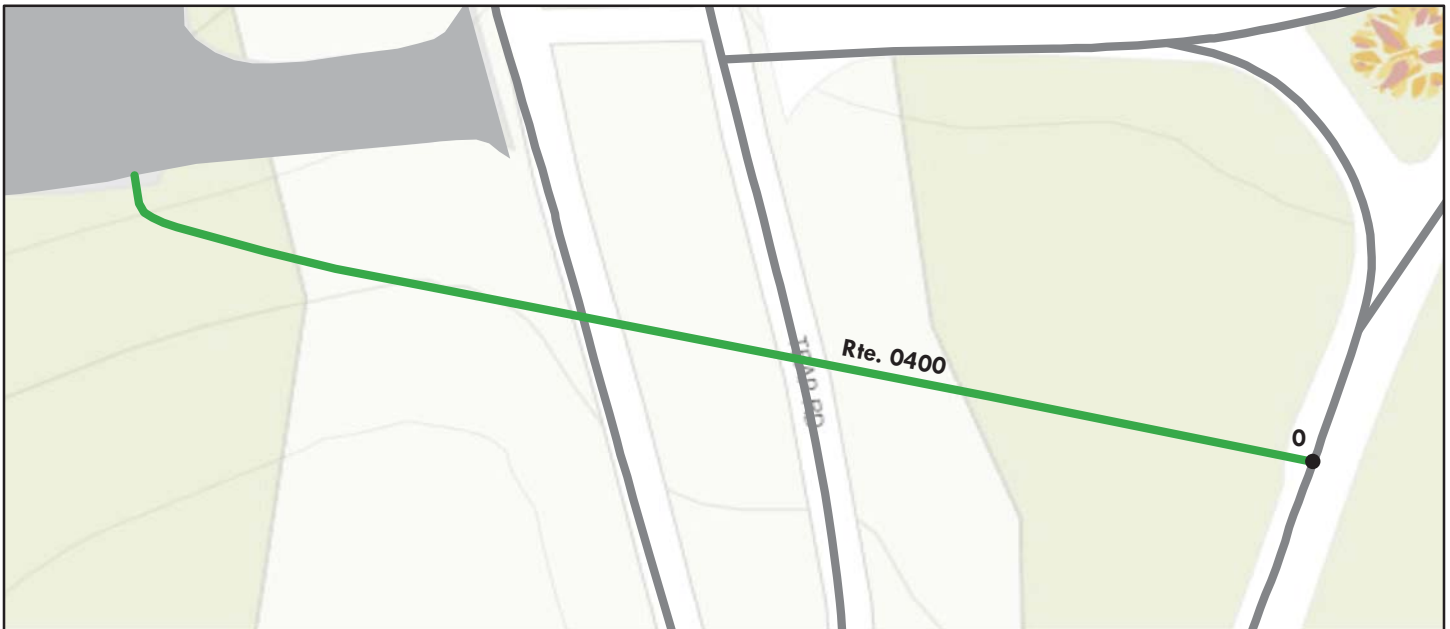
## ROUTE 0400: TUNNEL ROAD

<b>Inspection Date:</b>	3/26/2018	<b>Beginning Section MP</b>	0.00				
<b>Paved Length (Miles):</b>	0.08	<b>Section Length (MI)</b>	0.08				
<b>Surface Type:</b>	ASPHALT	<b>Route Summary</b>					
<b>Roadway Condition Information</b>							
Pavement Condition Rating (PCR)	90	90					
Surface Condition Rating (SCR)	90	90					
Roughness Condition Index (RCI)	N/A	N/A					
<b>Distress Index Values</b>							
Structural Crack Index	N/A	N/A					
Alligator Crack Index	90	90					
Longitudinal Crack Index	90	90					
Transverse Cracking Index	90	90					
Patching Index	90	90					
Rutting Index	90	90					
International Roughness Index (IRI)	N/A	N/A					
<b>Lane &amp; Width Information</b>							
Number of Lanes	2	2					
Paved Width (ft)	17.5	17.5					
Lane Width (ft)	8.8	8.8

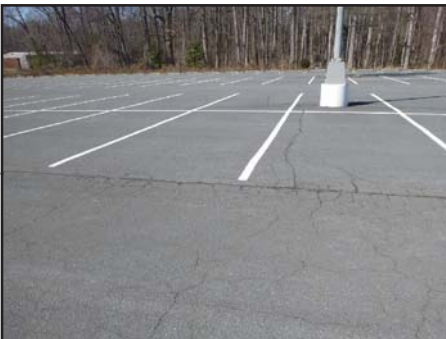
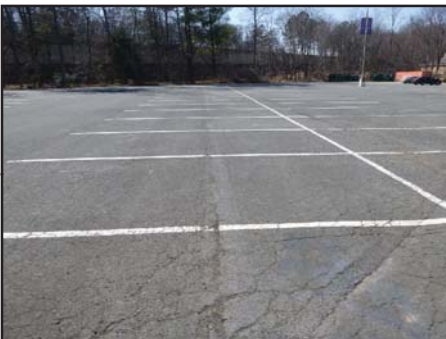
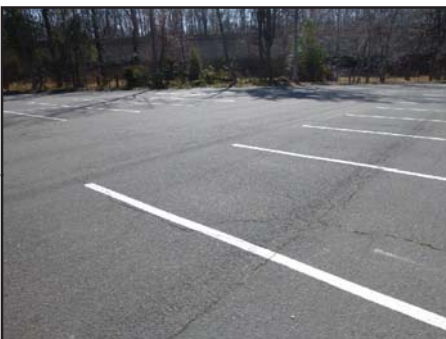
Inspection Date	FMSS Number	User Access	Surface Type
3/26/2018	44202	PUBLIC	ASPHALT
Area (Sq. Ft.)	Lane Miles (11' Widths)	Curb Reveal (Inches)	Curb Recommendation
270,159	4.651	NOT APPLICABLE	NOT APPLICABLE
Curb Type		Curb & Gutter Type	
NO CURB		NO CURB AND GUTTER	
Pavement Recommendation		Condition Rating / PCR	
HEAVY 3R TREATMENTS		POOR / 53

Note: Parking area consists of multiple surface types: 1 part Asphalt at 264,933 square feet; 1 part Concrete at 5,226 square feet.

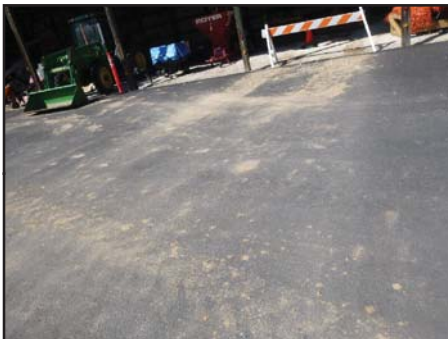
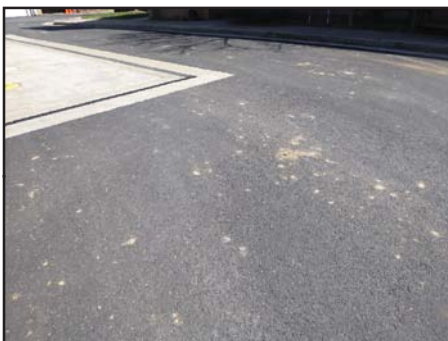
## ROUTE 0901: MAINTENANCE AREA

Inspection Date	FMSS Number	User Access	Surface Type
3/26/2018	91073	NONPUBLIC	ASPHALT
Area (Sq. Ft.)	Lane Miles (11' Widths)	Curb Reveal (Inches)	Curb Recommendation
22,137	0.381	NOT APPLICABLE	DO NOTHING
Curb Type		Curb & Gutter Type	
NO CURB		CONCRETE	
Pavement Recommendation		Condition Rating / PCR	
DO NOTHING		EXCELLENT / 97

Note: Parking area consists of multiple surface types: 1 part Asphalt at 21,303 square feet; 2 parts Concrete at 834 square feet.

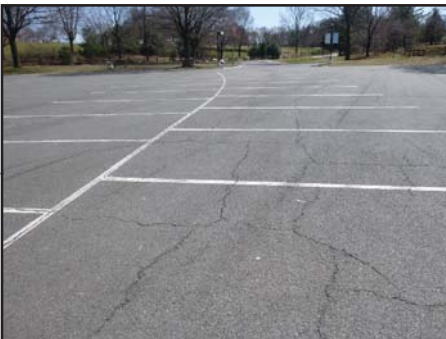
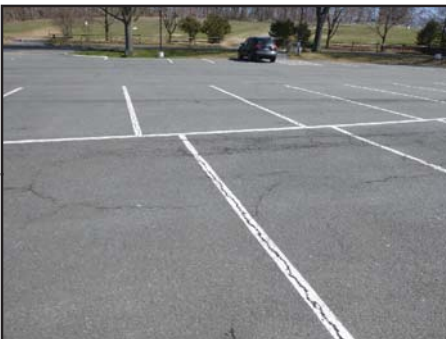
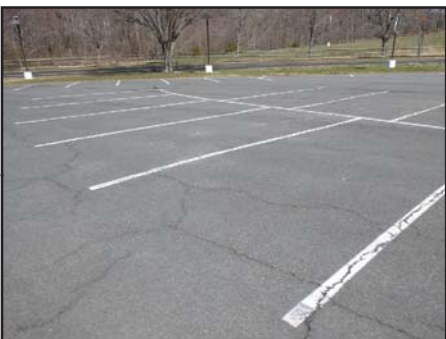
## ROUTE 0902: EAST LOT PARKING

Inspection Date	FMSS Number	User Access	Surface Type
3/26/2018	44203	PUBLIC	ASPHALT
Area (Sq. Ft.)	Lane Miles (11' Widths)	Curb Reveal (Inches)	Curb Recommendation
111,133	1.913	NOT APPLICABLE	NOT APPLICABLE
Curb Type		Curb & Gutter Type	
NO CURB		NO CURB AND GUTTER	
Pavement Recommendation		Condition Rating / PCR	
HEAVY 3R TREATMENTS		POOR / 53

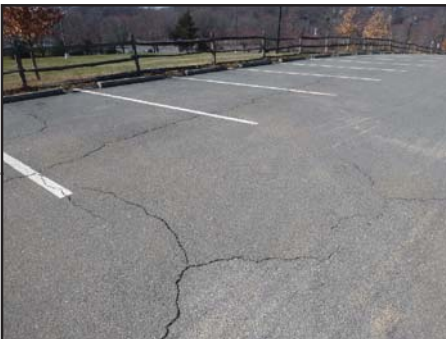
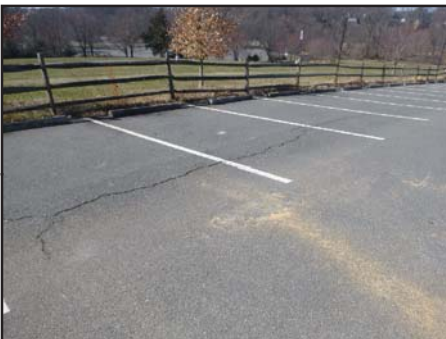
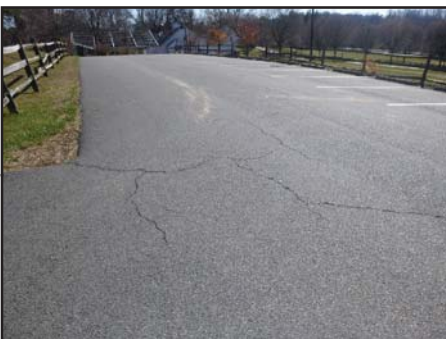
## ROUTE 0907: LOT 3 PARKING

Note: Parking area consists of multiple surface types: 1 part Asphalt at 21,762 square feet; 1 part Concrete at 413 square feet.
