# WRBR Cycle 6

# Final Report

# Road Inventory and Condition Assessment of Paved Routes Wright Brothers National Memorial

# Wright Brothers National Memorial in North Carolina

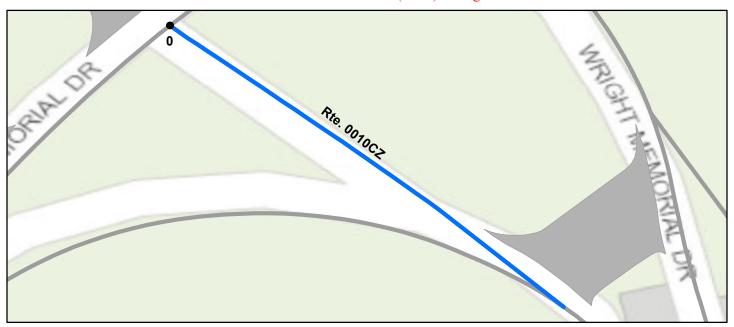
Pouto (	Condition Legend – Pa	vement Condi	ition Rating (	PCD)		
Poor (0 - 60)	Fair (6		(85 - 94)	Excellent (		Not Ra	ted
	,	dition scores at 0.10-mi			* · ·		
				e Appendix id	or definitions	and formulas.	
<b>Inspection Date:</b> 5/27	/2021	Beginning Section M	P 0				
Paved Length (Miles): 0.02		Section Length (MI)	0.02				
Surface Type: ASF	HALT	Route Summary		•		-	
Roadway Condition Inform	nation						
Pavement Condition Rating	g (PCR)	99	99				
Surface Condition Rating (S	CR)	99	99				
Roughness Condition Index	(RCI)	N/A	N/A				
Distress Index Values	Distress Index Values						
Structural Crack Index		100	100				
Alligator Crack Index		100	100				
Longitudinal Crack Index		100	100				
Transverse Cracking Index		100	100				
Patching Index		100	100				
Rutting Index		99	99				
International Roughness Index (IRI)		N/A	N/A				
Lane & Width Information	Lane & Width Information						
Number of Lanes		1	1

Paved Width (ft)		15.5	15.5				
Lane Width (ft)		13.6	13.6

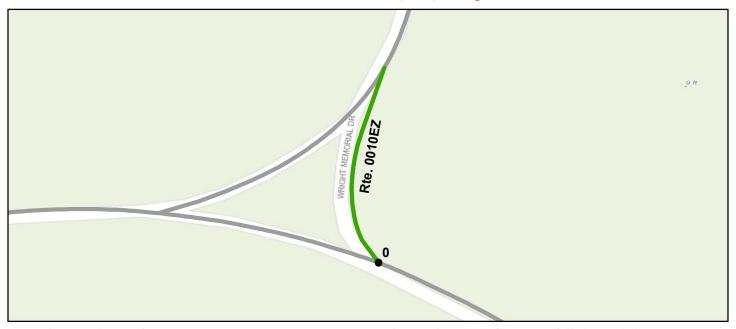
#### ROUTE 0010EZ: WB RD PARK ENTRANCE ROAD SPUR WITH PYLON LOOP ROAD

Route (	Condition Legend – Pav	ement Condi	tion Rating (	PCR)		
Poor (0 - 60	_		(85 - 94)	Excellent (		Not Rated	
*	•	dition scores at 0.10-mile				and formulas.	
Inspection Date:	5/27/2021	<b>Beginning Section MP</b>	0				
Paved Length (Mile	es): 0.04	Section Length (MI)	0.04				
Surface Type:	ASPHALT	Route Summary				•	
Roadway Condition	n Information						
Pavement Conditio	on Rating (PCR)	92	92				
Surface Condition R	Lating (SCR)	92	92				
Roughness Conditio	n Index (RCI)	N/A	N/A				
Distress Index Values							
Structural Crack In	dex	100	100				
Alligator Crack Ind	lex	100	100				
Longitudinal Crack	Index	100	100				
Transverse Crackin	ng Index	99	99				
Patching Index		100	100				
Rutting Index		92	92				
International Roughness Index (IRI)		N/A	N/A				
Lane & Width Info	rmation						
Number of Lanes		1	1				
Paved Width (ft)		19.2	19.2				
Lane Width (ft)		17	17

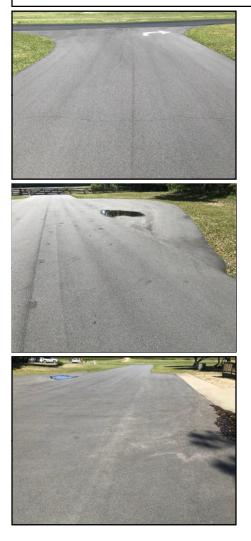
ROUTE 0903: WB RD PILOTS FACILITY PARKING

Inspection Date	FMSS Number	User Access	Surface Type	
5/6/2021	104898	PUBLIC	ASPHALT	
Area (Sq. Ft.)	Lane Miles (11' Widths)	Curb Reveal (Inches)	Curb Recommendation	
7,284	0.125	NOT APPLICABLE	NOT APPLICABLE	
Curb	Curb Type		Curb & Gutter Type	
NO C	NO CURB		NO CURB AND GUTTER	
Pavement Recommendation Condition Rating / PCR		eating / PCR		
PREVENTIVE MAINTENANCE		CE GOOD / 90		
Route Condition Legend – Pavement Condition Rating (PCR)				
Poor (0 - 60)	, ,	(85 - 94) <b>Excellent</b> (95 - 10	0) Not Rated	
See Appendix for definitions and formulas

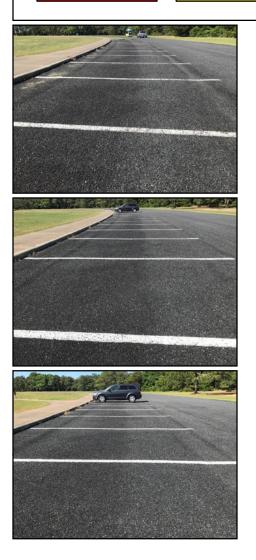
ROUTE 0907AZ: WB RD MONUMENT PARKING A

<b>Inspection Date</b>	FMSS Number	User Access	Surface Type	
5/6/2021	104915	PUBLIC	ASPHALT	
Area (Sq. Ft.)	Lane Miles (11' Widths)	Curb Reveal (Inches)	Curb Recommendation	
5,263	0.091	6	DO NOTHING	
Curb Type		Curb & Gutter Type		
CONC	CONCRETE		NO CURB AND GUTTER	
Pavement Recommendation		Condition Rating / PCR		
PREVENTIVE MAINTENANCE		GOOD / 90		
Douts Condition Logard Devement Condition Dating (BCD)

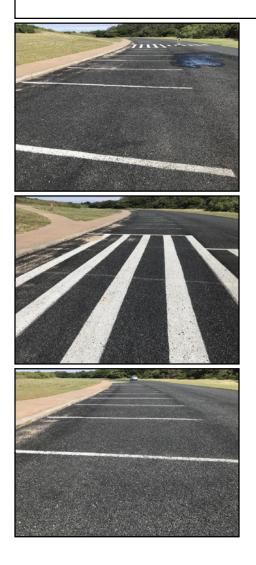
ROUTE 0907DZ: WB RD MONUMENT PARKING D

Inspection Date	FMSS Number	User Access	Surface Type	
5/6/2021	104915	PUBLIC	ASPHALT	
Area (Sq. Ft.)	Lane Miles (11' Widths)	Curb Reveal (Inches)	Curb Recommendation	
5,126	0.088	4	DO NOTHING	
Curb Type		Curb & Gutter Type		
CONC	CONCRETE		NO CURB AND GUTTER	
Pavement Recommendation		Condition Rating / PCR		
LIGHT 3R TREATMENTS		FAIR / 73		
Route Condition Legend – Pavement Condition Rating (PCR)
