WRST Cycle 6

Final Report

Road Inventory and Condition Assessment of Routes Wrangell-St. Elias National Park & Preserve

Report Date: February 2020

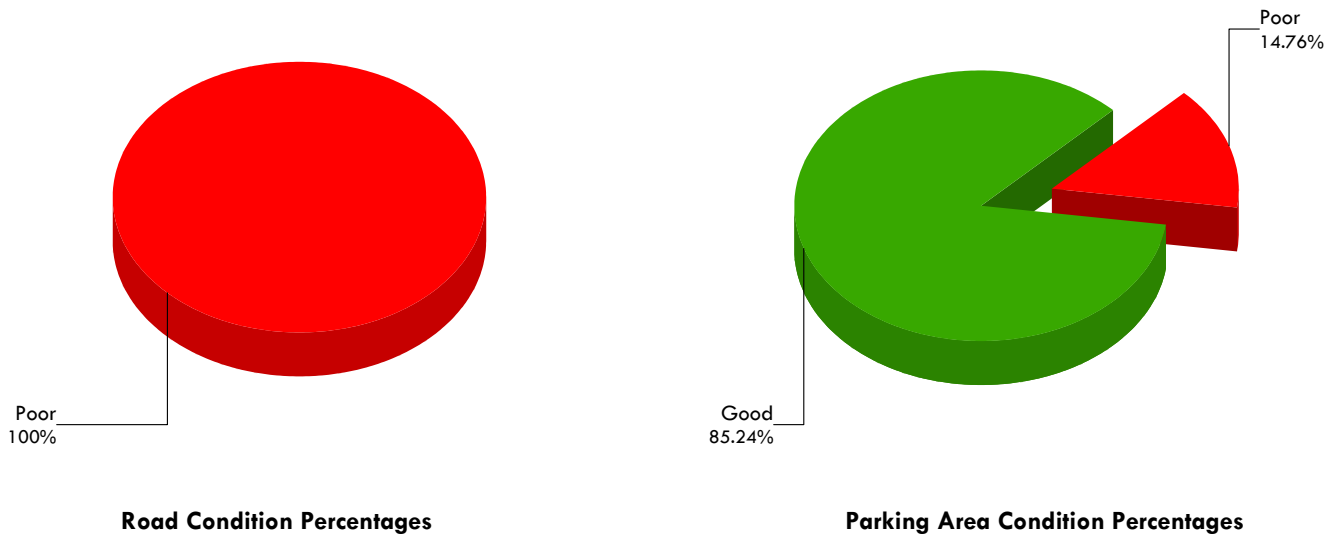
Figure 1: Pavement Condition Rating Breakdown for Paved Roads and Parking Areas

Parkwide Condition Percentages

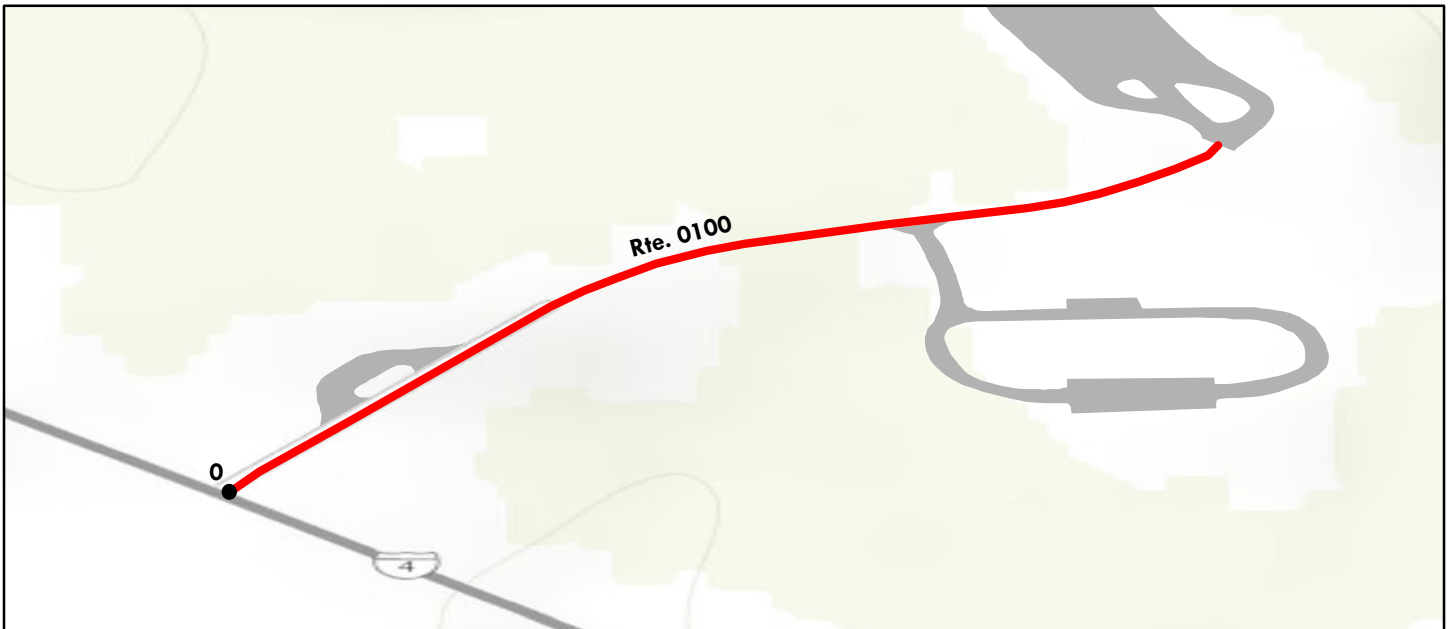
Manual Rating

Route Condition Legend – Pavement Condition Rating (PCR)						
Poor (0 - 60)	Fair (61- 84)	Good (85 - 94)	Excellent (95 - 100)	Not Rated		
See Appendix for definitions and formulas						
Inspection Date: 6/20/2019	Beginning Section MP	0.00				
Paved Length (Miles): 0.27	Section Length (MI)	0.27				
Surface Type: ASPHALT	Route Summary					
Roadway Condition Information						
Pavement Condition Rating (PCR)	0	0				
Surface Condition Rating (SCR)	0	0				
Roughness Condition Index (RCI)	N/A	N/A				
Distress Index Values						
Structural Crack Index	42	42				
Alligator Crack Index	100	100				
Longitudinal Crack Index	42	42				
Transverse Cracking Index	0	0				
Patching Index	100	100				
Rutting Index	100	100				
International Roughness Index (IRI)	N/A	N/A				
Lane & Width Information						
Number of Lanes	2	2				
Paved Width (ft)	26	26				
Lane Width (ft)	12	12

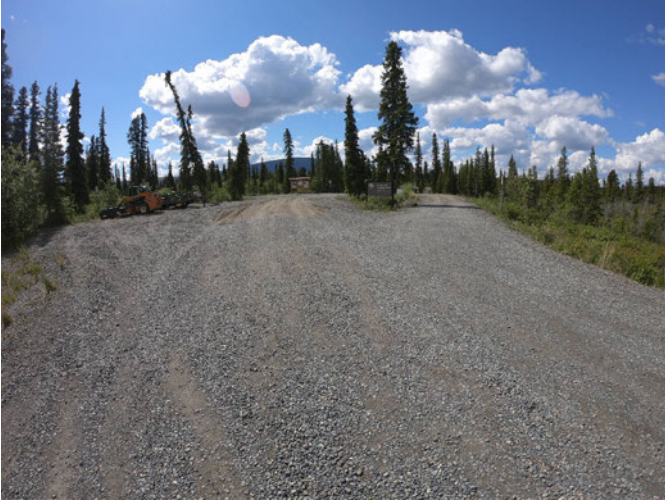
WRST_0200_0.009

Begin MP	End MP	Section Length	# of Lanes	Lane Width	Road Width	Treatment Recommendation	Treatment Cost	Unpaved Rating (Paser +)	Crown Severity	Drainage Severity	Rutting, Washboard Severity	Potholes / Loose Aggregate Severity
0.00	0.26	0.26	2	10.0	20.0	Light Rehabilitation	\$26,000	3	Med	Low	High	High
Route Level Data:		0.26	2	10.0	20.0	Light Rehabilitation	\$26,000	3	Med	Low	High	High

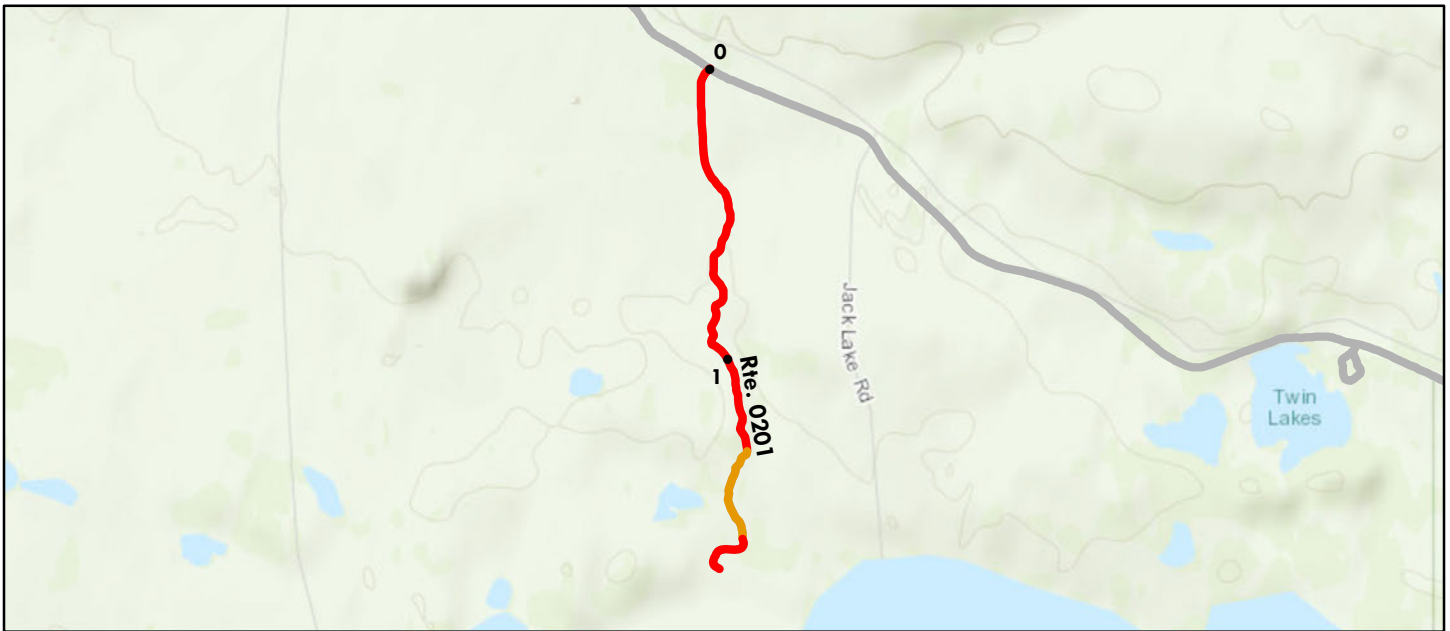
Manual Rating

Route Condition Legend					
Poor (1)	Poor (2)	Fair (3)	Good (4)	Excellent (5)	Not Rated
See Appendix for definitions and formulas					
Inspection Date: 6/20/2019		Unpaved Length (Miles): 1.78		Surface Type: GR

Begin MP	End MP	Section Length	# of Lanes	Lane Width	Road Width	Treatment Recommendation	Treatment Cost	Unpaved Rating (Paser +)	Crown Severity	Drainage Severity	Rutting, Washboard Severity	Potholes / Loose Aggregate Severity
0.00	1.00	1.00	1	10.0	10.0	Reconstruction	\$250,000	1	High	High	High	High
1.00	1.78	0.78	1	10.0	10.0	Reconstruction	\$193,750	1	High	High	High	High
Route Level Data:		1.78	1	10.0	10.0	Reconstruction	\$443,750	1	High	High	High	High

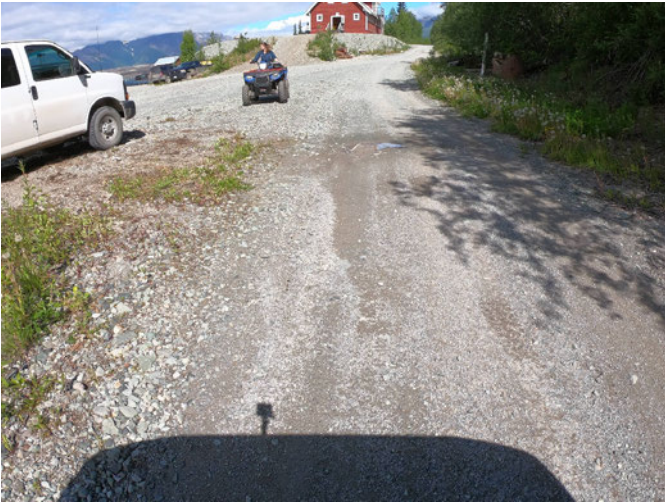
WRST_0202_0.001

Begin MP	End MP	Section Length	# of Lanes	Lane Width	Road Width	Treatment Recommendation	Treatment Cost	Unpaved Rating (Paser +)	Crown Severity	Drainage Severity	Rutting, Washboard Severity	Potholes / Loose Aggregate Severity
0.00	0.25	0.25	2	7.4	14.8	Light Rehabilitation	\$24,700	3	Med	Med	Low	Med
Route Level Data:		0.25	2	7.4	14.8	Light Rehabilitation	\$24,700	3	Med	Med	Low	Med

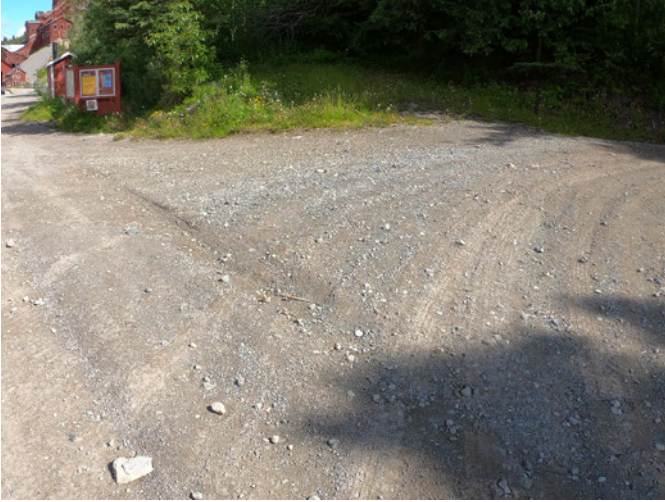
WRST_0203_0.002

Begin MP	End MP	Section Length	# of Lanes	Lane Width	Road Width	Treatment Recommendation	Treatment Cost	Unpaved Rating (Paser +)	Crown Severity	Drainage Severity	Rutting, Washboard Severity	Potholes / Loose Aggregate Severity
0.00	0.50	0.50	1	10.4	10.4	Reconstruction	\$124,000	1	High	High	Med	High
Route Level Data:		0.50	1	10.4	10.4	Reconstruction	\$124,000	1	High	High	Med	High

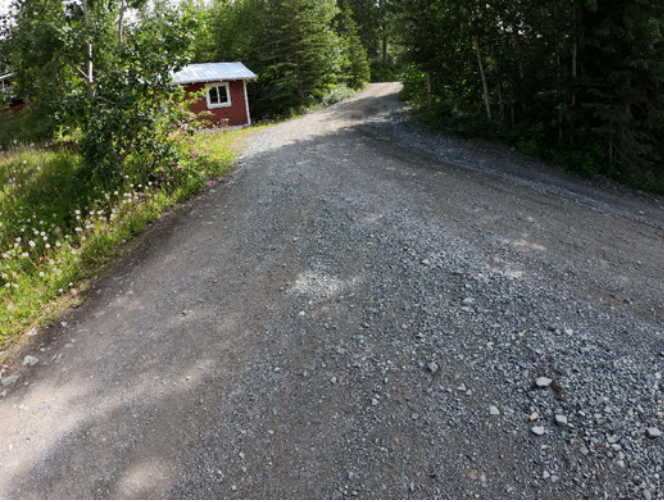
WRST_0204_0.005

Begin MP	End MP	Section Length	# of Lanes	Lane Width	Road Width	Treatment Recommendation	Treatment Cost	Unpaved Rating (Paser +)	Crown Severity	Drainage Severity	Rutting, Washboard Severity	Potholes / Loose Aggregate Severity
0.00	0.03	0.03	2	7.0	14.0	Reconstruction	\$6,500	1	High	High	High	High
Route Level Data:		0.03	2	7.0	14.0	Reconstruction	\$6,500	1	High	High	High	High

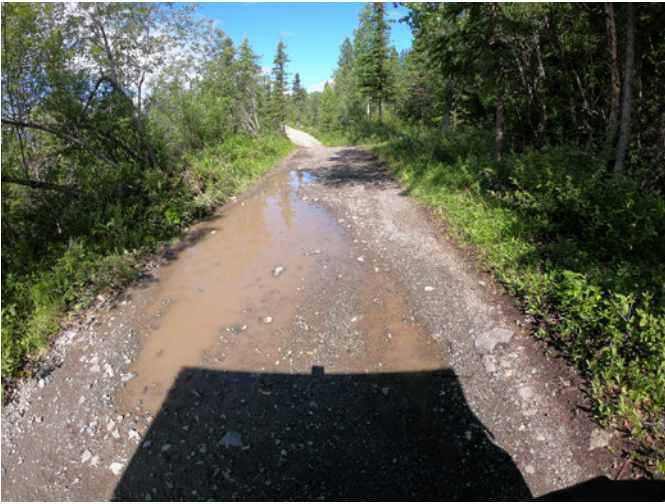
WRST_0205_0.001

Begin MP	End MP	Section Length	# of Lanes	Lane Width	Road Width	Treatment Recommendation	Treatment Cost	Unpaved Rating (Paser +)	Crown Severity	Drainage Severity	Rutting, Washboard Severity	Potholes / Loose Aggregate Severity	
0.00	1.00	1.00	1	8.6	8.6	Reconstruction	\$250,000	1	High	High	High	High	
1.00	2.00	1.00	1	8.0	8.0	Reconstruction	\$250,000	1	High	High	High	High	
2.00	2.24	0.24	1	8.0	8.0	Reconstruction	\$61,000	1	High	High	High	High	
Route Level Data:			2.24	1	8.3	8.3	Reconstruction	\$561,000	1	High	High	High	High

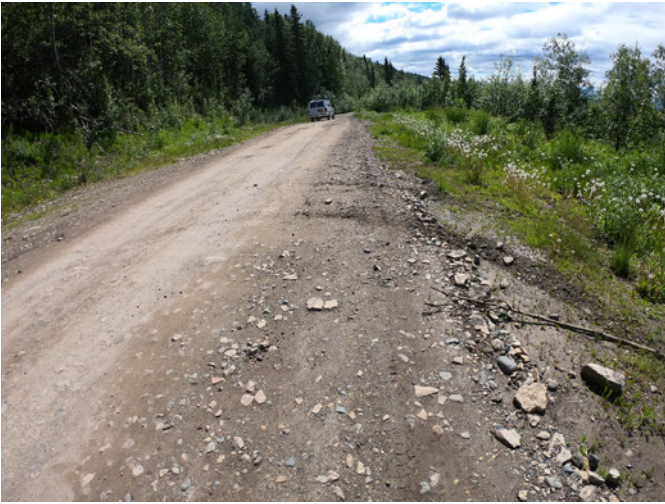
WRST_0206_0.011

Route Condition Legend					
Poor (1)	Poor (2)	Fair (3)	Good (4)	Excellent (5)	Not Rated
See Appendix for definitions and formulas					
Inspection Date: 6/19/2019		Unpaved Length (Miles): 1.24		Surface Type: GR

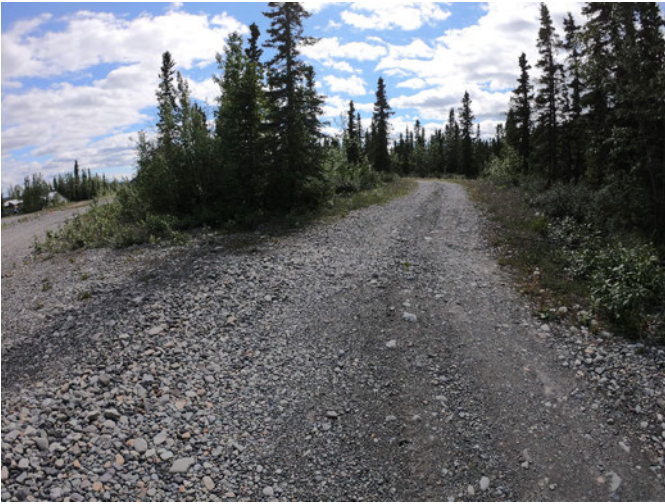
WRST_0207_0.000

Route Condition Legend					
Poor (1)	Poor (2)	Fair (3)	Good (4)	Excellent (5)	Not Rated
See Appendix for definitions and formulas					
Inspection Date: 6/19/2019		Unpaved Length (Miles): 0.29		Surface Type: GR

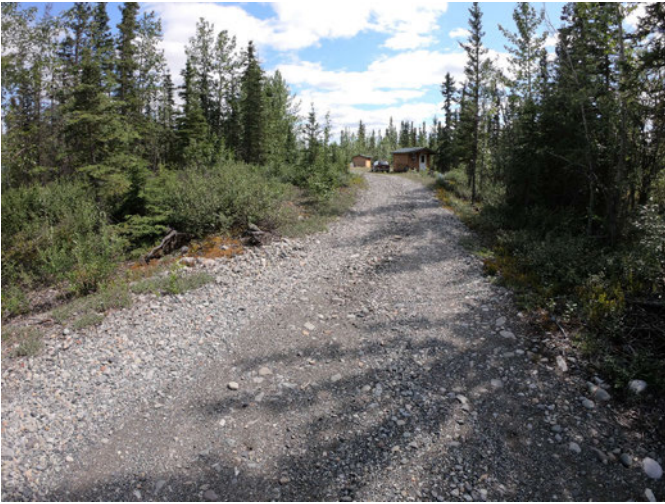
WRST_0208_0.002

Route Condition Legend					
Poor (1)	Poor (2)	Fair (3)	Good (4)	Excellent (5)	Not Rated
See Appendix for definitions and formulas					
Inspection Date: 6/19/2019		Unpaved Length (Miles): 0.12		Surface Type: GR

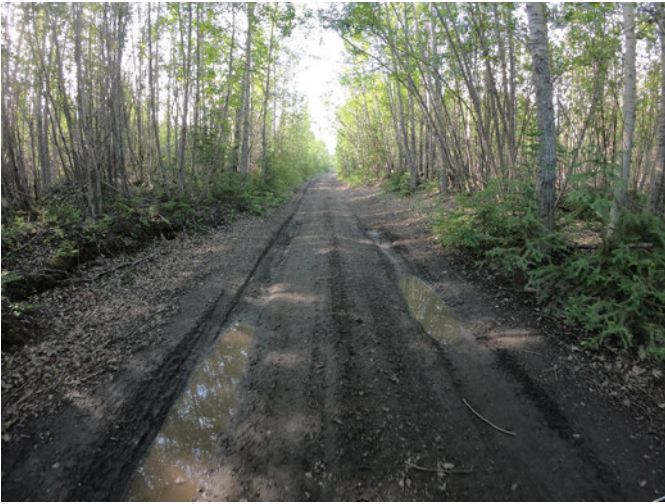
WRST_0209_0.005

Route Condition Legend					
Poor (1)	Poor (2)	Fair (3)	Good (4)	Excellent (5)	Not Rated
See Appendix for definitions and formulas					
Inspection Date: 6/20/2019		Unpaved Length (Miles): 1.15		Surface Type: GR

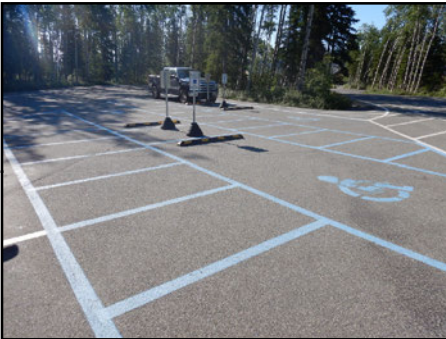
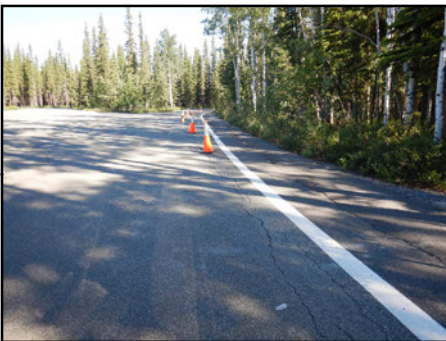
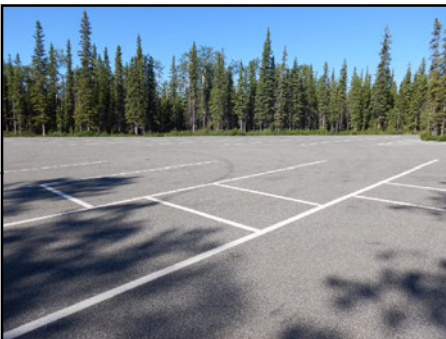
Inspection Date	FMSS Number	User Access	Surface Type
6/21/2019	82479	PUBLIC	ASPHALT
Area (Sq. Ft.)	Lane Miles (11' Widths)	Curb Reveal (Inches)	Curb Recommendation
65,328	1.125	NOT APPLICABLE	NOT APPLICABLE
Curb Type		Curb & Gutter Type	
NO CURB		NO CURB AND GUTTER	
Pavement Recommendation		Condition Rating / PCR	
PREVENTIVE MAINTENANCE		GOOD / 90

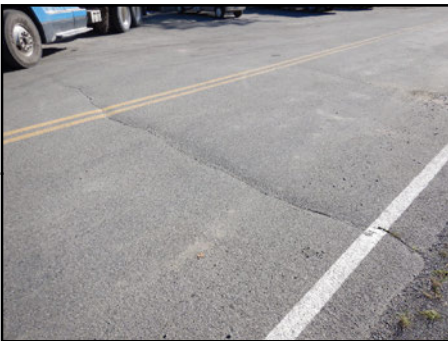
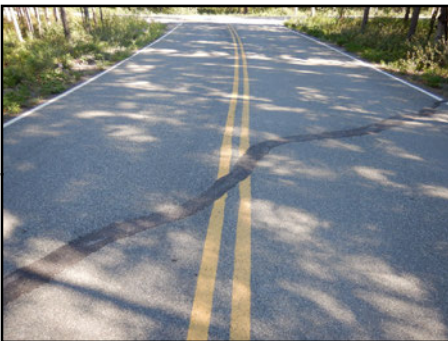
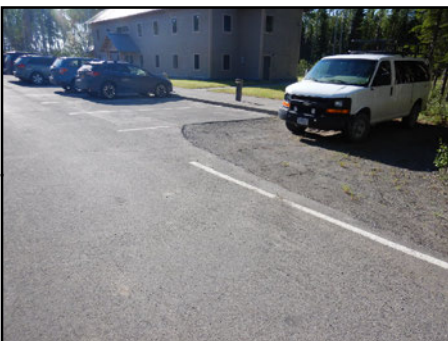
ROUTE 0901: COPPER CENTER ADMIN PARKING AREA

Inspection Date	FMSS Number	User Access	Surface Type
6/21/2019	82482	PUBLIC	ASPHALT
Area (Sq. Ft.)	Lane Miles (11' Widths)	Curb Reveal (Inches)	Curb Recommendation
45,509	0.784	NOT APPLICABLE	LIGHT REPAIR
Curb Type		Curb & Gutter Type	
NO CURB		CONCRETE	
Pavement Recommendation		Condition Rating / PCR	
PREVENTIVE MAINTENANCE		GOOD / 90

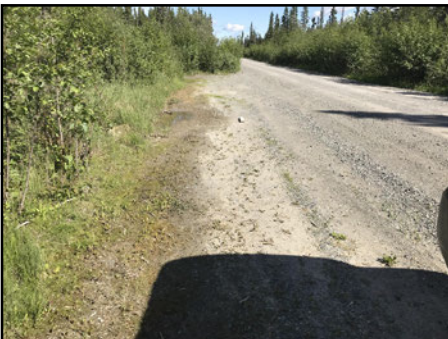
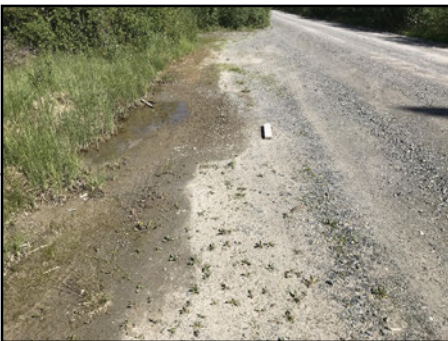
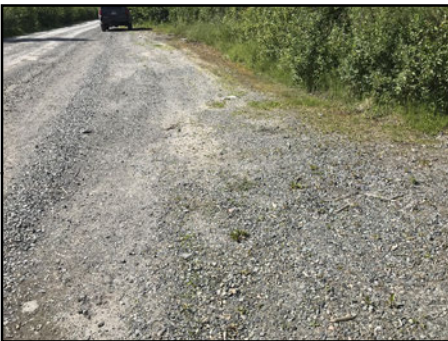
ROUTE 0902: TRAIL HEAD PARKING (CRYSTALLINE HILLS)

Inspection Date	FMSS Number	User Access	Surface Type
6/19/2019	93456	PUBLIC	GRAVEL
Area (Sq. Ft.)	Lane Miles (11' Widths)	Curb Reveal (Inches)	Curb Recommendation
3462	0.06	NOT APPLICABLE	NOT APPLICABLE
Curb Type		Curb & Gutter Type	
NO CURB		NO CURB AND GUTTER	
Treatment Recommendation		Condition Rating	
Routine Maintenance		4

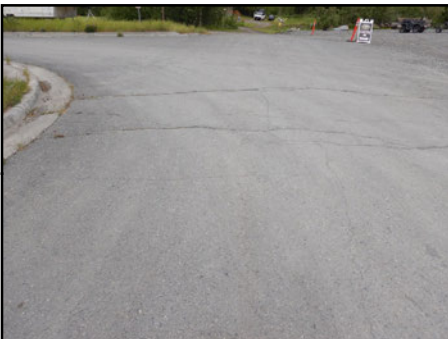
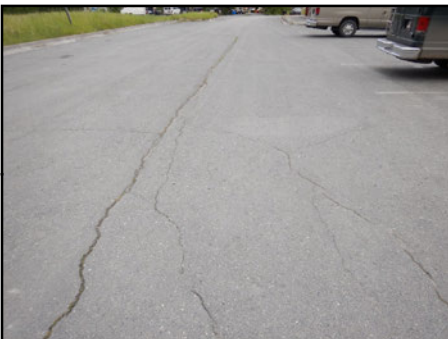
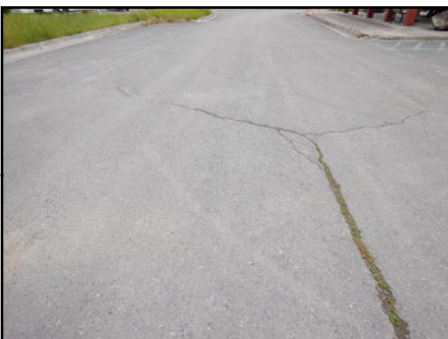
ROUTE 0905AZ: GULKANA AIRPORT PARKING

Inspection Date	FMSS Number	User Access	Surface Type
6/20/2019	114167	PUBLIC	GRAVEL
Area (Sq. Ft.)	Lane Miles (11' Widths)	Curb Reveal (Inches)	Curb Recommendation
3745	0.064	NOT APPLICABLE	NOT APPLICABLE
Curb Type		Curb & Gutter Type	
NO CURB		NO CURB AND GUTTER	
Treatment Recommendation		Condition Rating	
Routine Maintenance		4

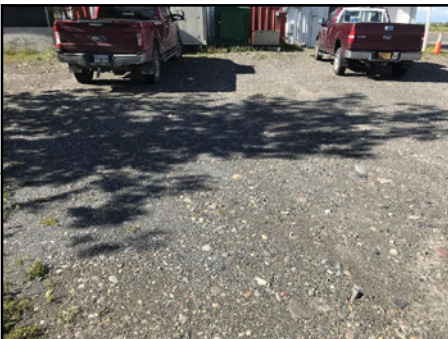
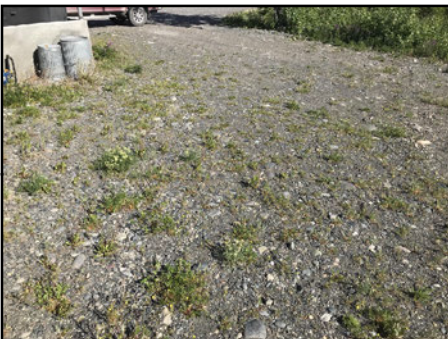
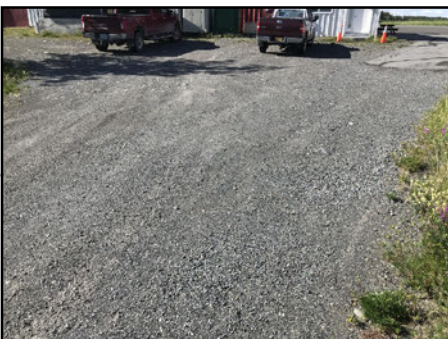
ROUTE 0905BZ: GULKANA AIRPORT OVERFLOW PARKING

Inspection Date	FMSS Number	User Access	Surface Type
6/21/2019	114167	PUBLIC	ASPHALT
Area (Sq. Ft.)	Lane Miles (11' Widths)	Curb Reveal (Inches)	Curb Recommendation
5,265	0.091	NOT APPLICABLE	NOT APPLICABLE
Curb Type		Curb & Gutter Type	
NO CURB		NO CURB AND GUTTER	
Pavement Recommendation		Condition Rating / PCR	
HEAVY 3R TREATMENTS		POOR / 53

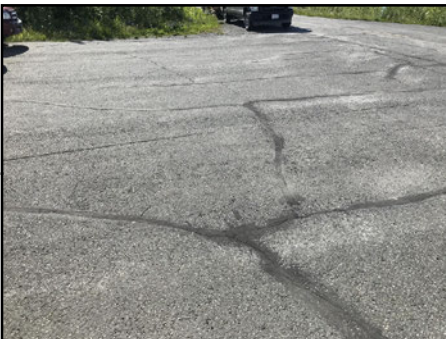
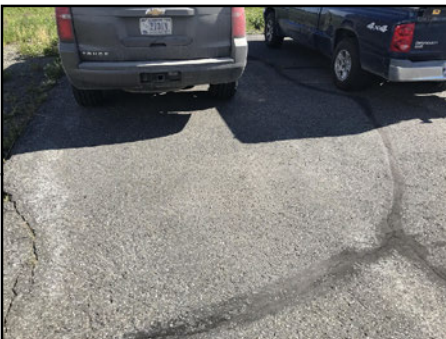
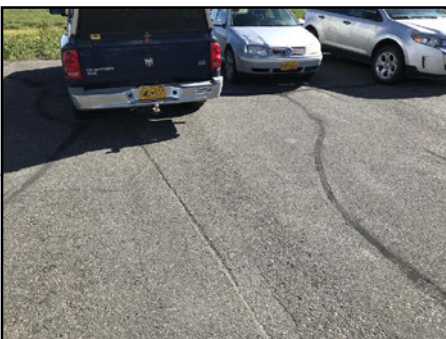
ROUTE 0906: COPPER CENTER HEADQUARTERS ENTRANCE WAYSIDE PARKING

Inspection Date	FMSS Number	User Access	Surface Type
6/21/2019	226321	PUBLIC	ASPHALT
Area (Sq. Ft.)	Lane Miles (11' Widths)	Curb Reveal (Inches)	Curb Recommendation
9,962	0.172	NOT APPLICABLE	NOT APPLICABLE
Curb Type		Curb & Gutter Type	
NO CURB		NO CURB AND GUTTER	
Pavement Recommendation		Condition Rating / PCR	
PREVENTIVE MAINTENANCE		GOOD / 90

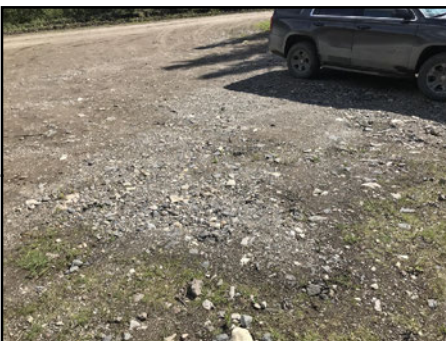
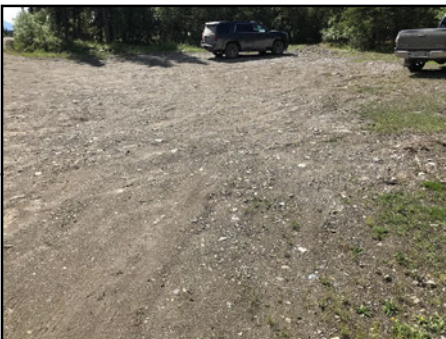
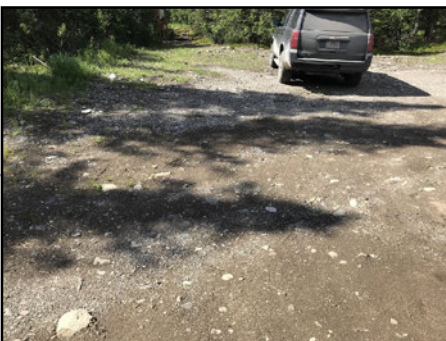
ROUTE 0907DZ: NABESNA ROAD - JACK CREEK EAST PARKING

Inspection Date	FMSS Number	User Access	Surface Type
6/20/2019		PUBLIC	GRAVEL
Area (Sq. Ft.)	Lane Miles (11' Widths)	Curb Reveal (Inches)	Curb Recommendation
3313	0.057	NOT APPLICABLE	NOT APPLICABLE
Curb Type		Curb & Gutter Type	
NO CURB		NO CURB AND GUTTER	
Treatment Recommendation		Condition Rating	
Reconstruction		1

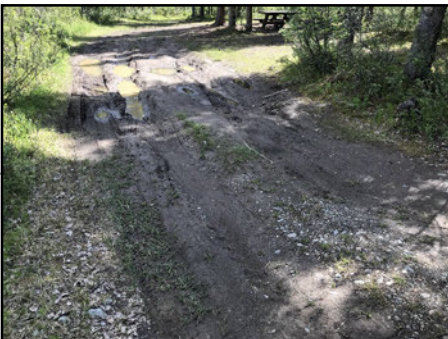
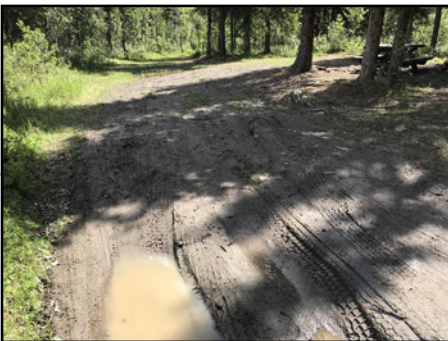
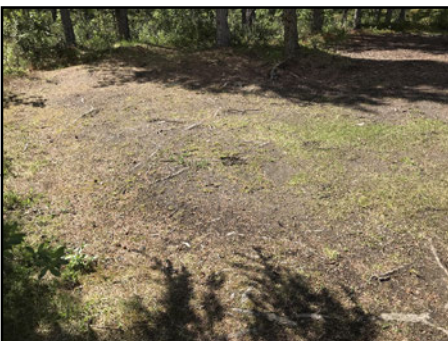
ROUTE 0907EZ: NABESNA ROAD - JACK CREEK REST AREA PARKING

Inspection Date	FMSS Number	User Access	Surface Type
6/20/2019		PUBLIC	GRAVEL
Area (Sq. Ft.)	Lane Miles (11' Widths)	Curb Reveal (Inches)	Curb Recommendation
5593	0.096	NOT APPLICABLE	NOT APPLICABLE
Curb Type		Curb & Gutter Type	
NO CURB		NO CURB AND GUTTER	
Treatment Recommendation		Condition Rating	
Light Rehabilitation		3

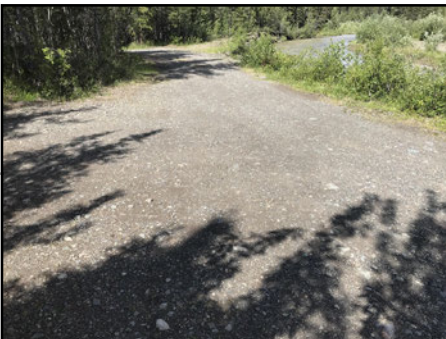
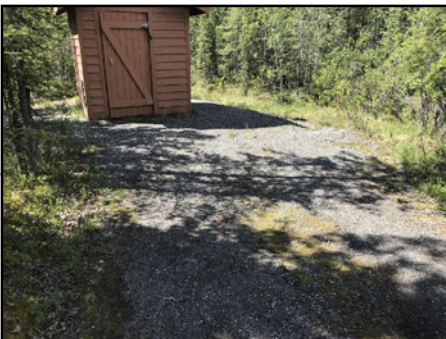
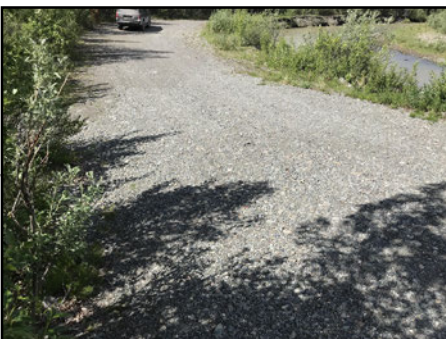
ROUTE 0907FZ: NABESNA ROAD - LOST CREEK TRAILHEAD PARKING

Inspection Date	FMSS Number	User Access	Surface Type
6/20/2019		PUBLIC	GRAVEL
Area (Sq. Ft.)	Lane Miles (11' Widths)	Curb Reveal (Inches)	Curb Recommendation
12421	0.214	NOT APPLICABLE	NOT APPLICABLE
Curb Type		Curb & Gutter Type	
NO CURB		NO CURB AND GUTTER	
Treatment Recommendation		Condition Rating	
Heavy Rehabilitation		2

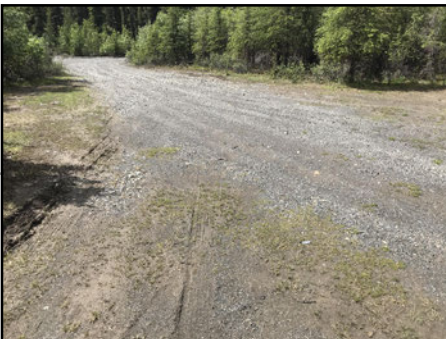
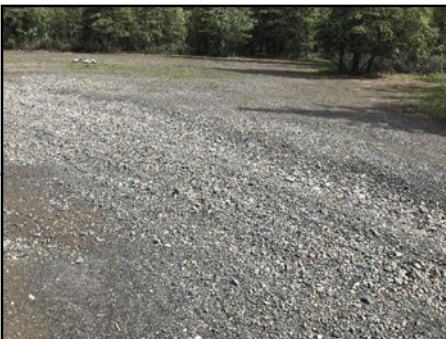
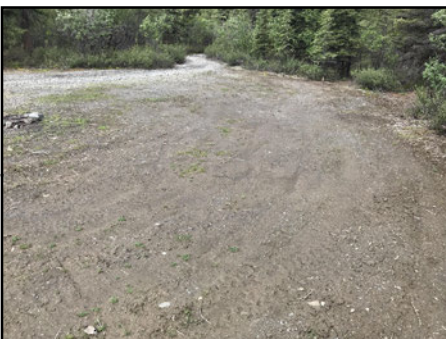
ROUTE 0907GZ: NABESNA ROAD - TRAIL CREEK TRAILHEAD PARKING

Inspection Date	FMSS Number	User Access	Surface Type
6/20/2019		PUBLIC	GRAVEL
Area (Sq. Ft.)	Lane Miles (11' Widths)	Curb Reveal (Inches)	Curb Recommendation
9432	0.162	NOT APPLICABLE	NOT APPLICABLE
Curb Type		Curb & Gutter Type	
NO CURB		NO CURB AND GUTTER	
Treatment Recommendation		Condition Rating	
Heavy Rehabilitation		2

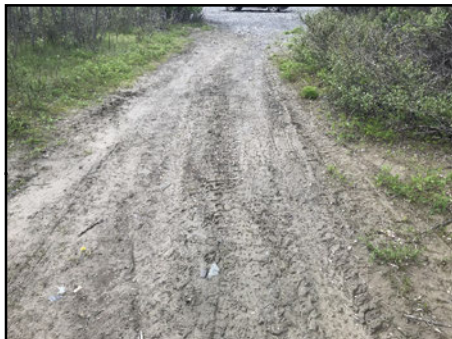
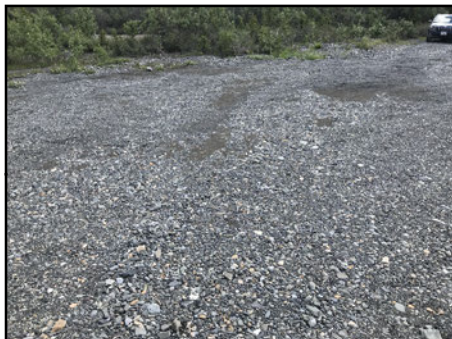
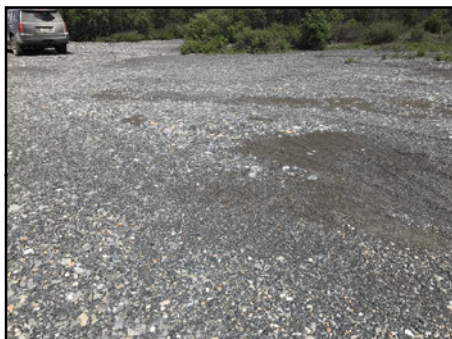
ROUTE 0907HZ: NABESNA ROAD - TWIN LAKE OVERLOOK PARKING

Inspection Date	FMSS Number	User Access	Surface Type
6/20/2019		PUBLIC	GRAVEL
Area (Sq. Ft.)	Lane Miles (11' Widths)	Curb Reveal (Inches)	Curb Recommendation
2498	0.043	NOT APPLICABLE	NOT APPLICABLE
Curb Type		Curb & Gutter Type	
NO CURB		NO CURB AND GUTTER	
Treatment Recommendation		Condition Rating	
Routine Maintenance		4

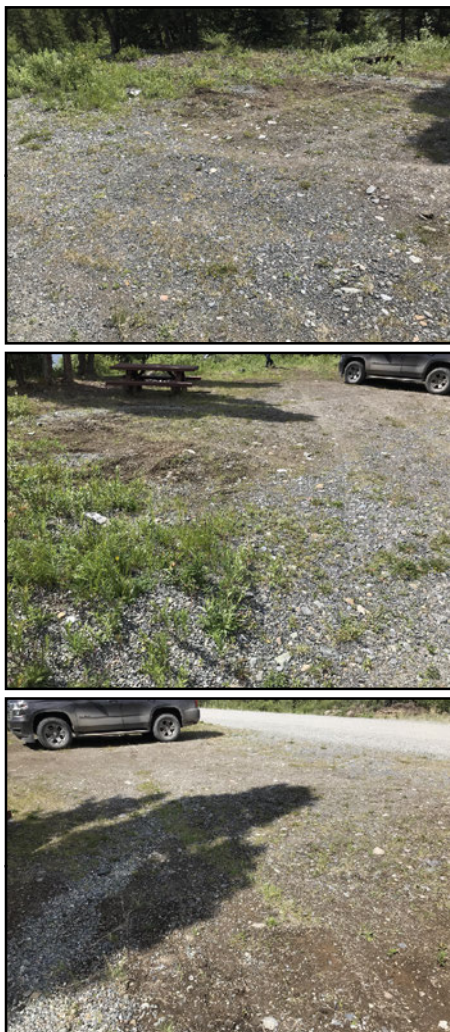
ROUTE 0907IZ: NABESNA ROAD - TANADA LAKE TRAILHEAD PARKING

Inspection Date	FMSS Number	User Access	Surface Type
6/20/2019		PUBLIC	GRAVEL
Area (Sq. Ft.)	Lane Miles (11' Widths)	Curb Reveal (Inches)	Curb Recommendation
5087	0.088	NOT APPLICABLE	NOT APPLICABLE
Curb Type		Curb & Gutter Type	
NO CURB		NO CURB AND GUTTER	
Treatment Recommendation		Condition Rating	
Reconstruction		1

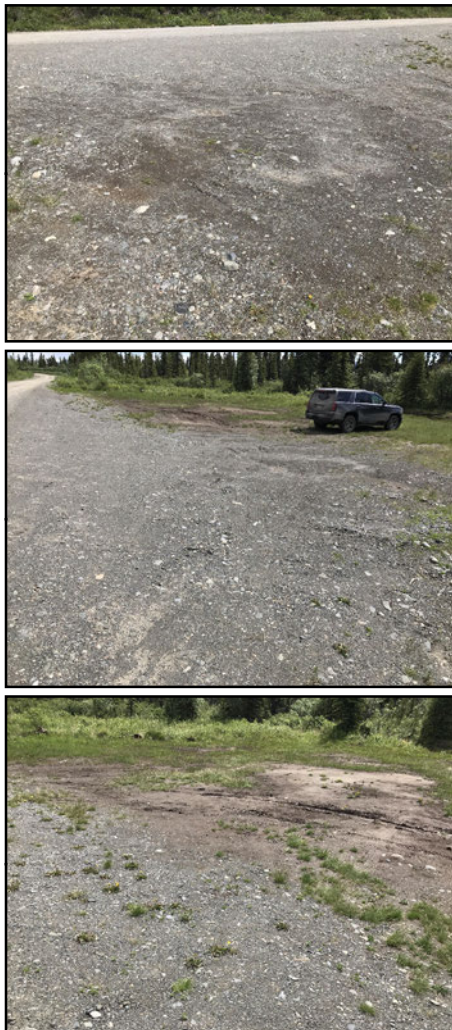
ROUTE 0907JZ: NABESNA ROAD - VIKING LODGE NORTH PARKING

Inspection Date	FMSS Number	User Access	Surface Type
6/20/2019		PUBLIC	GRAVEL
Area (Sq. Ft.)	Lane Miles (11' Widths)	Curb Reveal (Inches)	Curb Recommendation
3386	0.058	NOT APPLICABLE	NOT APPLICABLE
Curb Type		Curb & Gutter Type	
NO CURB		NO CURB AND GUTTER	
Treatment Recommendation		Condition Rating	
Routine Maintenance		4

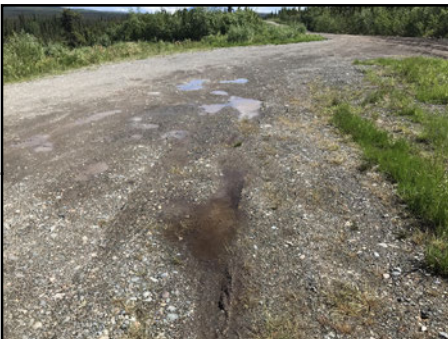
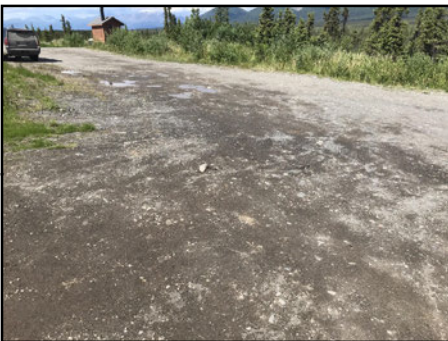
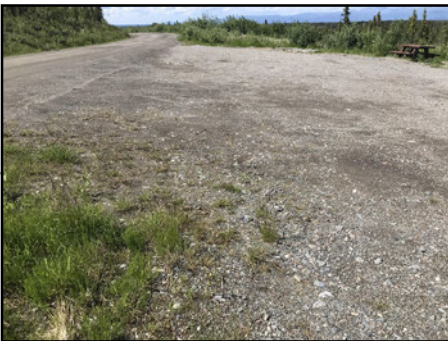
ROUTE 0907NZ: NABESNA ROAD - 16 MILE PARKING

Inspection Date	FMSS Number	User Access	Surface Type
6/20/2019		PUBLIC	GRAVEL
Area (Sq. Ft.)	Lane Miles (11' Widths)	Curb Reveal (Inches)	Curb Recommendation
4573	0.079	NOT APPLICABLE	NOT APPLICABLE
Curb Type		Curb & Gutter Type	
NO CURB		NO CURB AND GUTTER	
Treatment Recommendation		Condition Rating	
Routine Maintenance		4

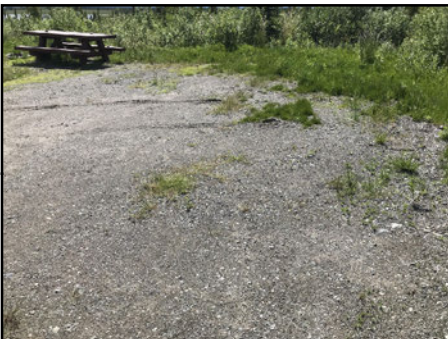
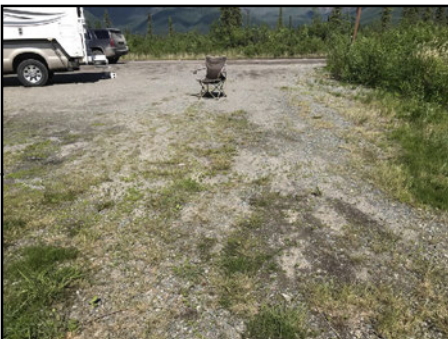
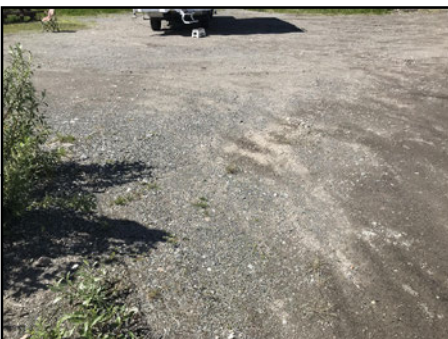
ROUTE 0907OZ: NABESNA ROAD - 15 MILE PARKING

Inspection Date	FMSS Number	User Access	Surface Type
6/20/2019		PUBLIC	GRAVEL
Area (Sq. Ft.)	Lane Miles (11' Widths)	Curb Reveal (Inches)	Curb Recommendation
4310	0.074	NOT APPLICABLE	NOT APPLICABLE
Curb Type		Curb & Gutter Type	
NO CURB		NO CURB AND GUTTER	
Treatment Recommendation		Condition Rating	
Routine Maintenance		4

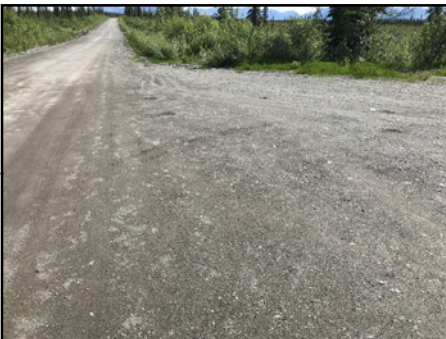
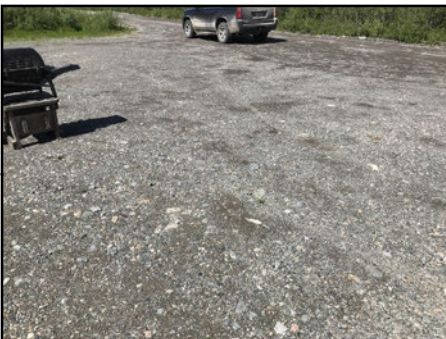
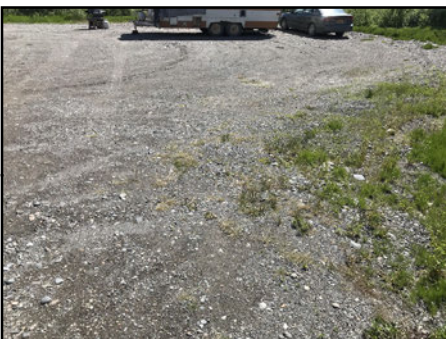
ROUTE 0907QZ: NABESNA ROAD - COPPER LAKE TRAILHEAD PARKING

Inspection Date	FMSS Number	User Access	Surface Type
6/20/2019		PUBLIC	GRAVEL
Area (Sq. Ft.)	Lane Miles (11' Widths)	Curb Reveal (Inches)	Curb Recommendation
14506	0.25	NOT APPLICABLE	NOT APPLICABLE
Curb Type		Curb & Gutter Type	
NO CURB		NO CURB AND GUTTER	
Treatment Recommendation		Condition Rating	
Routine Maintenance		4

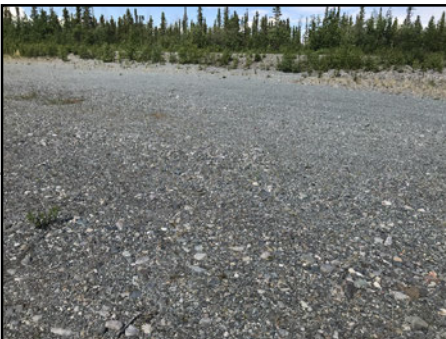
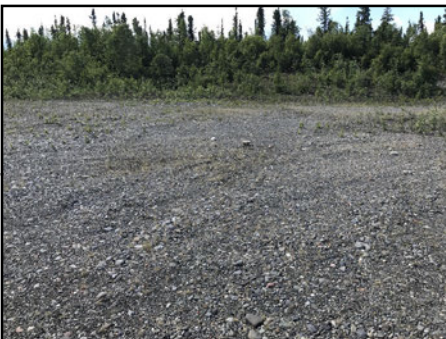
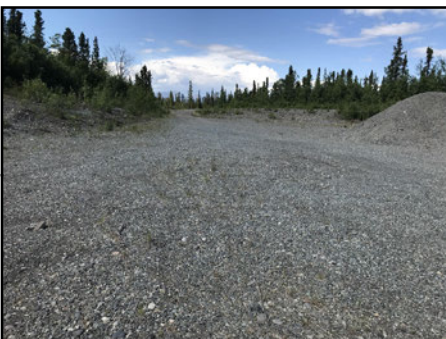
ROUTE 0907SZ: NABESNA ROAD - BATZULNETAS TRAILHEAD EAST PARKING

Inspection Date	FMSS Number	User Access	Surface Type
6/20/2019		PUBLIC	GRAVEL
Area (Sq. Ft.)	Lane Miles (11' Widths)	Curb Reveal (Inches)	Curb Recommendation
6185	0.106	NOT APPLICABLE	NOT APPLICABLE
Curb Type		Curb & Gutter Type	
NO CURB		NO CURB AND GUTTER	
Treatment Recommendation		Condition Rating	
Heavy Rehabilitation		2

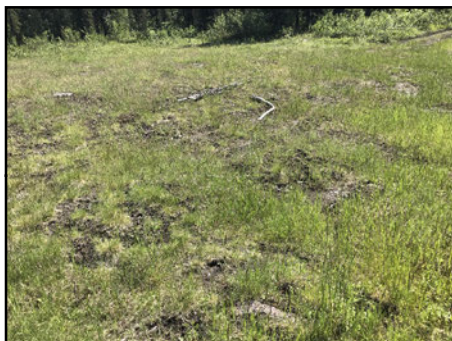
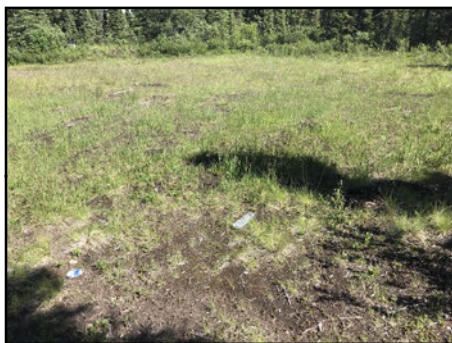
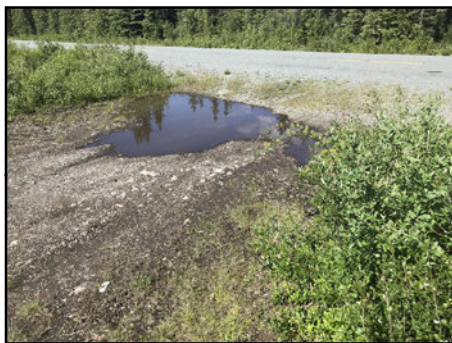
ROUTE 0907UZ: NABESNA ROAD - RUFUS CREEK WAYSIDE PARKING

Inspection Date	FMSS Number	User Access	Surface Type
6/20/2019		PUBLIC	GRAVEL
Area (Sq. Ft.)	Lane Miles (11' Widths)	Curb Reveal (Inches)	Curb Recommendation
3589	0.062	NOT APPLICABLE	NOT APPLICABLE
Curb Type		Curb & Gutter Type	
NO CURB		NO CURB AND GUTTER	
Treatment Recommendation		Condition Rating	
Heavy Rehabilitation		2

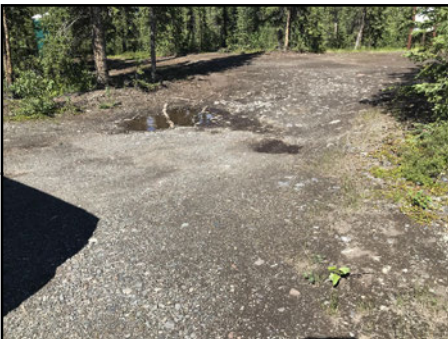
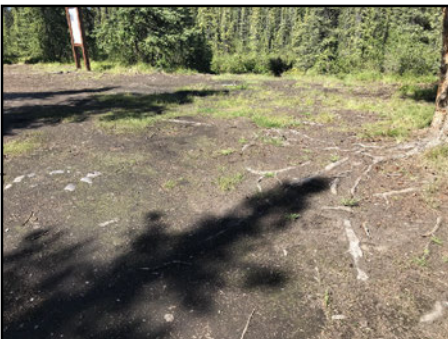
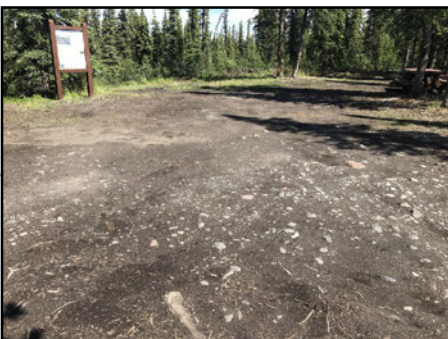
ROUTE 0908: KENNECOTT HOUSING PARKING

Inspection Date	FMSS Number	User Access	Surface Type
6/20/2019		PUBLIC	GRAVEL
Area (Sq. Ft.)	Lane Miles (11' Widths)	Curb Reveal (Inches)	Curb Recommendation
12203	0.21	NOT APPLICABLE	NOT APPLICABLE
Curb Type		Curb & Gutter Type	
NO CURB		NO CURB AND GUTTER	
Treatment Recommendation		Condition Rating	
Reconstruction		1

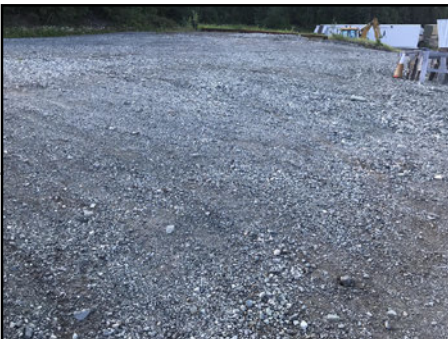
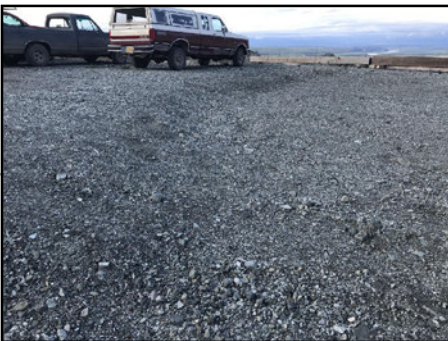
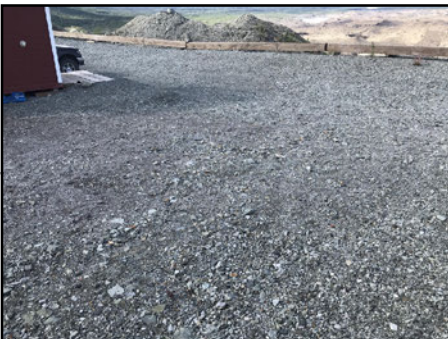
ROUTE 0909: BONEYARD PARKING

Inspection Date	FMSS Number	User Access	Surface Type
6/20/2019		PUBLIC	GRAVEL
Area (Sq. Ft.)	Lane Miles (11' Widths)	Curb Reveal (Inches)	Curb Recommendation
40728	0.701	NOT APPLICABLE	NOT APPLICABLE
Curb Type		Curb & Gutter Type	
NO CURB		NO CURB AND GUTTER	
Treatment Recommendation		Condition Rating	
Light Rehabilitation		3

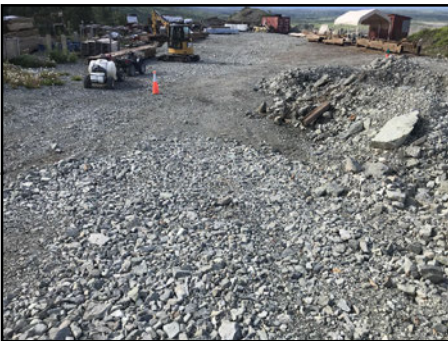
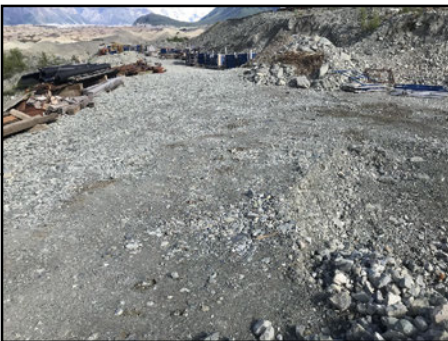
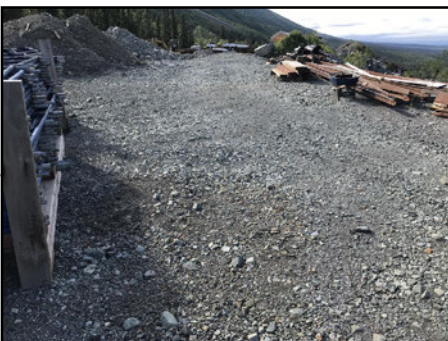
ROUTE 0910: DAIRY BARN PARKING

Inspection Date	FMSS Number	User Access	Surface Type
6/20/2019		PUBLIC	GRAVEL
Area (Sq. Ft.)	Lane Miles (11' Widths)	Curb Reveal (Inches)	Curb Recommendation
8641	0.149	NOT APPLICABLE	NOT APPLICABLE
Curb Type		Curb & Gutter Type	
NO CURB		NO CURB AND GUTTER	
Treatment Recommendation		Condition Rating	
Routine Maintenance		4

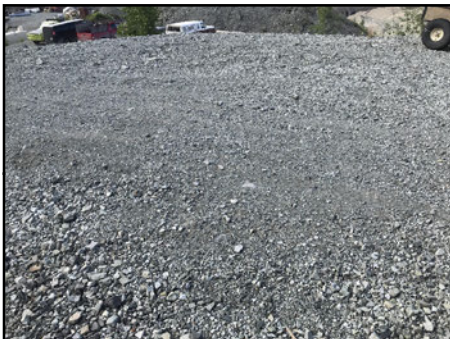
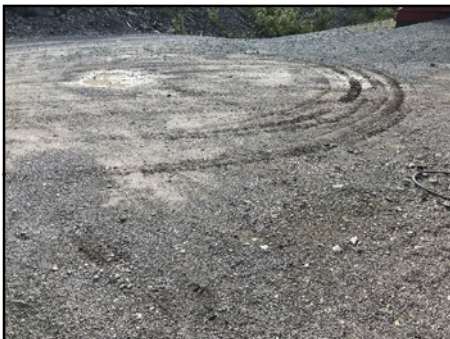
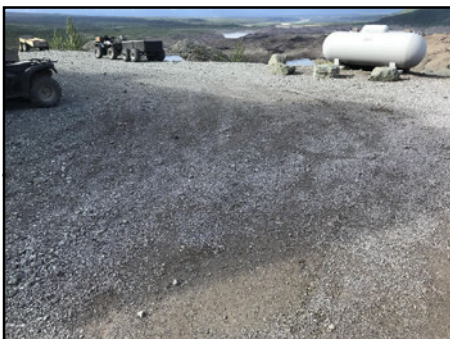
ROUTE 0911: NORTH VISITOR CENTER PARKING

Inspection Date	FMSS Number	User Access	Surface Type
6/20/2019		PUBLIC	GRAVEL
Area (Sq. Ft.)	Lane Miles (11' Widths)	Curb Reveal (Inches)	Curb Recommendation
450	0.008	NOT APPLICABLE	NOT APPLICABLE
Curb Type		Curb & Gutter Type	
NO CURB		NO CURB AND GUTTER	
Treatment Recommendation		Condition Rating	
Heavy Rehabilitation		2

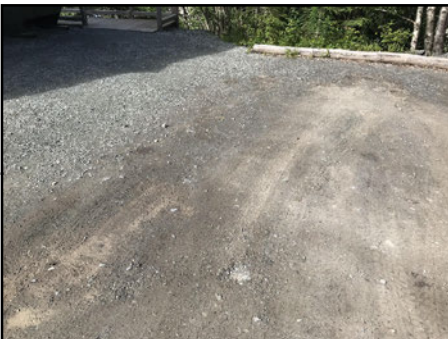
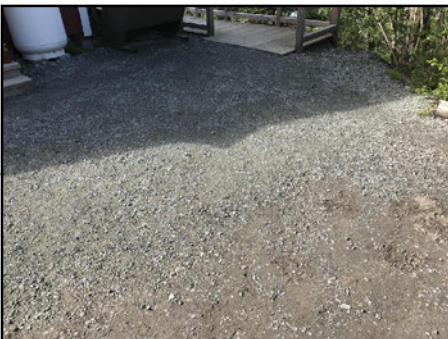
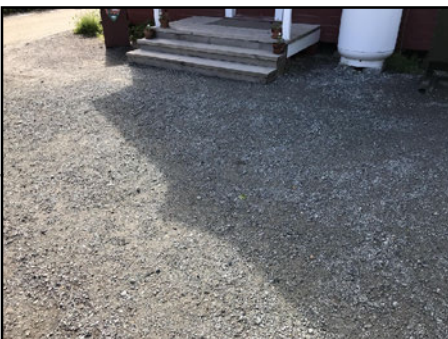
ROUTE 0912: VISITOR CENTER SHUTTLE TURNAROUND PARKING

Inspection Date	FMSS Number	User Access	Surface Type
6/20/2019		PUBLIC	GRAVEL
Area (Sq. Ft.)	Lane Miles (11' Widths)	Curb Reveal (Inches)	Curb Recommendation
4522	0.078	NOT APPLICABLE	NOT APPLICABLE
Curb Type		Curb & Gutter Type	
NO CURB		NO CURB AND GUTTER	
Treatment Recommendation		Condition Rating	
Routine Maintenance		4

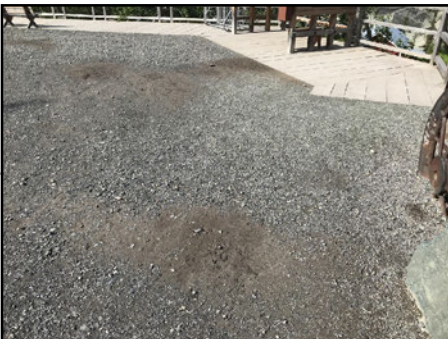
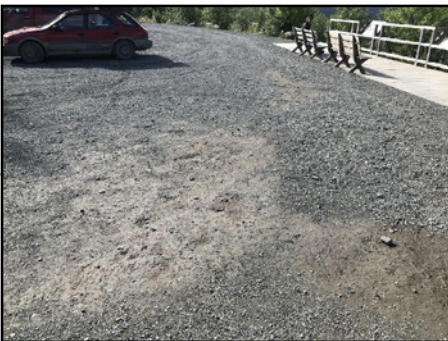
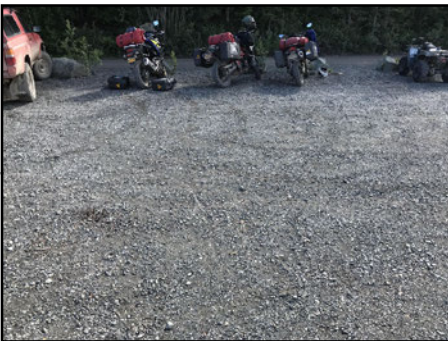
ROUTE 0913: KENNECOTT SCHOOL PARKING

Inspection Date	FMSS Number	User Access	Surface Type
6/20/2019		PUBLIC	GRAVEL
Area (Sq. Ft.)	Lane Miles (11' Widths)	Curb Reveal (Inches)	Curb Recommendation
8793	0.151	NOT APPLICABLE	NOT APPLICABLE
Curb Type		Curb & Gutter Type	
NO CURB		NO CURB AND GUTTER	
Treatment Recommendation		Condition Rating	
Limited Local Maintenance		5

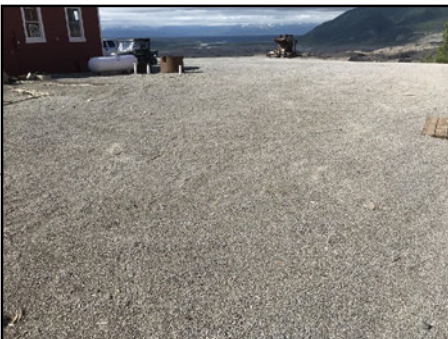
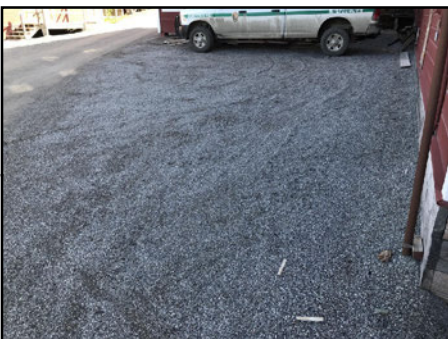
ROUTE 0914: WAREHOUSE PARKING

Inspection Date	FMSS Number	User Access	Surface Type
6/20/2019		PUBLIC	GRAVEL
Area (Sq. Ft.)	Lane Miles (11' Widths)	Curb Reveal (Inches)	Curb Recommendation
11029	0.19	NOT APPLICABLE	NOT APPLICABLE
Curb Type		Curb & Gutter Type	
NO CURB		NO CURB AND GUTTER	
Treatment Recommendation		Condition Rating	
Routine Maintenance		4

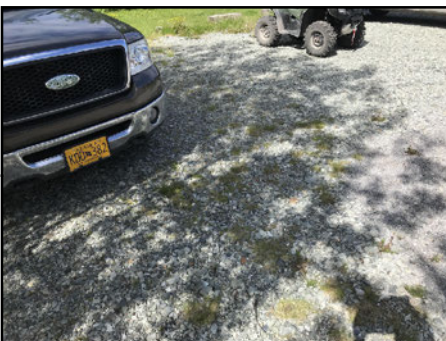
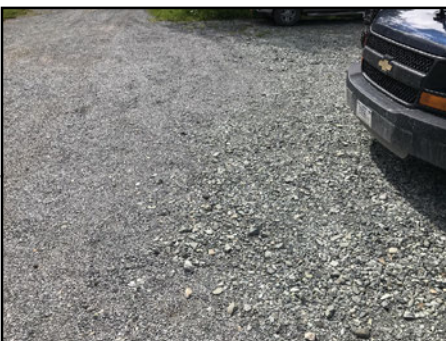
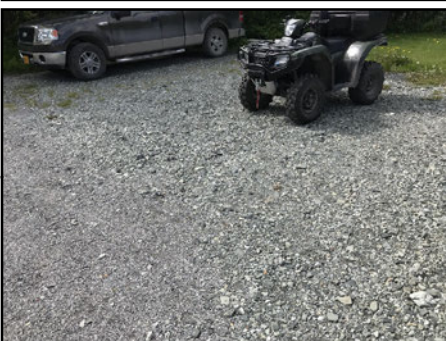
ROUTE 0916: DIXIE PARKING

Inspection Date	FMSS Number	User Access	Surface Type
6/20/2019		PUBLIC	GRAVEL
Area (Sq. Ft.)	Lane Miles (11' Widths)	Curb Reveal (Inches)	Curb Recommendation
4799	0.083	NOT APPLICABLE	NOT APPLICABLE
Curb Type		Curb & Gutter Type	
NO CURB		NO CURB AND GUTTER	
Treatment Recommendation		Condition Rating	
Reconstruction		1

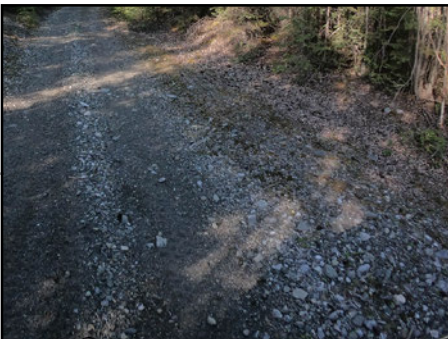
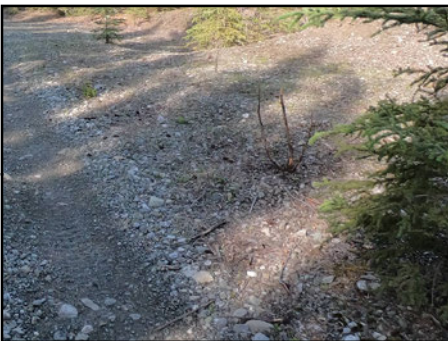
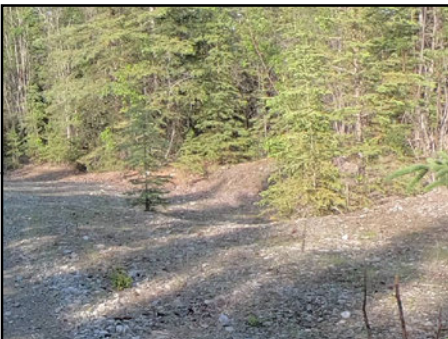
ROUTE 0917: MCCARTHY ROAD - WEST RESIDENCE PARKING

Inspection Date	FMSS Number	User Access	Surface Type
6/20/2019		PUBLIC	GRAVEL
Area (Sq. Ft.)	Lane Miles (11' Widths)	Curb Reveal (Inches)	Curb Recommendation
26547	0.457	NOT APPLICABLE	NOT APPLICABLE
Curb Type		Curb & Gutter Type	
NO CURB		NO CURB AND GUTTER	
Treatment Recommendation		Condition Rating	
Routine Maintenance		4

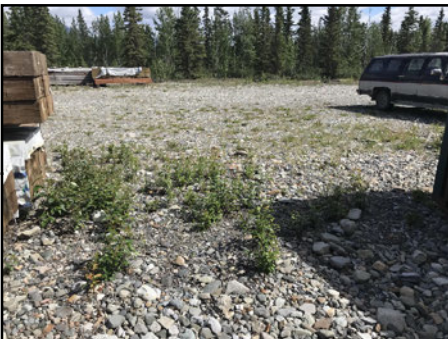
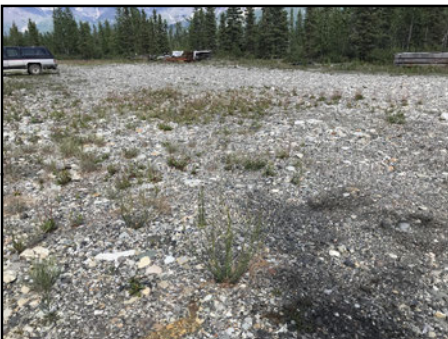
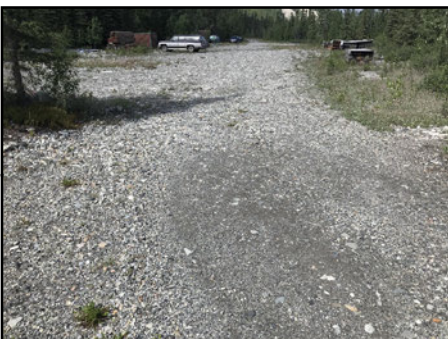
ROUTE 0918: MCCARTHY ROAD - WEST VISITOR CENTER PARKING

Inspection Date	FMS Number	User Access	Surface Type
6/20/2019		PUBLIC	GRAVEL
Area (Sq. Ft.)	Lane Miles (11' Widths)	Curb Reveal (Inches)	Curb Recommendation
10961	0.189	NOT APPLICABLE	NOT APPLICABLE
Curb Type		Curb & Gutter Type	
NO CURB		NO CURB AND GUTTER	
Treatment Recommendation		Condition Rating	
Reconstruction		1
