WRST Cycle 6

Final Report

Road Inventory and Condition Assessment of Routes Wrangell-St. Elias National Park & Preserve

Report Date: February 2020

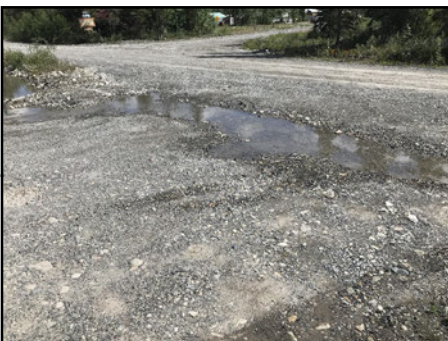
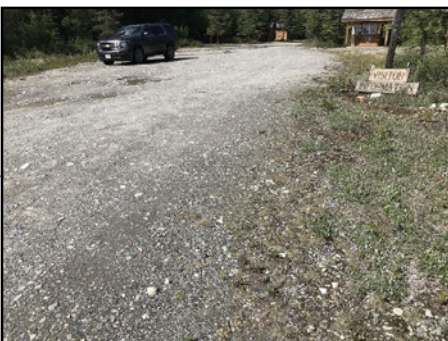
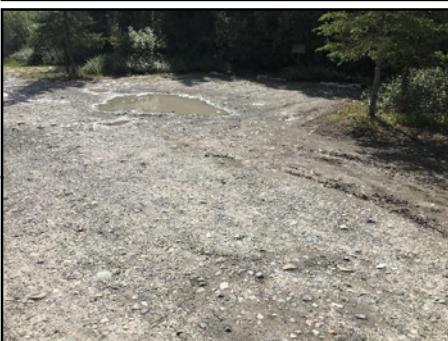
ROUTE 0919: MCCARTHY ROAD - GILAHINA PARKING

Inspection Date	FMSS Number	User Access	Surface Type
6/20/2019		PUBLIC	GRAVEL
Area (Sq. Ft.)	Lane Miles (11' Widths)	Curb Reveal (Inches)	Curb Recommendation
8179	0.141	NOT APPLICABLE	NOT APPLICABLE
Curb Type		Curb & Gutter Type	
NO CURB		NO CURB AND GUTTER	
Treatment Recommendation		Condition Rating	
Light Rehabilitation		3

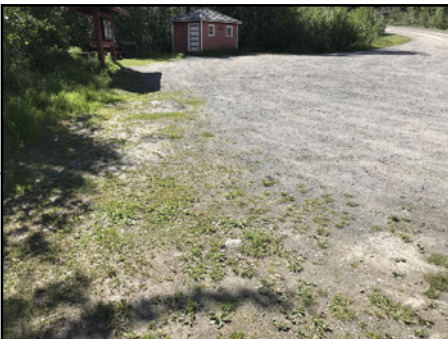
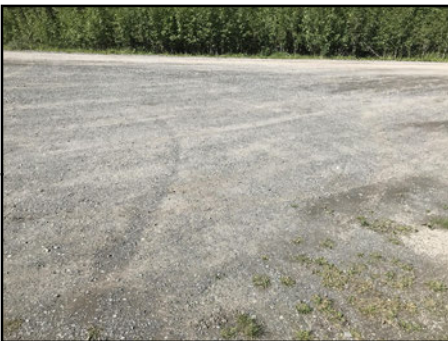
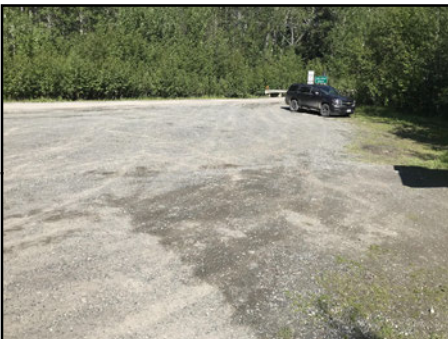
ROUTE 0920: MCCARTHY ROAD - KUSKULANA PARKING

Inspection Date	FMSS Number	User Access	Surface Type
6/20/2019		PUBLIC	GRAVEL
Area (Sq. Ft.)	Lane Miles (11' Widths)	Curb Reveal (Inches)	Curb Recommendation
8088	0.139	NOT APPLICABLE	NOT APPLICABLE
Curb Type		Curb & Gutter Type	
NO CURB		NO CURB AND GUTTER	
Treatment Recommendation		Condition Rating	
Light Rehabilitation		3
