## Final Report

# Road Inventory and Condition Assessment of Paved Routes Wupatki National Monument

Federal Highway Administration  
Eastern Federal Lands Highway Division  
Road Inventory Program (RIP)

Report Date: December 2016

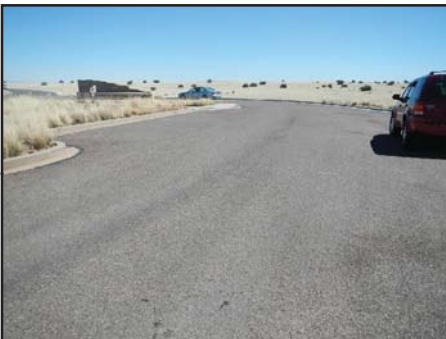
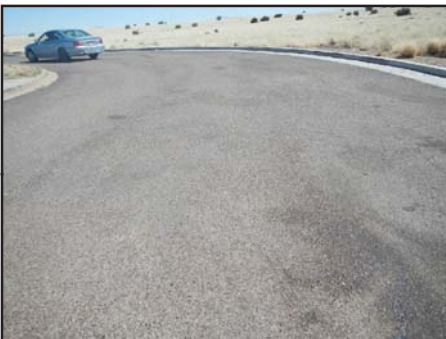
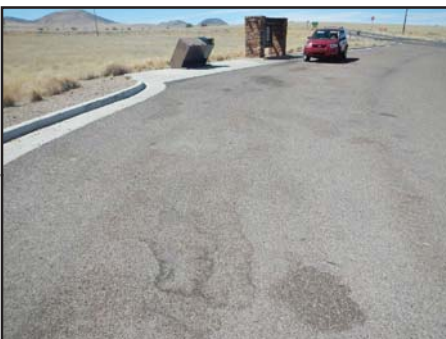
Inspection Date	FMSS Number	User Access	Surface Type
3/24/2016	45448	PUBLIC	ASPHALT
Area (Sq. Ft.)	Lane Miles (11' Widths)	Curb Reveal (Inches)	Curb Recommendation
8,949	0.154	NOT APPLICABLE	DO NOTHING
Curb Type		Curb & Gutter Type	
NO CURB		CONCRETE	
Pavement Recommendation		Condition Rating / PCR	
PREVENTIVE MAINTENANCE		GOOD / 90

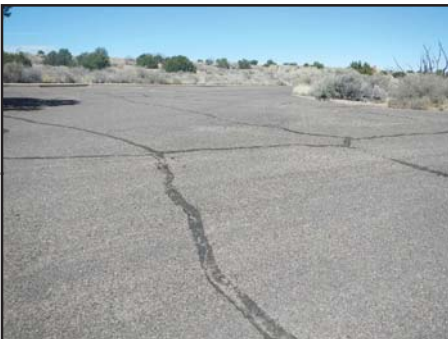
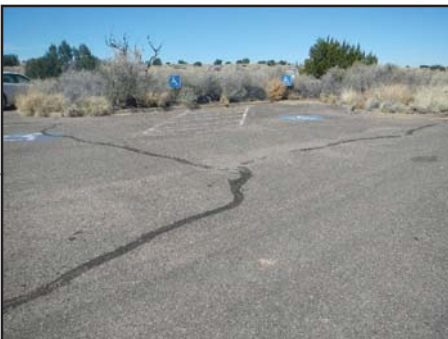
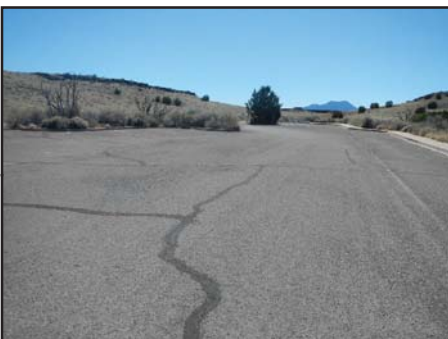
## ROUTE 0901: LOMAKI PARKING

Inspection Date	FMSS Number	User Access	Surface Type
3/24/2016	45442	PUBLIC	ASPHALT
Area (Sq. Ft.)	Lane Miles (11' Widths)	Curb Reveal (Inches)	Curb Recommendation
29,805	0.513	NOT APPLICABLE	DO NOTHING
Curb Type		Curb & Gutter Type	
NO CURB		CONCRETE	
Pavement Recommendation		Condition Rating / PCR	
LIGHT 3R TREATMENTS		FAIR / 73

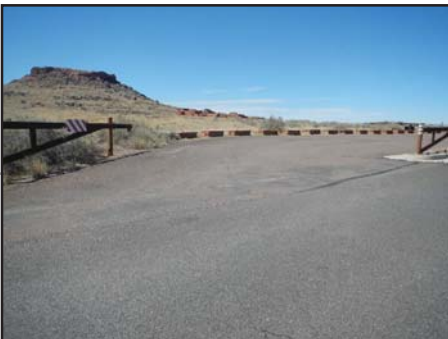
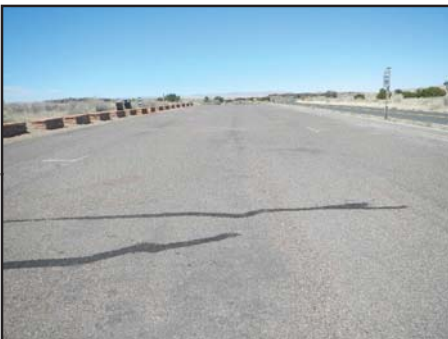
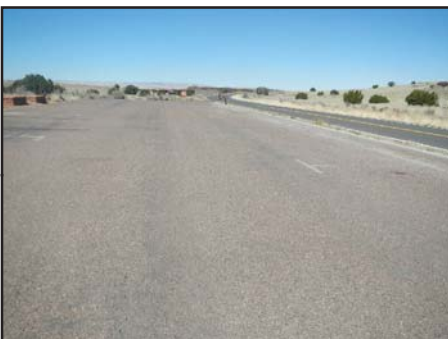
## ROUTE 0902: CITADEL PARKING

Inspection Date	FMSS Number	User Access	Surface Type
3/24/2016	45449	PUBLIC	ASPHALT
Area (Sq. Ft.)	Lane Miles (11' Widths)	Curb Reveal (Inches)	Curb Recommendation
12,089	0.208	NOT APPLICABLE	DO NOTHING
Curb Type		Curb & Gutter Type	
NO CURB		CONCRETE	
Pavement Recommendation		Condition Rating / PCR	
LIGHT 3R TREATMENTS		FAIR / 73

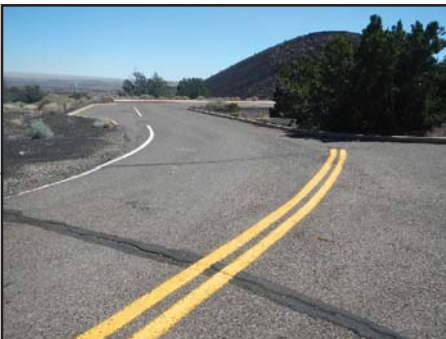
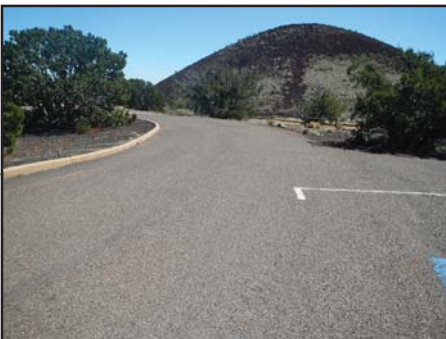
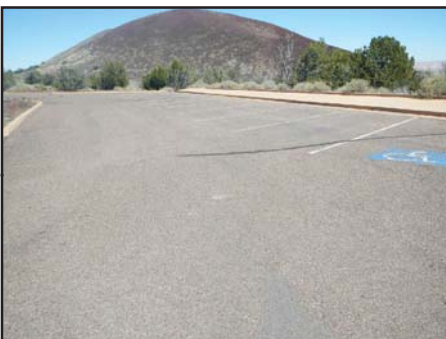
## ROUTE 0903: DONEY CRATER PICNIC AREA PARKING

Inspection Date	FMSS Number	User Access	Surface Type
3/24/2016	45443	PUBLIC	ASPHALT
Area (Sq. Ft.)	Lane Miles (11' Widths)	Curb Reveal (Inches)	Curb Recommendation
15,602	0.269	6	DO NOTHING
Curb Type		Curb & Gutter Type	
CONCRETE		CONCRETE	
Pavement Recommendation		Condition Rating / PCR	
PREVENTIVE MAINTENANCE		GOOD / 90

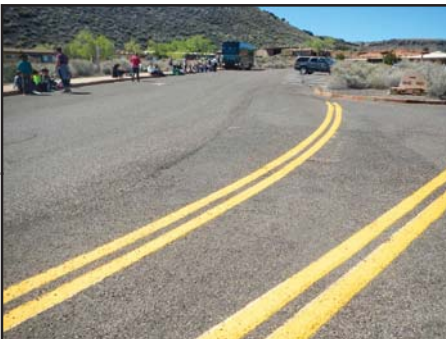
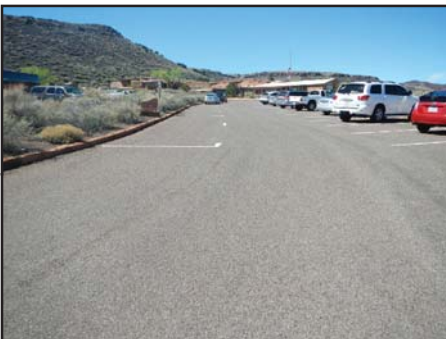
## ROUTE 0904: WUPATKI VISITOR CENTER PARKING

Inspection Date	FMSS Number	User Access	Surface Type
3/24/2016	45444	PUBLIC	ASPHALT
Area (Sq. Ft.)	Lane Miles (11' Widths)	Curb Reveal (Inches)	Curb Recommendation
34,549	0.595	3	DO NOTHING
Curb Type		Curb & Gutter Type	
STONE		NO CURB AND GUTTER	
Pavement Recommendation		Condition Rating / PCR	
LIGHT 3R TREATMENTS		FAIR / 73

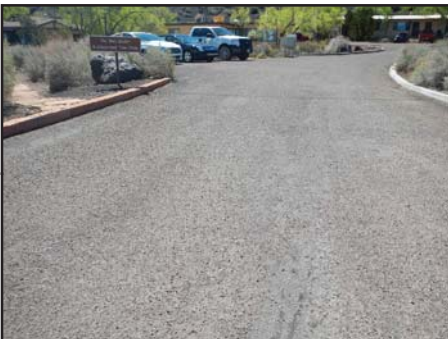
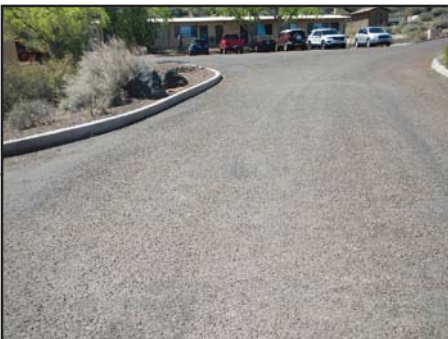
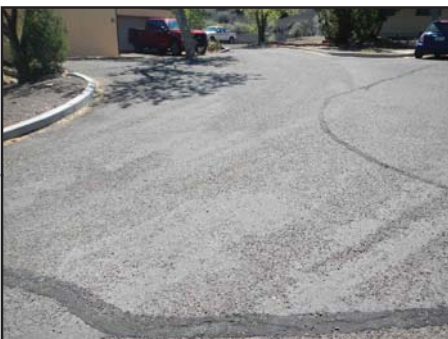
## ROUTE 0905: WUPATKI RESIDENCE AREA PARKING

Inspection Date	FMSS Number	User Access	Surface Type
3/24/2016	45445	NONPUBLIC	ASPHALT
Area (Sq. Ft.)	Lane Miles (11' Widths)	Curb Reveal (Inches)	Curb Recommendation
16,178	0.279	6	DO NOTHING
Curb Type		Curb & Gutter Type	
CONCRETE AND STONE		CONCRETE	
Pavement Recommendation		Condition Rating / PCR	
LIGHT 3R TREATMENTS		FAIR / 73

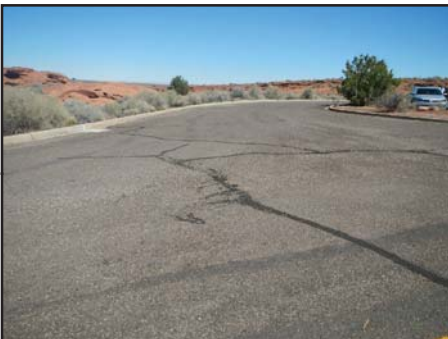
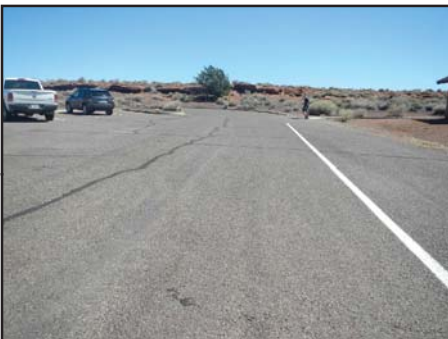
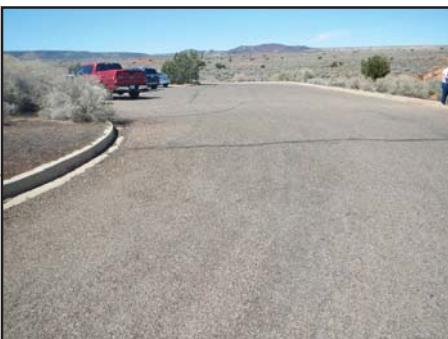
## ROUTE 0906: WUKOKI PARKING

Inspection Date	FMSS Number	User Access	Surface Type
3/24/2016	45446	PUBLIC	ASPHALT
Area (Sq. Ft.)	Lane Miles (11' Widths)	Curb Reveal (Inches)	Curb Recommendation
19,897	0.343	NOT APPLICABLE	DO NOTHING
Curb Type		Curb & Gutter Type	
NO CURB		CONCRETE	
Pavement Recommendation		Condition Rating / PCR	
LIGHT 3R TREATMENTS		FAIR / 73

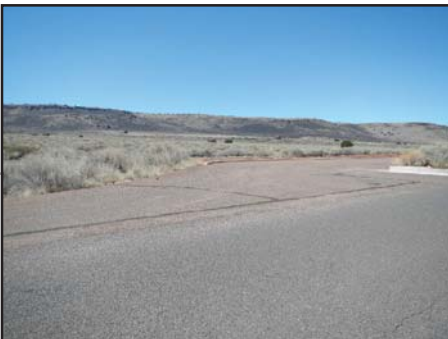
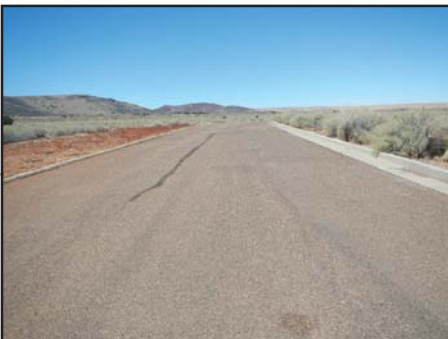
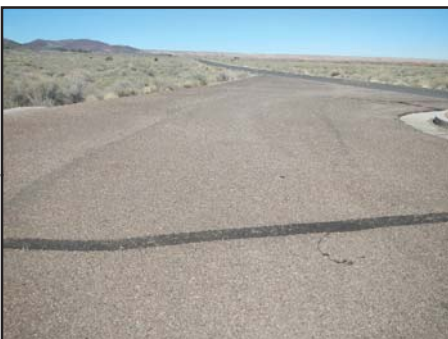
## ROUTE 0907: PIT HOUSE PULLOUT

Inspection Date	FMSS Number	User Access	Surface Type
3/24/2016	45447	PUBLIC	ASPHALT
Area (Sq. Ft.)	Lane Miles (11' Widths)	Curb Reveal (Inches)	Curb Recommendation
9,019	0.155	3	DO NOTHING
Curb Type		Curb & Gutter Type	
CONCRETE		CONCRETE	
Pavement Recommendation		Condition Rating / PCR	
LIGHT 3R TREATMENTS		FAIR / 73

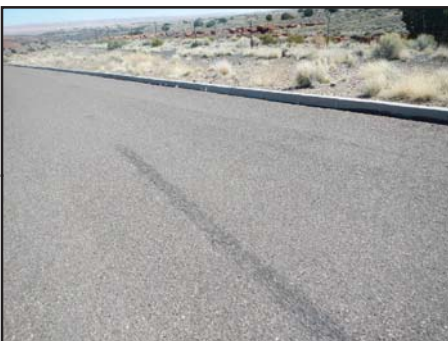
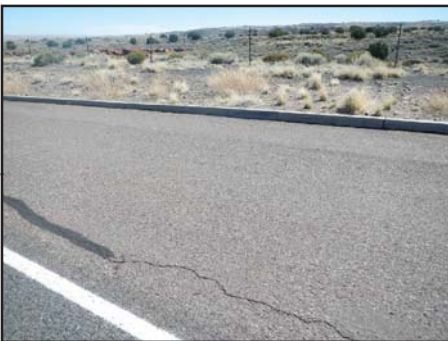
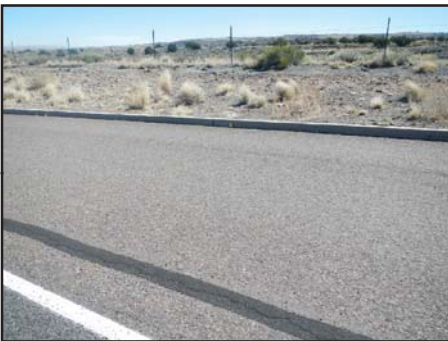
## ROUTE 0909: PAINTED DESERT VISTA PULLOUT

Inspection Date	FMSS Number	User Access	Surface Type
3/24/2016	228026	PUBLIC	ASPHALT
Area (Sq. Ft.)	Lane Miles (11' Widths)	Curb Reveal (Inches)	Curb Recommendation
3,486	0.06	6	DO NOTHING
Curb Type		Curb & Gutter Type	
CONCRETE		NO CURB AND GUTTER	
Pavement Recommendation		Condition Rating / PCR	
PREVENTIVE MAINTENANCE		GOOD / 90

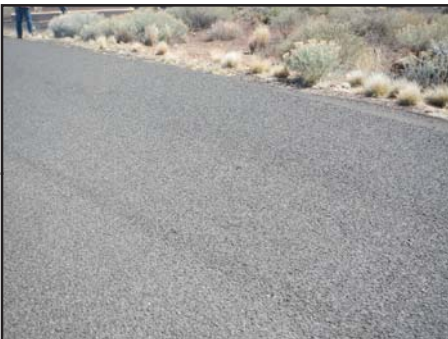
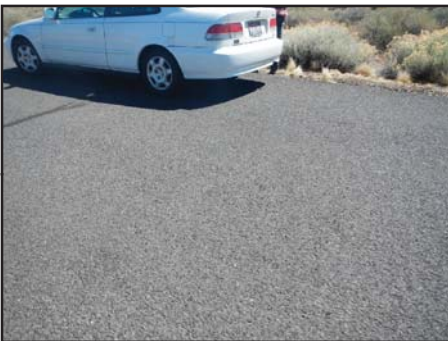
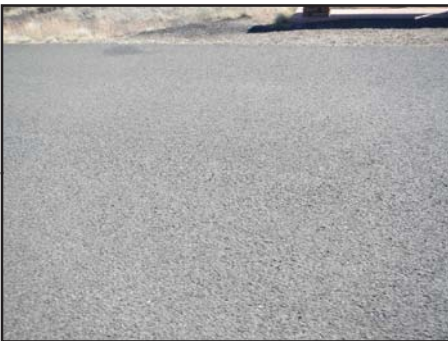
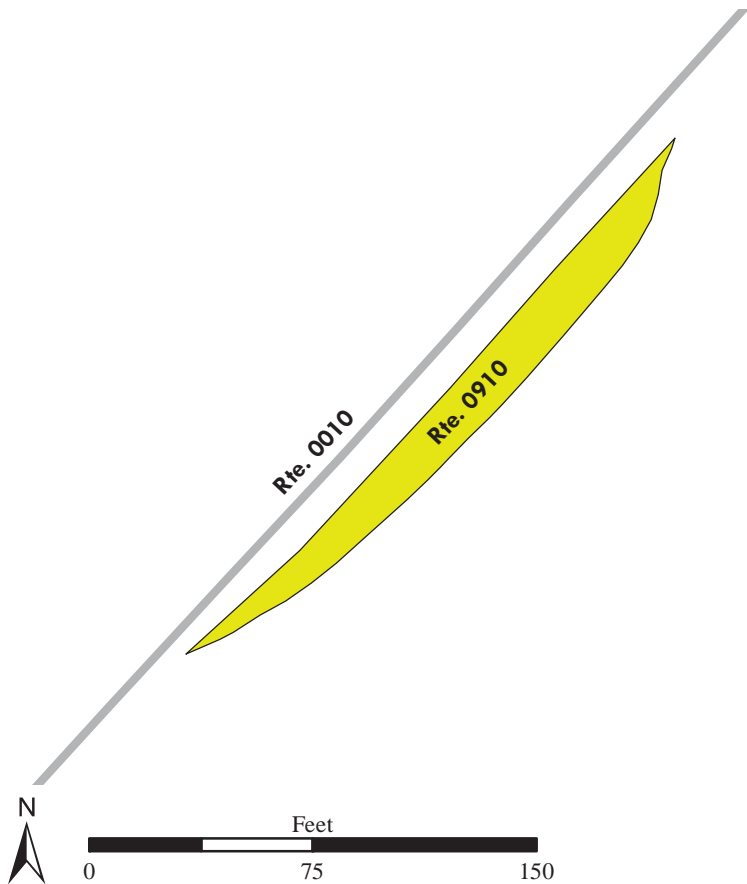
## ROUTE 0910: SOUTH ENTRANCE PULLOUT PARKING

Inspection Date	FMSS Number	User Access	Surface Type
3/24/2016	228028	PUBLIC	ASPHALT
Area (Sq. Ft.)	Lane Miles (11' Widths)	Curb Reveal (Inches)	Curb Recommendation
2,429	0.042	NOT APPLICABLE	NOT APPLICABLE
Curb Type		Curb & Gutter Type	
NO CURB		NO CURB AND GUTTER	
Pavement Recommendation		Condition Rating / PCR	
LIGHT 3R TREATMENTS		FAIR / 73
