ZION Cycle 6

Final Report

Road Inventory and Condition Assessment of Paved Routes Zion National Park

**Federal Highway Administration
Eastern Federal Lands Highway Division
Road Inventory Program (RIP)**

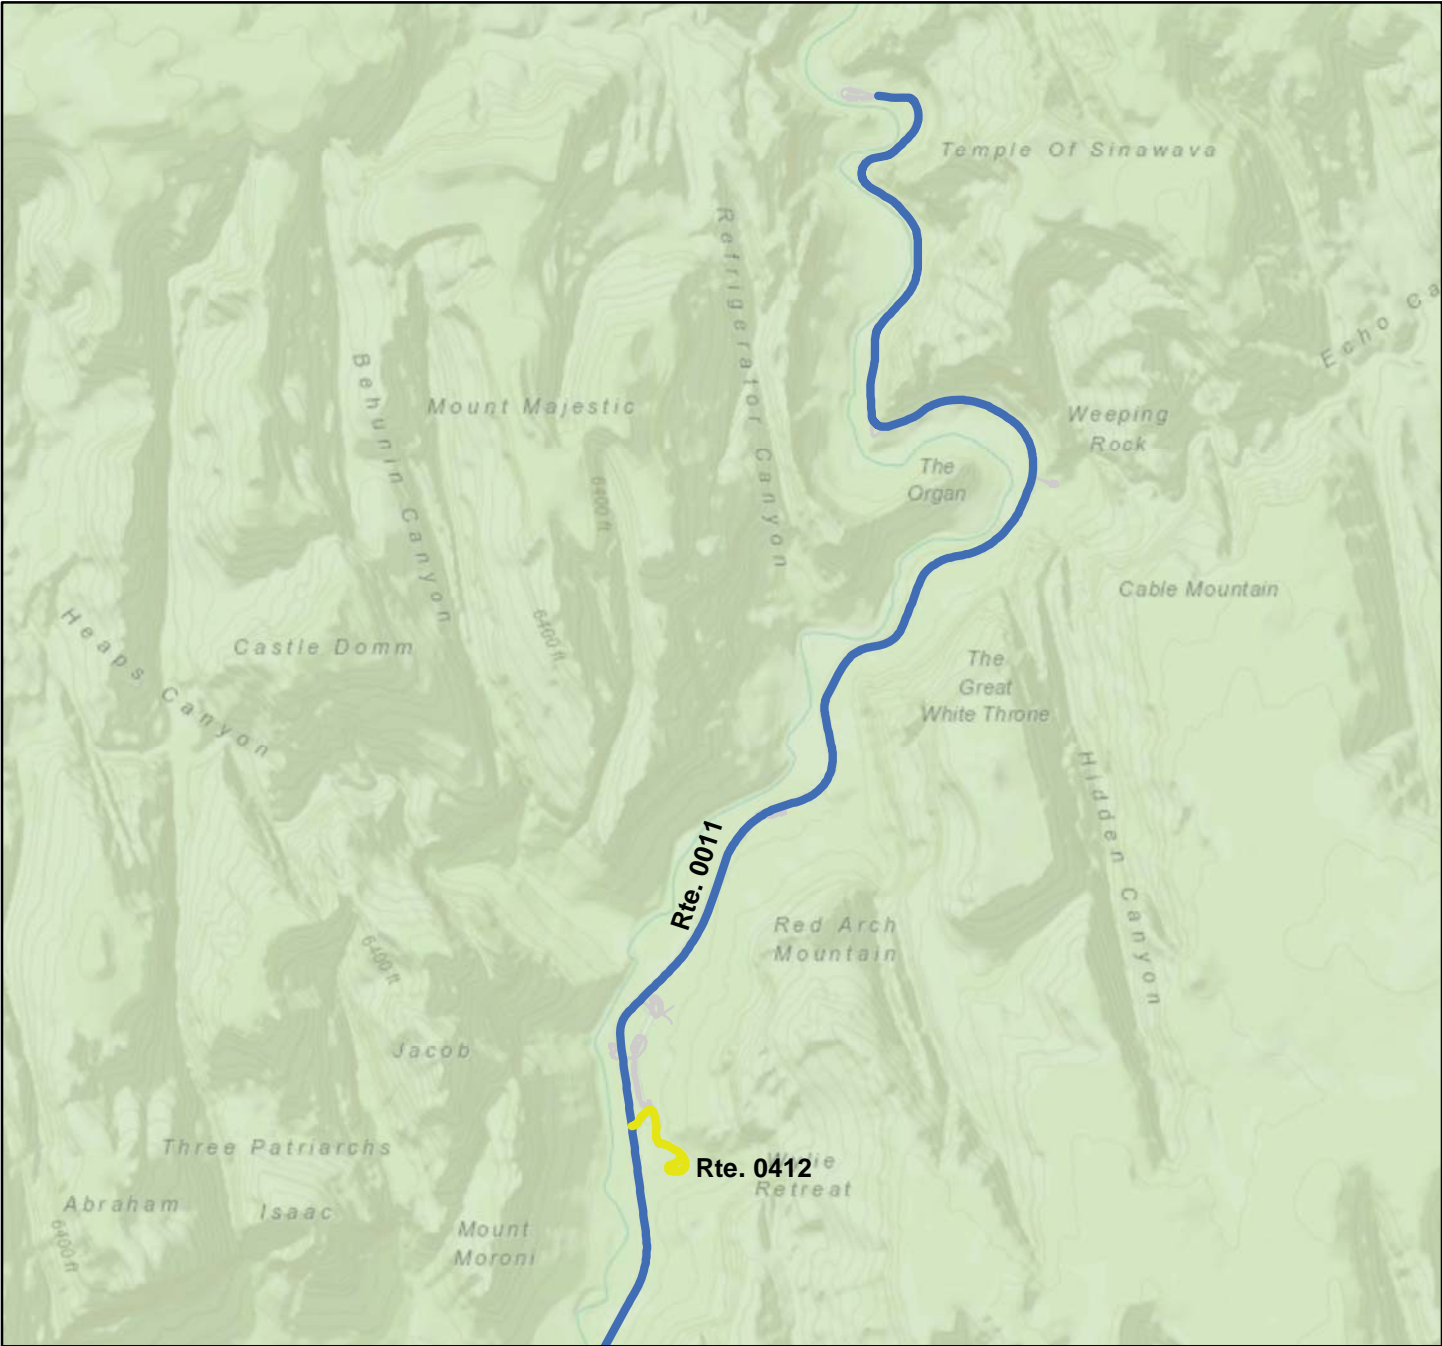
Area Map 6

PCR - MILE BY MILE

Route Condition Legend – Pavement Condition Rating (PCR)				
Poor (0 - 60)	Fair (61- 84)	Good (85 - 94)	Excellent (95 - 100)	Not Rated
See Appendix for definitions and formulas				
Only Data Collection Vehicle and Manually Rated Roads are displayed

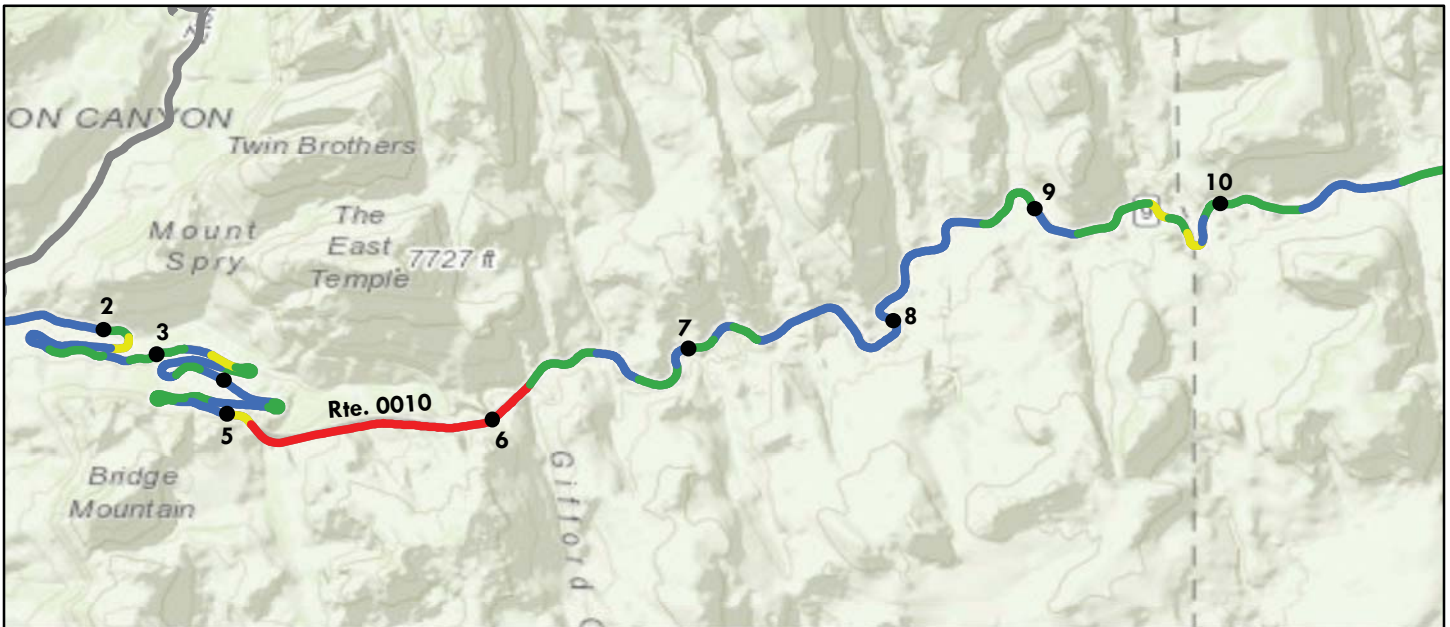
ROUTE 0010: SOUTH TO EAST ENTRANCE (ZION-MT CARMEL HIGHWAY)

Route Condition Legend – Pavement Condition Rating (PCR)						
Poor (0 - 60)	Fair (61- 84)	Good (85 - 94)	Excellent (95 - 100)	Not Rated		
See Appendix for definitions and formulas						
Inspection Date: 4/21/2017	Beginning Section MP	5	6	7	8	9
Paved Length (Miles): 12.25	Section Length (MI)	1	1	1	1	1
Surface Type: ASPHALT	Route Summary					
Roadway Condition Information						
Pavement Condition Rating (PCR)	93	0	89	97	97	91
Surface Condition Rating (SCR)	98	N/A	96	99	98	99
Roughness Condition Index (RCI)	86	0	78	95	96	79
Distress Index Values						
Structural Crack Index	98	N/A	96	99	98	99
Alligator Crack Index	100	N/A	100	100	100	100
Longitudinal Crack Index	98	N/A	96	99	98	99
Transverse Cracking Index	99	N/A	100	100	100	100
Patching Index	100	N/A	100	100	100	100
Rutting Index	98	N/A	99	99	99	99
International Roughness Index (IRI)	152	329	176	126	125	172
Lane & Width Information						
Number of Lanes	2	2	2	2	2	2

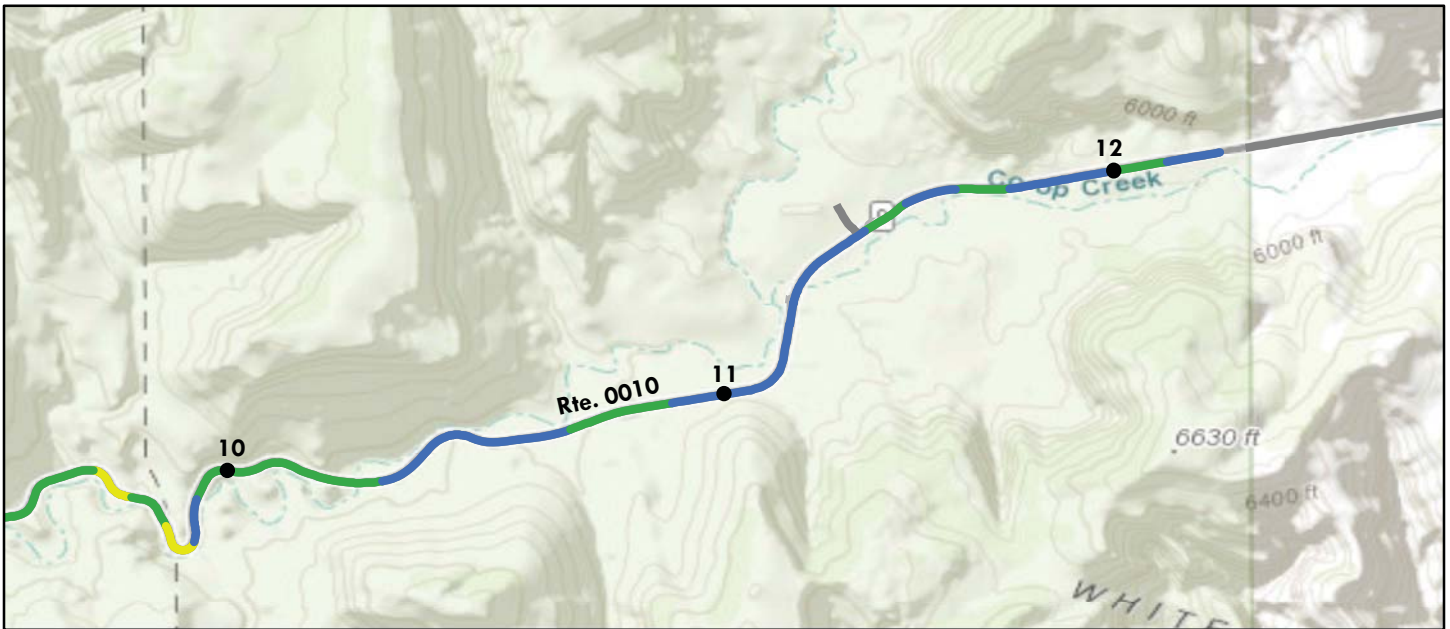
ROUTE 0010: SOUTH TO EAST ENTRANCE (ZION-MT CARMEL HIGHWAY)

Route Condition Legend – Pavement Condition Rating (PCR)						
Poor (0 - 60)	Fair (61- 84)	Good (85 - 94)	Excellent (95 - 100)	Not Rated		
See Appendix for definitions and formulas						
Inspection Date: 4/21/2017	Beginning Section MP	10	11	12		
Paved Length (Miles): 12.25	Section Length (MI)	1	1	0.25		
Surface Type: ASPHALT	Route Summary					
Roadway Condition Information						
Pavement Condition Rating (PCR)	93	97	97	92		
Surface Condition Rating (SCR)	98	95	96	91		
Roughness Condition Index (RCI)	86	99	99	94		
Distress Index Values						
Structural Crack Index	98	95	98	99		
Alligator Crack Index	100	100	100	100		
Longitudinal Crack Index	98	95	98	99		
Transverse Cracking Index	99	99	99	98		
Patching Index	100	100	100	100		
Rutting Index	98	98	96	91		
International Roughness Index (IRI)	152	118	117	130		
Lane & Width Information						
Number of Lanes	2	2	2	2		
Paved Width (ft)	25.8	24.7	28	25.7		
Lane Width (ft)	11.8	12	11.9	11.5

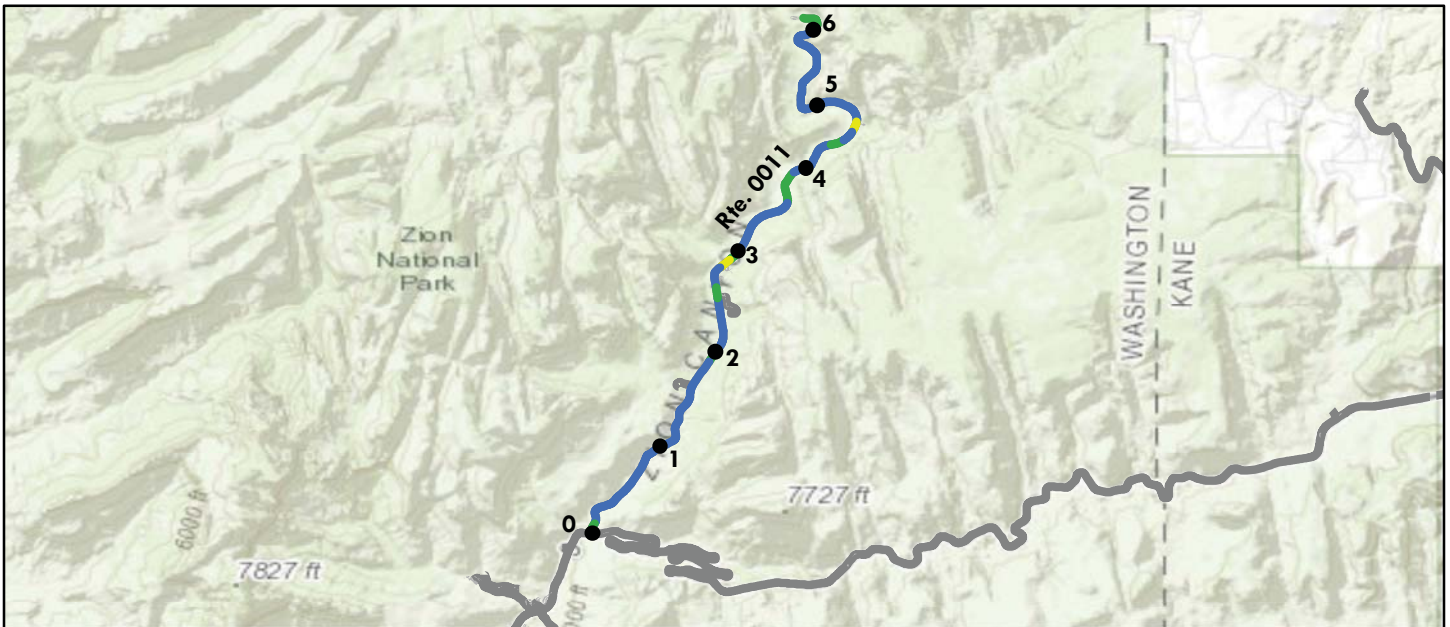
ROUTE 0011: ZION CANYON SCENIC DRIVE

Route Condition Legend – Pavement Condition Rating (PCR)						
Poor (0 - 60)	Fair (61- 84)	Good (85 - 94)	Excellent (95 - 100)	Not Rated		
See Appendix for definitions and formulas						
Inspection Date: 4/21/2017	Beginning Section MP	0	1	2	3	4
Paved Length (Miles): 6.19	Section Length (MI)	1	1	1	1	1
Surface Type: ASPHALT	Route Summary					
Roadway Condition Information						
Pavement Condition Rating (PCR)	97	98	97	96	97	96
Surface Condition Rating (SCR)	95	96	95	93	97	94
Roughness Condition Index (RCI)	100	100	100	100	98	100
Distress Index Values						
Structural Crack Index	100	100	100	100	100	100
Alligator Crack Index	100	100	100	100	100	100
Longitudinal Crack Index	100	100	100	100	100	100
Transverse Cracking Index	100	100	100	100	100	100
Patching Index	100	100	100	100	100	100
Rutting Index	95	96	95	93	97	94
International Roughness Index (IRI)	107	97	93	111	121	114
Lane & Width Information						
Number of Lanes	2	2	2	2	2	2

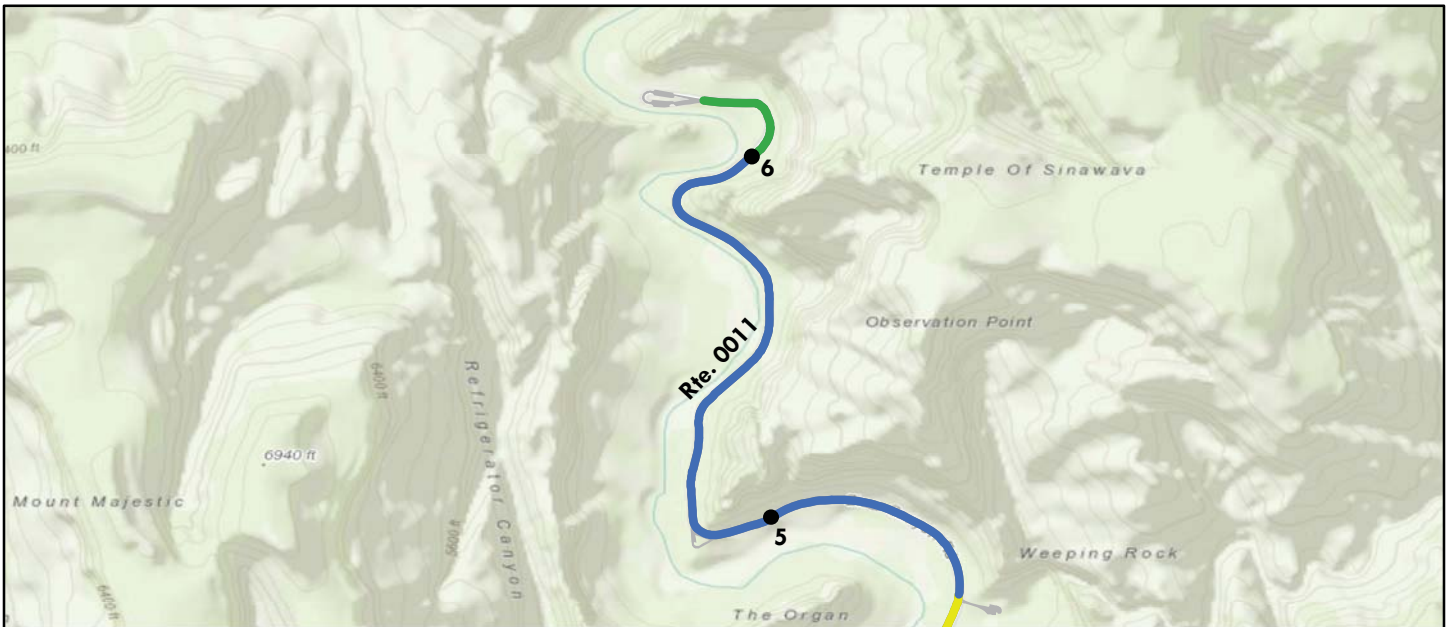
ROUTE 0011: ZION CANYON SCENIC DRIVE

Route Condition Legend – Pavement Condition Rating (PCR)						
Poor (0 - 60)	Fair (61- 84)	Good (85 - 94)	Excellent (95 - 100)	Not Rated		
See Appendix for definitions and formulas						
Inspection Date: 4/21/2017	Beginning Section MP	5	6			
Paved Length (Miles): 6.19	Section Length (MI)	1	0.19			
Surface Type: ASPHALT	Route Summary					
Roadway Condition Information						
Pavement Condition Rating (PCR)	97	98	96			
Surface Condition Rating (SCR)	95	97	96			
Roughness Condition Index (RCI)	100	100	N/A			
Distress Index Values						
Structural Crack Index	100	100	100			
Alligator Crack Index	100	100	100			
Longitudinal Crack Index	100	100	100			
Transverse Cracking Index	100	100	100			
Patching Index	100	100	100			
Rutting Index	95	97	96			
International Roughness Index (IRI)	107	101	N/A			
Lane & Width Information						
Number of Lanes	2	2	2			
Paved Width (ft)	25.3	25	24			
Lane Width (ft)	12	12	11.4

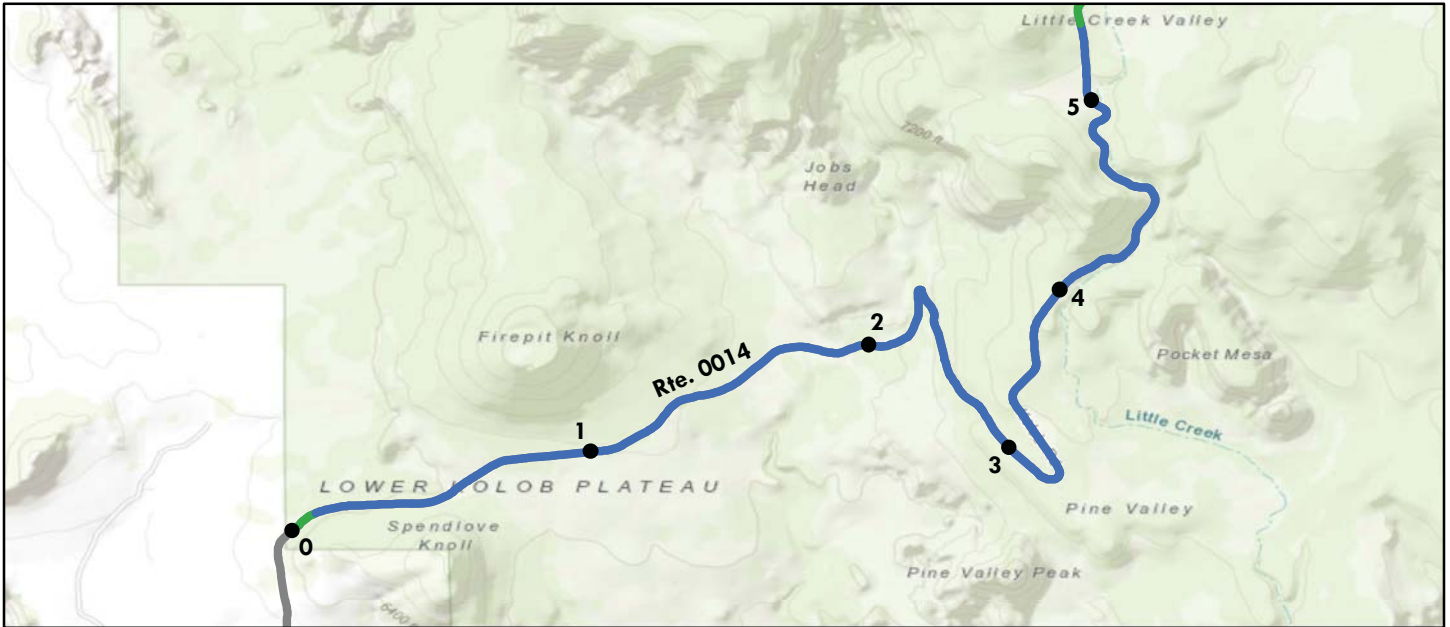
ROUTE 0014: KOLOB TERRACE ROAD NORTH

Route Condition Legend – Pavement Condition Rating (PCR)						
Poor (0 - 60)	Fair (61- 84)	Good (85 - 94)	Excellent (95 - 100)	Not Rated		
See Appendix for definitions and formulas						
Inspection Date: 4/20/2017	Beginning Section MP	0	1	2	3	4
Paved Length (Miles): 5.88	Section Length (MI)	1	1	1	1	1
Surface Type: ASPHALT	Route Summary					
Roadway Condition Information						
Pavement Condition Rating (PCR)	99	99	100	100	99	100
Surface Condition Rating (SCR)	99	99	100	100	98	100
Roughness Condition Index (RCI)	100	100	100	100	100	100
Distress Index Values						
Structural Crack Index	99	99	100	100	98	100
Alligator Crack Index	100	100	100	100	100	100
Longitudinal Crack Index	99	99	100	100	98	100
Transverse Cracking Index	100	100	100	100	100	100
Patching Index	100	100	100	100	100	100
Rutting Index	100	99	100	100	100	100
International Roughness Index (IRI)	97	98	90	91	98	99
Lane & Width Information						
Number of Lanes	2	2	2	2	2	2

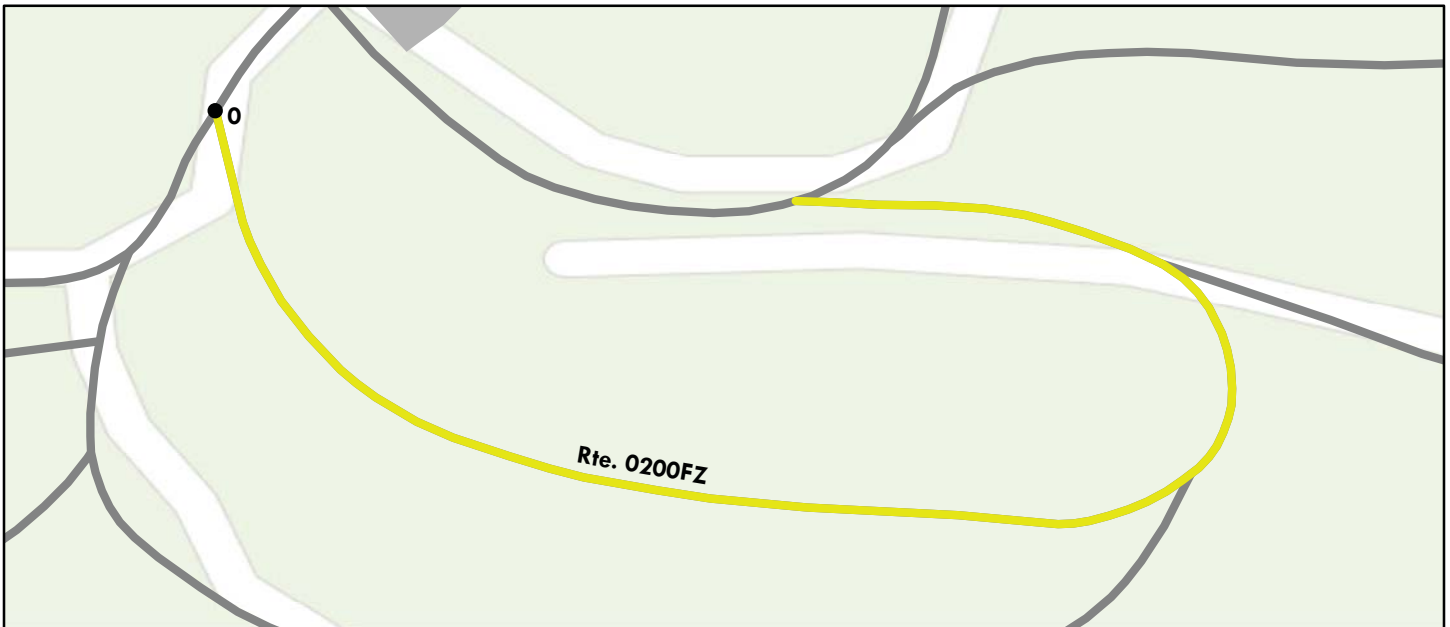
ROUTE 0200FZ: SOUTH CAMPGROUND INSIDE ROAD F (SITES 91-100)

Route Condition Legend – Pavement Condition Rating (PCR)						
Poor (0 - 60)	Fair (61- 84)	Good (85 - 94)	Excellent (95 - 100)	Not Rated		
See Appendix for definitions and formulas						
Inspection Date: 4/20/2017	Beginning Section MP	0				
Paved Length (Miles): 0.12	Section Length (MI)	0.12				
Surface Type: ASPHALT	Route Summary					
Roadway Condition Information						
Pavement Condition Rating (PCR)	75	75				
Surface Condition Rating (SCR)	75	75				
Roughness Condition Index (RCI)	N/A	N/A				
Distress Index Values						
Structural Crack Index	75	75				
Alligator Crack Index	100	100				
Longitudinal Crack Index	75	75				
Transverse Cracking Index	81	81				
Patching Index	98	98				
Rutting Index	89	89				
International Roughness Index (IRI)	N/A	N/A				
Lane & Width Information						
Number of Lanes	1	1				
Paved Width (ft)	11.4	11.4				
Lane Width (ft)	11.4	11.4

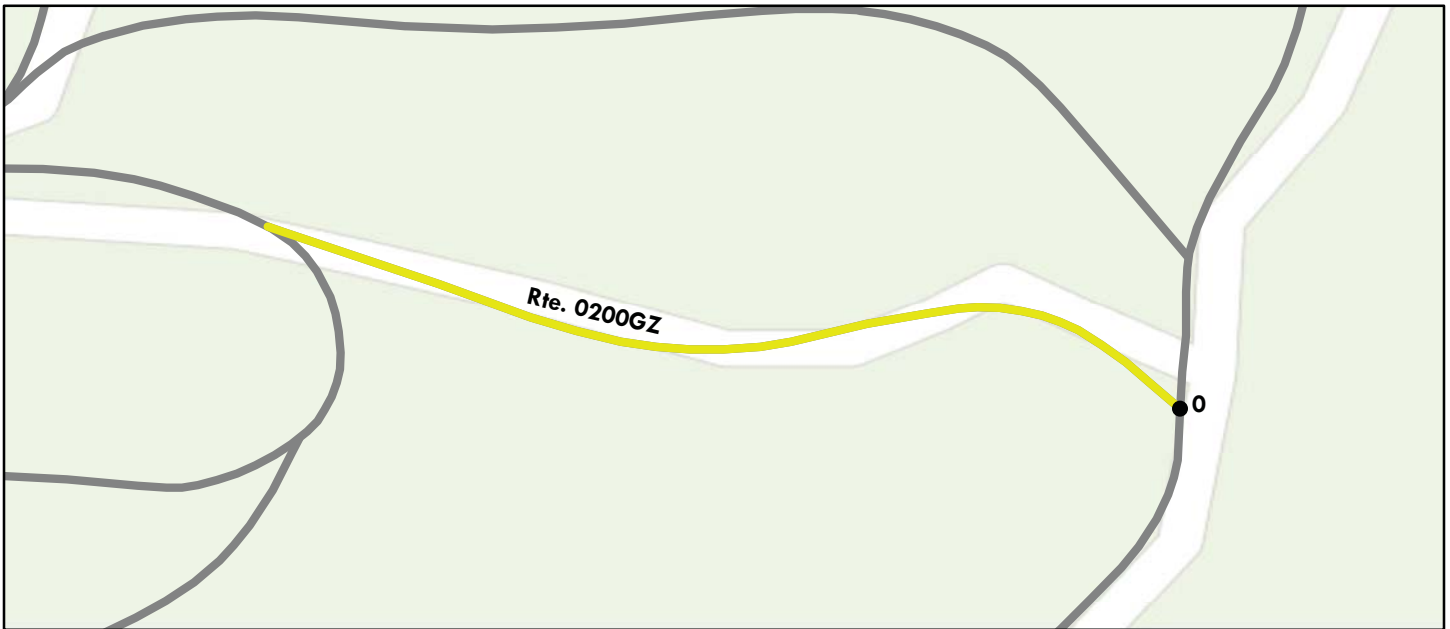
ROUTE 0200GZ: SOUTH CAMPGROUND INSIDE ROAD G (SITES 86-89)

Route Condition Legend – Pavement Condition Rating (PCR)						
Poor (0 - 60)	Fair (61- 84)	Good (85 - 94)	Excellent (95 - 100)	Not Rated		
See Appendix for definitions and formulas						
Inspection Date: 4/20/2017	Beginning Section MP	0				
Paved Length (Miles): 0.06	Section Length (MI)	0.06				
Surface Type: ASPHALT	Route Summary					
Roadway Condition Information						
Pavement Condition Rating (PCR)	70	70				
Surface Condition Rating (SCR)	70	70				
Roughness Condition Index (RCI)	N/A	N/A				
Distress Index Values						
Structural Crack Index	84	84				
Alligator Crack Index	100	100				
Longitudinal Crack Index	84	84				
Transverse Cracking Index	70	70				
Patching Index	98	98				
Rutting Index	93	93				
International Roughness Index (IRI)	N/A	N/A				
Lane & Width Information						
Number of Lanes	1	1				
Paved Width (ft)	10.8	10.8				
Lane Width (ft)	10.8	10.8

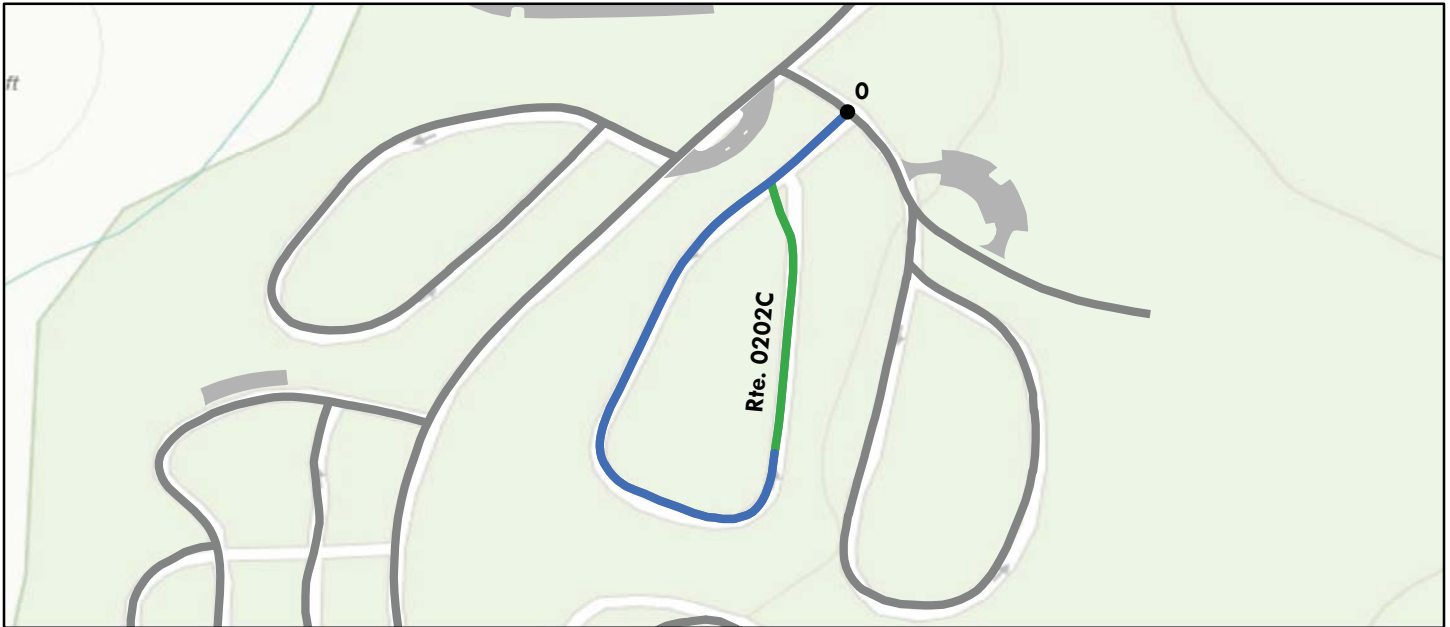
ROUTE 0202C: WATCHMAN CAMPGROUND LOOP C

Route Condition Legend – Pavement Condition Rating (PCR)						
Poor (0 - 60)	Fair (61- 84)	Good (85 - 94)	Excellent (95 - 100)	Not Rated		
See Appendix for definitions and formulas						
Inspection Date: 4/20/2017	Beginning Section MP	0				
Paved Length (Miles): 0.29	Section Length (MI)	0.29				
Surface Type: ASPHALT	Route Summary					
Roadway Condition Information						
Pavement Condition Rating (PCR)	96	96				
Surface Condition Rating (SCR)	96	96				
Roughness Condition Index (RCI)	N/A	N/A				
Distress Index Values						
Structural Crack Index	96	96				
Alligator Crack Index	100	100				
Longitudinal Crack Index	96	96				
Transverse Cracking Index	99	99				
Patching Index	100	100				
Rutting Index	97	97				
International Roughness Index (IRI)	N/A	N/A				
Lane & Width Information						
Number of Lanes	1	1				
Paved Width (ft)	13.9	13.9				
Lane Width (ft)	13.9	13.9

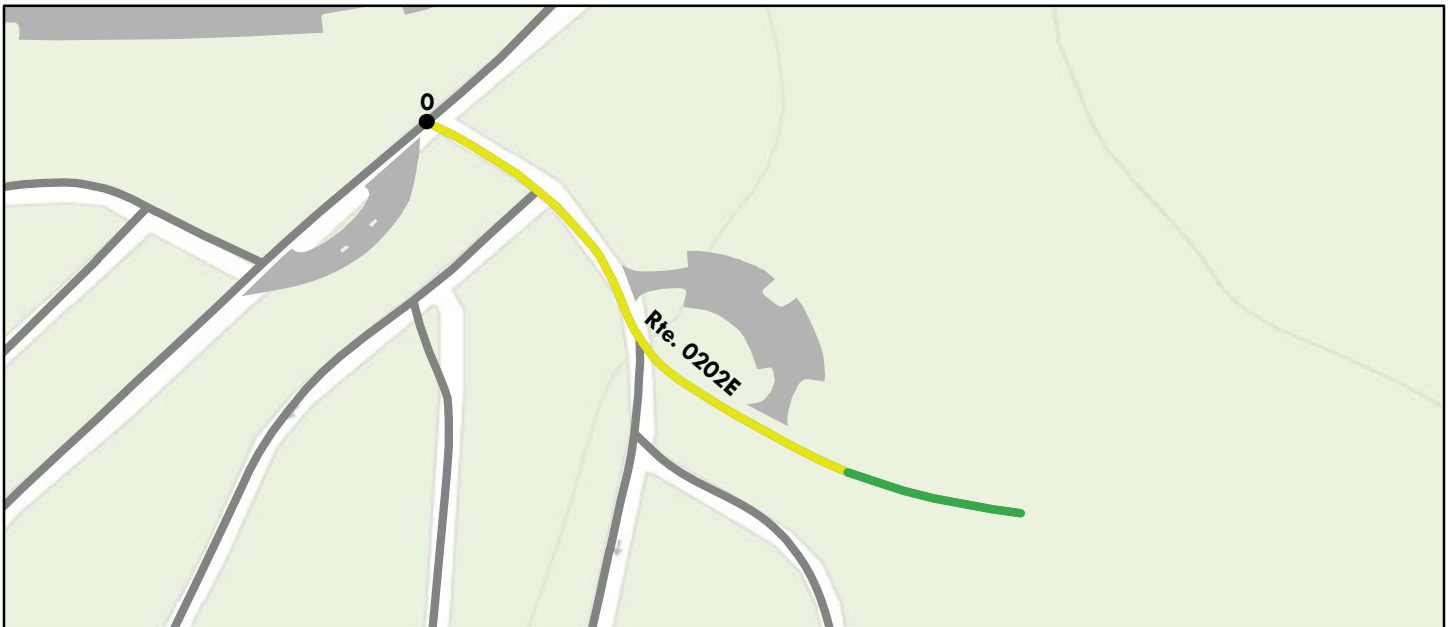
ROUTE 0202E: WATCHMAN CAMPGROUND LOOPS C AND D MAINTENANCE ACCESS

Route Condition Legend – Pavement Condition Rating (PCR)						
Poor (0 - 60)	Fair (61- 84)	Good (85 - 94)	Excellent (95 - 100)	Not Rated		
See Appendix for definitions and formulas						
Inspection Date: 4/20/2017	Beginning Section MP	0				
Paved Length (Miles): 0.13	Section Length (MI)	0.13				
Surface Type: ASPHALT	Route Summary					
Roadway Condition Information						
Pavement Condition Rating (PCR)	87	87				
Surface Condition Rating (SCR)	87	87				
Roughness Condition Index (RCI)	N/A	N/A				
Distress Index Values						
Structural Crack Index	89	89				
Alligator Crack Index	99	99				
Longitudinal Crack Index	90	90				
Transverse Cracking Index	87	87				
Patching Index	100	100				
Rutting Index	95	95				
International Roughness Index (IRI)	N/A	N/A				
Lane & Width Information						
Number of Lanes	2	2				
Paved Width (ft)	20.4	20.4				
Lane Width (ft)	11.2	11.2

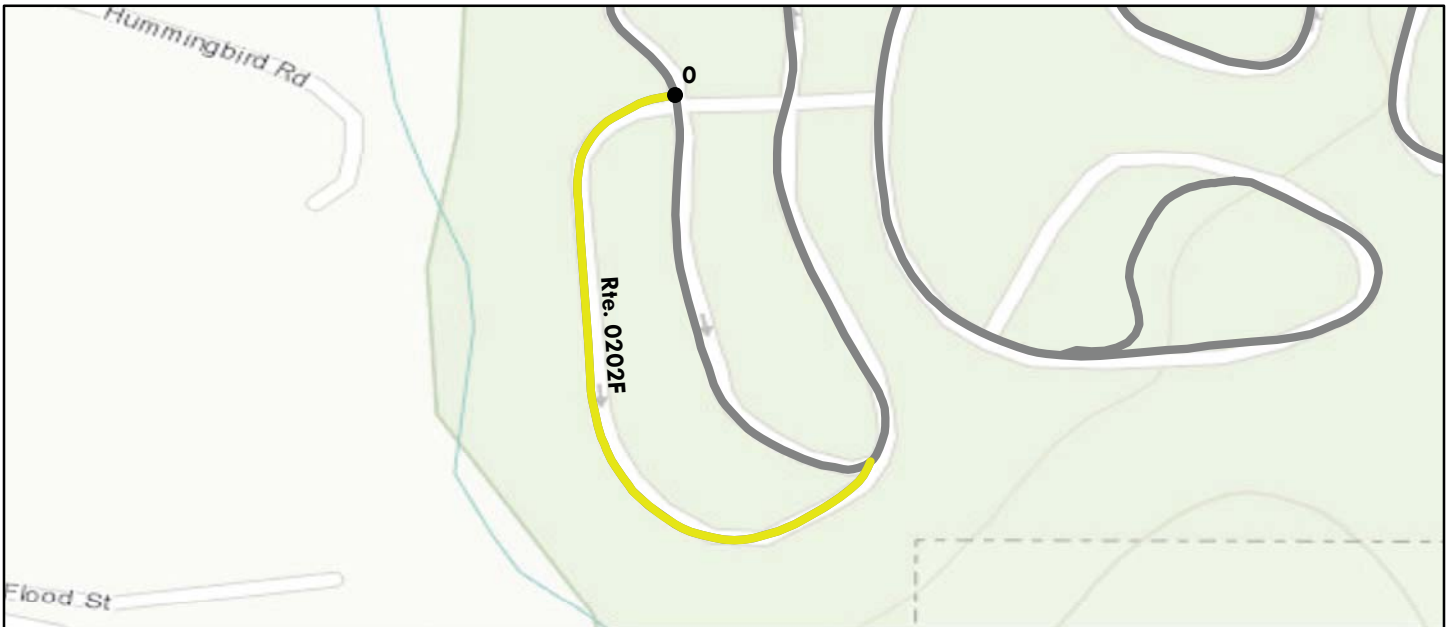
ROUTE 0202F: WATCHMAN CAMPGROUND LOOP B (SIDE LOOP)

Route Condition Legend – Pavement Condition Rating (PCR)						
Poor (0 - 60)	Fair (61- 84)	Good (85 - 94)	Excellent (95 - 100)	Not Rated		
See Appendix for definitions and formulas						
Inspection Date: 4/20/2017	Beginning Section MP	0				
Paved Length (Miles): 0.19	Section Length (MI)	0.19				
Surface Type: ASPHALT	Route Summary					
Roadway Condition Information						
Pavement Condition Rating (PCR)	82	82				
Surface Condition Rating (SCR)	82	82				
Roughness Condition Index (RCI)	N/A	N/A				
Distress Index Values						
Structural Crack Index	96	96				
Alligator Crack Index	100	100				
Longitudinal Crack Index	96	96				
Transverse Cracking Index	82	82				
Patching Index	99	99				
Rutting Index	88	88				
International Roughness Index (IRI)	N/A	N/A				
Lane & Width Information						
Number of Lanes	1	1				
Paved Width (ft)	12.7	12.7				
Lane Width (ft)	12.7	12.7

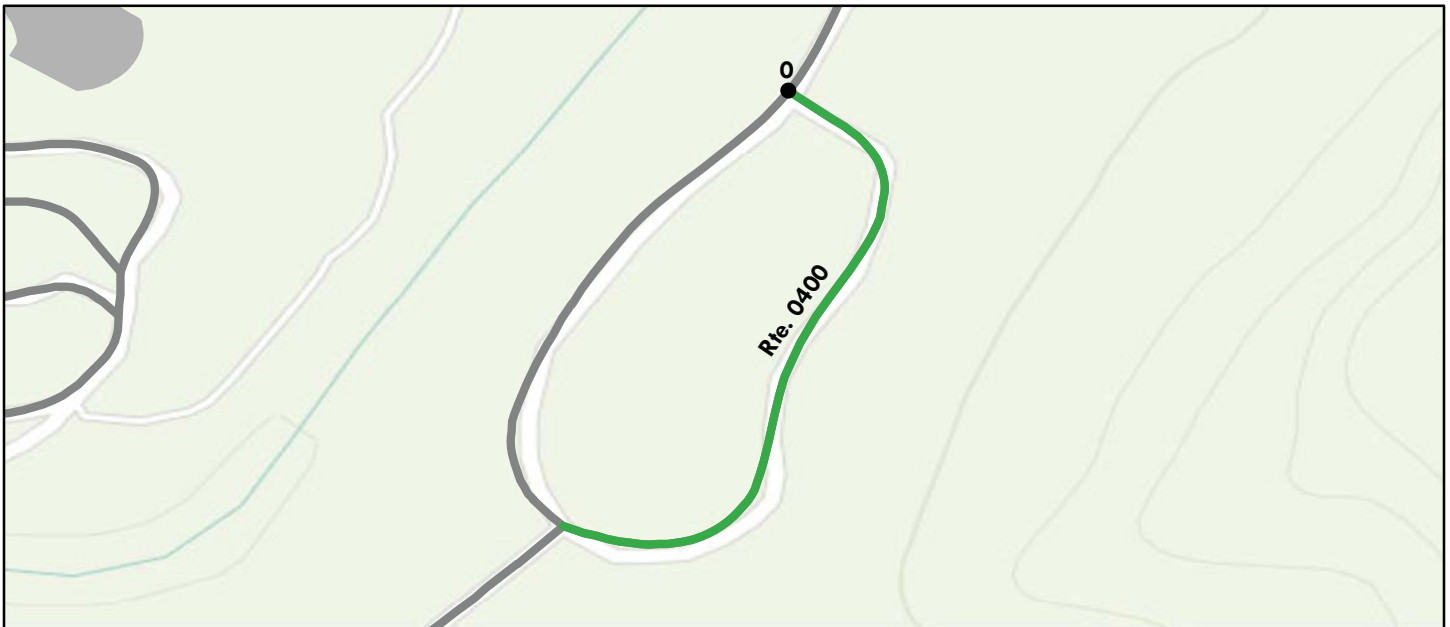
ROUTE 0400: WATCHMAN HOUSING COMPLEX ROAD

Route Condition Legend – Pavement Condition Rating (PCR)						
Poor (0 - 60)	Fair (61- 84)	Good (85 - 94)	Excellent (95 - 100)	Not Rated		
See Appendix for definitions and formulas						
Inspection Date: 4/20/2017	Beginning Section MP	0				
Paved Length (Miles): 0.18	Section Length (MI)	0.18				
Surface Type: ASPHALT	Route Summary					
Roadway Condition Information						
Pavement Condition Rating (PCR)	88	88				
Surface Condition Rating (SCR)	88	88				
Roughness Condition Index (RCI)	N/A	N/A				
Distress Index Values						
Structural Crack Index	94	94				
Alligator Crack Index	100	100				
Longitudinal Crack Index	94	94				
Transverse Cracking Index	88	88				
Patching Index	100	100				
Rutting Index	95	95				
International Roughness Index (IRI)	N/A	N/A				
Lane & Width Information						
Number of Lanes	2	2				
Paved Width (ft)	22.3	22.3				
Lane Width (ft)	11.2	11.2

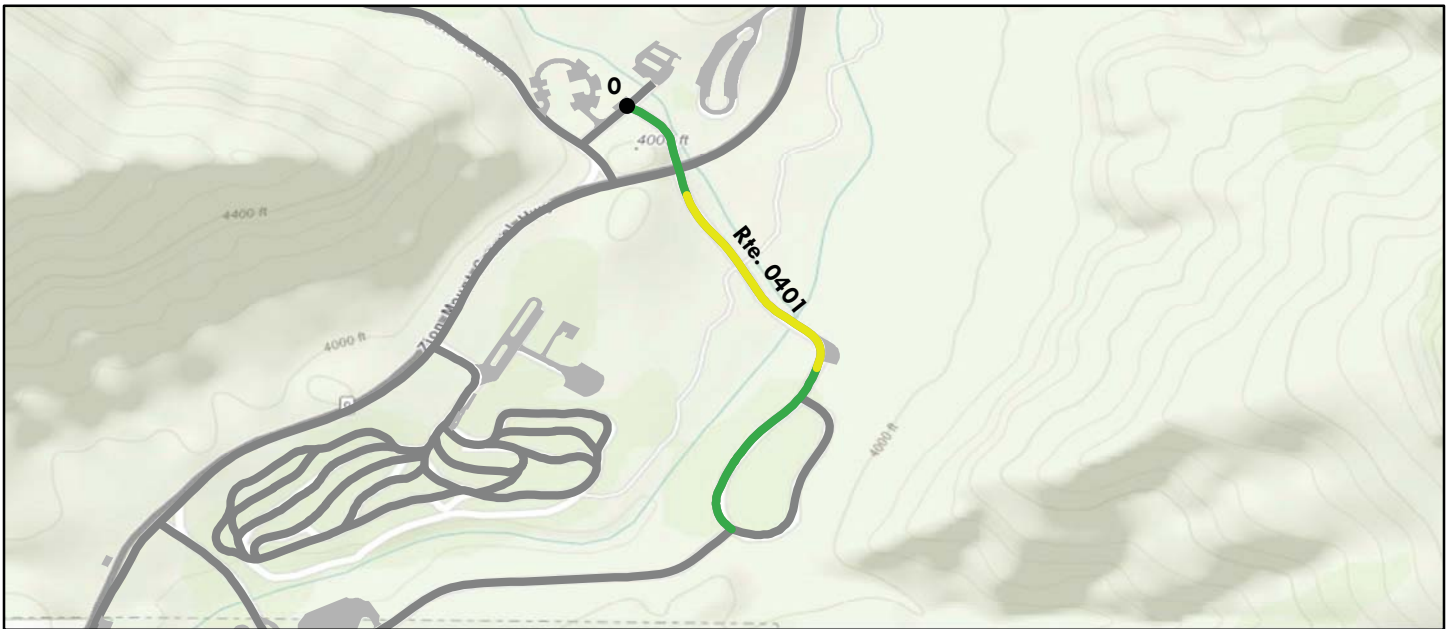
ROUTE 0401: WATCHMAN RESIDENCE ROAD

Route Condition Legend – Pavement Condition Rating (PCR)						
Poor (0 - 60)	Fair (61- 84)	Good (85 - 94)	Excellent (95 - 100)	Not Rated		
See Appendix for definitions and formulas						
Inspection Date: 4/20/2017	Beginning Section MP	0				
Paved Length (Miles): 0.48	Section Length (MI)	0.48				
Surface Type: ASPHALT	Route Summary					
Roadway Condition Information						
Pavement Condition Rating (PCR)	86	86				
Surface Condition Rating (SCR)	86	86				
Roughness Condition Index (RCI)	N/A	N/A				
Distress Index Values						
Structural Crack Index	93	93				
Alligator Crack Index	100	100				
Longitudinal Crack Index	93	93				
Transverse Cracking Index	86	86				
Patching Index	100	100				
Rutting Index	95	95				
International Roughness Index (IRI)	N/A	N/A				
Lane & Width Information						
Number of Lanes	2	2				
Paved Width (ft)	21.5	21.5				
Lane Width (ft)	10.5	10.5

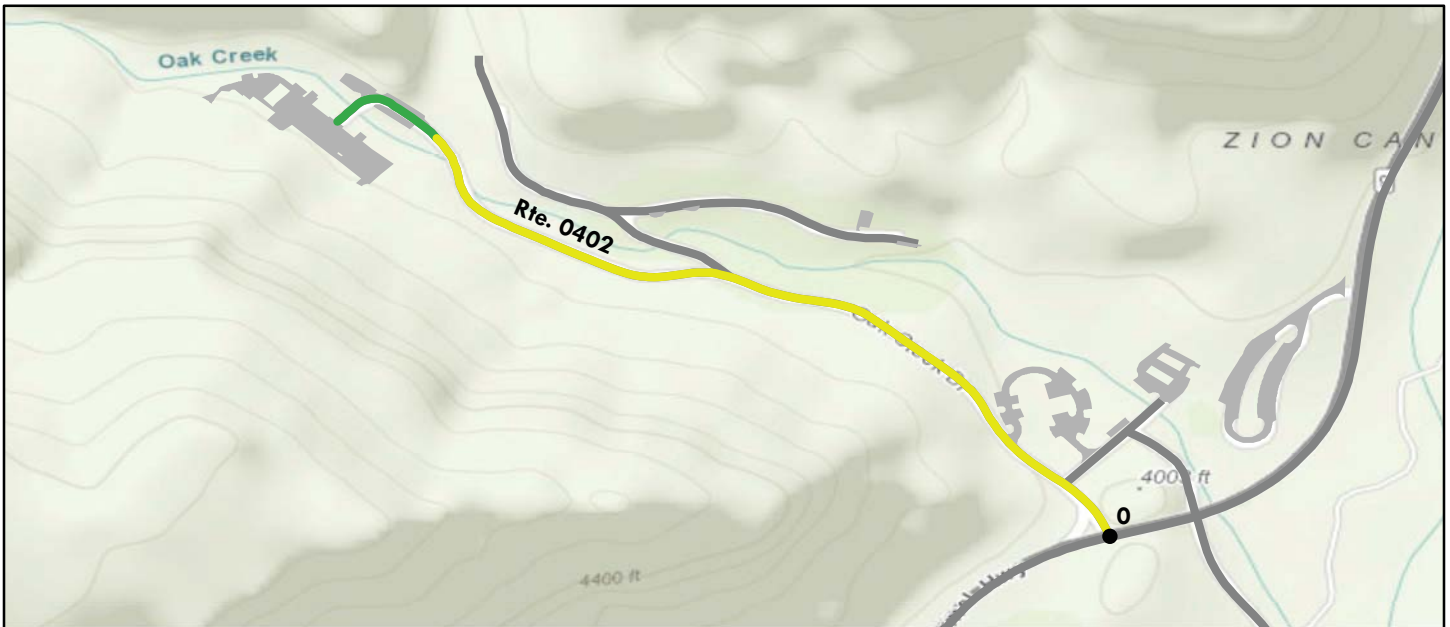
ROUTE 0402: MAINTENANCE ACCESS ROAD

Route Condition Legend – Pavement Condition Rating (PCR)						
Poor (0 - 60)	Fair (61- 84)	Good (85 - 94)	Excellent (95 - 100)	Not Rated		
See Appendix for definitions and formulas						
Inspection Date: 4/20/2017	Beginning Section MP	0				
Paved Length (Miles): 0.57	Section Length (MI)	0.57				
Surface Type: ASPHALT	Route Summary					
Roadway Condition Information						
Pavement Condition Rating (PCR)	67	67				
Surface Condition Rating (SCR)	77	77				
Roughness Condition Index (RCI)	51	51				
Distress Index Values						
Structural Crack Index	86	86				
Alligator Crack Index	100	100				
Longitudinal Crack Index	86	86				
Transverse Cracking Index	77	77				
Patching Index	100	100				
Rutting Index	94	94				
International Roughness Index (IRI)	279	279				
Lane & Width Information						
Number of Lanes	2	2				
Paved Width (ft)	21.6	21.6				
Lane Width (ft)	10.4	10.4

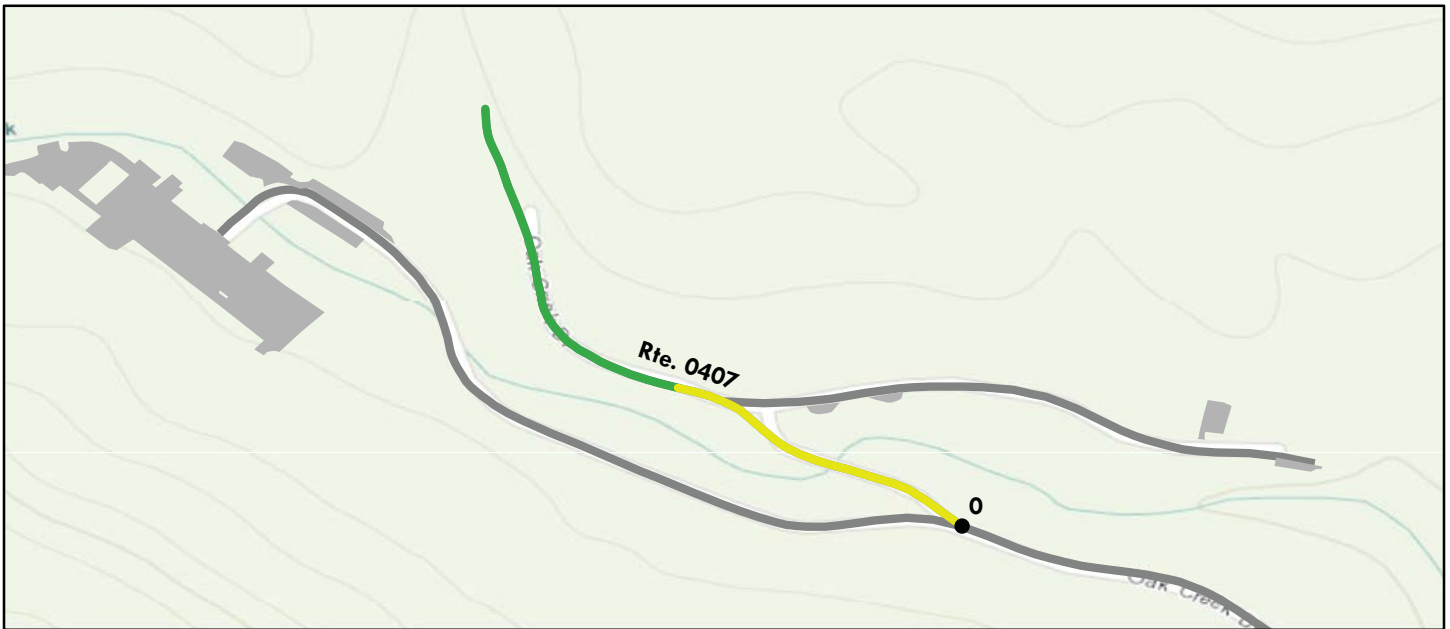
ROUTE 0407: OAK CREEK RESIDENCE ROAD

Route Condition Legend – Pavement Condition Rating (PCR)						
Poor (0 - 60)	Fair (61- 84)	Good (85 - 94)	Excellent (95 - 100)	Not Rated		
See Appendix for definitions and formulas						
Inspection Date: 4/20/2017	Beginning Section MP	0				
Paved Length (Miles): 0.23	Section Length (MI)	0.23				
Surface Type: ASPHALT	Route Summary					
Roadway Condition Information						
Pavement Condition Rating (PCR)	82	82				
Surface Condition Rating (SCR)	82	82				
Roughness Condition Index (RCI)	N/A	N/A				
Distress Index Values						
Structural Crack Index	85	85				
Alligator Crack Index	100	100				
Longitudinal Crack Index	85	85				
Transverse Cracking Index	82	82				
Patching Index	100	100				
Rutting Index	93	93				
International Roughness Index (IRI)	N/A	N/A				
Lane & Width Information						
Number of Lanes	2	2				
Paved Width (ft)	17.7	17.7				
Lane Width (ft)	8.9	8.9

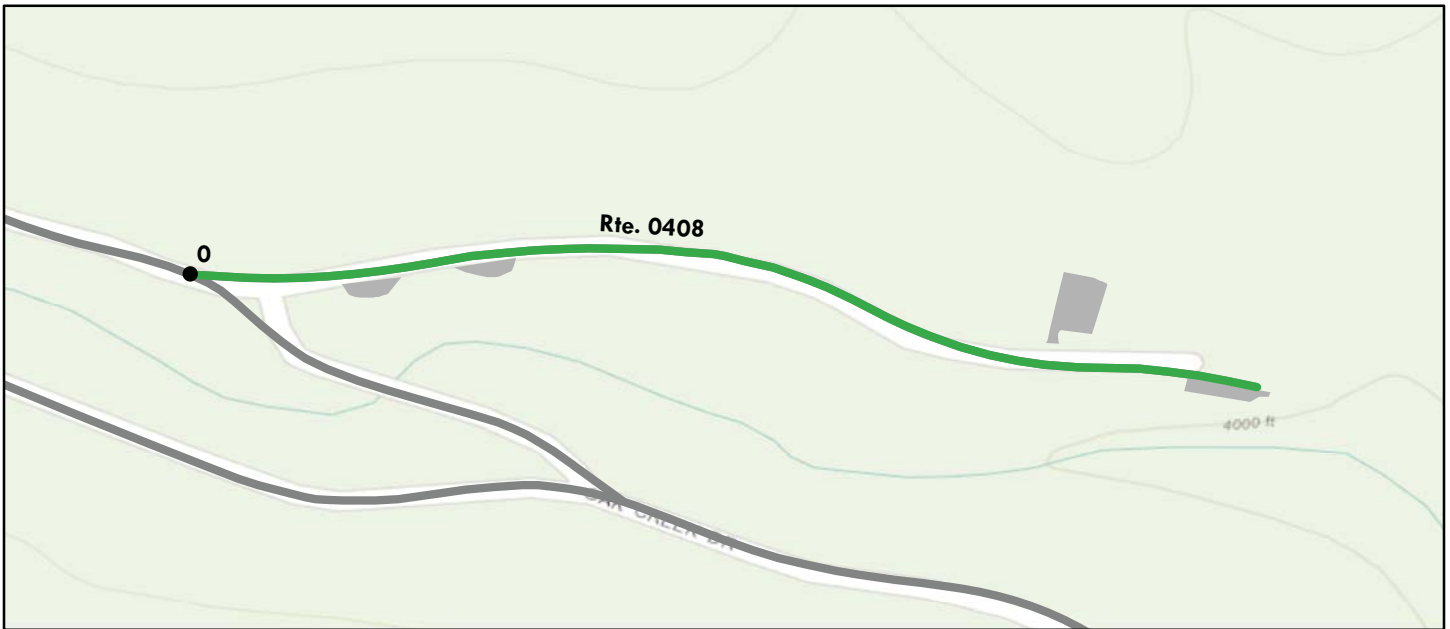
ROUTE 0408: OAK CREEK RESIDENCE SPUR ROAD

Route Condition Legend – Pavement Condition Rating (PCR)						
Poor (0 - 60)	Fair (61- 84)	Good (85 - 94)	Excellent (95 - 100)	Not Rated		
See Appendix for definitions and formulas						
Inspection Date: 4/20/2017	Beginning Section MP	0				
Paved Length (Miles): 0.18	Section Length (MI)	0.18				
Surface Type: ASPHALT	Route Summary					
Roadway Condition Information						
Pavement Condition Rating (PCR)	87	87				
Surface Condition Rating (SCR)	87	87				
Roughness Condition Index (RCI)	N/A	N/A				
Distress Index Values						
Structural Crack Index	90	90				
Alligator Crack Index	100	100				
Longitudinal Crack Index	90	90				
Transverse Cracking Index	87	87				
Patching Index	100	100				
Rutting Index	92	92				
International Roughness Index (IRI)	N/A	N/A				
Lane & Width Information						
Number of Lanes	2	2				
Paved Width (ft)	22.4	22.4				
Lane Width (ft)	11.2	11.2

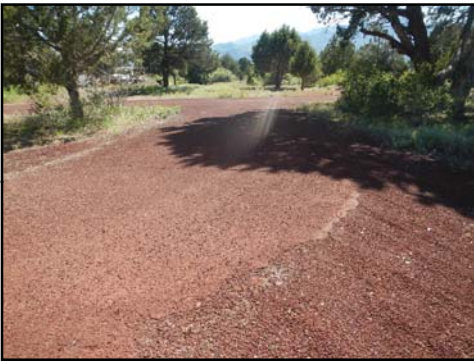
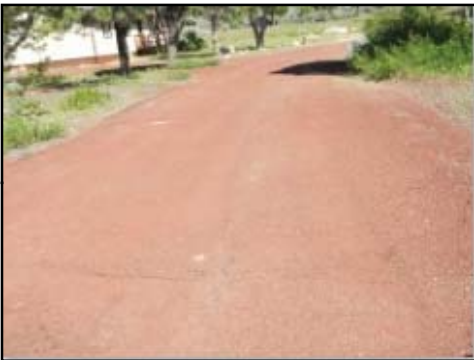
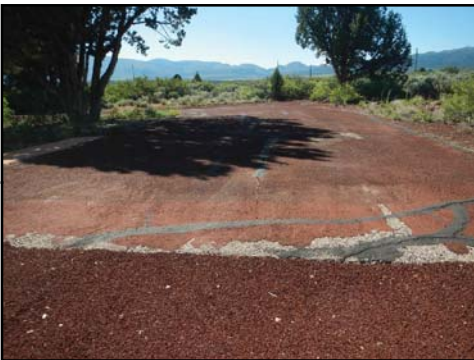
TO ROUTE 0410 (KOLOB SERVICE ROAD)

Inspection Date	FMSS Number	User Access	Surface Type
5/21/2016	90349	NONPUBLIC	ASPHALT
Area (Sq. Ft.)	Lane Miles (11' Widths)	Pavement Recommendation	
6,094	0.105	LIGHT 3R TREATMENTS	
Condition Rating / PCR			
FAIR / 73			
Route Condition Legend – Pavement Condition Rating (PCR)			
Poor (0 - 60)	Fair (61- 84)	Good (85 - 94)	Excellent (95 - 100)
See Appendix for definitions and formulas

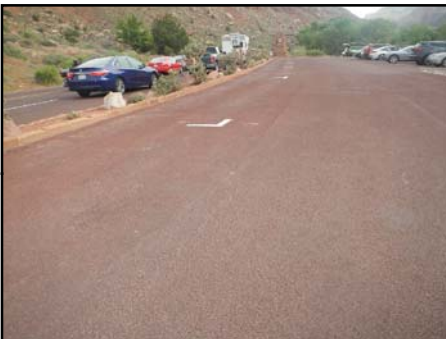
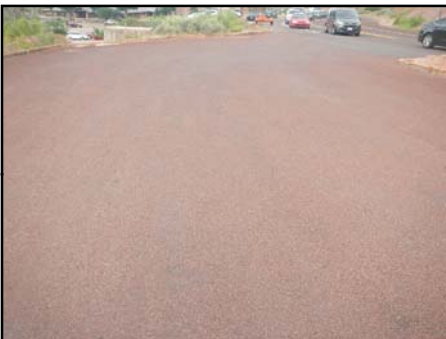
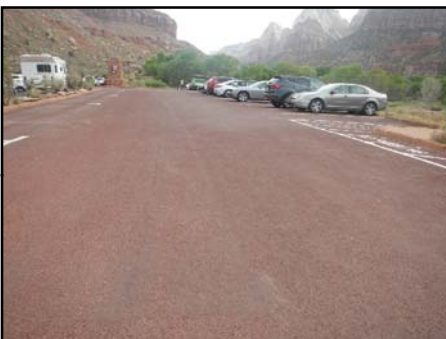
Inspection Date	FMSS Number	User Access	Surface Type
5/21/2016	65438	PUBLIC	ASPHALT
Area (Sq. Ft.)	Lane Miles (11' Widths)	Curb Reveal (Inches)	Curb Recommendation
12,526	0.216	5	DO NOTHING
Curb Type		Curb & Gutter Type	
STONE		NO CURB AND GUTTER	
Pavement Recommendation		Condition Rating / PCR	
PREVENTIVE MAINTENANCE		GOOD / 90

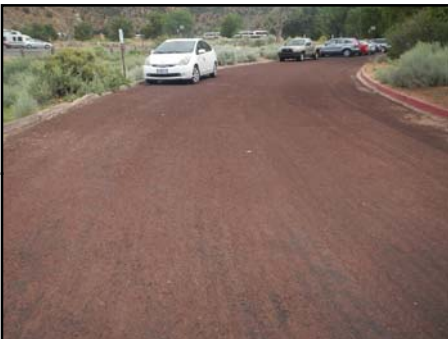
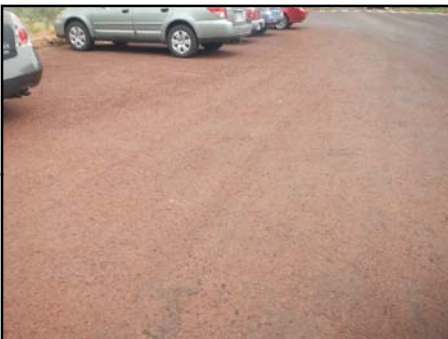
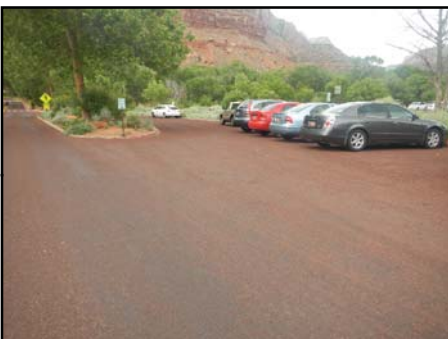
ROUTE 0901: EMPLOYEE VISITOR CENTER PARKING

Inspection Date	FMSS Number	User Access	Surface Type
5/20/2016	65470	PUBLIC	ASPHALT
Area (Sq. Ft.)	Lane Miles (11' Widths)	Curb Reveal (Inches)	Curb Recommendation
5,900	0.102	4	MODERATE REPAIR
Curb Type		Curb & Gutter Type	
CONCRETE AND STONE		CONCRETE	
Pavement Recommendation		Condition Rating / PCR	
PREVENTIVE MAINTENANCE		GOOD / 90

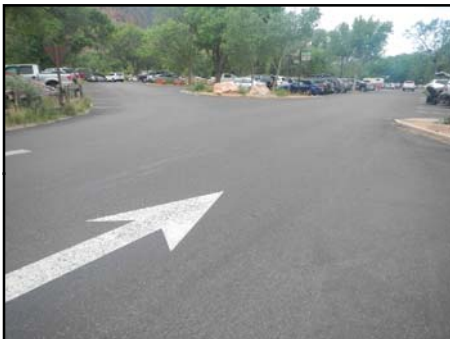
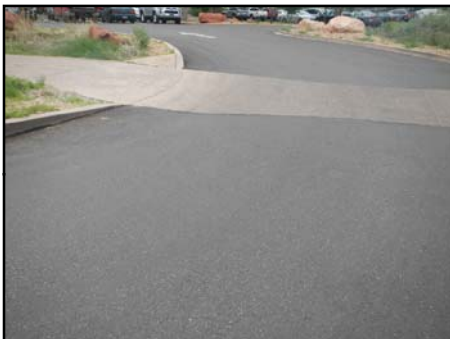
ROUTE 0902: VISITOR CENTER PARKING

Inspection Date	FMSS Number	User Access	Surface Type
5/21/2016	65482	PUBLIC	ASPHALT
Area (Sq. Ft.)	Lane Miles (11' Widths)	Curb Reveal (Inches)	Curb Recommendation
209,089	3.6	5	DO NOTHING
Curb Type		Curb & Gutter Type	
CONCRETE		CONCRETE	
Pavement Recommendation		Condition Rating / PCR	
PREVENTIVE MAINTENANCE		GOOD / 90

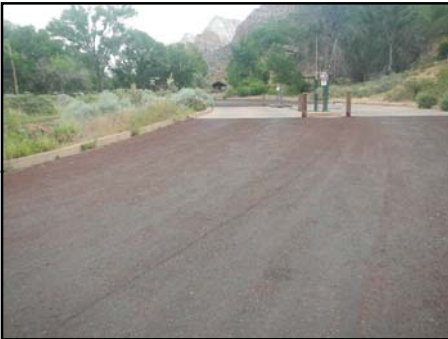
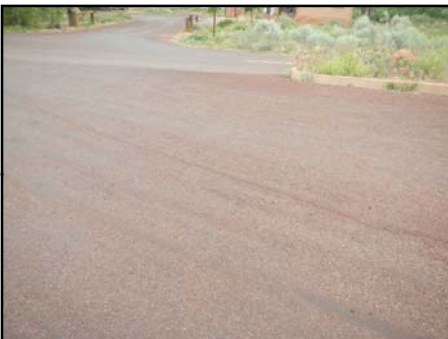
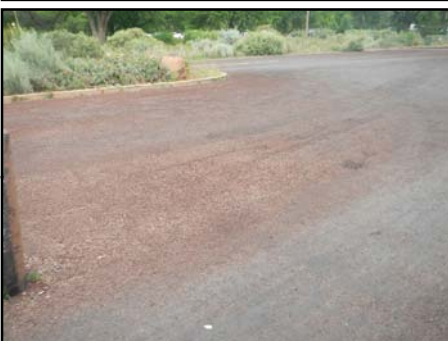
ROUTE 0903: WATCHMAN CAMPGROUND DUMP STATION PARKING

Inspection Date	FMSS Number	User Access	Surface Type
5/21/2016	65483	PUBLIC	ASPHALT
Area (Sq. Ft.)	Lane Miles (11' Widths)	Curb Reveal (Inches)	Curb Recommendation
6,458	0.111	7	DO NOTHING
Curb Type		Curb & Gutter Type	
CONCRETE		NO CURB AND GUTTER	
Pavement Recommendation		Condition Rating / PCR	
PREVENTIVE MAINTENANCE		GOOD / 90

Note: Parking area consists of multiple surface types: 1 part Asphalt at 4,805 square feet; 1 part Concrete at 1,653 square feet.
