ZION Cycle 6

Final Report

Road Inventory and Condition Assessment of Paved Routes Zion National Park

**Federal Highway Administration
Eastern Federal Lands Highway Division
Road Inventory Program (RIP)**

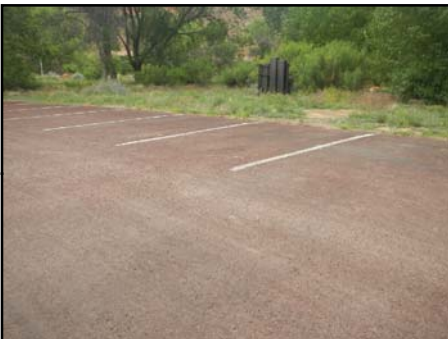
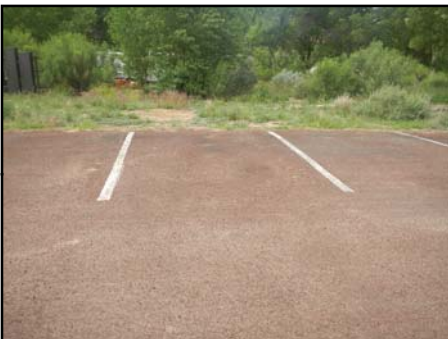
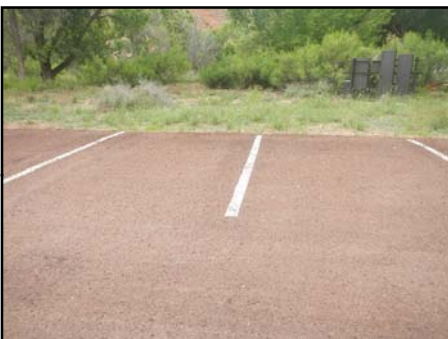
Inspection Date	FMSS Number	User Access	Surface Type
5/20/2016	65471	PUBLIC	ASPHALT
Area (Sq. Ft.)	Lane Miles (11' Widths)	Curb Reveal (Inches)	Curb Recommendation
3,334	0.057	NOT APPLICABLE	NOT APPLICABLE
Curb Type		Curb & Gutter Type	
NO CURB		NO CURB AND GUTTER	
Pavement Recommendation		Condition Rating / PCR	
PREVENTIVE MAINTENANCE		GOOD / 90

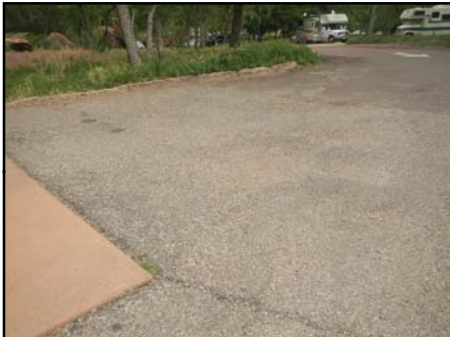
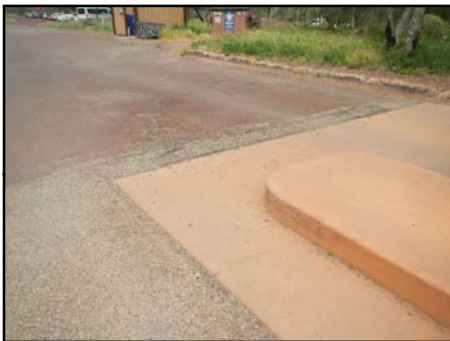
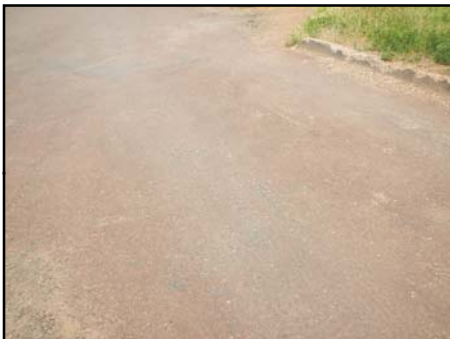
ROUTE 0905: SOUTH CAMPGROUND DUMP STATION

Inspection Date	FMSS Number	User Access	Surface Type
5/20/2016	65484	PUBLIC	ASPHALT
Area (Sq. Ft.)	Lane Miles (11' Widths)	Curb Reveal (Inches)	Curb Recommendation
4,305	0.074	6	MODERATE REPAIR
Curb Type		Curb & Gutter Type	
CONCRETE		NO CURB AND GUTTER	
Pavement Recommendation		Condition Rating / PCR	
LIGHT 3R TREATMENTS		FAIR / 73

Note: Parking area consists of multiple surface types: 1 part Asphalt at 3,437 square feet; 1 part Concrete at 868 square feet.

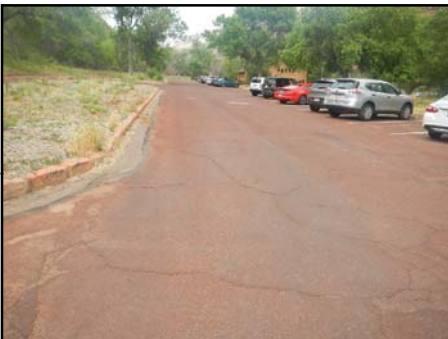
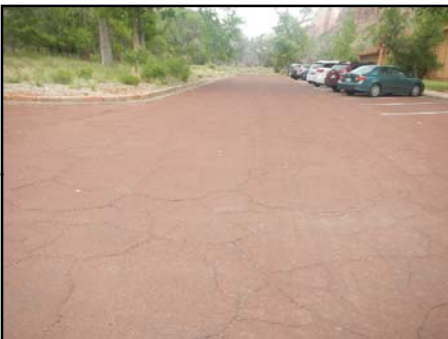
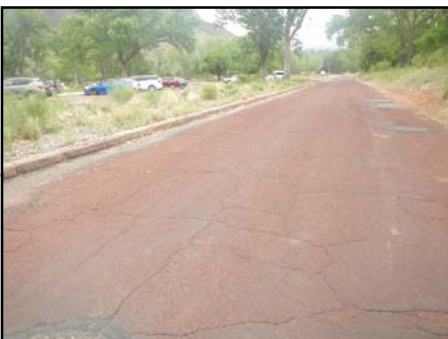
Inspection Date	FMSS Number	User Access	Surface Type
5/20/2016	65472	PUBLIC	ASPHALT
Area (Sq. Ft.)	Lane Miles (11' Widths)	Curb Reveal (Inches)	Curb Recommendation
31,043	0.534	NOT APPLICABLE	DO NOTHING
Curb Type		Curb & Gutter Type	
NO CURB		STONE	
Pavement Recommendation		Condition Rating / PCR	
HEAVY 3R TREATMENTS		POOR / 53

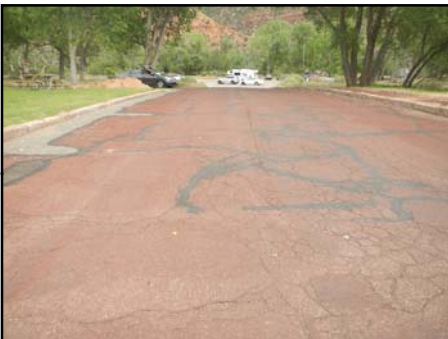
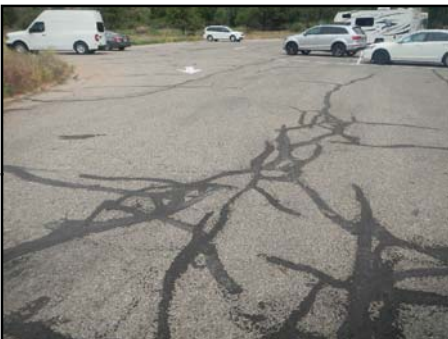
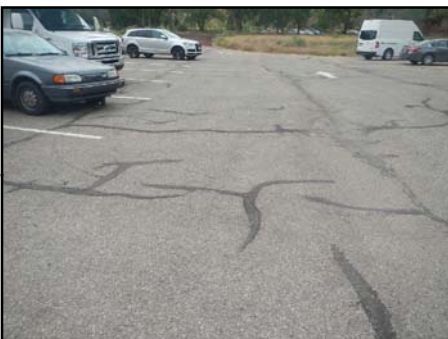
ROUTE 0907: SOUTH CAMPGROUND / AMPHITHEATER PARKING

Inspection Date	FMSS Number	User Access	Surface Type
5/20/2016	65474	PUBLIC	ASPHALT
Area (Sq. Ft.)	Lane Miles (11' Widths)	Curb Reveal (Inches)	Curb Recommendation
25,326	0.436	3	MODERATE REPAIR
Curb Type		Curb & Gutter Type	
STONE		CONCRETE	
Pavement Recommendation		Condition Rating / PCR	
LIGHT 3R TREATMENTS		FAIR / 73

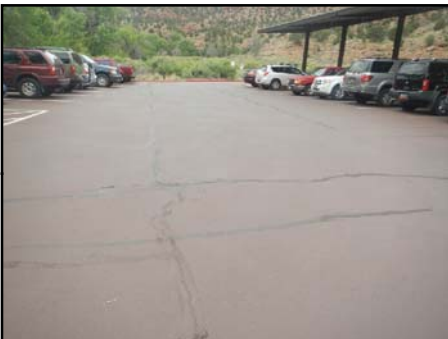
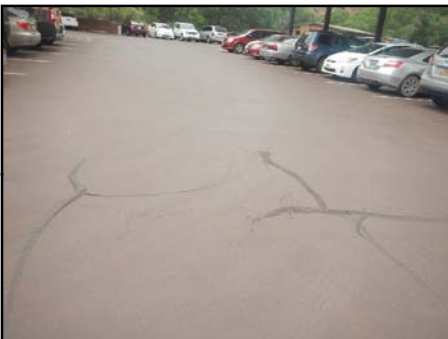
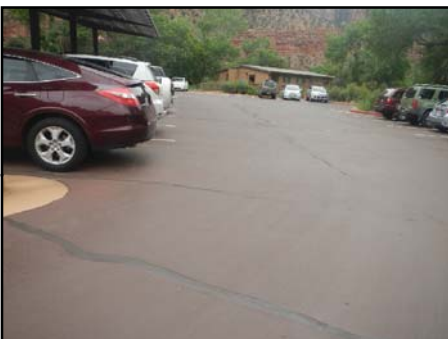
ROUTE 0908: ADMINISTRATION PARKING

Inspection Date	FMSS Number	User Access	Surface Type
5/20/2016	65475	NONPUBLIC	ASPHALT
Area (Sq. Ft.)	Lane Miles (11' Widths)	Curb Reveal (Inches)	Curb Recommendation
19,493	0.336	NOT APPLICABLE	DO NOTHING
Curb Type		Curb & Gutter Type	
NO CURB		CONCRETE	
Pavement Recommendation		Condition Rating / PCR	
PREVENTIVE MAINTENANCE		GOOD / 90

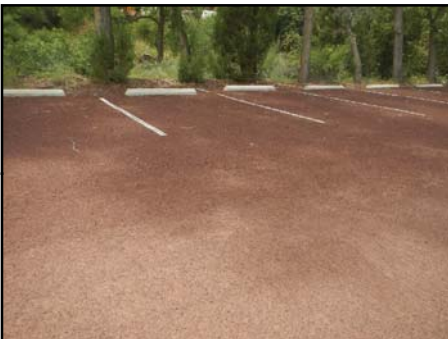
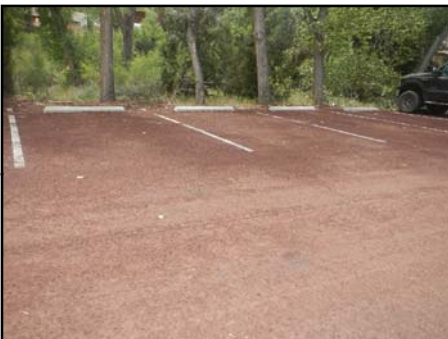
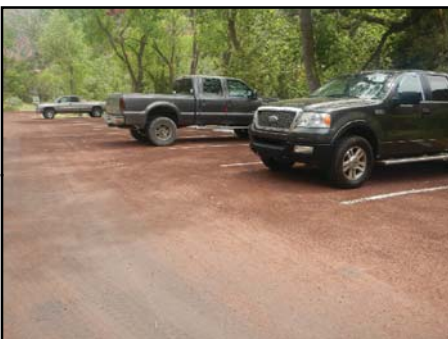
ROUTE 0909A: NORTH MAINTENANCE AREA PARKING A

Inspection Date	FMSS Number	User Access	Surface Type
5/20/2016	65476	NONPUBLIC	ASPHALT
Area (Sq. Ft.)	Lane Miles (11' Widths)	Curb Reveal (Inches)	Curb Recommendation
2,928	0.05	NOT APPLICABLE	NOT APPLICABLE
Curb Type		Curb & Gutter Type	
NO CURB		NO CURB AND GUTTER	
Pavement Recommendation		Condition Rating / PCR	
PREVENTIVE MAINTENANCE		GOOD / 90

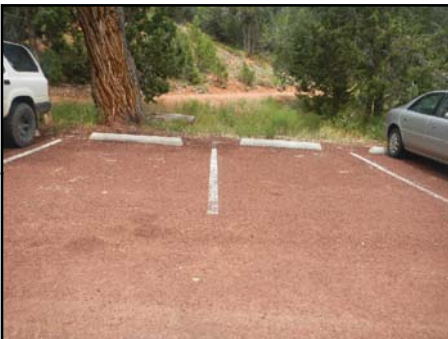
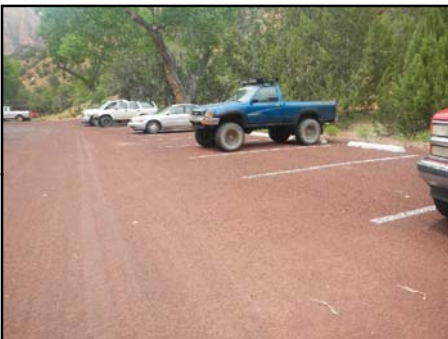
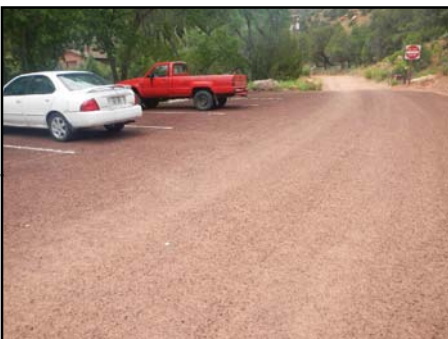
ROUTE 0909B: OAK CREEK MAINTENANCE OVERFLOW PARKING B

Inspection Date	FMSS Number	User Access	Surface Type
5/20/2016	104999	NONPUBLIC	ASPHALT
Area (Sq. Ft.)	Lane Miles (11' Widths)	Curb Reveal (Inches)	Curb Recommendation
8,282	0.143	NOT APPLICABLE	NOT APPLICABLE
Curb Type		Curb & Gutter Type	
NO CURB		NO CURB AND GUTTER	
Pavement Recommendation		Condition Rating / PCR	
LIGHT 3R TREATMENTS		FAIR / 73

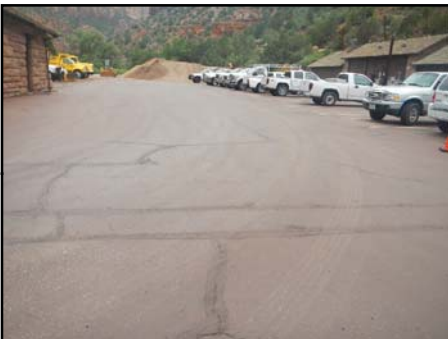
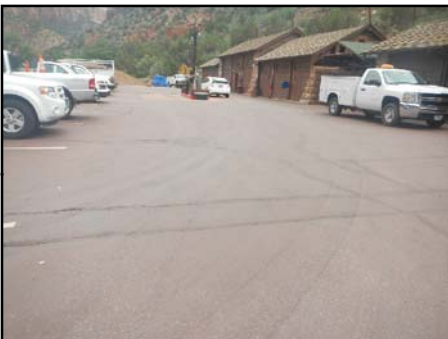
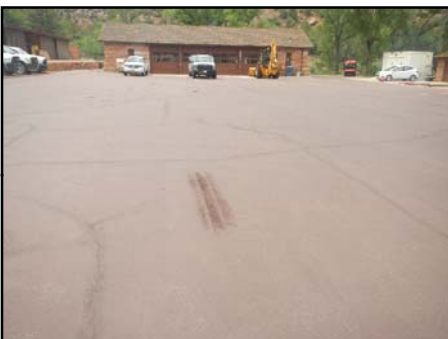
ROUTE 0909C: OAK CREEK MAINTENANCE YARD

Inspection Date	FMSS Number	User Access	Surface Type
5/20/2016	105003	NONPUBLIC	ASPHALT
Area (Sq. Ft.)	Lane Miles (11' Widths)	Curb Reveal (Inches)	Curb Recommendation
58,197	1.002	NOT APPLICABLE	NOT APPLICABLE
Curb Type		Curb & Gutter Type	
NO CURB		NO CURB AND GUTTER	
Pavement Recommendation		Condition Rating / PCR	
HEAVY 3R TREATMENTS		POOR / 53

Note: Parking area consists of multiple surface types: 1 part Asphalt at 52,146 square feet; 6 parts Concrete at 6,051 square feet.

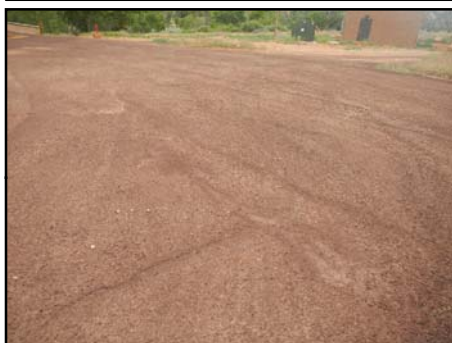
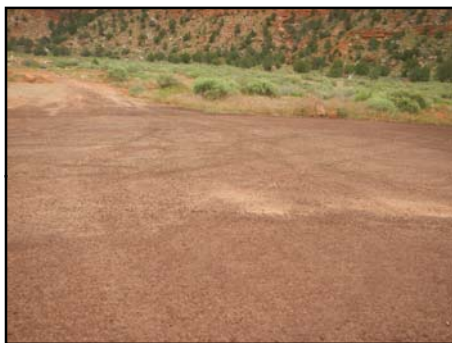
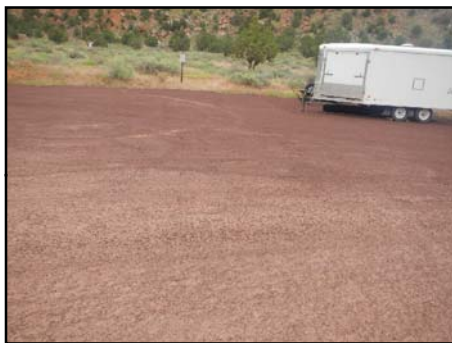
Inspection Date	FMSS Number	User Access	Surface Type
5/20/2016	65485	NONPUBLIC	ASPHALT
Area (Sq. Ft.)	Lane Miles (11' Widths)	Curb Reveal (Inches)	Curb Recommendation
6,010	0.103	NOT APPLICABLE	NOT APPLICABLE
Curb Type		Curb & Gutter Type	
NO CURB		NO CURB AND GUTTER	
Pavement Recommendation		Condition Rating / PCR	
PREVENTIVE MAINTENANCE		GOOD / 90

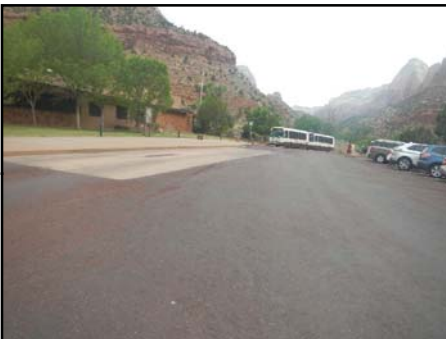
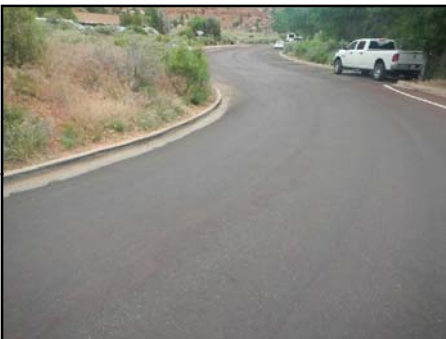
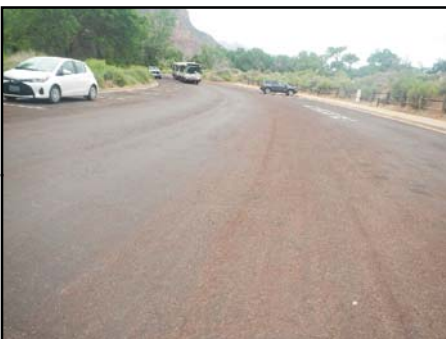
ROUTE 0911: MUSEUM PARKING AREA

Inspection Date	FMSS Number	User Access	Surface Type
5/21/2016	65477	PUBLIC	ASPHALT
Area (Sq. Ft.)	Lane Miles (11' Widths)	Curb Reveal (Inches)	Curb Recommendation
49,926	0.86	NOT APPLICABLE	DO NOTHING
Curb Type		Curb & Gutter Type	
NO CURB		CONCRETE	
Pavement Recommendation		Condition Rating / PCR	
LIGHT 3R TREATMENTS		FAIR / 73

Note: Parking area consists of multiple surface types: 1 part Asphalt at 47,899 square feet; 2 parts Concrete at 2,037 square feet.

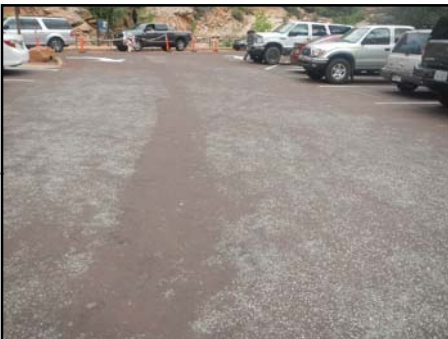
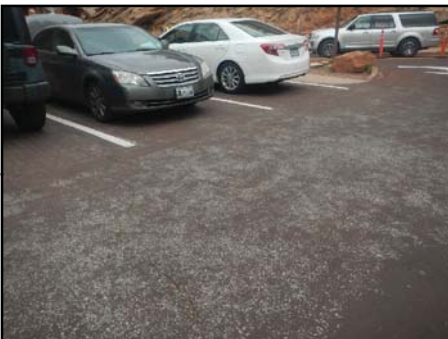
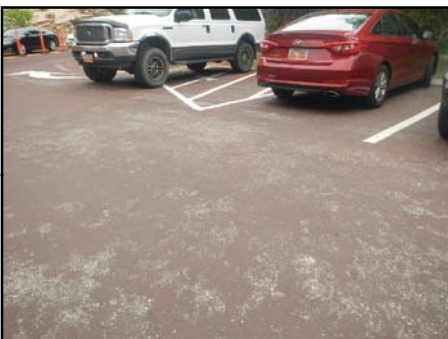
ROUTE 0912: TUNNEL EAST (CANYON OVERLOOK) PARKING

Inspection Date	FMSS Number	User Access	Surface Type
5/21/2016	65478	PUBLIC	ASPHALT
Area (Sq. Ft.)	Lane Miles (11' Widths)	Curb Reveal (Inches)	Curb Recommendation
4,705	0.081	4	DO NOTHING
Curb Type		Curb & Gutter Type	
STONE		NO CURB AND GUTTER	
Pavement Recommendation		Condition Rating / PCR	
PREVENTIVE MAINTENANCE		GOOD / 90

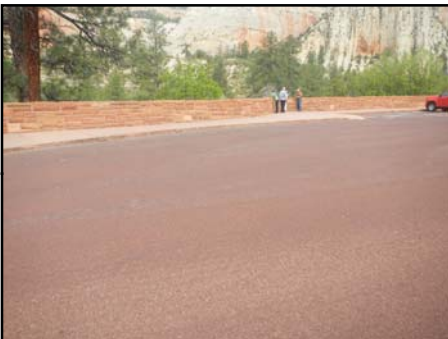
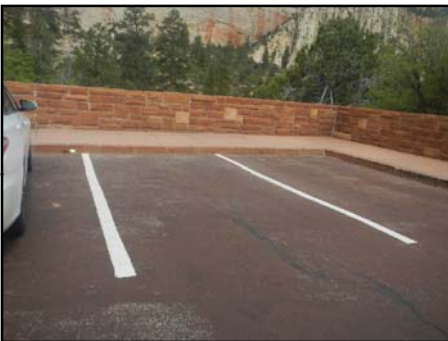
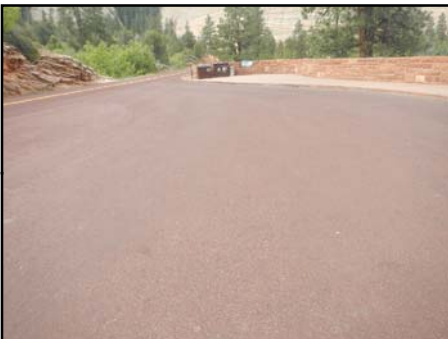
ROUTE 0913: CHECKERBOARD MESA VIEWPOINT PARKING

Inspection Date	FMSS Number	User Access	Surface Type
5/21/2016	65479	PUBLIC	ASPHALT
Area (Sq. Ft.)	Lane Miles (11' Widths)	Curb Reveal (Inches)	Curb Recommendation
9,116	0.157	NOT APPLICABLE	NOT APPLICABLE
Curb Type		Curb & Gutter Type	
NO CURB		NO CURB AND GUTTER	
Pavement Recommendation		Condition Rating / PCR	
PREVENTIVE MAINTENANCE		GOOD / 90

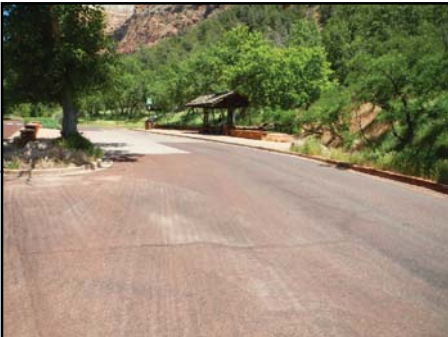
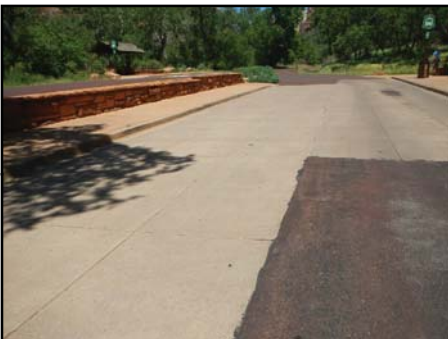
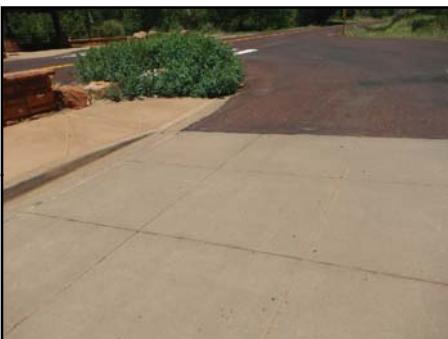
ROUTE 0915: COURT OF THE PATRIARCHS PARKING

Inspection Date	FMSS Number	User Access	Surface Type
5/21/2016	65491	PUBLIC	ASPHALT
Area (Sq. Ft.)	Lane Miles (11' Widths)	Curb Reveal (Inches)	Curb Recommendation
4,724	0.081	7	DO NOTHING
Curb Type		Curb & Gutter Type	
STONE		CONCRETE	
Pavement Recommendation		Condition Rating / PCR	
PREVENTIVE MAINTENANCE		GOOD / 90

Note: Parking area consists of multiple surface types: 1 part Asphalt at 3,219 square feet; 1 part Concrete at 1,505 square feet.

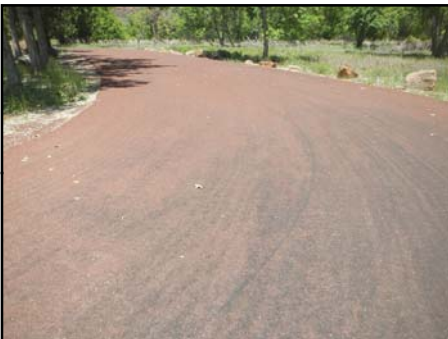
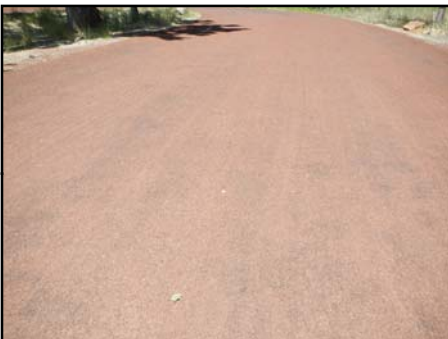
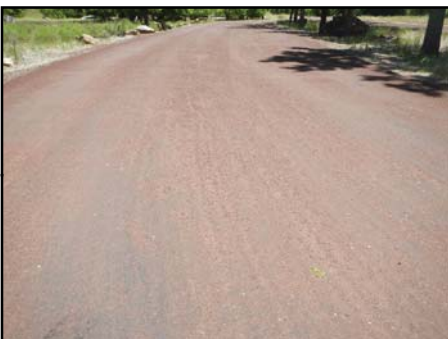
Inspection Date	FMSS Number	User Access	Surface Type
5/21/2016	65494	PUBLIC	ASPHALT
Area (Sq. Ft.)	Lane Miles (11' Widths)	Curb Reveal (Inches)	Curb Recommendation
7,439	0.128	NOT APPLICABLE	NOT APPLICABLE
Curb Type		Curb & Gutter Type	
NO CURB		NO CURB AND GUTTER	
Pavement Recommendation		Condition Rating / PCR	
PREVENTIVE MAINTENANCE		GOOD / 90

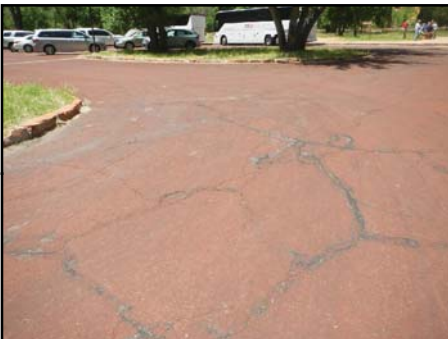
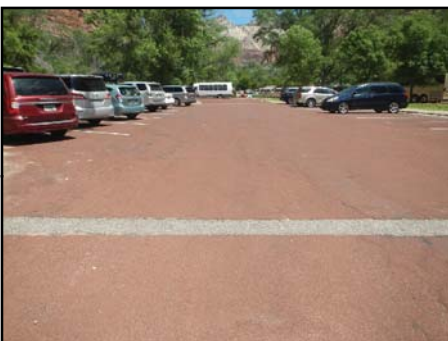
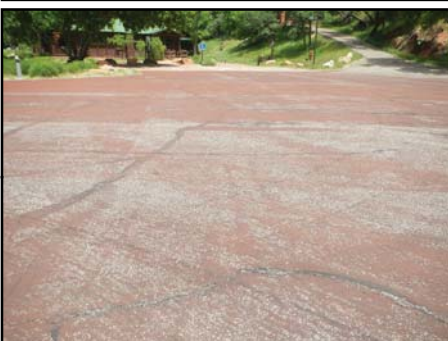
ROUTE 0917: ZION LODGE CABIN PARKING

Inspection Date	FMSS Number	User Access	Surface Type
5/21/2016	65496	PUBLIC	ASPHALT
Area (Sq. Ft.)	Lane Miles (11' Widths)	Curb Reveal (Inches)	Curb Recommendation
85,246	1.468	5	DO NOTHING
Curb Type		Curb & Gutter Type	
STONE		NO CURB AND GUTTER	
Pavement Recommendation		Condition Rating / PCR	
HEAVY 3R TREATMENTS		POOR / 53

Note: Parking area consists of multiple surface types: 1 part Asphalt at 84,450 square feet; 1 part Concrete at 796 square feet.

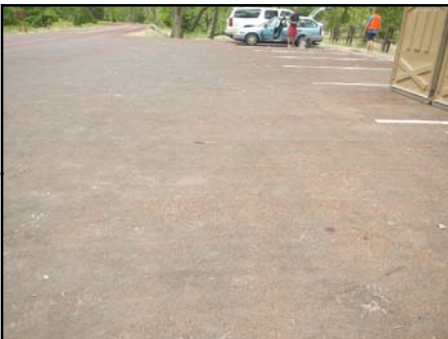
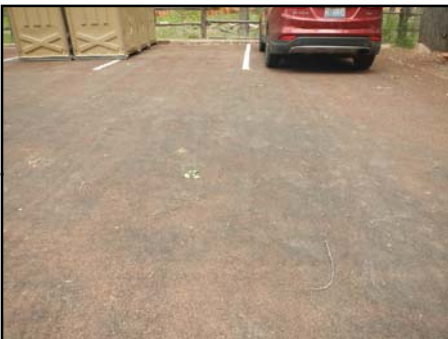
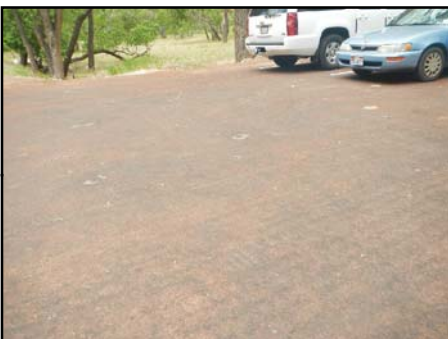
ROUTE 0918: WEST RIM TRAILHEAD PARKING

Inspection Date	FMSS Number	User Access	Surface Type
5/21/2016	65497	PUBLIC	ASPHALT
Area (Sq. Ft.)	Lane Miles (11' Widths)	Curb Reveal (Inches)	Curb Recommendation
3,628	0.062	3	DO NOTHING
Curb Type		Curb & Gutter Type	
STONE		NO CURB AND GUTTER	
Pavement Recommendation		Condition Rating / PCR	
PREVENTIVE MAINTENANCE		GOOD / 90

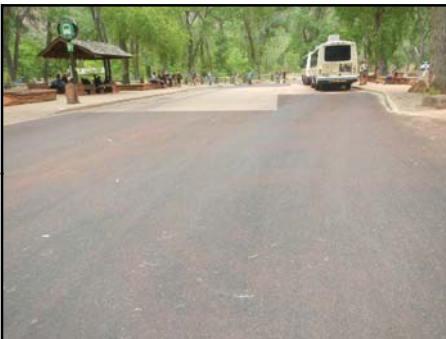
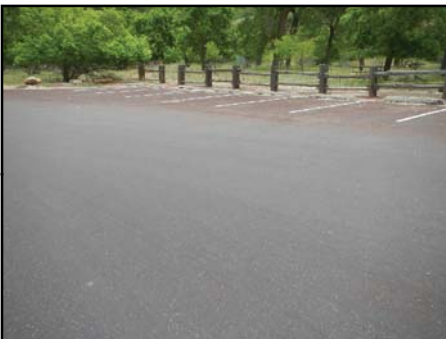
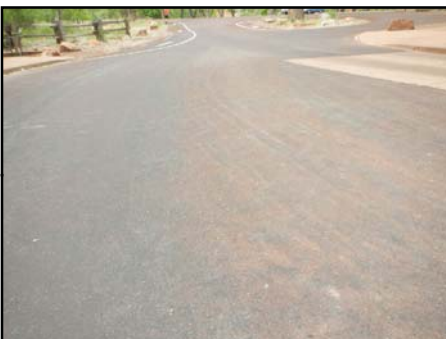
ROUTE 0919: GROTTO PICNIC PARKING

Inspection Date	FMSS Number	User Access	Surface Type
5/21/2016	65498	PUBLIC	ASPHALT
Area (Sq. Ft.)	Lane Miles (11' Widths)	Curb Reveal (Inches)	Curb Recommendation
17,141	0.295	5	DO NOTHING
Curb Type		Curb & Gutter Type	
CONCRETE		CONCRETE	
Pavement Recommendation		Condition Rating / PCR	
LIGHT 3R TREATMENTS		FAIR / 73

Note: Parking area consists of multiple surface types: 1 part Asphalt at 13,915 square feet; 1 part Concrete at 3,226 square feet.

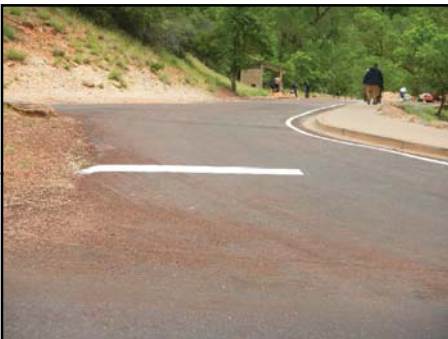
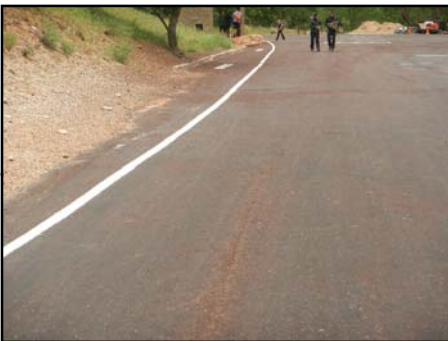
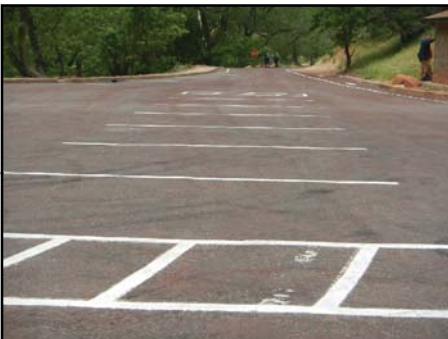
Inspection Date	FMSS Number	User Access	Surface Type
5/21/2016	65499	PUBLIC	ASPHALT
Area (Sq. Ft.)	Lane Miles (11' Widths)	Curb Reveal (Inches)	Curb Recommendation
17,318	0.298	6	DO NOTHING
Curb Type		Curb & Gutter Type	
STONE		NO CURB AND GUTTER	
Pavement Recommendation		Condition Rating / PCR	
PREVENTIVE MAINTENANCE		GOOD / 90

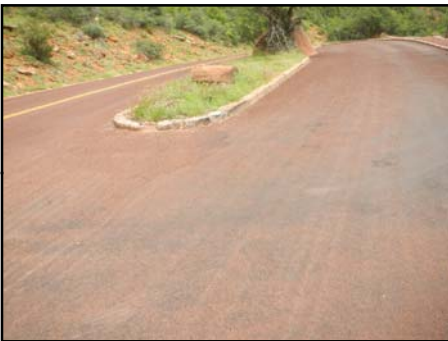
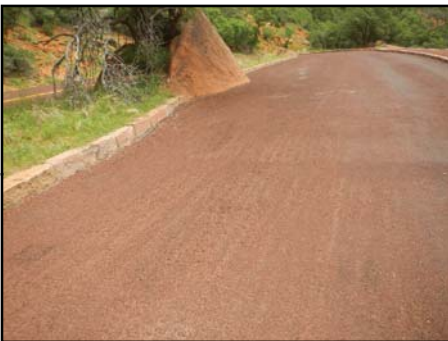
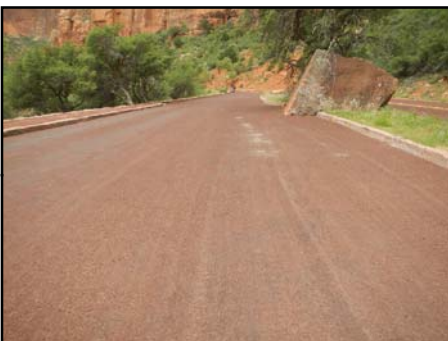
ROUTE 0921: THE GREAT WHITE THRONE PARKING

Inspection Date	FMSS Number	User Access	Surface Type
5/21/2016	65500	PUBLIC	ASPHALT
Area (Sq. Ft.)	Lane Miles (11' Widths)	Curb Reveal (Inches)	Curb Recommendation
6,030	0.104	6	DO NOTHING
Curb Type		Curb & Gutter Type	
STONE		NO CURB AND GUTTER	
Pavement Recommendation		Condition Rating / PCR	
PREVENTIVE MAINTENANCE		GOOD / 90

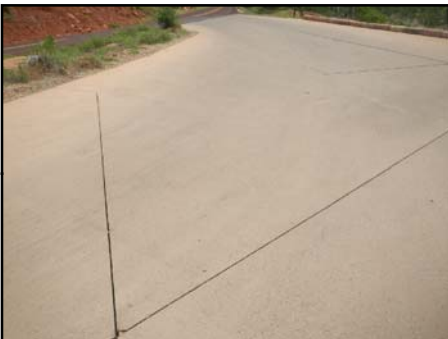
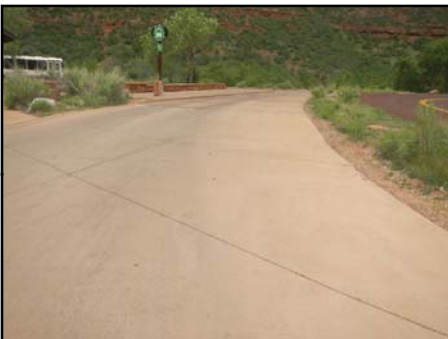
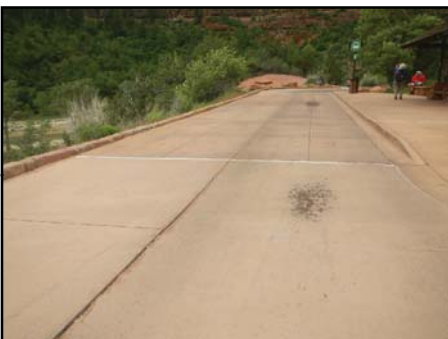
ROUTE 0922: BIG BEND BUS AND TRAILER PARKING

Inspection Date	FMSS Number	User Access	Surface Type
5/21/2016	65501	PUBLIC	CONCRETE
Area (Sq. Ft.)	Lane Miles (11' Widths)	Curb Reveal (Inches)	Curb Recommendation
14,288	0.246	6	DO NOTHING
Curb Type		Curb & Gutter Type	
STONE		NOT APPLICABLE	
Pavement Recommendation		Condition Rating / PCR	
PREVENTIVE MAINTENANCE		GOOD / 90

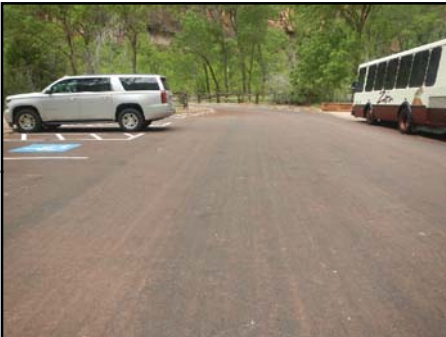
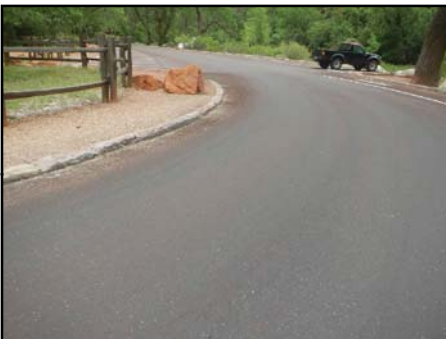
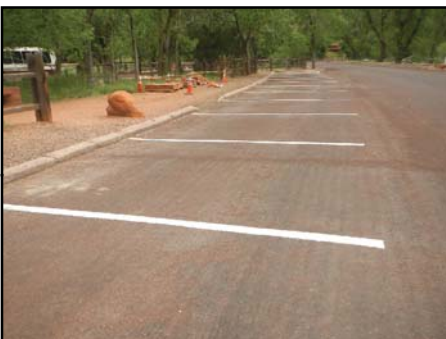
ROUTE 0923: TEMPLE OF SINAWAVA PARKING

Inspection Date	FMSS Number	User Access	Surface Type
5/21/2016	65502	PUBLIC	ASPHALT
Area (Sq. Ft.)	Lane Miles (11' Widths)	Curb Reveal (Inches)	Curb Recommendation
39,231	0.675	5	DO NOTHING
Curb Type		Curb & Gutter Type	
STONE		NOT APPLICABLE	
Pavement Recommendation		Condition Rating / PCR	
LIGHT 3R TREATMENTS		FAIR / 73

Note: Parking area consists of multiple surface types: 1 part Asphalt at 37,459 square feet; 1 part Concrete at 1,772 square feet.

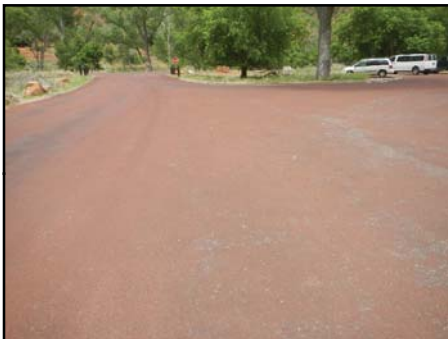
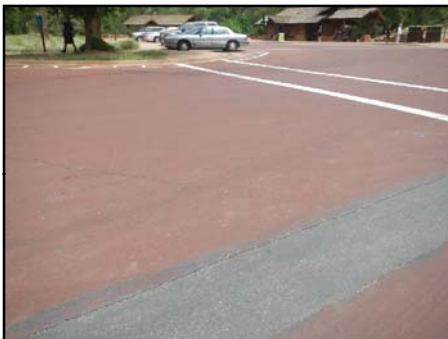
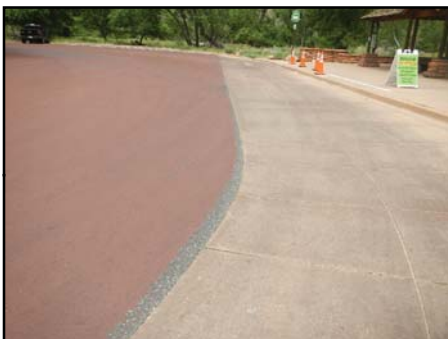
ROUTE 0925A: ZION LODGE VISITOR PARKING

Inspection Date	FMSS Number	User Access	Surface Type
5/21/2016	65504	PUBLIC	ASPHALT
Area (Sq. Ft.)	Lane Miles (11' Widths)	Curb Reveal (Inches)	Curb Recommendation
41,491	0.714	NOT APPLICABLE	DO NOTHING
Curb Type		Curb & Gutter Type	
NO CURB		CONCRETE	
Pavement Recommendation		Condition Rating / PCR	
PREVENTIVE MAINTENANCE		GOOD / 90

Note: Parking area consists of multiple surface types: 1 part Asphalt at 38,082 square feet; 1 part Concrete at 3,409 square feet.

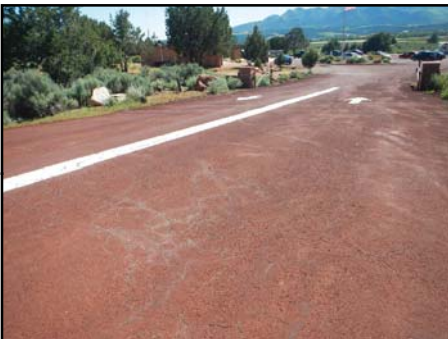
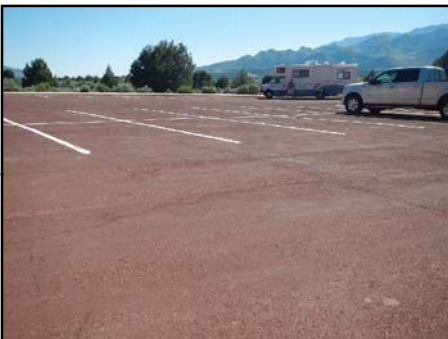
ROUTE 0926: KOLOB VISITORS CENTER PARKING

Inspection Date	FMSS Number	User Access	Surface Type
5/21/2016	65661	PUBLIC	ASPHALT
Area (Sq. Ft.)	Lane Miles (11' Widths)	Curb Reveal (Inches)	Curb Recommendation
41,277	0.711	6	DO NOTHING
Curb Type		Curb & Gutter Type	
CONCRETE		CONCRETE	
Pavement Recommendation		Condition Rating / PCR	
LIGHT 3R TREATMENTS		FAIR / 73

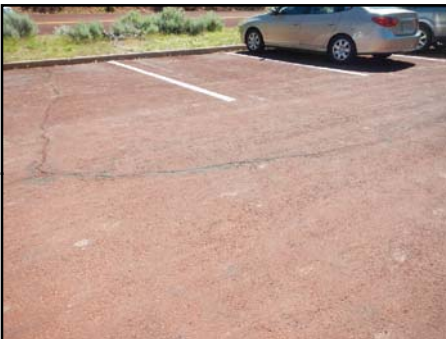
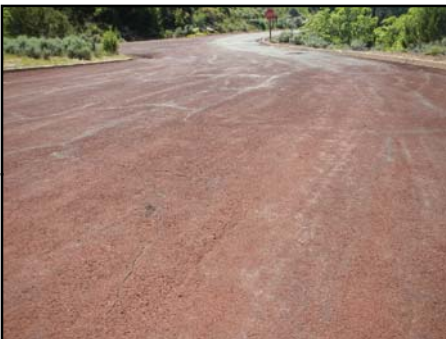
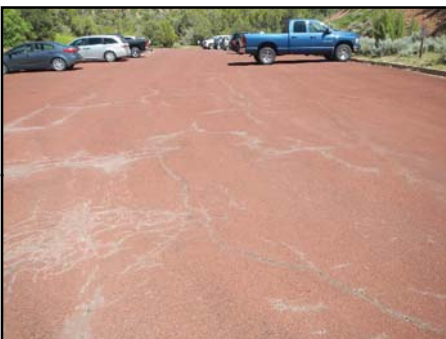
ROUTE 0927: TAYLOR CREEK TRAILHEAD PARKING

Inspection Date	FMSS Number	User Access	Surface Type
5/21/2016	65665	PUBLIC	ASPHALT
Area (Sq. Ft.)	Lane Miles (11' Widths)	Curb Reveal (Inches)	Curb Recommendation
16,227	0.279	NOT APPLICABLE	LIGHT REPAIR
Curb Type		Curb & Gutter Type	
NO CURB		CONCRETE	
Pavement Recommendation		Condition Rating / PCR	
LIGHT 3R TREATMENTS		FAIR / 73

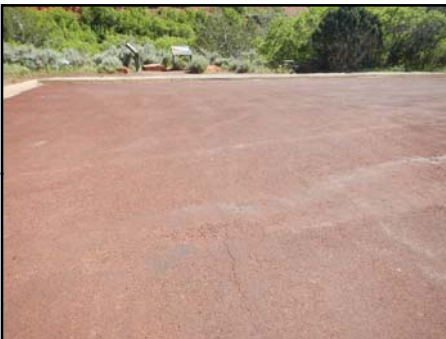
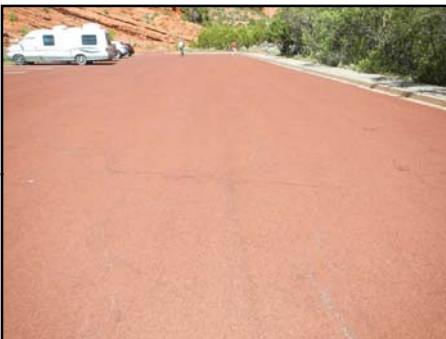
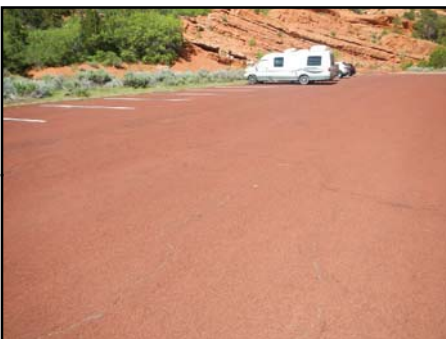
ROUTE 0928: SOUTH FORK PARKING AREA

Inspection Date	FMSS Number	User Access	Surface Type
5/21/2016	65663	PUBLIC	ASPHALT
Area (Sq. Ft.)	Lane Miles (11' Widths)	Curb Reveal (Inches)	Curb Recommendation
16,318	0.281	NOT APPLICABLE	LIGHT REPAIR
Curb Type		Curb & Gutter Type	
NO CURB		CONCRETE	
Pavement Recommendation		Condition Rating / PCR	
LIGHT 3R TREATMENTS		FAIR / 73

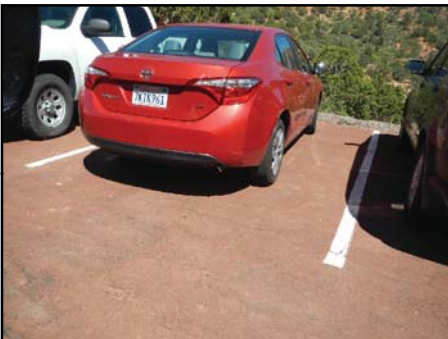
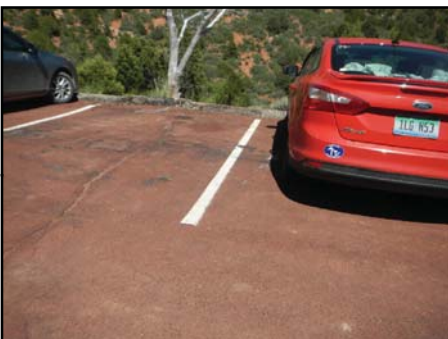
ROUTE 0929: LEE PASS TRAILHEAD PARKING

Inspection Date	FMSS Number	User Access	Surface Type
5/21/2016	65664	PUBLIC	ASPHALT
Area (Sq. Ft.)	Lane Miles (11' Widths)	Curb Reveal (Inches)	Curb Recommendation
4,871	0.084	5	DO NOTHING
Curb Type		Curb & Gutter Type	
ASPHALT		NO CURB AND GUTTER	
Pavement Recommendation		Condition Rating / PCR	
LIGHT 3R TREATMENTS		FAIR / 73

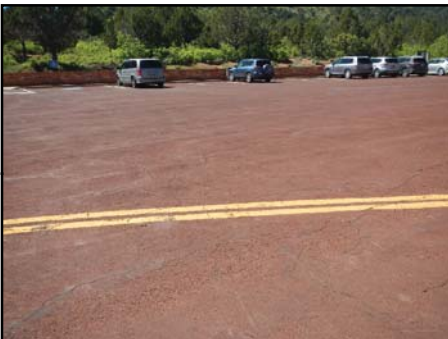
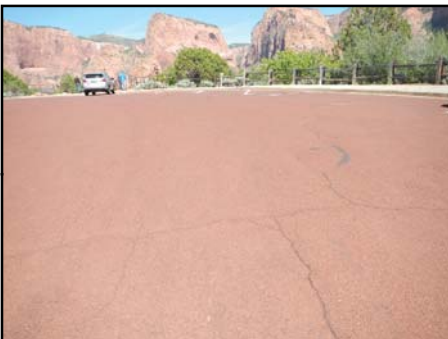
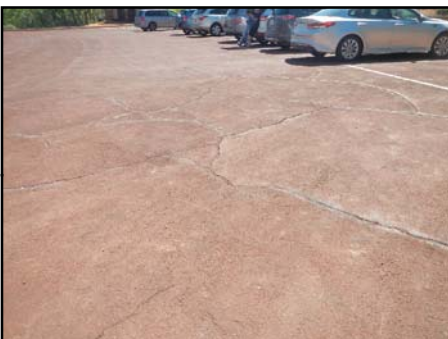
ROUTE 0930: KOLOB CANYON OVERLOOK PARKING

Inspection Date	FMSS Number	User Access	Surface Type
5/21/2016	65662	PUBLIC	ASPHALT
Area (Sq. Ft.)	Lane Miles (11' Widths)	Curb Reveal (Inches)	Curb Recommendation
29,057	0.5	6	DO NOTHING
Curb Type		Curb & Gutter Type	
CONCRETE		CONCRETE	
Pavement Recommendation		Condition Rating / PCR	
HEAVY 3R TREATMENTS		POOR / 53

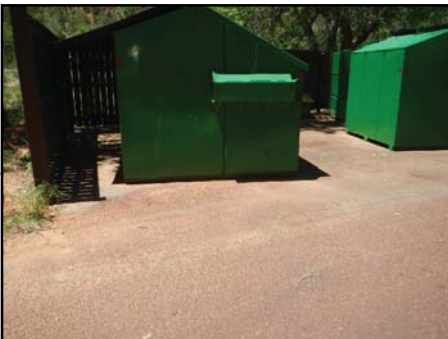
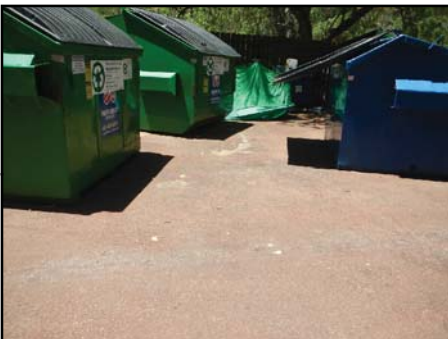
ROUTE 0931A: CONCESSIONAIRE / DORM PARKING A

Inspection Date	FMSS Number	User Access	Surface Type
5/21/2016	90355	NONPUBLIC	ASPHALT
Area (Sq. Ft.)	Lane Miles (11' Widths)	Curb Reveal (Inches)	Curb Recommendation
1,376	0.024	NOT APPLICABLE	NOT APPLICABLE
Curb Type		Curb & Gutter Type	
NO CURB		NO CURB AND GUTTER	
Pavement Recommendation		Condition Rating / PCR	
PREVENTIVE MAINTENANCE		GOOD / 90

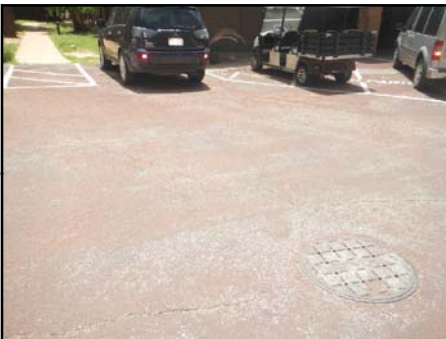
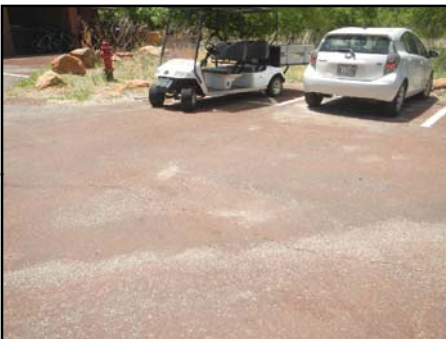
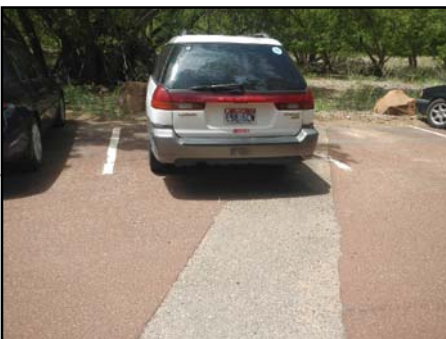
ROUTE 0931B: CONCESSIONAIRE / DORM PARKING B

Inspection Date	FMSS Number	User Access	Surface Type
5/21/2016	104971	NONPUBLIC	ASPHALT
Area (Sq. Ft.)	Lane Miles (11' Widths)	Curb Reveal (Inches)	Curb Recommendation
5,730	0.099	NOT APPLICABLE	NOT APPLICABLE
Curb Type		Curb & Gutter Type	
NO CURB		NO CURB AND GUTTER	
Pavement Recommendation		Condition Rating / PCR	
PREVENTIVE MAINTENANCE		GOOD / 90

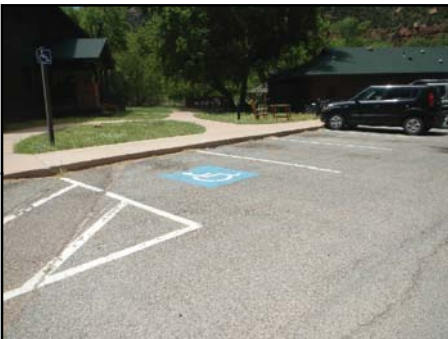
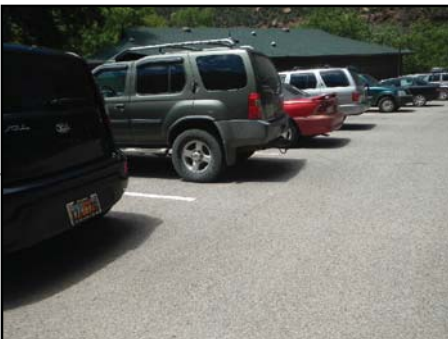
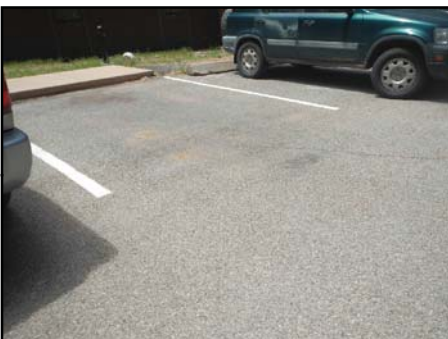
ROUTE 0931C: CONCESSIONAIRE / DORM PARKING C

Inspection Date	FMSS Number	User Access	Surface Type
5/21/2016	104972	NONPUBLIC	ASPHALT
Area (Sq. Ft.)	Lane Miles (11' Widths)	Curb Reveal (Inches)	Curb Recommendation
2,453	0.042	NOT APPLICABLE	NOT APPLICABLE
Curb Type		Curb & Gutter Type	
NO CURB		NO CURB AND GUTTER	
Pavement Recommendation		Condition Rating / PCR	
PREVENTIVE MAINTENANCE		GOOD / 90

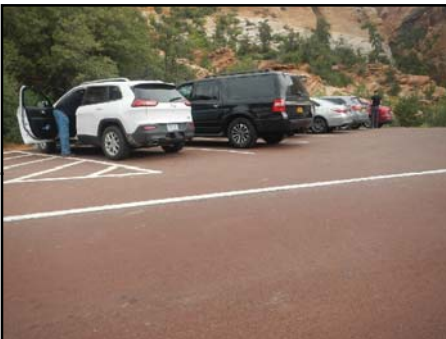
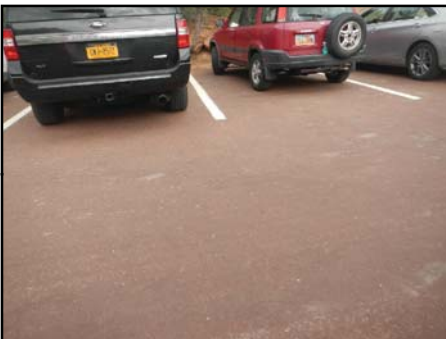
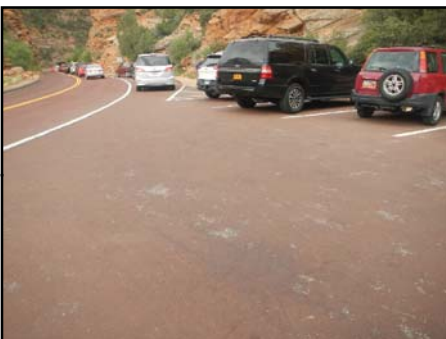
ROUTE 0932: CANYON OVERLOOK PARKING

Inspection Date	FMSS Number	User Access	Surface Type
5/21/2016	90403	PUBLIC	ASPHALT
Area (Sq. Ft.)	Lane Miles (11' Widths)	Curb Reveal (Inches)	Curb Recommendation
4,085	0.07	NOT APPLICABLE	NOT APPLICABLE
Curb Type		Curb & Gutter Type	
NO CURB		NO CURB AND GUTTER	
Pavement Recommendation		Condition Rating / PCR	
PREVENTIVE MAINTENANCE		GOOD / 90

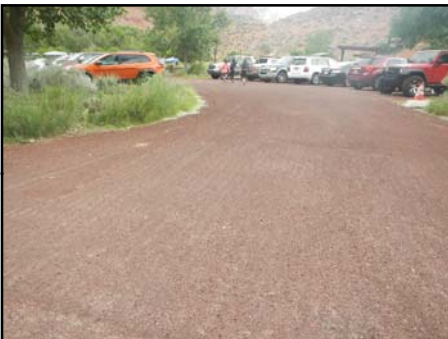
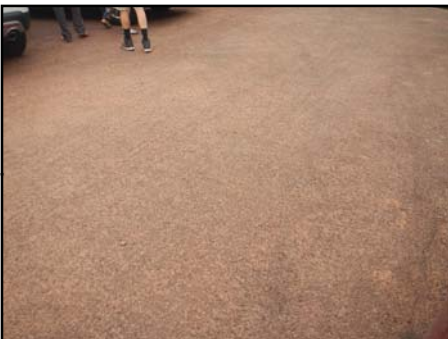
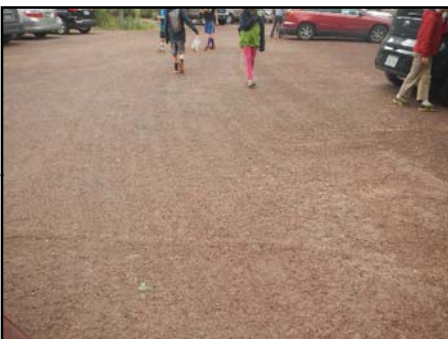
ROUTE 0936: ZION NATURE CENTER REAR PARKING

Inspection Date	FMSS Number	User Access	Surface Type
5/20/2016	65437	PUBLIC	ASPHALT
Area (Sq. Ft.)	Lane Miles (11' Widths)	Curb Reveal (Inches)	Curb Recommendation
6,940	0.119	7	DO NOTHING
Curb Type		Curb & Gutter Type	
STONE		STONE	
Pavement Recommendation		Condition Rating / PCR	
LIGHT 3R TREATMENTS		FAIR / 73

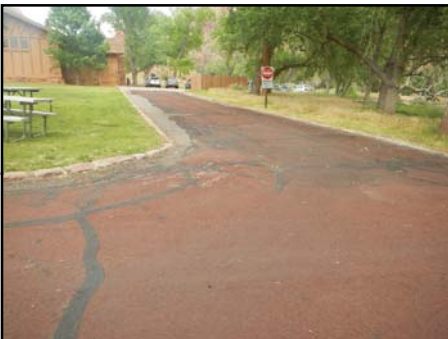
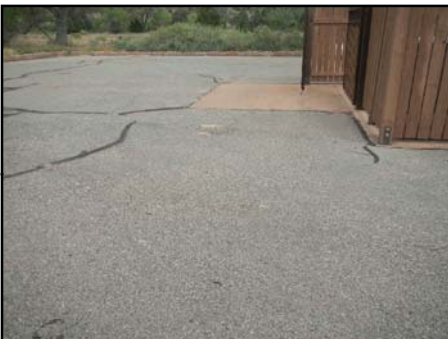
ROUTE 0937: ZION CANYON VISITOR CENTER SHUTTLE BUS VISITOR PICK UP

Inspection Date	FMSS Number	User Access	Surface Type
5/21/2016	90407	NONPUBLIC	ASPHALT
Area (Sq. Ft.)	Lane Miles (11' Widths)	Curb Reveal (Inches)	Curb Recommendation
13,799	0.238	NOT APPLICABLE	NOT APPLICABLE
Curb Type		Curb & Gutter Type	
NO CURB		NO CURB AND GUTTER	
Pavement Recommendation		Condition Rating / PCR	
PREVENTIVE MAINTENANCE		GOOD / 90

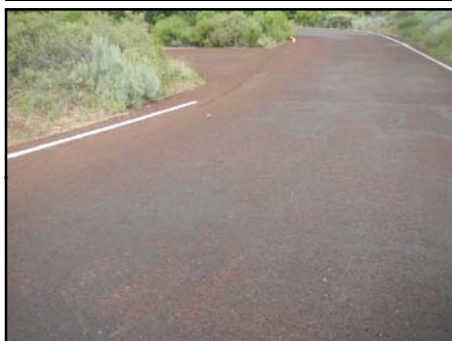
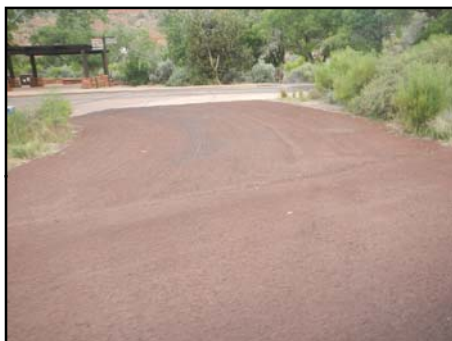
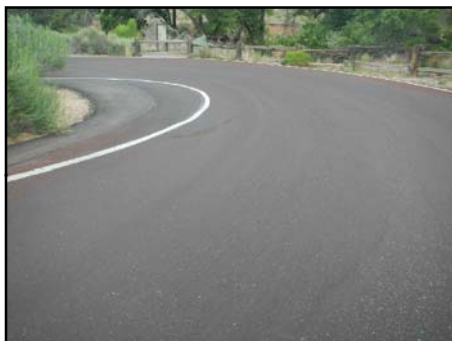
Note: Parking area consists of multiple surface types: 1 part Asphalt at 10,199 square feet; 1 part Concrete at 3,600 square feet.

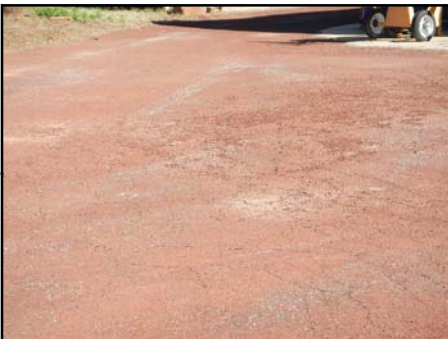
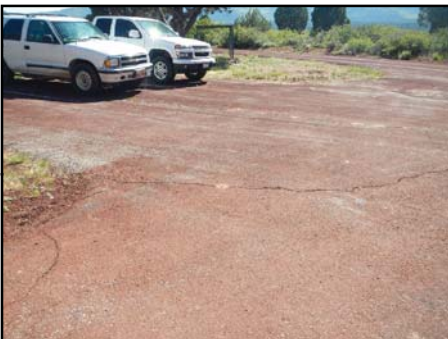
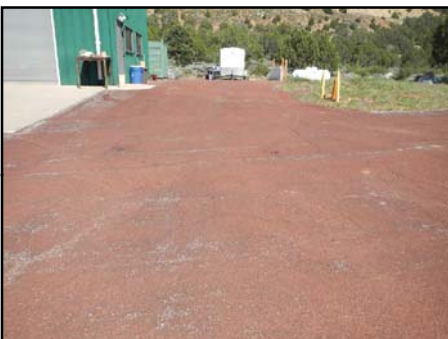
Inspection Date	FMSS Number	User Access	Surface Type
5/21/2016	90409	NONPUBLIC	ASPHALT
Area (Sq. Ft.)	Lane Miles (11' Widths)	Curb Reveal (Inches)	Curb Recommendation
8,565	0.147	NOT APPLICABLE	NOT APPLICABLE
Curb Type		Curb & Gutter Type	
NO CURB		NO CURB AND GUTTER	
Pavement Recommendation		Condition Rating / PCR	
LIGHT 3R TREATMENTS		FAIR / 73

Note: Parking area consists of multiple surface types: 1 part Asphalt at 7,373 square feet; 2 parts Concrete at 1,192 square feet.

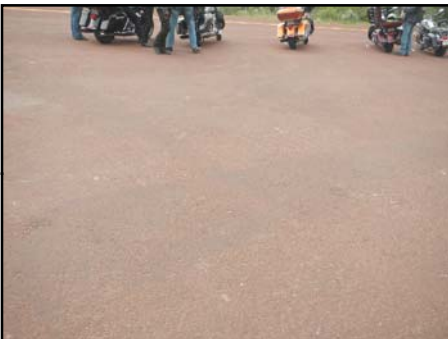
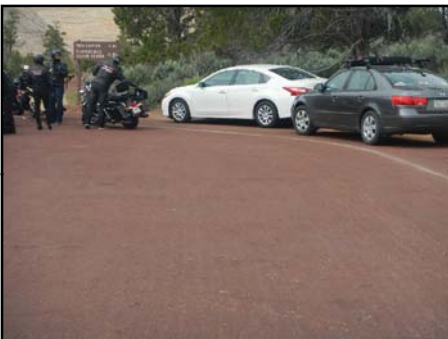
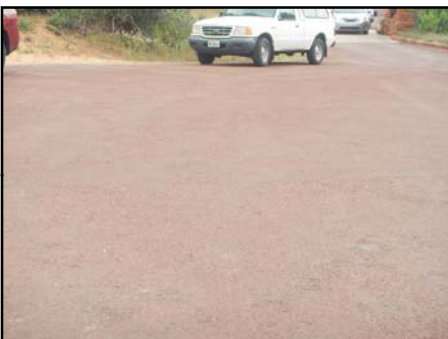
Inspection Date	FMSS Number	User Access	Surface Type
5/21/2016	65612	PUBLIC	ASPHALT
Area (Sq. Ft.)	Lane Miles (11' Widths)	Curb Reveal (Inches)	Curb Recommendation
4,933	0.085	NOT APPLICABLE	NOT APPLICABLE
Curb Type		Curb & Gutter Type	
NO CURB		NO CURB AND GUTTER	
Pavement Recommendation		Condition Rating / PCR	
PREVENTIVE MAINTENANCE		GOOD / 90

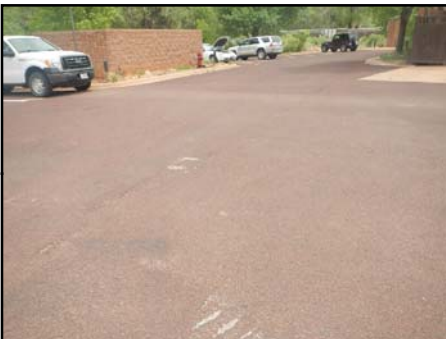
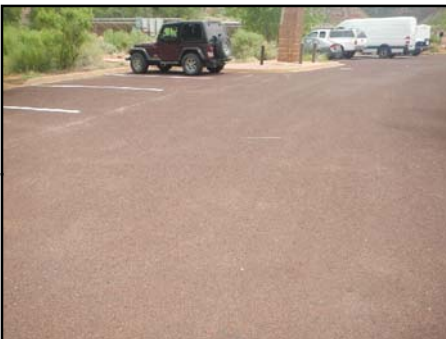
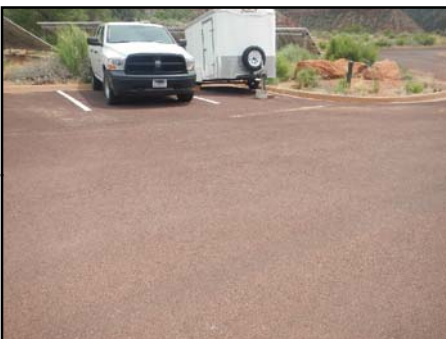
ROUTE 0941: HEADQUARTERS WATCHMAN JUNCTION PARKING

Inspection Date	FMSS Number	User Access	Surface Type
5/20/2016	231229	NONPUBLIC	ASPHALT
Area (Sq. Ft.)	Lane Miles (11' Widths)	Curb Reveal (Inches)	Curb Recommendation
1,748	0.03	NOT APPLICABLE	NOT APPLICABLE
Curb Type		Curb & Gutter Type	
NO CURB		NO CURB AND GUTTER	
Pavement Recommendation		Condition Rating / PCR	
PREVENTIVE MAINTENANCE		GOOD / 90

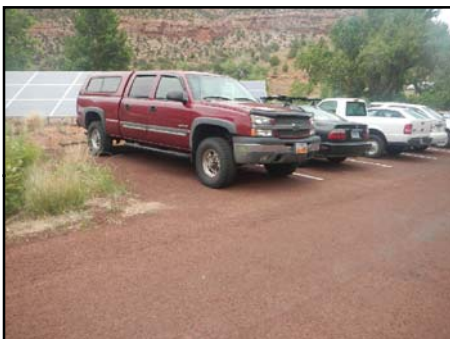
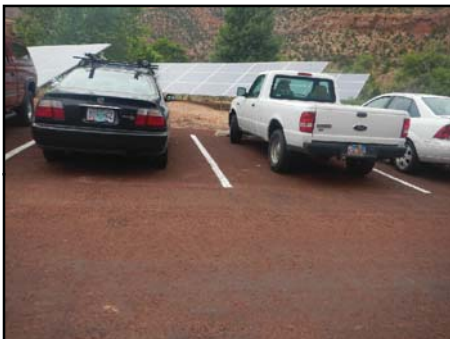
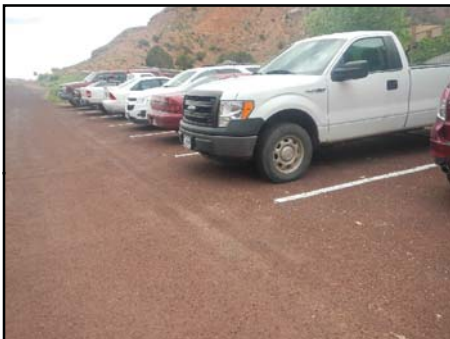
ROUTE 0943: UPPER LEE PASS PARKING

Inspection Date	FMSS Number	User Access	Surface Type
5/21/2016	231581	PUBLIC	ASPHALT
Area (Sq. Ft.)	Lane Miles (11' Widths)	Curb Reveal (Inches)	Curb Recommendation
5,890	0.101	6	LIGHT REPAIR
Curb Type		Curb & Gutter Type	
ASPHALT		NO CURB AND GUTTER	
Pavement Recommendation		Condition Rating / PCR	
HEAVY 3R TREATMENTS		POOR / 53

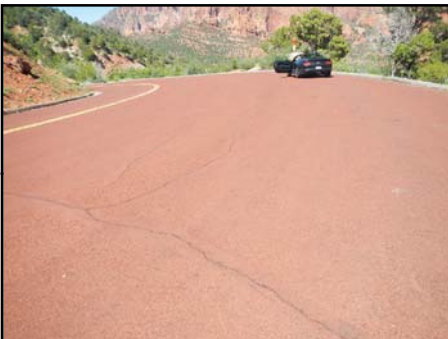
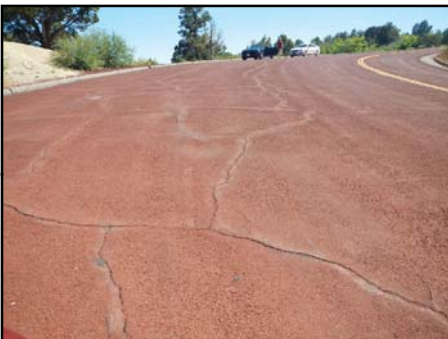
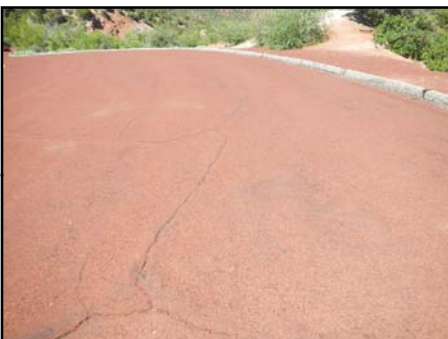
ROUTE 0945: SOUTH ENTRANCE STATION EMPLOYEE PARKING

Inspection Date	FMSS Number	User Access	Surface Type
5/21/2016	231580	NONPUBLIC	ASPHALT
Area (Sq. Ft.)	Lane Miles (11' Widths)	Curb Reveal (Inches)	Curb Recommendation
1,486	0.026	NOT APPLICABLE	NOT APPLICABLE
Curb Type		Curb & Gutter Type	
NO CURB		NO CURB AND GUTTER	
Pavement Recommendation		Condition Rating / PCR	
LIGHT 3R TREATMENTS		FAIR / 73
