The Road Inventory
of
Manassas National Battlefield Park
MANA - 3840

Prepared By:
Federal Highway Administration
Eastern Federal Lands Highway Division
Cycle 3

Manassas National Battlefield Park
in
Virginia

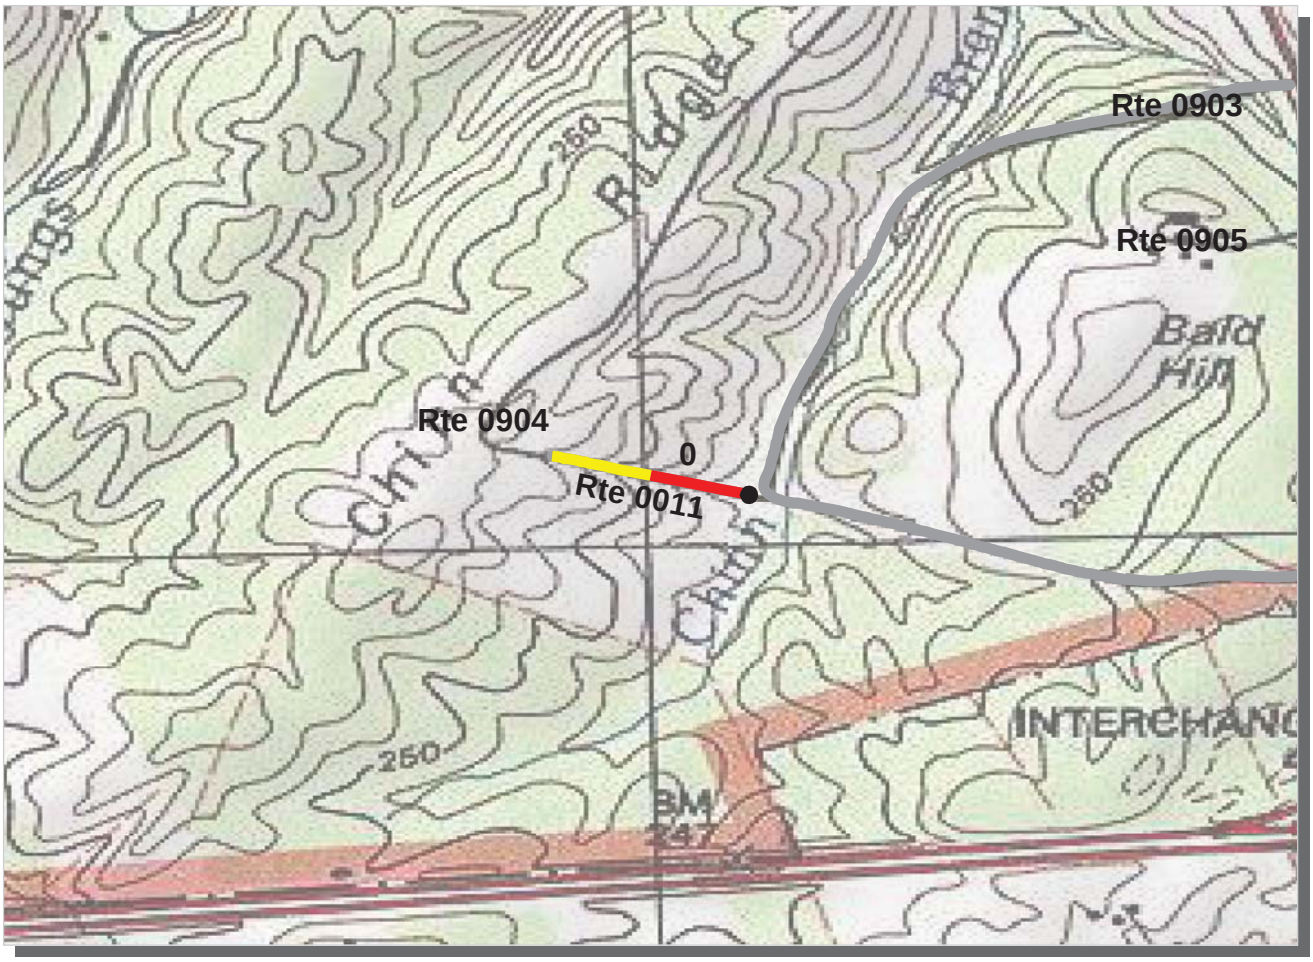
Section Number	0				
Section Length (mi)	0.18				
AADT	**				
SADT	**				
ADT Date	**				
Cross Section Information					
Number of Lanes	2				
Paved Width (ft)	16				
Lane Width (ft)	8				
Shoulder Width (ft)	4				
Roadway Condition Information					
PCR (Pavement Condition Rating)	45				
RCI (Roughness Condition Index)	82				
SCR (Surface Condition Rating)	36				
Alligator Cracking Index	96				
Rutting Index	64				
Patching Index	100				
Tranverse Cracking Index	85				
Longitudinal Cracking Index	88				
Shoulder Condition Rating	GOOD				
Drainage Condition Rating	GOOD

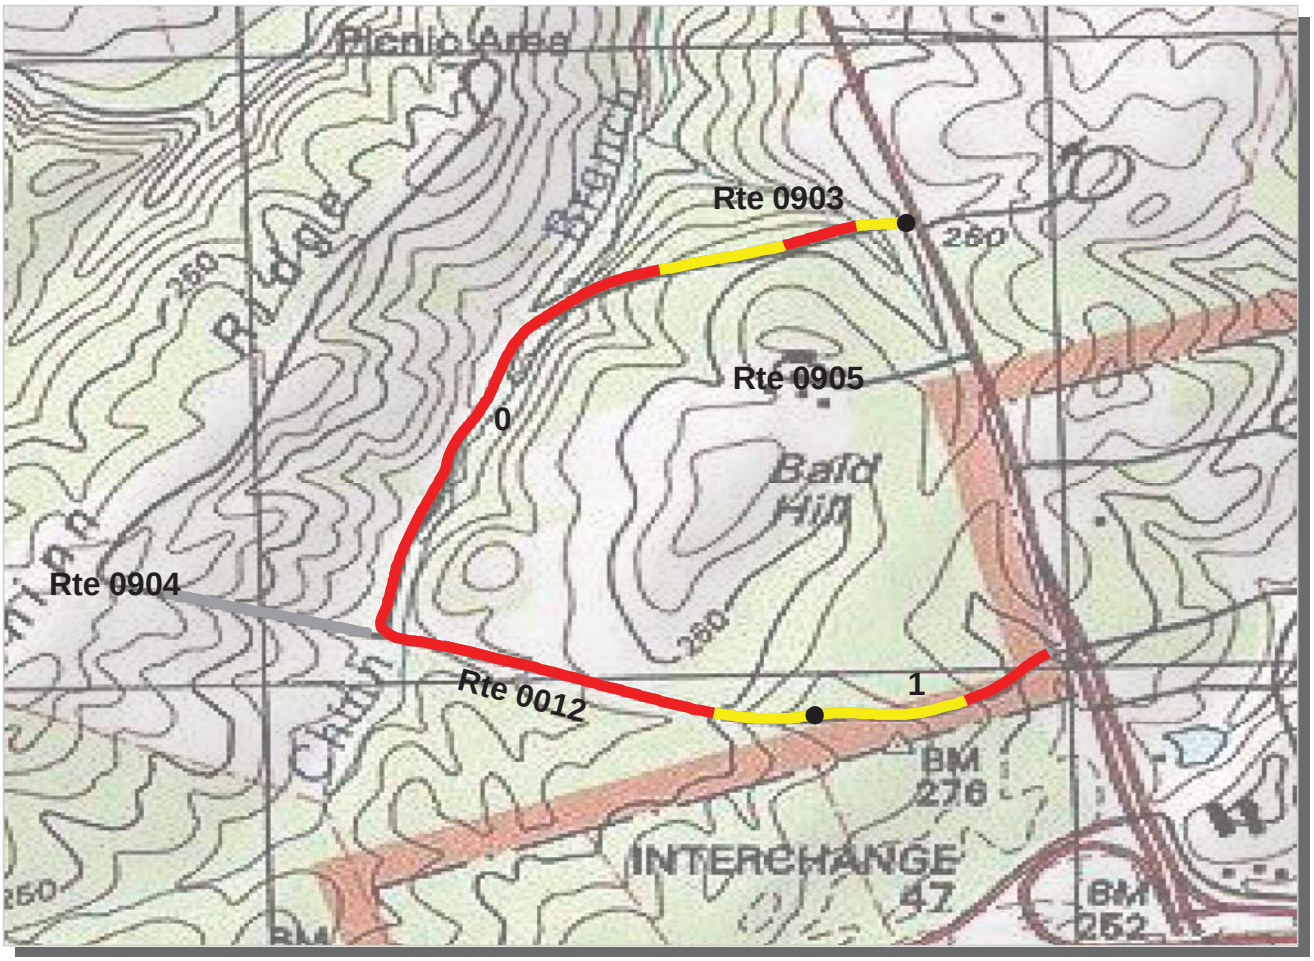
Section Number	0	1			
Section Length (mi)	1.00	0.22			
AADT	**				
SADT	**				
ADT Date	**				
Cross Section Information					
Number of Lanes	2	2			
Paved Width (ft)	17	15			
Lane Width (ft)	9	9			
Shoulder Width (ft)	6	4			
Roadway Condition Information					
PCR (Pavement Condition Rating)	48	53			
RCI (Roughness Condition Index)	79	82			
SCR (Surface Condition Rating)	33	43			
Alligator Cracking Index	82	81			
Rutting Index	61	65			
Patching Index	99	100			
Tranverse Cracking Index	93	98			
Longitudinal Cracking Index	92	93			
Shoulder Condition Rating	POOR	POOR			
Drainage Condition Rating	POOR	POOR

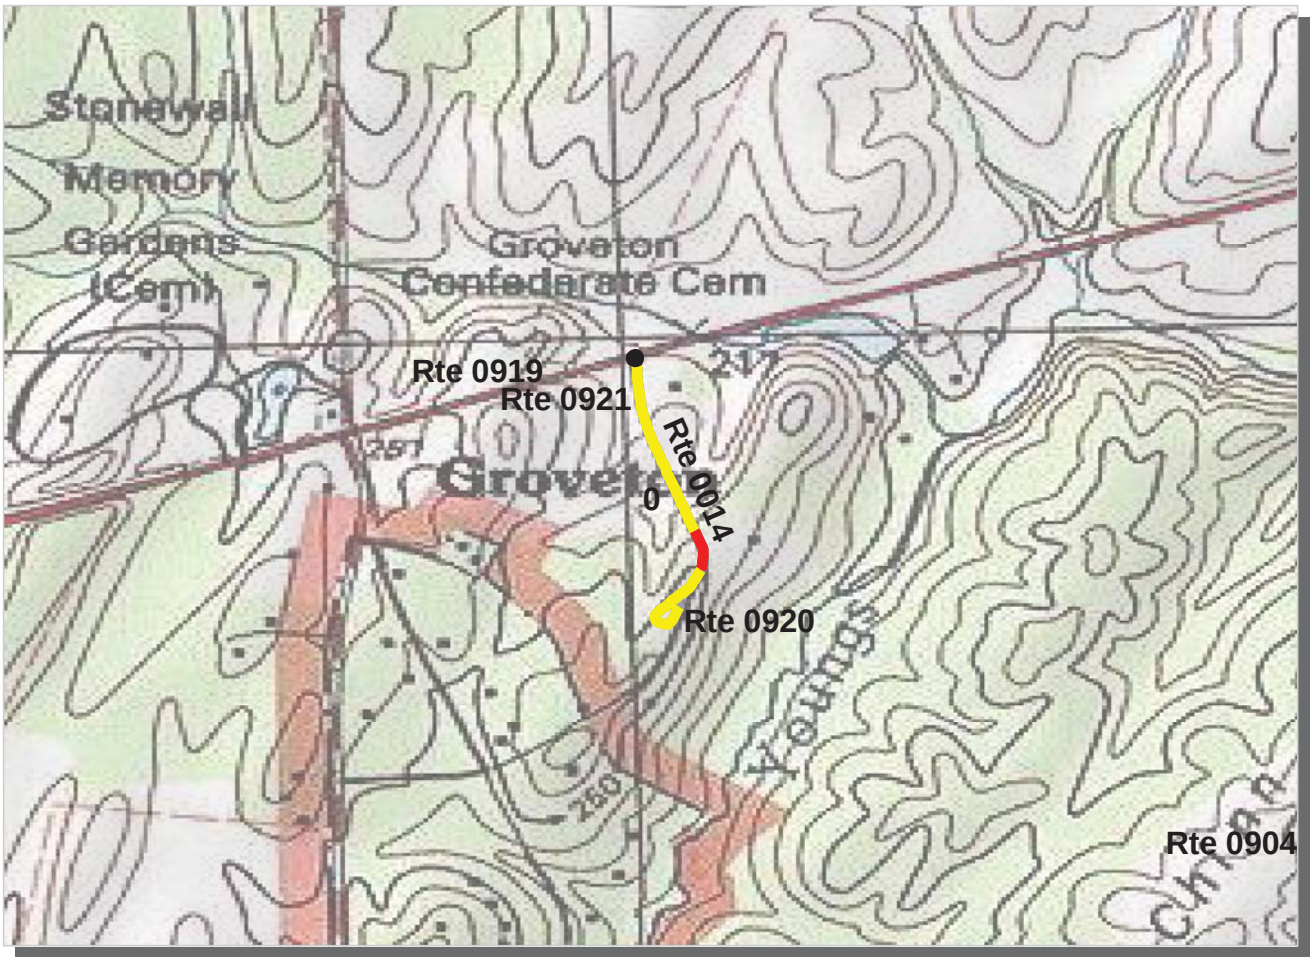
Section Number	0				
Section Length (mi)	0.34				
AADT	**				
SADT	**				
ADT Date	**				
Cross Section Information					
Number of Lanes	2				
Paved Width (ft)	16				
Lane Width (ft)	8				
Shoulder Width (ft)	0				
Roadway Condition Information					
PCR (Pavement Condition Rating)	63				
RCI (Roughness Condition Index)	83				
SCR (Surface Condition Rating)	58				
Alligator Cracking Index	99				
Rutting Index	66				
Patching Index	100				
Tranverse Cracking Index	97				
Longitudinal Cracking Index	95				
Shoulder Condition Rating	N/A				
Drainage Condition Rating	GOOD

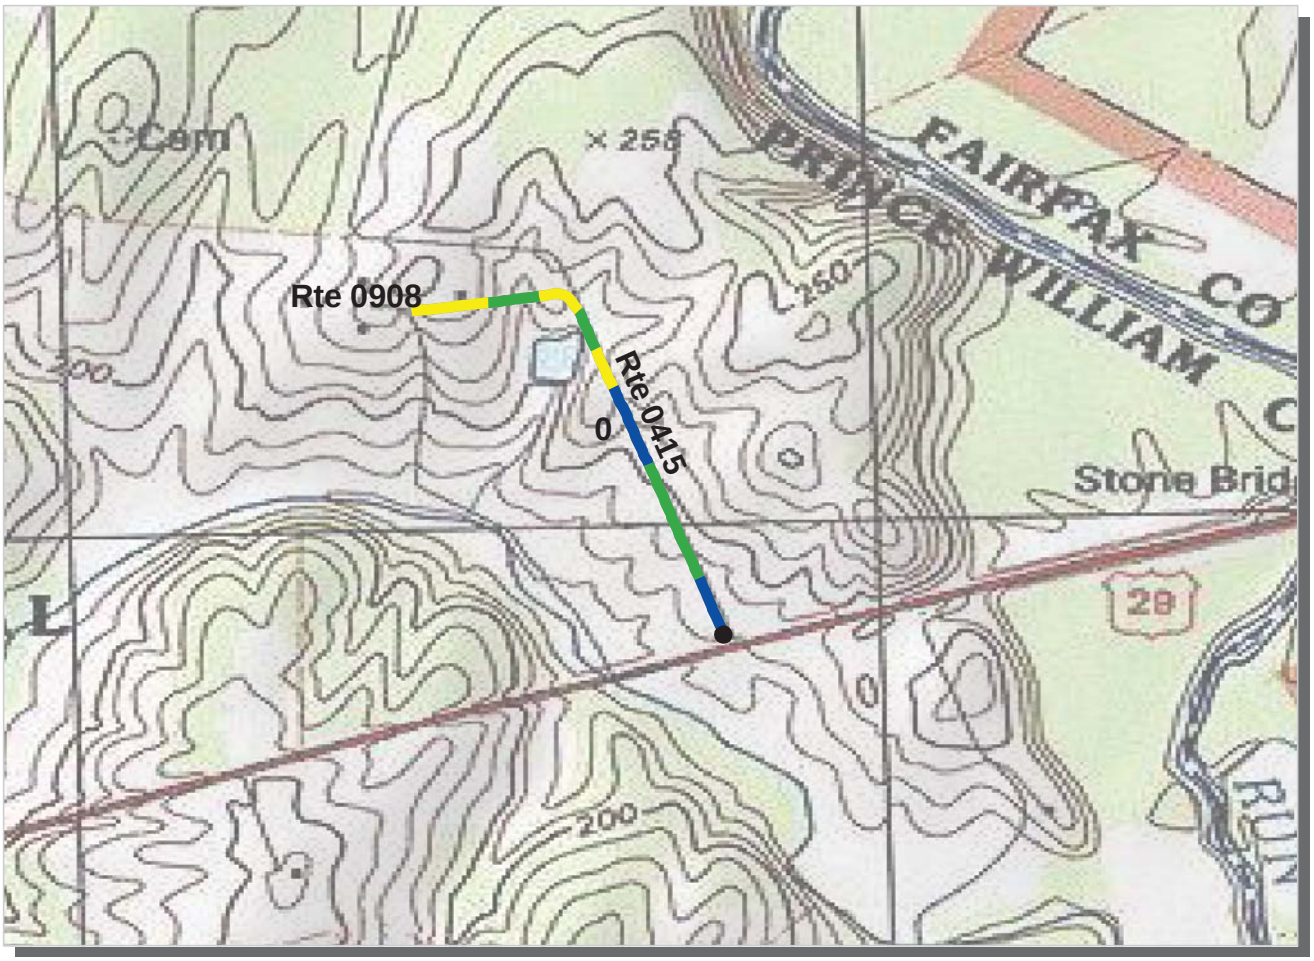
Section Number	0				
Section Length (mi)	0.50				
AADT	**				
SADT	**				
ADT Date	**				
Cross Section Information					
Number of Lanes	1				
Paved Width (ft)	9				
Lane Width (ft)	9				
Shoulder Width (ft)	5				
Roadway Condition Information					
PCR (Pavement Condition Rating)	84				
RCI (Roughness Condition Index)	74				
SCR (Surface Condition Rating)	89				
Alligator Cracking Index	100				
Rutting Index	89				
Patching Index	100				
Tranverse Cracking Index	100				
Longitudinal Cracking Index	100				
Shoulder Condition Rating	POOR				
Drainage Condition Rating	POOR

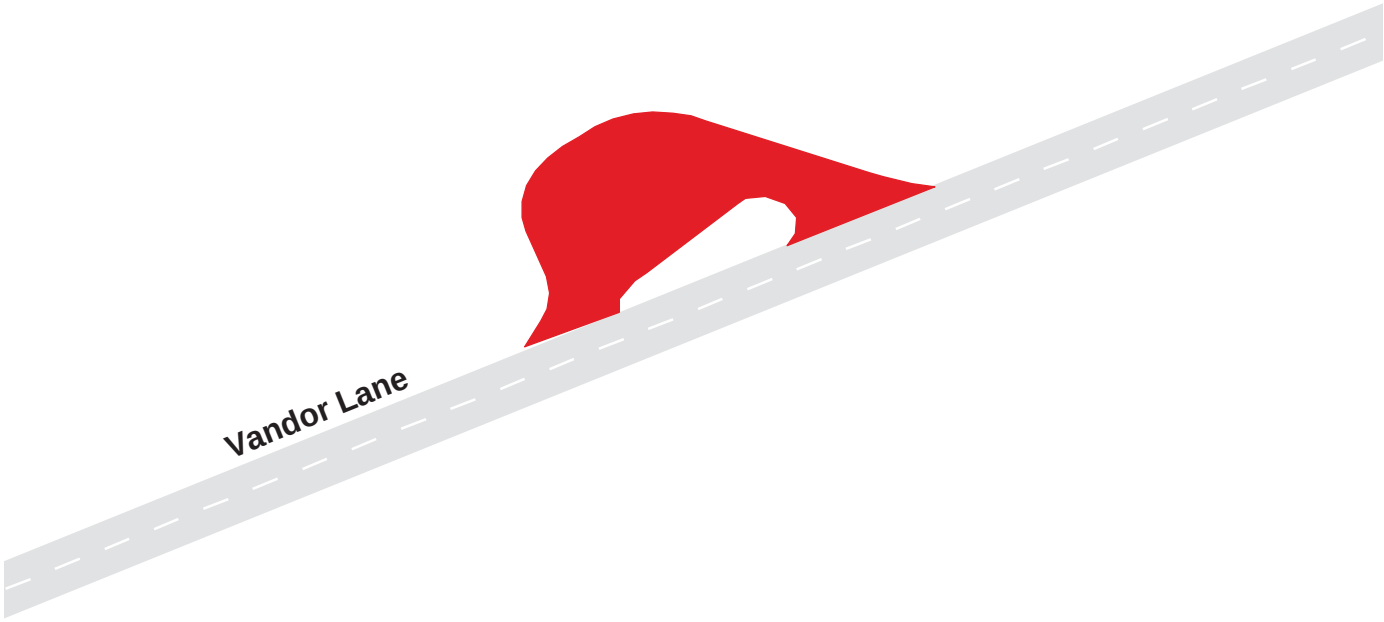
Route	Public / NonPublic	Date Visited	Area (sq ft)	Lane Miles *	Surface Type	Condition / PCR
0900	Public	4/25/2002	13289	0.23	AS	GOOD / 90

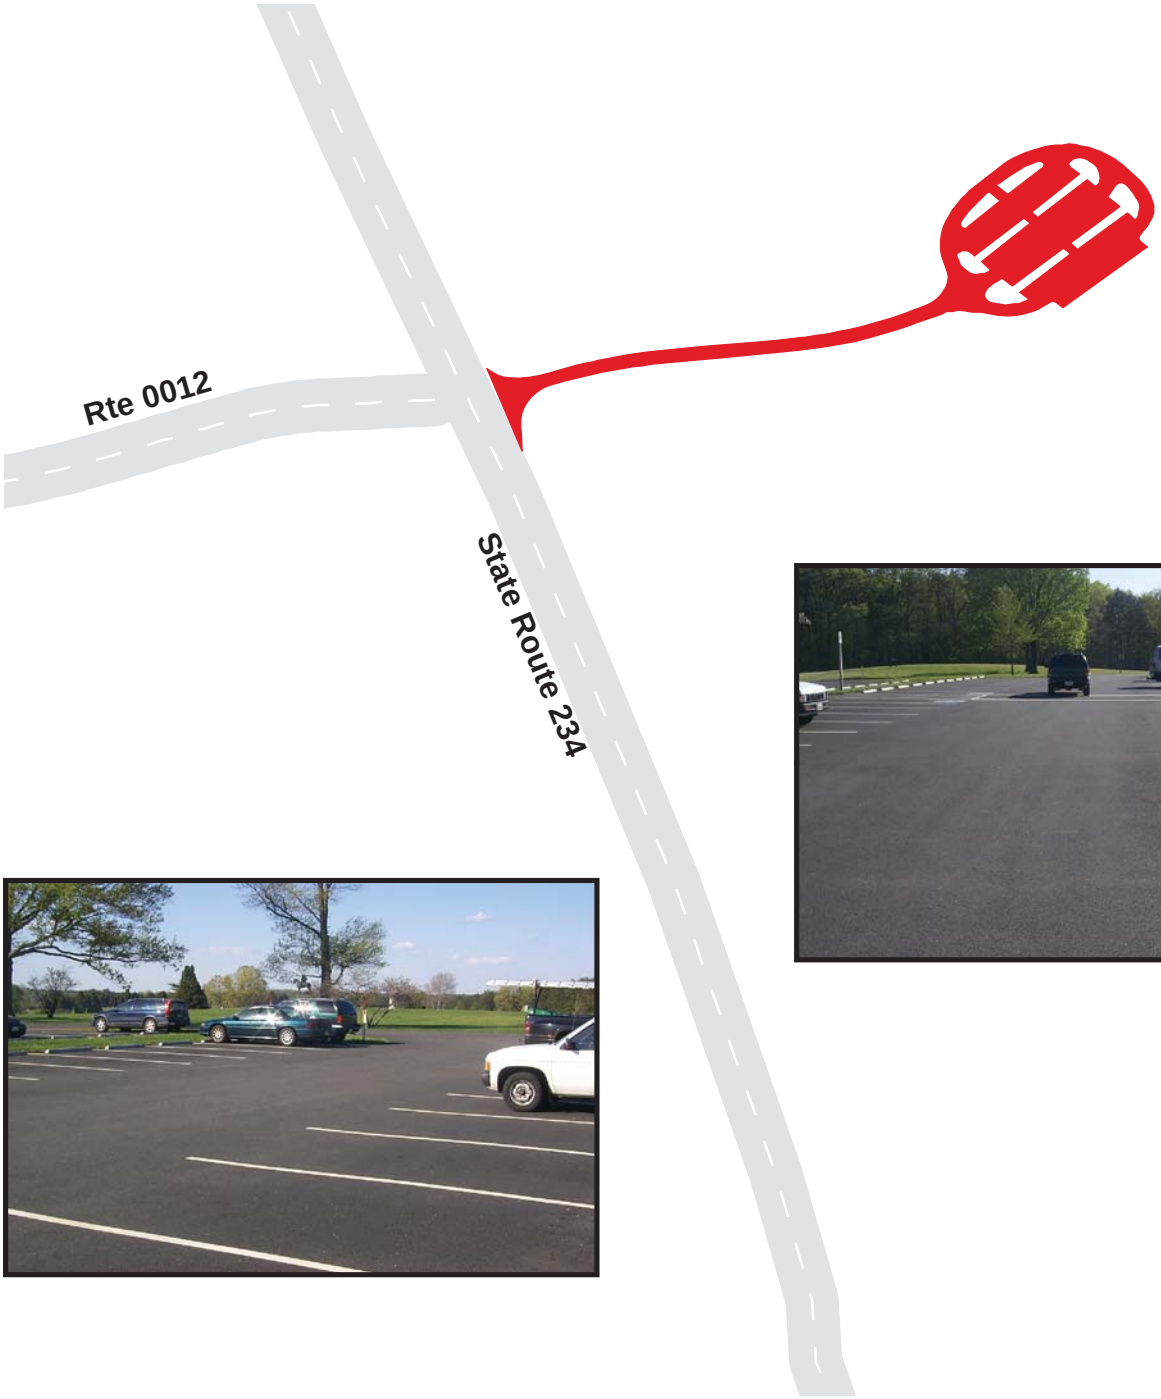
Route	Public / NonPublic	Date Visited	Area (sq ft)	Lane Miles *	Surface Type	Condition / PCR
0902	Public	4/25/2002	64439	1.11	AS	GOOD / 90

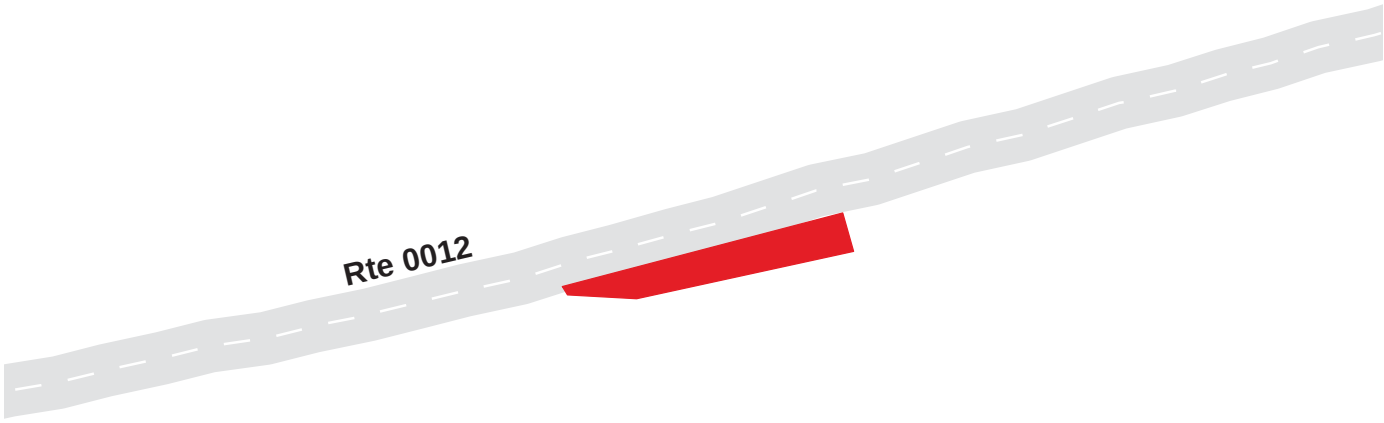
Route	Public / NonPublic	Date Visited	Area (sq ft)	Lane Miles *	Surface Type	Condition / PCR
0903	Public	4/25/2002	869	0.01	AS	EXCELLENT / 97

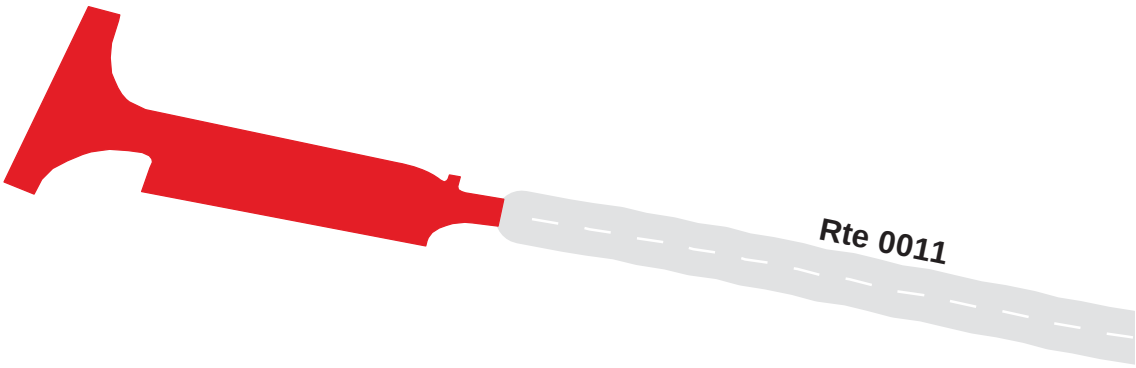
Manassas National Battlefield Park
Route 0904
SOUTH CHINN RIDGE PARKING
From Route 0011

Route	Public / NonPublic	Date Visited	Area (sq ft)	Lane Miles *	Surface Type	Condition / PCR
0904	Public	4/25/2002	14093	0.24	AS	EXCELLENT / 97

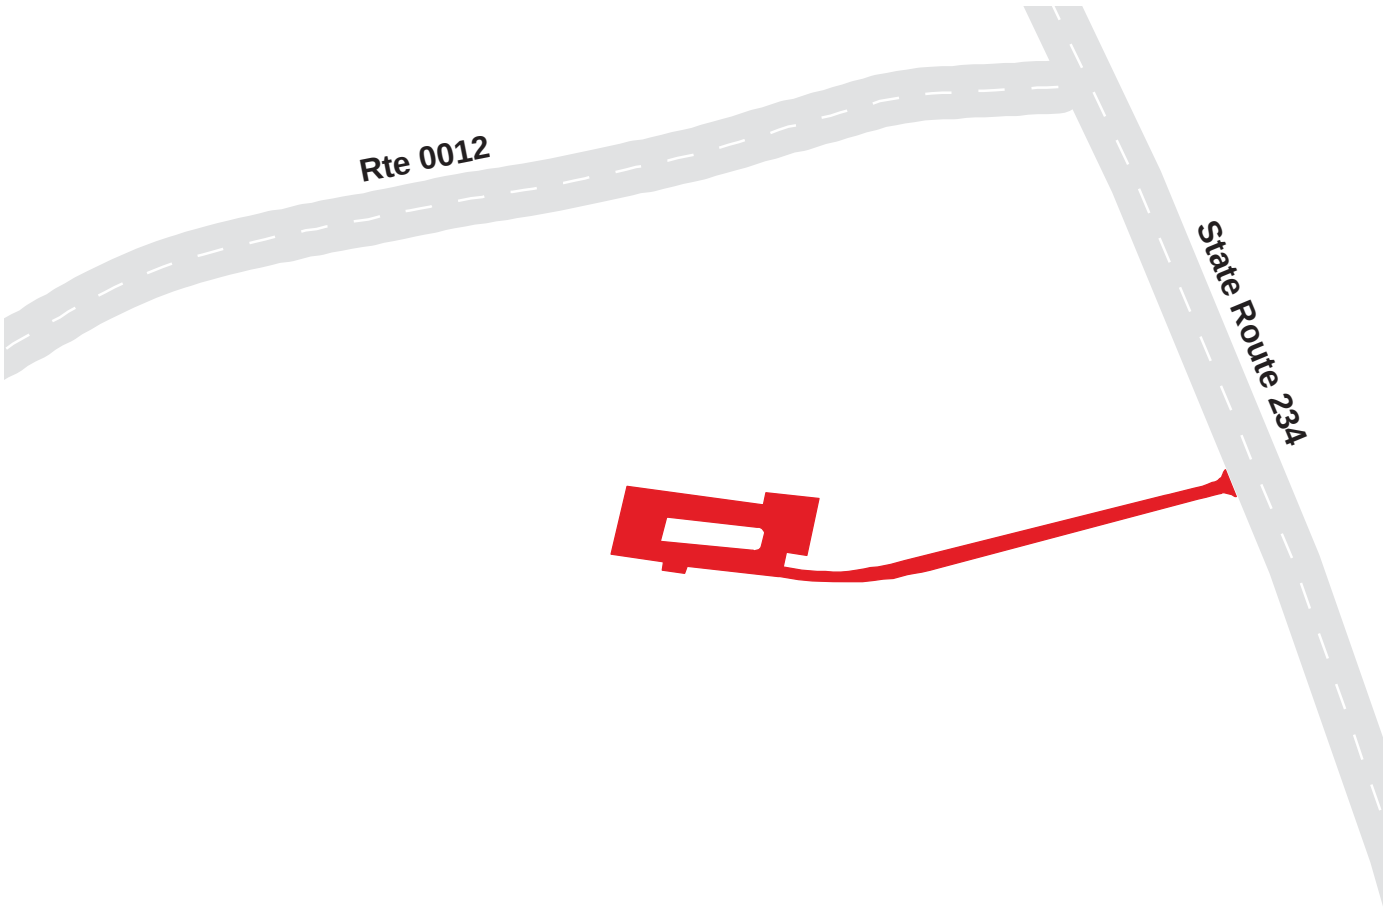
Manassas National Battlefield Park
Route 0905
MAINTENANCE AREA
From State Route 234

Route	Public / NonPublic	Date Visited	Area (sq ft)	Lane Miles *	Surface Type	Condition / PCR
0905	NonPublic	4/26/2002	40867	0.70	AS	EXCELLENT / 97

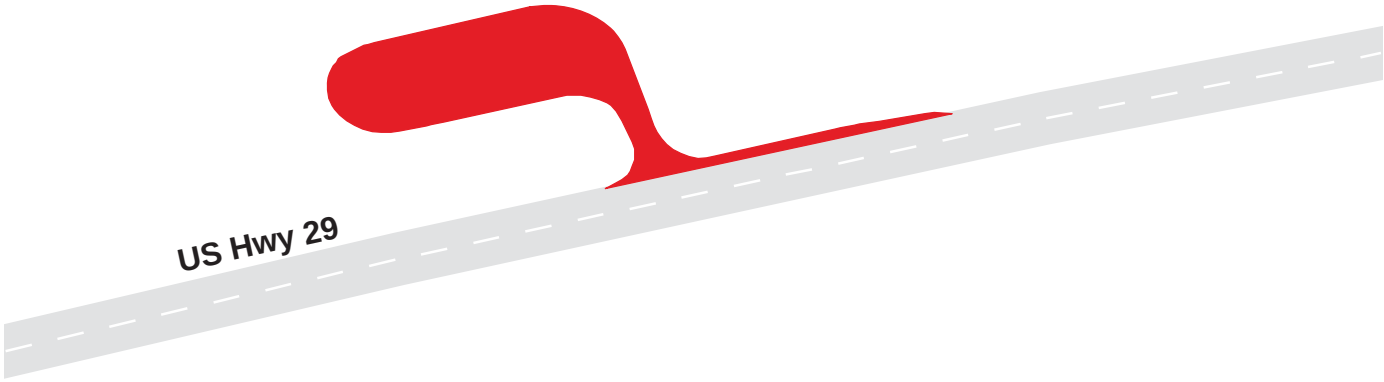
Route	Public / NonPublic	Date Visited	Area (sq ft)	Lane Miles *	Surface Type	Condition / PCR
0907	Public	4/25/2002	40681	0.70	AS	EXCELLENT / 97

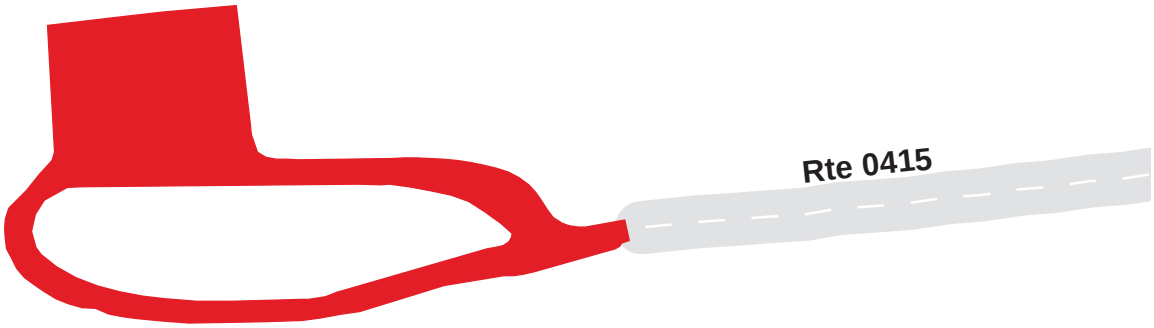
Route	Public / NonPublic	Date Visited	Area (sq ft)	Lane Miles *	Surface Type	Condition / PCR
0908	Public	4/25/2002	12480	0.21	AS	EXCELLENT / 97

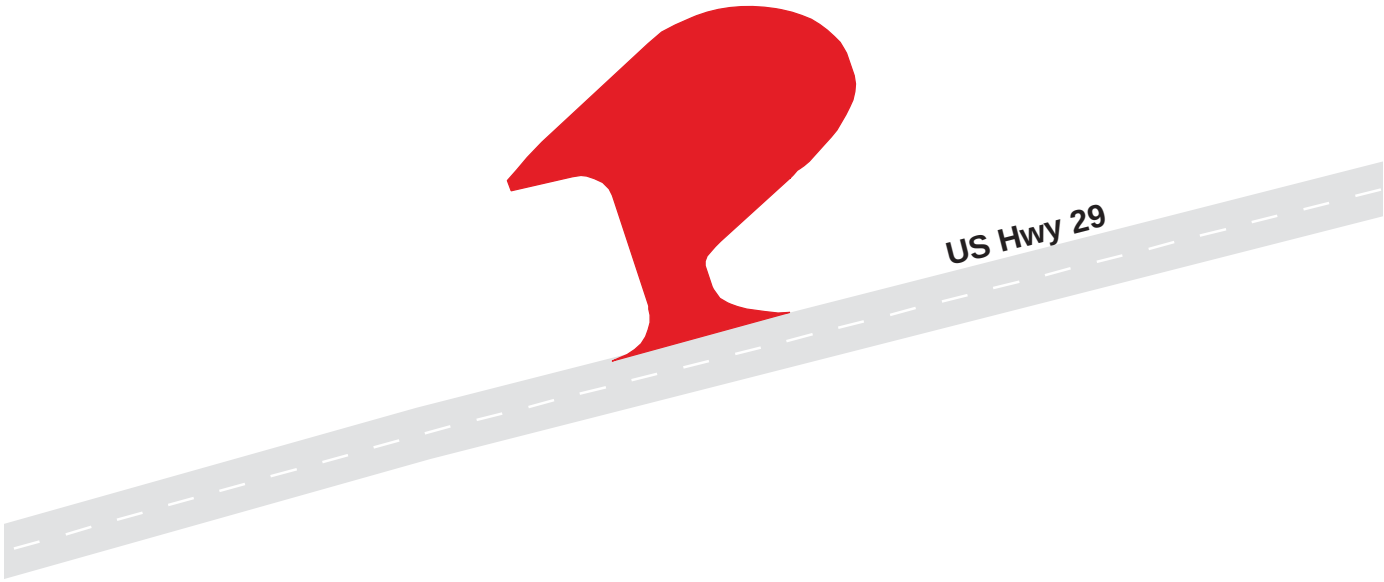
Route	Public / NonPublic	Date Visited	Area (sq ft)	Lane Miles *	Surface Type	Condition / PCR
0909	Public	4/25/2002	16605	0.29	AS	EXCELLENT / 97

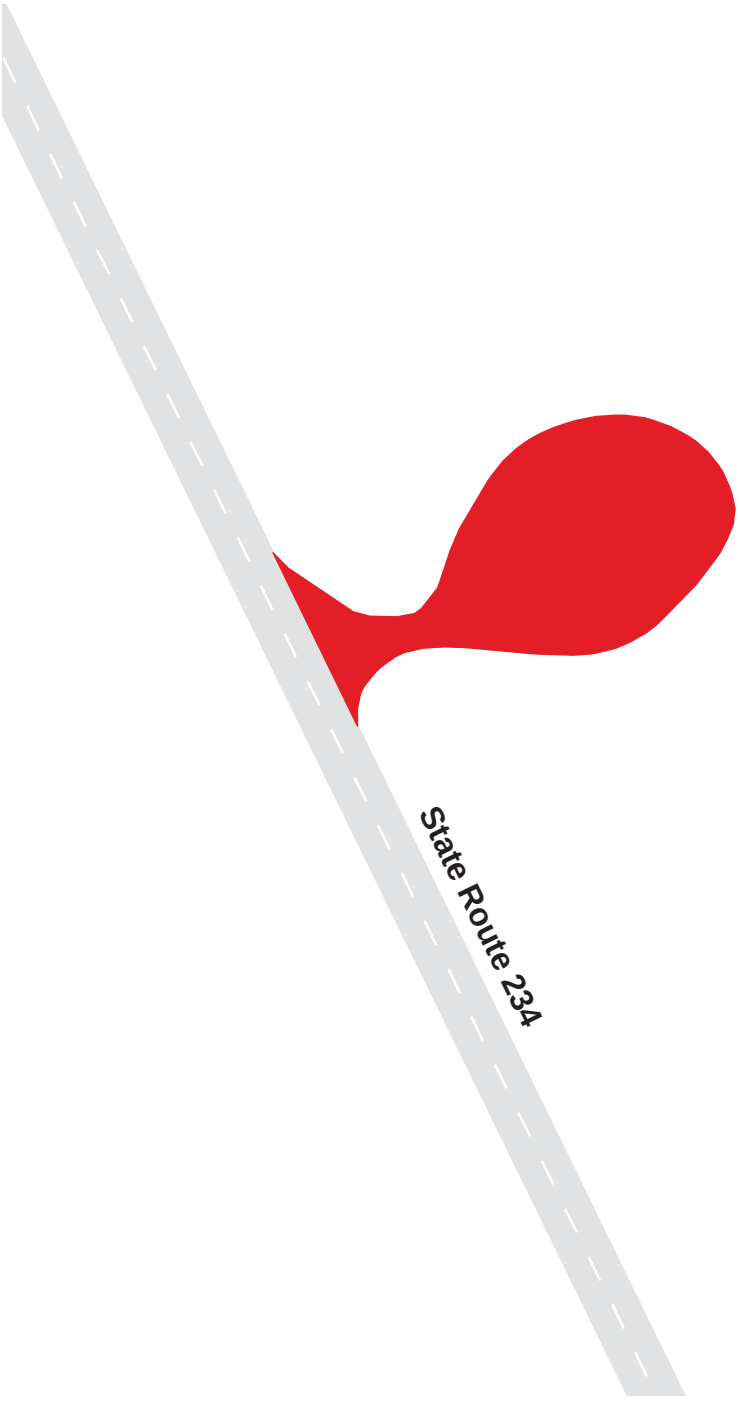
Route	Public / NonPublic	Date Visited	Area (sq ft)	Lane Miles *	Surface Type	Condition / PCR
0910	Public	4/25/2002	16453	0.28	AS	EXCELLENT / 97

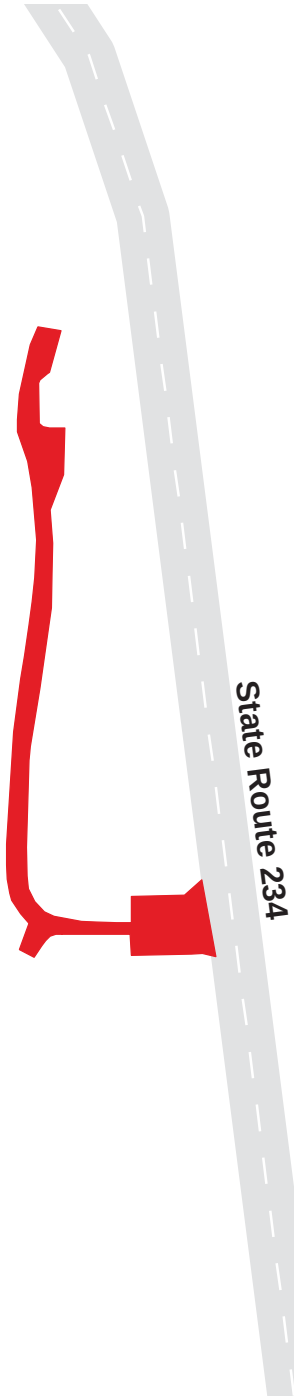
Route	Public / NonPublic	Date Visited	Area (sq ft)	Lane Miles *	Surface Type	Condition / PCR
0911	Public	4/25/2002	6100	0.11	OC	POOR / 45

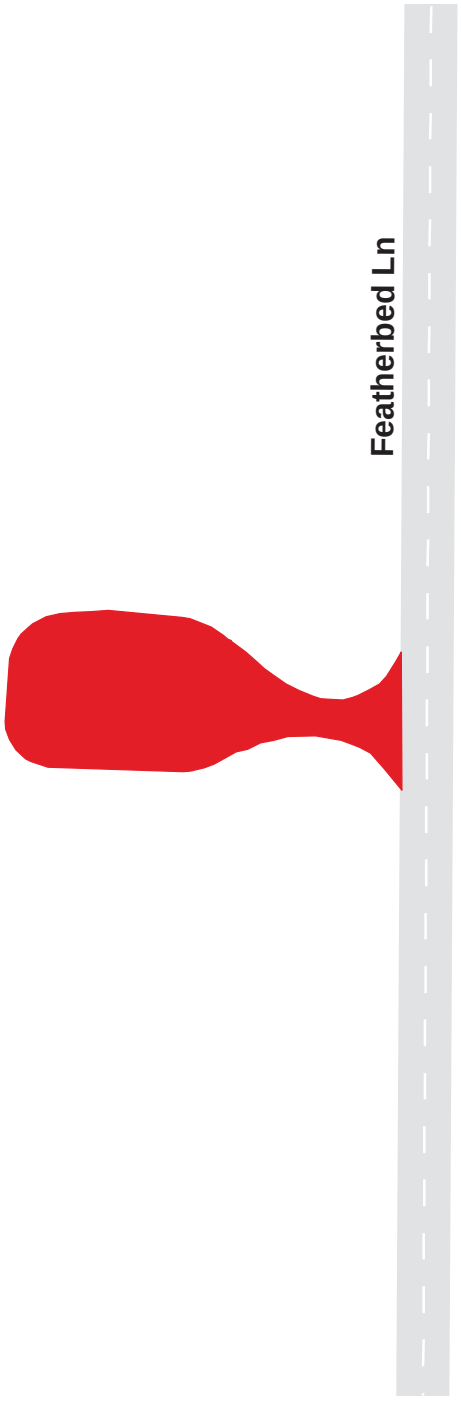
Route	Public / NonPublic	Date Visited	Area (sq ft)	Lane Miles *	Surface Type	Condition / PCR
0913	Public	4/26/2002	17656	0.30	AS	EXCELLENT / 97

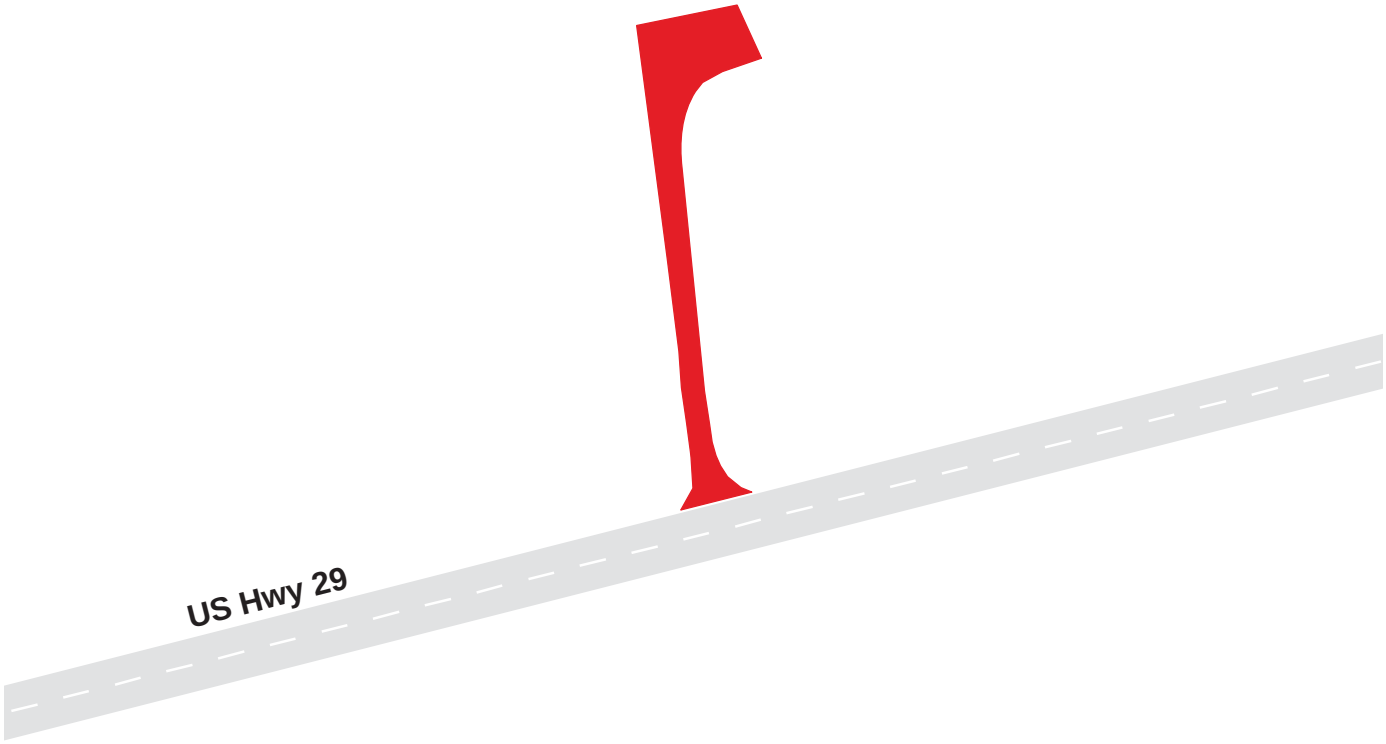
Manassas National Battlefield Park
Route 0914
BATTERY HEIGHTS PARKING
From US Highway 29

Route	Public / NonPublic	Date Visited	Area (sq ft)	Lane Miles *	Surface Type	Condition / PCR
0914	Public	4/26/2002	5131	0.09	AS	FAIR / 73

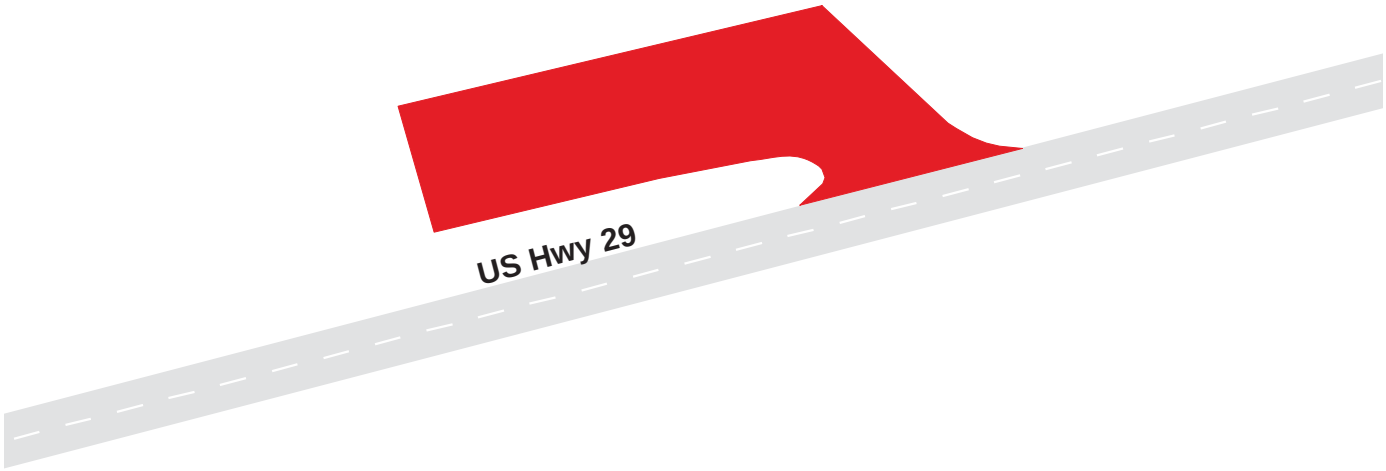
Route	Public / NonPublic	Date Visited	Area (sq ft)	Lane Miles *	Surface Type	Condition / PCR
0919	Public	4/26/2002	13760	0.24	AS	EXCELLENT / 97

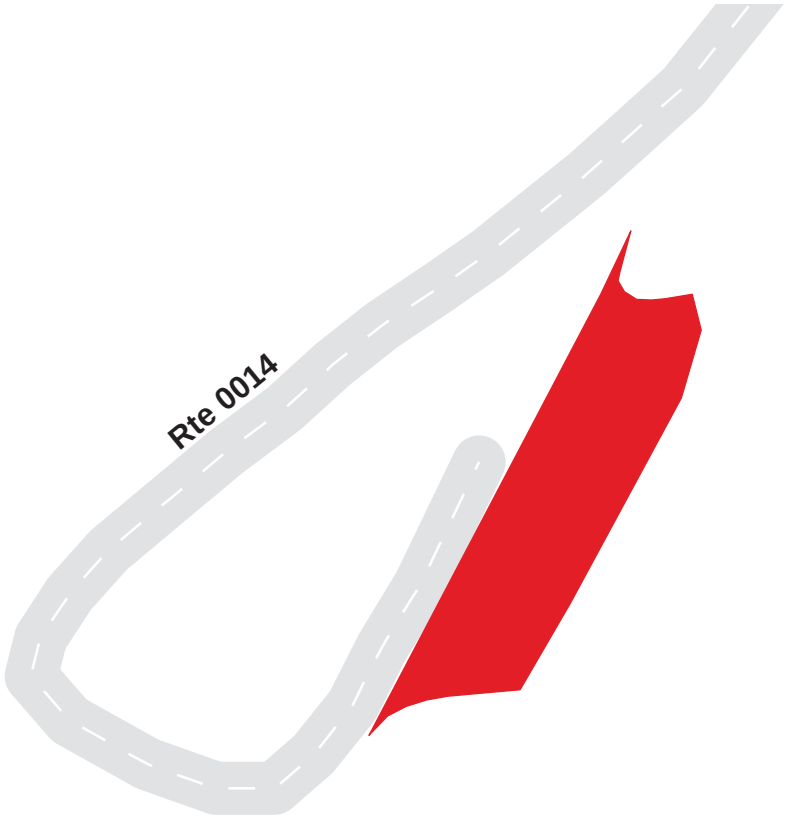
Route	Public / NonPublic	Date Visited	Area (sq ft)	Lane Miles *	Surface Type	Condition / PCR
0920	Public	4/26/2002	3350	0.06	AS	GOOD / 90

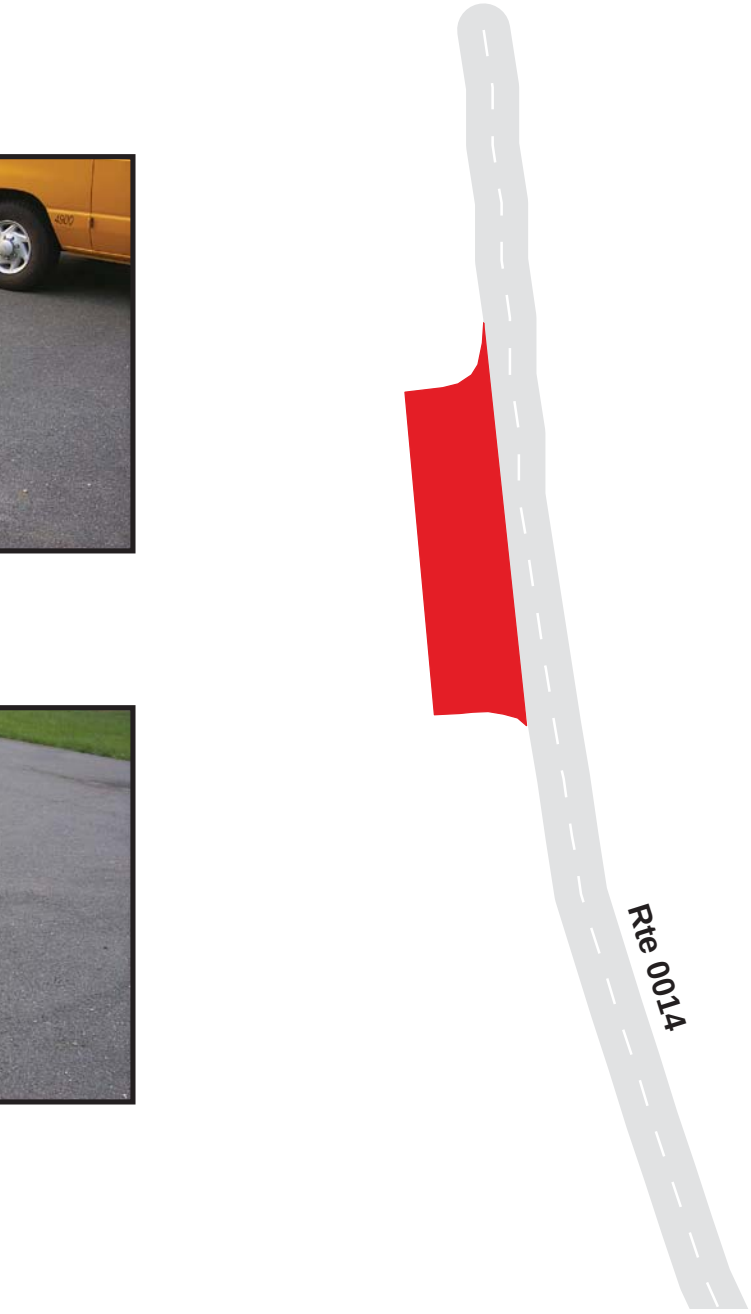
Route	Public / NonPublic	Date Visited	Area (sq ft)	Lane Miles *	Surface Type	Condition / PCR
0921	Public	4/26/2002	2264	0.04	AS	GOOD / 90

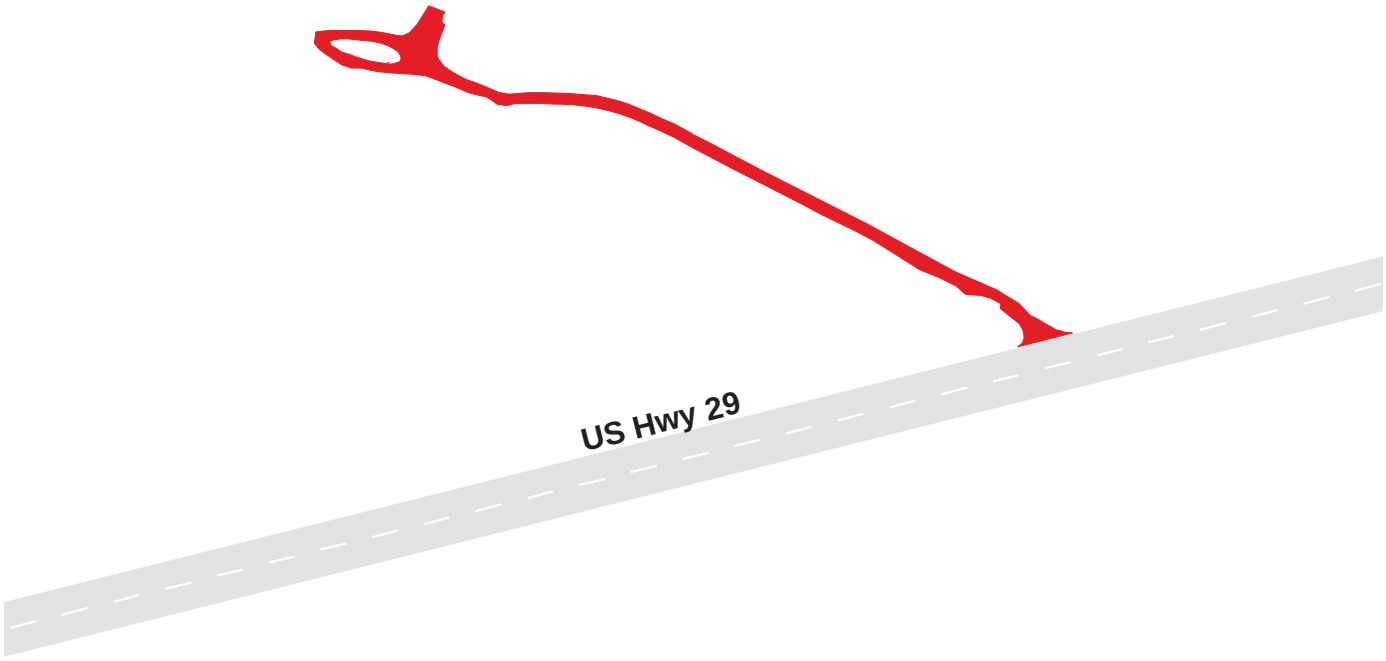
Manassas National Battlefield Park
Route 0922
RESOURCE MANAGEMENT PARKING
From US Highway 29

Route	Public / NonPublic	Date Visited	Area (sq ft)	Lane Miles *	Surface Type	Condition / PCR
0922	NonPublic	4/27/2002	11556	0.20	AS	EXCELLENT / 97
